Situation Photo Log

Monday, July 2, 2012

Kalamazoo River / Enbridge Spill

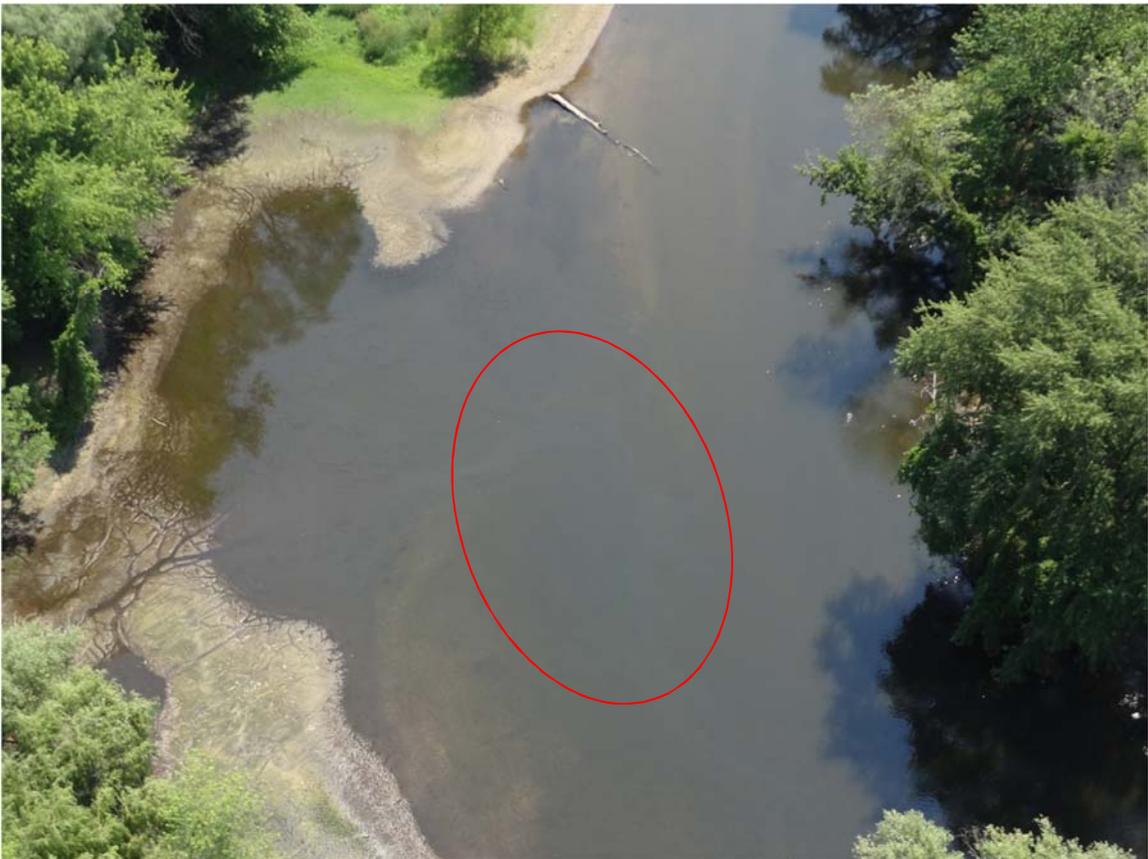
24. MP26.25 LDB sheen observed.

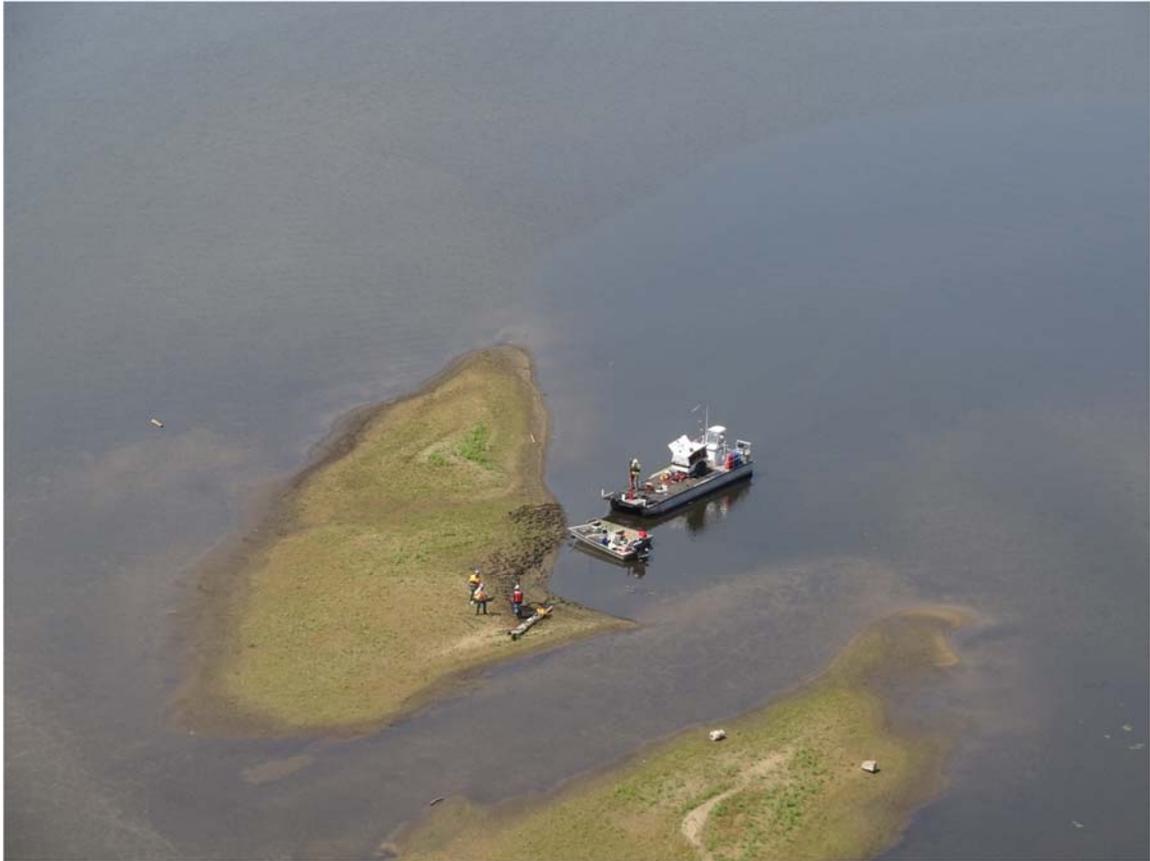
25. Morrow Lake Delta observed crews installing anchors for the E4 Boom System.

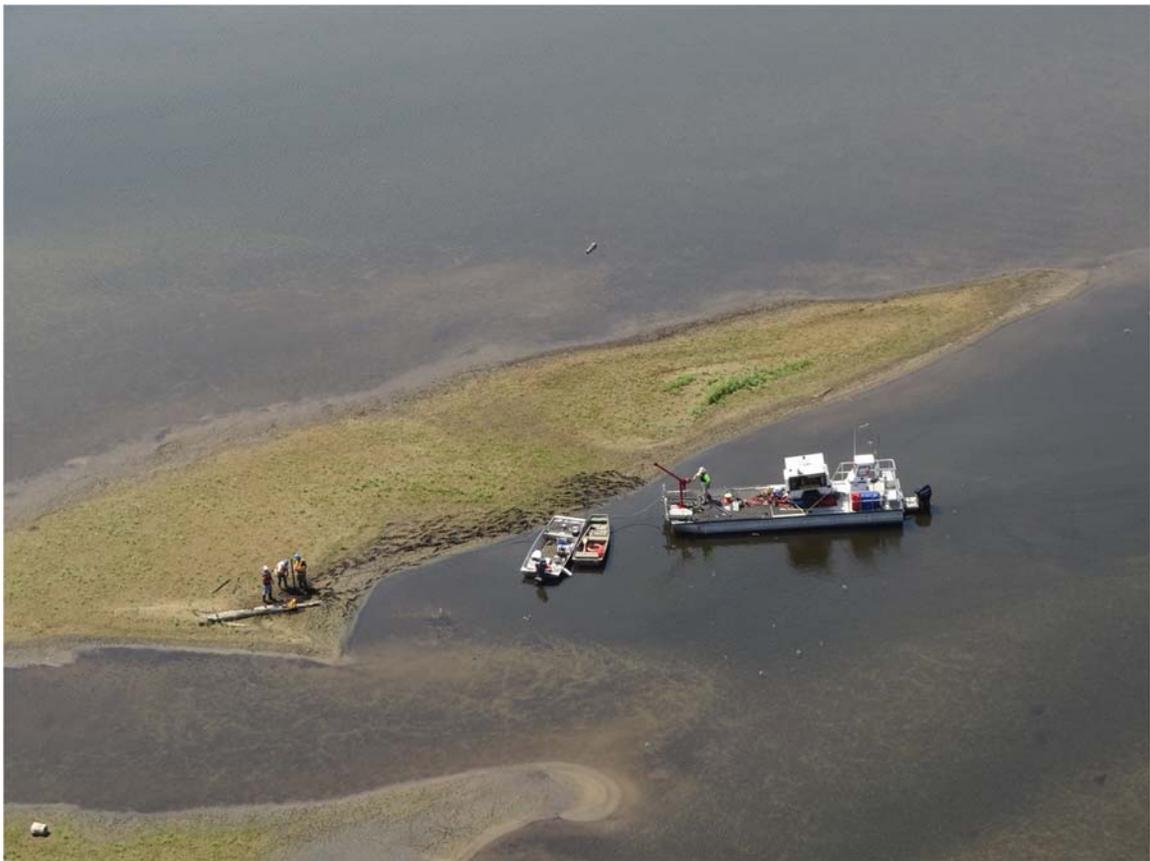
26. Morrow Lake Delta observed crews installing anchors for the E4 Boom System.

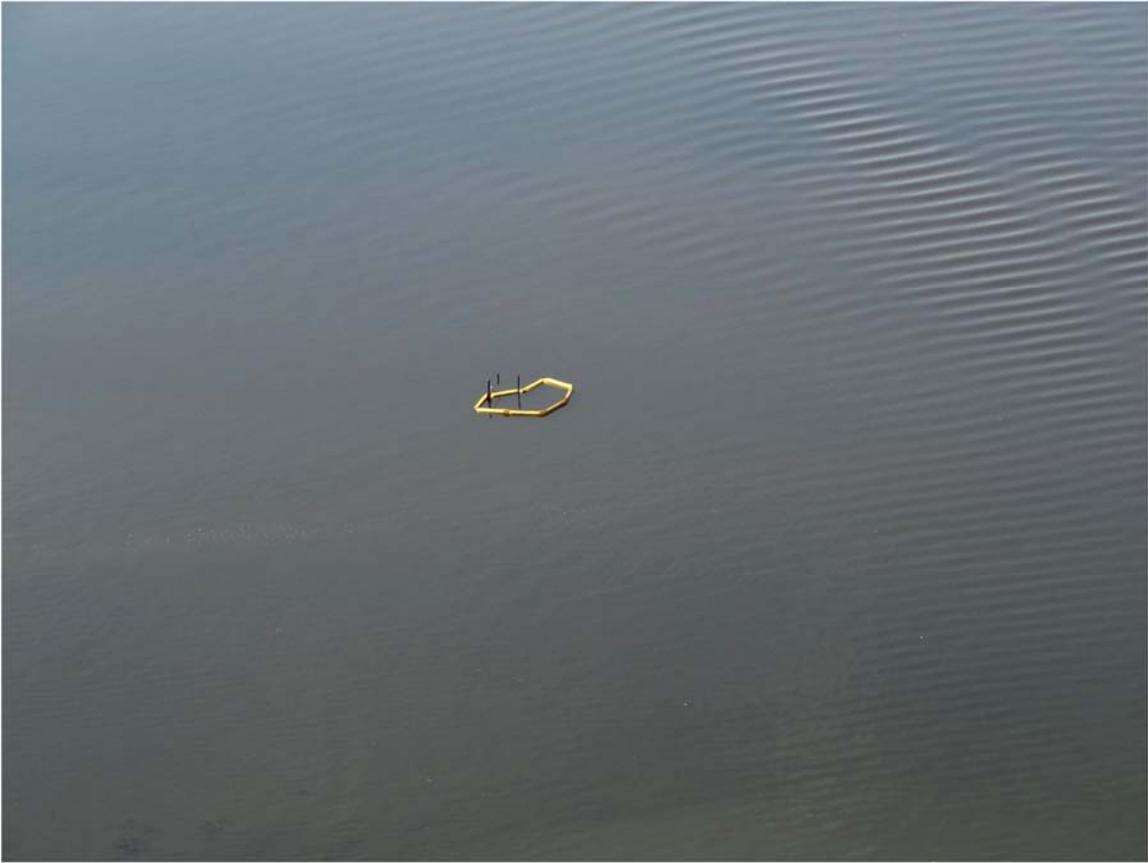
27. Morrow Lake Delta observed anchors for the E4 Boom System.

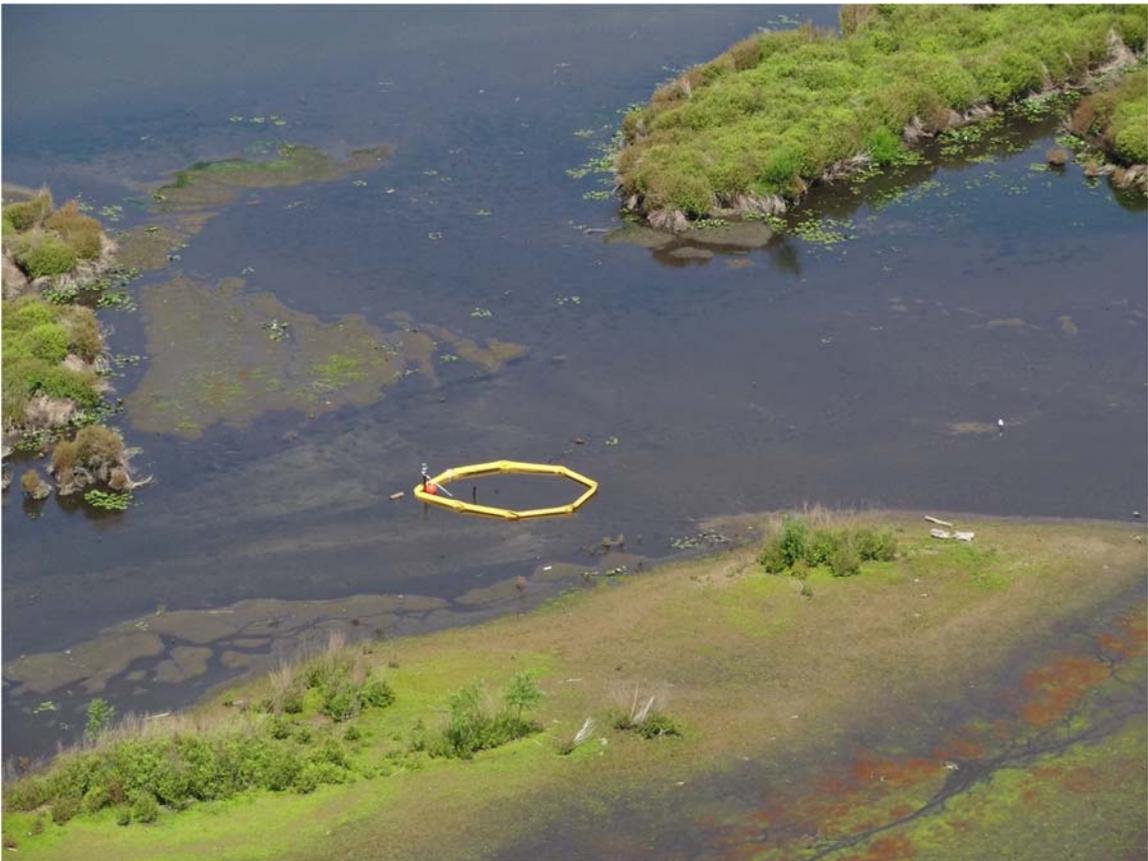
28. Morrow Lake Delta observed anchors for the E4 Boom System.

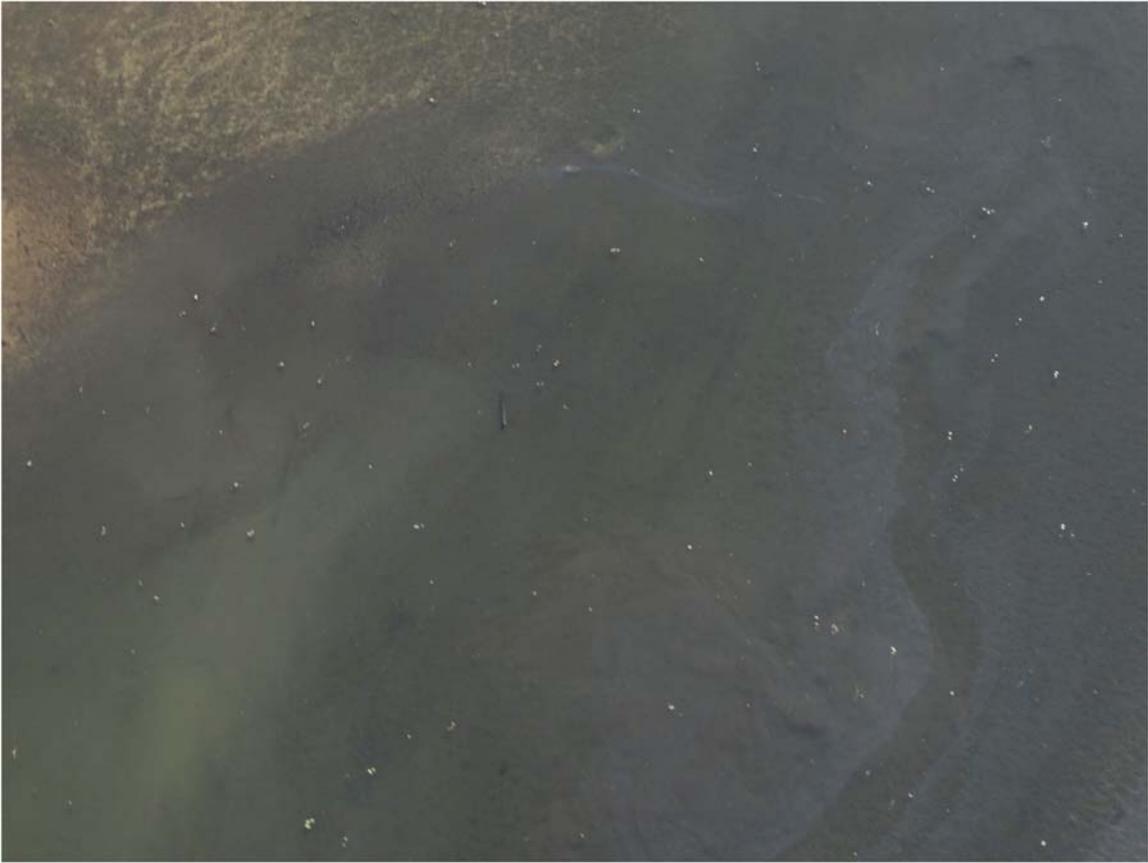
29. Morrow Lake Delta boats agitated sediment and sheen observed.

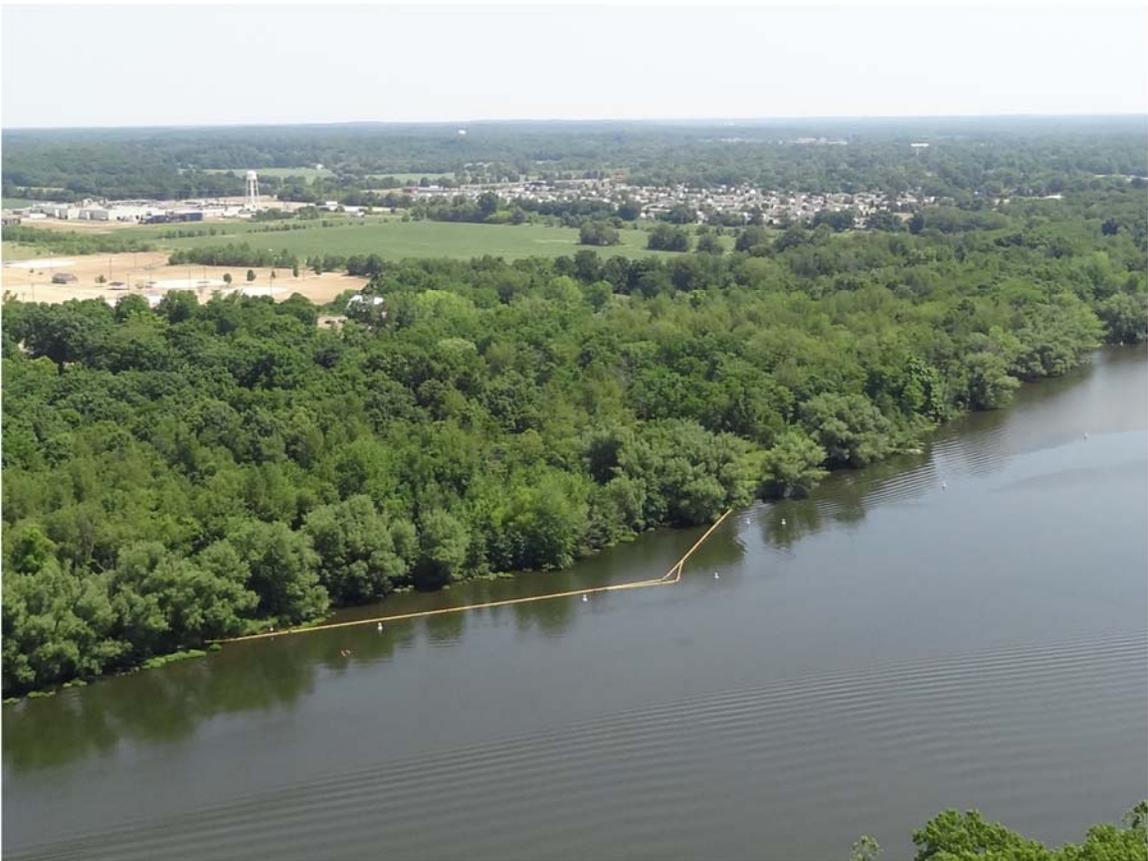
30. Morrow Lake Delta boom installed as part of the E4 Boom System.

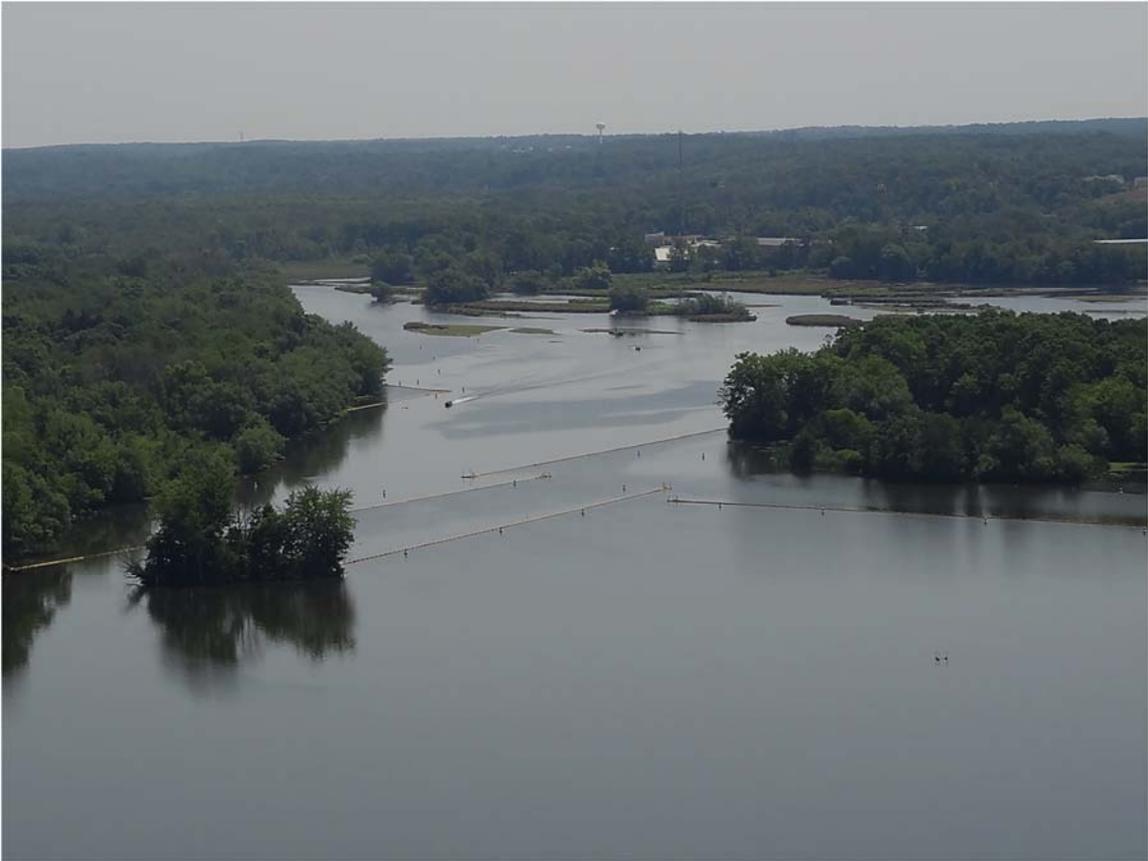
31. Morrow Lake Delta E4 Boom System.

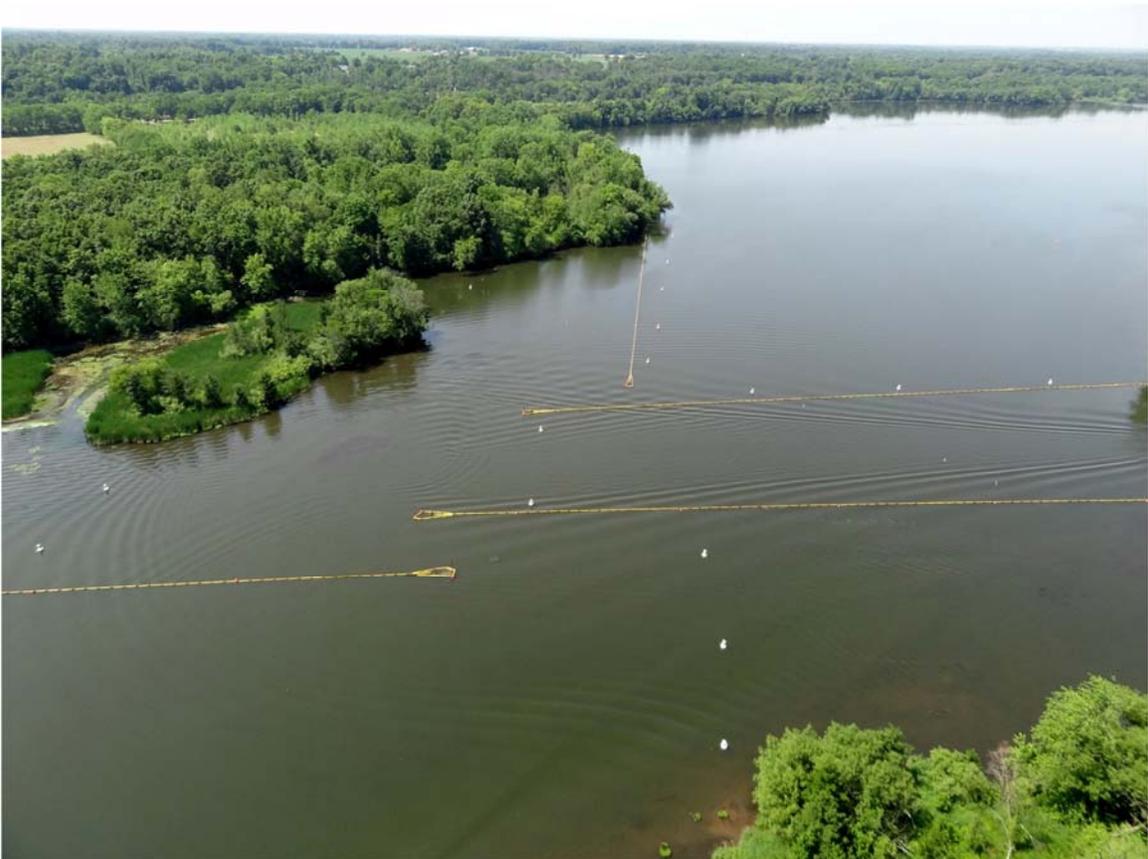
32. Morrow Lake Delta E4 Boom System.

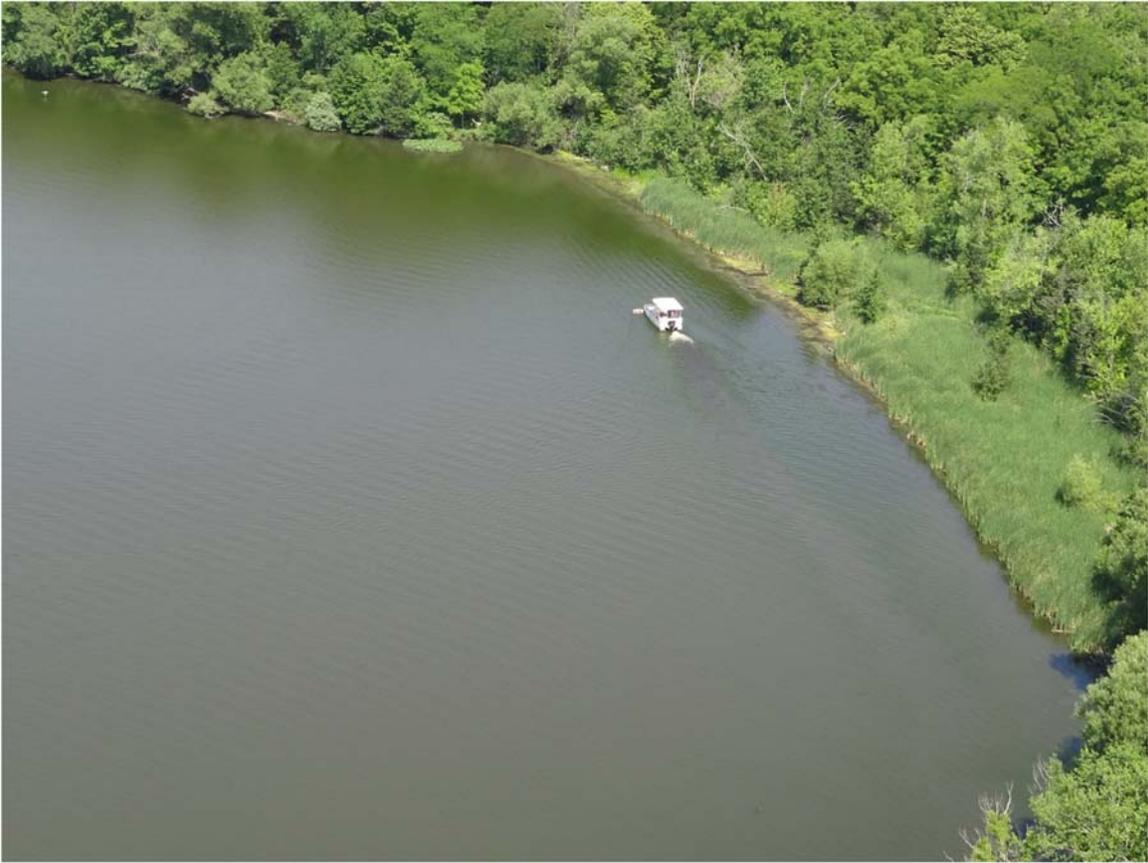
33. Morrow Lake observed sweep boat operating in the north cove.

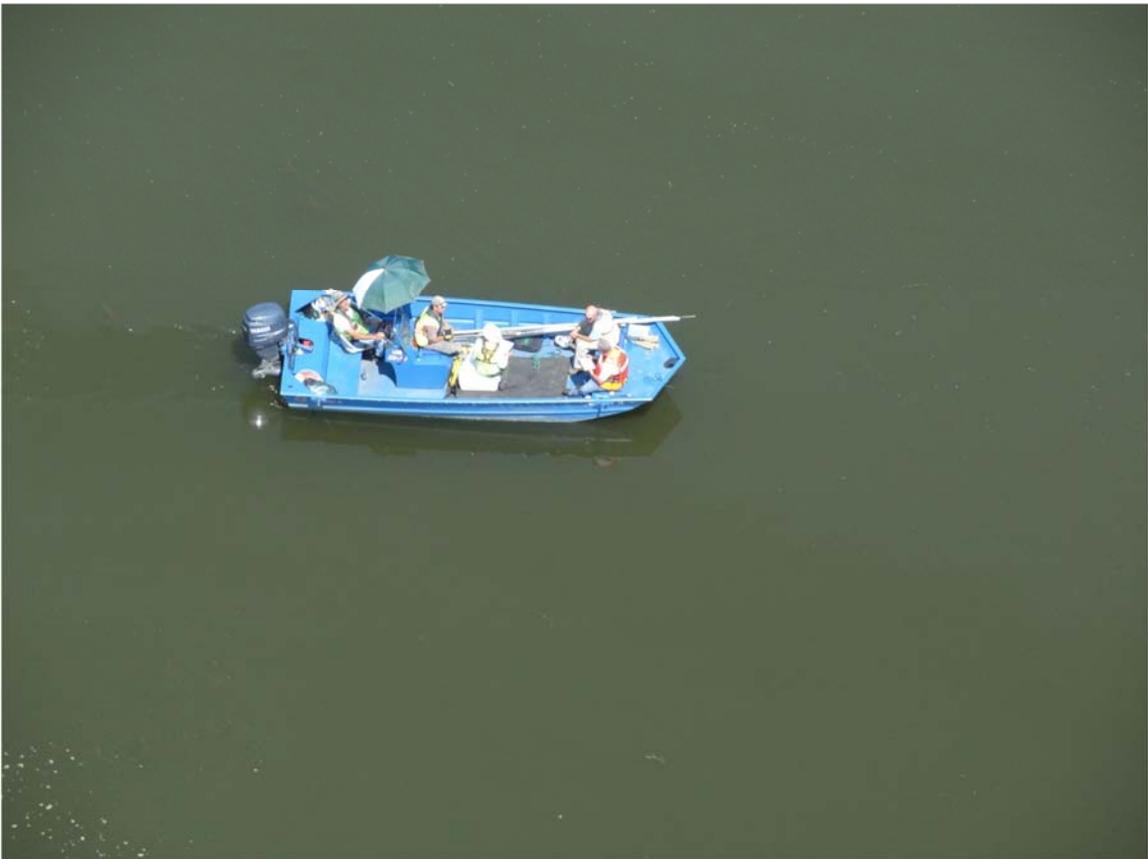
34. Morrow Lake poling crew observed in the southwest corner of the lake.

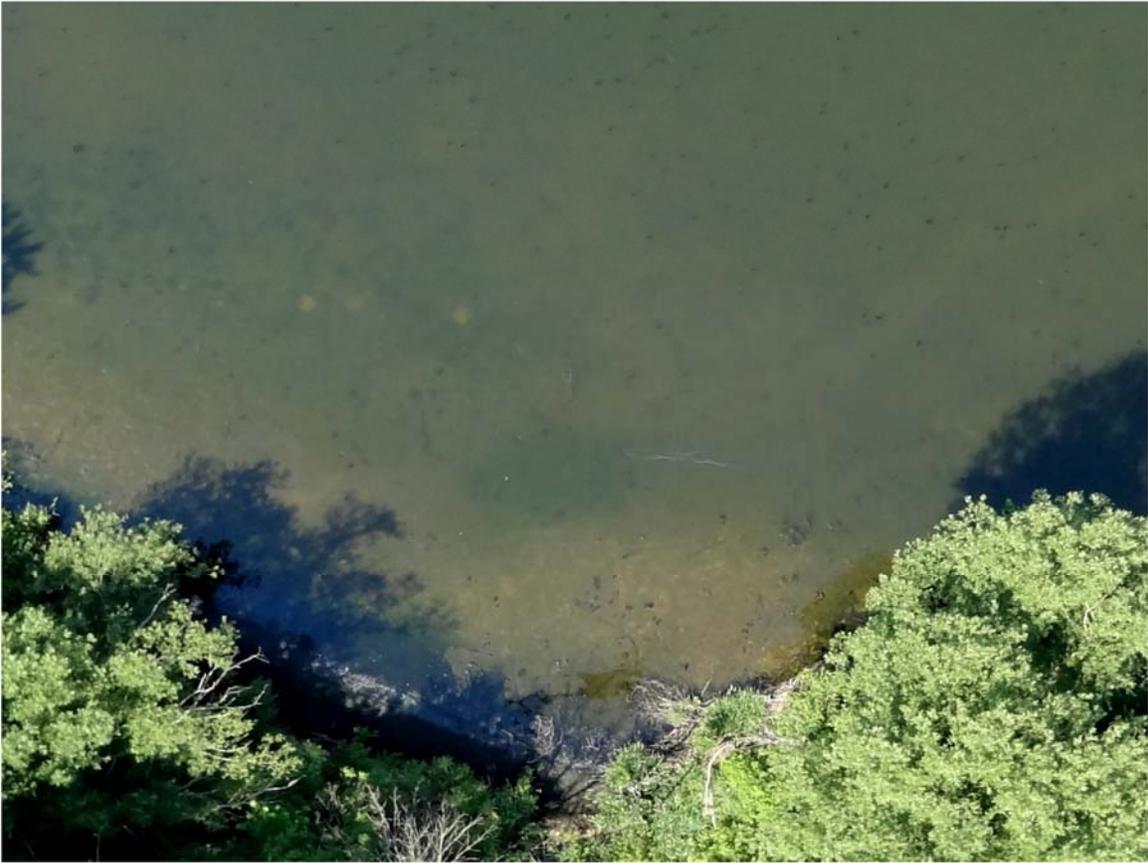
35. Morrow Lake southeast cove sheen observed.

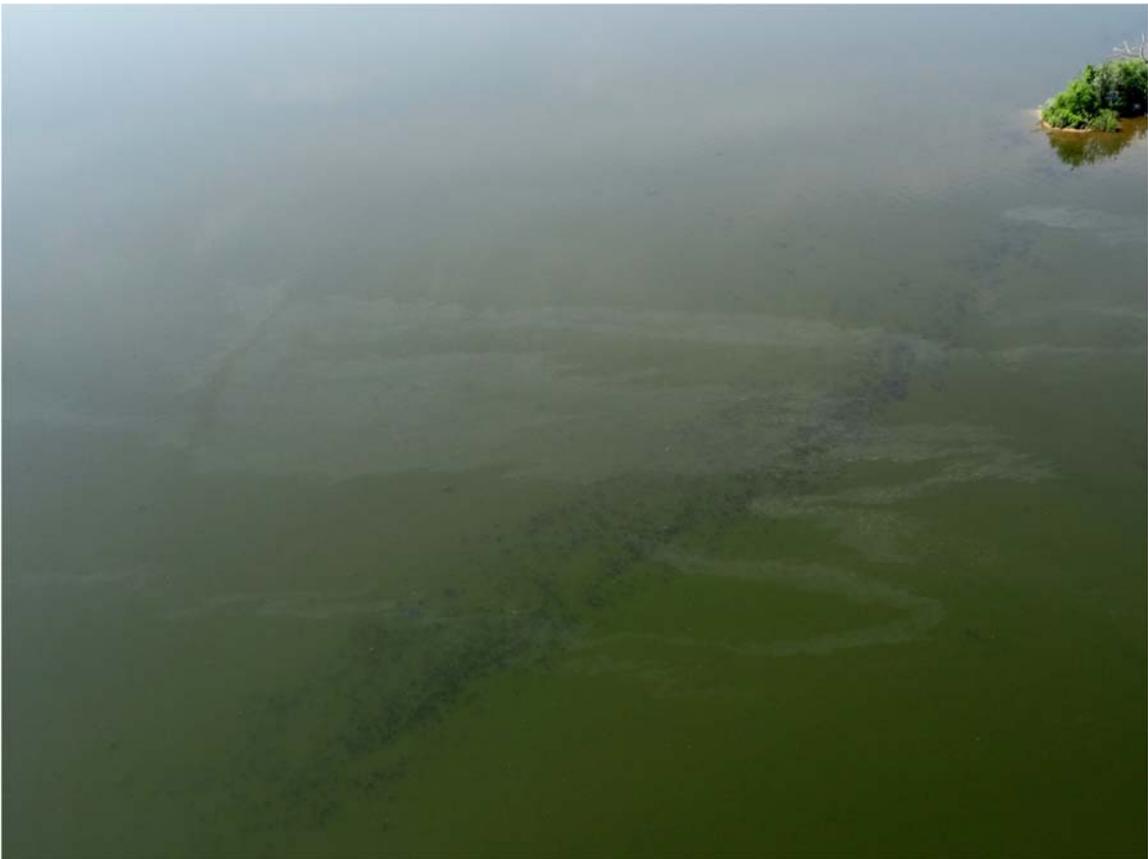
36. Morrow Lake film observed.
