# Situation Photo Log

Thursday, July 5, 2012

Kalamazoo River / Enbridge Spill

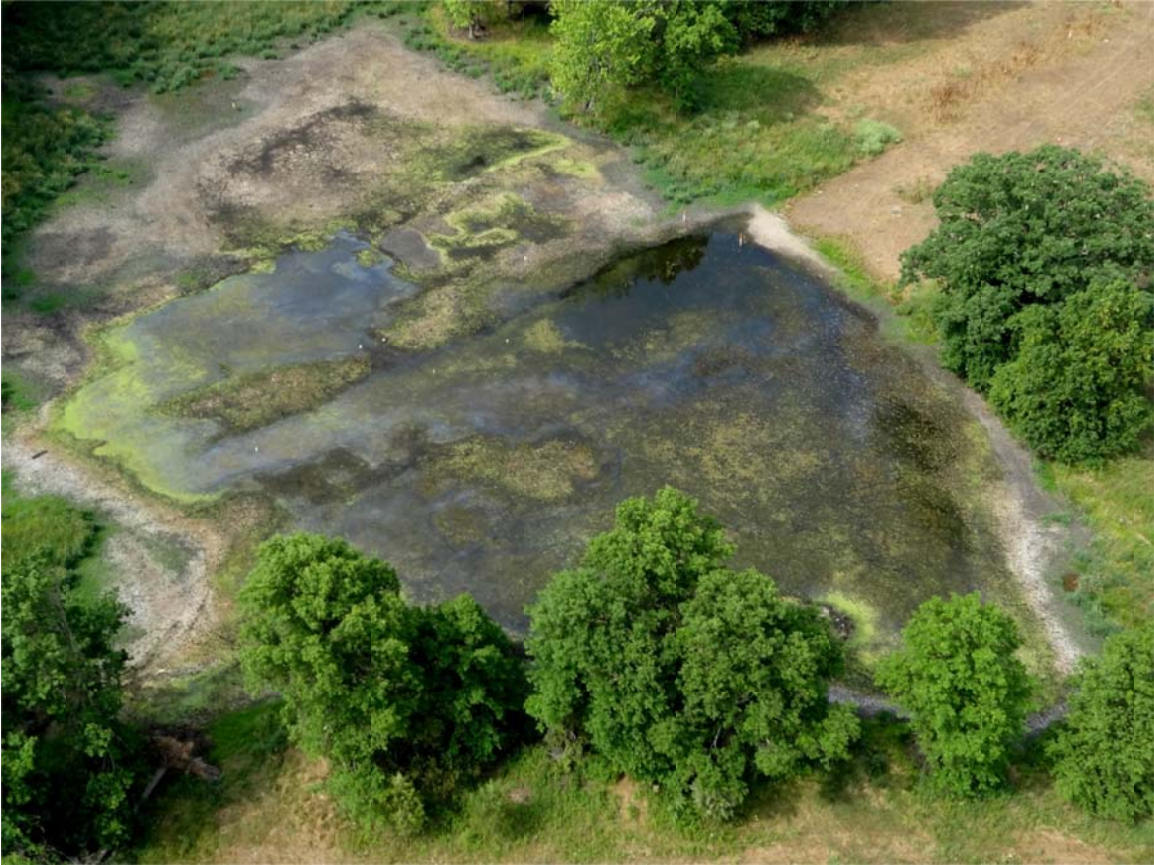
1. Source area pond, sheen observed.

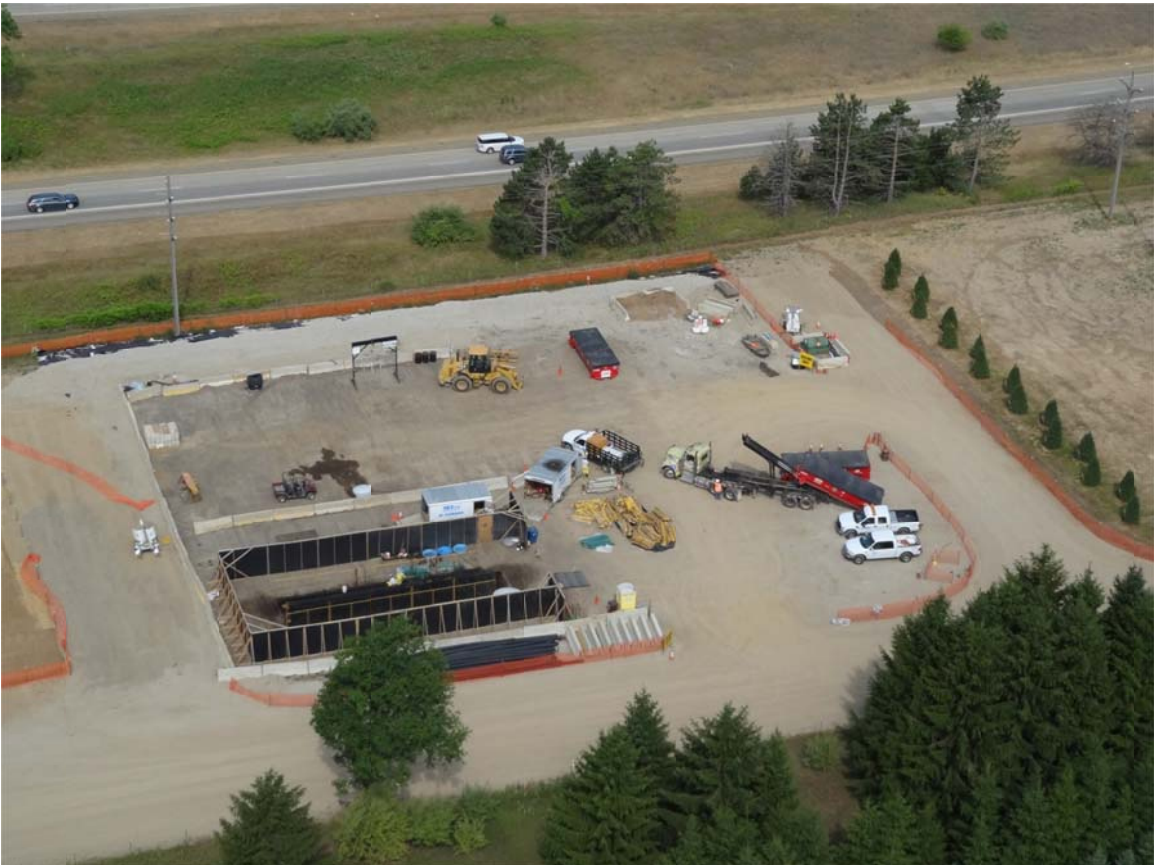
2. Frac-City, observed crews cleaning boom in the decon pad.

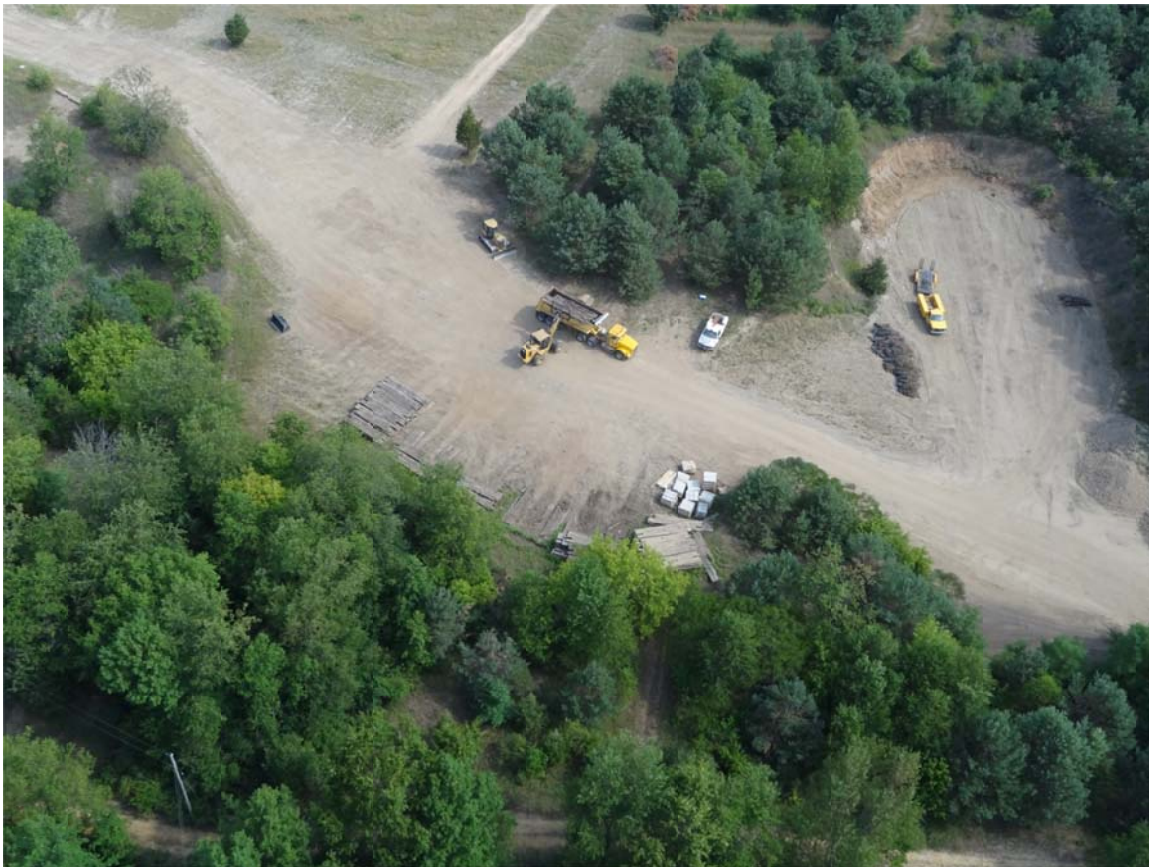
**3. Former Talmadge Creek dewatering pad location. Observed crew loading mats onto a truck at this location.**

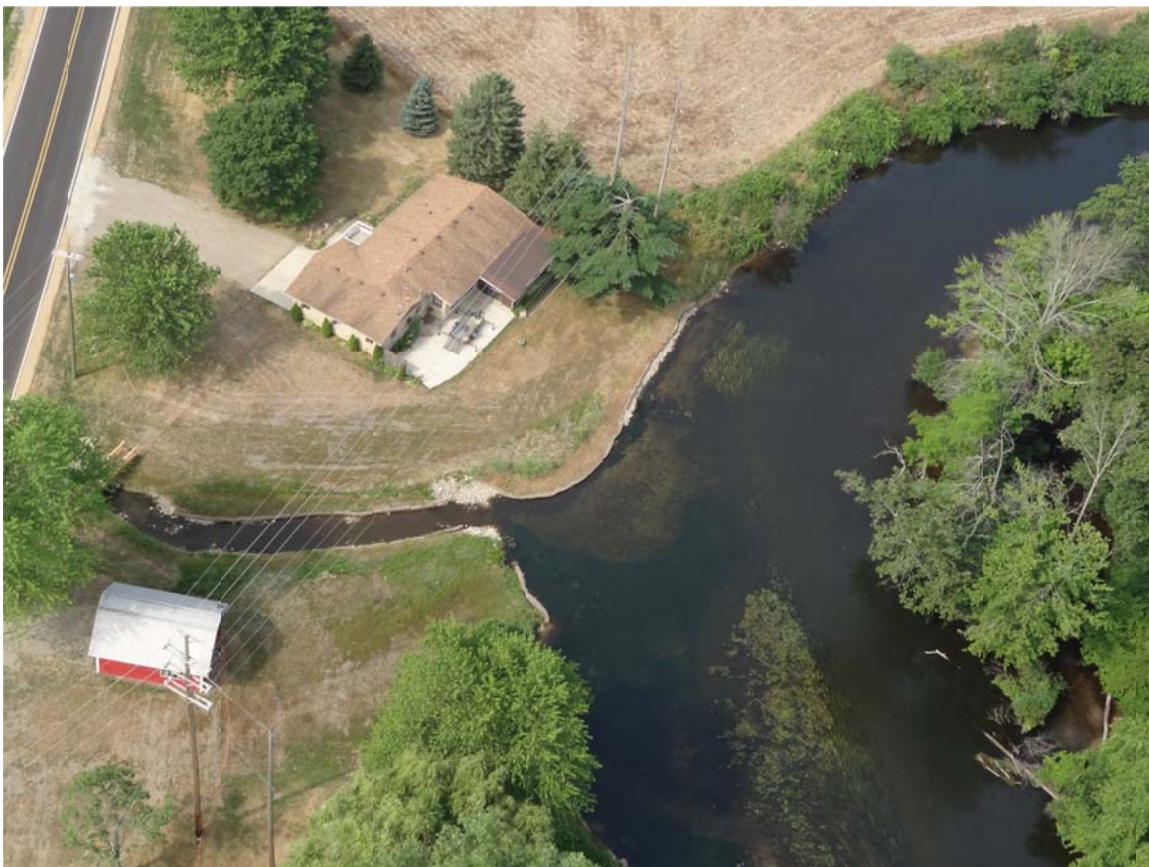
**4. Confluence, no sheen observed.**

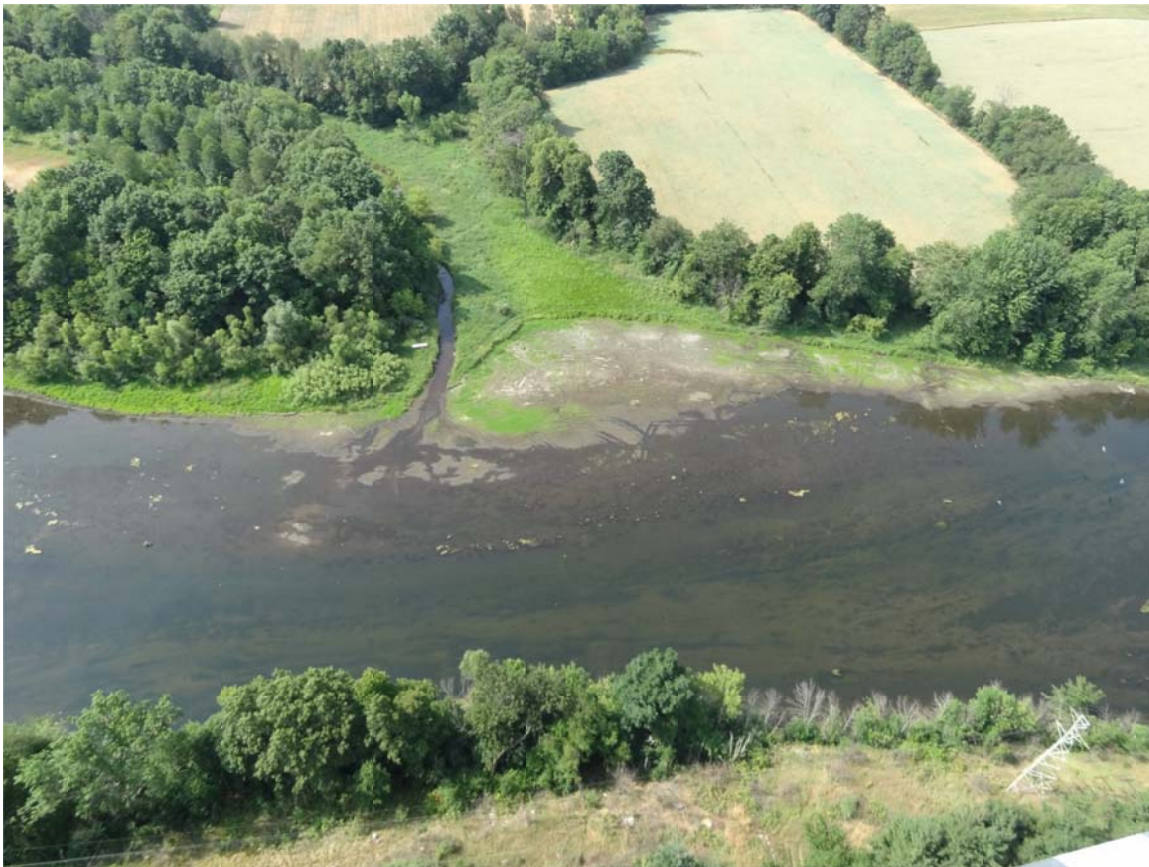
5. Lily Pad area, no sheen observed.

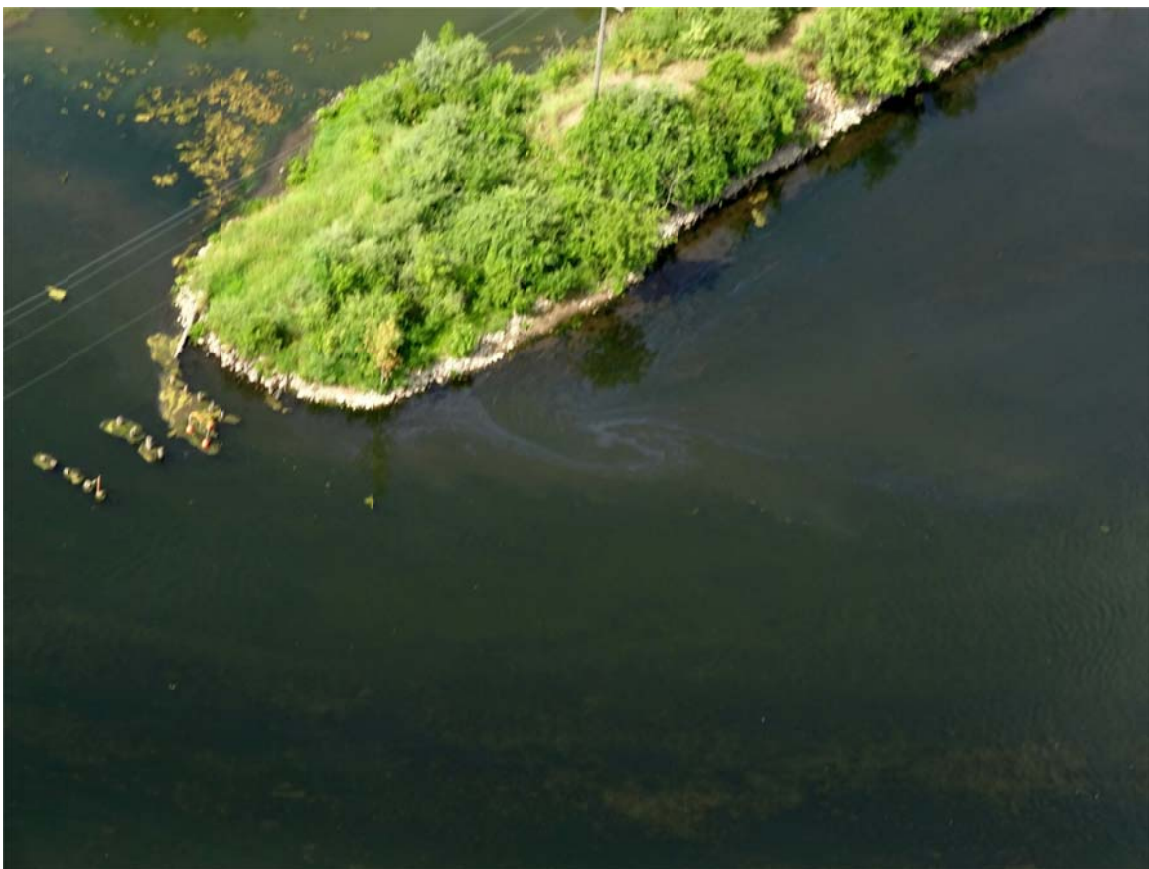
6. South peninsula above Ceresco Dam, observed sheen on downstream side of peninsula. Sheen sweep boat was notified.

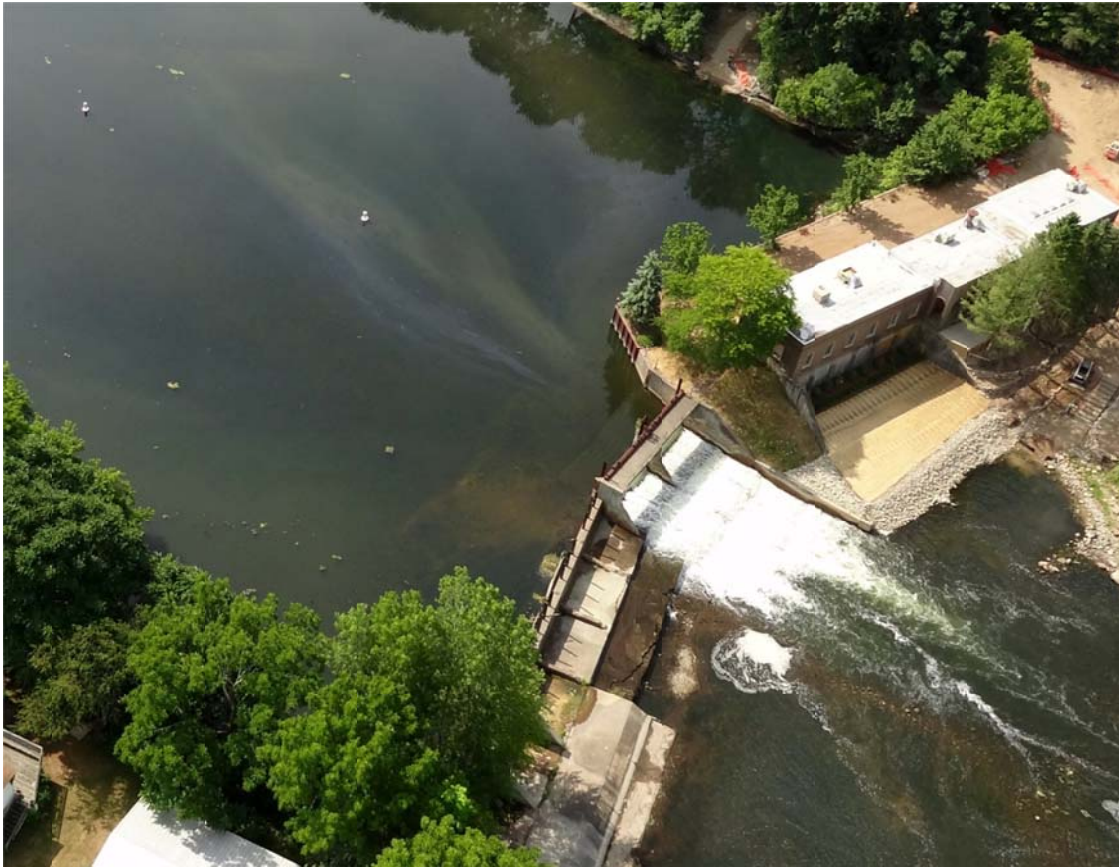
7. Sheen observed above Ceresco Dam. Sweep boat was observed operating in the area.

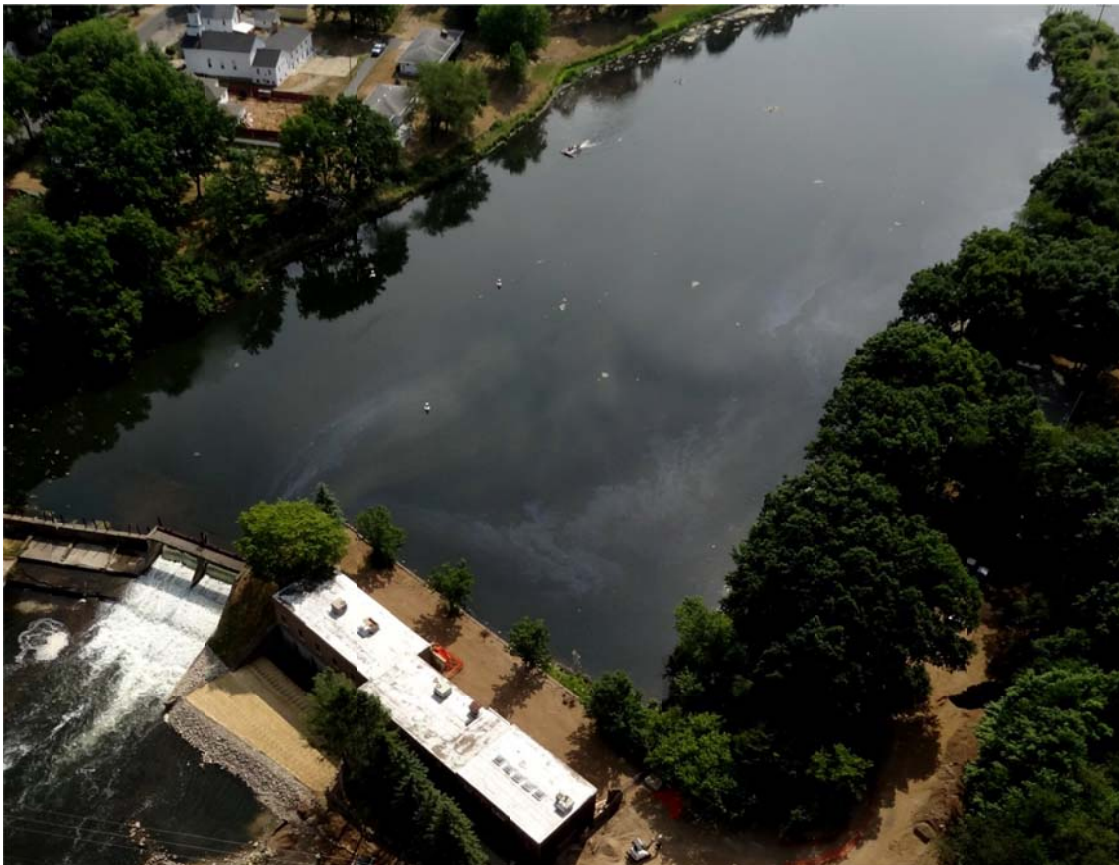
8. Ceresco Dam, sheen observed in southwest corner above dam and in river channel. Sheen sweep boat was notified.

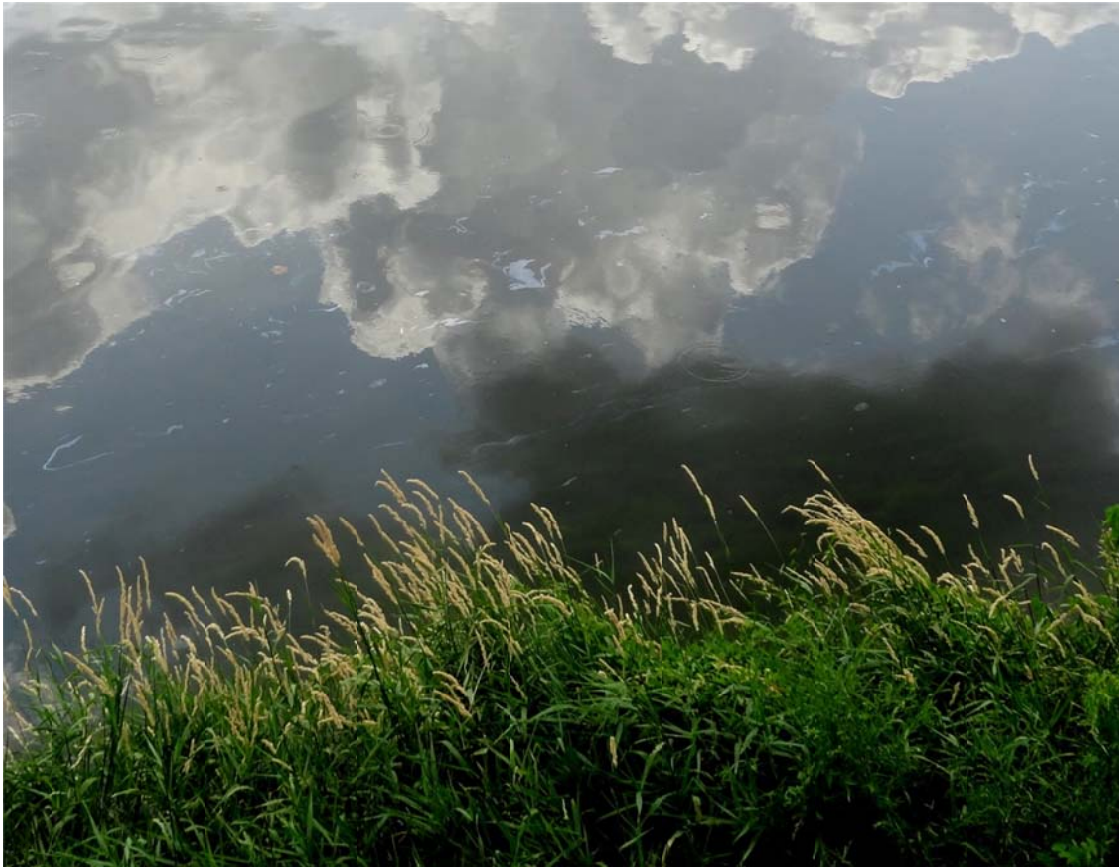
9. Ceresco Dam, sheen and globules observed along the RDB, just upstream from the dam.

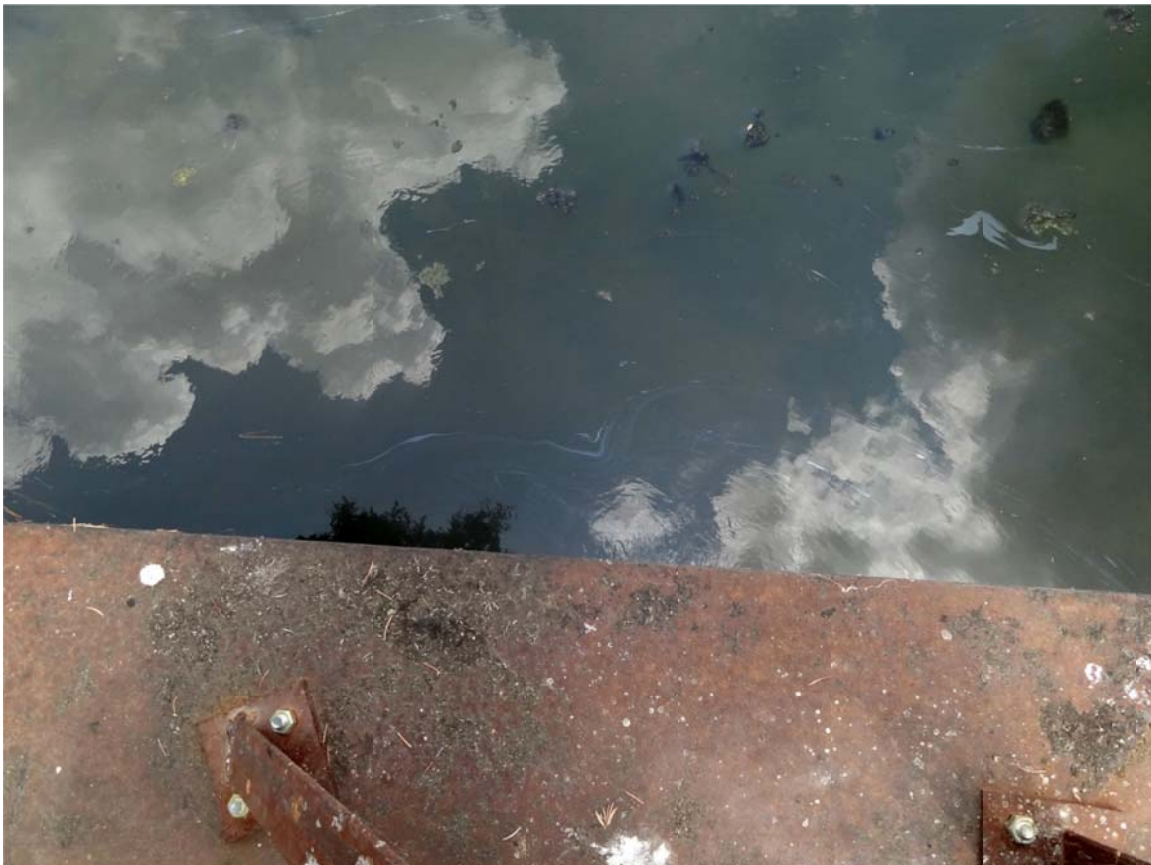
10. Ceresco Dam, sheen observed along the LDB along the southern wall of the dam.

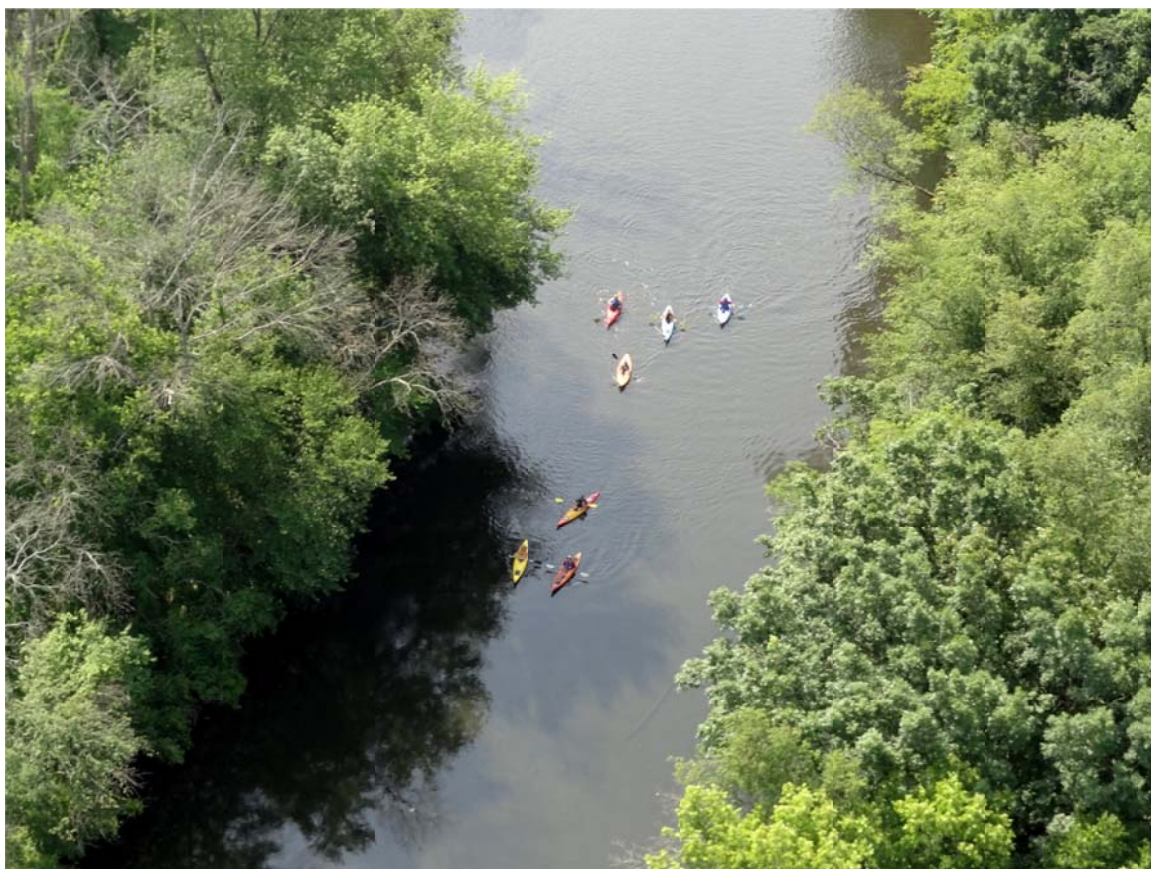
11. MP6.5, group of kayakers observed.

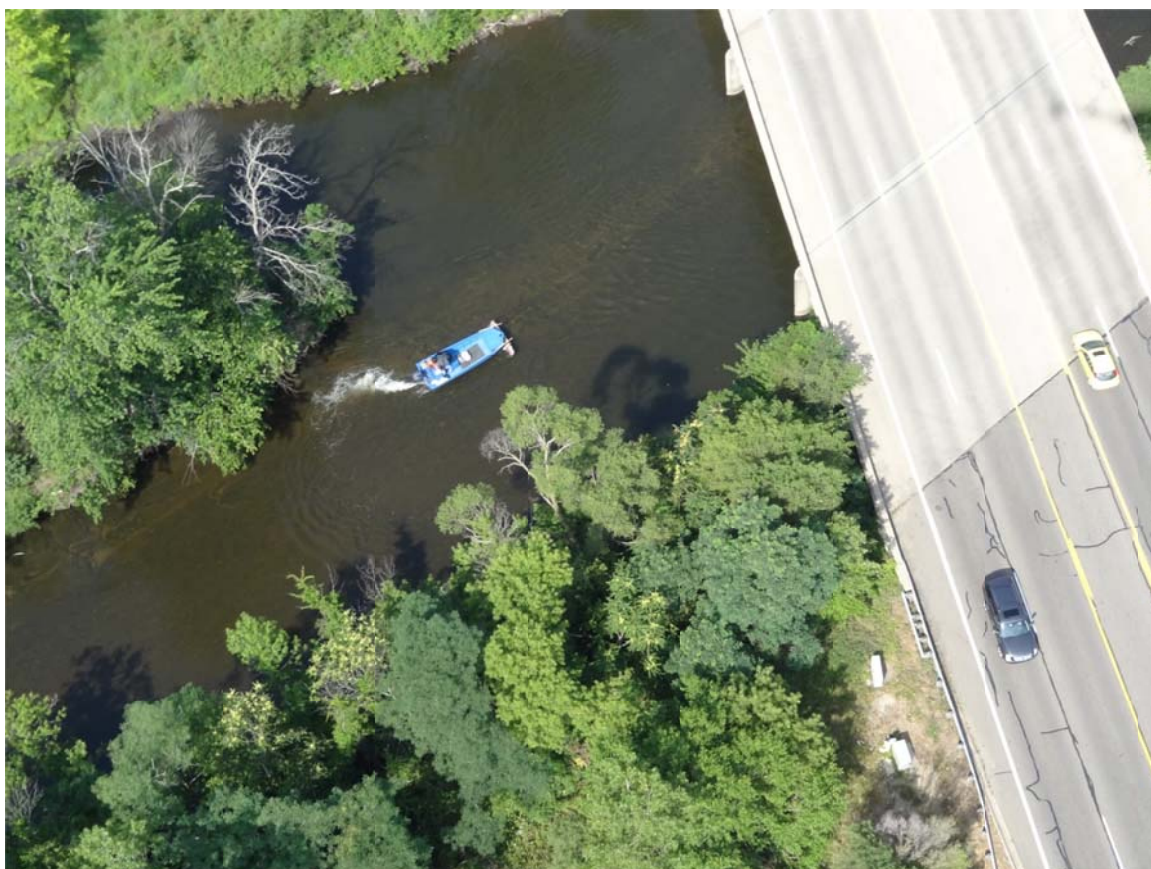
12. Sheen sweep boat observed near MP 14.0.

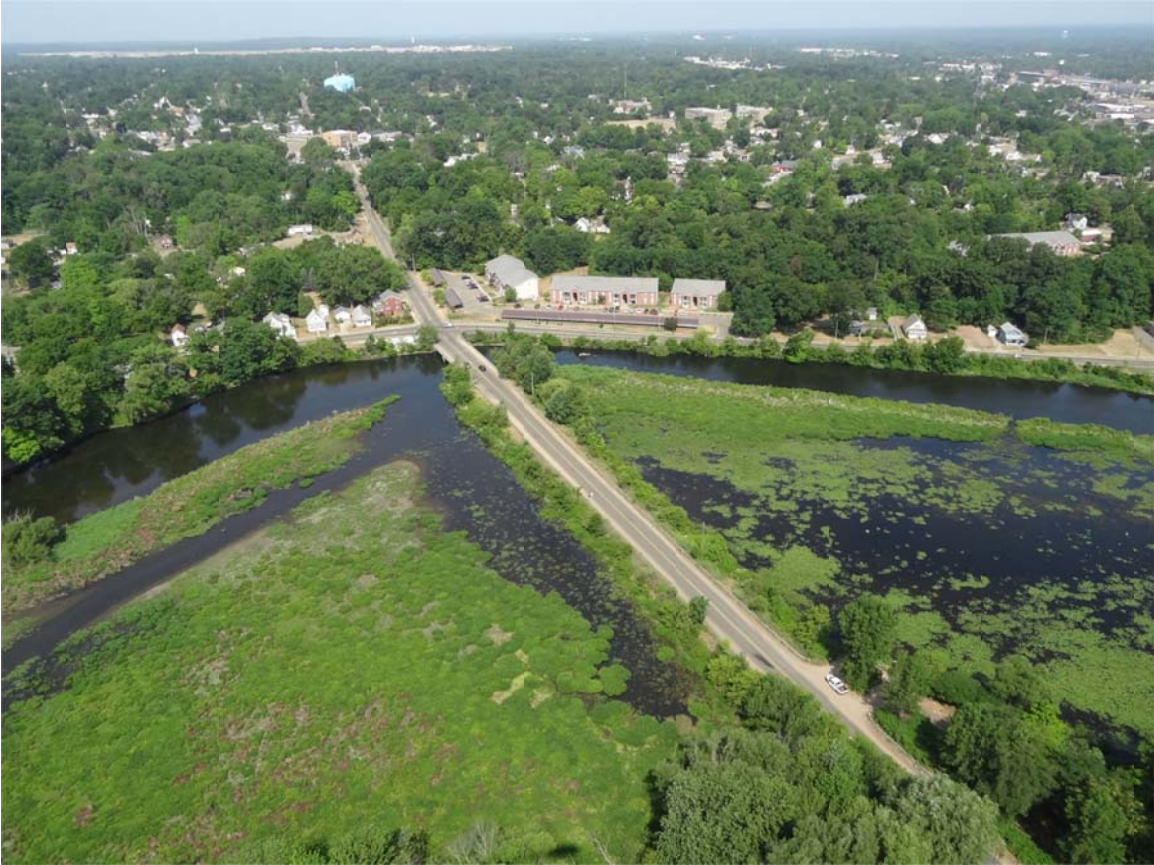
13. South side of Mill Pond, no sheen observed. One sweeper boat observed near bridge.

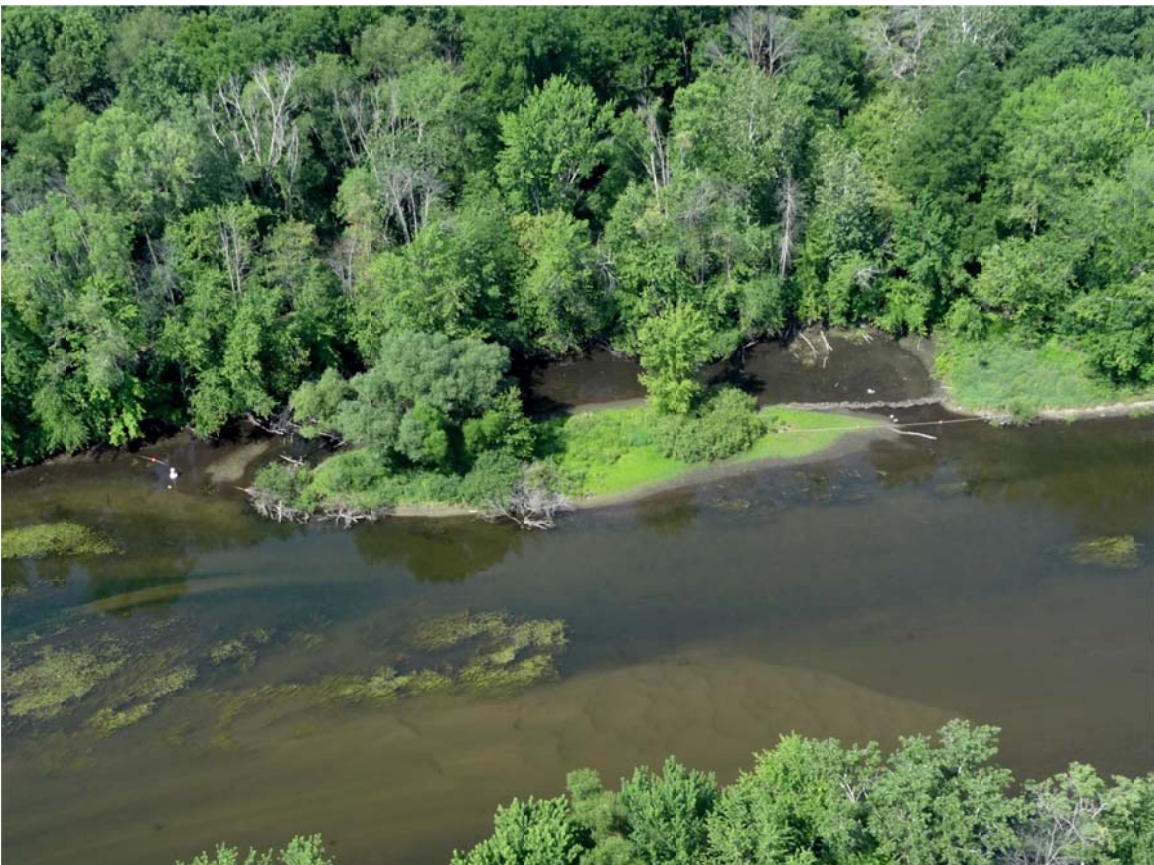
14. MP 19.25 sediment trap, no sheen observed.

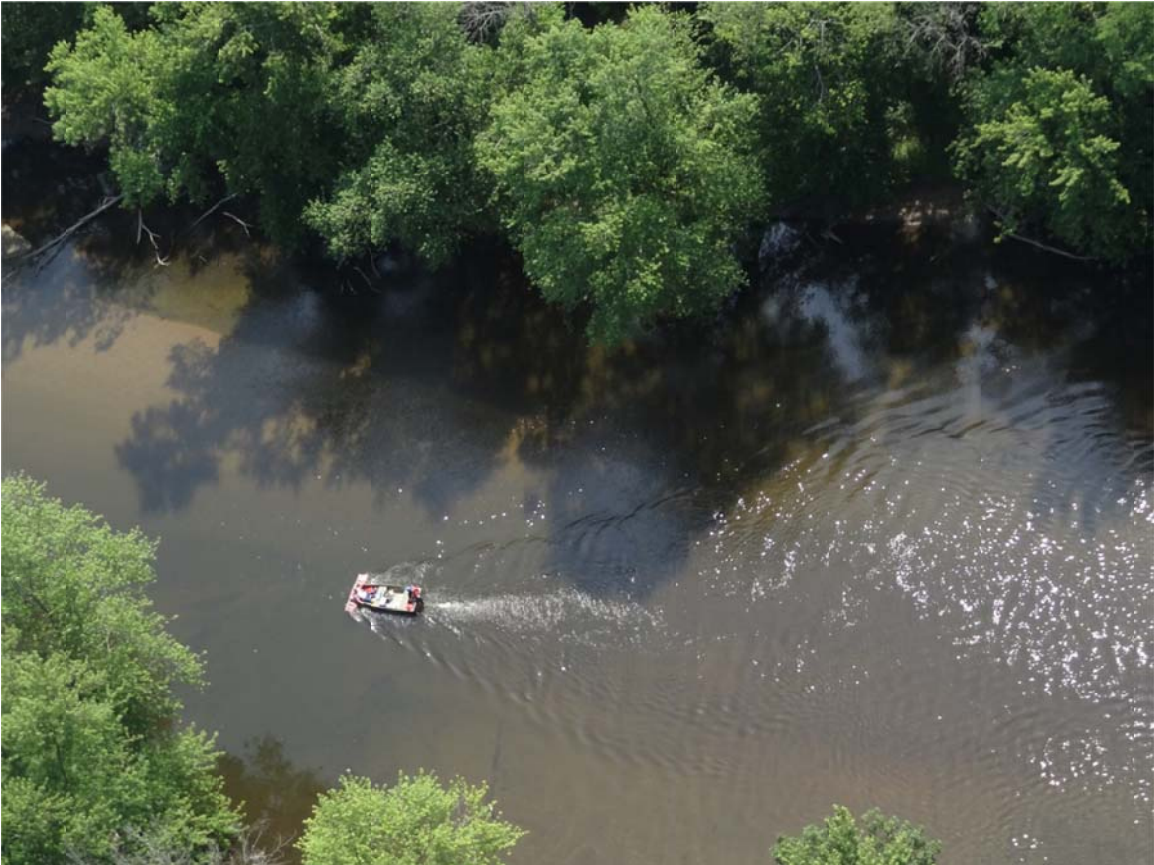
15. Sheen sweep boat operating near MP27.5.

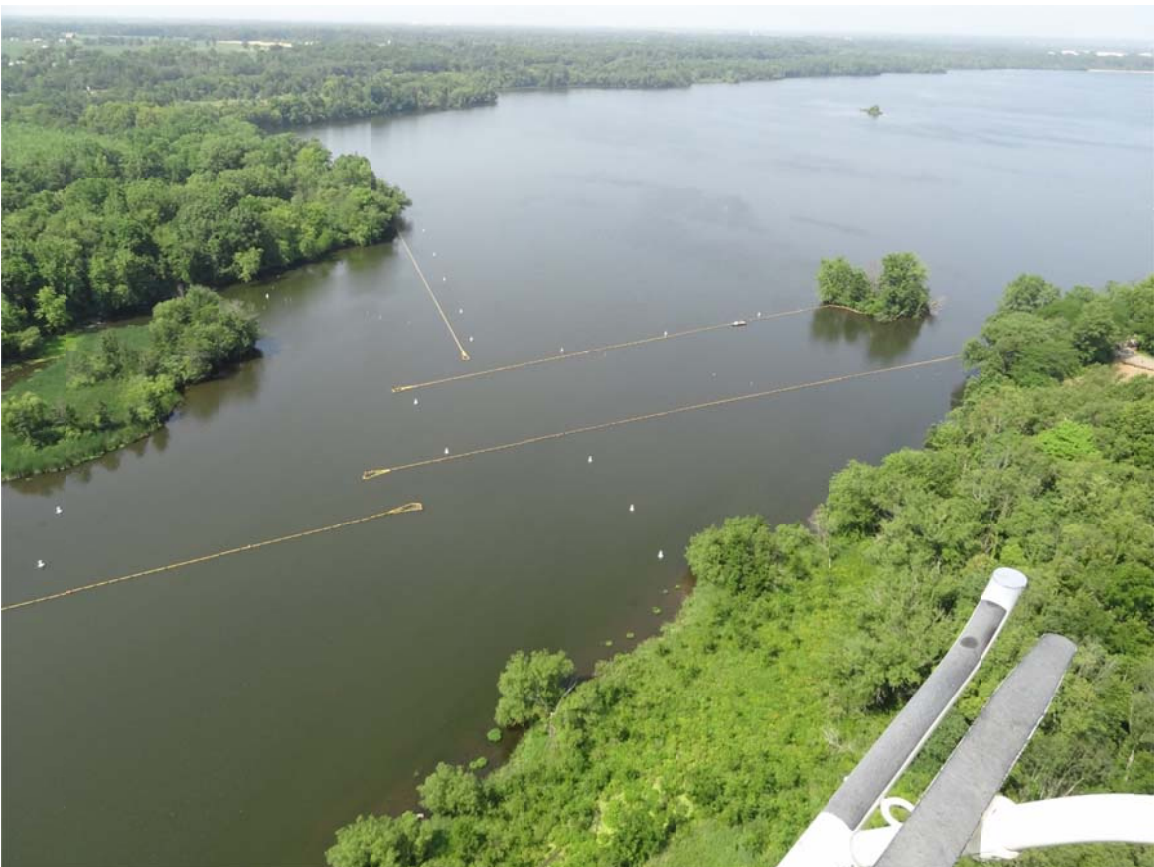
16. Morrow Lake Delta, current configuration of E4 Boom System.

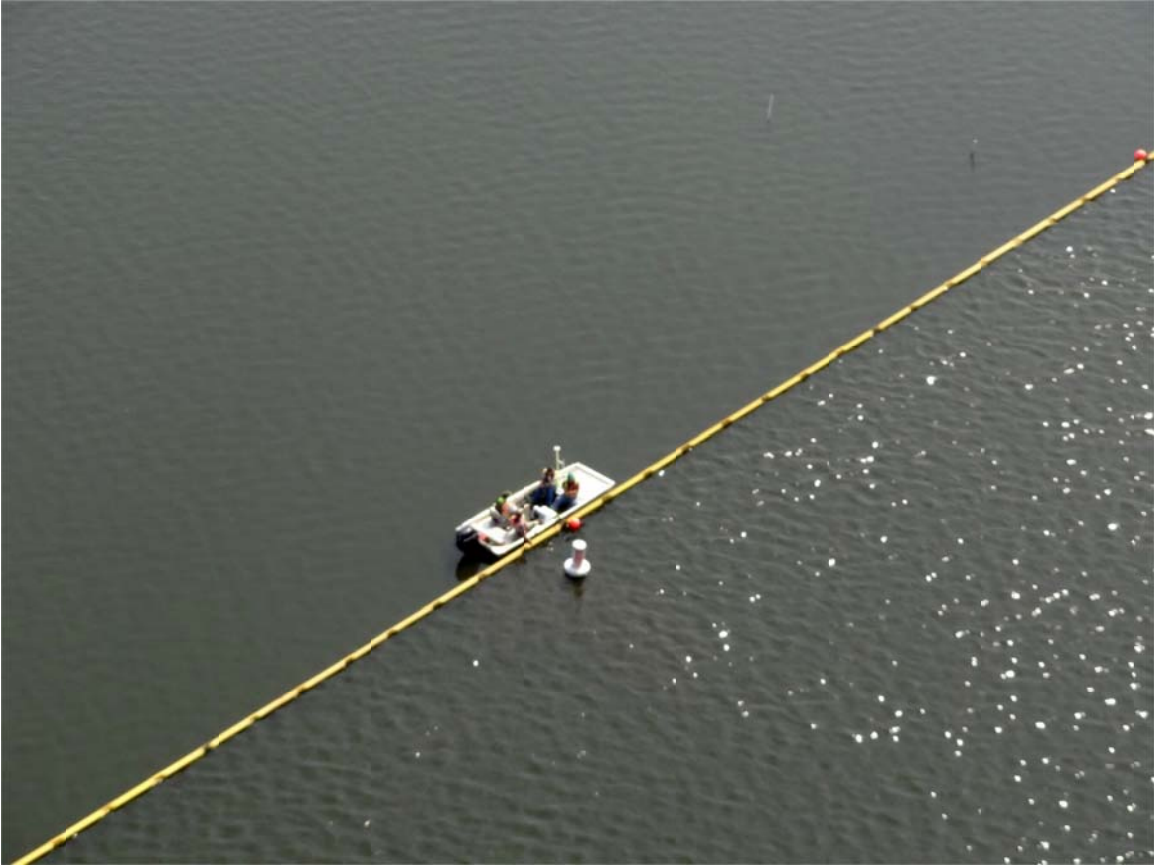
**17. Crews inspecting the curtain along the E4 Boom System.**

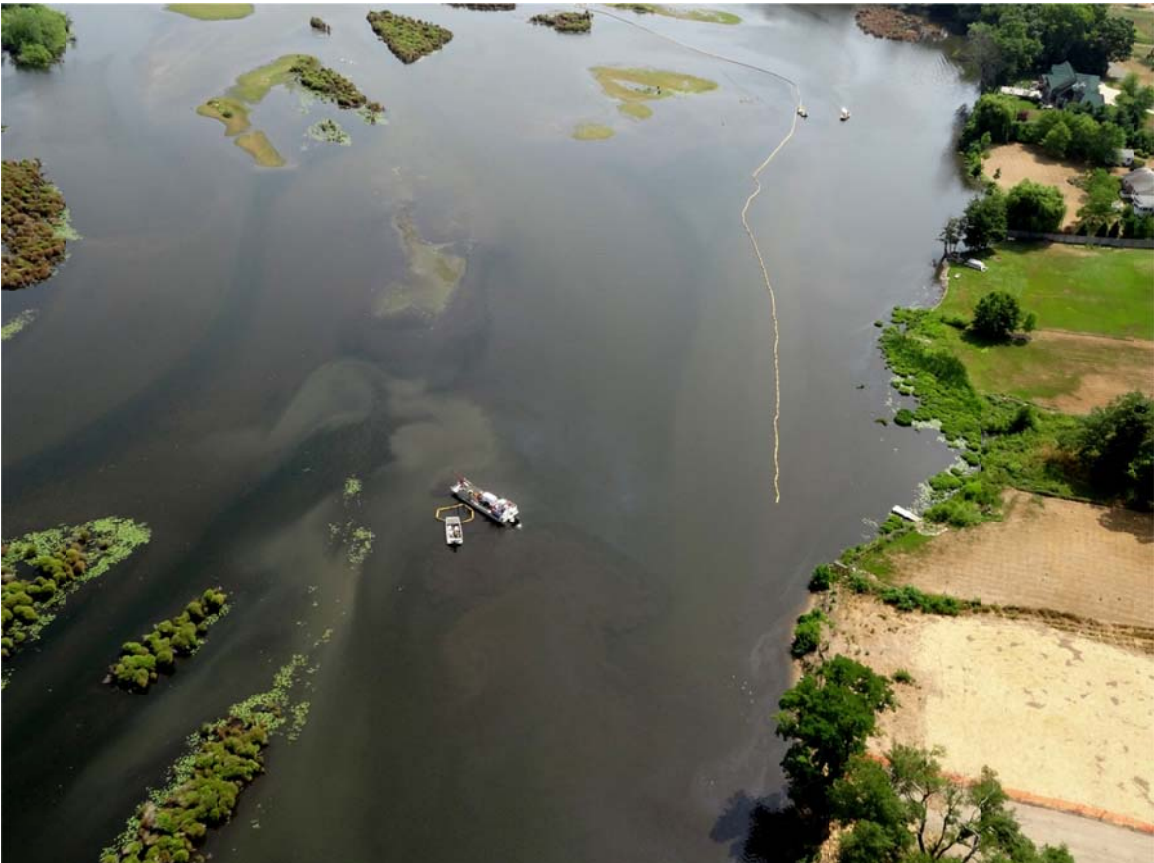
**18. Morrow Lake Delta, Crews installing boom in southern of delta. Sheen observed in vicinity of boat.**

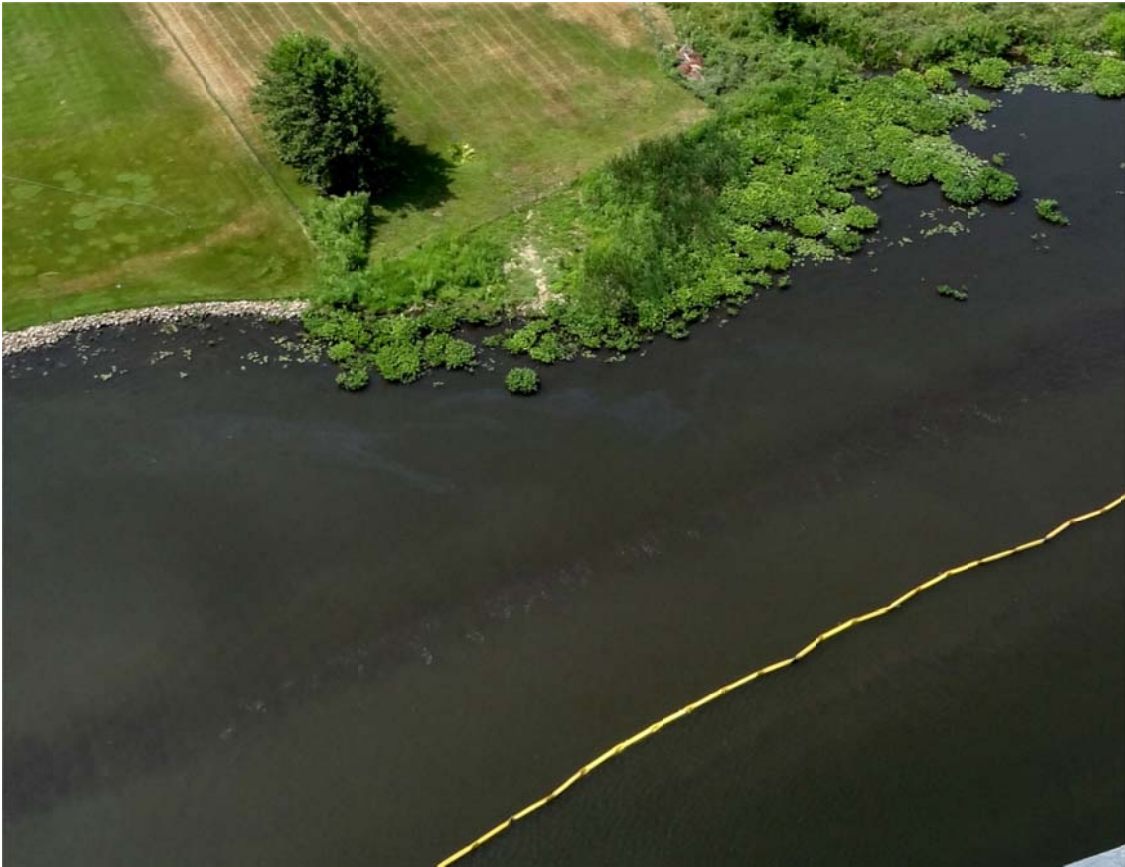
**19. Morrow Lake Delta, sheen observed along southern shore in vicinity of boats.**

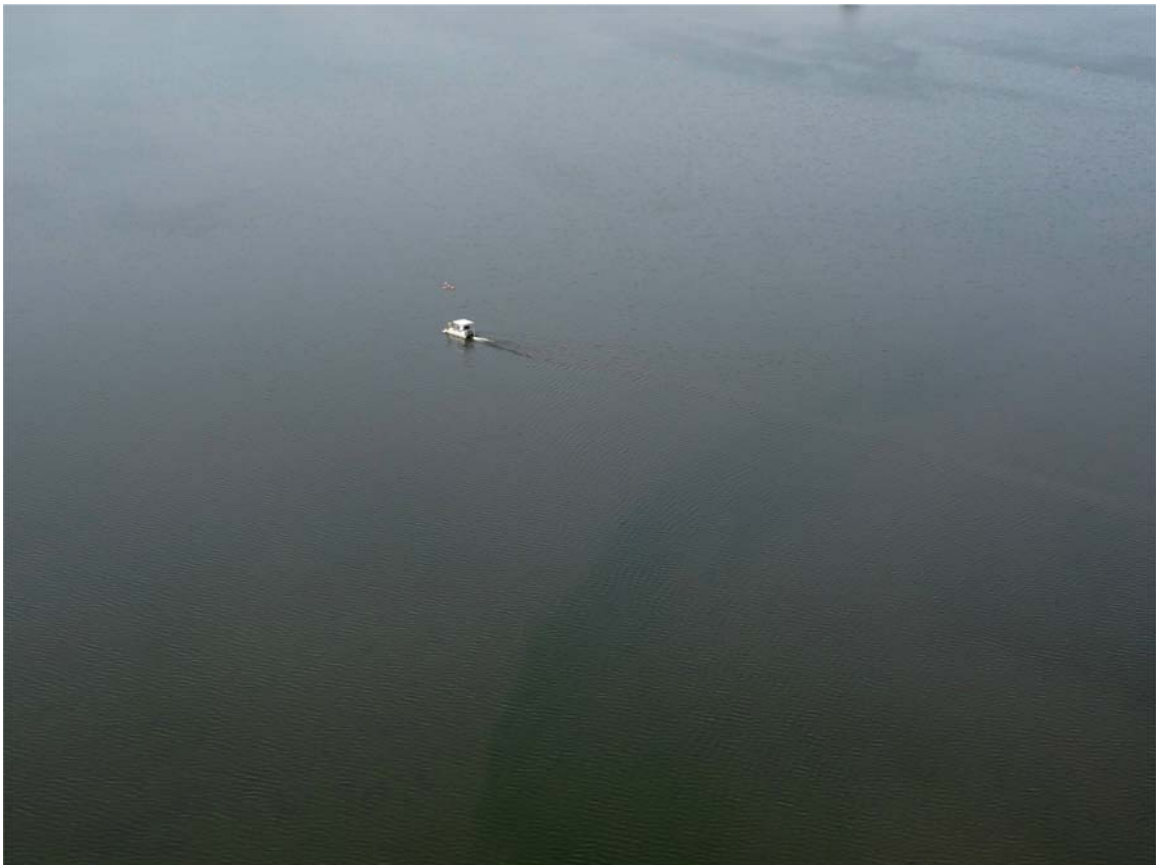
**20. Morrow Lake, sheen sweep pontoon operating in northern portion of lake.**

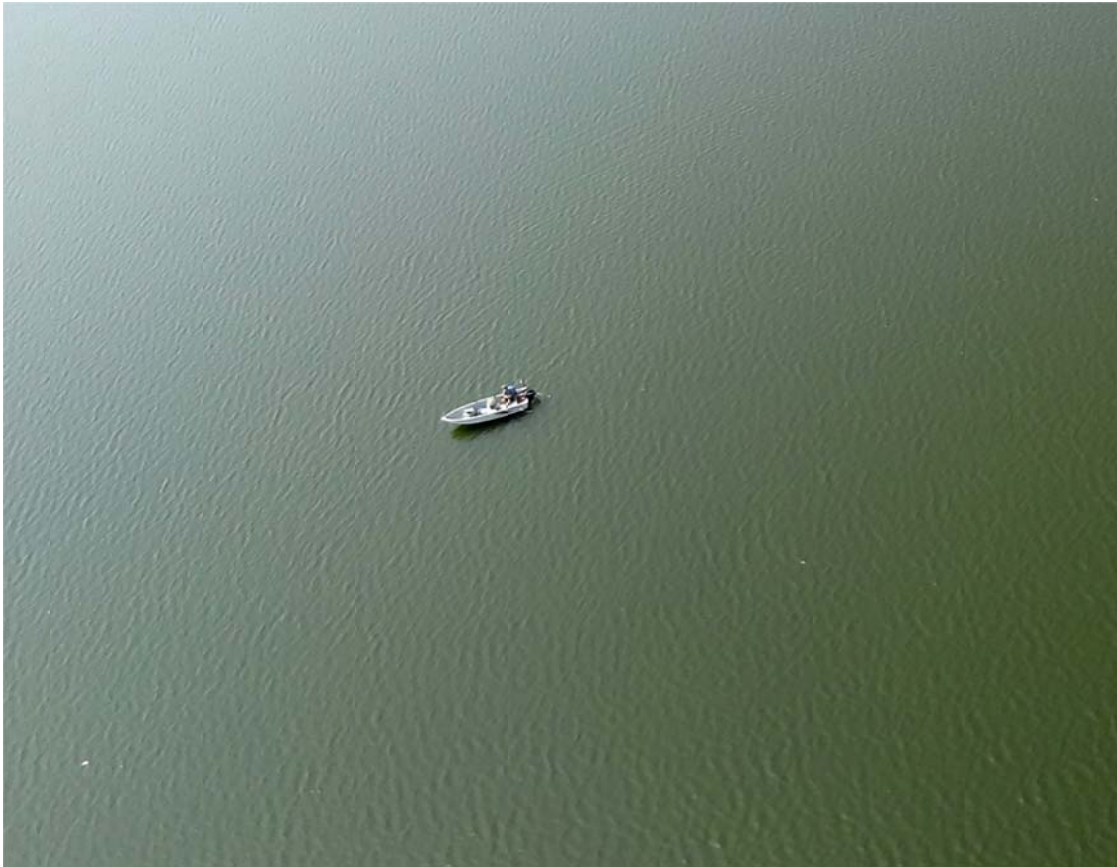
**21. Fishing boat observed in northwestern corner of Morrow Lake.**

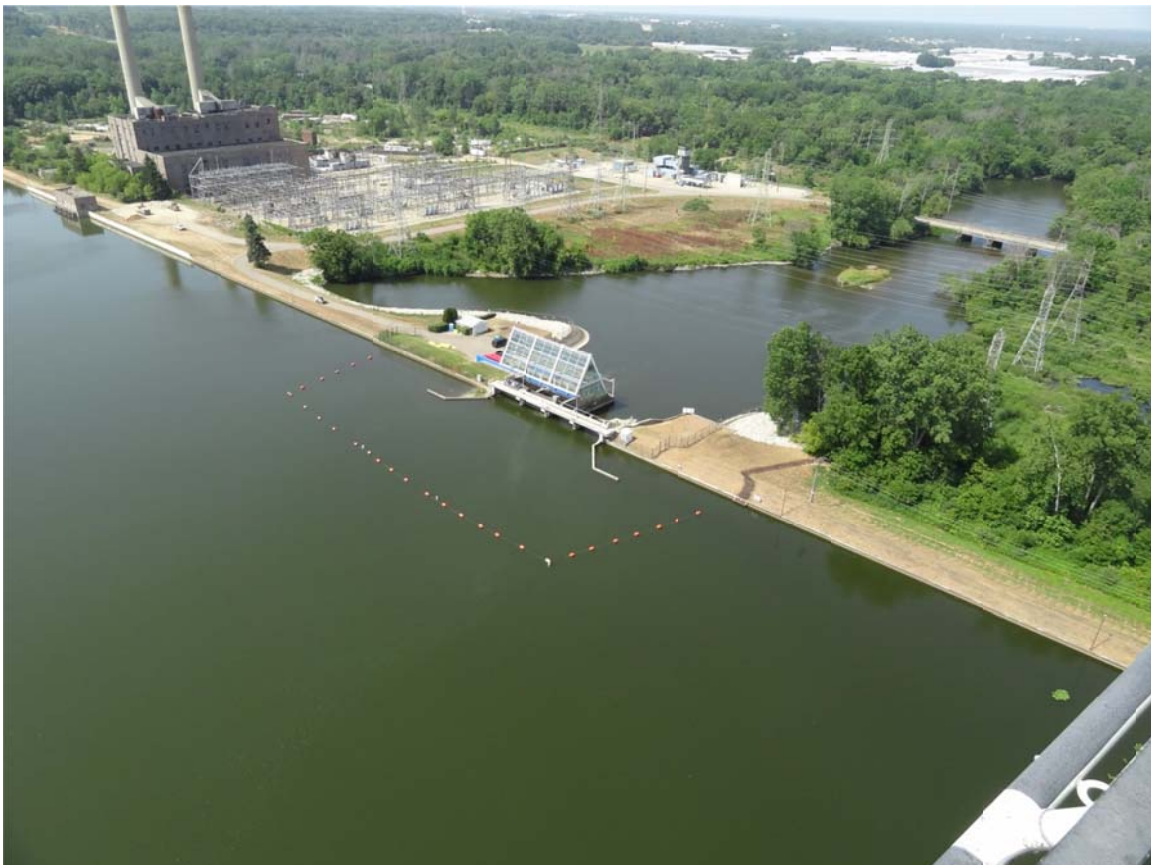
**22. Morrow Lake Dam, no sheen observed.**
