# Situation Photo Log

Monday, July 9, 2012

Kalamazoo River / Enbridge Spill

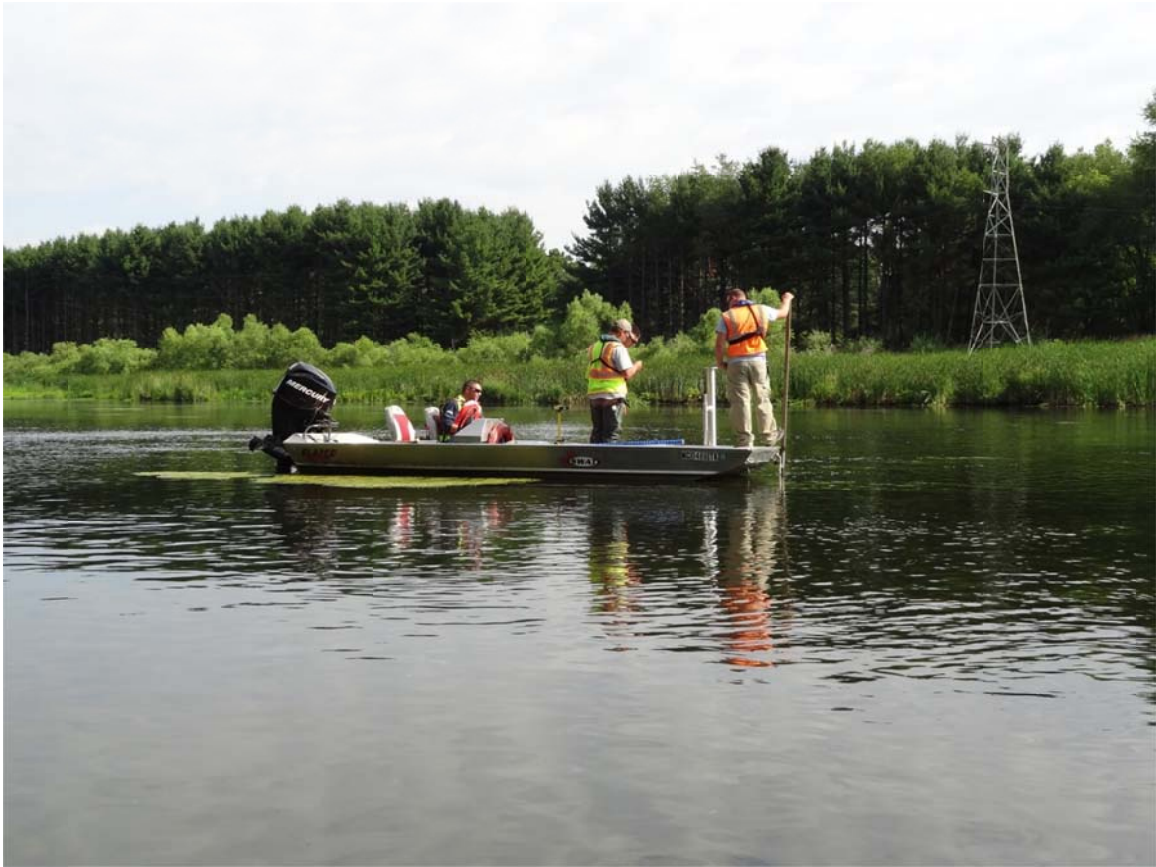
1. Crew collecting river velocity measurements near MP 5.4 above Ceresco Dam.

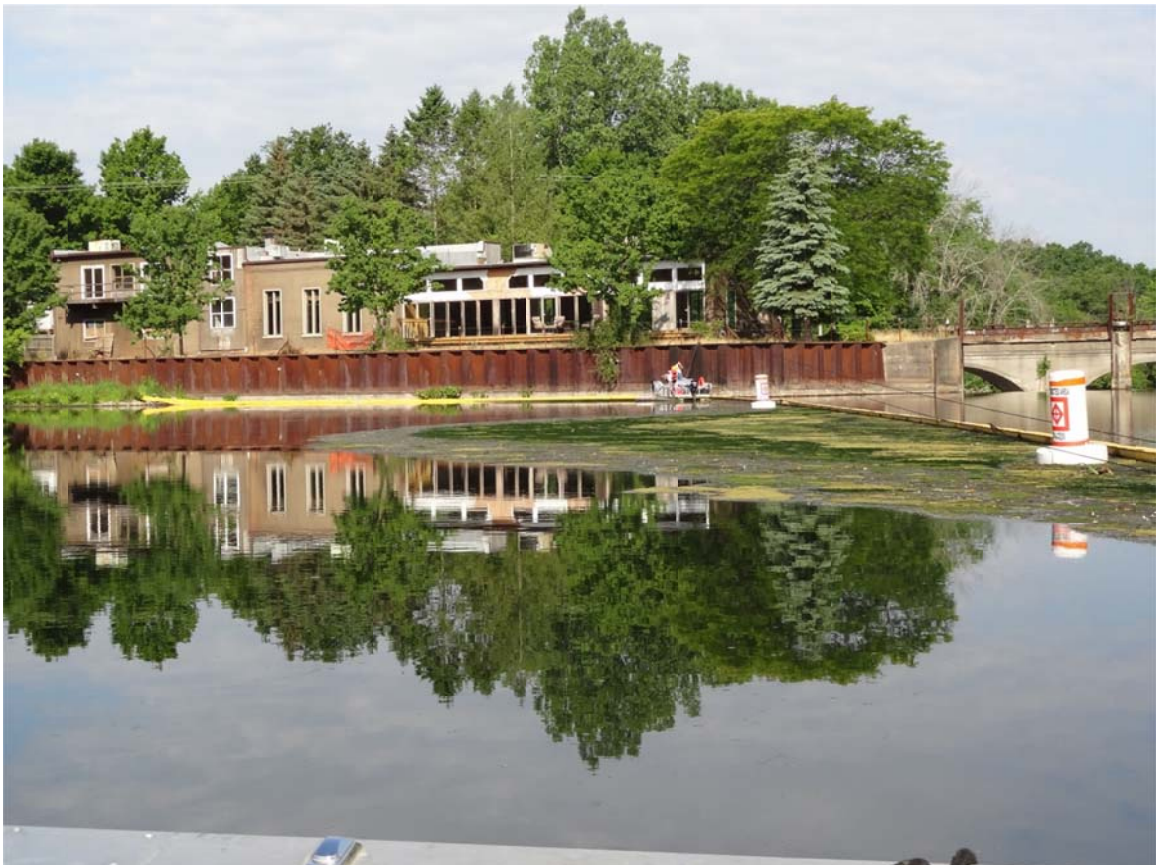
2. Crew removing vegetation from control point above Ceresco Dam.

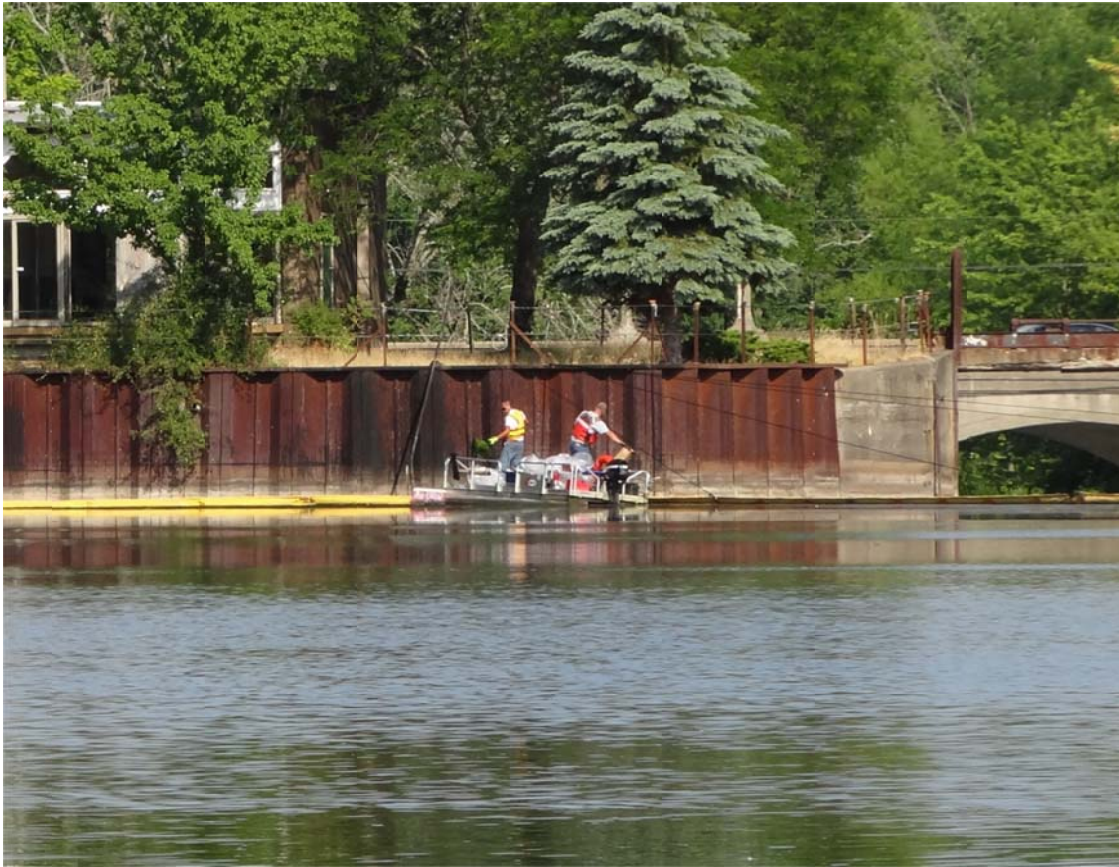
3. Crew maintaining containment boom above Ceresco Dam.

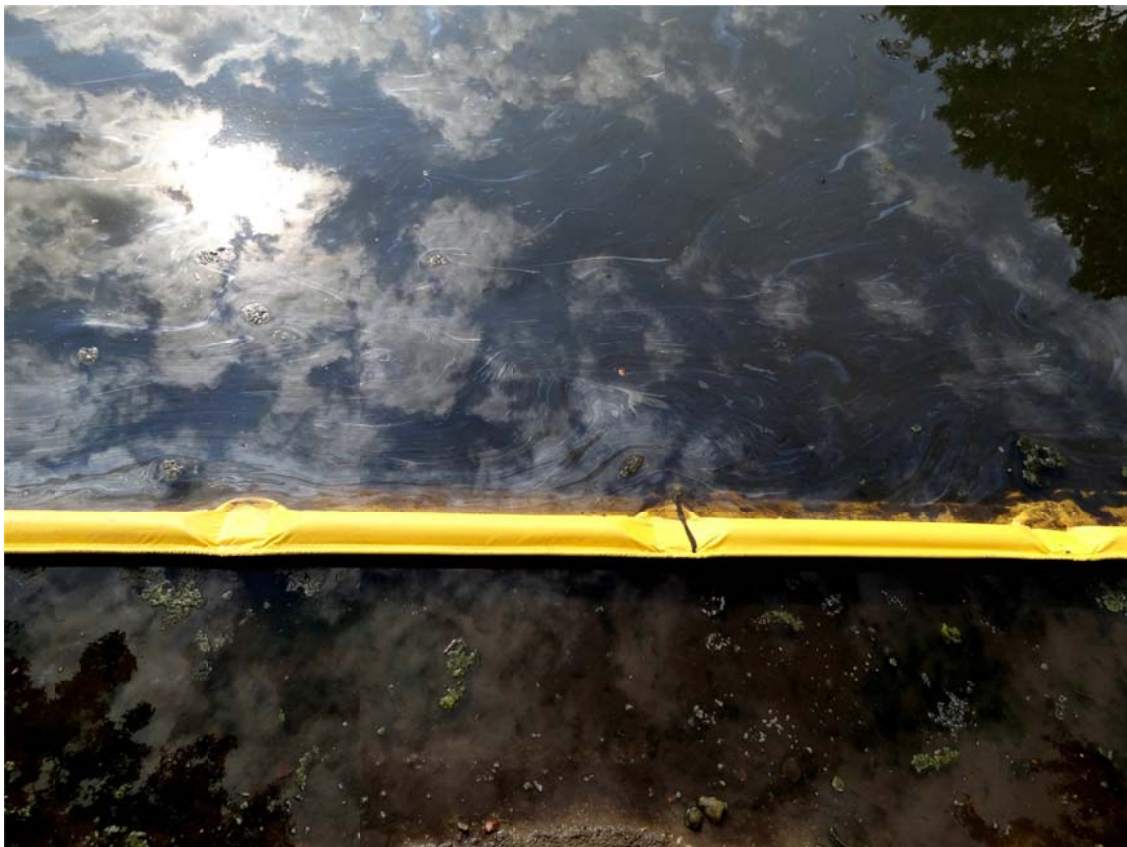
4. Sheen within containment along southern wall of Ceresco Dam.

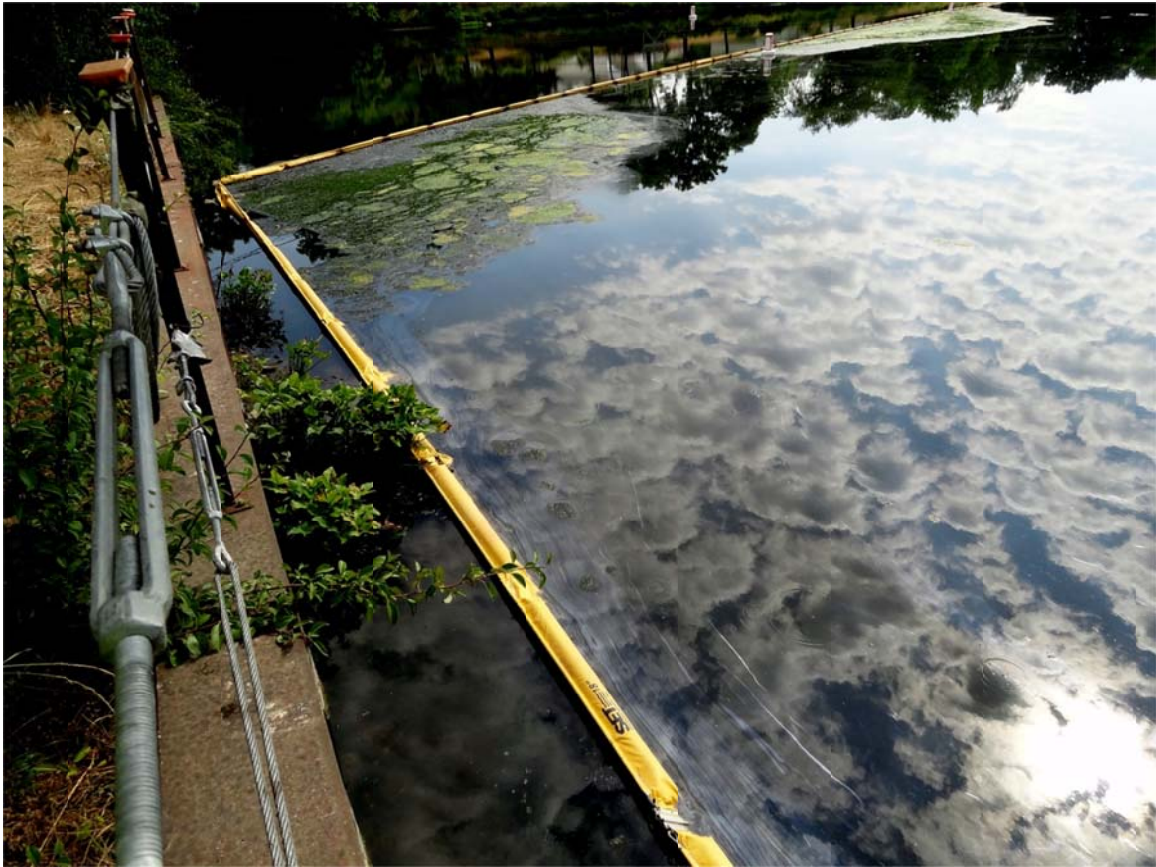
5. Vegetation and sheen within containment above Ceresco Dam.

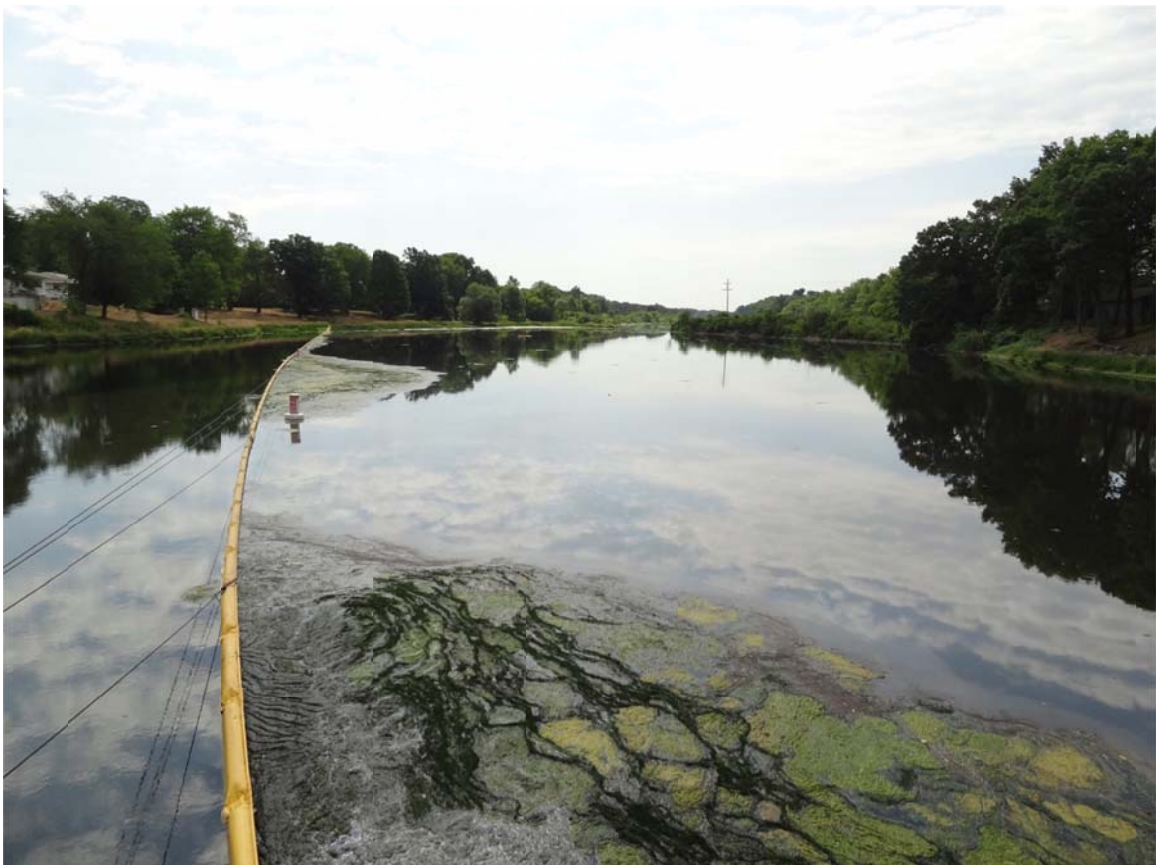
6. View of Ceresco containment boom, looking east (upstream). No sheen observed going over dam beyond containment.

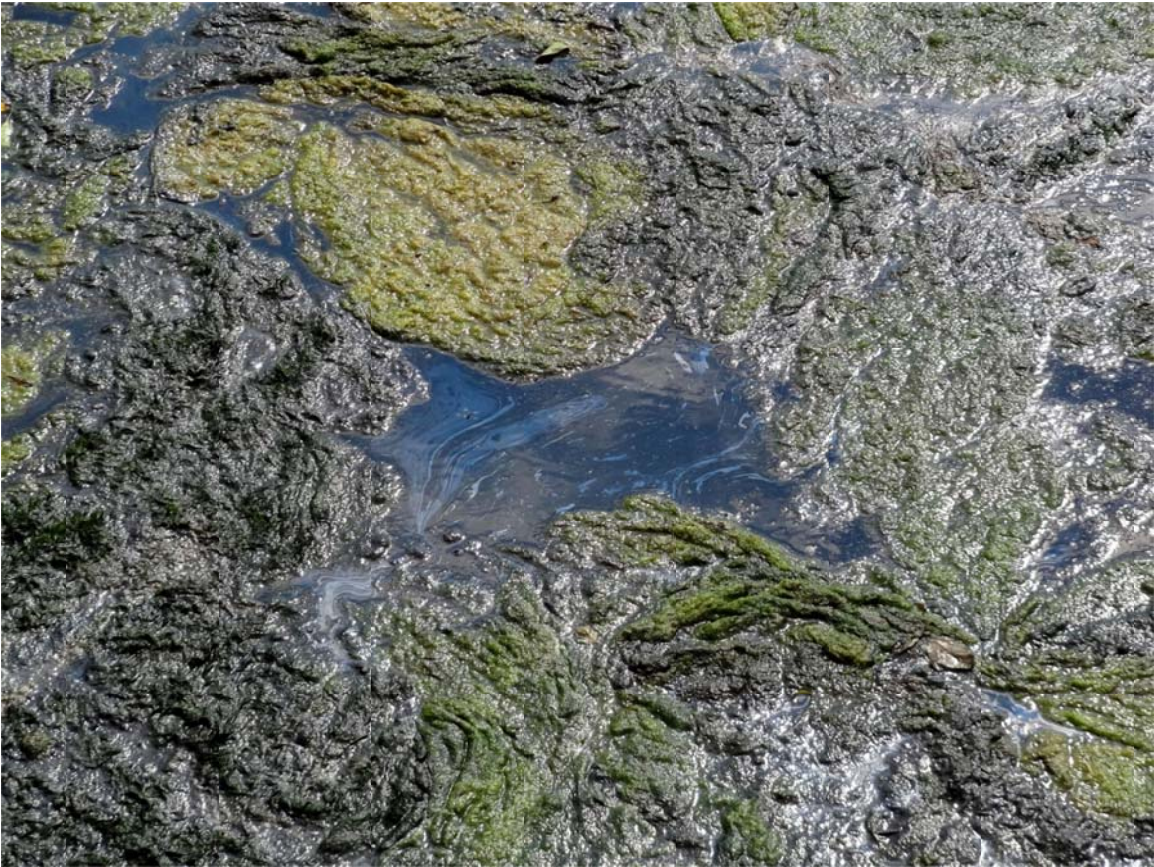
7. Sheen observed within vegetation in containment above Ceresco Dam.

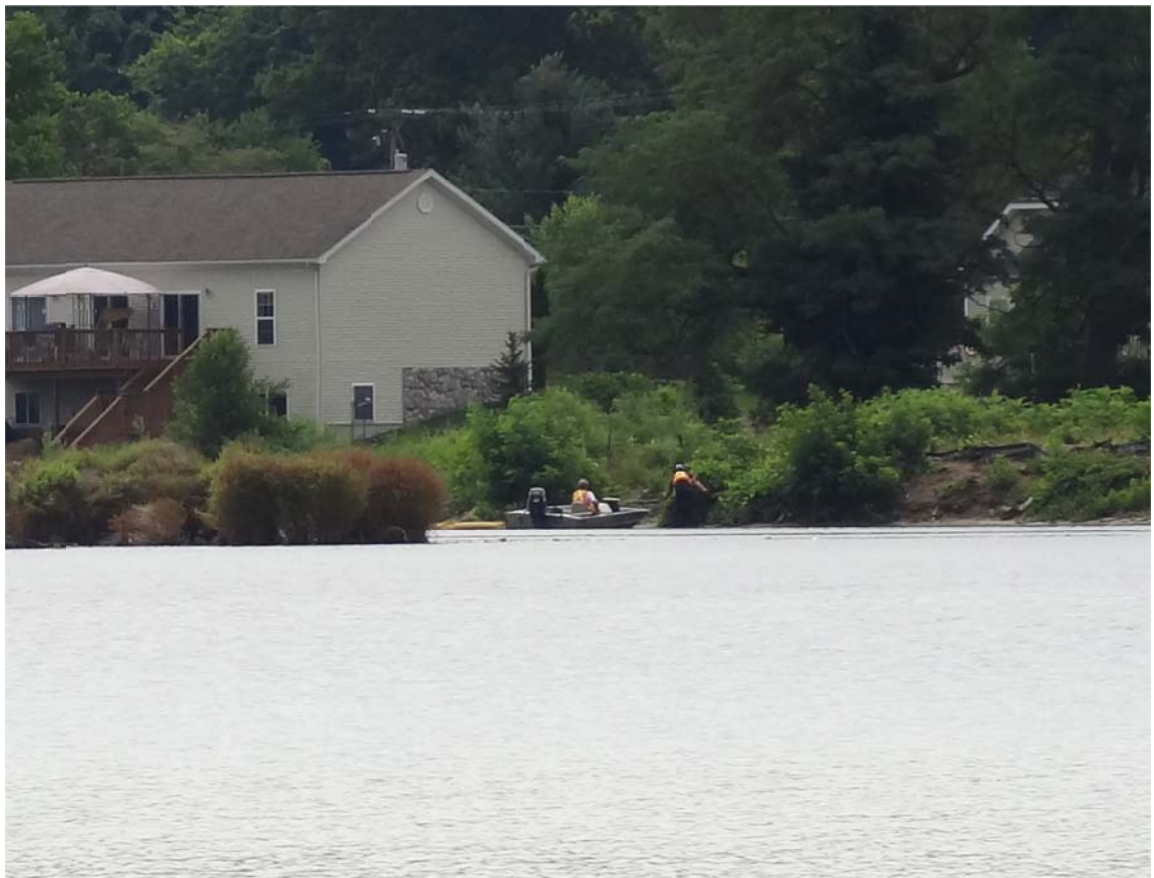
8. Crews installing containment boom in southern end of Morrow Lake Delta.

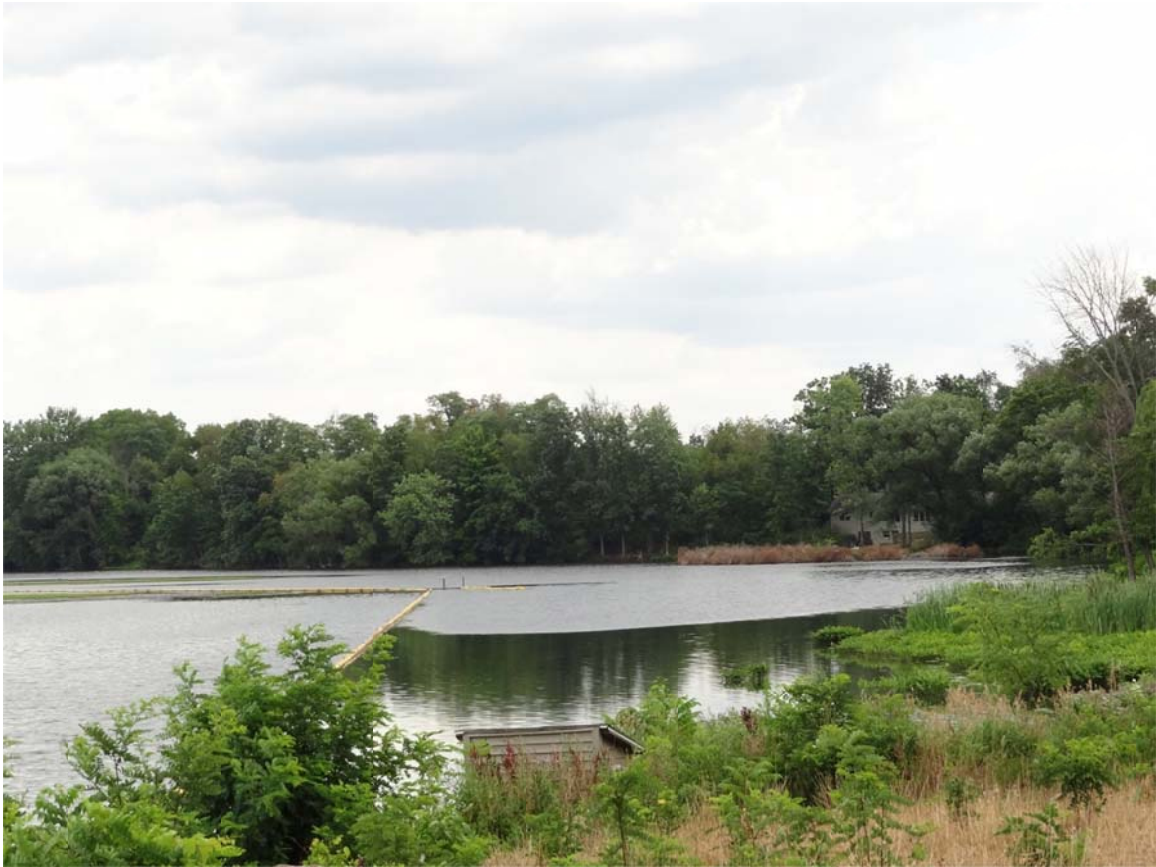
**9. Newly installed containment boom along southern shore of Morrow Lake Delta.**

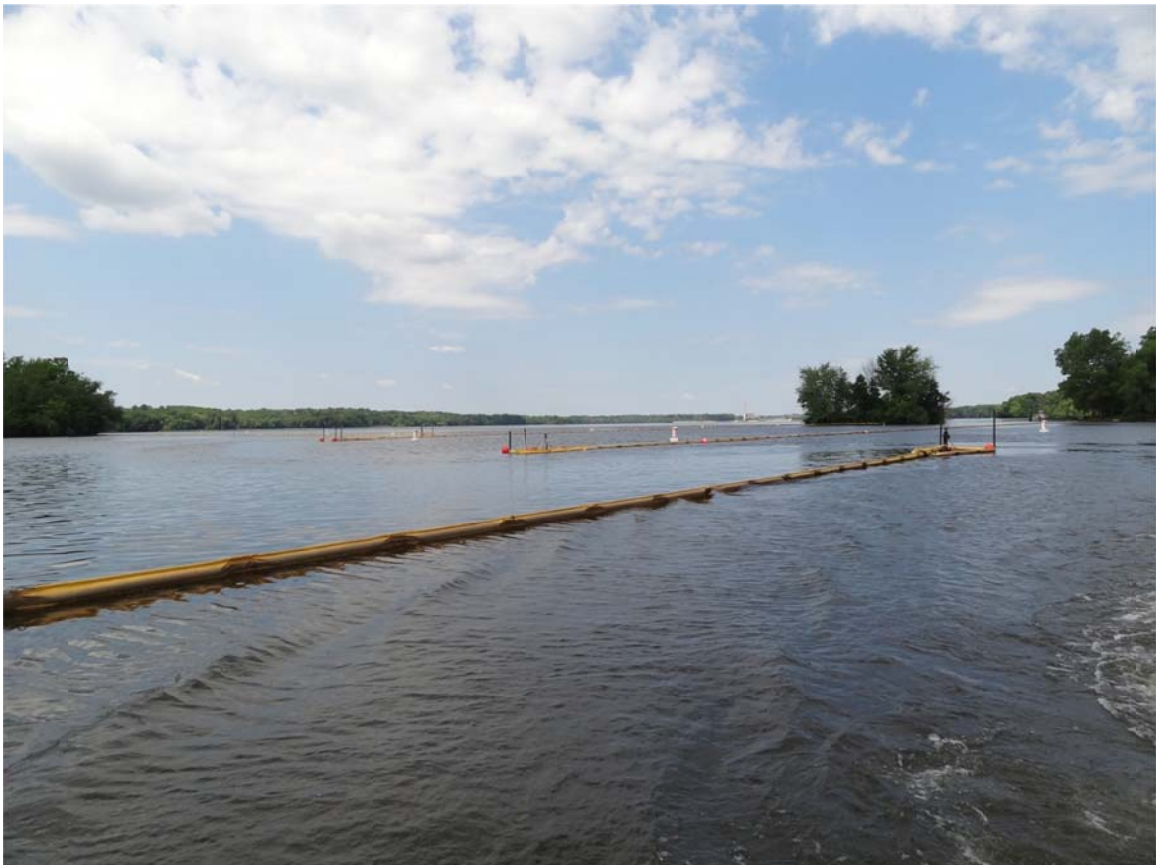
**10. Control Point E4 gate boom configuration, looking west into mouth of Morrow Lake.**

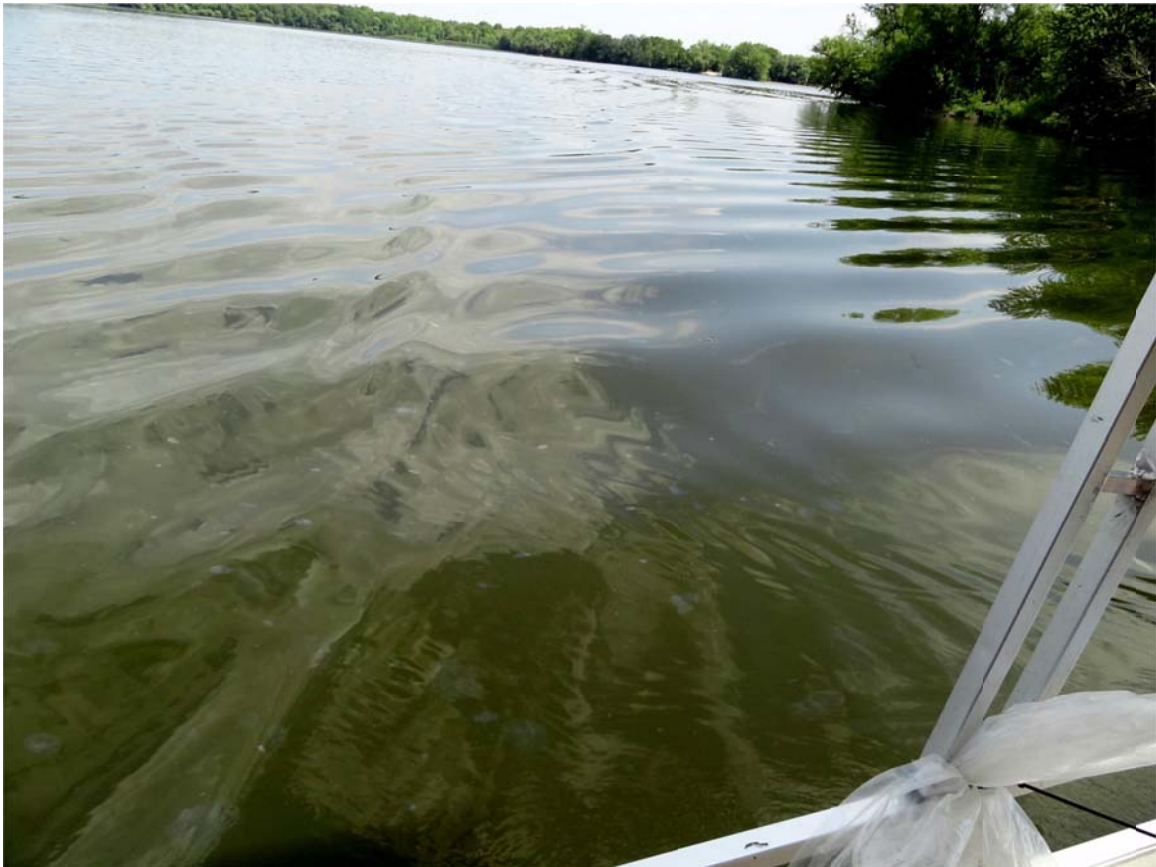
**11. Globules and sheen observed from front of sweeper boat on Morrow Lake, south of the fan area.**

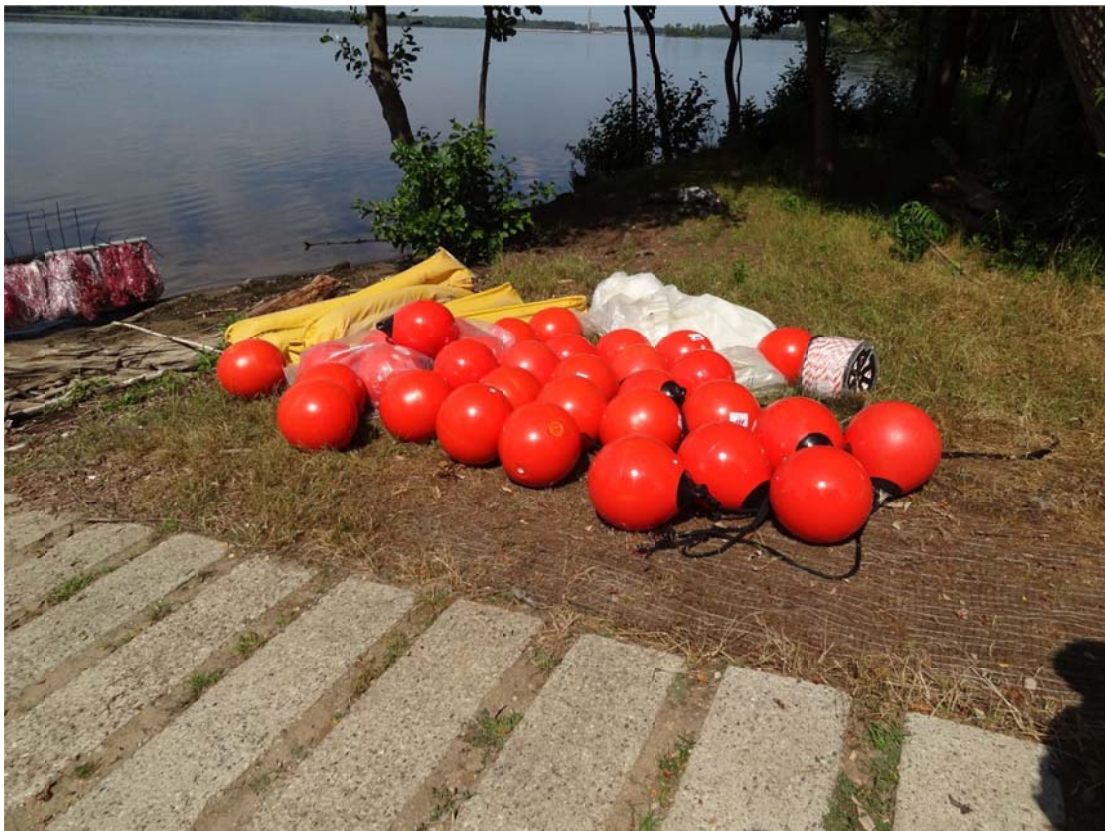
**12. Additional containment boom and buoys staged for deployment at E4 boat launch.**

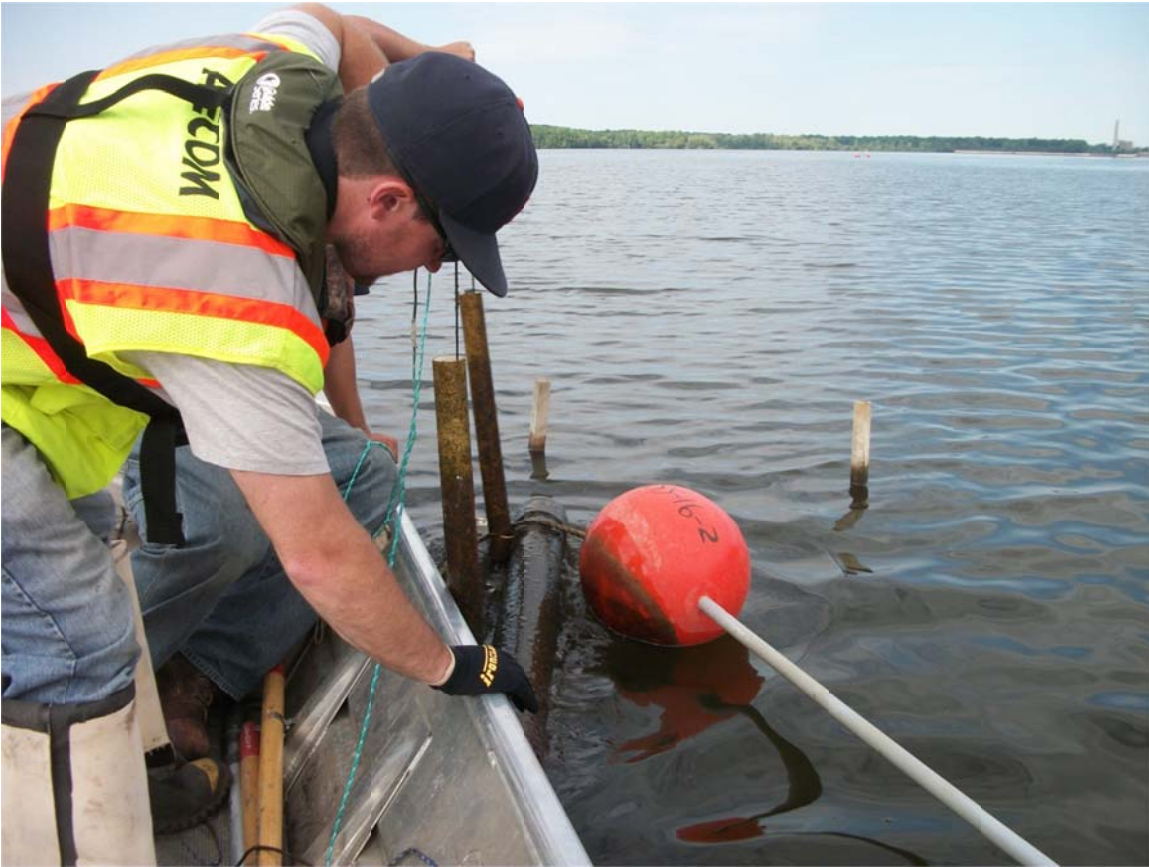
13. Crews collecting walling tube samplers on Morrow Lake.

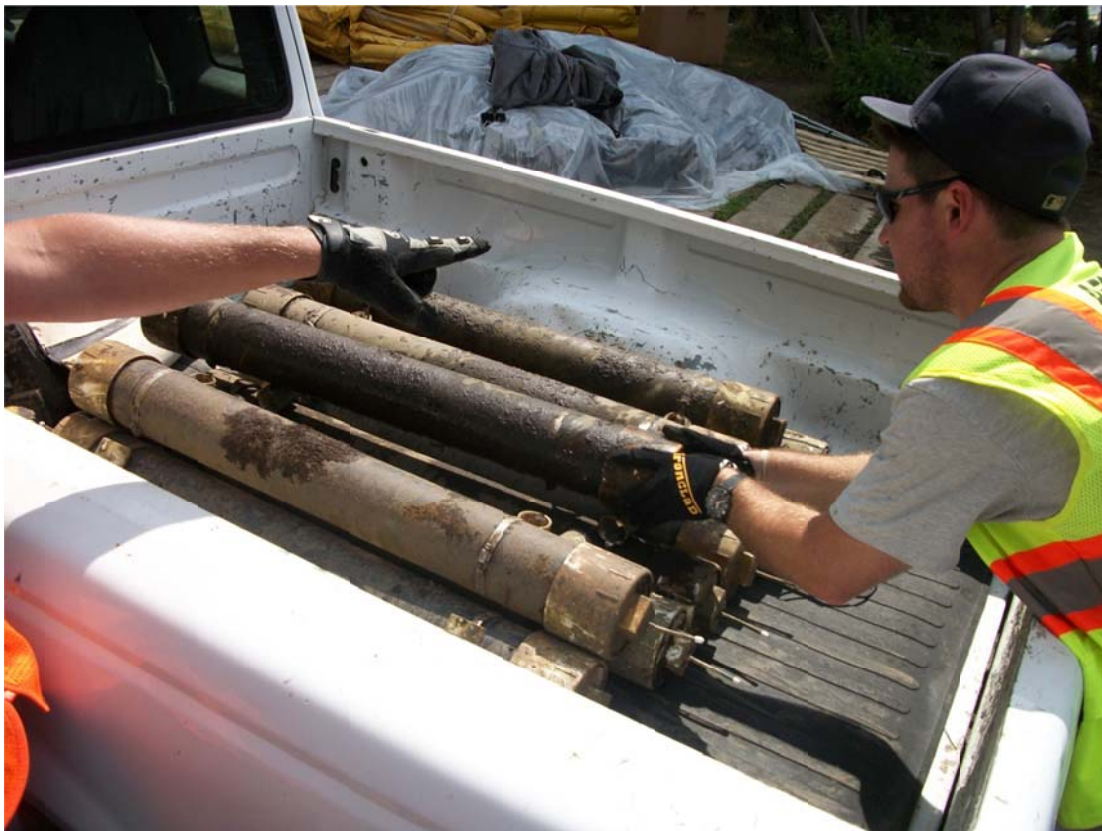
14. Collected walling tubes ready for transport to the processing center.
