# Situation Photo Log

Tuesday, July 10, 2012

Kalamazoo River / Enbridge Spill

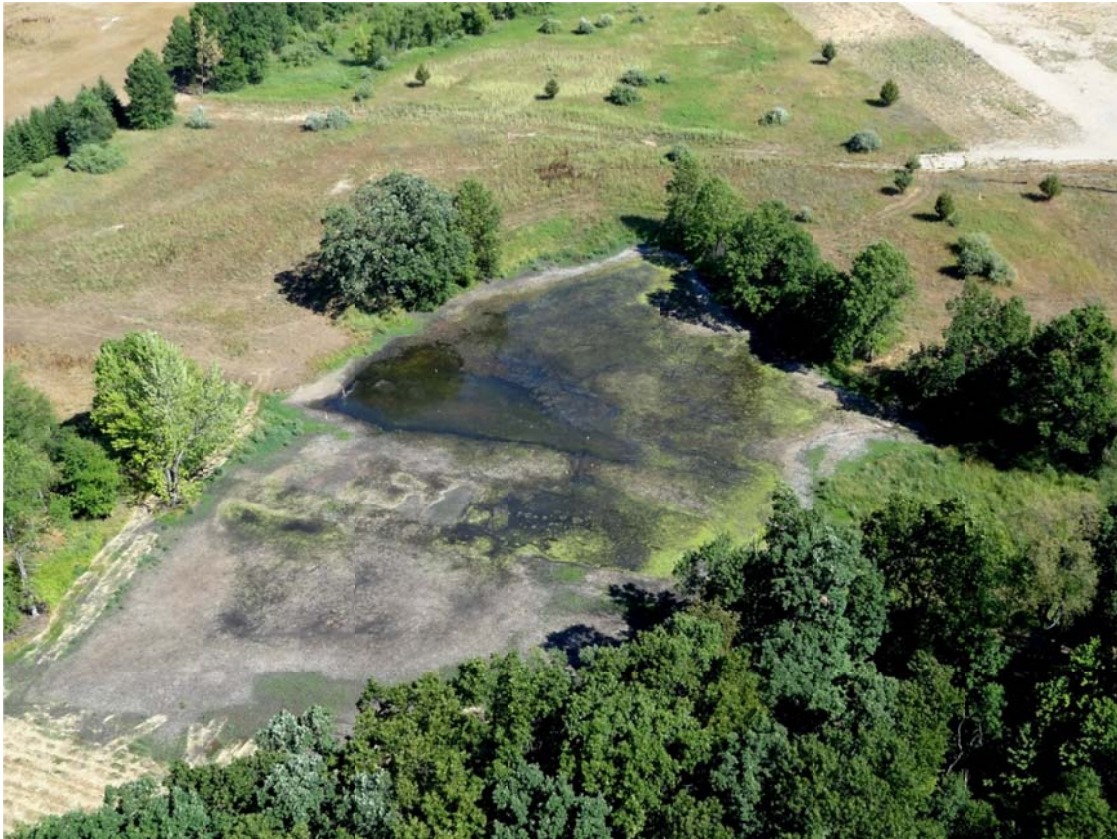
1. Source area pond, sheen observed.

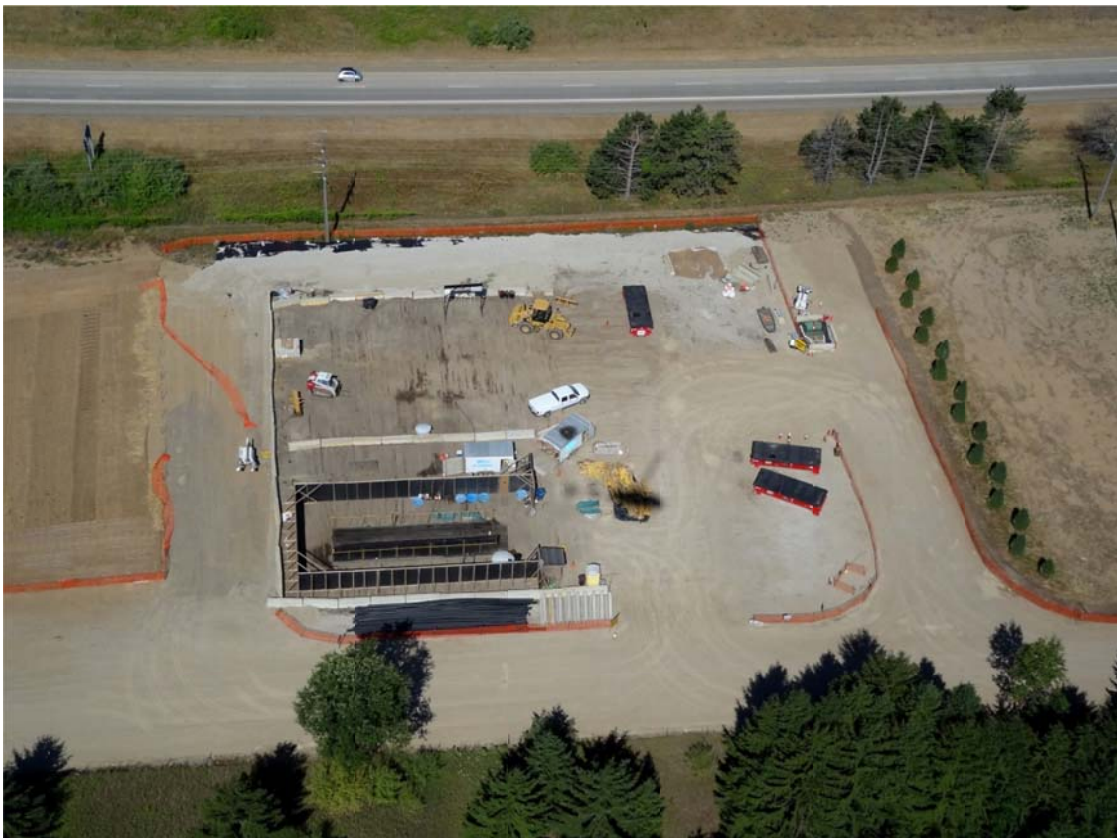
2. Frac-City, no activity observed.

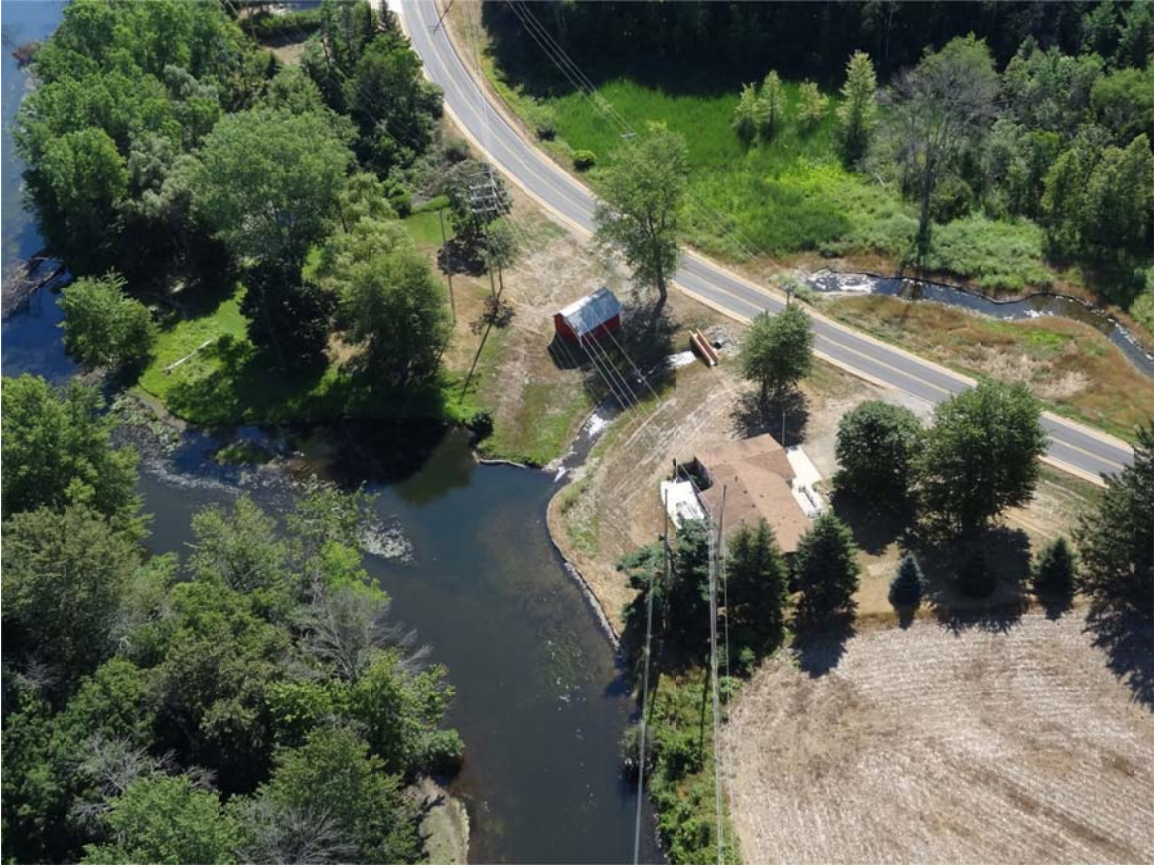
3. Confluence, no sheen observed.

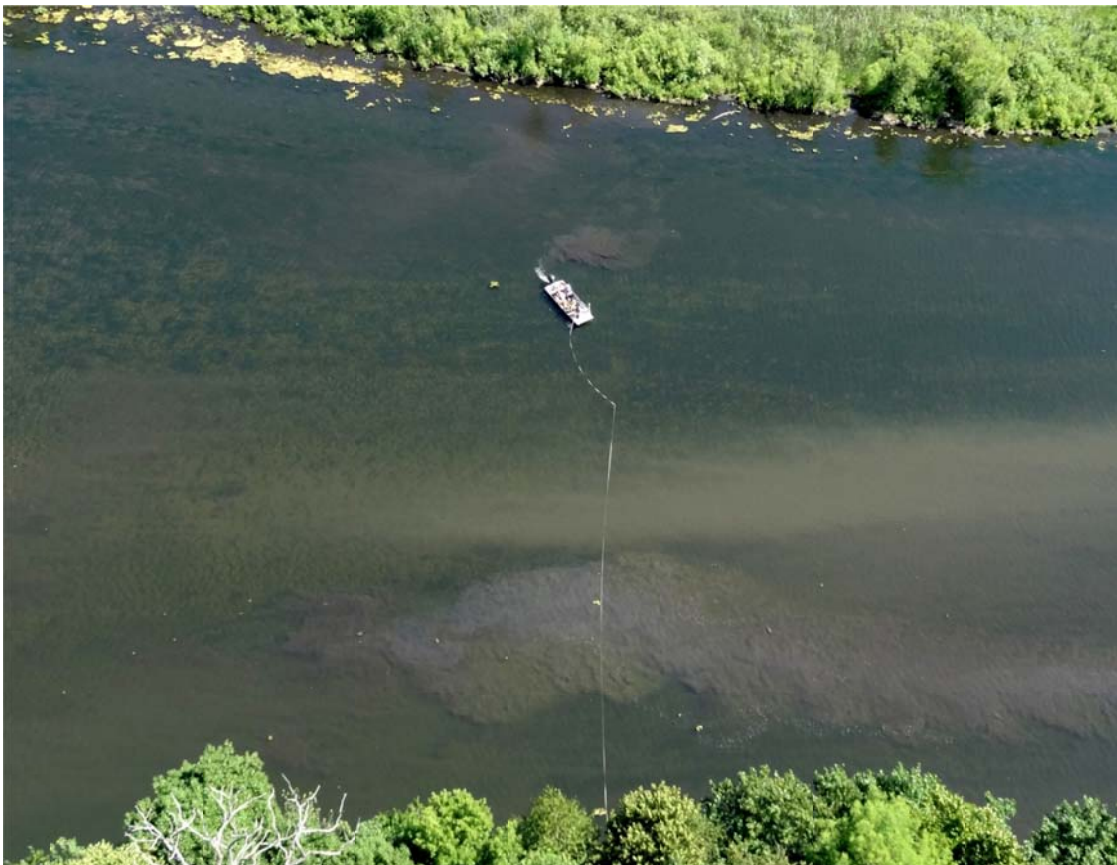
4. River velocity measurement crew measuring transect near MP5.4.

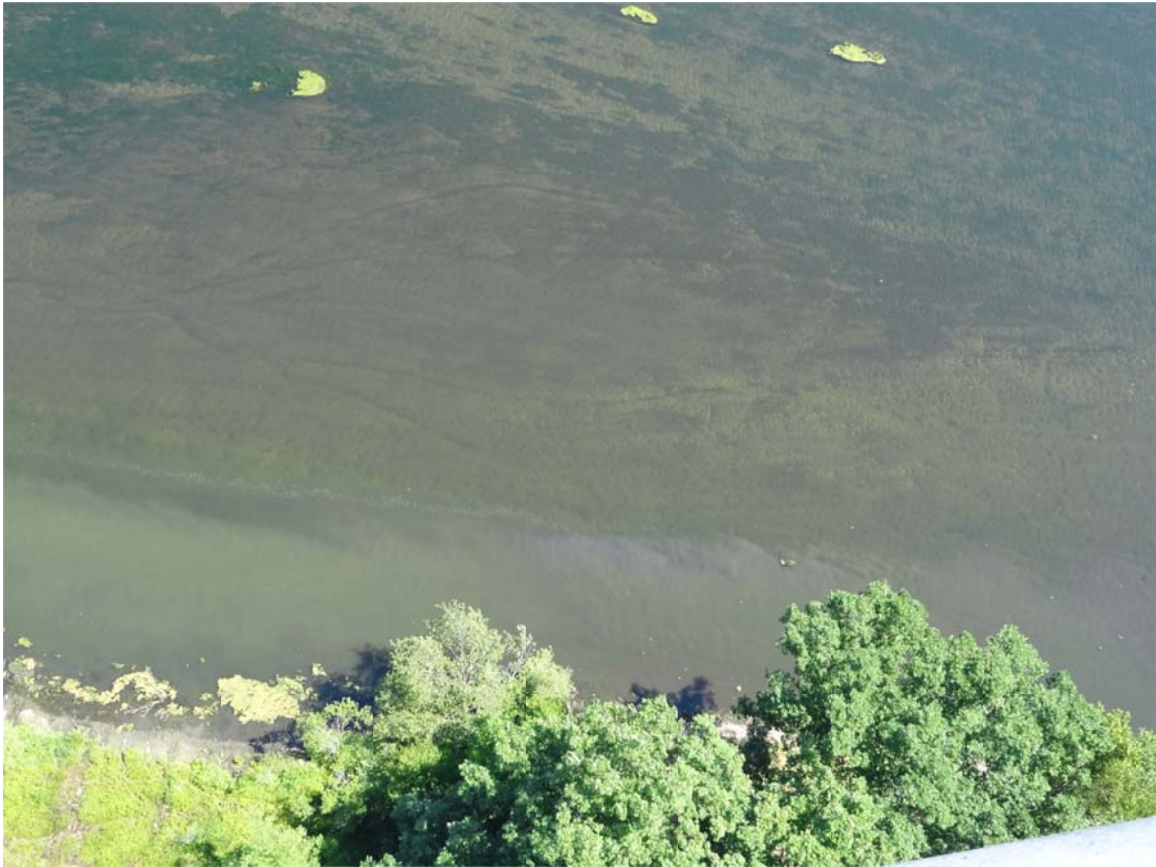
5. Sheen observed along LDB just downstream from C0.4 boat launch, sweeper boat notified.

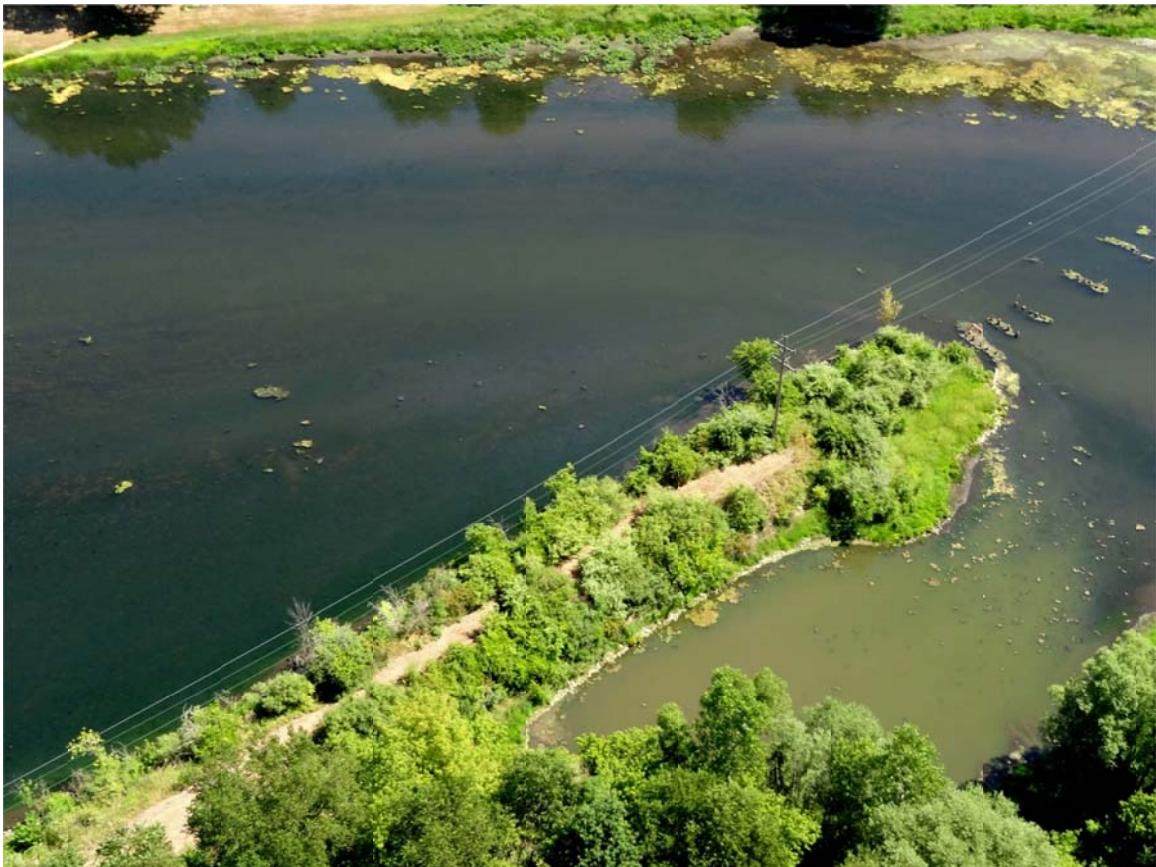
6. South peninsula above Ceresco Dam, observed sheen on downstream side of peninsula. Sheen response crews were notified.

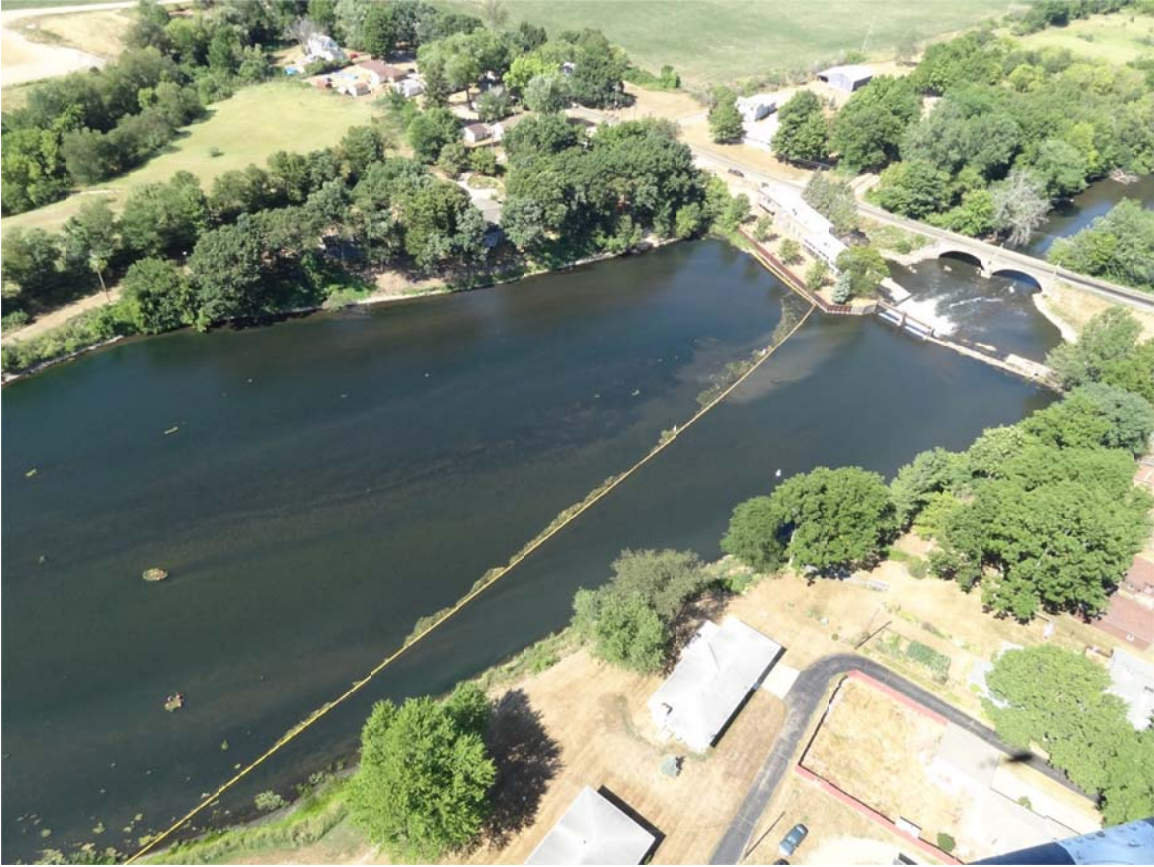
7. Overview of control point above Ceresco Dam.

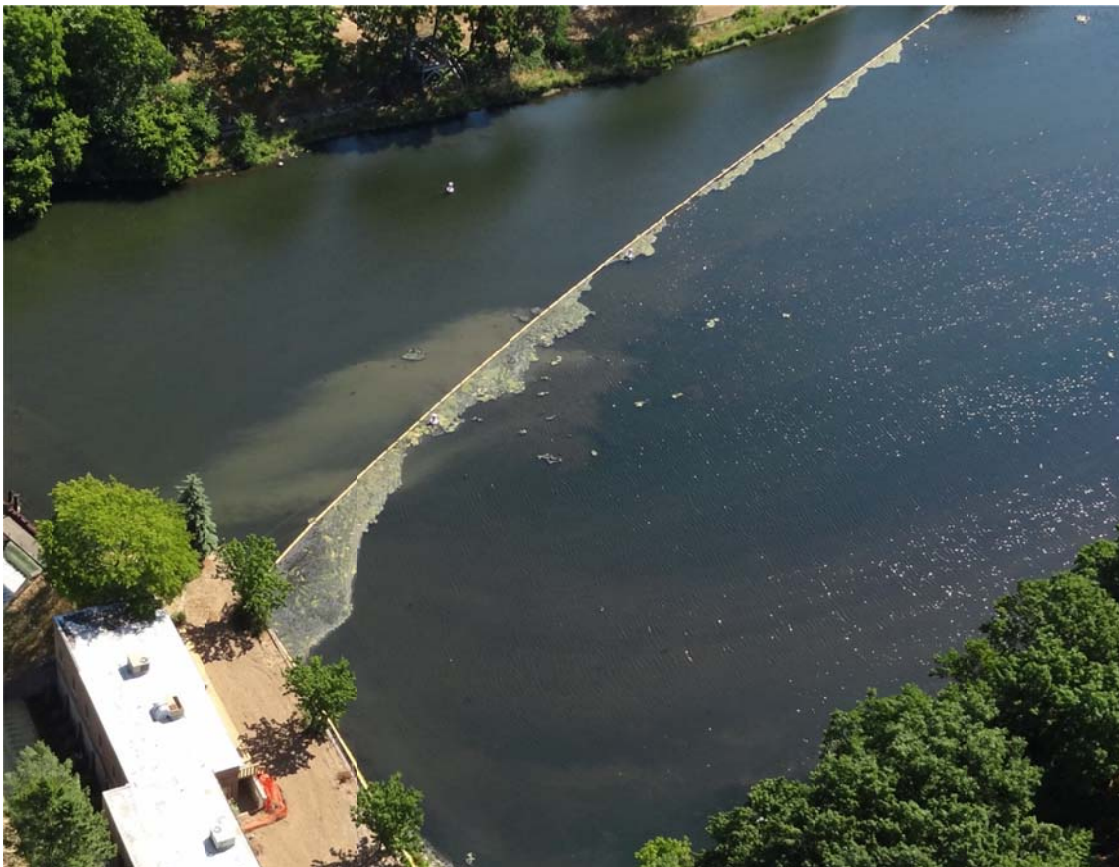
8. Vegetation and turbidity observed in vicinity of Ceresco Dam control point.

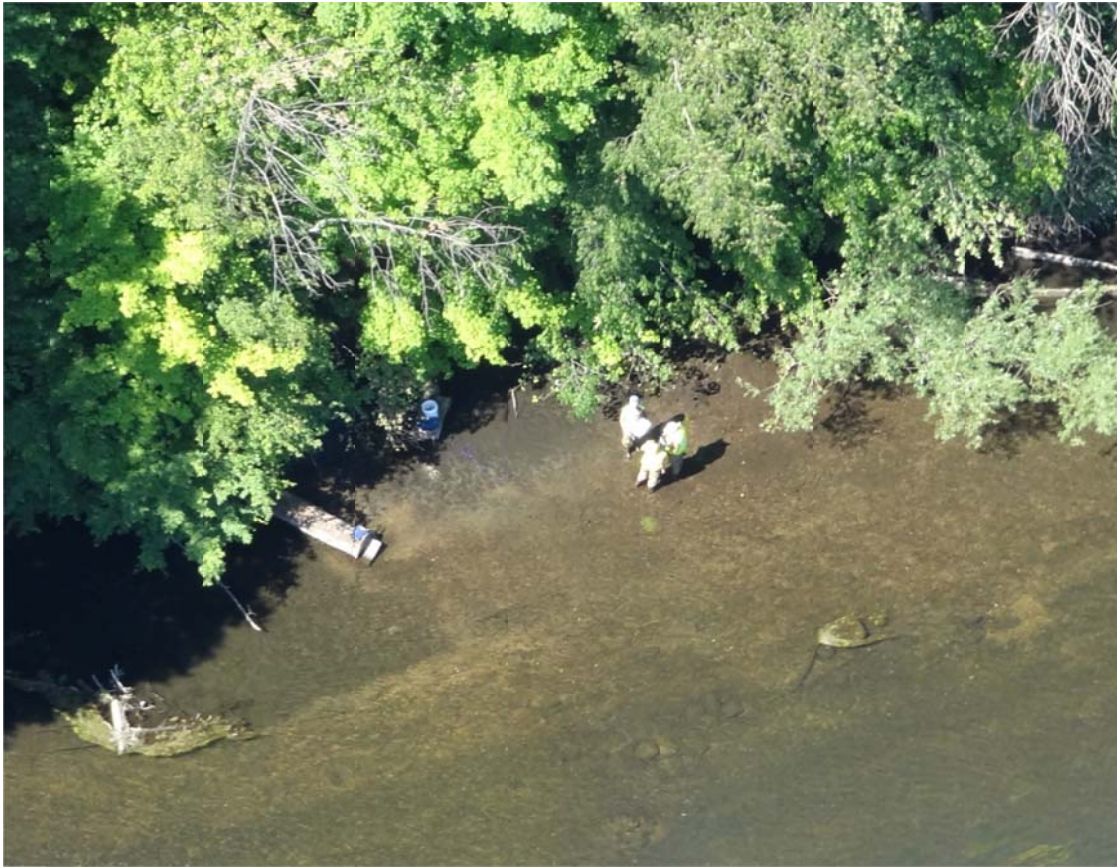
9. RI crew observed along LDB near MP 8.0.

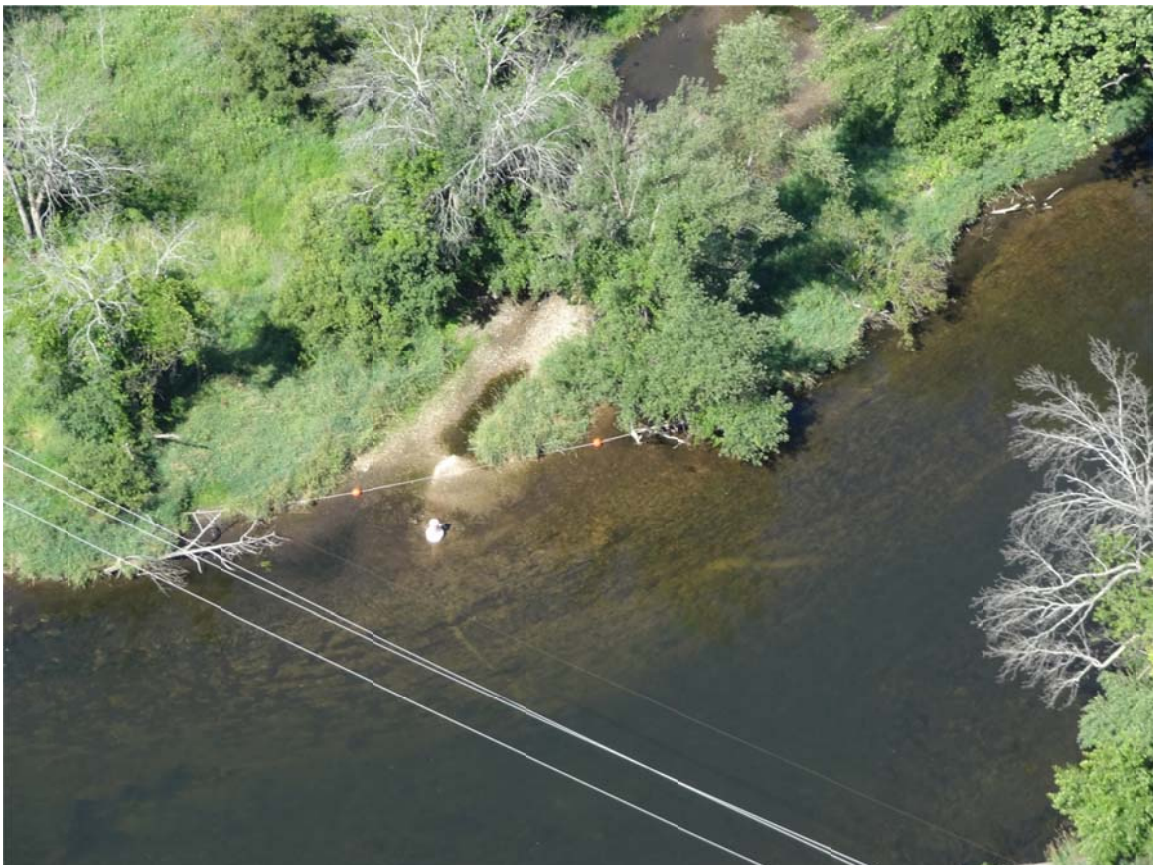
10. Upstream side of MP 10.75 sediment trap. Inlet is almost dry.

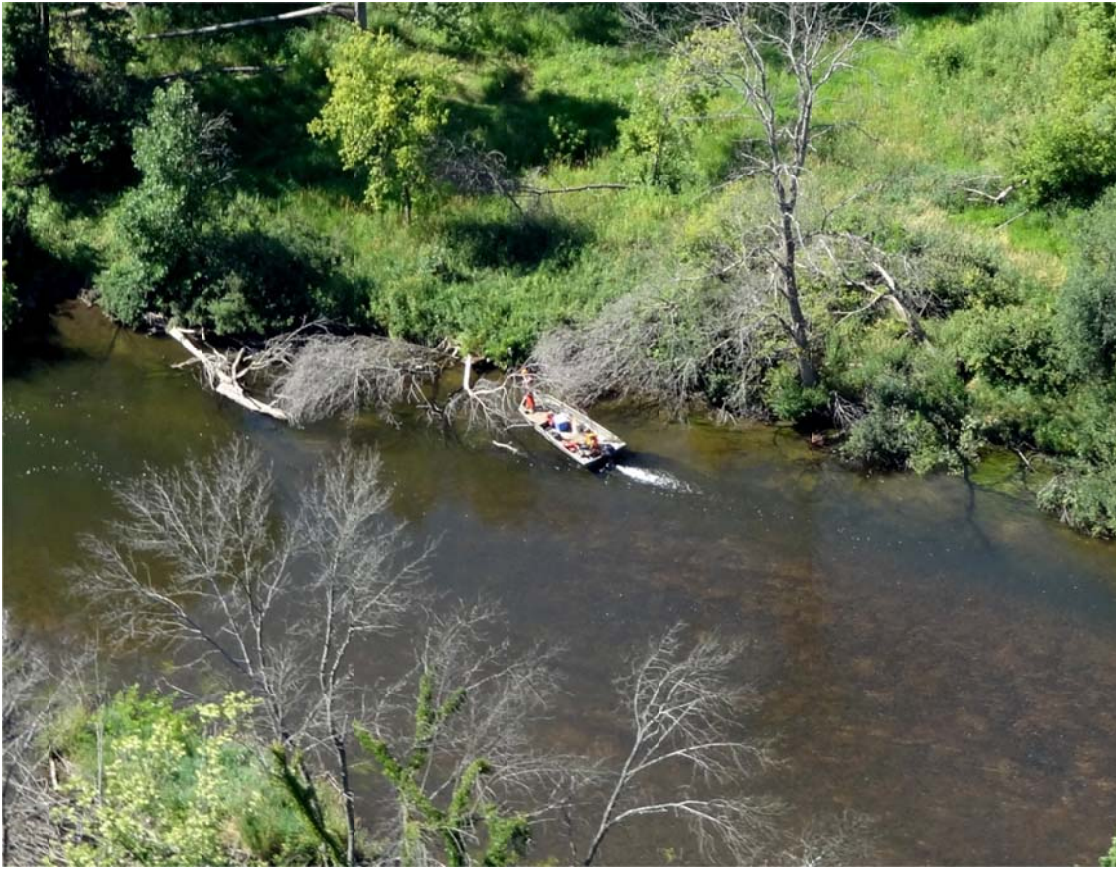
**11. Boat crew observed along LDB near MP 12.0.**

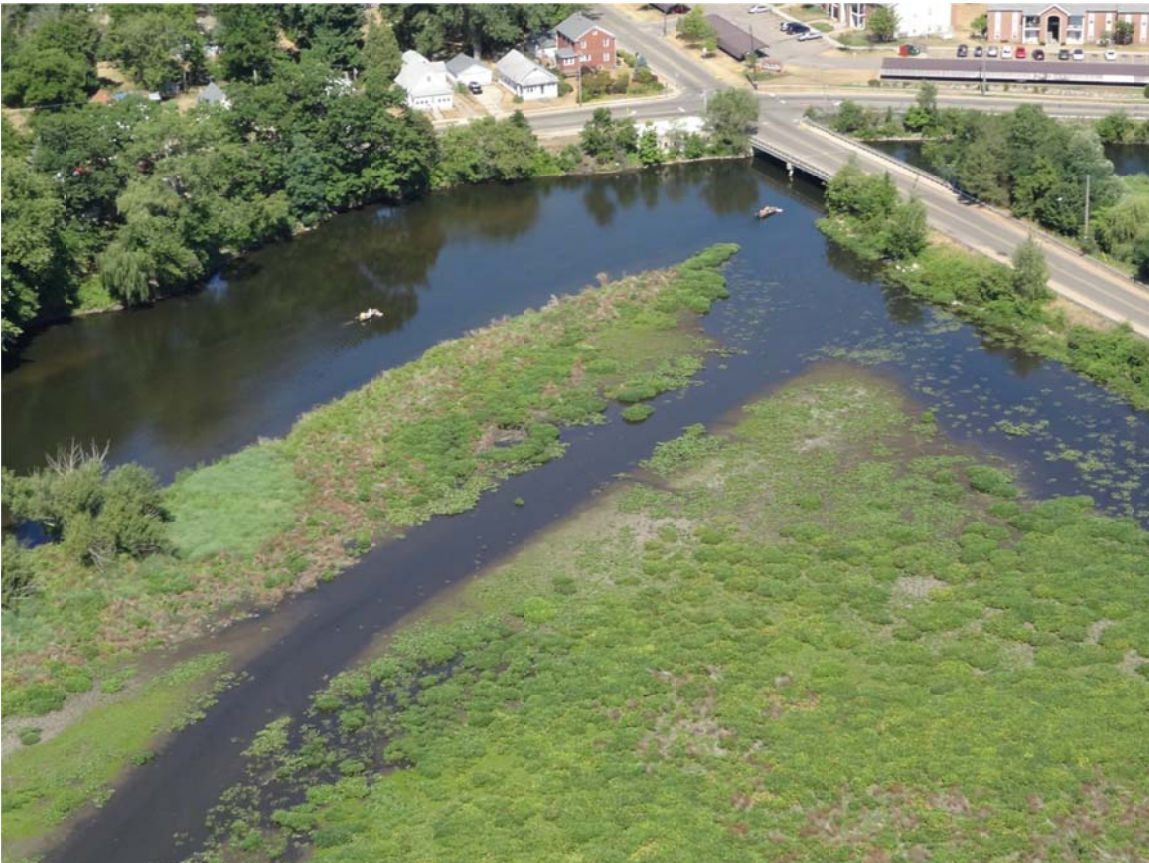
**12. South end of Mill Pond, two sweeper boats observed. No sheen observed.**

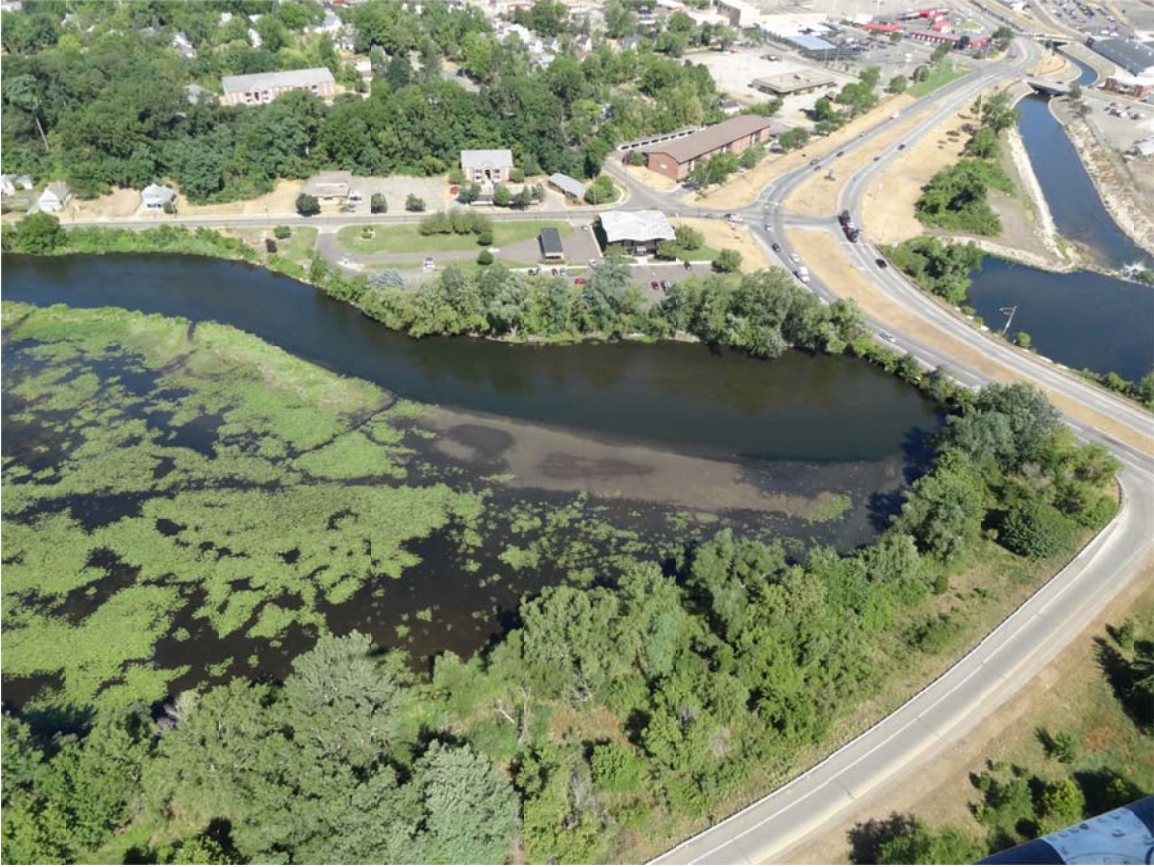
**13. North end of Mill Pond and Battle Creek spillway, no sheen observed.**

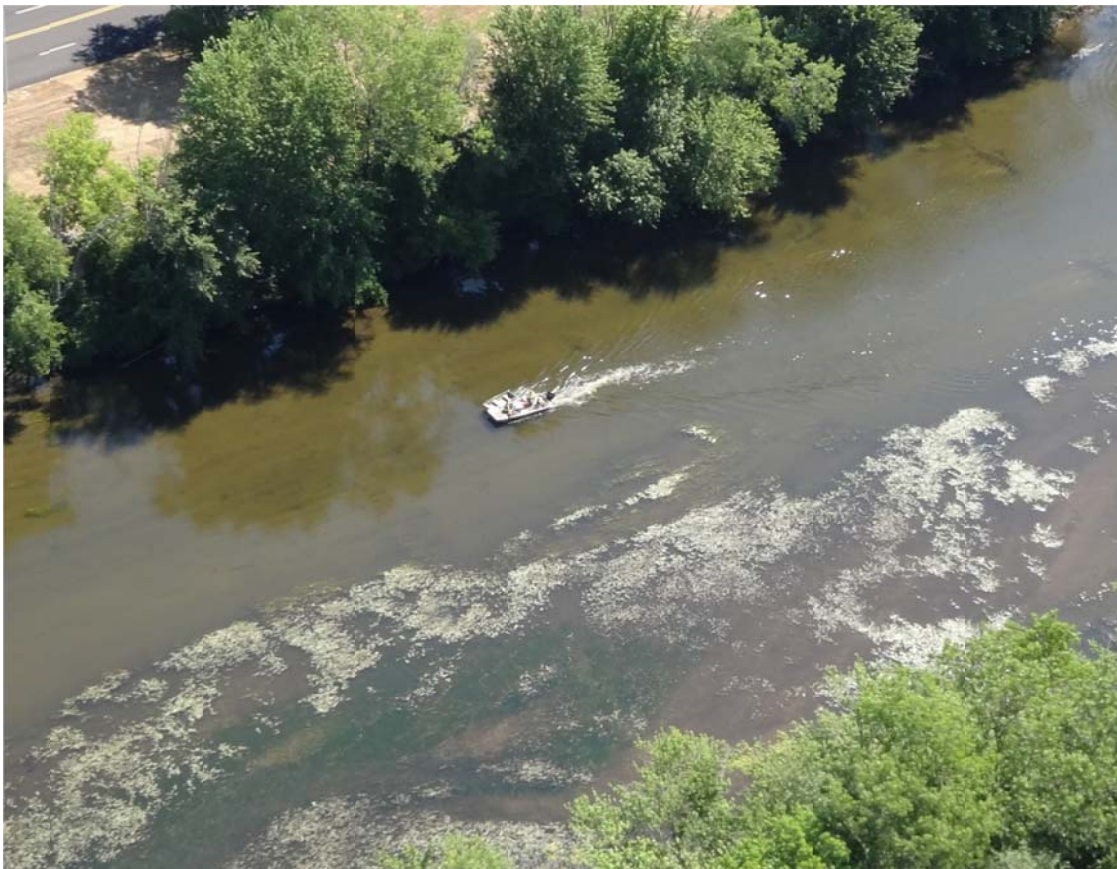
**14. Boat crew moving downstream near MP 18.00.**

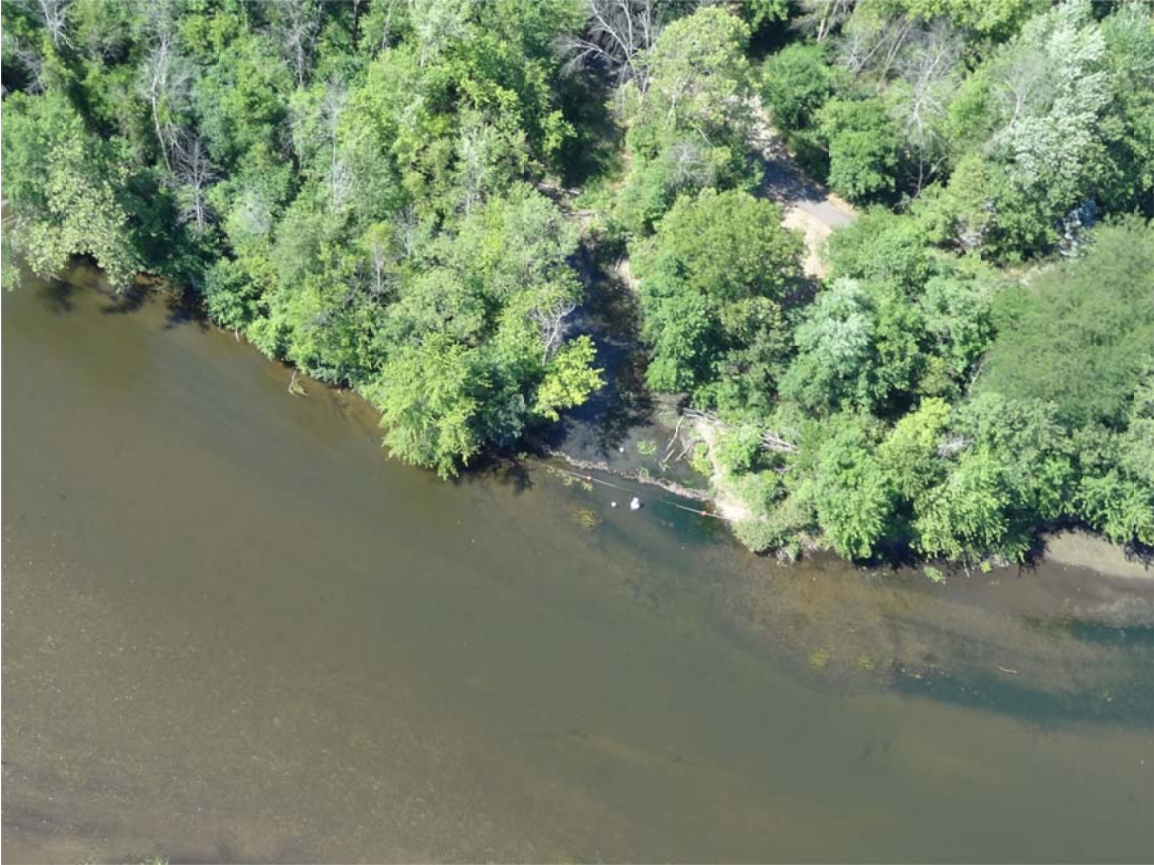
**15. Downstream side of MP19.25 sediment trap, no sheen observed.**

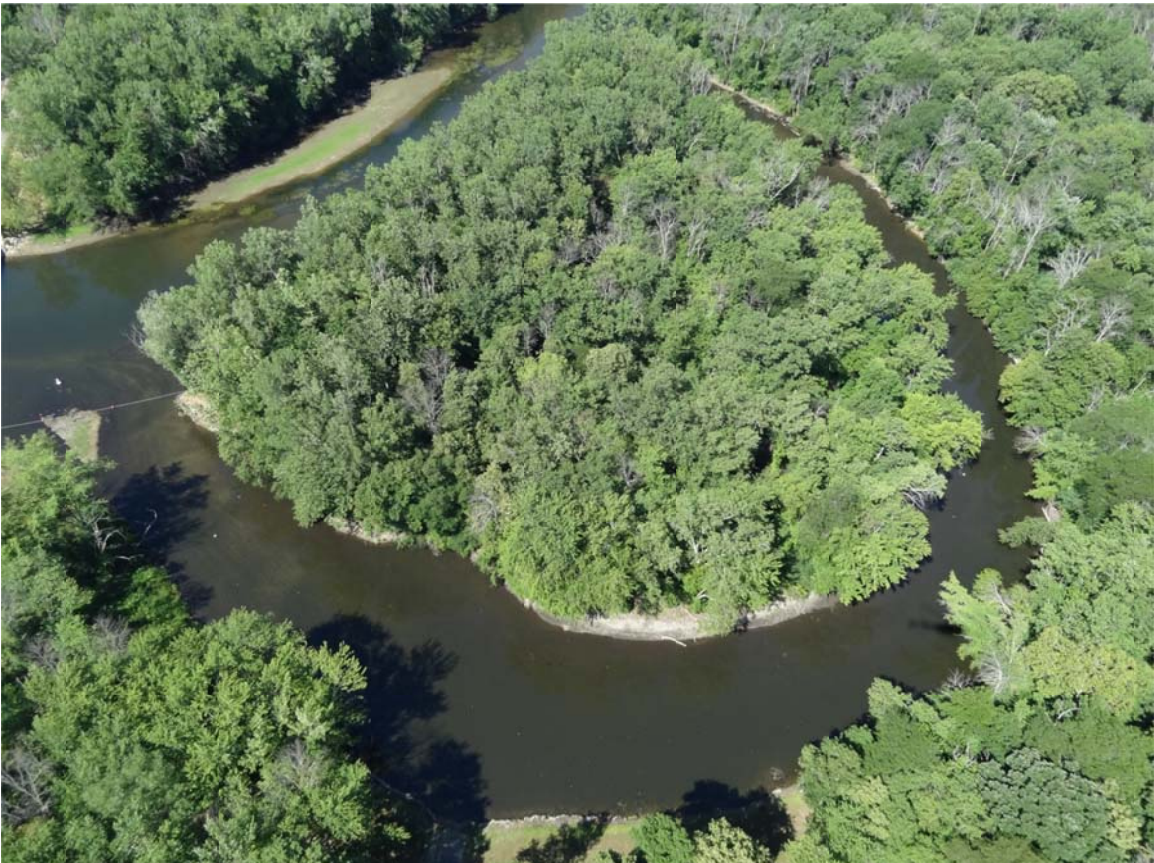
**16. Oxbow at MP21.5, no sheen observed.**

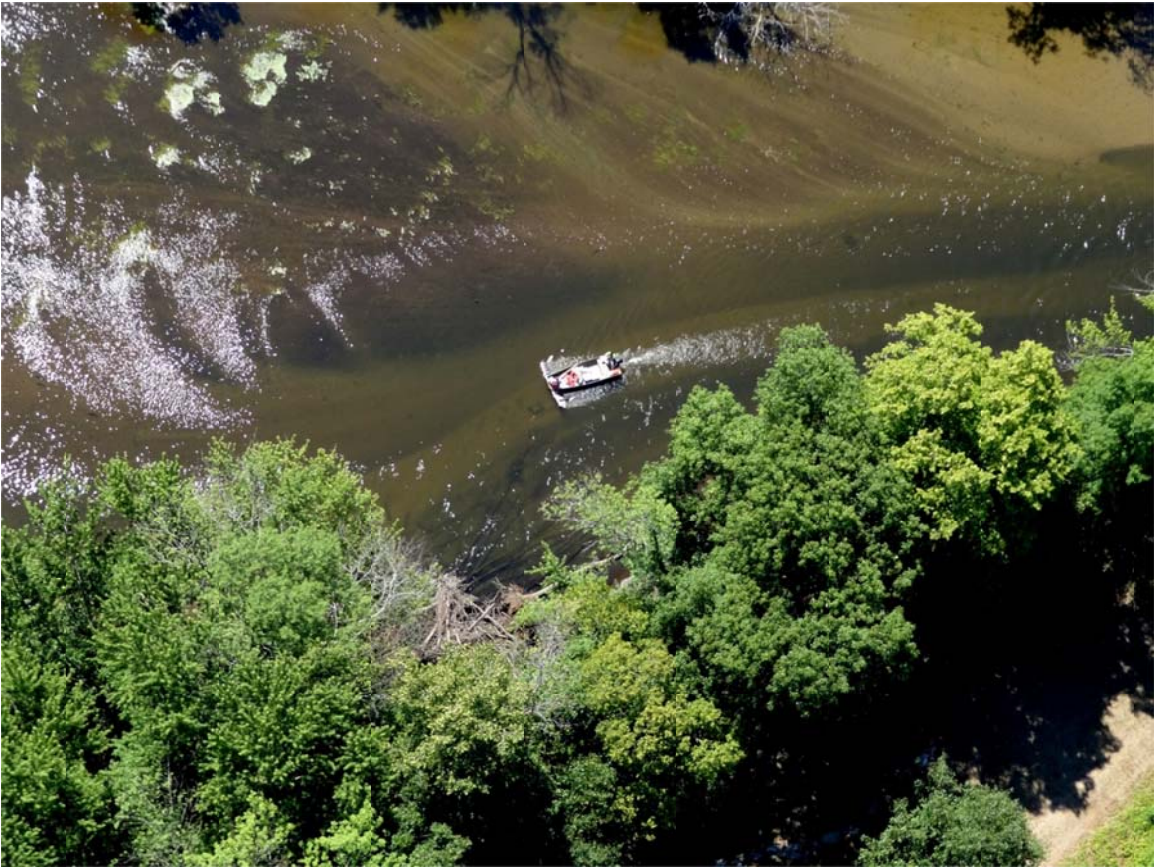
17. Sheen sweeper boat observed near MP 25.00.

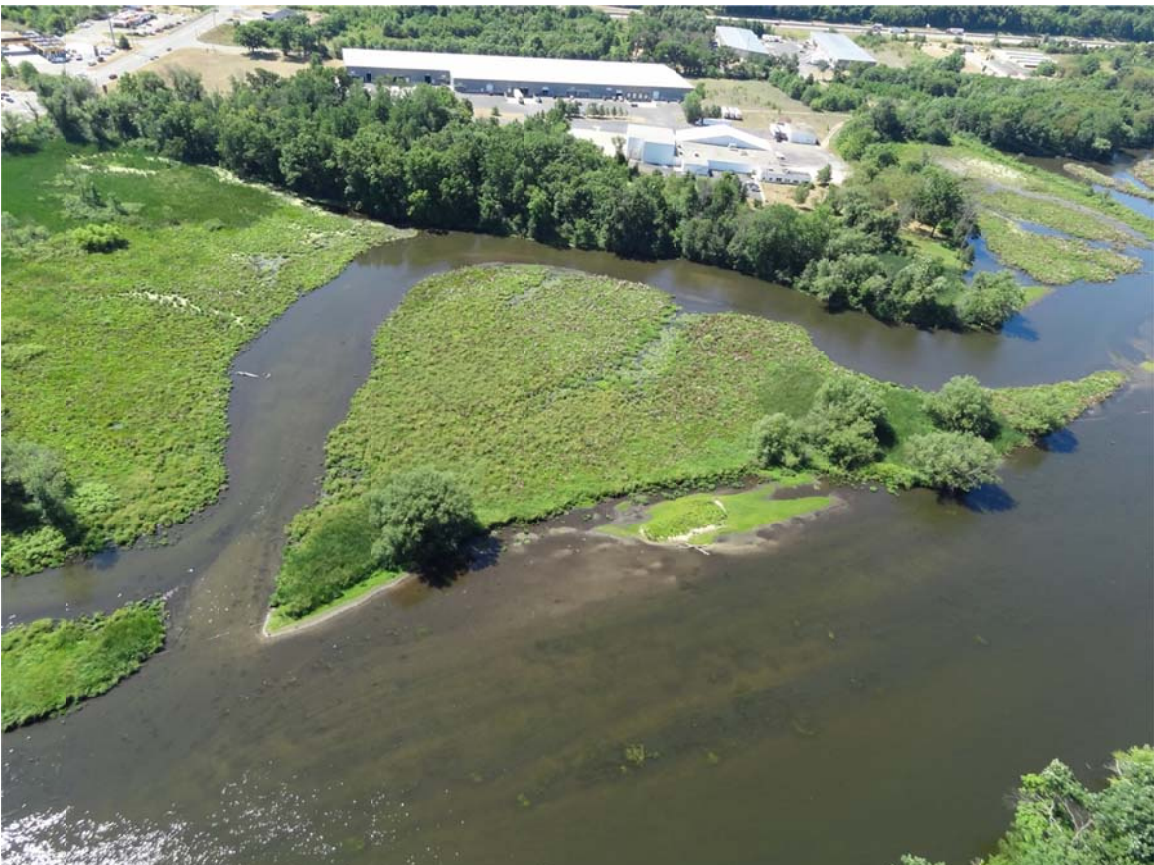
18. East end of Morrow Lake Delta, no sheen or activity observed.

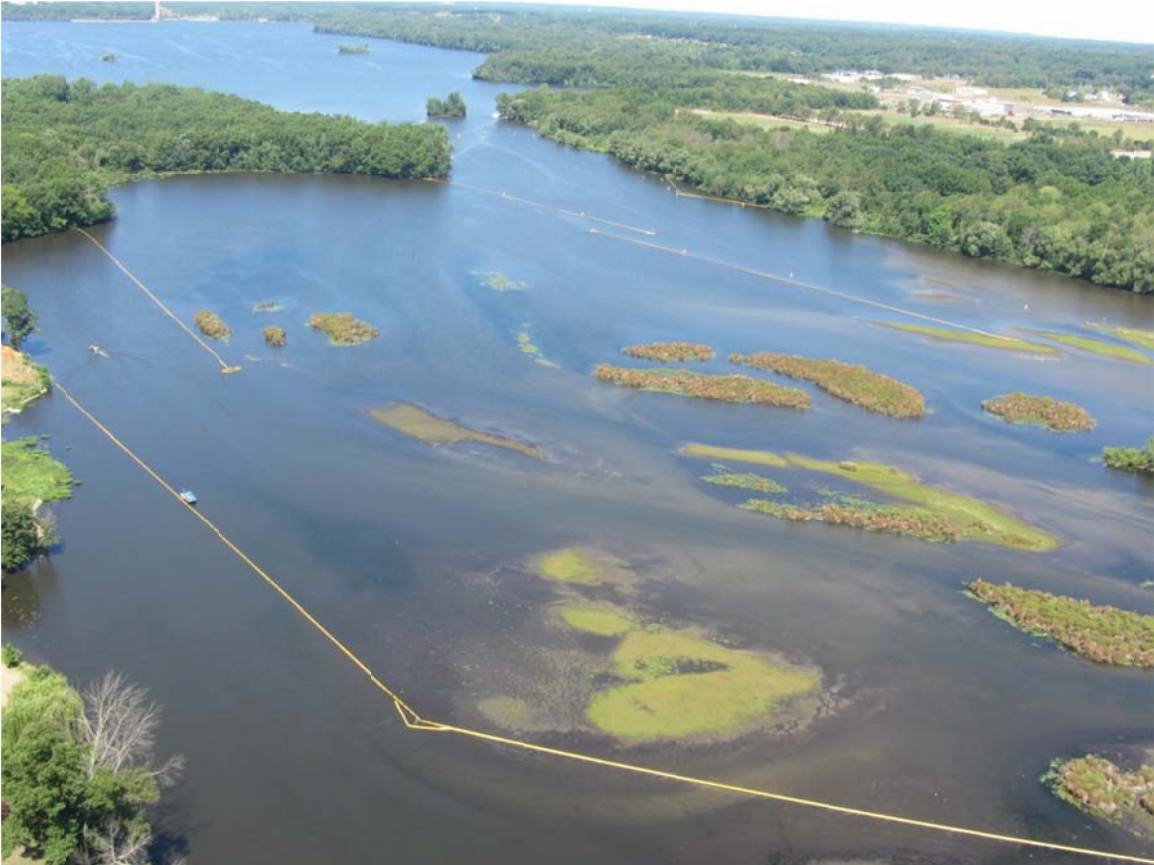
**19. E 3.5 containment boom installed in southern end of Morrow Lake Delta.**

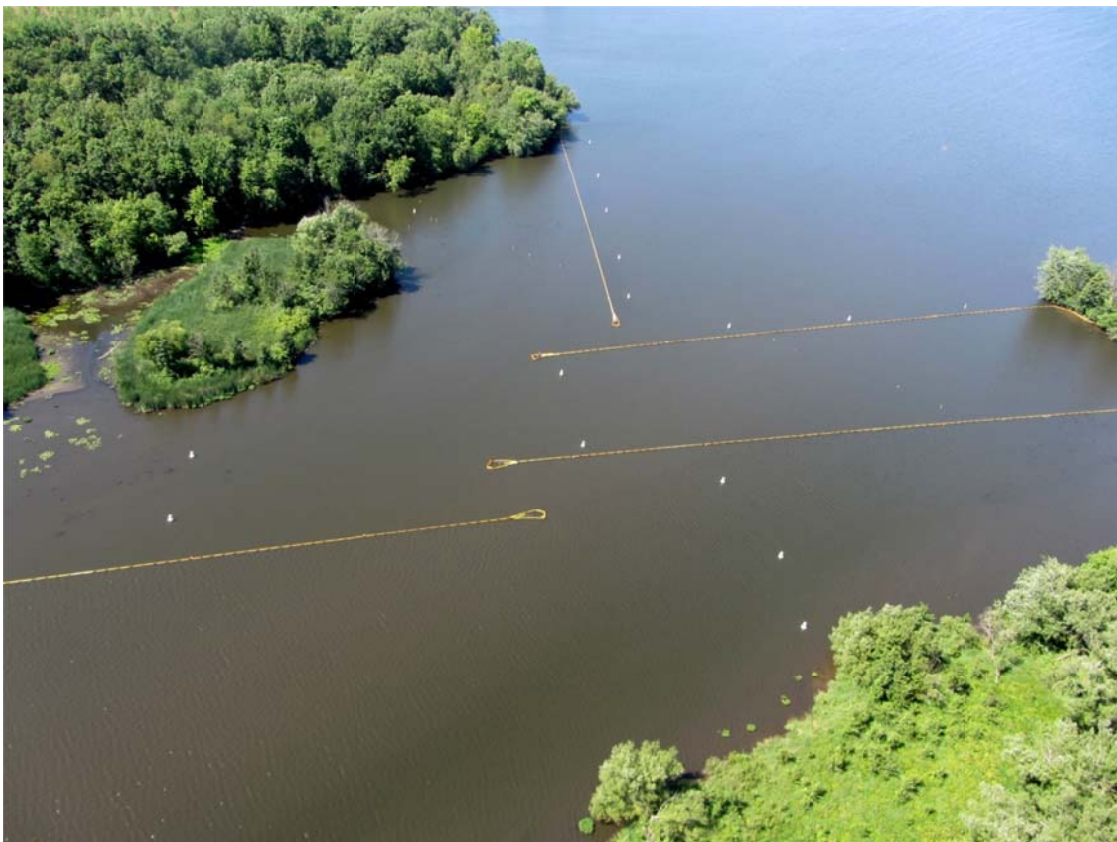
**20. Current boom configuration at E4 control point.**

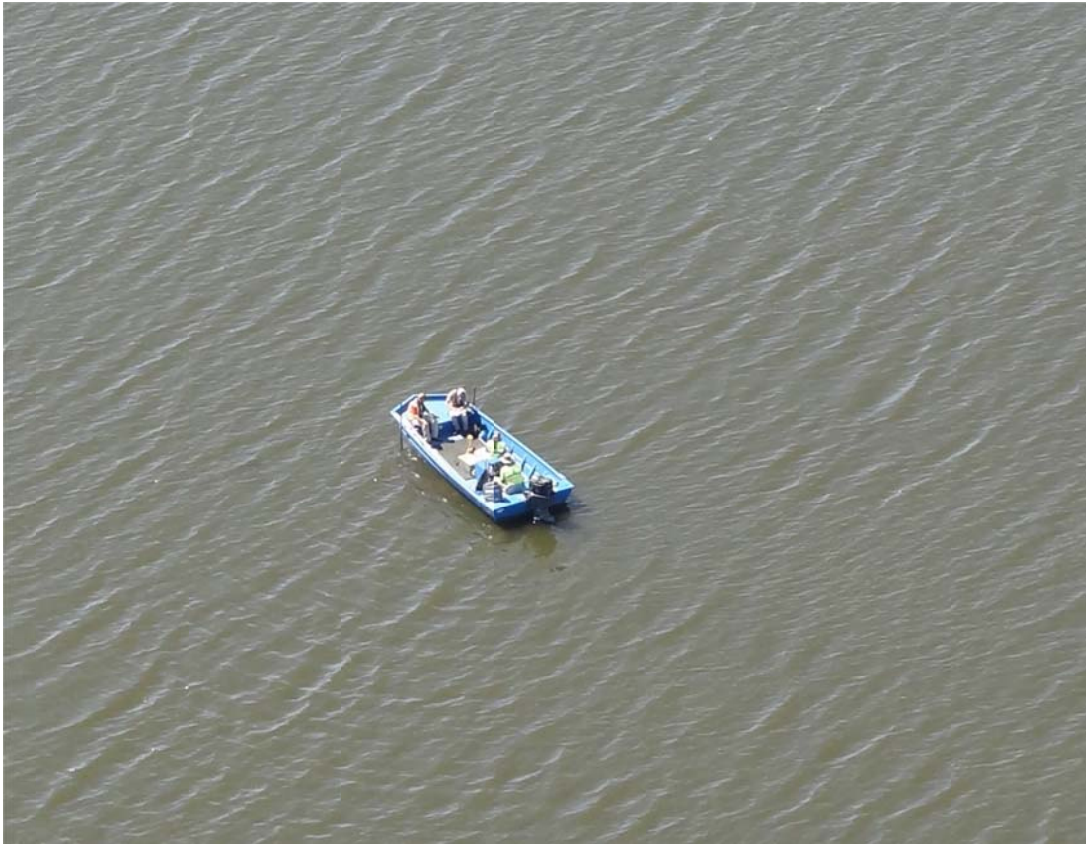
21. Poling crew observed in central portion of Morrow Lake.

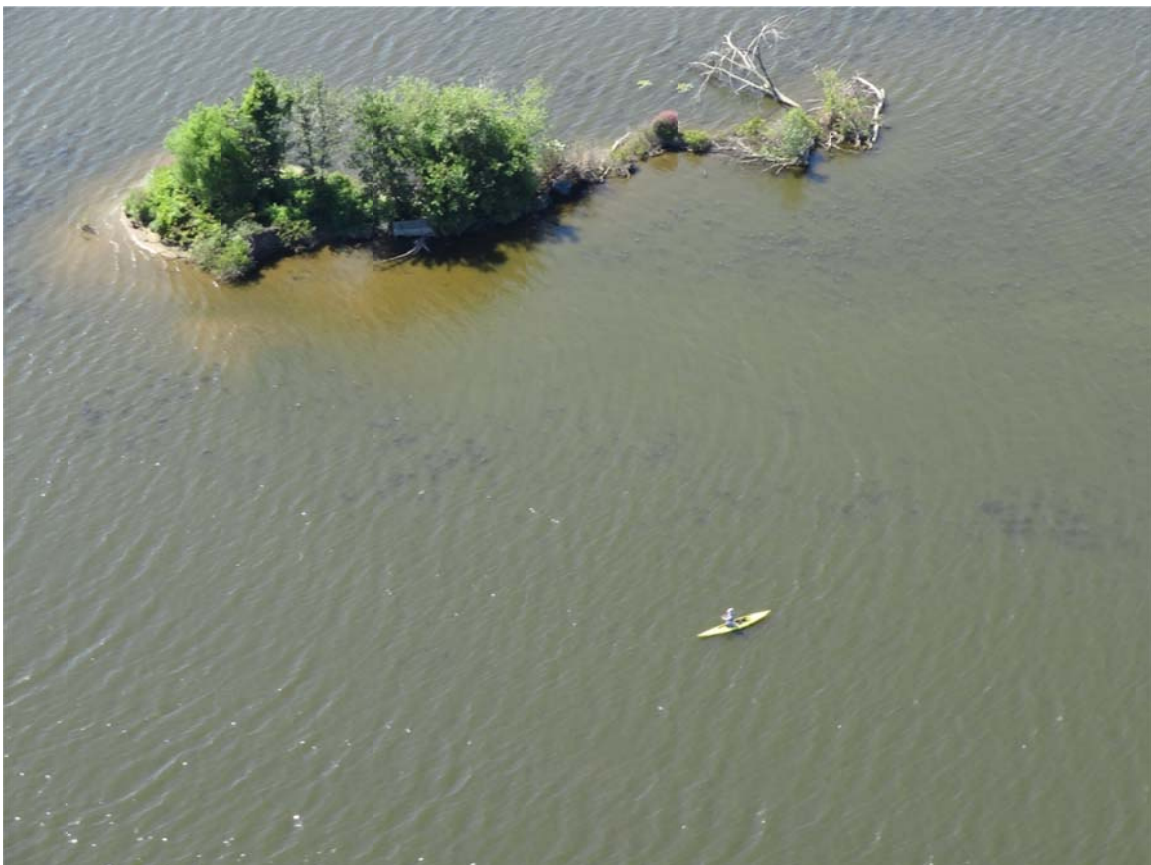
22. Canoe fisherman observed in central portion of Morrow Lake.

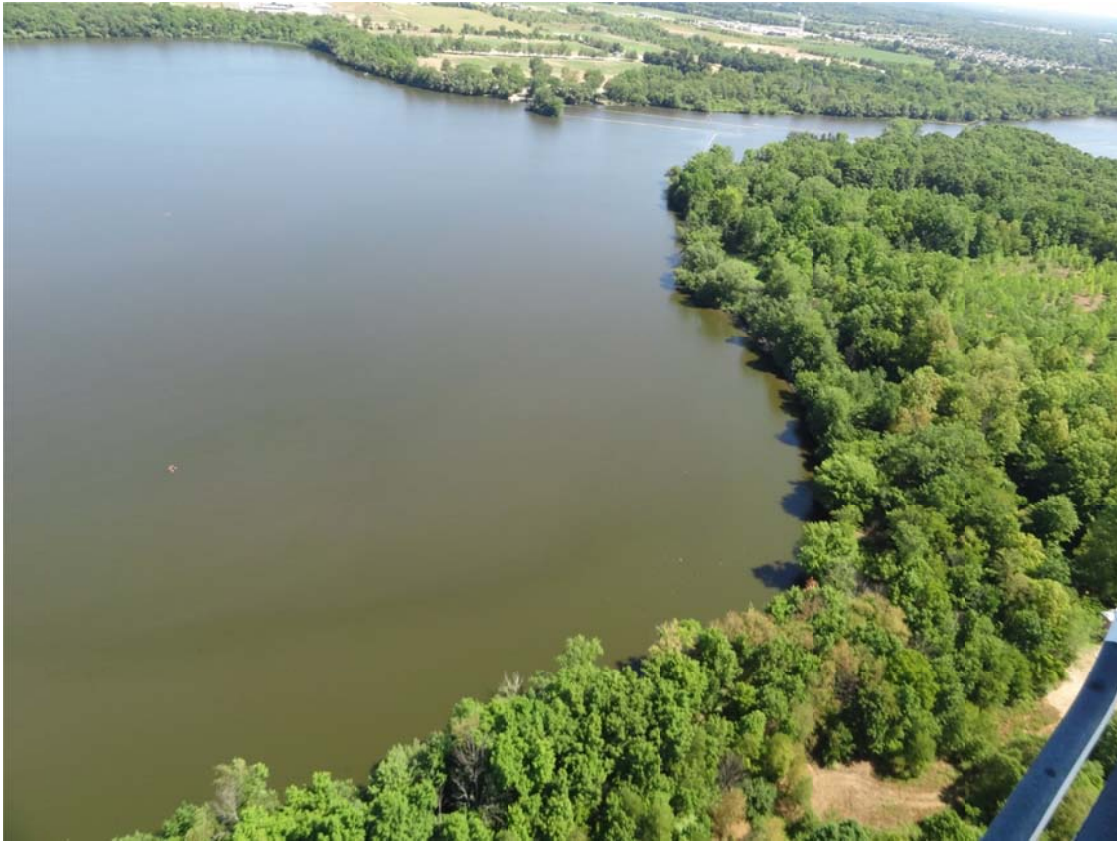
**23. South shore of Morrow Lake south of the fan. No sheen observed here today.**
