# Situation Photo Log

Tuesday, July 10, 2012

Kalamazoo River / Enbridge Spill

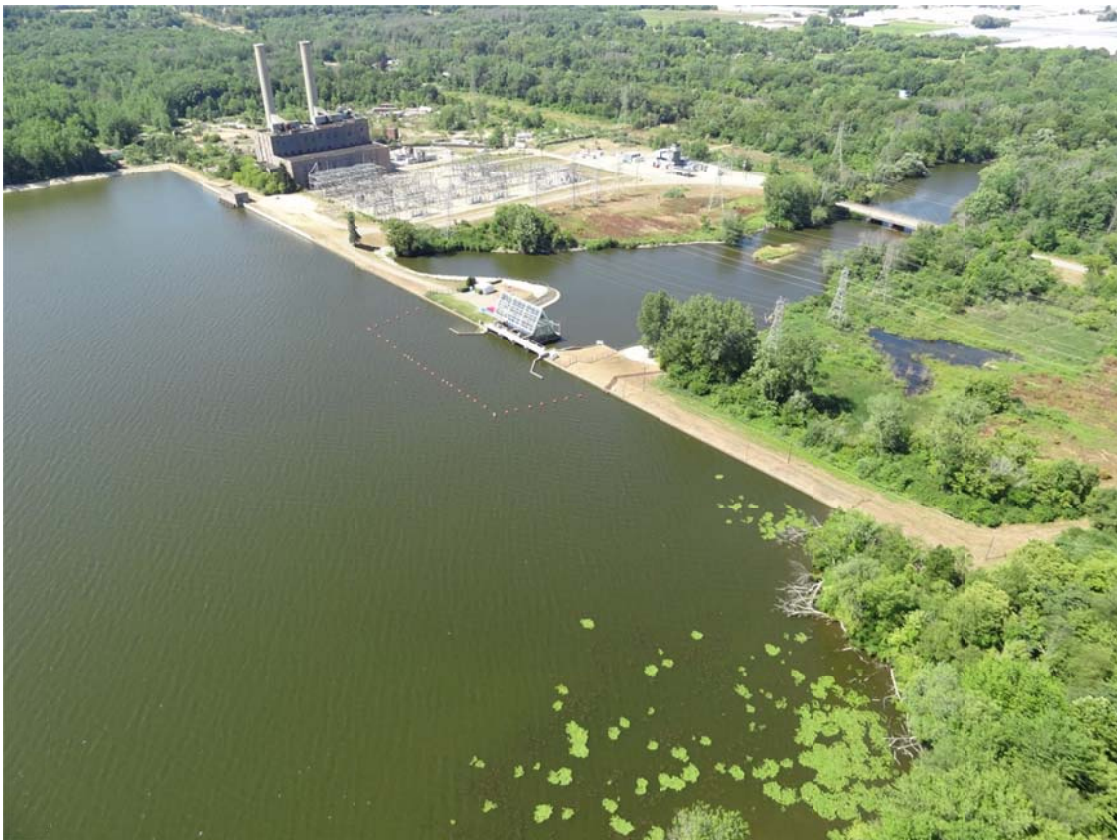
**24. Morrow Lake Dam, no sheen or activity observed.**
