# Situation Photo Log

Friday, July 13, 2012

Kalamazoo River / Enbridge Spill

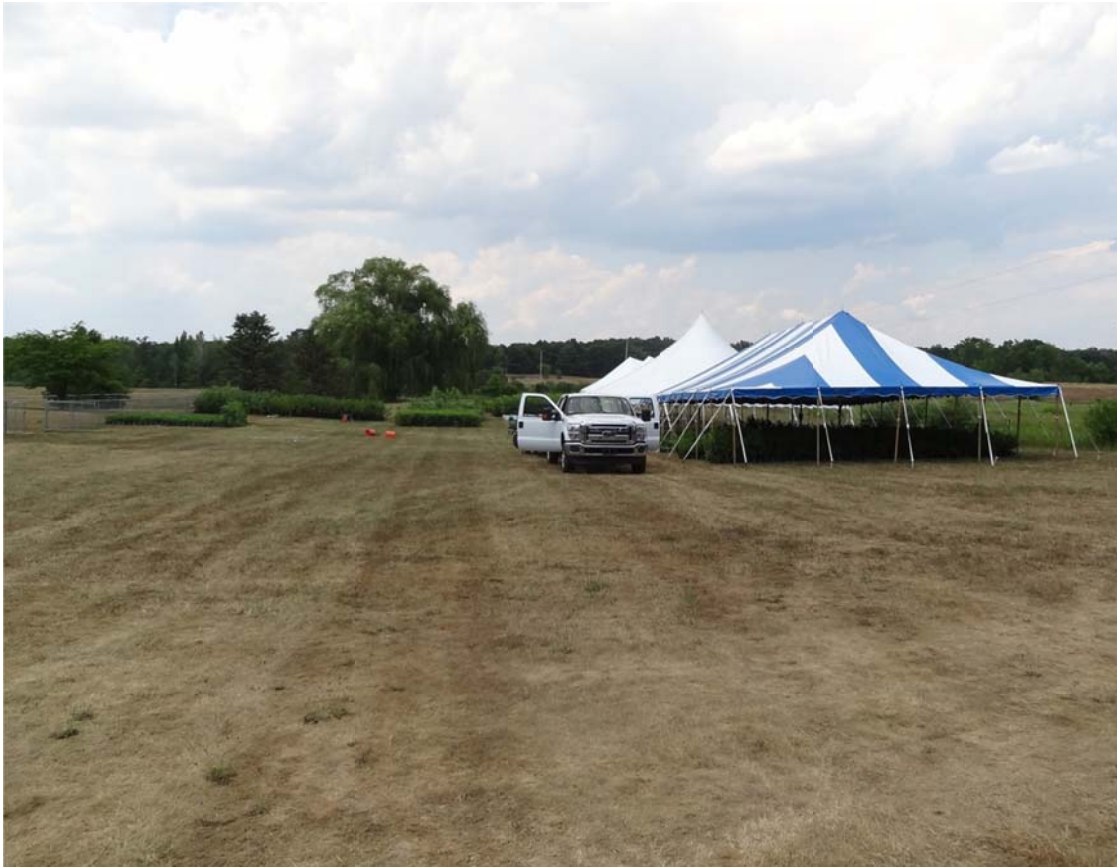
**1. Plant staging area set up along Division Drive for Talmadge Creek tree planting activities.**

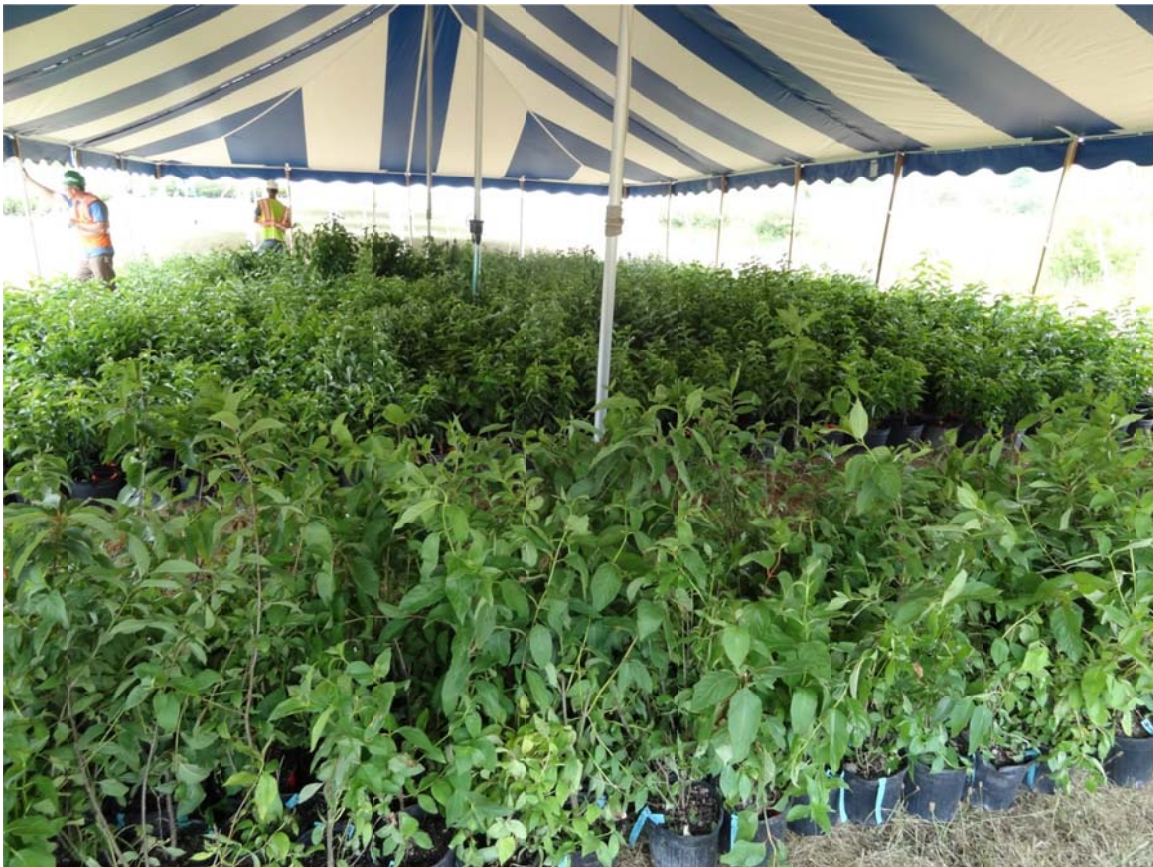
**2. Trees unloaded and stored in shade for planting along Talmadge Creek.**

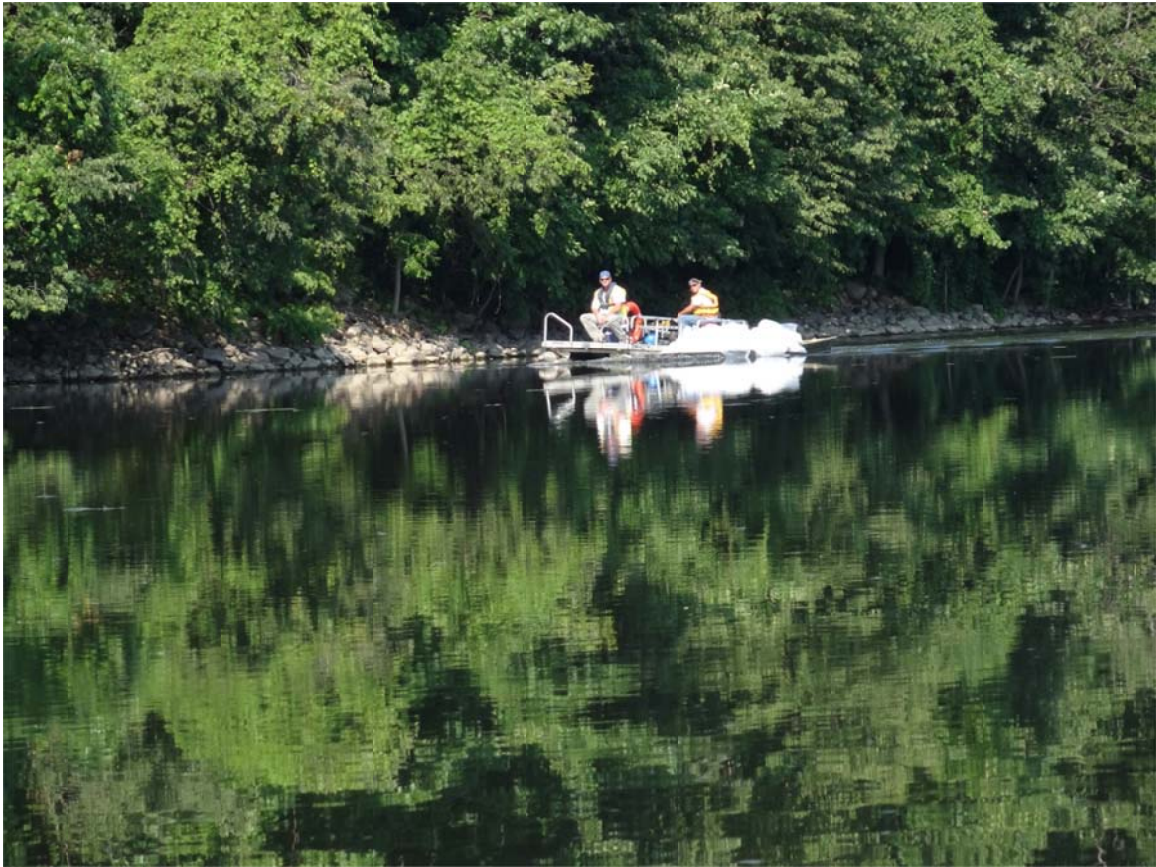
3. Crew transporting debris bags from Ceresco Dam control point upstream to C0.4 boat launch.

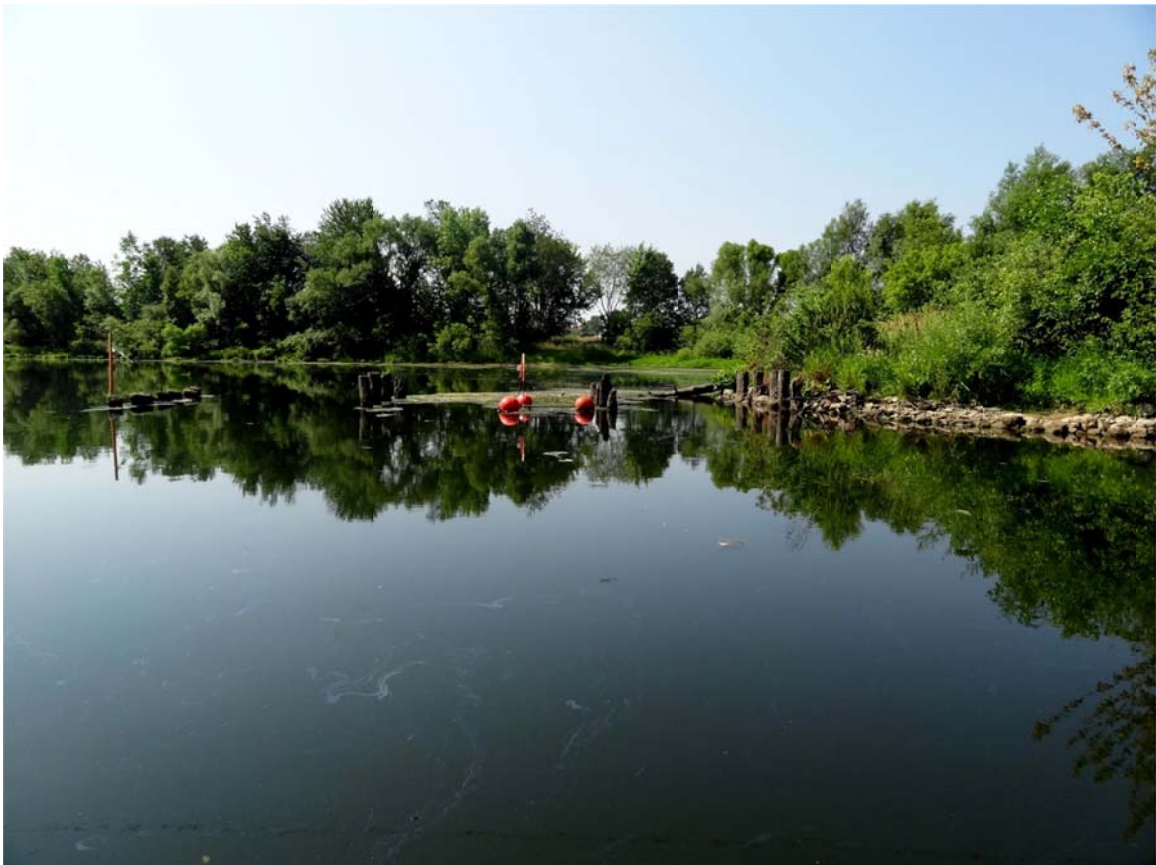
4. Sheen and vegetation observed at former trestle above Ceresco Dam.

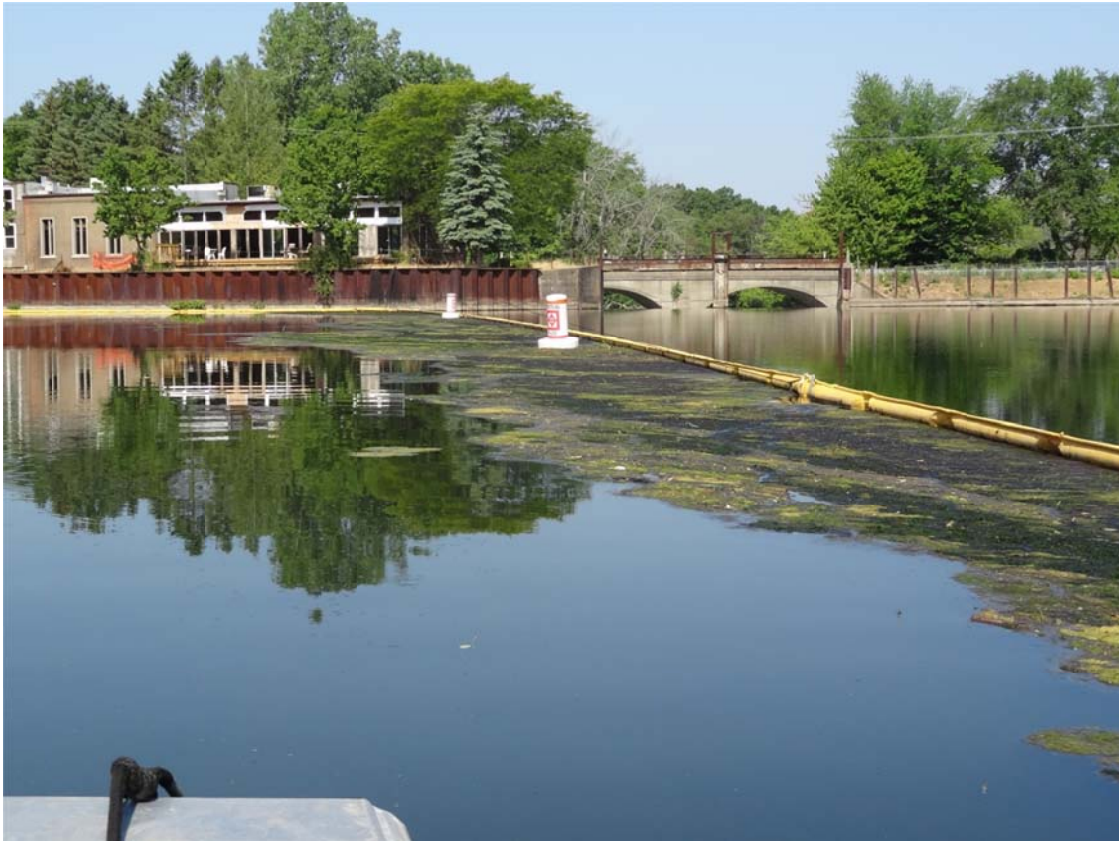
5. Vegetation and sheen observed along containment boom above Ceresco Dam.

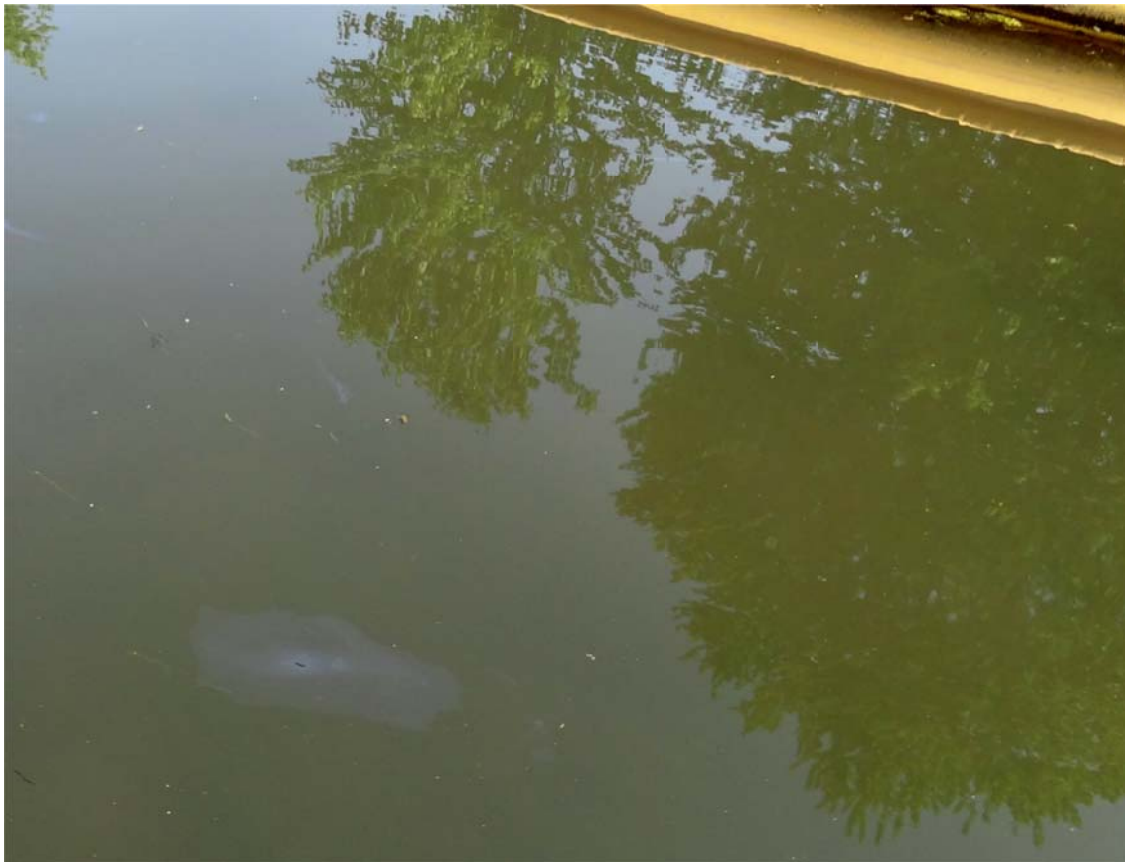
6. Globules and sheen within containment above Ceresco Dam.

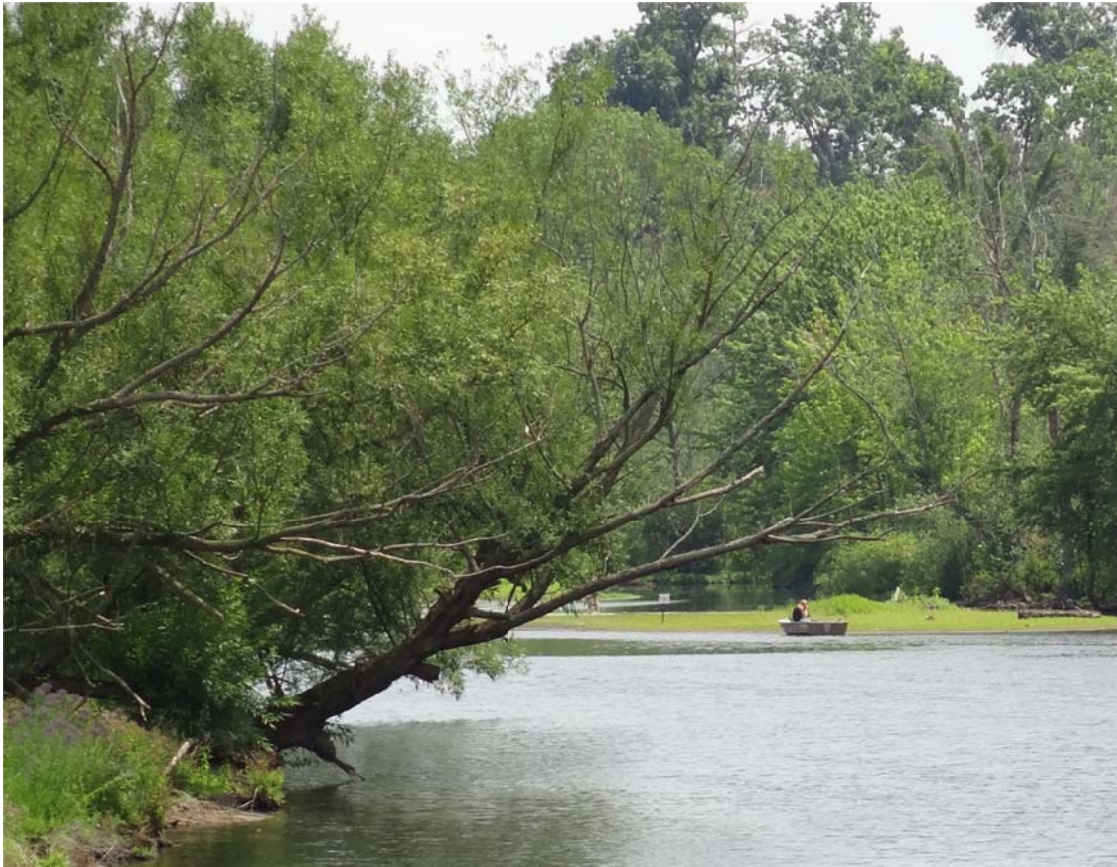
7. Recreational boaters near MP 15.0 upstream from the Mill Ponds.

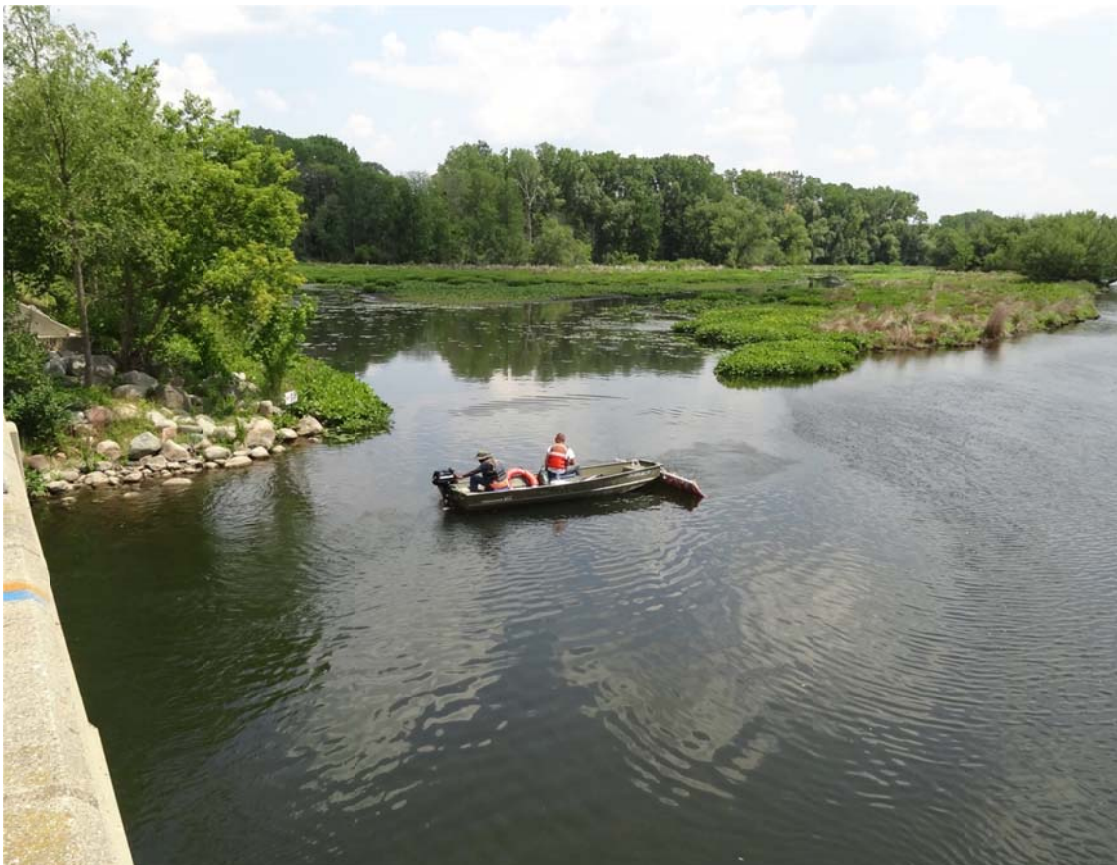
8. Sheen sweep boat operating in the southern half of the Mill Pond.

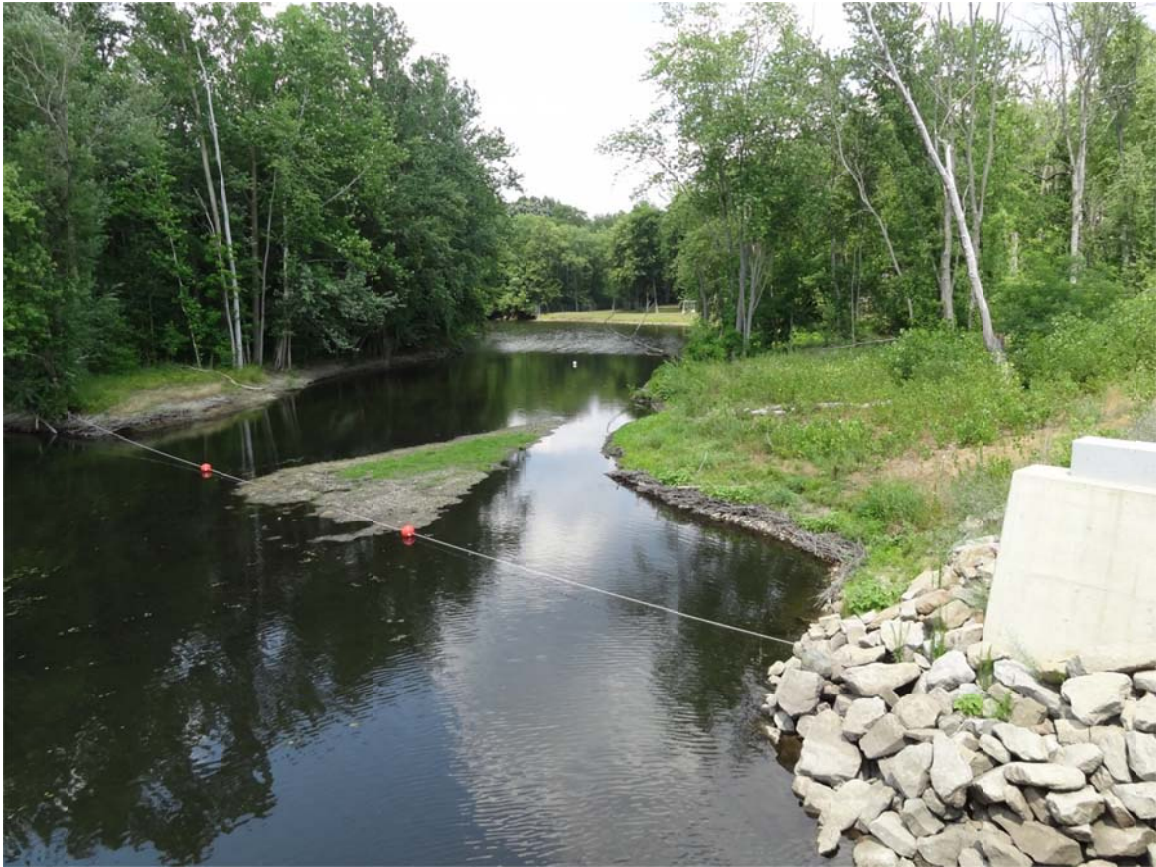
9. View of MP 21.5 oxbow from Custer Road Bridge. Sheen sweep boat observed operating downstream from bridge.

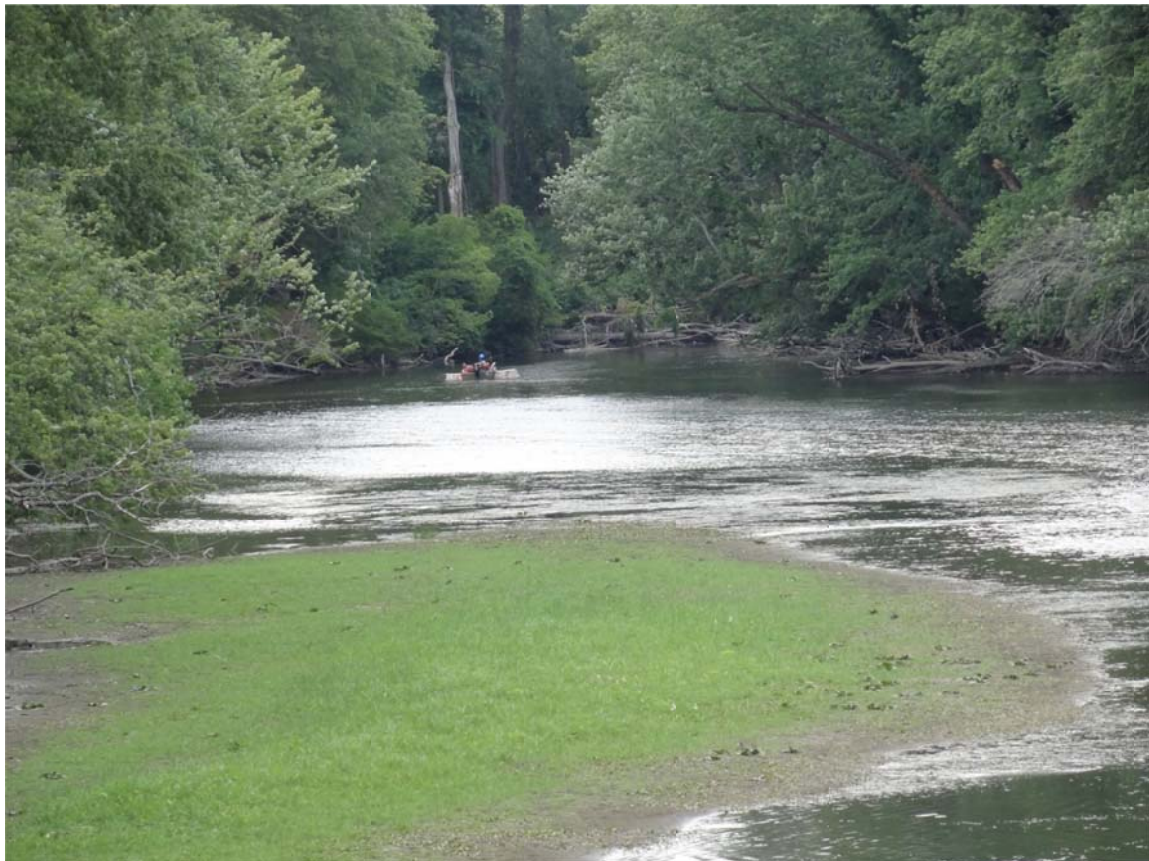
10. Sheen sweep boat observed downstream from MP 21.5 oxbow.

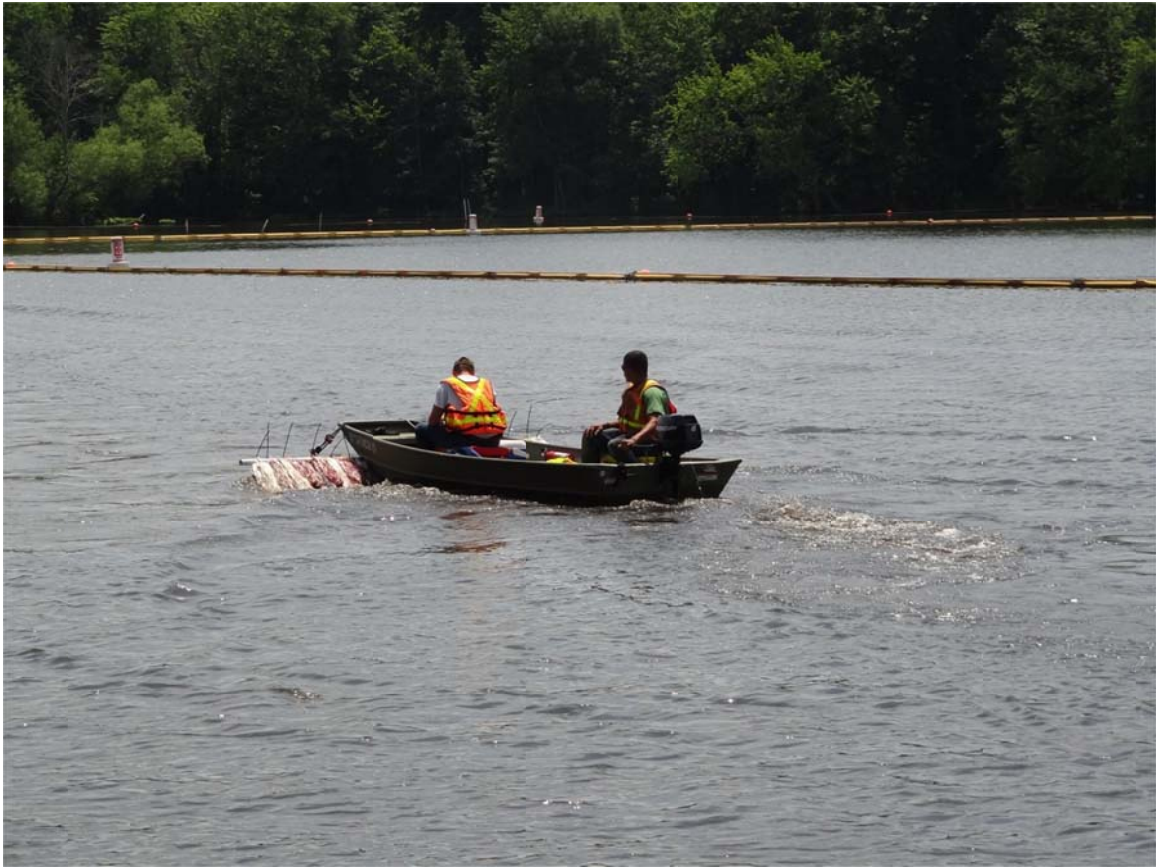
11. Sheen sweep boat operating in Morrow Lake Delta.

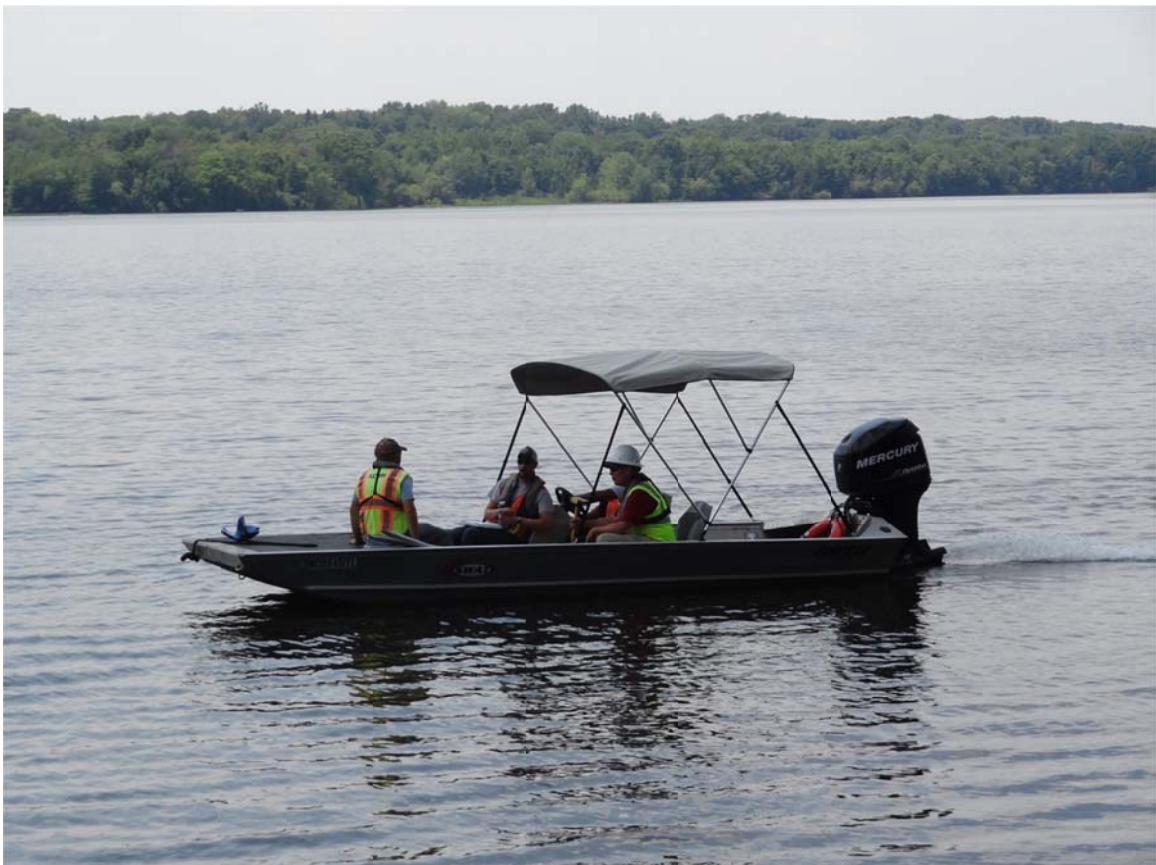
12. Morrow Lake Delta poling crew moving to next poling location.

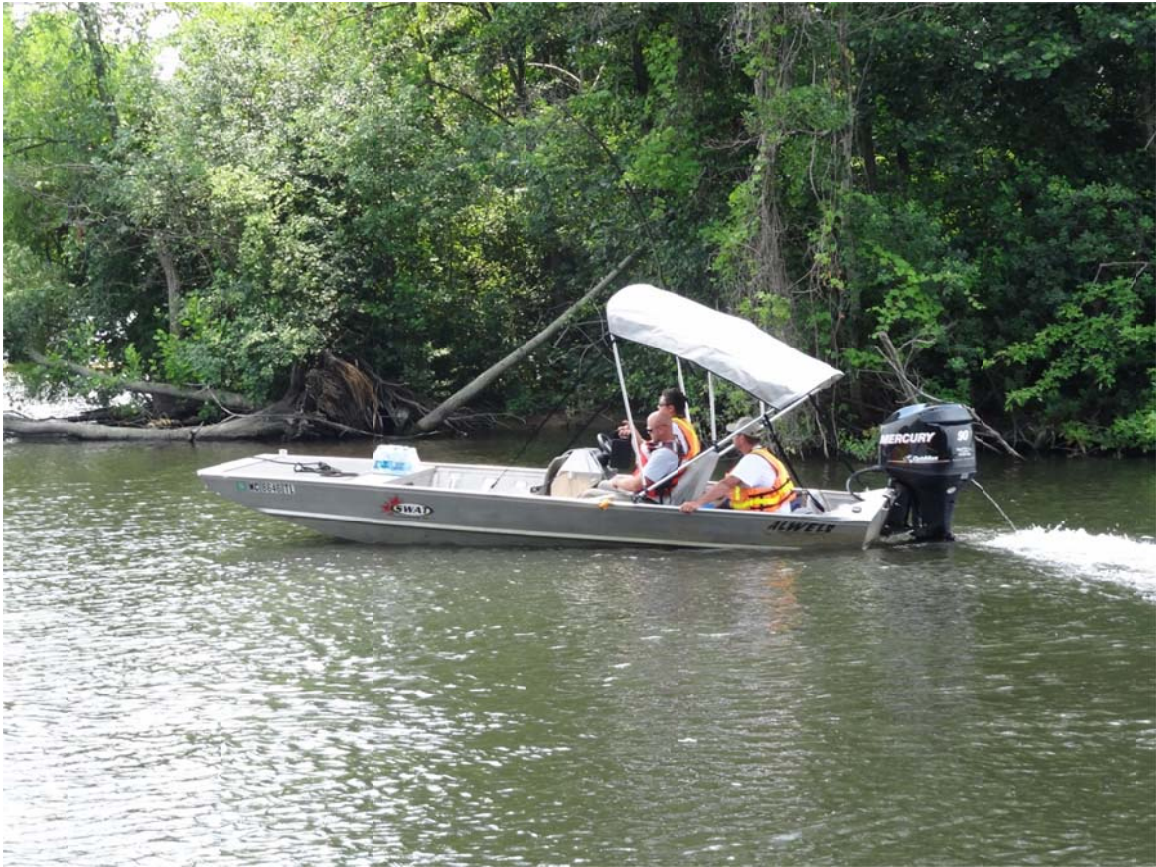
13. Sediment curtain inspection crew working at E 4.0 control point.

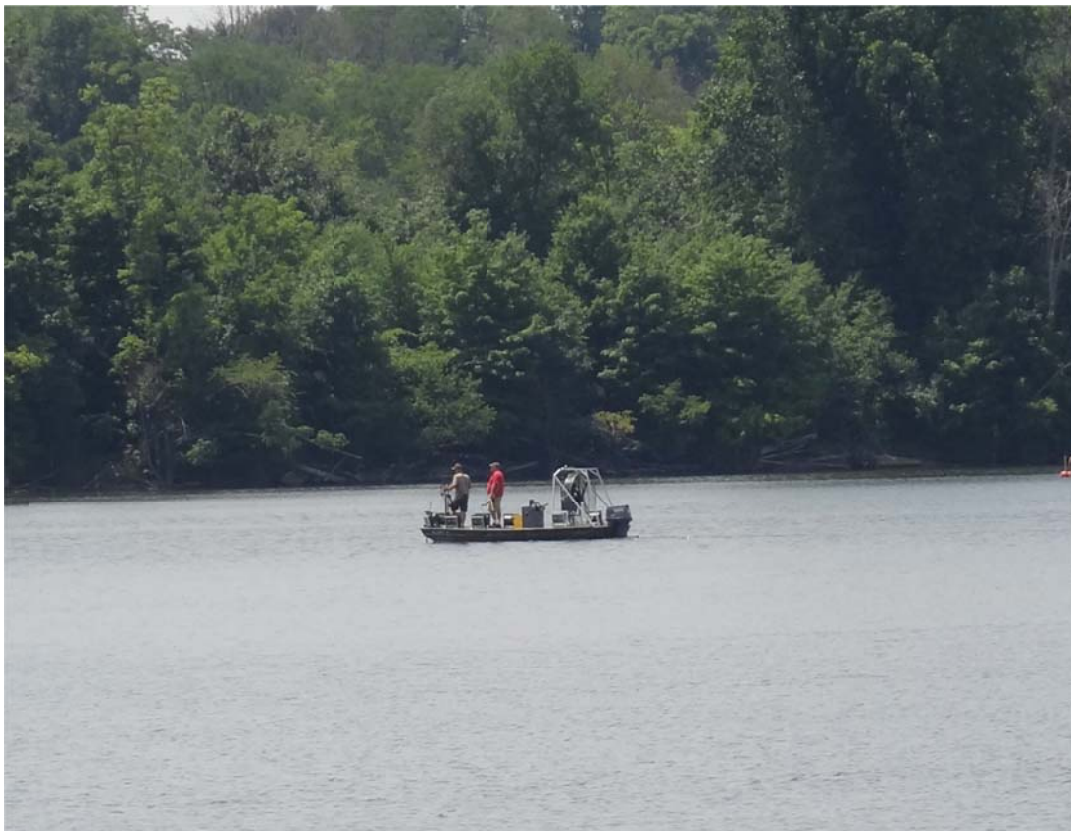
14. Recreational air boat observed along southern of Morrow Lake.
