Situation Photo Log

Saturday, July 14, 2012

Kalamazoo River / Enbridge Spill

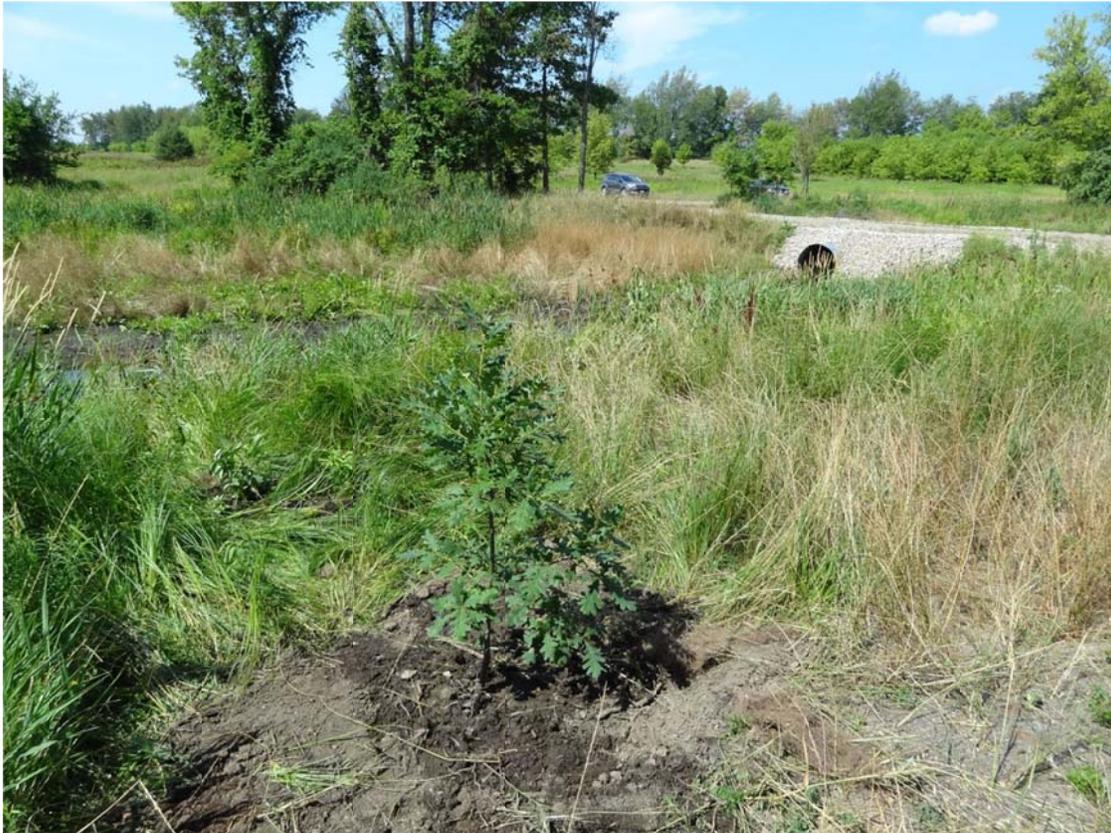
1. Trees planted along Talmadge Creek as part of restoration activities.

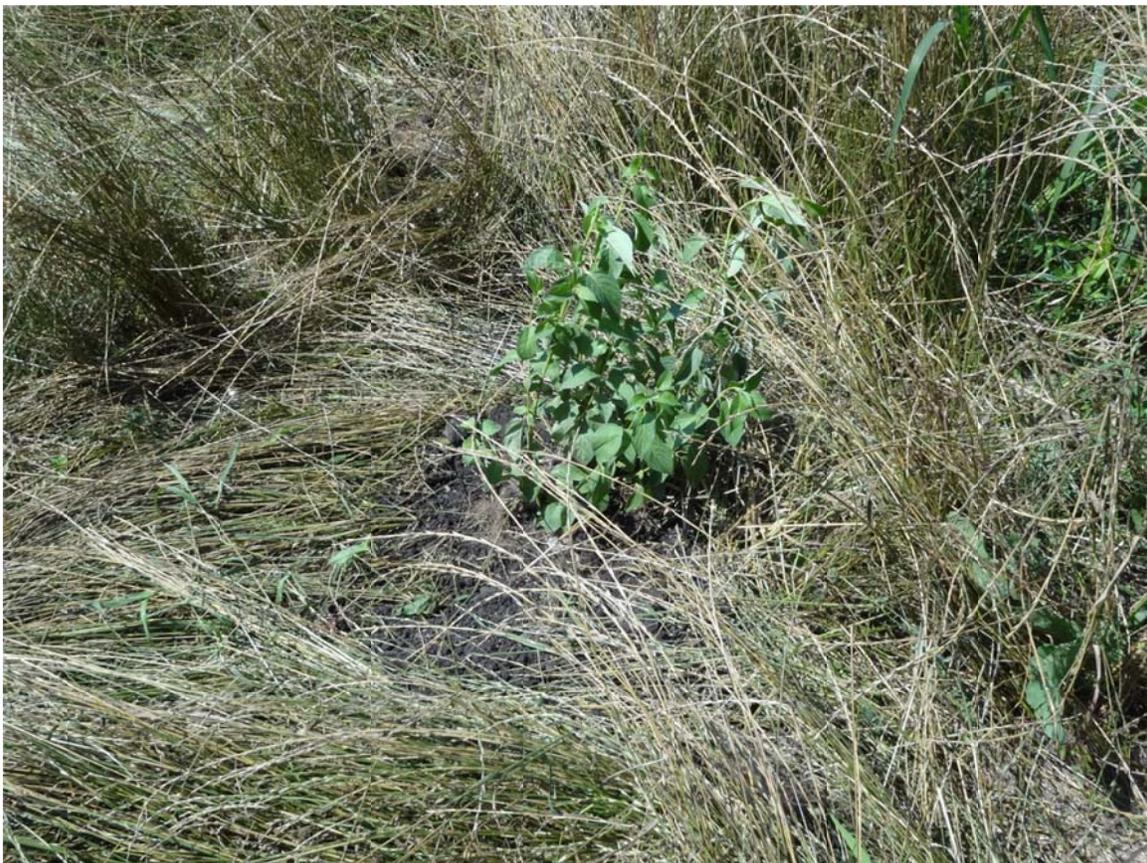
2. Shrub planted along Talmadge Creek as part of restoration activities.

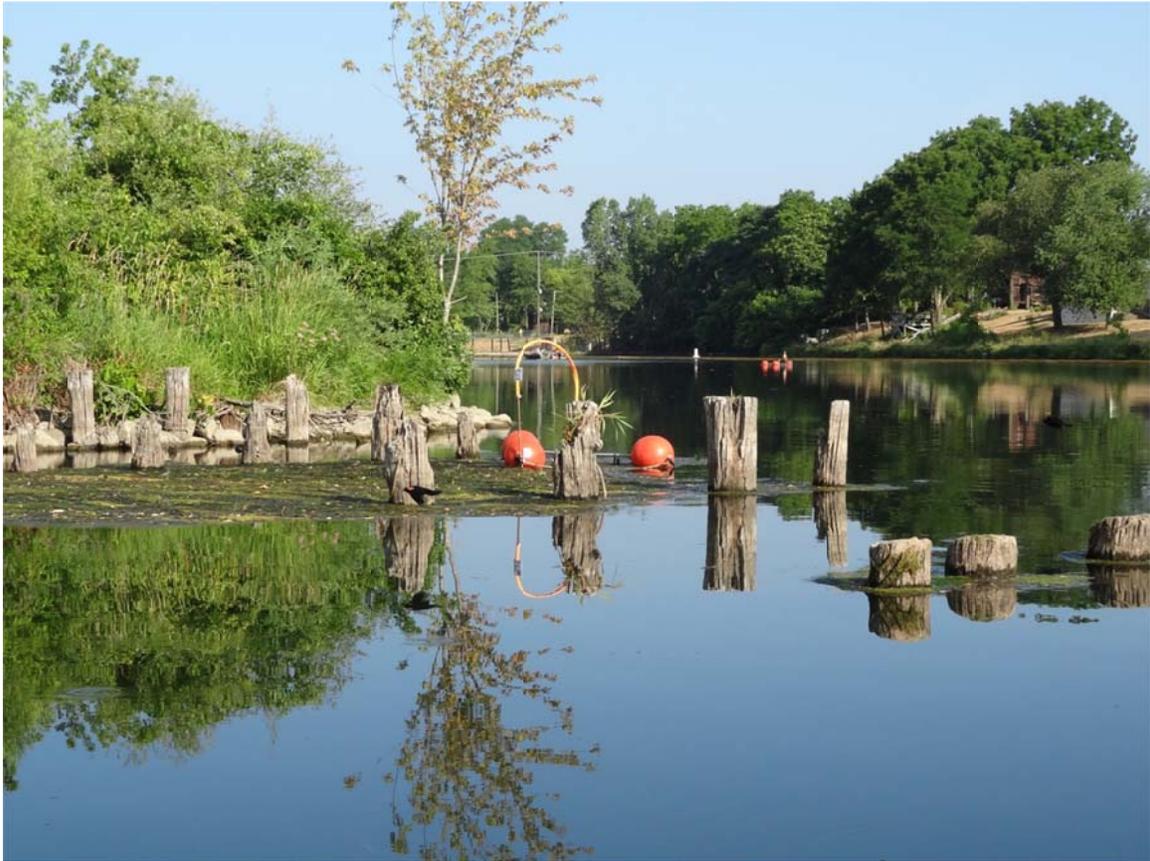
3. Vegetation and sheen observed at trestle above Ceresco Dam.

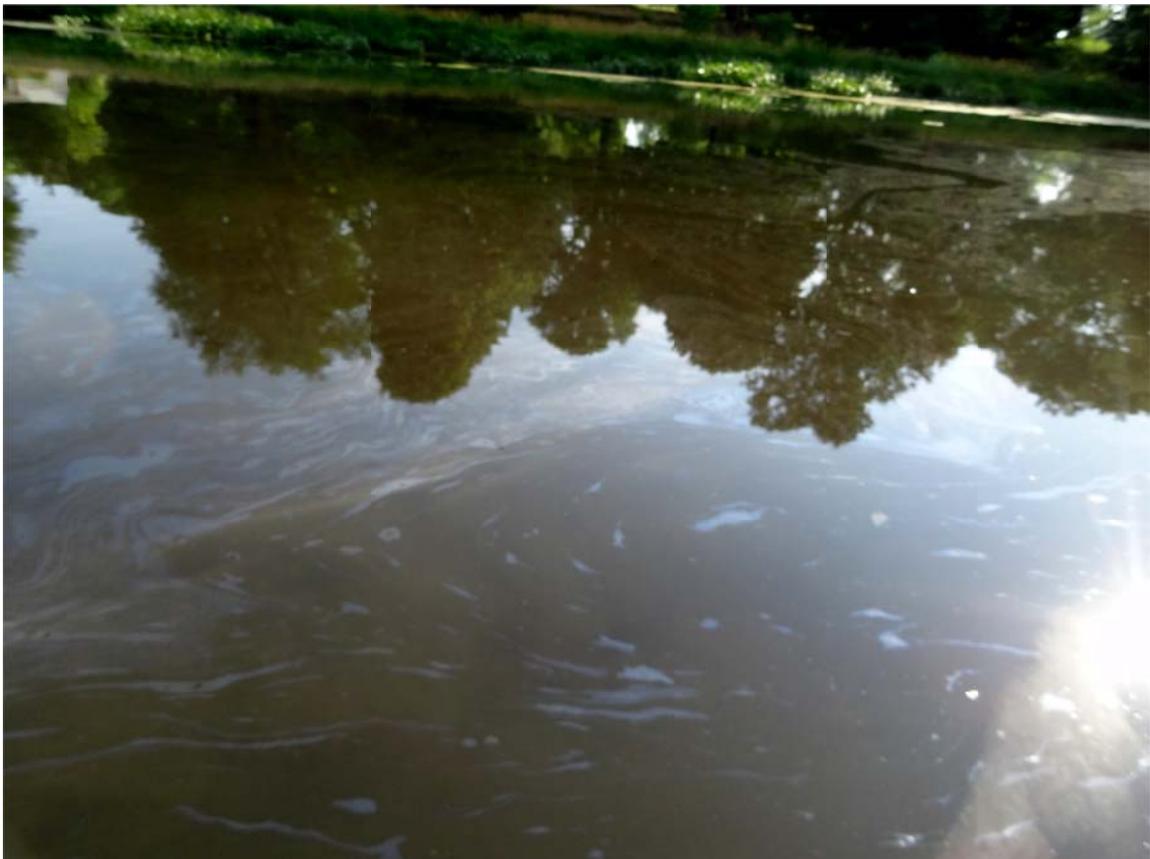
4. Sheen observed along containment boom above Ceresco Dam.

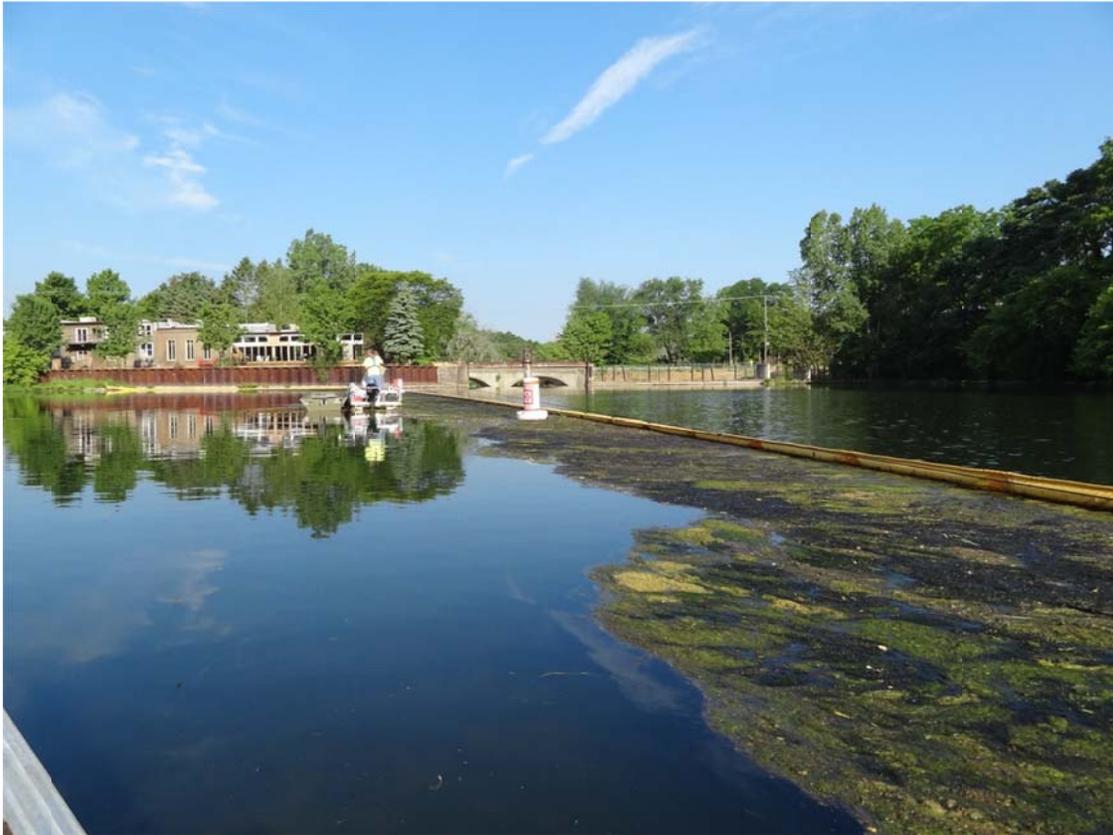
5. Vegetation and sheen observed along containment boom above Ceresco Dam.

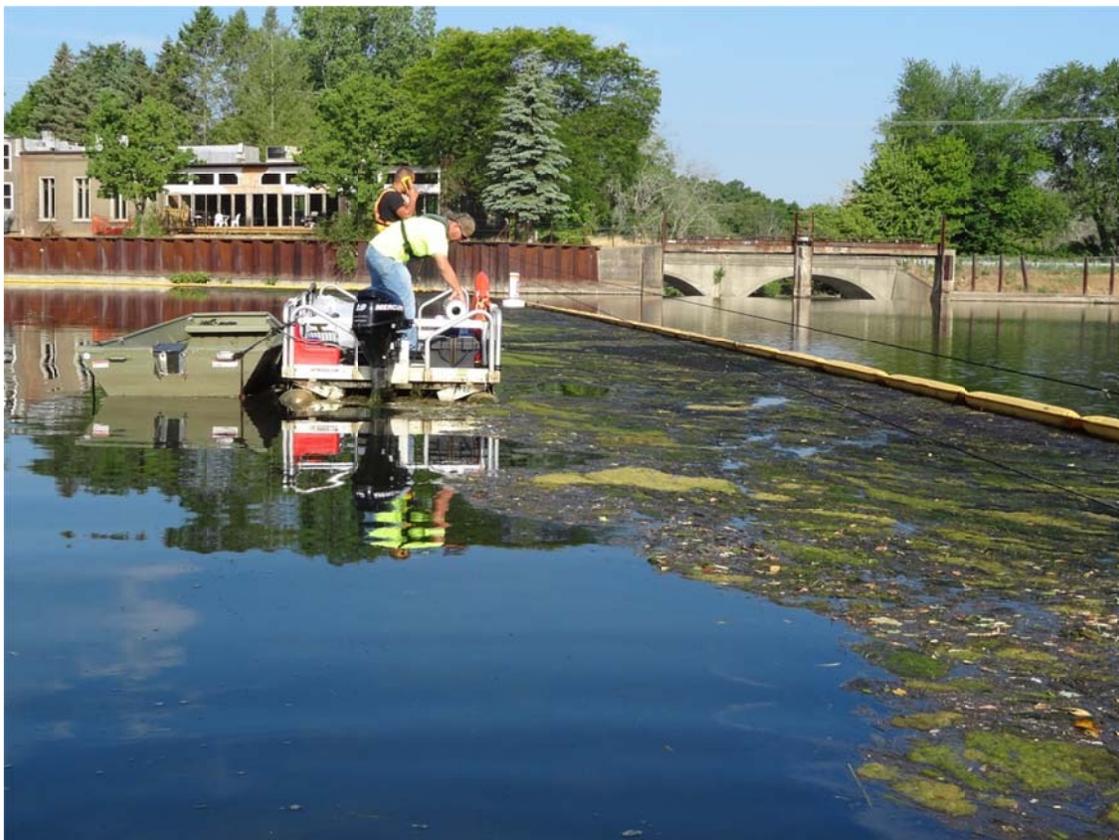
6. Crews removing vegetation within containment above Ceresco Dam.

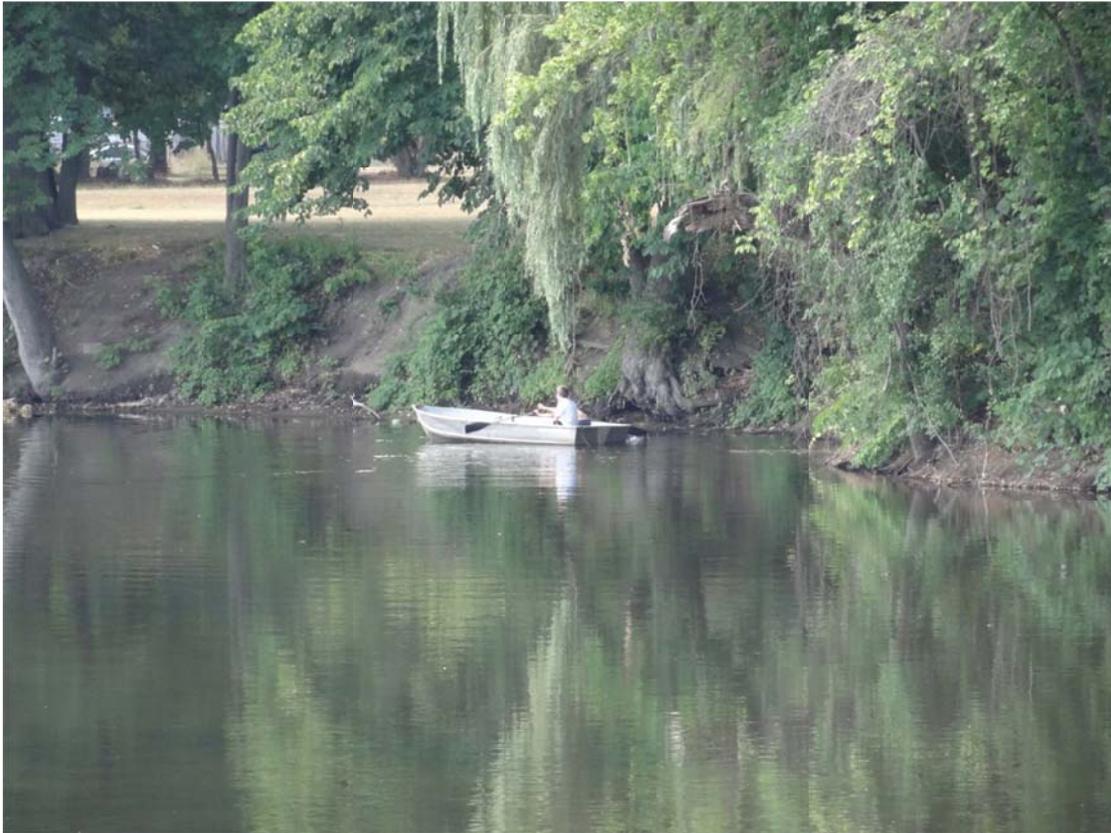
7. Recreational boaters near MP 15.0 upstream from the Mill Ponds.

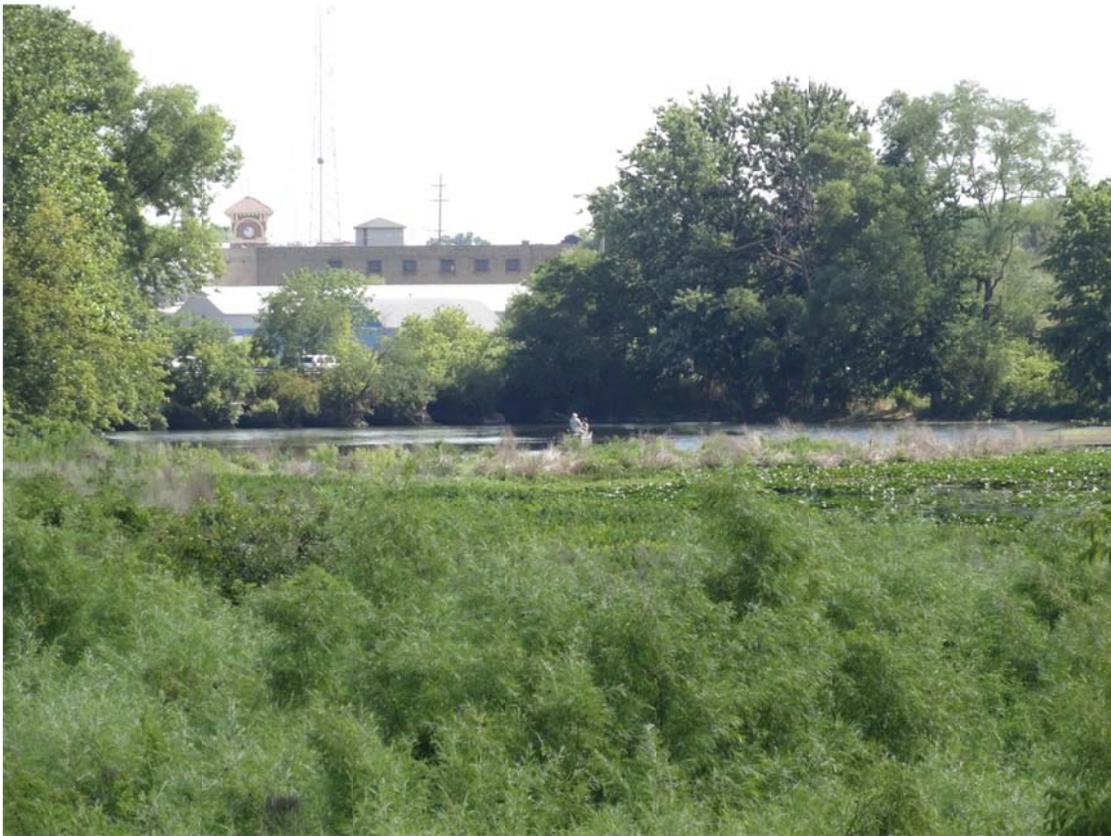
8. Fishermen observed at MP 15.75 in northern end of Mill Ponds.

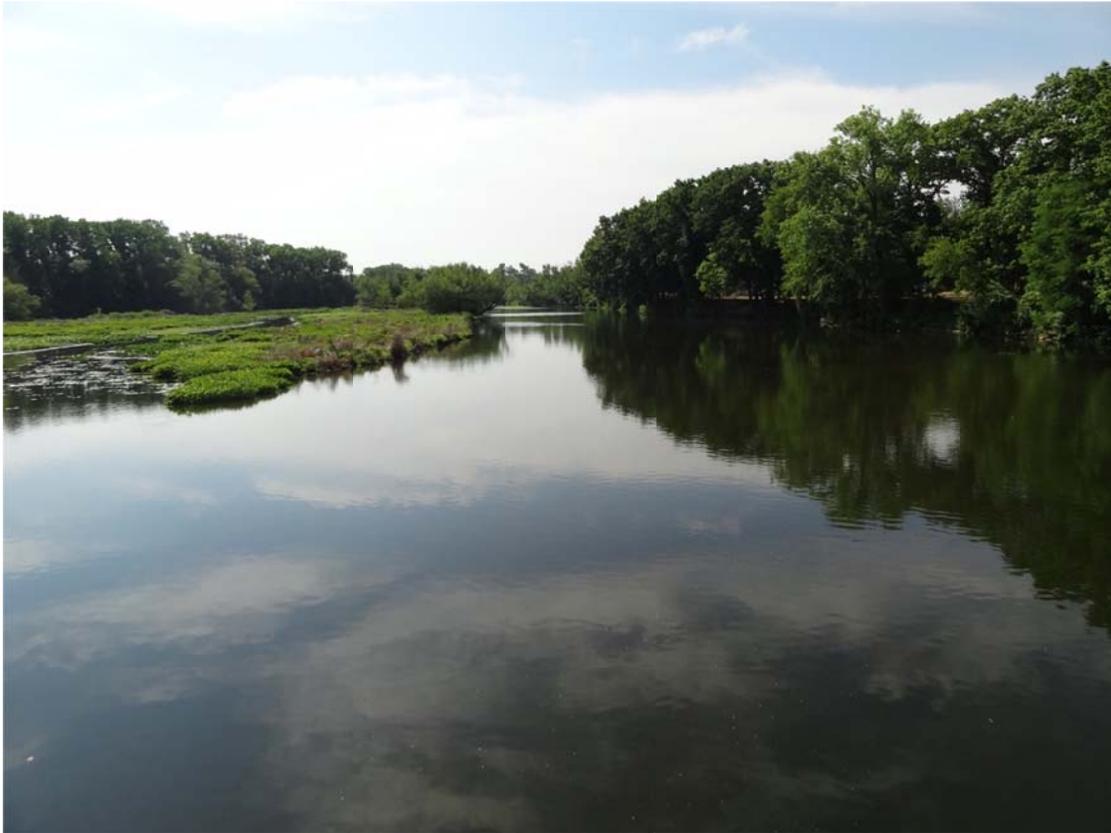
9. South end of Mill Pond, no sheen observed.

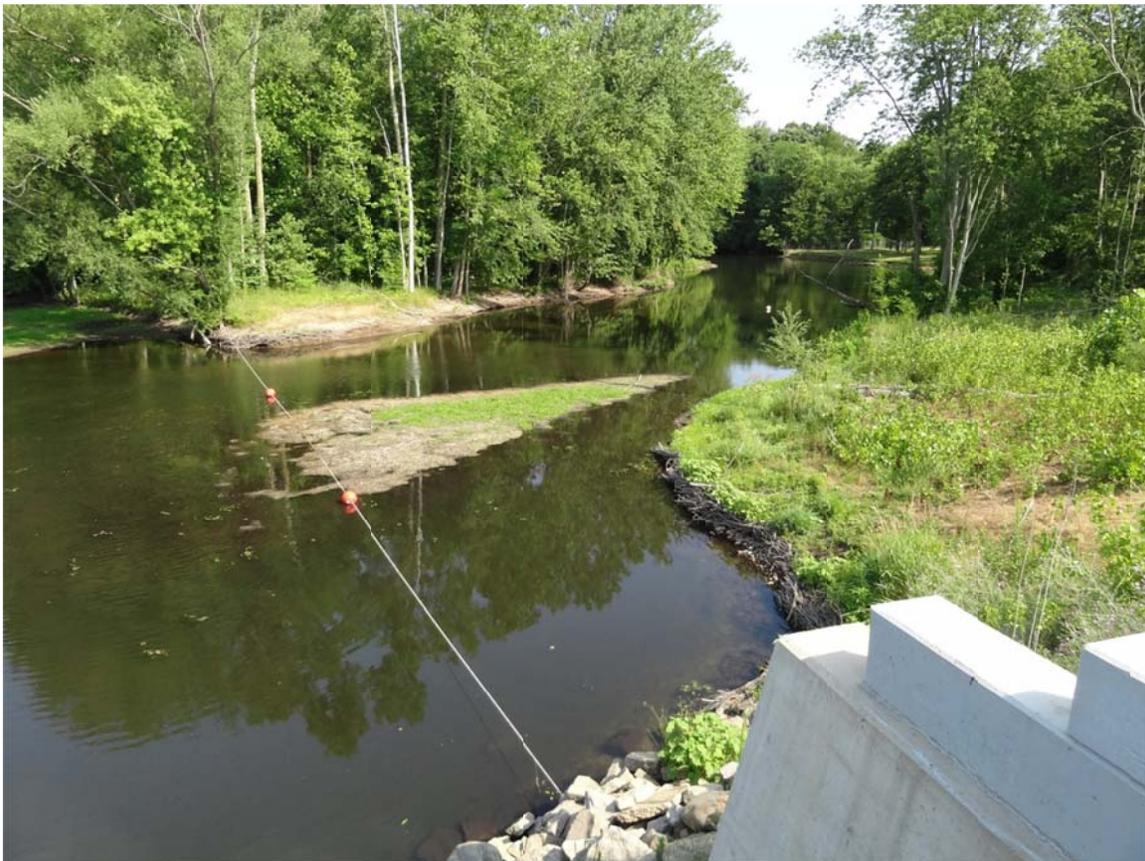
10. View of MP 21.5 oxbow from Custer Road Bridge. No sheen observed on western side of Custer Road Bridge.

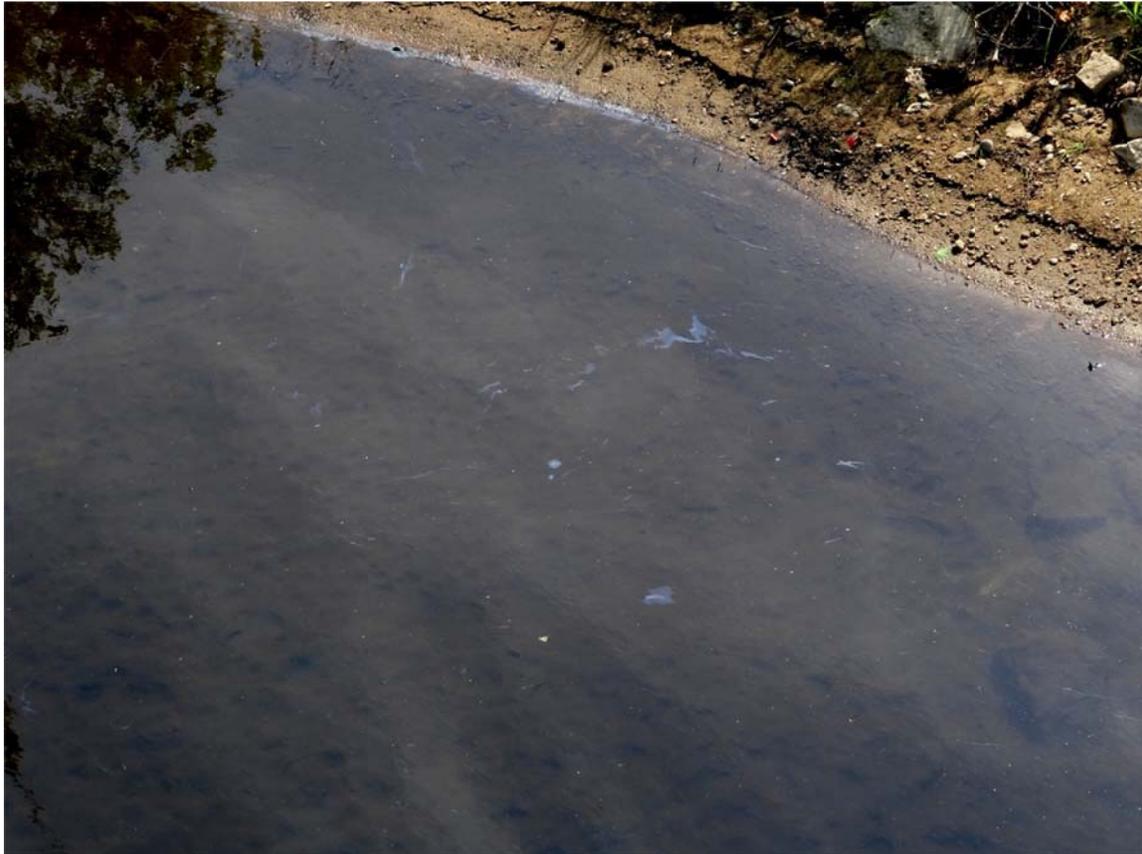
11. Sheen observed on eastern side of Custer Road Bridge, just upstream from MP 21.5 oxbow.

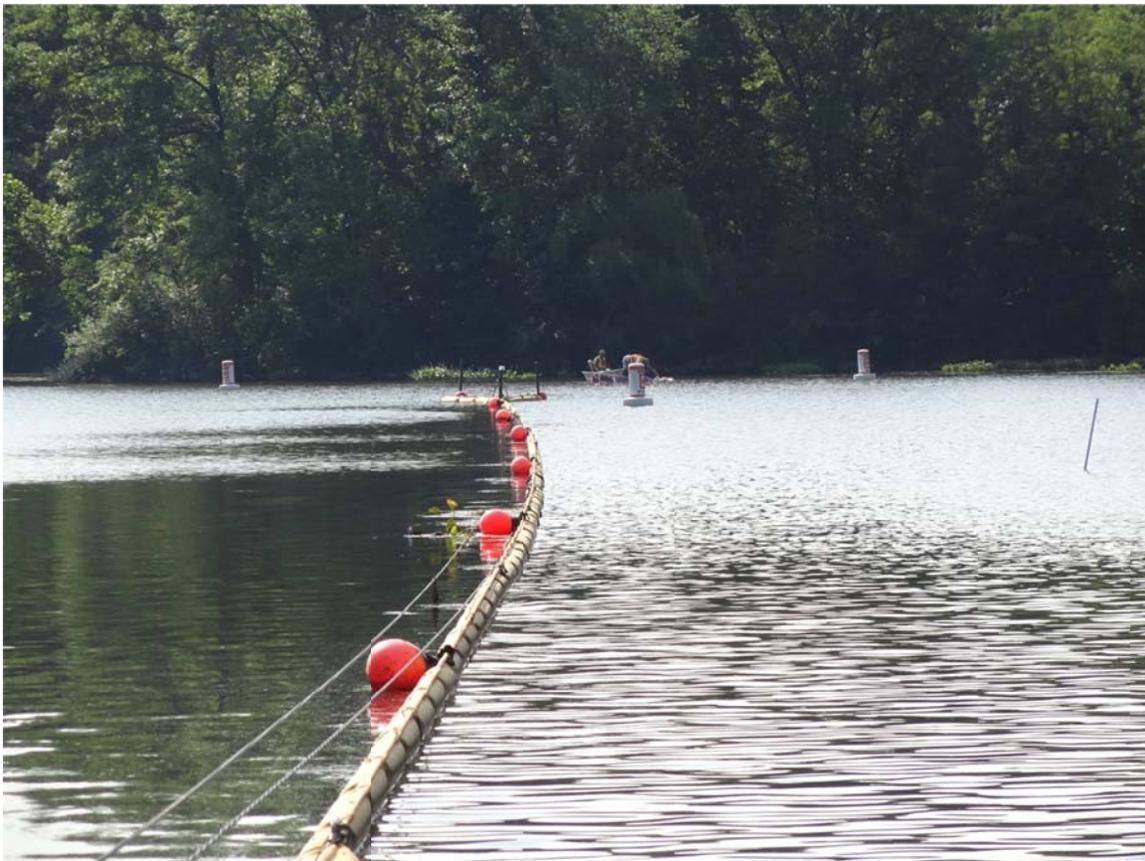
12. Sheen sweep boat operating in Morrow Lake Delta.

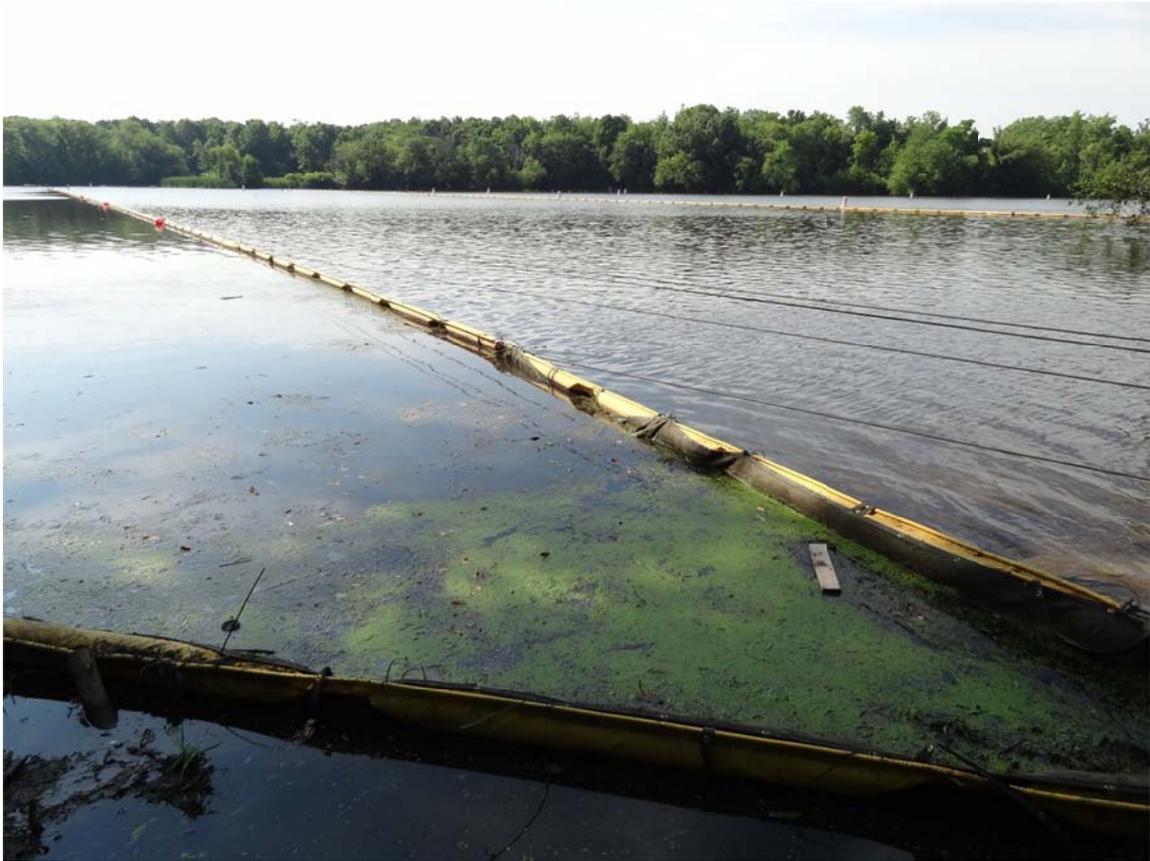
13. E4 Control Point, debris observed within containment.

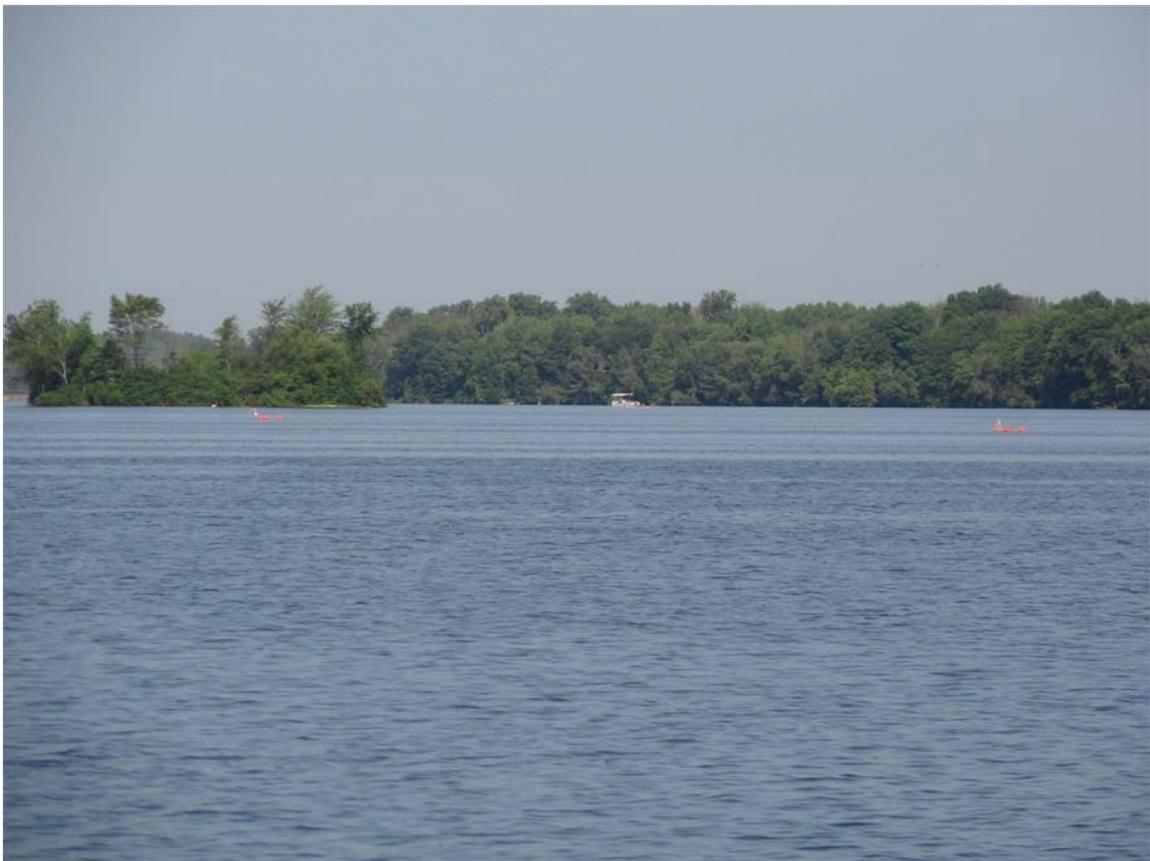
14. Sheen sweeper boat observed operating in far western end of Morrow Lake.
