# Situation Photo Log

Monday, July 16, 2012

Kalamazoo River / Enbridge Spill

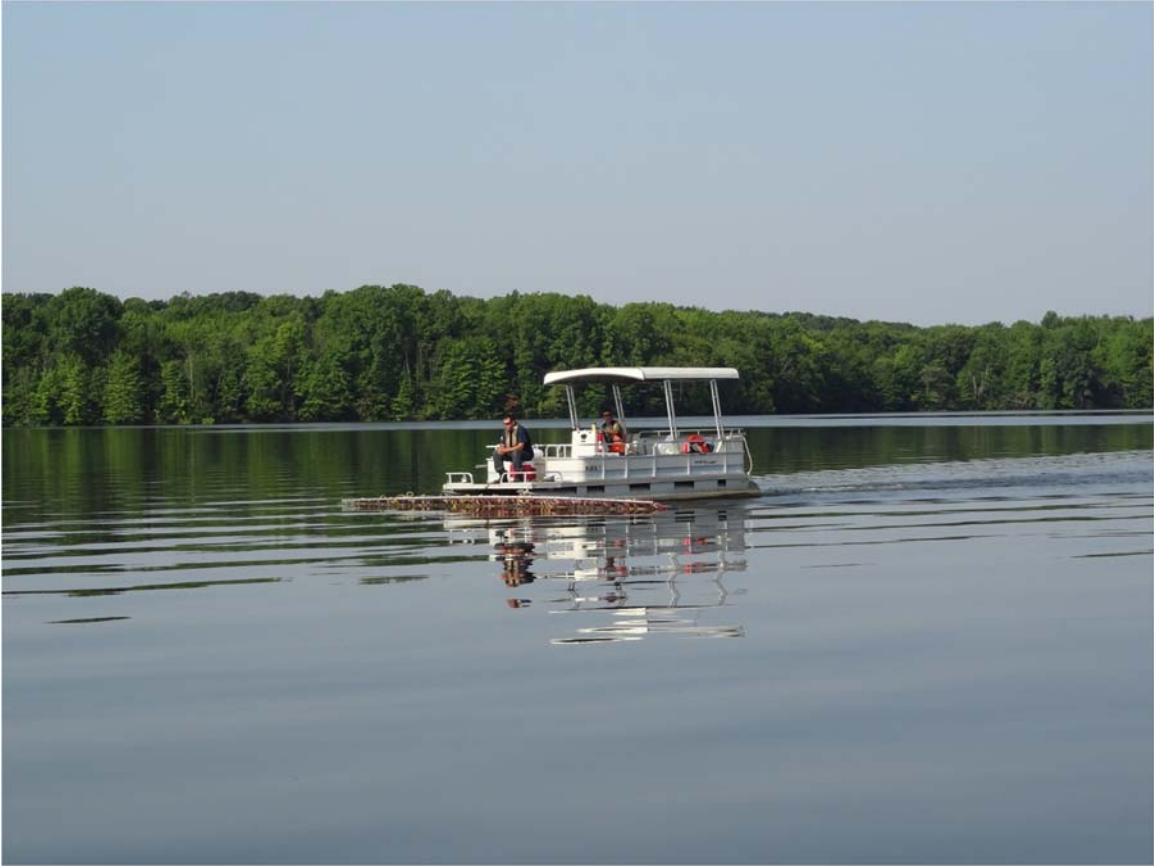
1. Morrow Lake sheen sweep boat observed operating between Rowe Island and the small island the E4.5 Boom was previously anchored to.

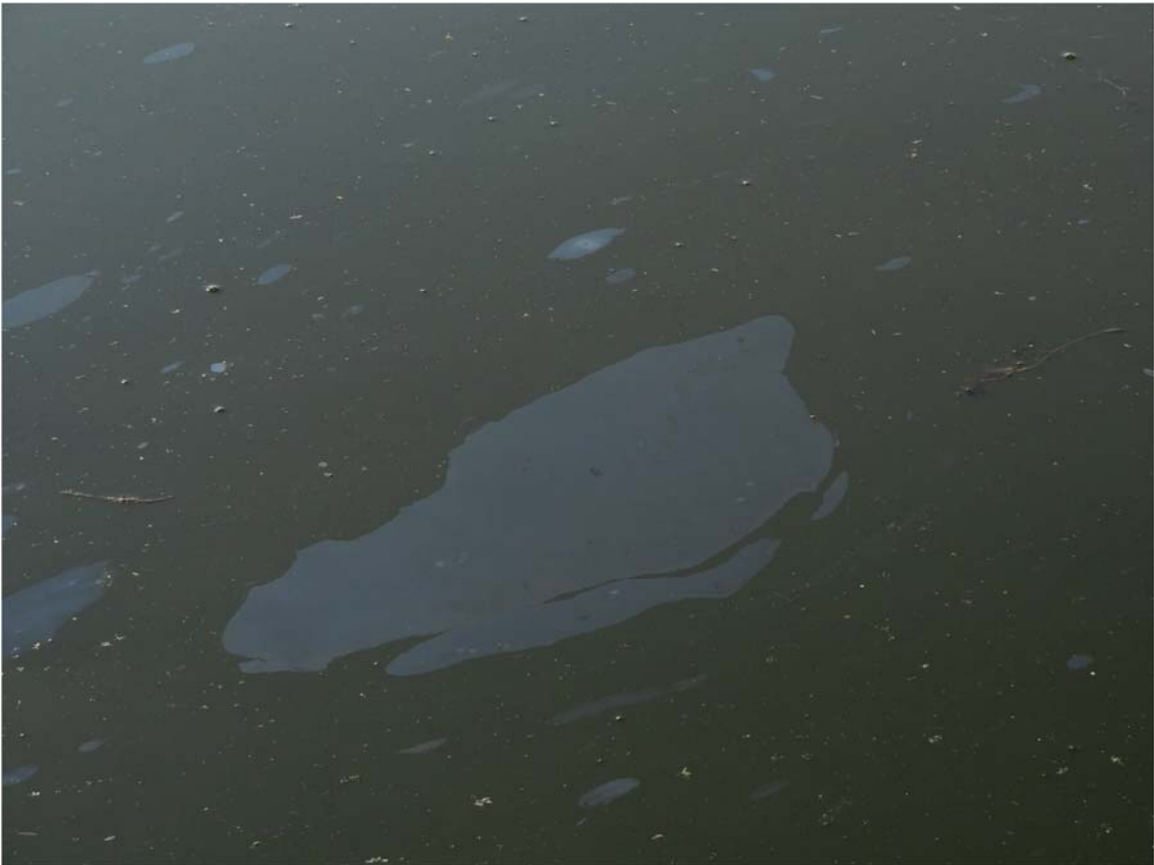
2. Morrow Lake sheen observed between Rowe Island and the small island the E4.5 Boom was previously anchored to.

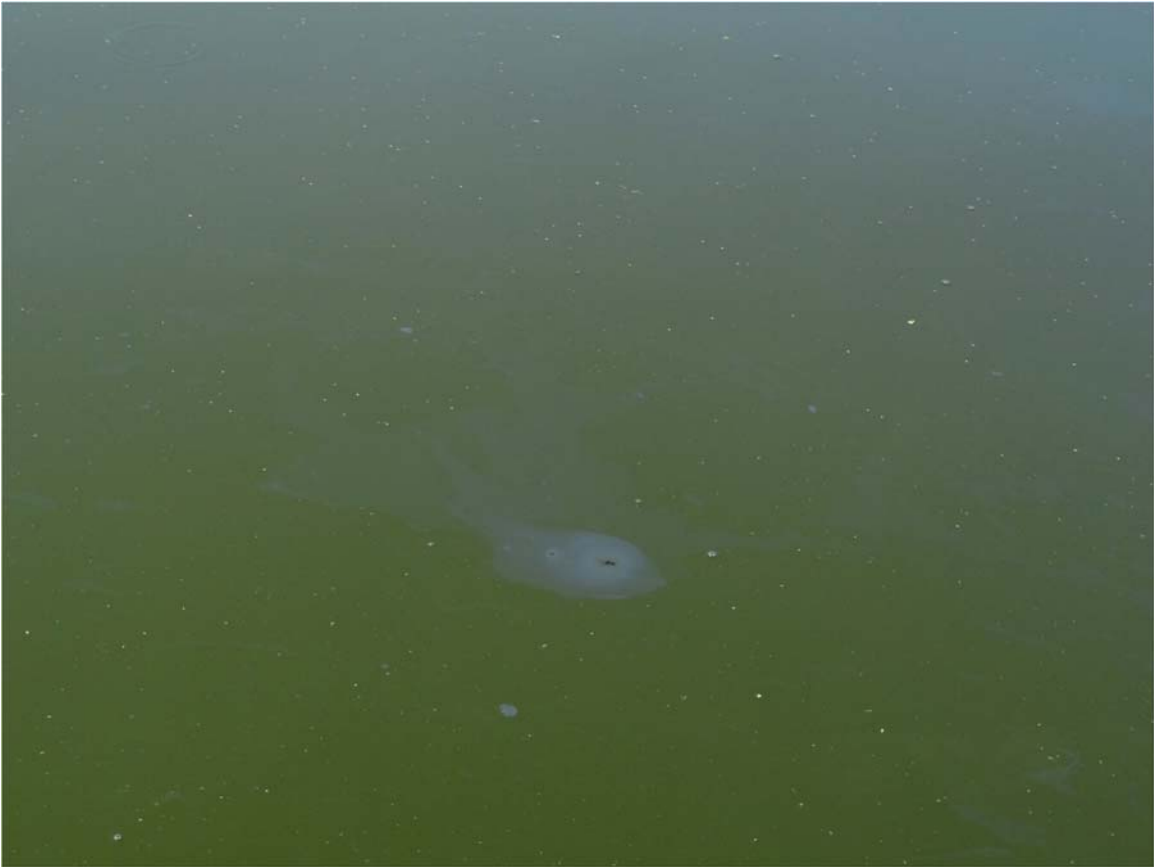
3. Morrow Lake sheen observed between Rowe Island and the small island the E4.5 Boom was previously anchored to.

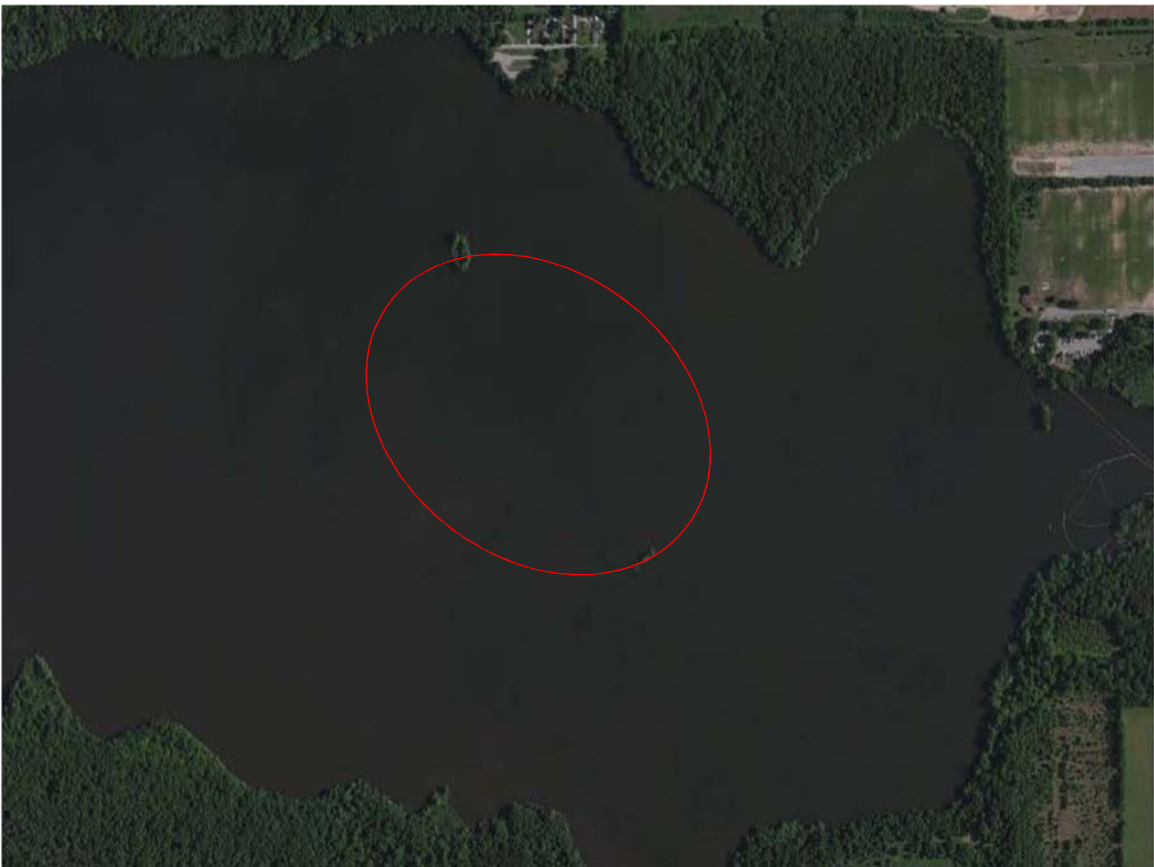
4. Morrow Lake sheen observed between Rowe Island and the small island the E4.5 Boom was previously anchored to.

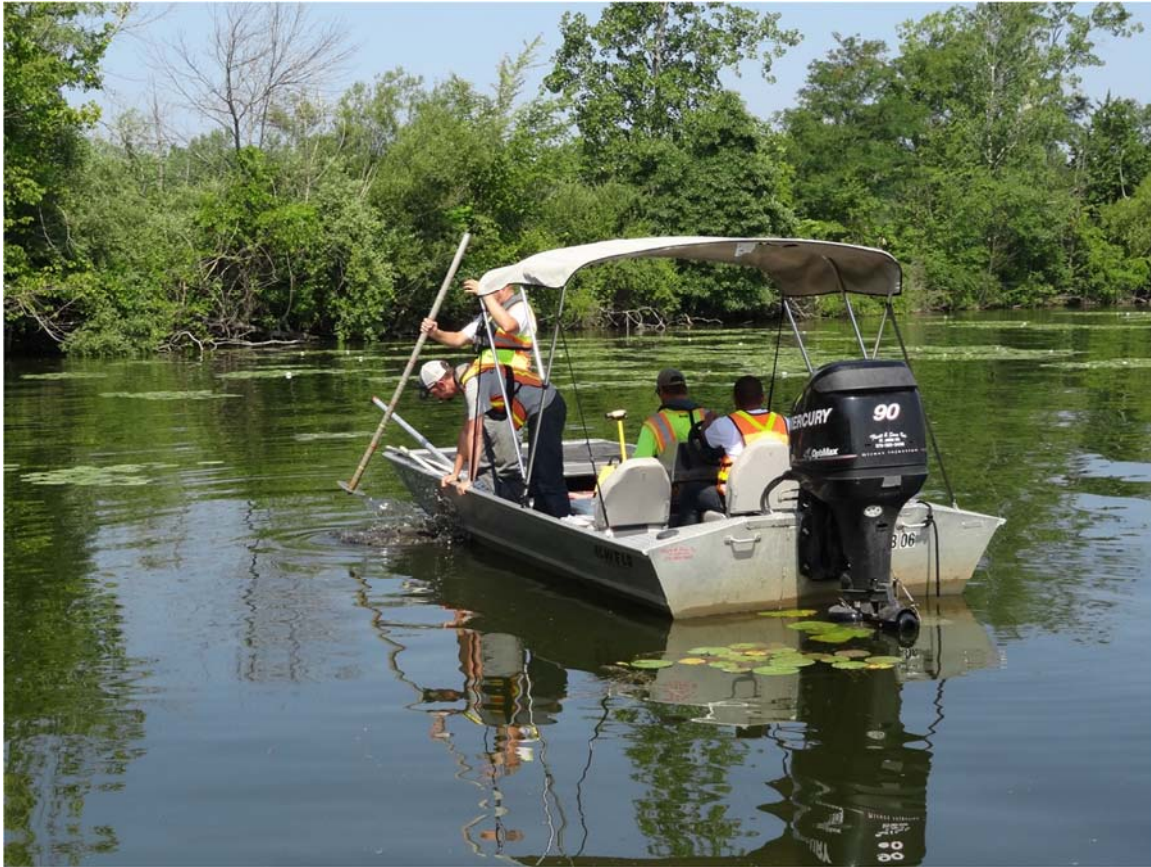
5. Morrow Lake poling crew observed on the southwest corner of the lake.

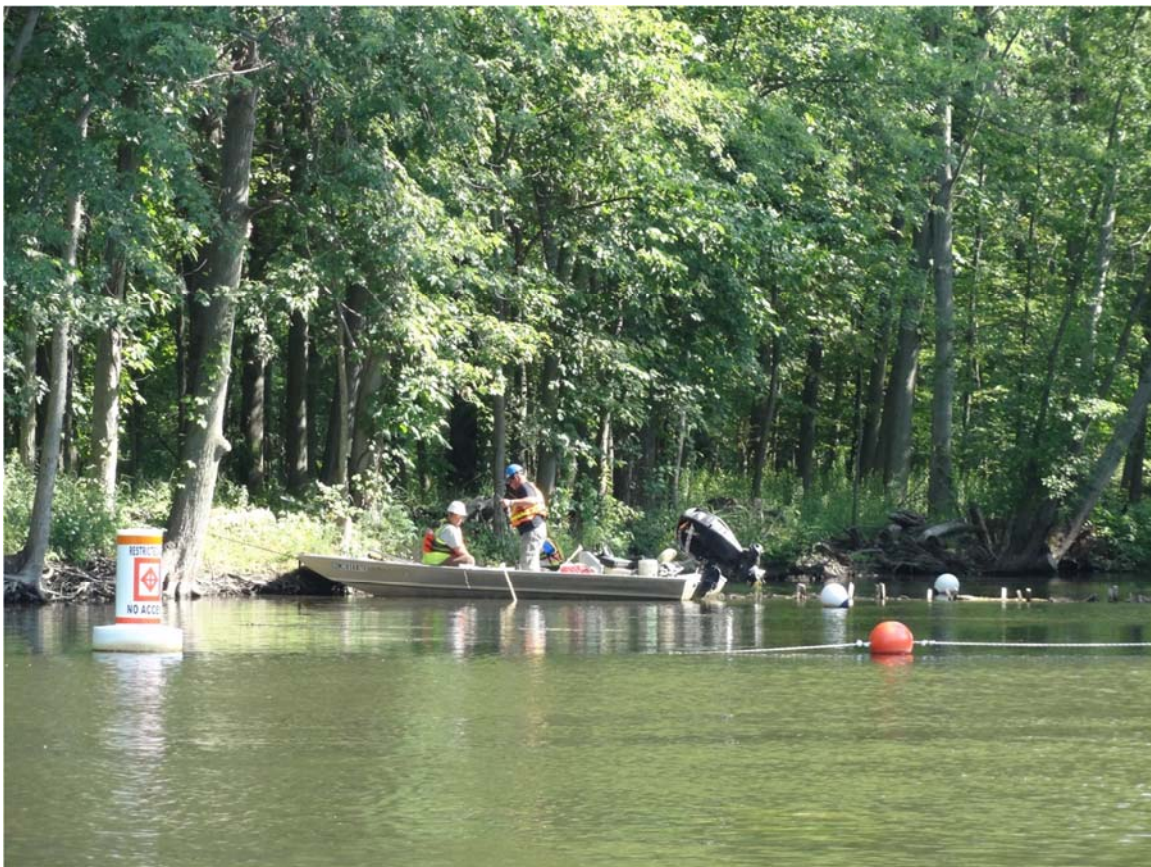
6. MP36.10 Sediment Trap monitoring team observed.

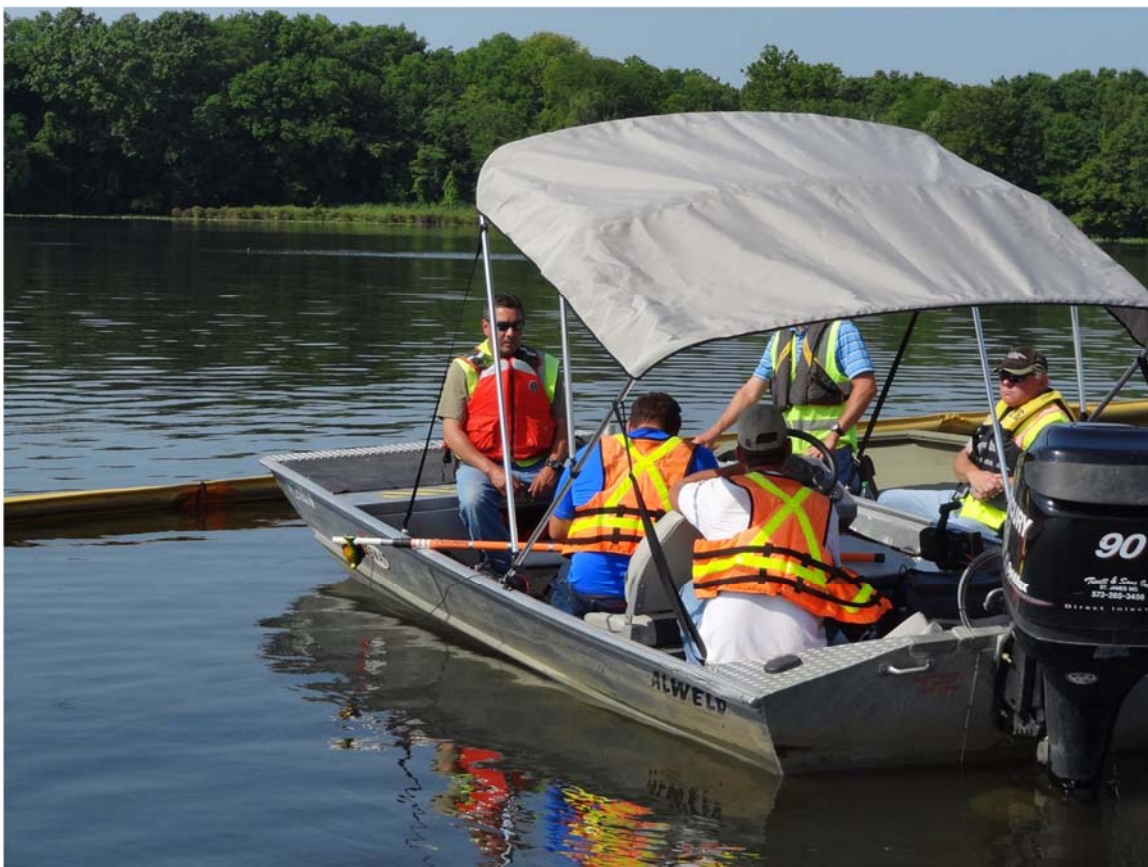
7. Morrow Lake Delta observed crew preparing to perform a video inspection of the containment curtain.

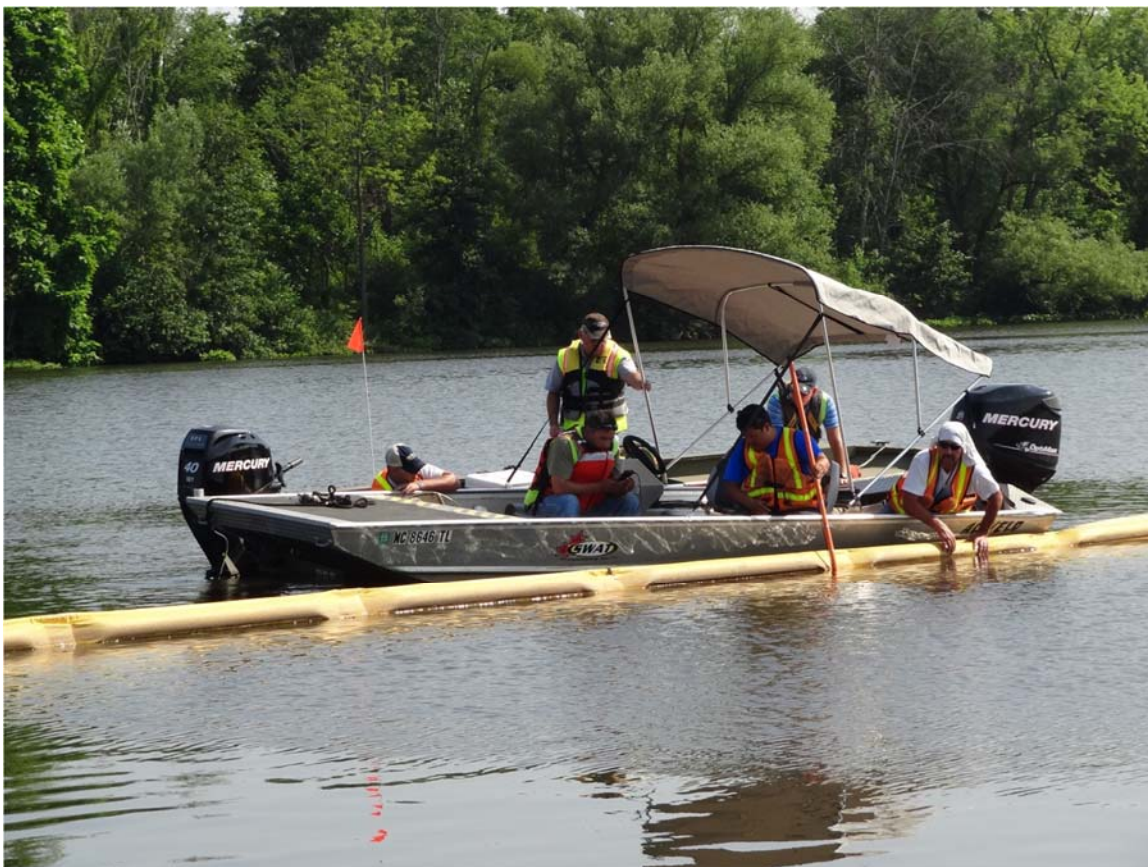
8. Morrow Lake Delta observed crew performing a video inspection of the containment curtain.

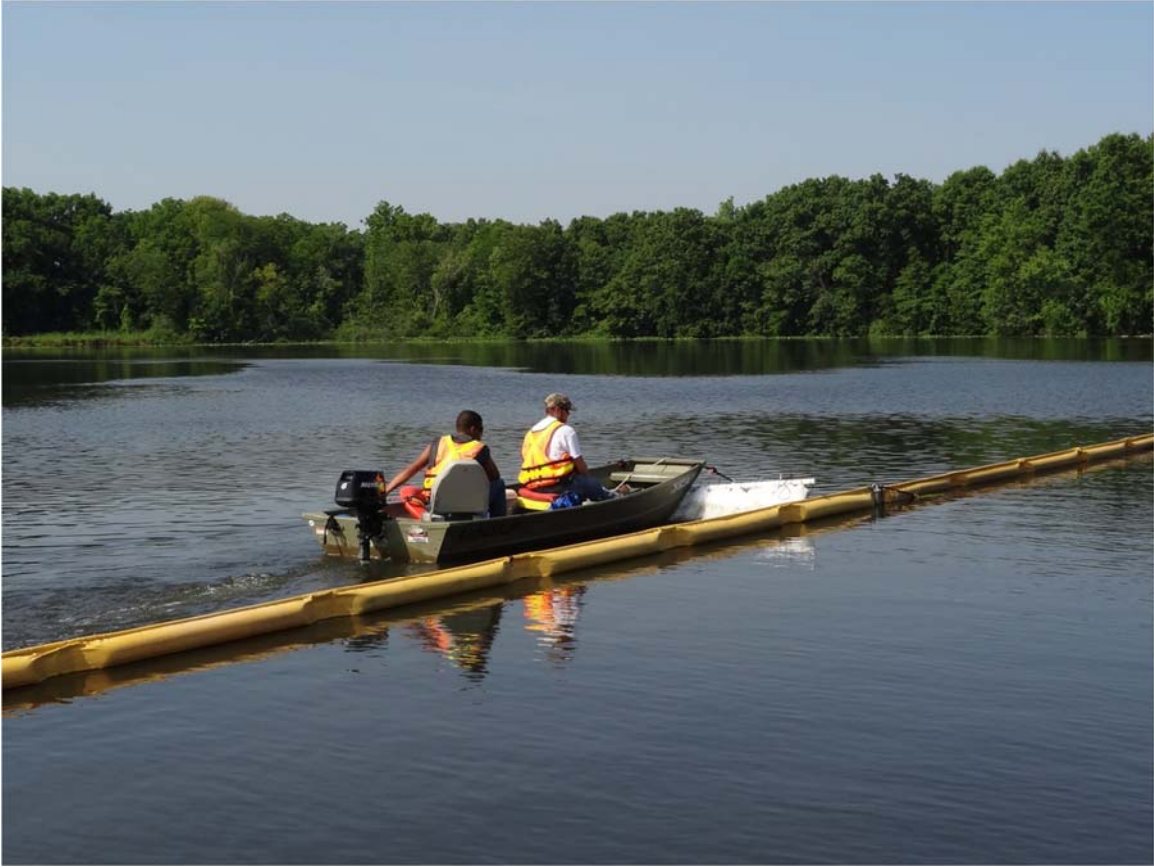
**9. Morrow Lake Delta observed a sweep boat operating along containment boom.**

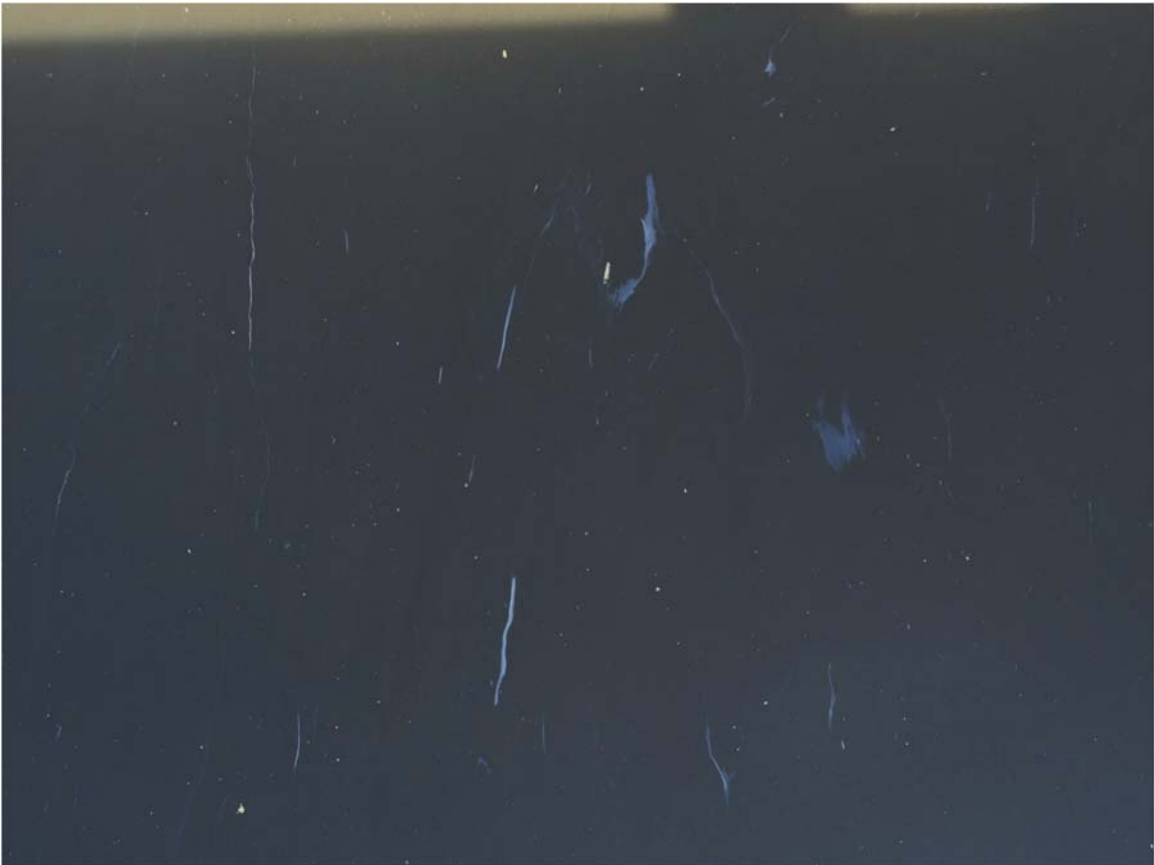
**10. Sheen observed on eastern and western side of Custer Road Bridge, just upstream from MP 21.5 oxbow. Operations was notified.**

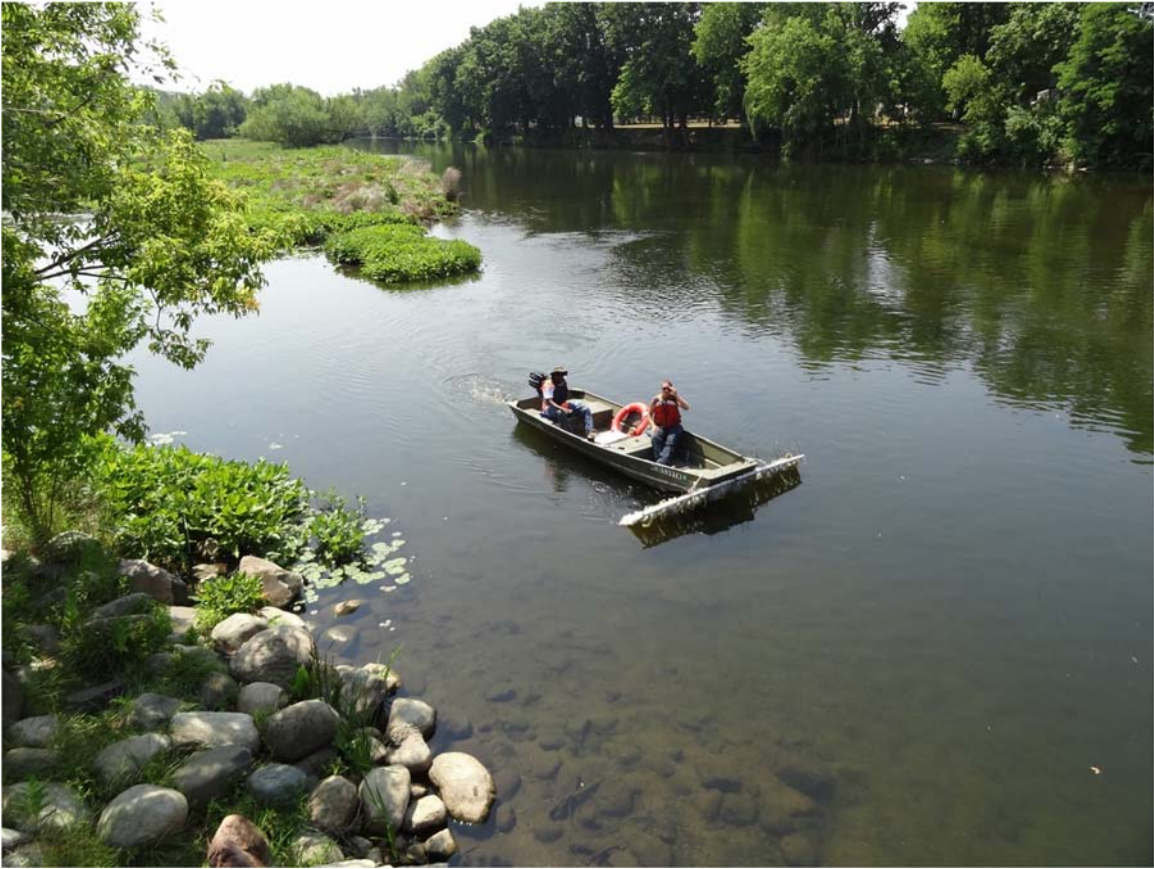
11. Sheen sweep boat operating at MP15.5 Mill Ponds.

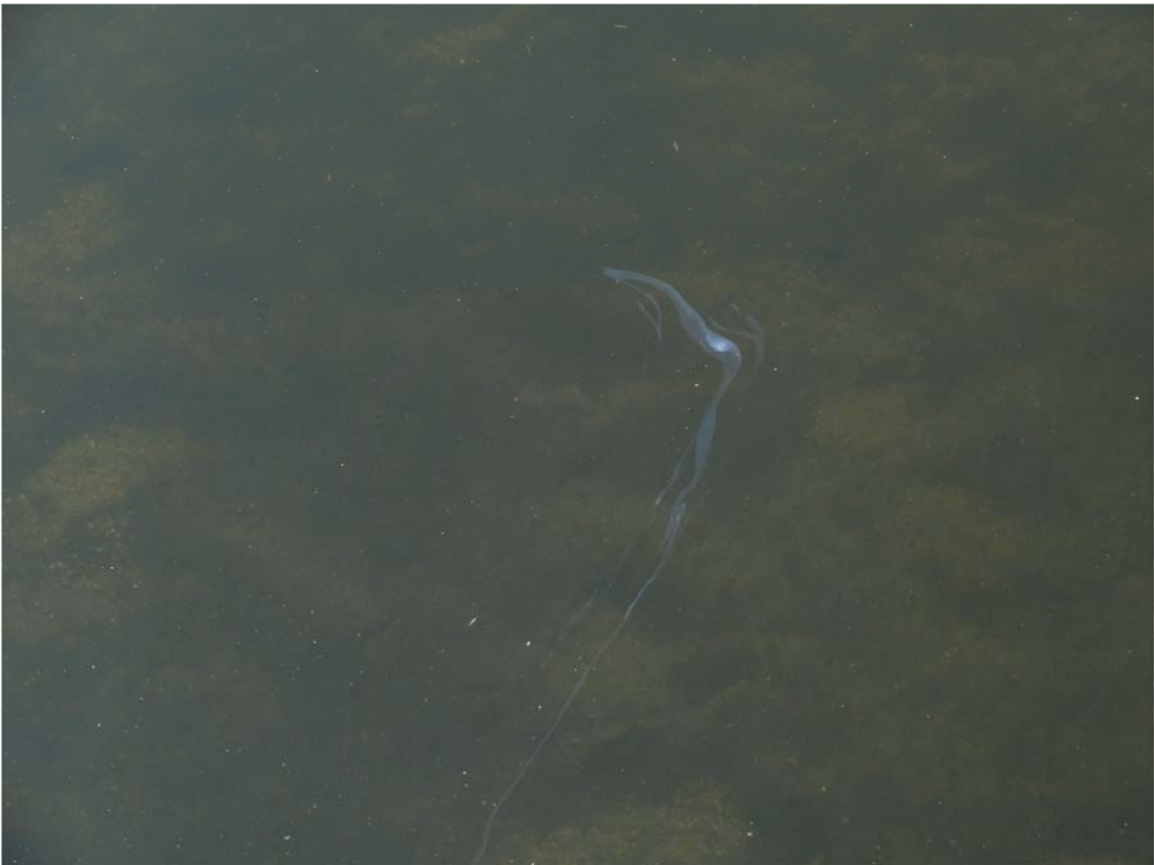
12. MP15.5 South Mill Pond sheen observed in river channel, sweep boat was operating in the area.

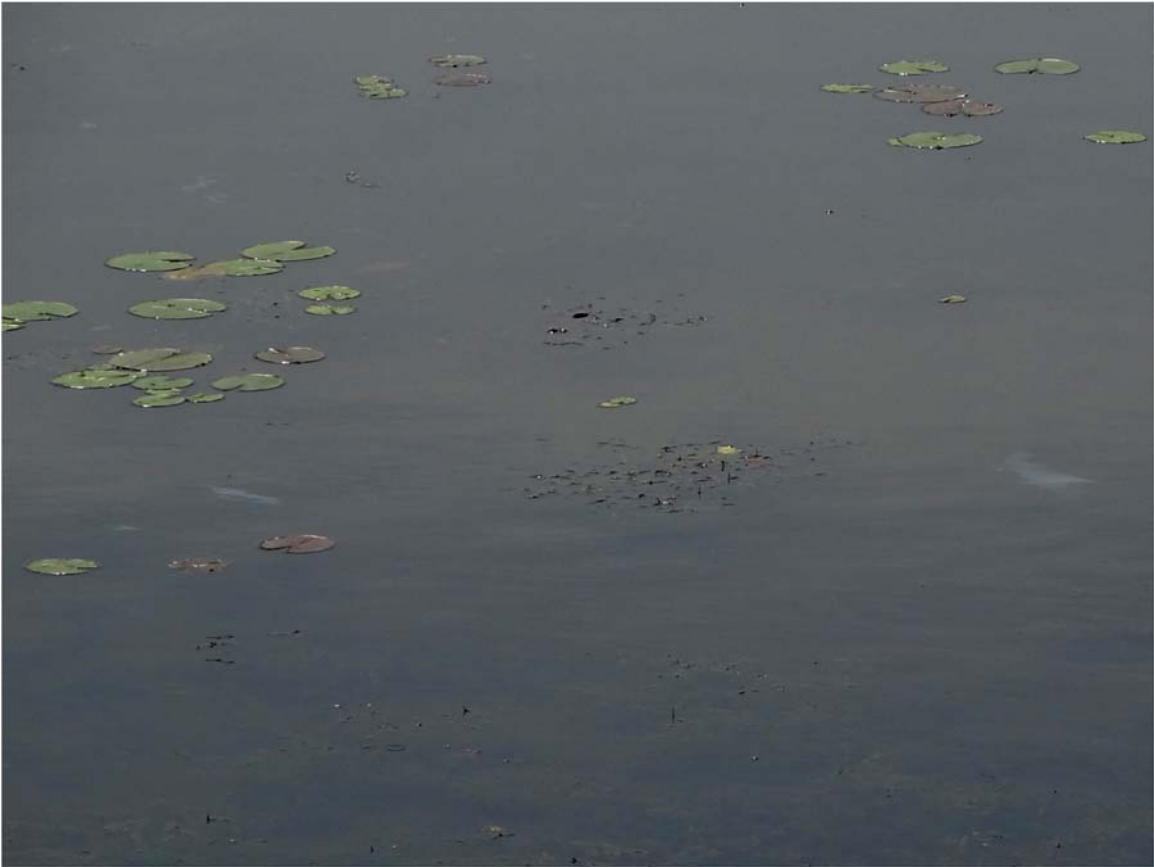
13. Sheen observed within the South Mill Pond.

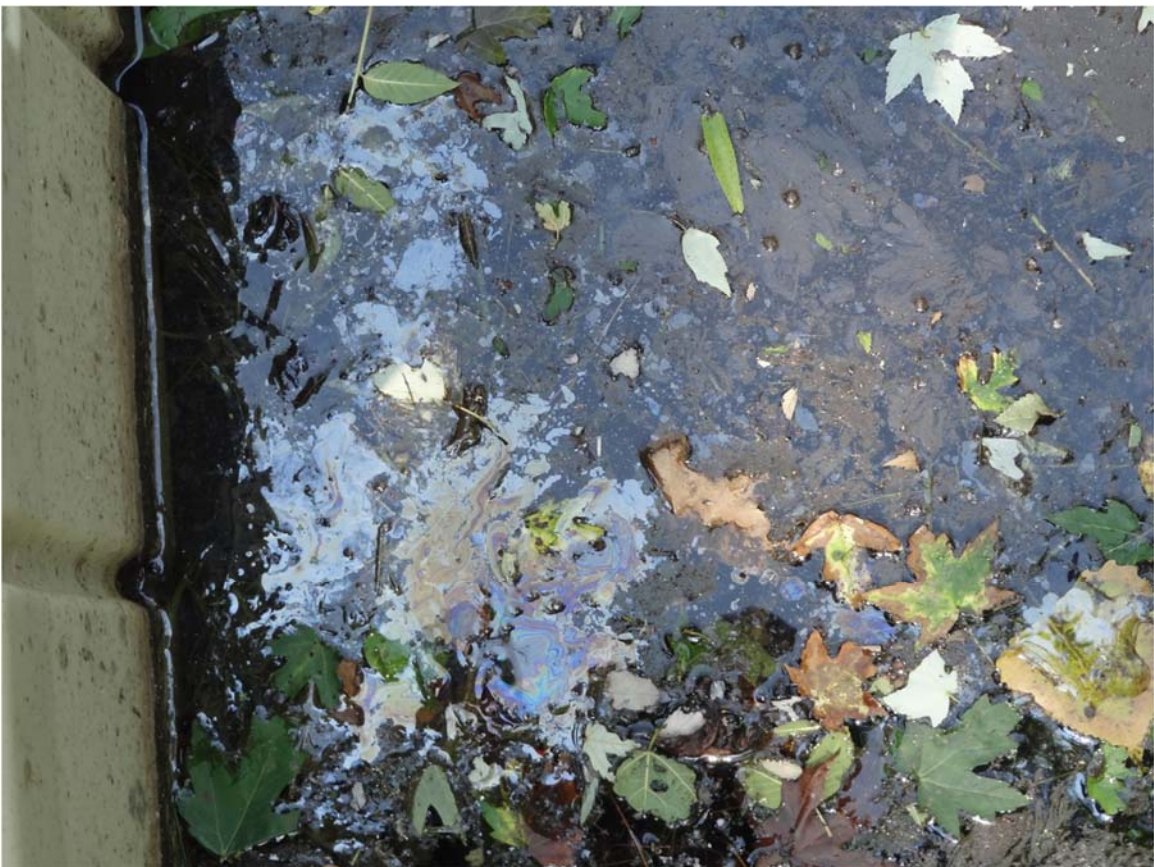
14. Sheen observed accumulating at the Paddlers Grove handicap boat launch.

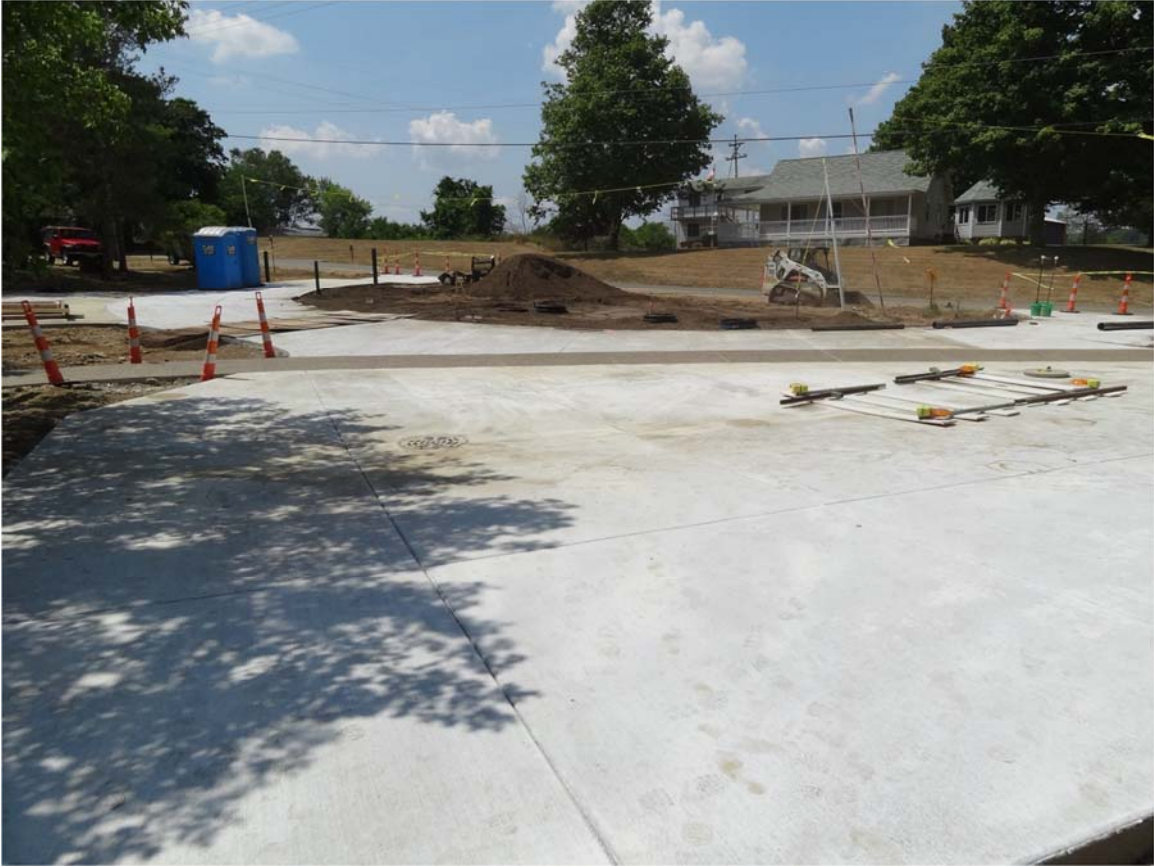
15. Ceresco Dam Portage work continued.

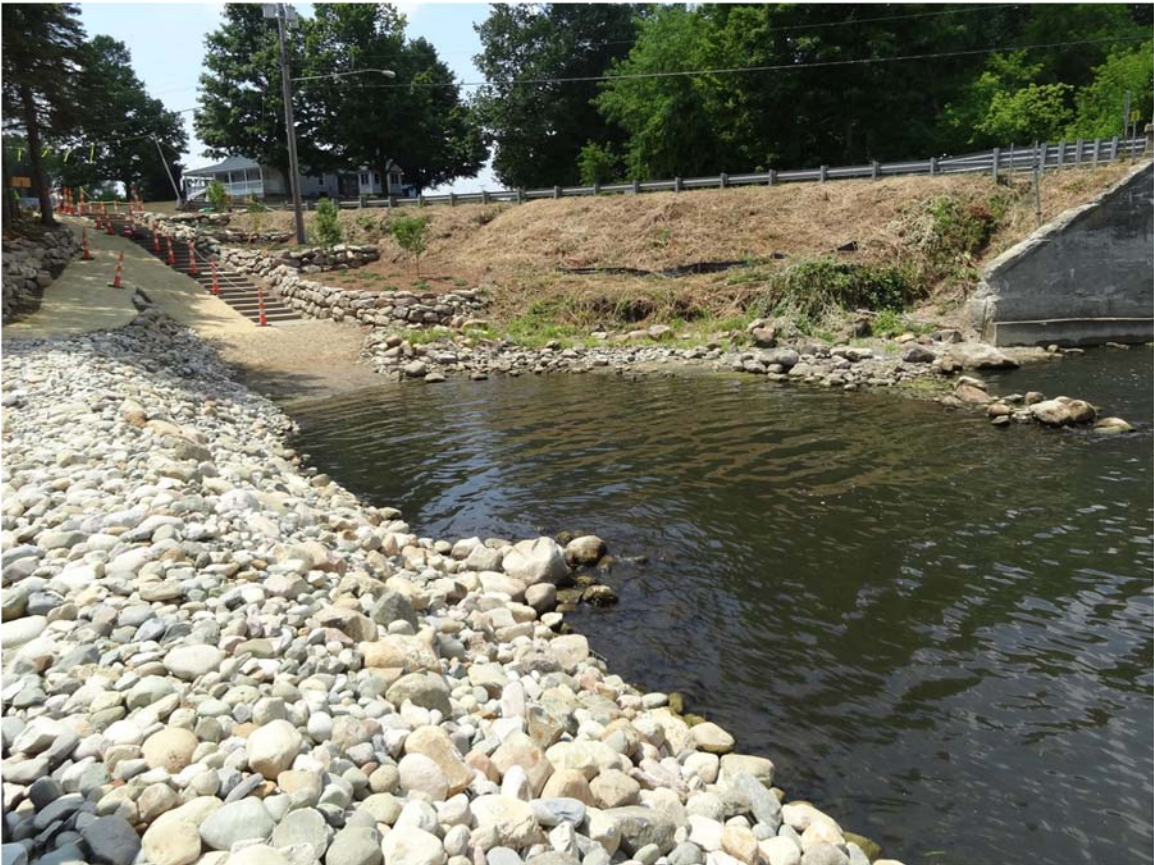
16. Ceresco Dam Portage work continued.

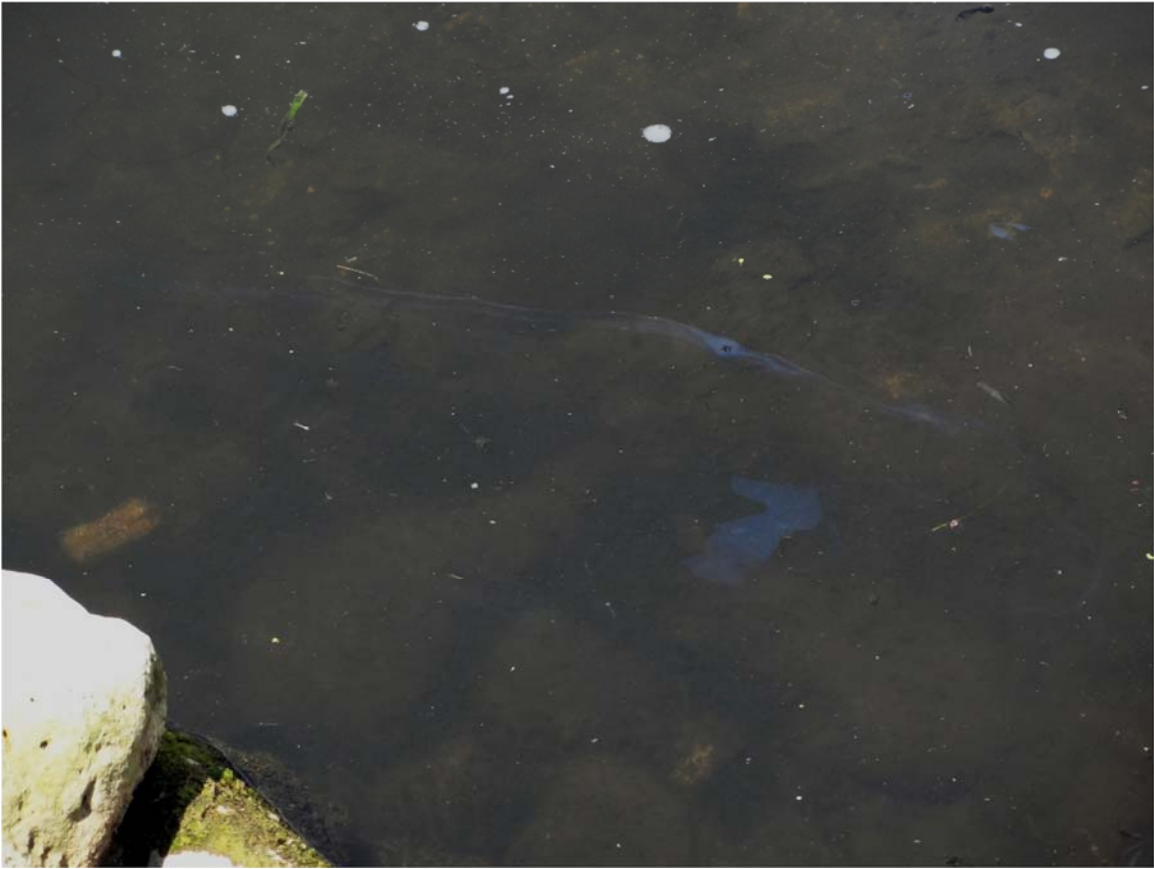
17. Ceresco Dam sheen observed within the downstream Portage cove.

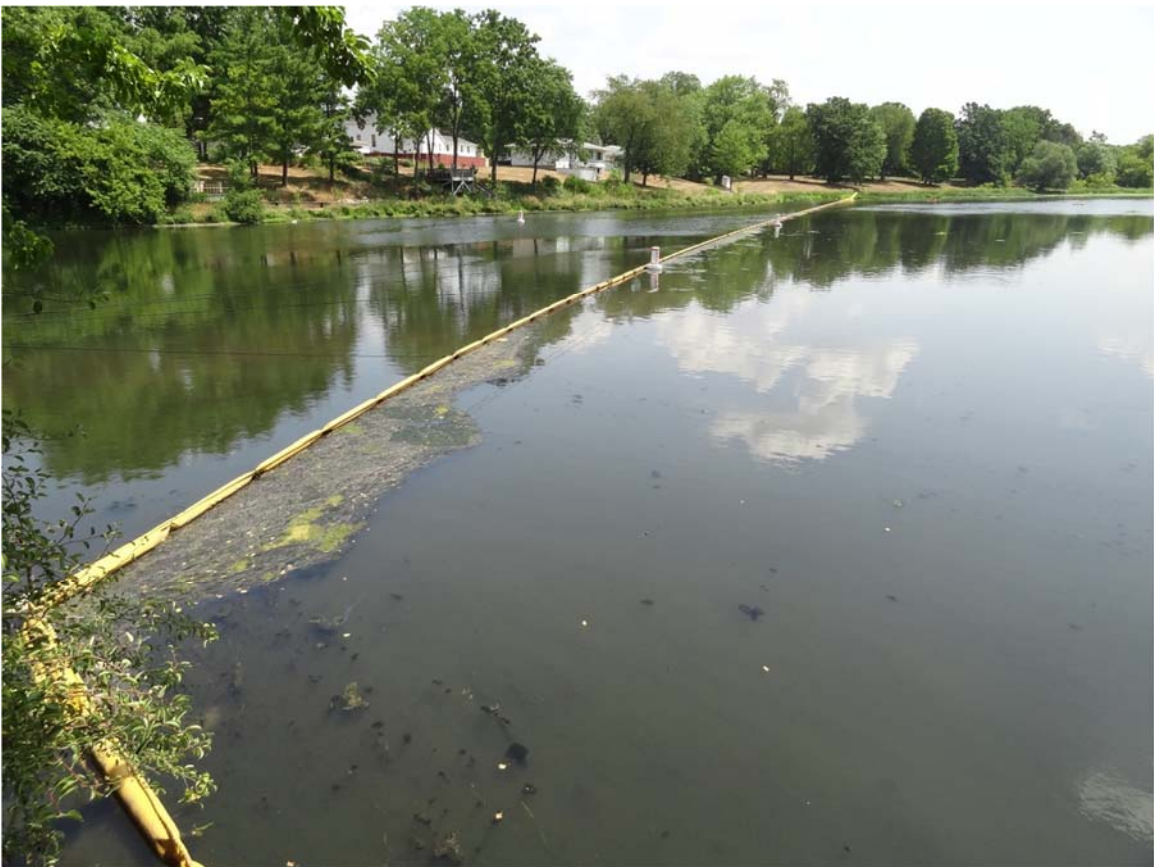
18. Ceresco Dam boom.

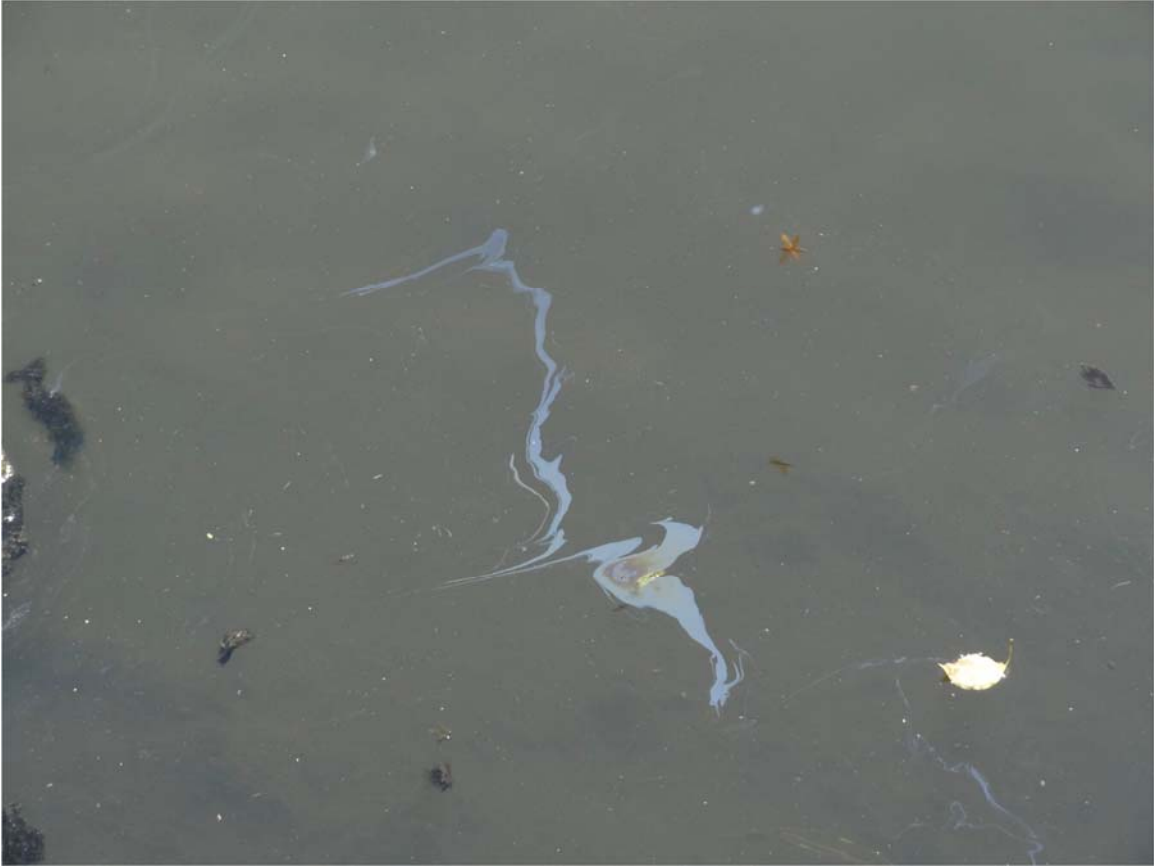
19. Sheen observed collecting within the boom at Ceresco Dam

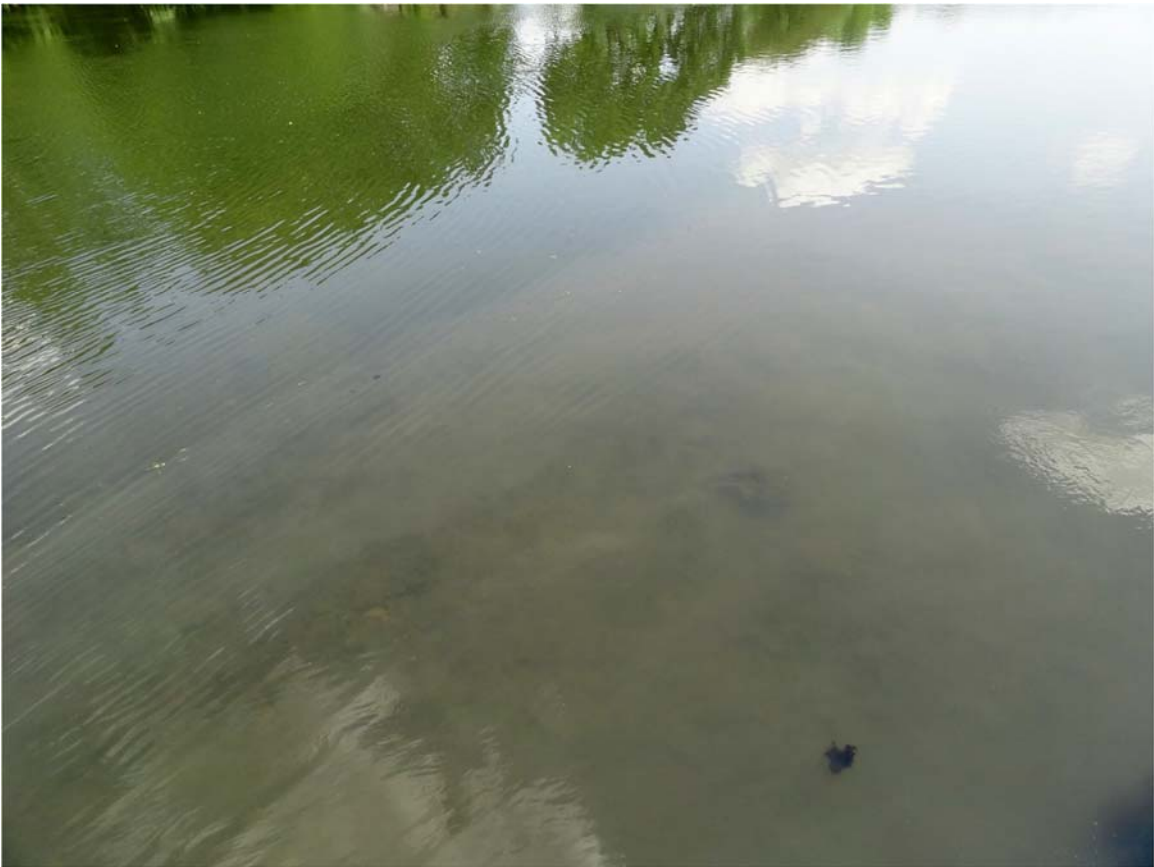
20. Ceresco Dam sediment plume observed going over the dam.

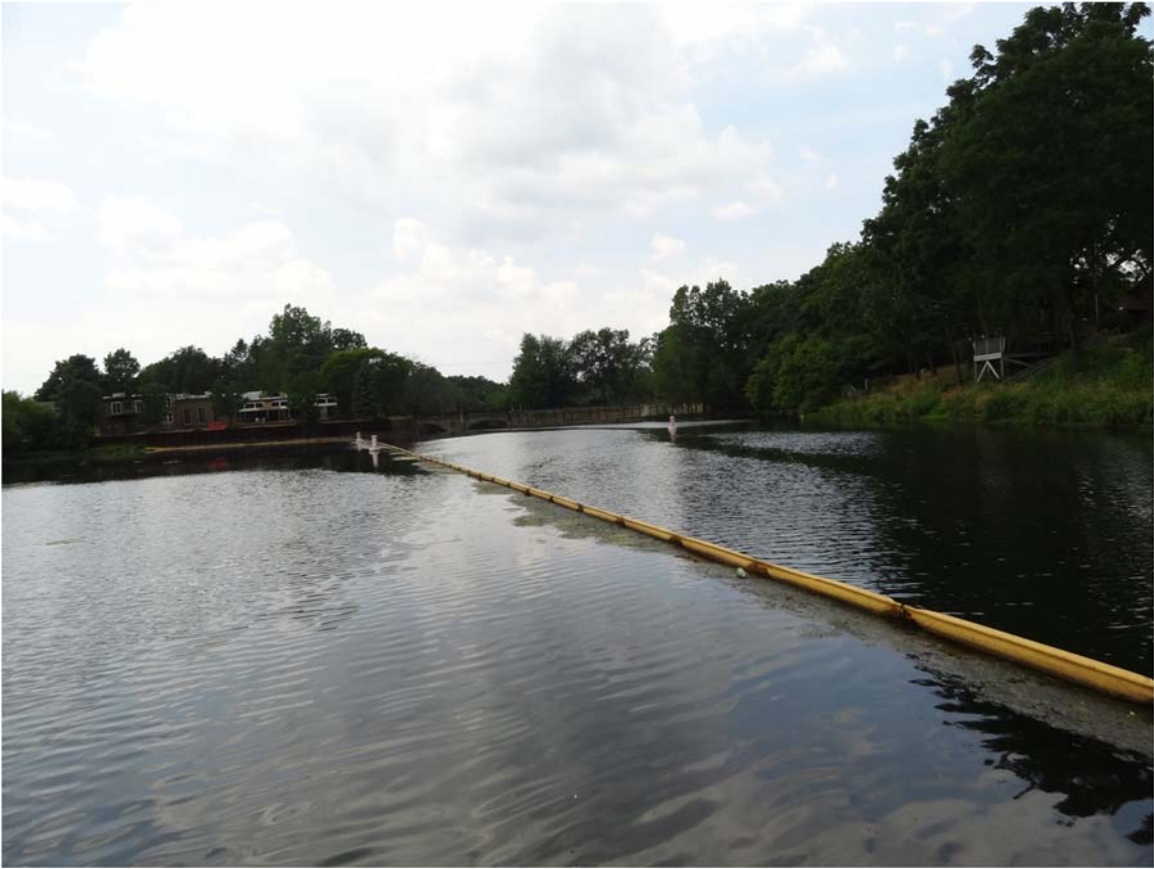
21. Ceresco Dam containment boom.

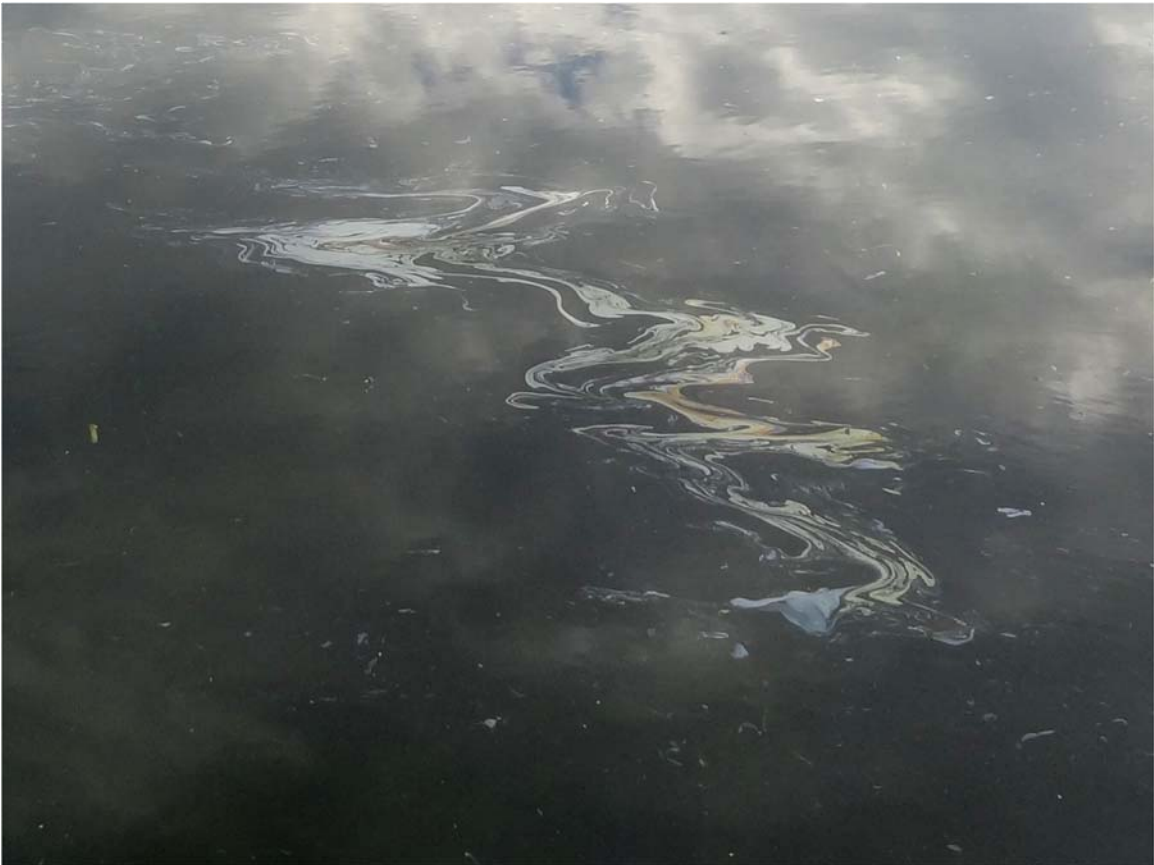
22. Ceresco DamRDB sheen observed at the top end of boom.
