# Situation Photo Log

Monday, July 16, 2012

Kalamazoo River / Enbridge Spill

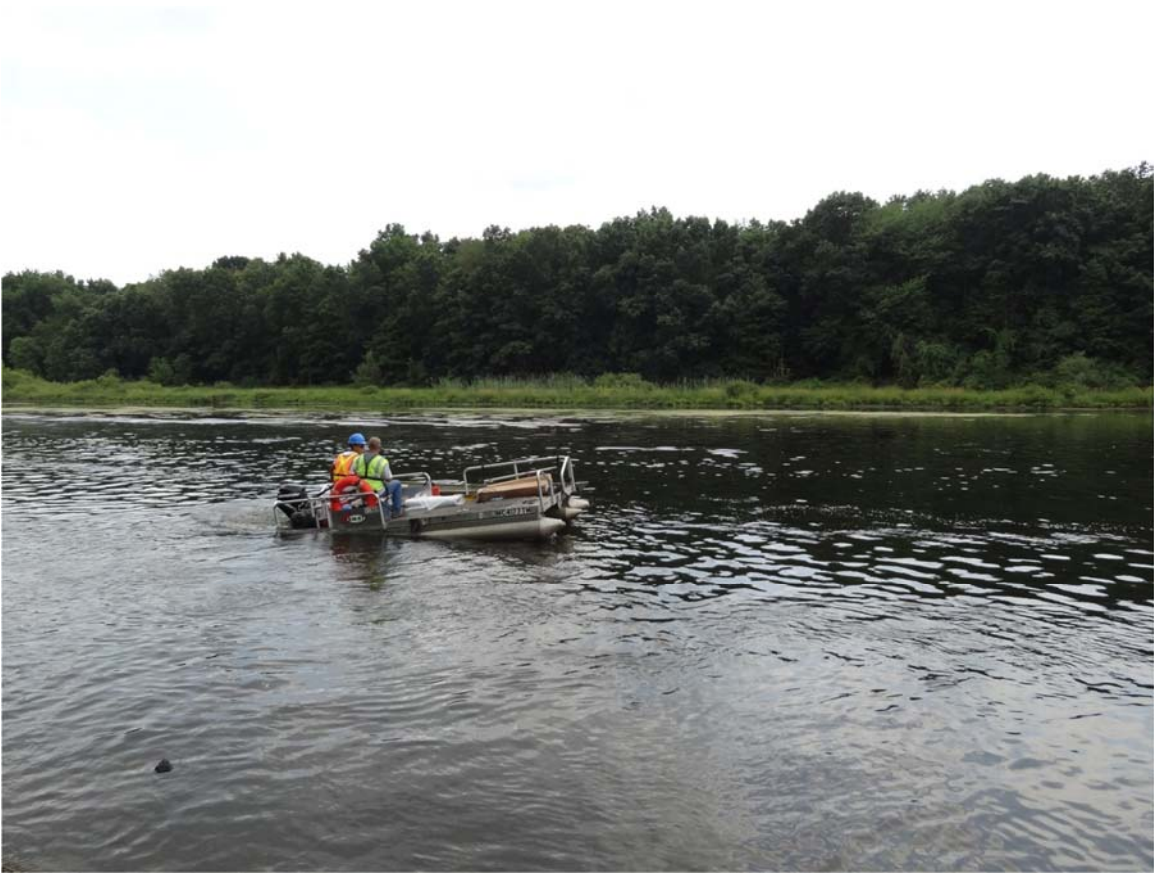
**23. C0.4 Boat launch observed boom maintenance crew heading back out to clean the boom.**

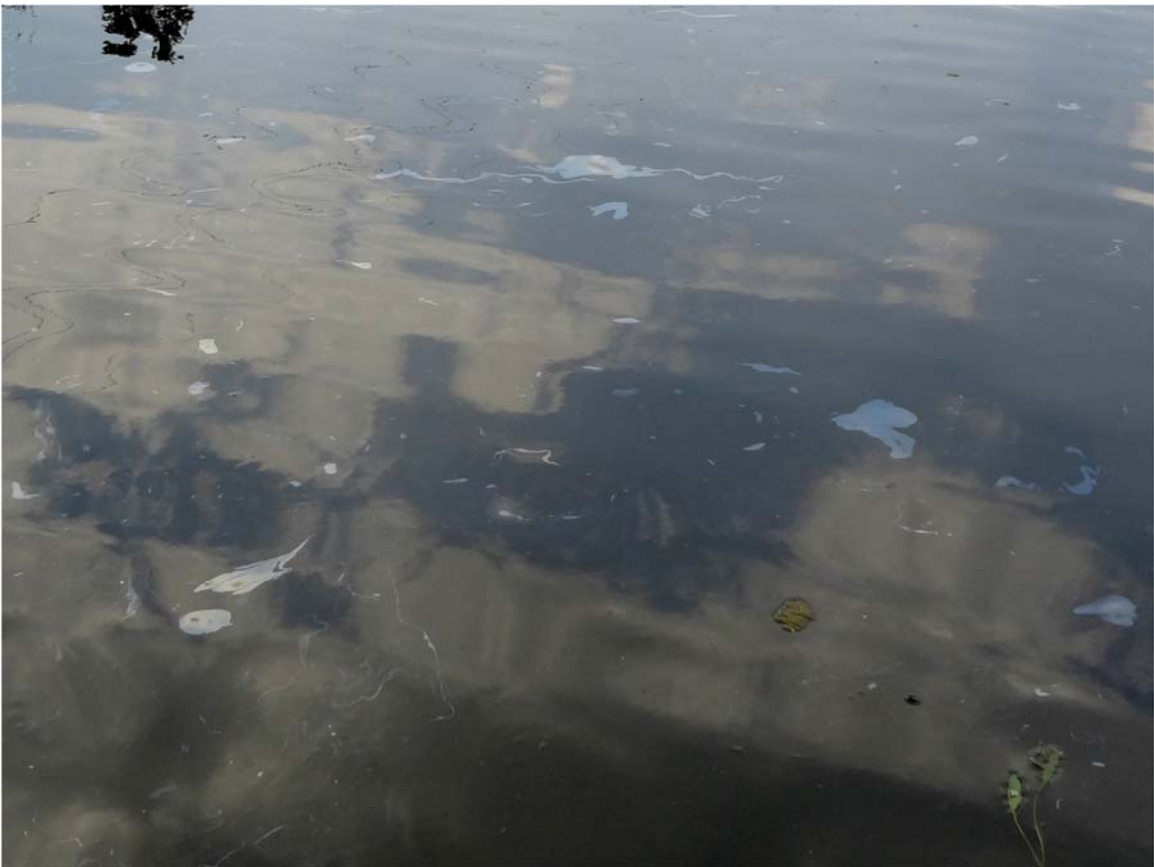
**24. MP5.63 LDB Railroad Crossing sheen observed.**

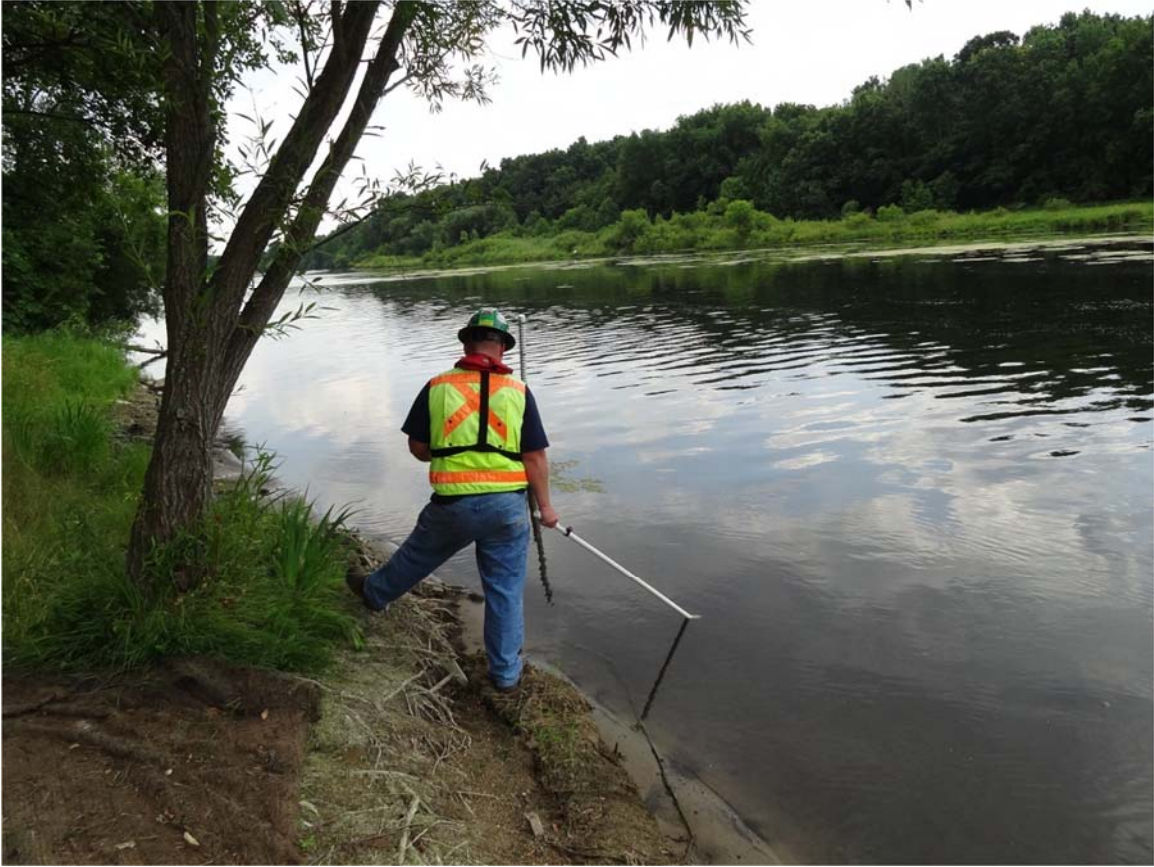
25. C0.4 Boat launch observed containment branch collecting temp.

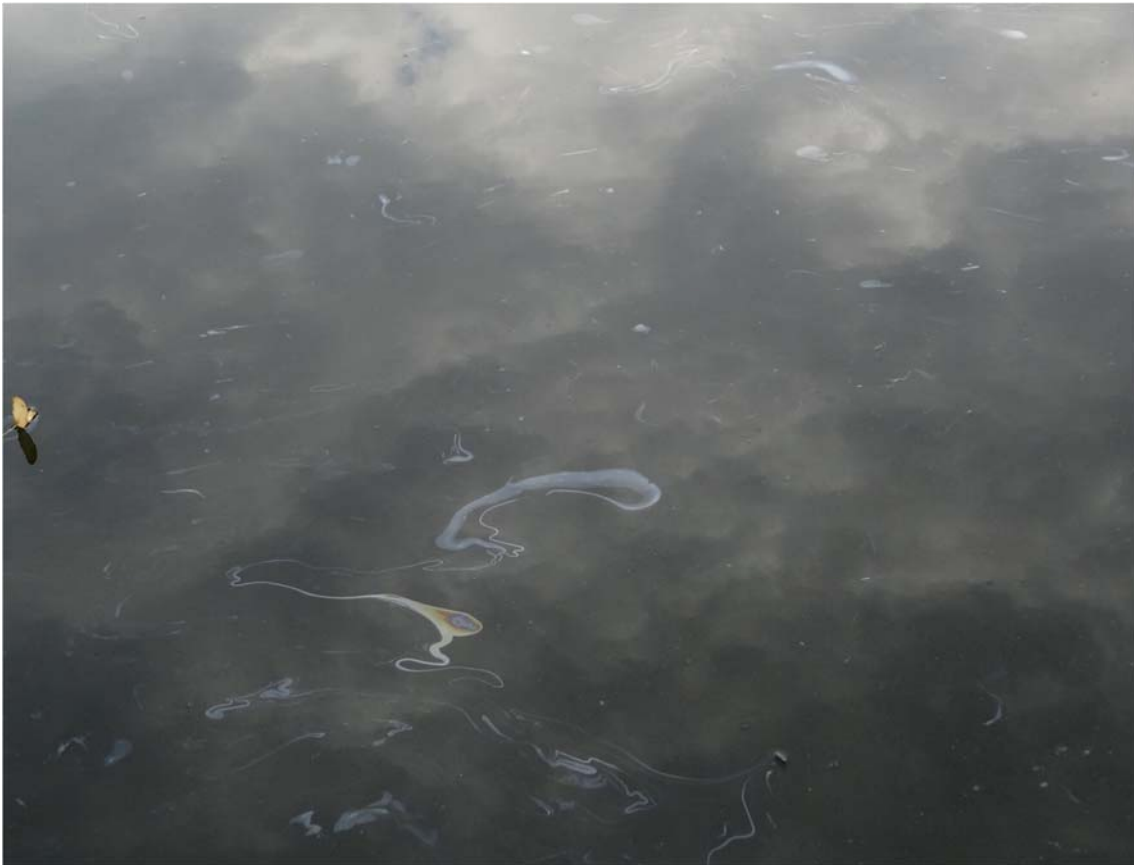
26. MP5.5 LDB sheen observed, operations was notified.

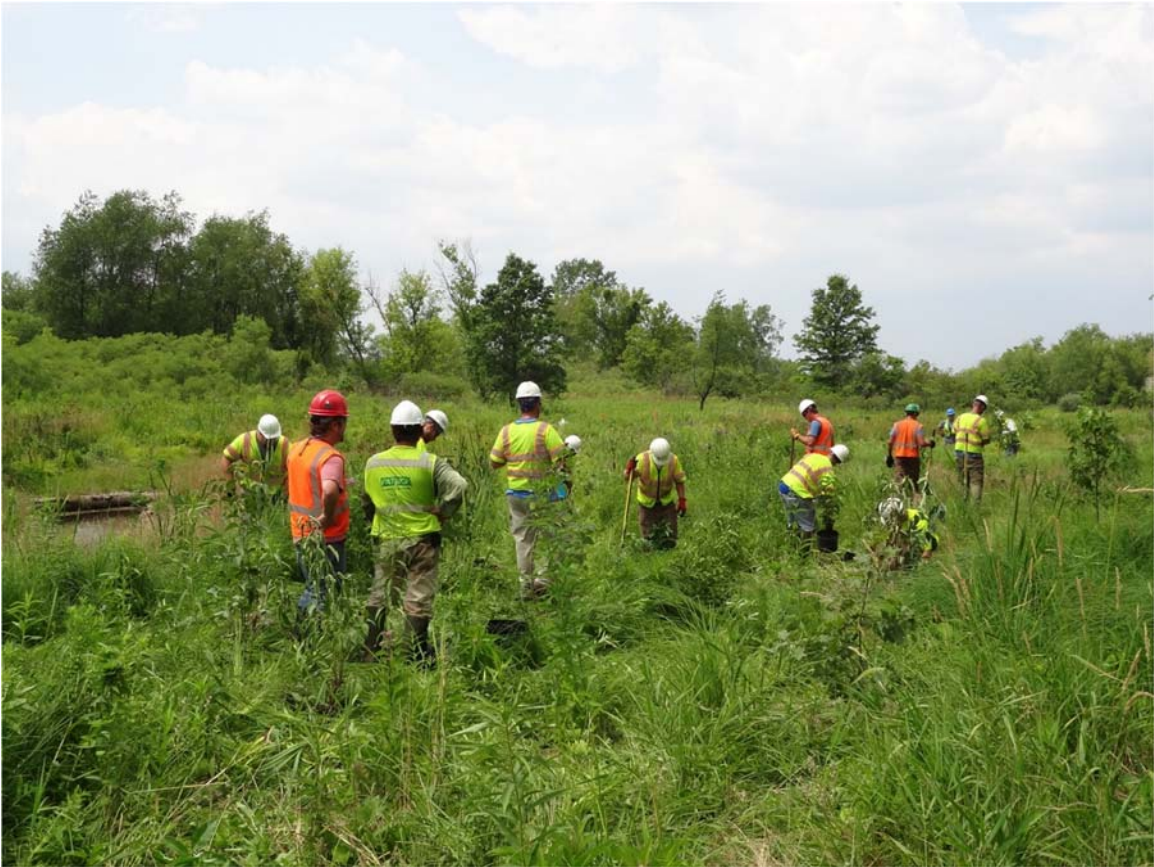
**27. Talmadge Creek restoration work observed.**

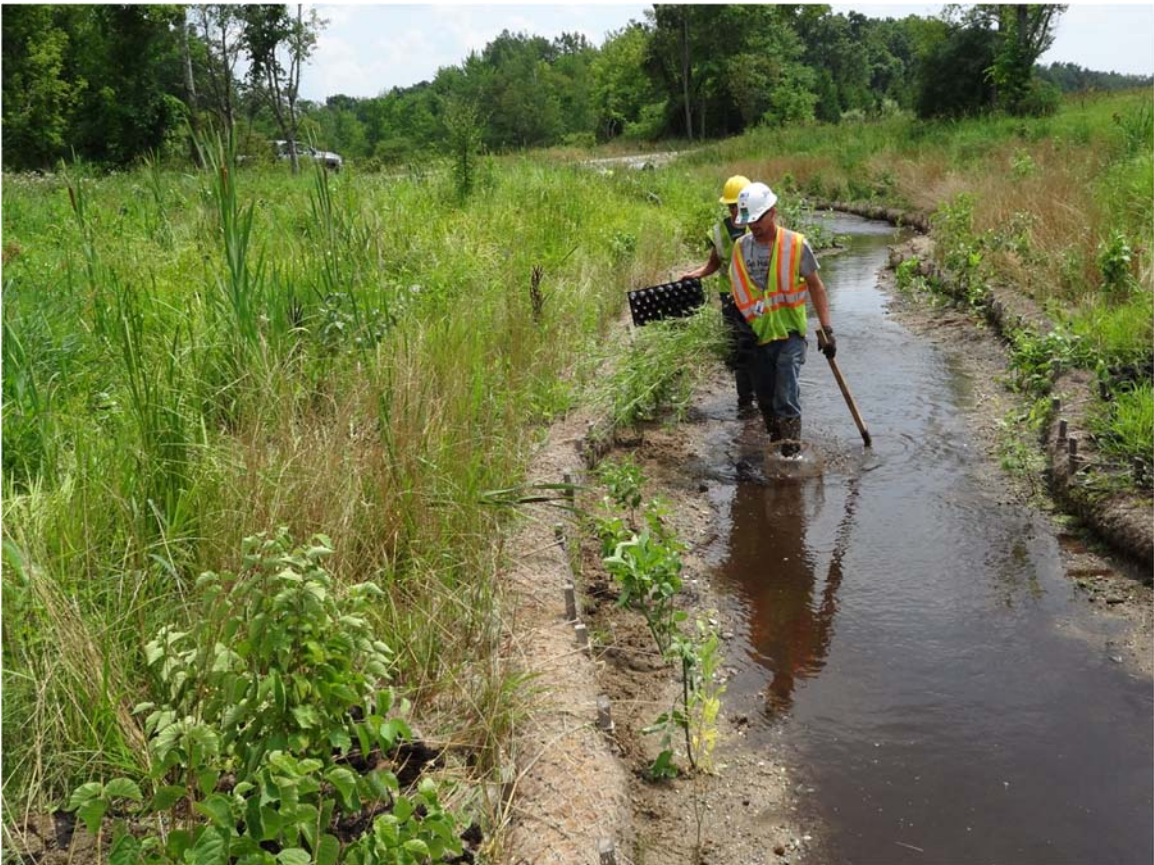
**28. Talmadge Creek restoration work observed.**

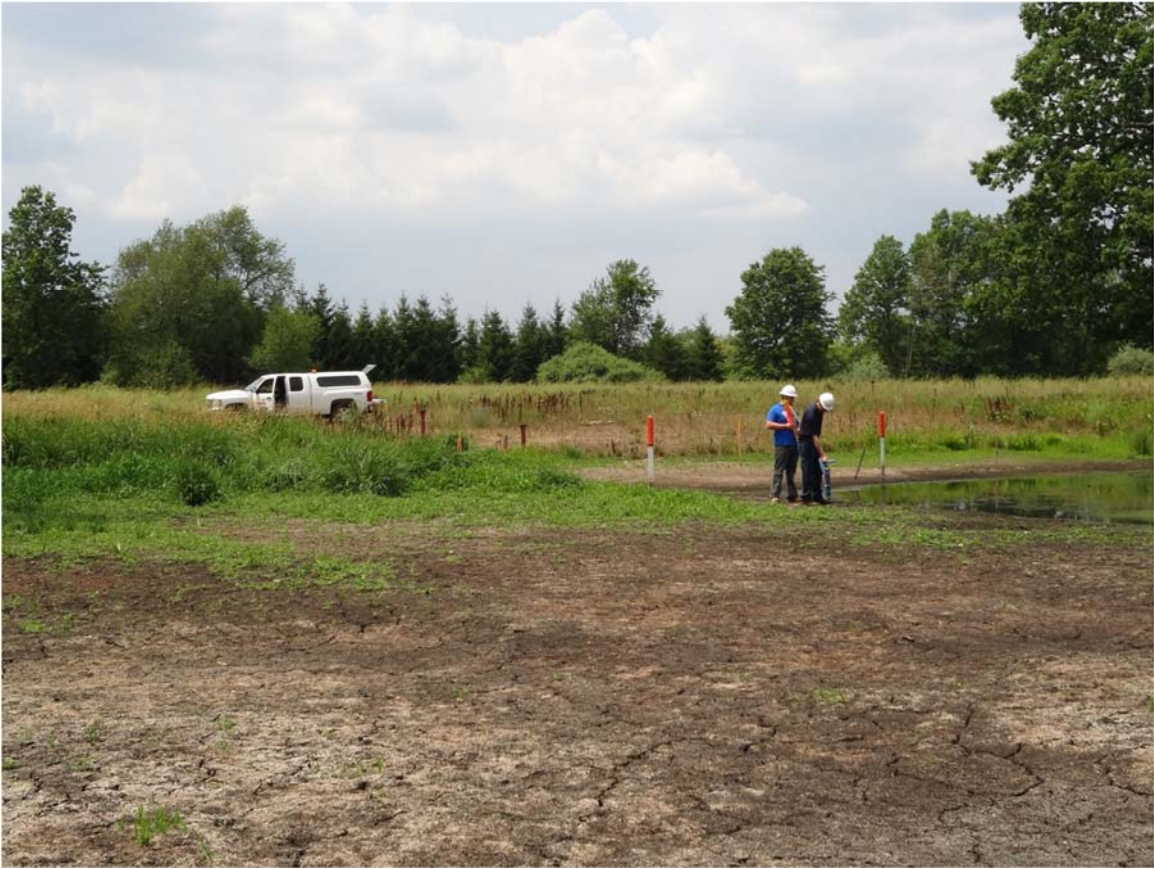
29. Source Area Pond observed crew locating and staking the pipeline.

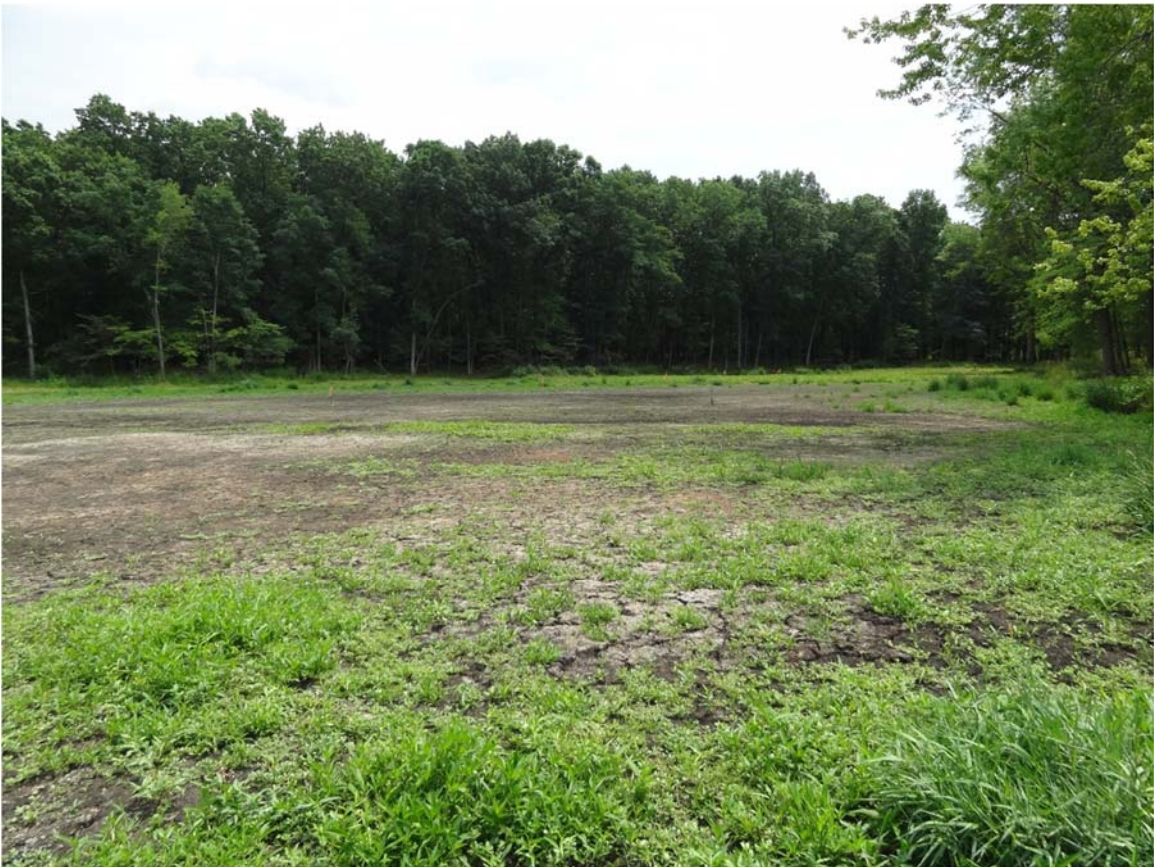
30. Source area nearly completely dry.
