# Situation Photo Log

Tuesday, July 17, 2012

Kalamazoo River / Enbridge Spill

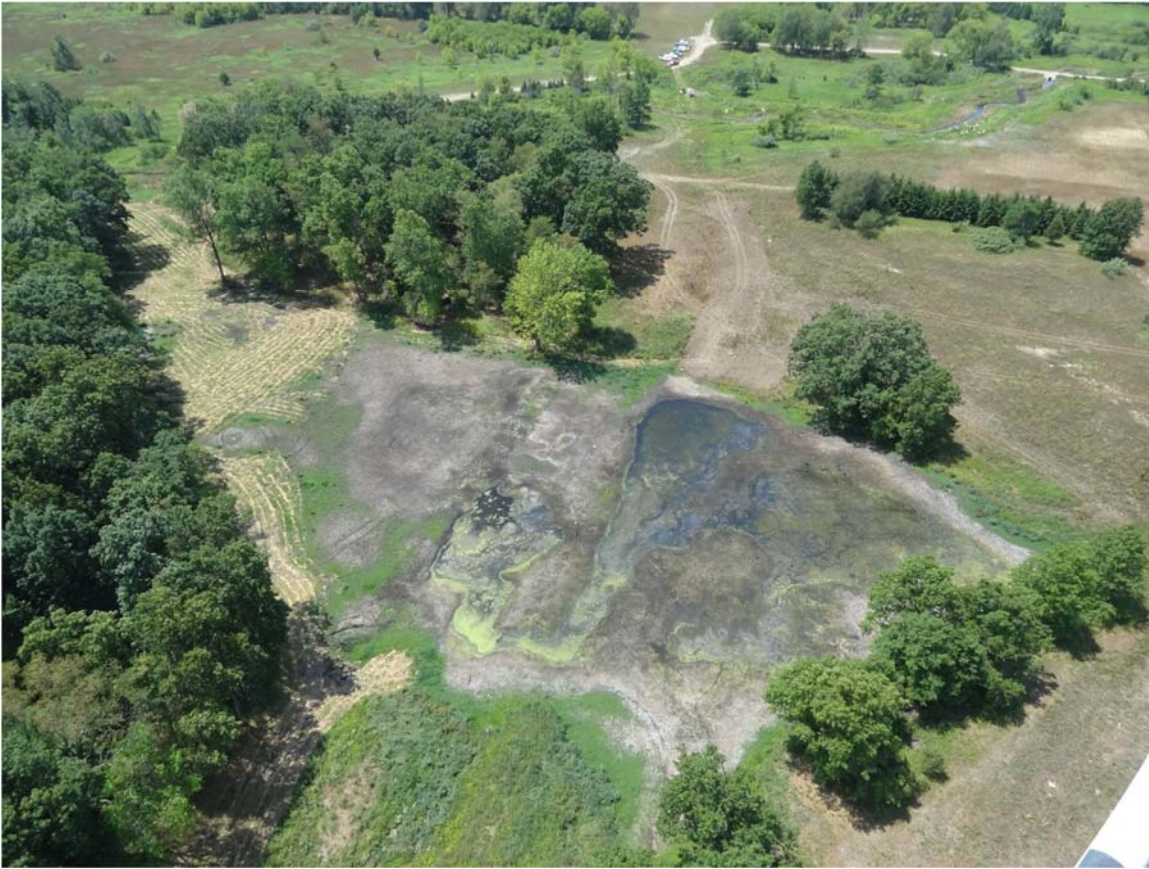
1. Source area pond nearly dry.

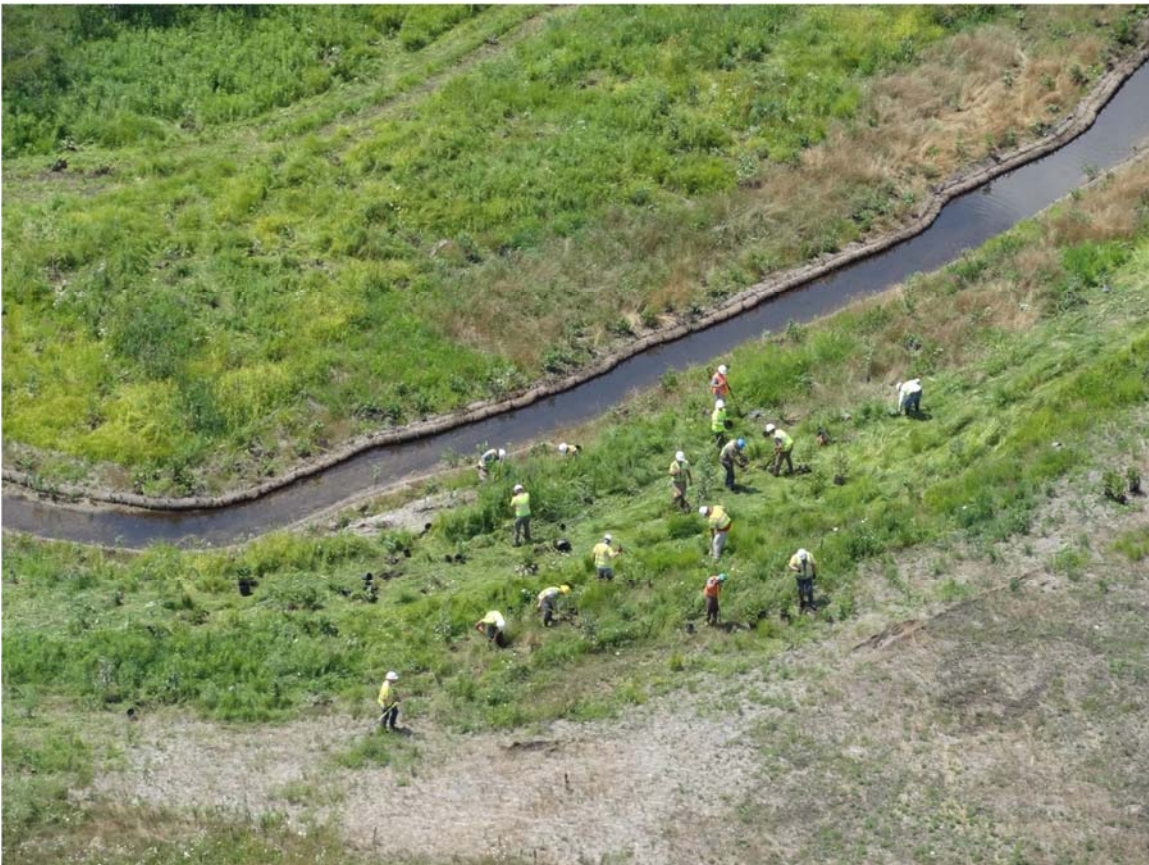
2. Talmadge Creek restoration work.

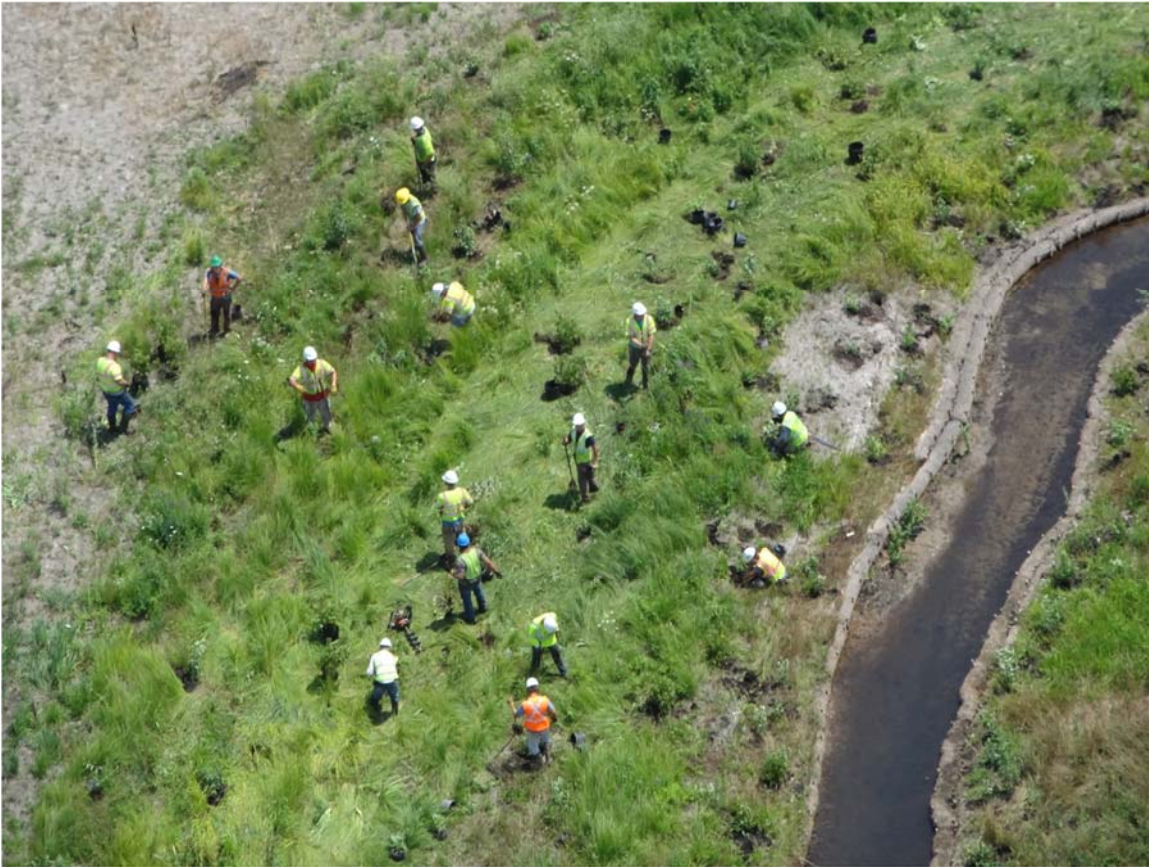
3. Talmadge Creek restoration work.

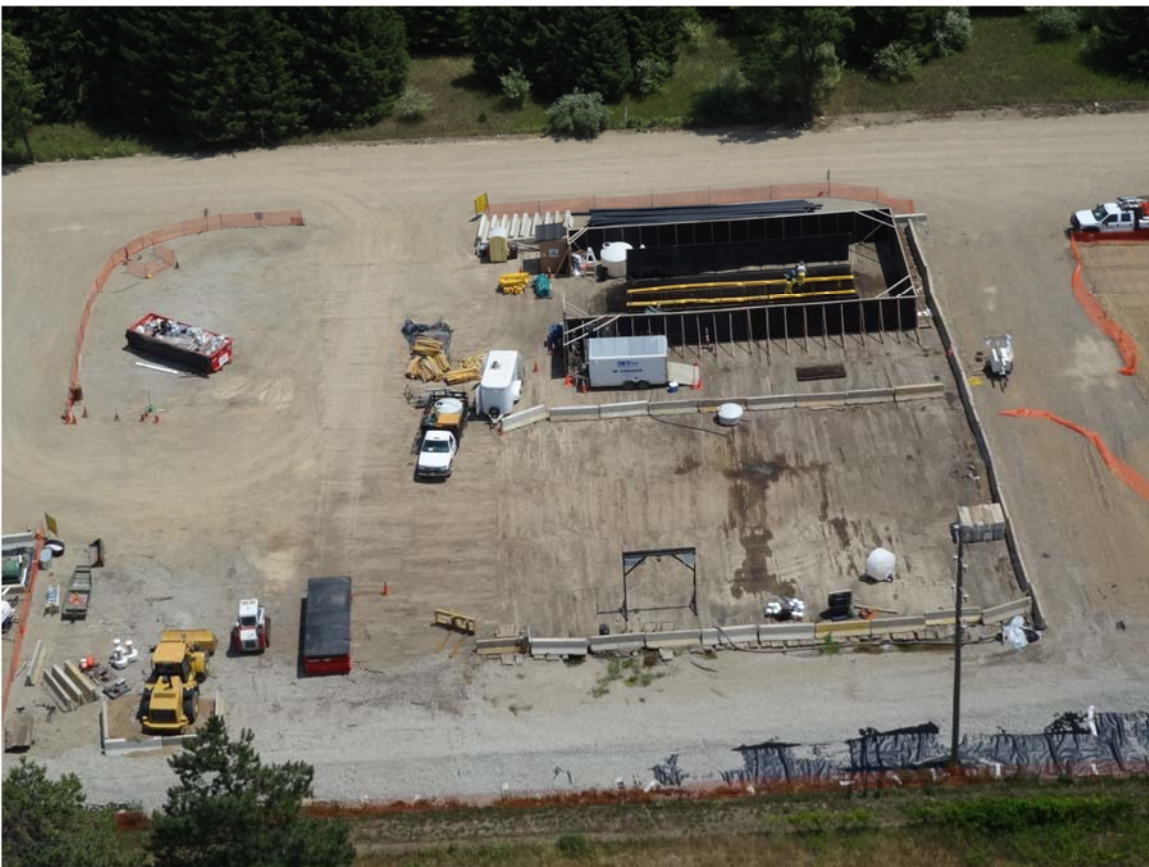
4. Frac-Tank City observed boom being decontaminated.

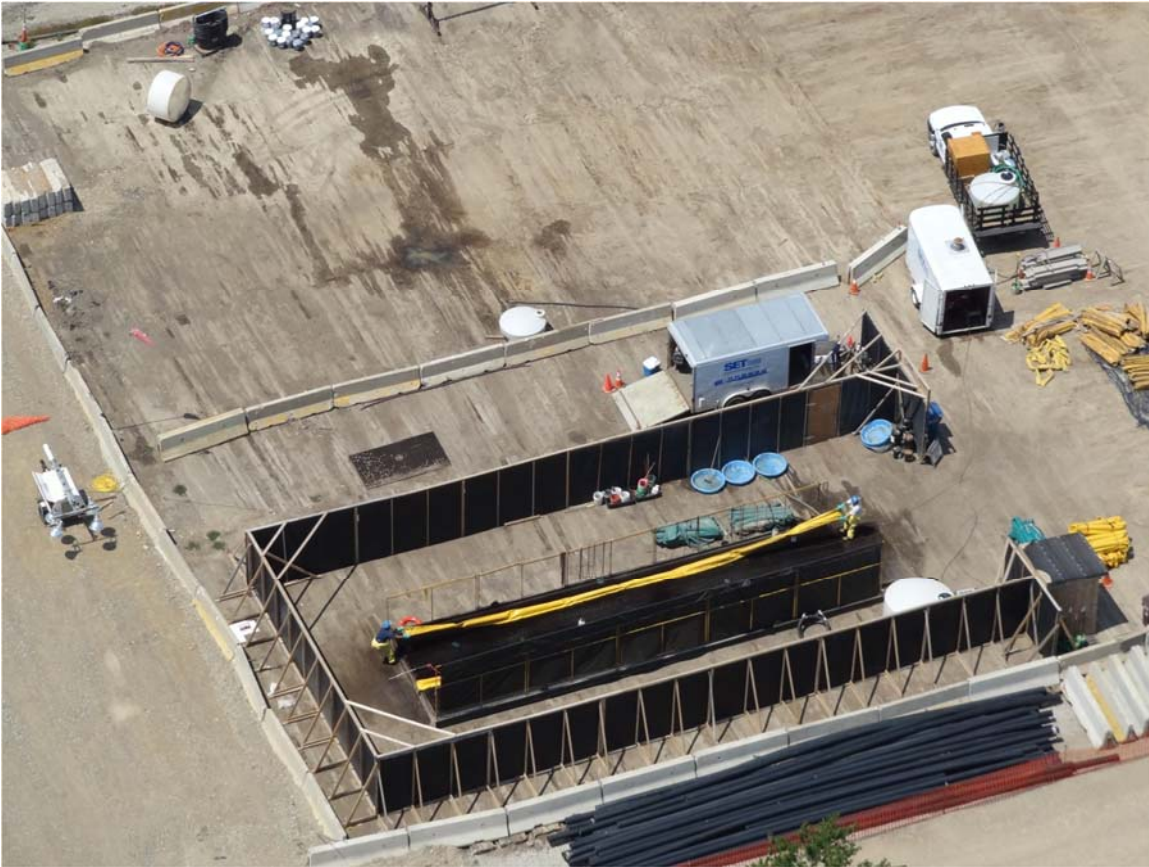
5. Frac-Tank City observed boom being decontaminated.

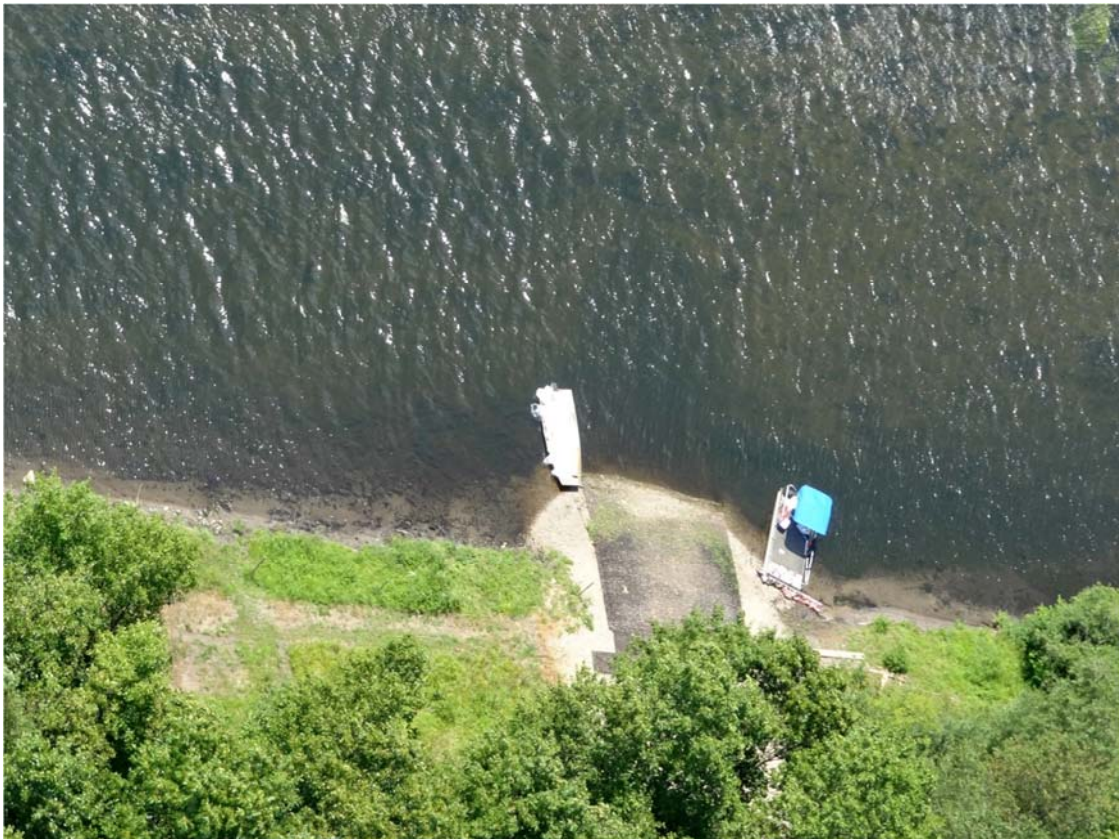
6. Ceresco Dam boom maintenance/sweep boat observed at C0.4 boat launch.

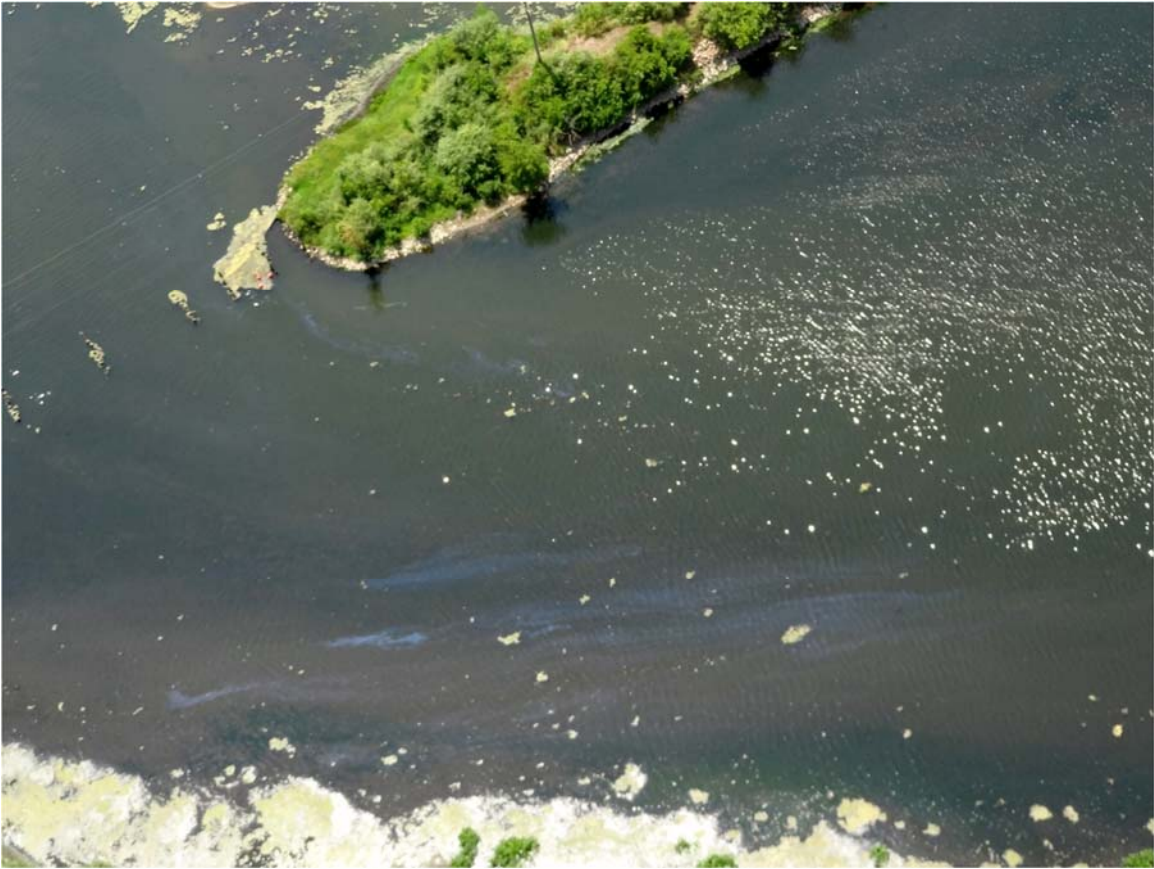
7. Railroad trestle above Ceresco Dam, observed sheen on downstream side. Operations was notified.

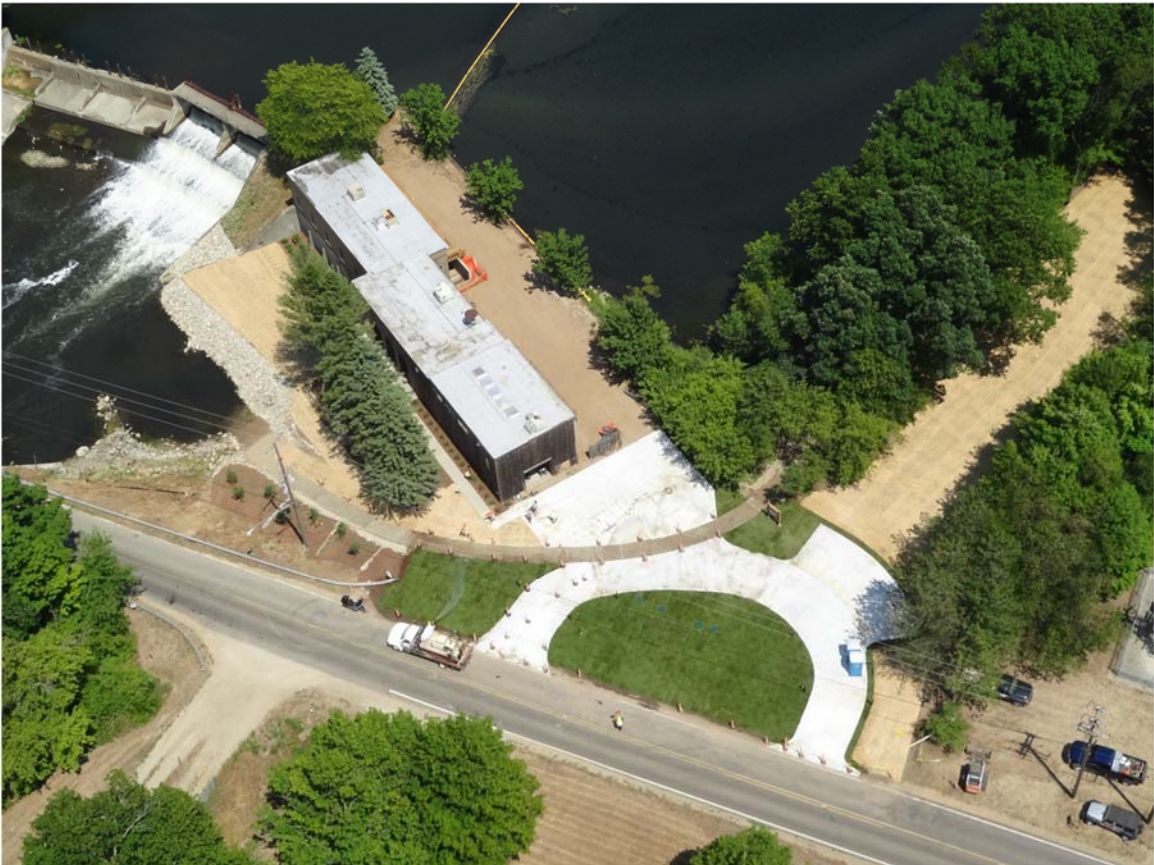
8. Ceresco Dam portage work.

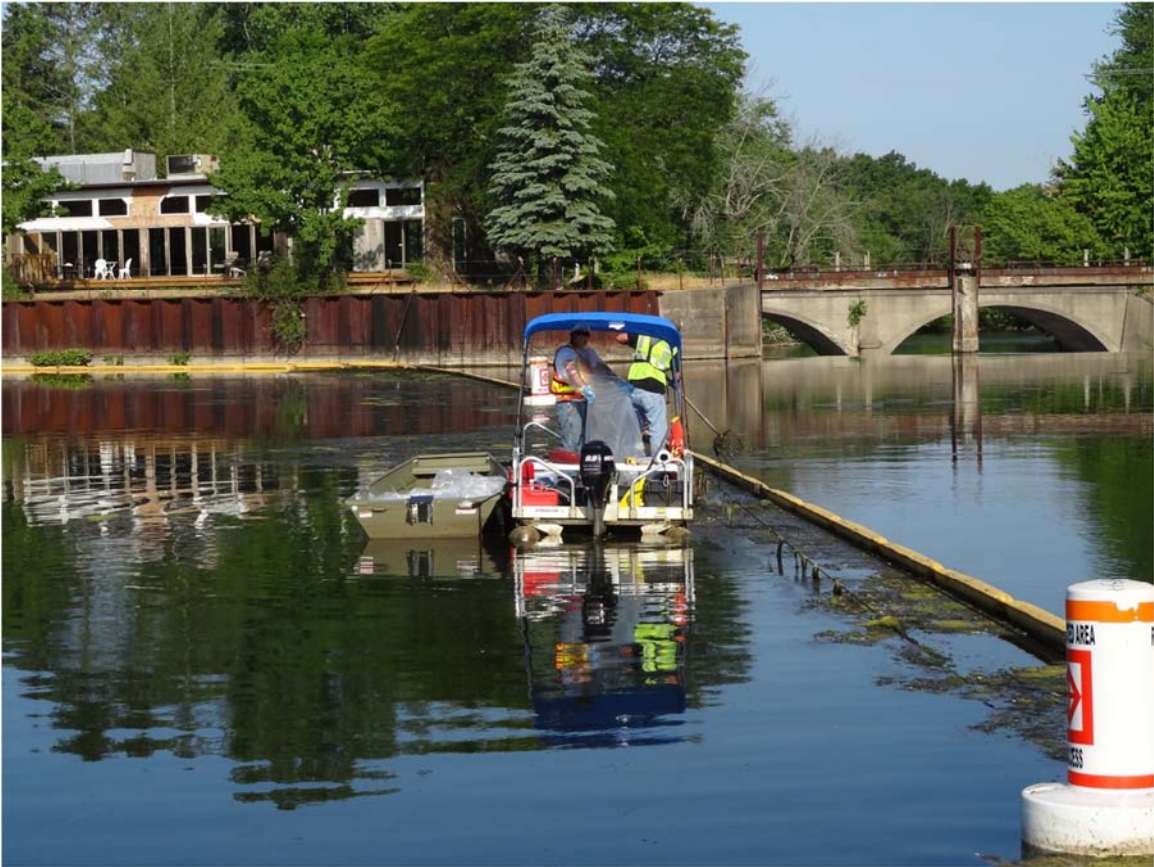
9. Ceresco Dam observed debris removal from the control point.

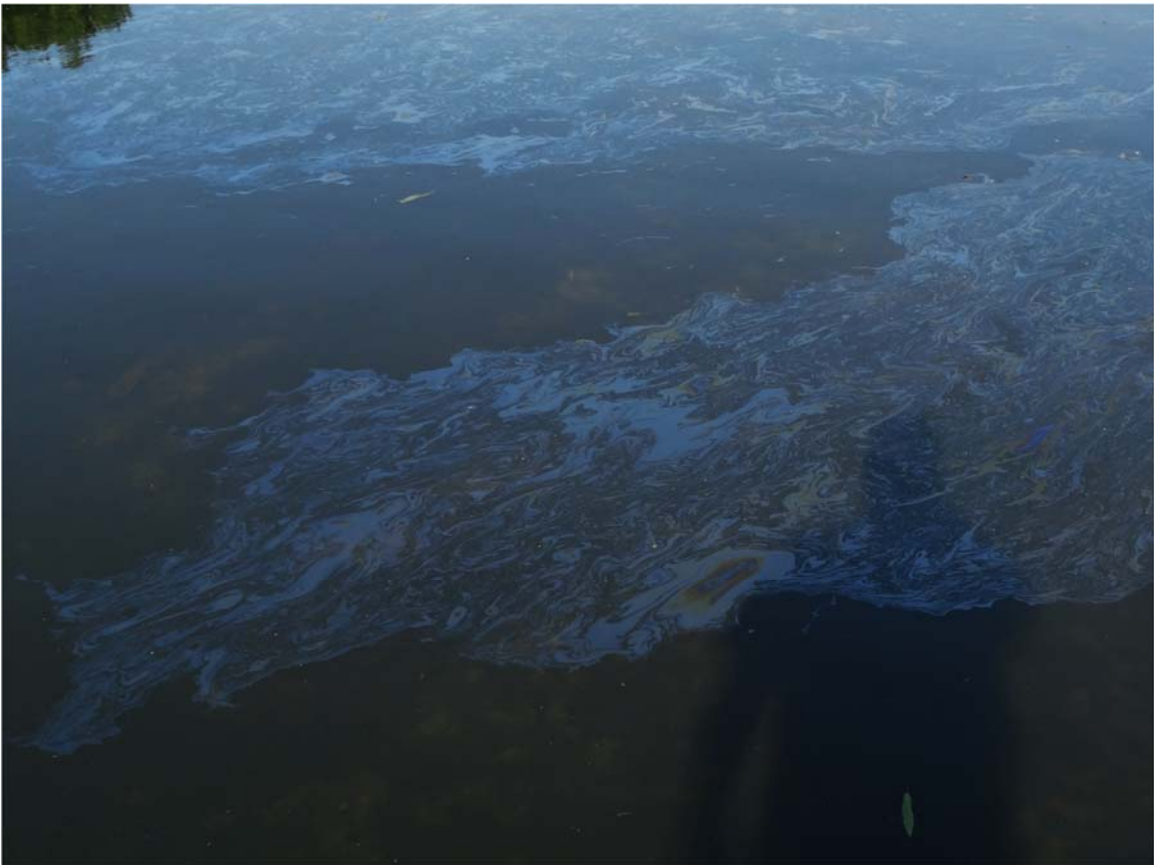
10. Ceresco Dam sheen observed. Sheen was generated from the boom maintenance boat.

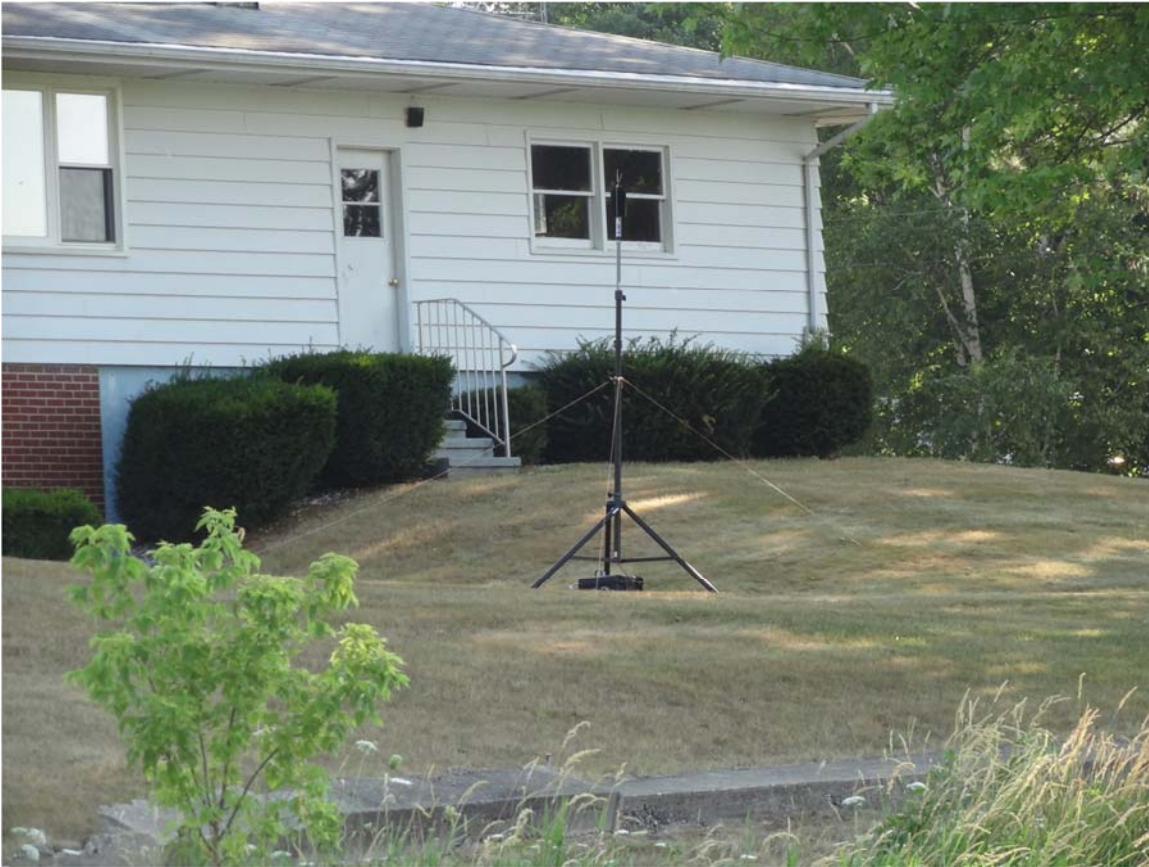
11. Ceresco Dam decibel monitoring station.

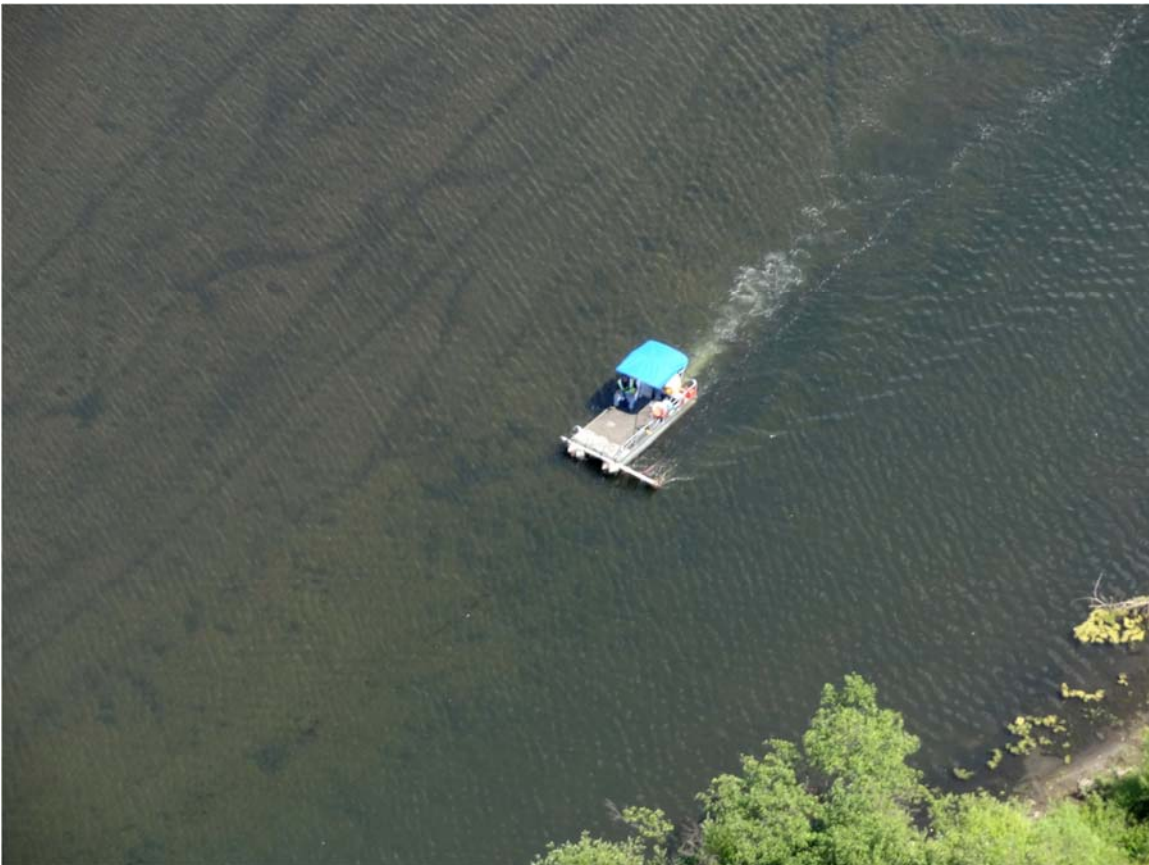
12. Flight back up river, observed sheen sweep boat at MP5.25 LDB.

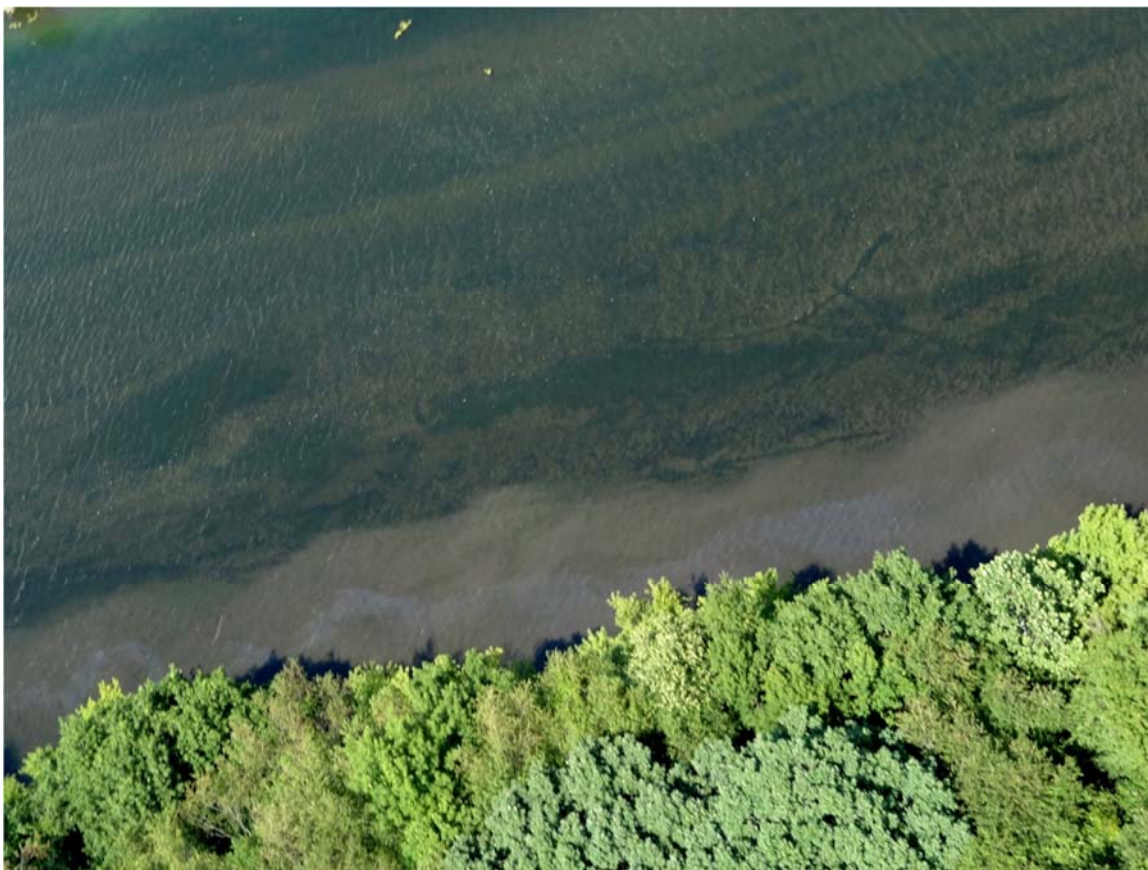
13. MP5.25 Sheen observed along LDB behind the sheen sweep boat.

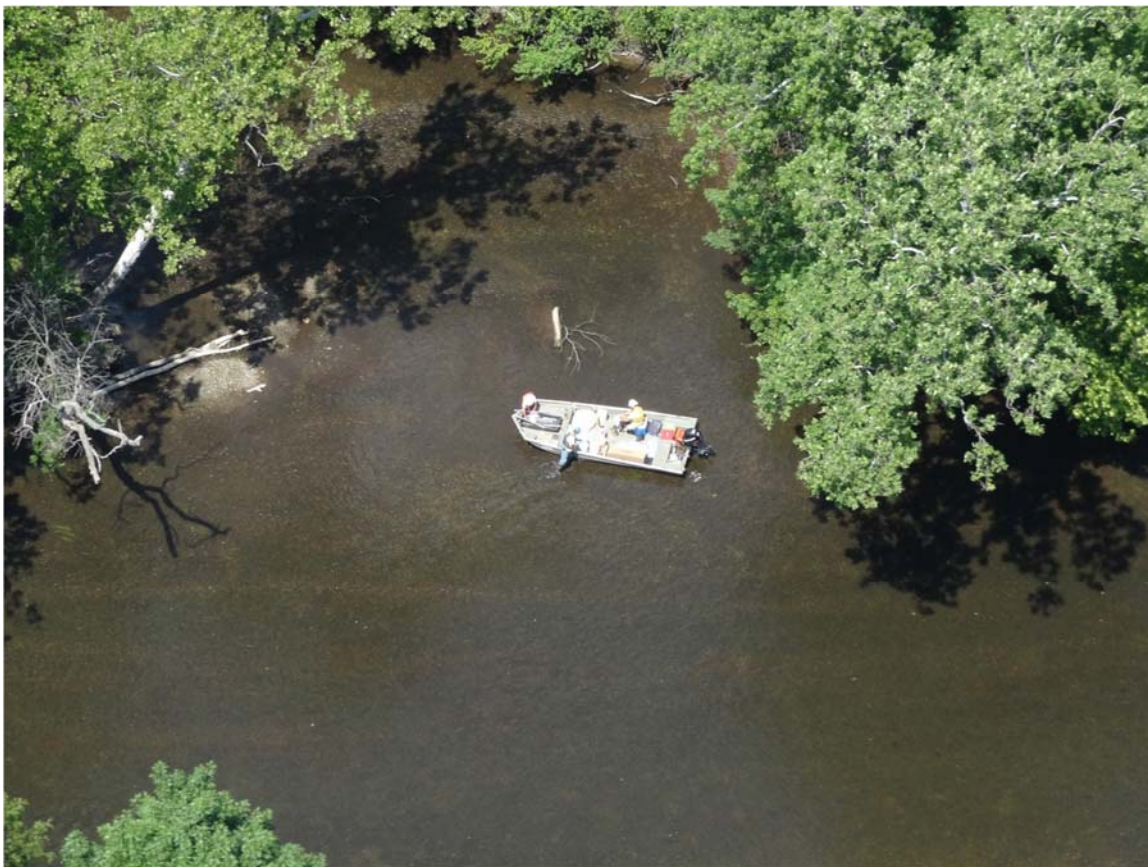
14. MP8.25 RI crew observed.

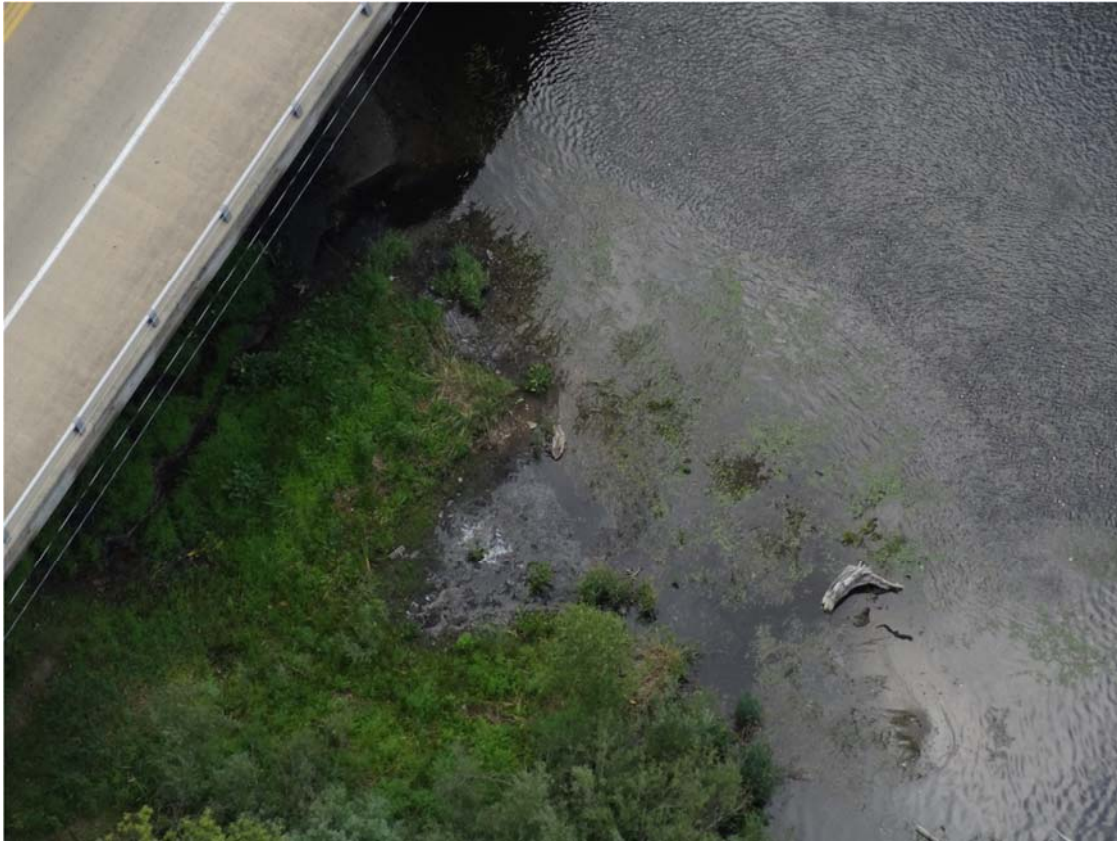
15. MP9.75 RDB sheen observed.

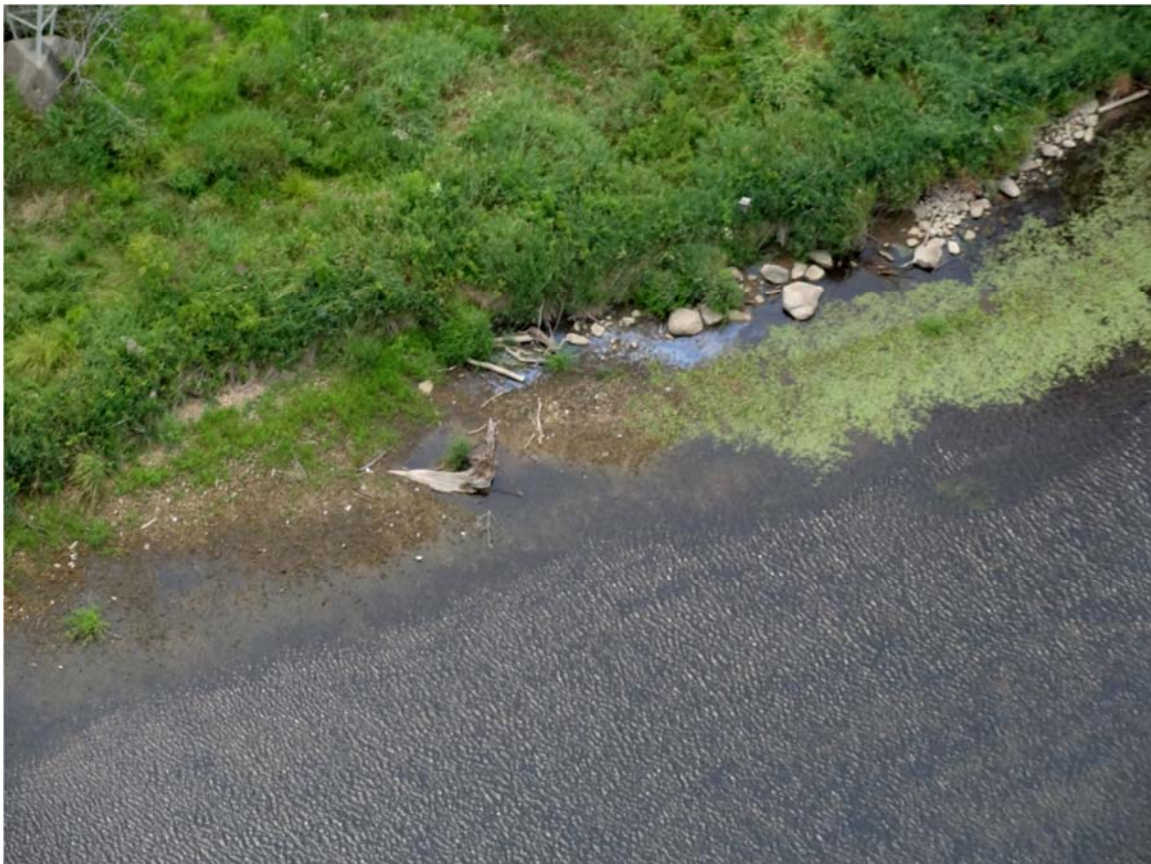
16. MP9.75 LDB sheen observed.

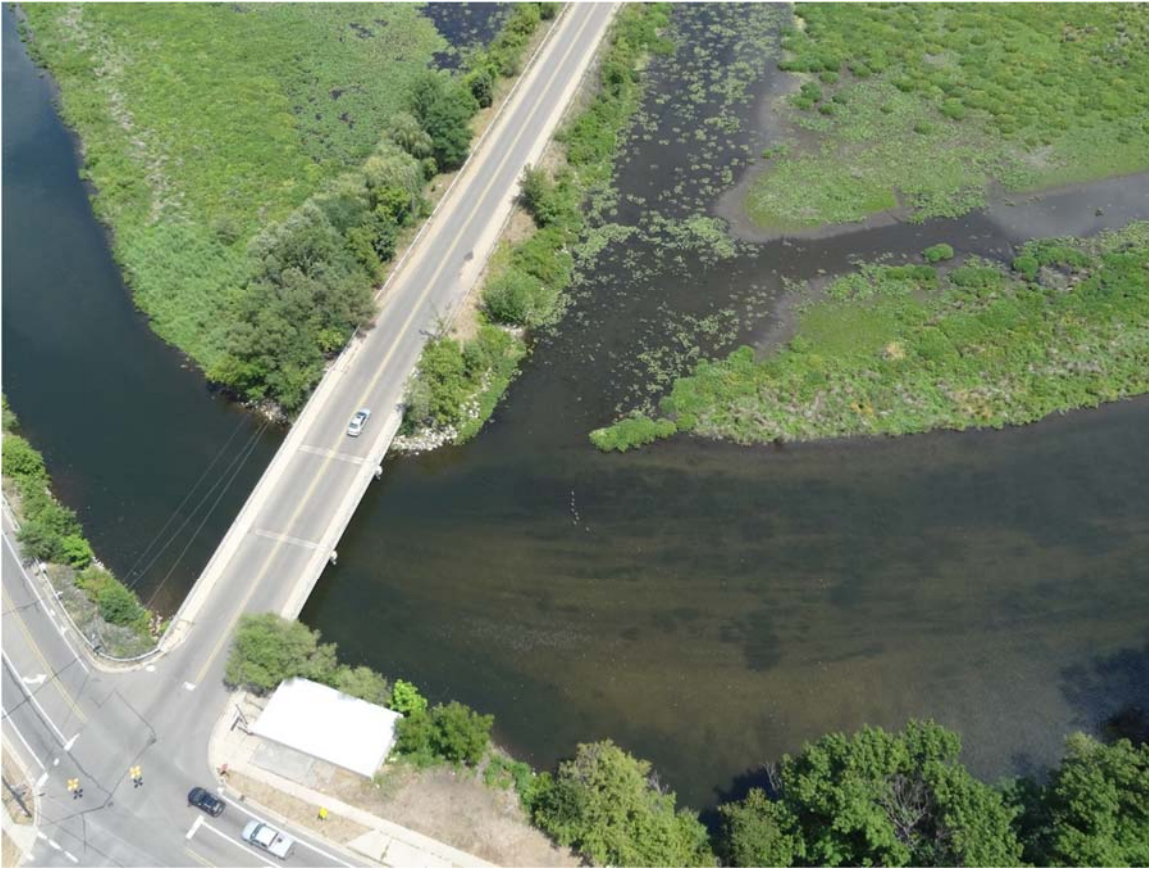
17. MP15.5 South Mill Pond, no sheen observed.

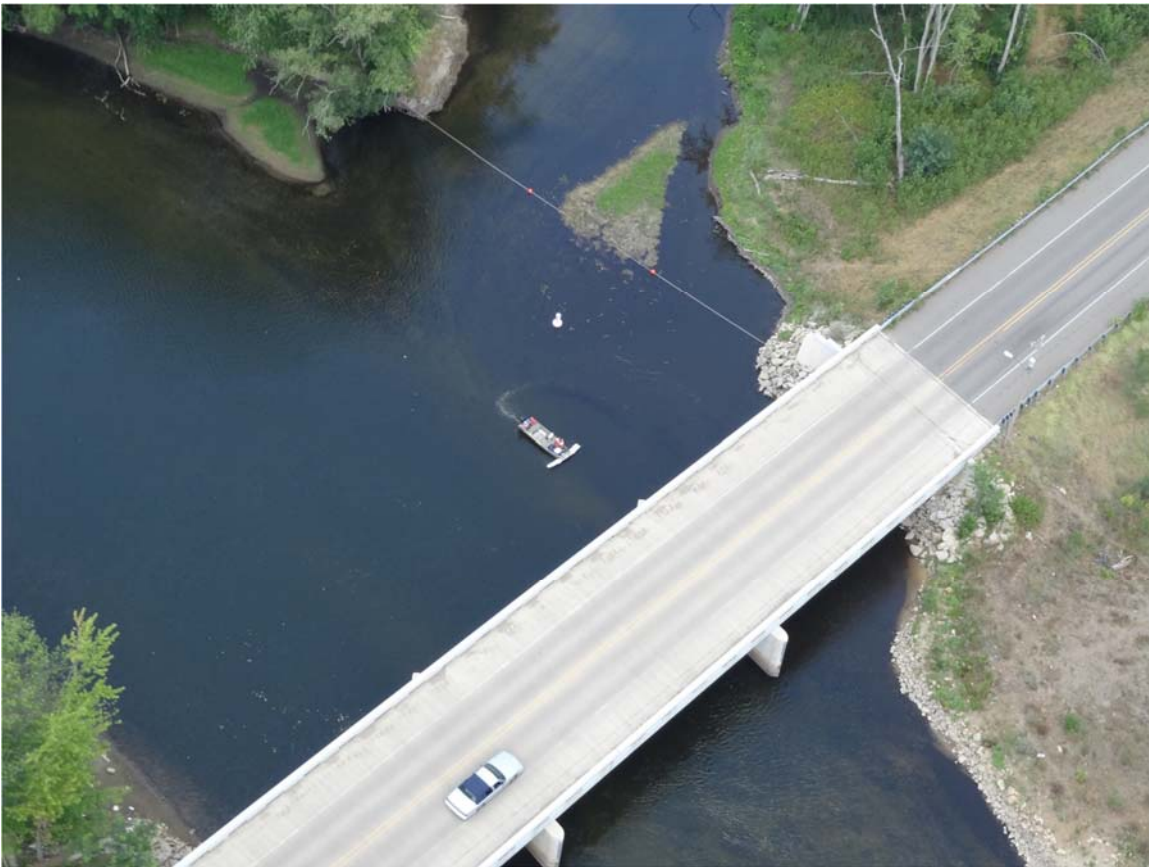
18. Sheen sweeper boat observed at MP 21.5.

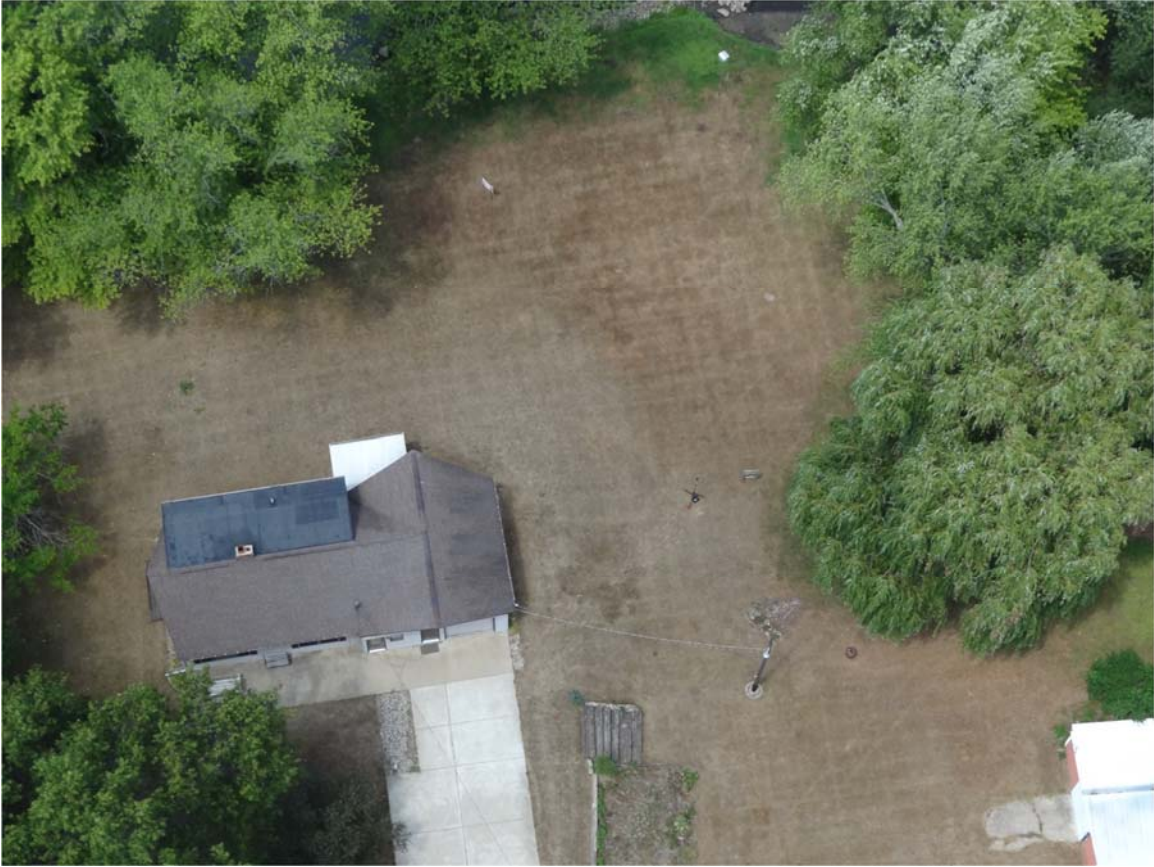
19. MP28.25 decibel monitoring station.

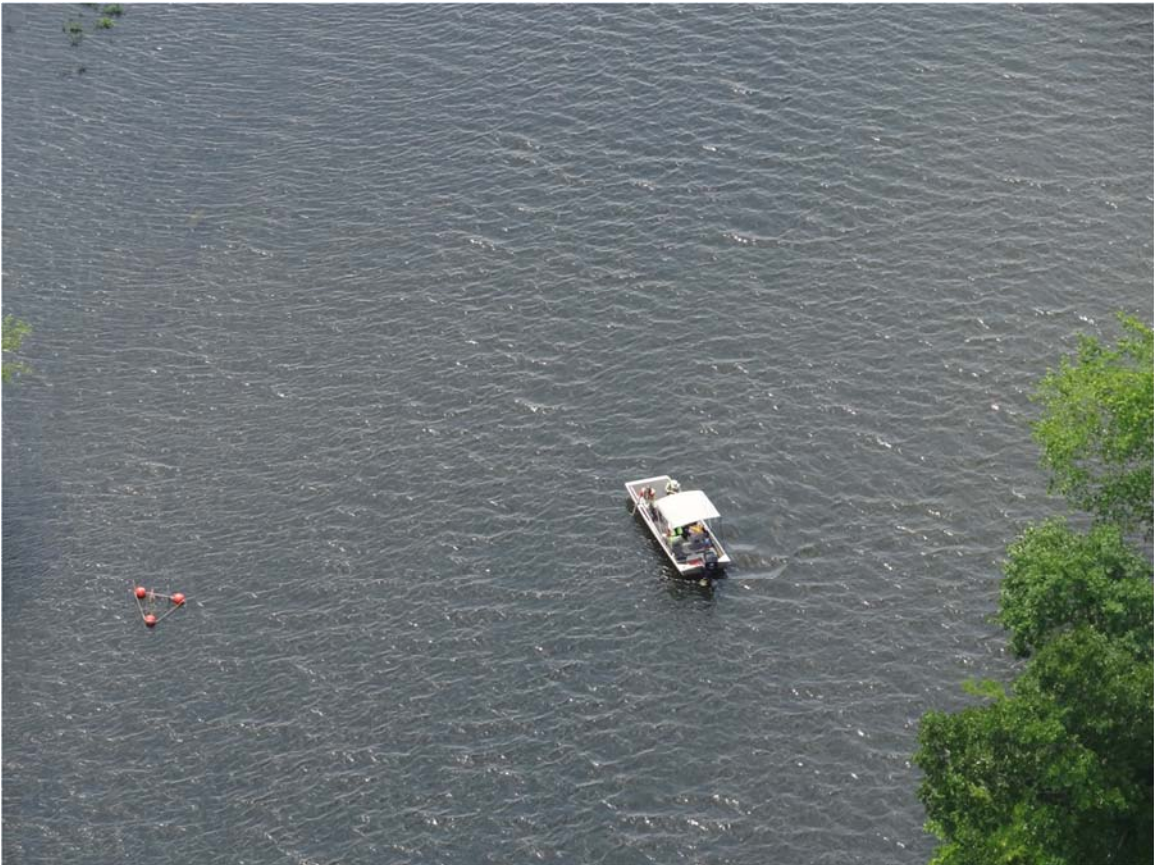
20. Morrow Lake Delta poling crew just west of 35<sup>th</sup> Street Bridge.

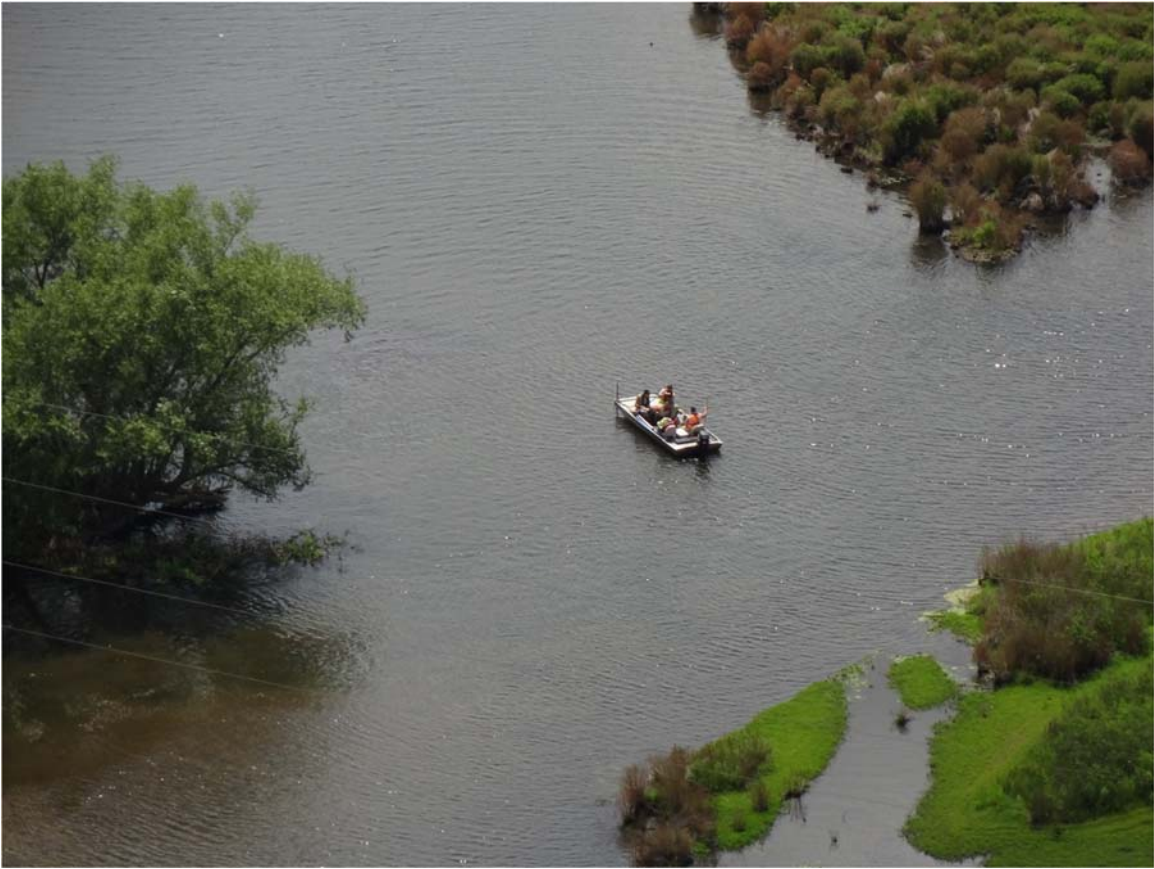
**21. Morrow Lake Delta poling crew observed.**

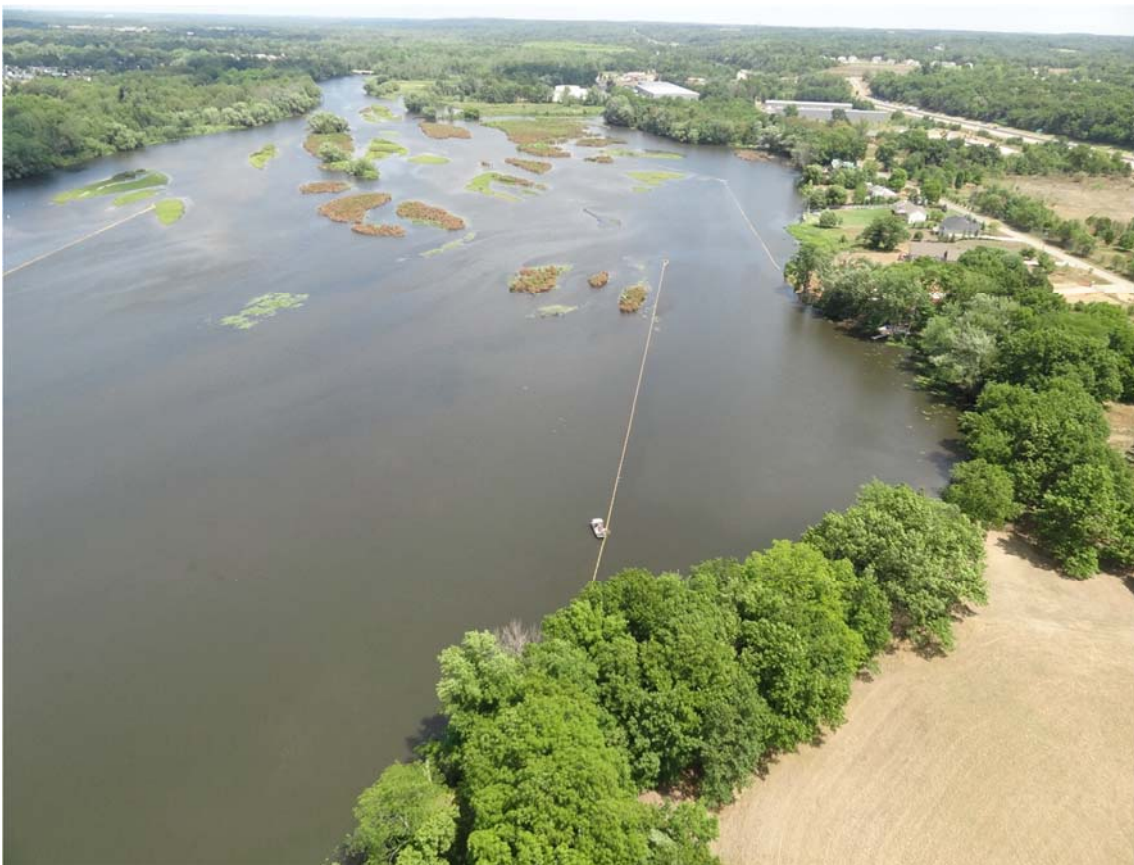
**22. Morrow Lake Delta, observed boom maintenance along Boom B.**

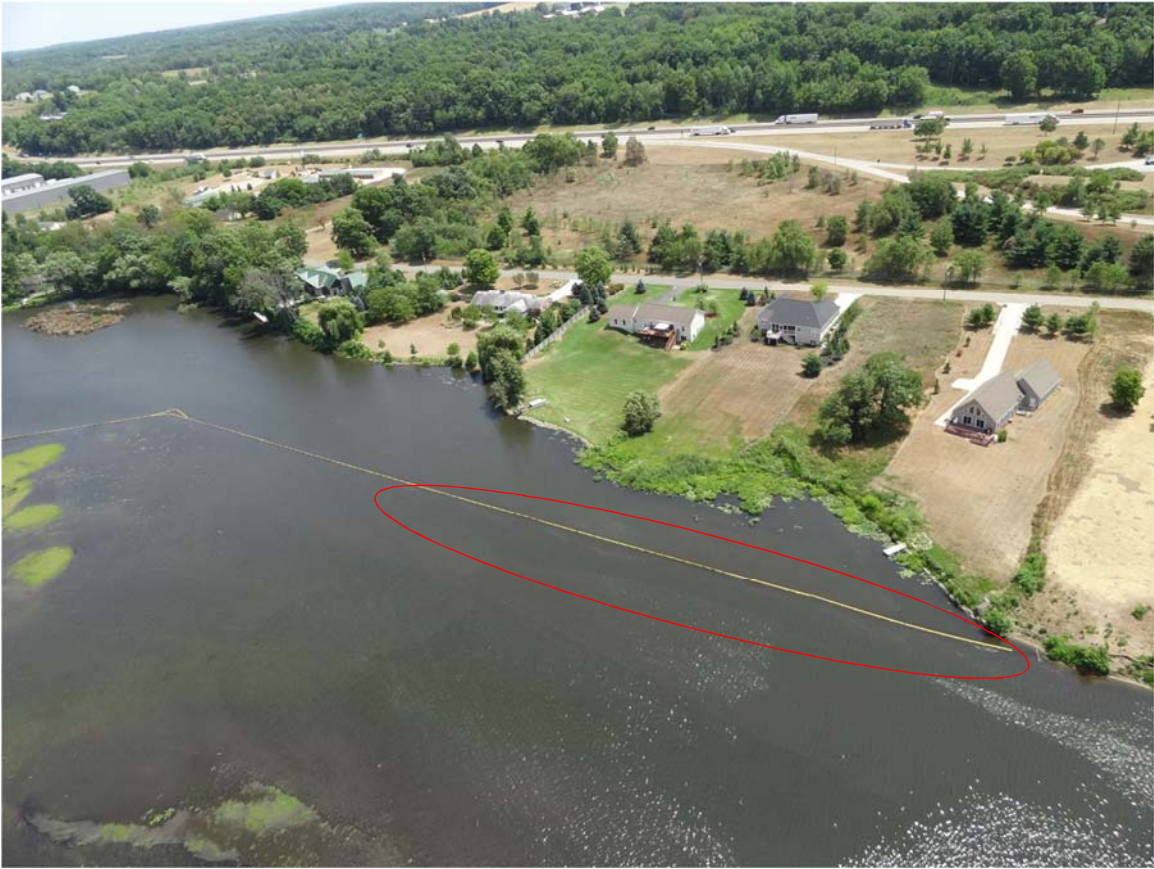
**23. Morrow Lake Delta sheen observed along Boom A.**
