# Situation Photo Log

Tuesday, July 17, 2012

Kalamazoo River / Enbridge Spill

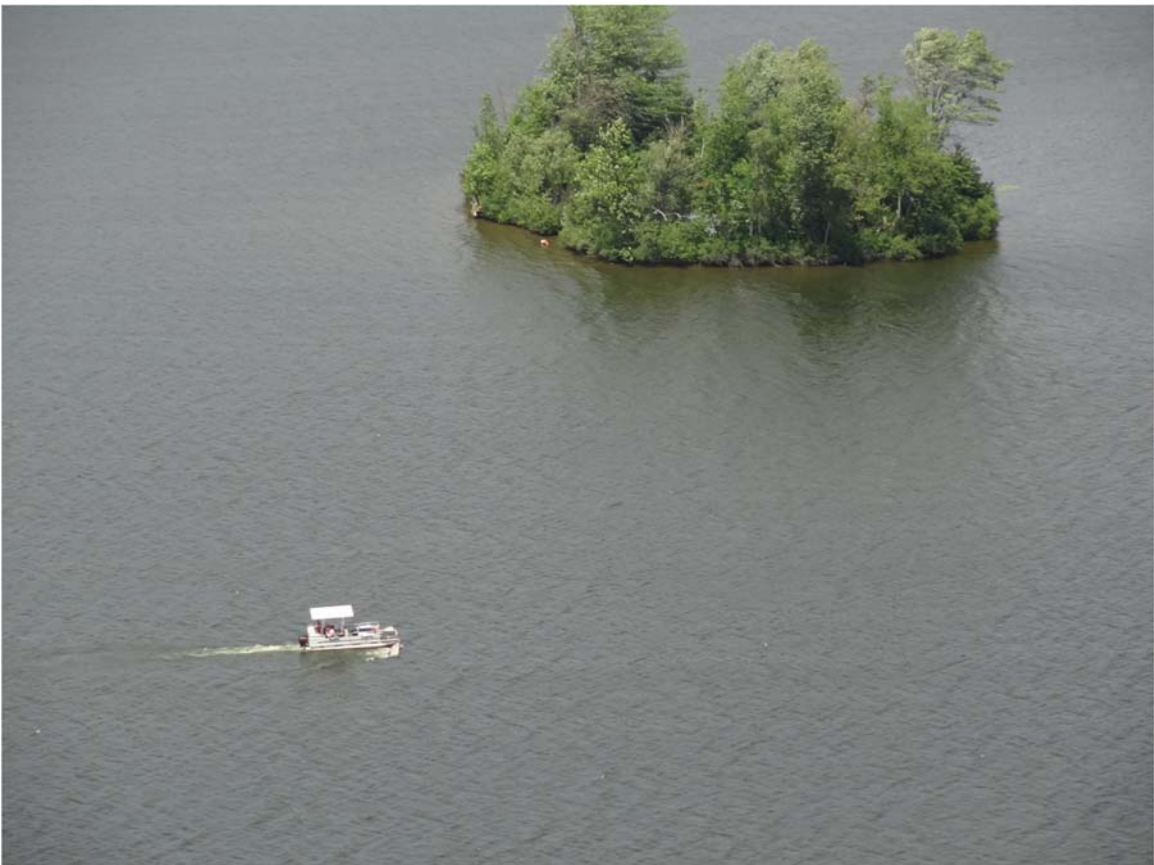
**24. Morrow Lake observed sweep boat operating south of Rowe Island.**
