# Situation Photo Log

Monday, July 23, 2012

Kalamazoo River / Enbridge Spill

Prepared by:  
Matthew Haak  
START-USEPA  
Situation Unit Leader

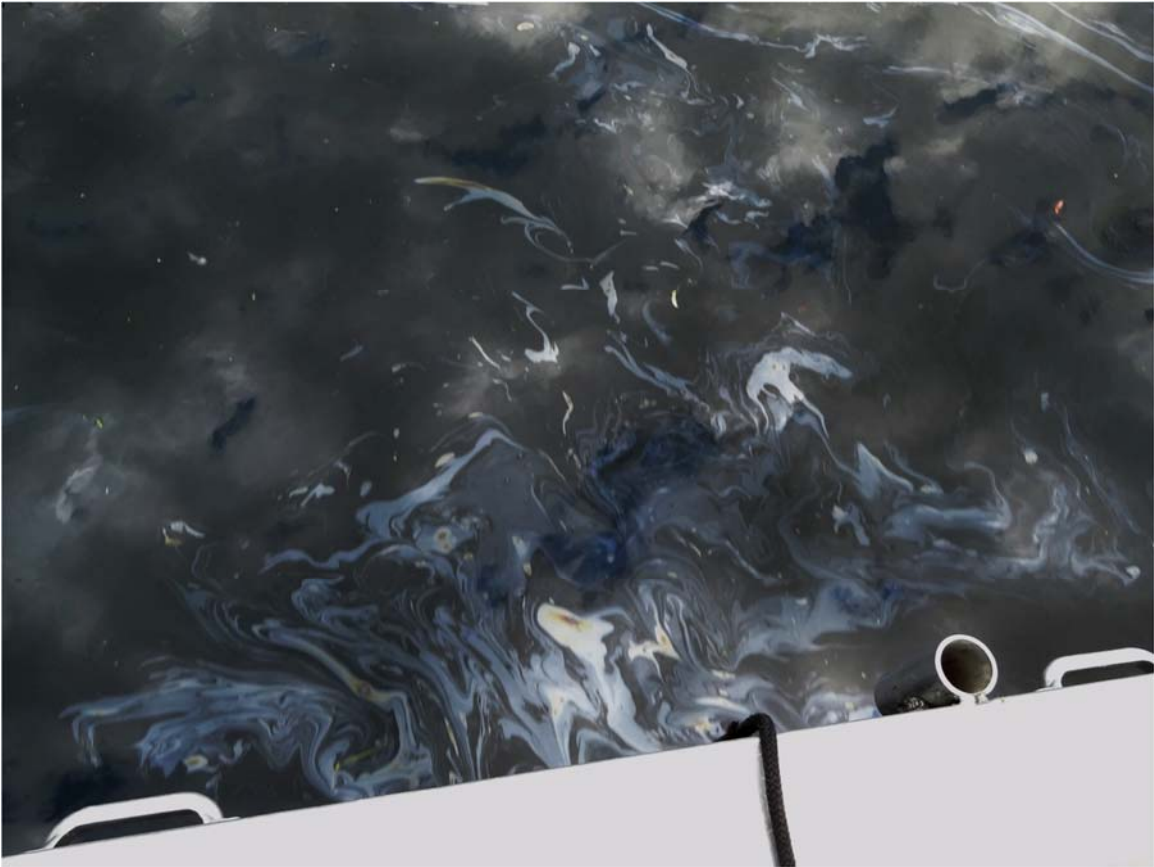
1. MP5.63 Railroad Trestles observed sheen and tar globs.

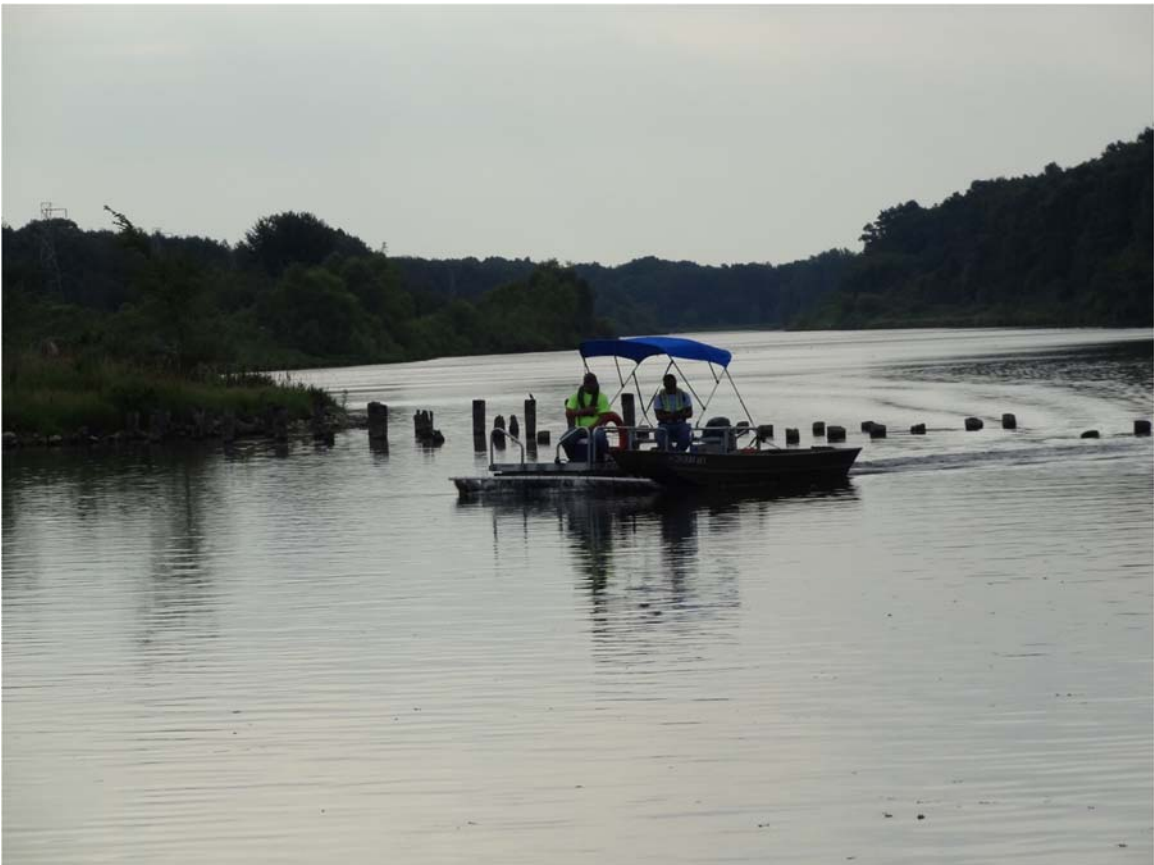
2. MP5.63 Railroad Trestles observed sheen sweep boat/boom maintenance boom.

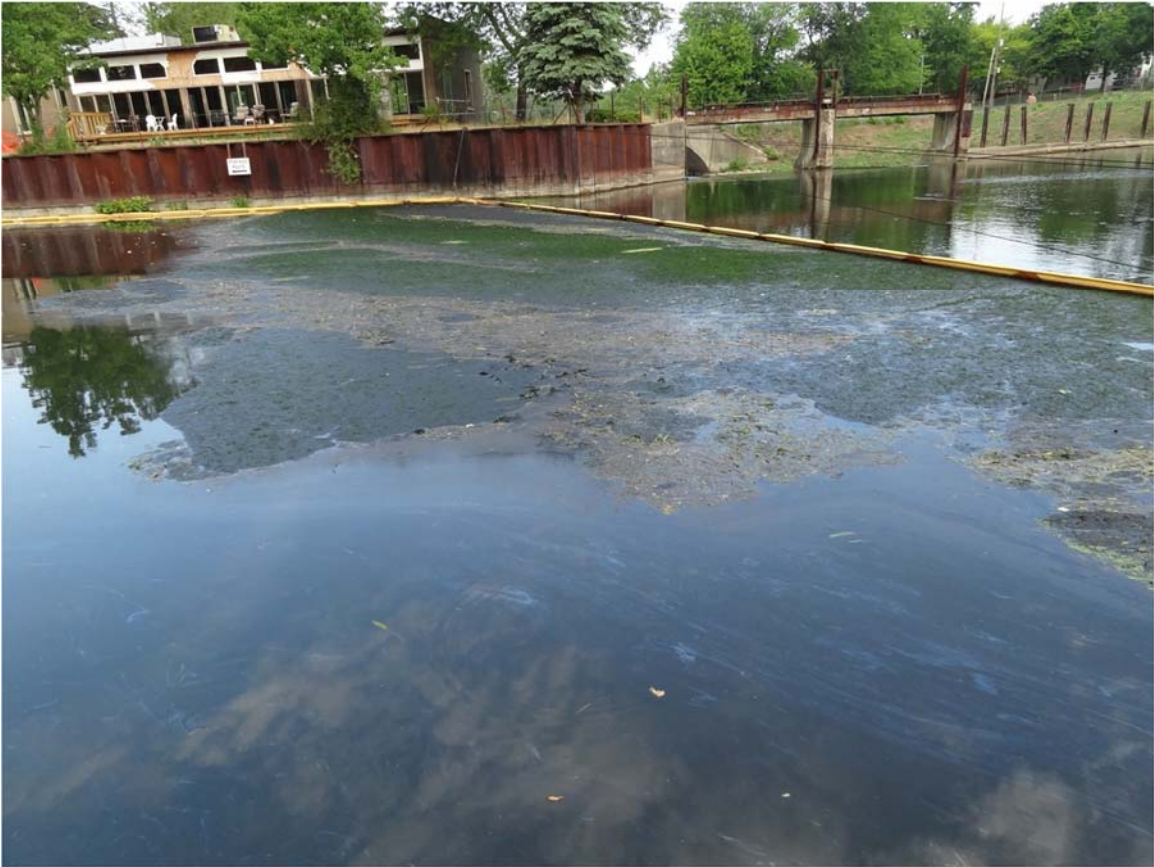
3. Ceresco Dam Control Point sheen and debris collecting.

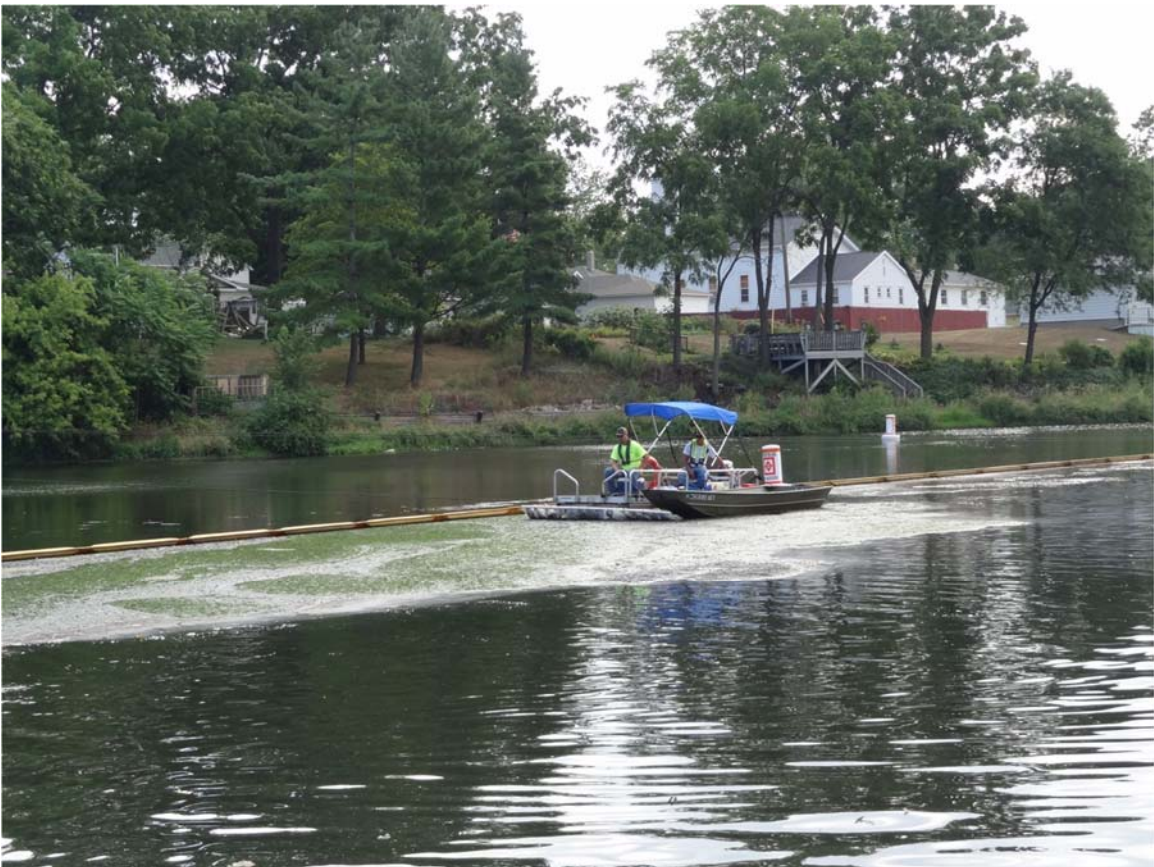
4. Ceresco Dam Control Point boom maintenance crew.

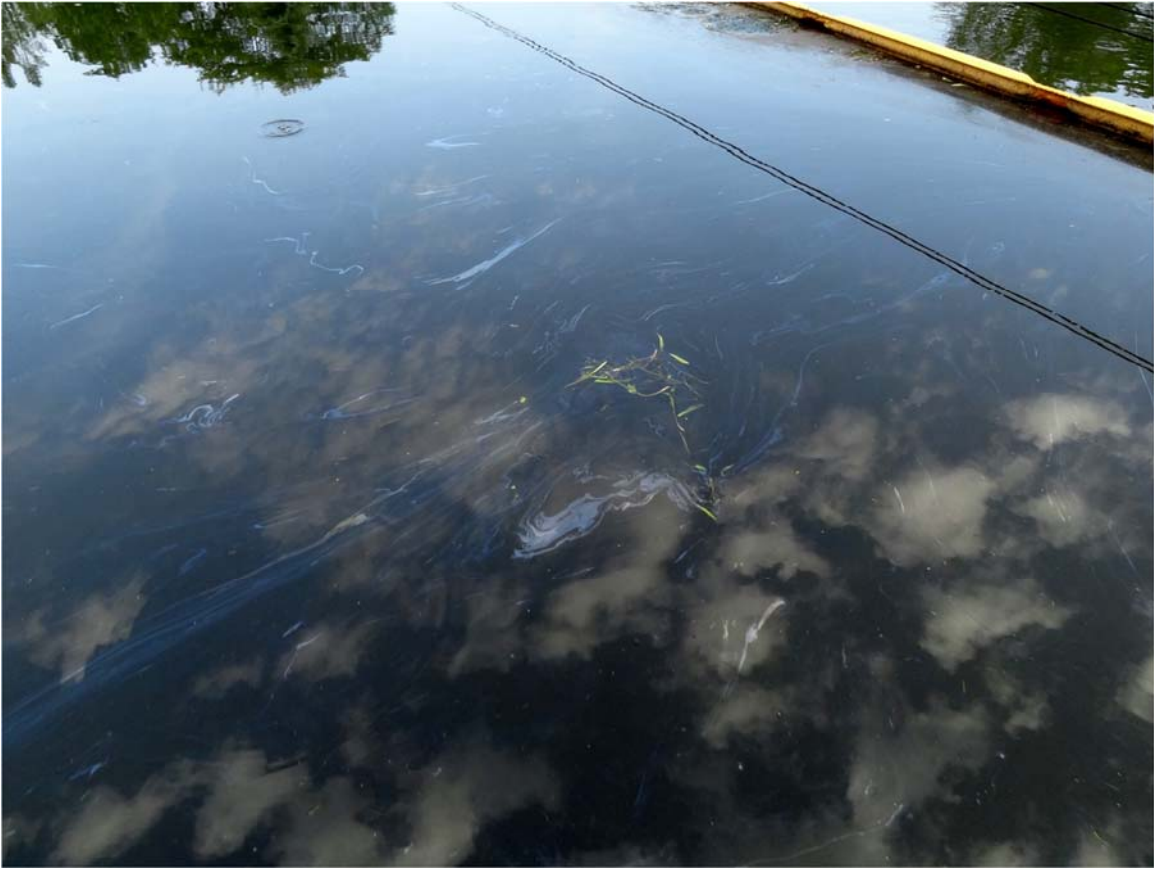
5. Ceresco Dam Control Point boom observed sheen collecting.

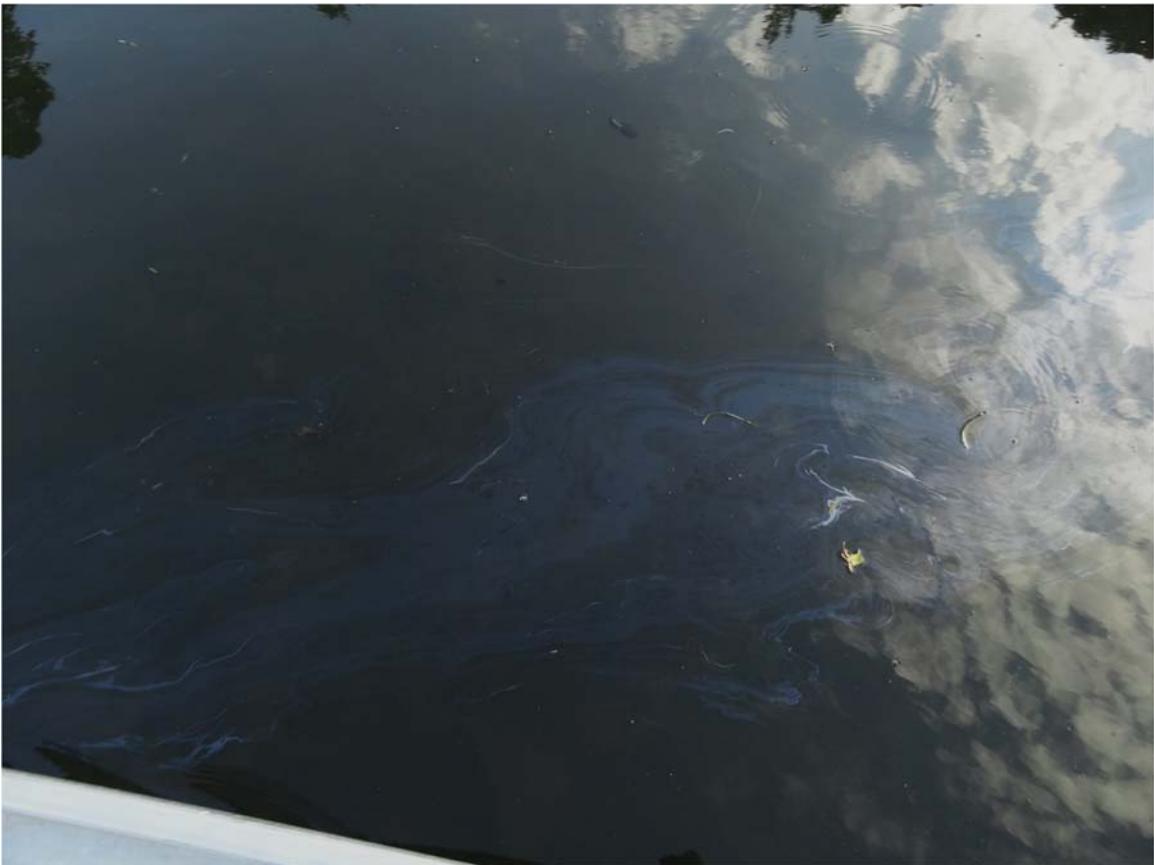
6. MP5.7 RDB sheen observed.

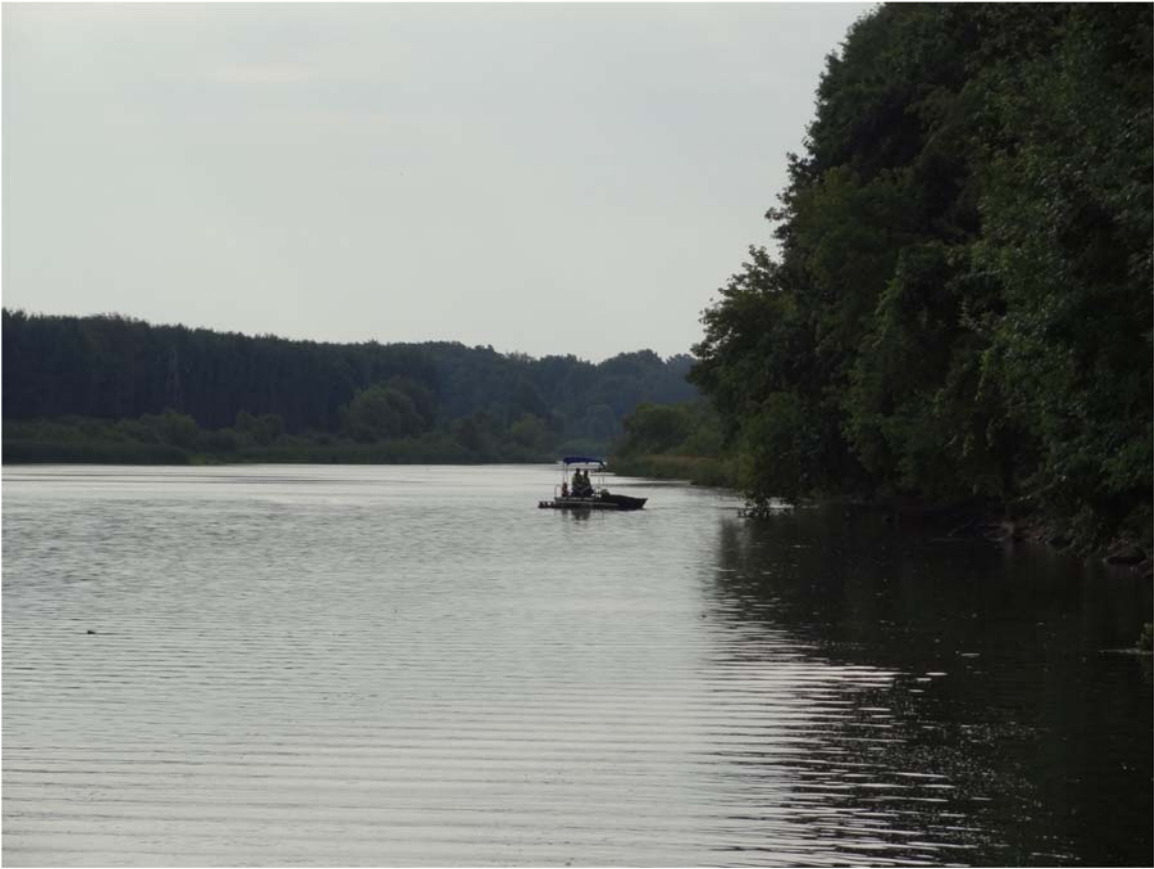
7. MP5.25 observed the sheen sweep boat operating.

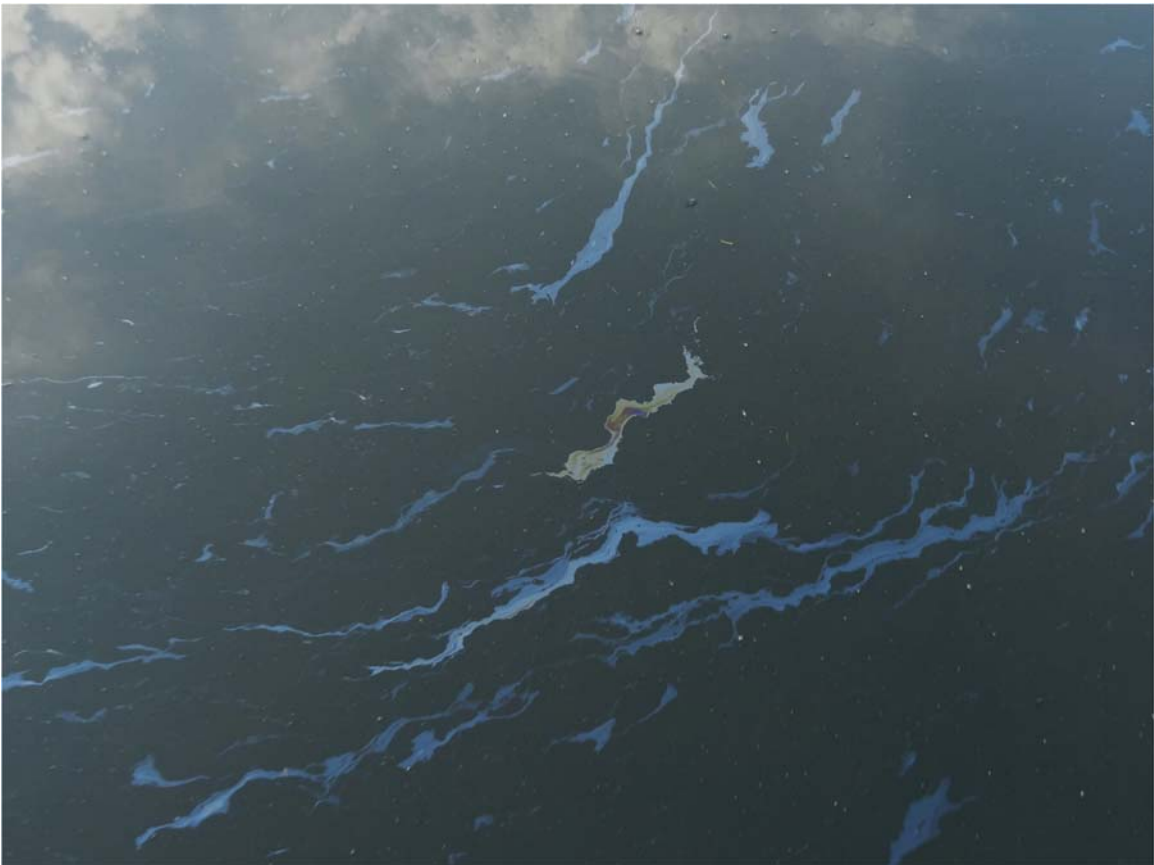
8. MP5.5 center channel sheen observed.

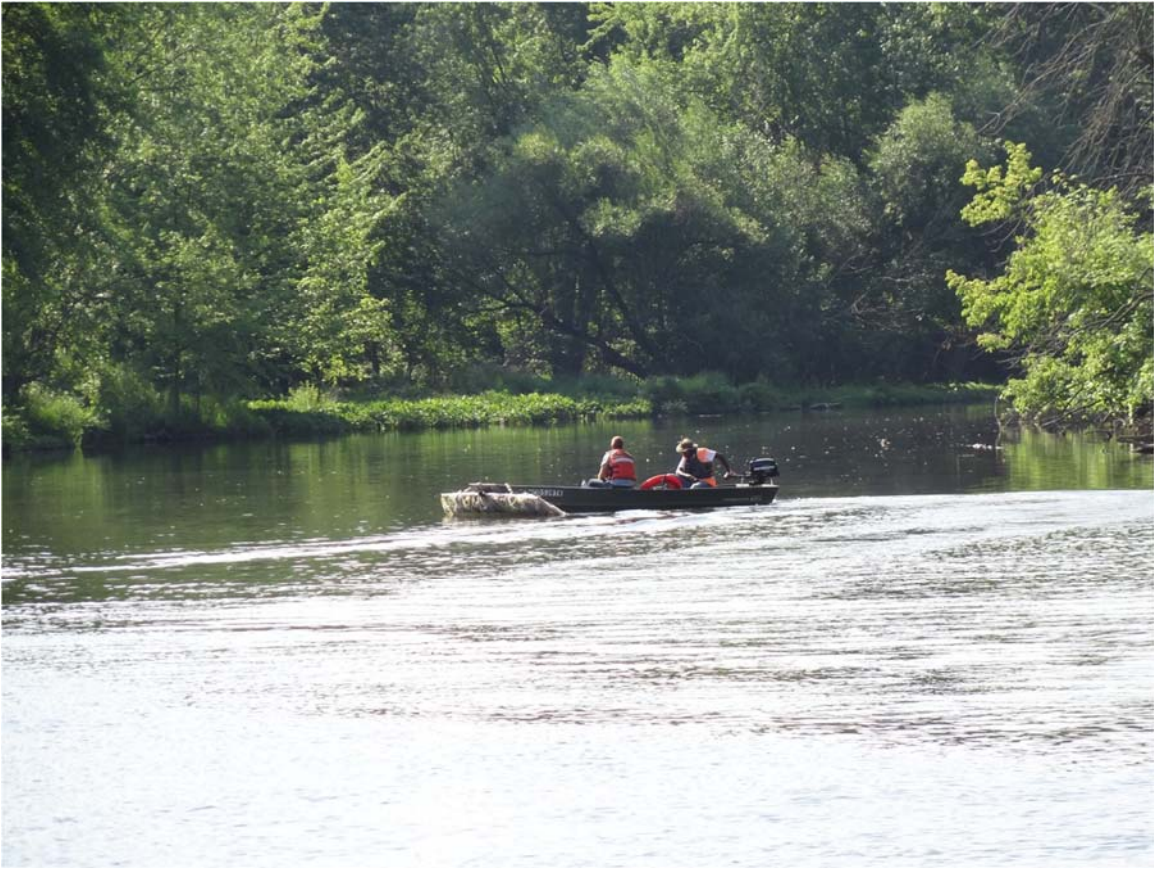
9. MP14.75 Observed the sheen sweep boat operating.

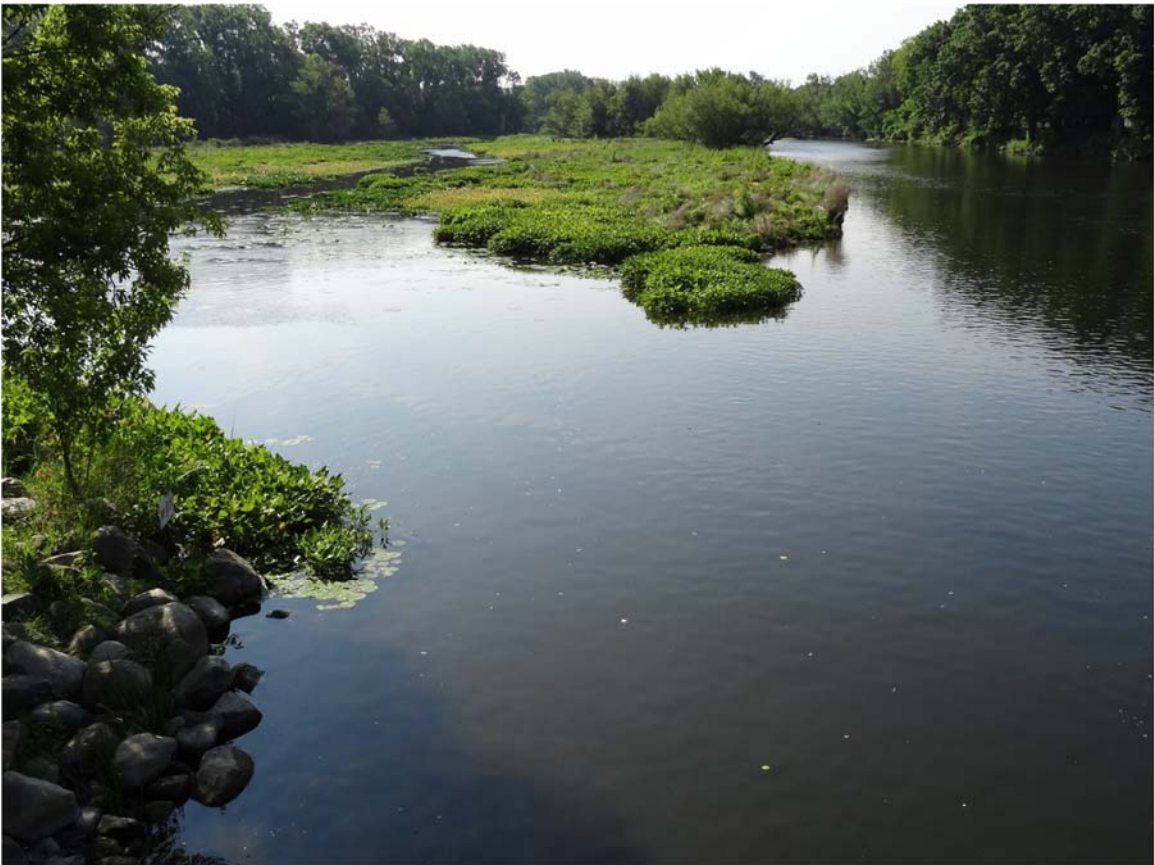
10. MP15.5 South Mill Pond no sheen observed.

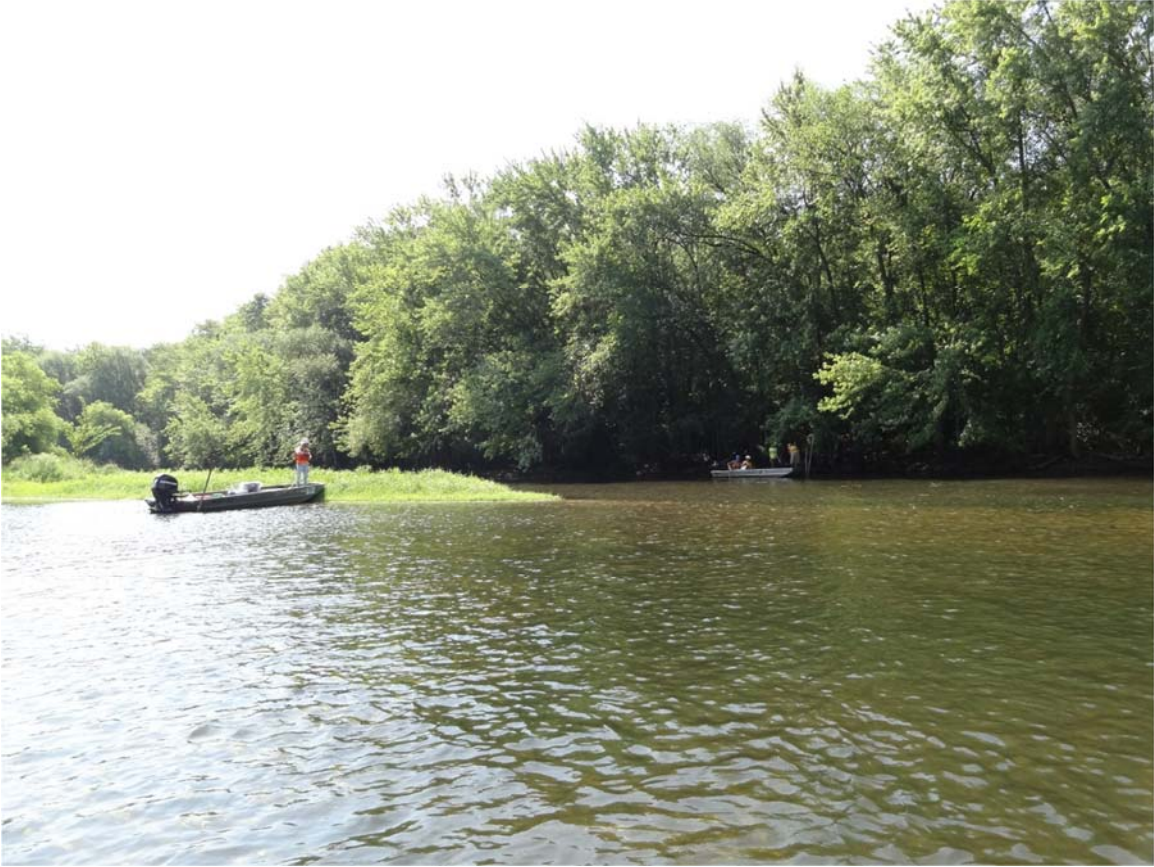
11. MP20.4 Observed quantification coring.

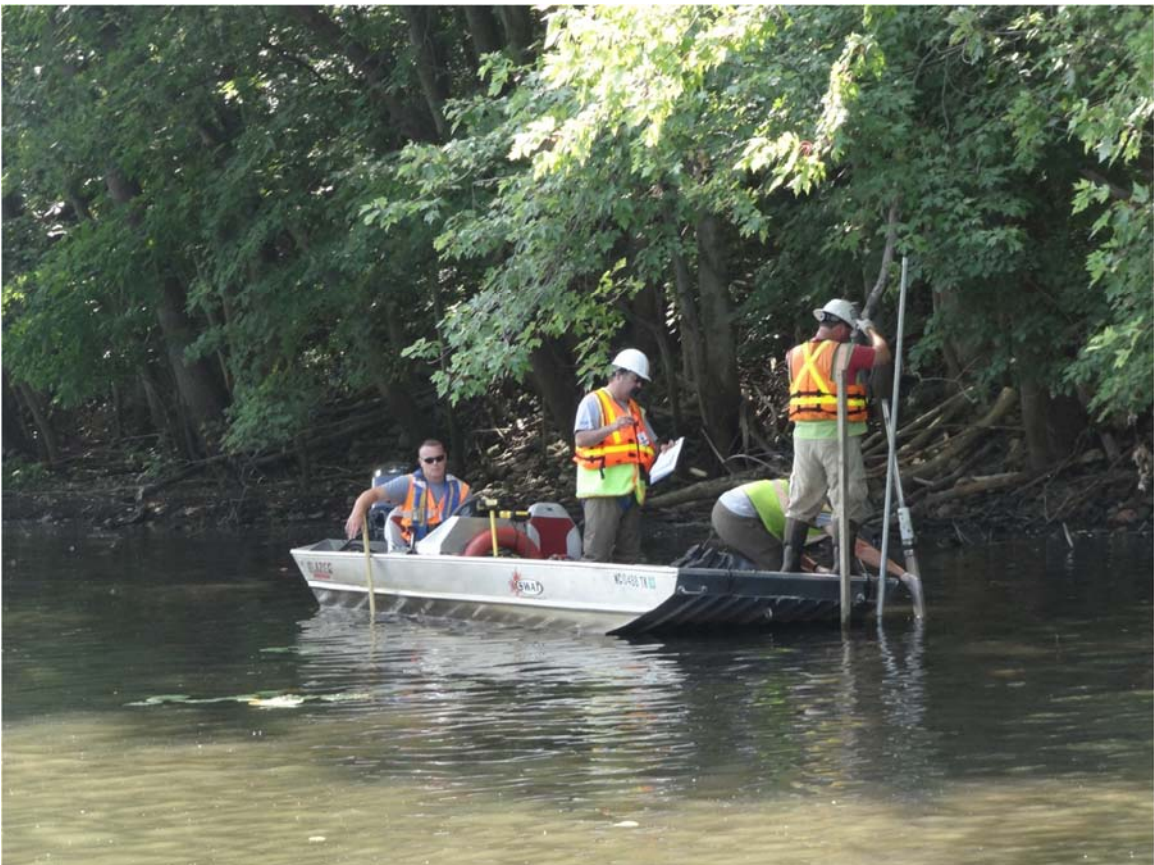
12. MP20.4 Observed quantification coring.

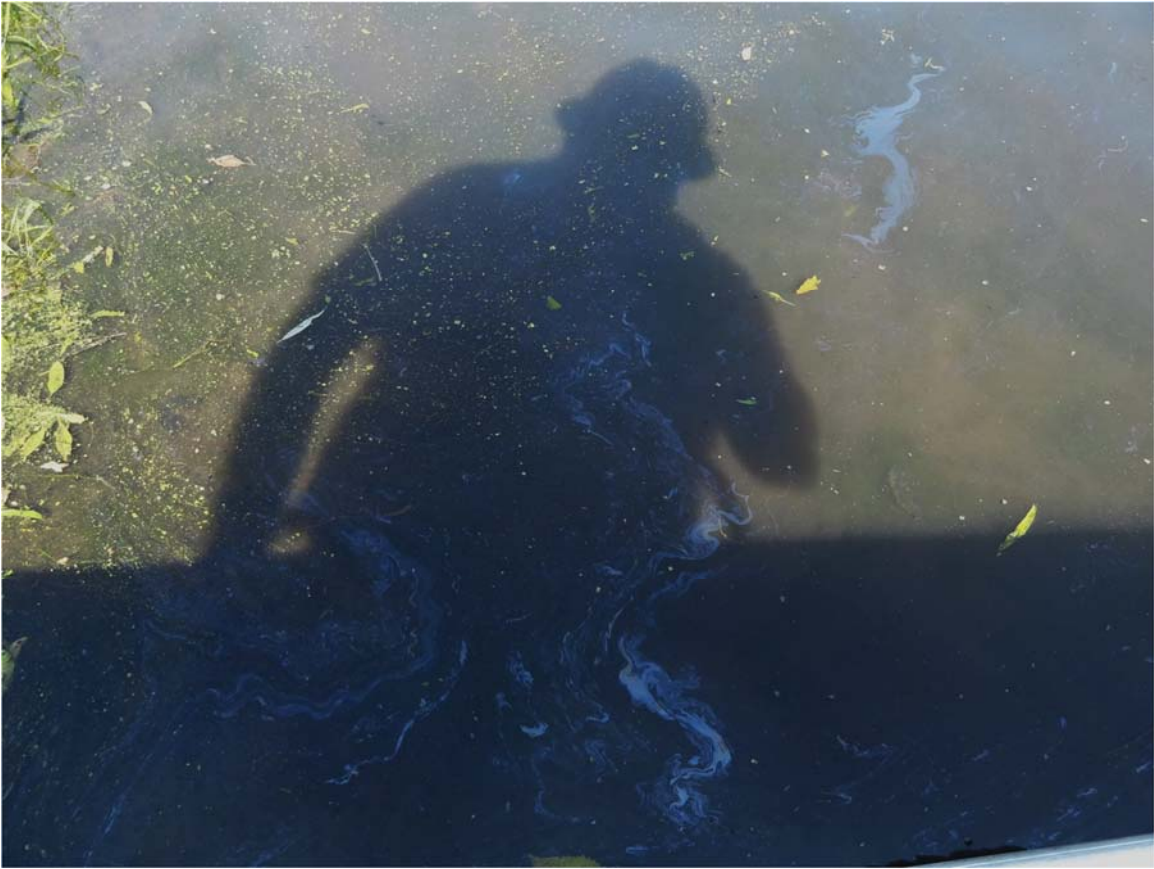
13. MP20.4 observed sheen when boat agitated the sediment.

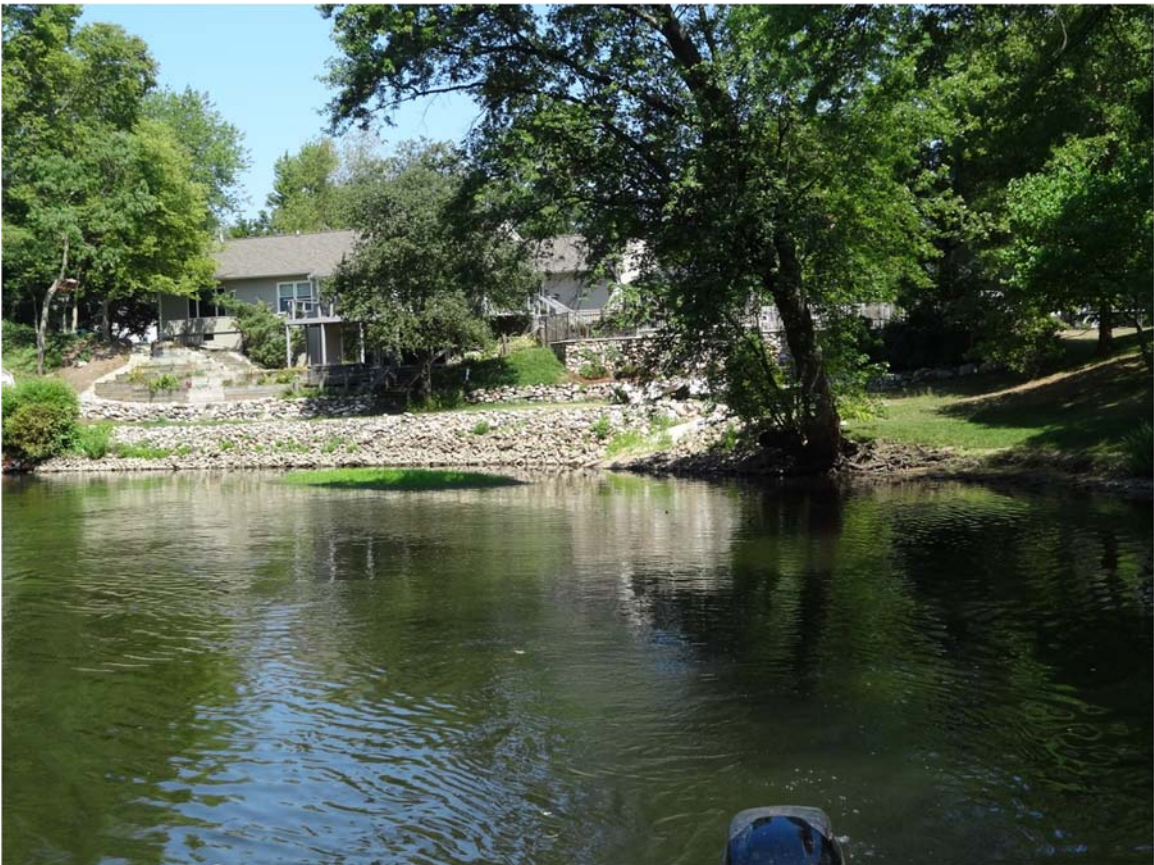
14. MP23.10 observed sheen, operations was notified.

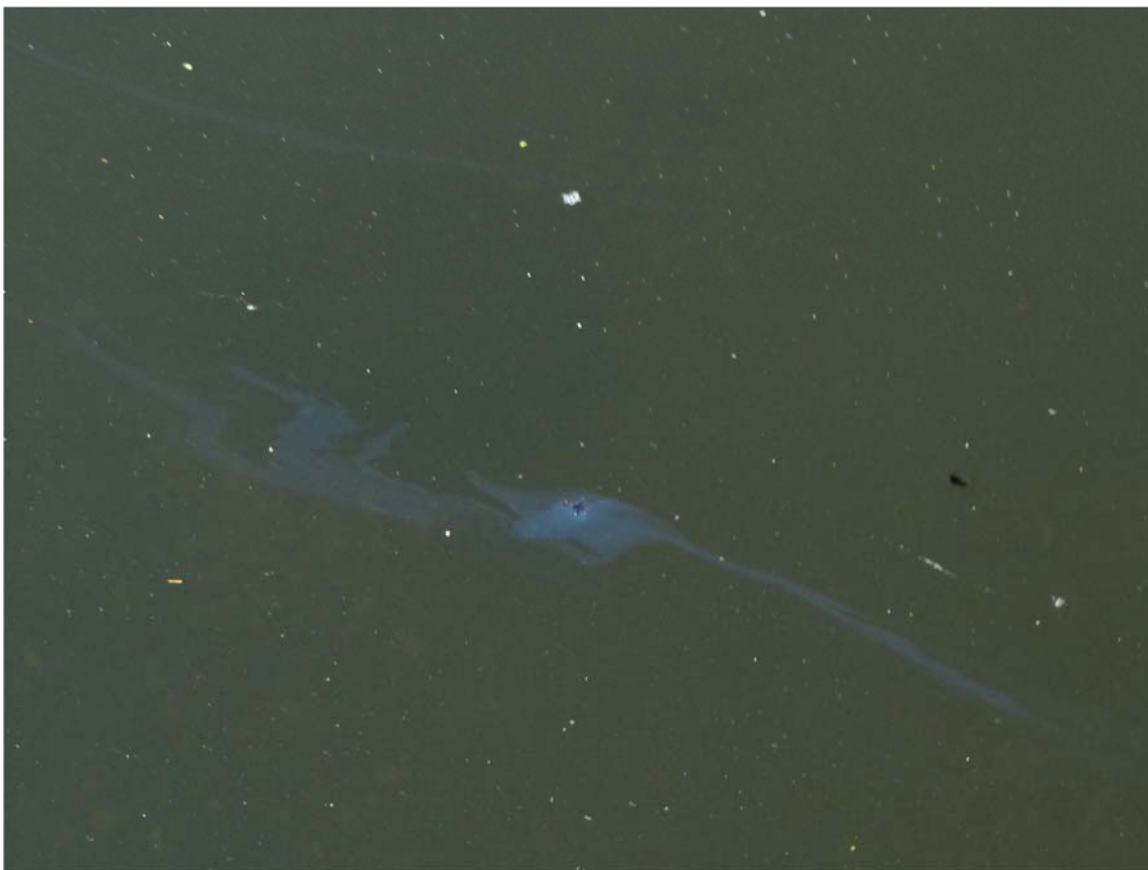
15. MP23.10 observed sheen, operations was notified.

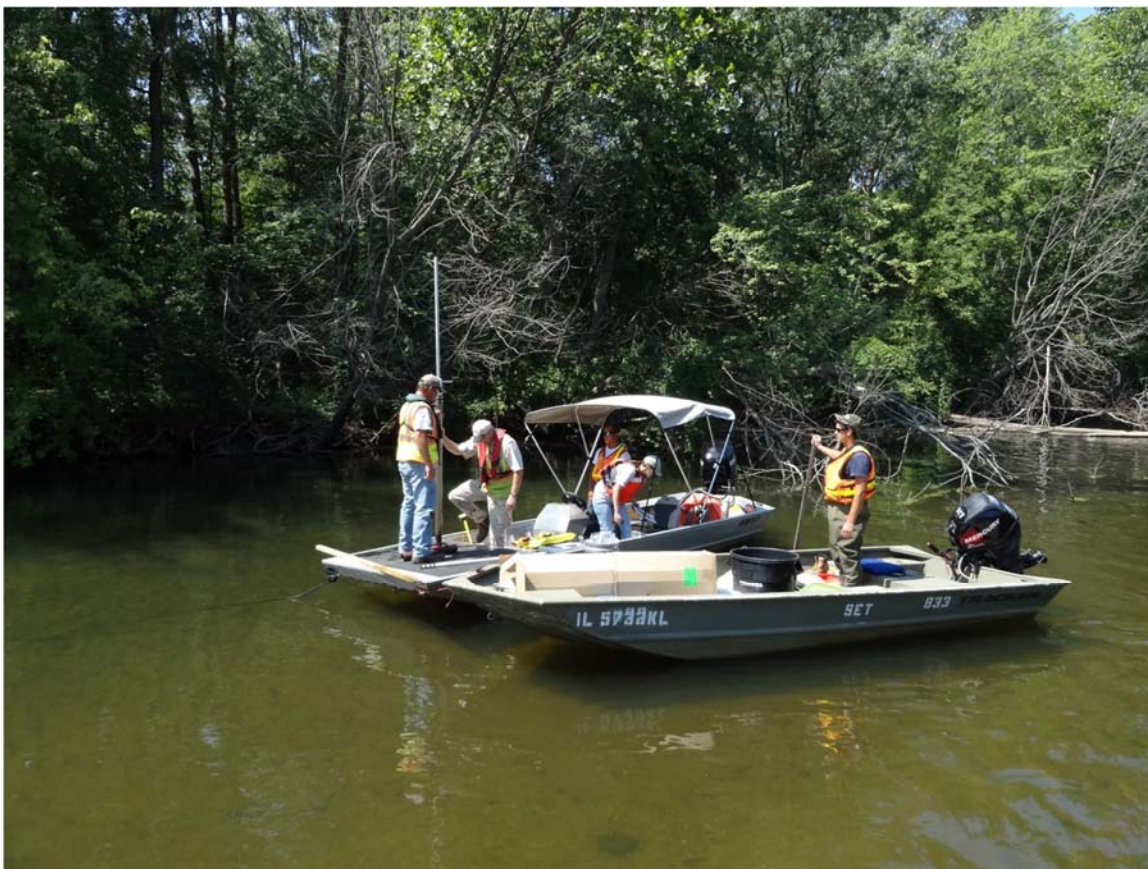
16. MP20.0 LDB observed quantification coring team.

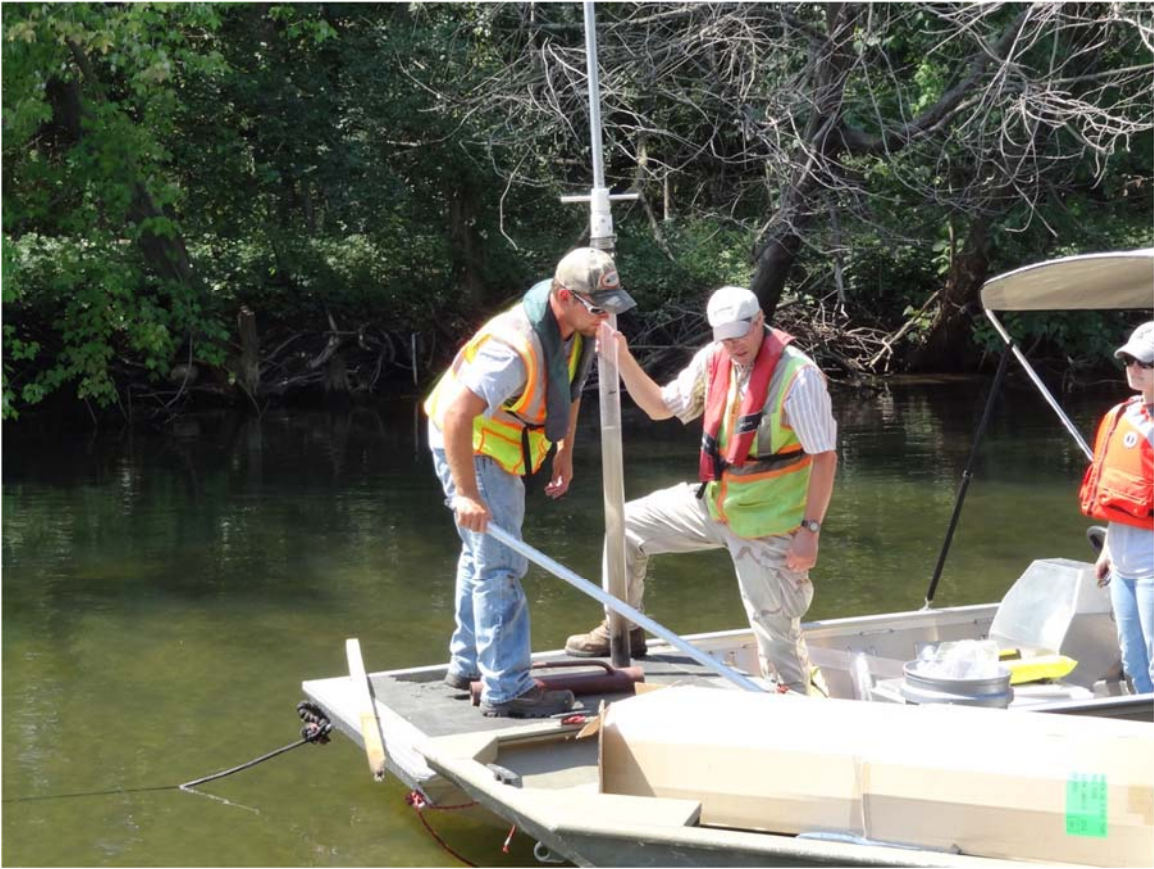
17. MP20.0 LDB observed quantification coring team.

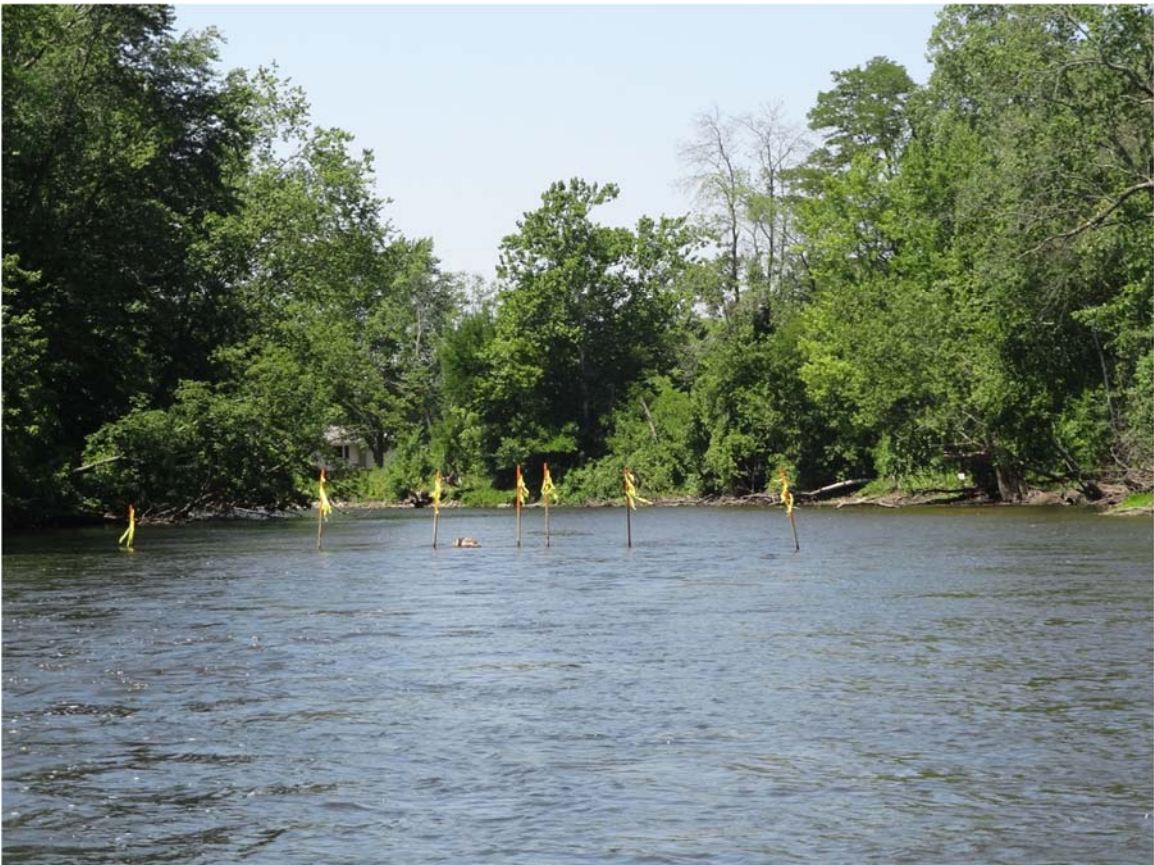
18. MP29.25 observed the navigational stakes reinstalled.

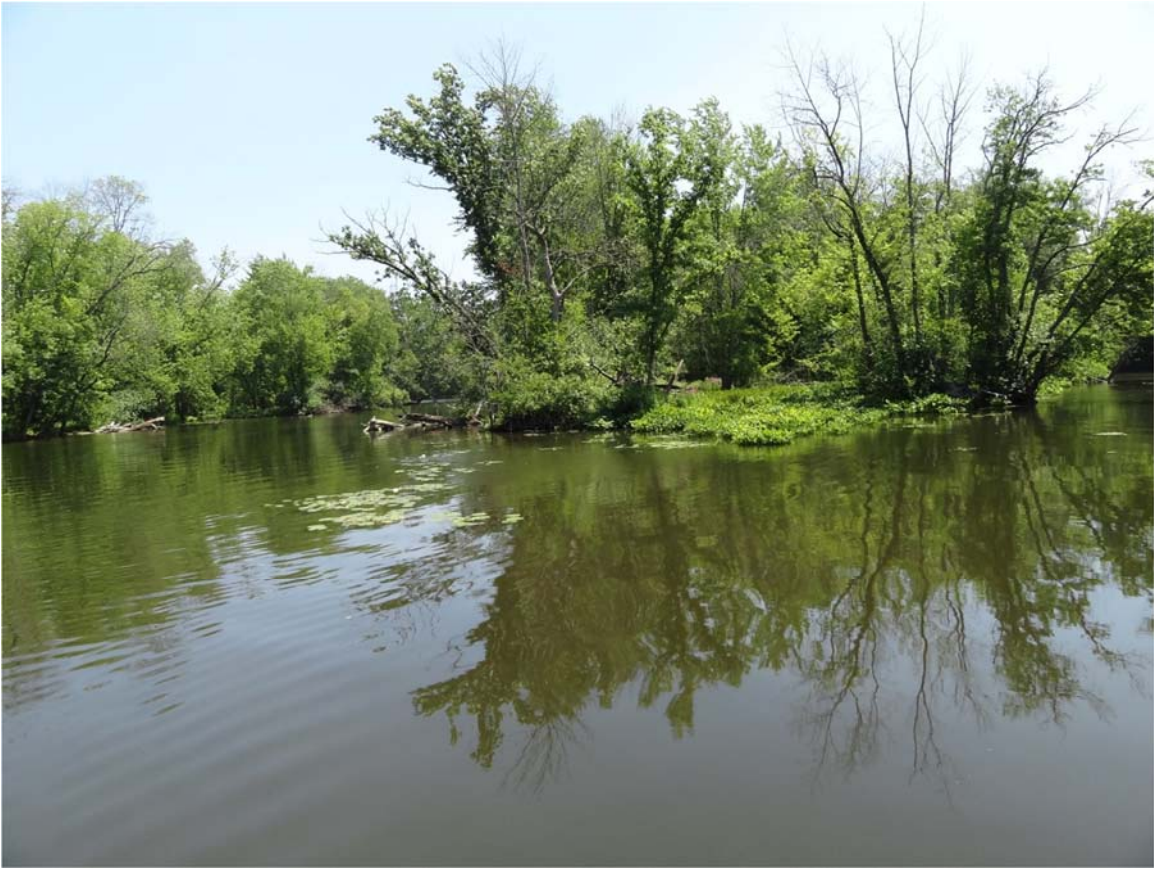
19. MP36.25 area where sheen was observed.

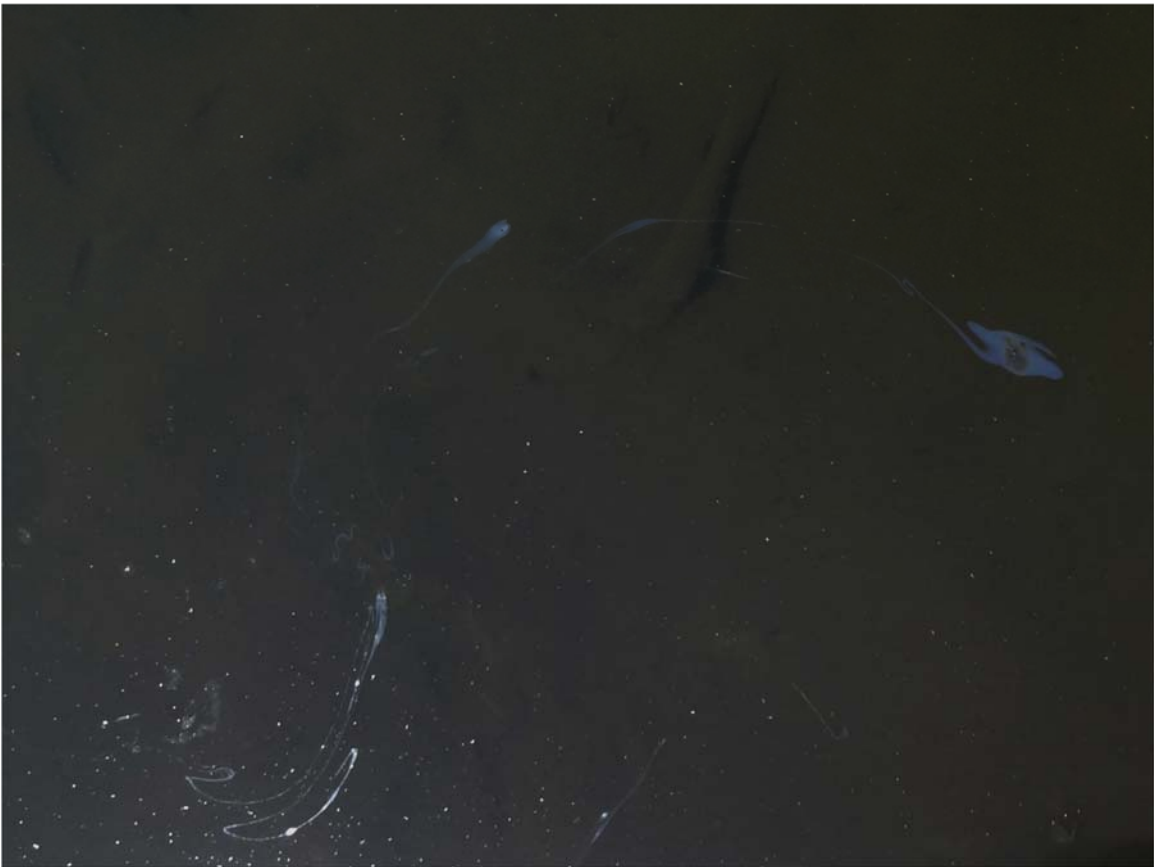
20. MP36.25 observed sheen.

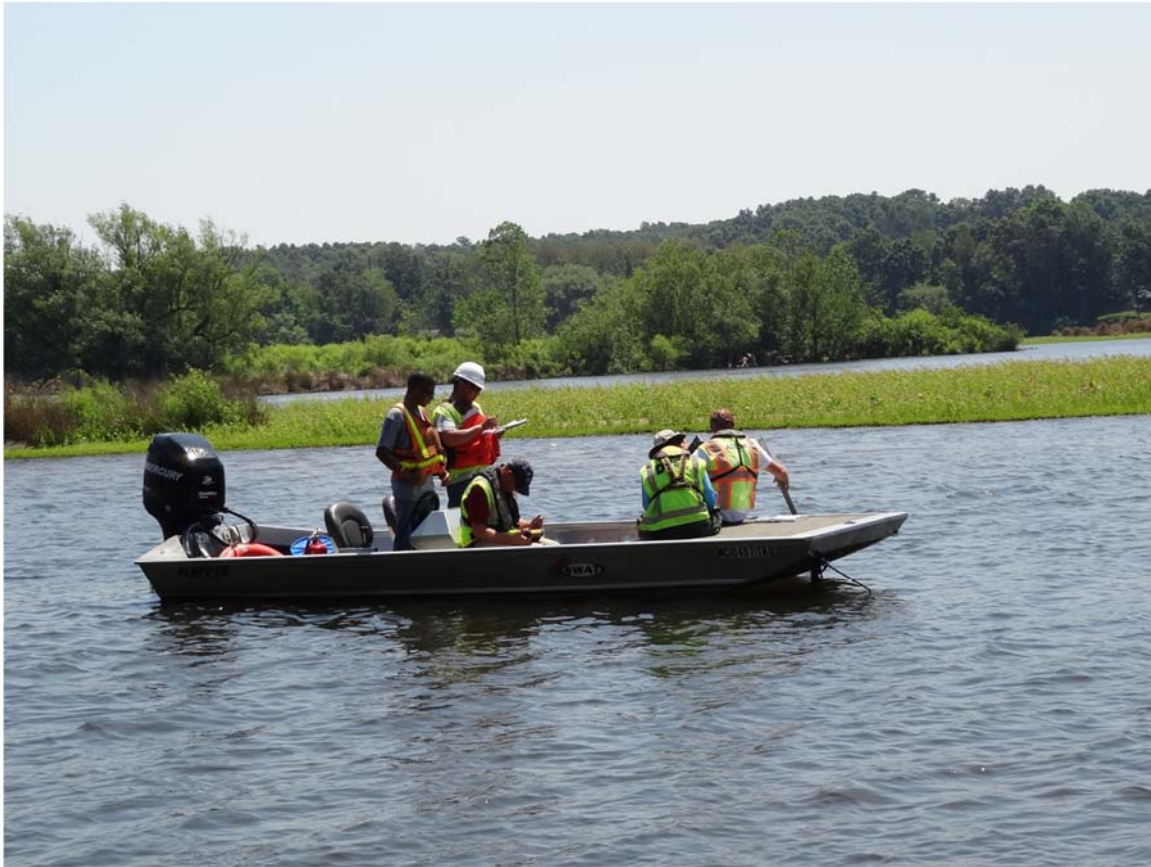
21. Morrow Lake Delta observed the poling crew.

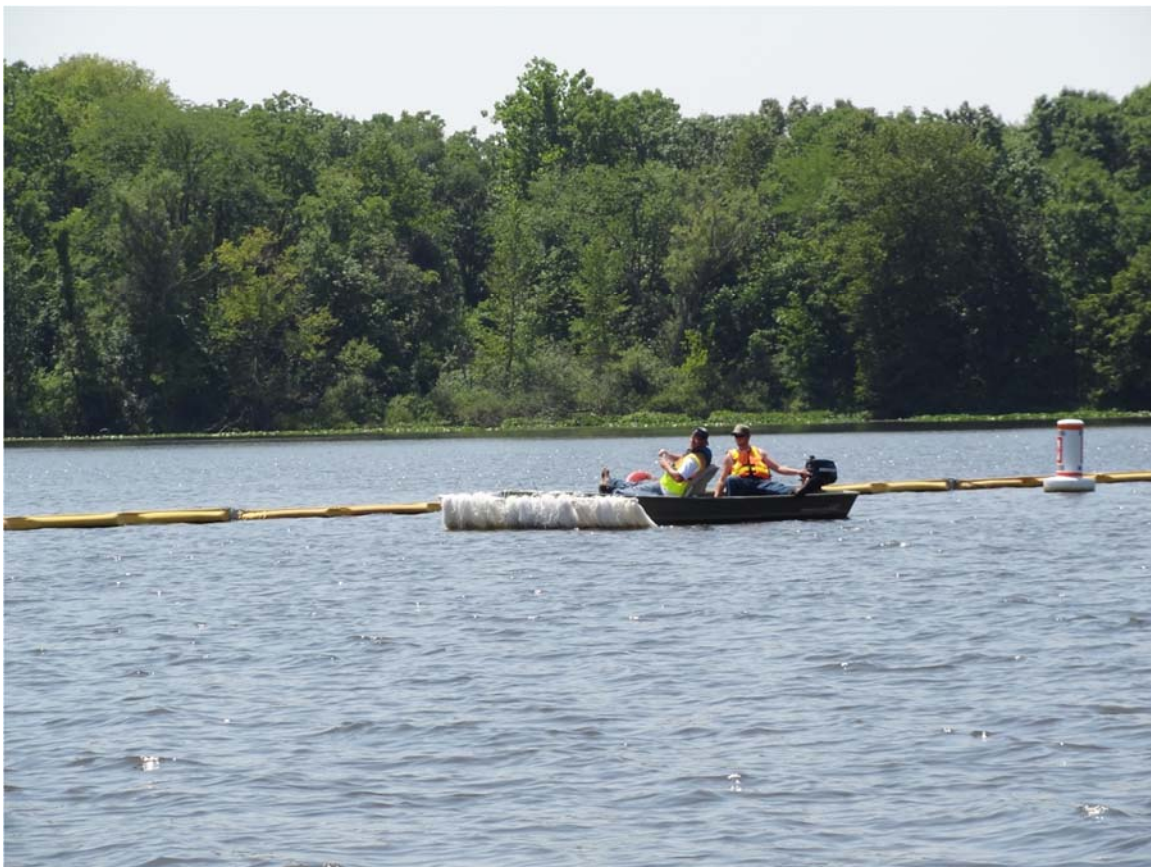
22. Morrow Lake Delta observed sheen sweep boat operating along Boom C.

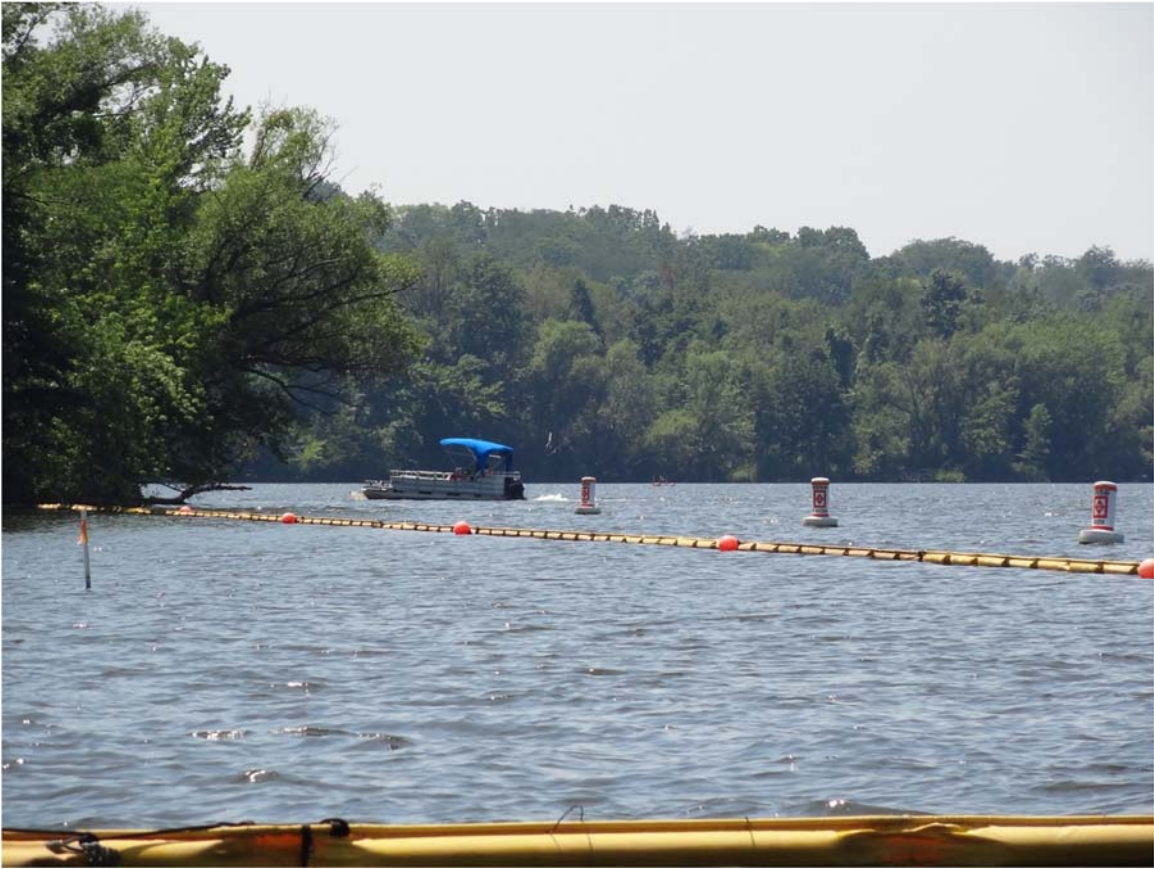
23. Morrow Lake, observed the sweep boat operating.
