# Situation Photo Log

Monday, July 23, 2012

Kalamazoo River / Enbridge Spill

Prepared by:  
Matthew Haak  
START-USEPA  
Situation Unit Leader

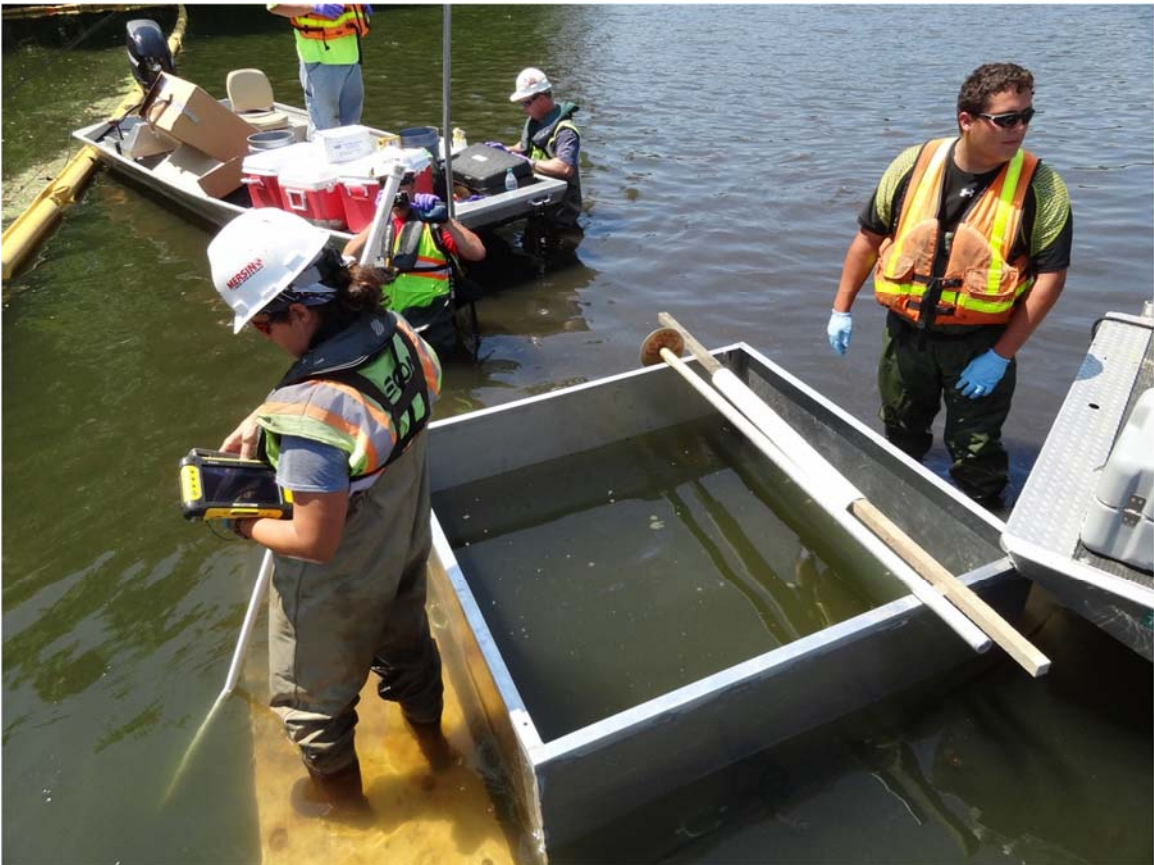
24. Morrow Lake Delta agitation effects study.

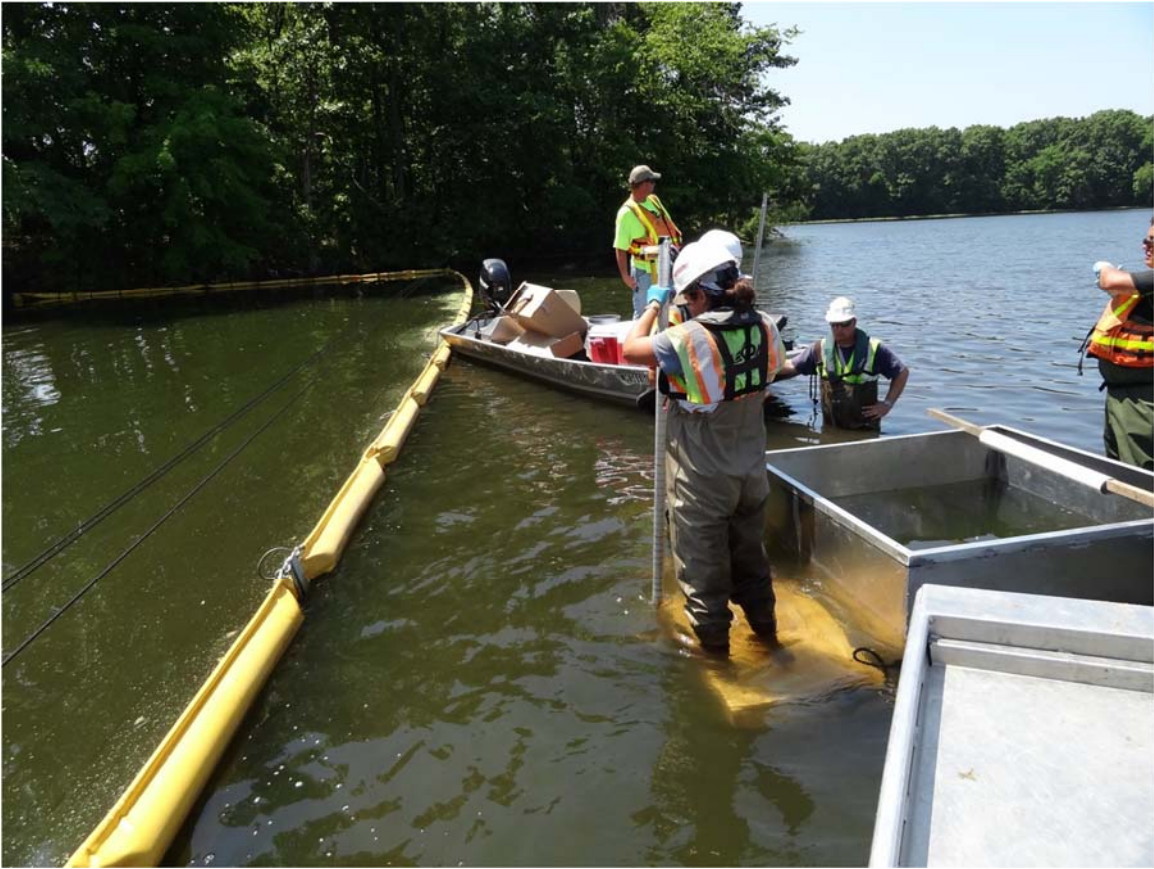
25. Morrow Lake Delta agitation effects study.

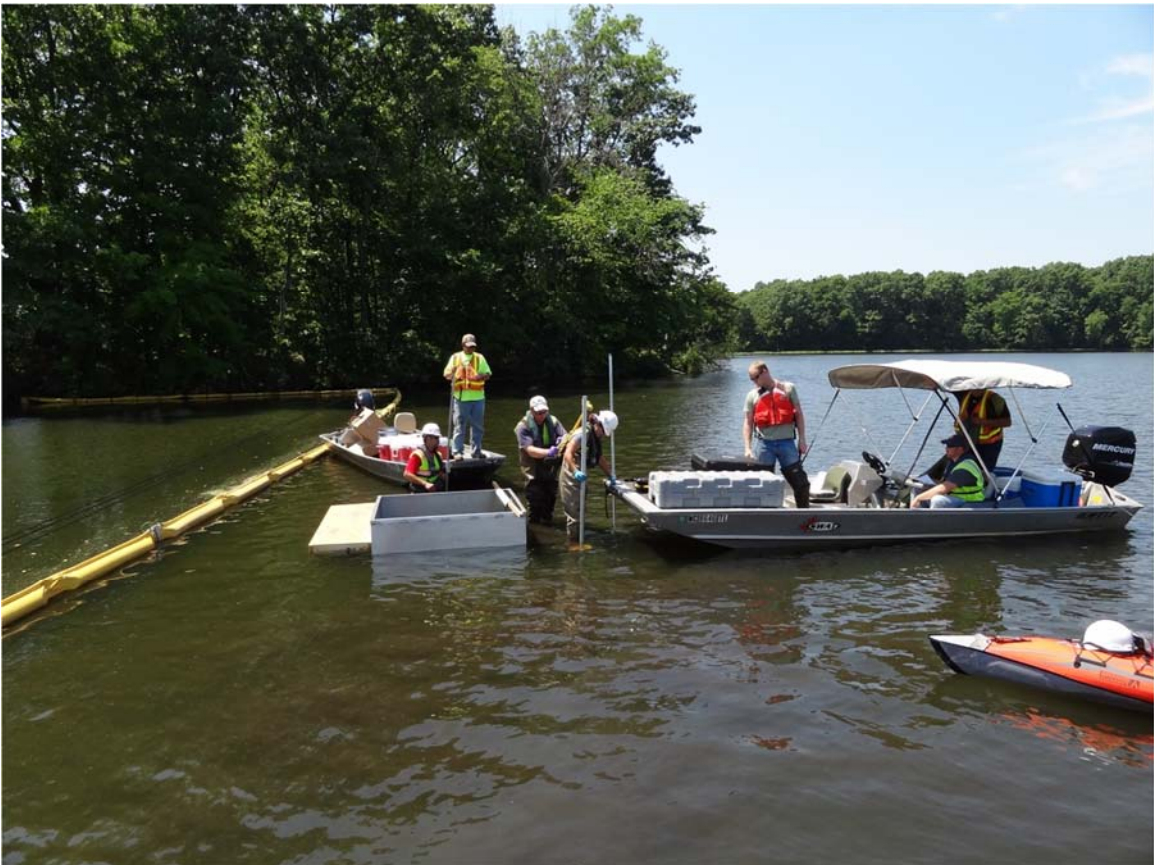
26. Morrow Lake Delta agitation effects study.

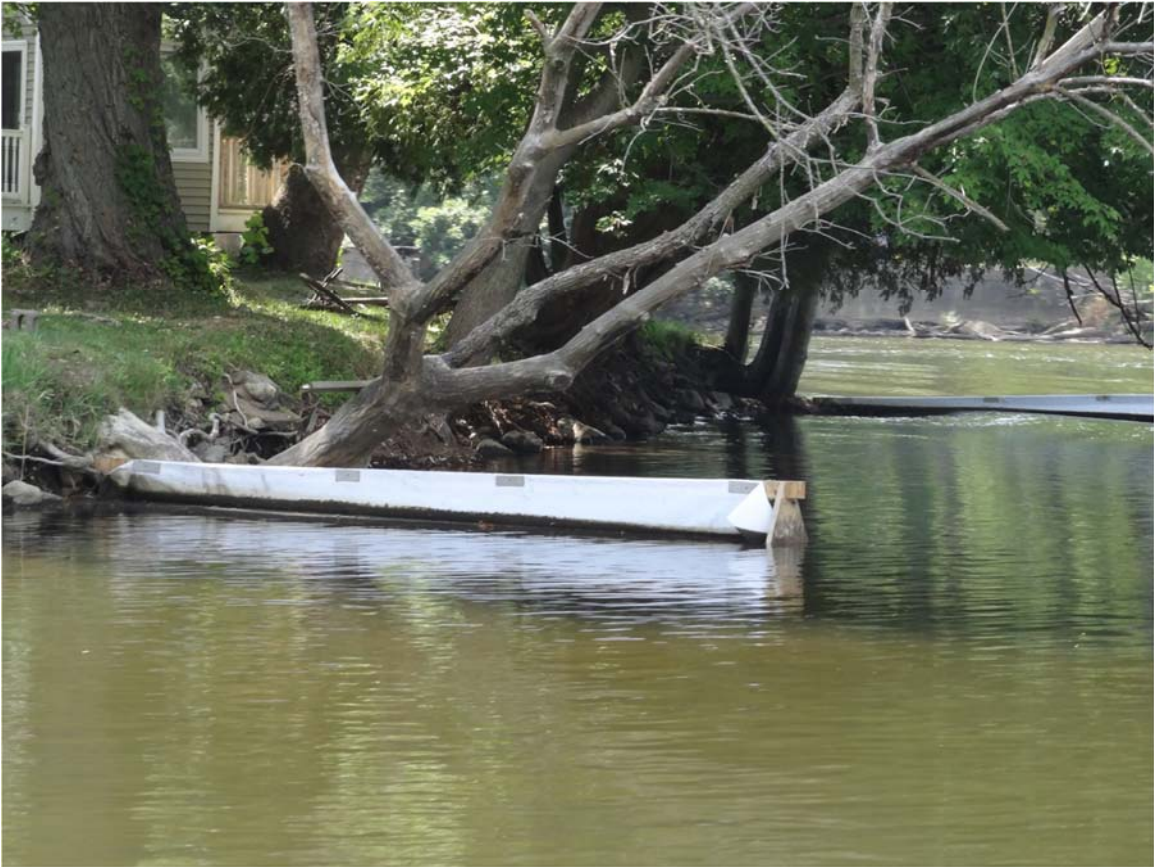
27. MP34.5 LDB observed unknown structure deployed in the river.

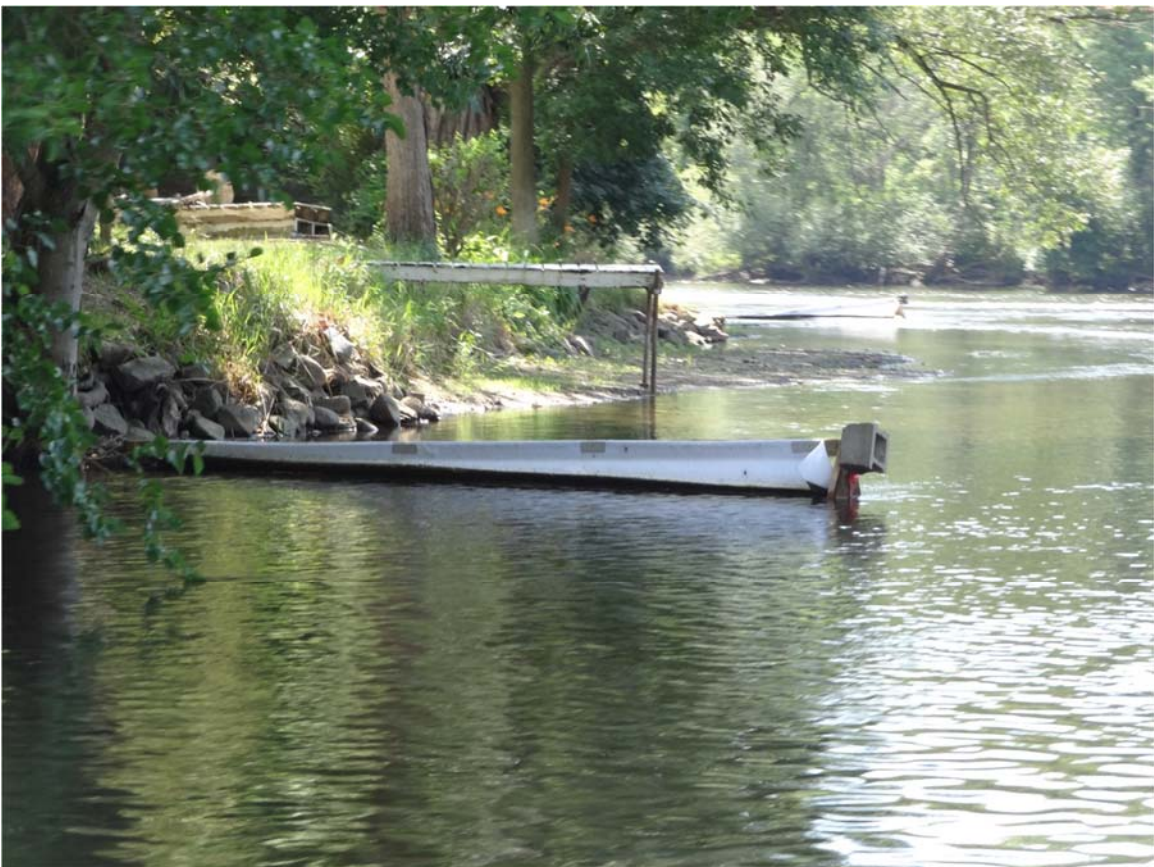
28. MP34.5 LDB observed unknown structure deployed in the river.
