# Situation Photo Log

Tuesday, July 31, 2012

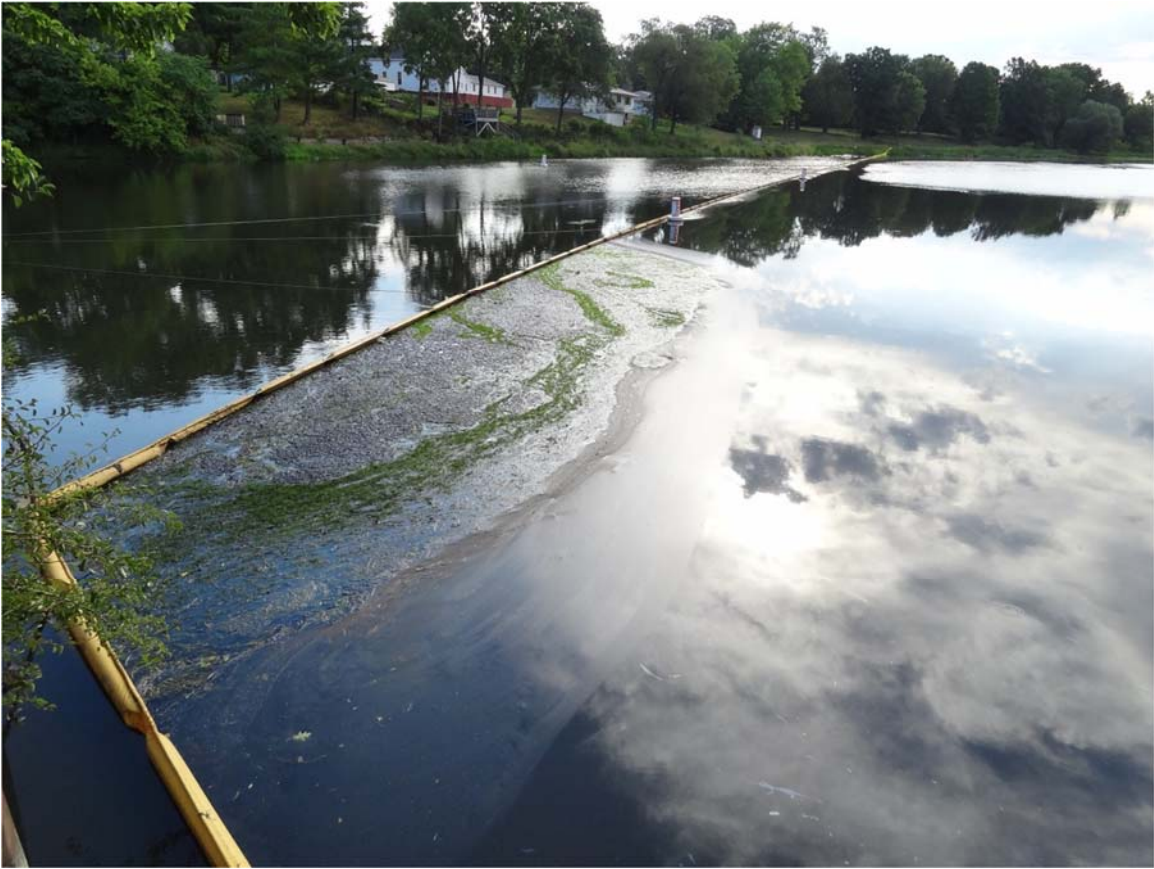
1. Ceresco Dam Control Point Boom, debris observed prior to boom maintenance crew arriving.

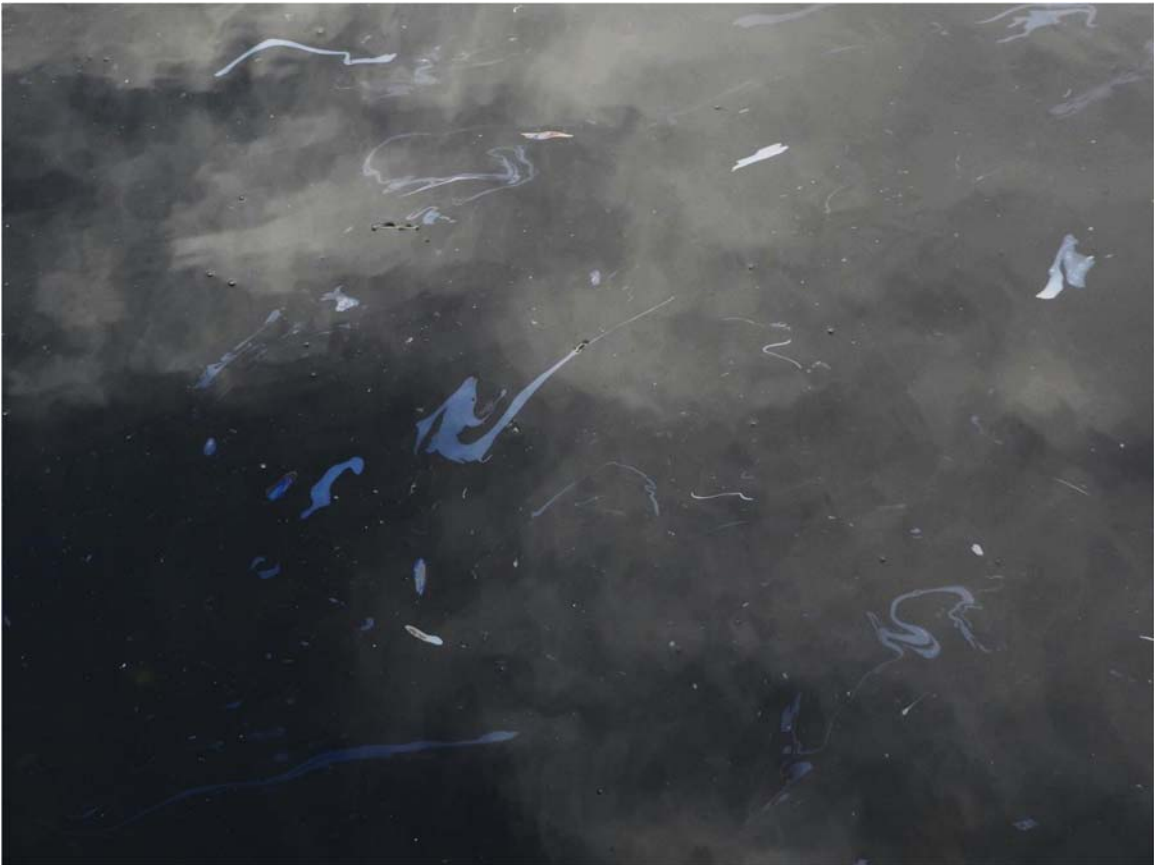
2. Ceresco Dam sheen observed collecting in the control point.

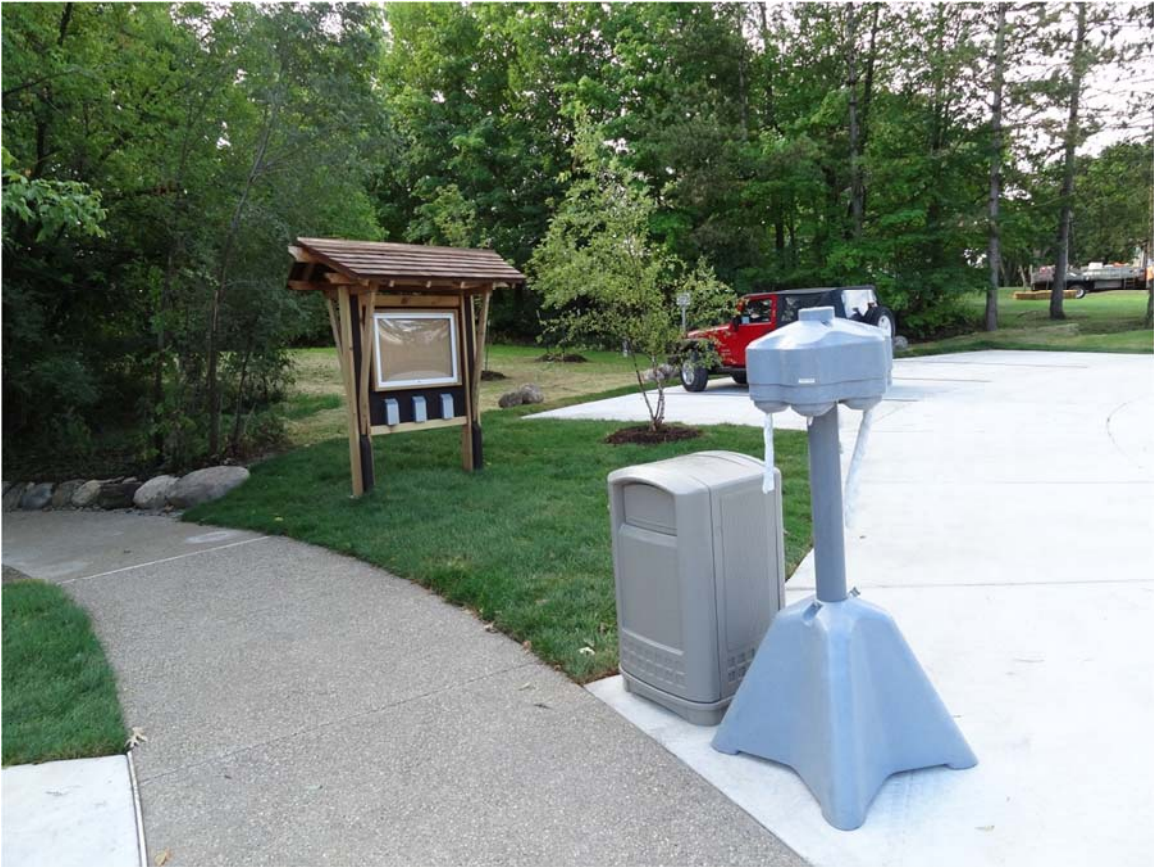
3. Ceresco Dam portage decontamination station observed.

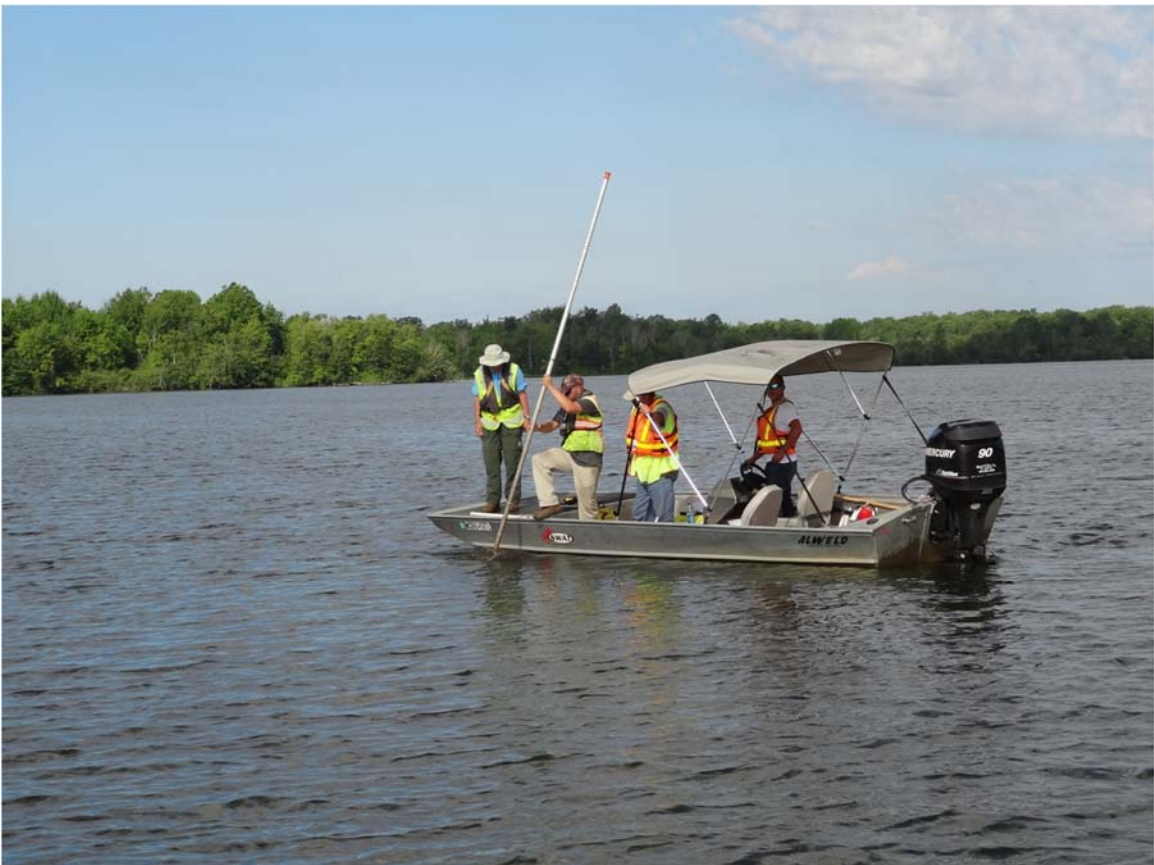
4. Morrow Lake poling team observed.

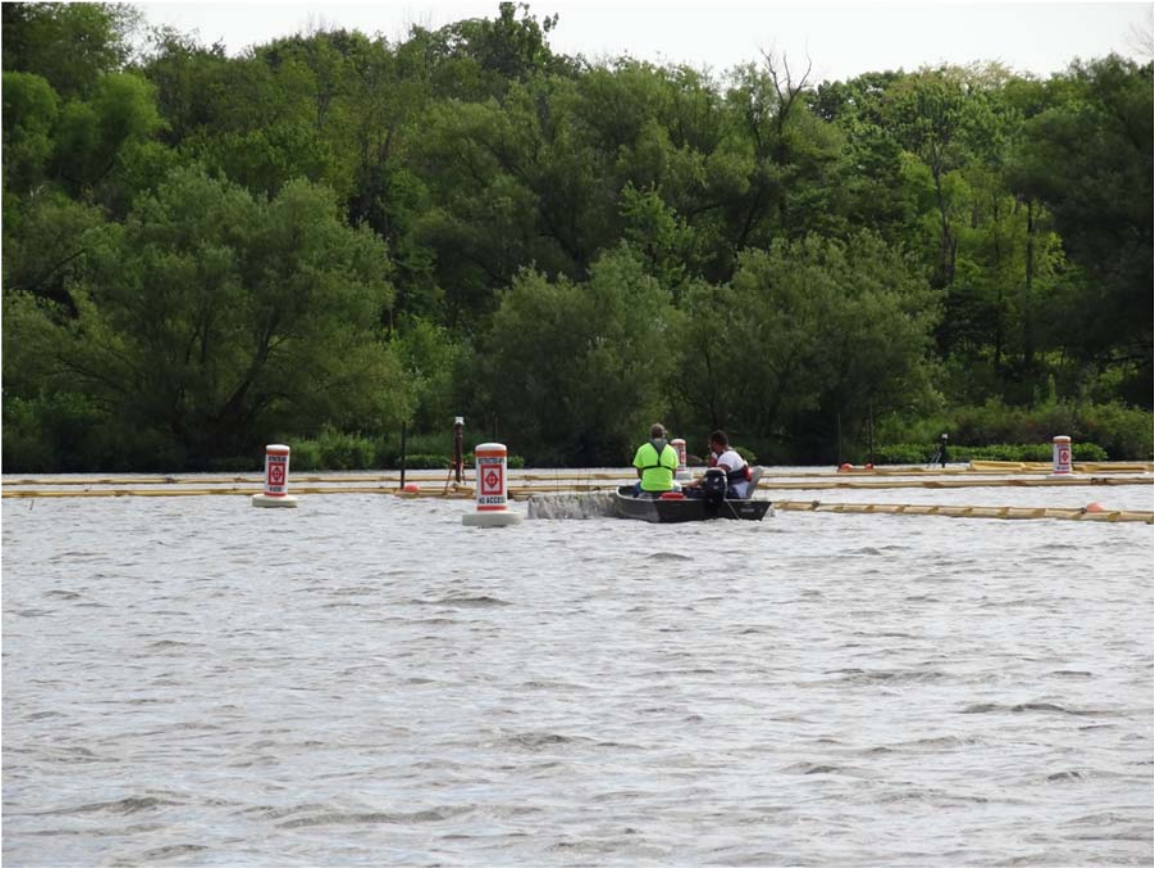
5. Morrow Lake Delta Boom F, observed a sweep boat operating.

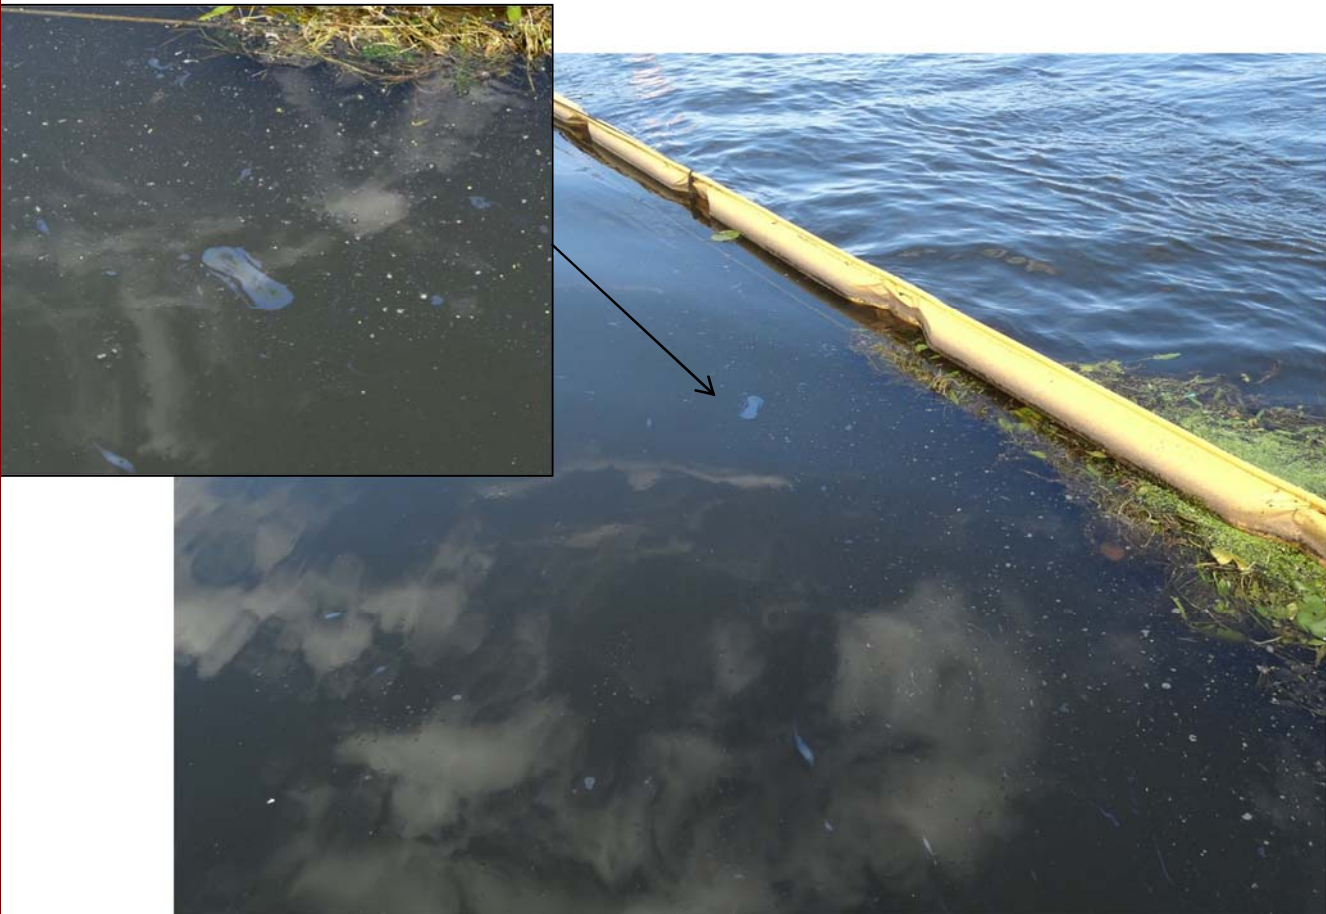
6. Morrow Lake Delta Boom C, observed sheen collecting along the boom.

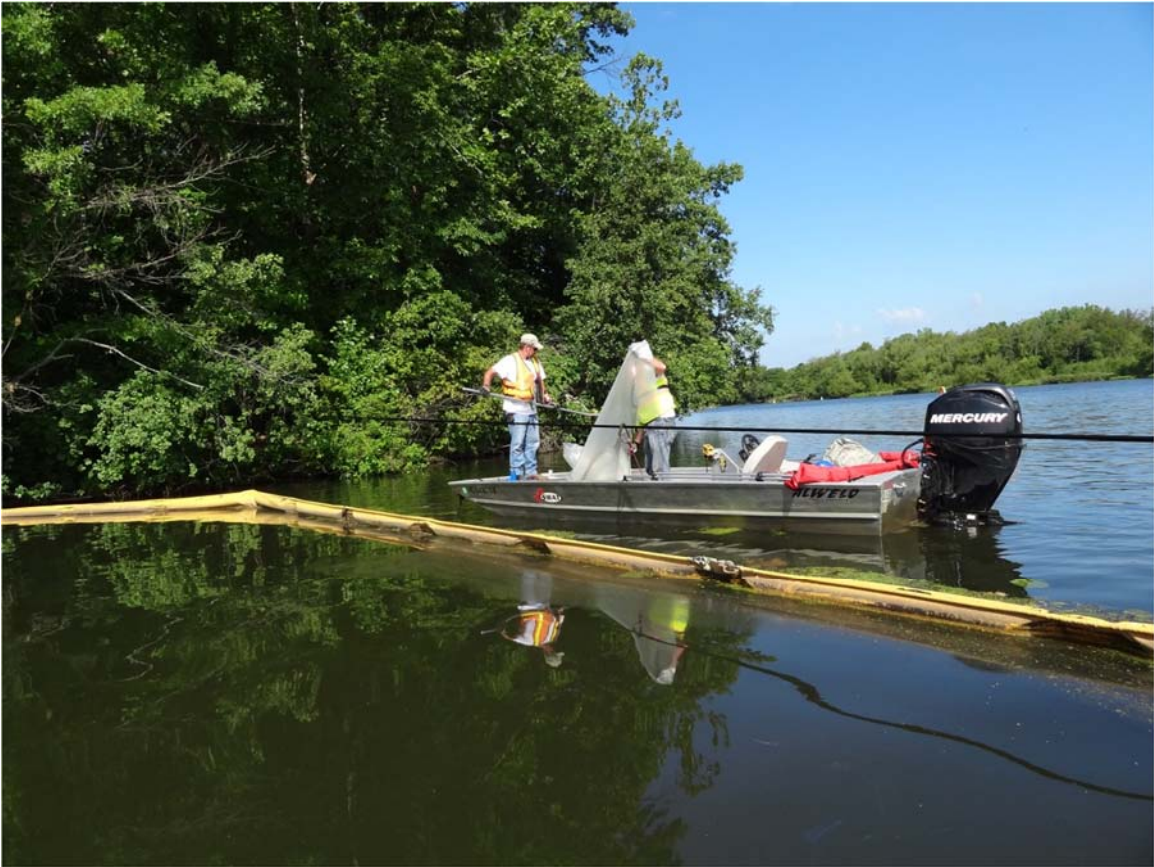
7. Morrow Lake Delta Boom C, observed boom maintenance crew.

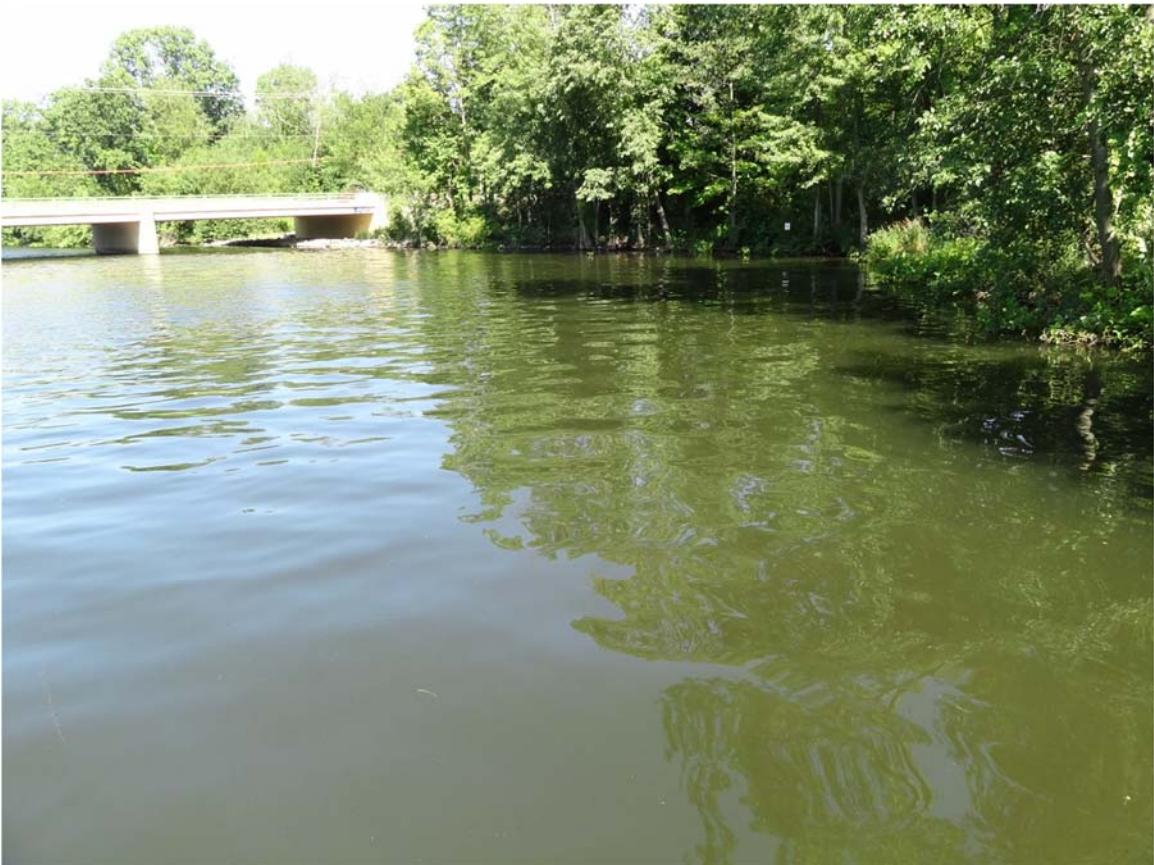
8. MP36.25 RDB sheen was observed, no sweep boat was warranted.

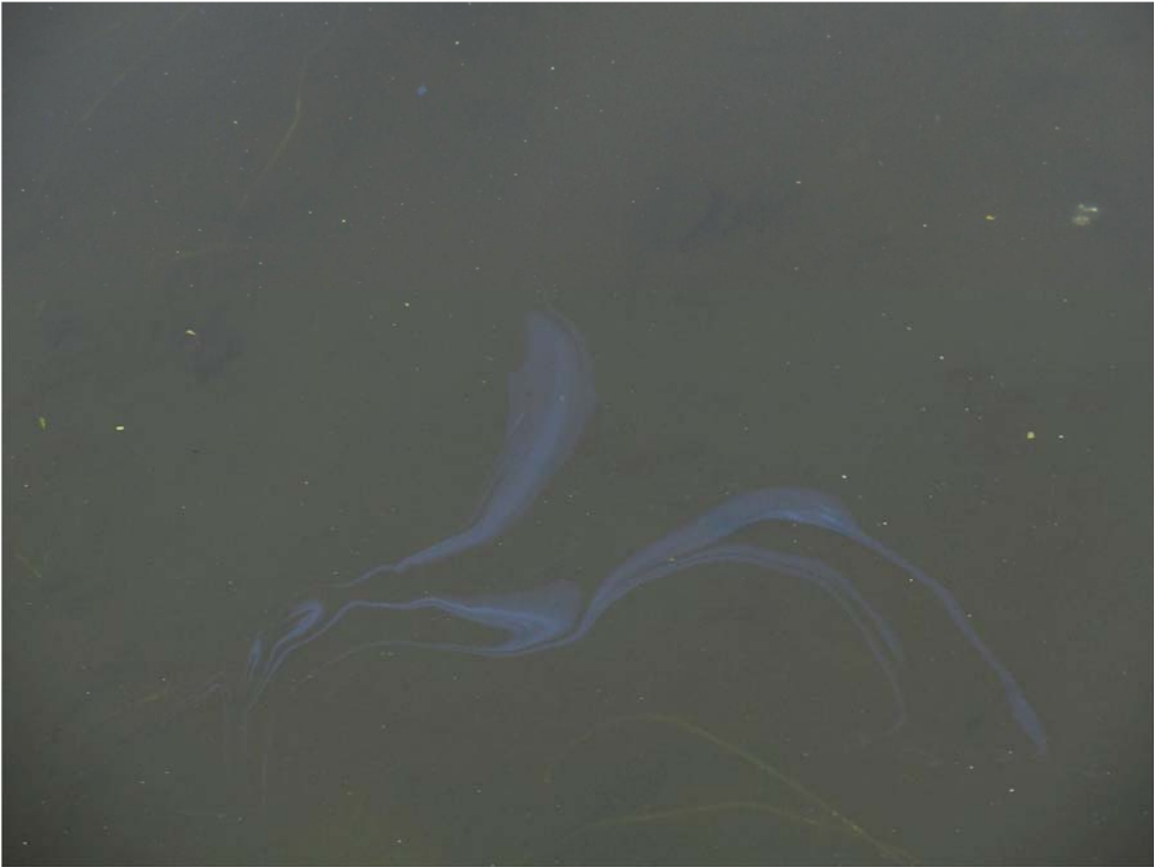
9. MP36.25 RDB sheen was observed, no sweep boat was warranted.

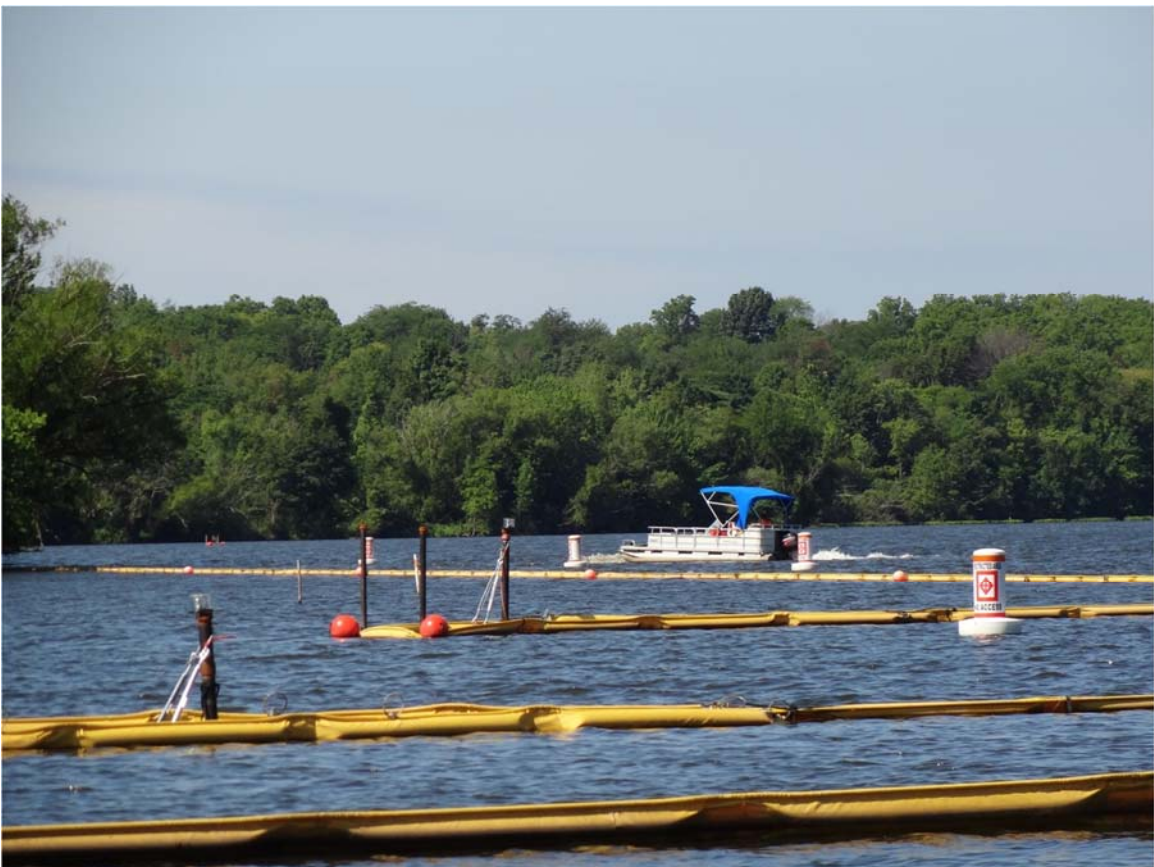
10. Morrow Lake observed the sweep boat operating.

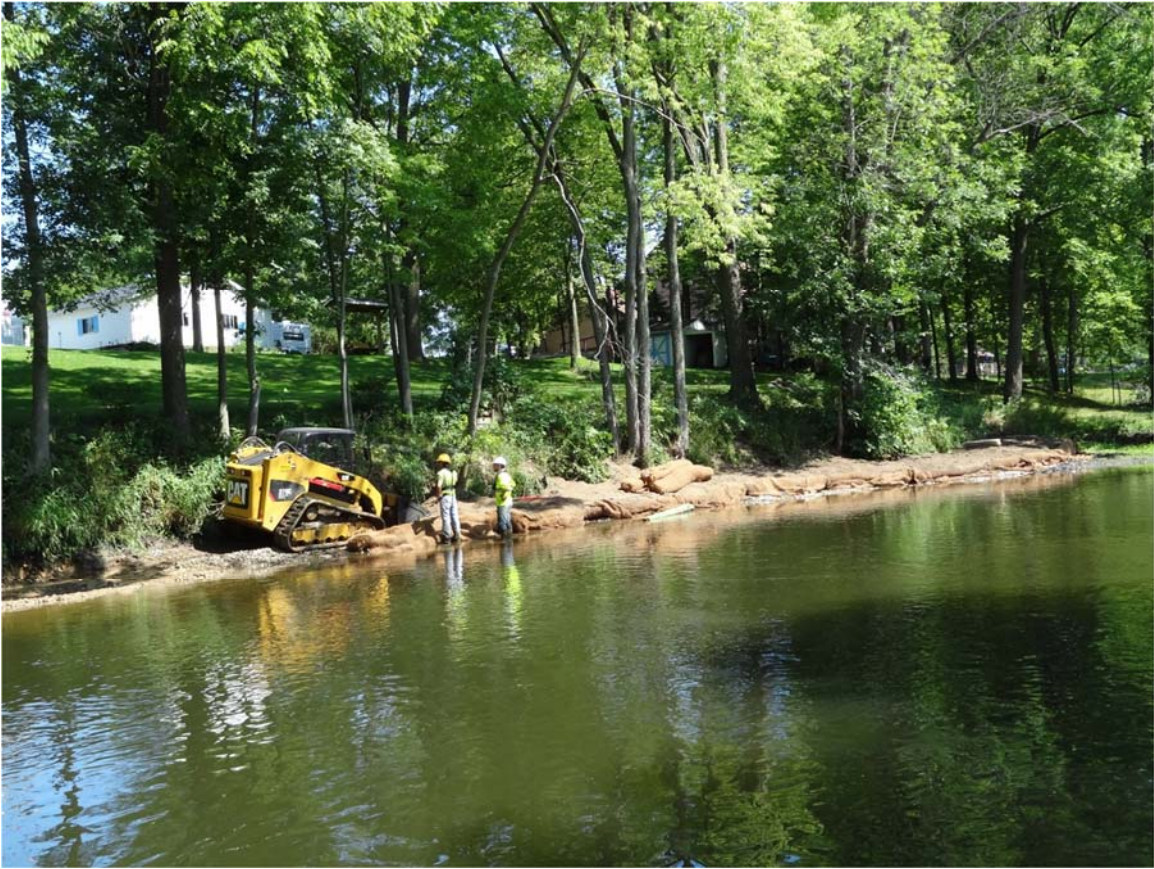
11. MP27.0 RDB observed river bank erosion restoration work.

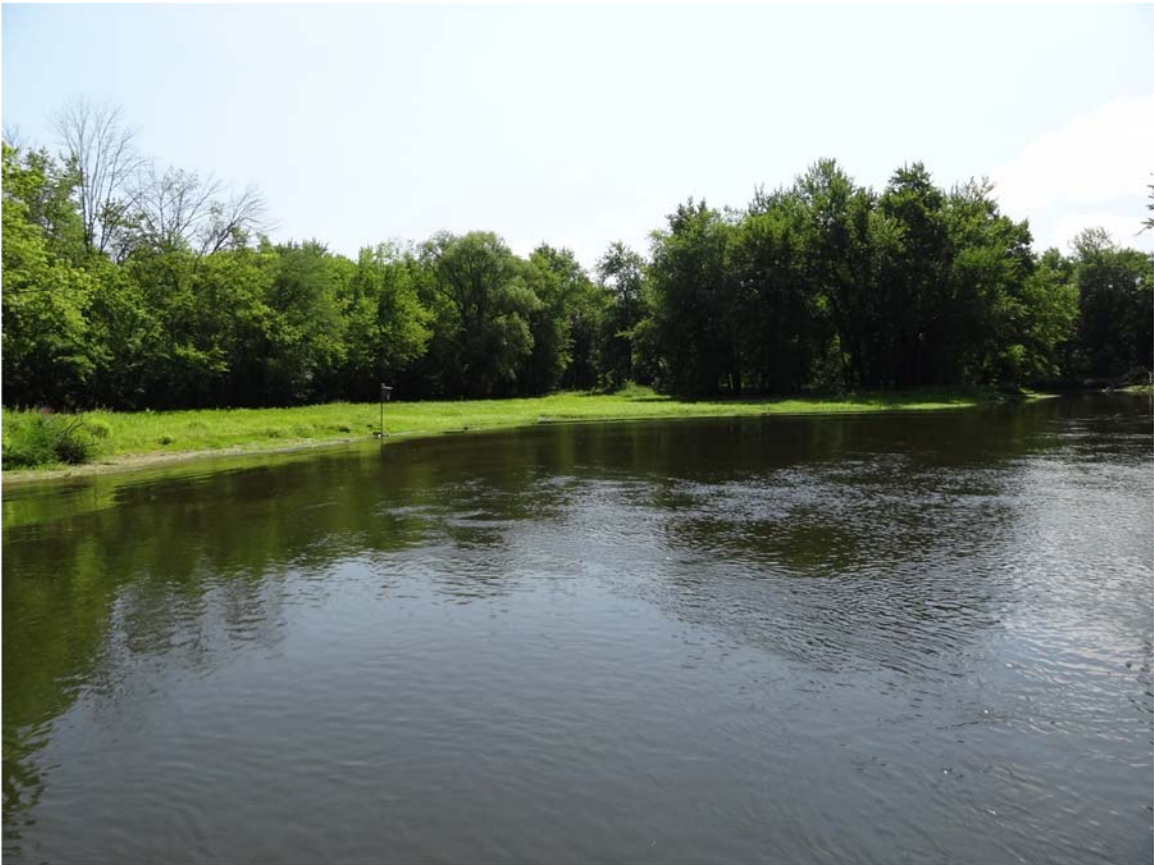
12. MP26.0 RDB, observed ribbons of sheen, sheen sweep boat not warranted.

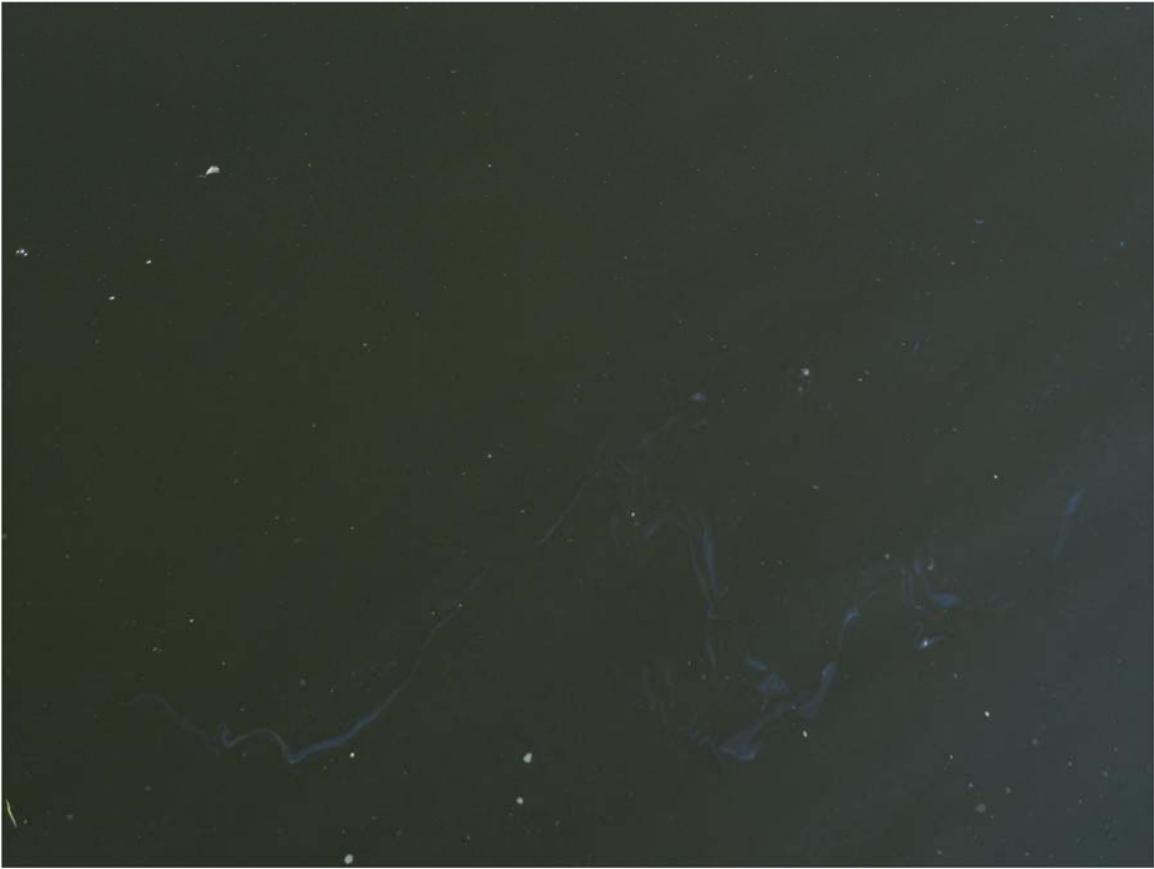
13. MP5.25 RDB sheen observed.

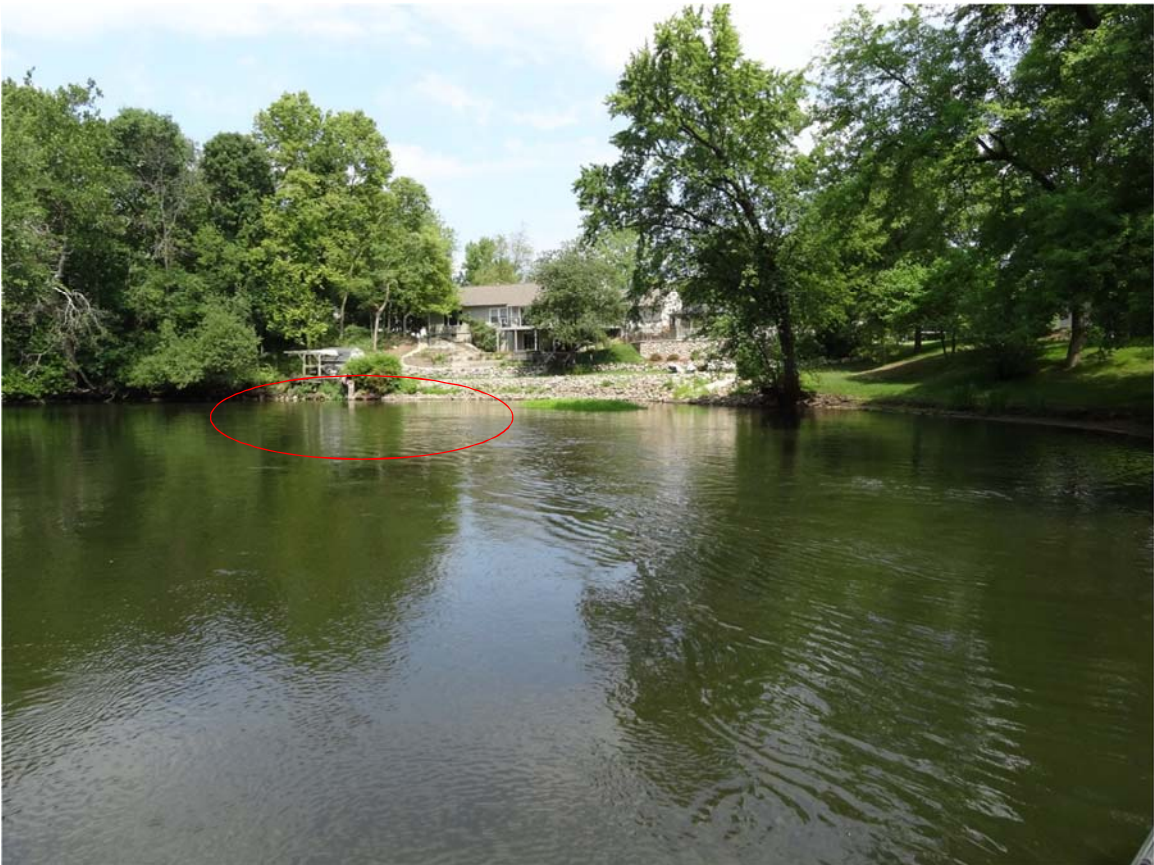
14. MP23.10 RDB sheen observed, no sweep boat was warranted.

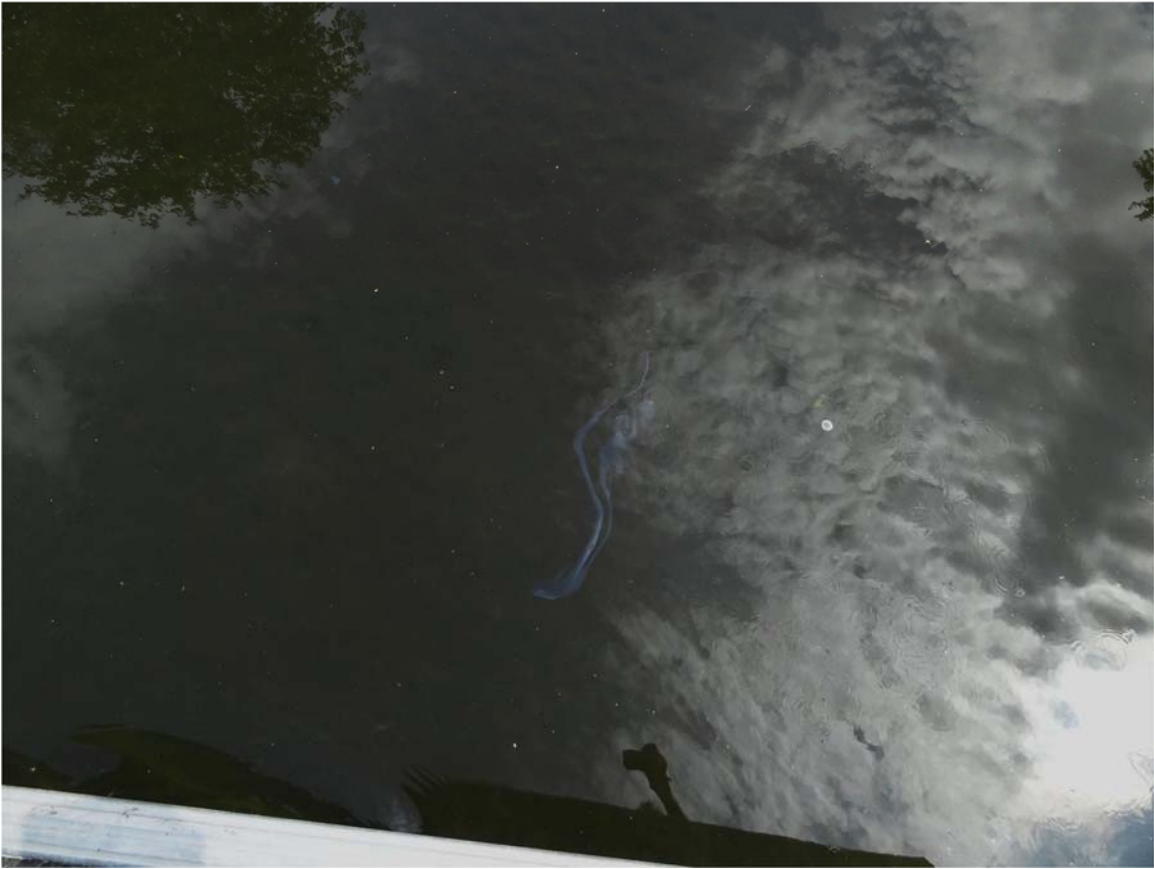
15. MP23.10 RDB sheen observed, no sweep boat was warranted.

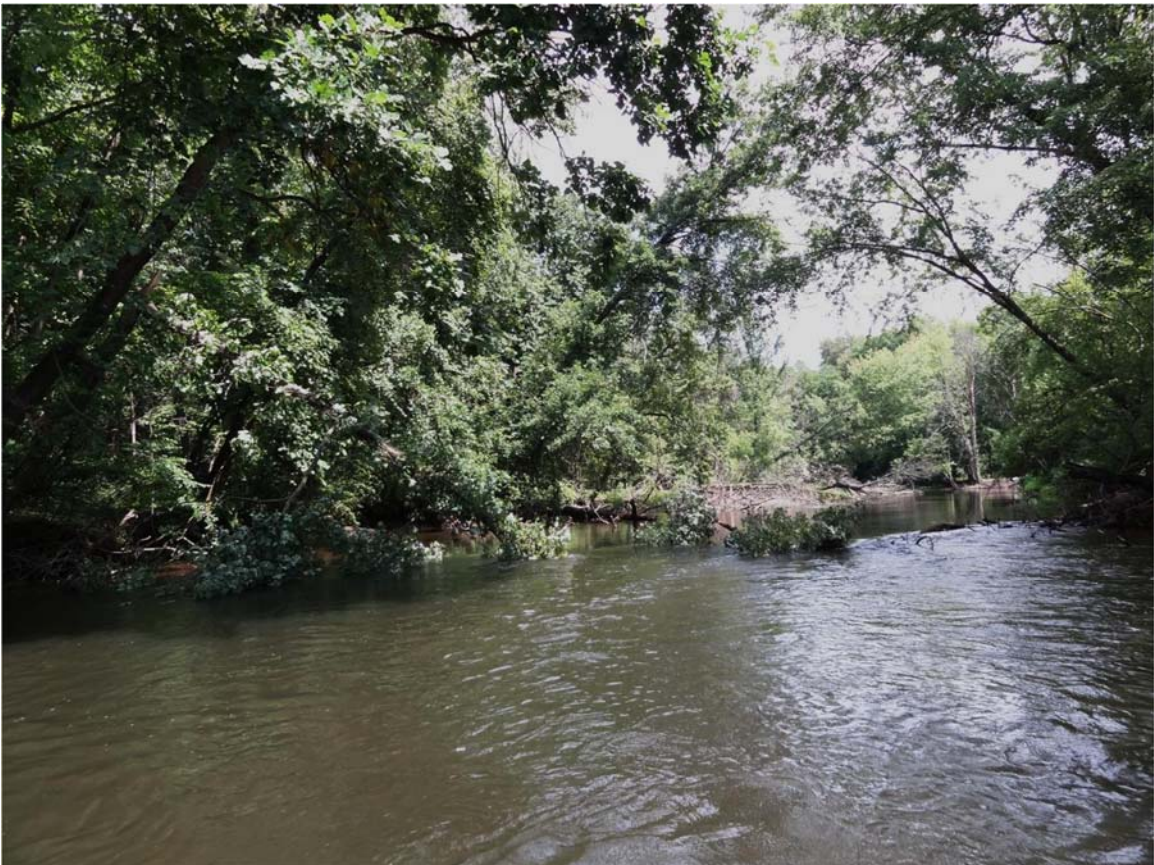
16. MP22.6 observed newly fallen tree branch obstructing river navigation.

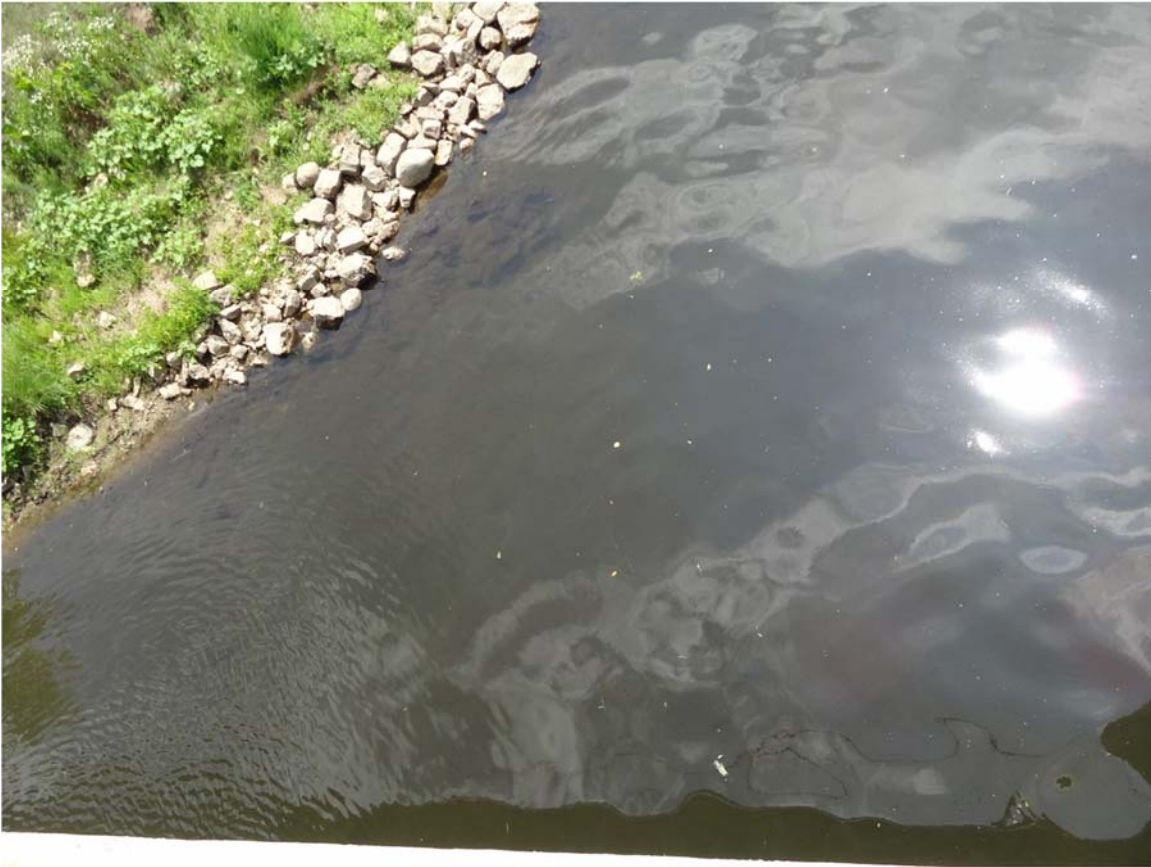
17. MP21.5 Custer Bridge sheen observed, no sweep boat warranted.

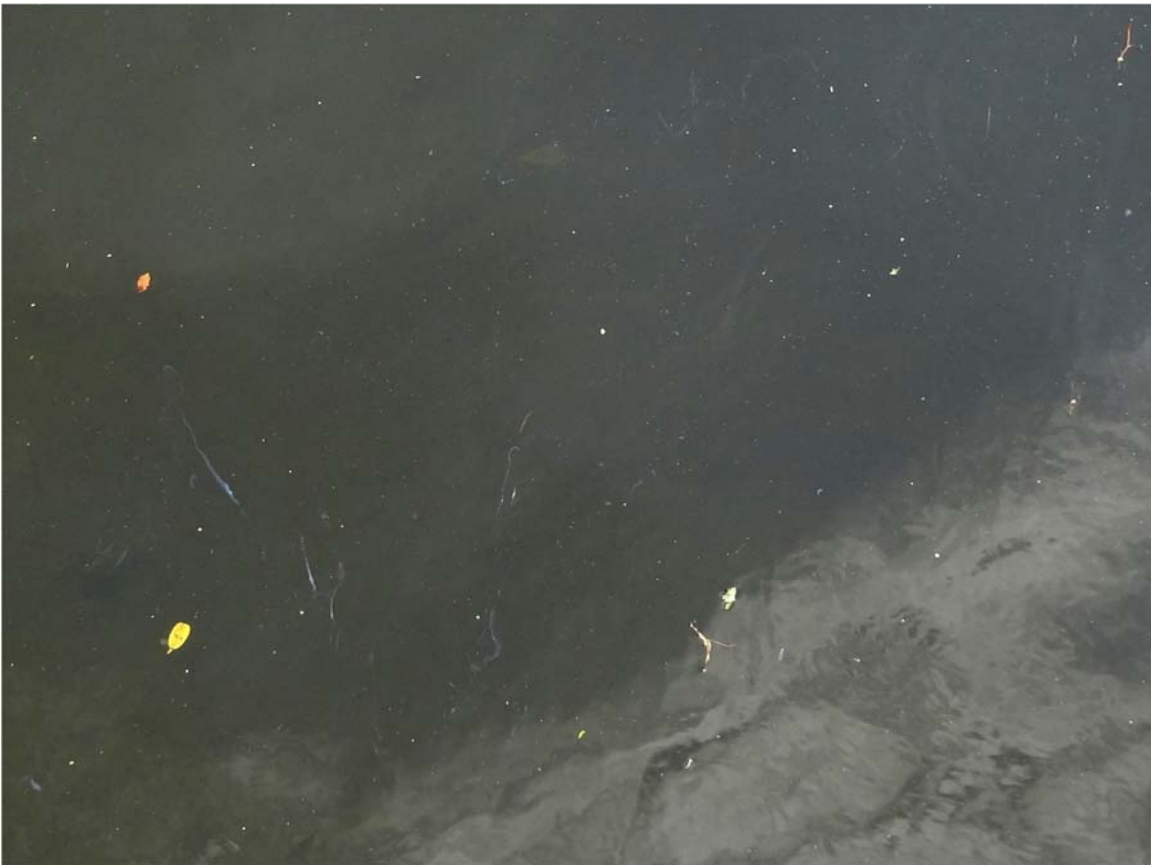
18. MP21.5 Custer Bridge sheen observed, no sweep boat warranted.

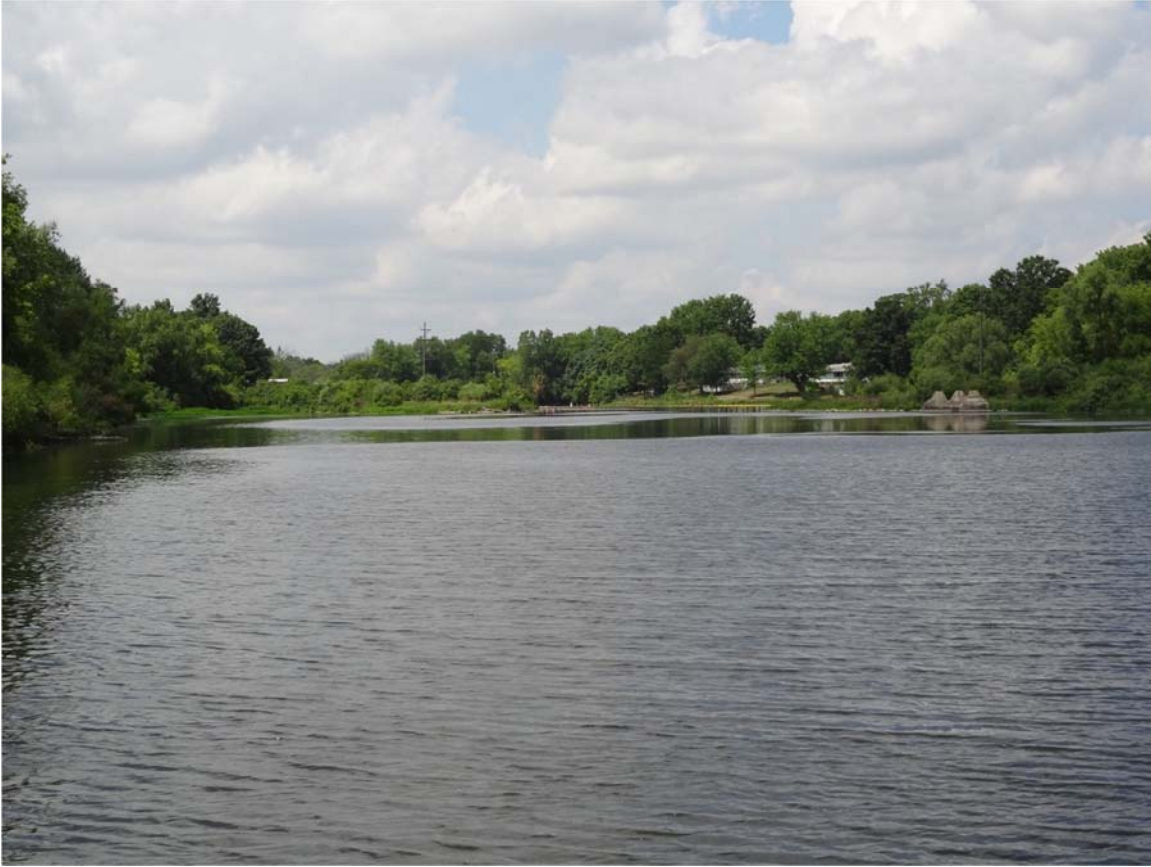
19. MP5.45 LDB observed sheen, sheen sweep boat was observed operating in the area.

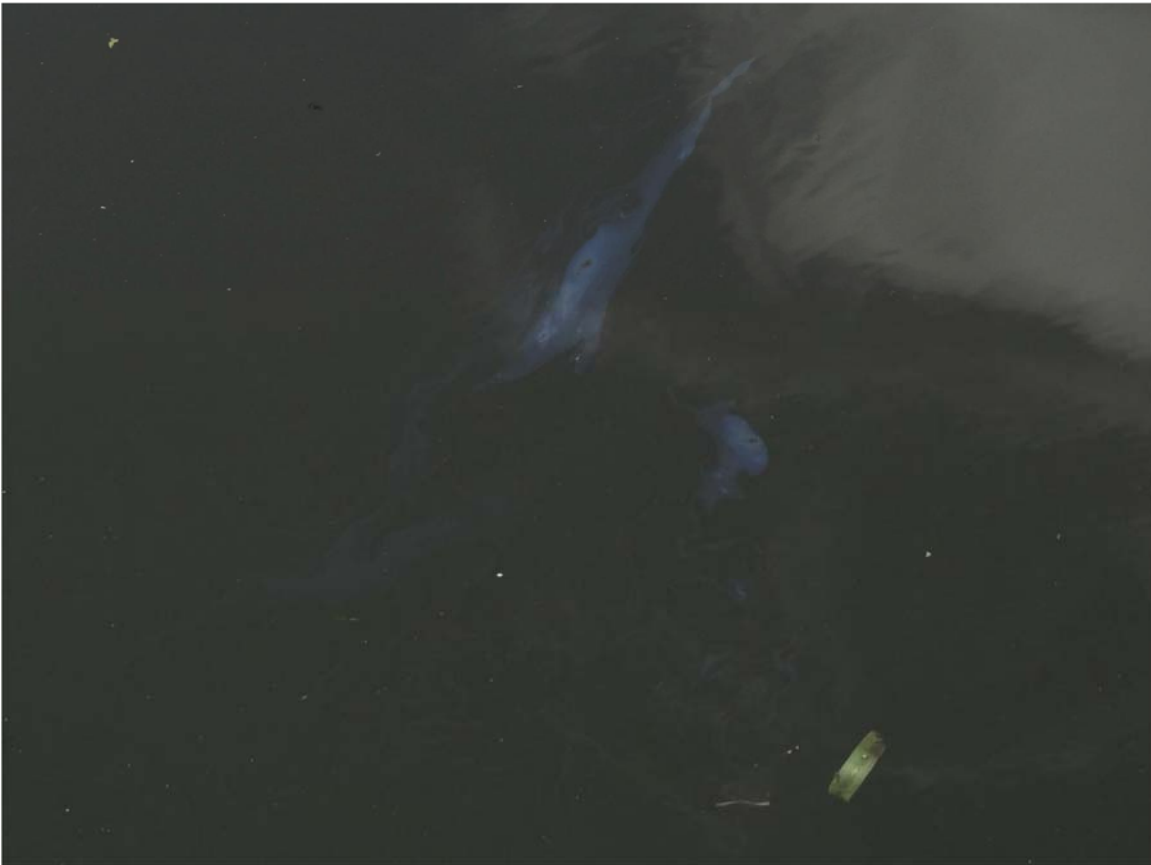
20. MP5.45 LDB observed sheen, sheen sweep boat was observed operating in the area.

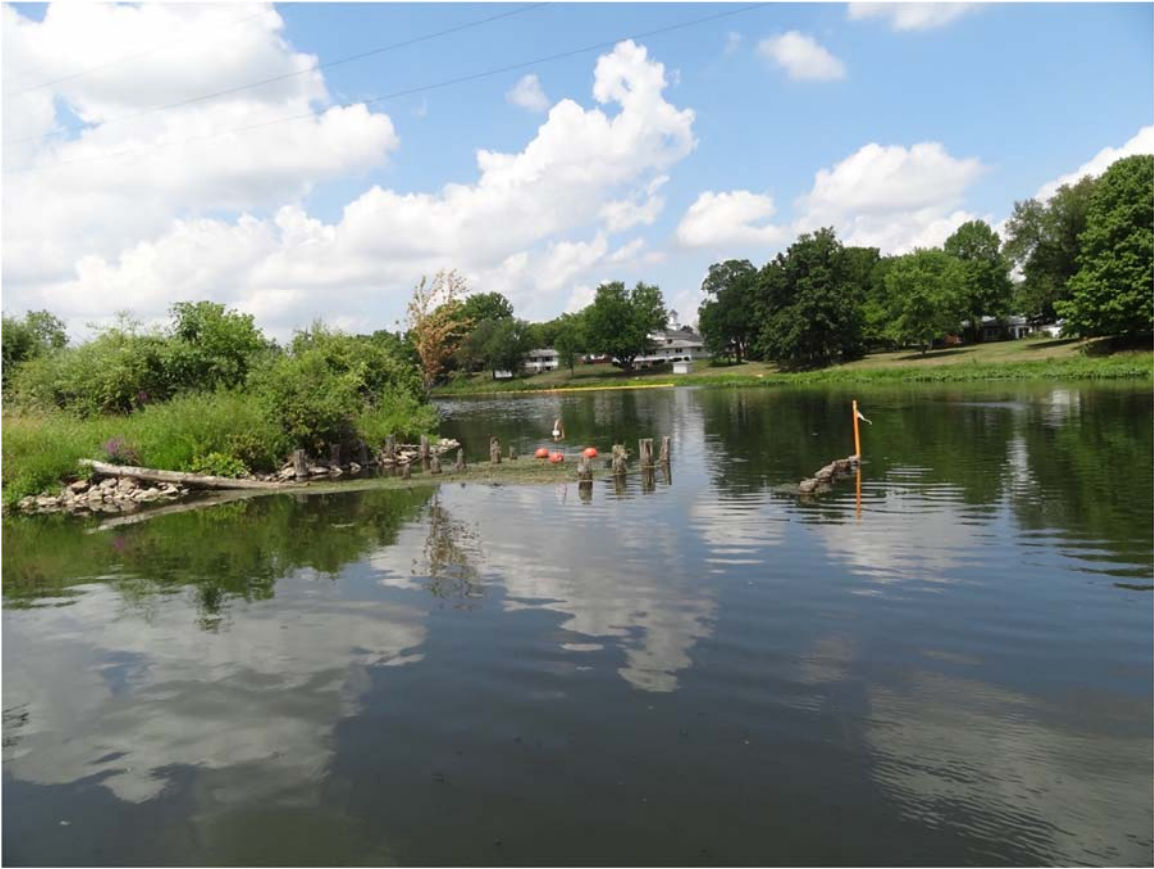
**21. MP5.63 LDB Railroad trestles sheen observed, sheen sweep boat was observed operating in the area.**

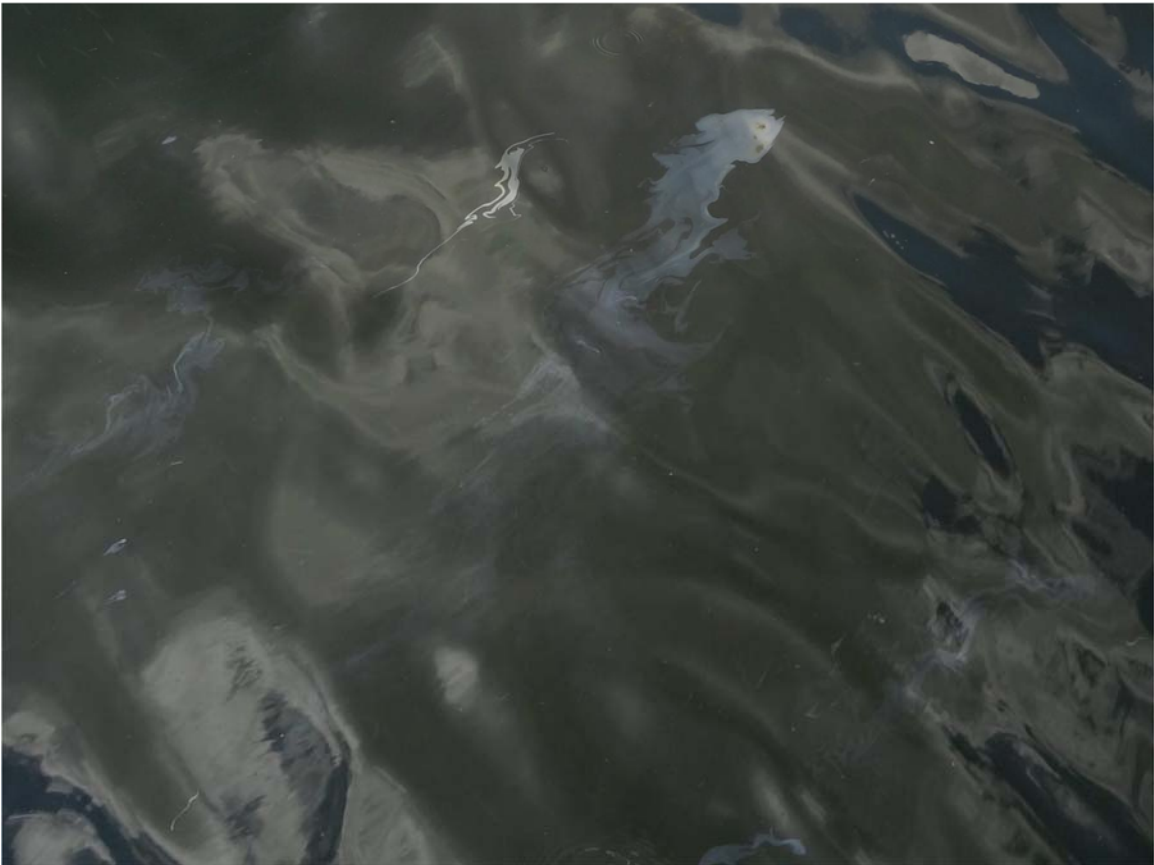
**22. MP5.63 LDB Railroad trestles sheen observed, sheen sweep boat was observed operating in the area.**
