# Situation Photo Log

Tuesday, July 31, 2012

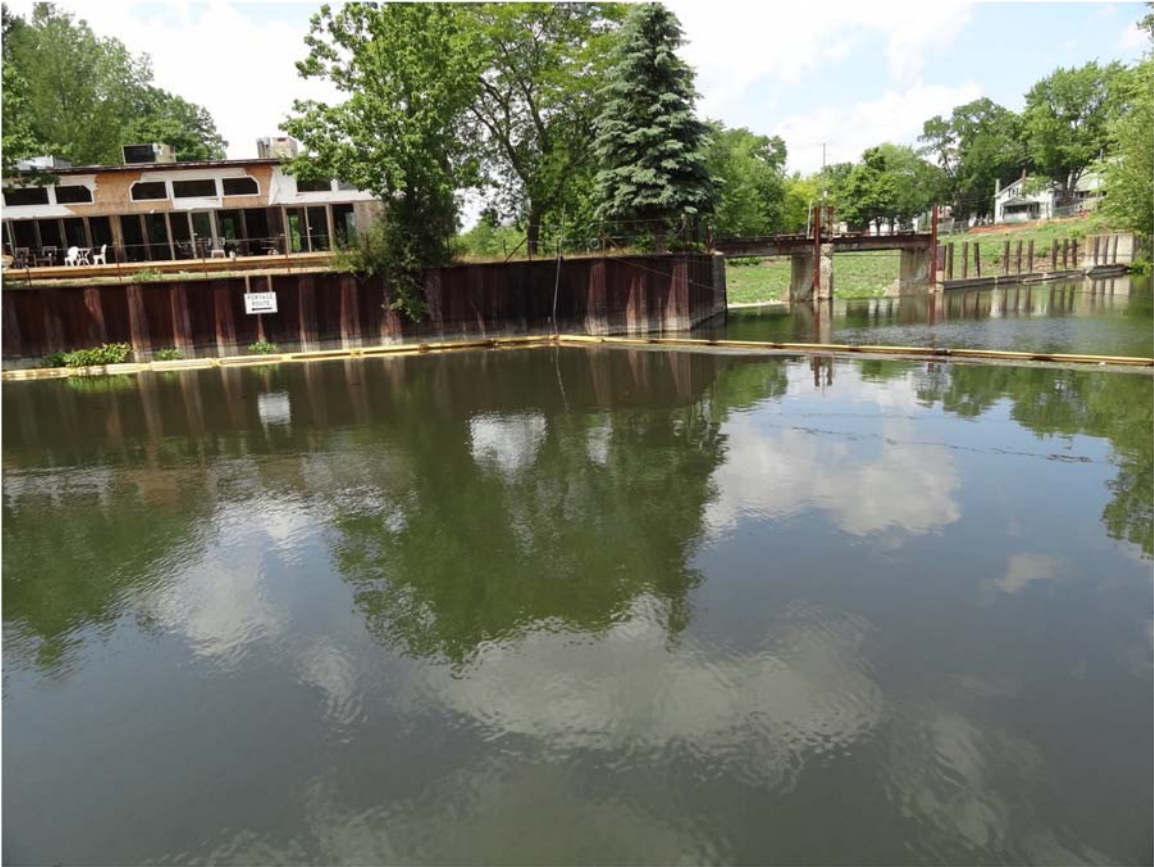
23. Ceresco Dam control point boom, observed the debris removed from the boom.

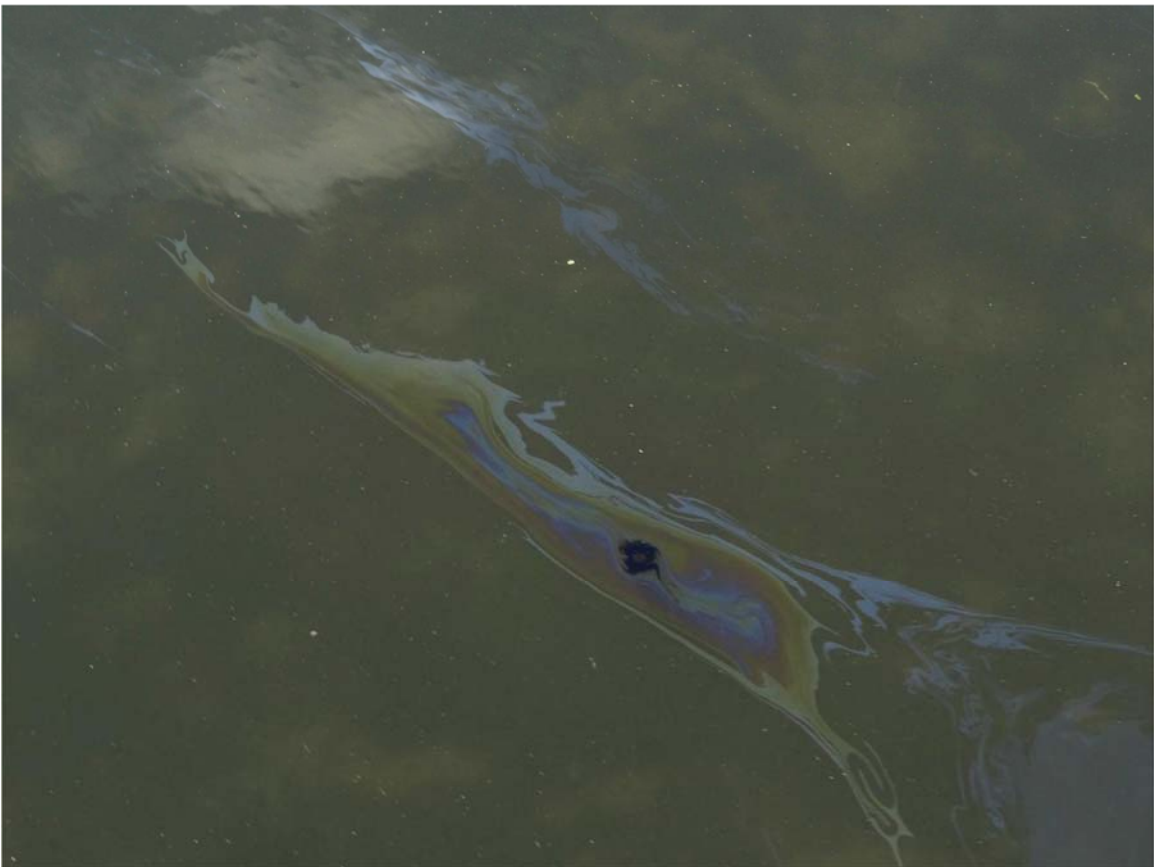
24. Ceresco Dam control point boom, observed sheen and tar glob collecting at the boom.

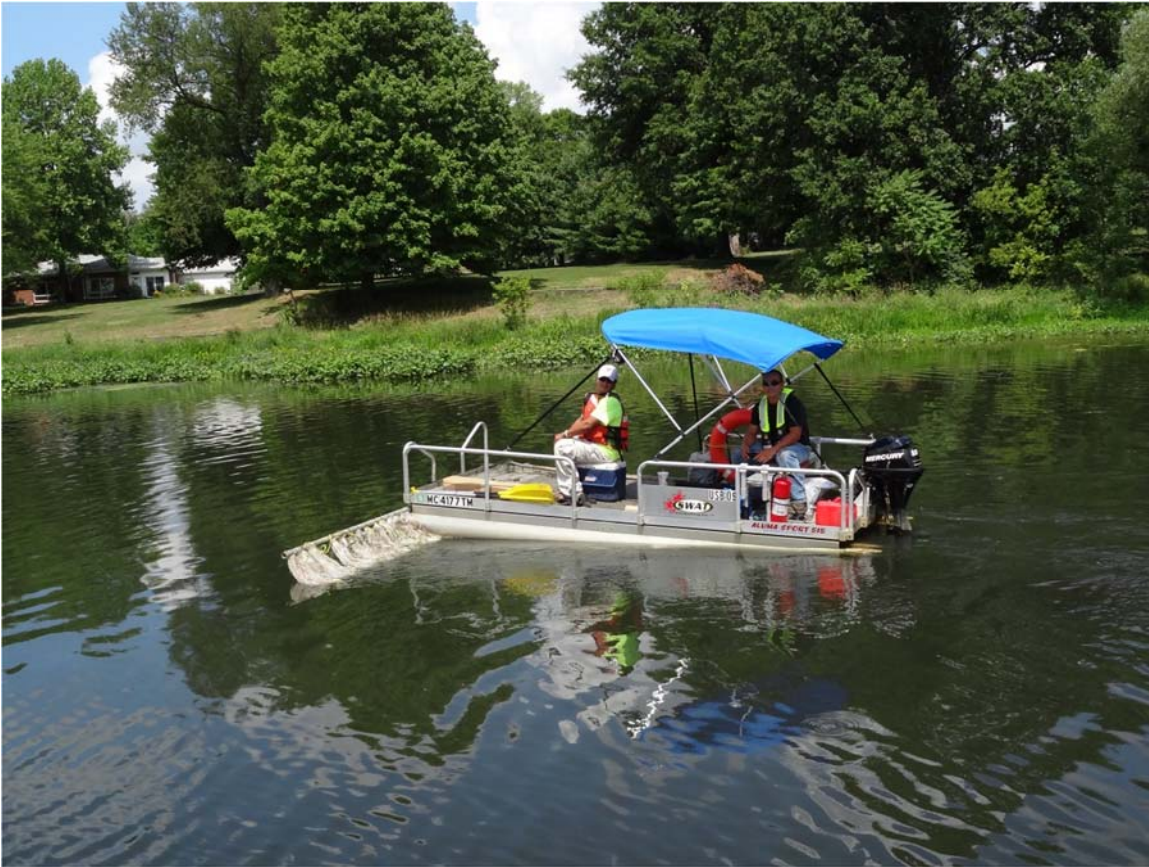
25. Observed the sheen sweep boat operating above Ceresco Dam.

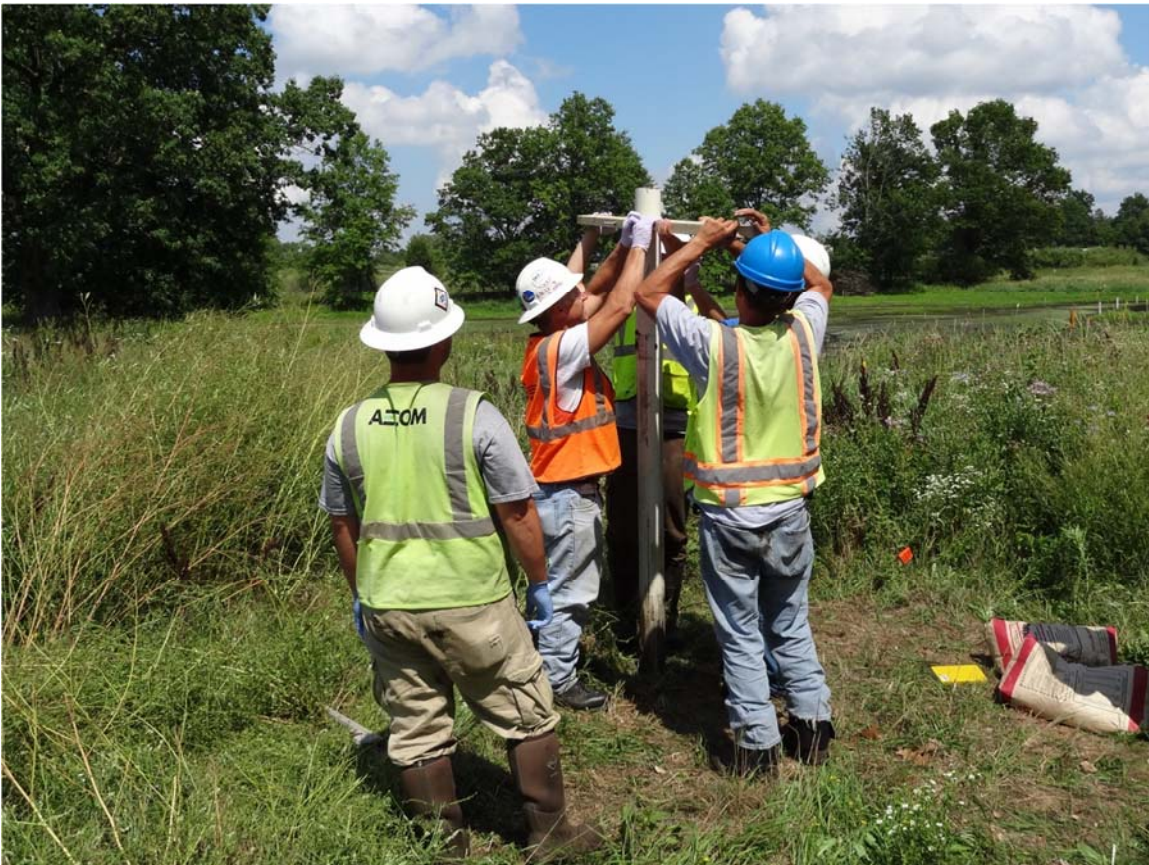
26. Source area observed crew pulling well casing.

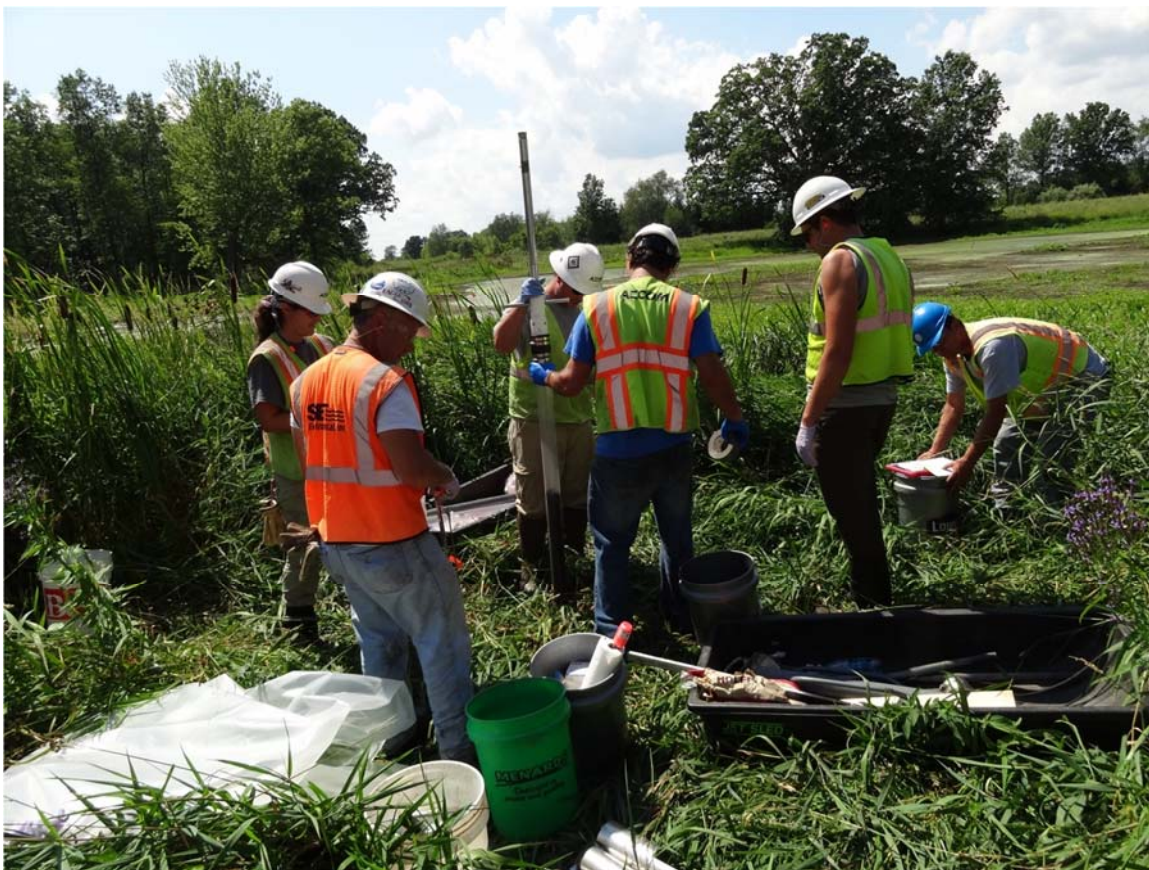
27. Source area coring work.

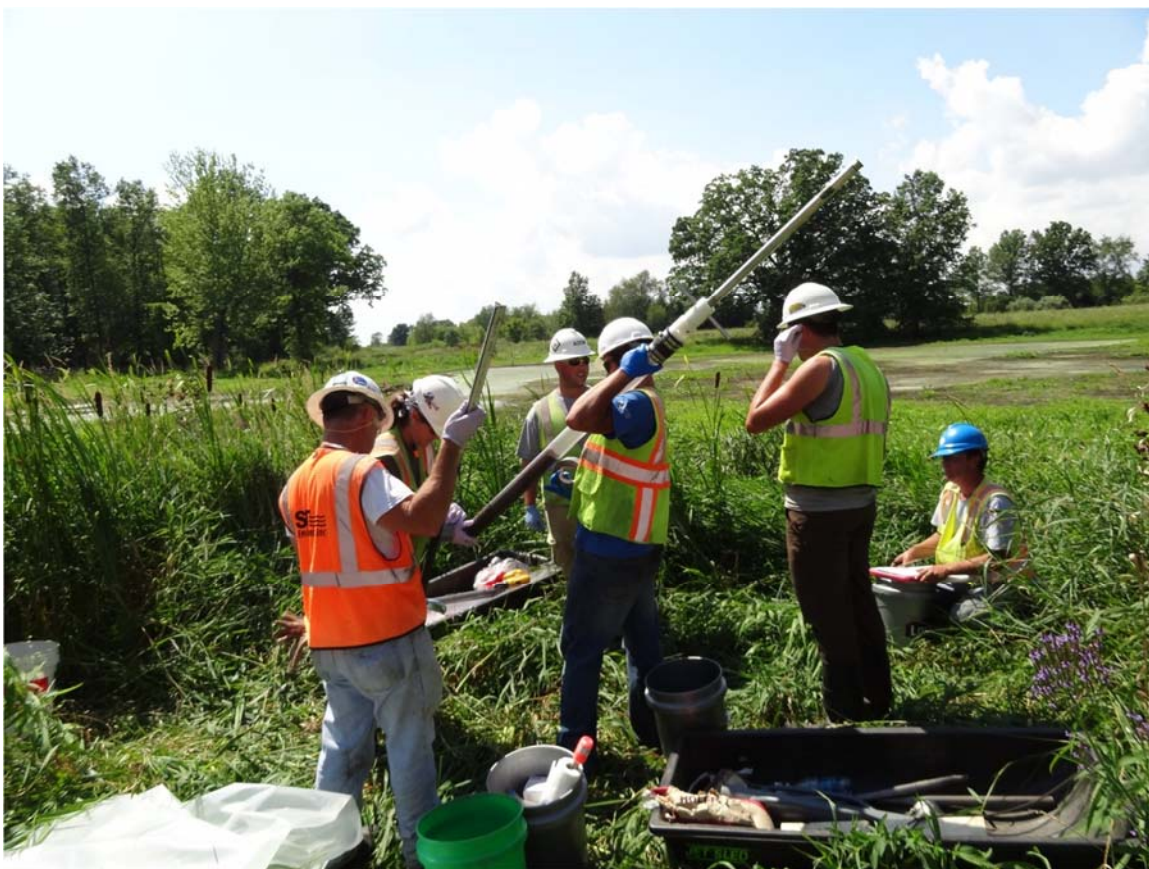
28. Source area coring work.
