# Situation Photo Log

Thursday, August 3, 2012

Kalamazoo River / Enbridge Spill

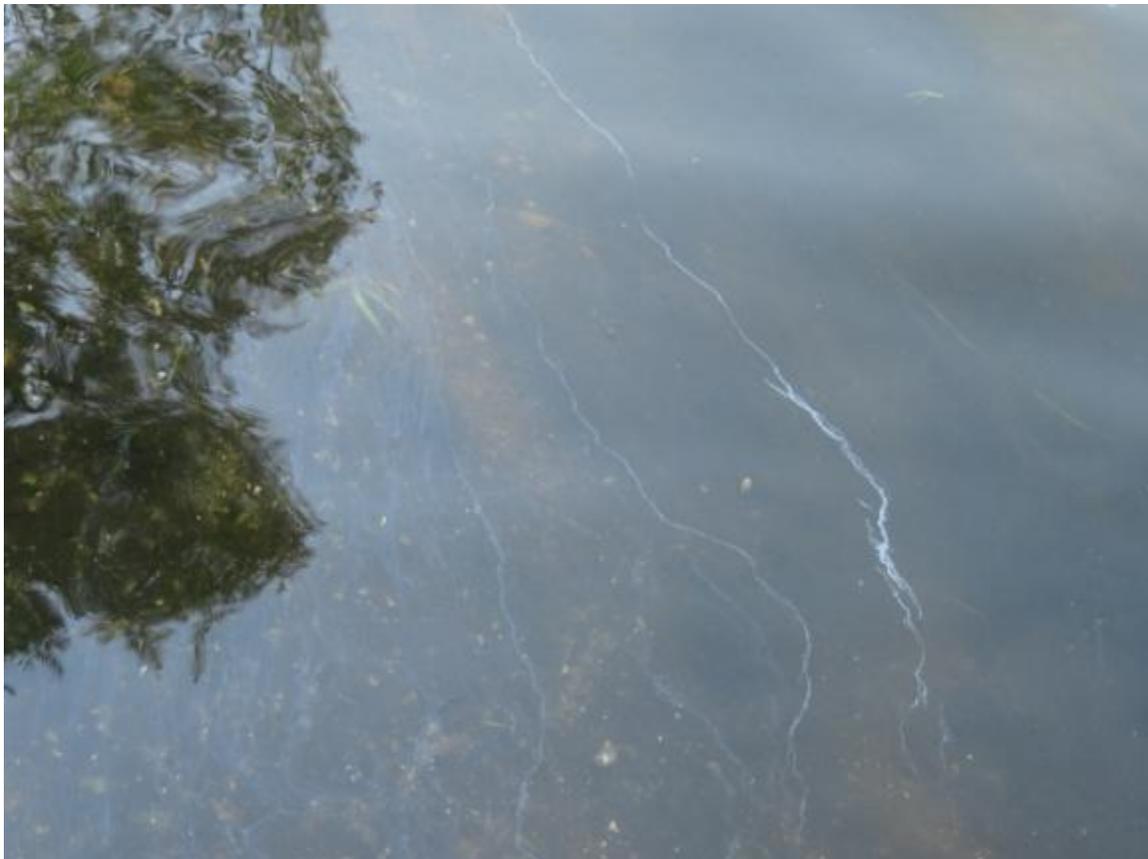
2. MP 5.0 RDB sheen observed.

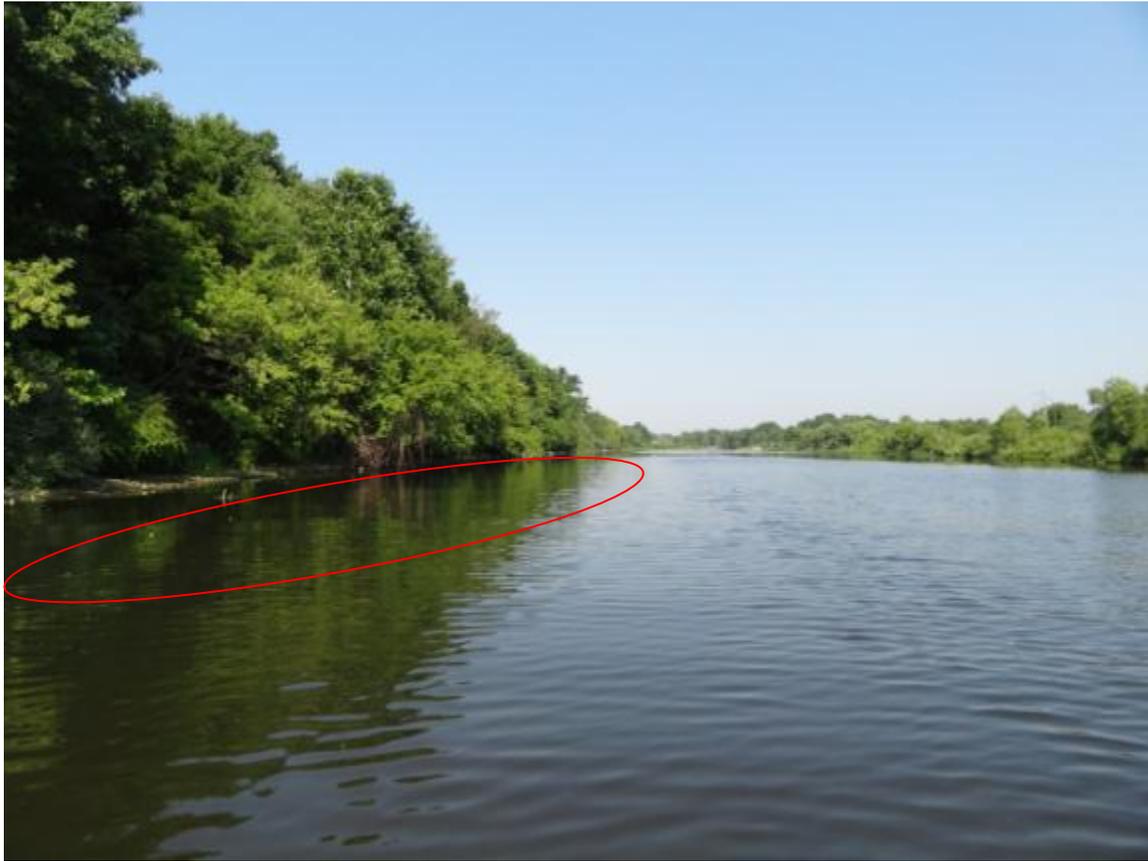
3. MP 5.0 to MP 5.63 LDB sheen observed, sheen sweep boat observed working in the area.

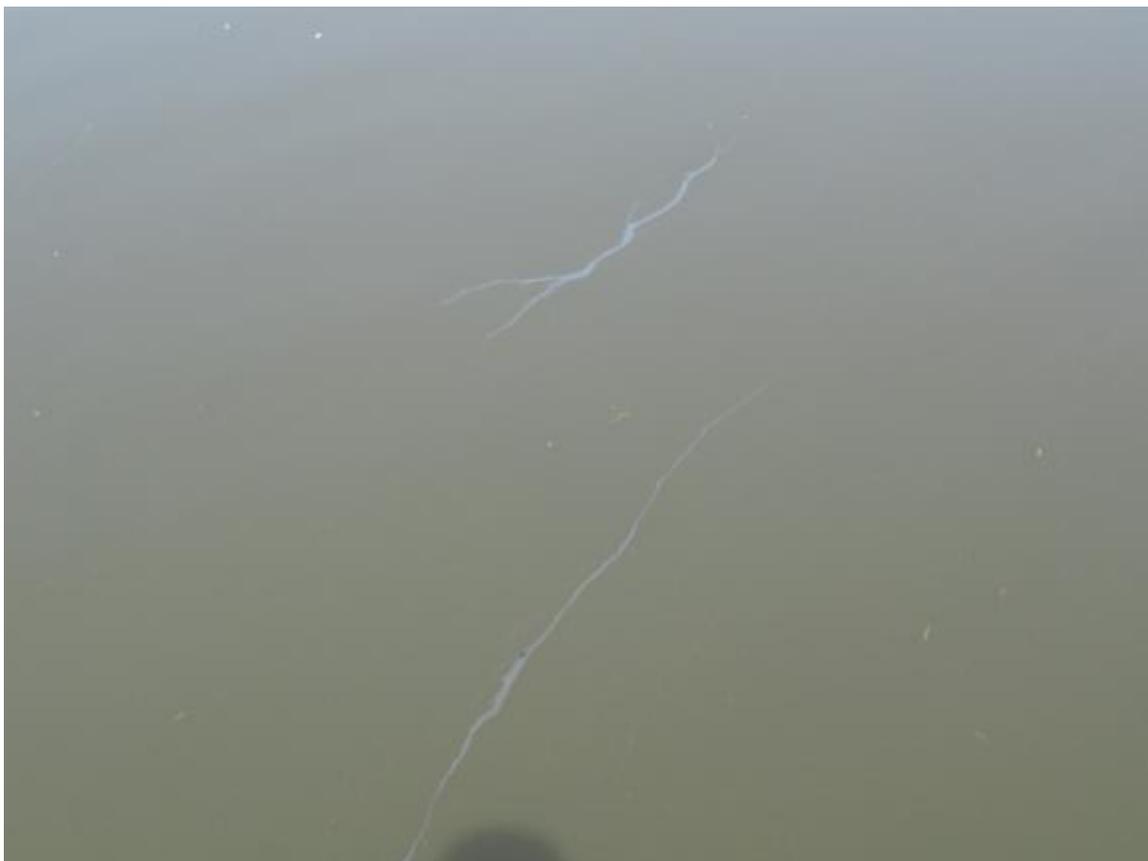
4. MP 5.25 sheen observed, sheen sweep boat observed working in the area.

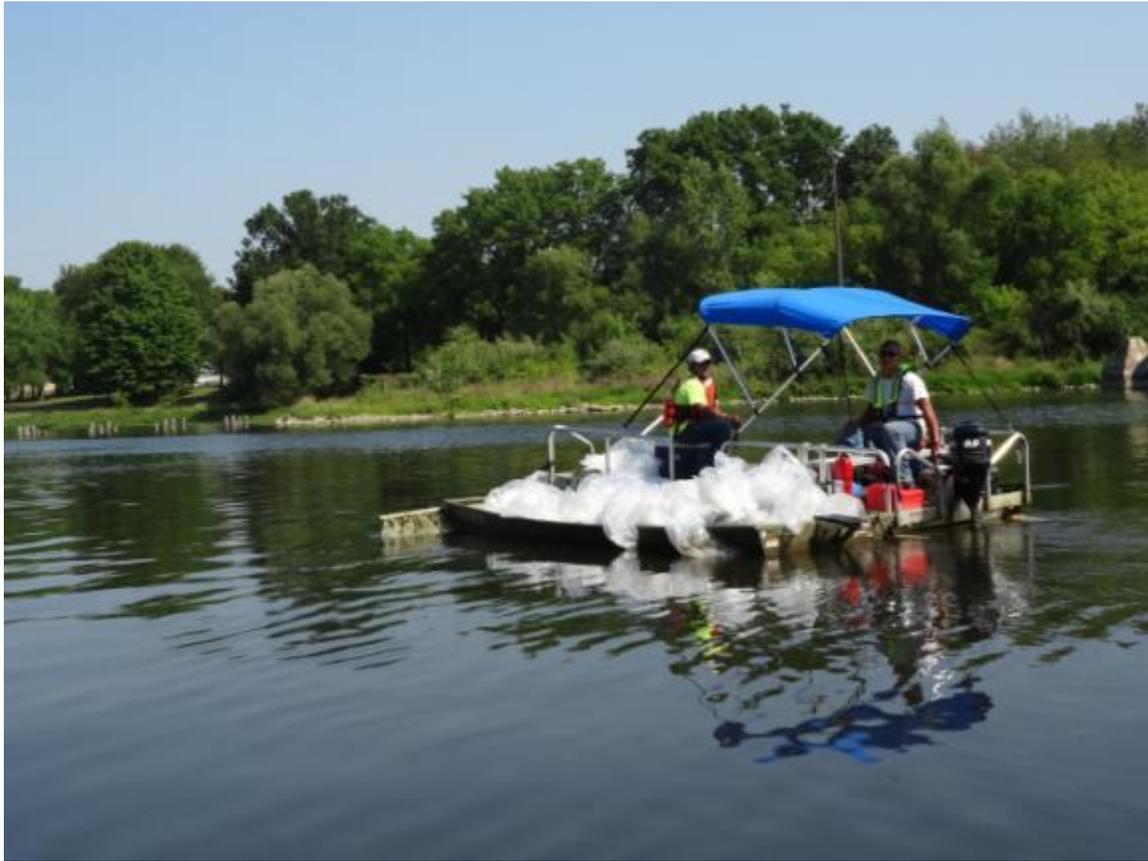
5. MP 5.55 observed sheen sweep boat operating.

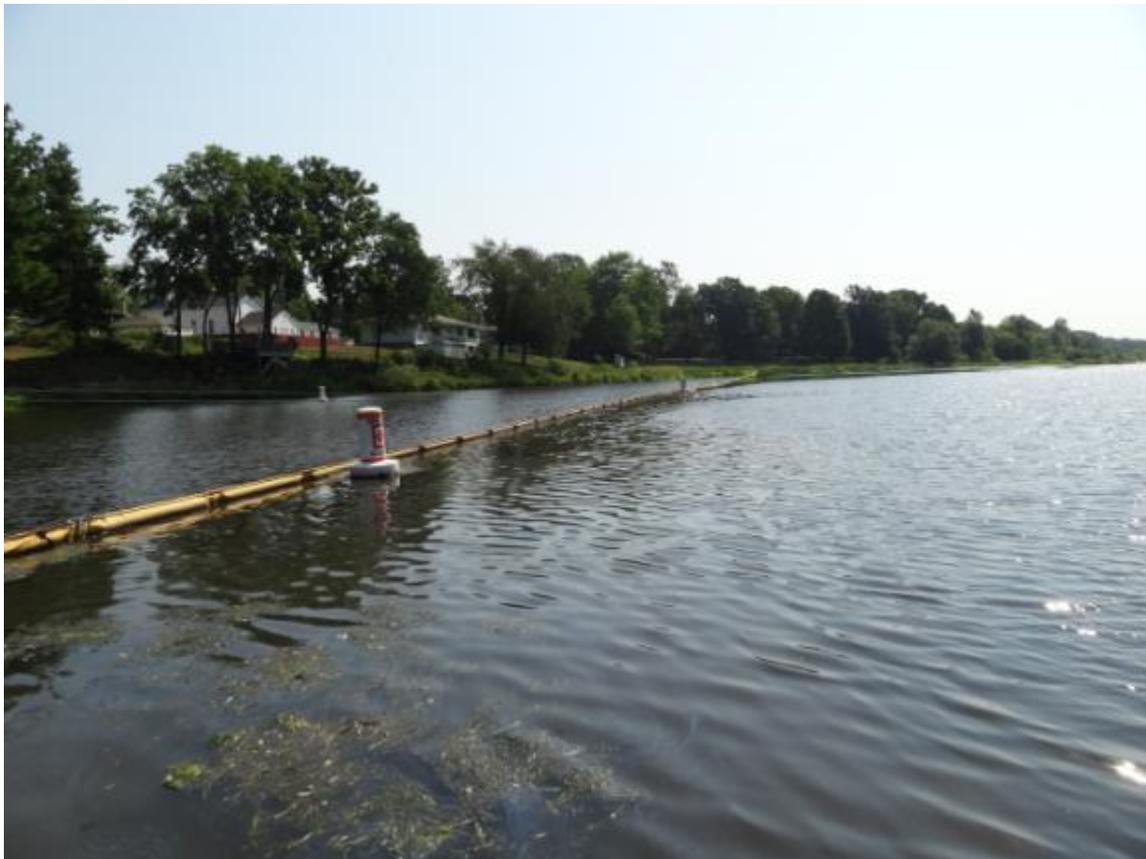
6. Ceresco Dam control point boom, observed vegetative debris and sheen.

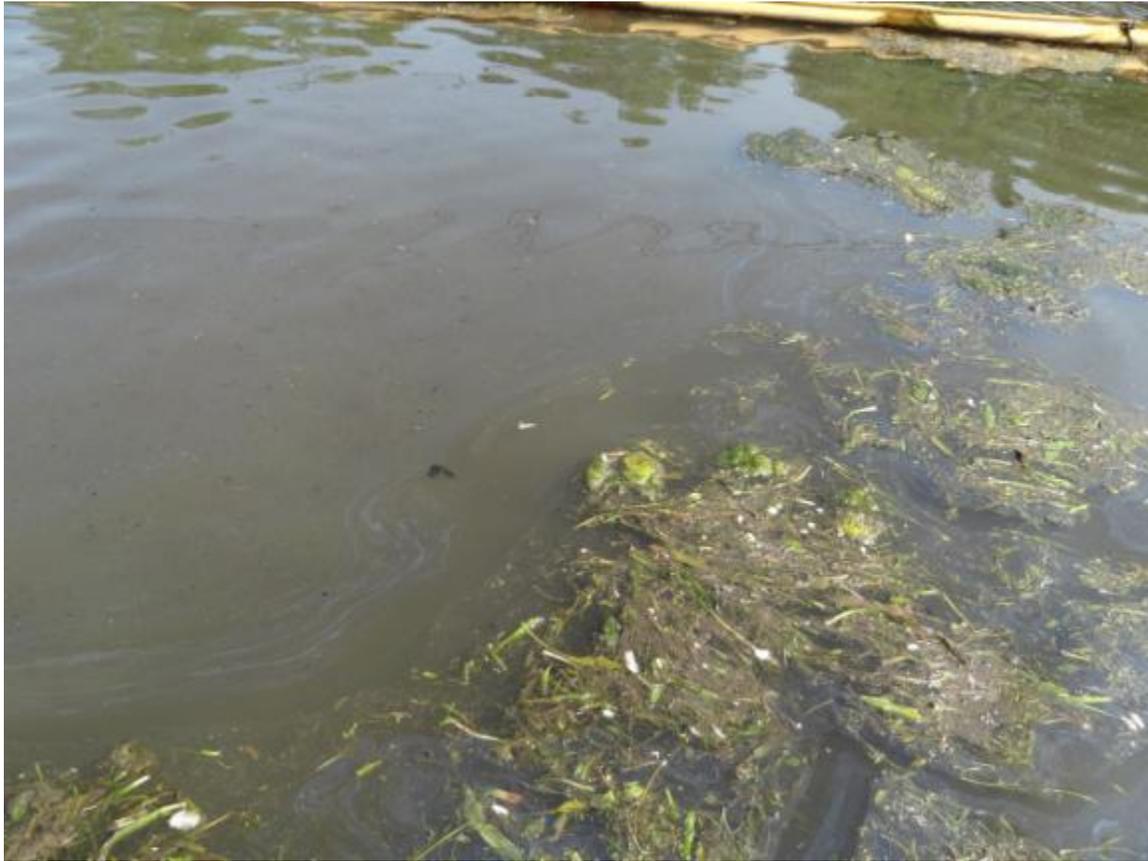
7. Ceresco Dam control point boom, observed vegetative debris and sheen.

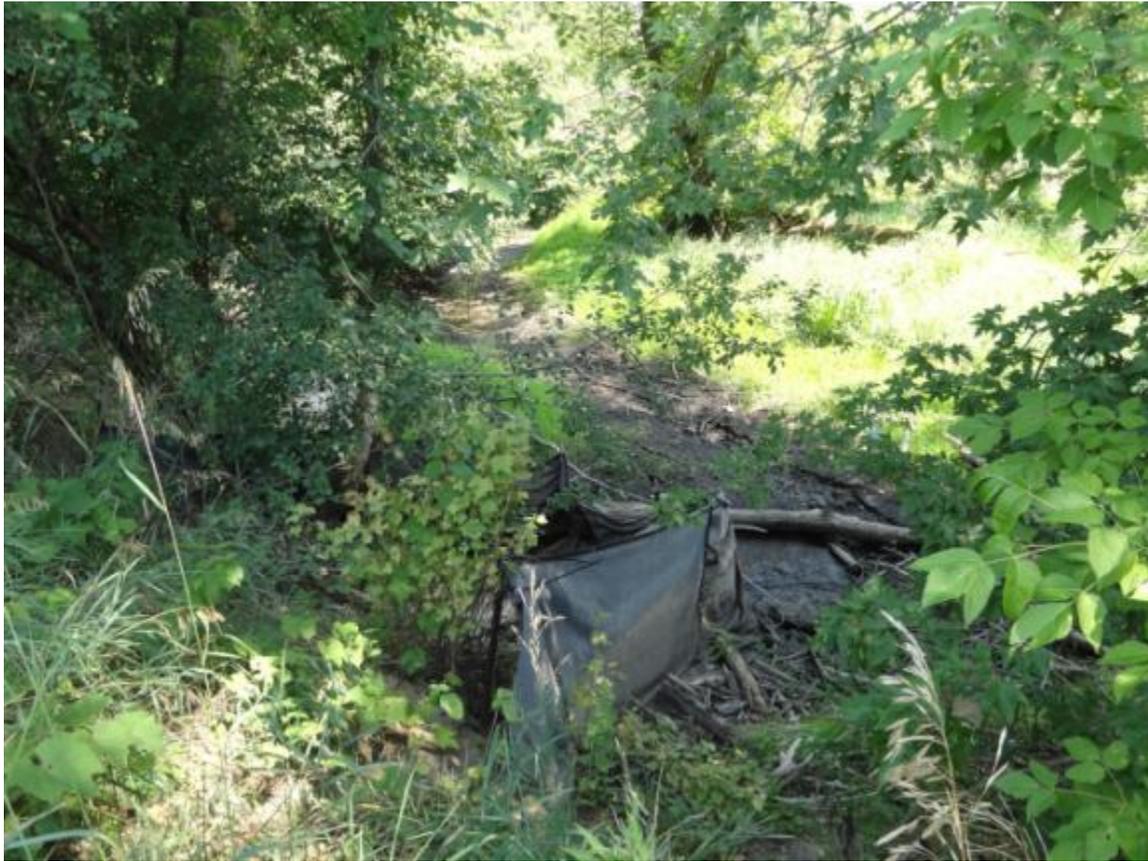
9. MP 12.15 east side of Raymond Road culvert, site for coir log structure installation at MP 11.79 Sediment Trap.

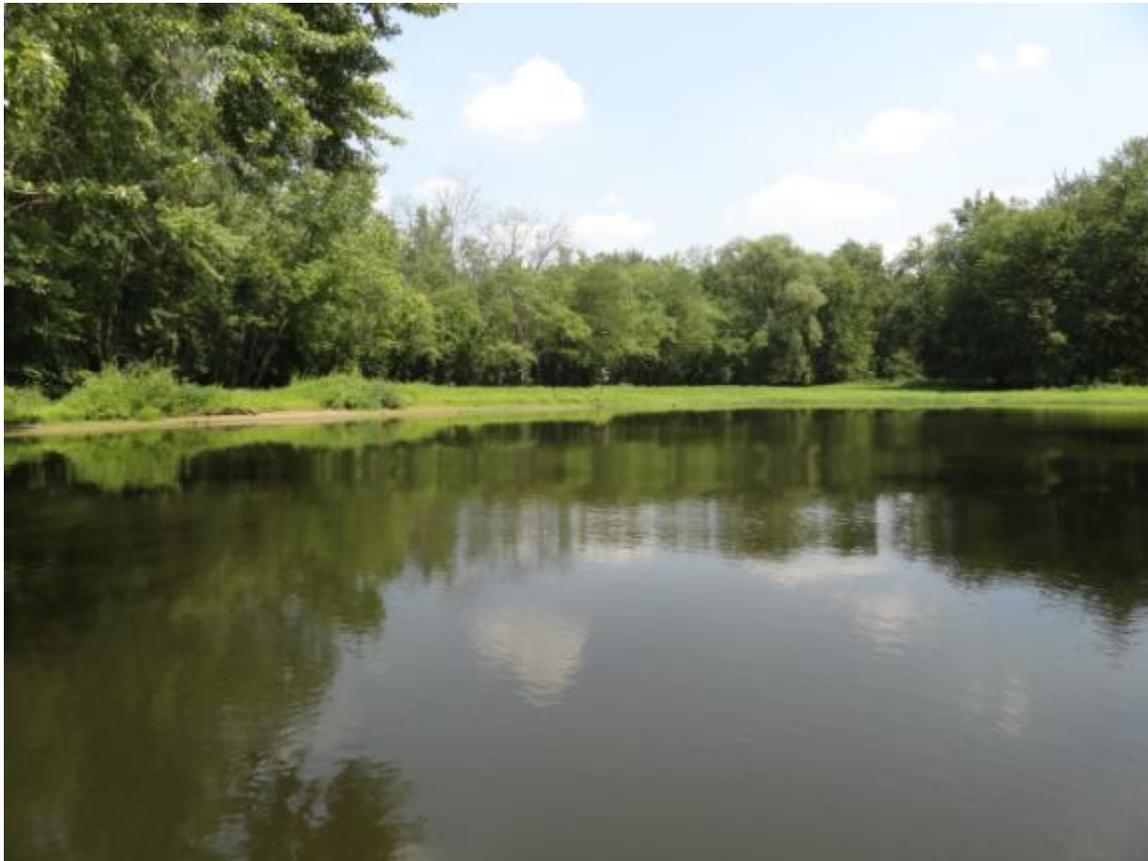
10. MP 26.00 RDB sediment trap location, no sheen observed.

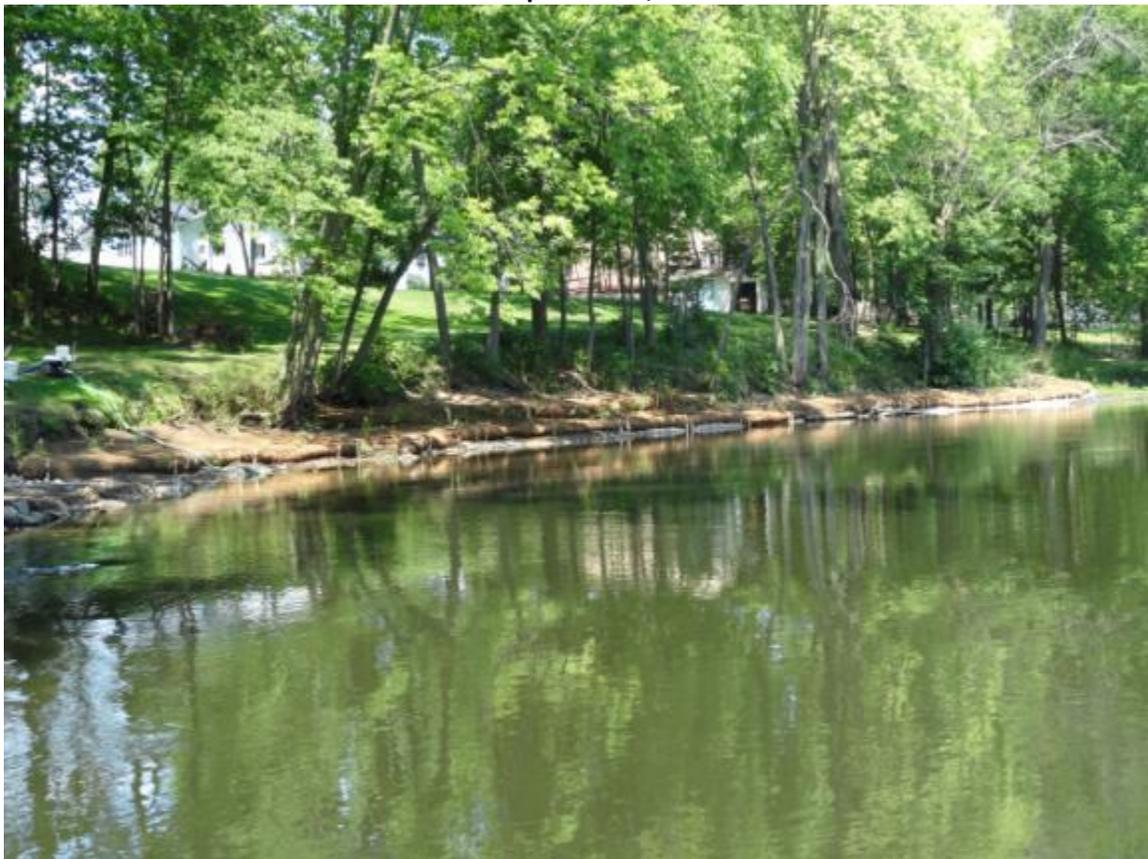
11. MP 26.75 RDB river bank restoration location.

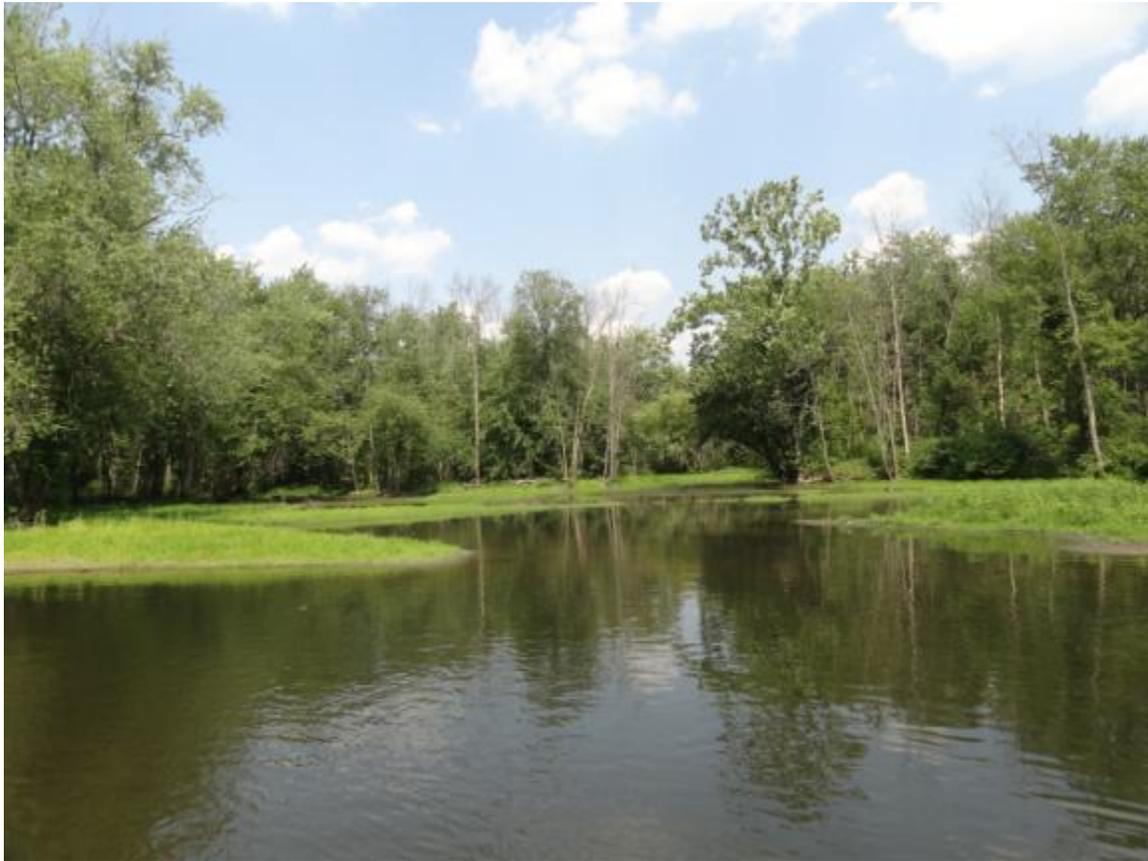
12. MP 30.8 LDB sediment trap location, no sheen observed.

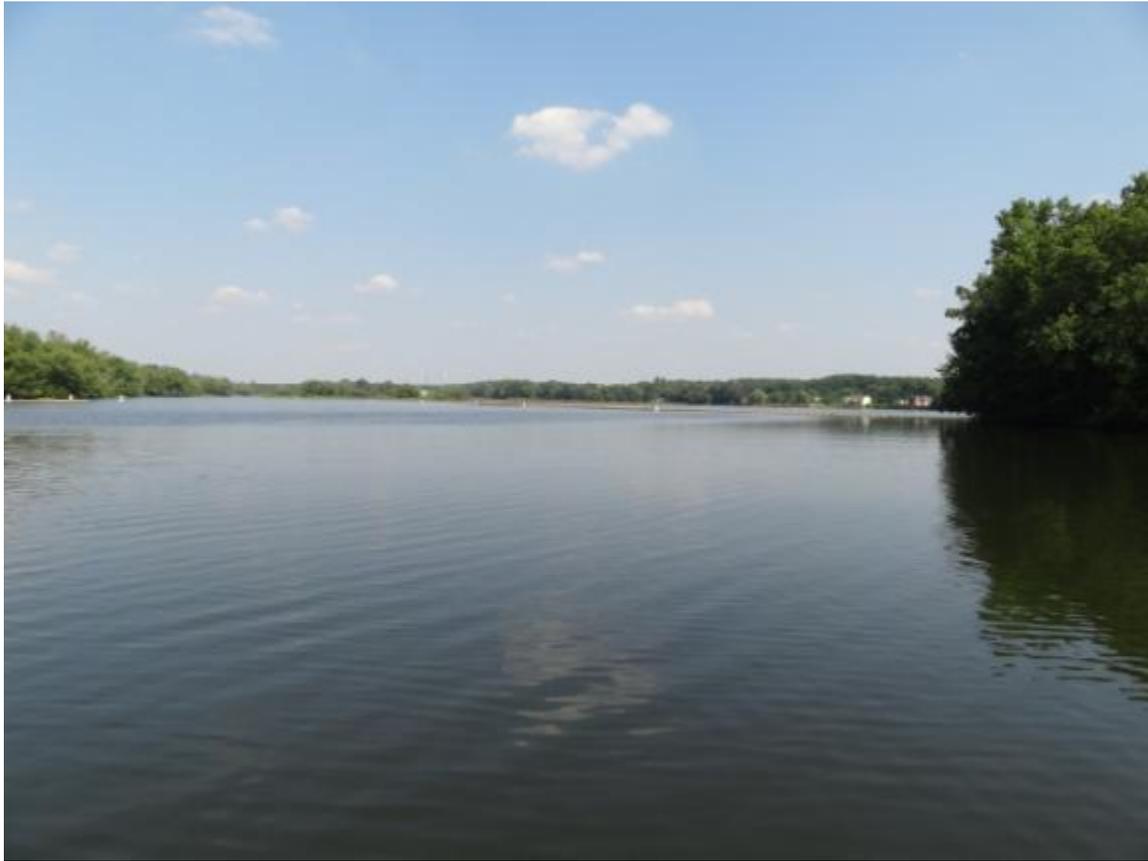
14. Morrow Lake Delta, no sheen observed.

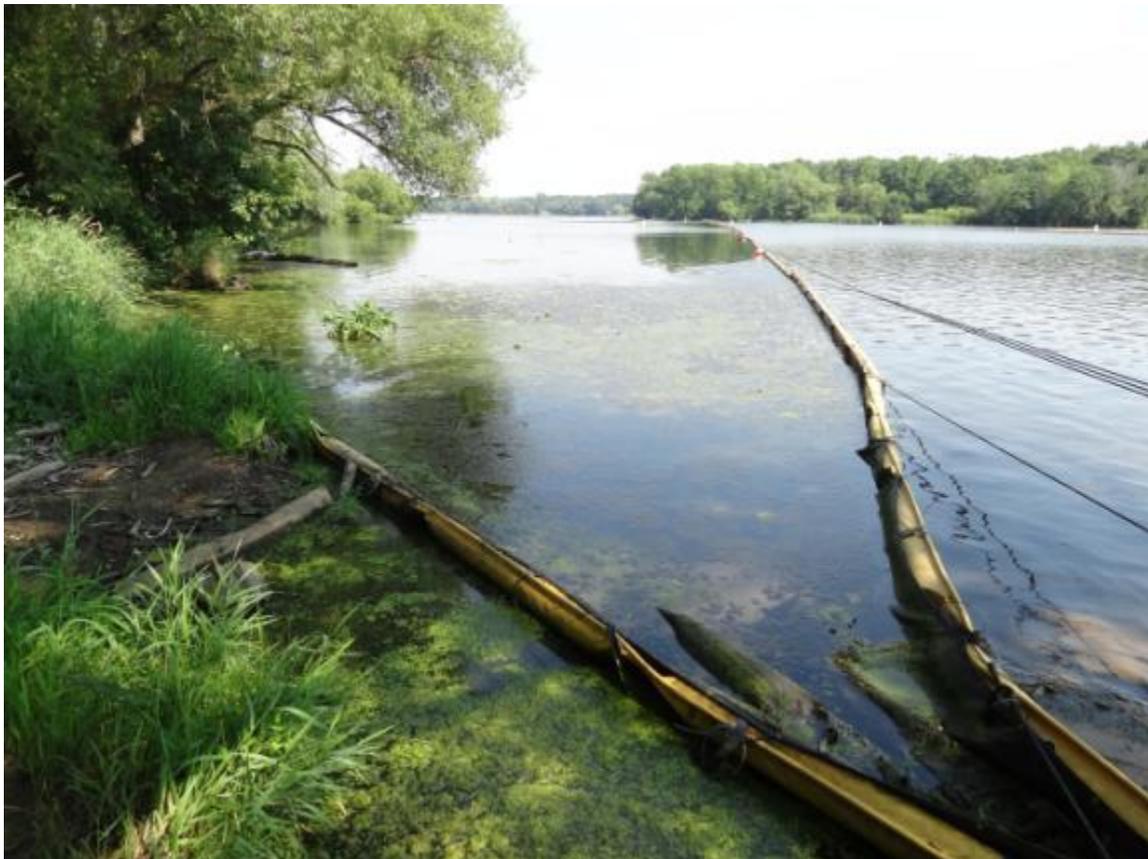
15. Morrow Lake Delta Gate E North, vegetative debris collecting.

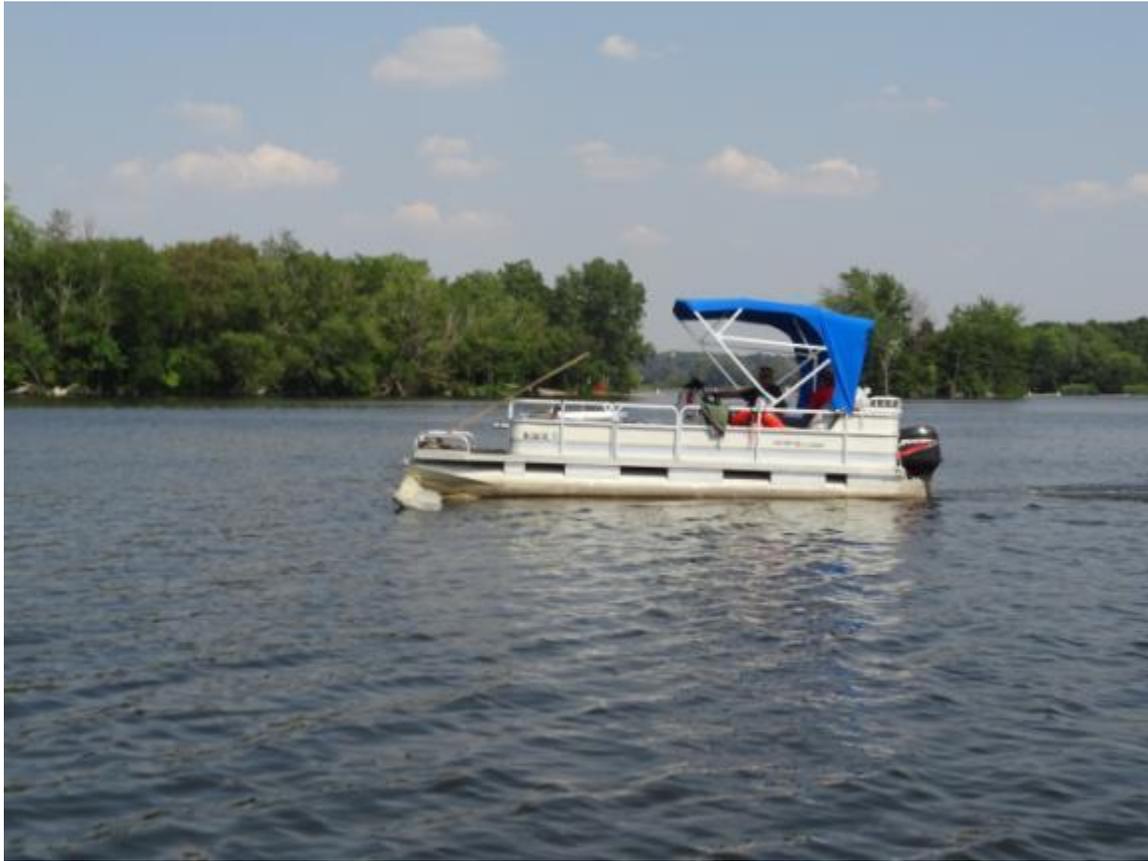
16. Morrow Lake observed the sweep boat operating.
