# Situation Photo Log

Monday, August 6, 2012

Kalamazoo River / Enbridge Spill

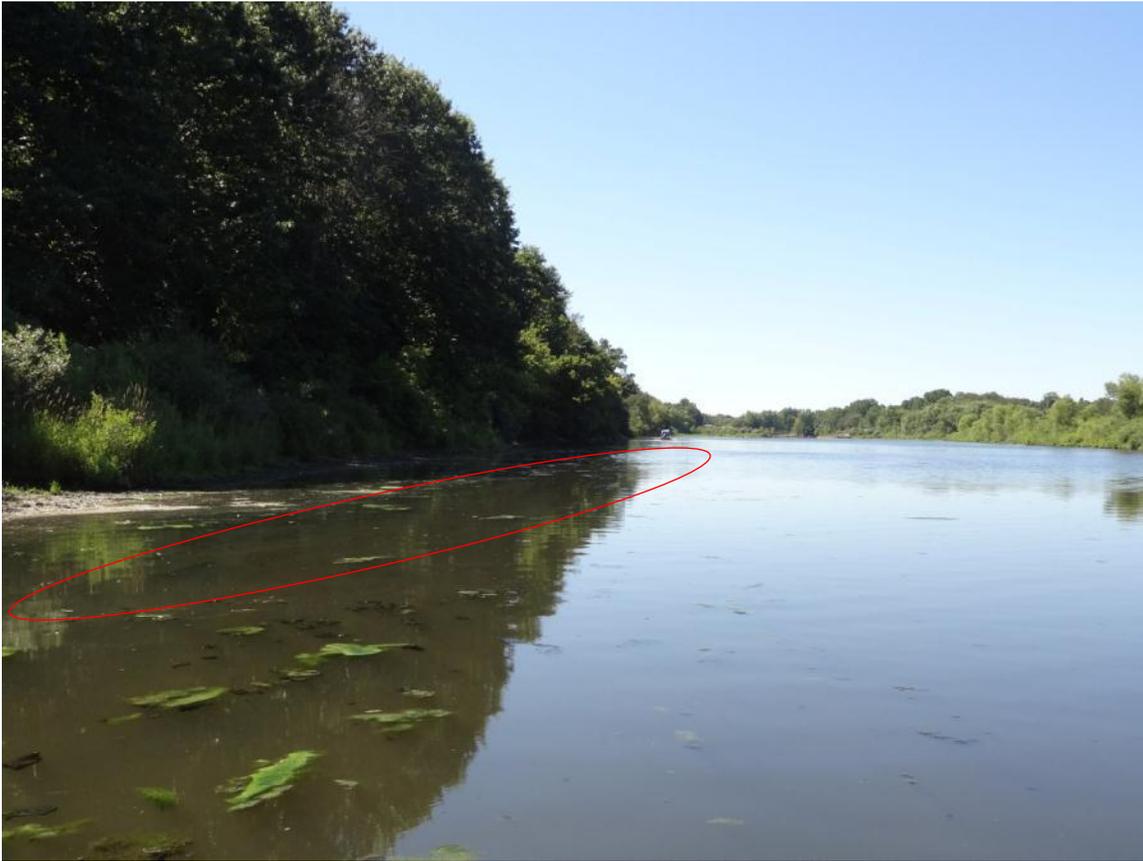
1. MP 5.25 to MP 5.60 LDB sheen observed, sweep boat was observed operating in area.

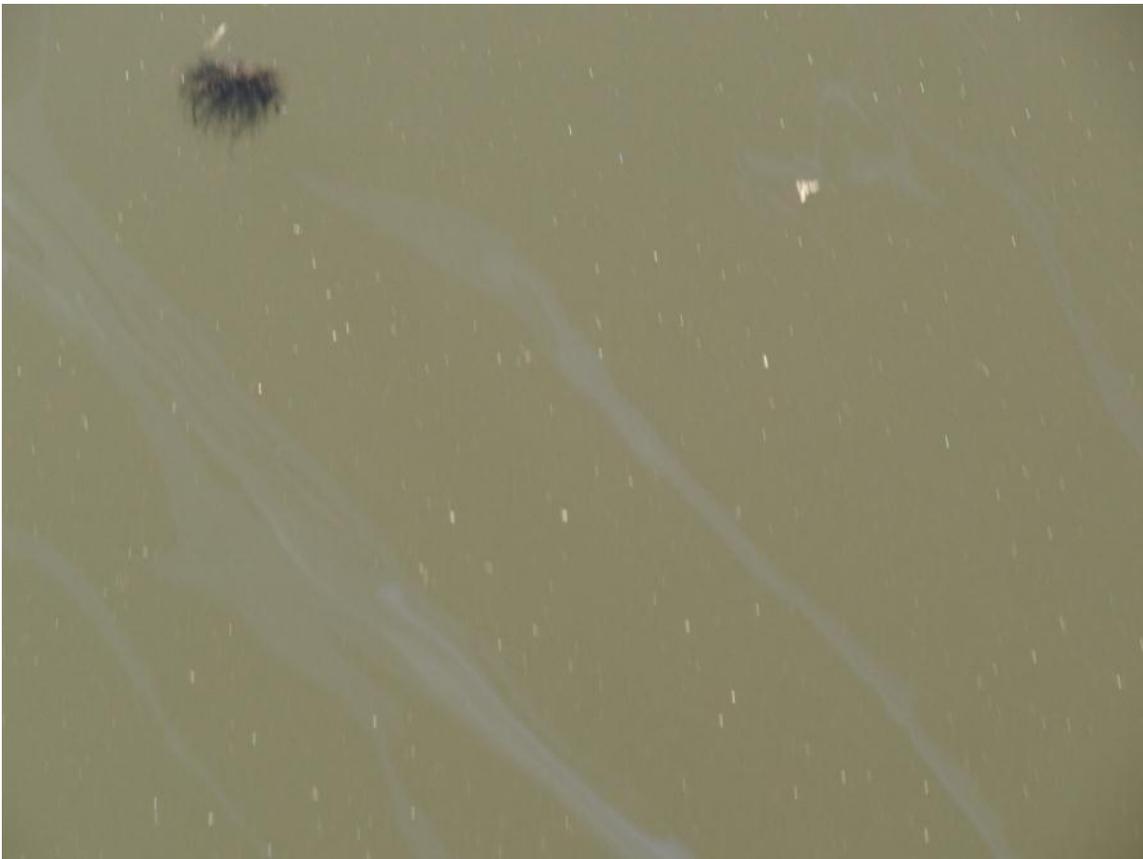
2. MP 5.25 LDB sheen observed.

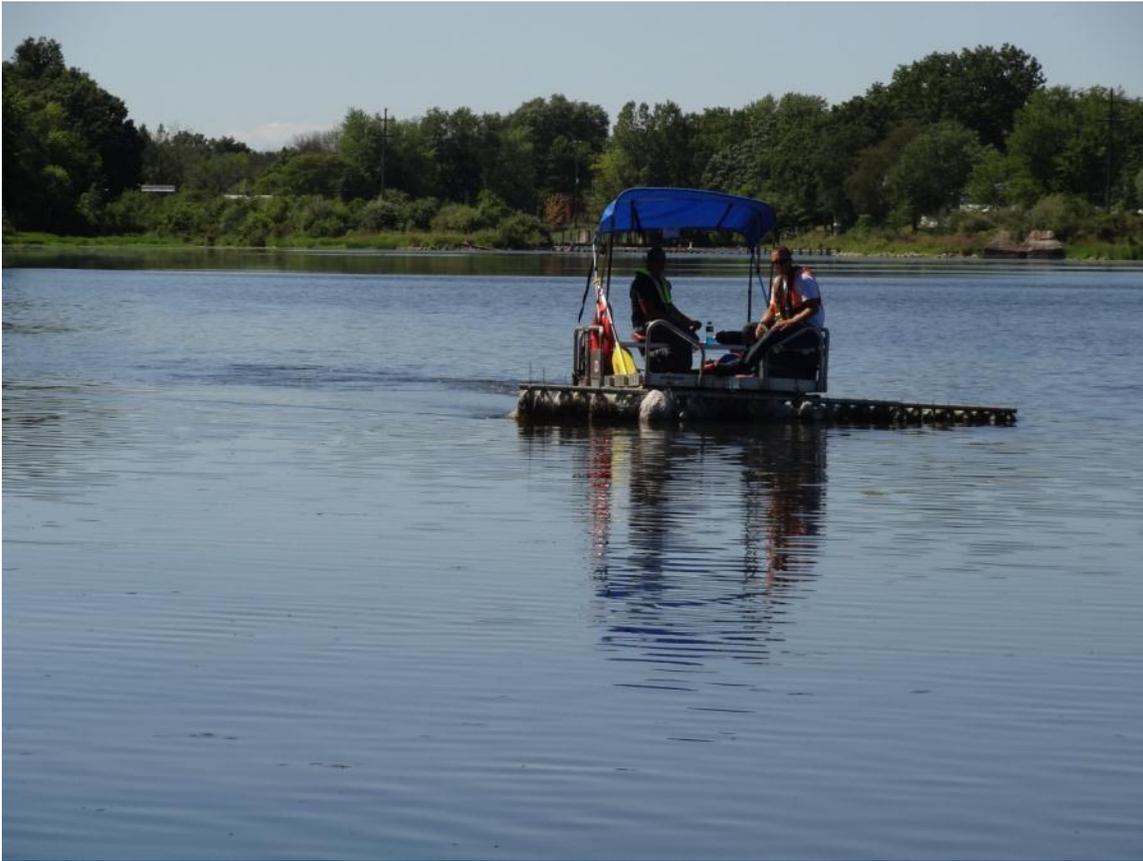
3. MP 5.50 LDB observed the sweep boat operating.

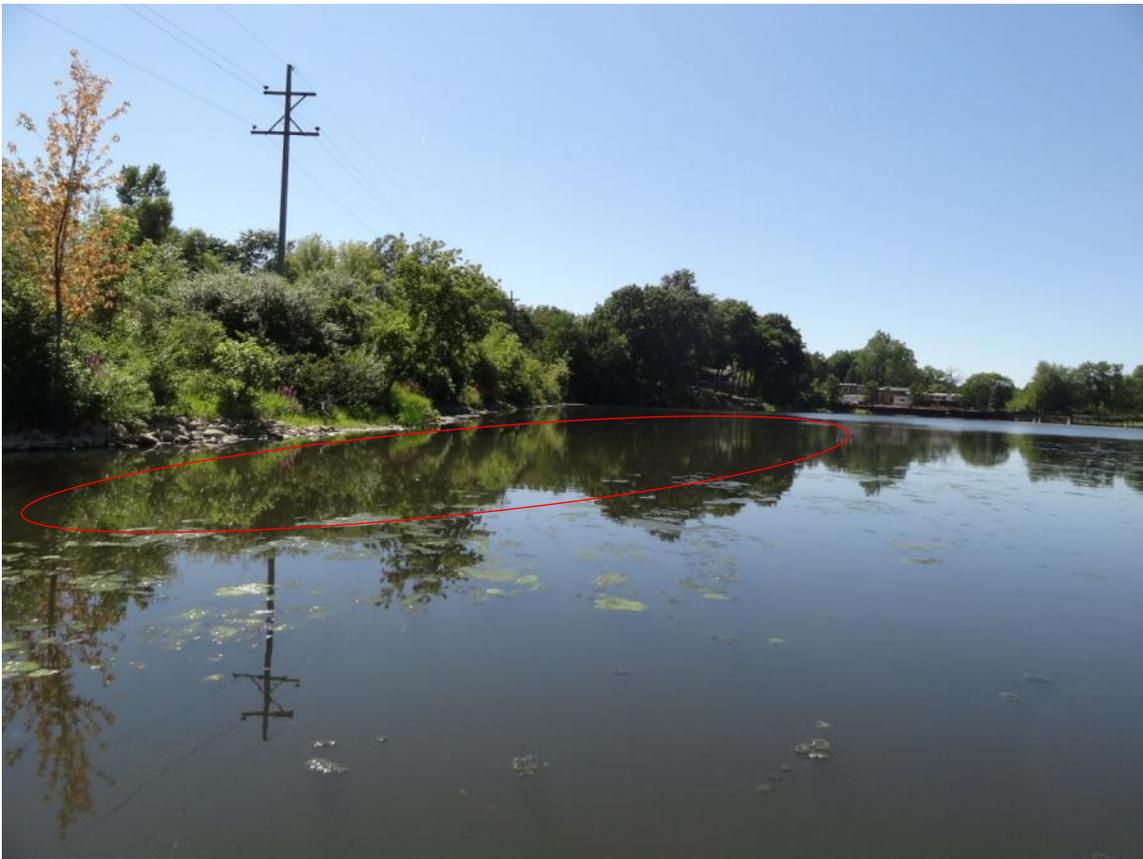
4. MP 5.63 to control point LDB sheen observed, sweep boat operating in area.

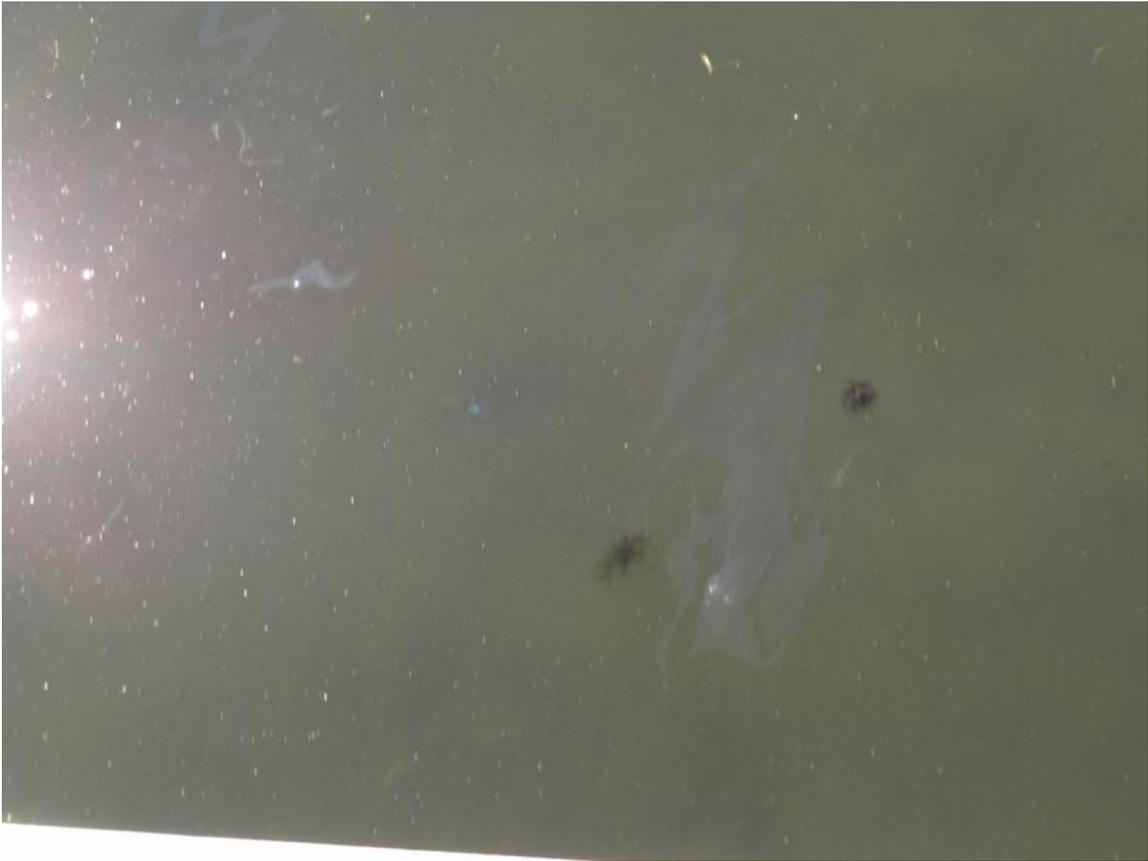
5. MP 5.65 LDB sheen observed.

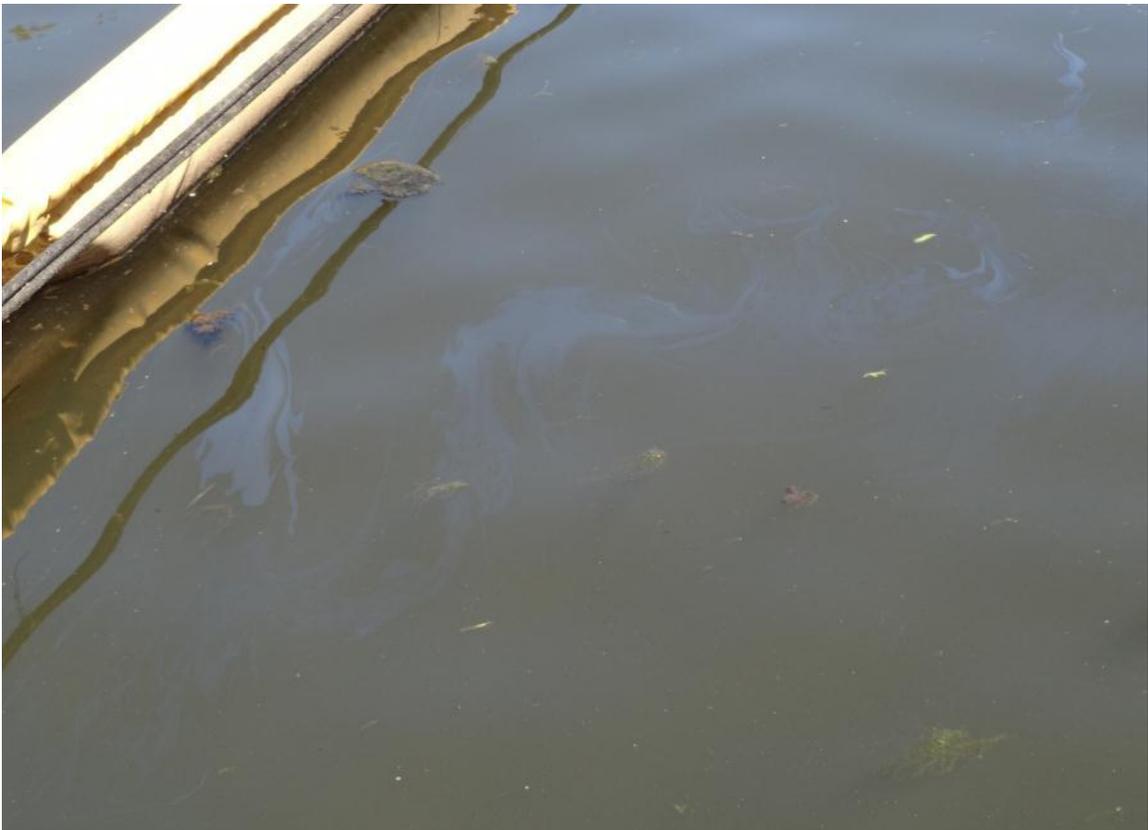
6. Ceresco Dam, sheen collecting along the control point.

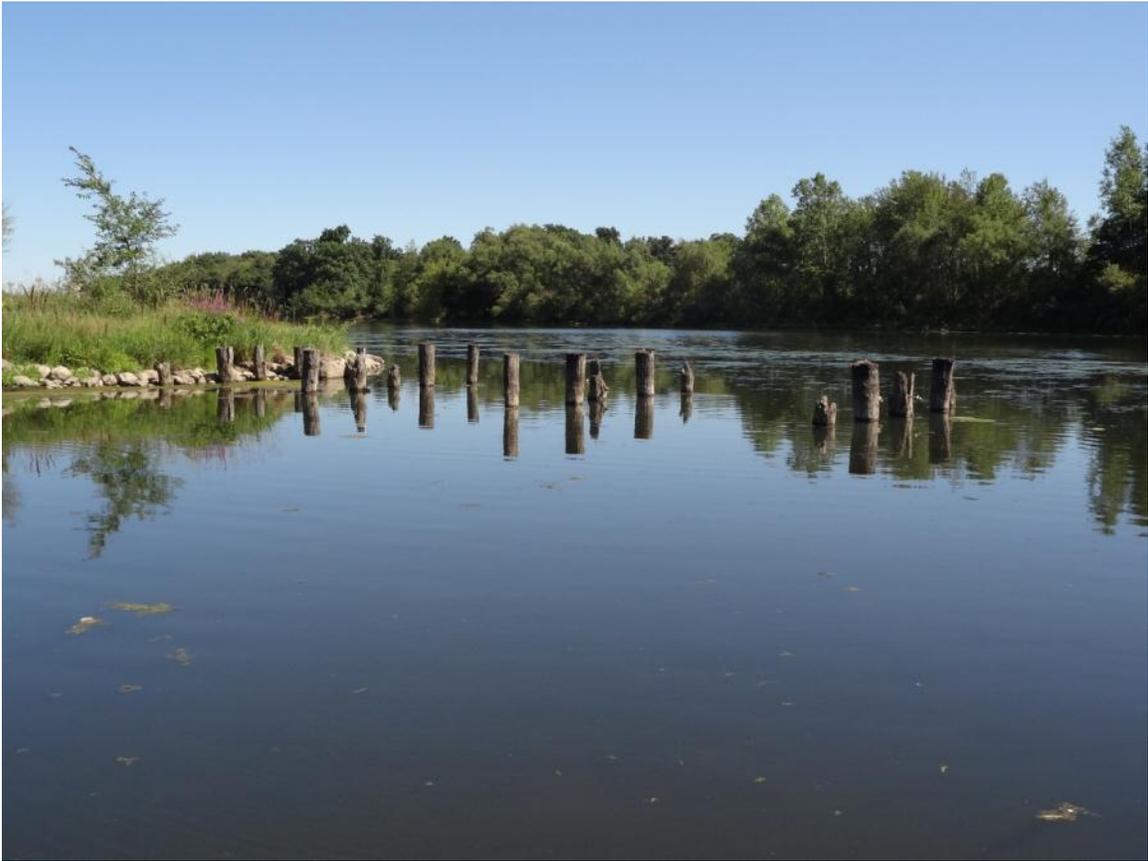
7. MP 5.63 Railroad trestles sheen observed, sweep boat observed operating in area.

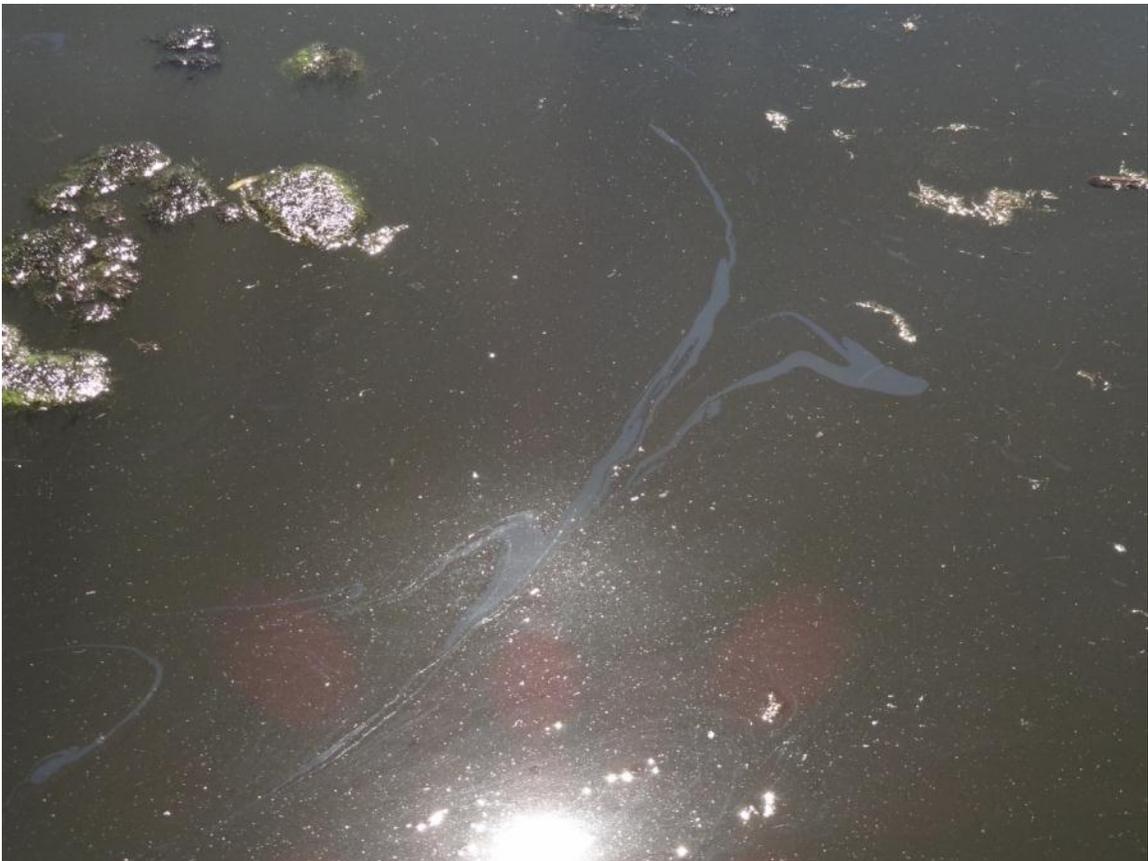
8. MP 5.63 Railroad trestles sheen observed.

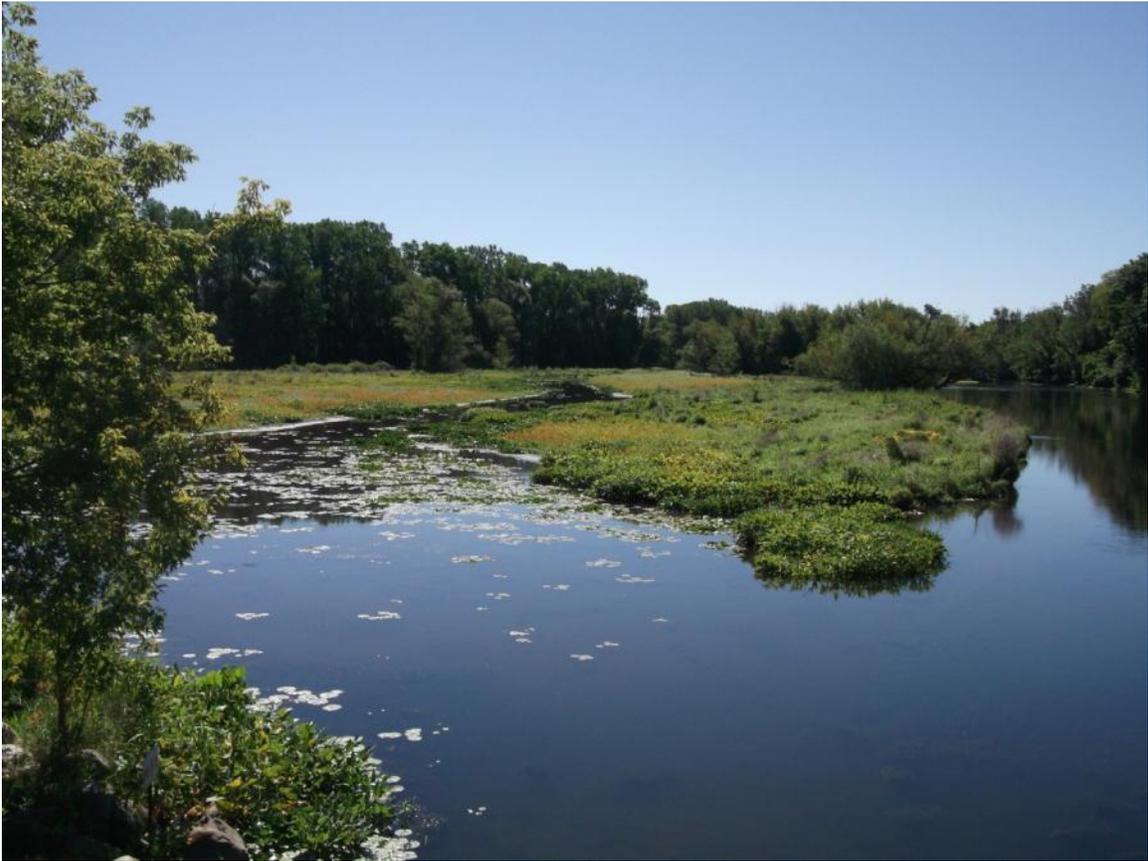
9. MP 15.5 South Mill Pond, sheen observed from Burnham Street Bridge, sweep boat not warranted.

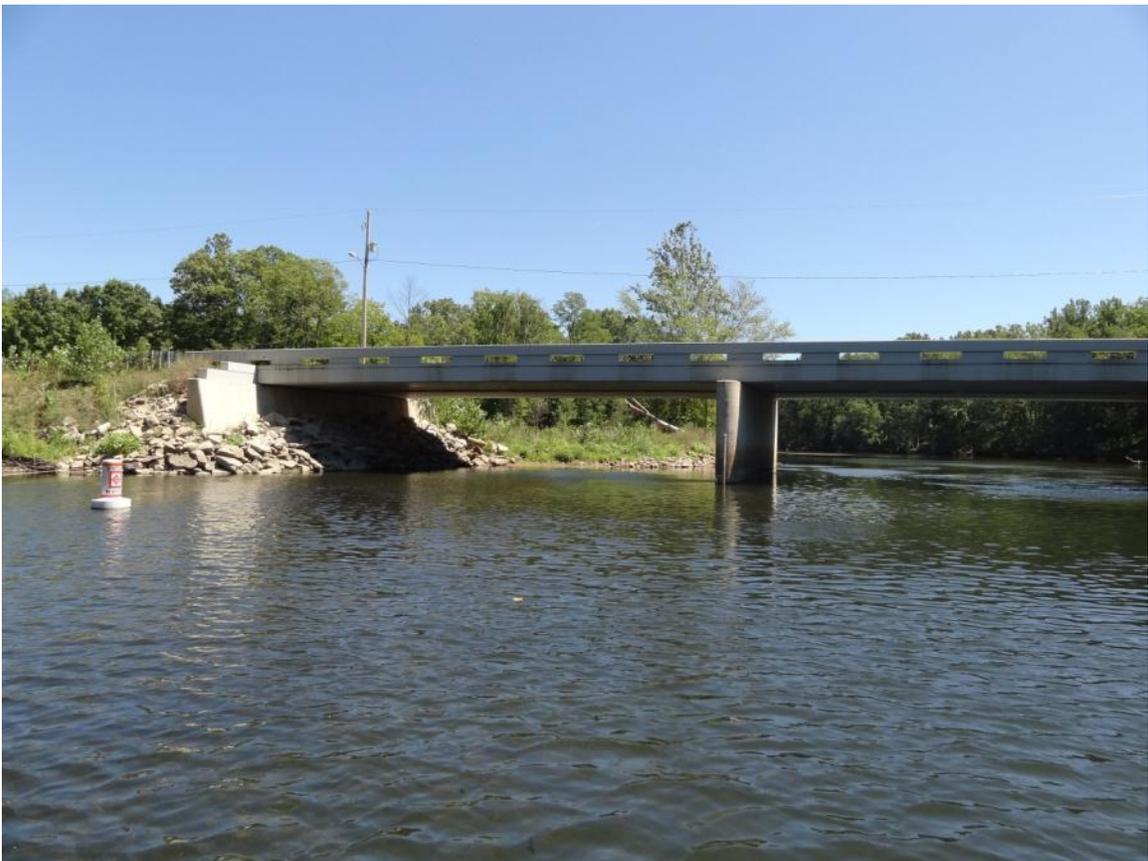
10. MP 21.50 RDB sheen observed from Custer Drive Bridge, sweep boat requested.

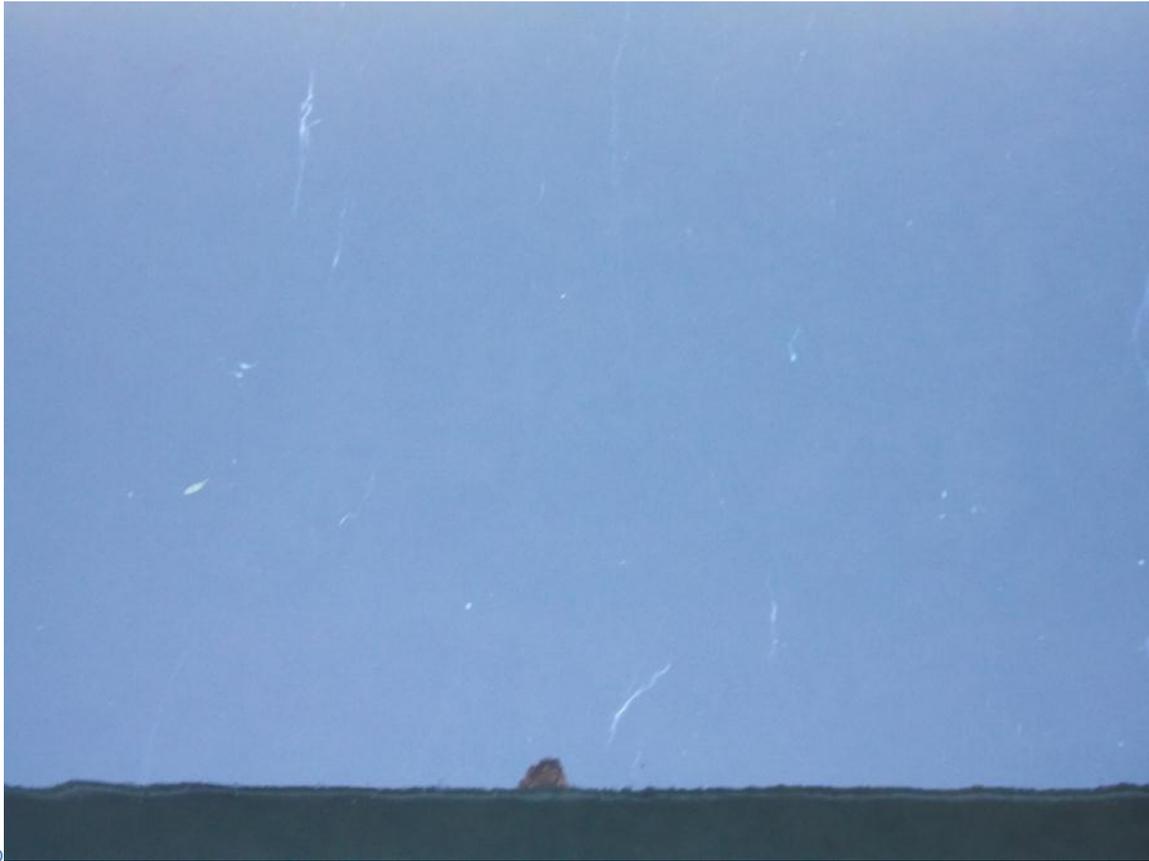
11. MP 21.5 RDB Sheen observed from Custer Drive Bridge.

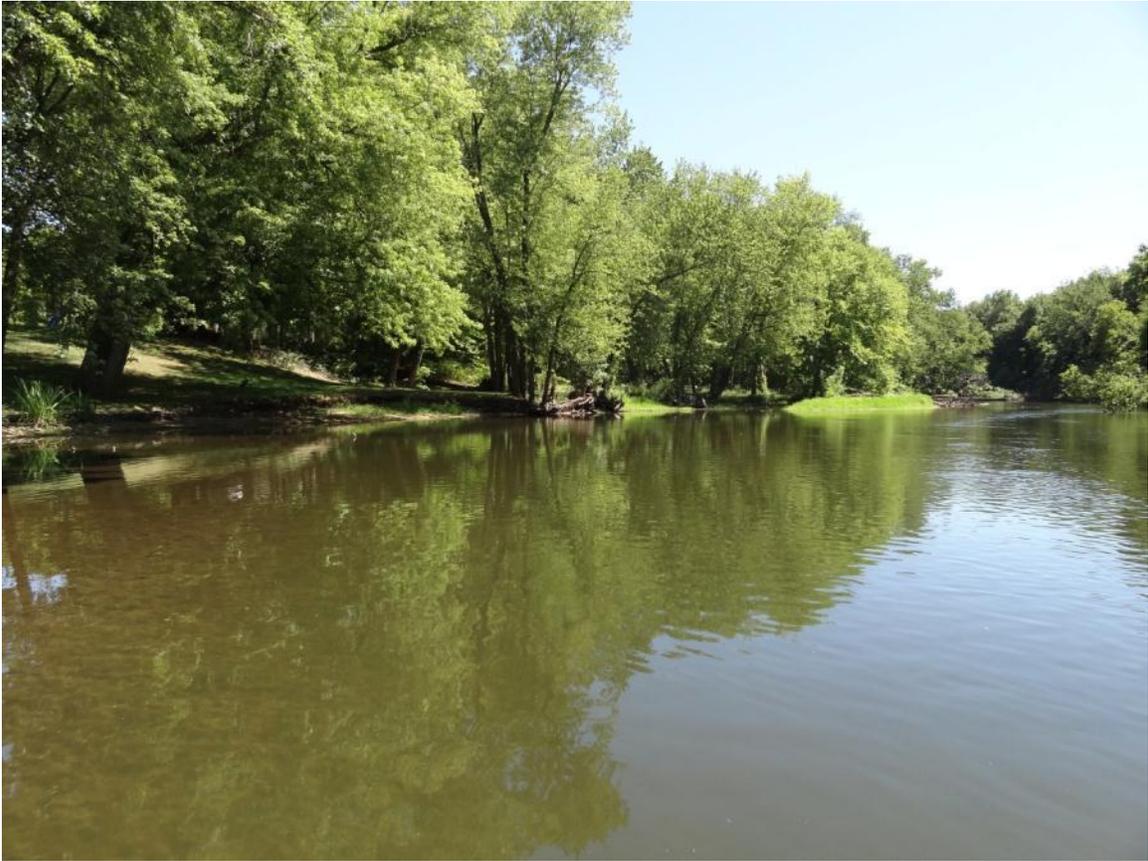
12. MP 23.10 RDB no sheen observed.

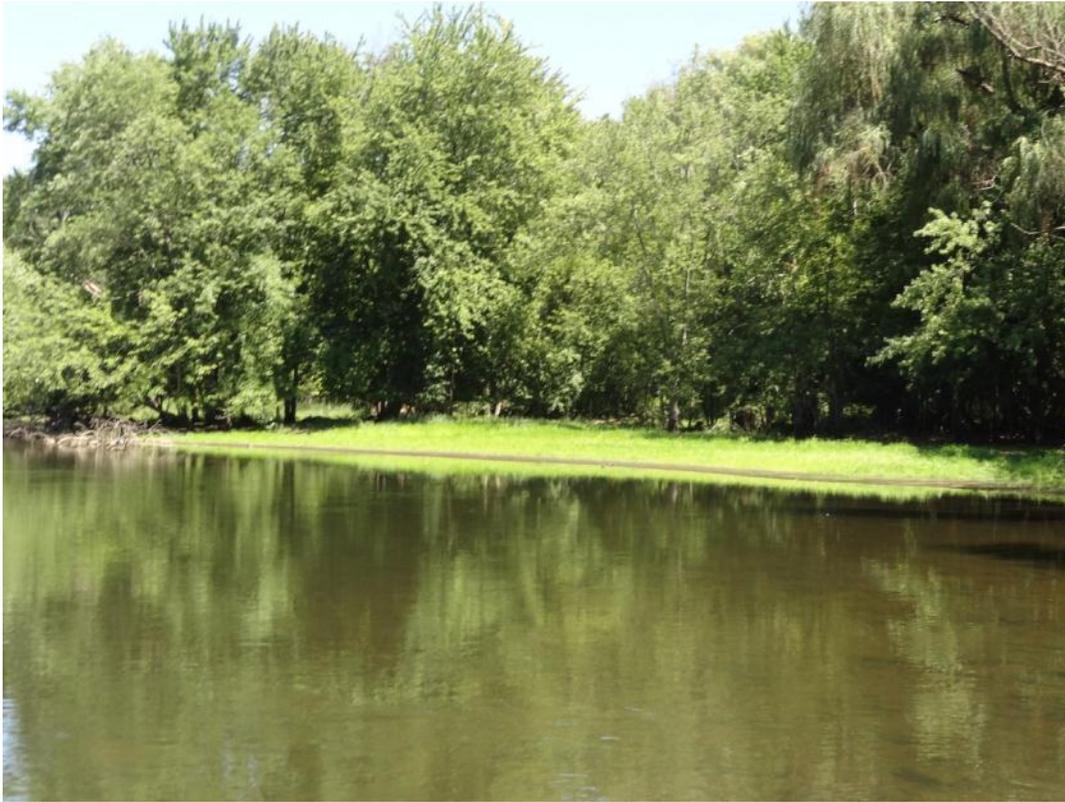
**13. MP 24.75 LDB no sheen observed.**

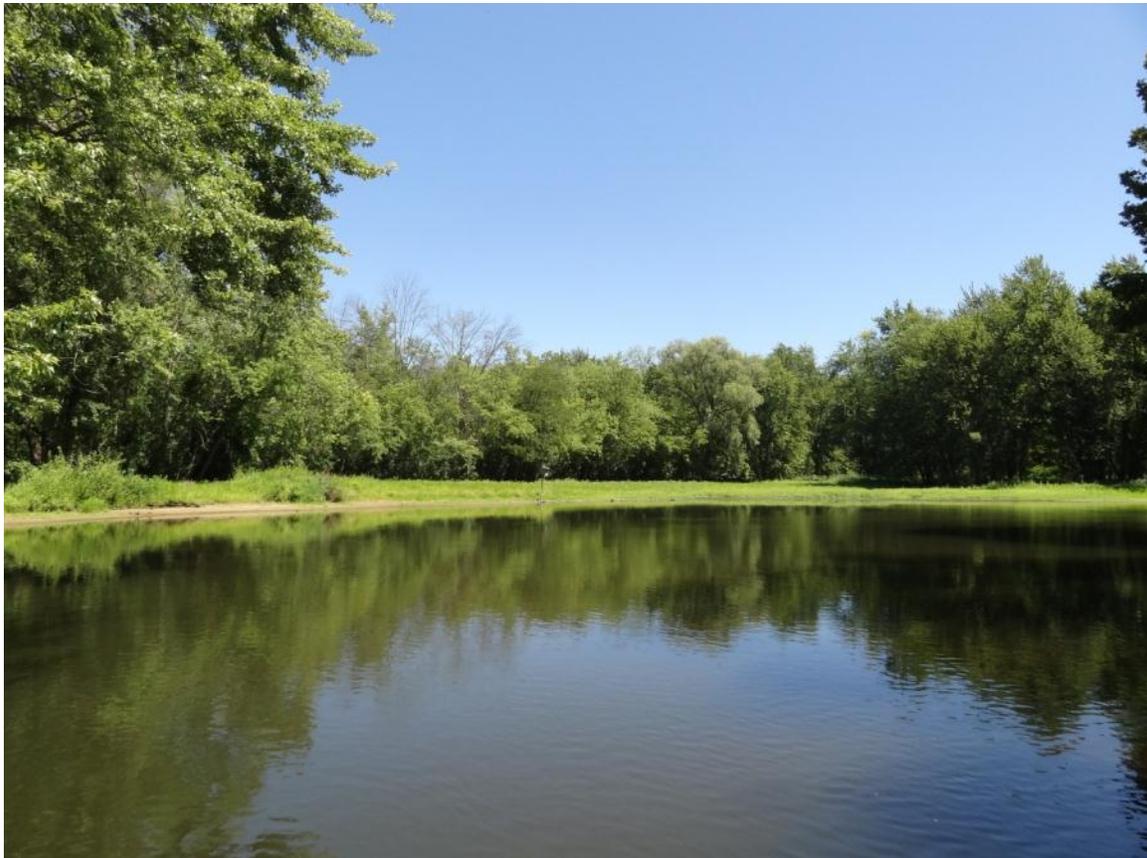
**14. MP 26.00 RDB no sheen observed.**

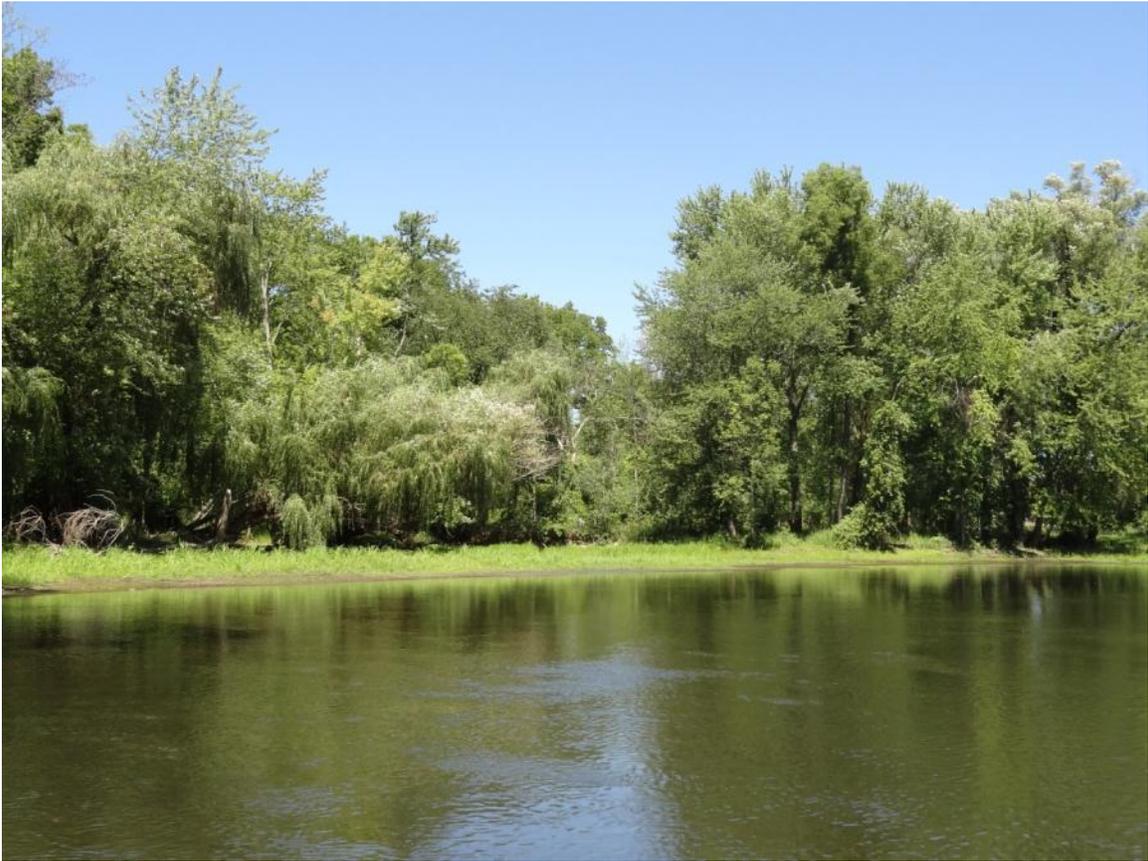
15. MP 26.25 RDB no sheen observed.

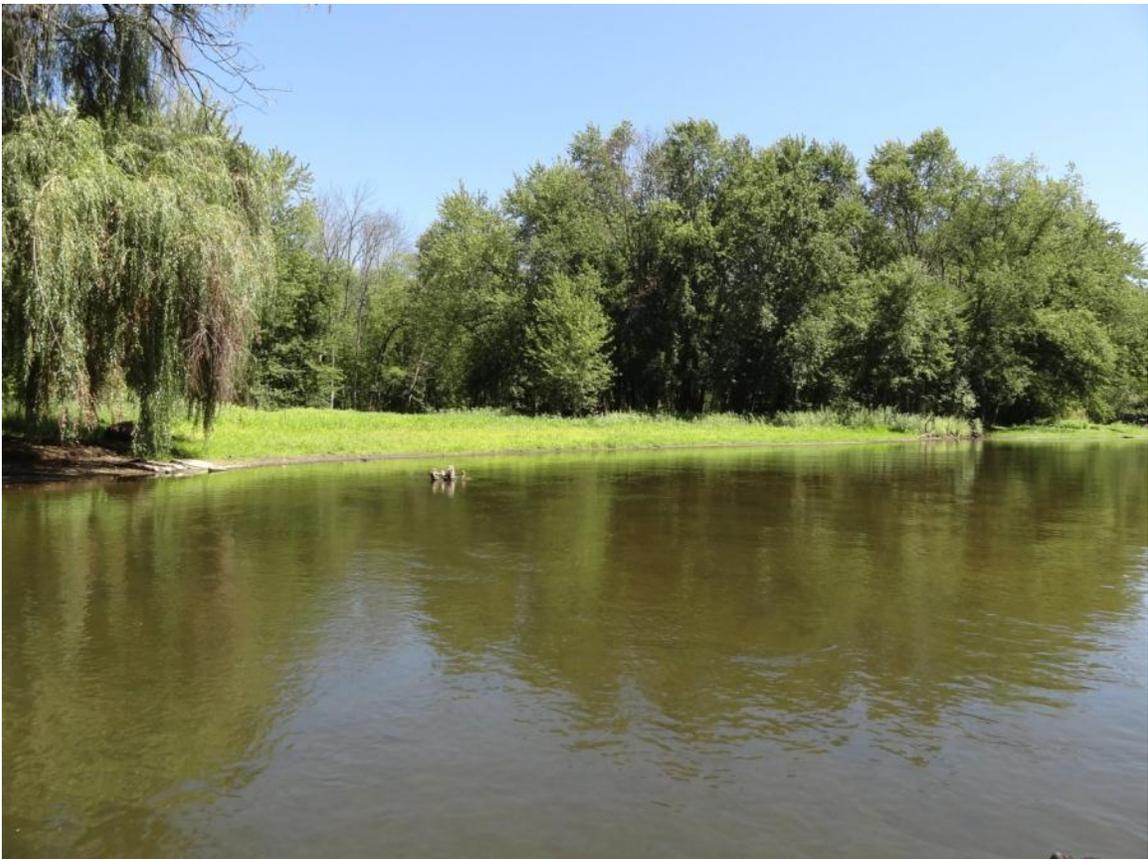
16. MP 26.75 RDB no sheen observed.

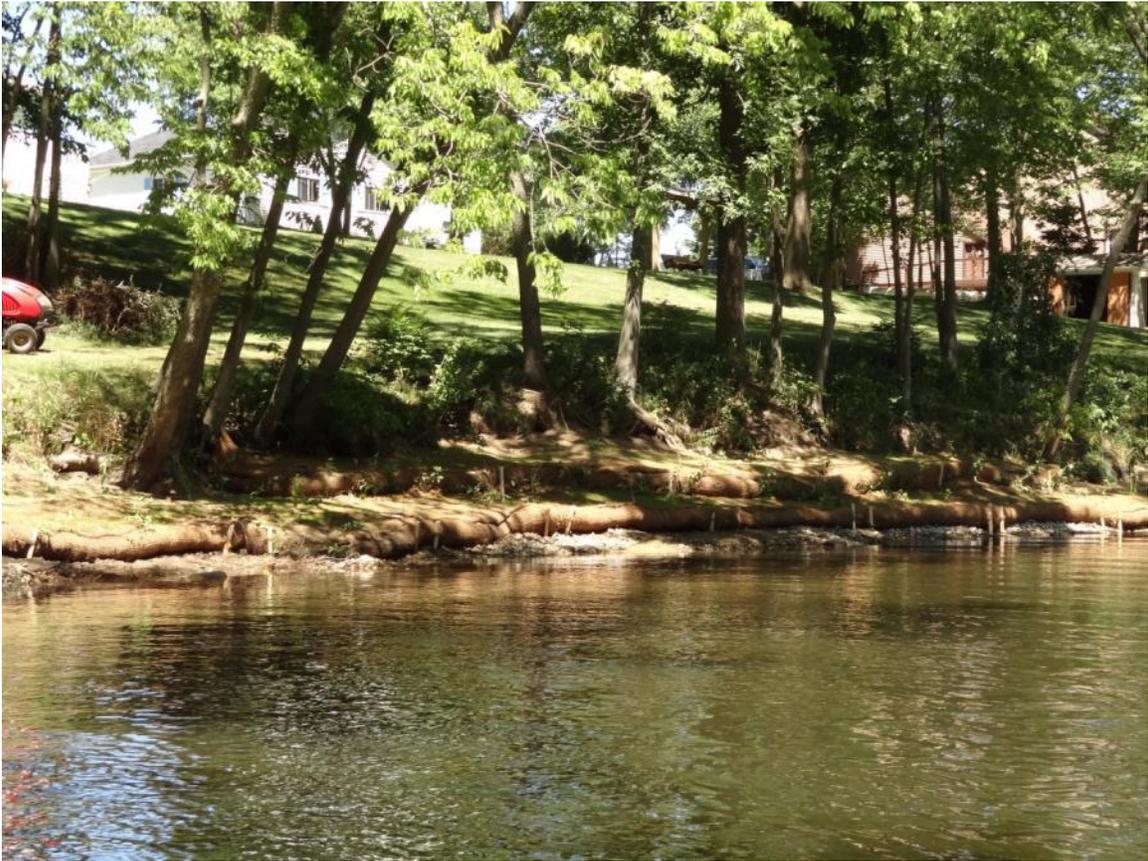
17. MP 27.00 RDB river bank erosion restoration work completed.

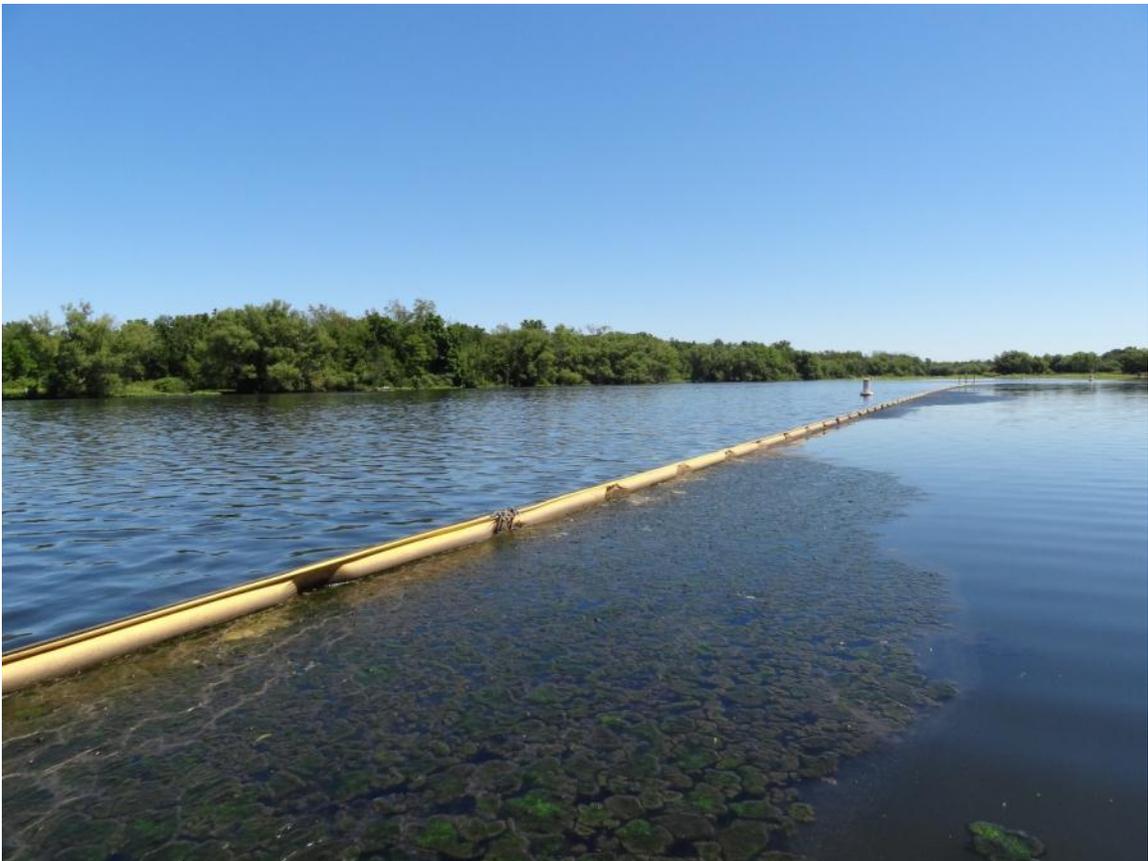
18. Morrow Lake Delta Gate C, organic matter collecting along boom.

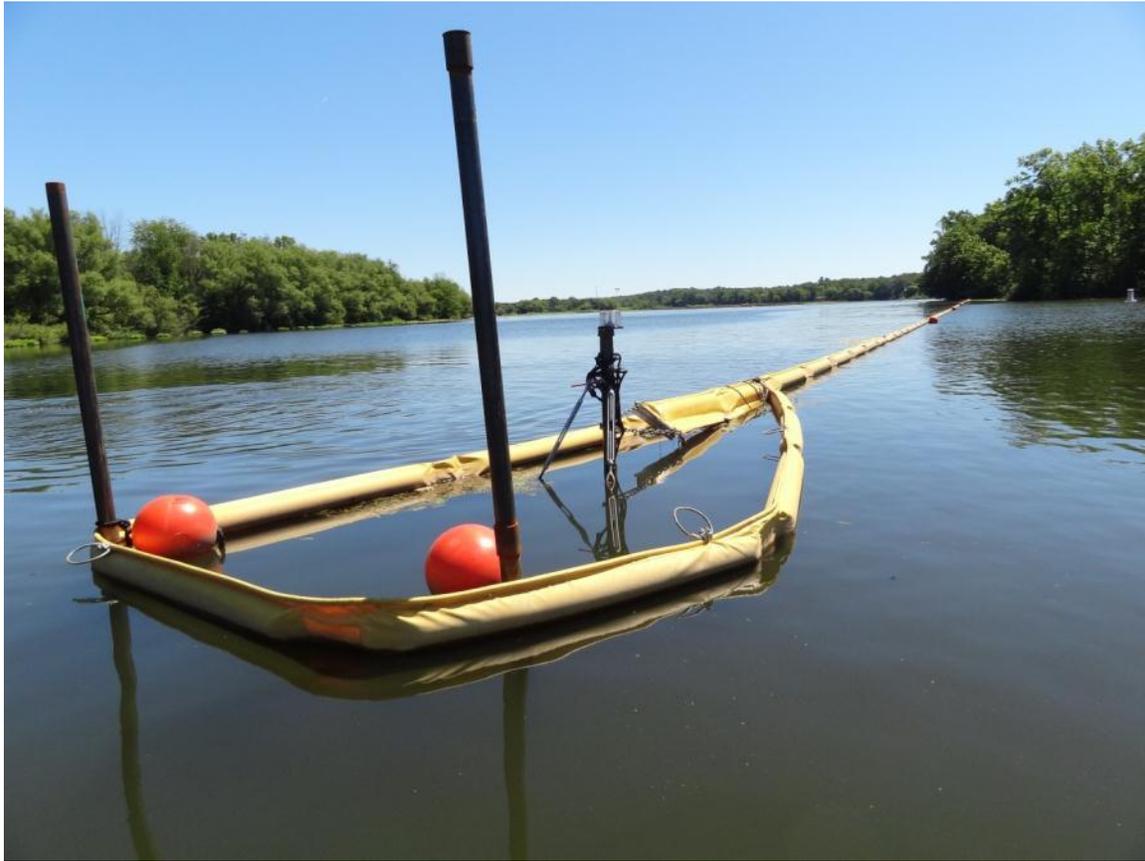
19. Morrow Lake Delta Gate E, sheen observed collecting along boom.

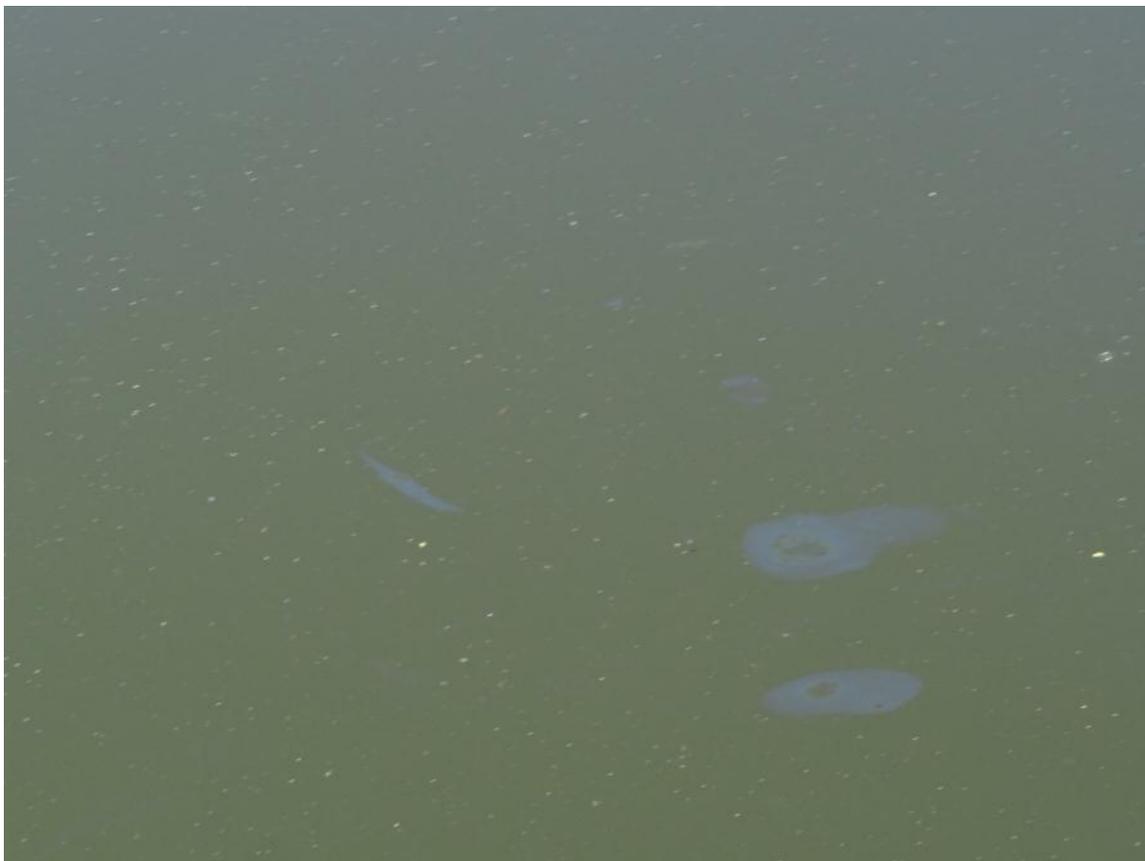
20. Morrow Lake Delta Gate E, sheen and tar globules observed along boom.

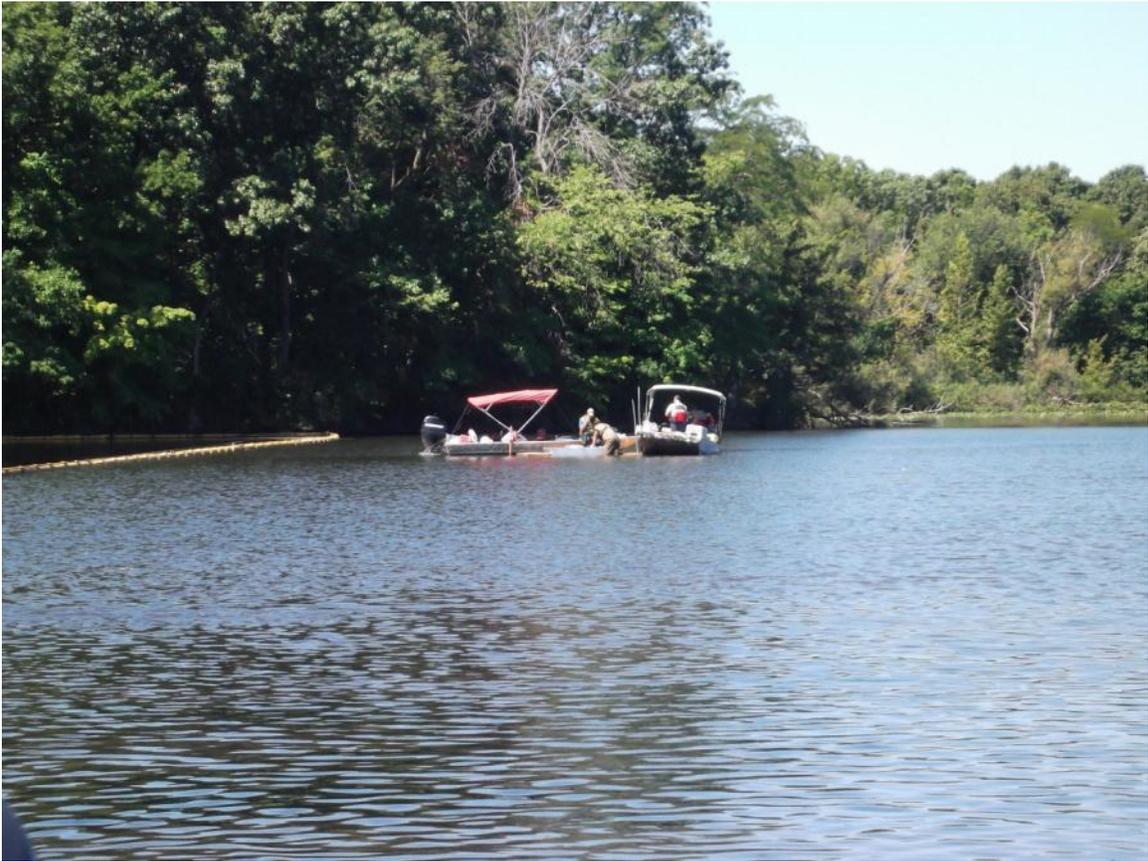
21. Morrow Lake Delta Z, agitation study being conducted.

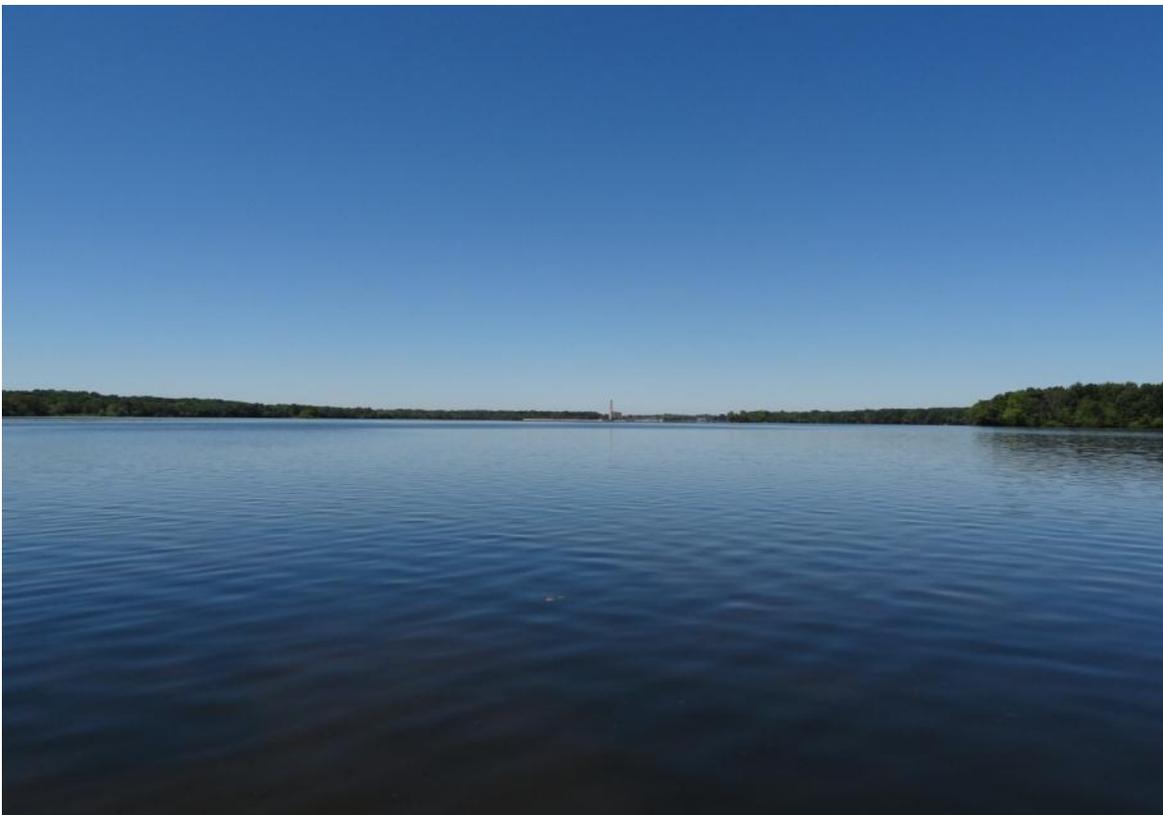
22. Morrow Lake no sheen observed.
