# Situation Photo Log

Monday, August 13, 2012

Kalamazoo River / Enbridge Spill

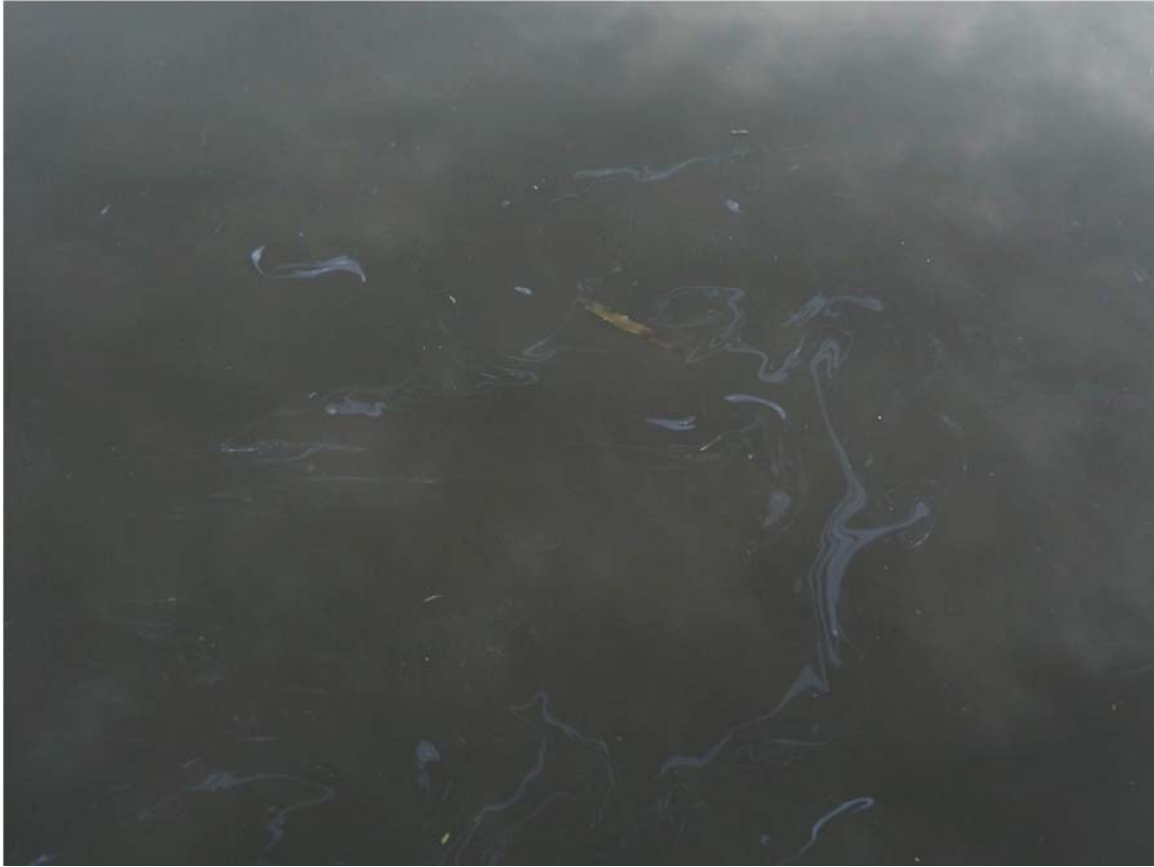
1. MP5.25 – MP5.63 LDB sheen observed.

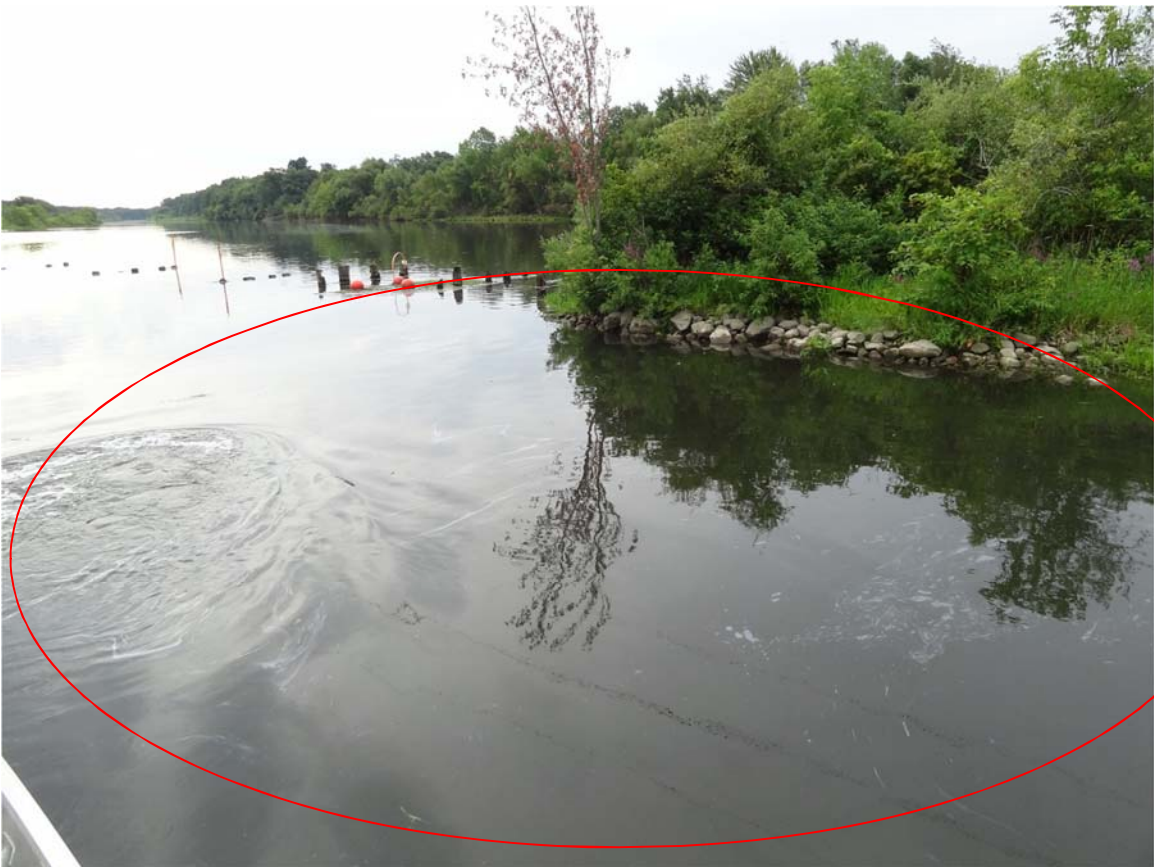
2. MP5.63 LDB area where sheen and tar globules were observed.

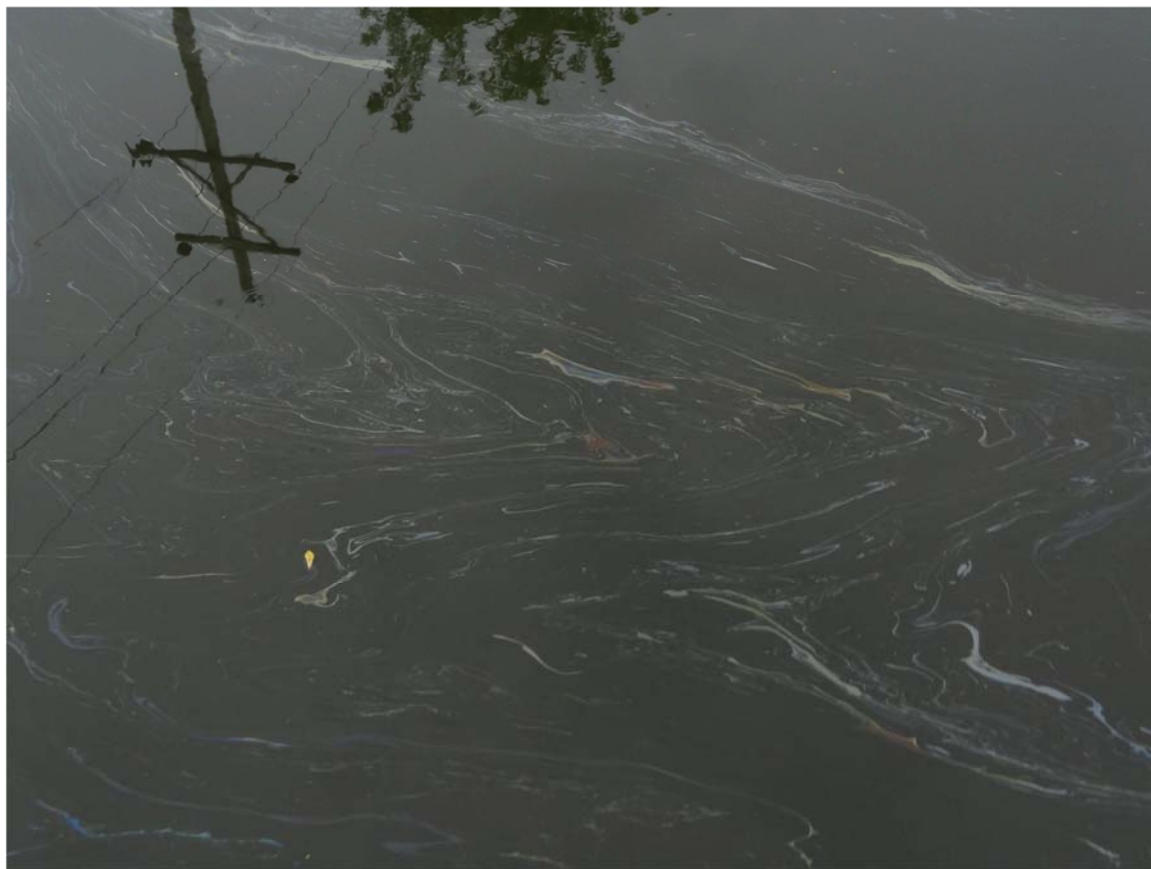
**3. MP5.63 LDB sheen and tar globules observed.**

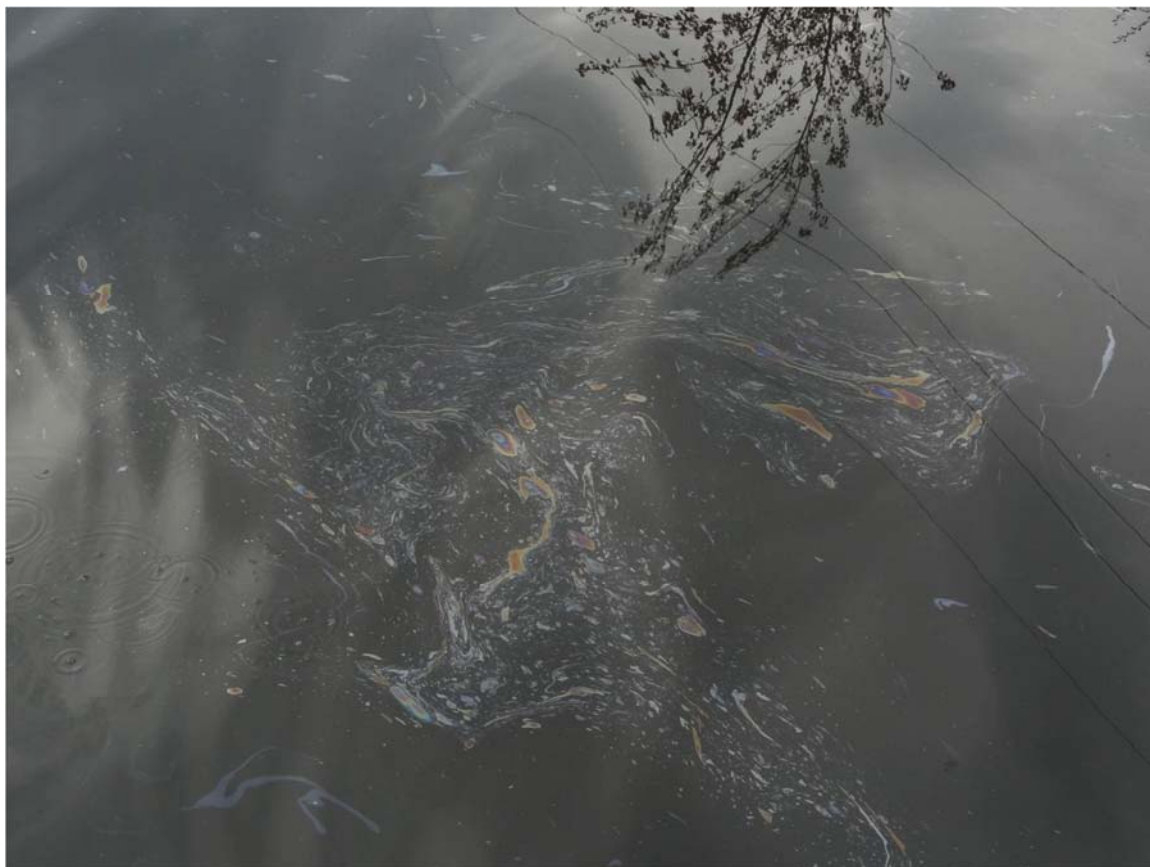
**4. MP5.63 LDB sheen and tar globules observed.**

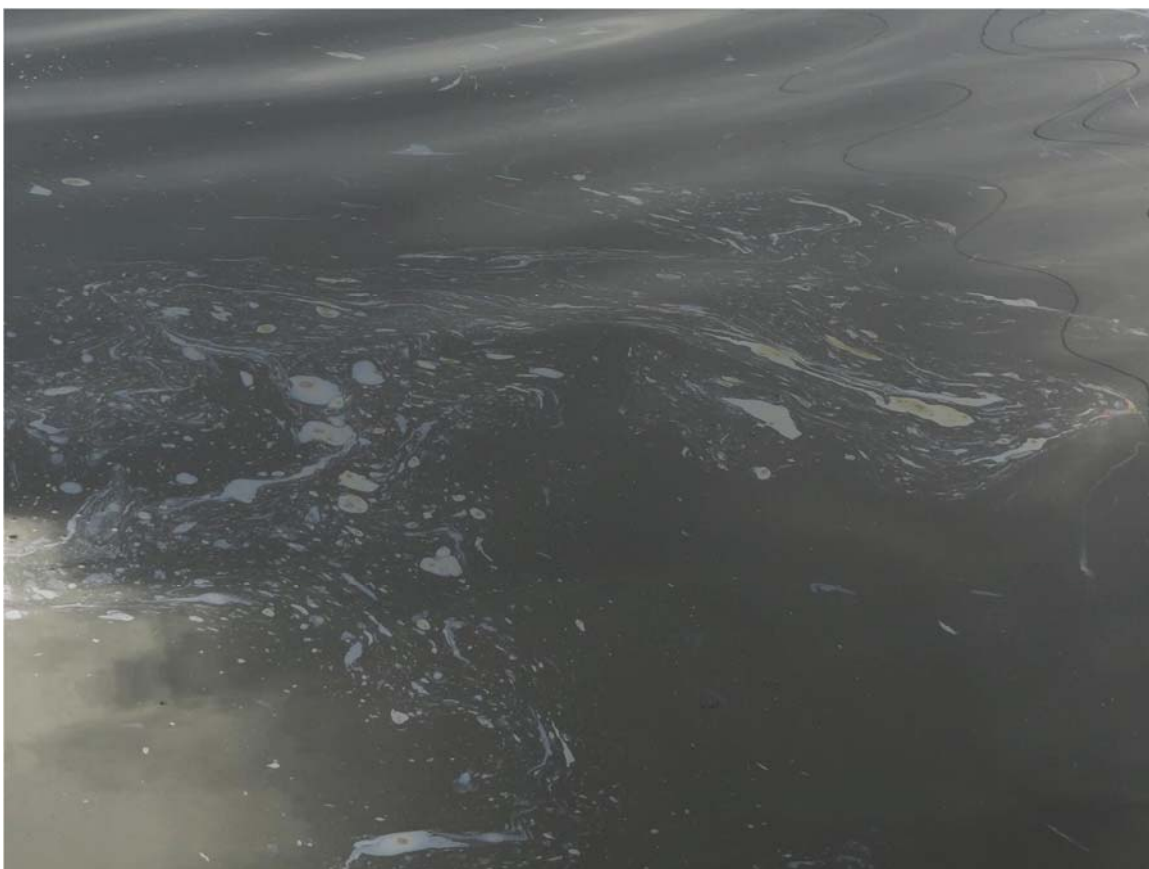
5. MP5.63 LDB sheen and tar globules observed.

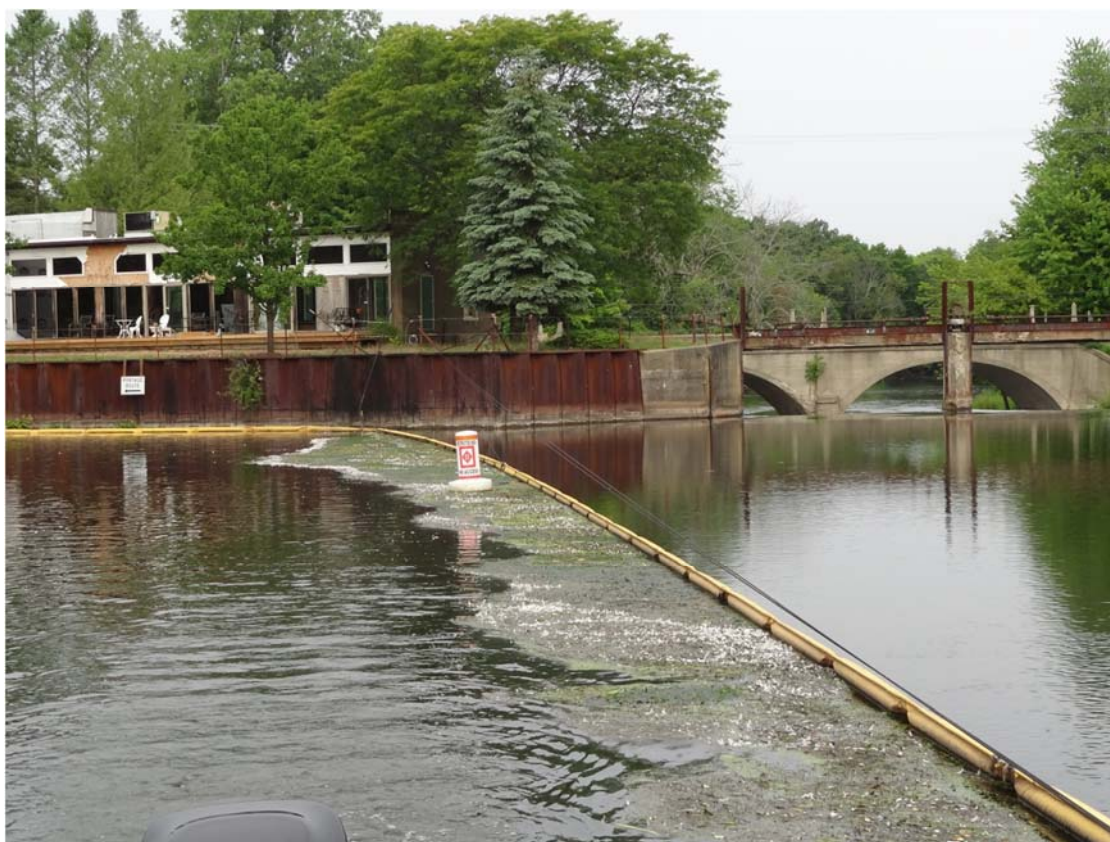
6. Ceresco Dam control point boom, observed sheen and debris collecting along the boom.

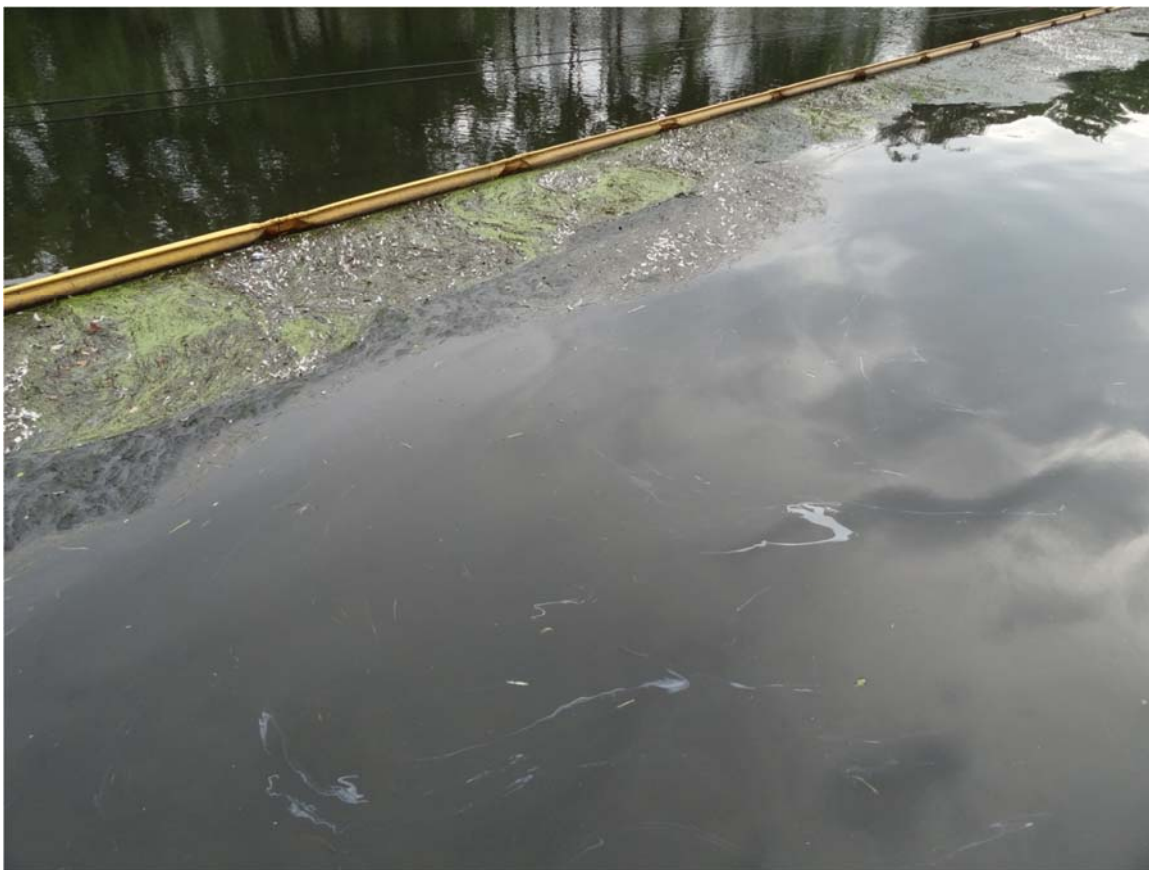
7. Ceresco Dam control point boom, observed sheen and debris collecting along the boom.

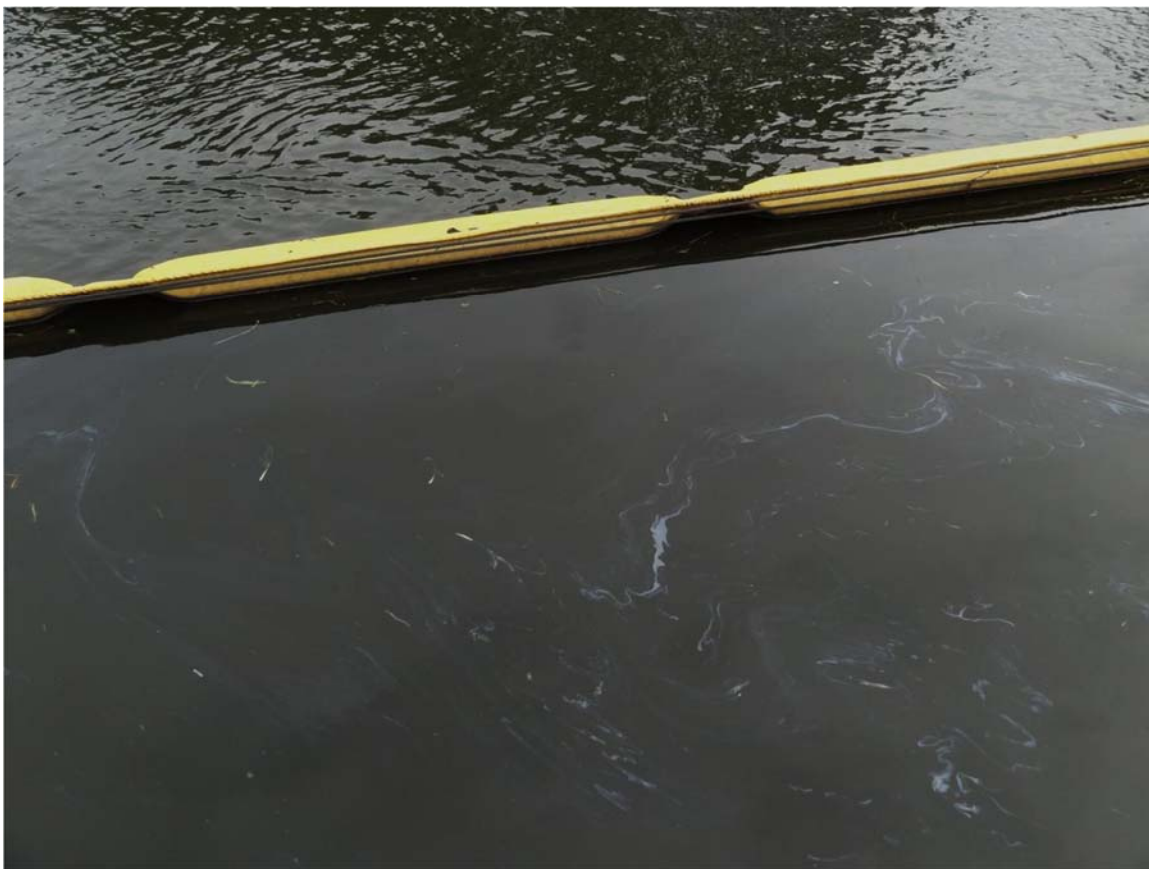
8. Ceresco Dam sheen observed along control point.

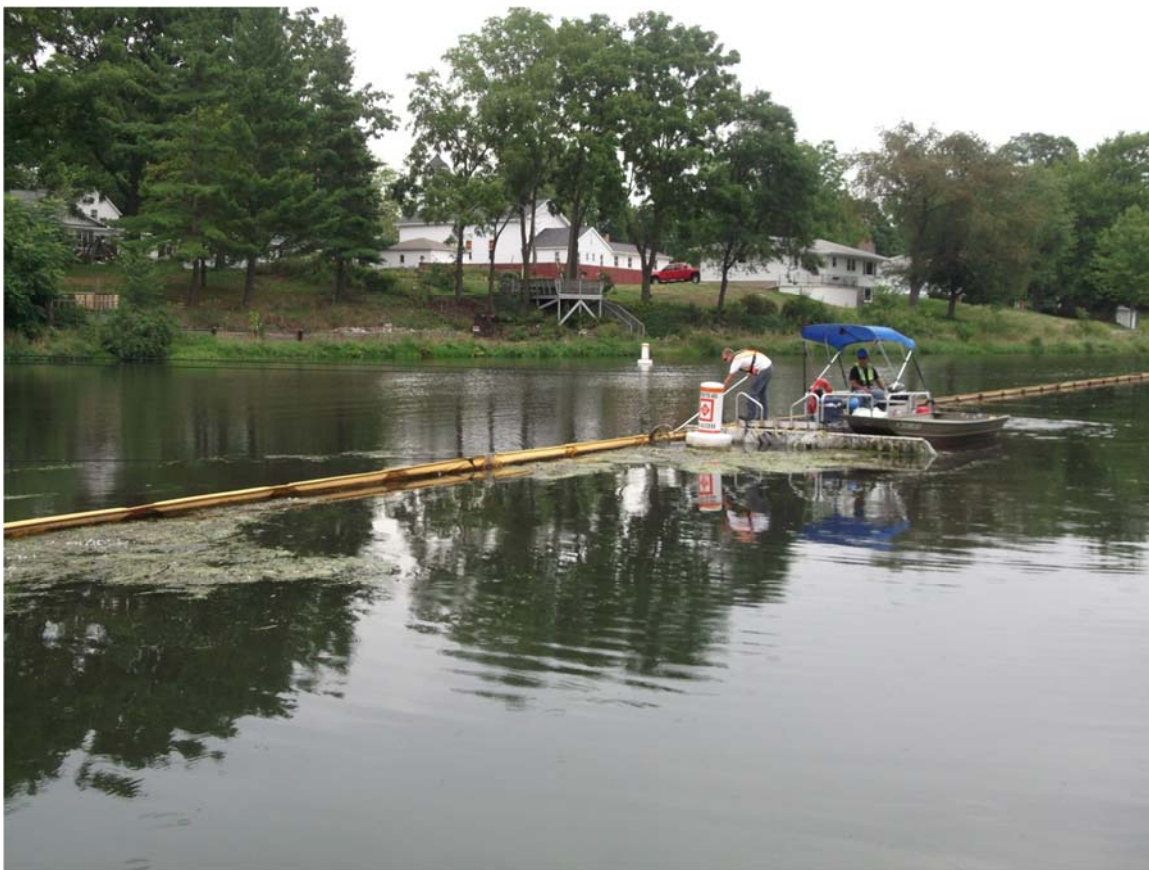
9. MPC0.4 observed the sheen sweep boat removing debris from Ceresco Dam control point boom.

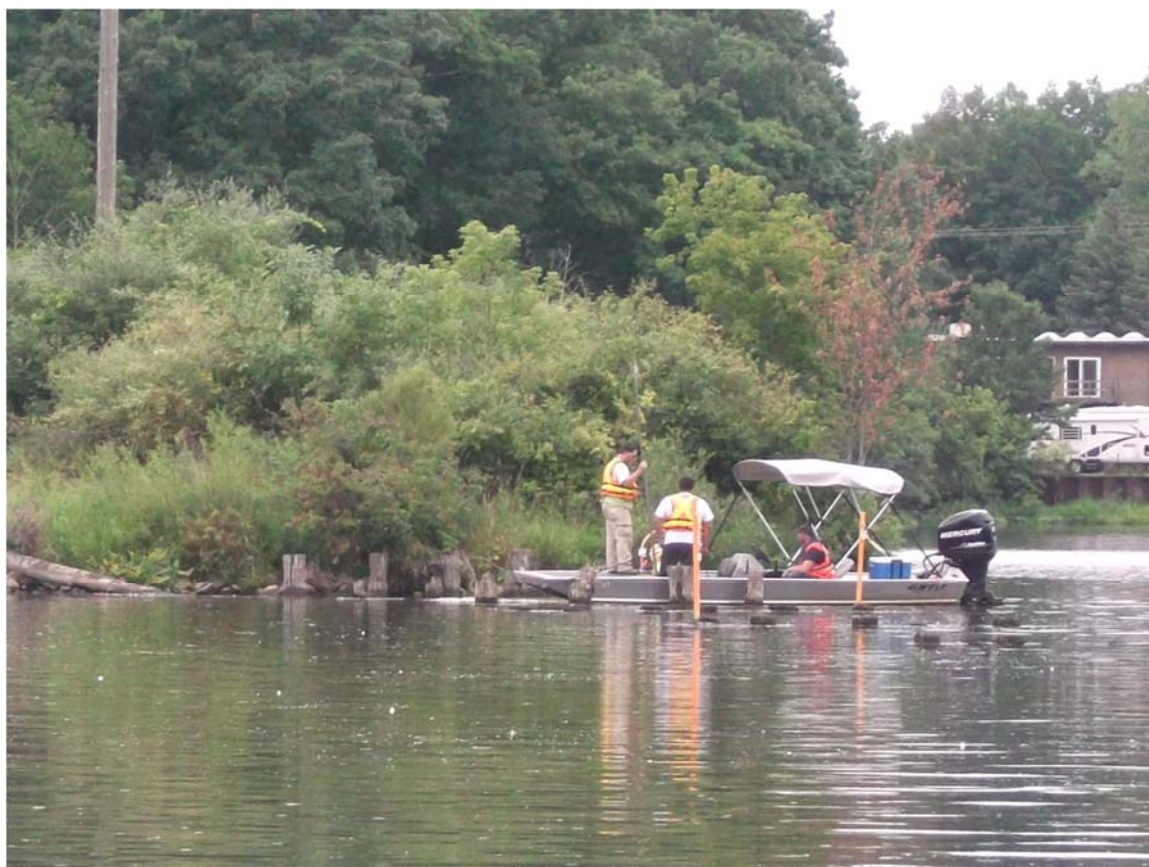
10. MP5.63 Observed crew performing Walling Tube sampling.

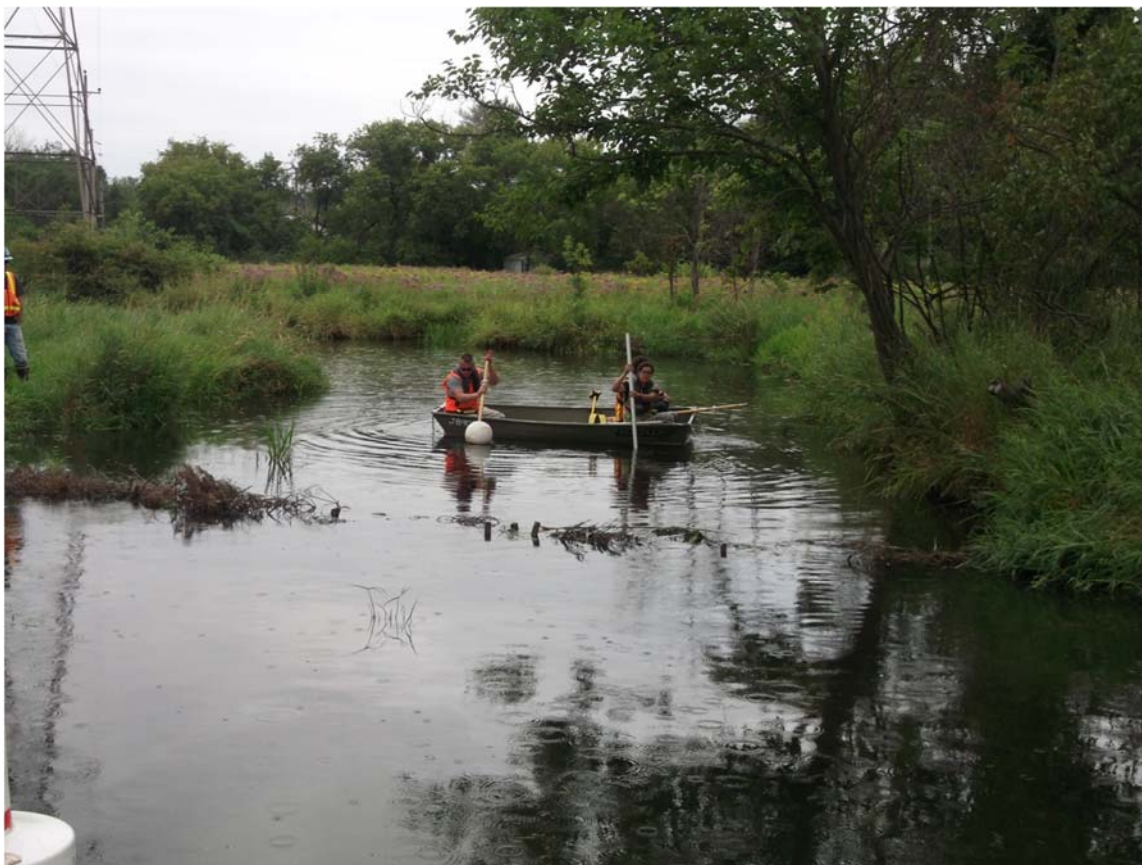
**11. MP10.75 Area where heavy rainbow sheen was observed emanating from the bank.**

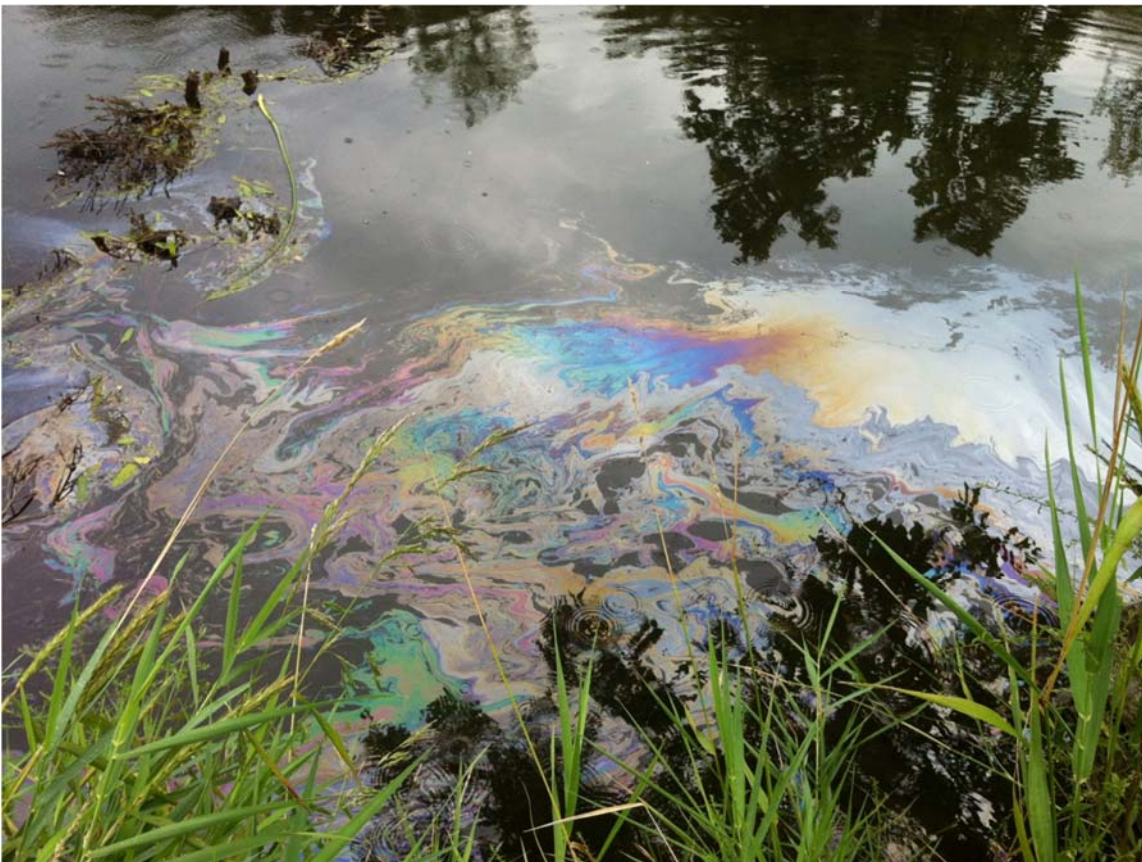
**12. MP10.75 Area where heavy rainbow sheen was observed.**

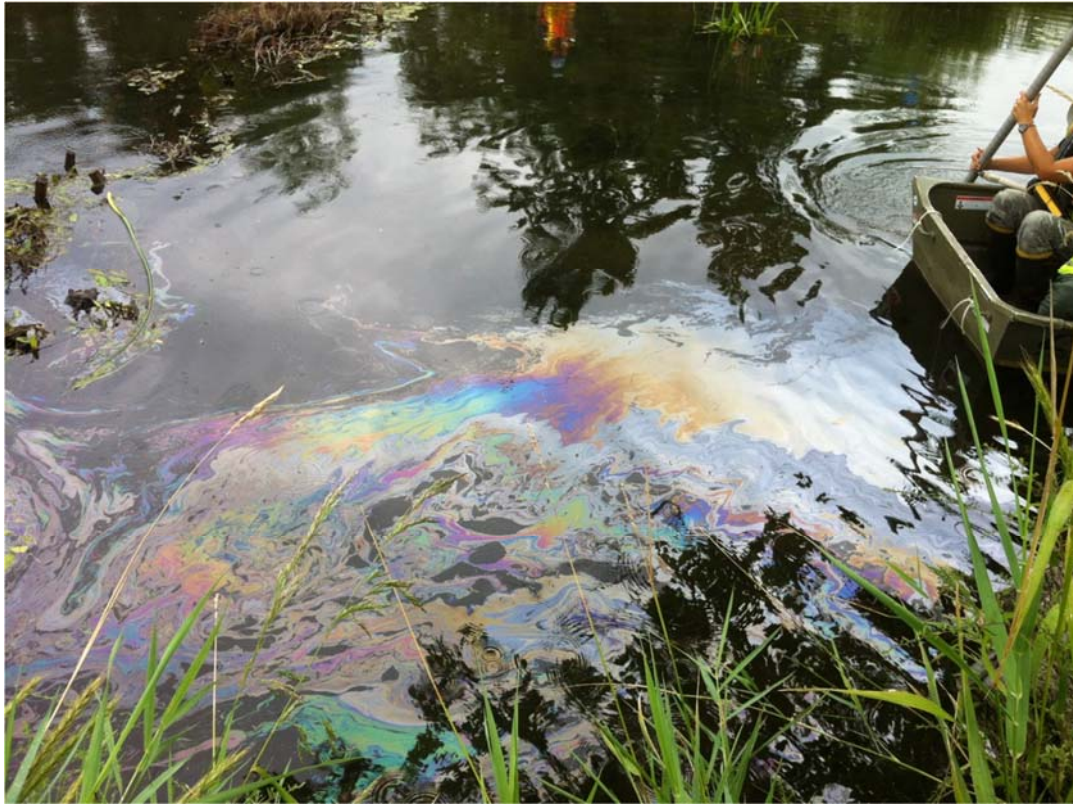
**13. MP10.75 Area where heavy rainbow sheen was observed.**

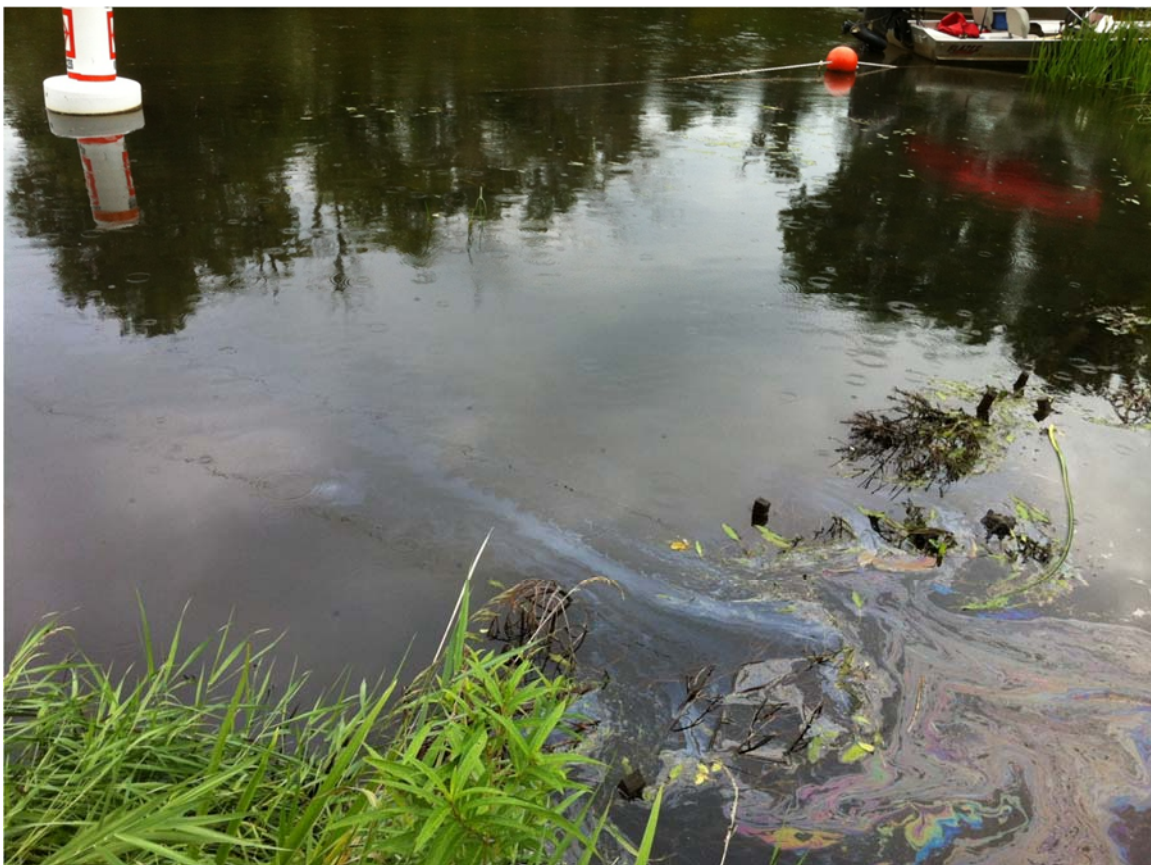
**14. MP10.75 Area where heavy rainbow sheen was observed flowing over the sediment trap into the river.**

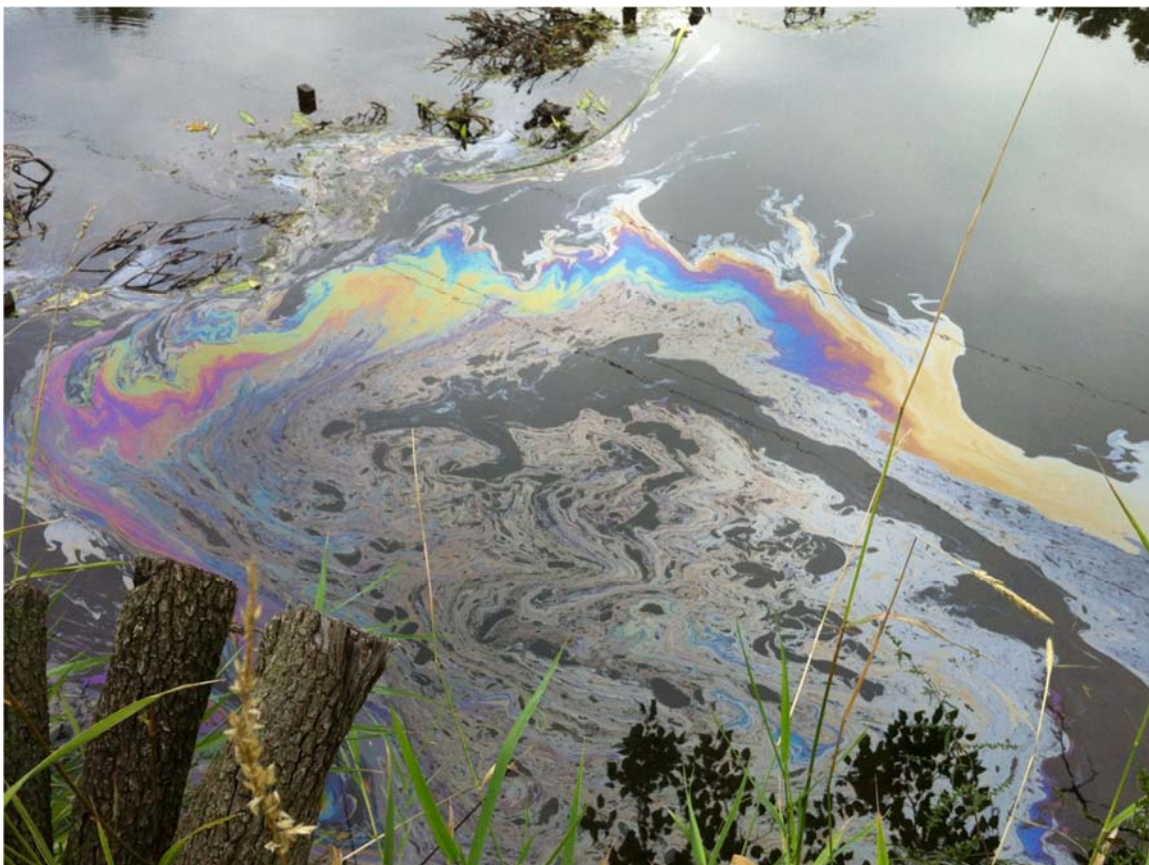
**15. MP10.75 Area where heavy rainbow sheen was observed flowing over the sediment trap into the river.**

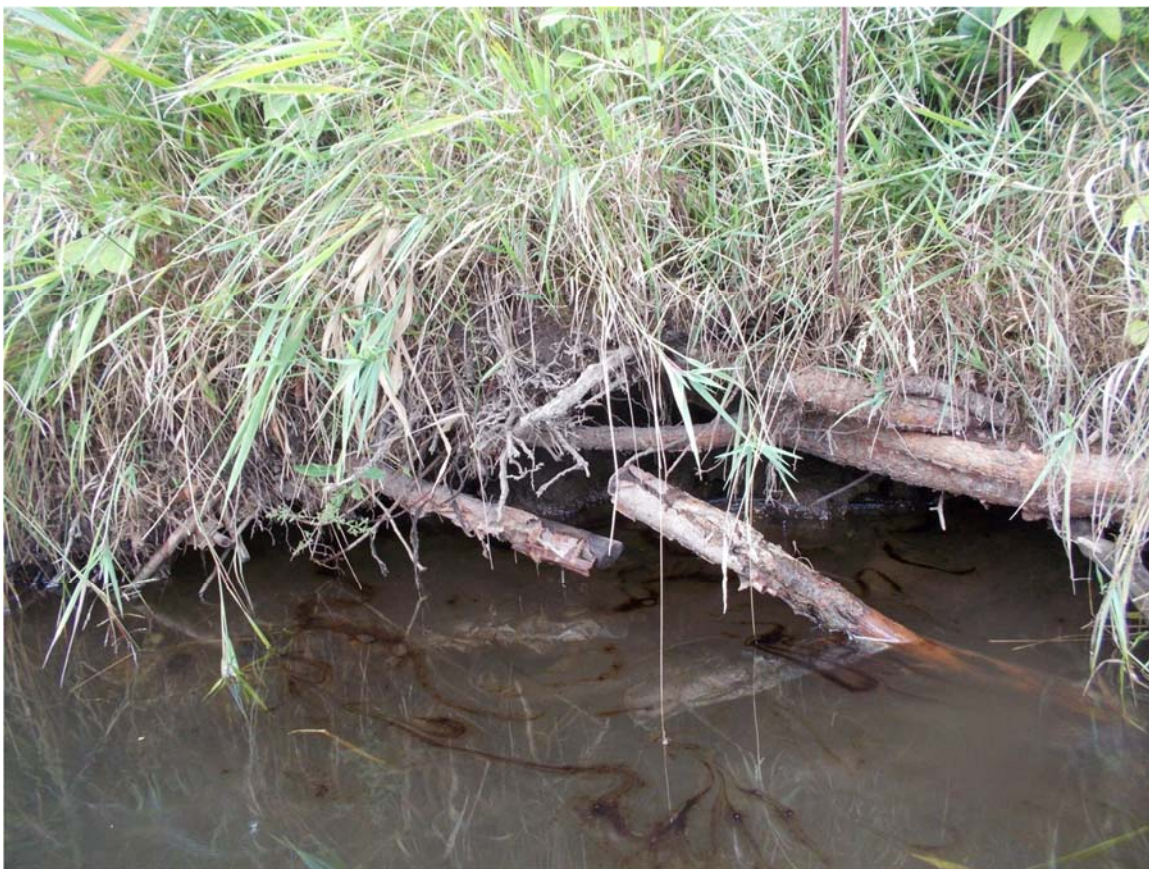
**16. MP10.75 observed product flowing out of river bank.**

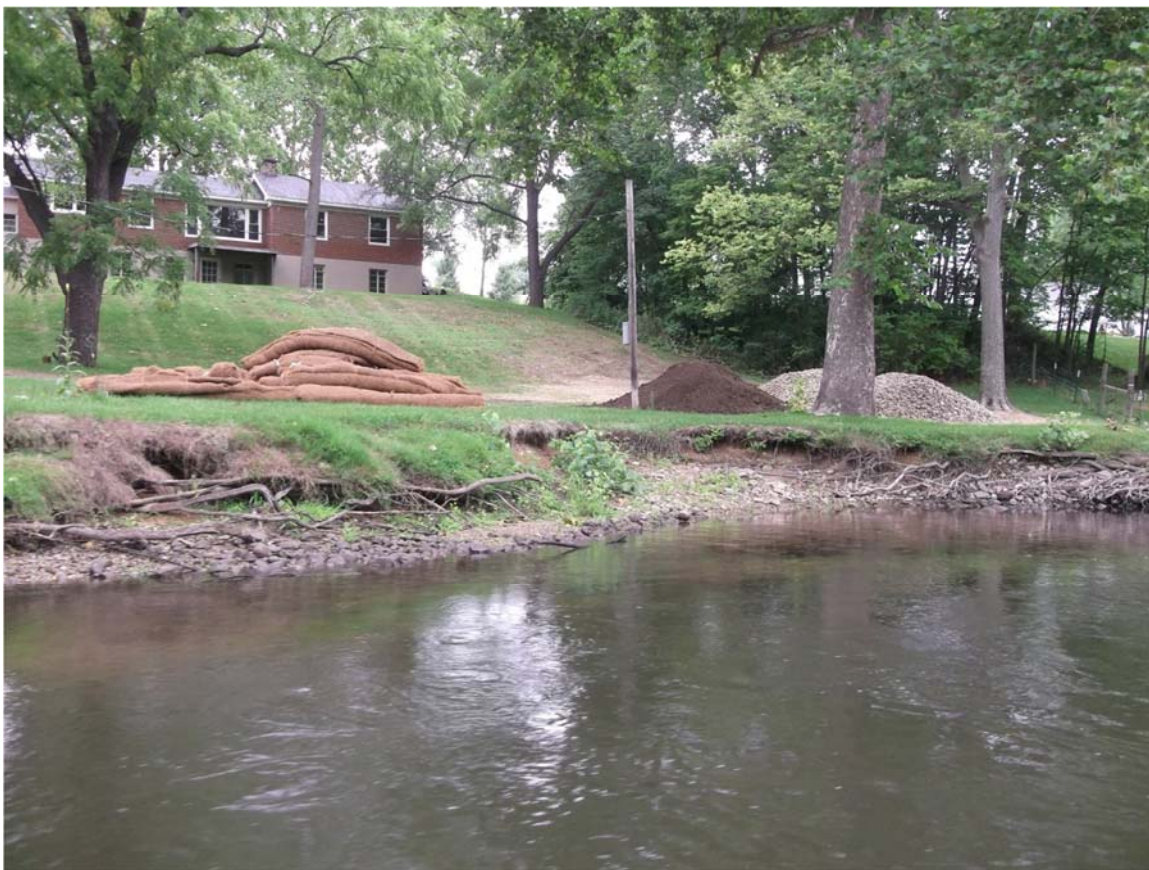
17. MP27.0 RDB observed shoreline restoration.

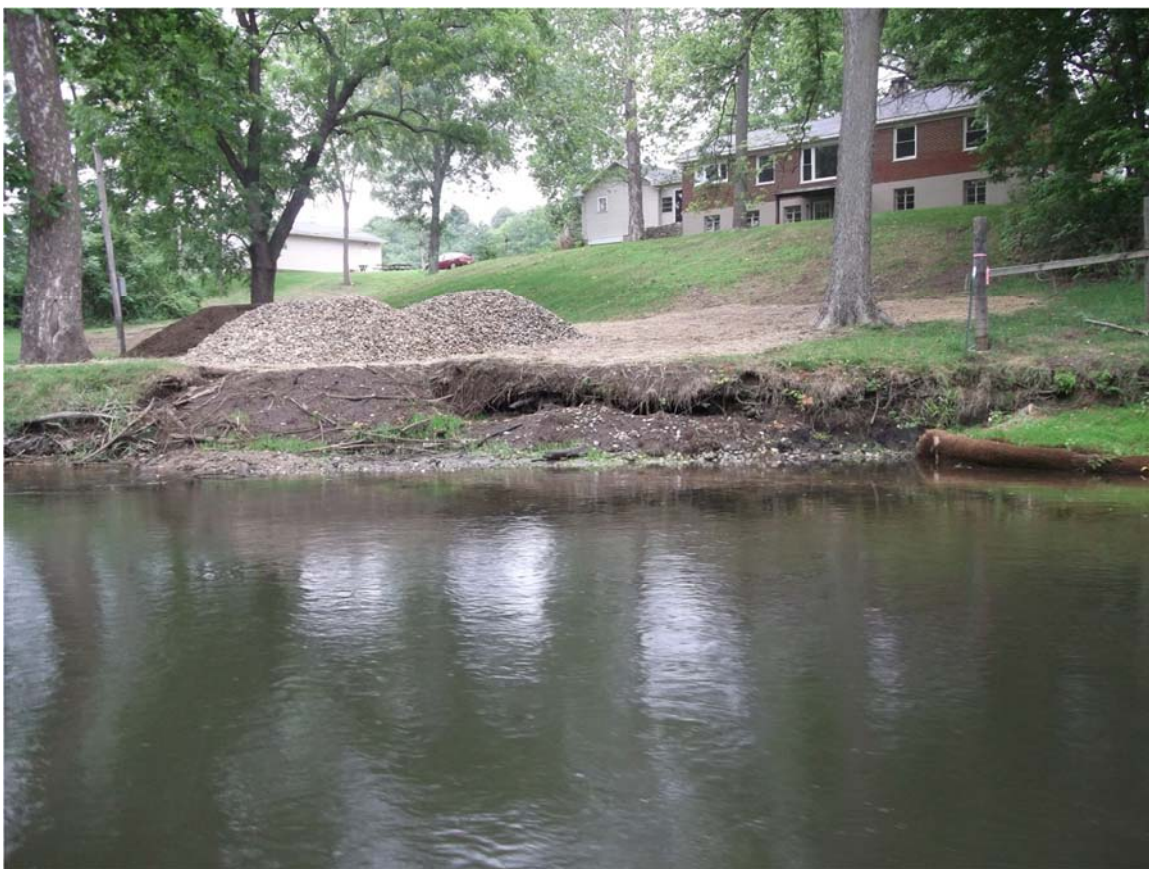
18. MP27.0 RDB observed shoreline restoration.
