Situation Photo Log

Tuesday, August 14, 2012

Kalamazoo River / Enbridge Spill

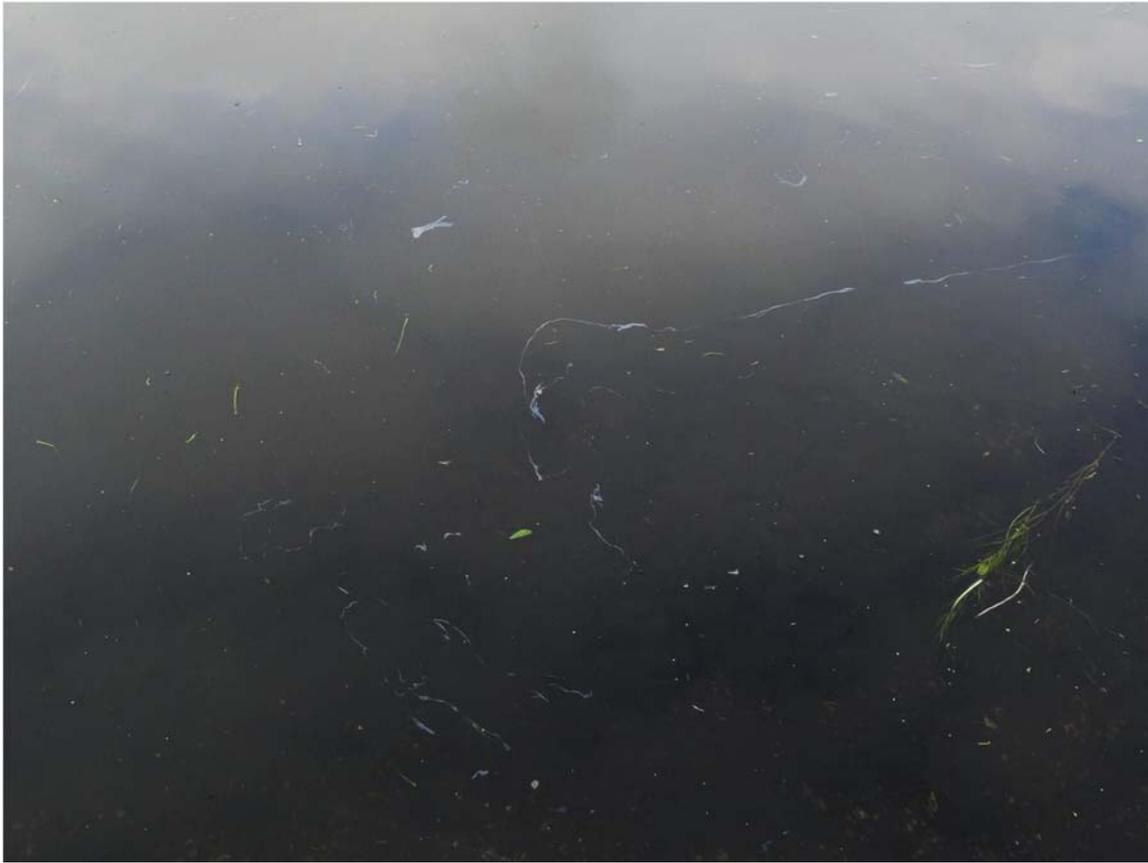
1. C0.4 boat launch sheen observed.

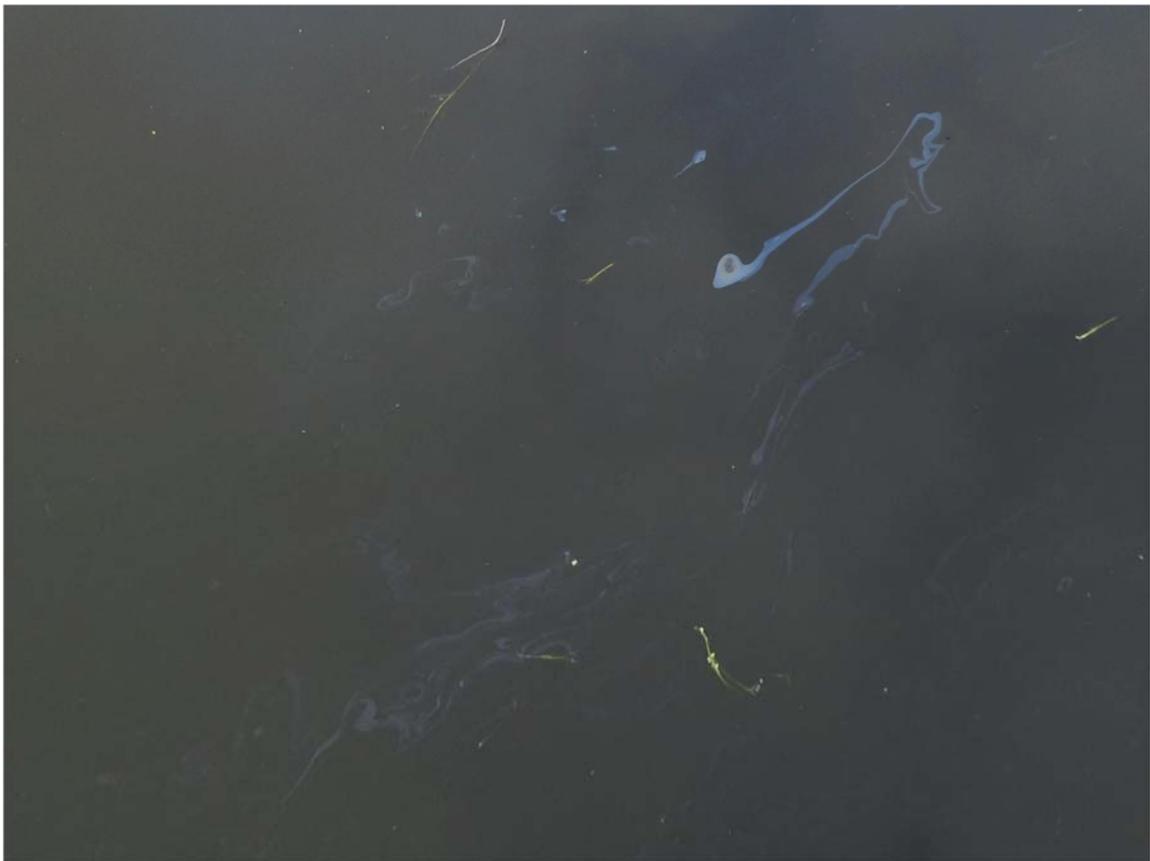
2. MP5.3 LDB sheen and tar globules were observed.

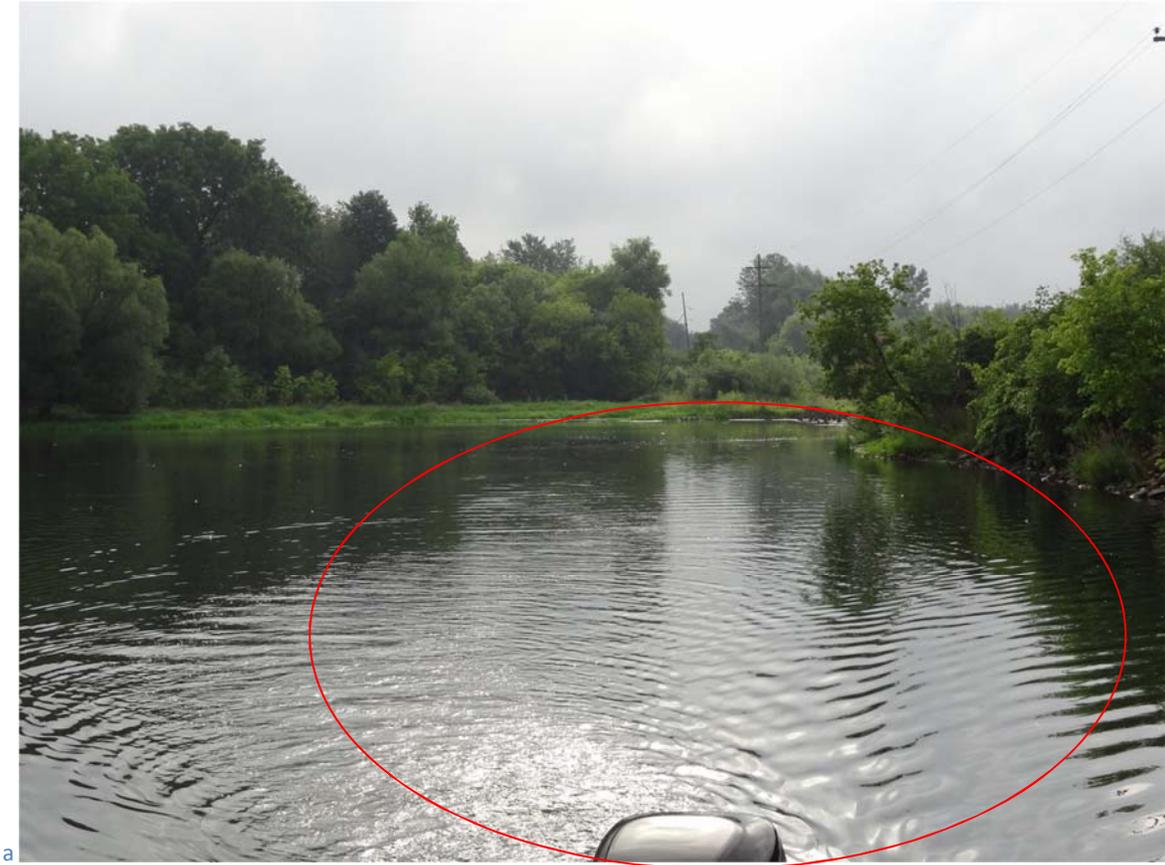
3. MP5.63 LDB area where sheen and tar globules observed.

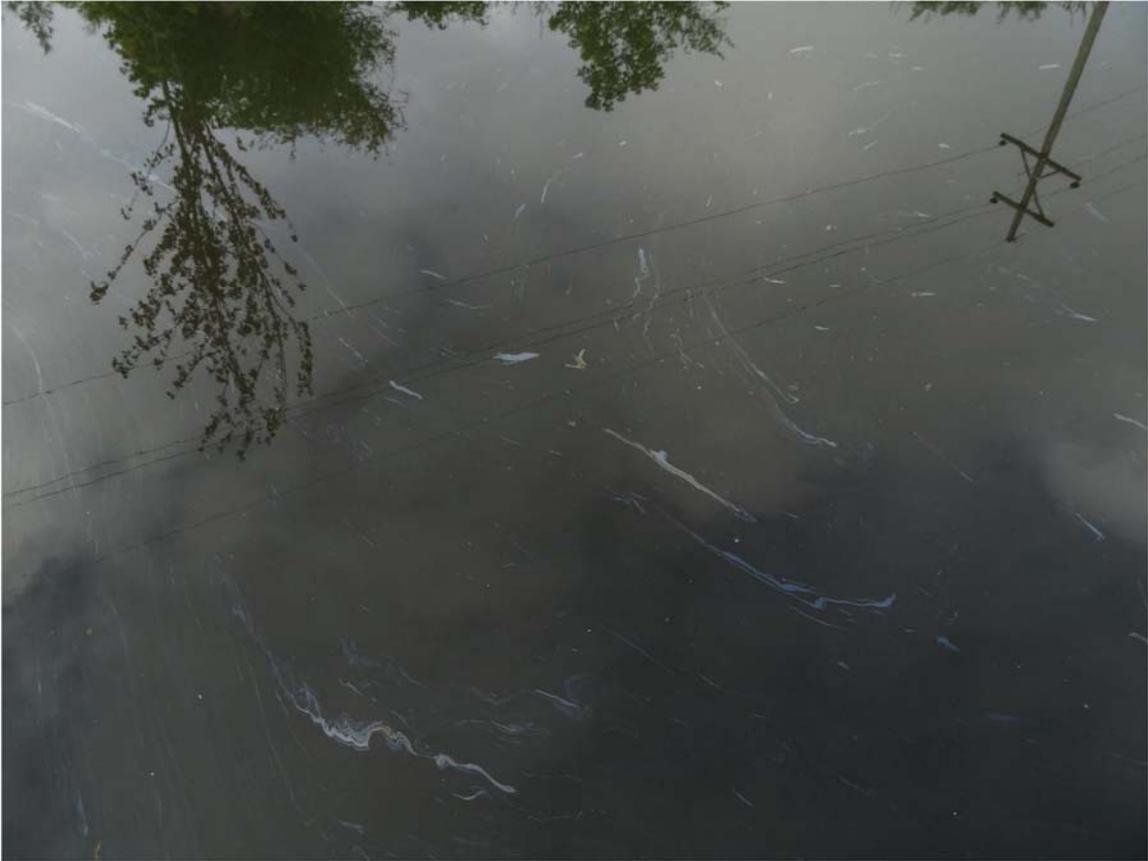
4. MP5.63 LDB sheen and tar globules observed.

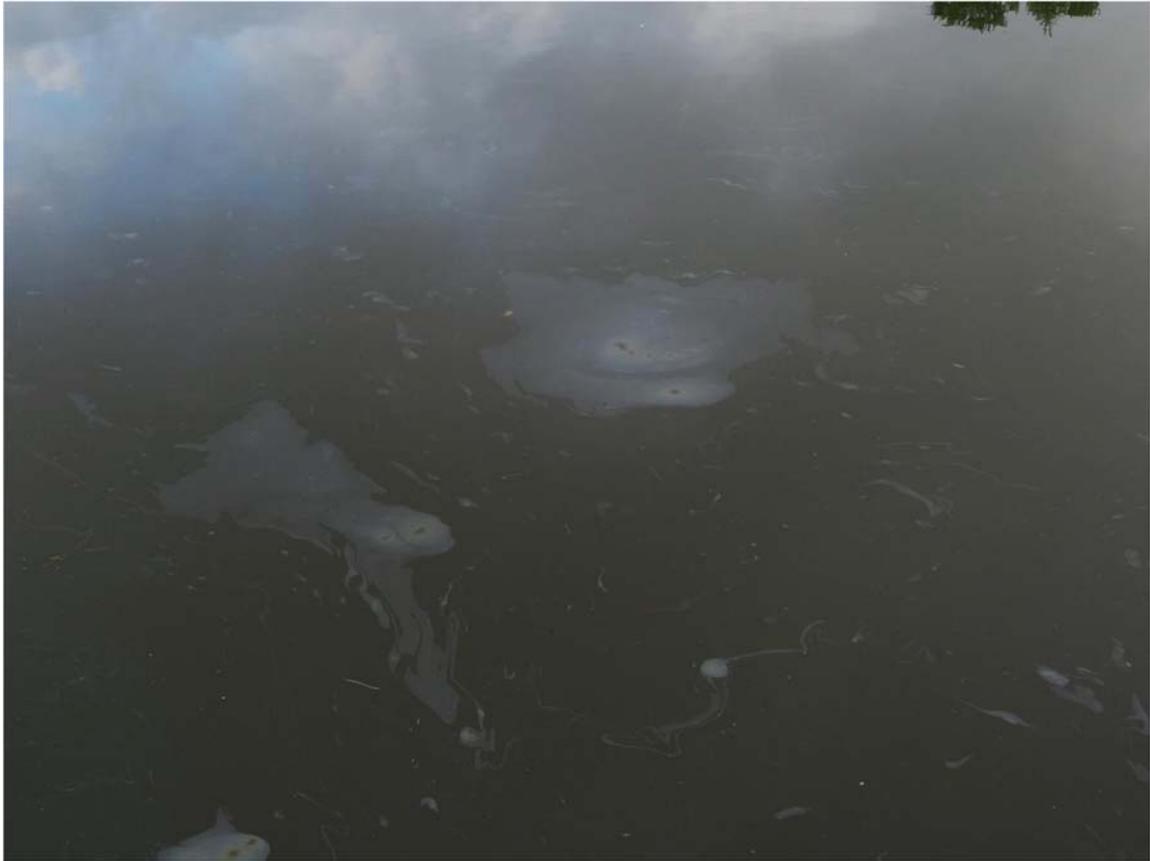
5. MP5.63 LDB sheen and tar globules observed.

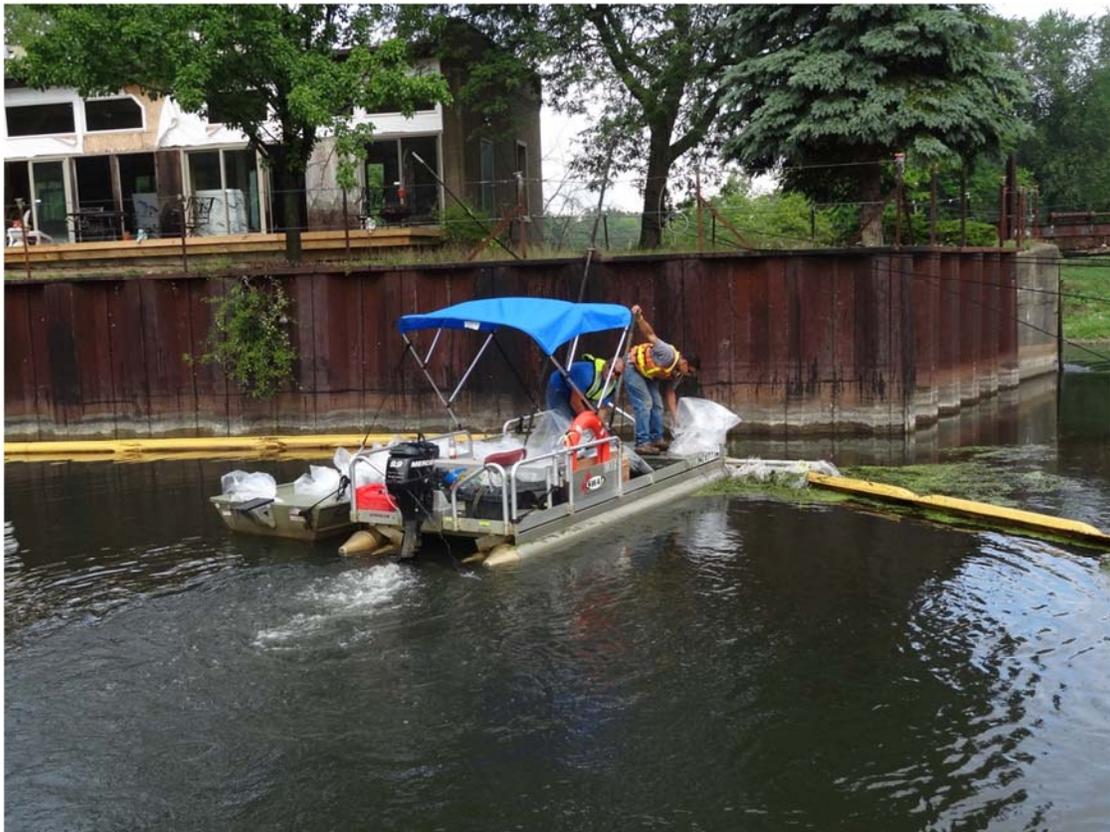
6. Ceresco Dam control point boom, observed crew removing debris from the boom.

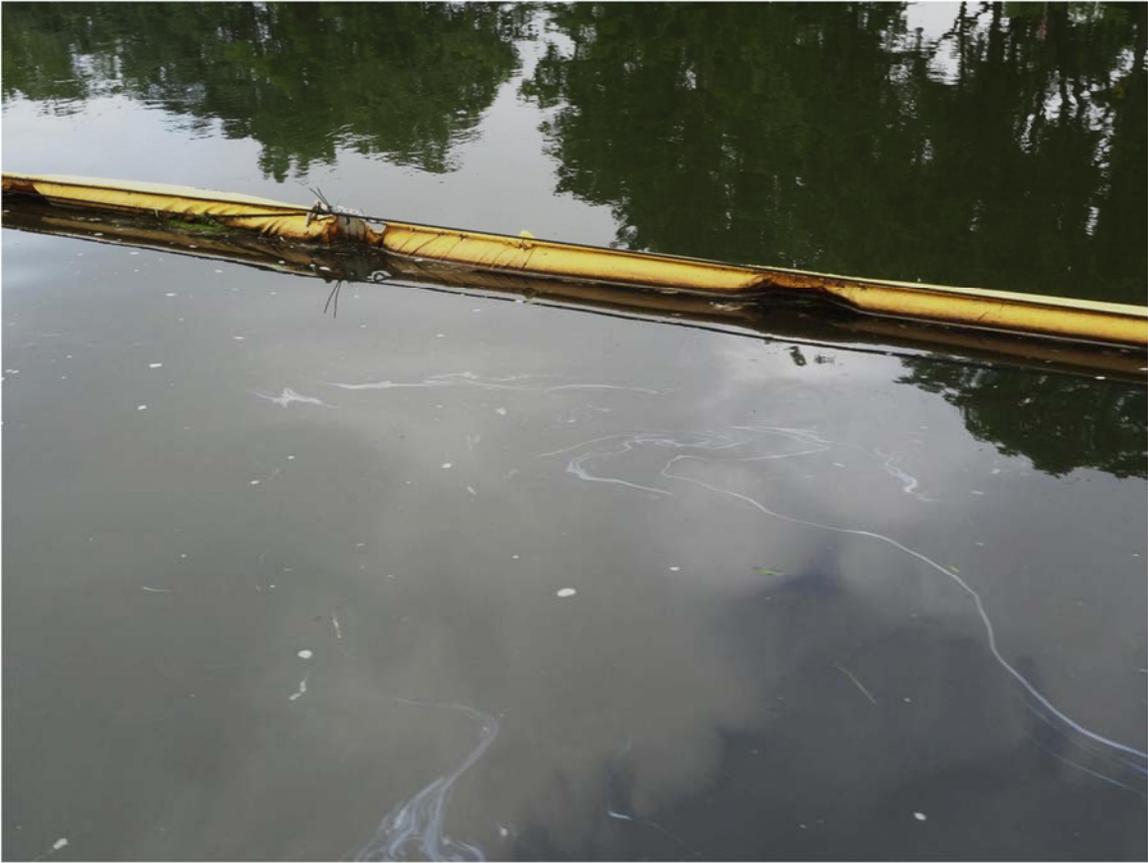
7. Ceresco Dam control point boom, observed sheen collecting along the boom.

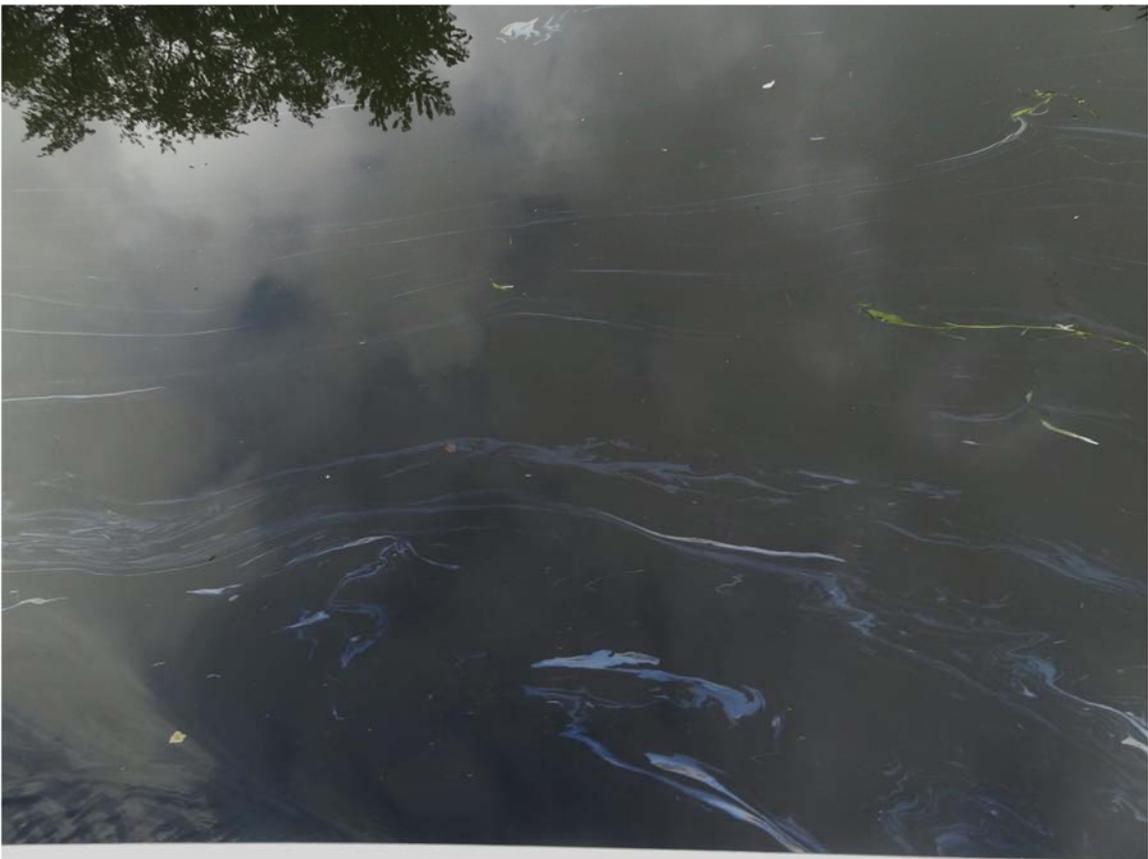
8. Ceresco Dam sheen observed along control point.

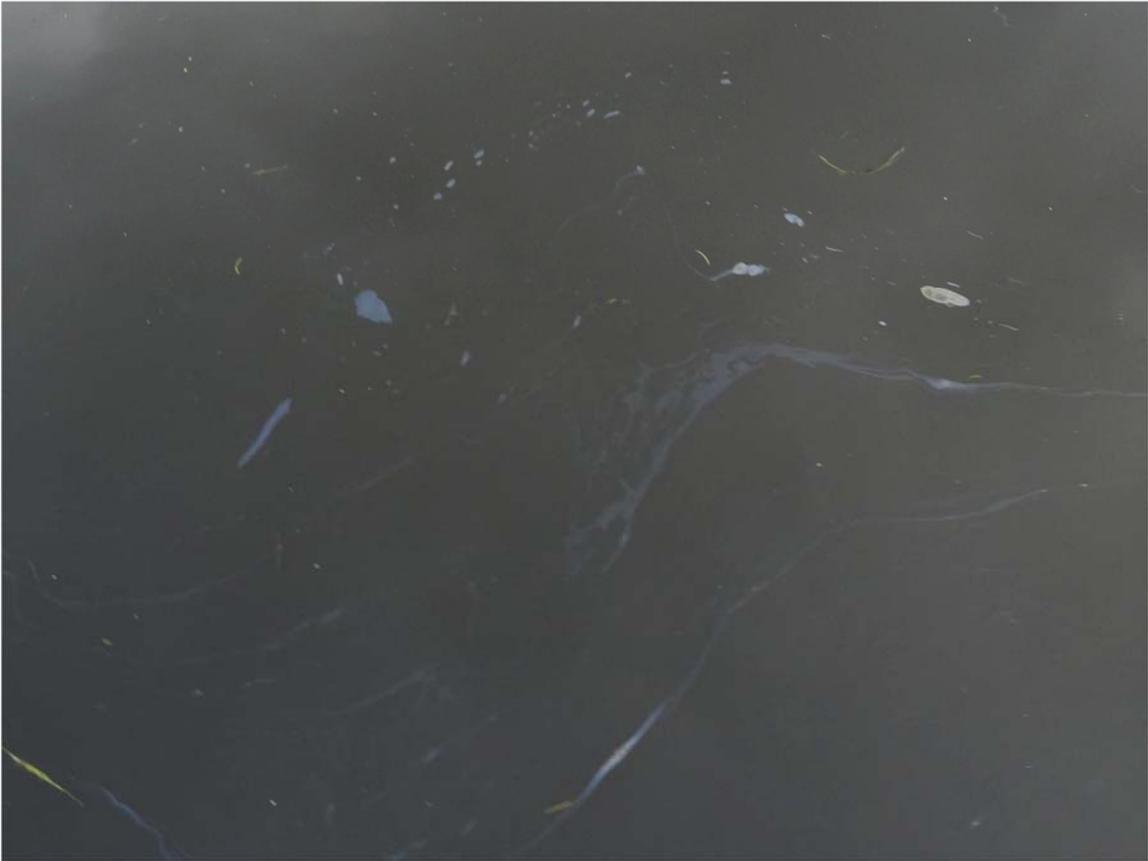
9. MP5.25 RDB observed sheen.

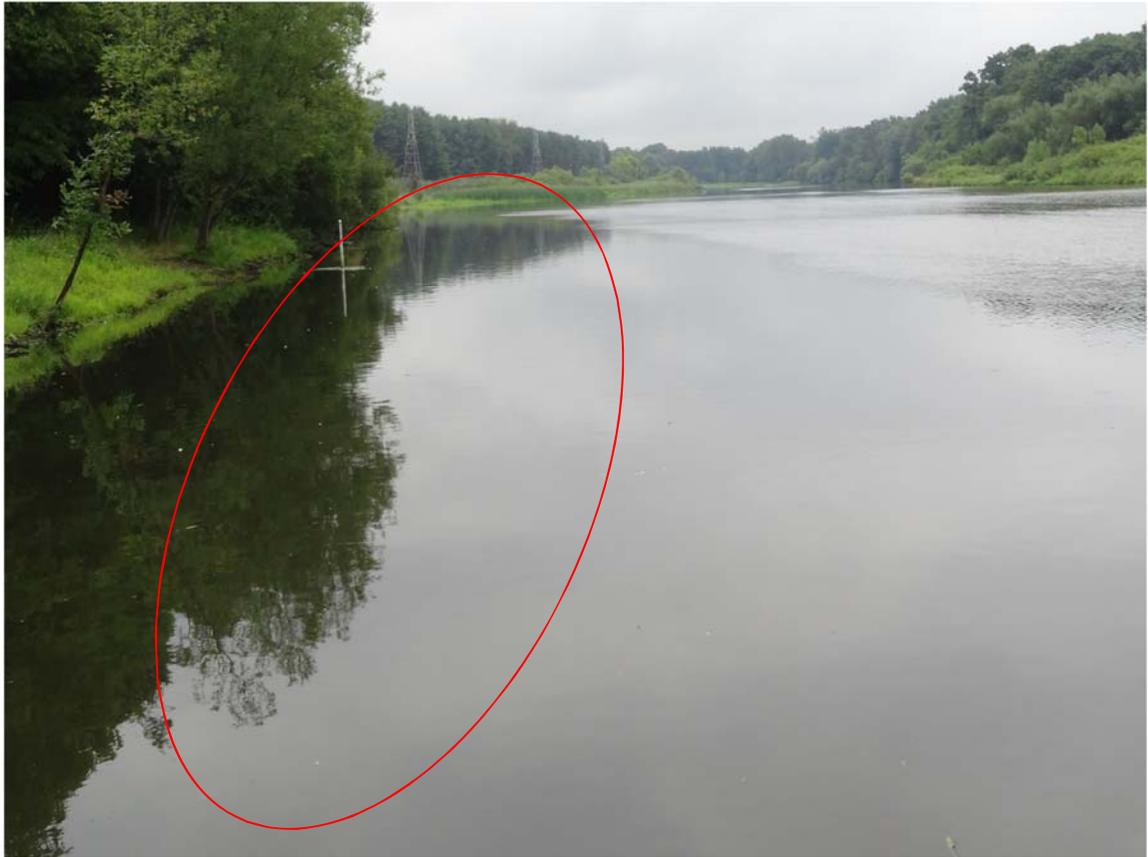
10. MP4.5 RDB - C0.4 boat launch observed ribbons of sheen.

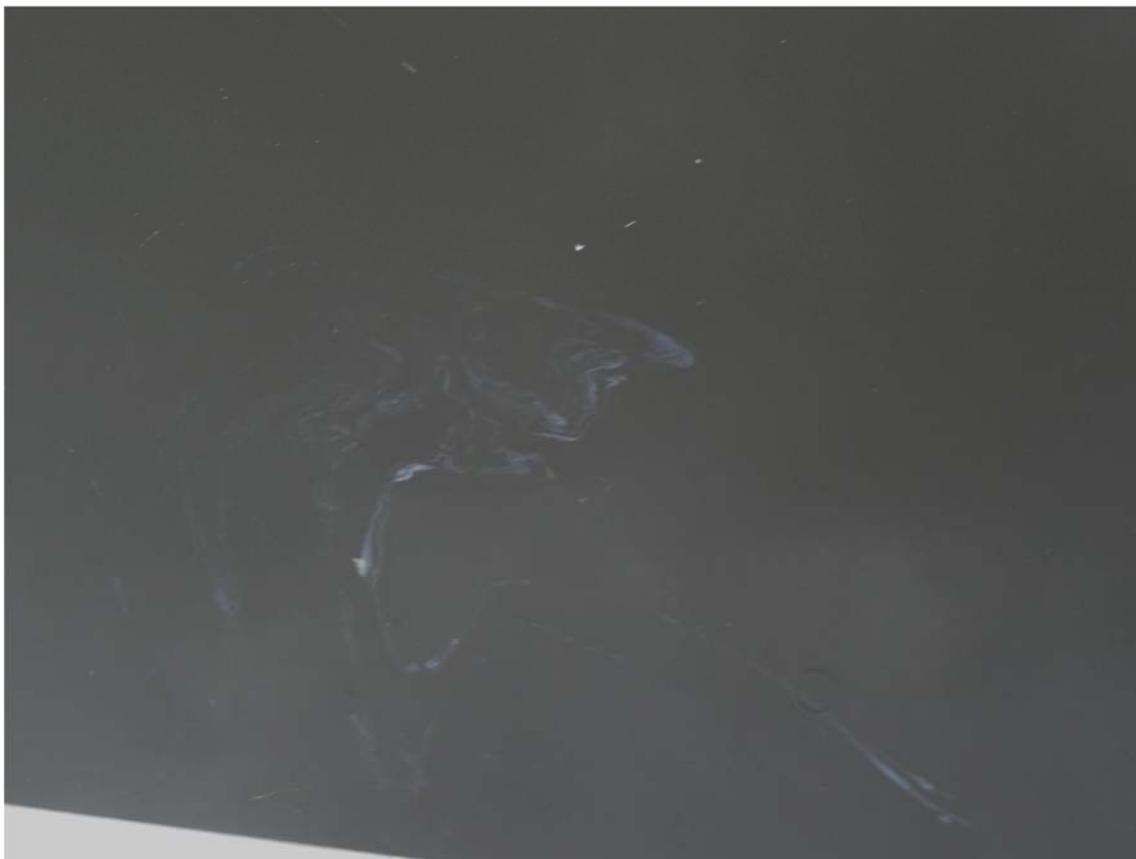
11. MP4.5 RDB - C0.4 boat launch observed ribbons of sheen.

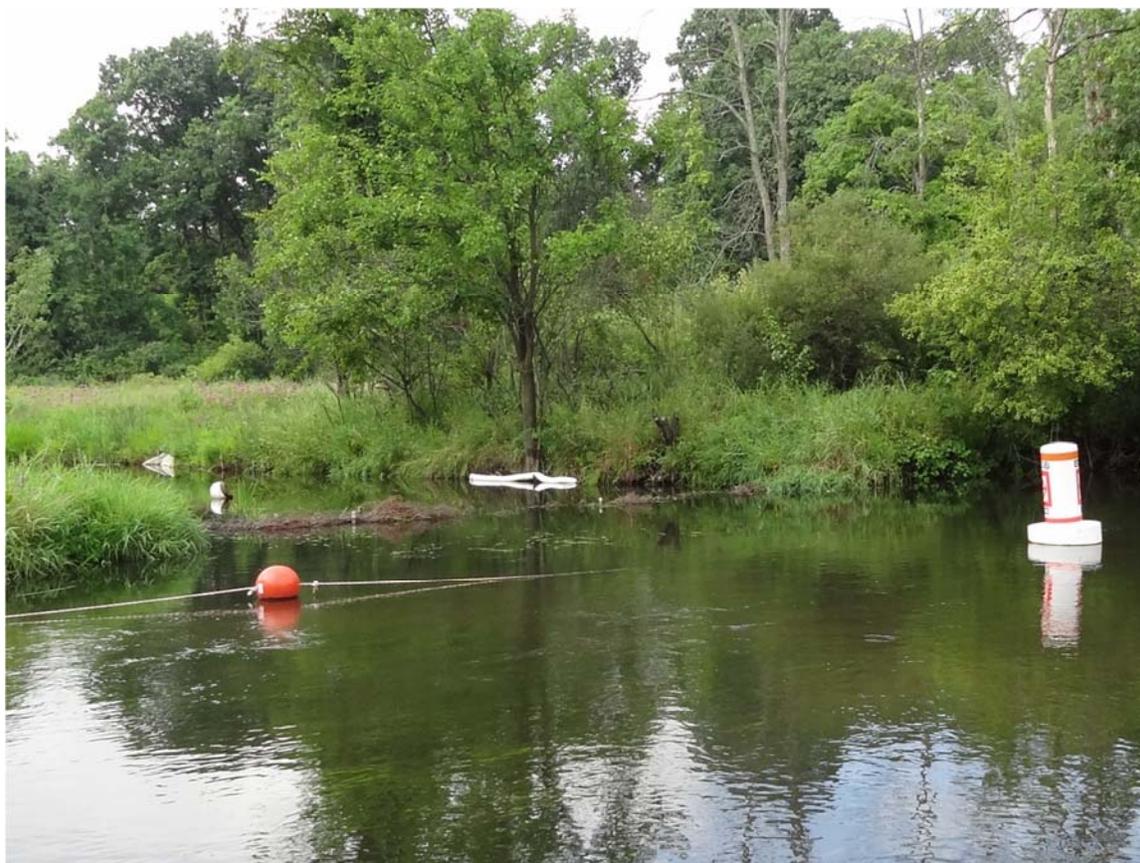
12. MP10.75 observed absorbent boom in area where heavy rainbow sheen was previously observed.

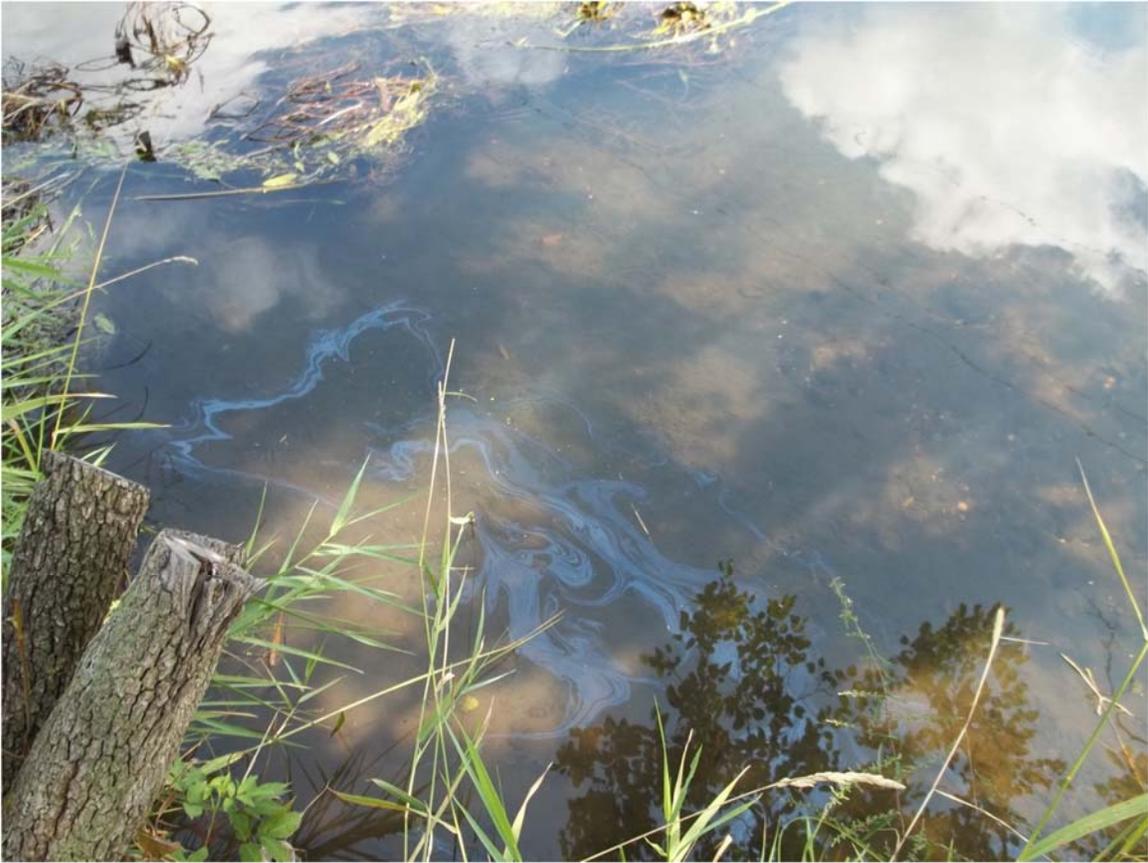
13. MP10.75 sheen was observed.

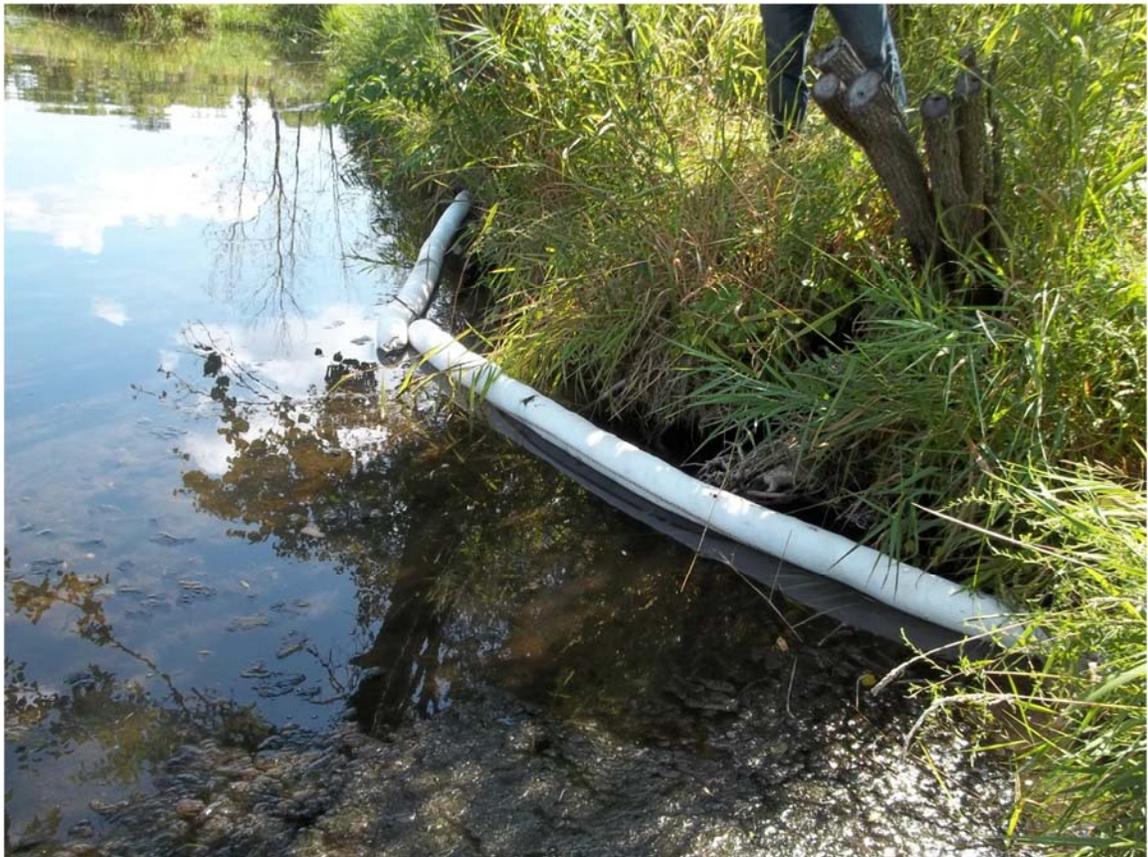
14. MP10.75 new absorbent boom configuration.

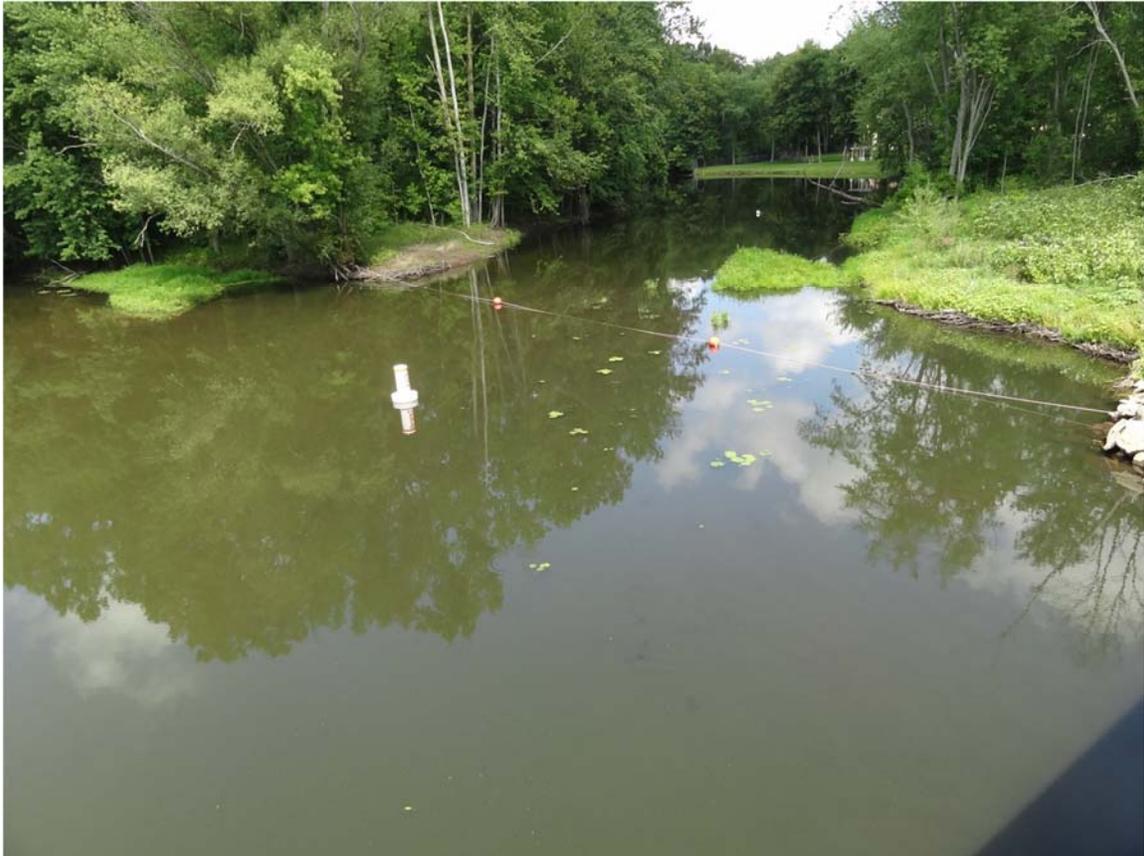
15. MP21.5 no sheen was observed.

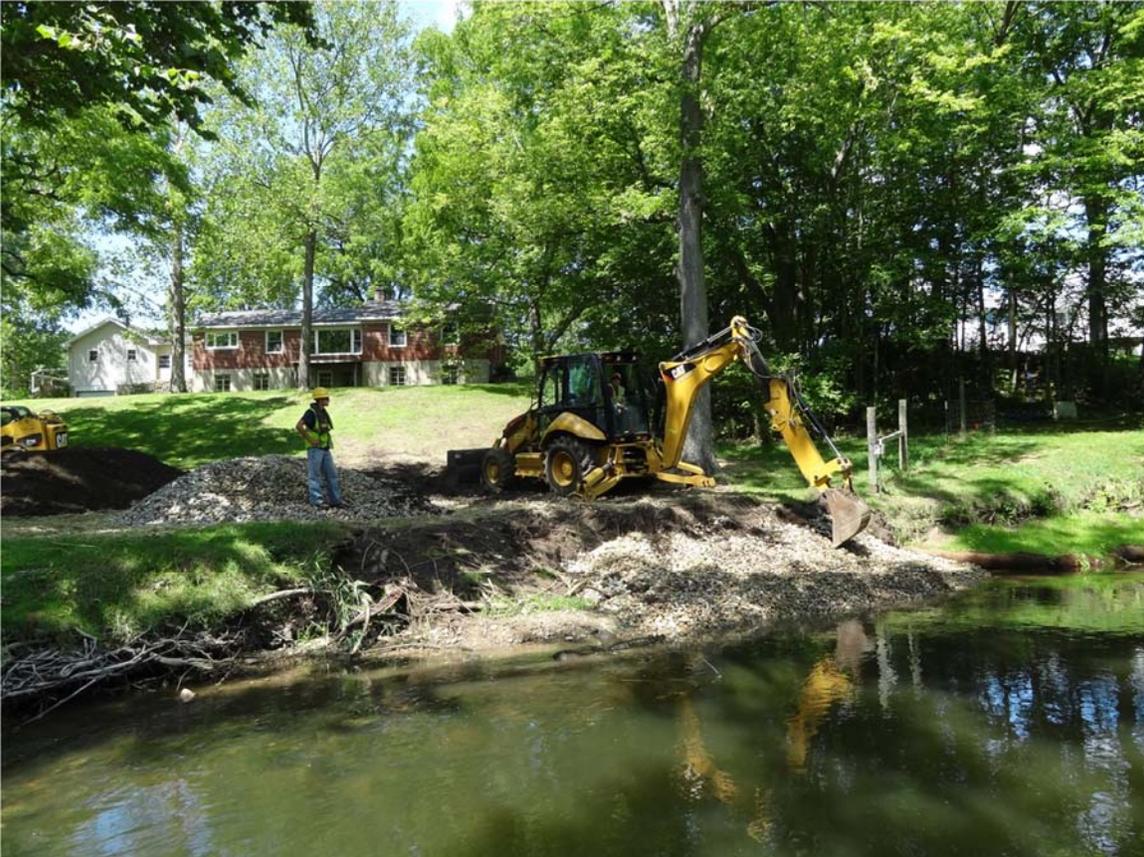
16. MP27.0 RDB observed river bank erosion restoration work.

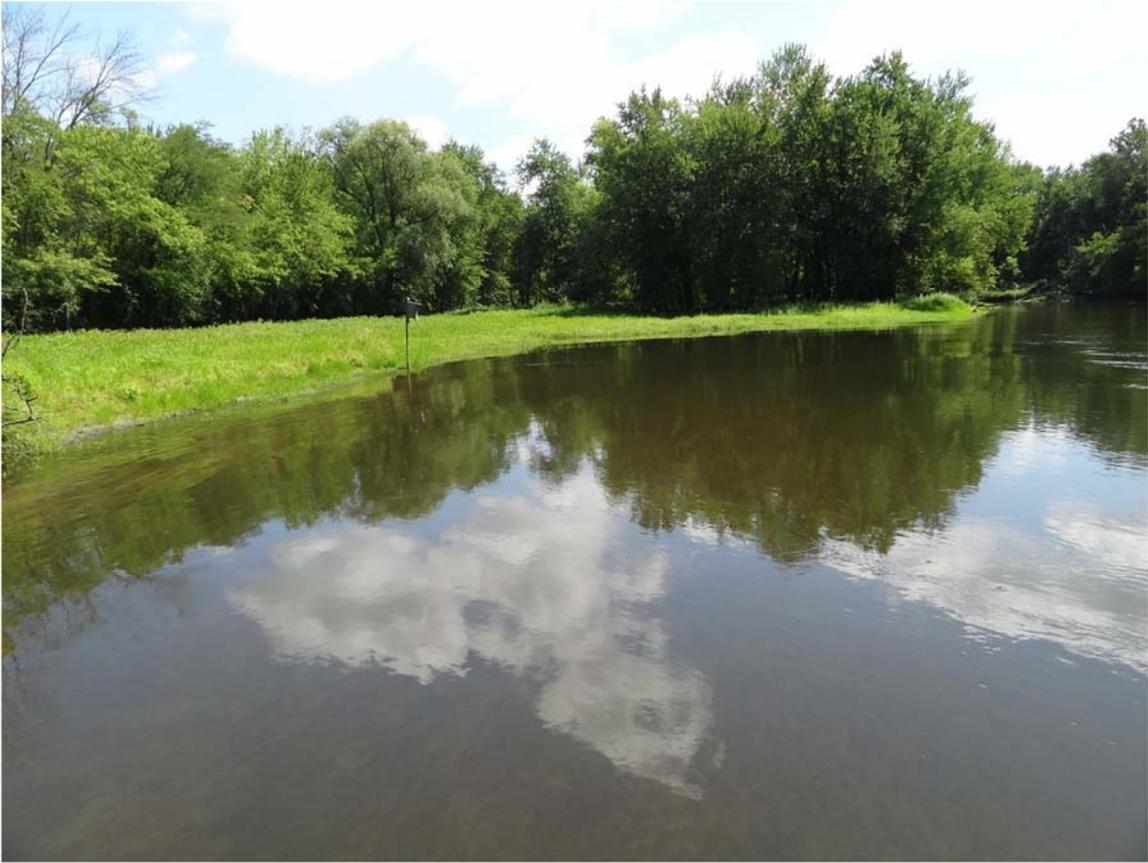
17. MP26.0 observed ribbon of sheen.

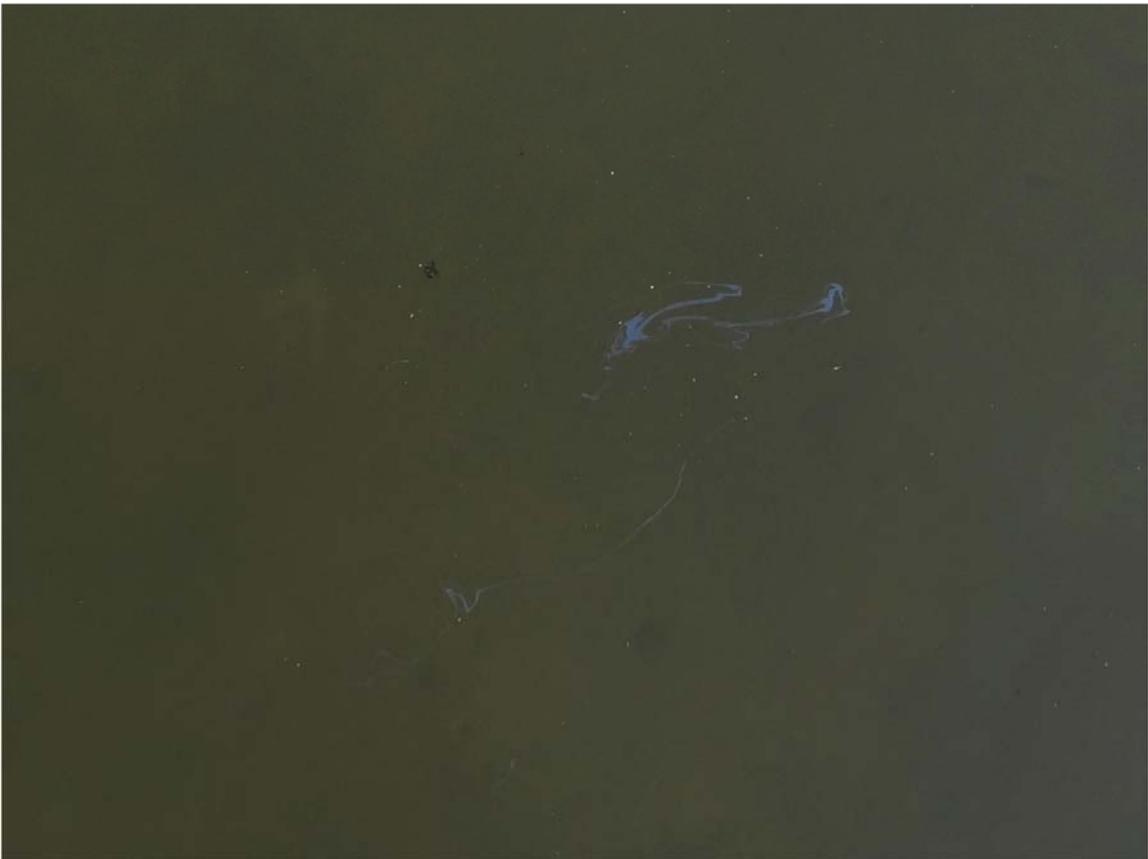
18. MP26.0 observed ribbon of sheen. Sheen response was not warranted.

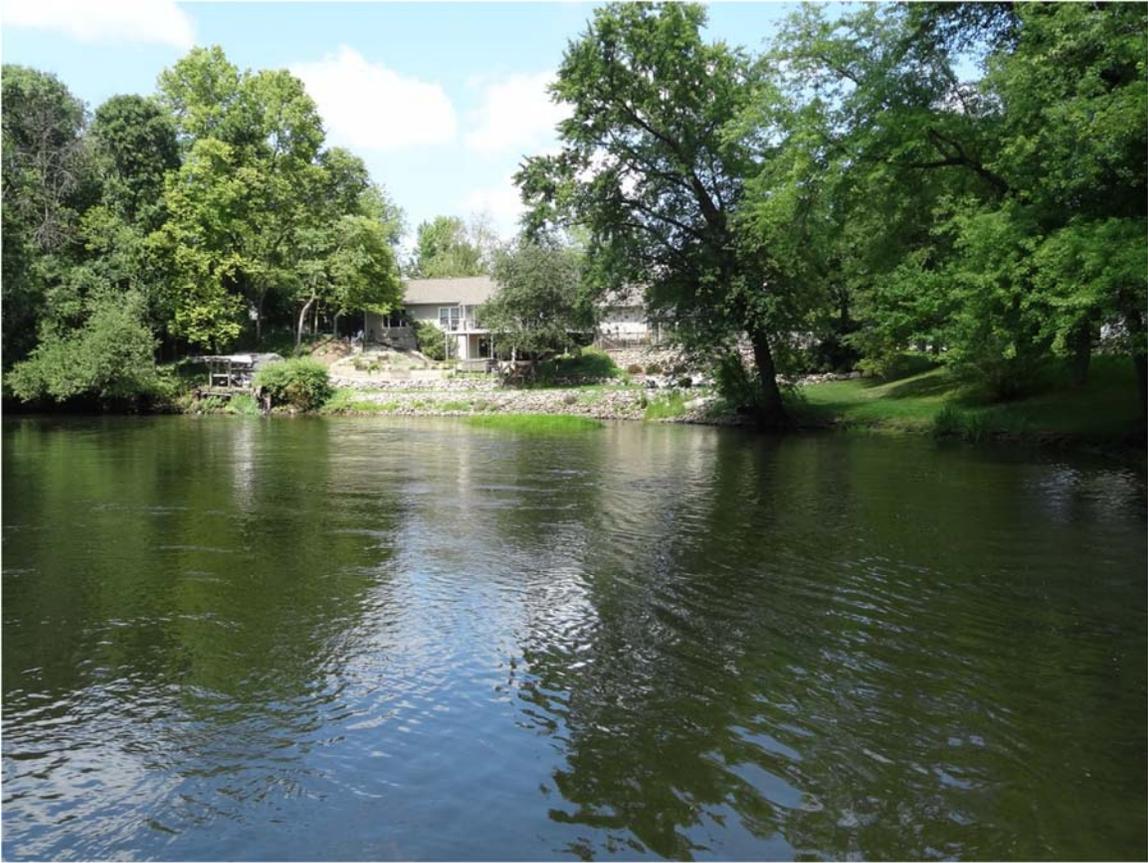
19. MP23.10 no sheen observed.

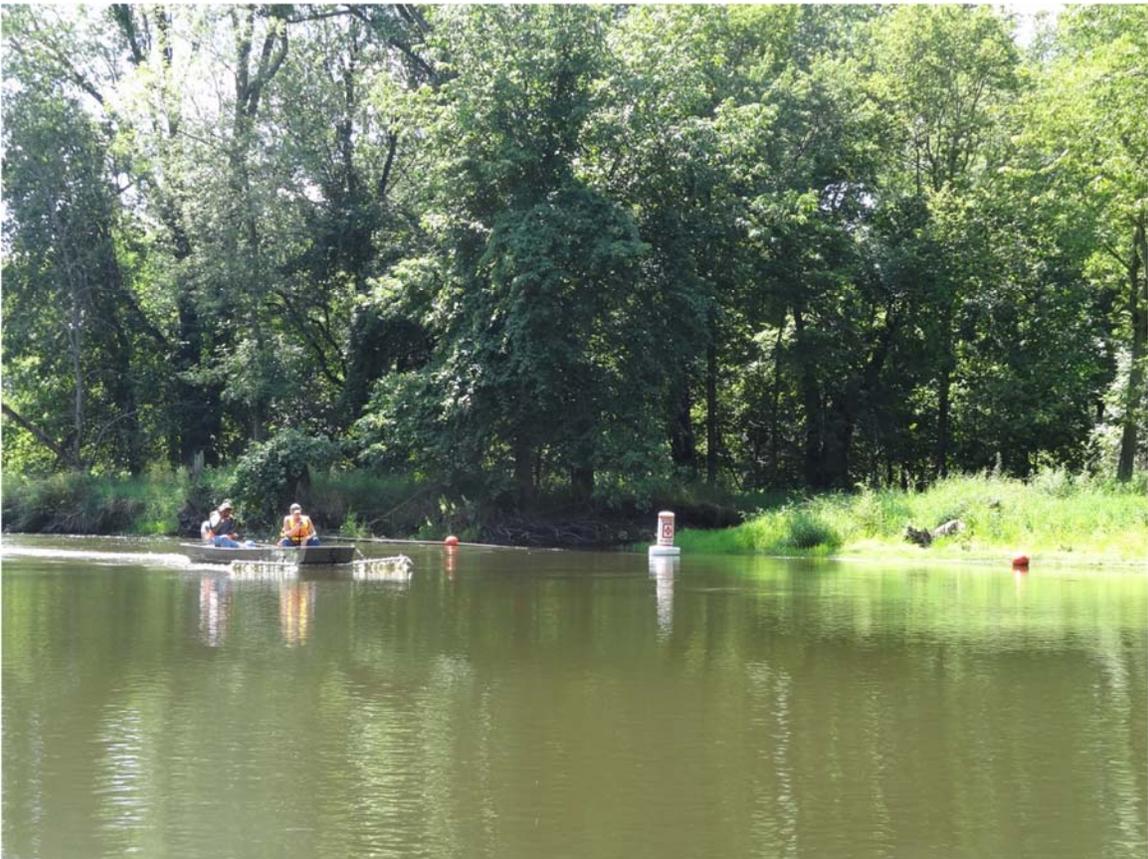
20. MP28.25 observed a sheen sweep boat operating.

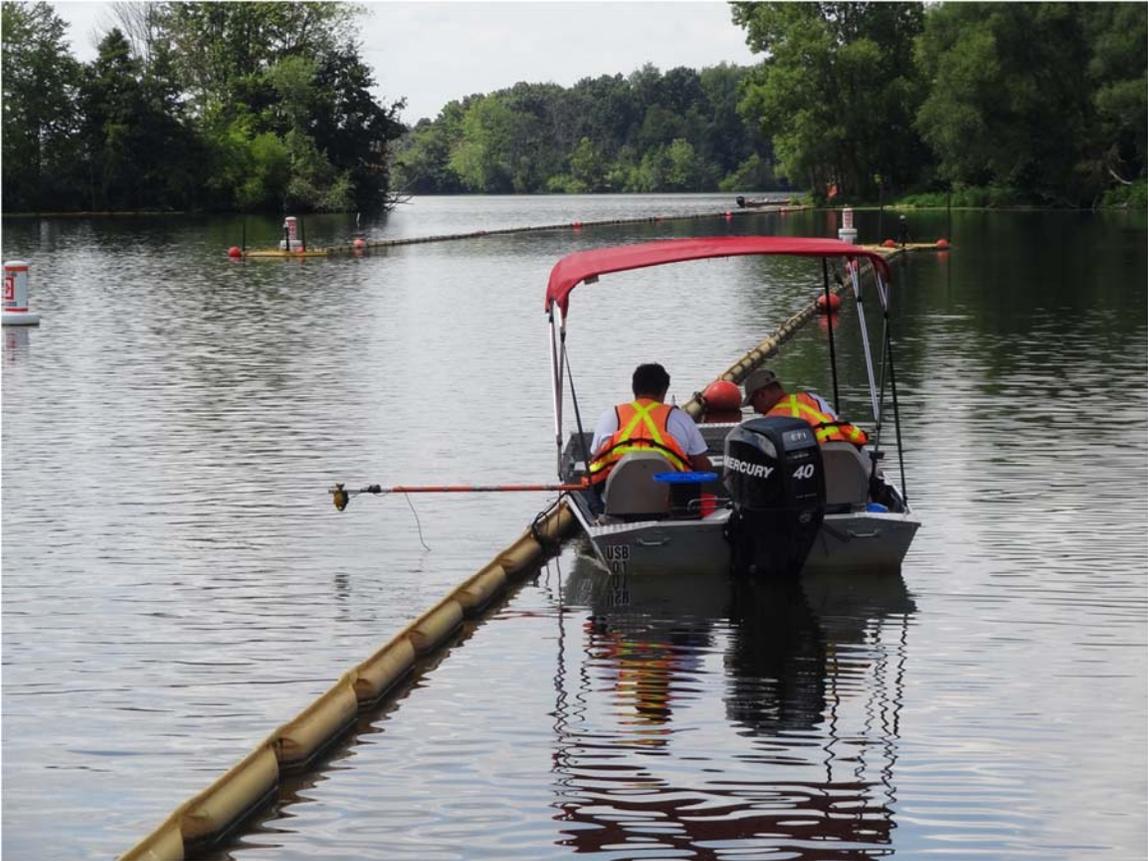
21. Morrow Lake Delta Boom E inspection.

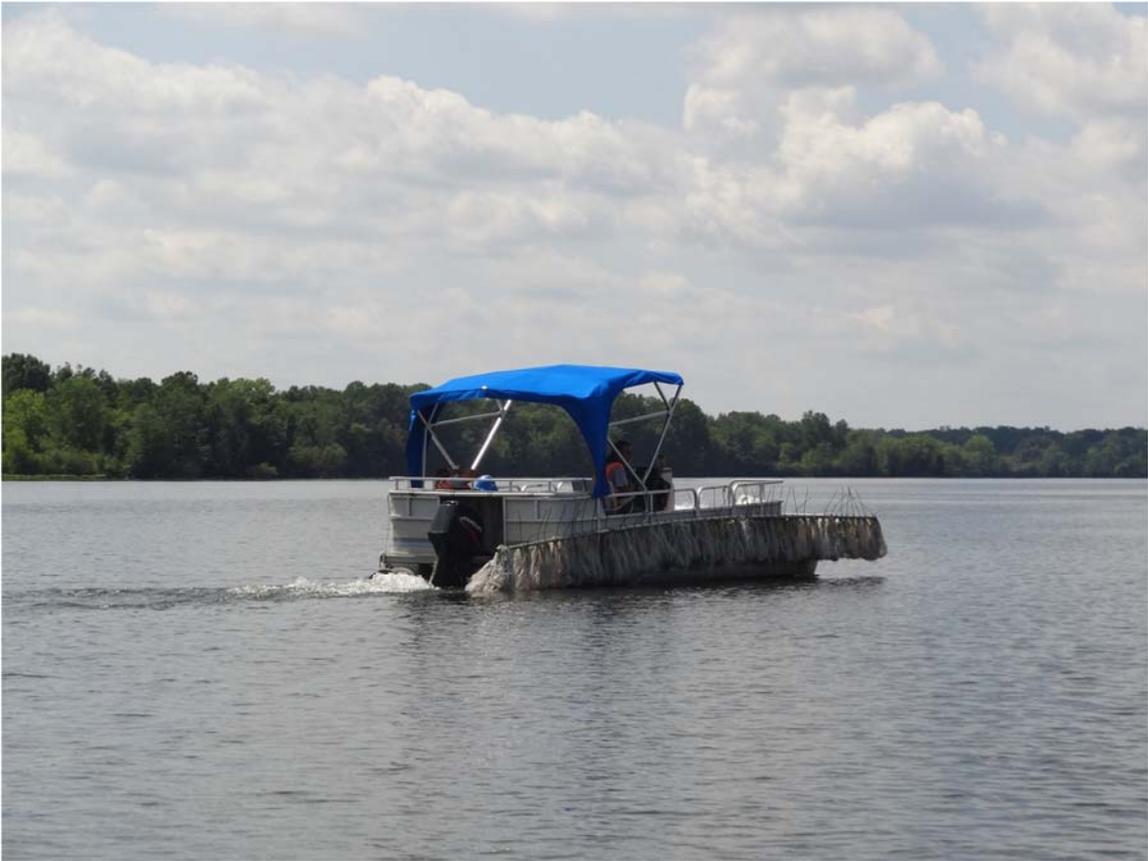
22. Morrow Lake observed sheen sweep boat.
