# Situation Photo Log

Wednesday, August 15, 2012

Kalamazoo River / Enbridge Spill

Prepared by:  
Matthew Haak  
START-USEPA  
Situation Unit Leader

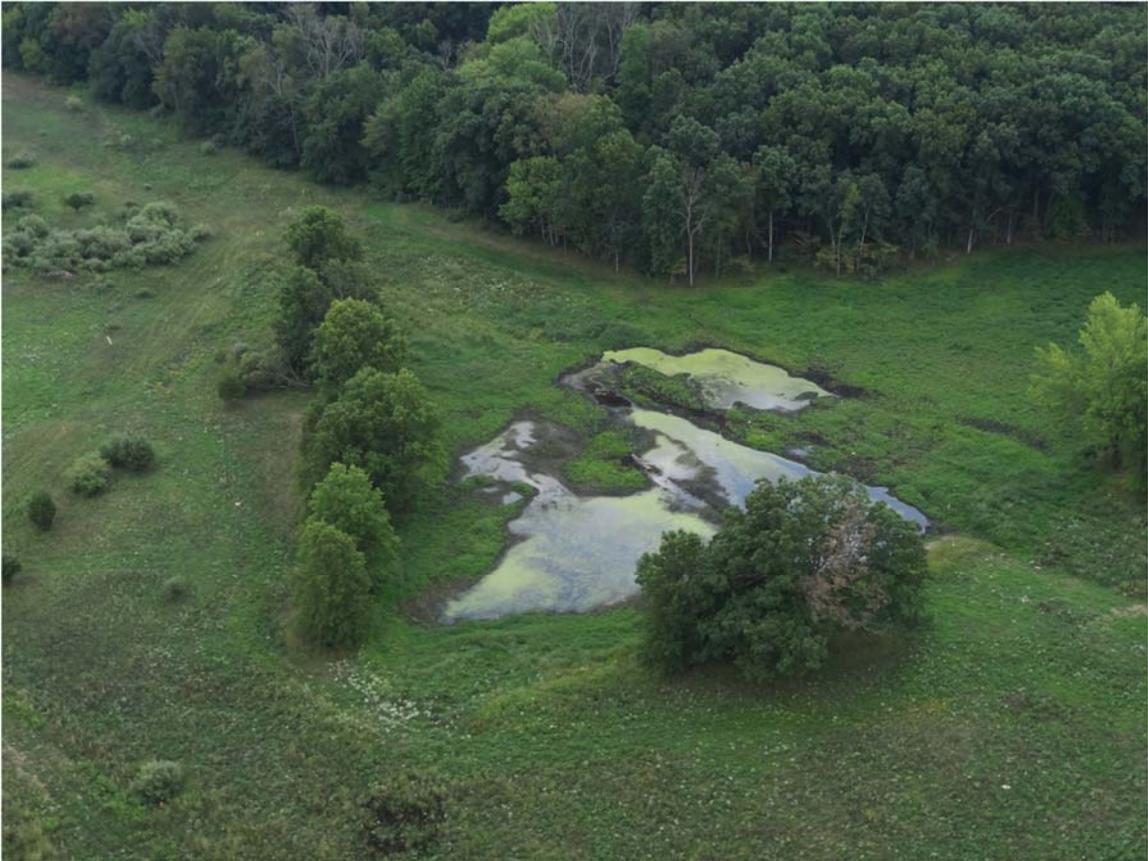
1. Source Area sheen observed.

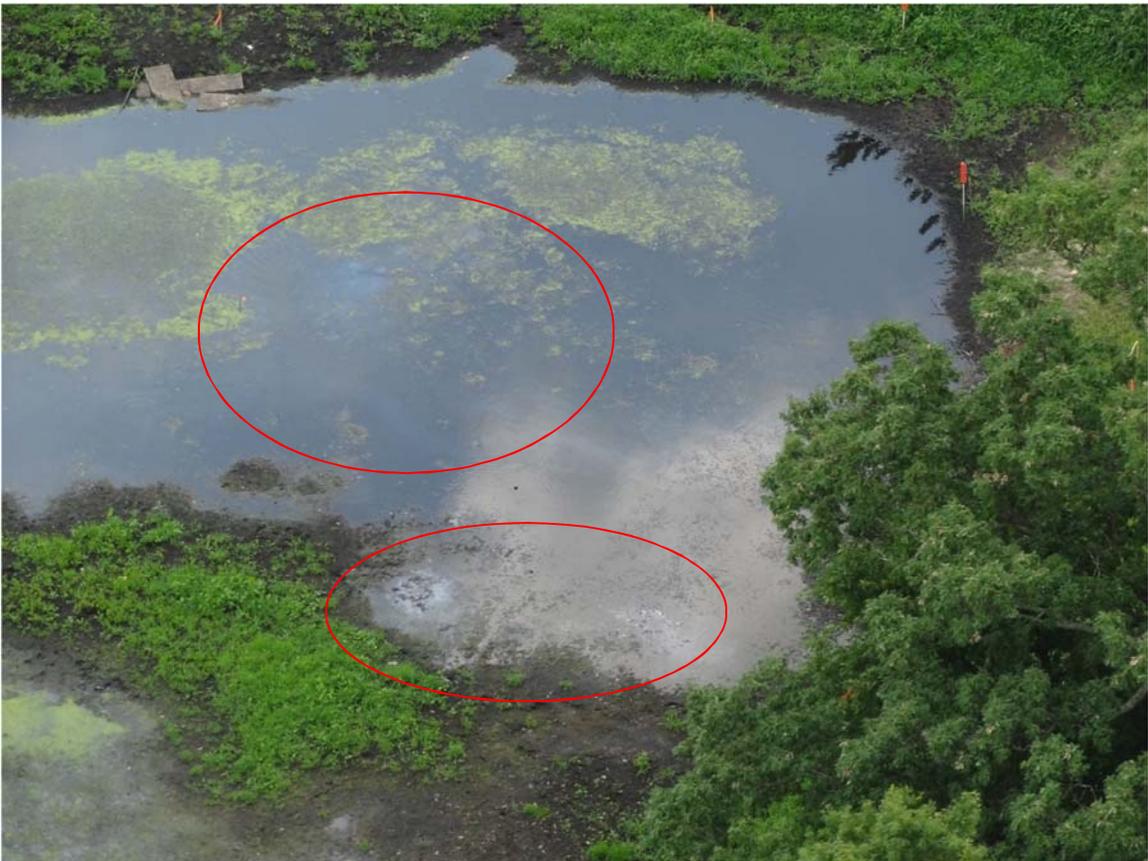
2. Source Area sheen observed.

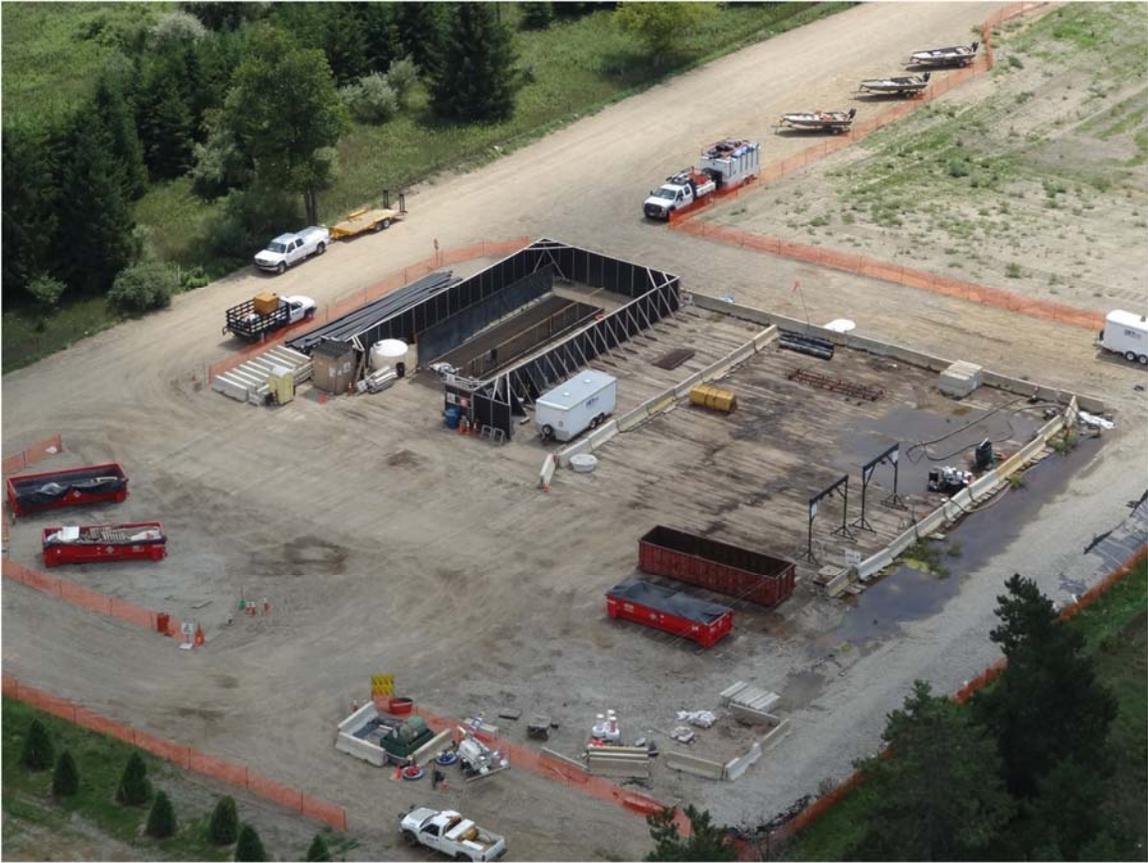
3. Frac-City decontamination pad, no activity observed.

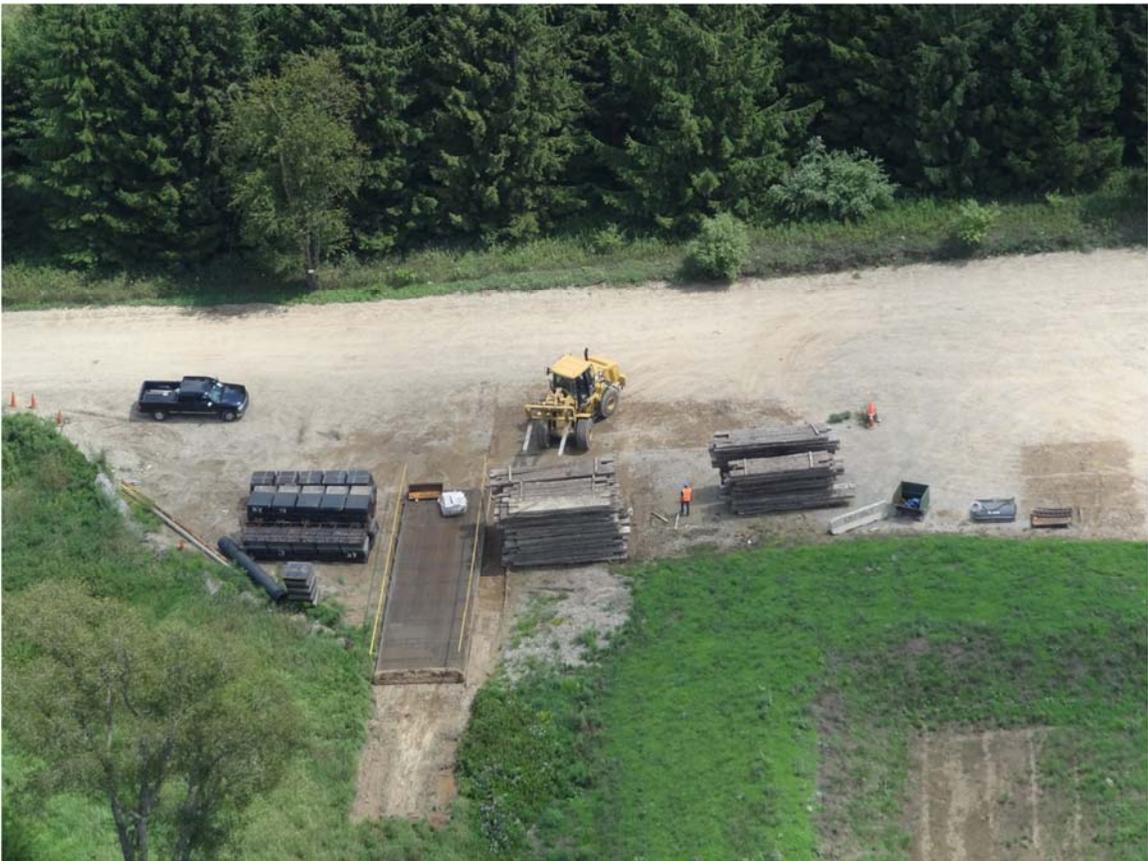
4. Frac-City observed crews consolidating materials.

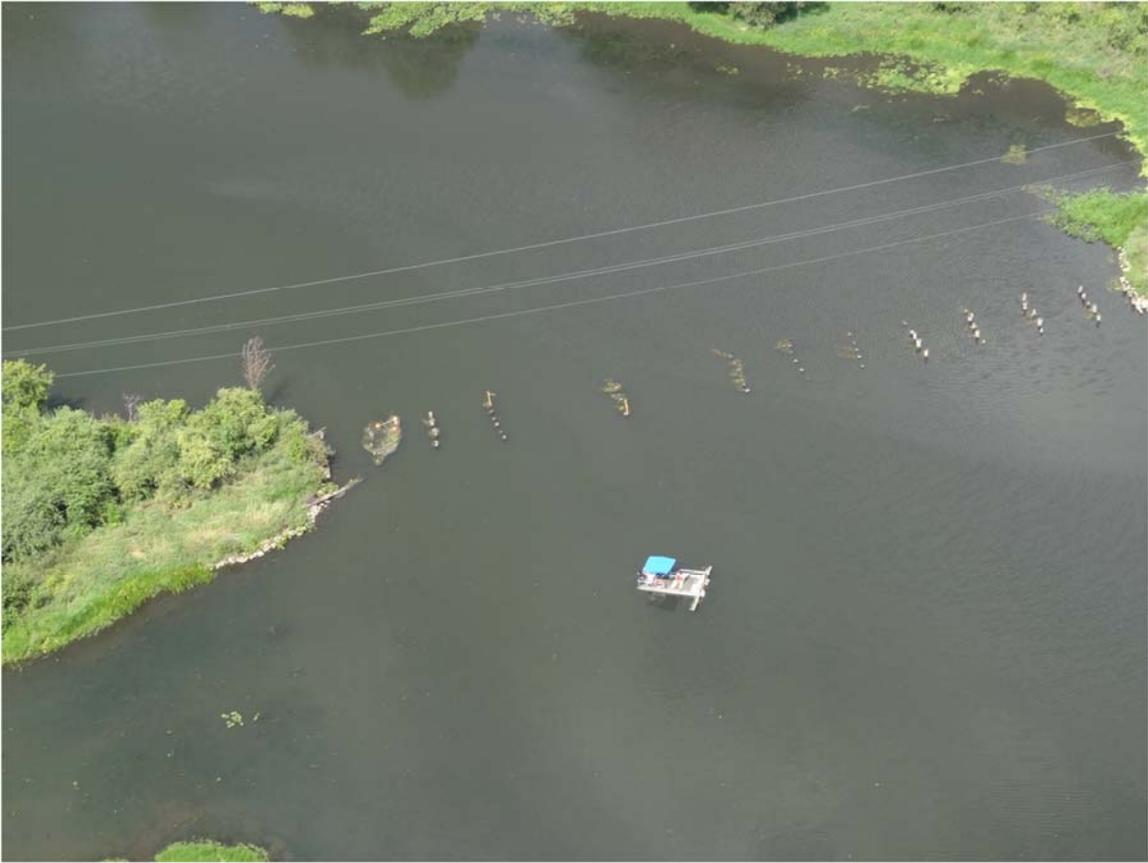
5. MP5.63 observed the sheen sweep boat operating.

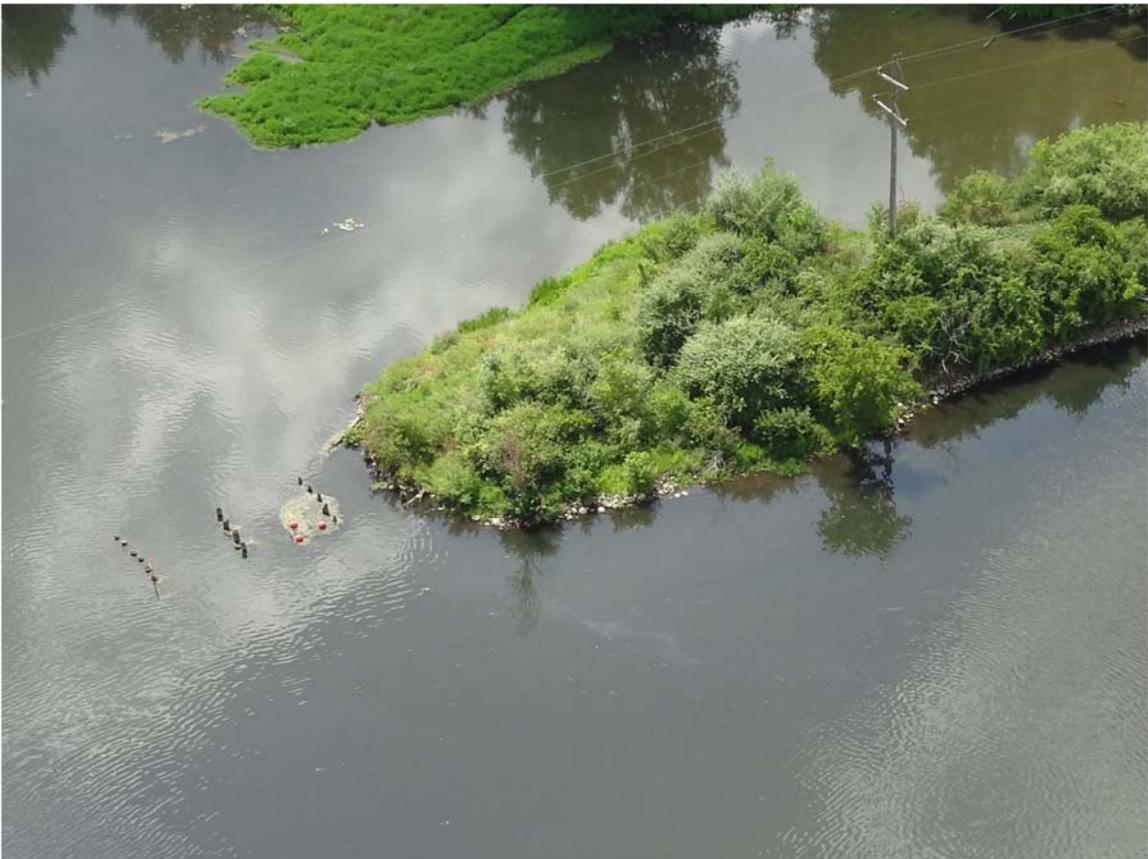
6. MP5.63 LDB sheen observed.

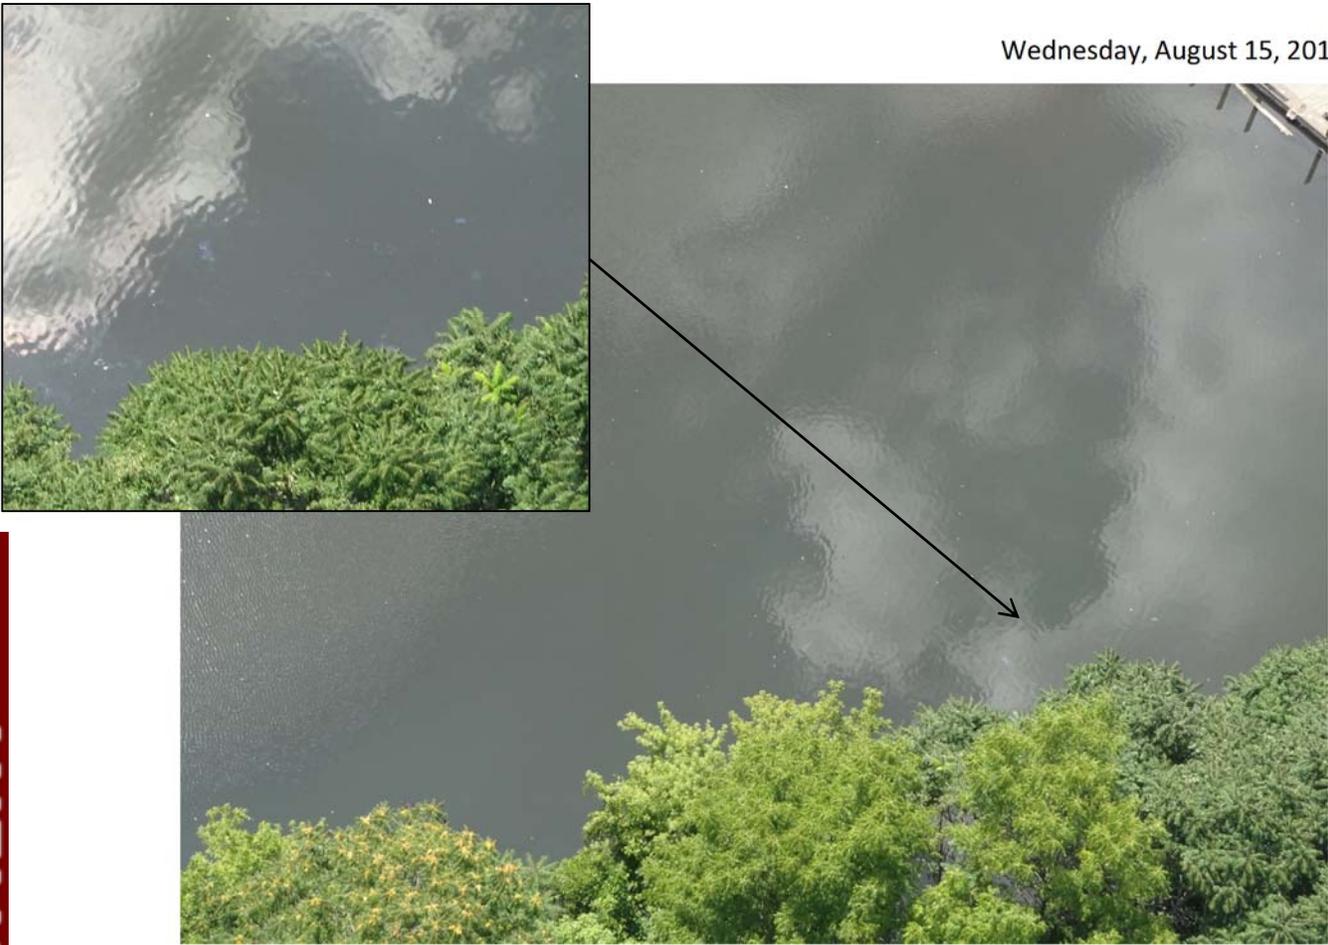
7. MP5.9 RDB sheen observed.

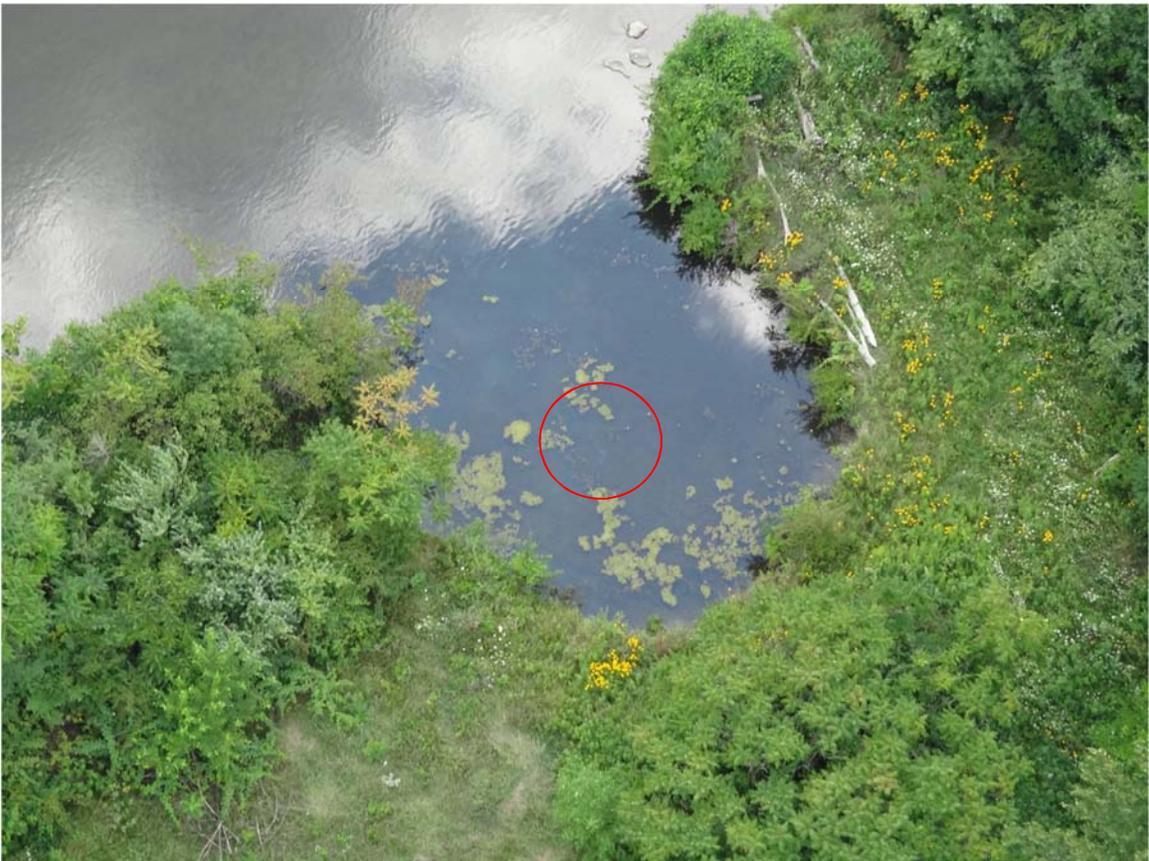
8. MP7.0 "Nook" sheen observed.

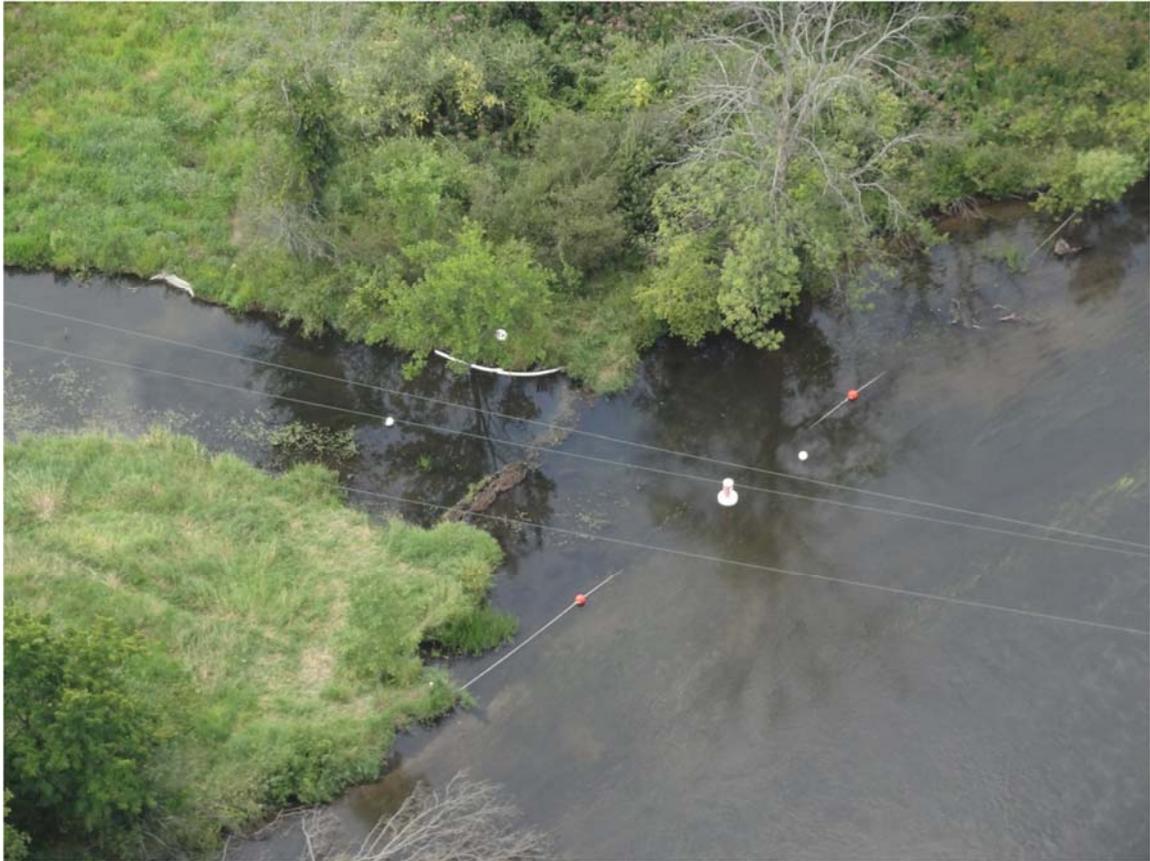
9. MP10.75 absorbent boom remains in place, no sheen observed.

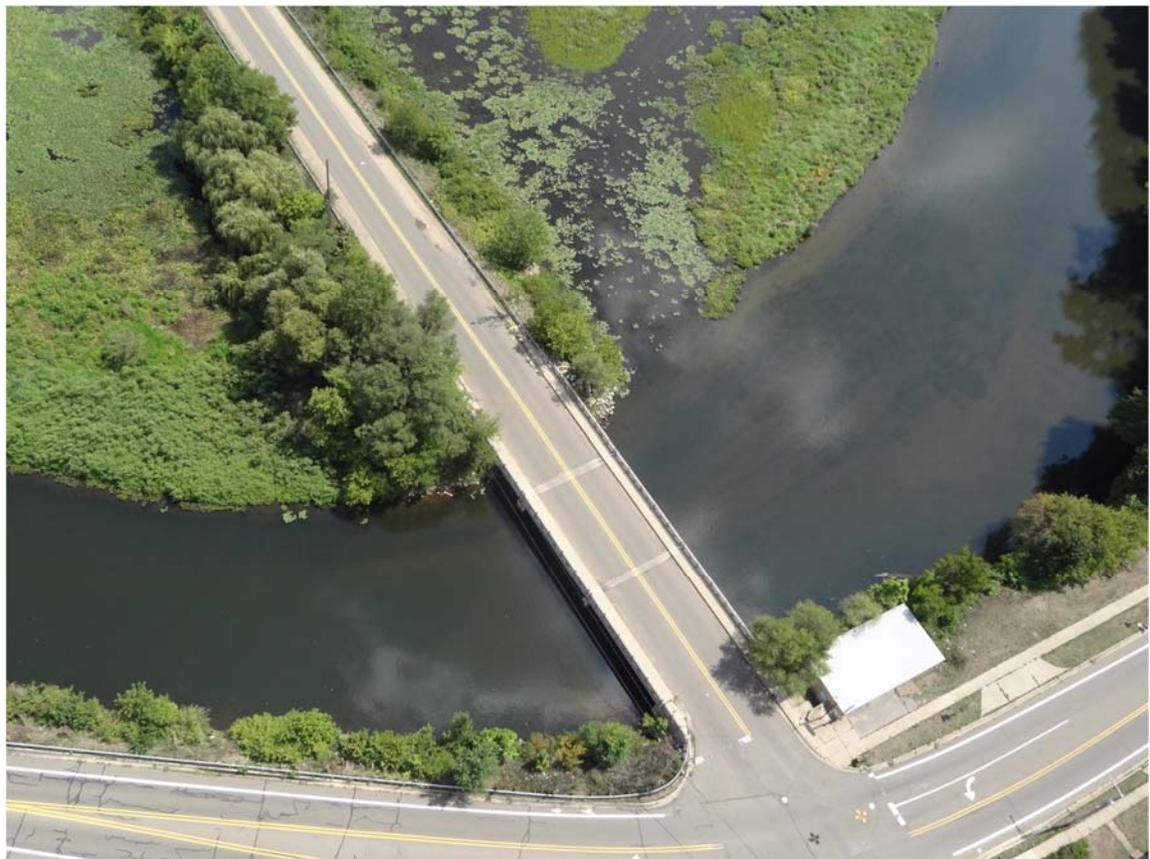
10. MP15.25 Burnham Street Bridge observed sheen flowing within the river channel.

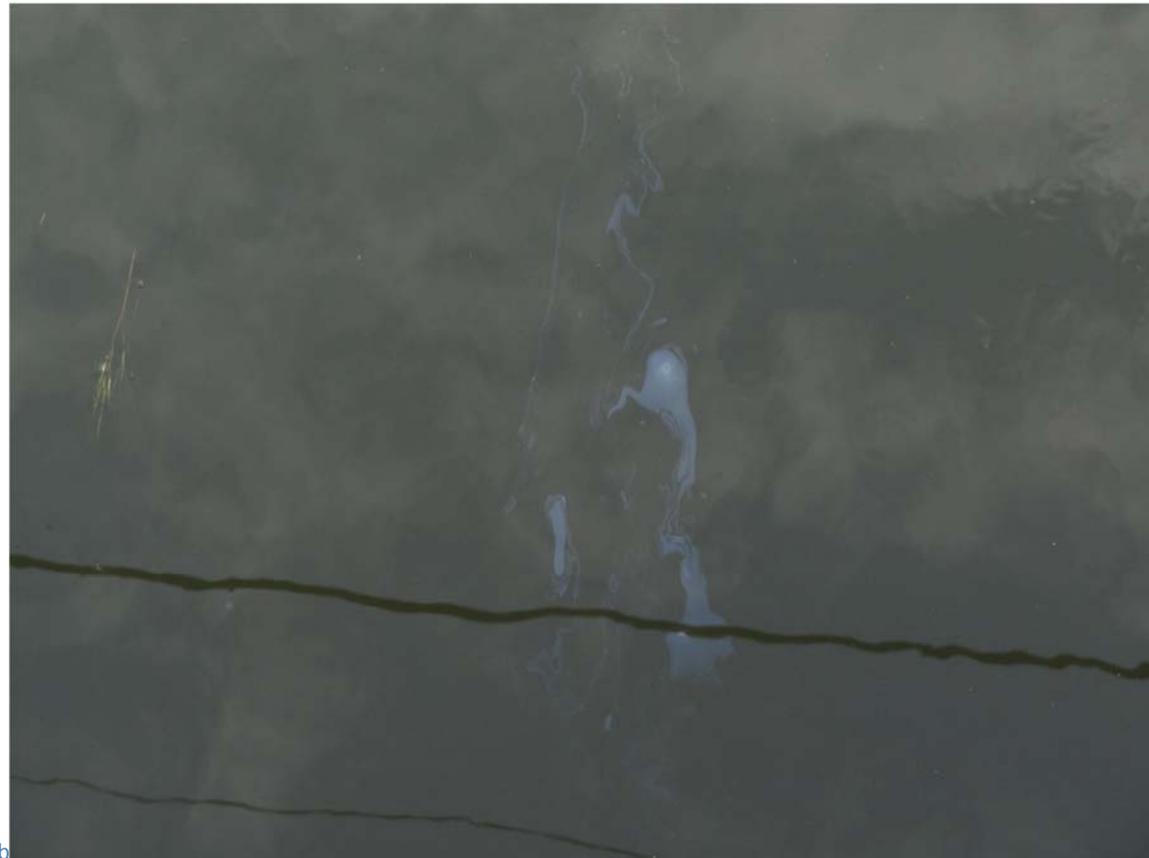
11. MP15.25 Burnham Street Bridge observed sheen flowing within the river channel.

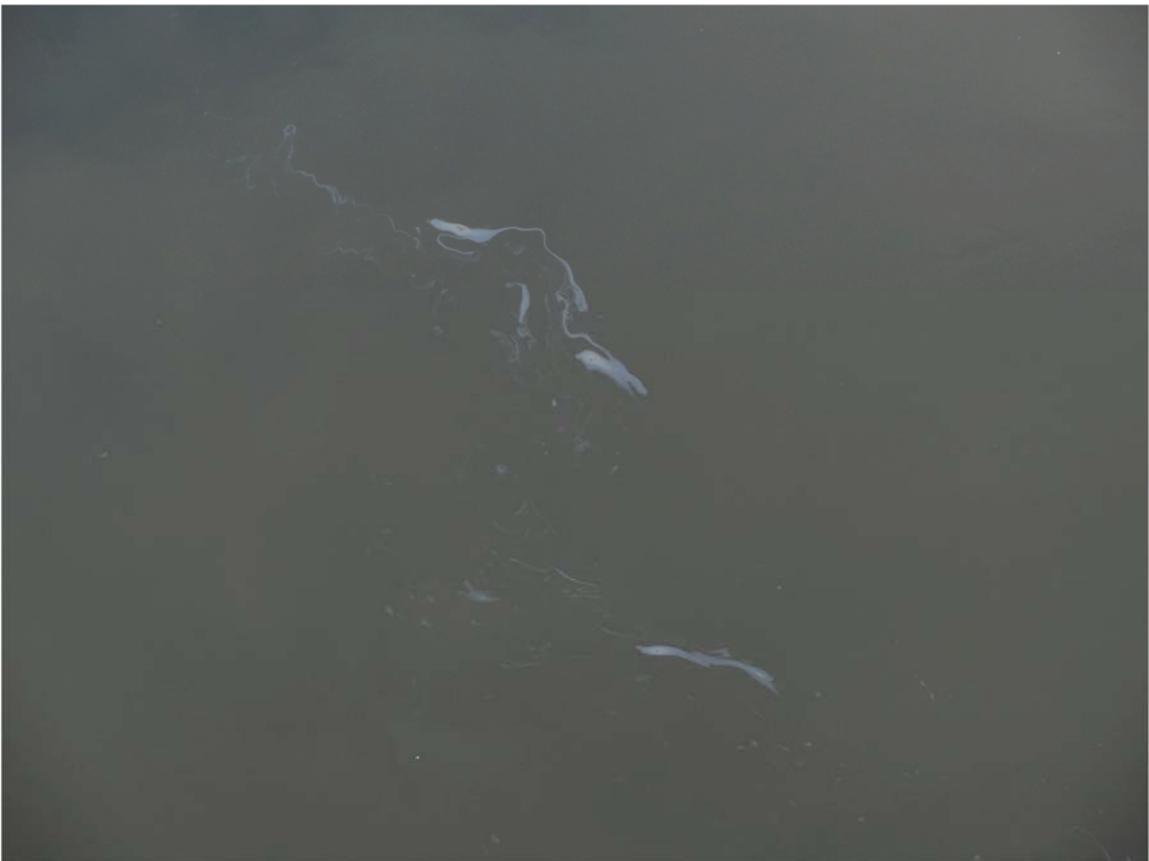
12. MP15.25 Burnham Street Bridge observed sheen flowing within the river channel.

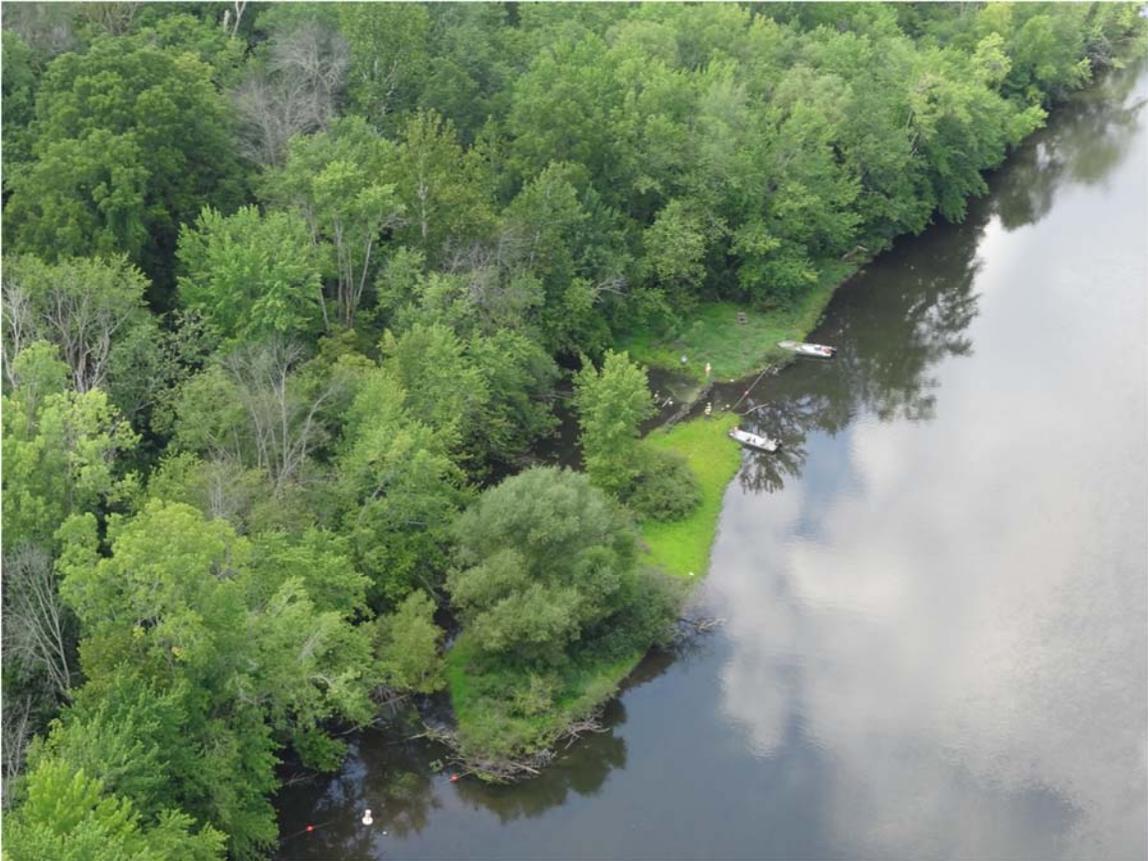
13. MP19.25 Observed crews performing monthly sediment trap monitoring.

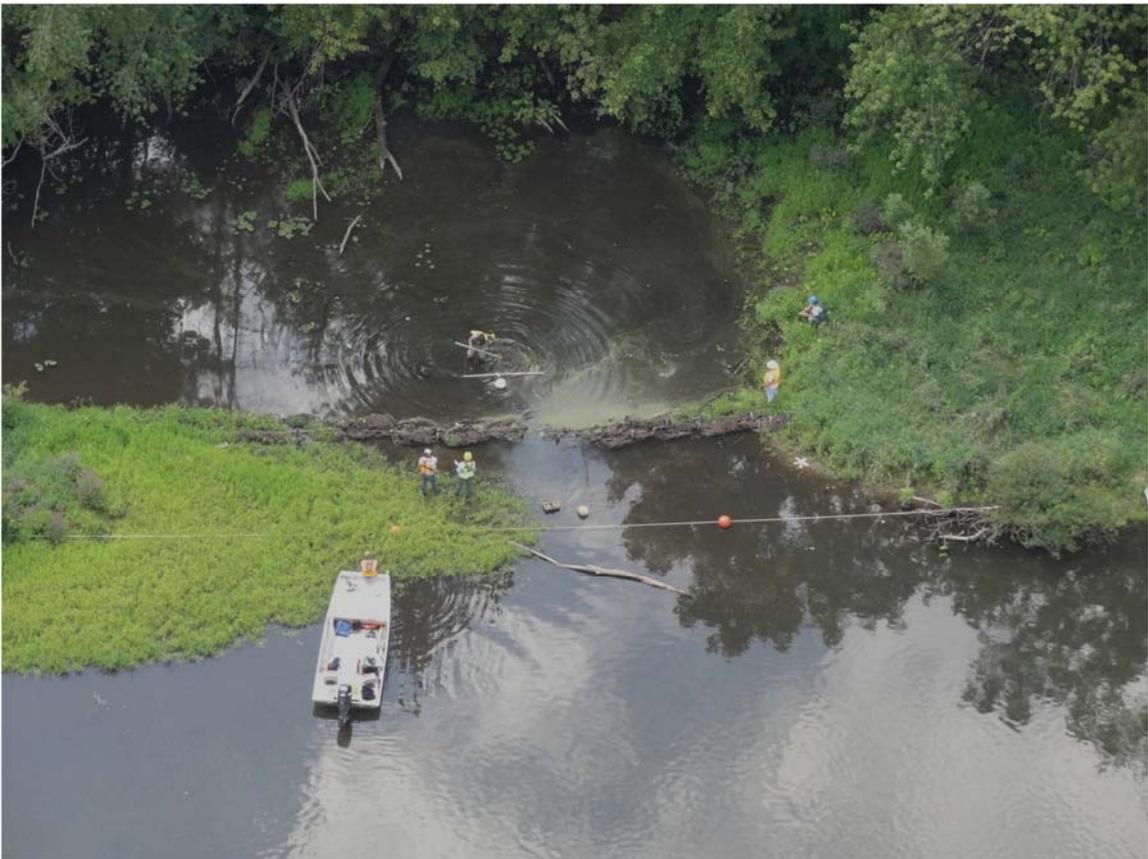
14. MP19.25 Observed crews performing monthly sediment trap monitoring.

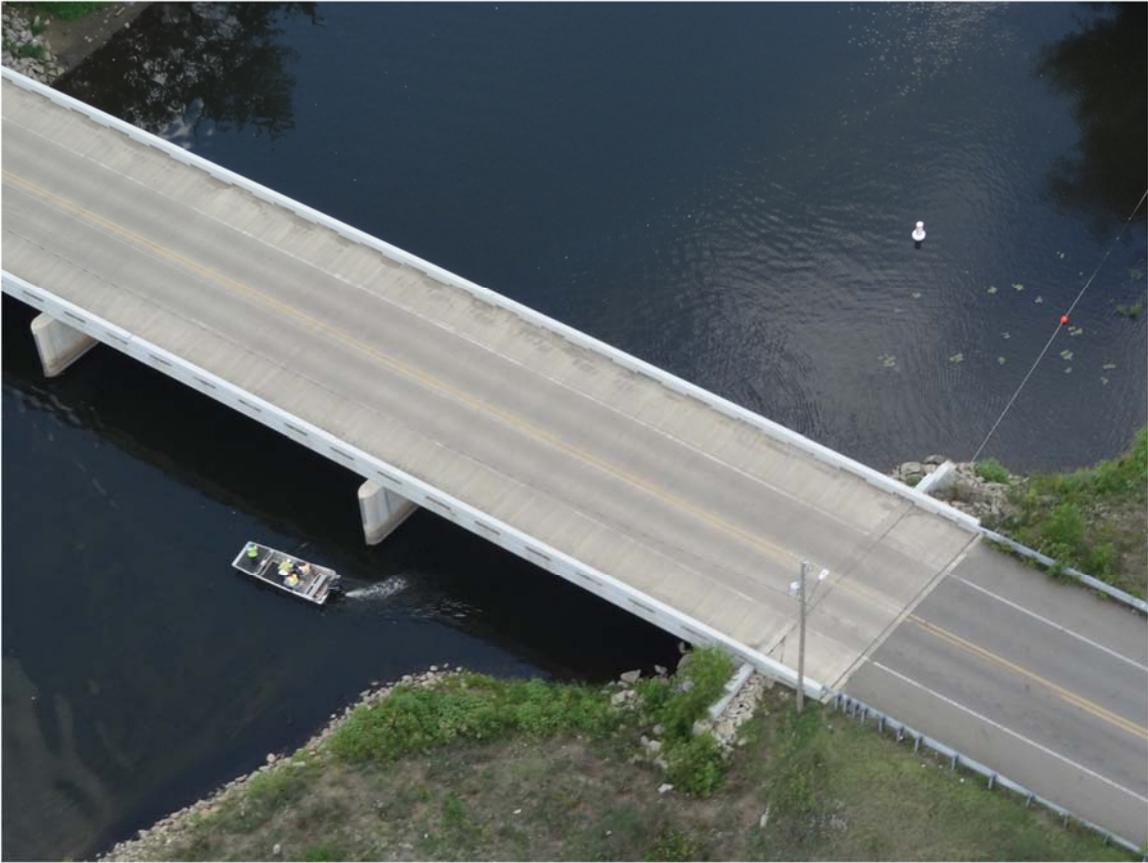
15. MP21.5 Custer Drive Bridge, observed Situation crew.

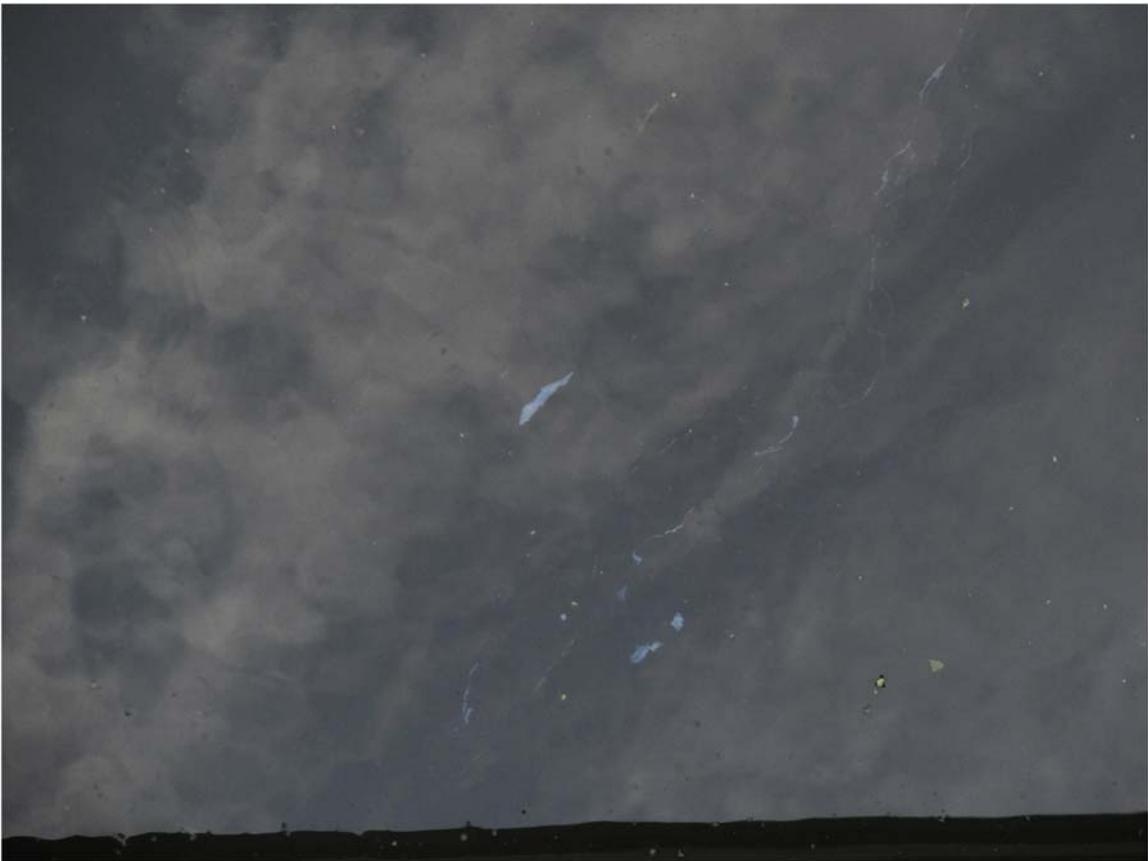
16. MP21.5 Custer Drive Bridge sheen observed. No sweep boat warranted.

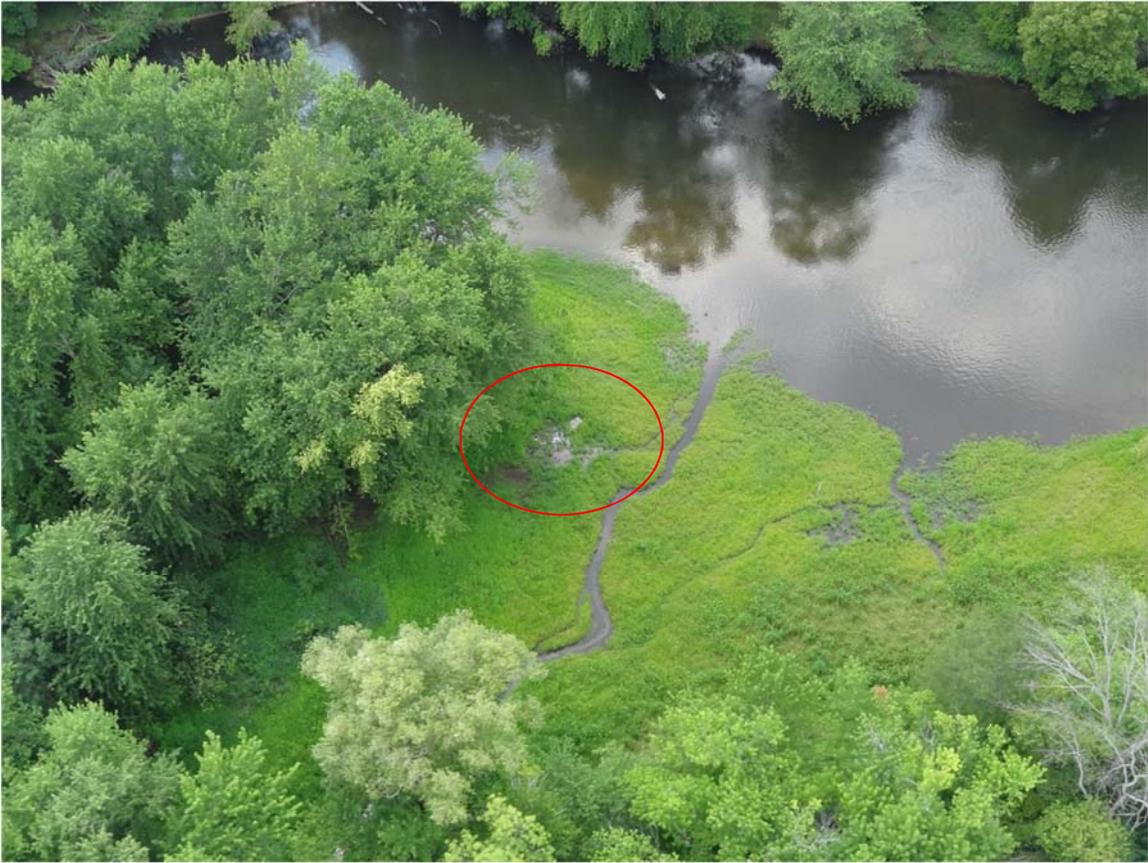
17. MP 26.00 RDB sheen observed.

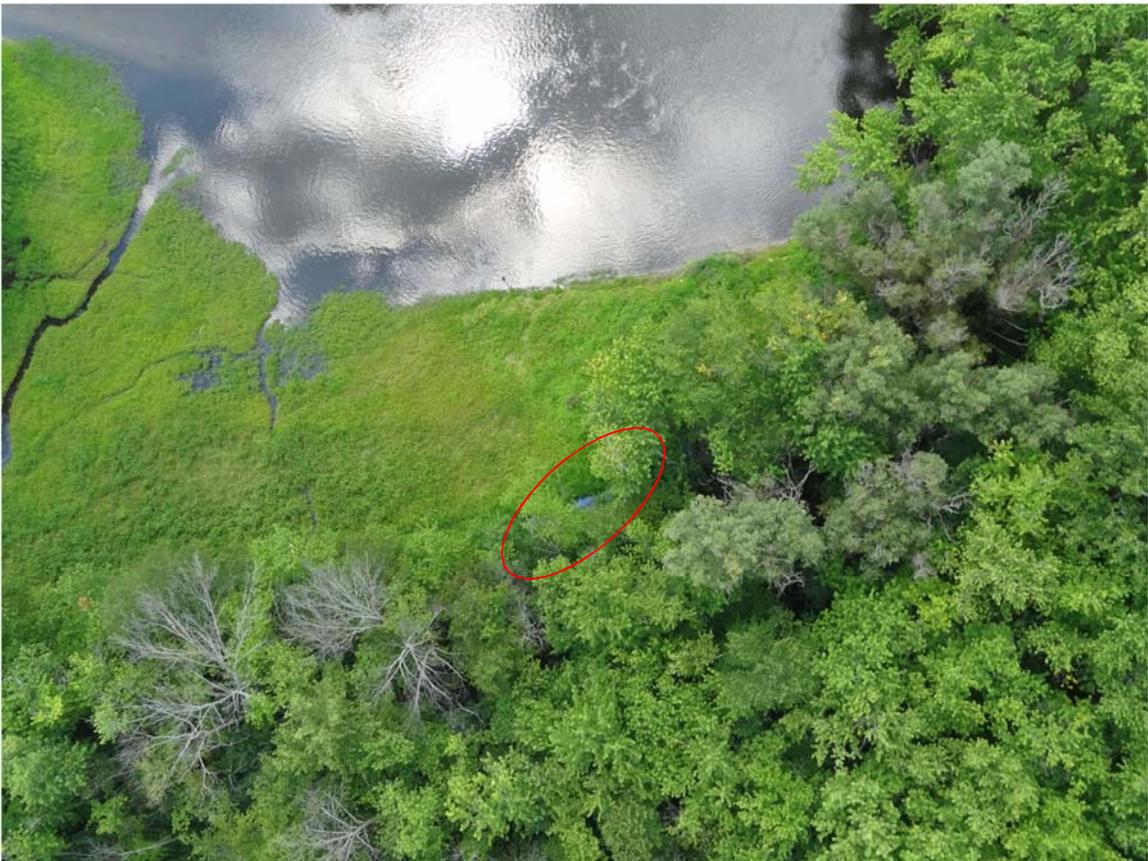
18. MP 26.00 RDB sheen observed.

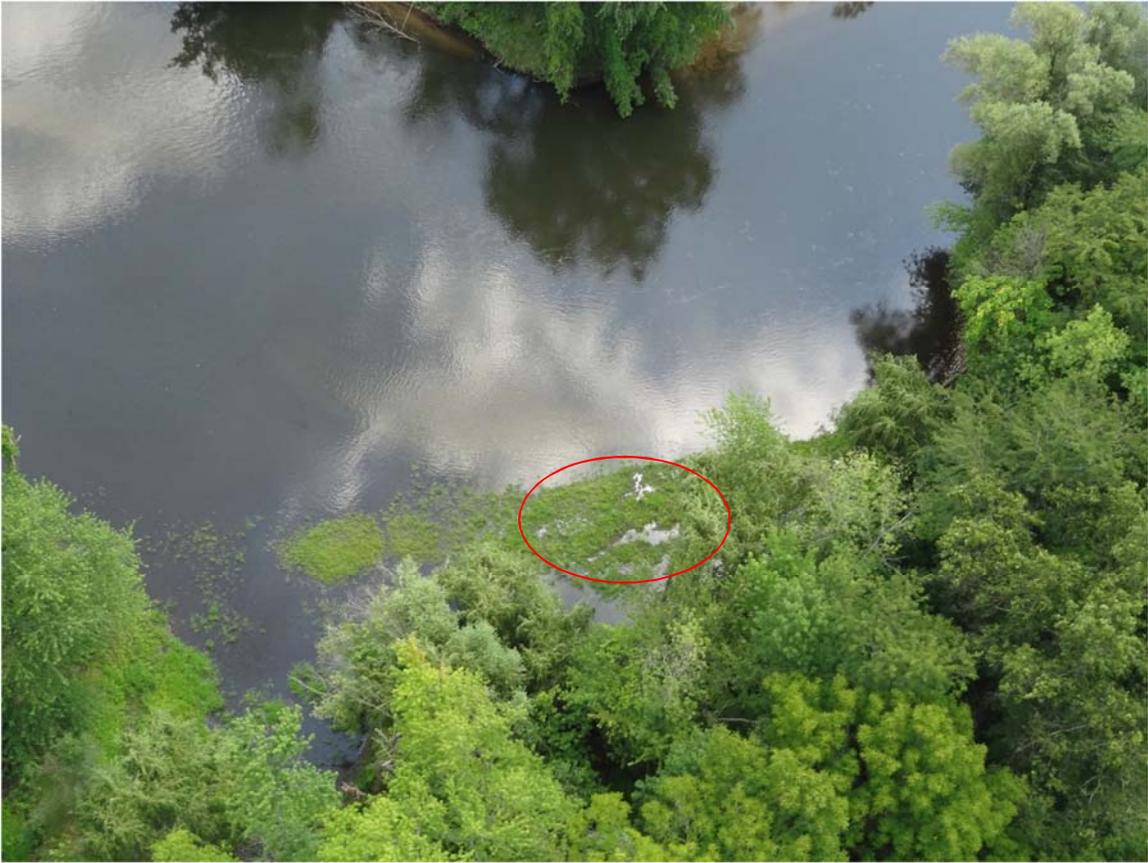
19. MP 26.25 RDB sheen observed.

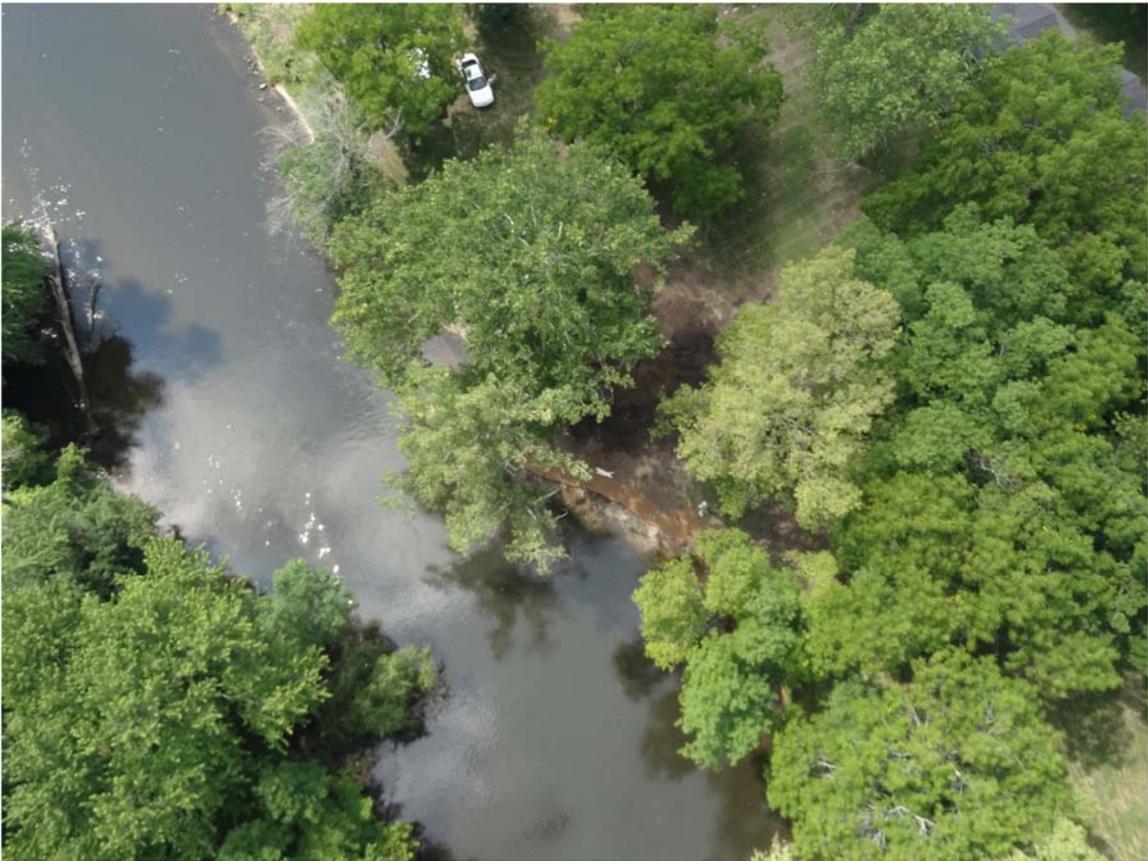
20. MP27.0 RDB observed shoreline restoration work.

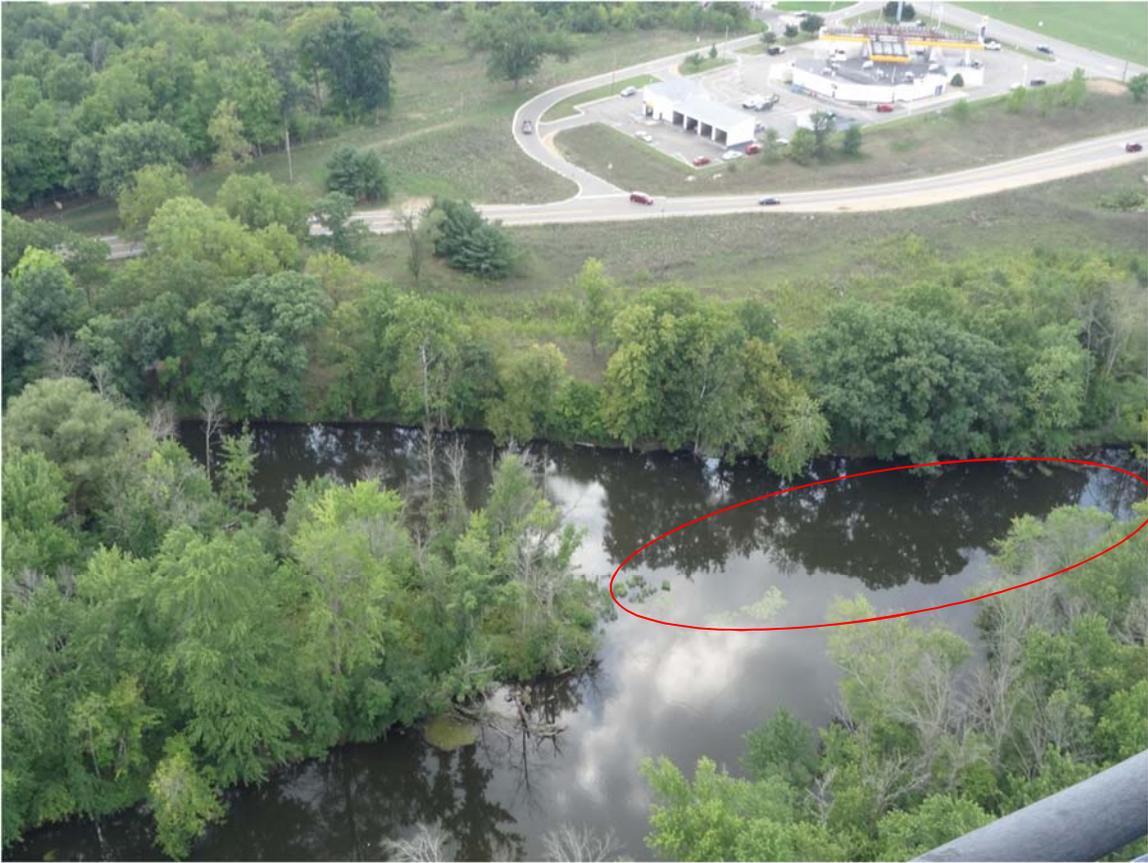
21. MP36.25 area where sheen was observed.

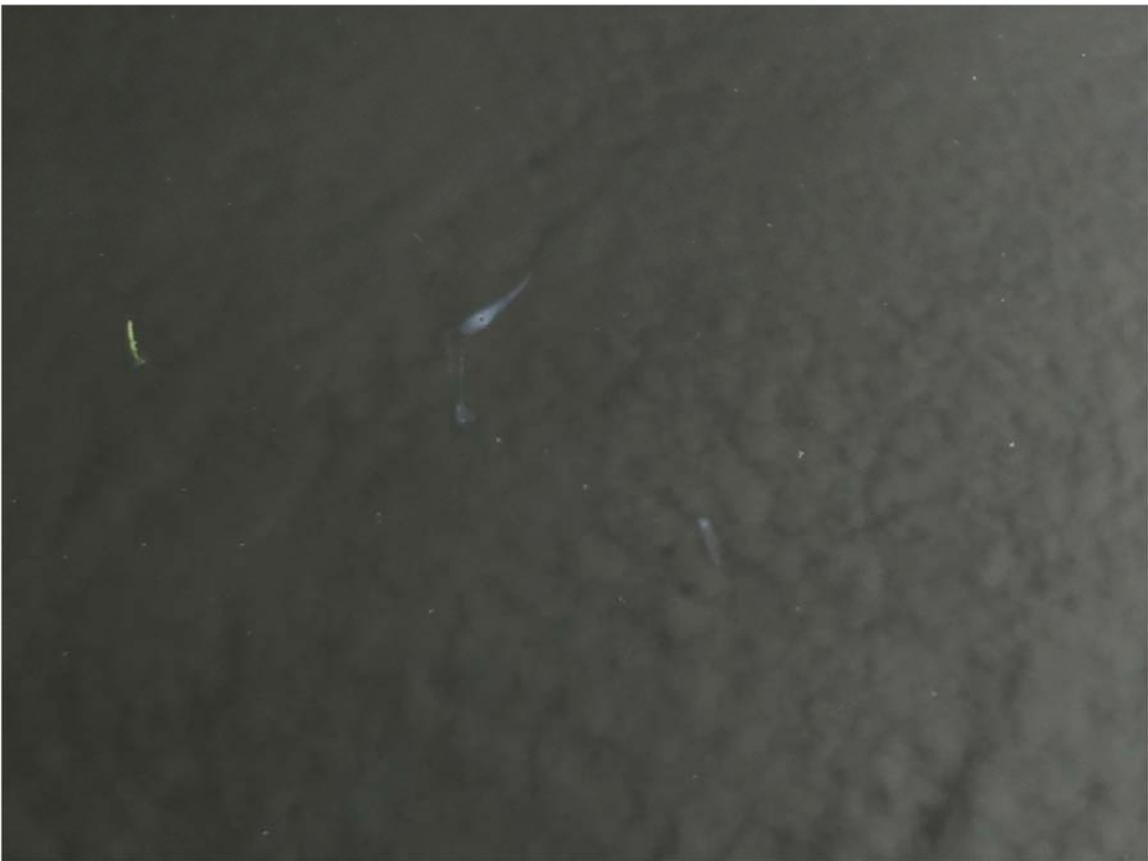
22. MP36.25 sheen was observed. Sweep boat was not warranted.

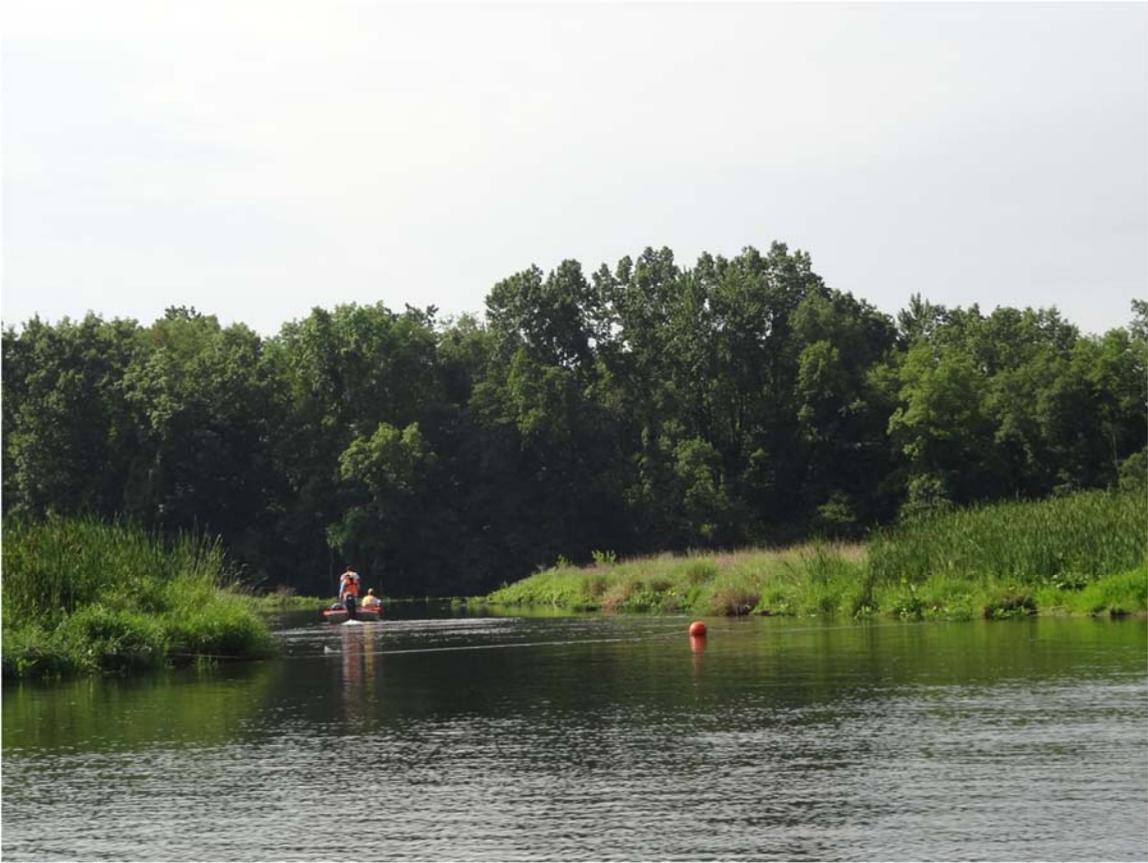
23. Morrow Lake Delta, observed crew inspecting Delta A.
