# Situation Photo Log

Wednesday, August 15, 2012

Kalamazoo River / Enbridge Spill

Prepared by:  
Matthew Haak  
START-USEPA  
Situation Unit Leader

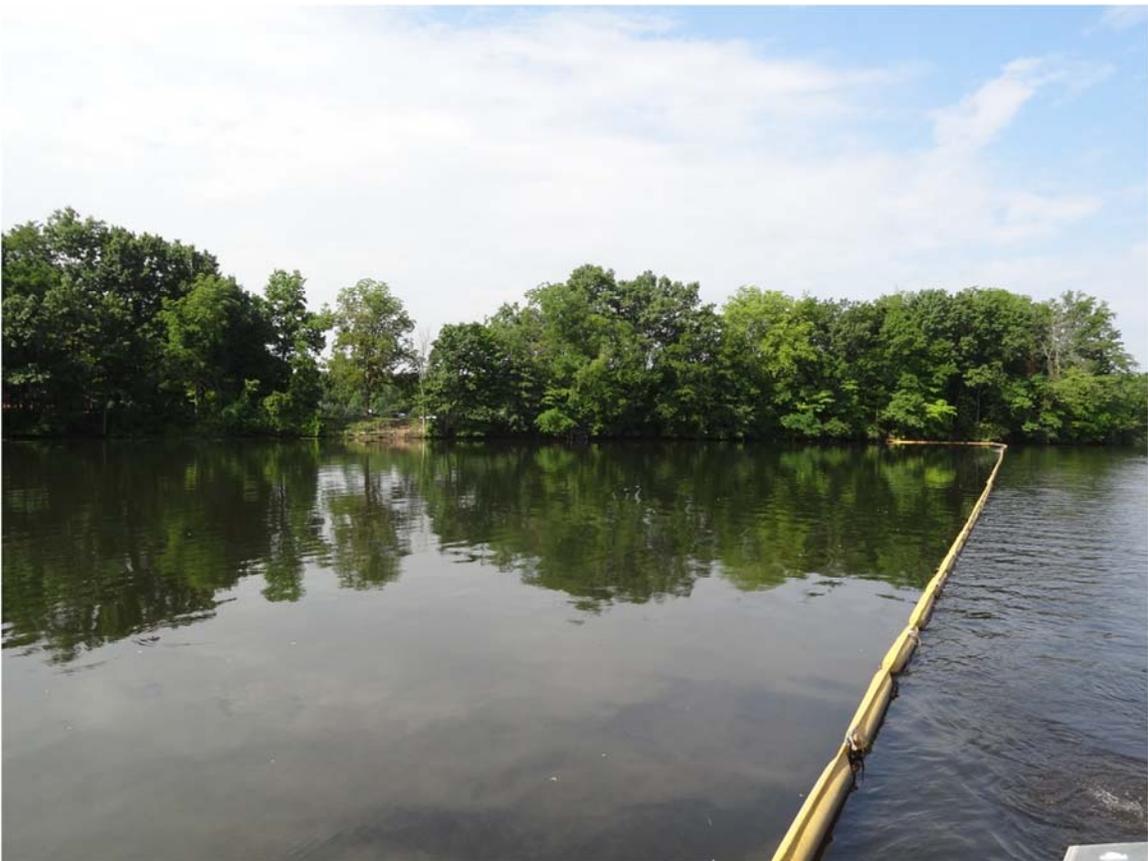
24. Morrow Lake Delta Boom B, observed sheen collecting along the boom.

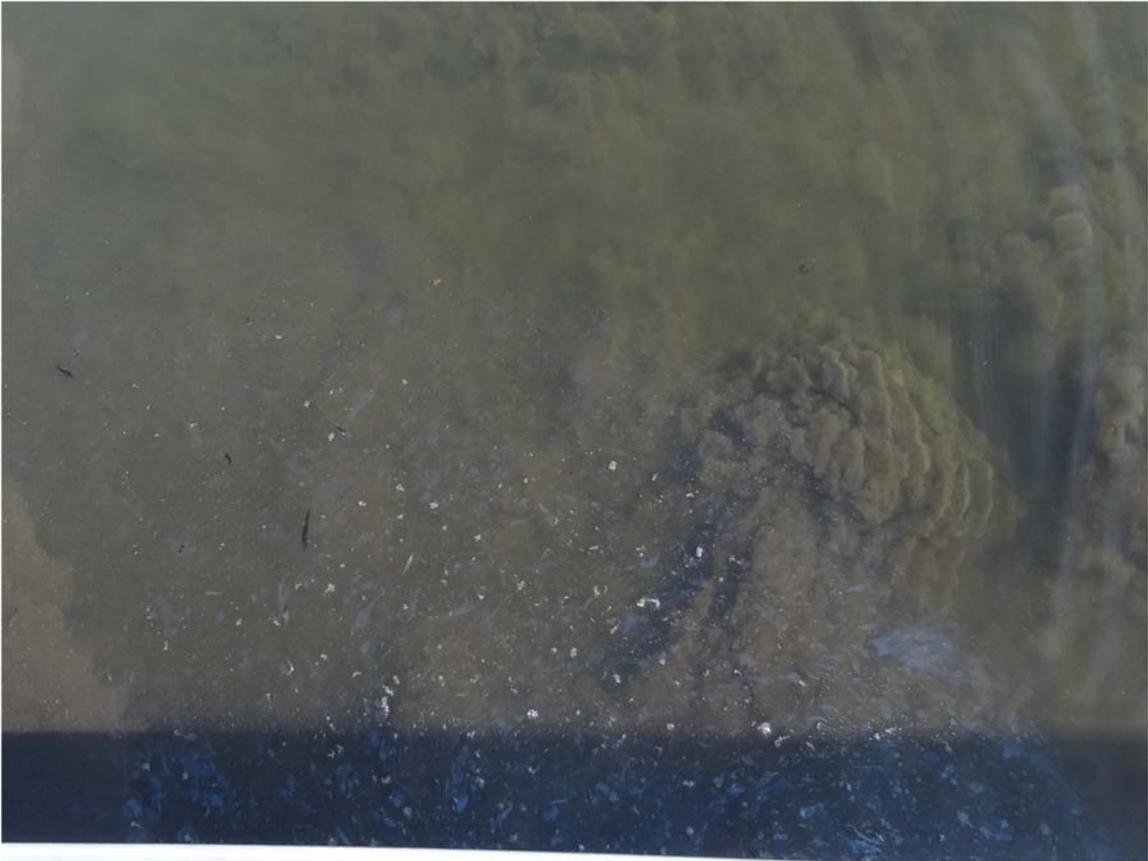
25. Morrow Lake Delta Boom B, observed sheen when boat reversed.

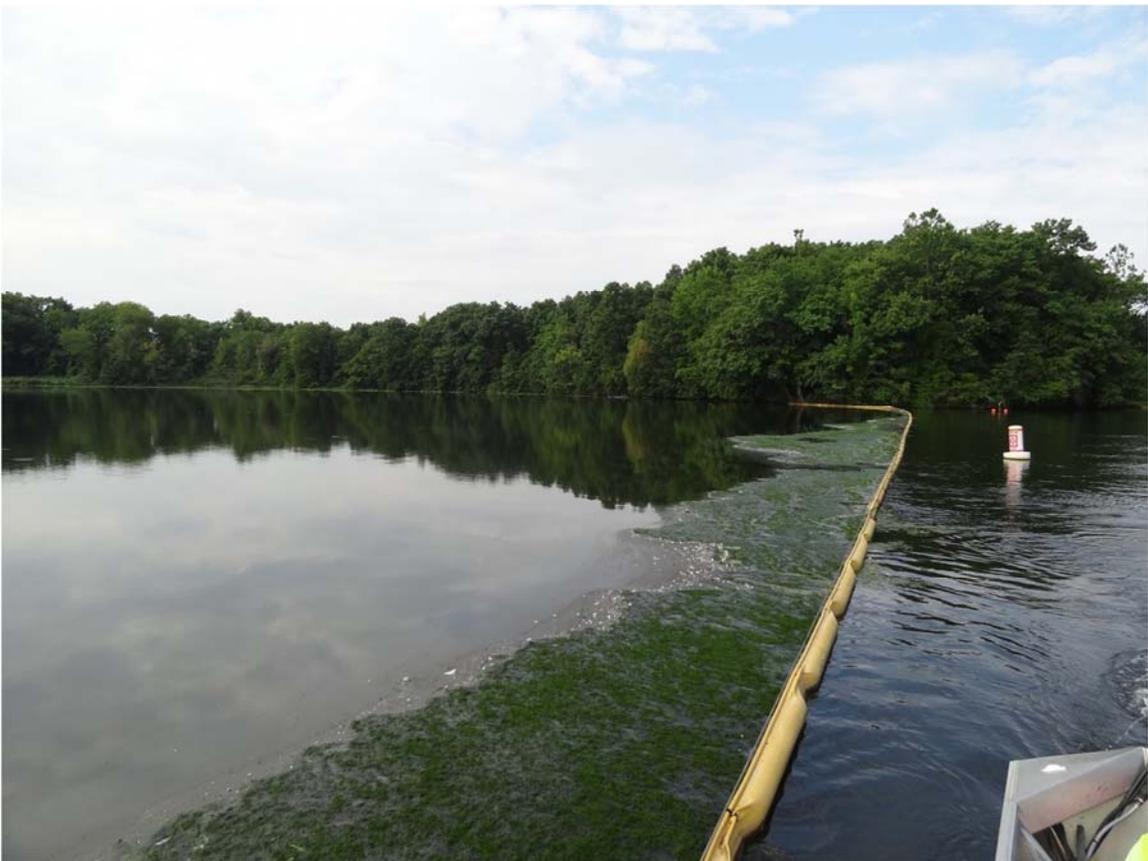
26. Morrow Lake Delta Boom C, observed sheen and debris collecting along the boom.

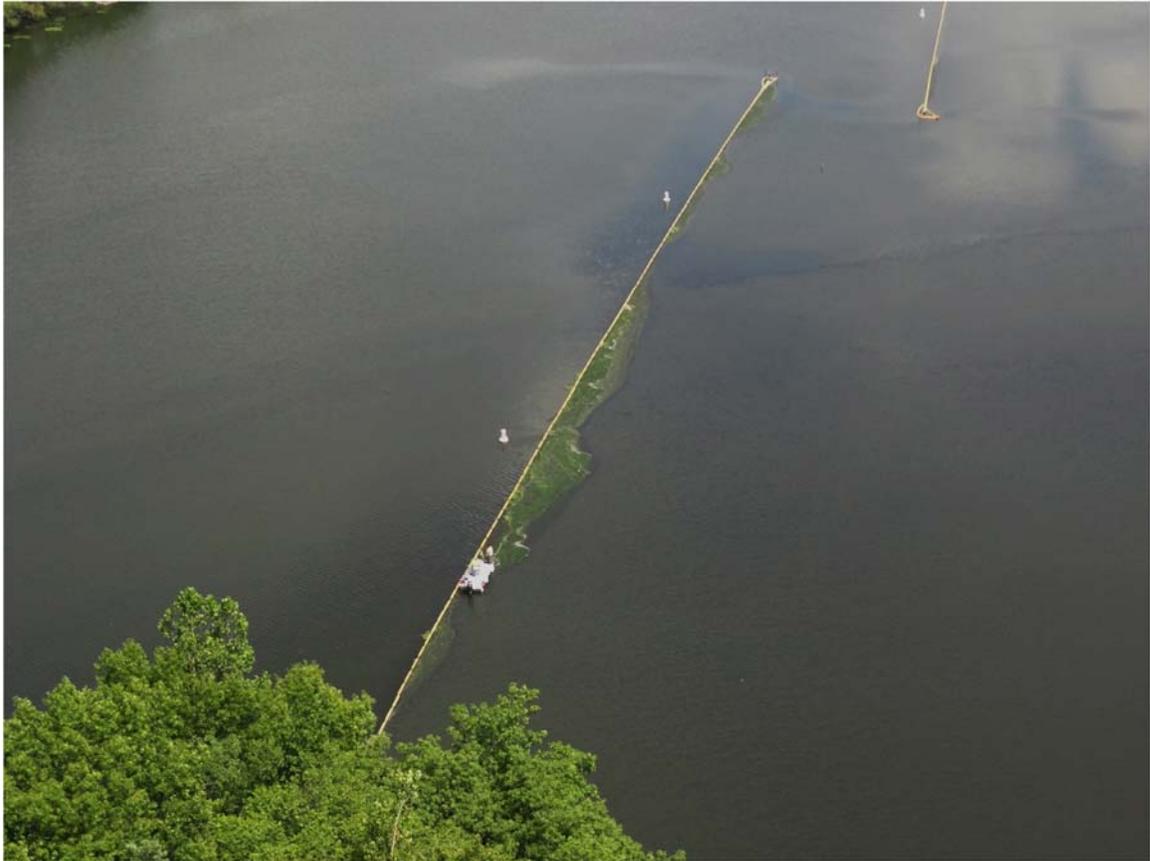
**27. Morrow Lake Delta Boom C, observed crew removing sheen and debris collecting along the boom.**

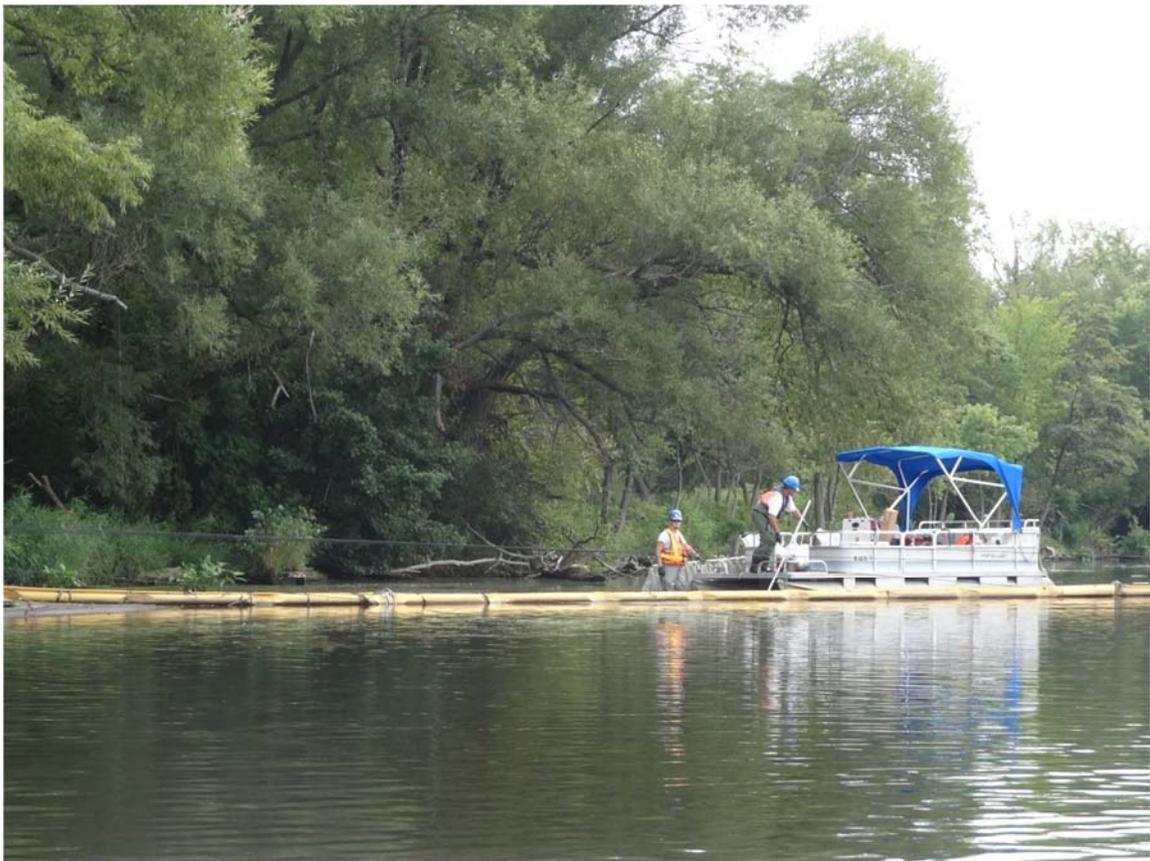
**28. Morrow Lake Delta Boom E, observed crew removing sheen and debris collecting along the boom.**

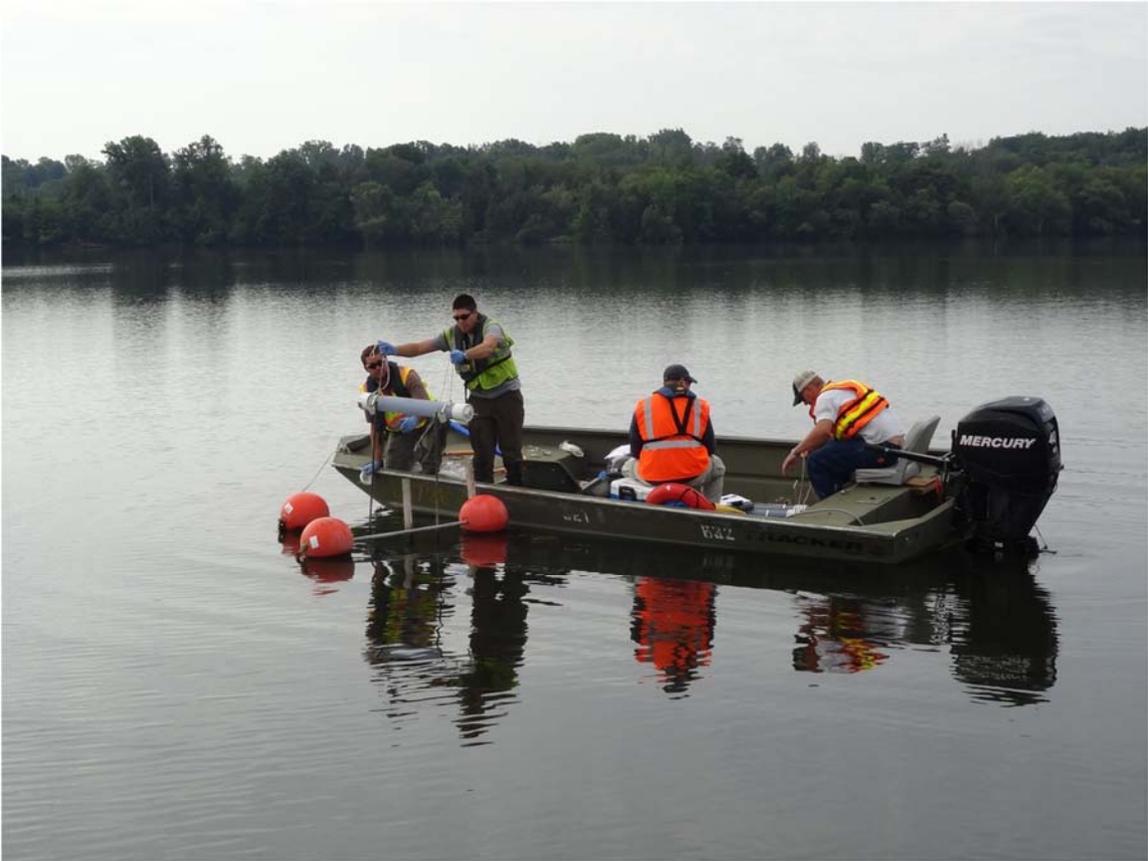
29. Morrow Lake observed crew redeploying Walling Tube sampling devices.

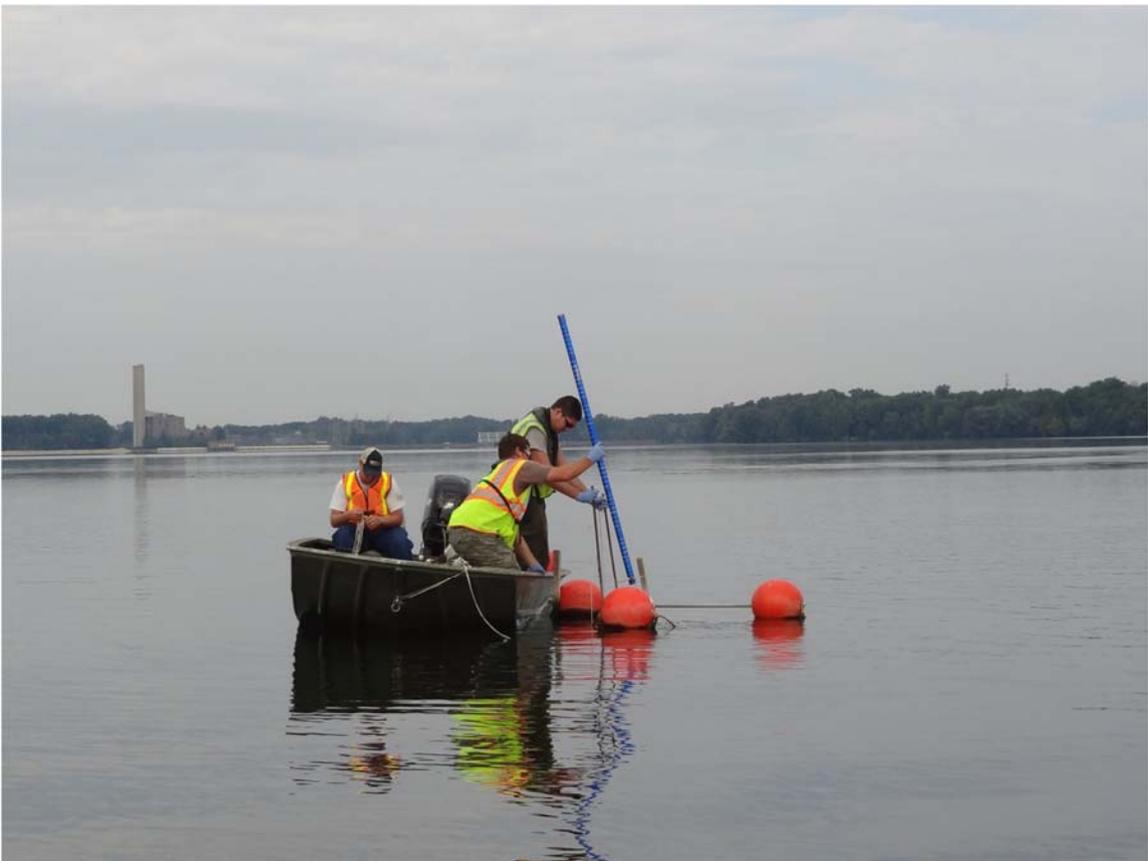
30. Morrow Lake observed crew redeploying Walling Tube sampling devices.

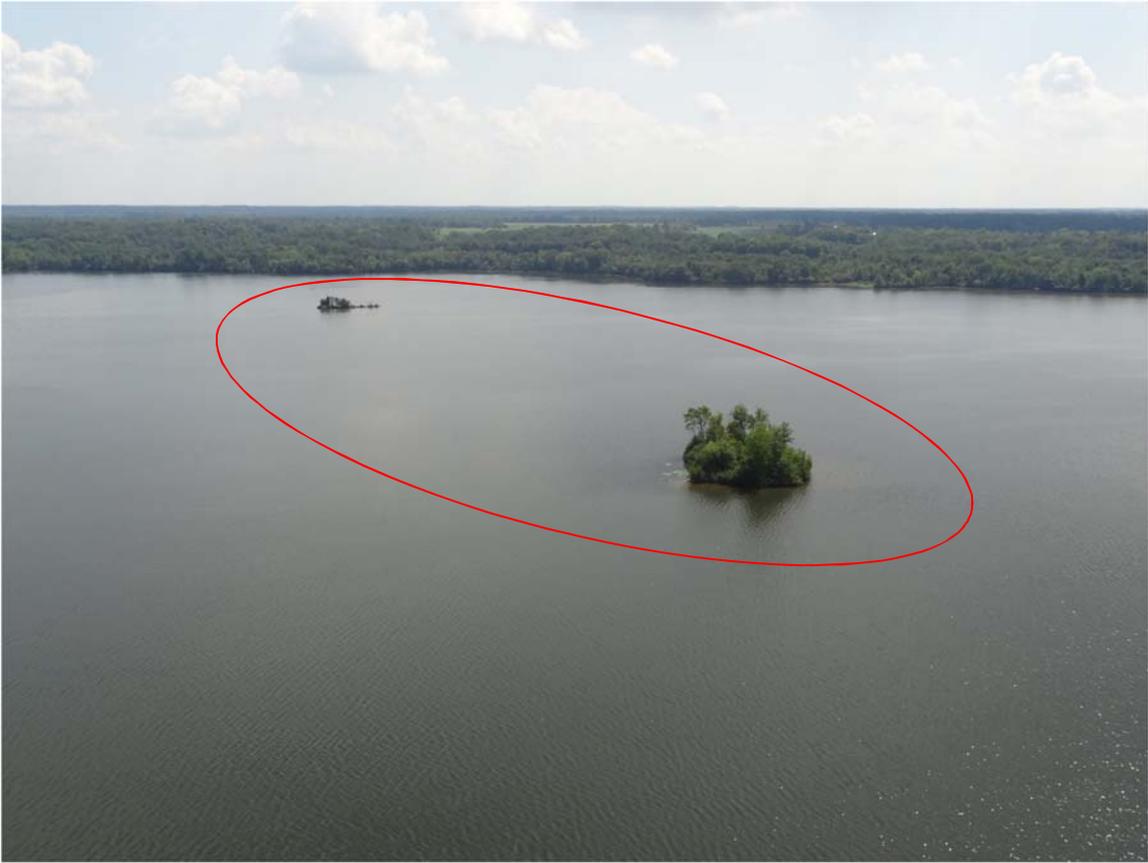
31. Morrow Lake area where sheen was observed.

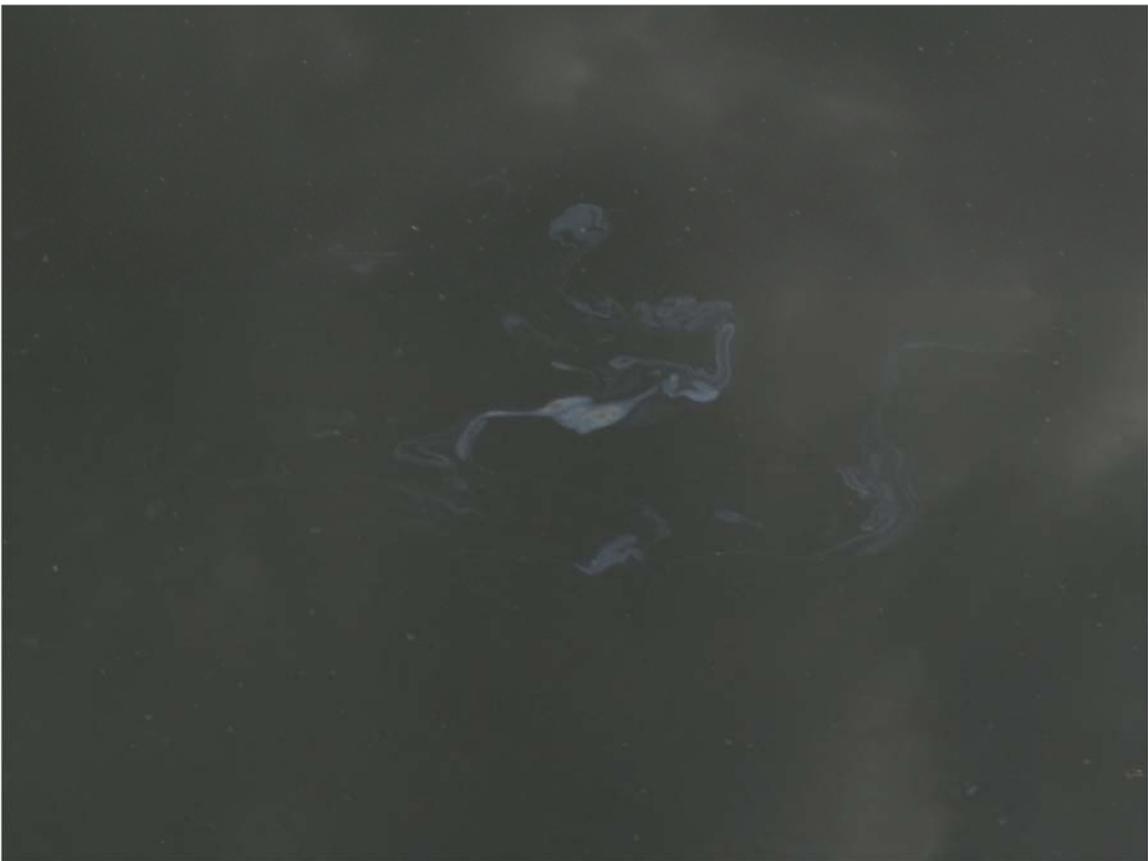
32. Morrow Lake sheen was observed between Rowe Island and the small island.

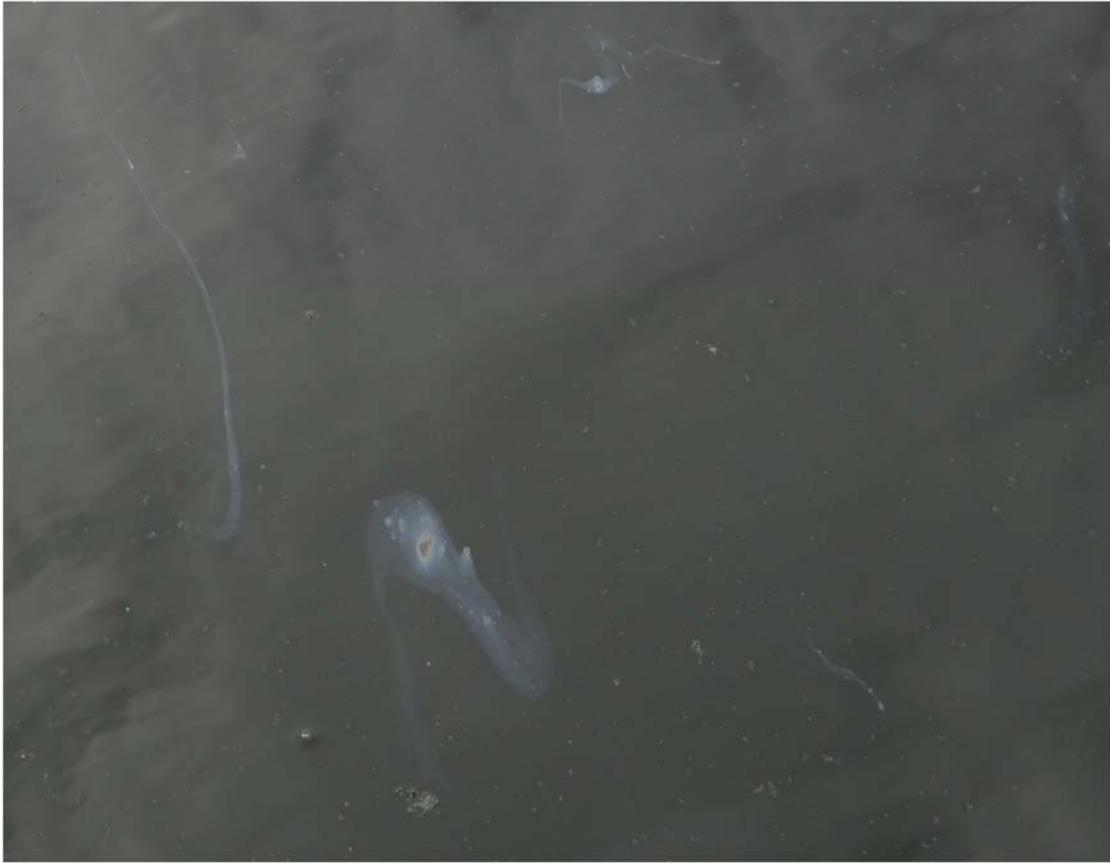
**33. Morrow Lake sheen was observed between Rowe Island and the small island.**

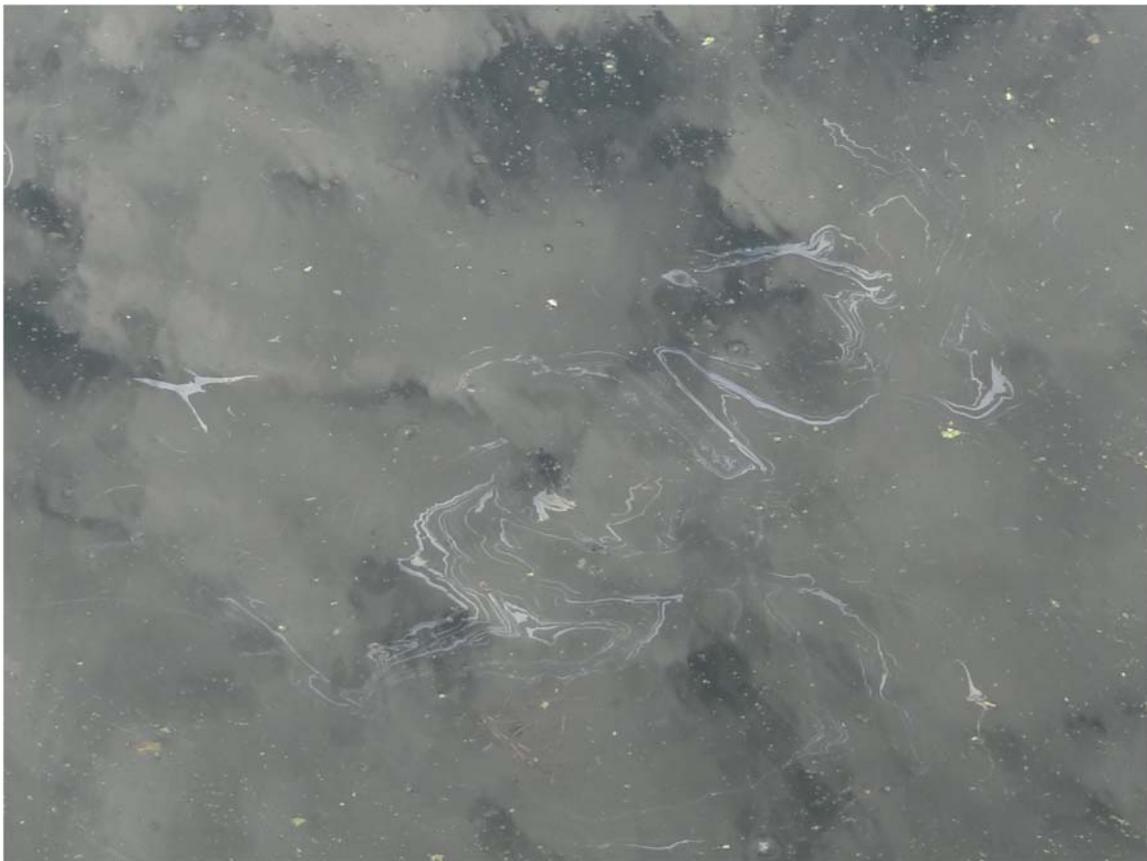
**34. Morrow Lake sheen was observed between Rowe Island and the small island.**

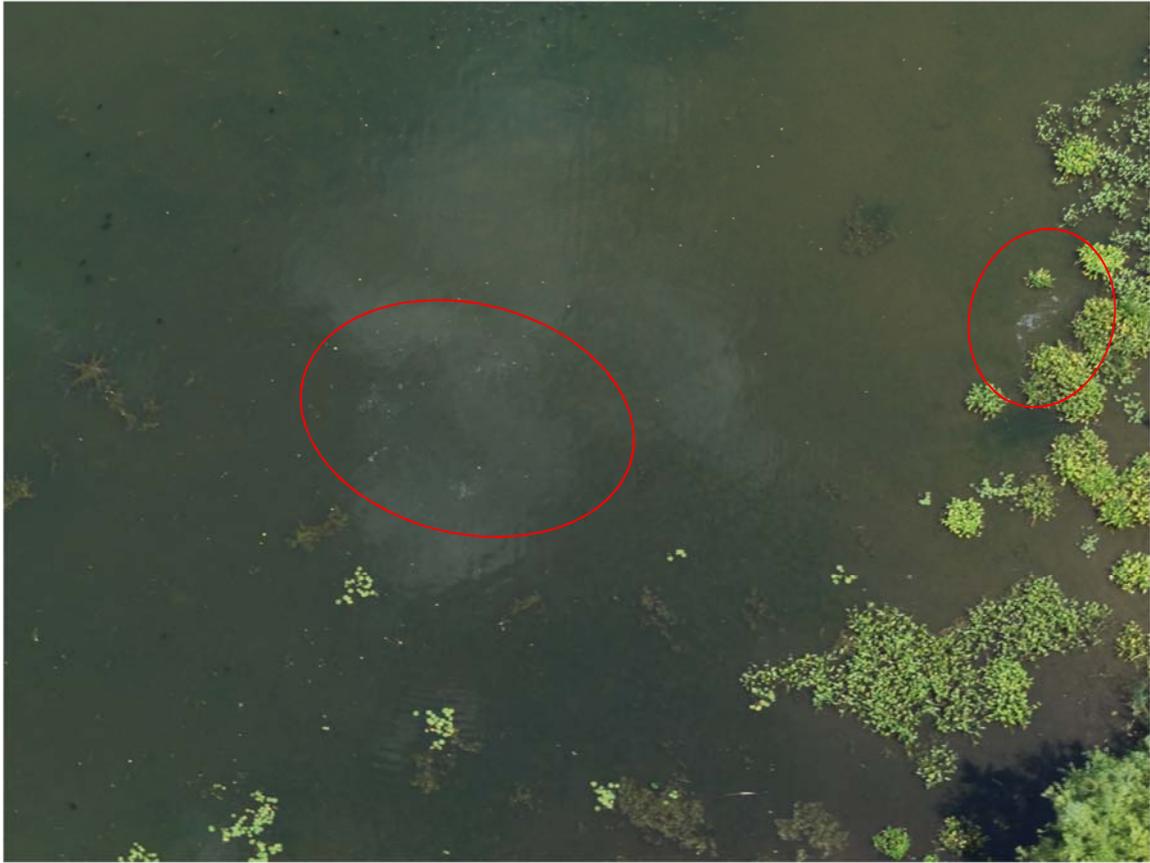
35. Morrow Lake southwest cove sheen observed.
