Situation Photo Log

Friday, August 17, 2012

Kalamazoo River / Enbridge Spill

Prepared by:
Matthew Haak
START-USEPA
Situation Unit Leader

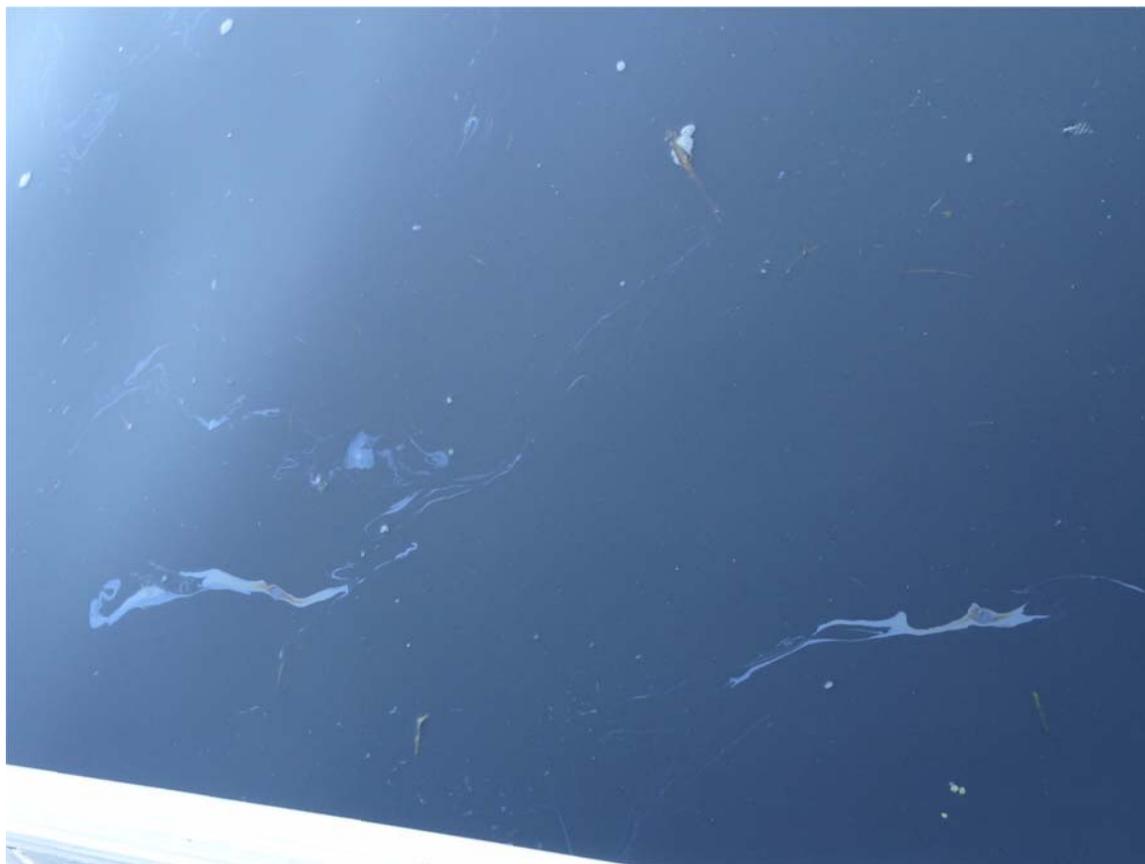
1. C0.4 boat launch sheen was observed.

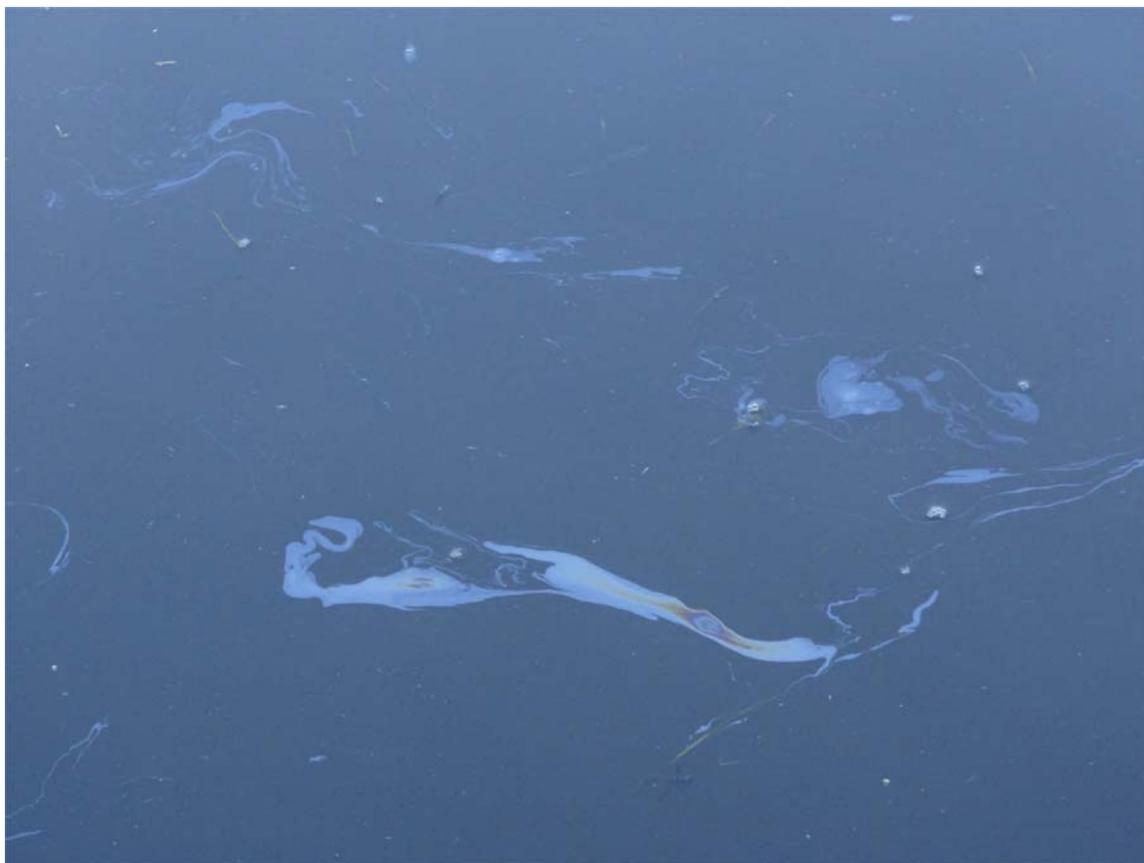
2. C0.4 boat launch sheen was observed.

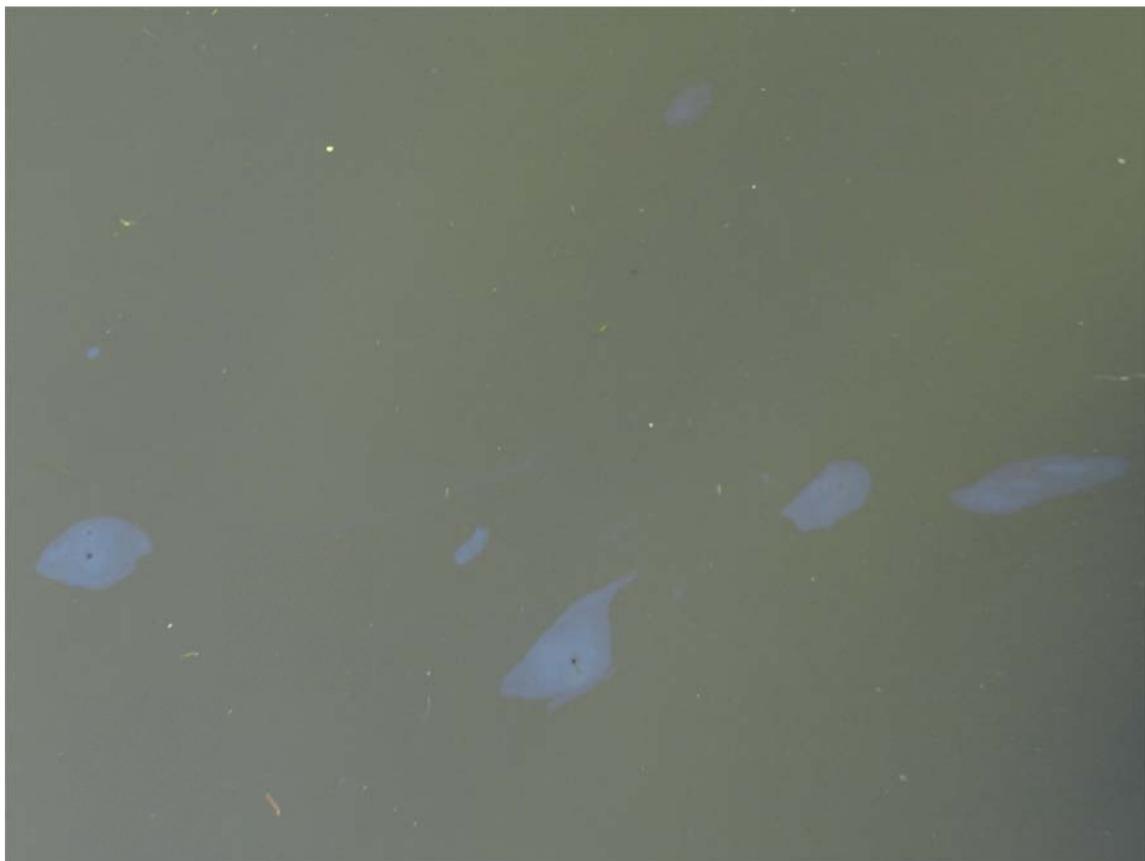
3. MP5.3 LDB tar globs and sheen observed.

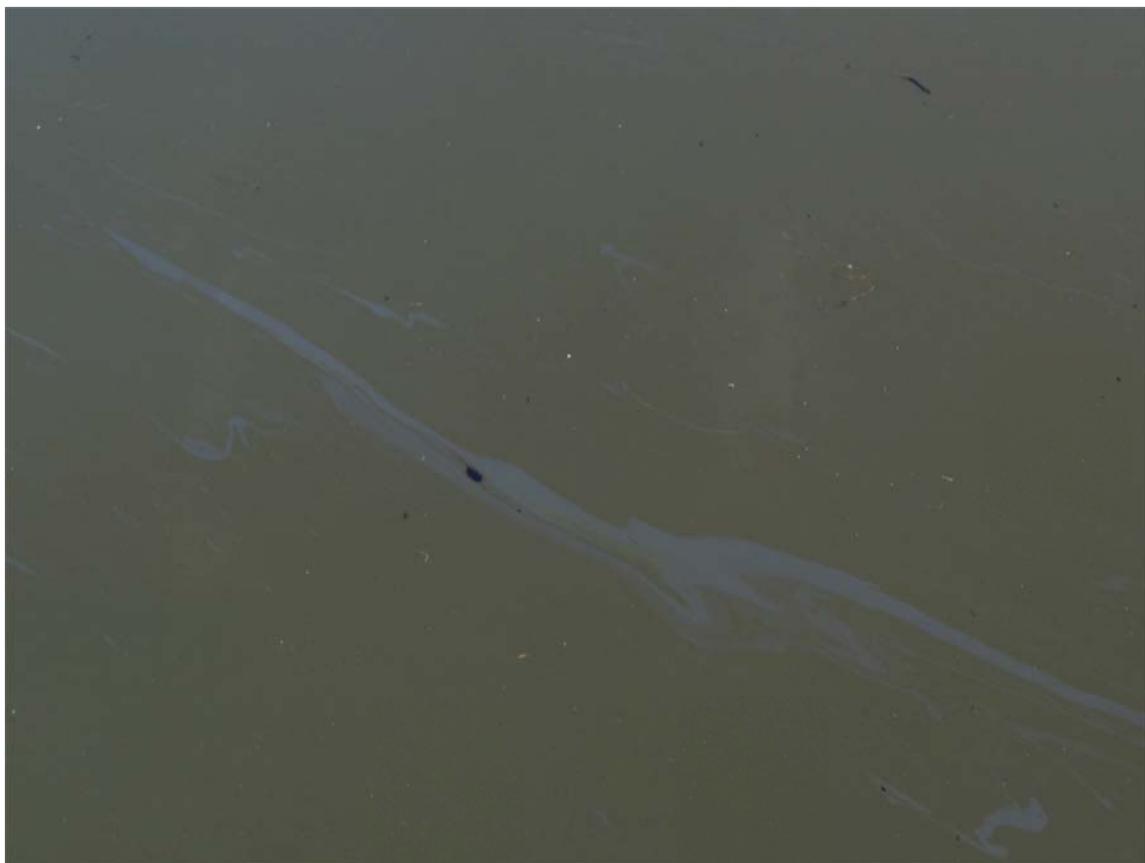
4. MP5.63 LDB tar globs and sheen observed.

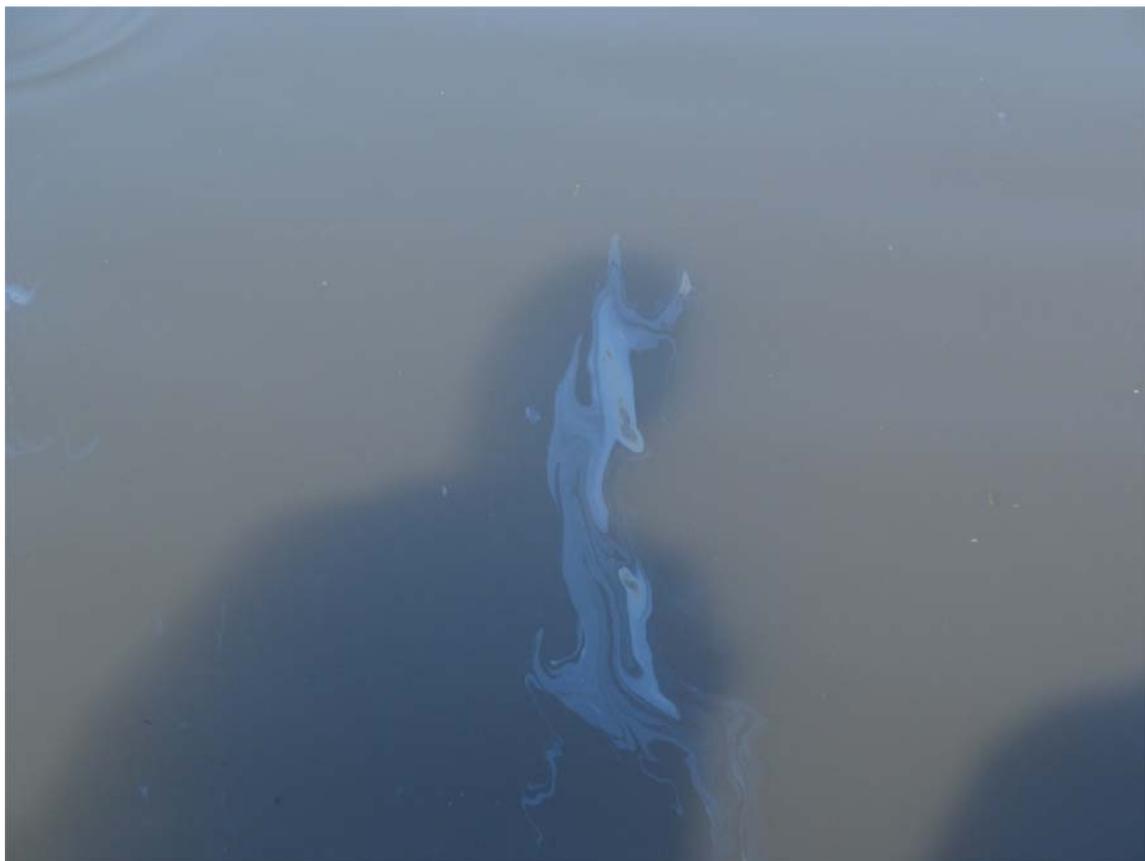
5. MP5.63 LDB tar globs and sheen observed.

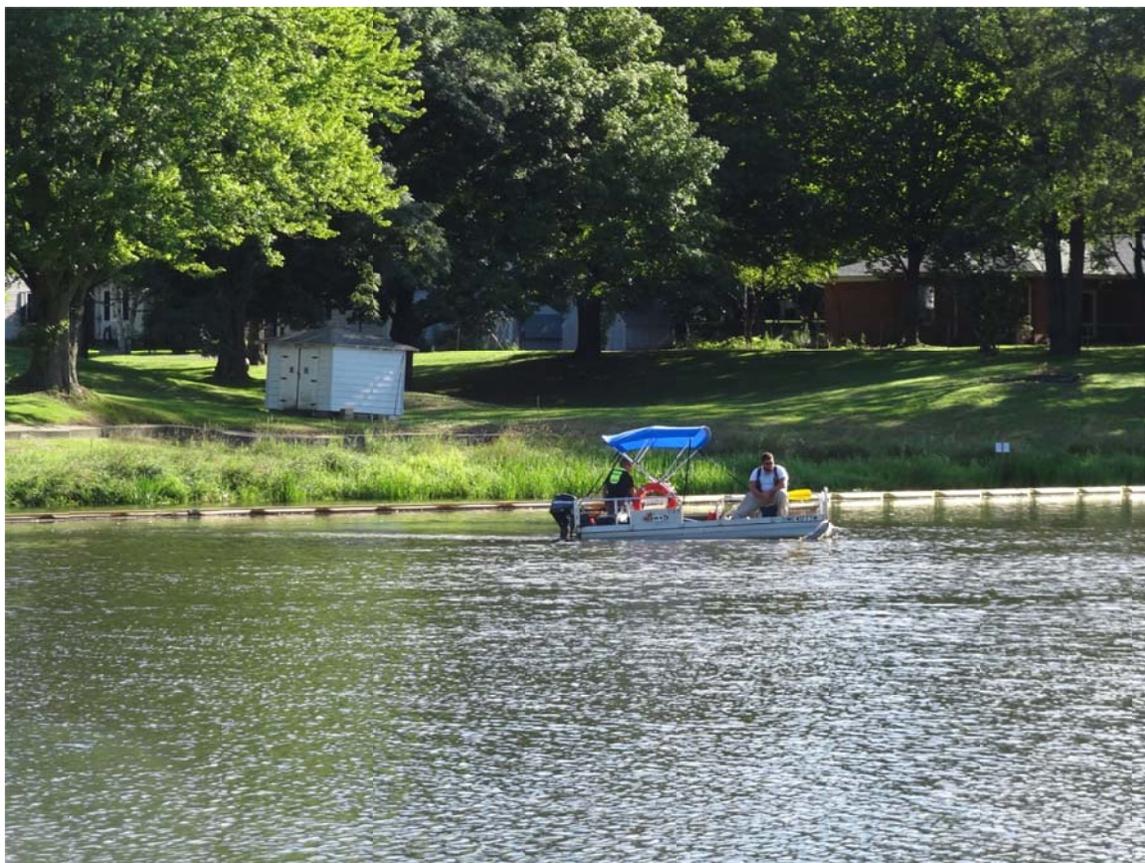
6. Ceresco Dam sheen sweep observed operating.

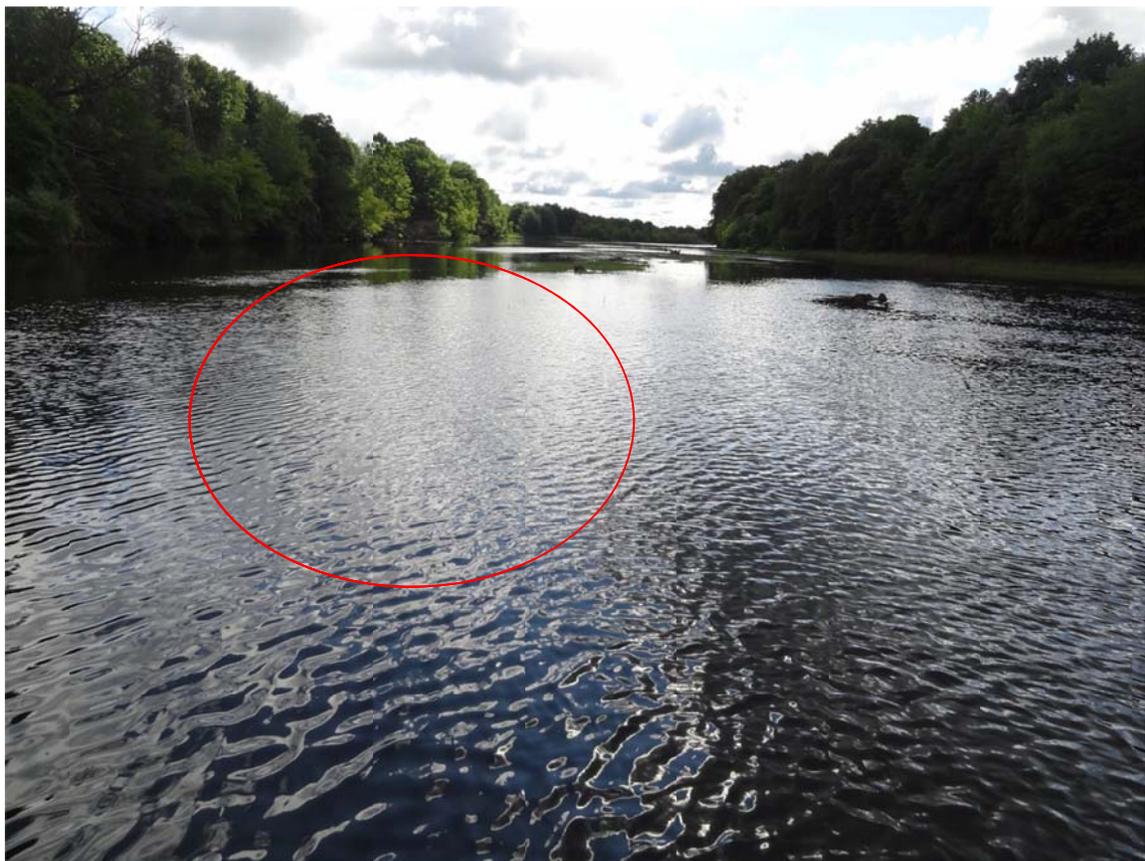
7. MP4.5 below the former Island F area where sheen was observed.

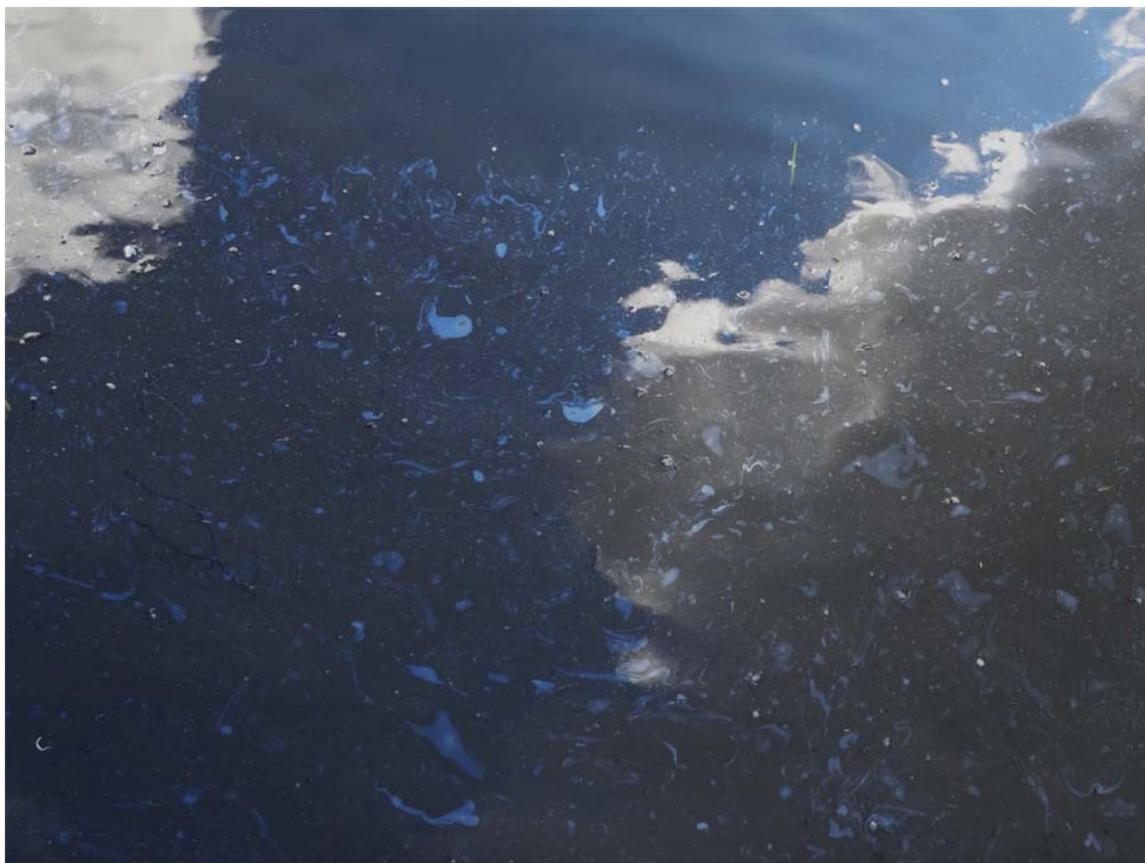
8. MP4.5 below the former Island F sheen was observed when the boat reversed.

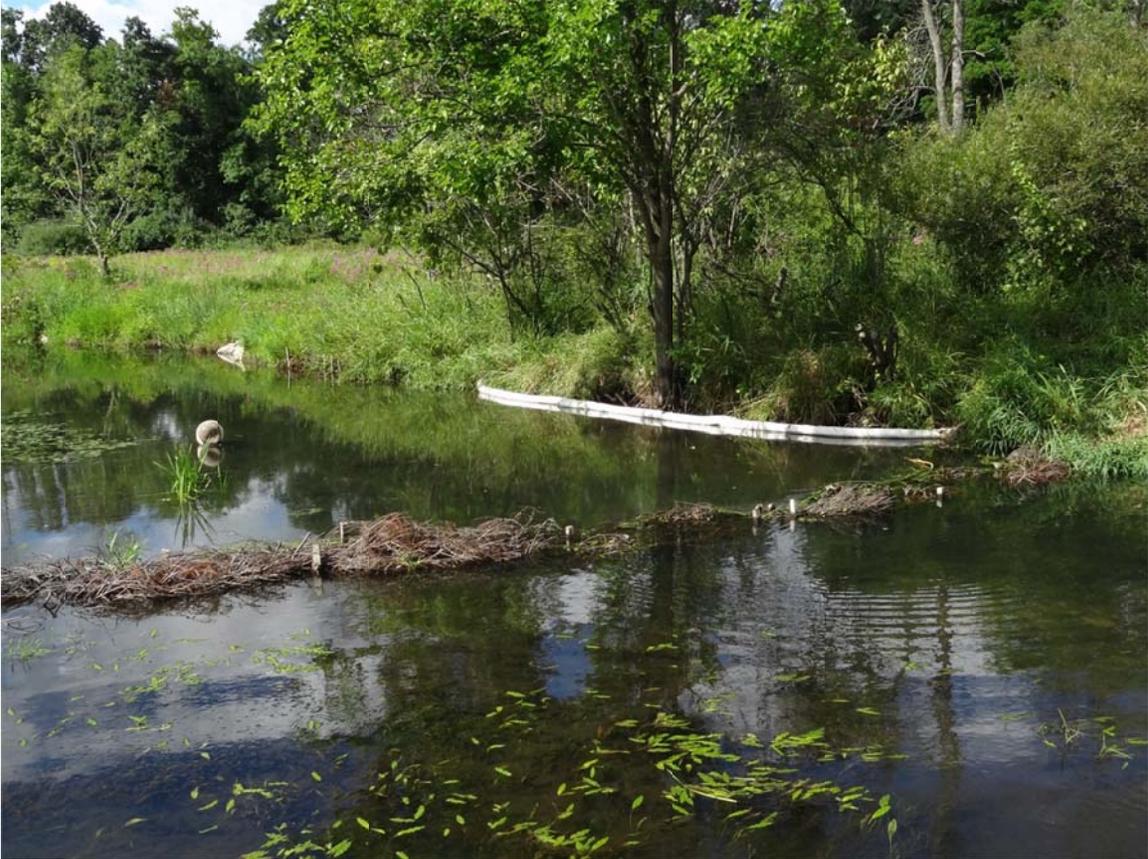
9. MP10.75 no sheen observed.

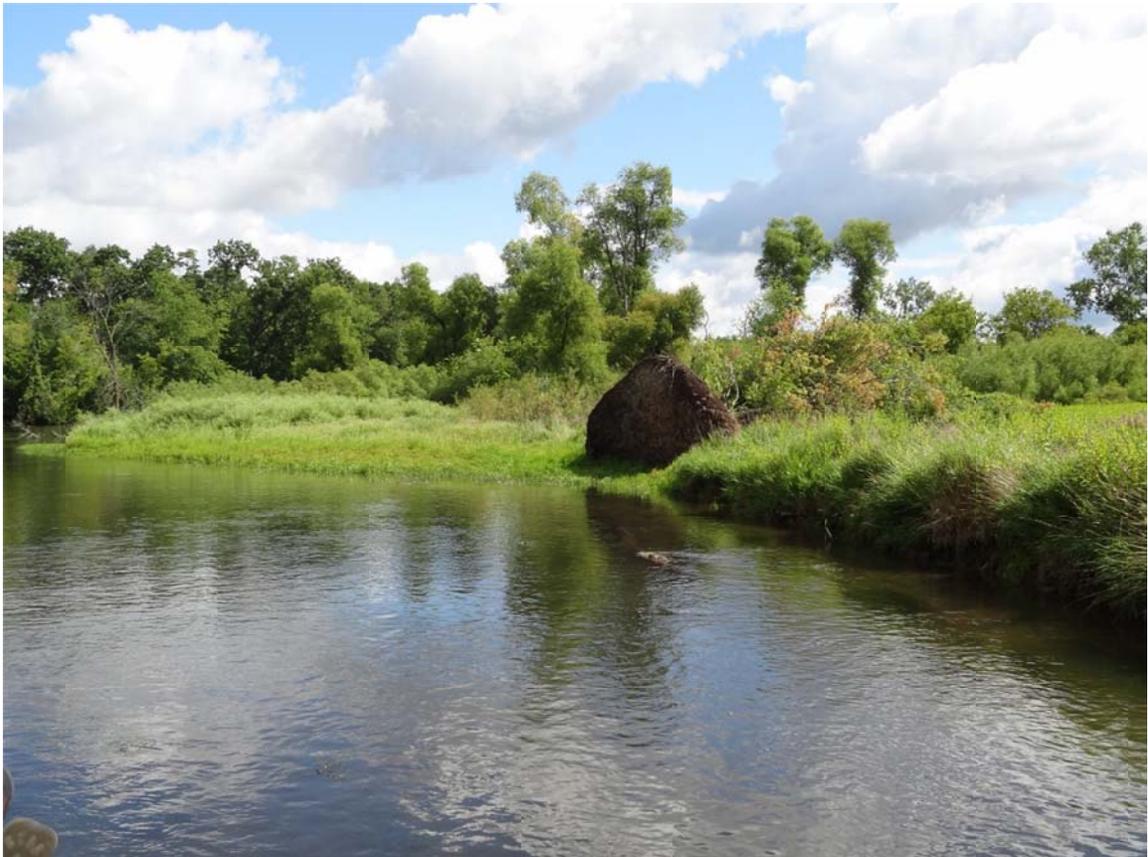
10. MP13.4 LDB no sheen observed.

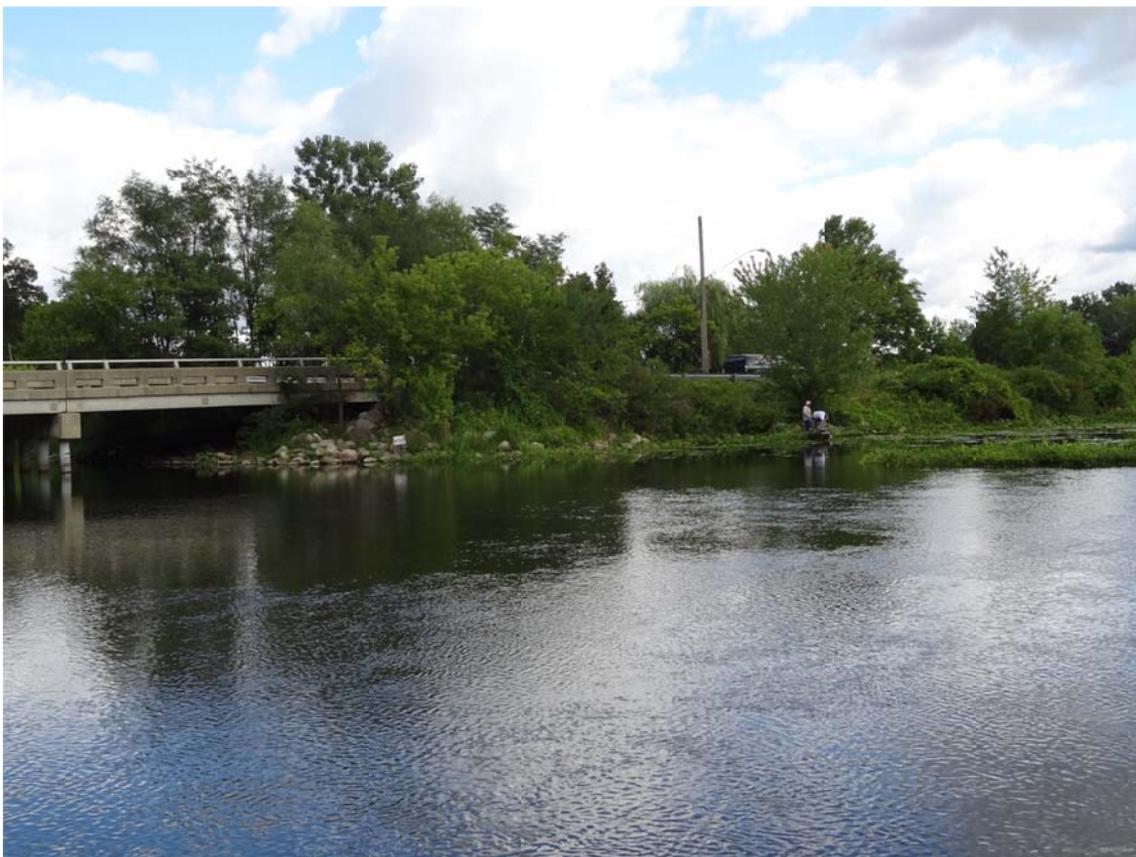
11. MP15.5 RDB South Mill Pond no sheen observed.

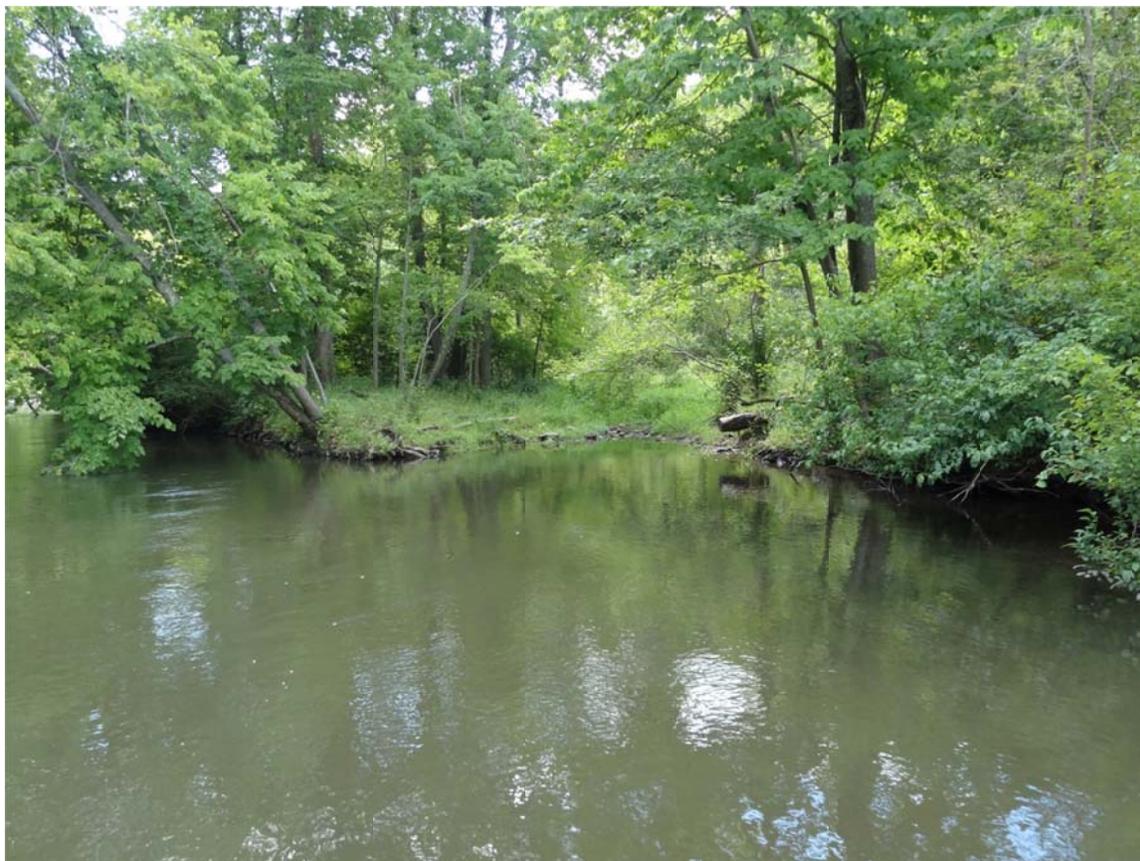
12. MP8.4 LDB no sheen observed.

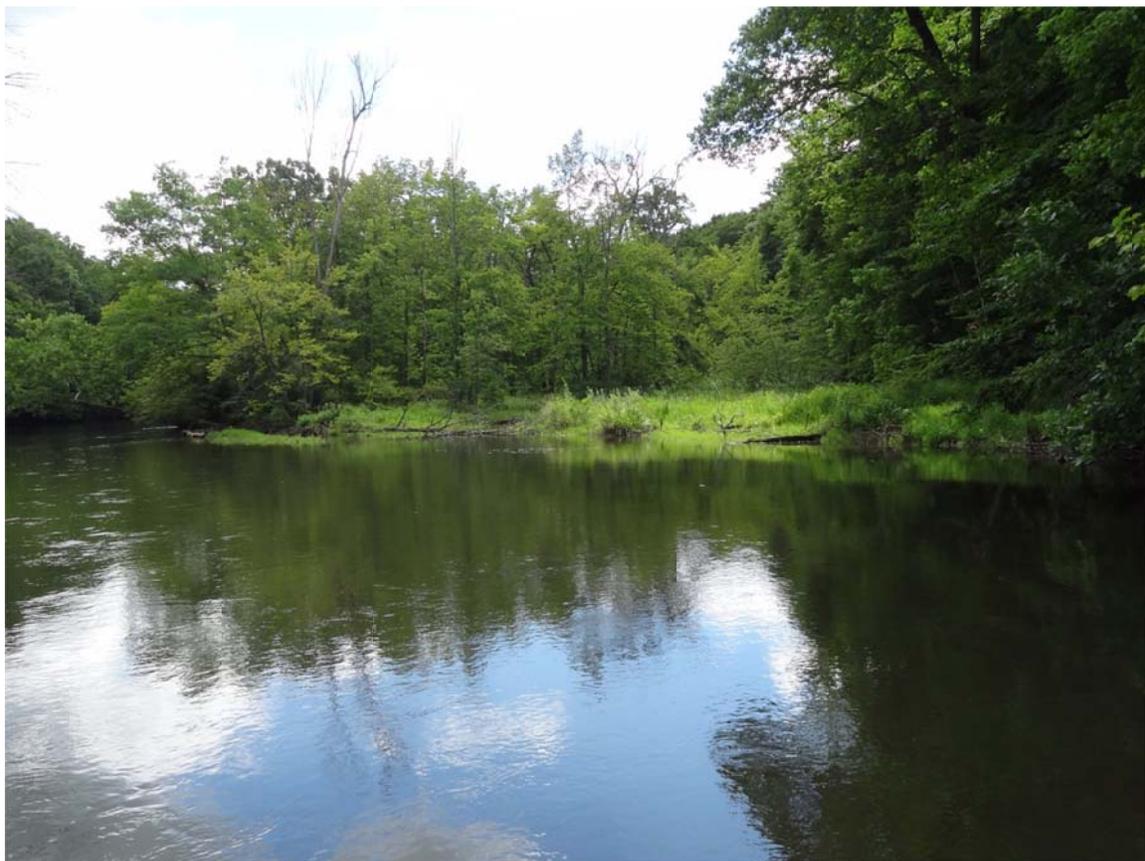
13. MP8.48 LDB no sheen observed.

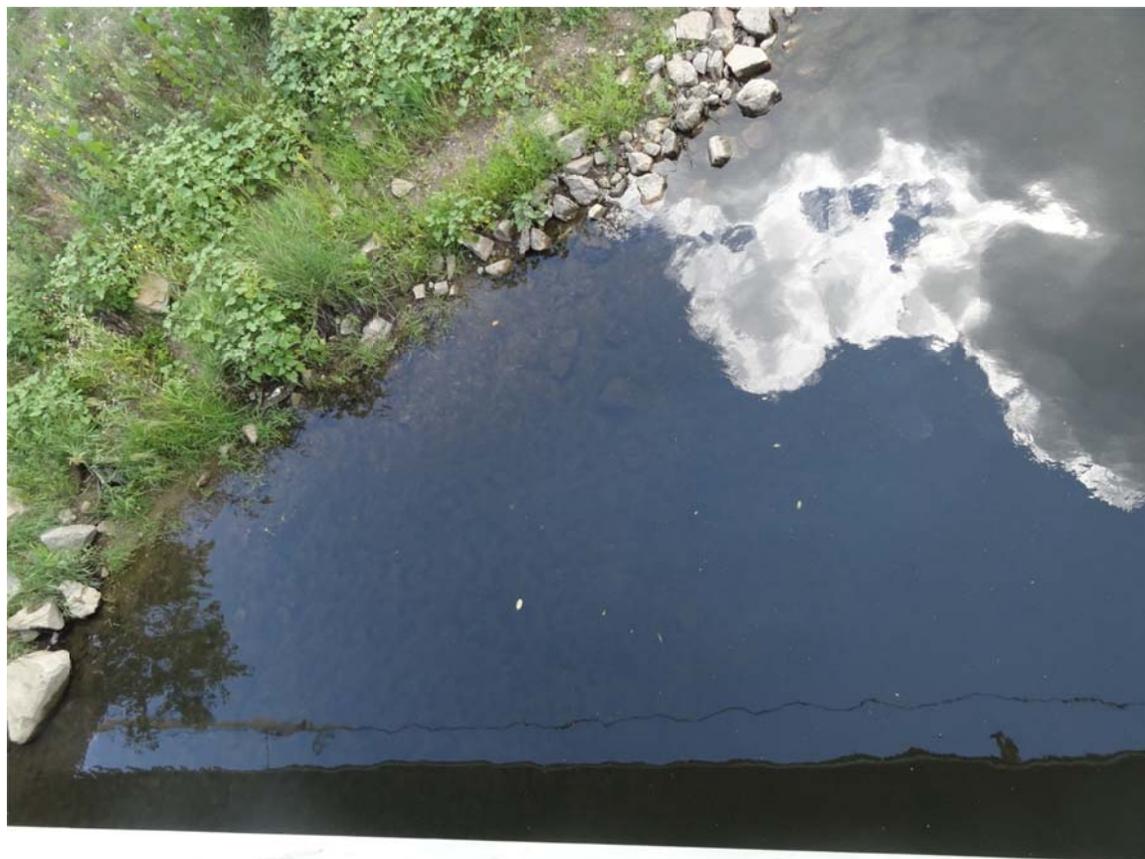
14. MP21.5 Custer Drive Bridge no sheen observed.

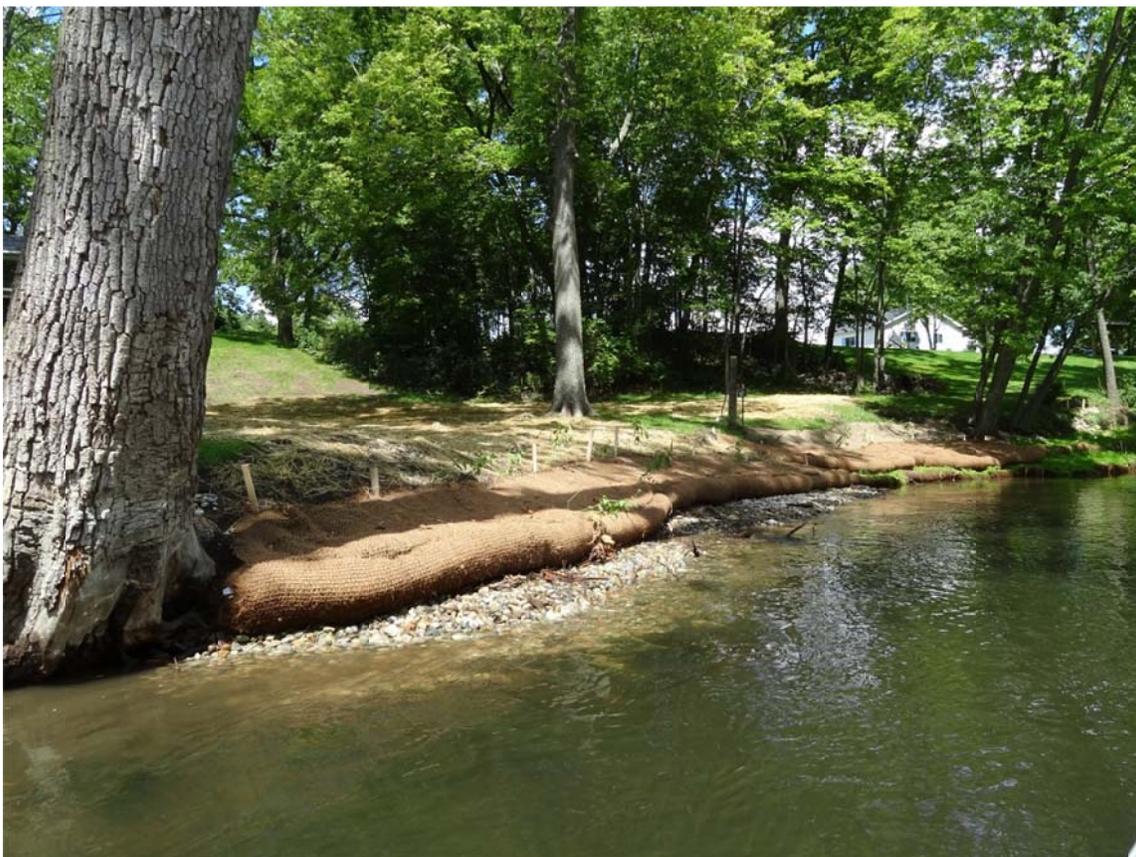
15. MP27.0 RDB river bank erosion restoration work appeared completed.

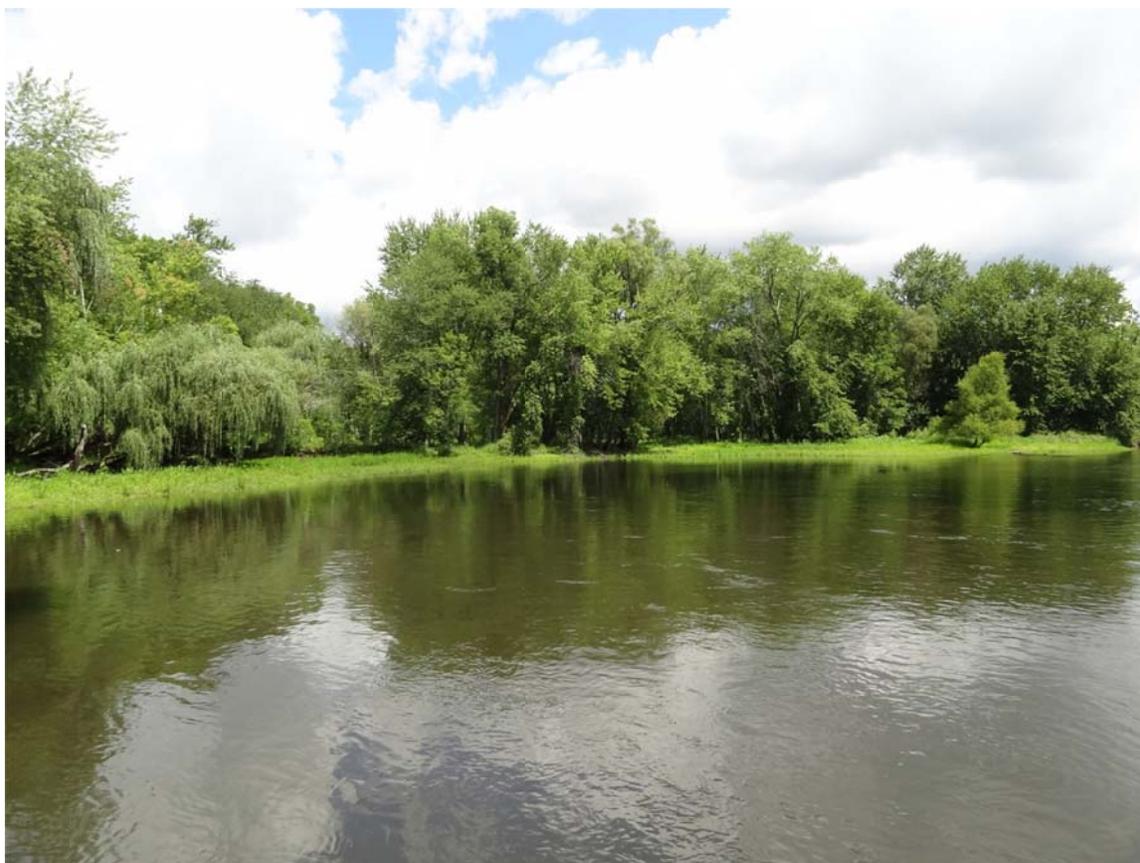
16. MP26.25 RDB no sheen observed.

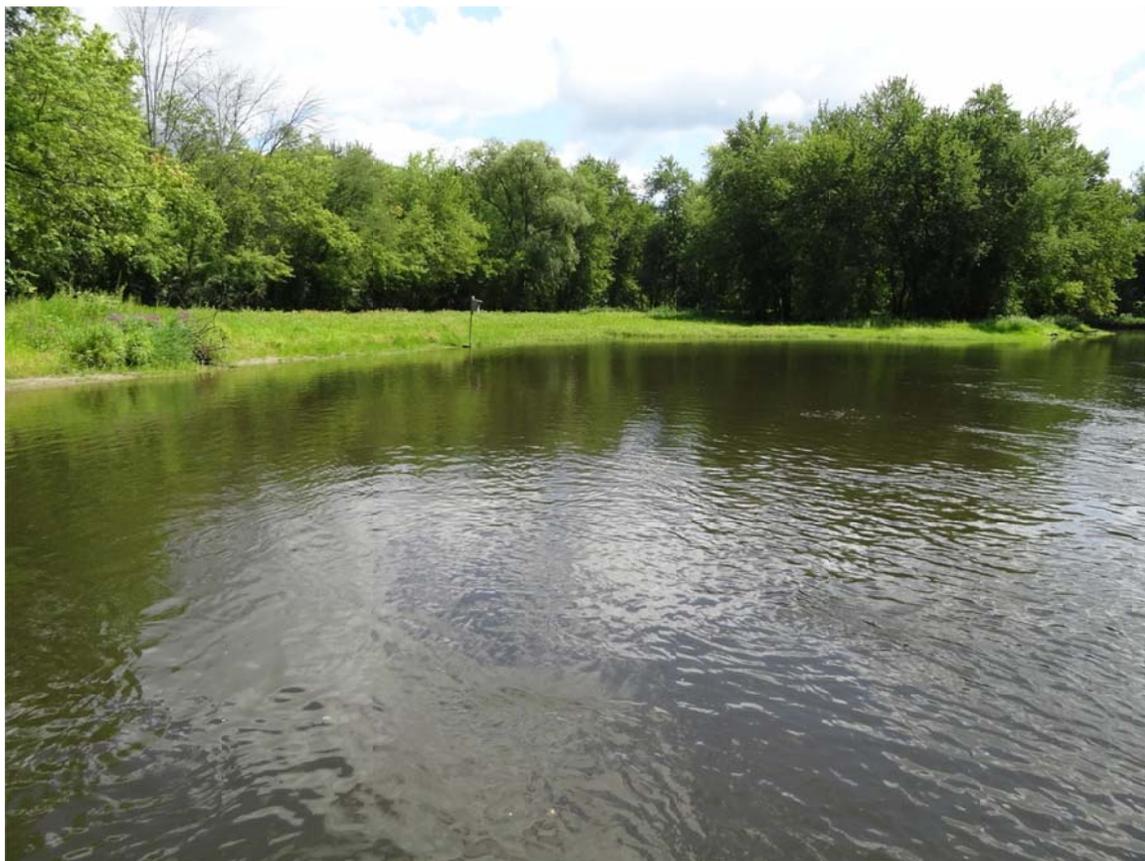
17. MP26.0 RDB no sheen observed.

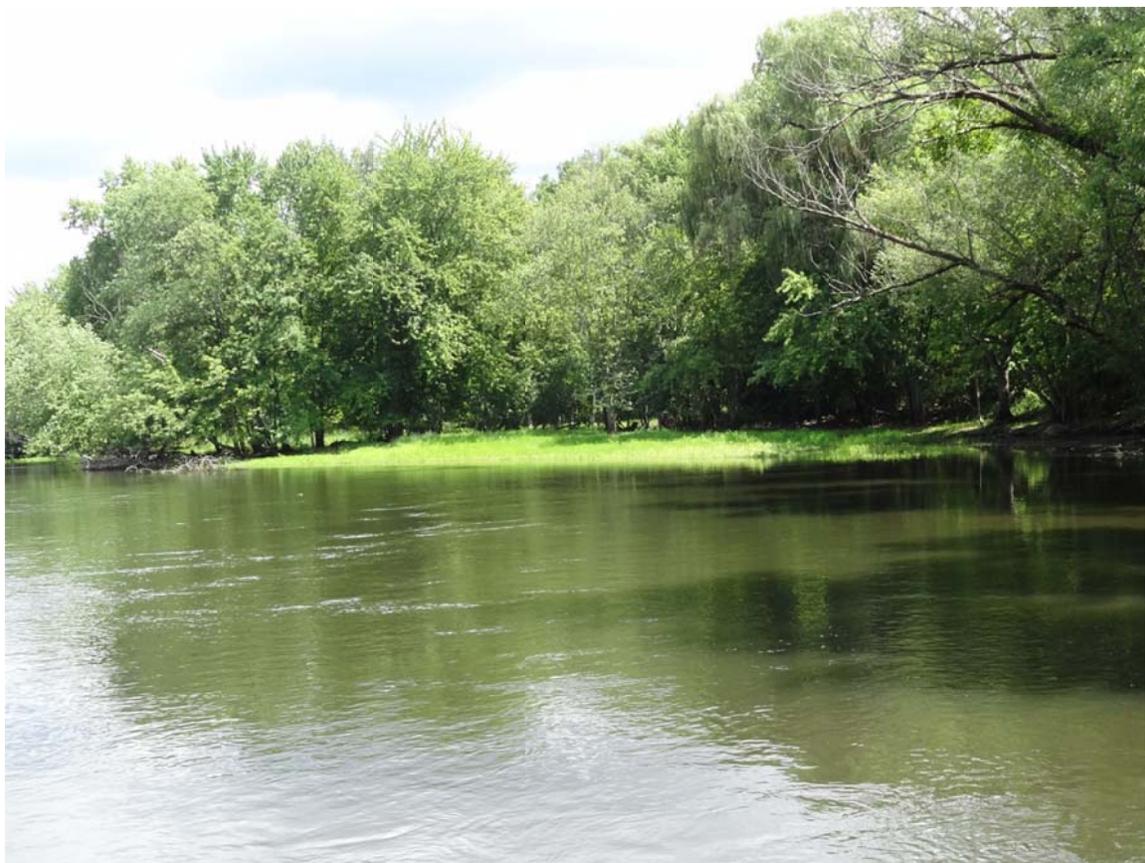
18. MP24.75 LDB no sheen observed.

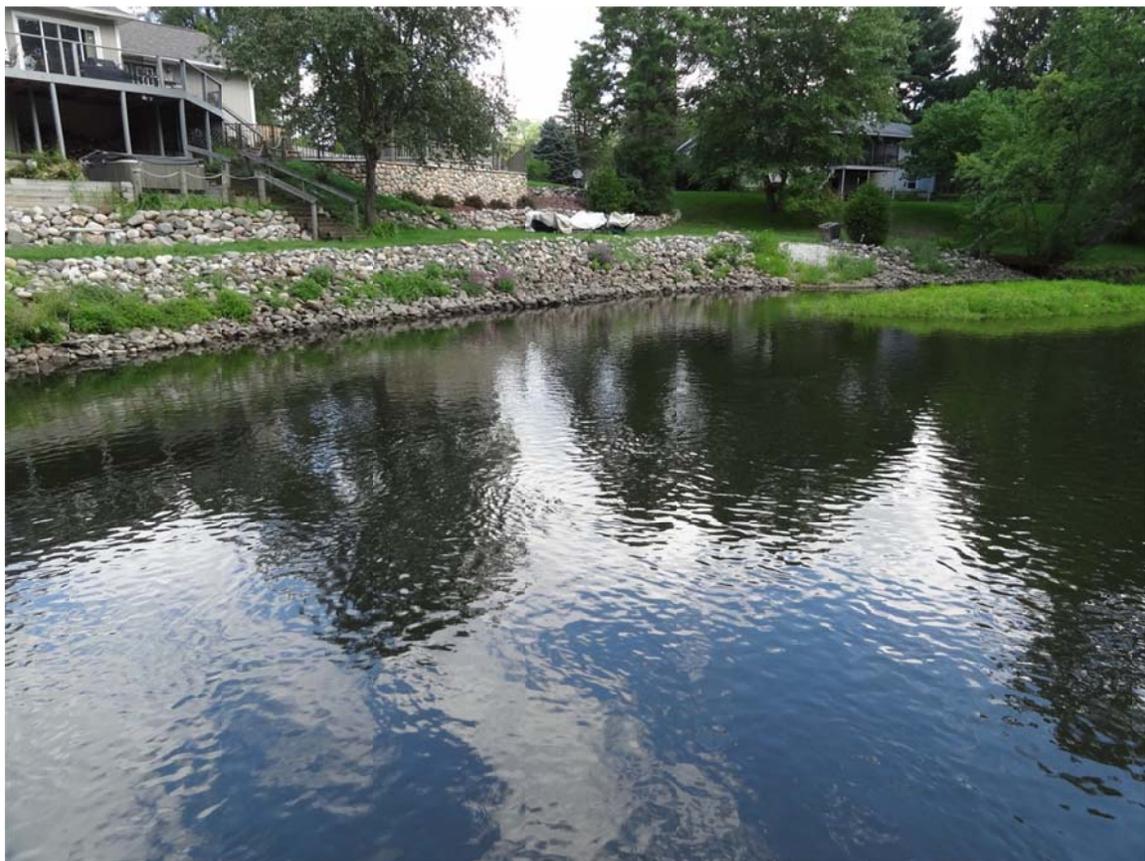
19. MP23.10 RDB no sheen observed.

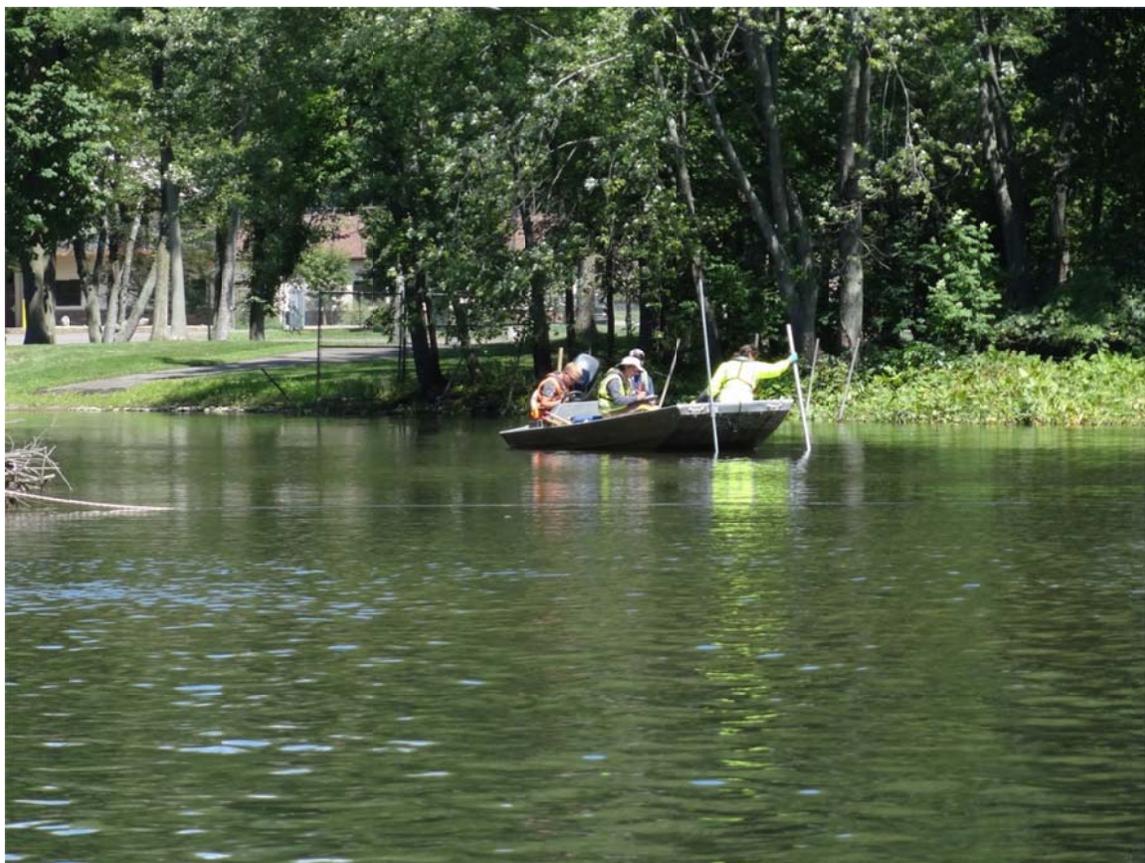
20. MP21.5 Oxbow observed crew performing monthly sediment trap monitoring.

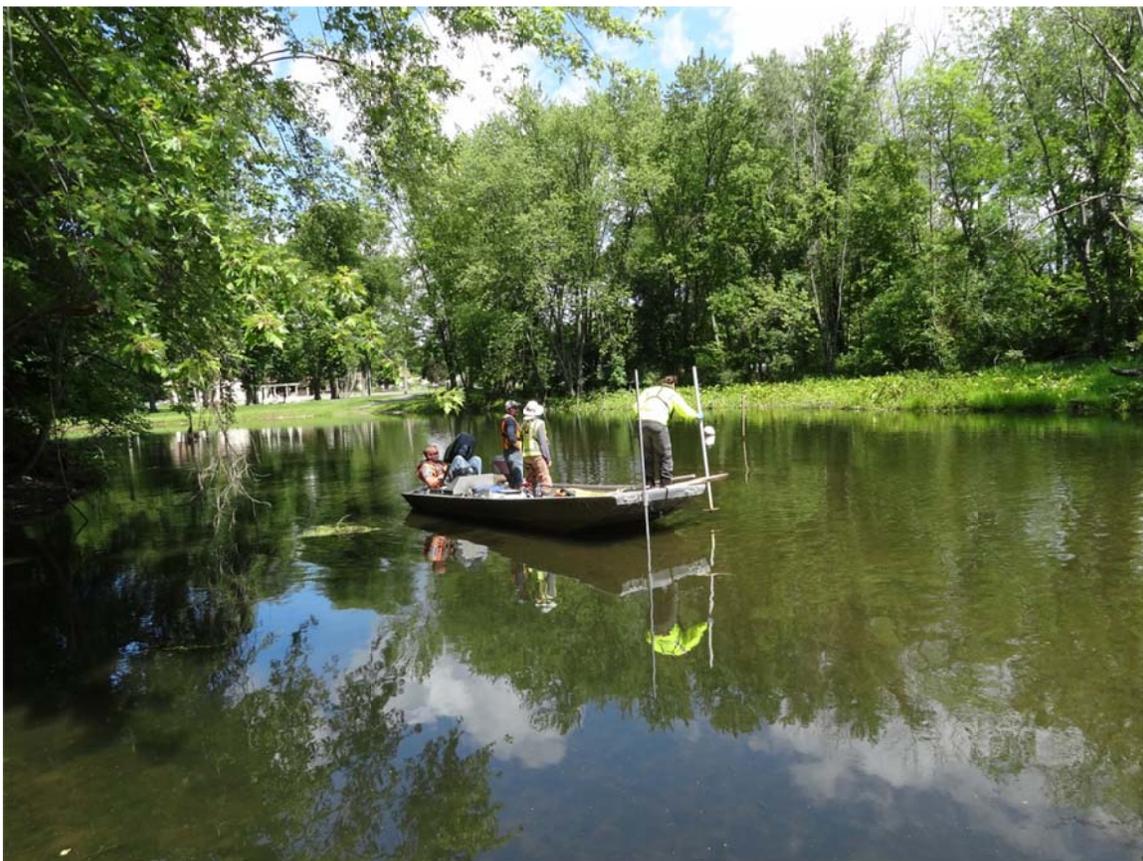
21. MP21.5 Oxbow observed crew performing monthly sediment trap monitoring.

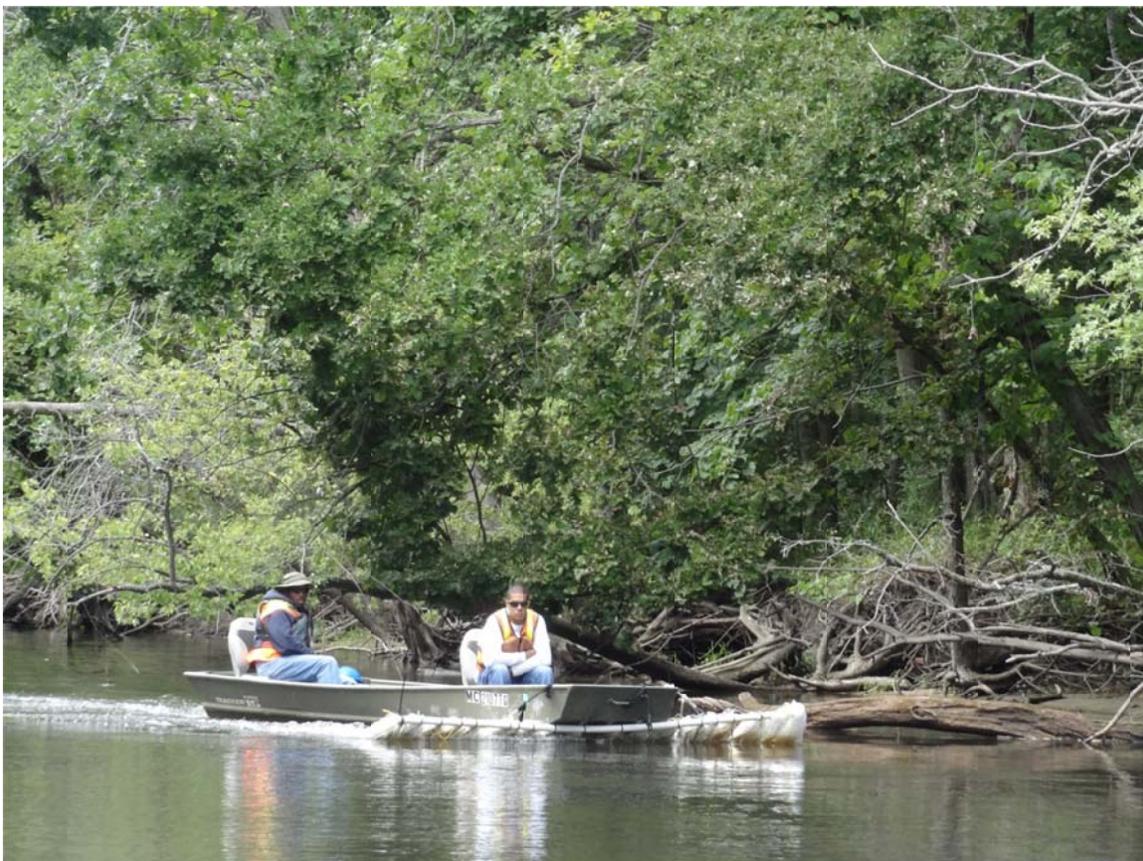
22. Observed a sheen sweep boat operating between MP21.5 – MP28.0.

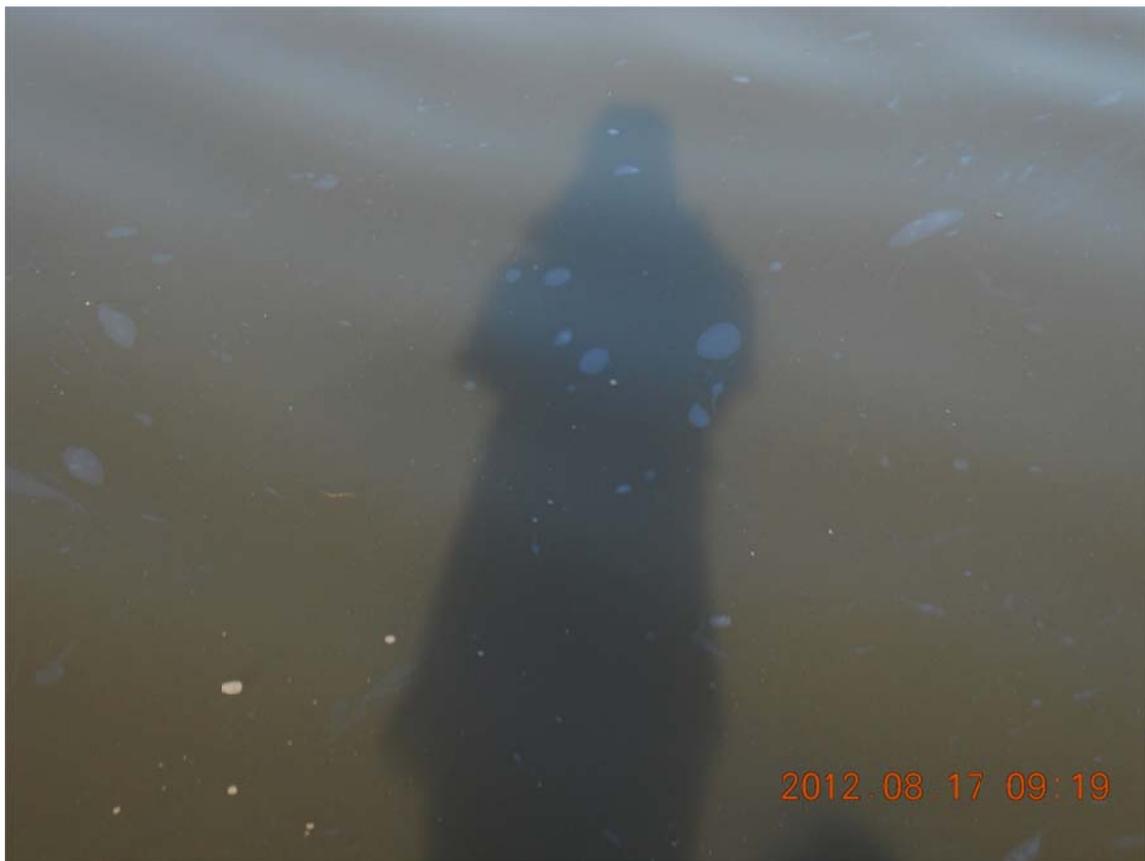
23. Morrow Lake sheen observed.
