Situation Photo Log

Friday, August 17, 2012

Kalamazoo River / Enbridge Spill

Prepared by:
Matthew Haak
START-USEPA
Situation Unit Leader

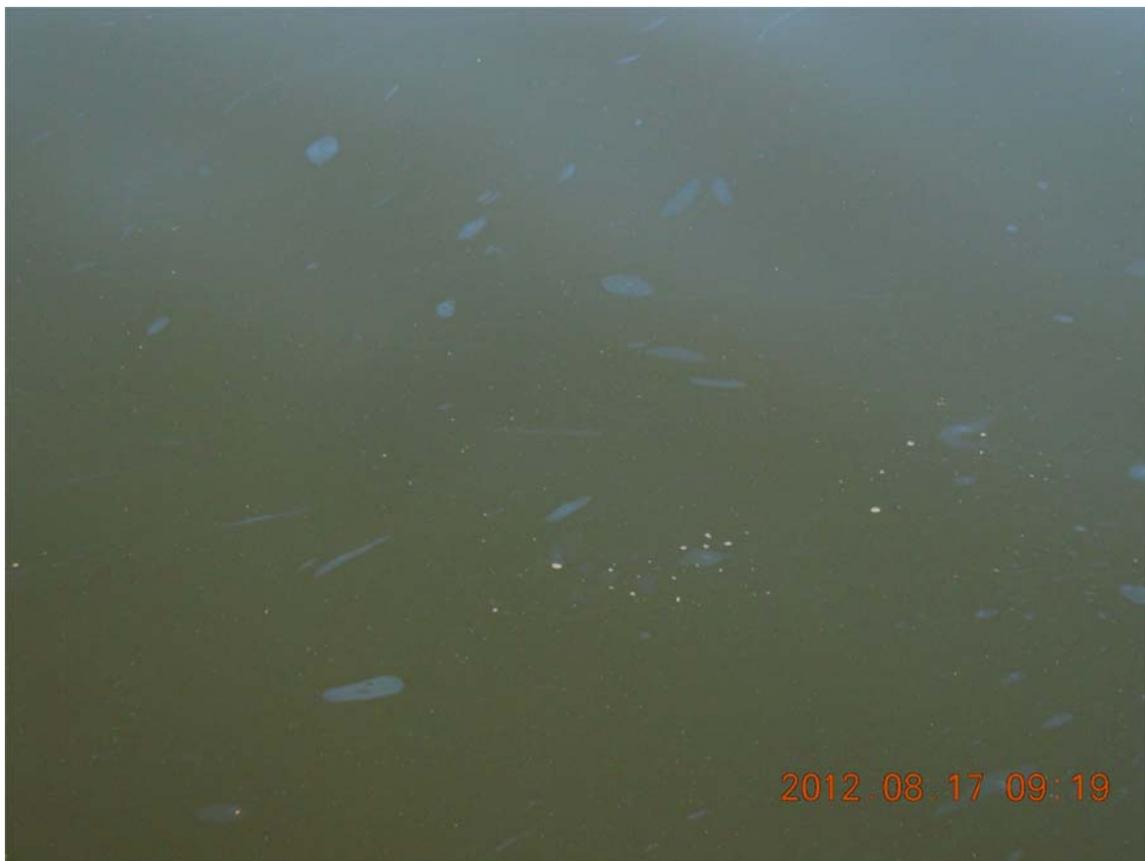
24. Morrow Lake sheen observed.
