Situation Photo Log

Tuesday, August 21, 2012

Kalamazoo River / Enbridge Spill

Prepared by:
Matthew Haak
START-USEPA
Situation Unit Leader

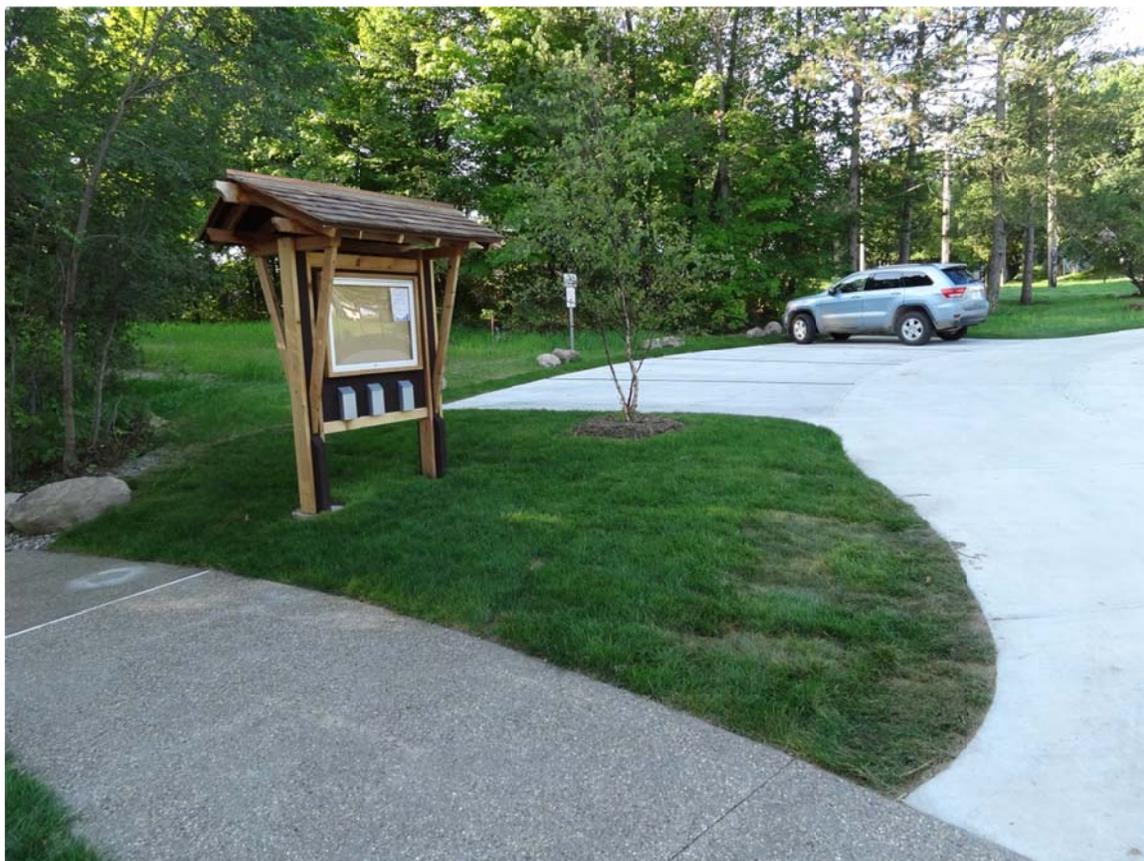
1. Ceresco Dam kiosk with no documentation observed and no decontamination station observed.

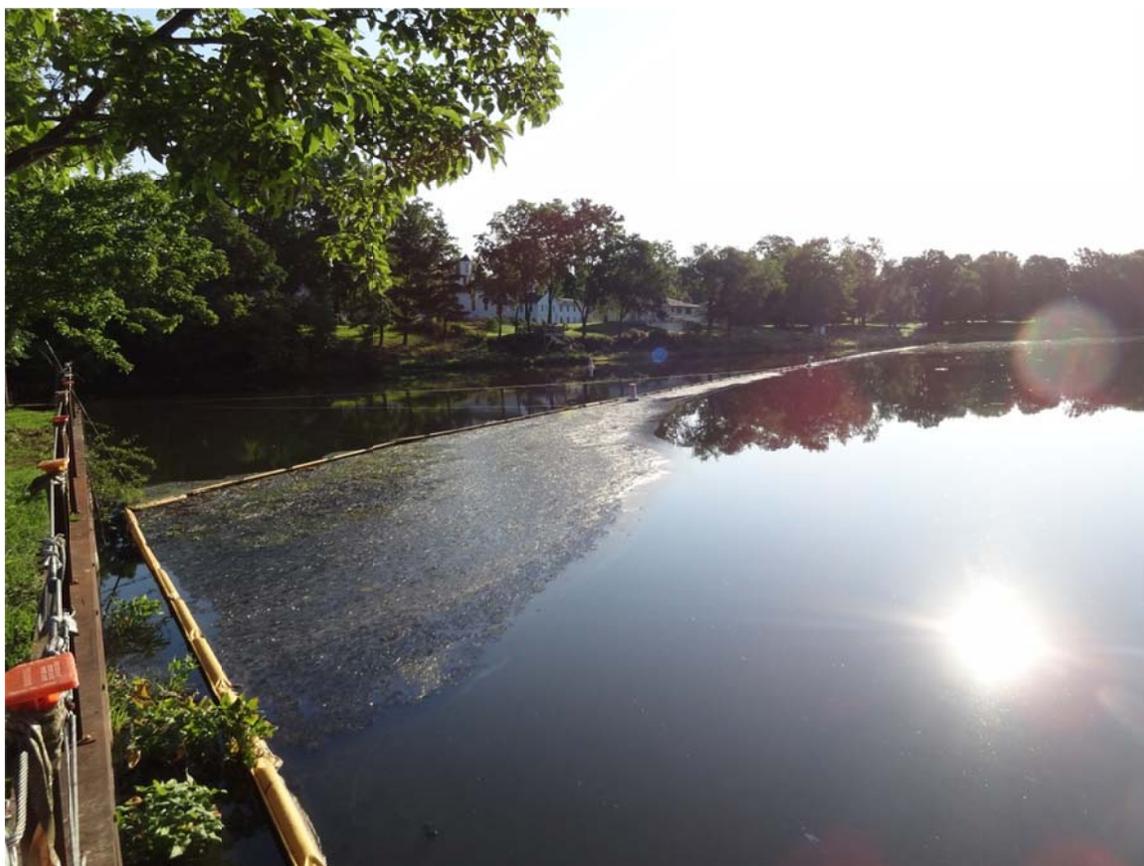
2. Ceresco Dam control point boom.

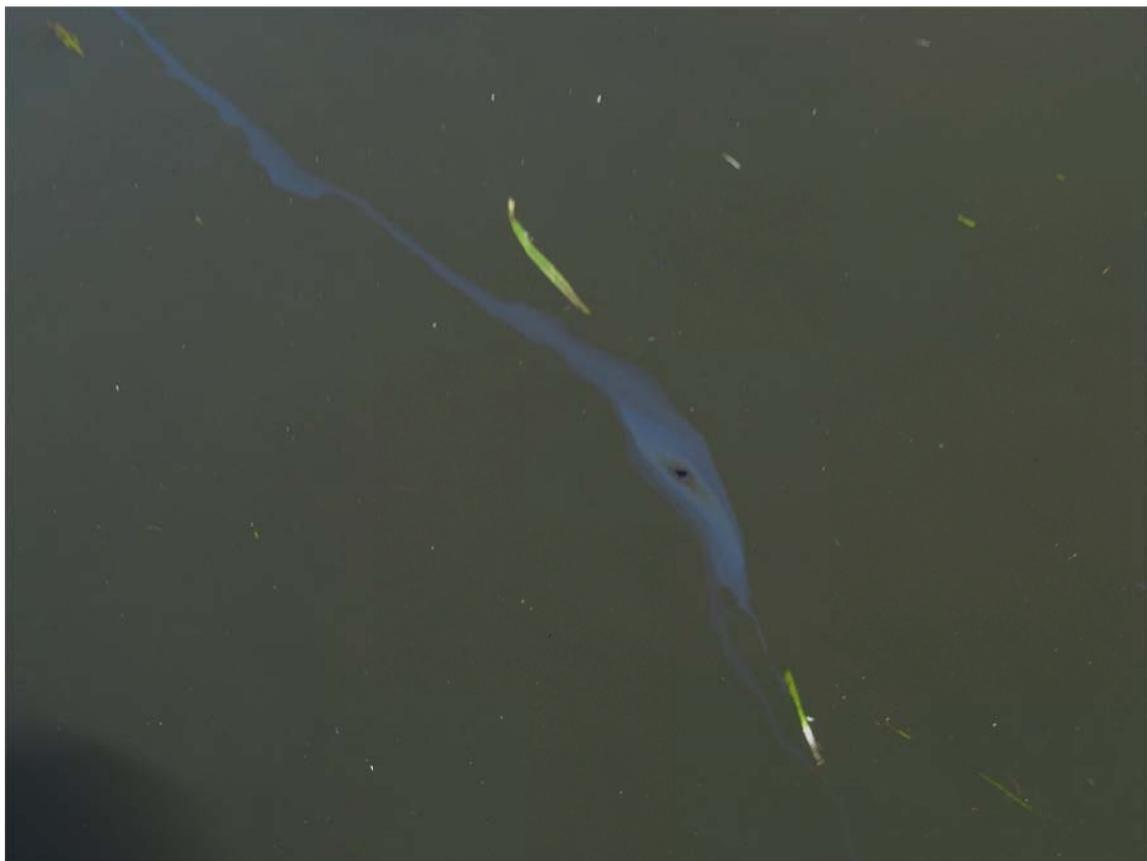
3. MP5.3 LDB sheen and tar globs observed.

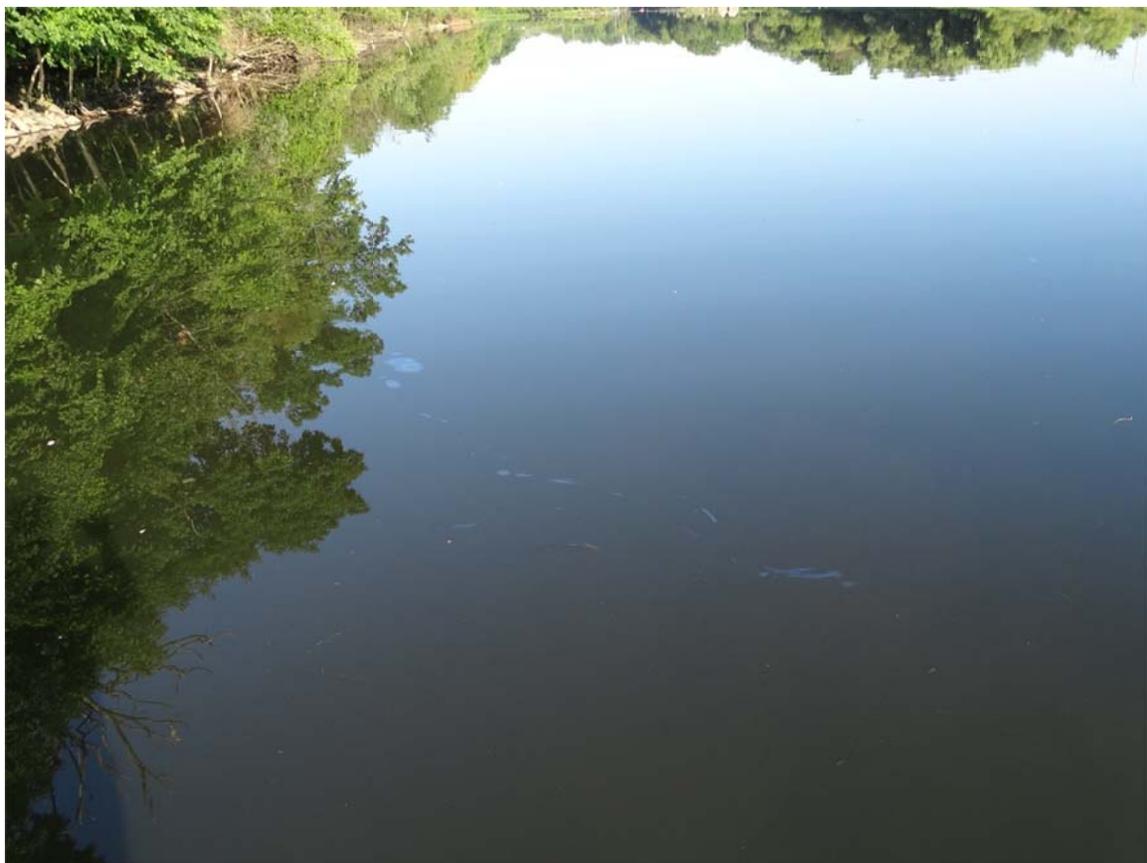
4. MP5.5 LDB sheen and tar globs observed.

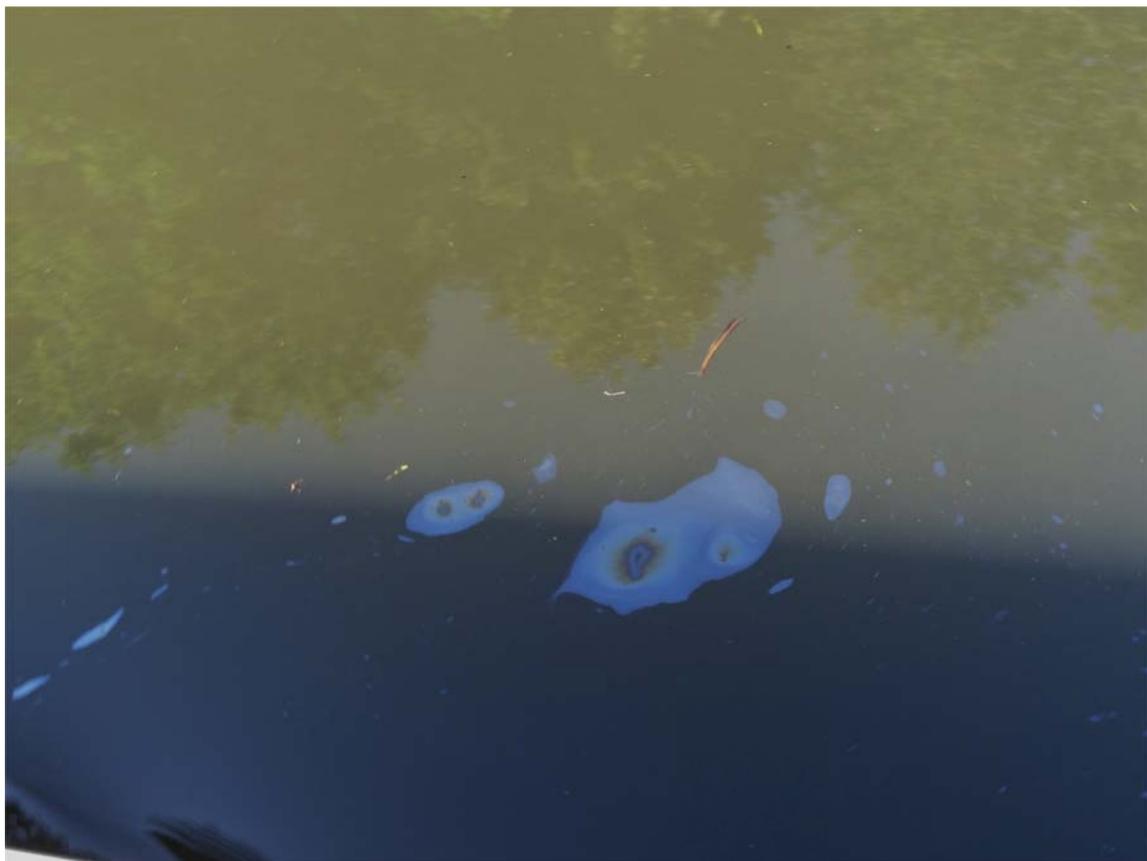
5. MP5.5 LDB sheen and tar globs observed.

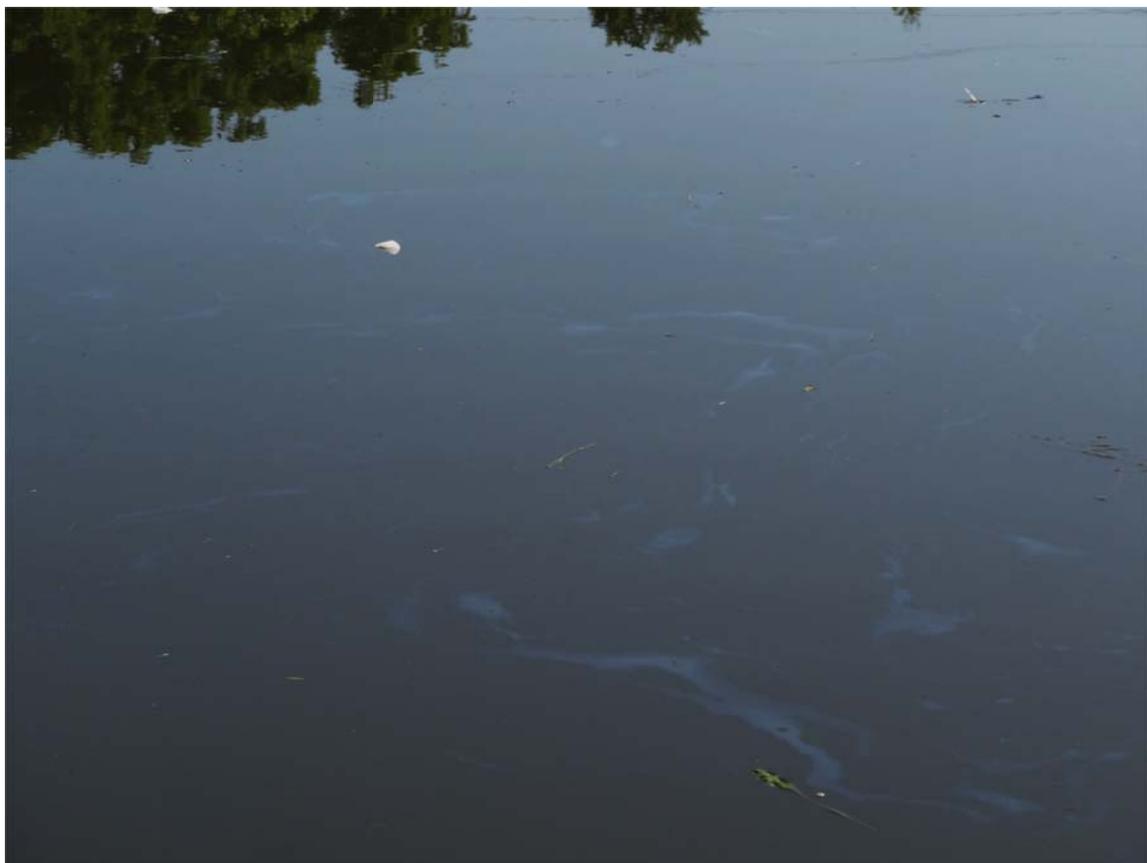
6. MP5.55 center channel sheen and tar globs observed.

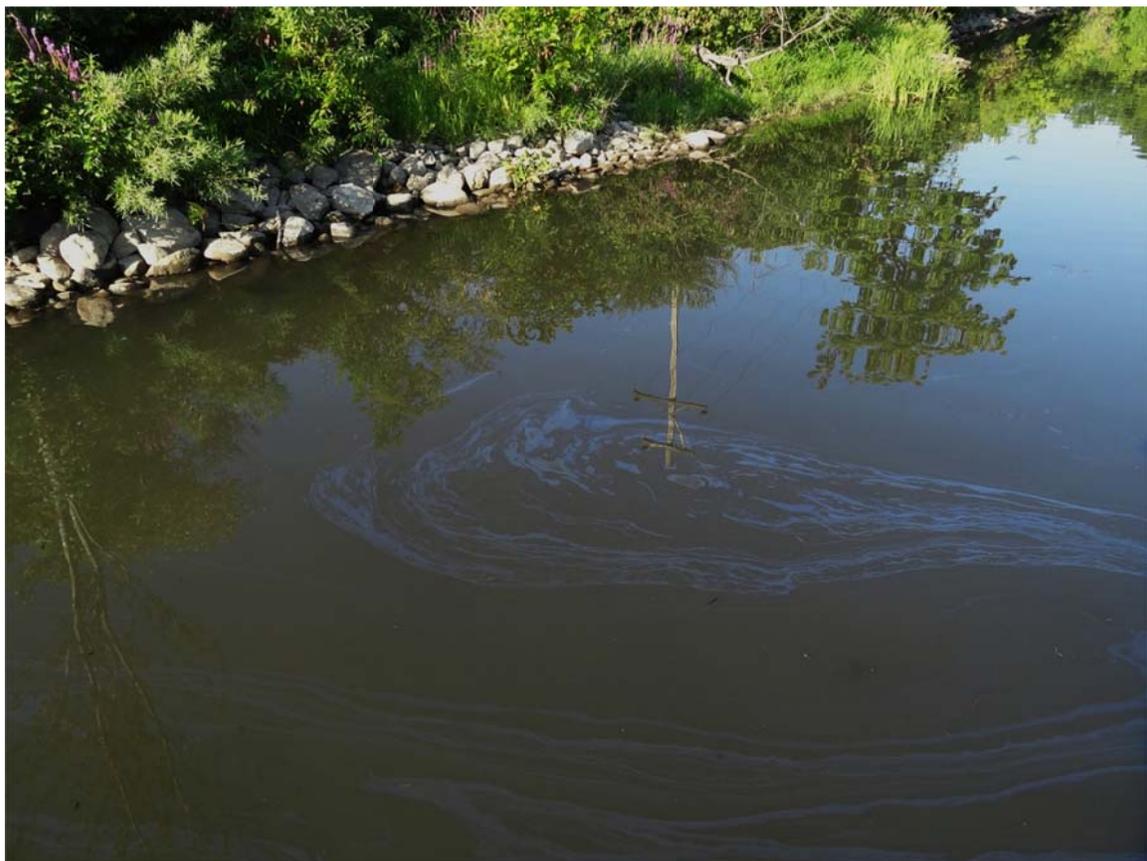
7. MP5.63 LDB sheen and tar globs observed.

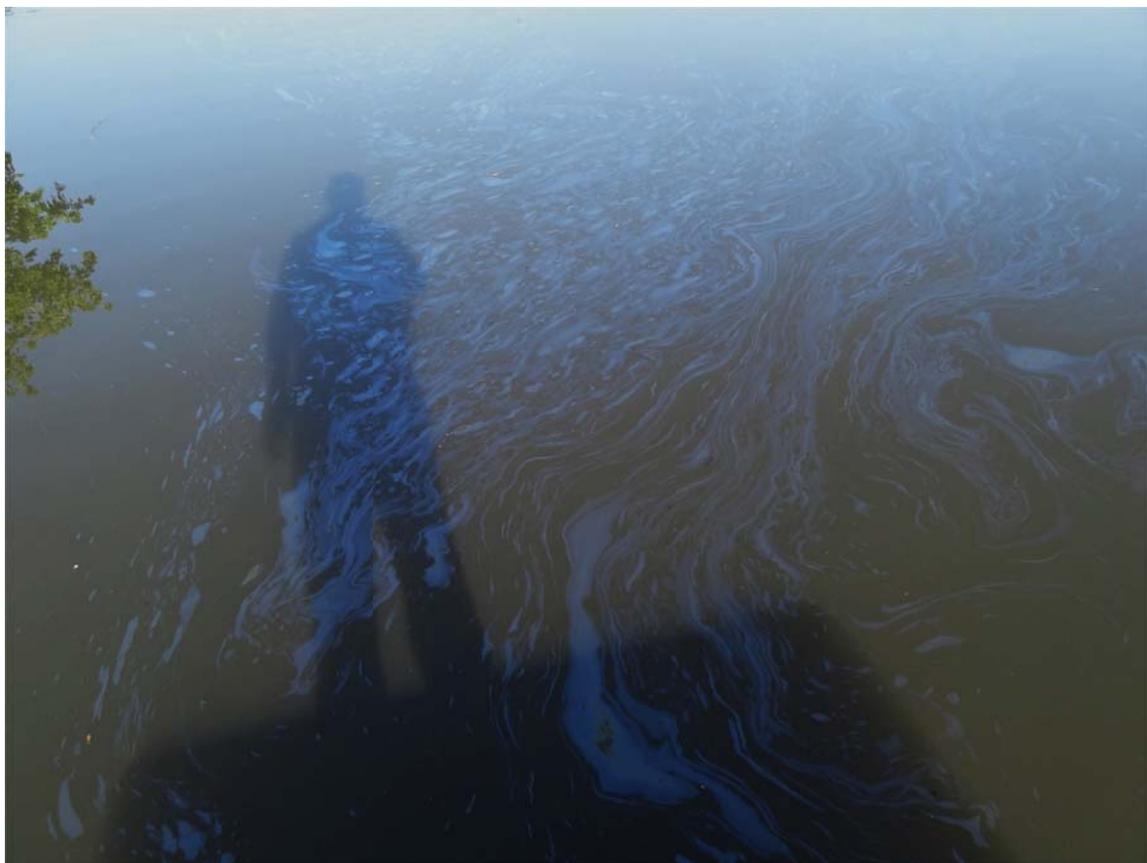
8. MP5.63 LDB sheen and tar globs observed.

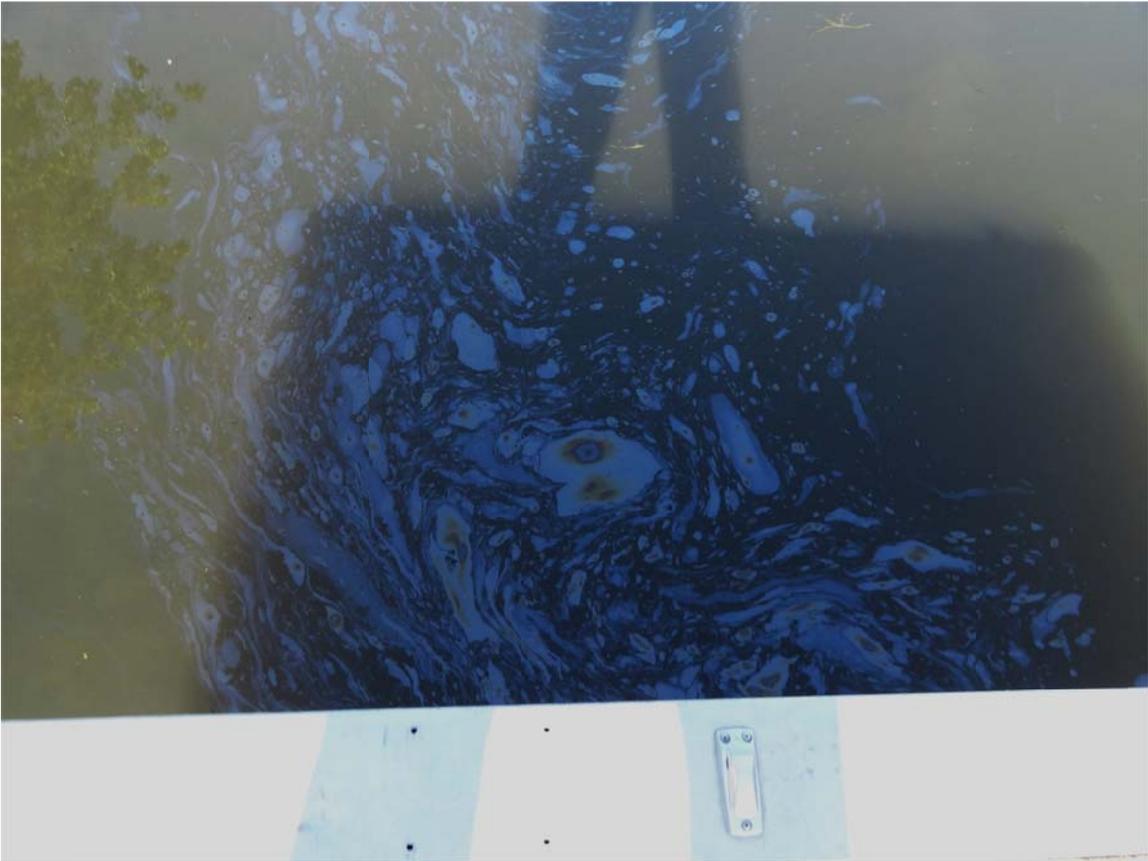
9. MP5.63 LDB sheen and tar globs observed.

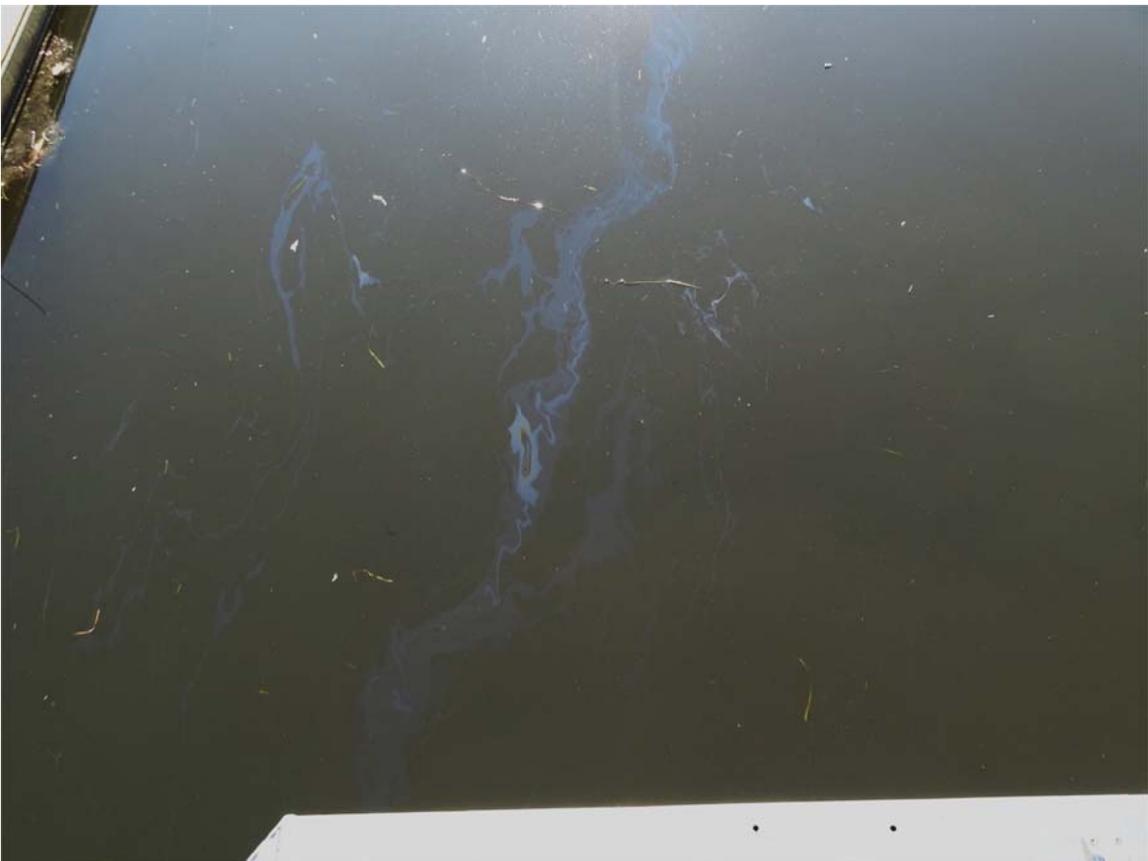
10. Ceresco Dam control point boom observed sheen collecting along the boom.

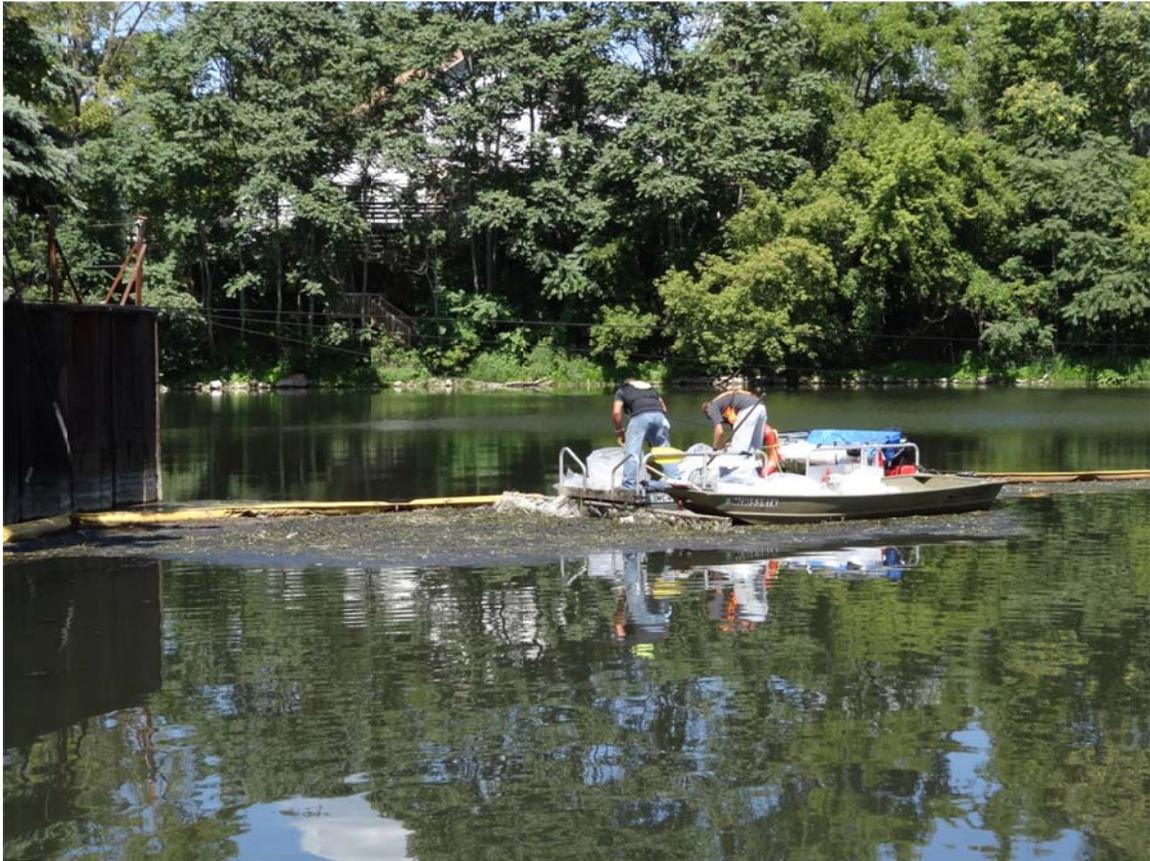
11. Ceresco Dam observed a crew performing debris removal from the boom.

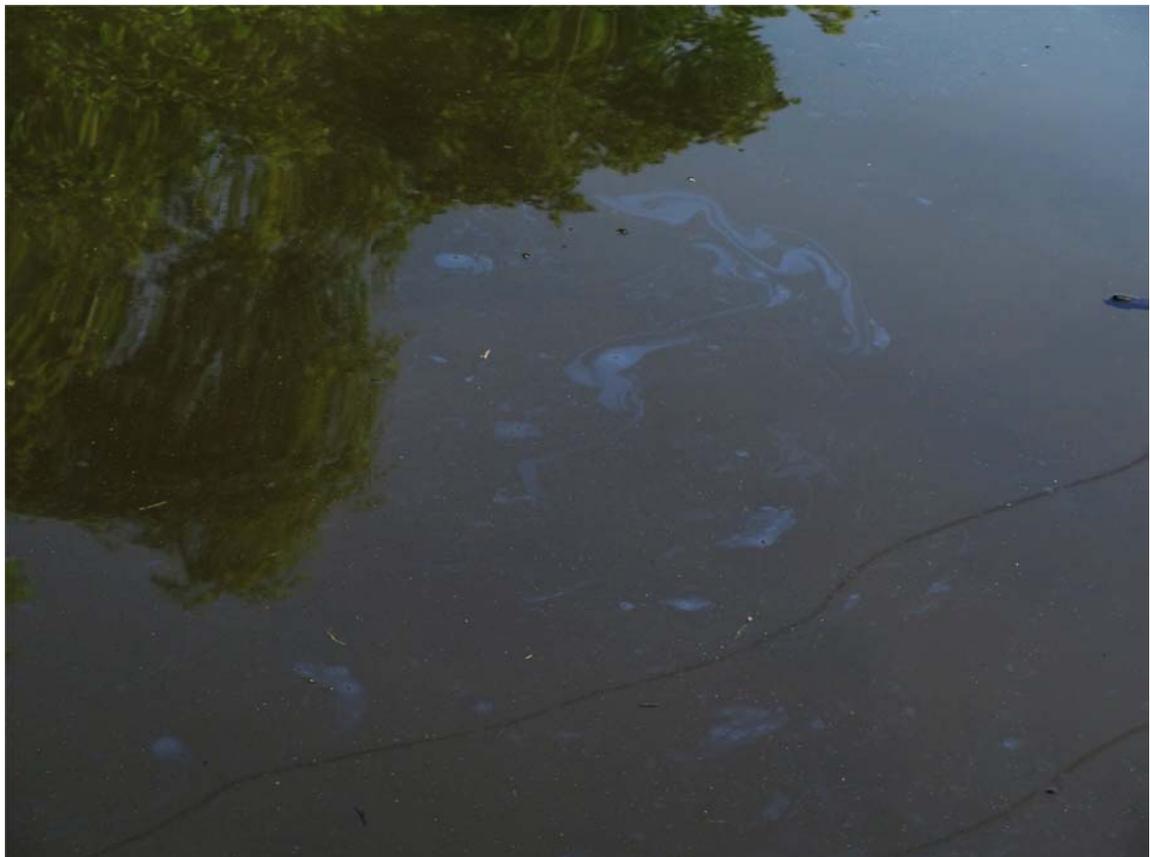
12. MP5.55 RDB sheen observed.

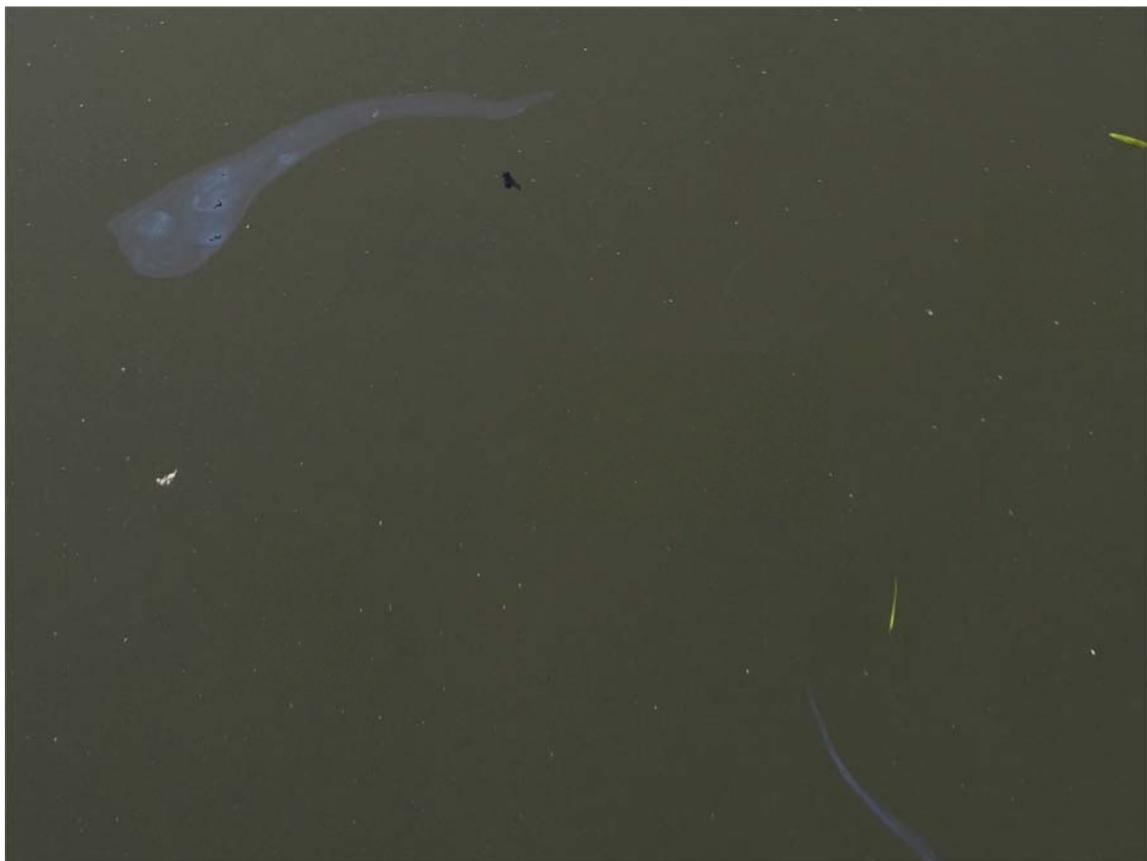
13. MP5.0 RDB tar globs and sheen observed.

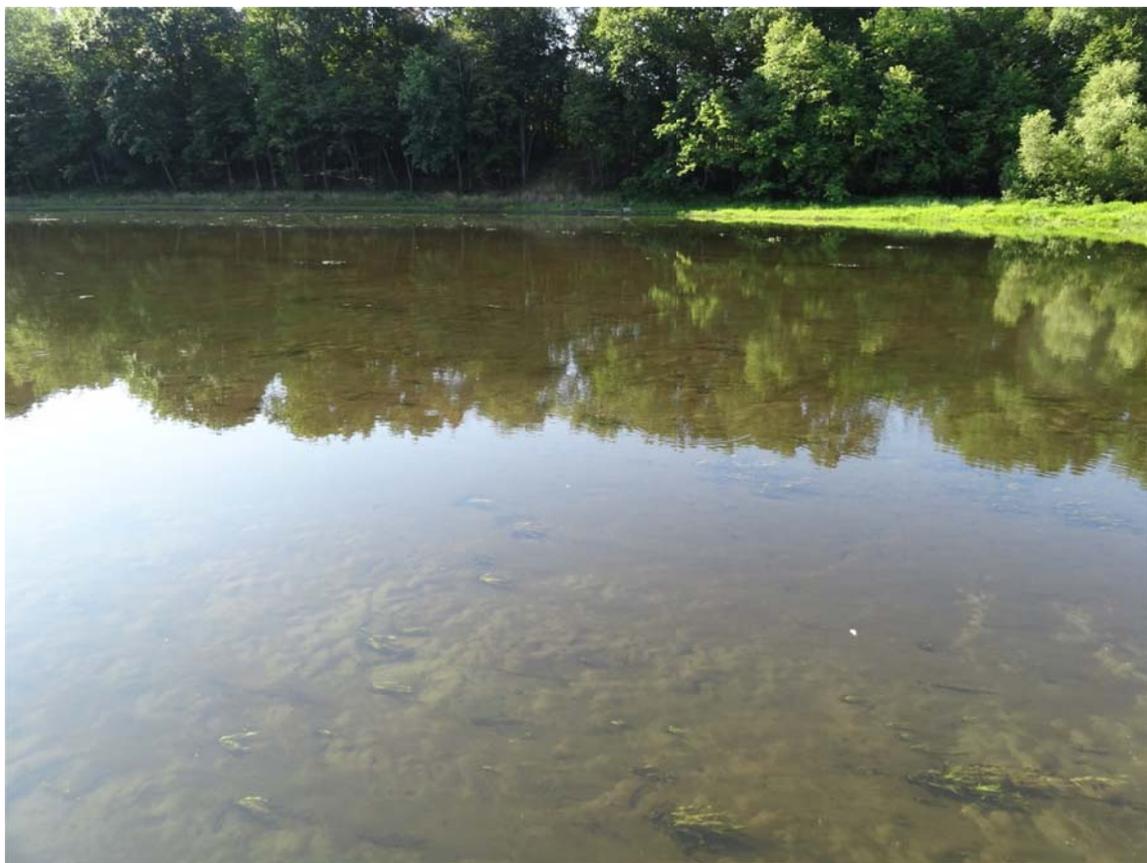
14. MP4.5 no sheen observed.

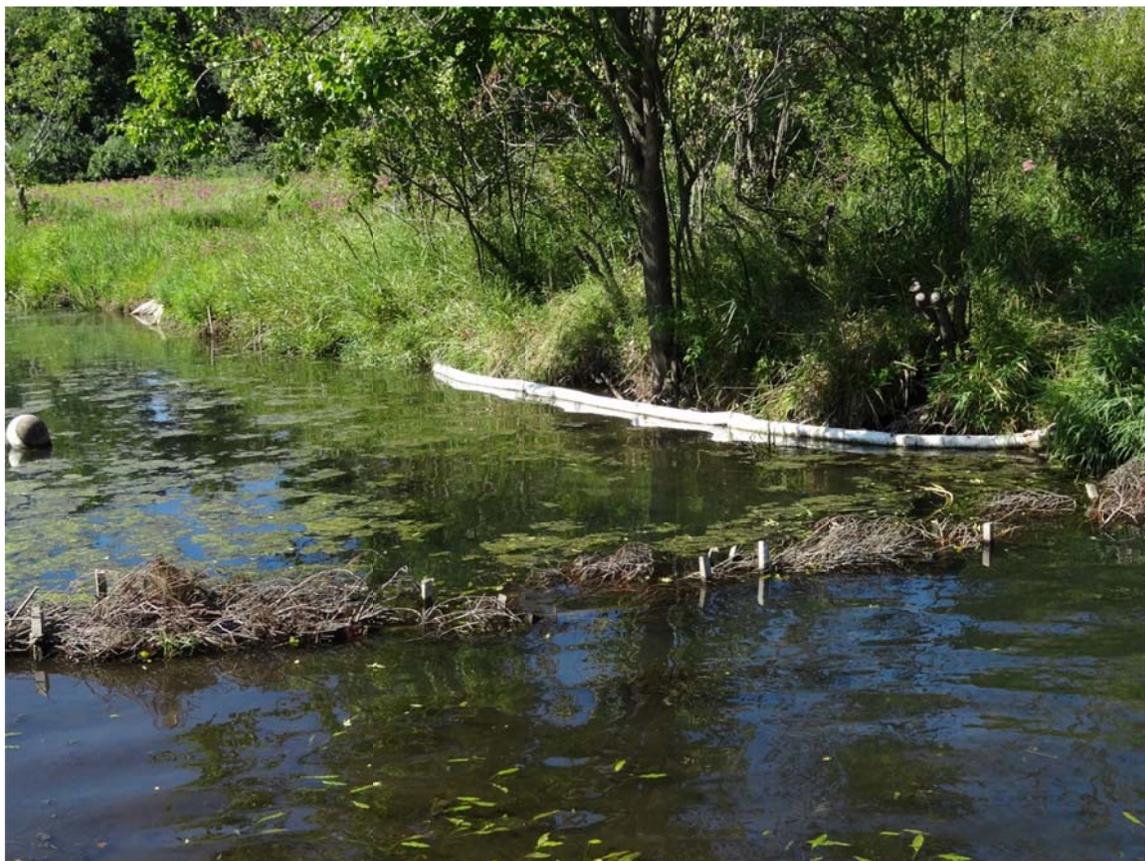
15. MP10.75 no sheen observed.

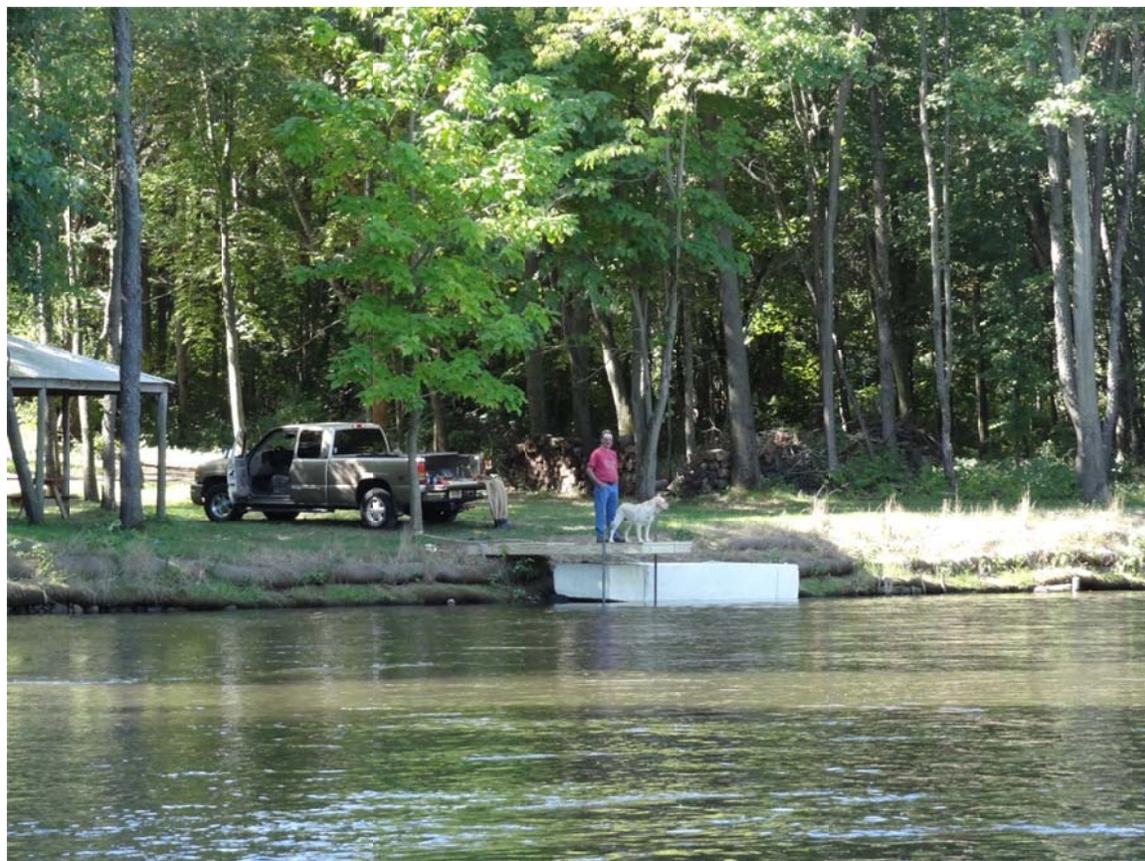
16. MP12.75 new dock along the LDB.

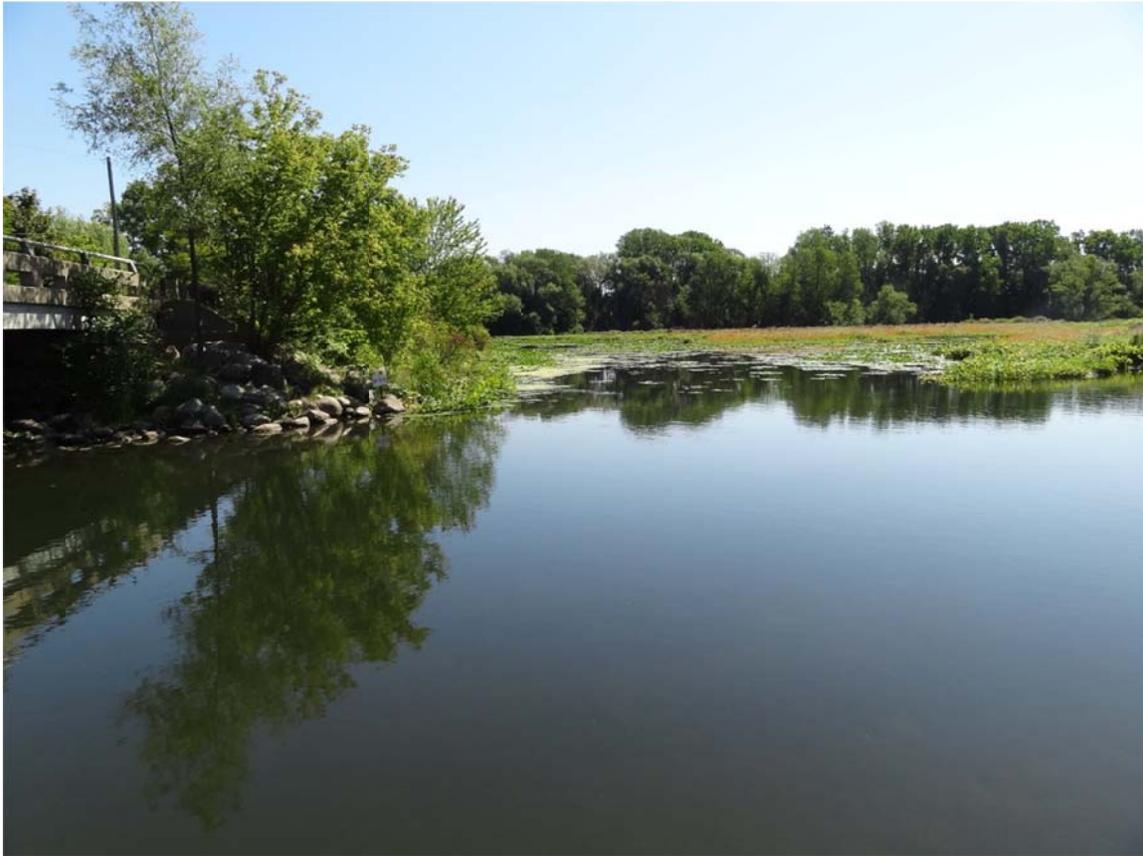
17. MP15.5 South Mill Pond no sheen observed.

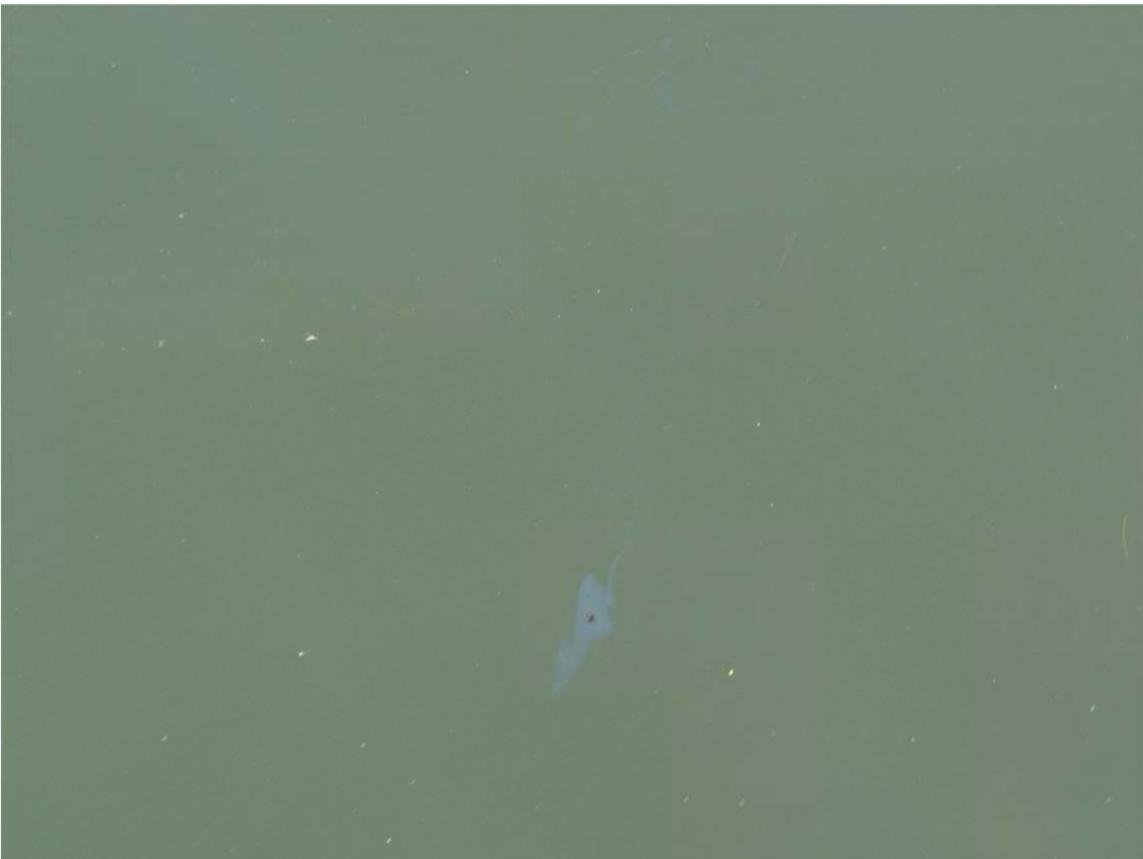
18. MP15.6 LDB observed sheen and tar glob. Quantity of sheen did not warrant a sheen sweep boat.
