# Situation Photo Log

Thursday, August 23, 2012

Kalamazoo River / Enbridge Spill

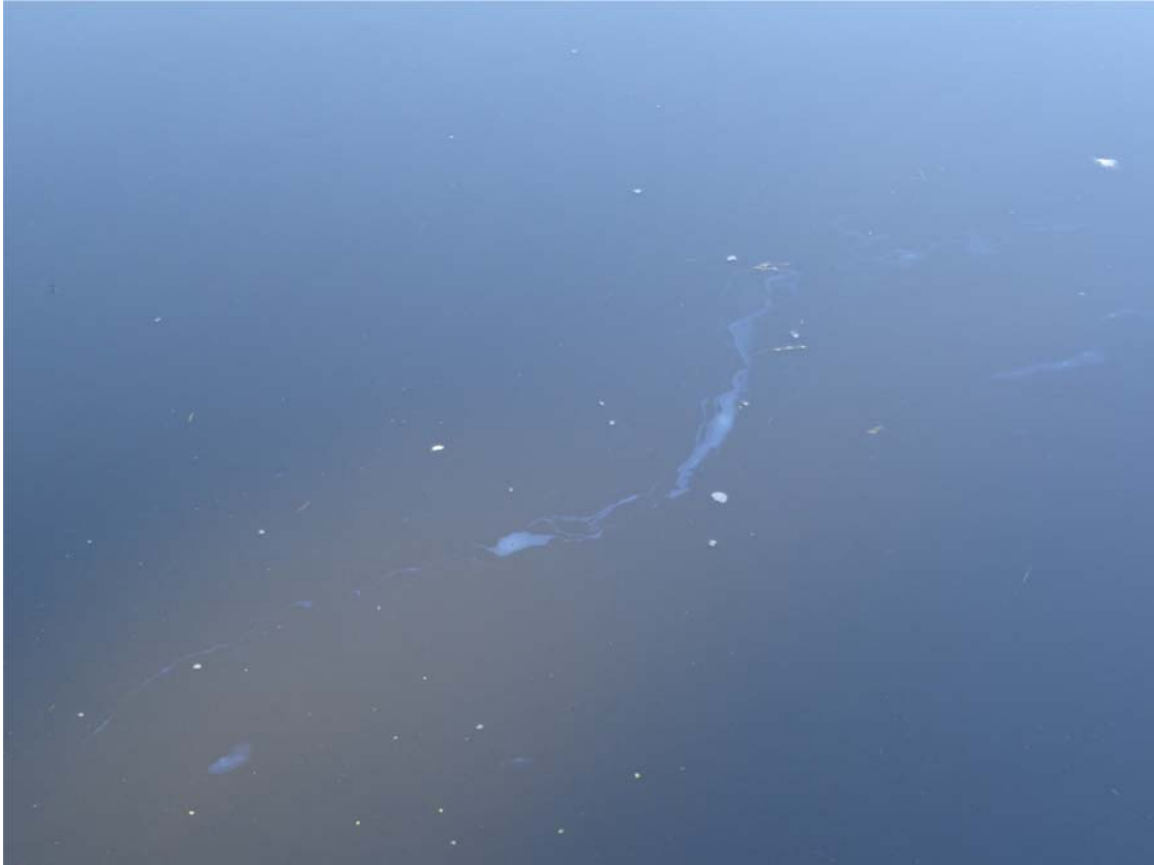
1. C0.4 Boat launch observed sheen and tar glob.

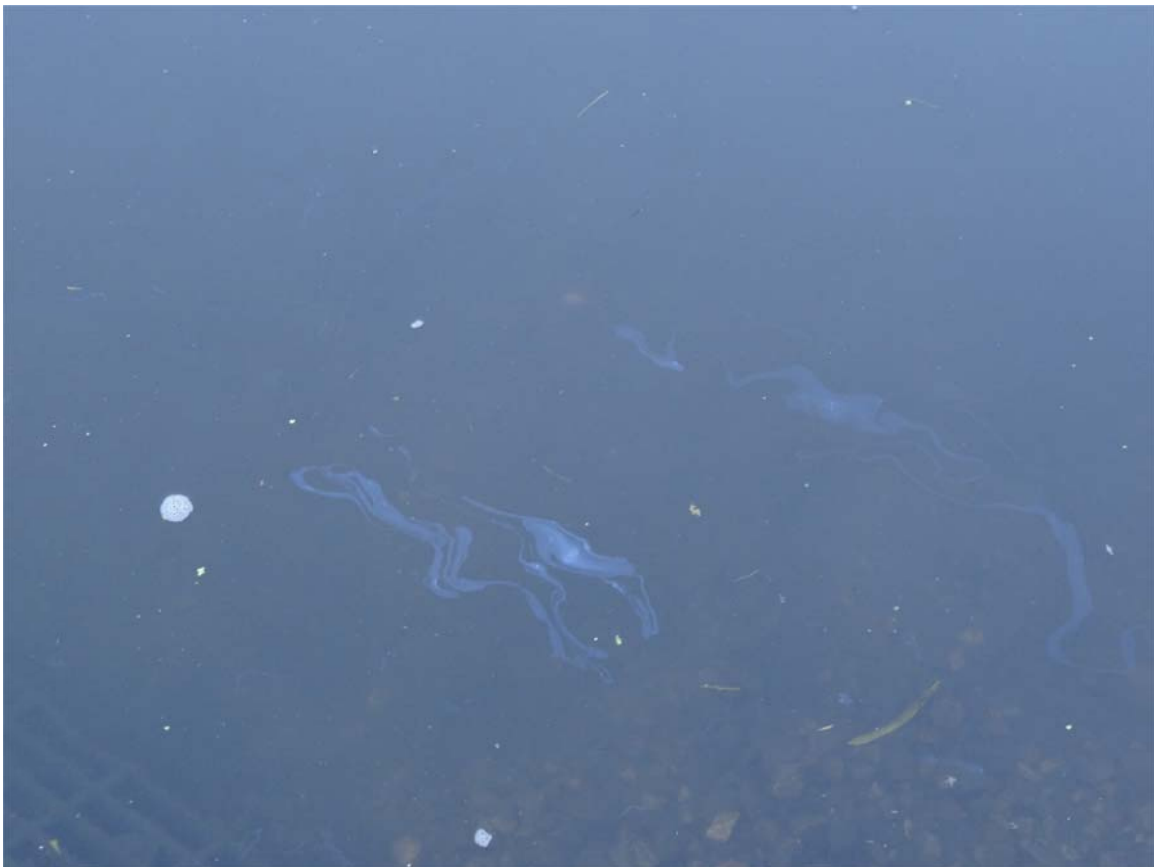
2. C0.4 Boat launch observed sheen and tar glob.

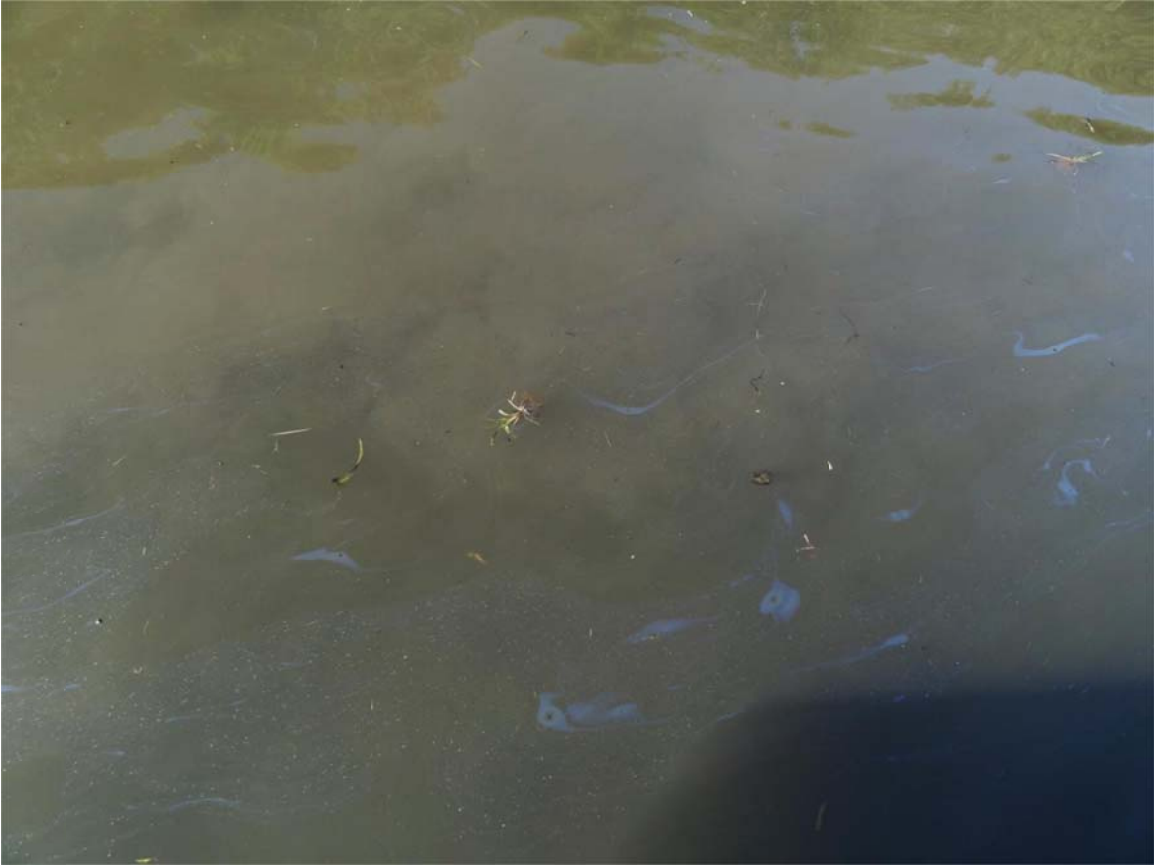
3. MP5.15 LDB sheen and tar globs observed.

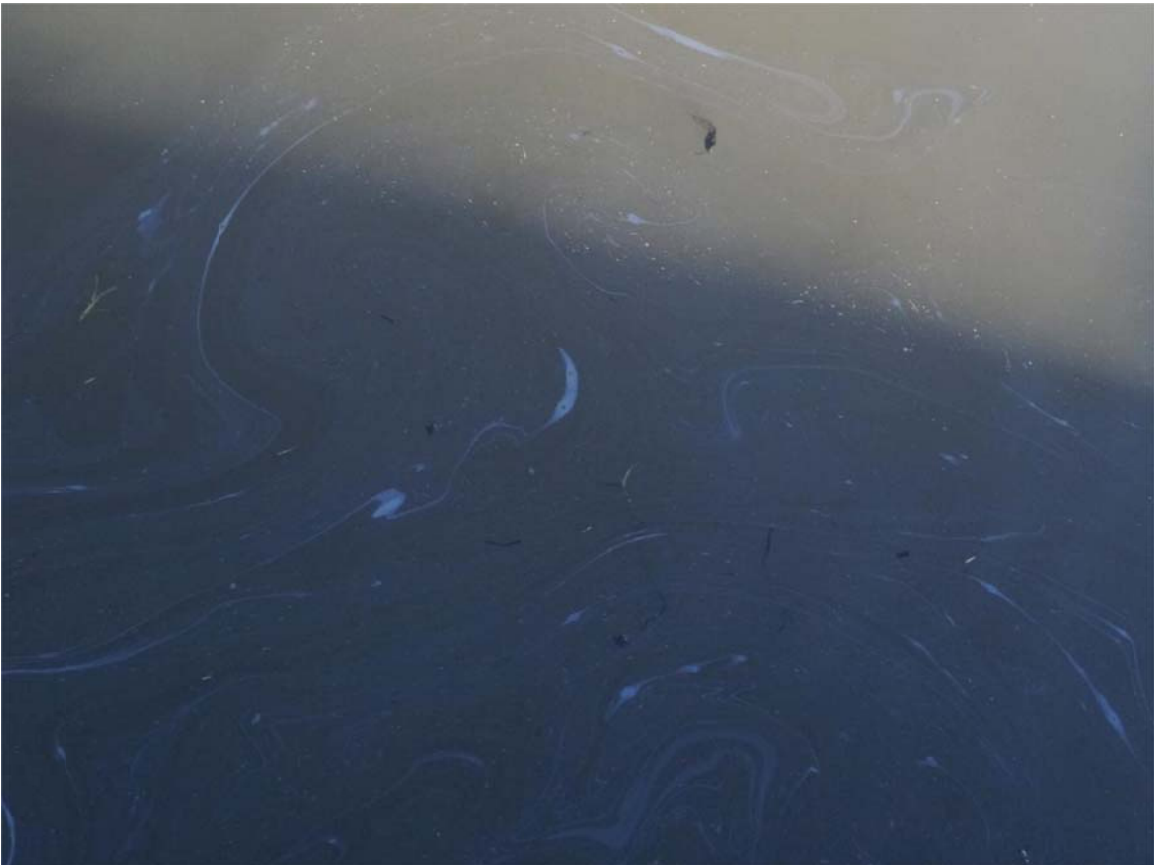
4. MP5.15 LDB sheen and tar globs observed.

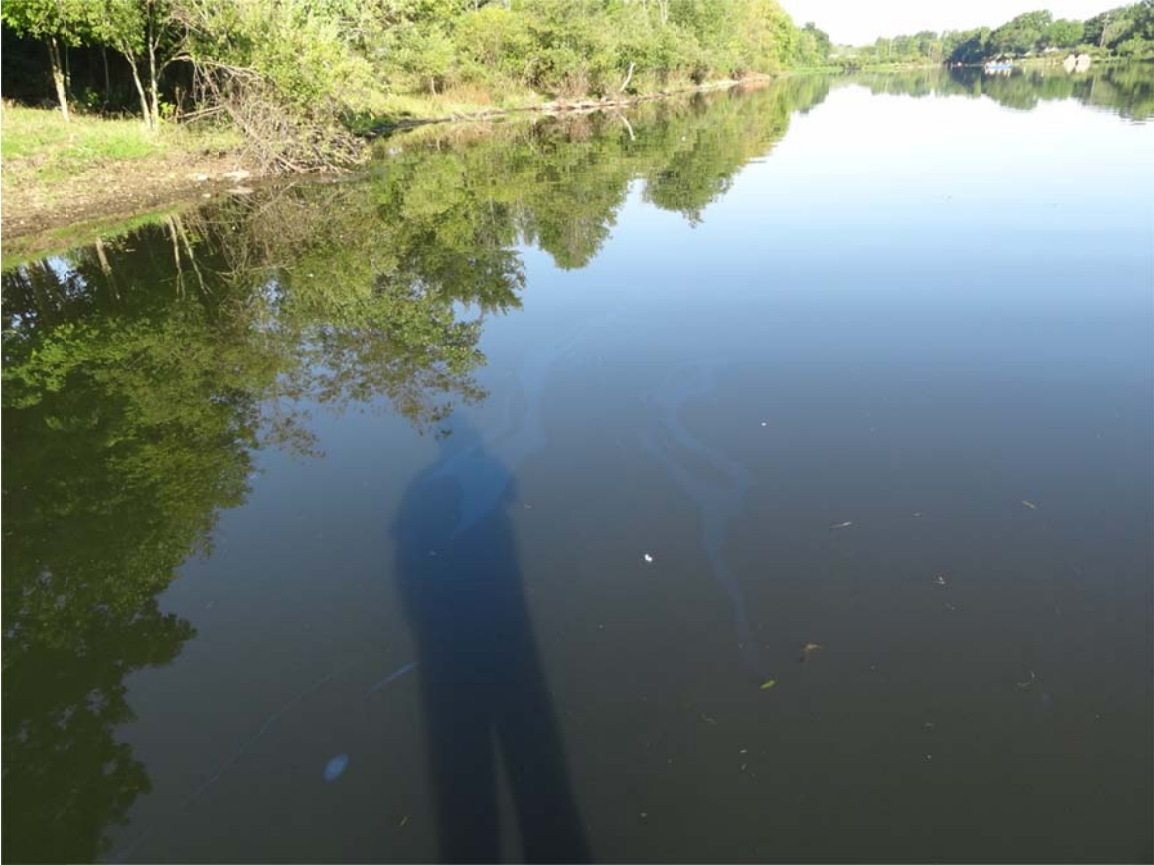
5. MP5.25 LDB sheen observed.

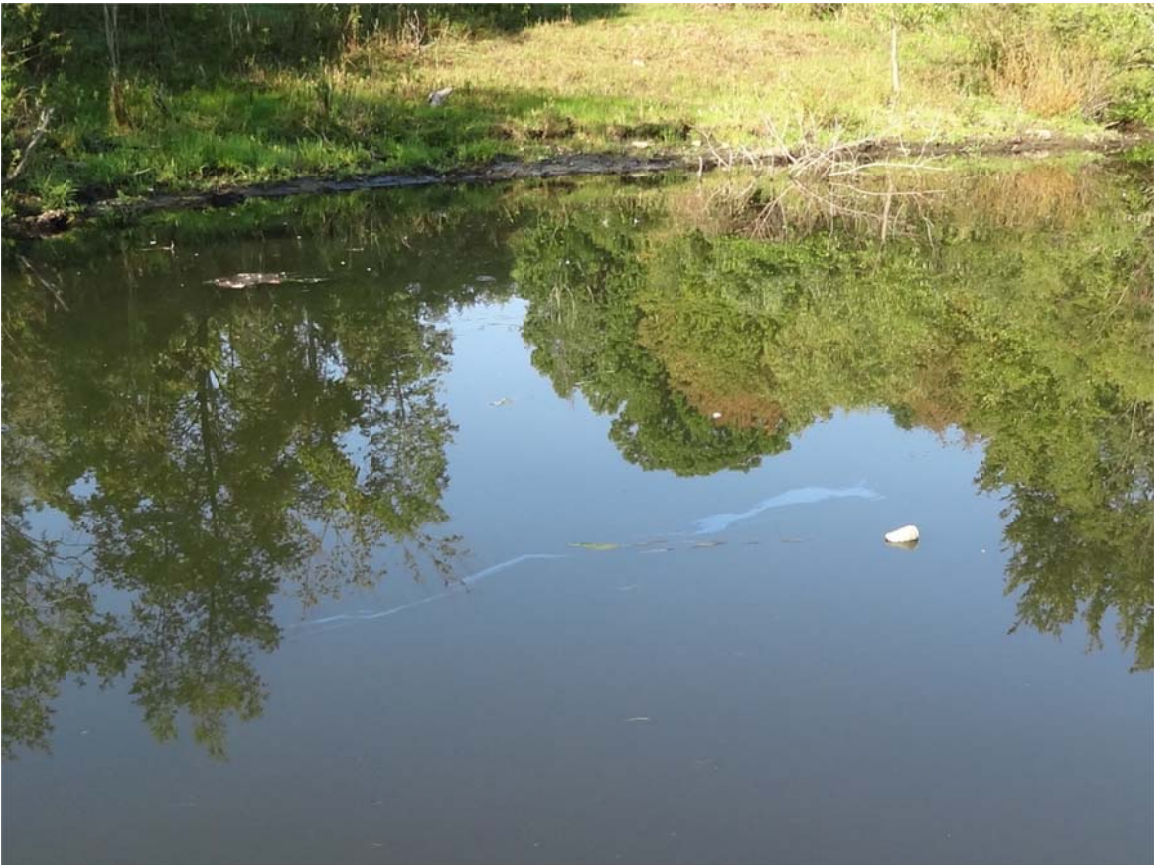
6. MP5.35 LDB sheen observed.

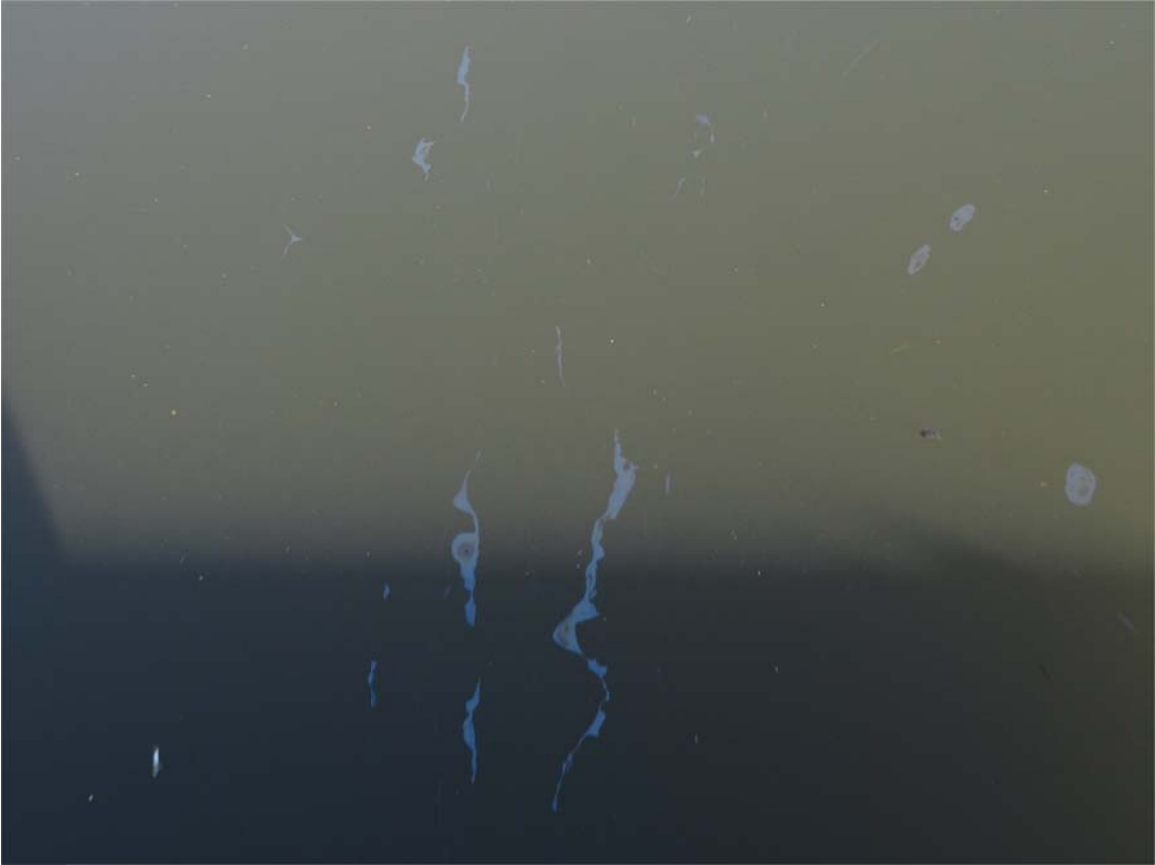
7. MP5.45 LDB sheen and tar globs observed.

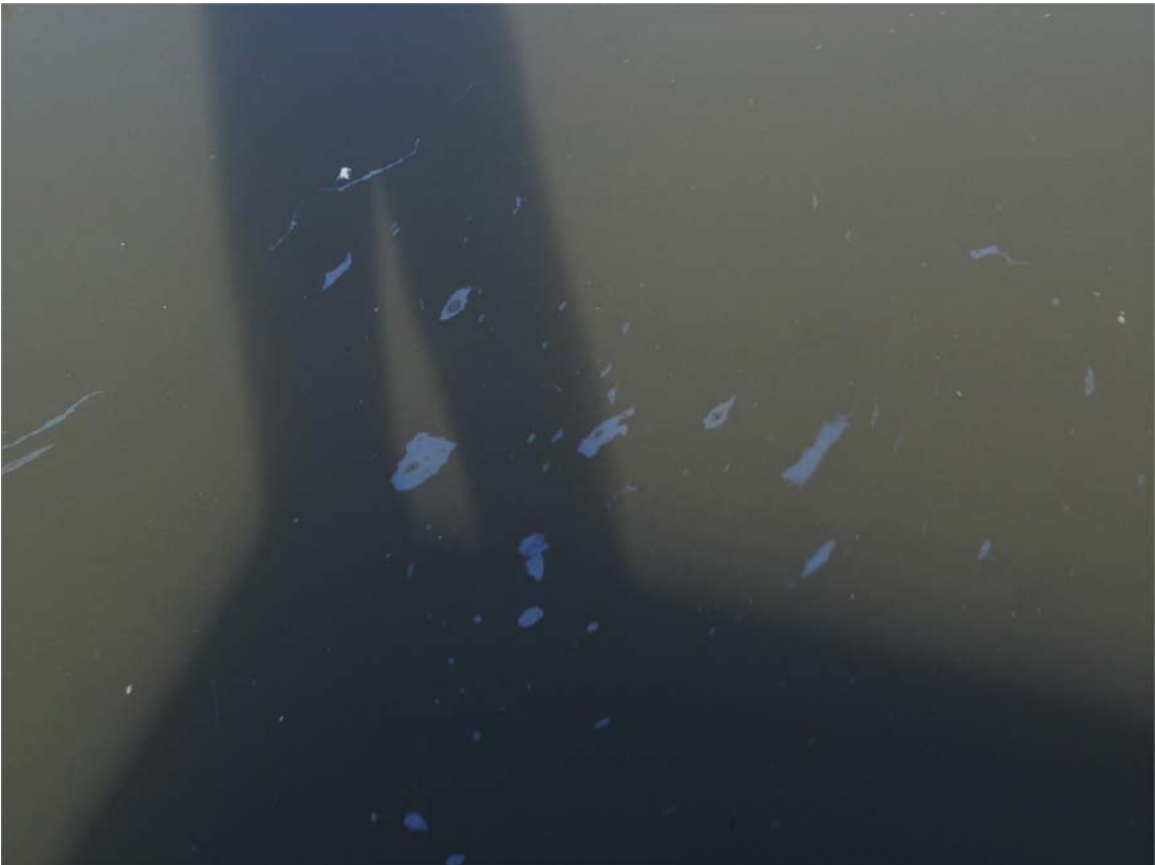
8. MP5.45 LDB sheen and tar globs observed.

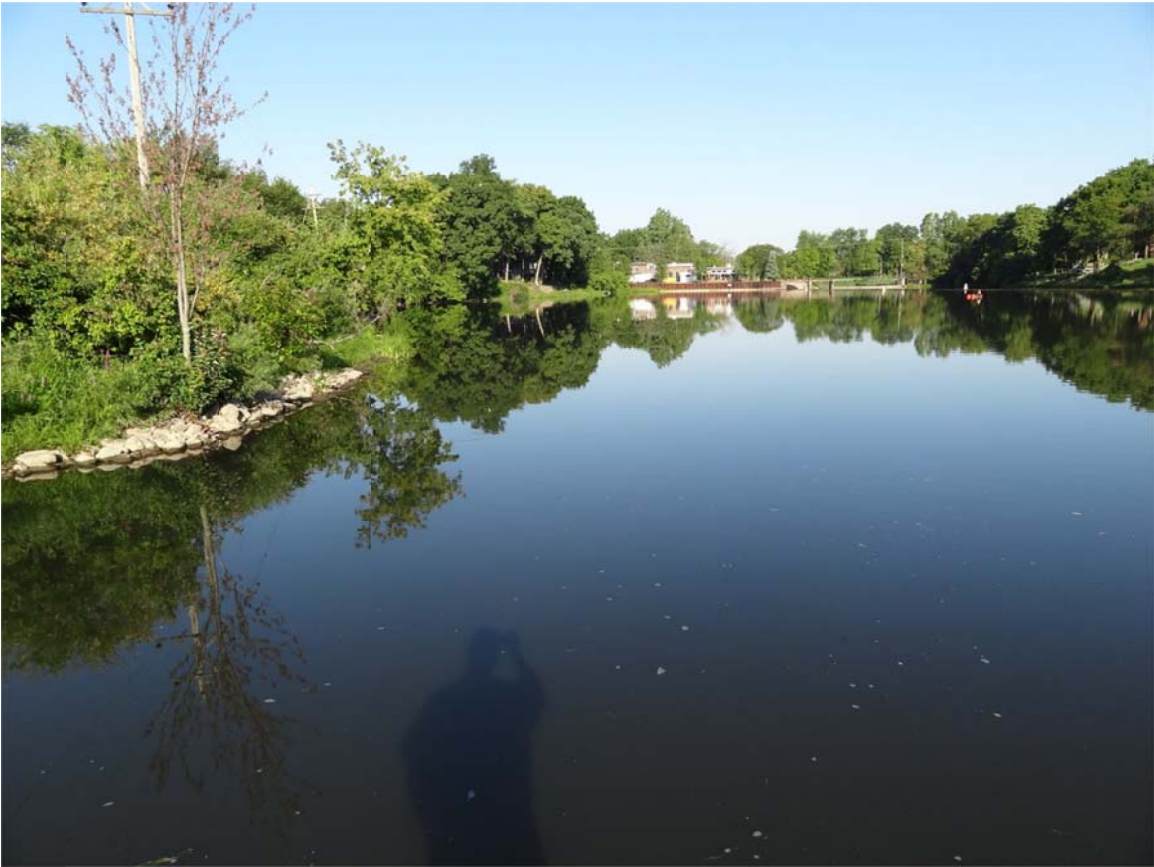
**9. MP5.63 LDB minimal sheen observed in this location today compared to previous day's observations.**

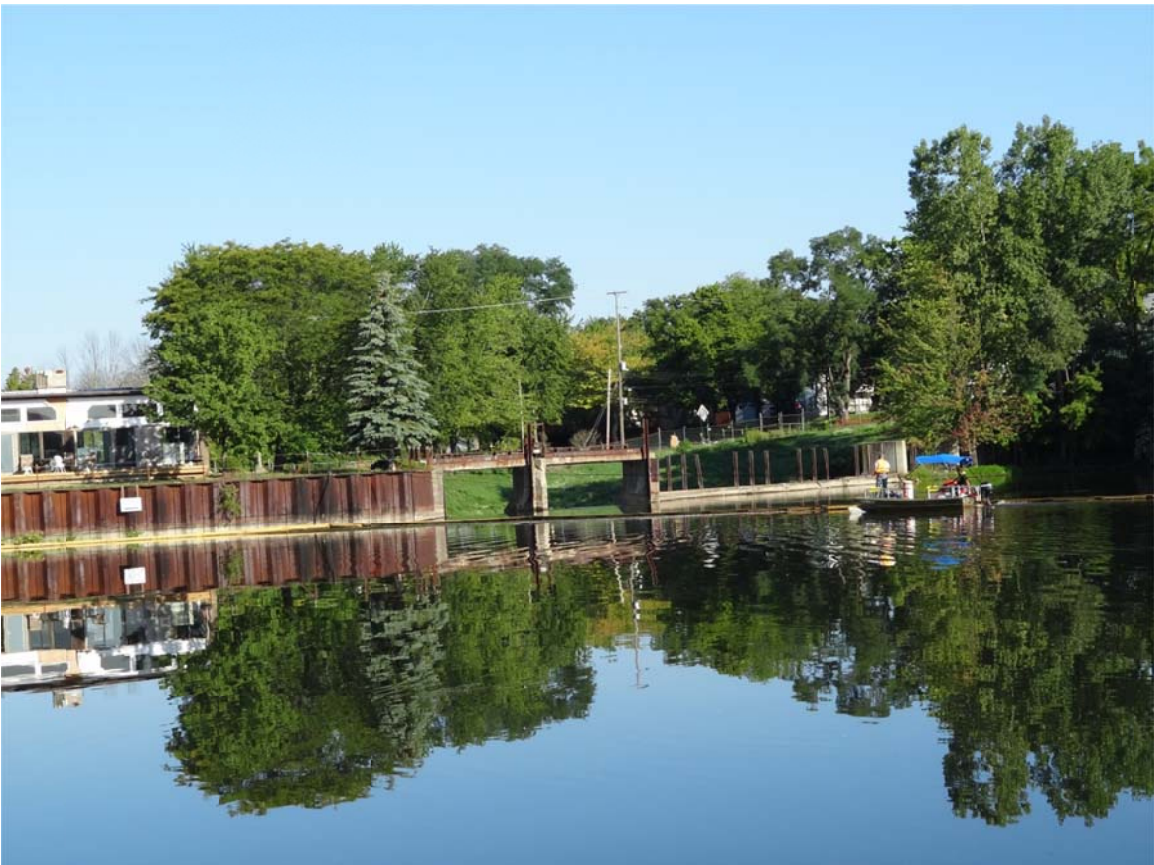
**10. Ceresco Dam control point boom observed the sheen sweep boat operating along the boom.**

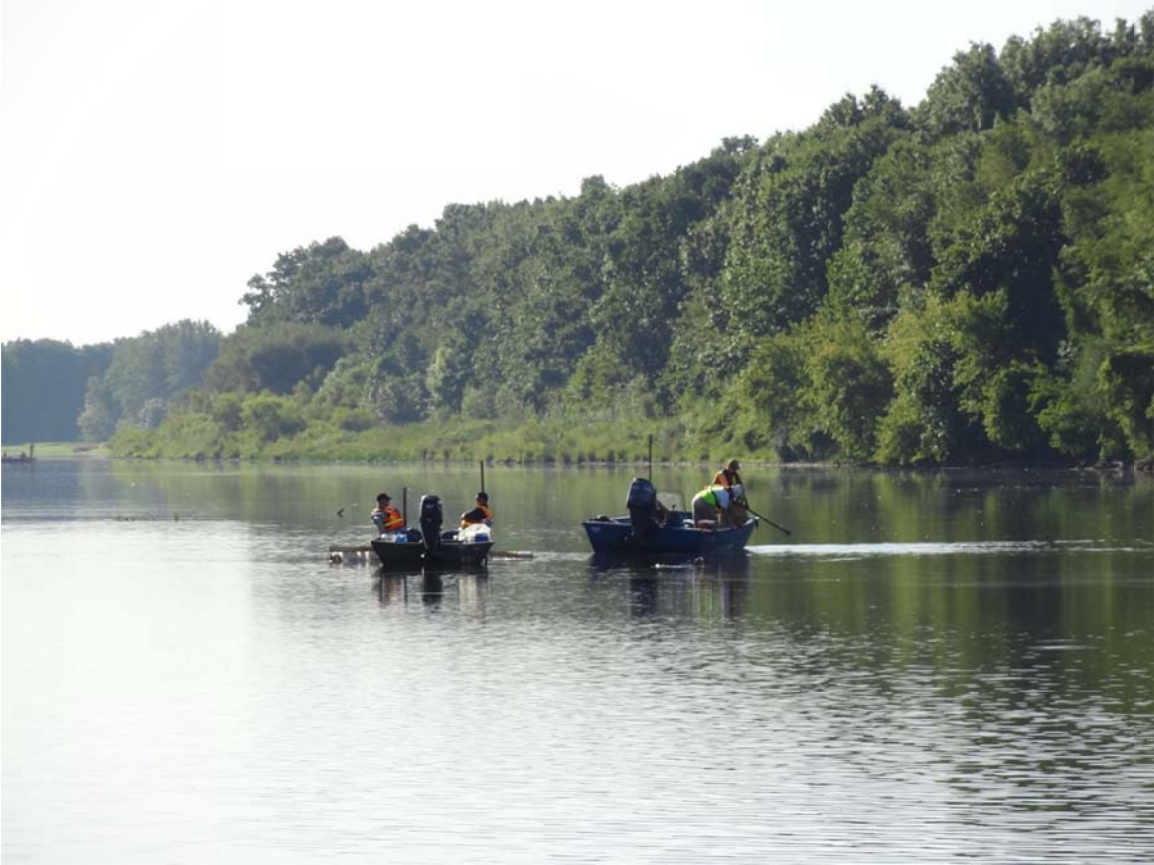
11. MP5.55 observed a LSR poling crew.

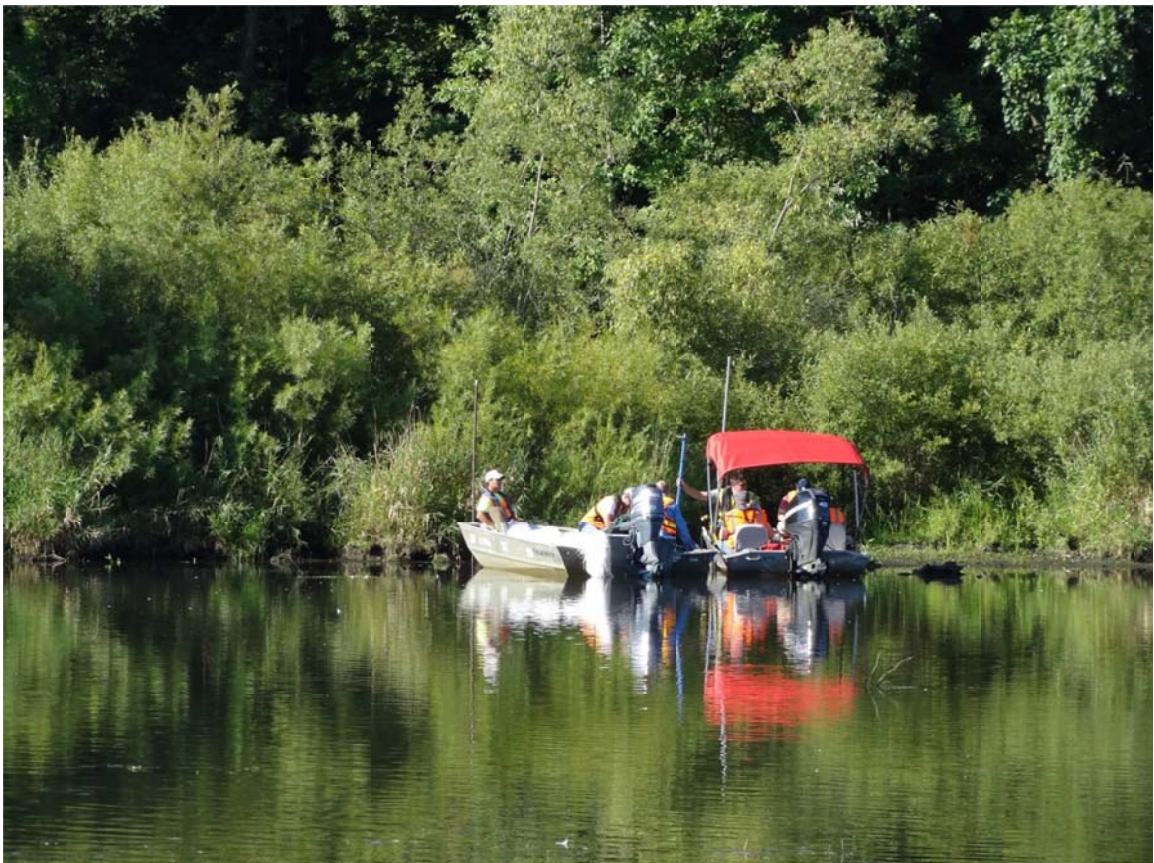
12. MP5.0 LDB observed a LSR poling crew.

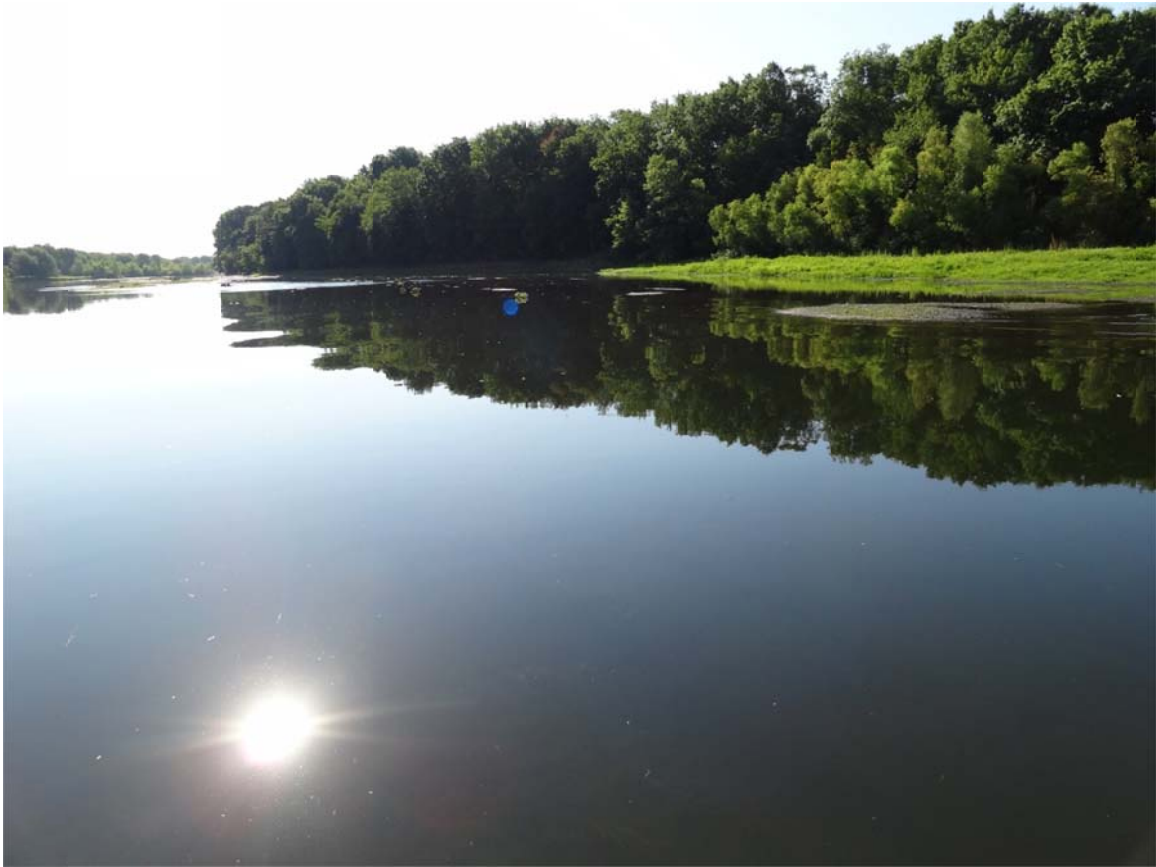
**13. MP4.5 center channel area where tar globs and sheen observed.  
Quantities observed did not meet the criteria for a sweep boat.**

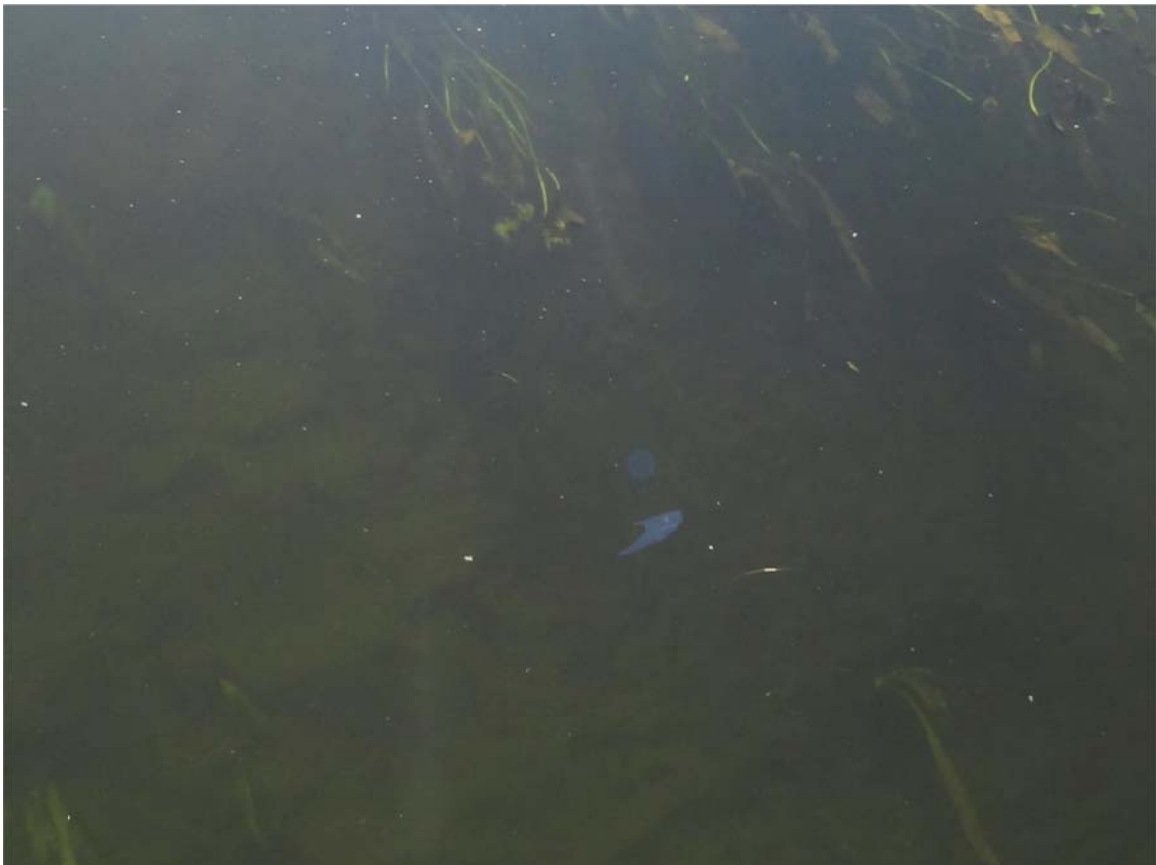
**14. MP4.5 center channel area where tar globs and sheen observed.  
Quantities observed did not meet the criteria for a sweep boat.**

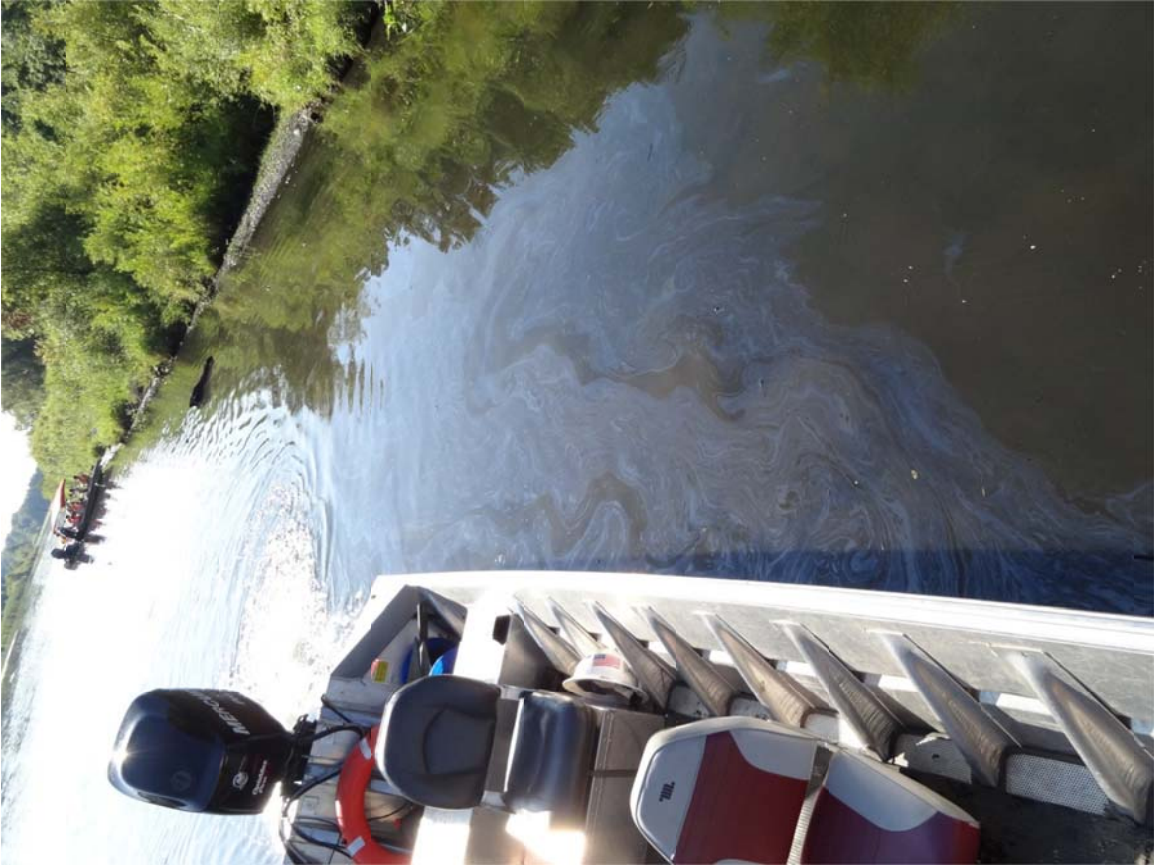
15. MP5.0 LDB sheen and tar globs observed downstream of poling crew.

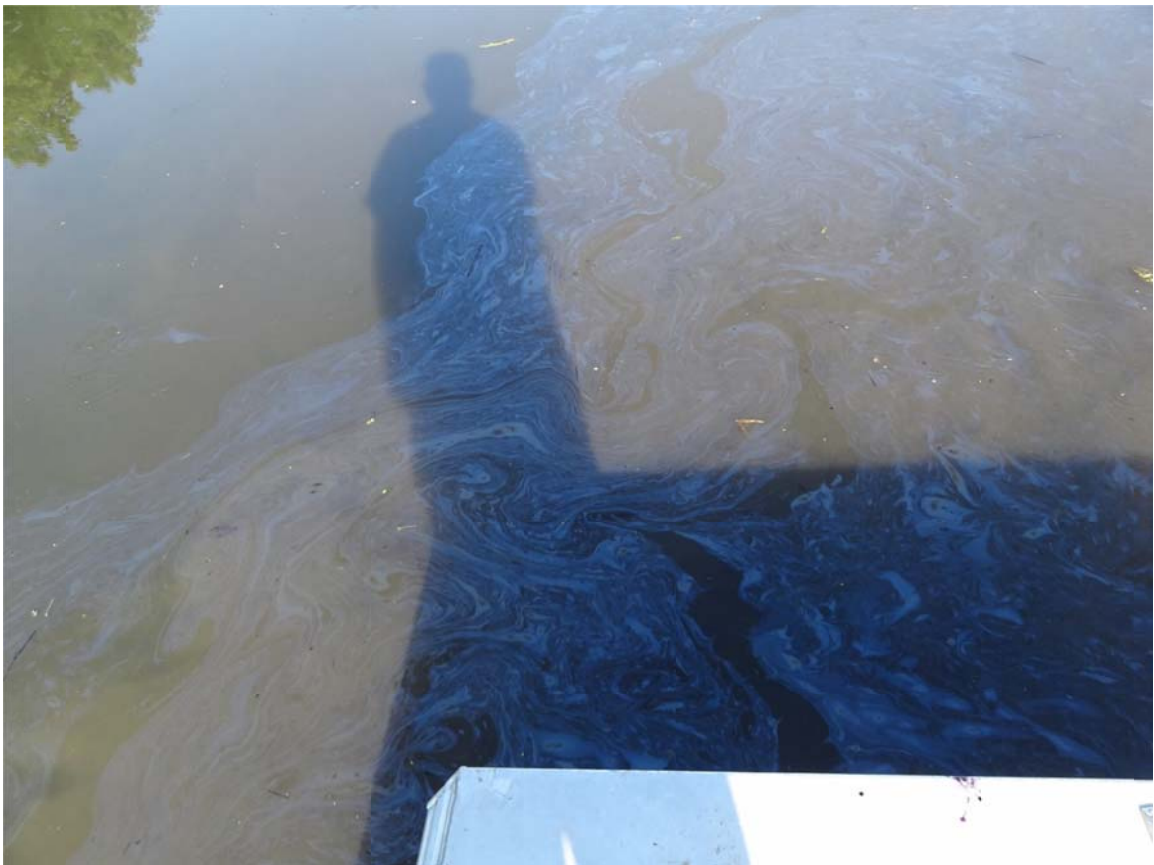
16. MP5.0 LDB sheen and tar globs observed downstream of poling crew.

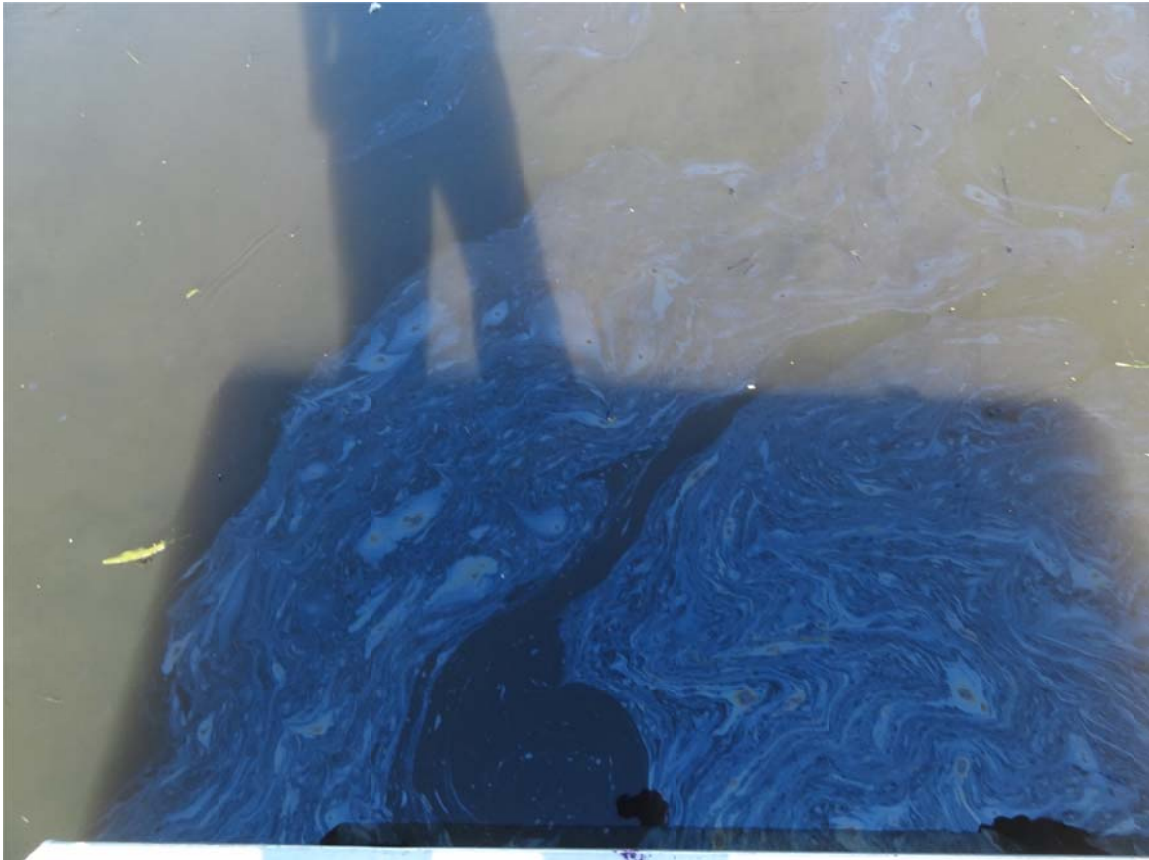
17. MP5.0 LDB sheen and tar globs observed downstream of poling crew.

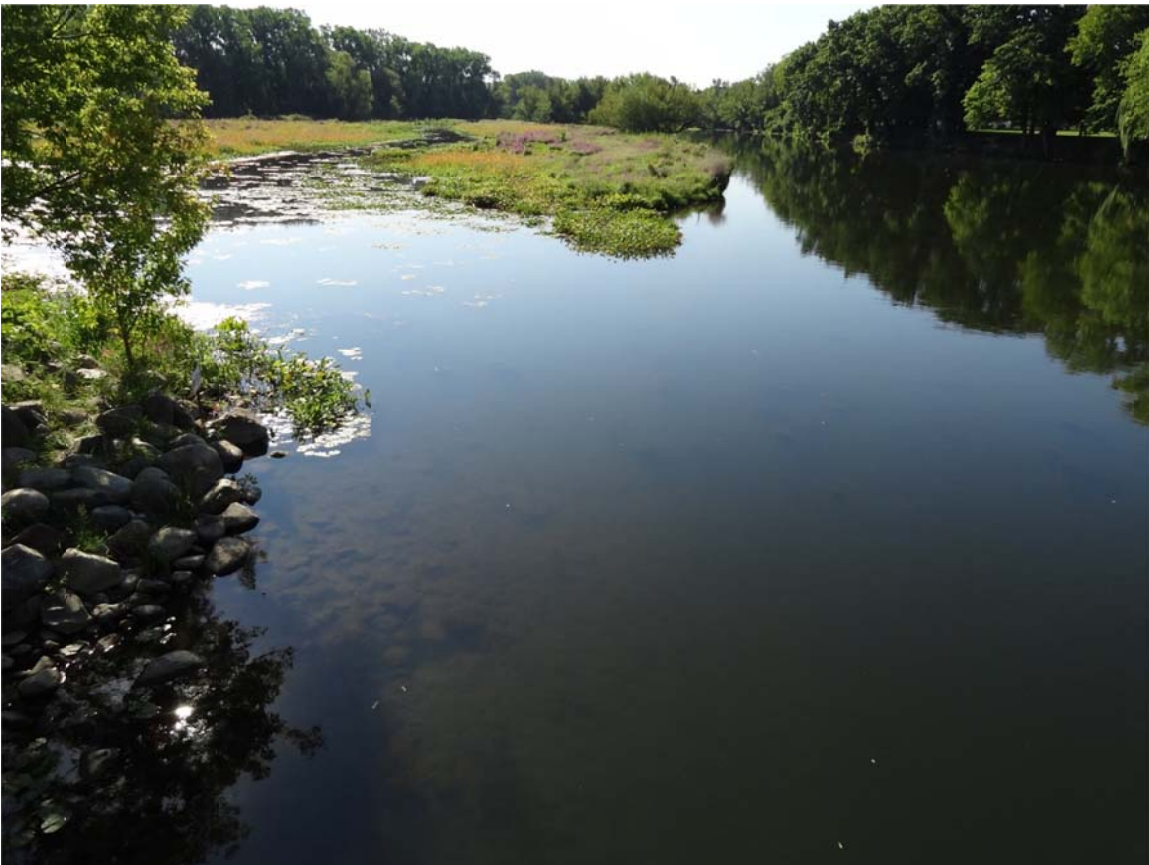
18. MP15.5 South Mill Pond observed small ribbons of sheen flowing out of the south Mill Pond.

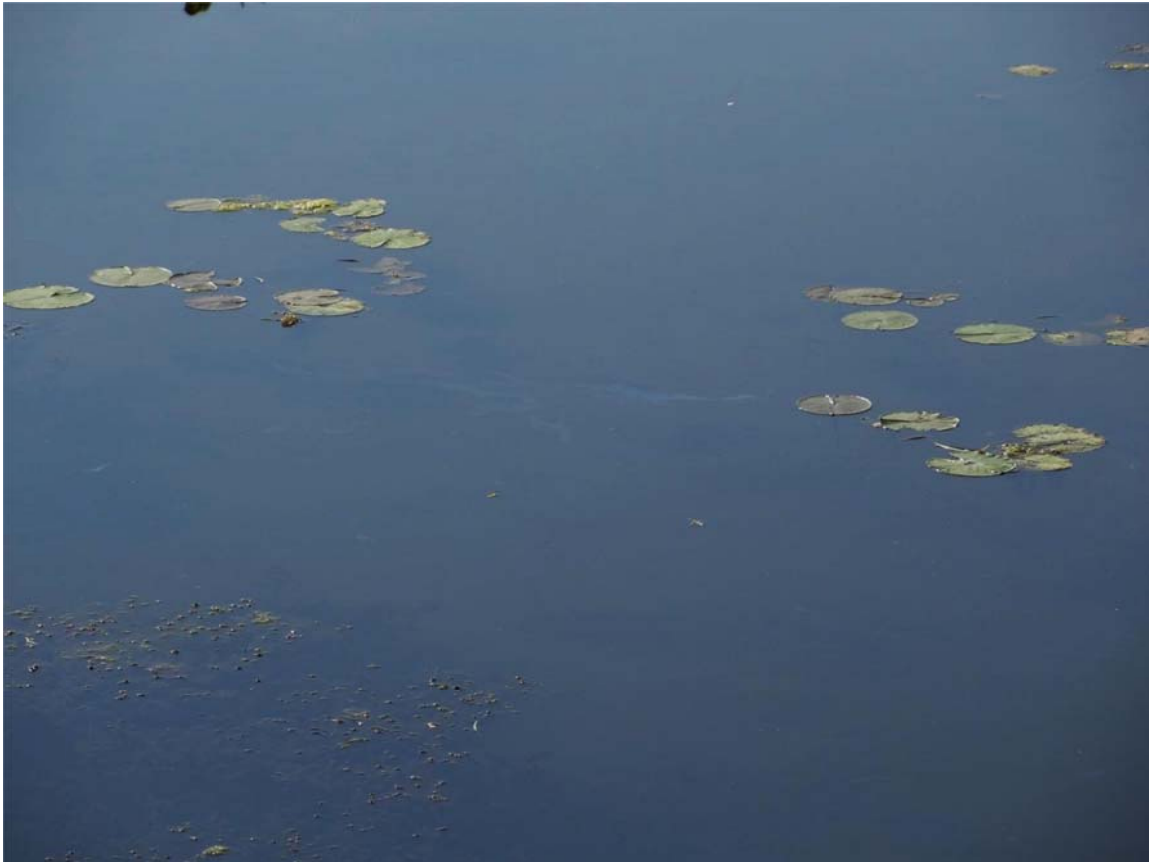
**19. MP15.5 South Mill Pond observed small ribbons of sheen flowing out of the south Mill Pond.**

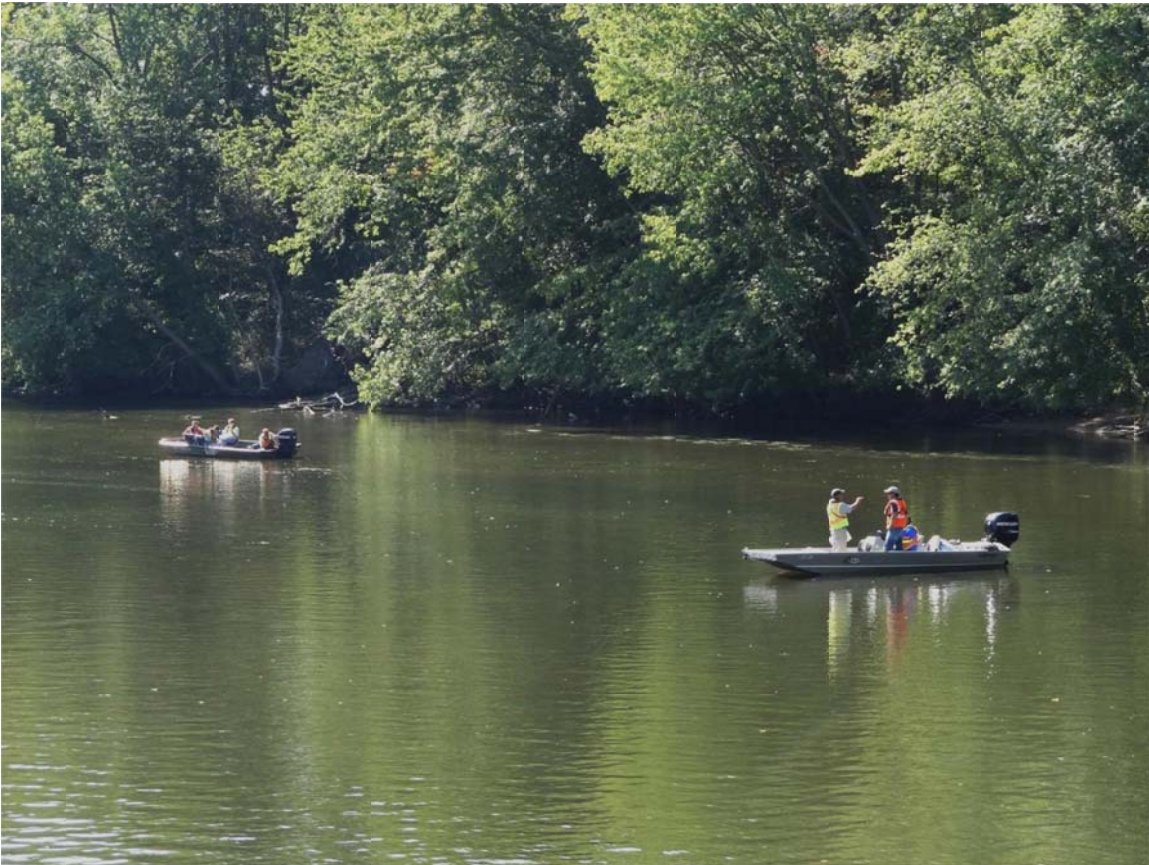
**20. MP21.5 observed the river bank erosion inspecting teams.**

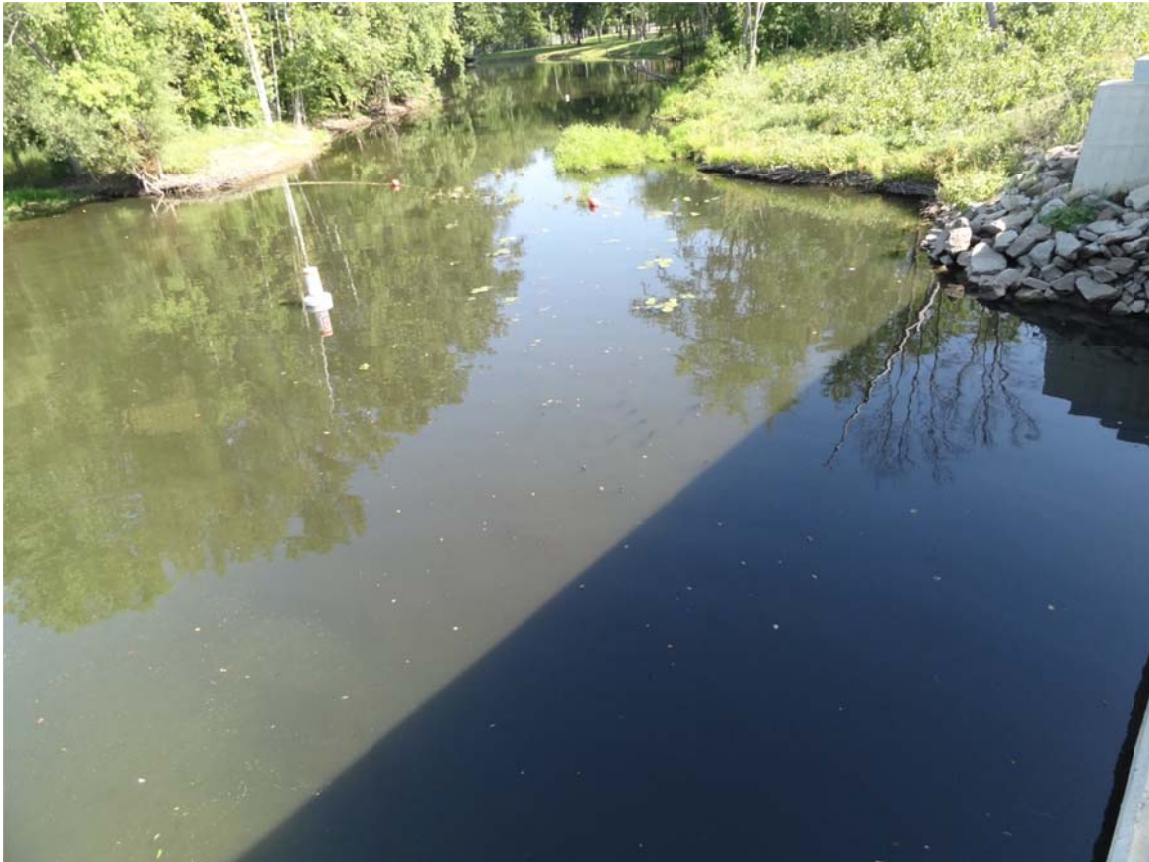
**21. MP21.5 Custer Drive Bridge observed ribbons of sheen. The quantity of sheen did not meet the requirements for a sheen sweep boat.**

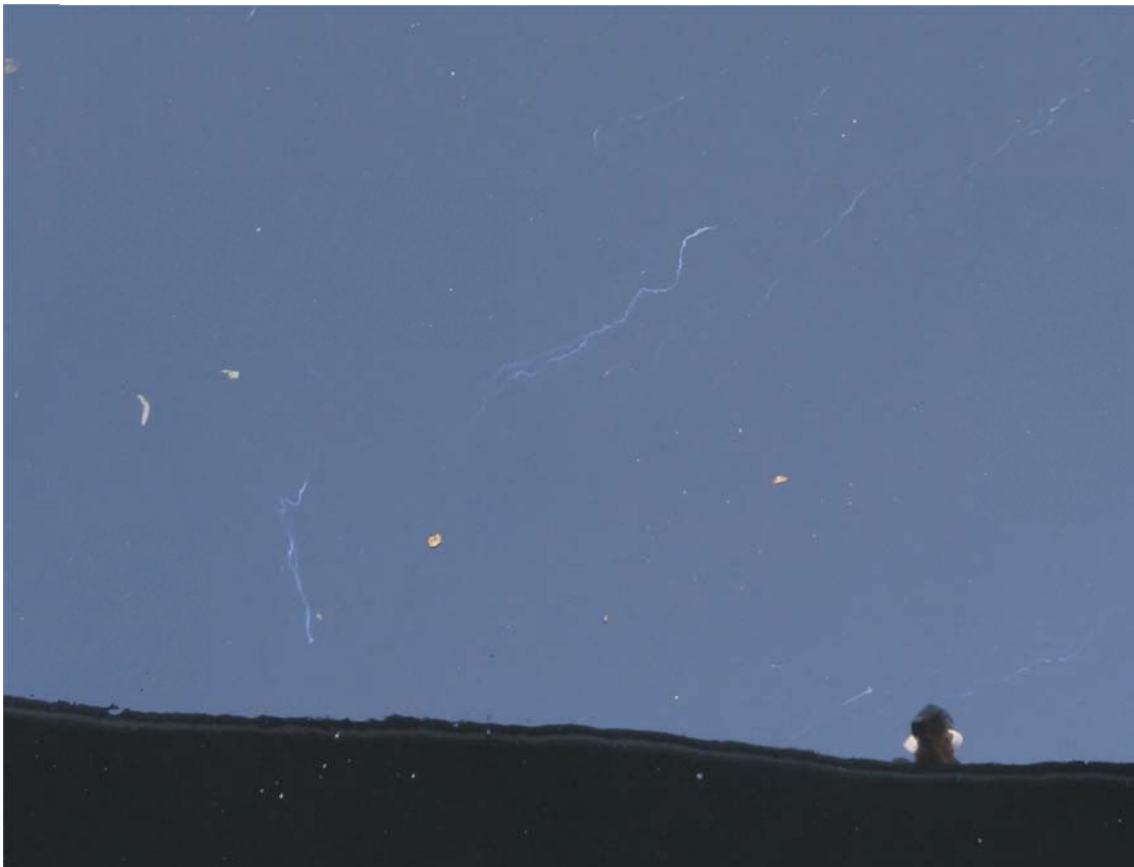
**22. MP21.5 Custer Drive Bridge observed ribbons of sheen. The quantity of sheen did not meet the requirements for a sheen sweep boat.**

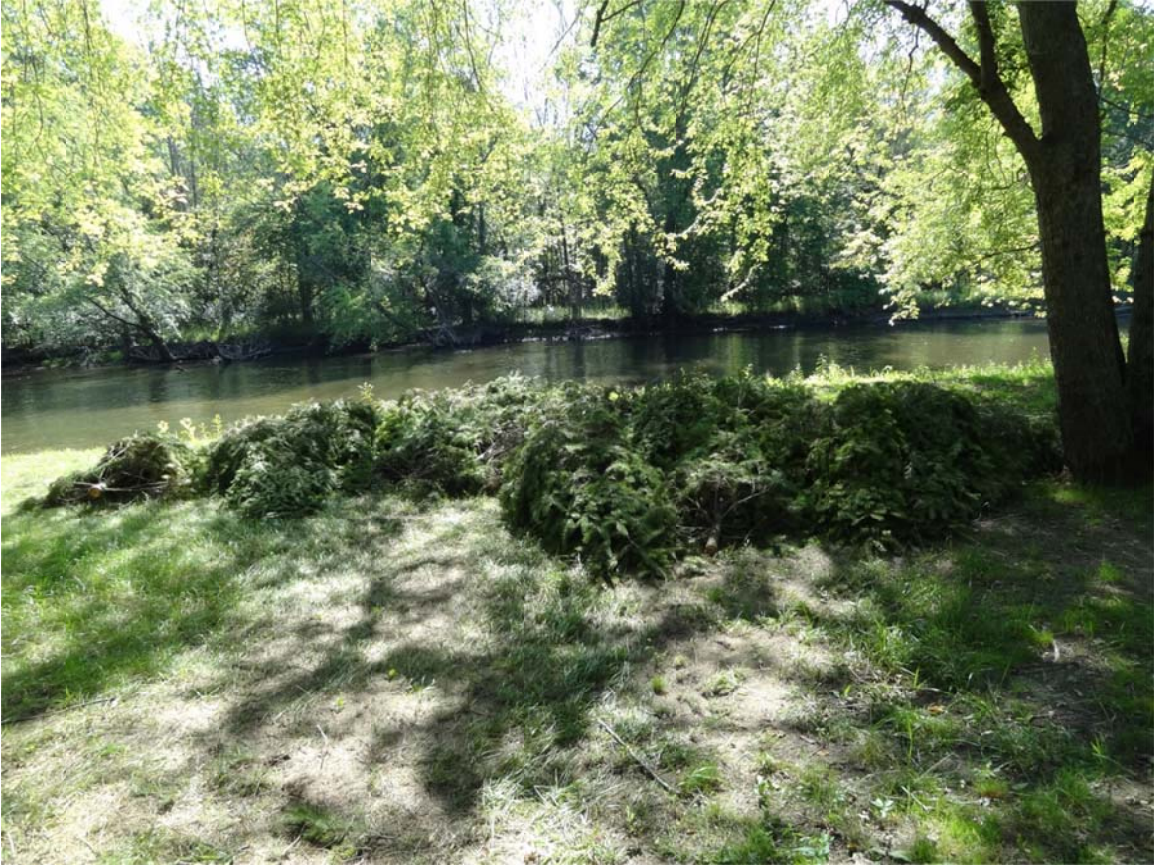
**23. Shady Bend Campground observed conifers staged for installation of future sediment traps.**
