# Situation Photo Log

Thursday, August 23, 2012

Kalamazoo River / Enbridge Spill

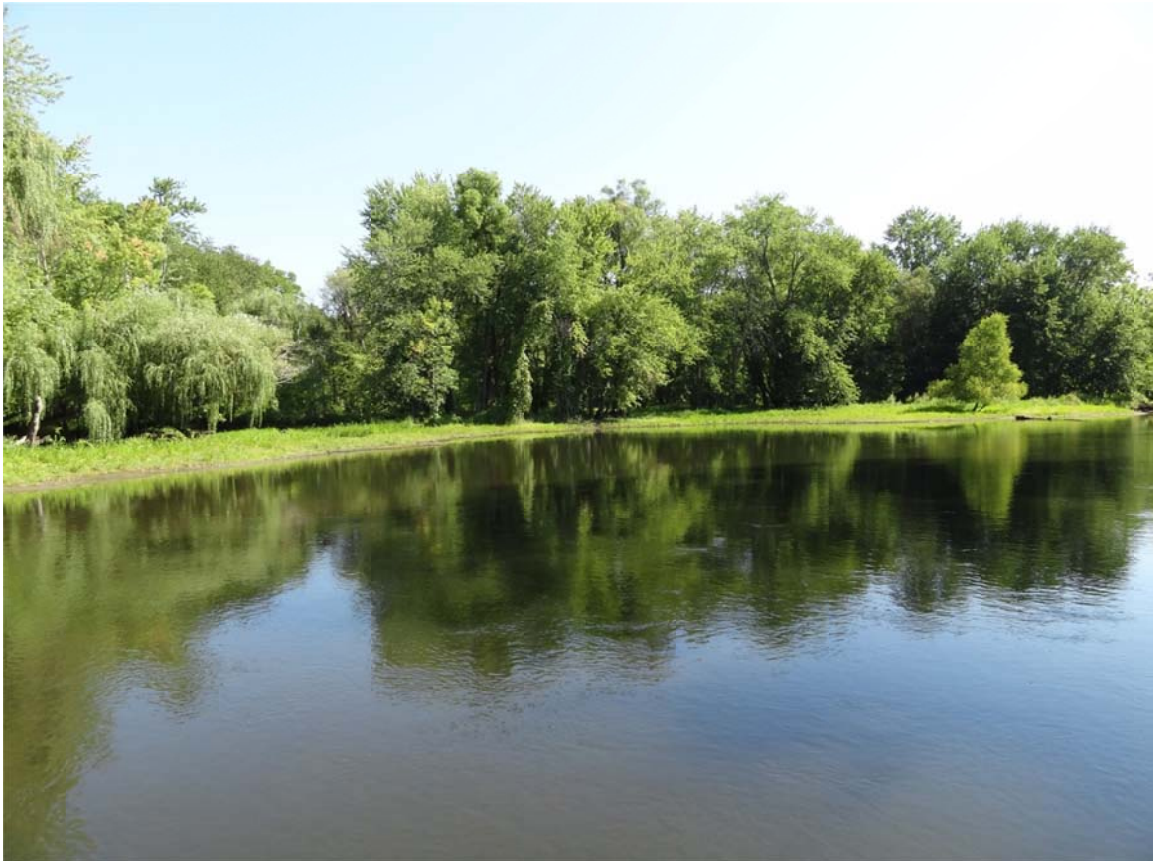
**24. MP26.25 RDB no sheen observed.**

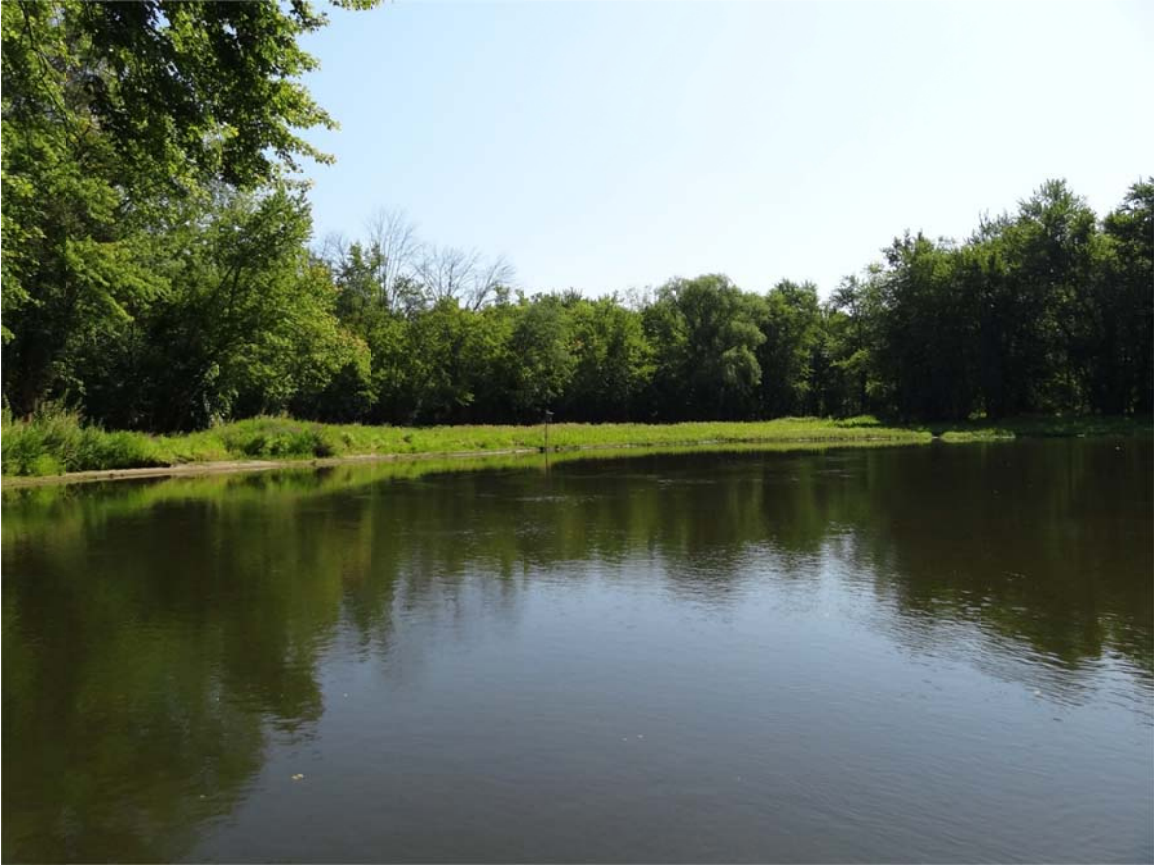
25. MP26.0 RDB no sheen observed.

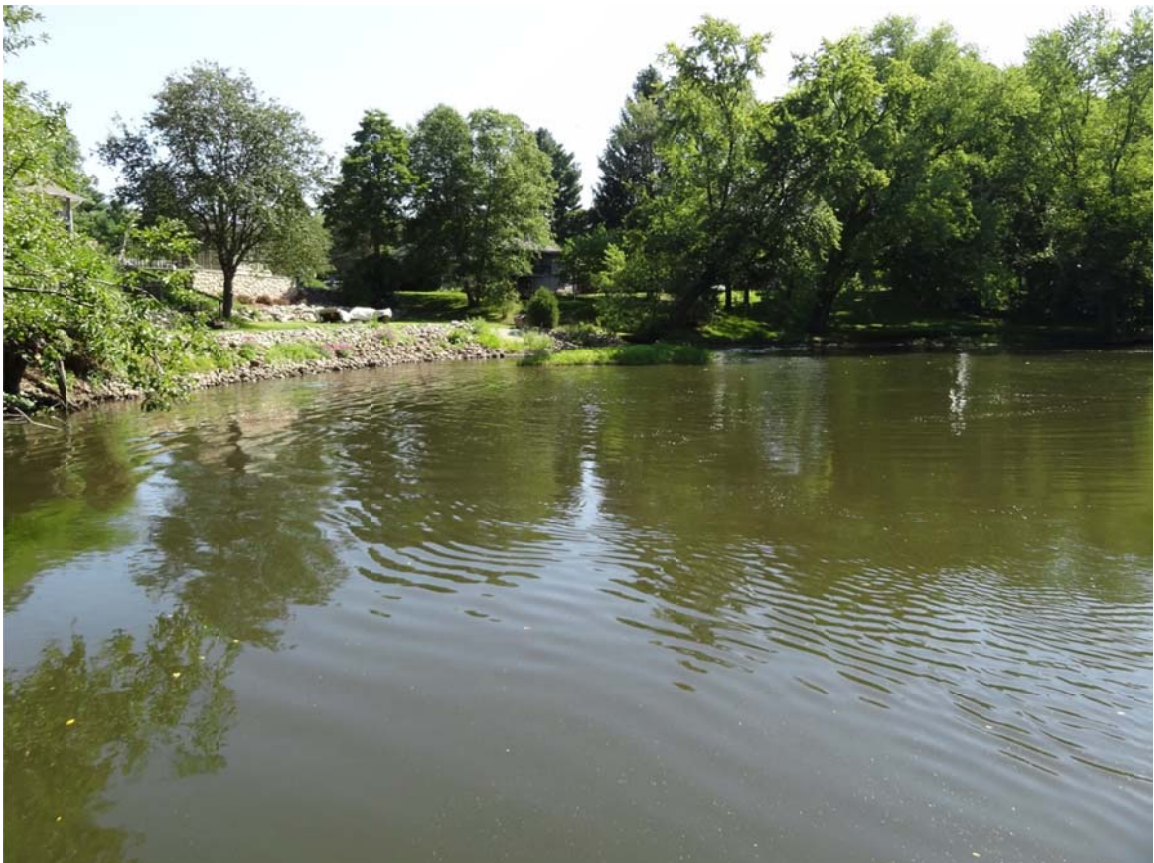
26. MP23.10 RDB no sheen observed.

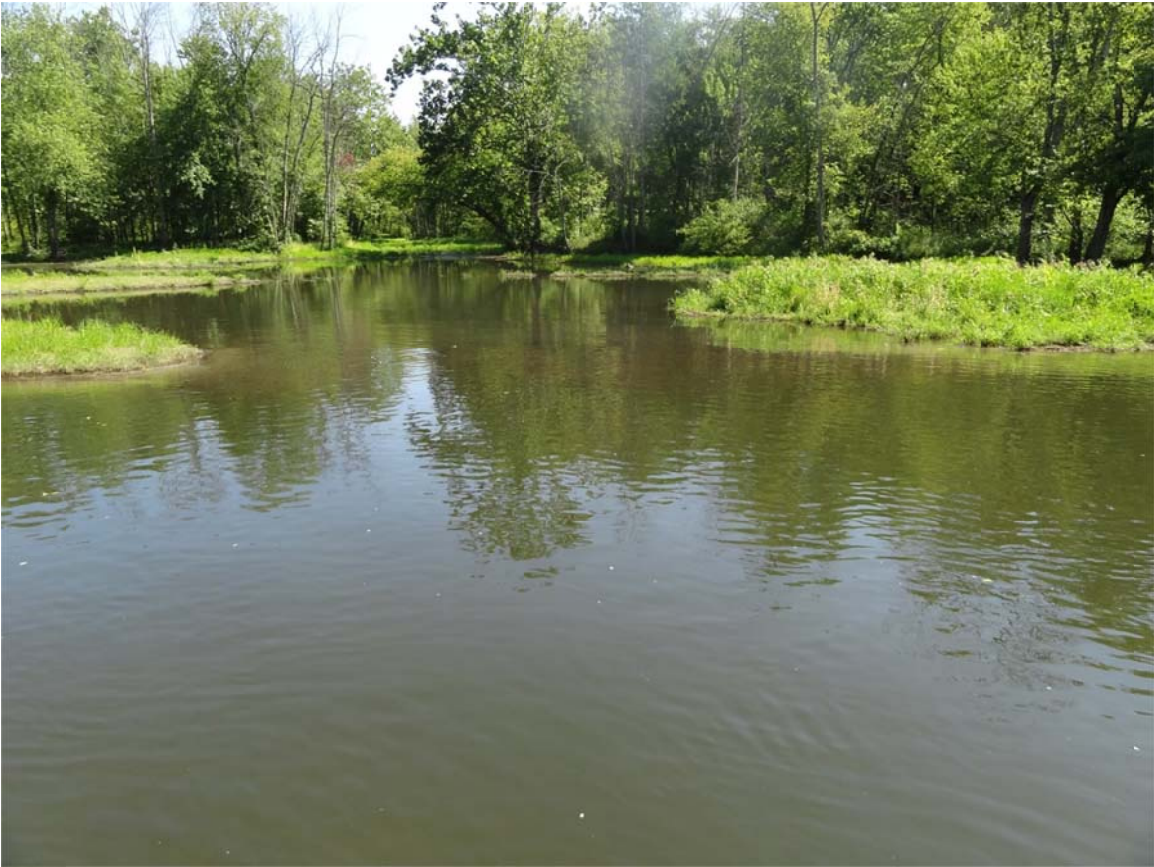
**27. MP30.8 LDB no sheen observed.**

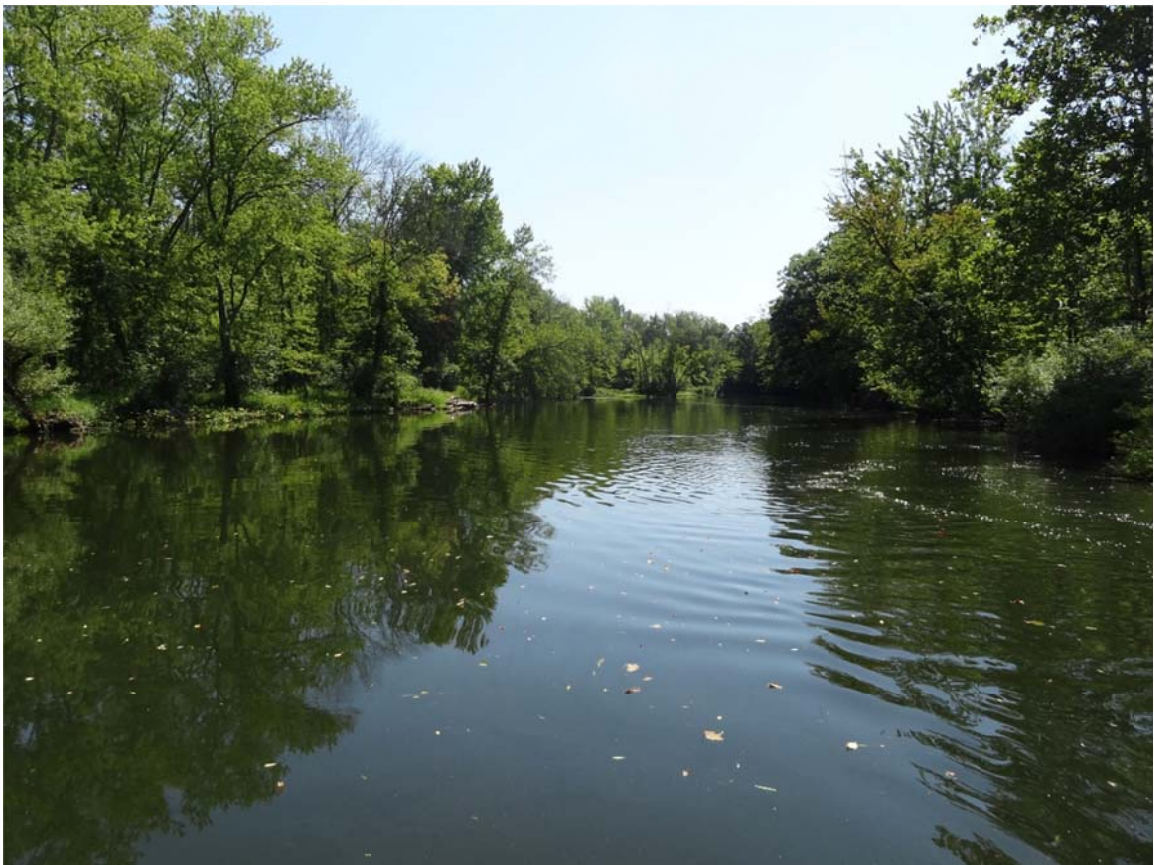
**28. MP36.25 area where ribbons of sheen were observed. The quantity of sheen did not meet the requirements for a sheen sweep boat.**

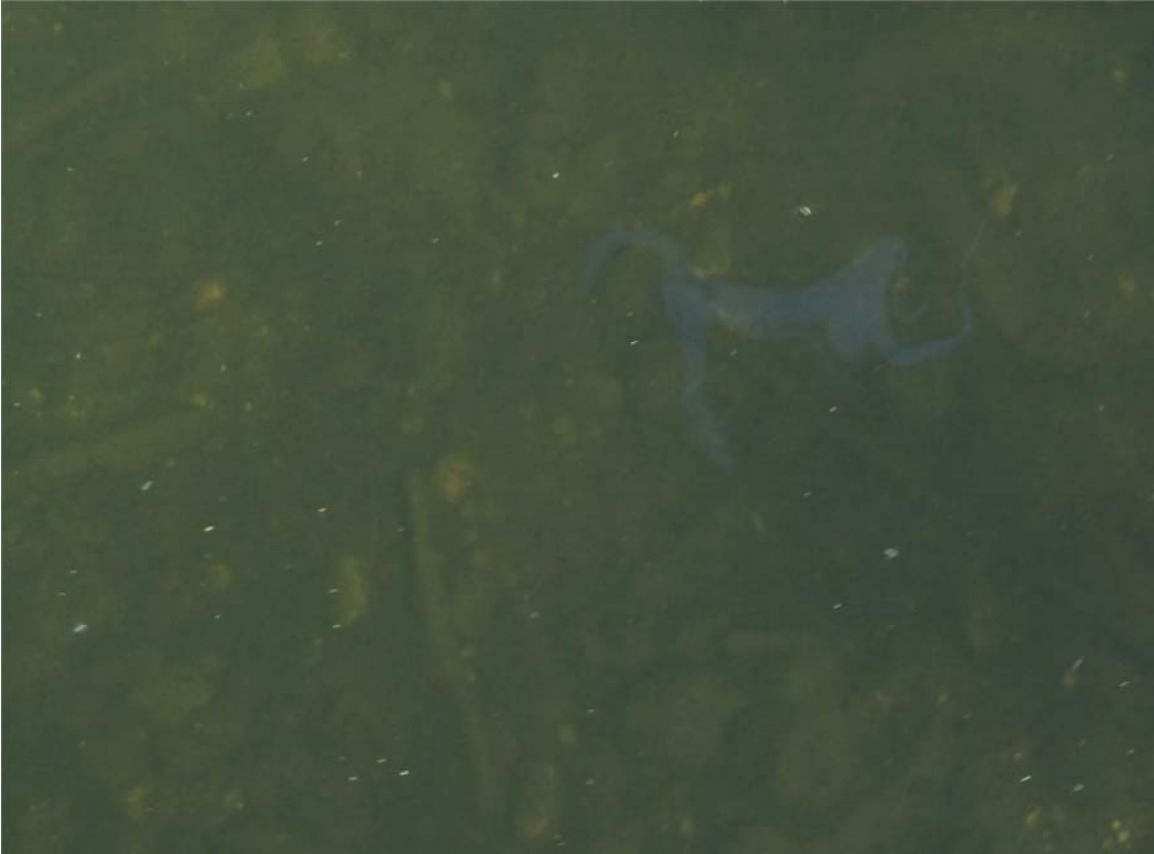
**29. MP36.25 area where ribbons of sheen were observed. The quantity of sheen did not meet the requirements for a sheen sweep boat.**

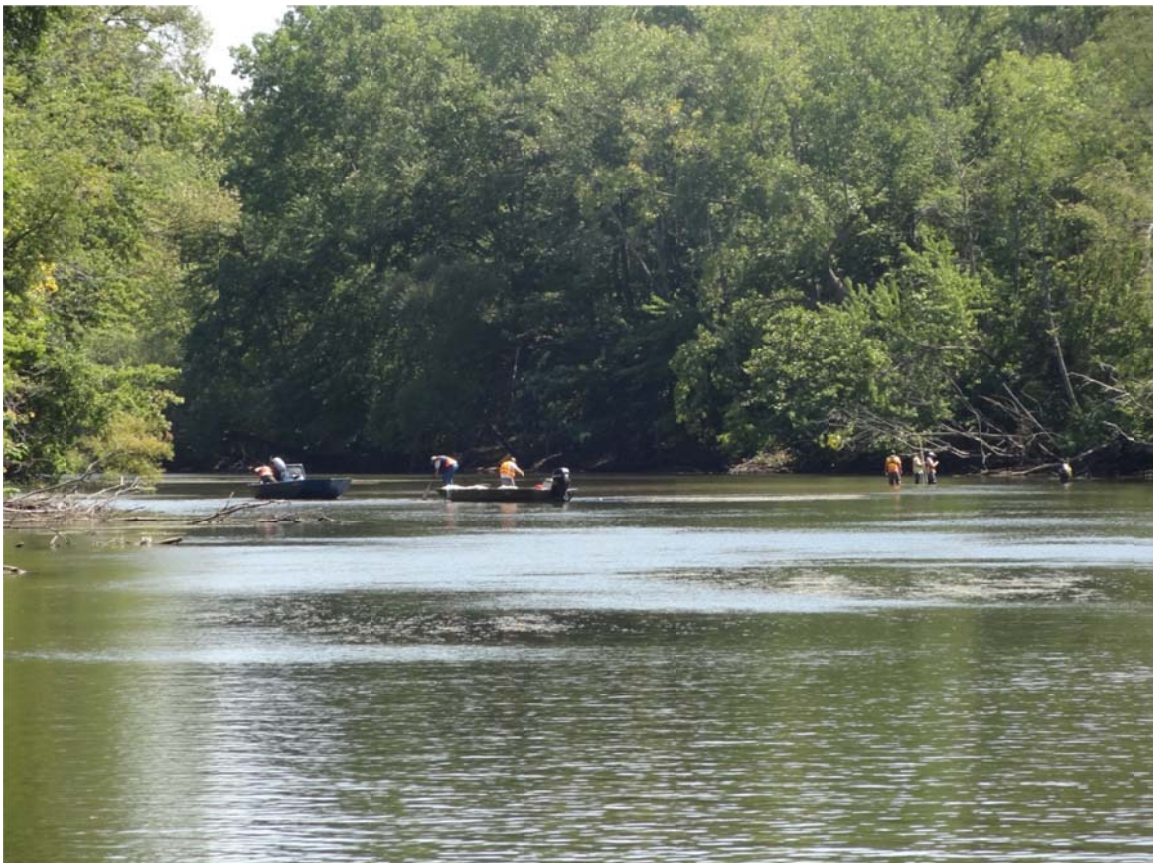
**30. MP21.0 LDB observed a LSR poling crew.**

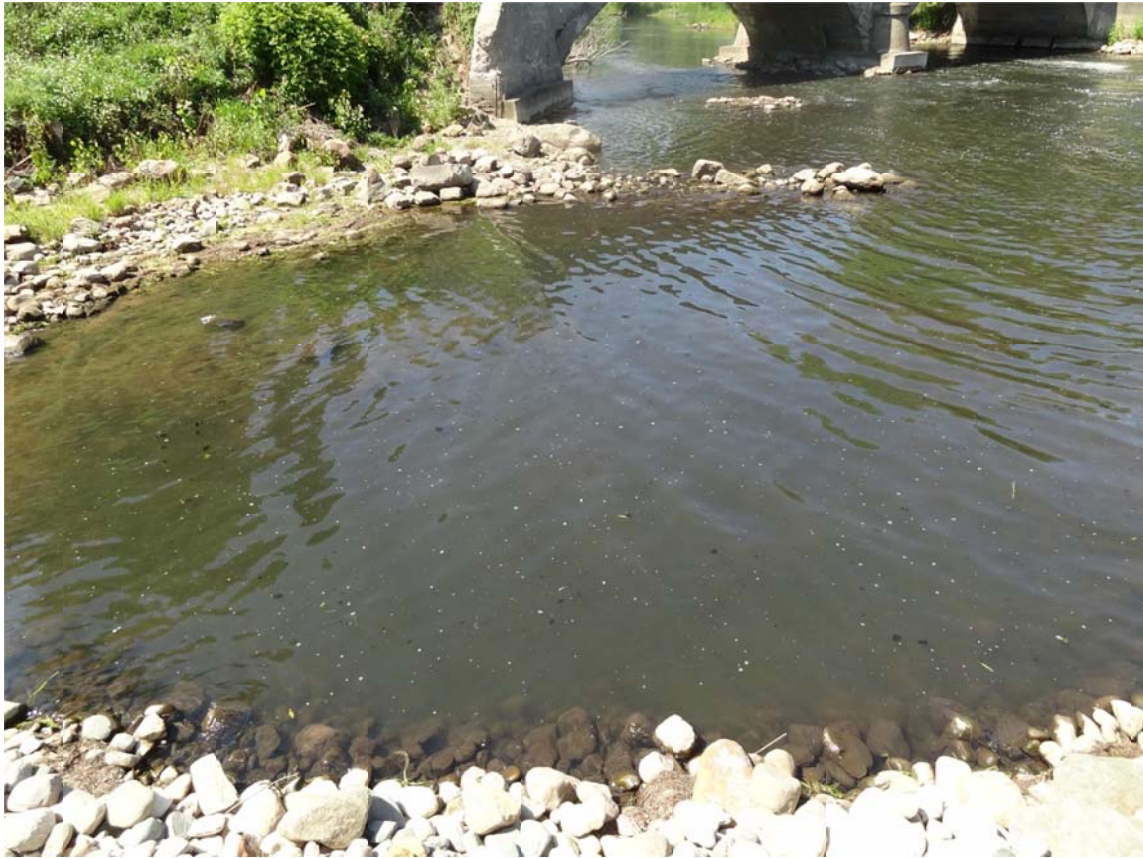
**31. Portage launch below Ceresco Dam, sheen observed. The quantity of sheen did not meet the requirements for a sheen sweep boat.**

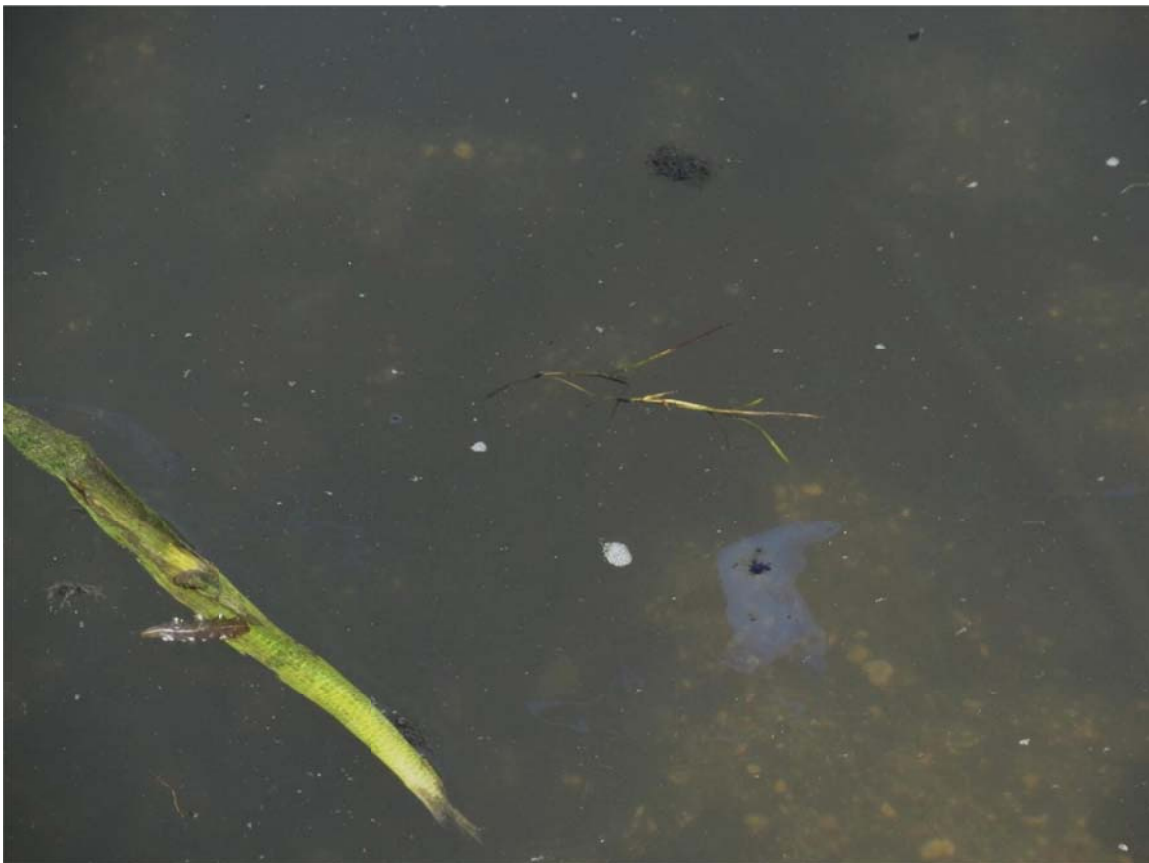
**32. Portage launch below Ceresco Dam, tar globs and sheen observed. The quantity of sheen did not meet the requirements for a sheen sweep boat.**

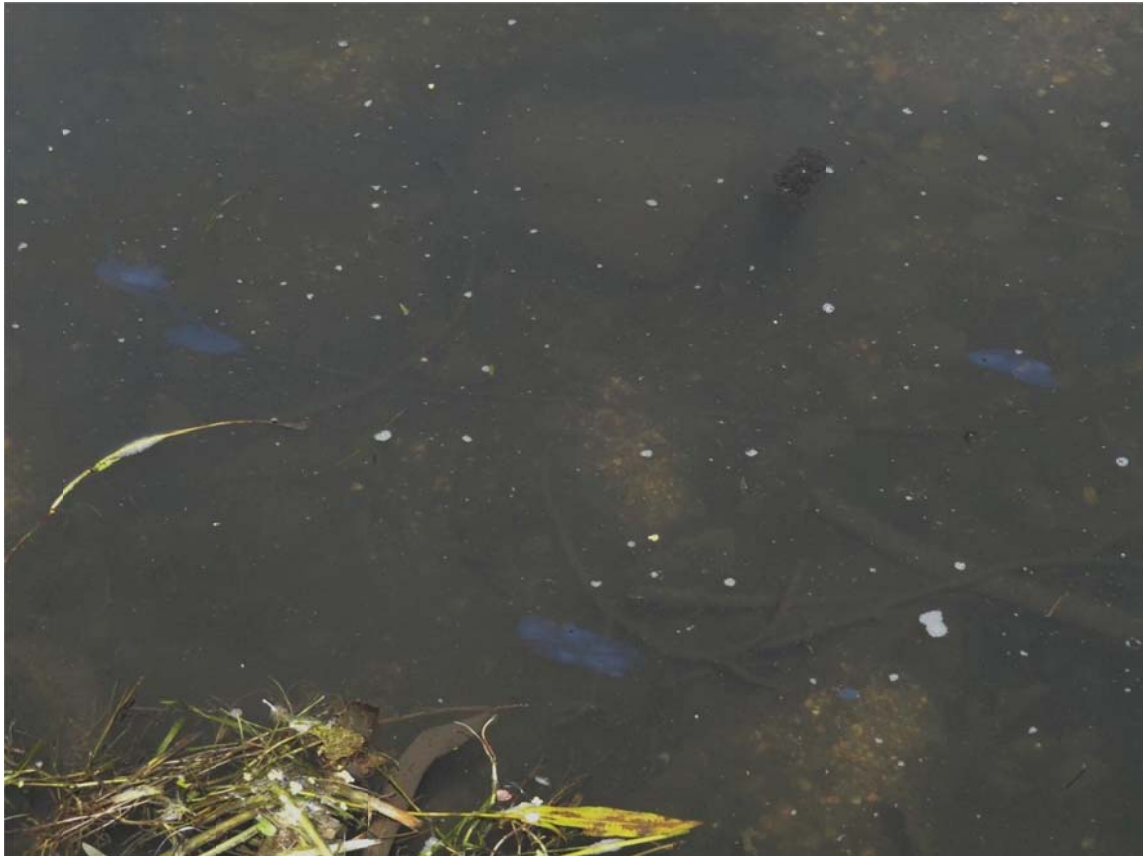
**33. Portage launch below Ceresco Dam, tar globs and sheen observed. The quantity of sheen did not meet the requirements for a sheen sweep boat.**

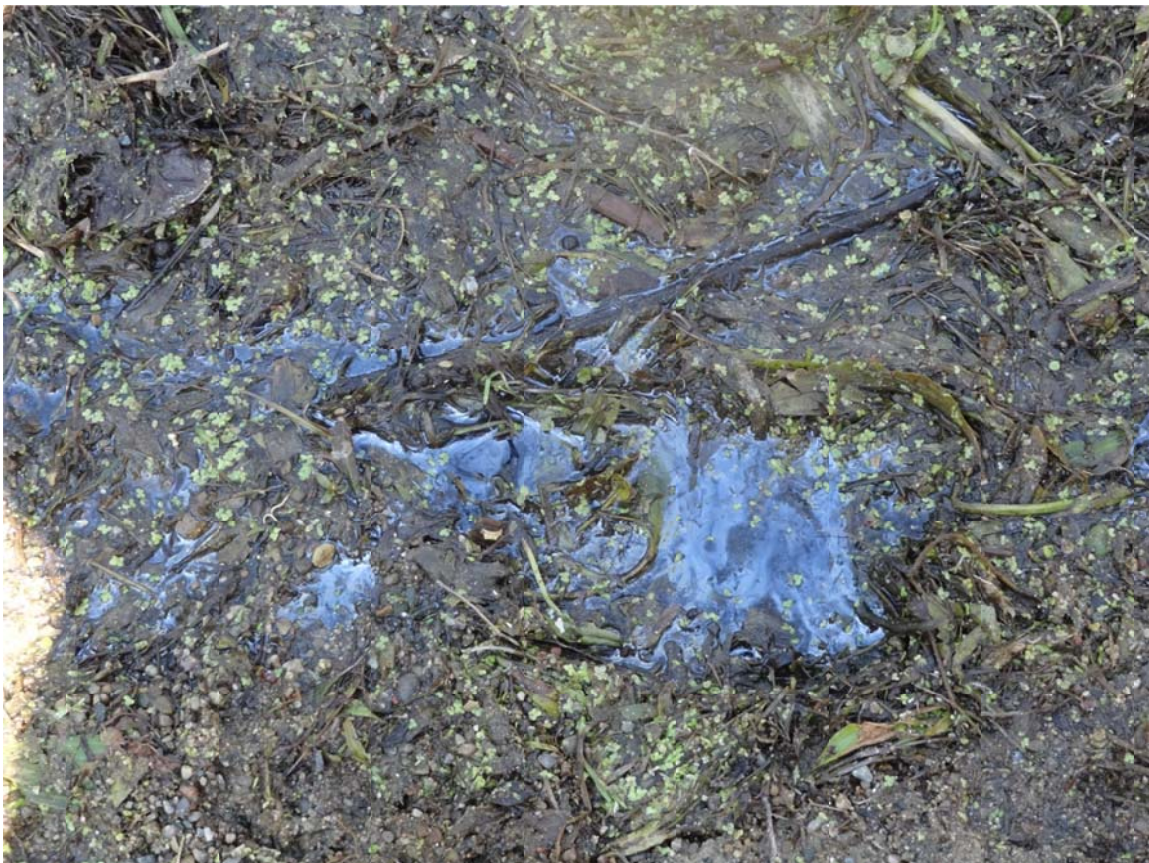
**34. Portage launch below Ceresco Dam, sheen observed. The quantity of sheen did not meet the requirements for a sheen sweep boat.**

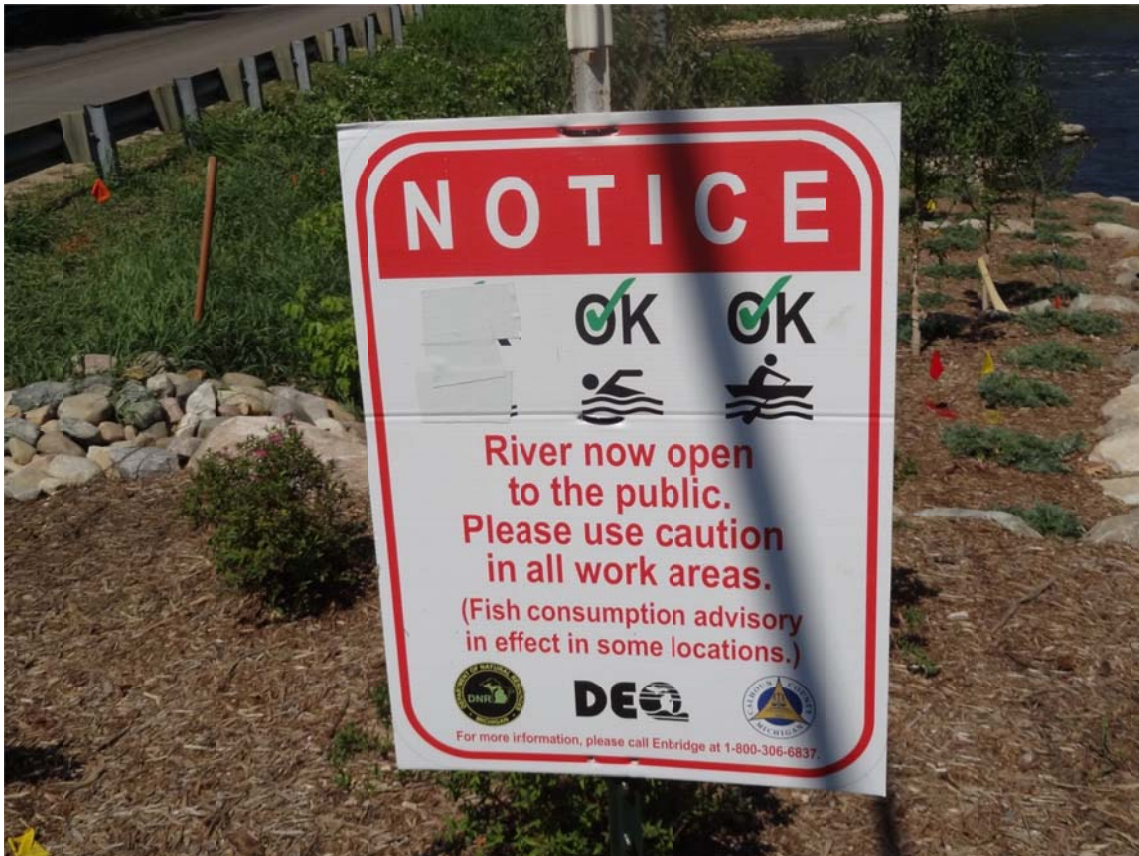
35. Portage launch below Ceresco Dam, notice of river opening sign altered.

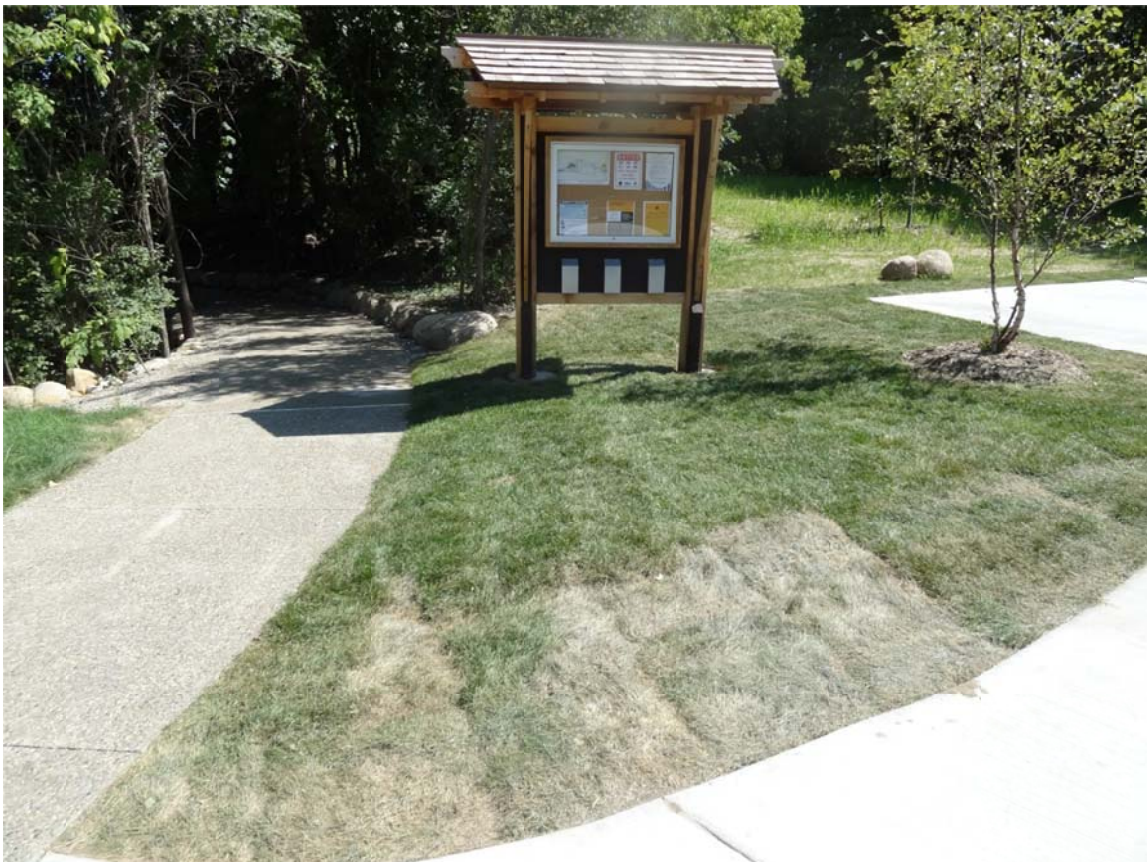
36. Ceresco Dam portage kiosk materials have been added. No decontamination station observed.
