# Situation Photo Log

Friday, August 24, 2012

Kalamazoo River / Enbridge Spill

Prepared by:  
Matthew Haak  
START-USEPA  
Situation Unit Leader

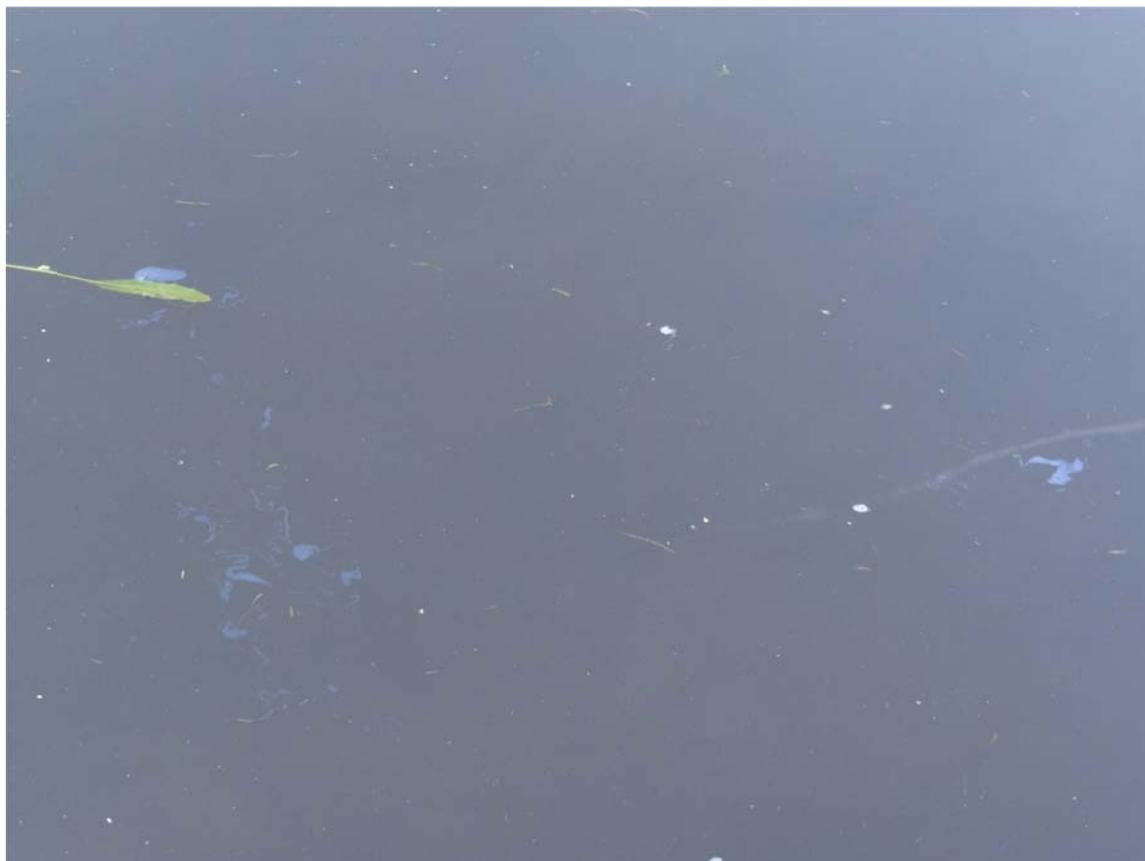
1. C0.4 Boat launch observed sheen and tar glob.

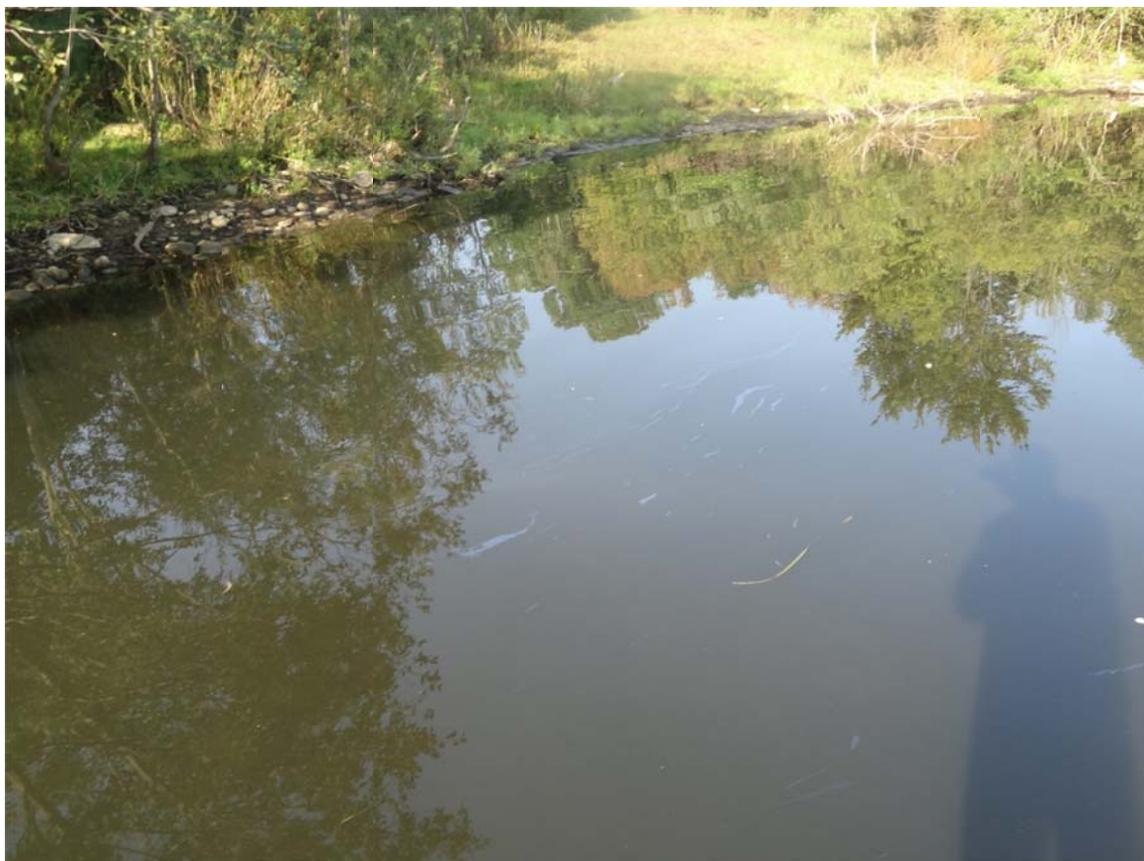
2. MP5.35 LDB observed sheen and tar glob.

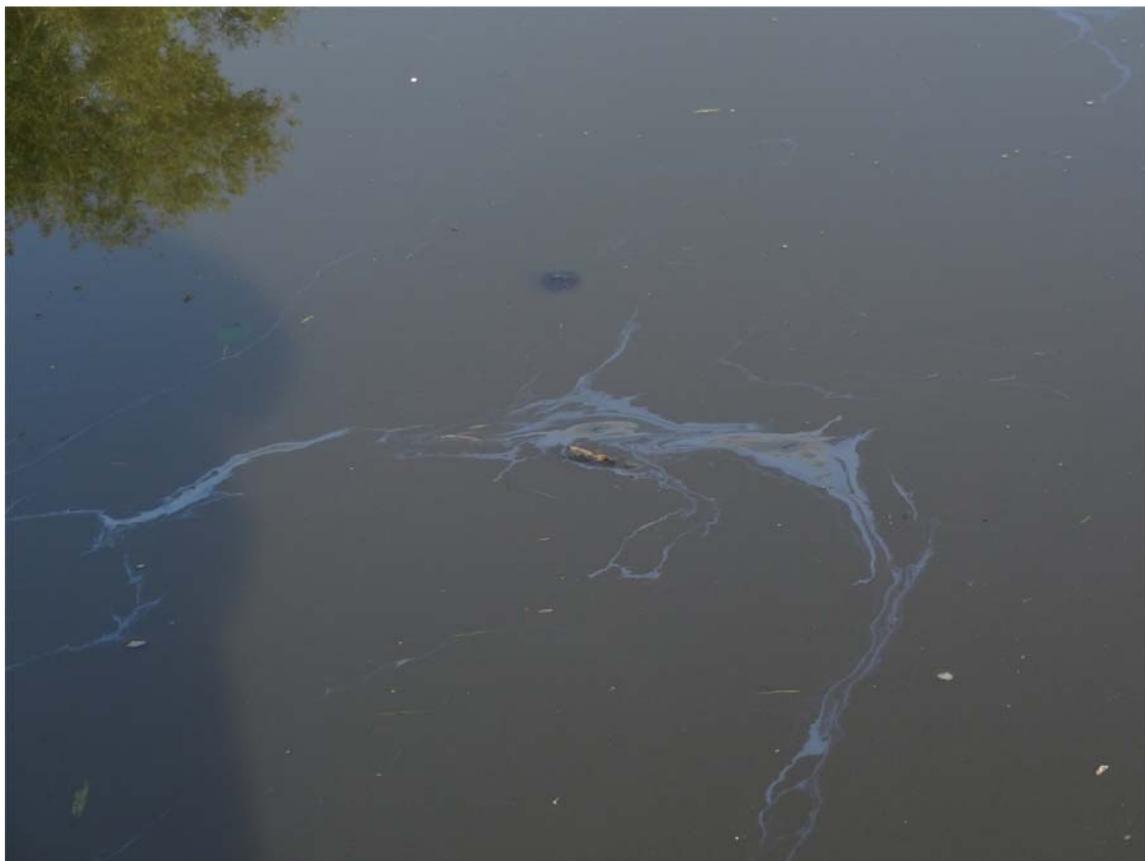
3. MP5.55 LDB sheen and tar globs observed.

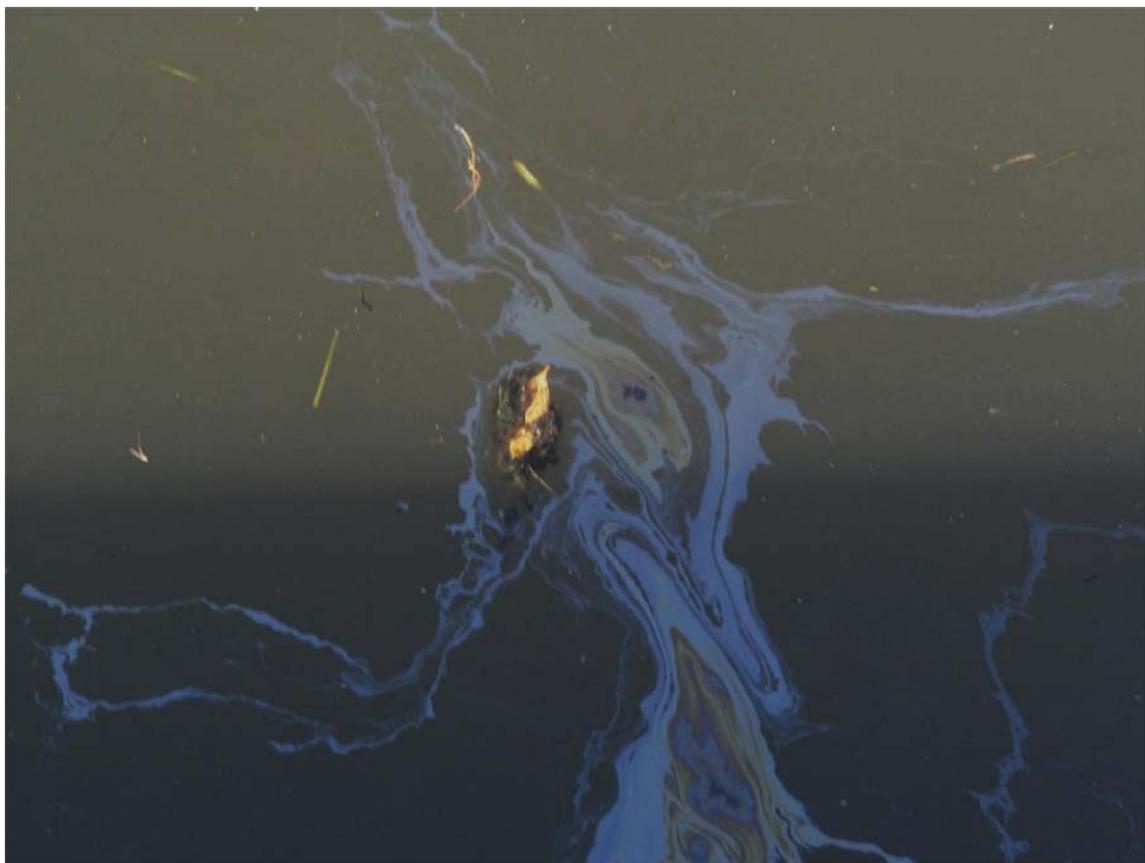
4. MP5.55 LDB sheen and tar globs observed.

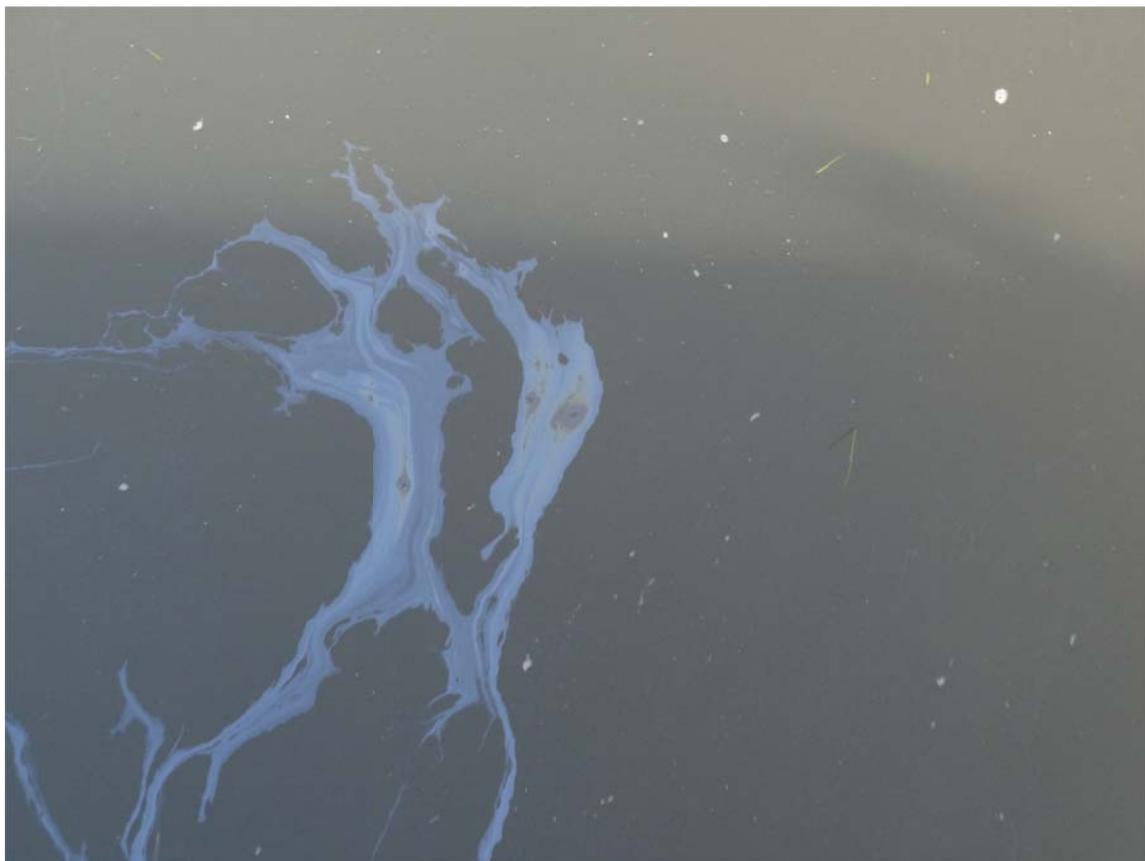
5. MP5.60 LDB sheen observed.

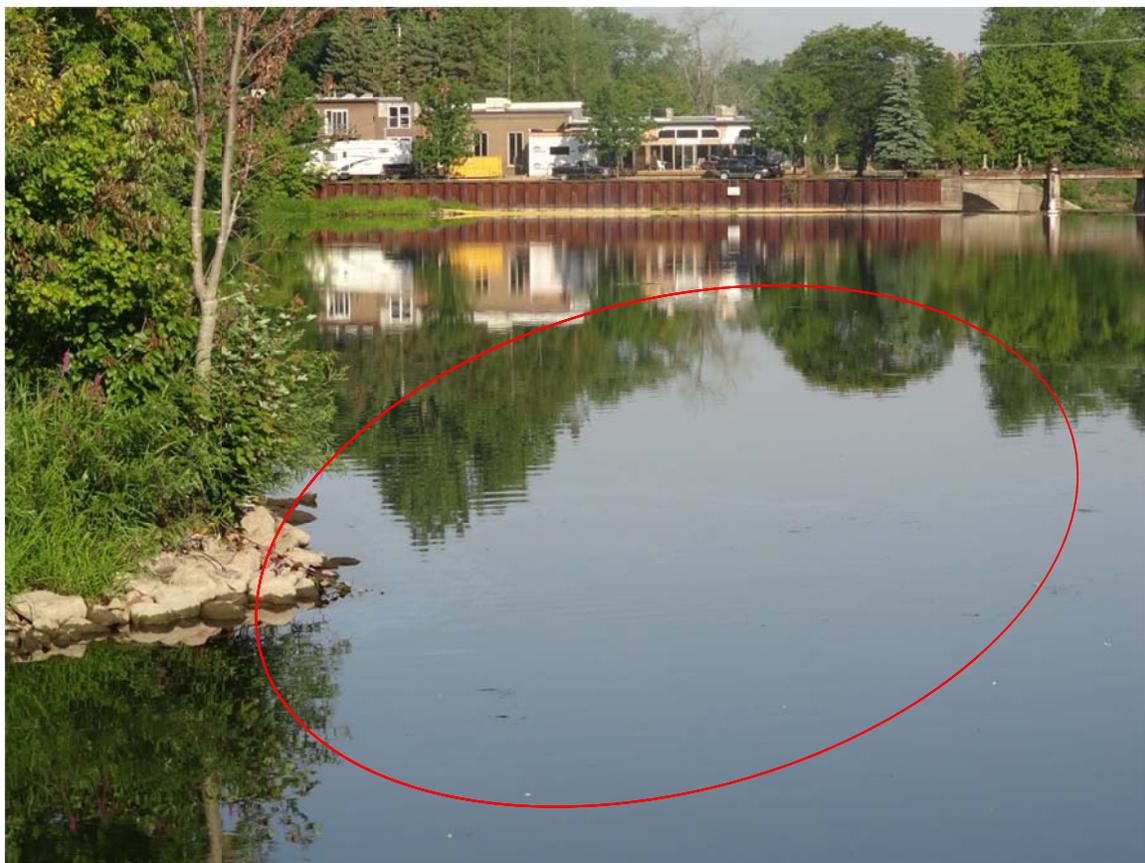
6. MP5.63 LDB area where tar globs, rainbow sheen, and silver sheen were observed.

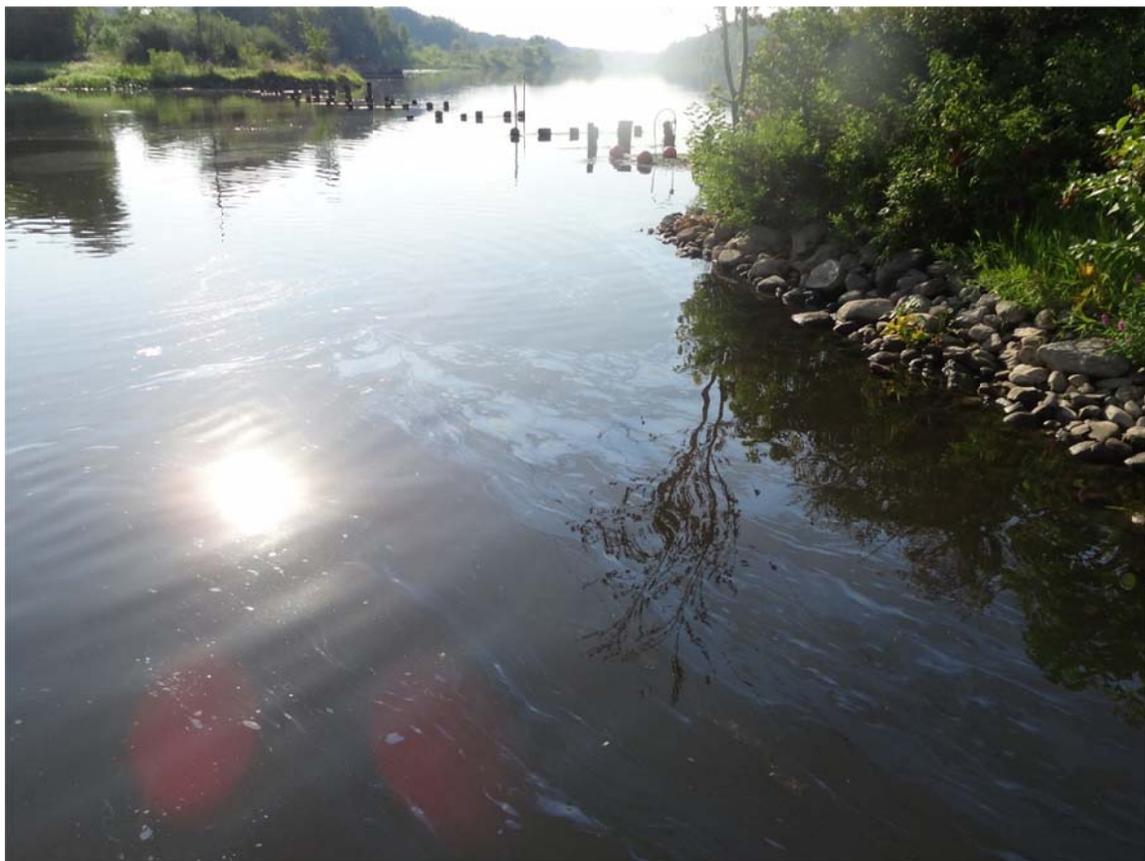
7. MP5.63 LDB area where tar globs, rainbow sheen, and silver sheen were observed.

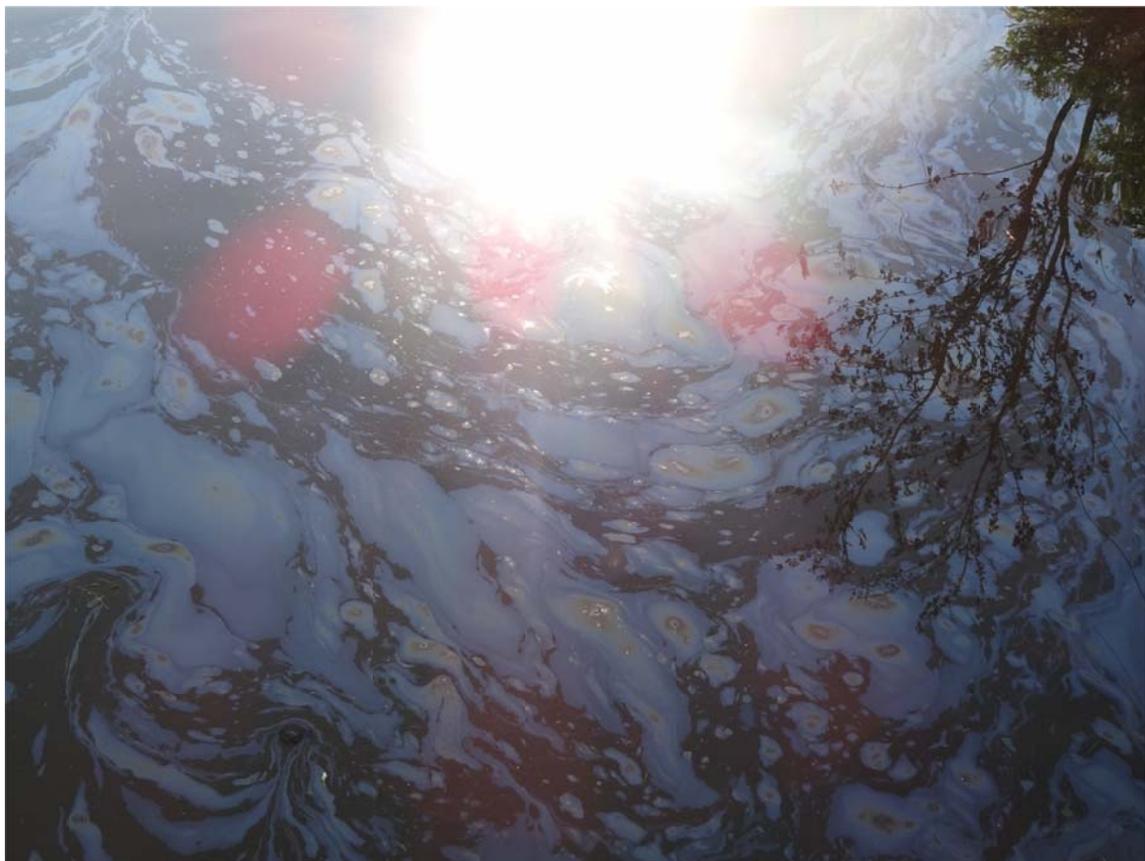
8. MP5.63 LDB area where tar globs, rainbow sheen, and silver sheen were observed.

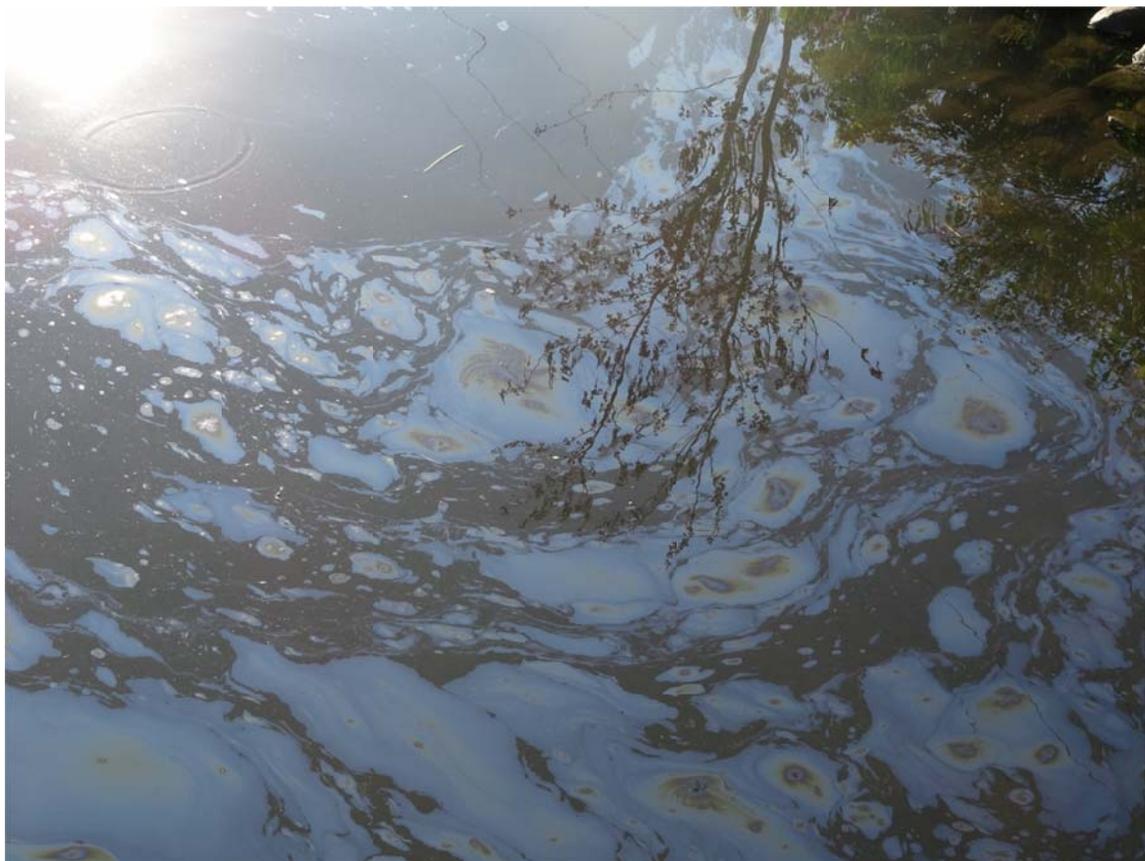
9. MP5.63 LDB area where tar globs, rainbow sheen, and silver sheen were observed.

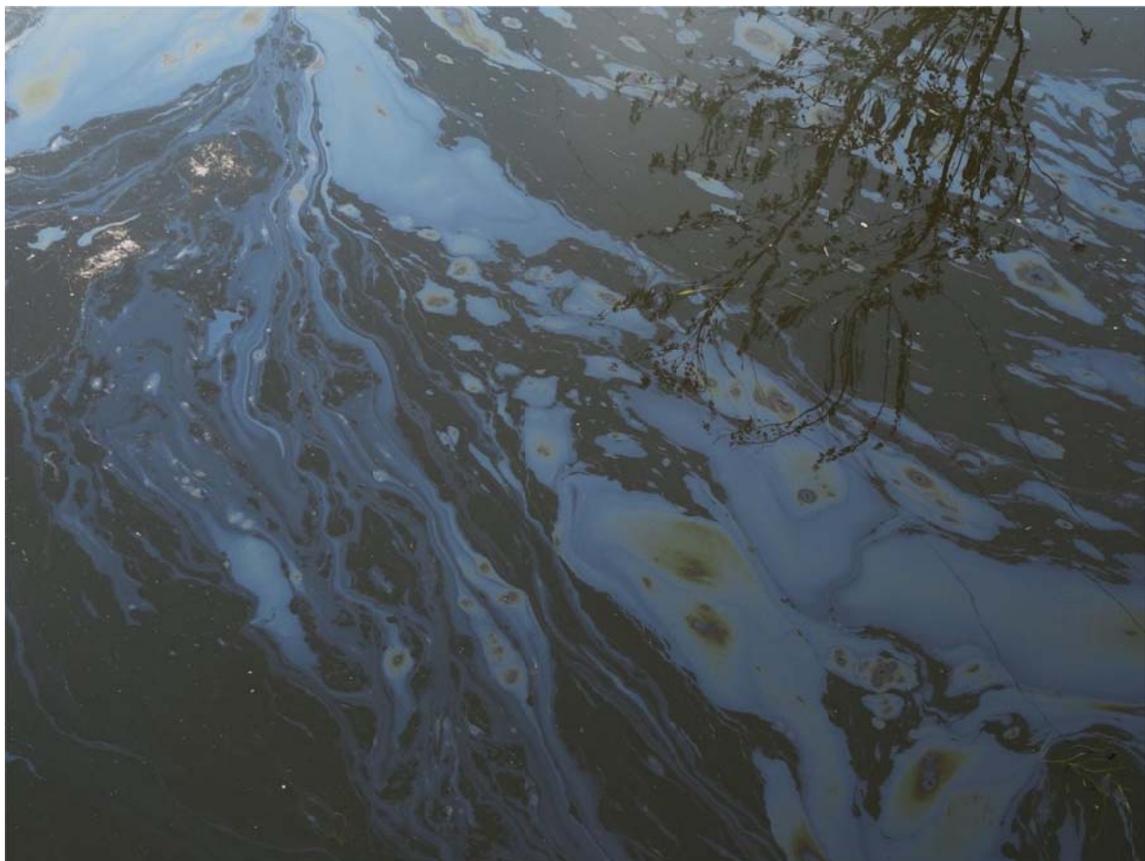
10. MP5.63 LDB area where tar globs, rainbow sheen, and silver sheen were observed.

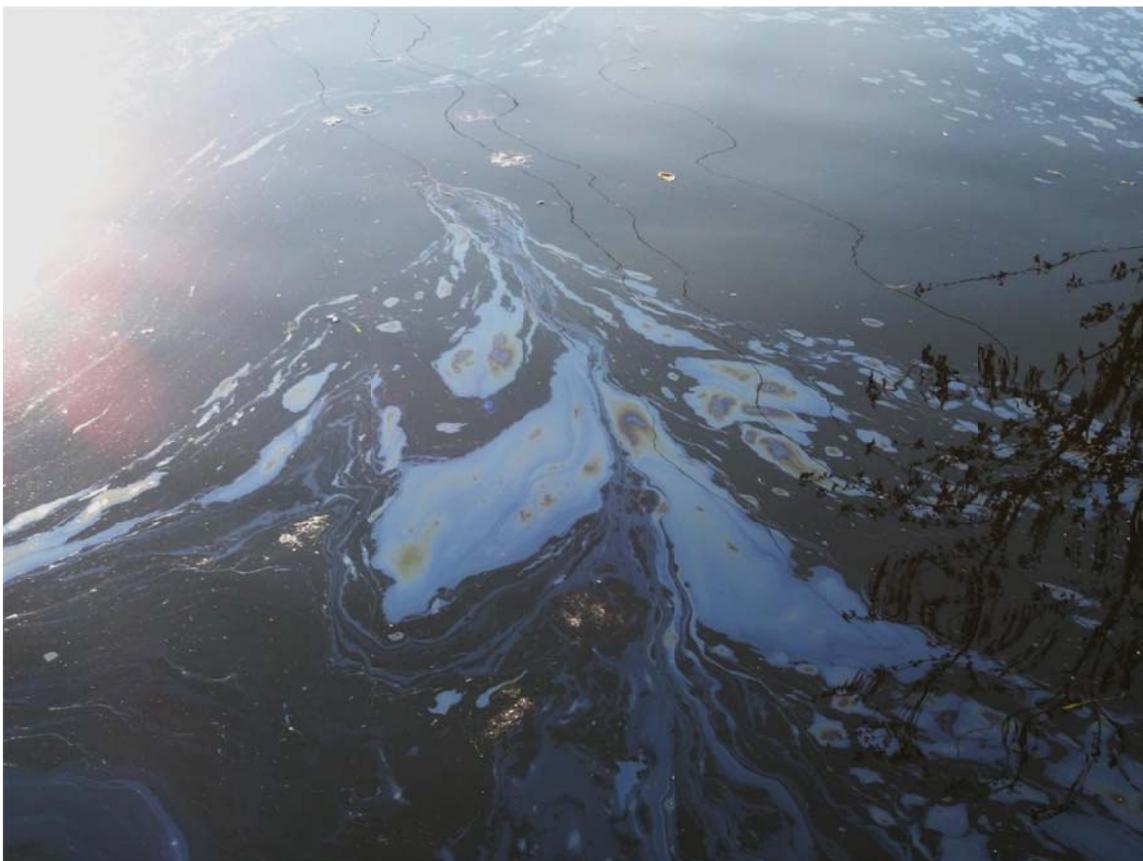
11. MP5.63 LDB area where tar globs, rainbow sheen, and silver sheen observed.

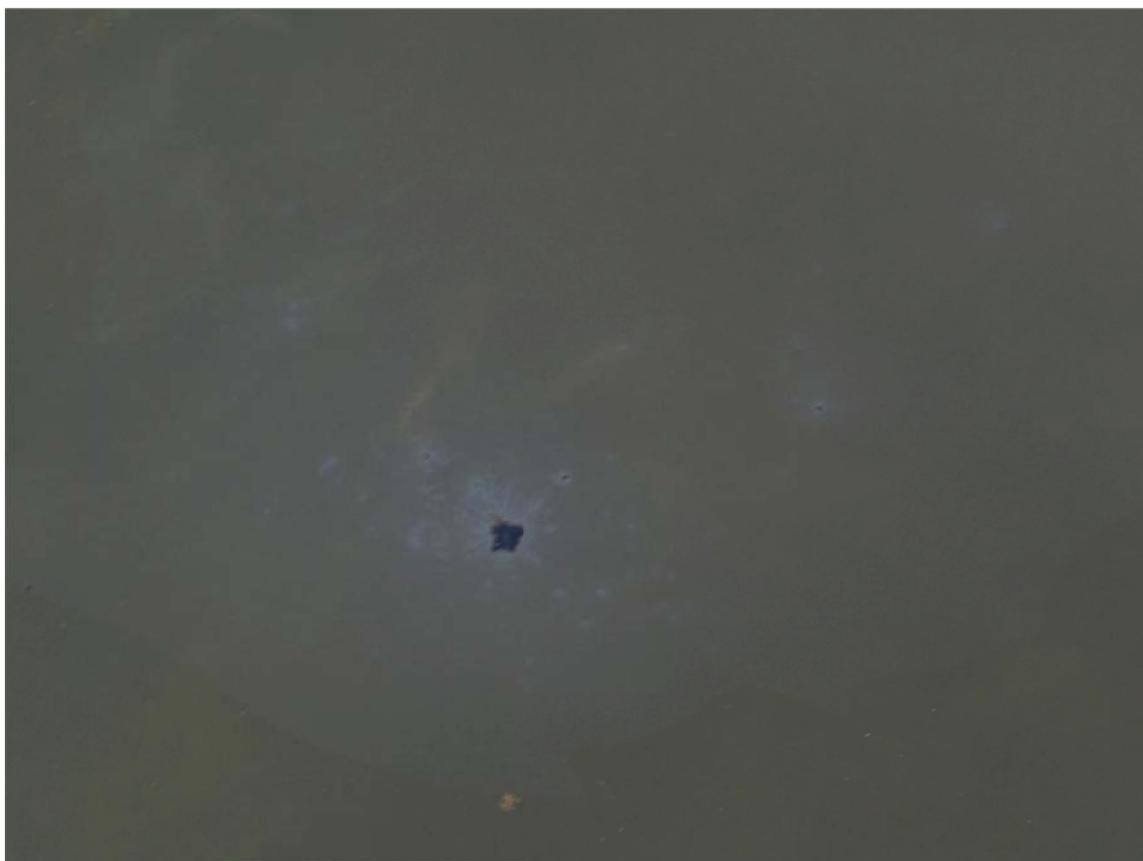
12. MP5.7 LDB observed a nickel sized tar glob.

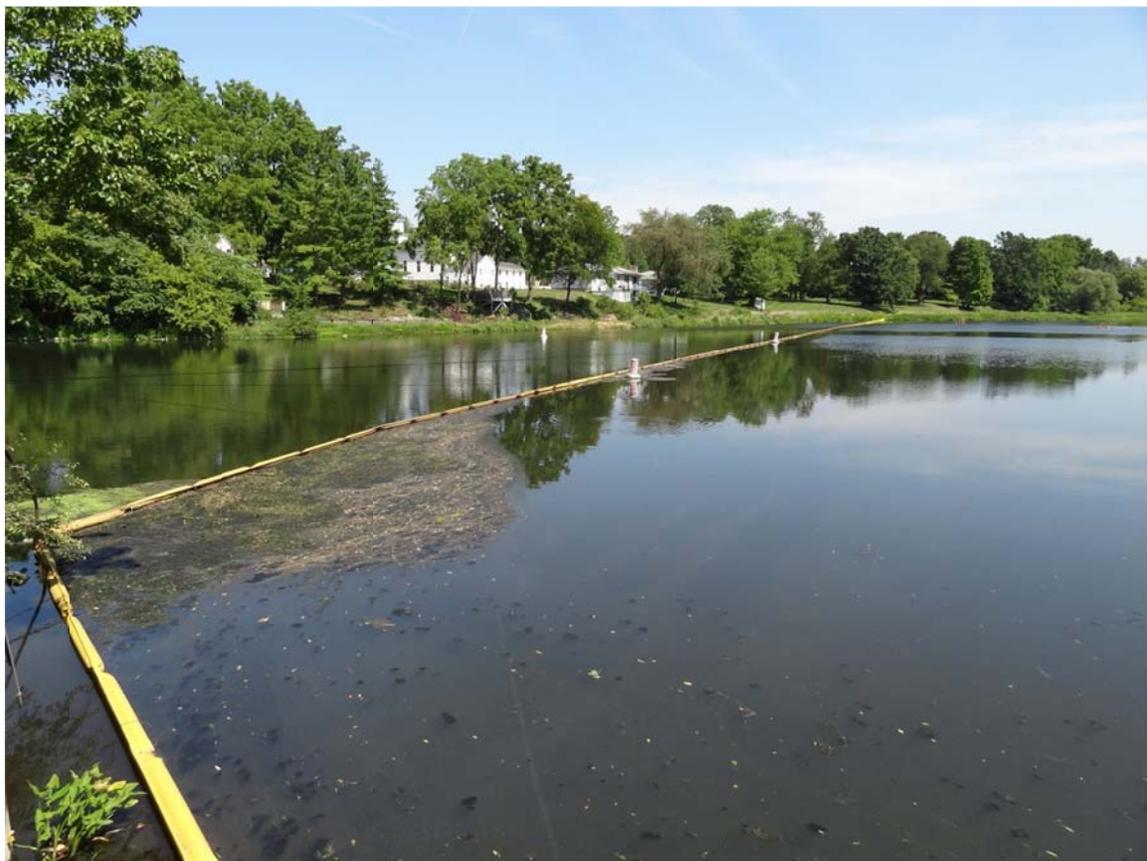
13. Ceresco Dam control point boom.

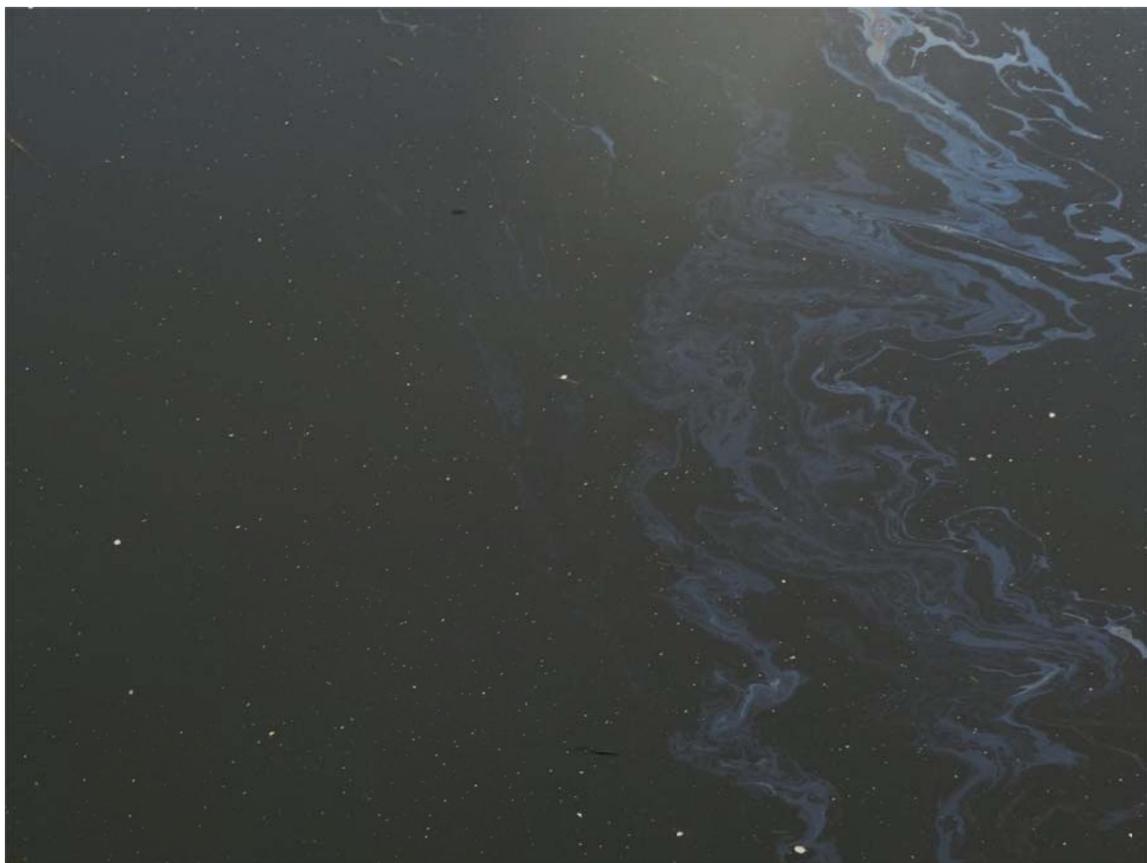
14. Observed sheen collecting along the Ceresco Dam control point boom.

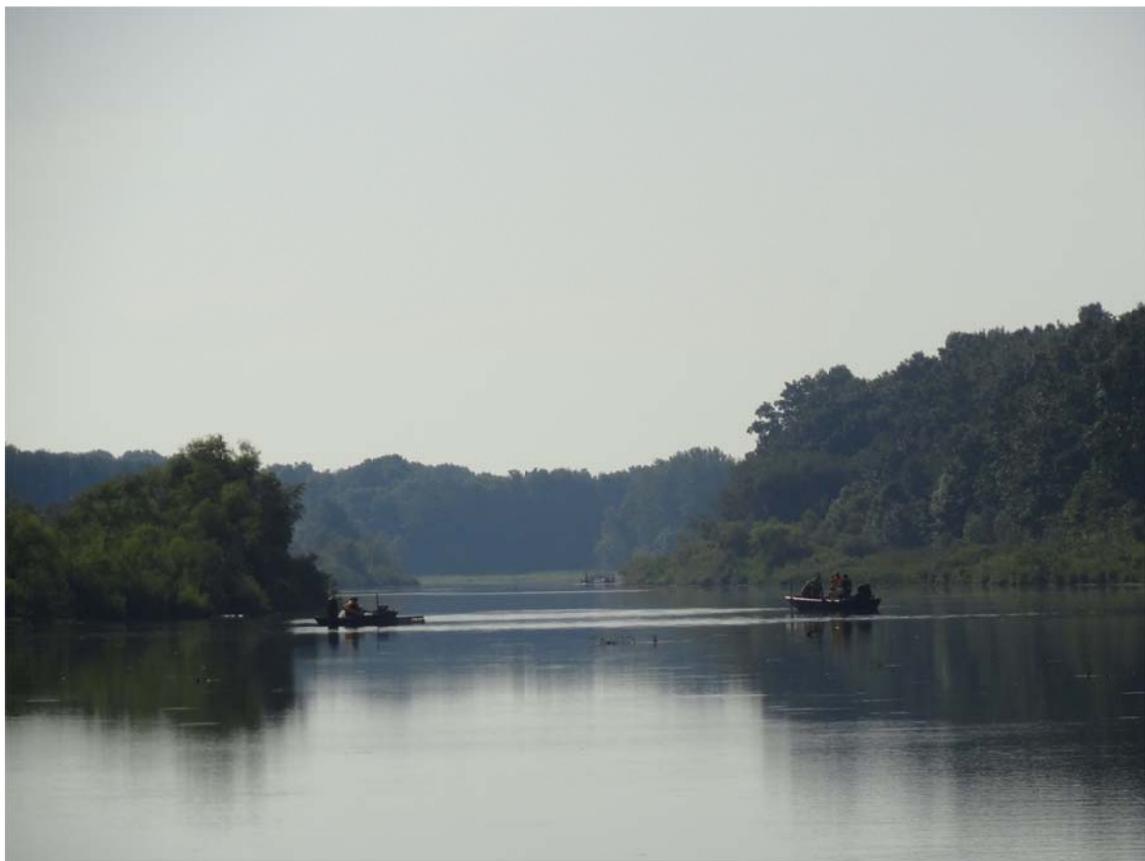
15. Observed poling crews above Ceresco Dam.

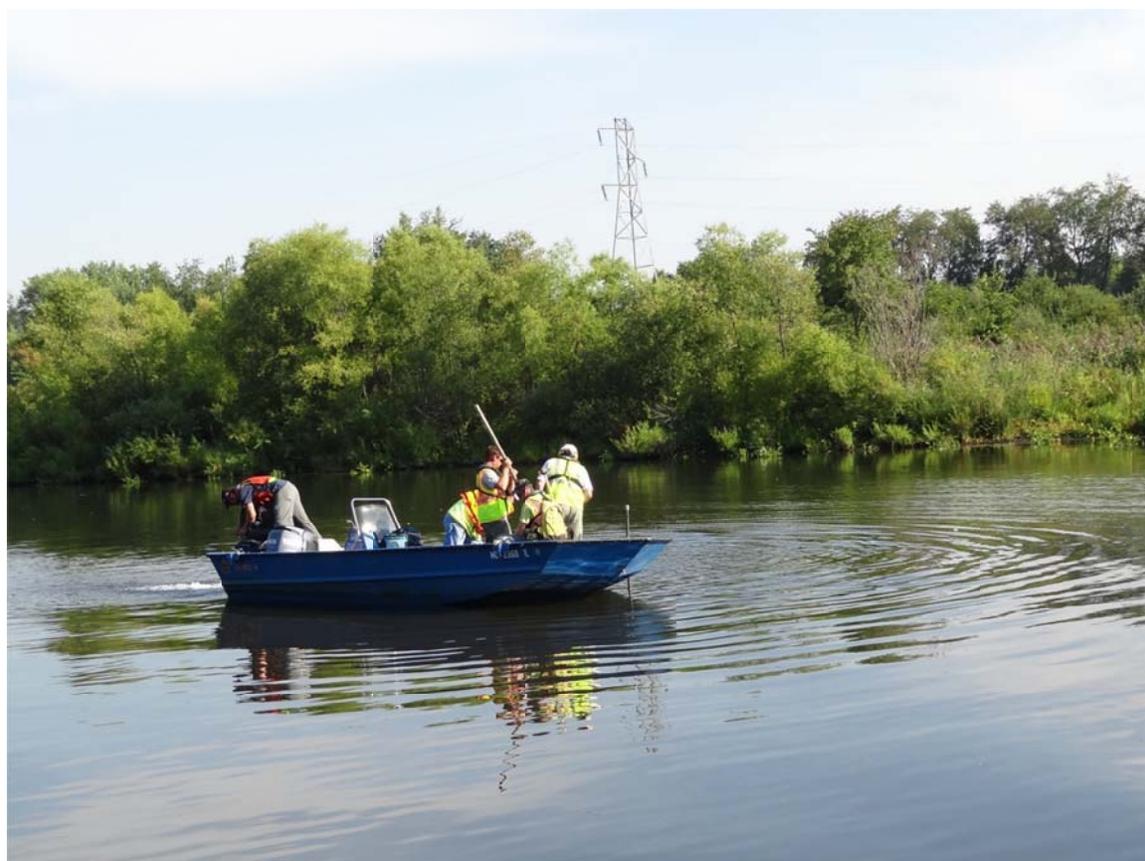
16. MP5.45 observed a LSR poling crew.

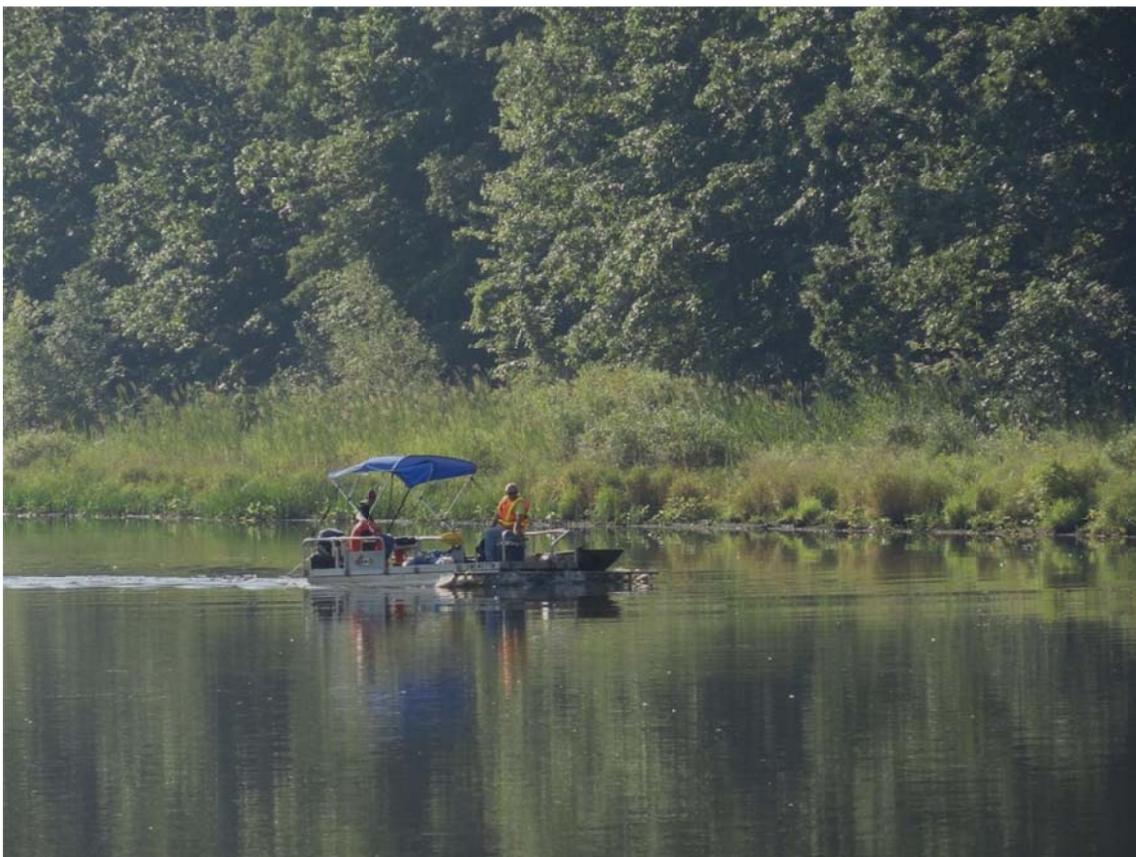
17. Observed the sweep boat departing the C0.4 boat launch.

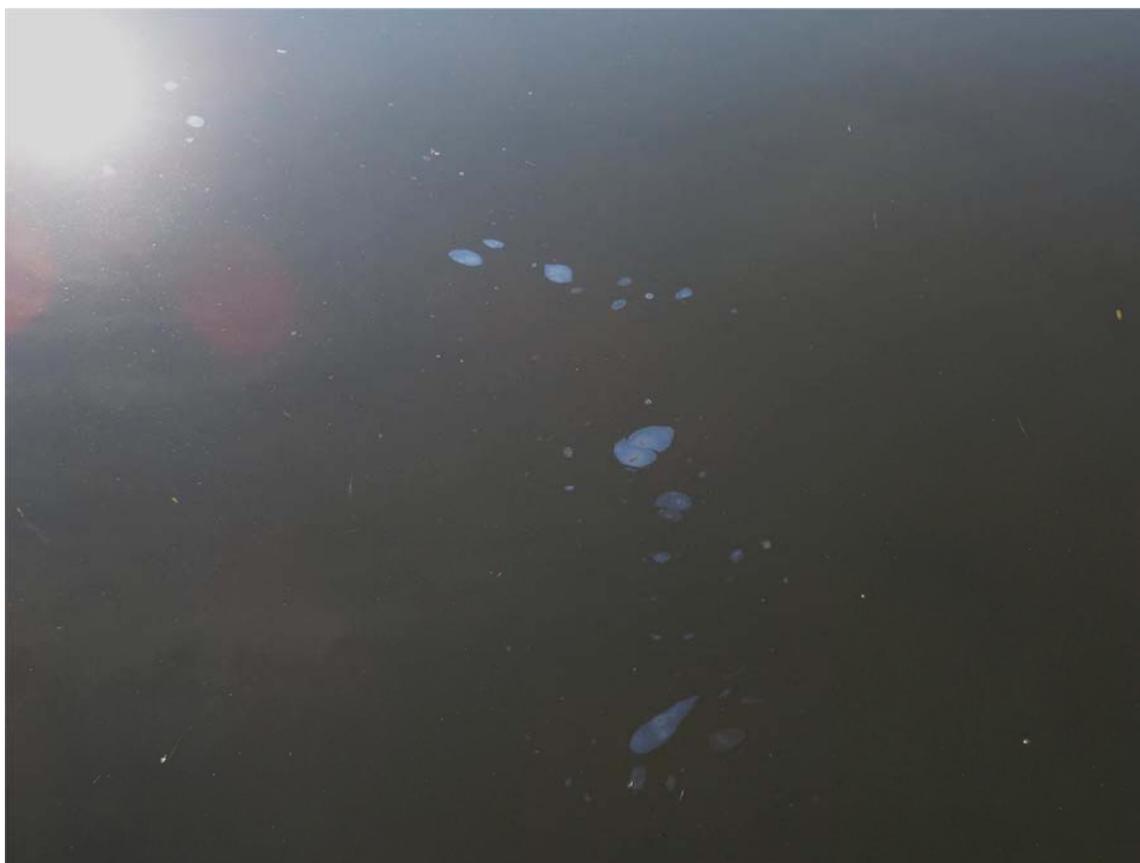
18. MP5.0 RDB observed sheen and tar globs.

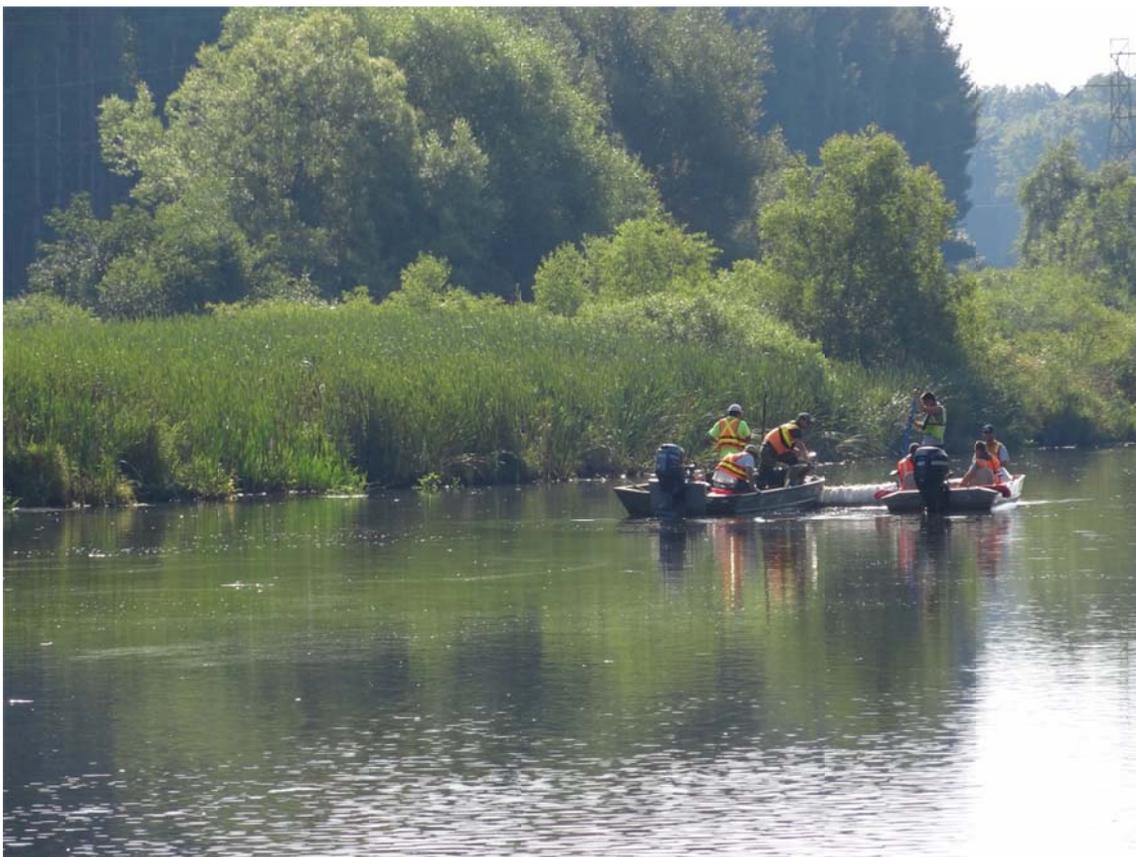
19. MP4.8 RDB observed a LSR poling crew.

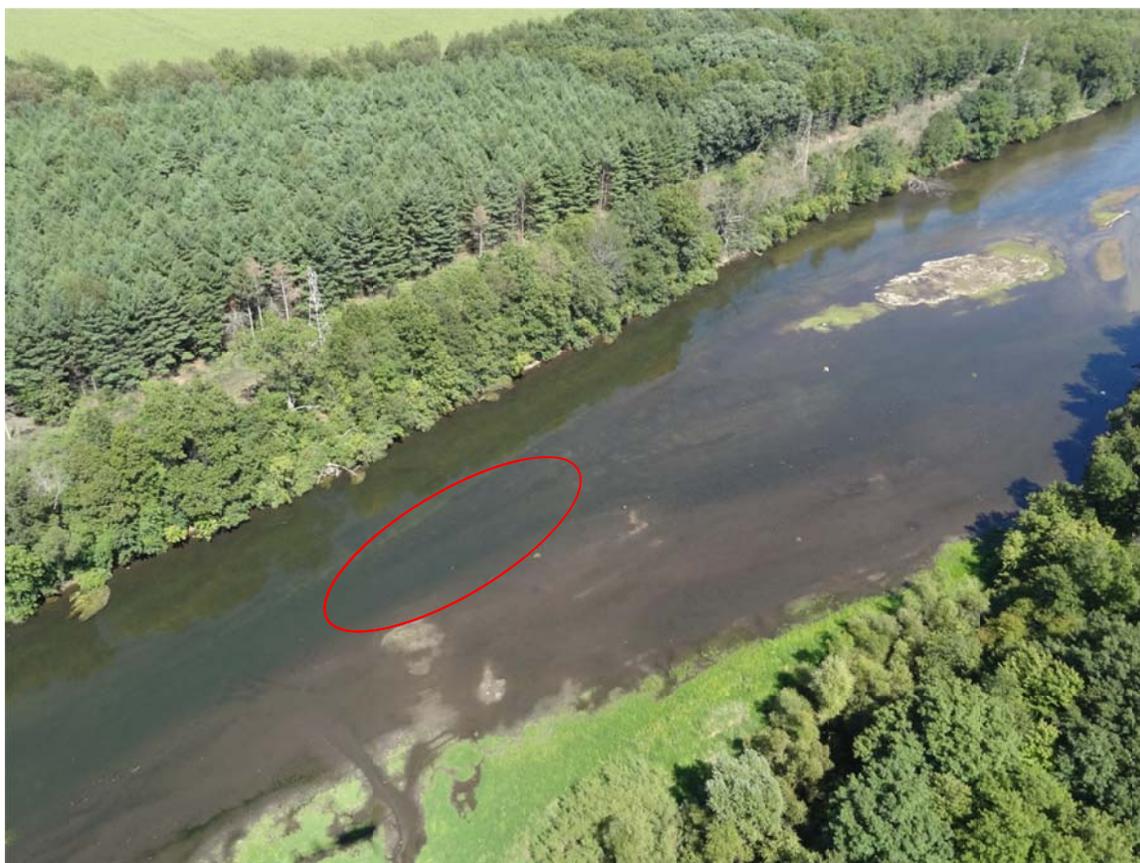
20. MP4.5 area where sheen was observed.

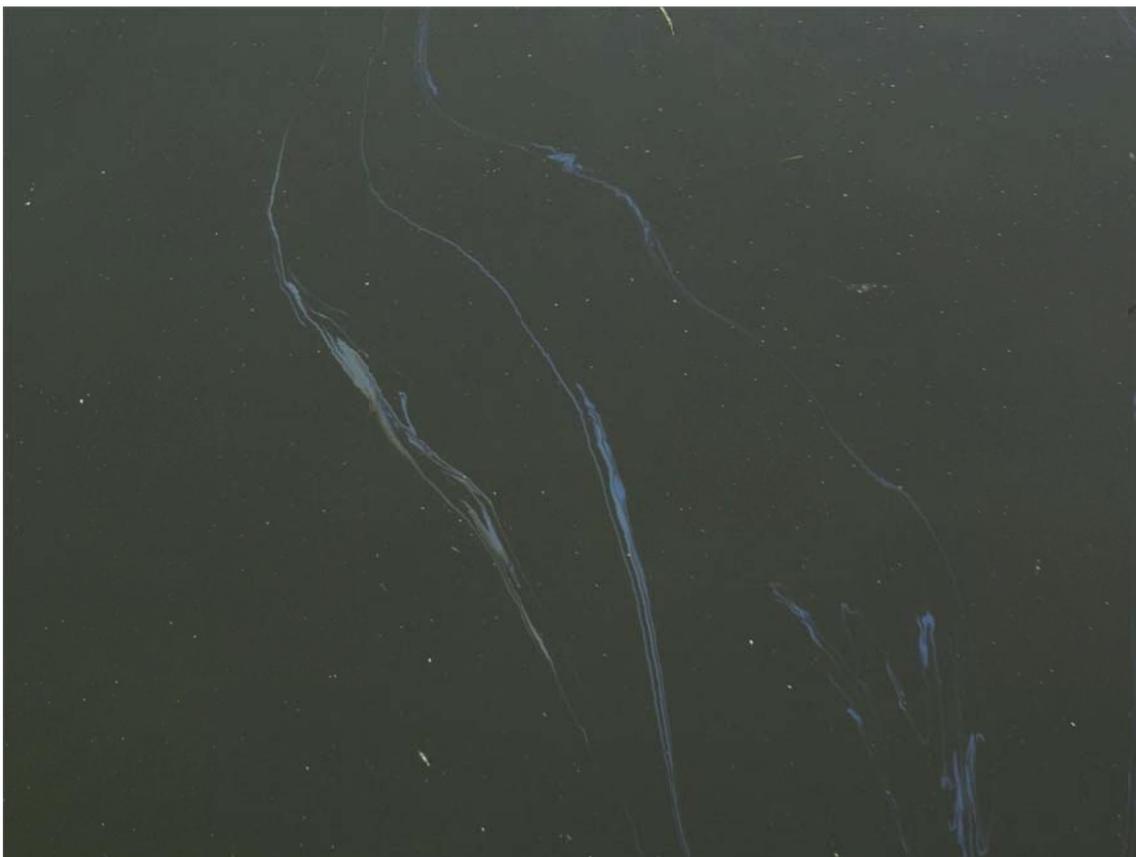
21. MP4.5 sheen was observed.

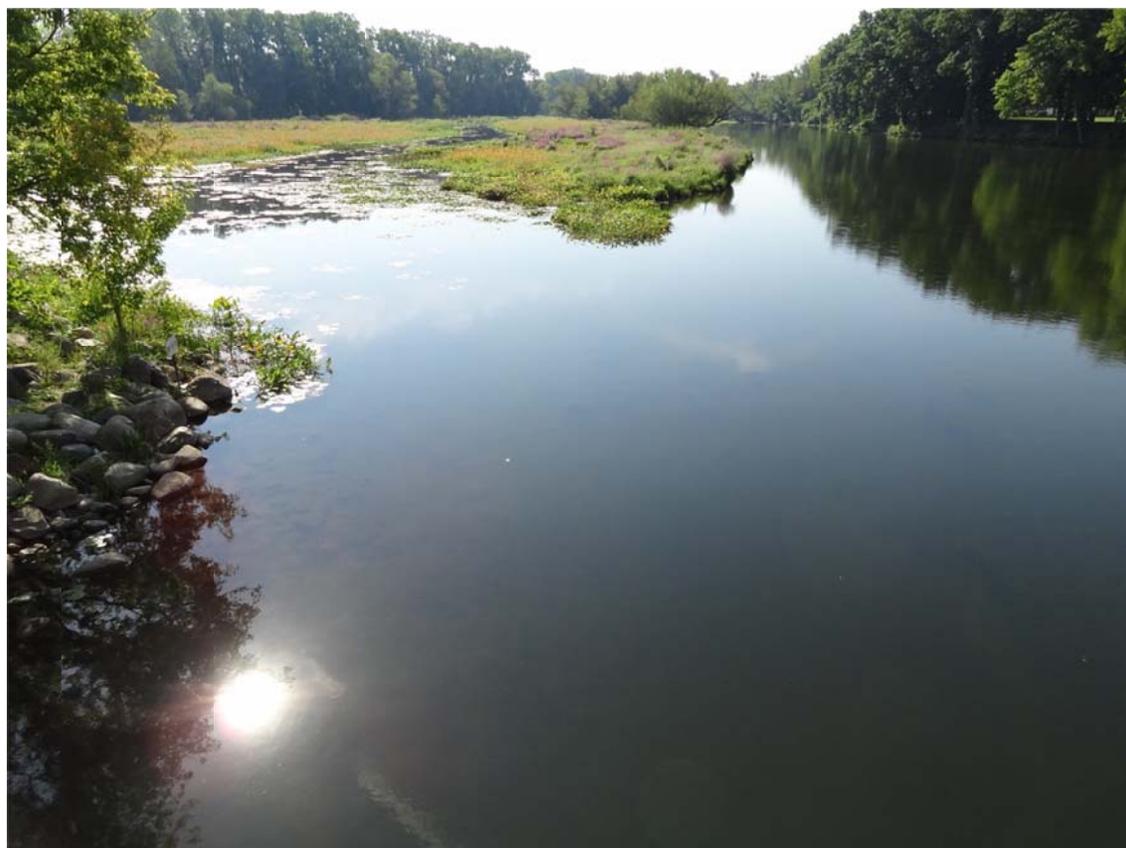
22. MP15.5 South Mill Pond no sheen was observed.

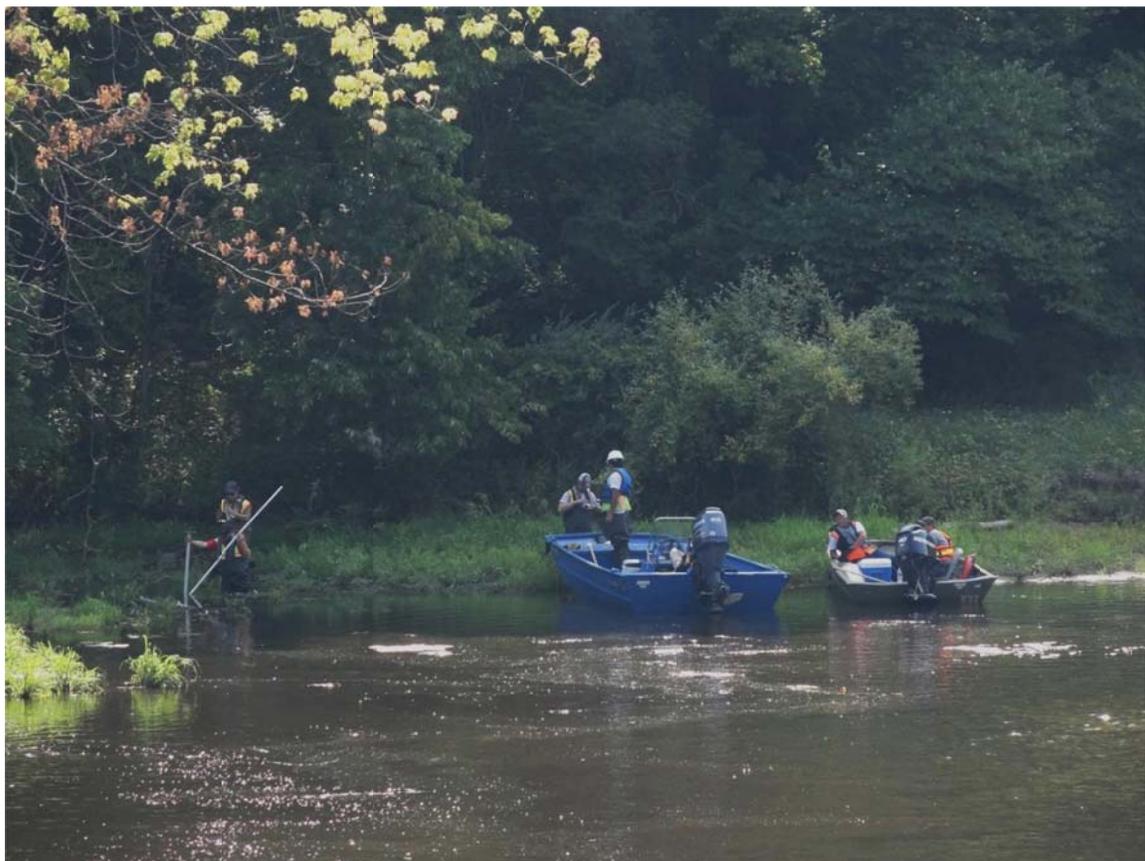
23. MP21.25 RDB observed a LSR poling crew.
