# Situation Photo Log

Friday, August 24, 2012

Kalamazoo River / Enbridge Spill

Prepared by:  
Matthew Haak  
START-USEPA  
Situation Unit Leader

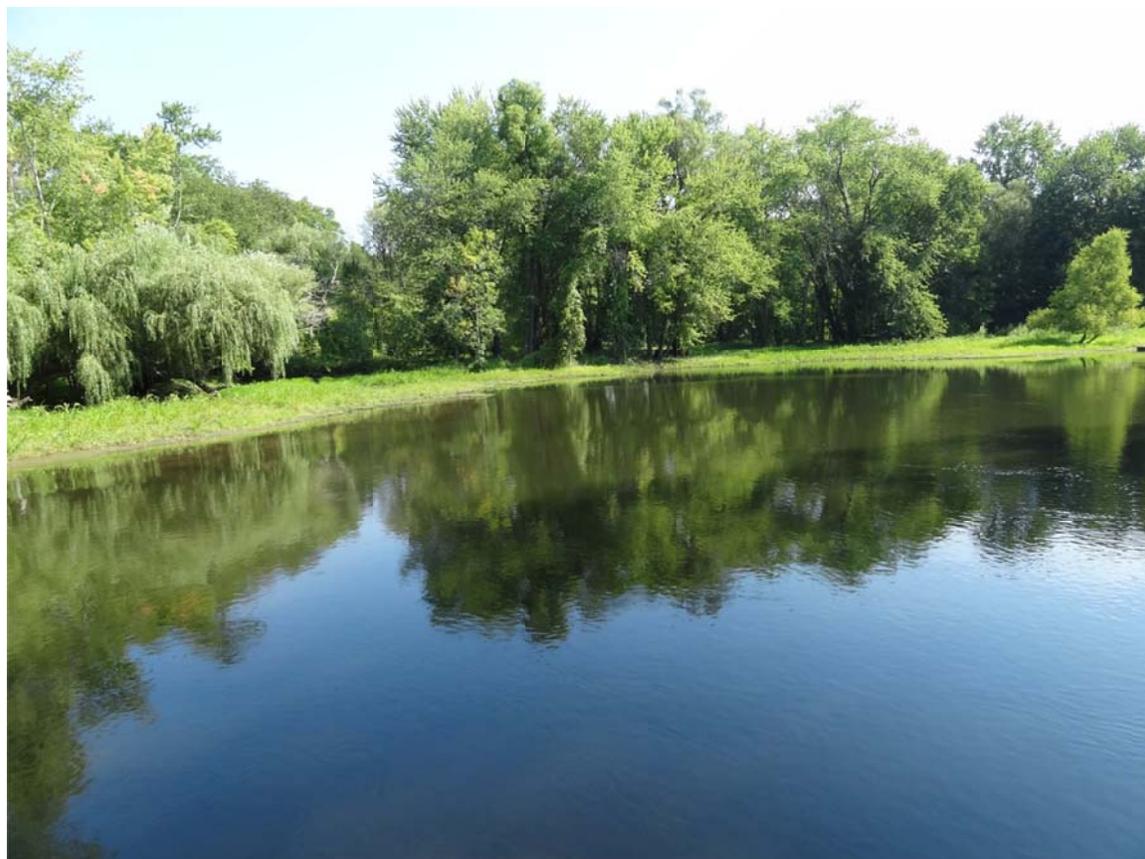
24. MP26.25 RDB no sheen observed.

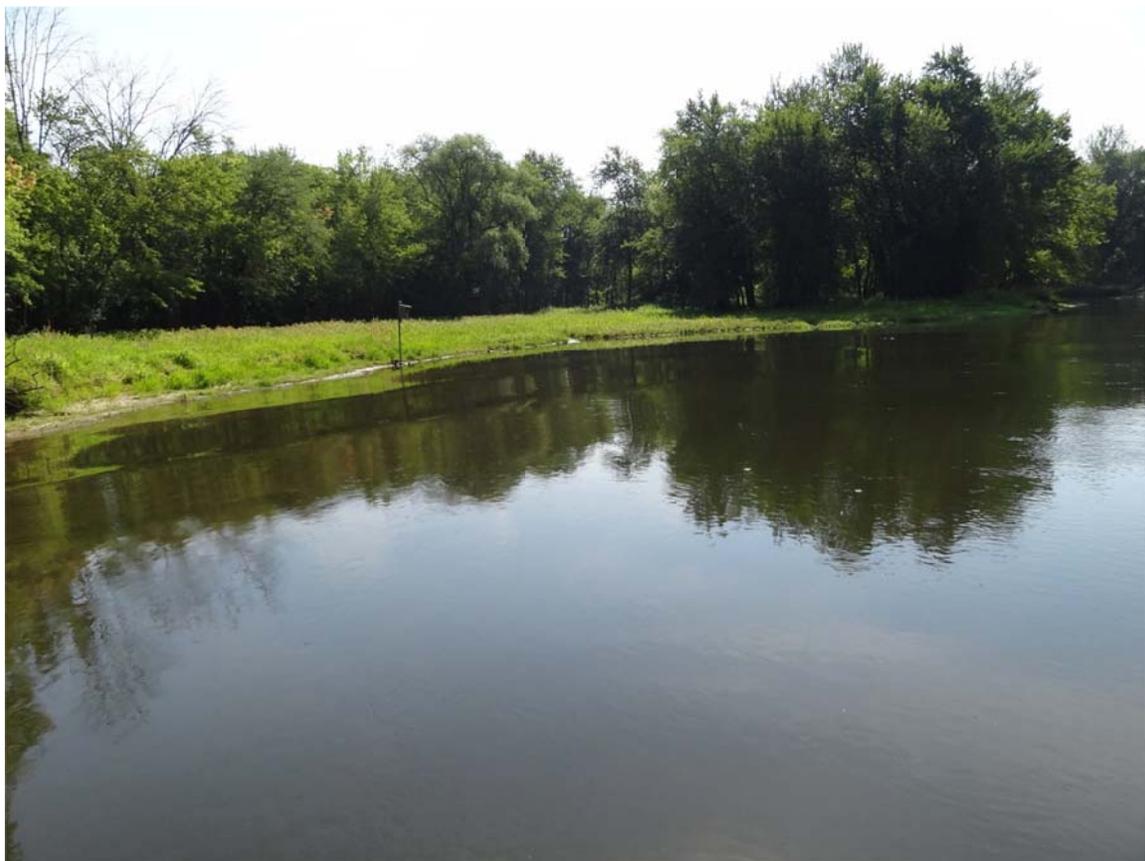
25. MP26.0 RDB no sheen observed.

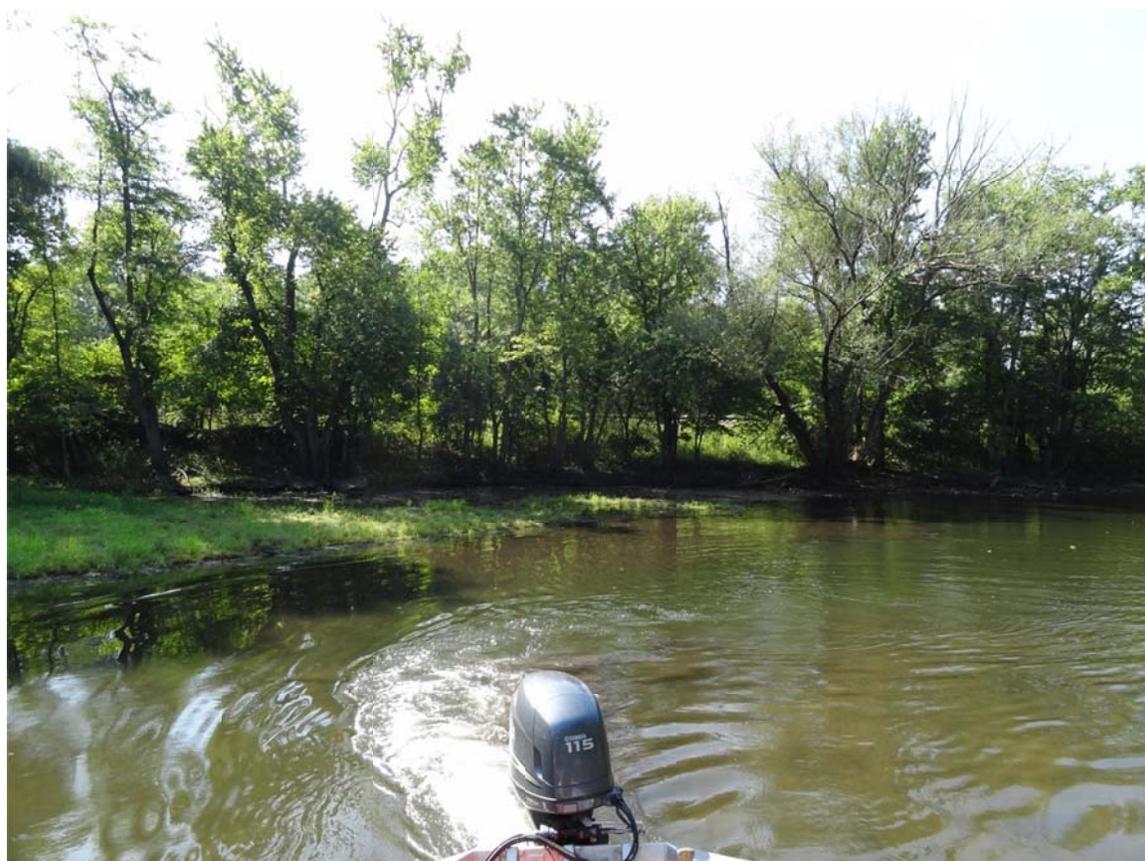
26. MP24.75 LDB sheen observed quantity of sheen did not meet the criteria for a sheen sweep boat.

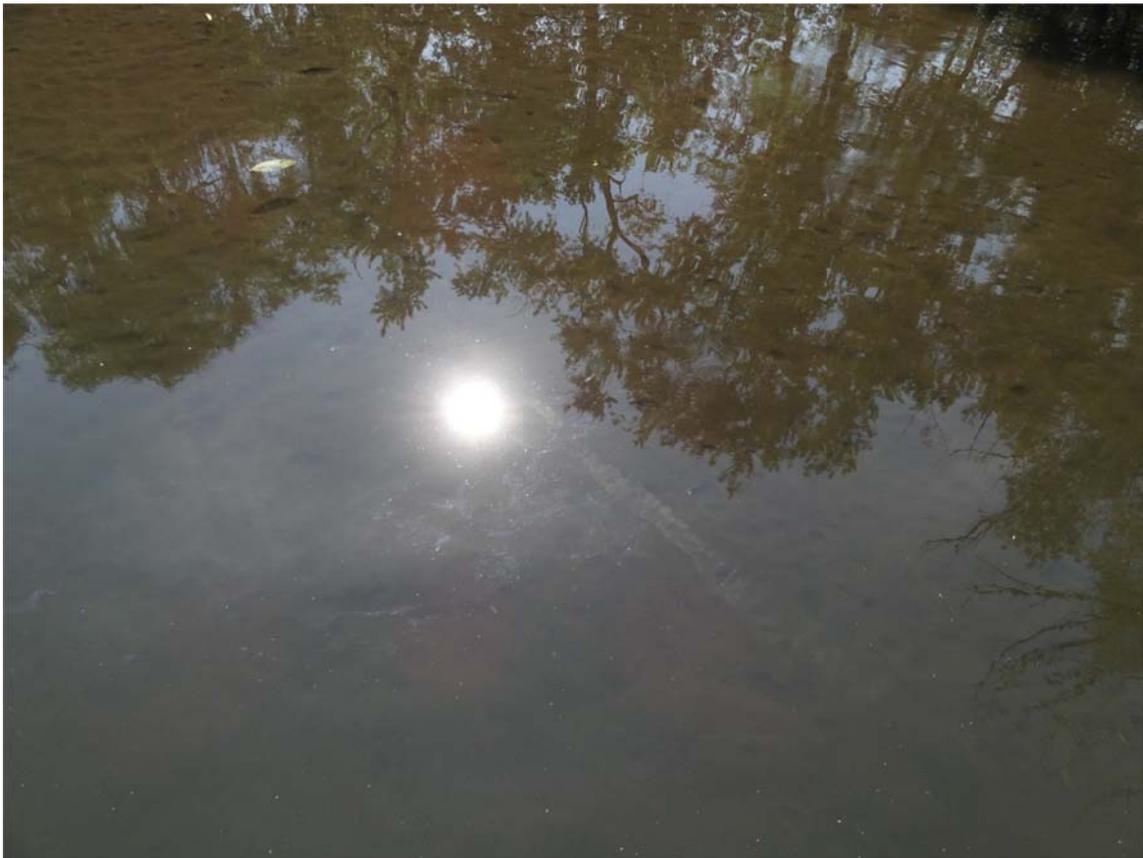
**27. MP24.75 LDB sheen observed quantity of sheen did not meet the criteria for a sheen sweep boat.**

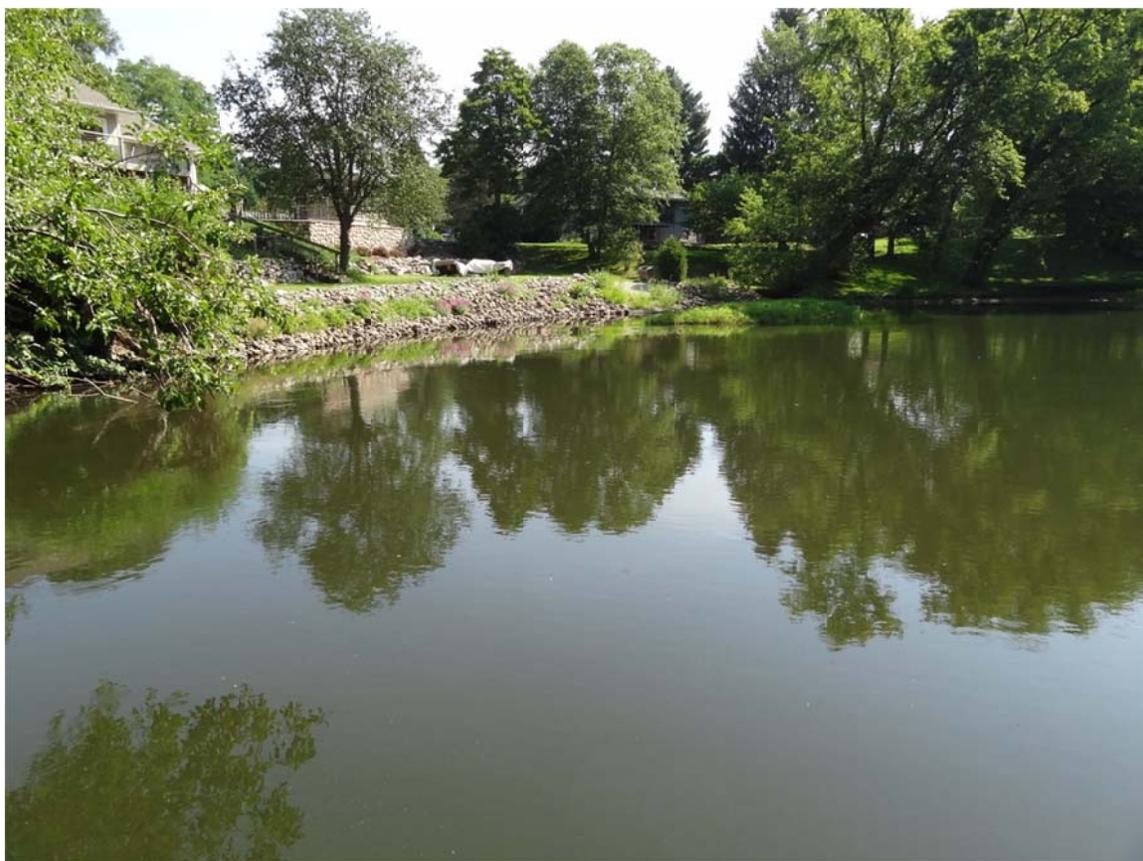
**28. MP23.10 RDB no sheen observed.**

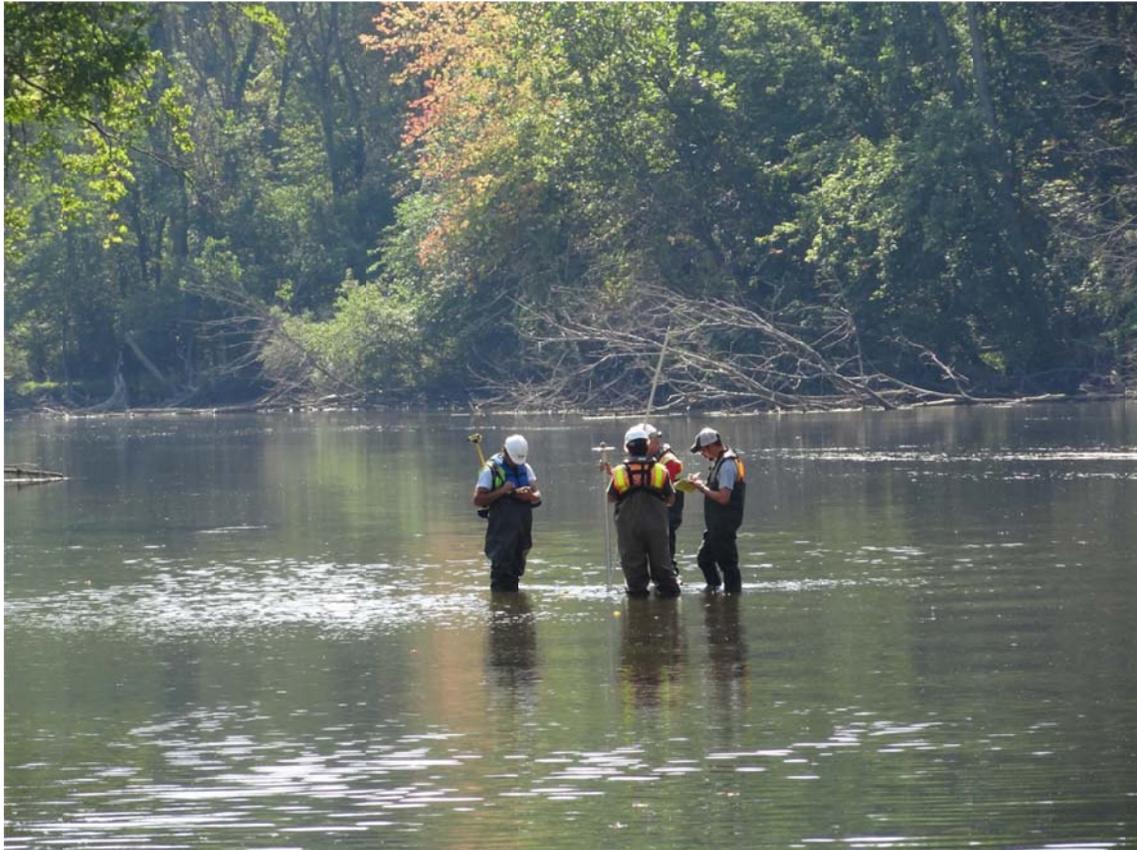
29. MP21.25 RDB observed a LSR poling crew.

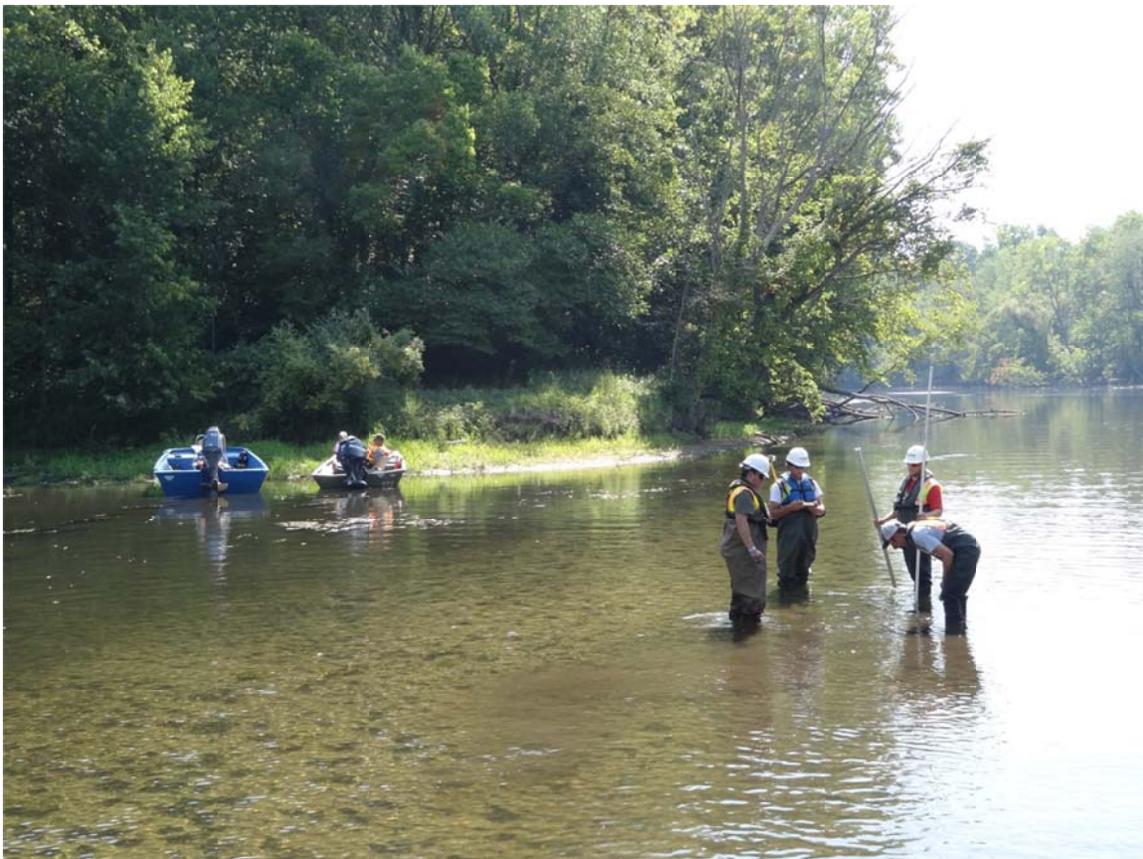
30. MP21.25 RDB observed a LSR poling crew.

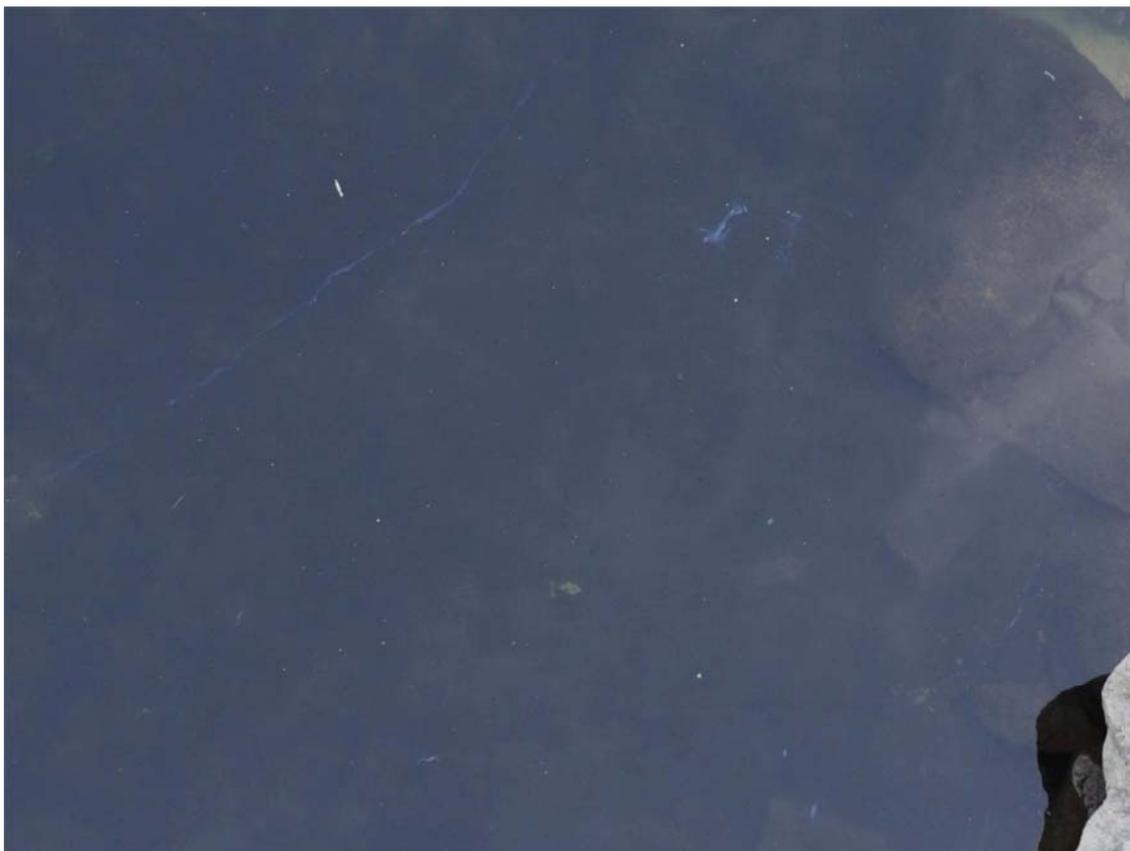
31. MP21.5 Custer Drive observed sheen.

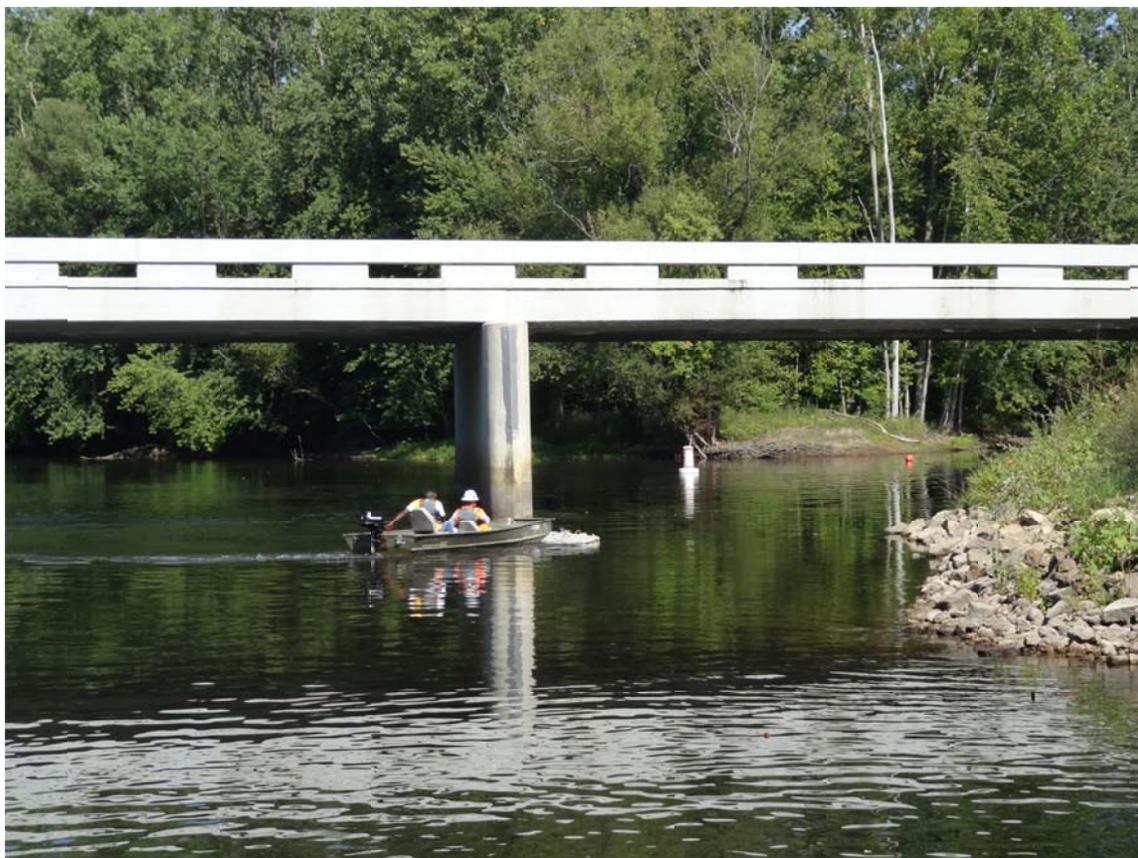
32. MP21.5 Custer Drive observed sheen sweep operating.

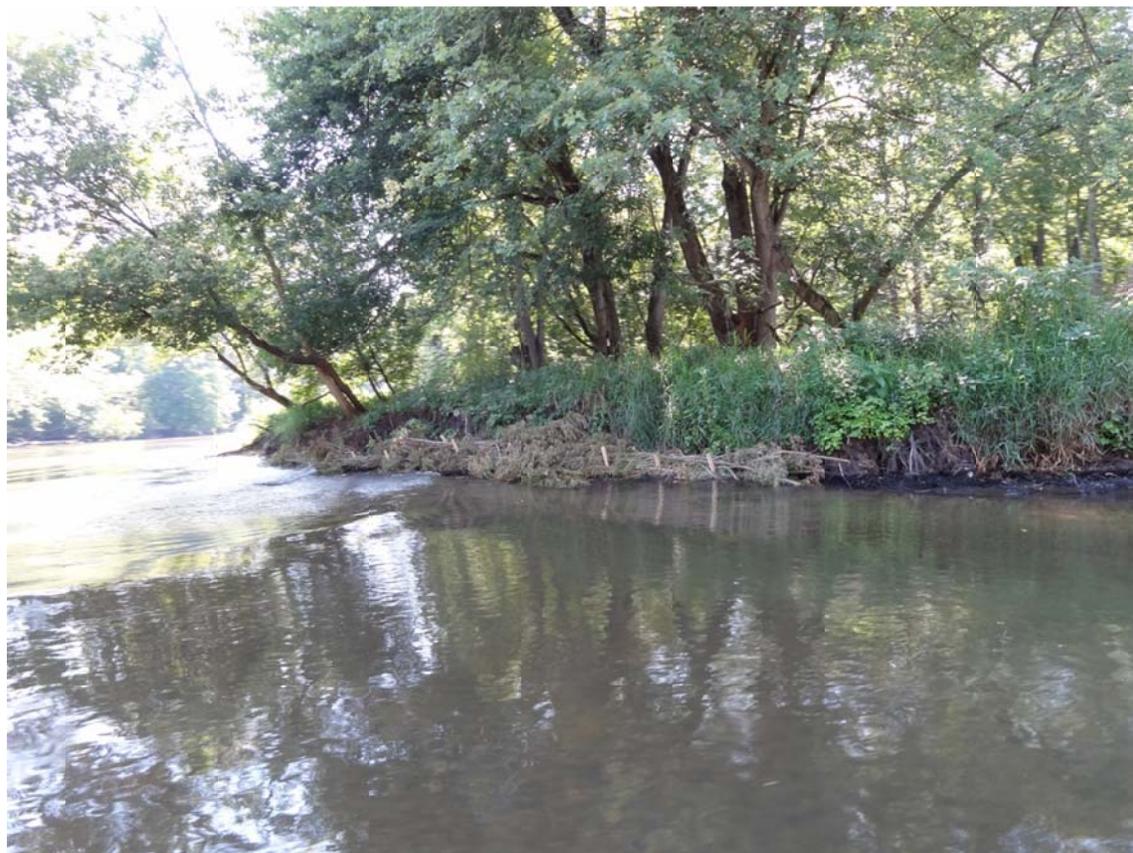
**33. MP22.5 LDB observed river bank erosion restoration.**

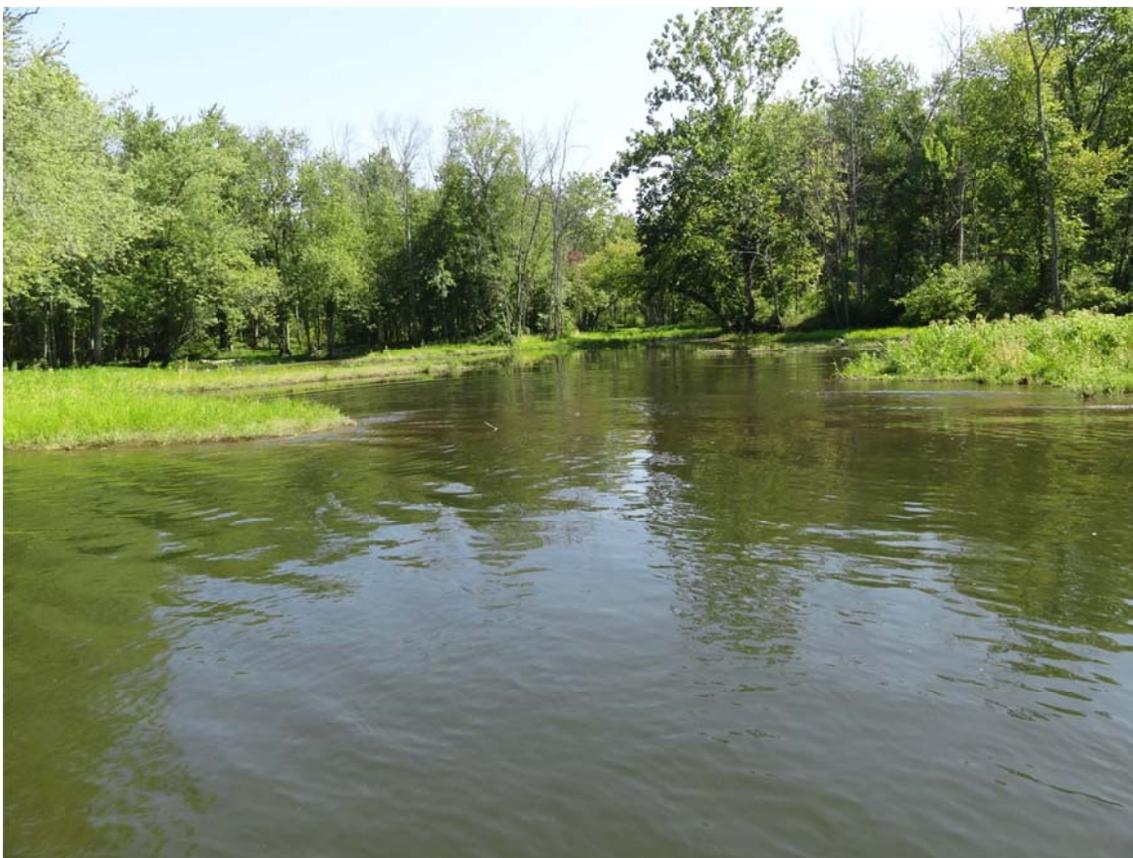
**34. MP30.8 LDB no sheen observed.**

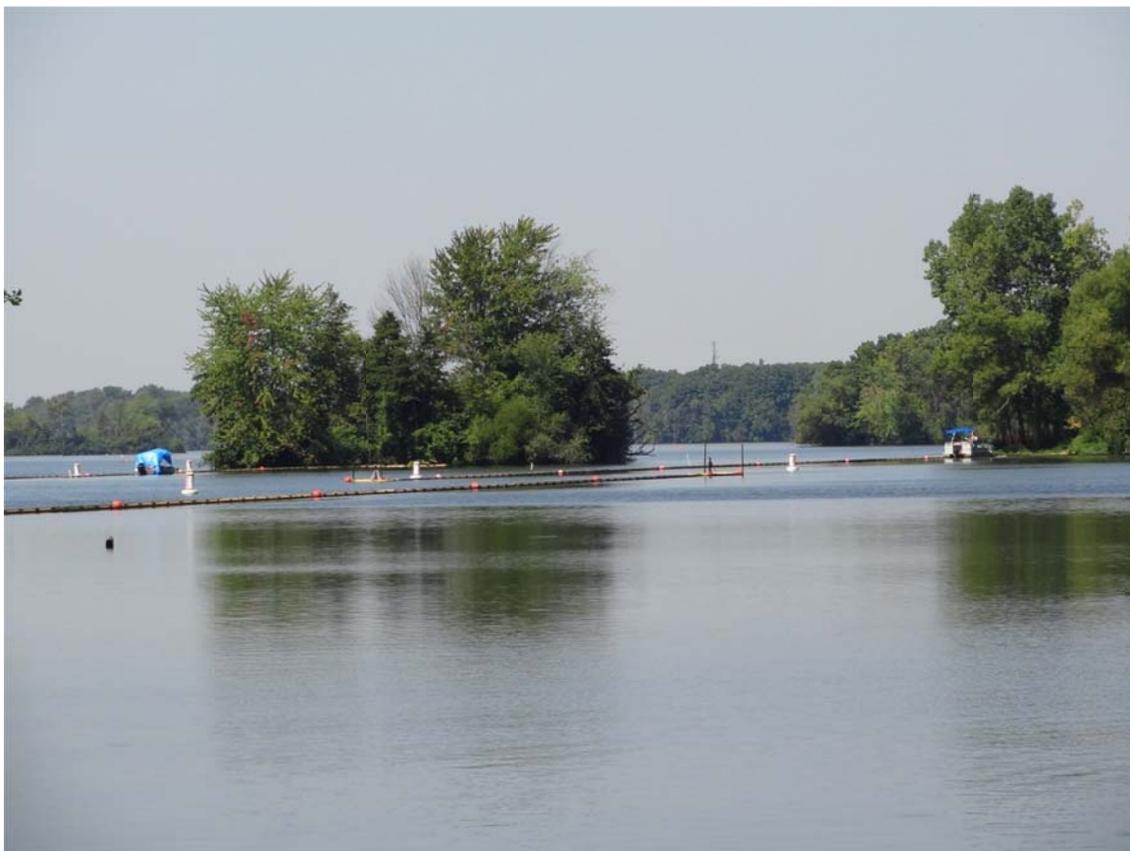
**35. Morrow Lake Delta Booms E & F observed crews working on both booms.**

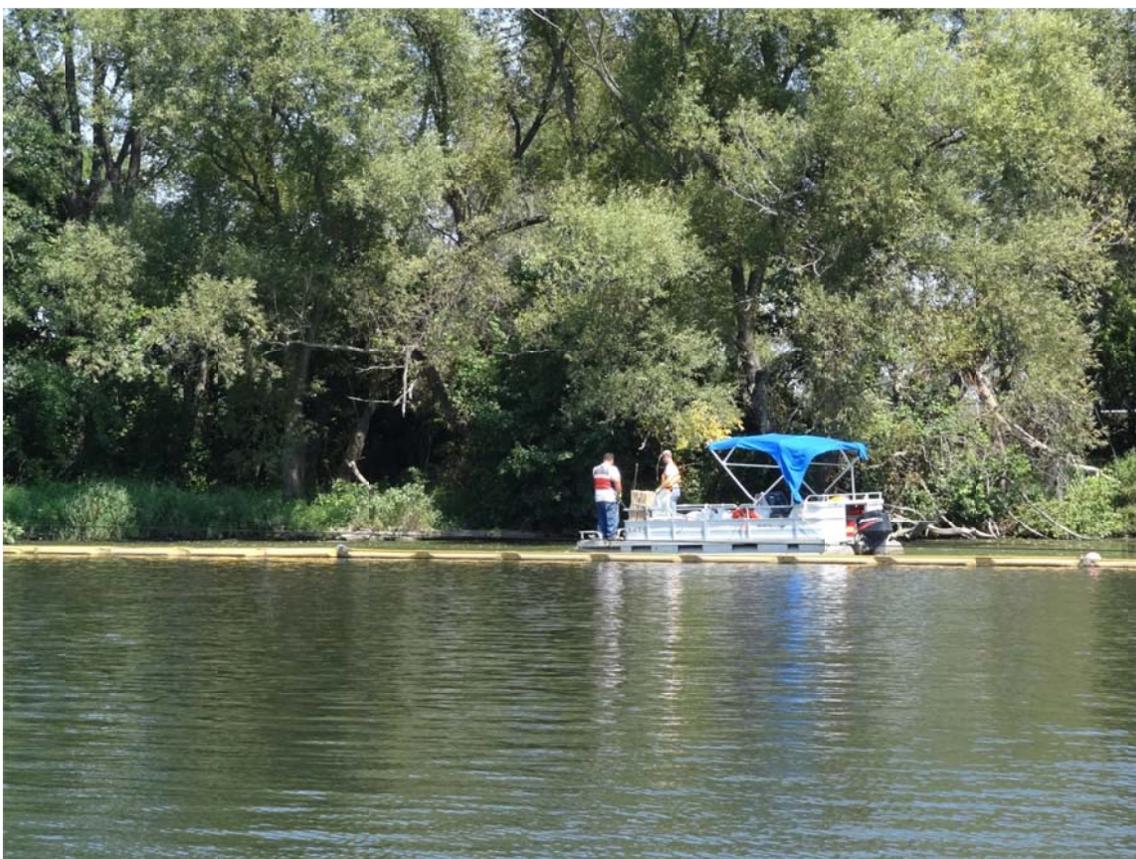
**36. Morrow Lake Delta Boom E observed crew removing debris from the boom.**

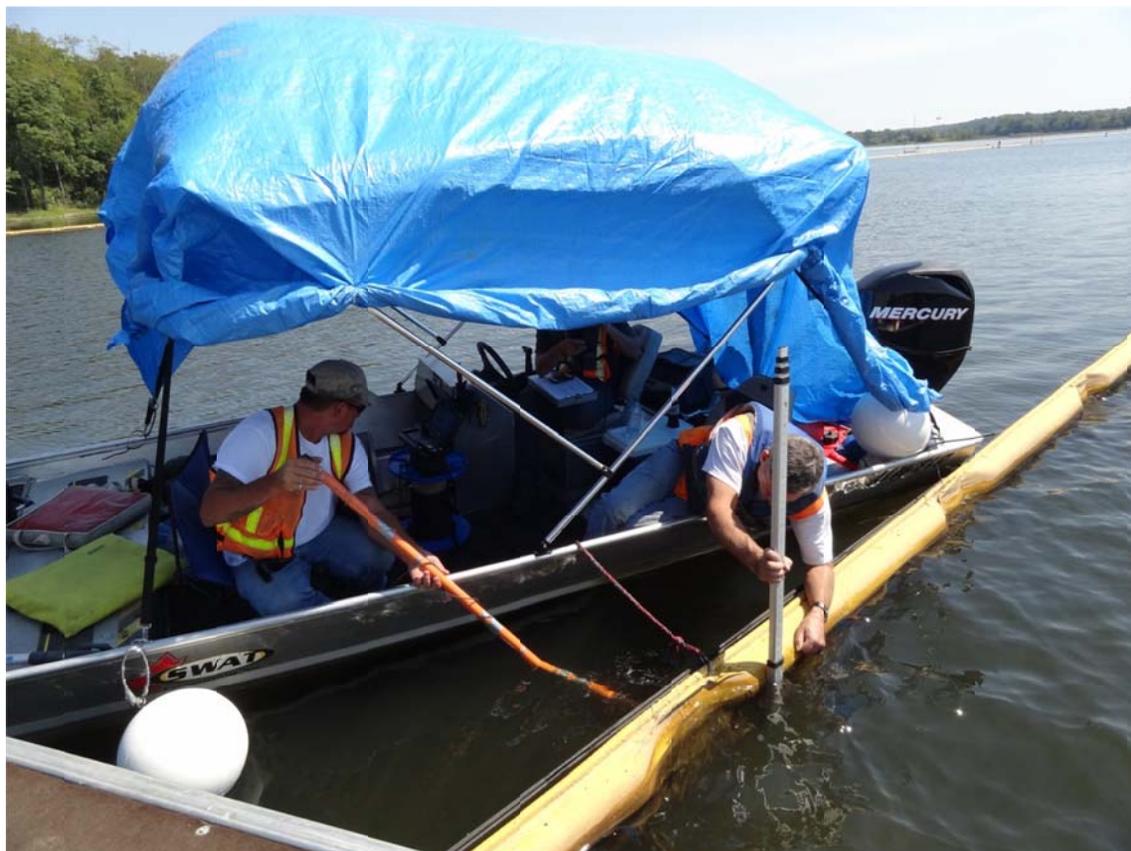
37. Morrow Lake Delta Boom F observed crews performing camera inspection of the curtain.

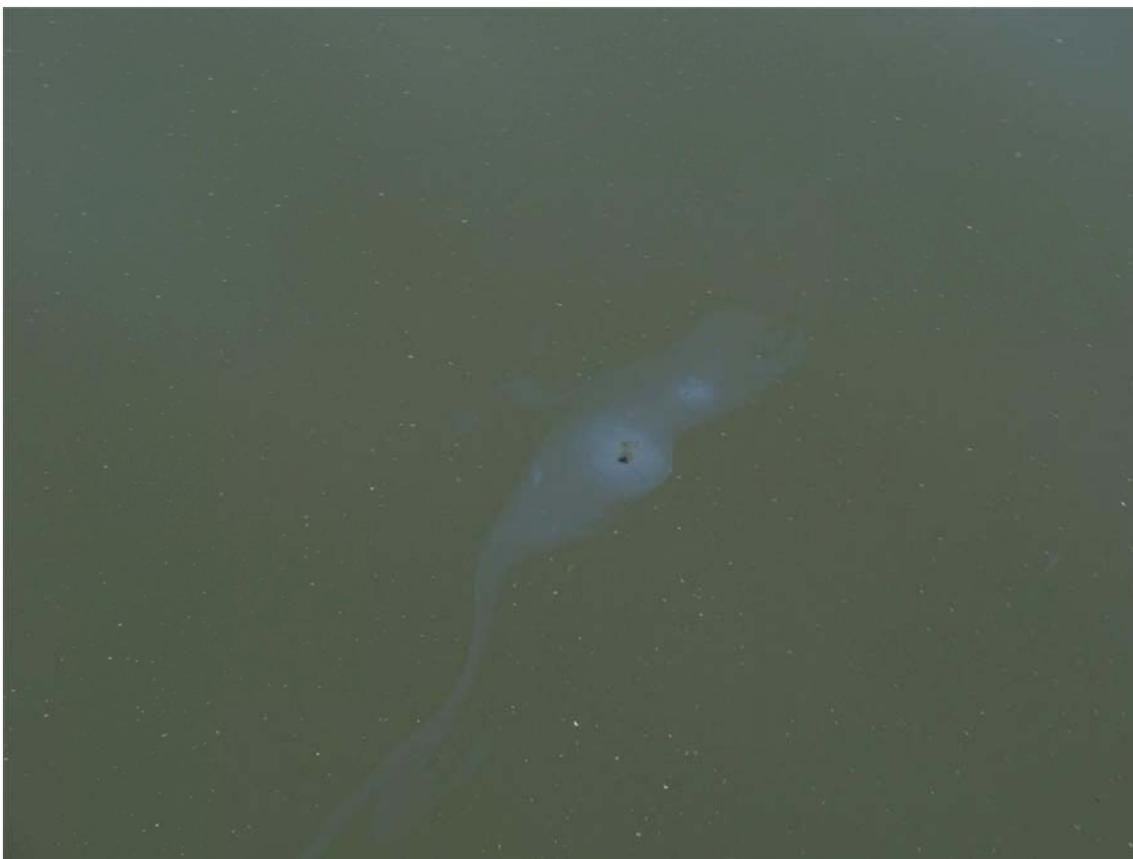
38. Morrow Lake southern cove observed sheen and tar globs.

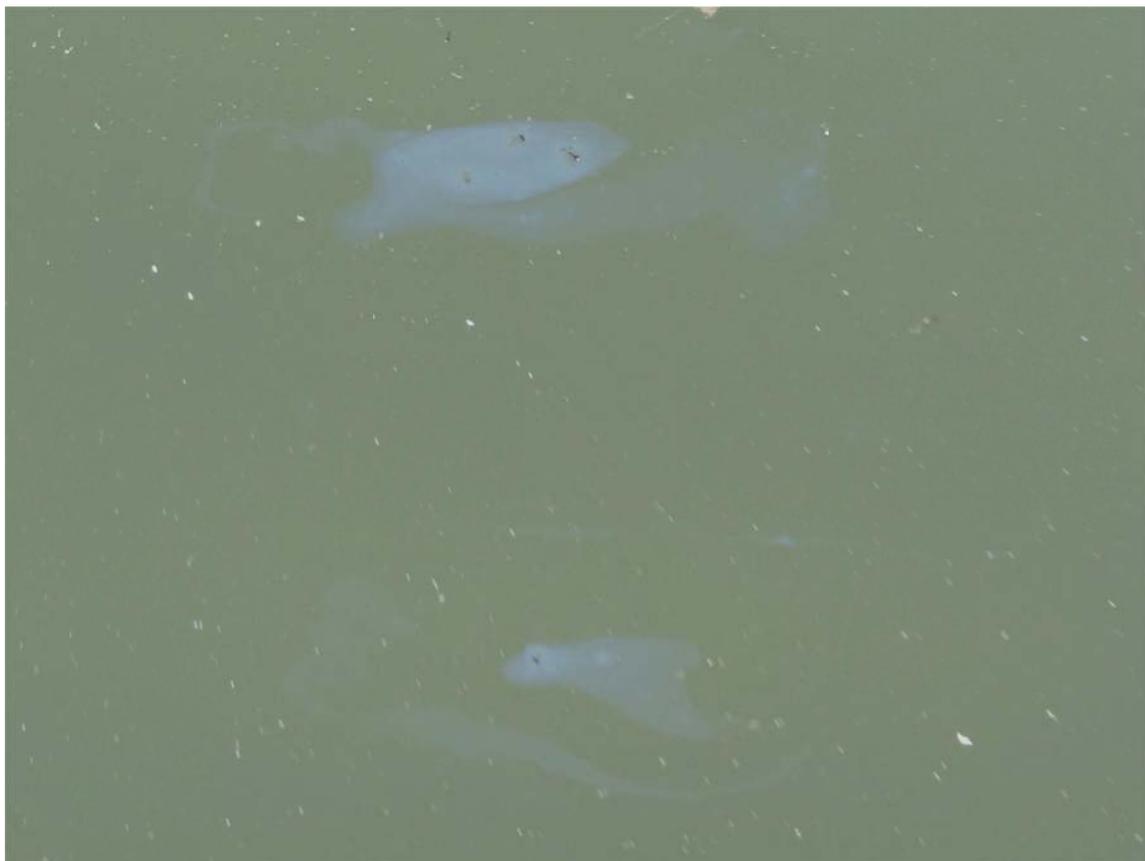
39. Morrow Lake southern cove observed sheen and tar globs.

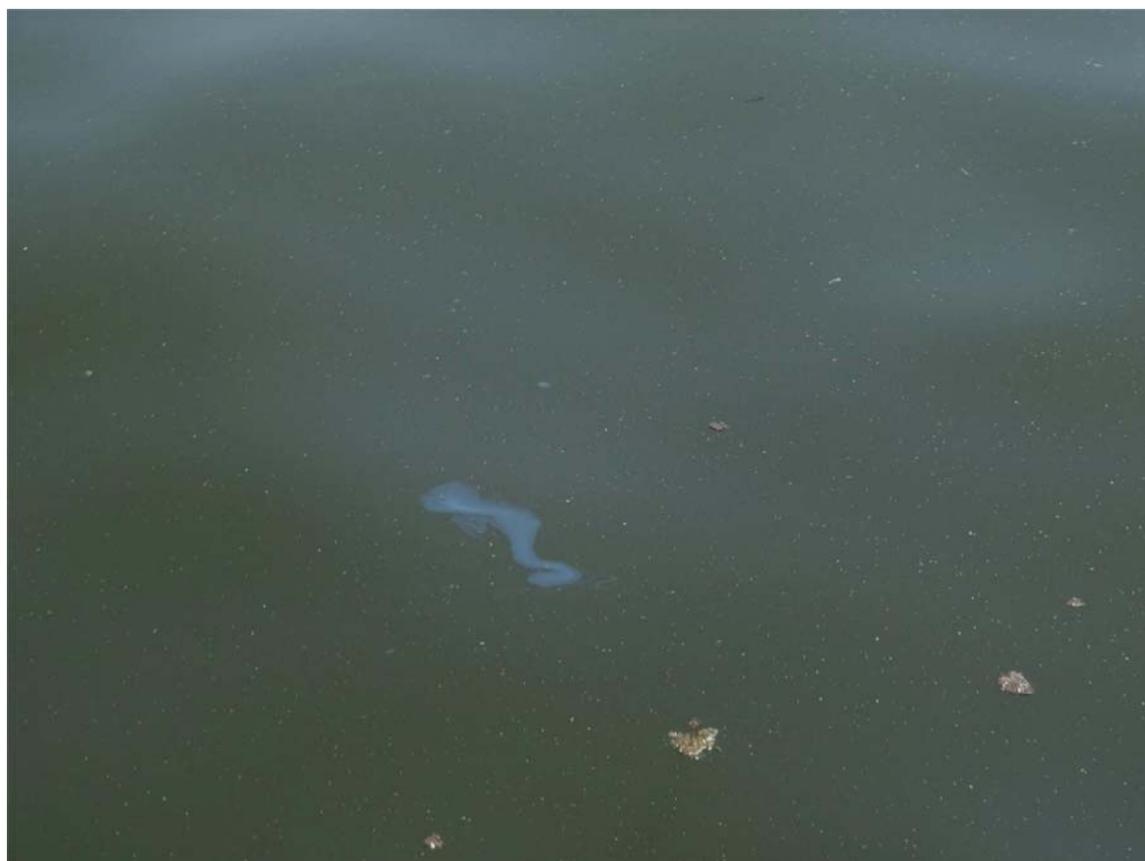
40. Morrow Lake MP38.25 northern shoreline sheen observed.

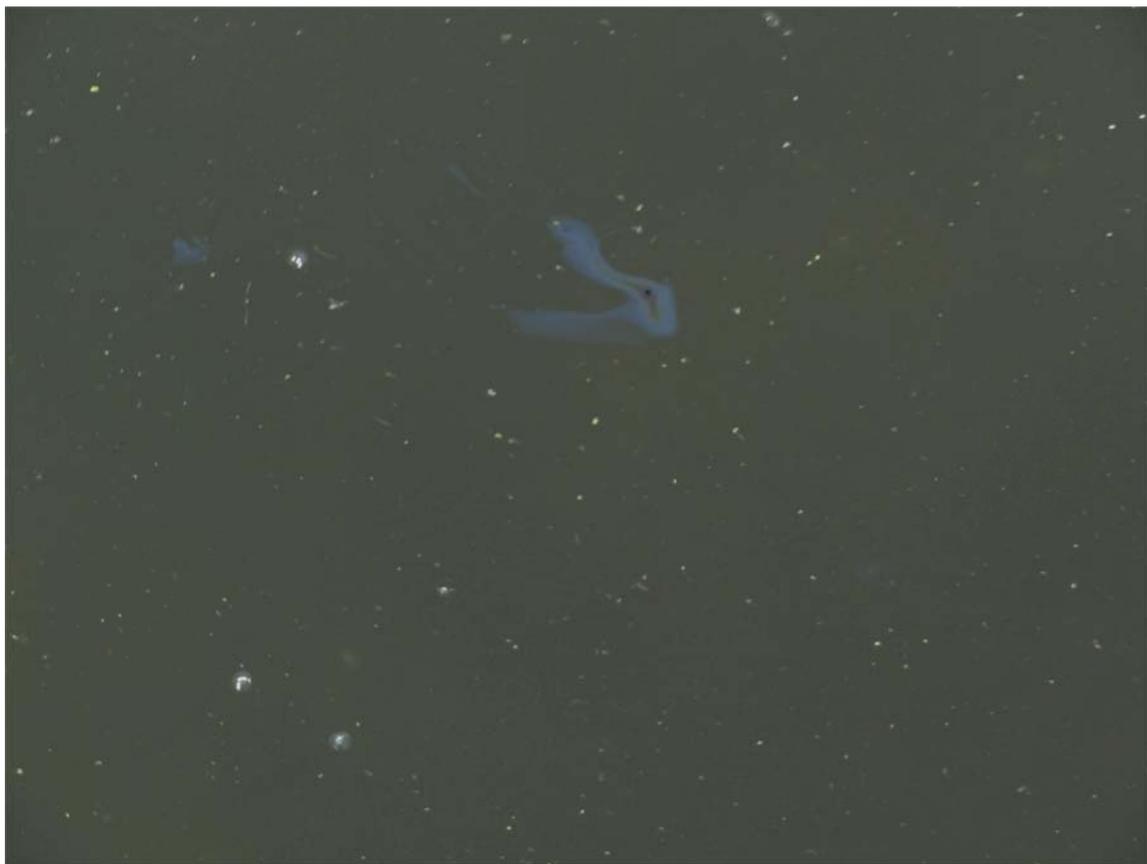
41. Morrow Lake northern cove observed sheen and tar globs.

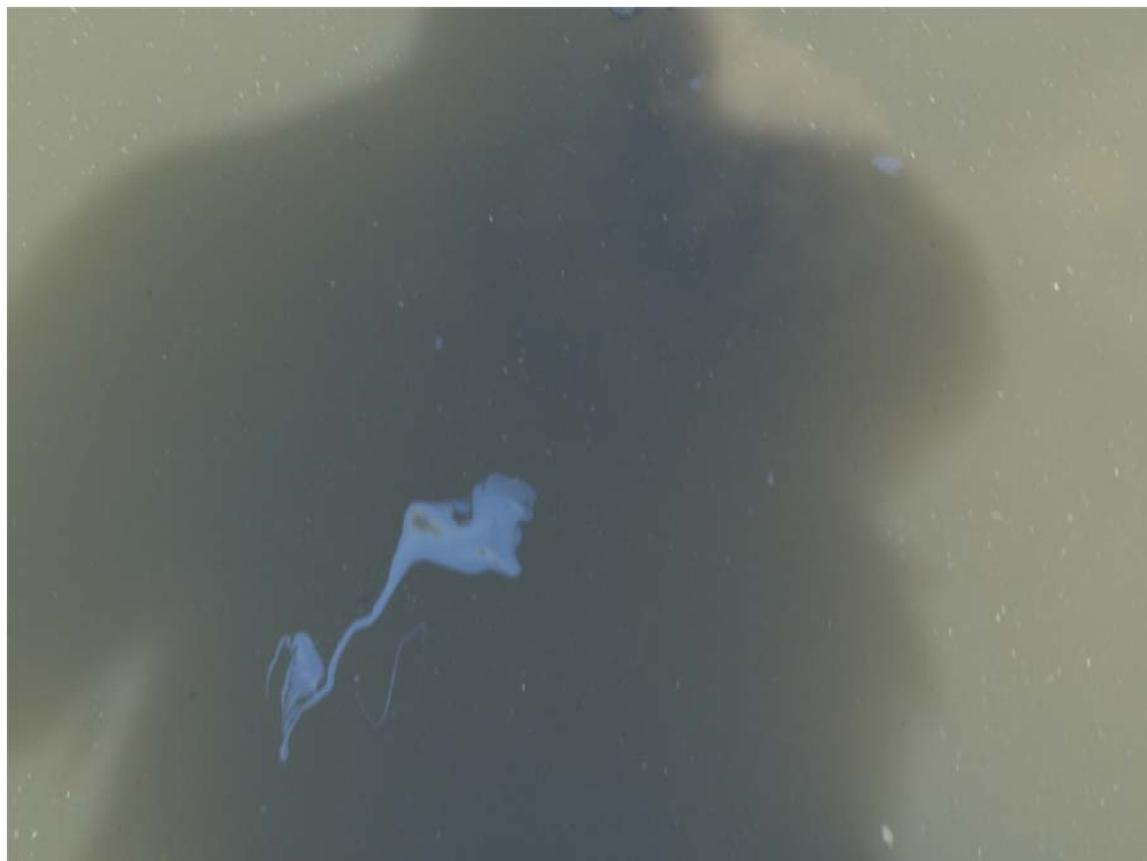
42. Morrow Lake northern cove observed sheen and tar globs.

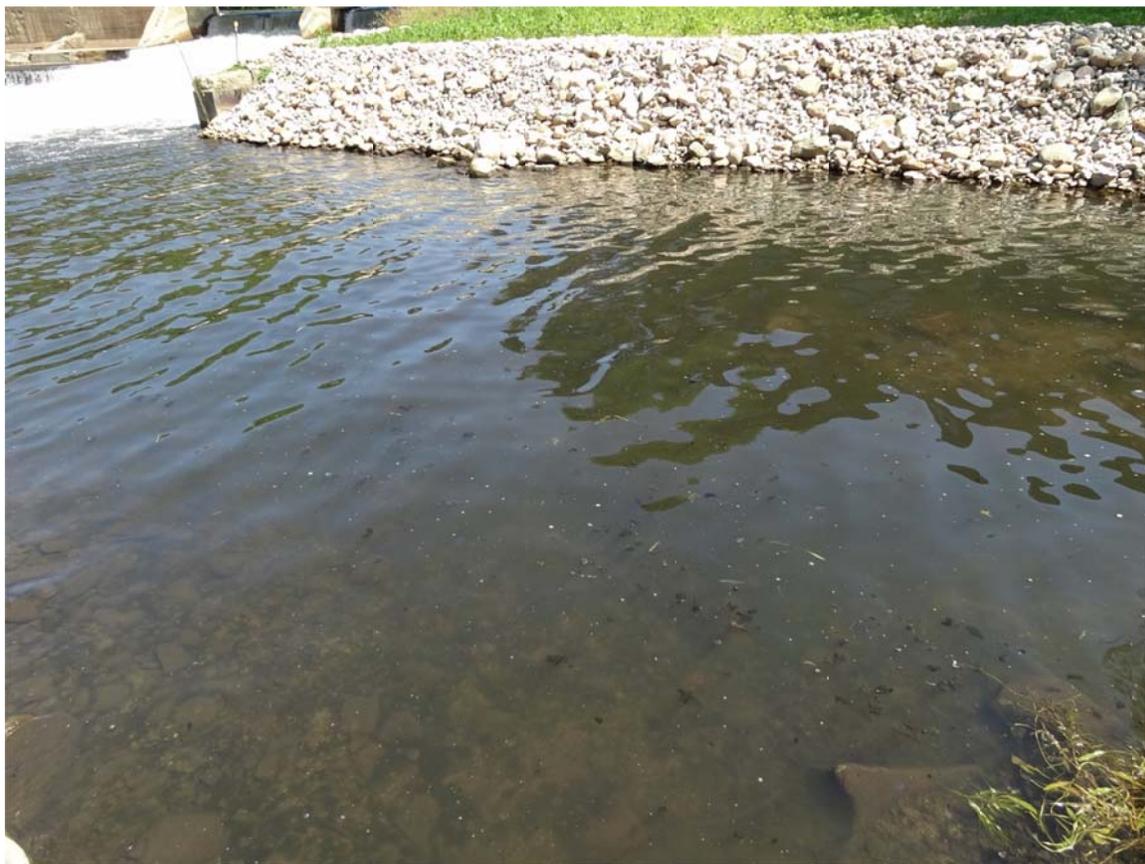
43. Ceresco Dam portage put in below Ceresco Dam.

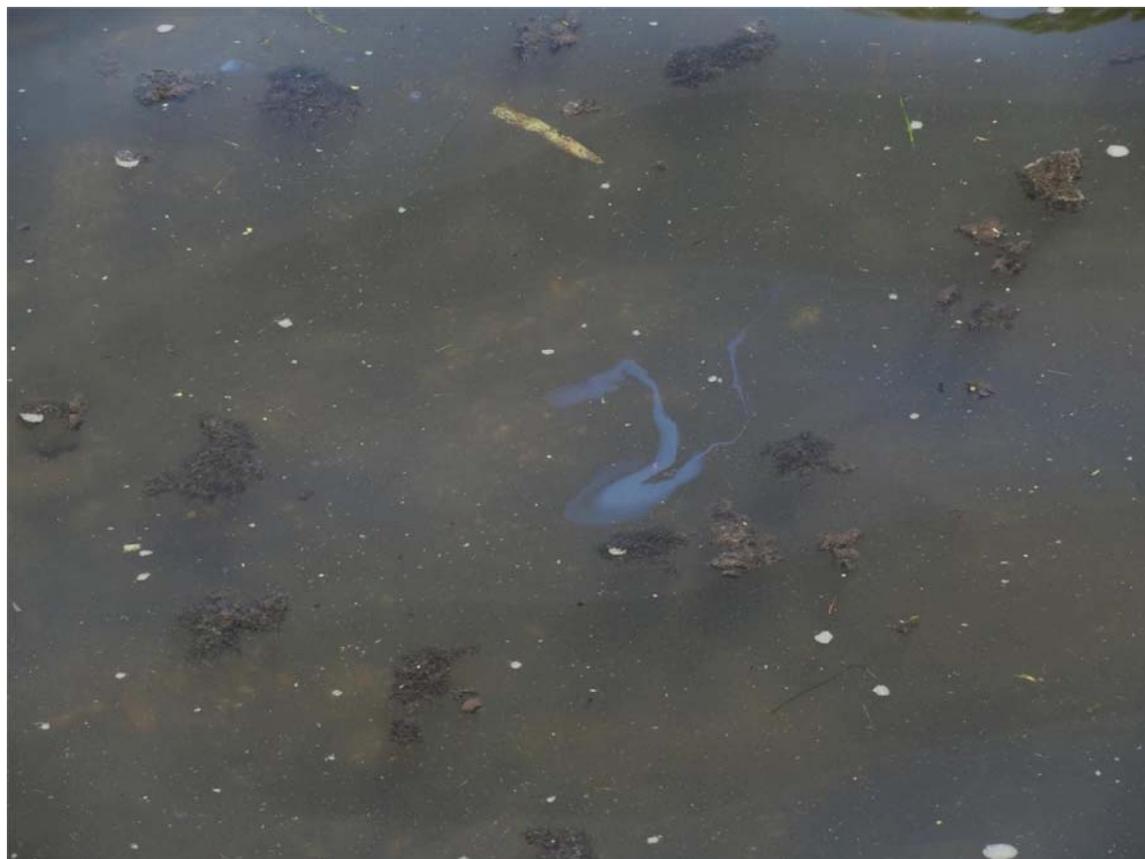
44. Ceresco Dam portage put in below Ceresco Dam sheen and tar globs observed.

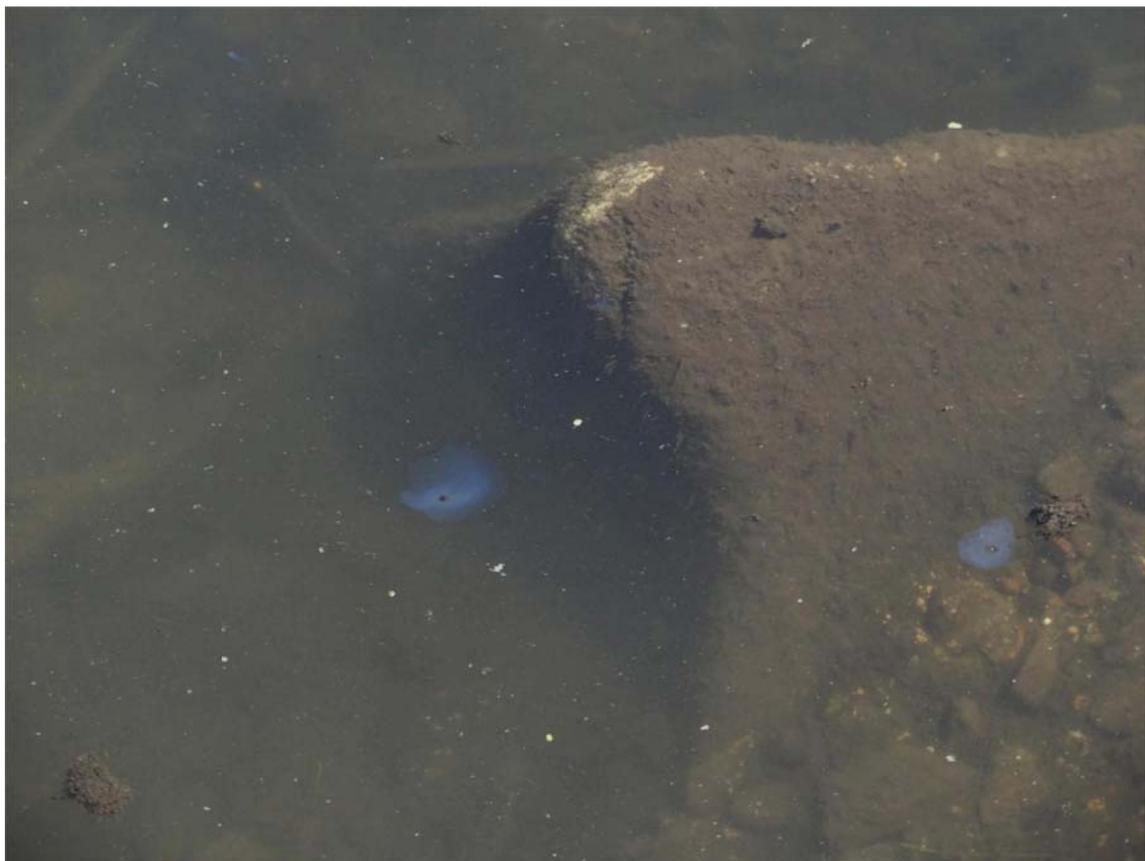
45. Ceresco Dam portage put in below Ceresco Dam sheen and tar globs observed.

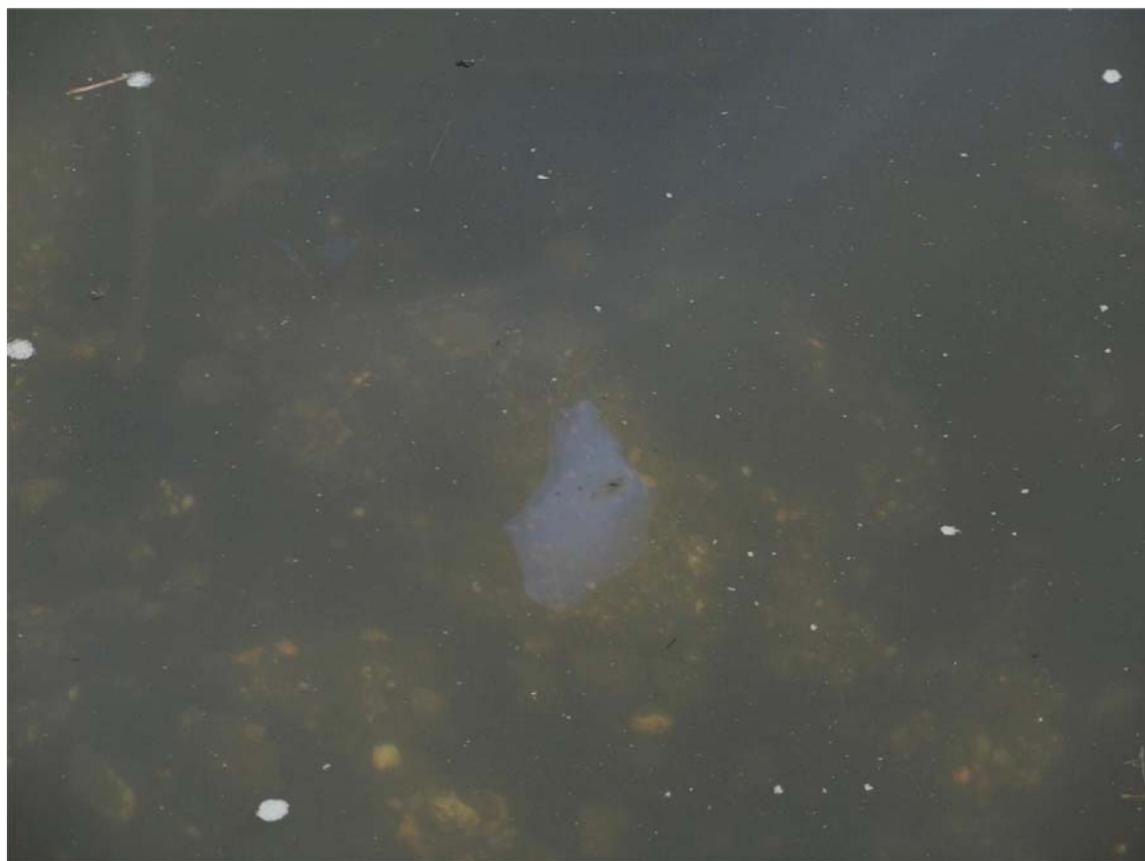
46. Ceresco Dam portage put in below Ceresco Dam sheen and tar globs observed
