# Situation Photo Log

Friday, August 24, 2012

Kalamazoo River / Enbridge Spill

Prepared by:  
Matthew Haak  
START-USEPA  
Situation Unit Leader

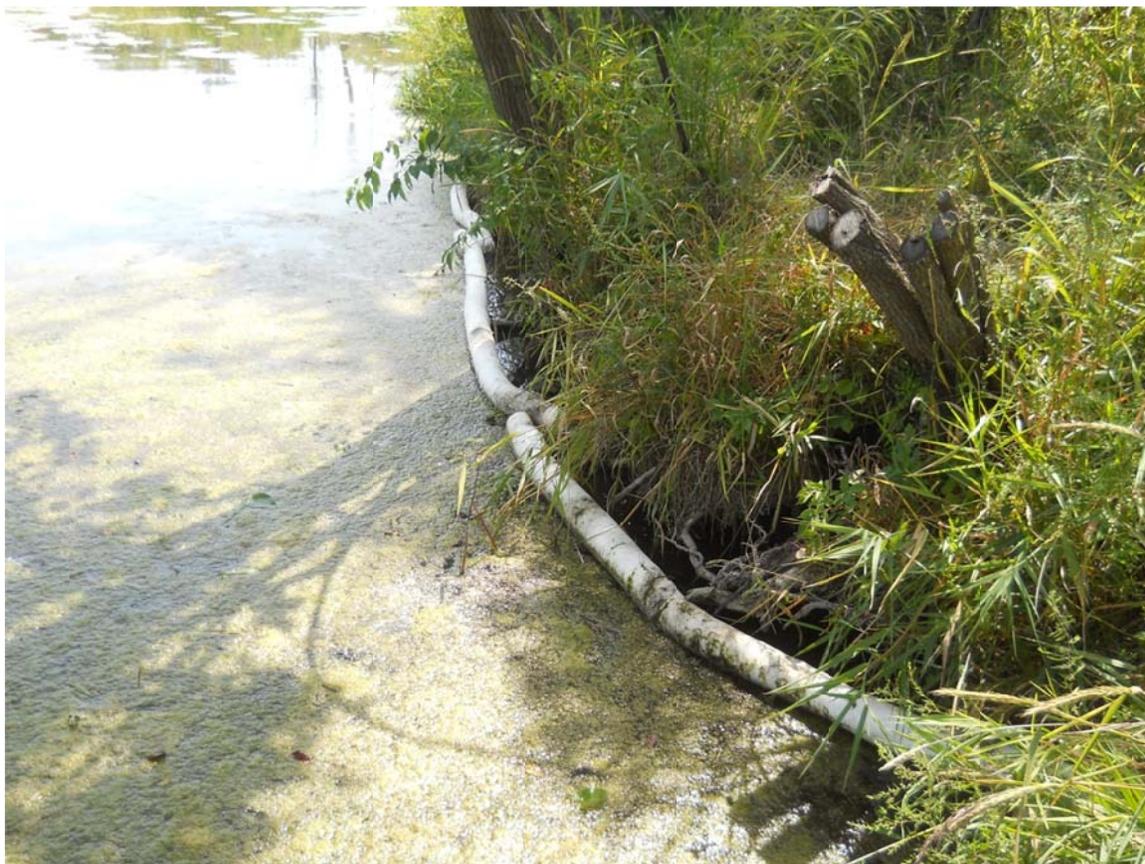
47. MP10.75 Sediment traps.

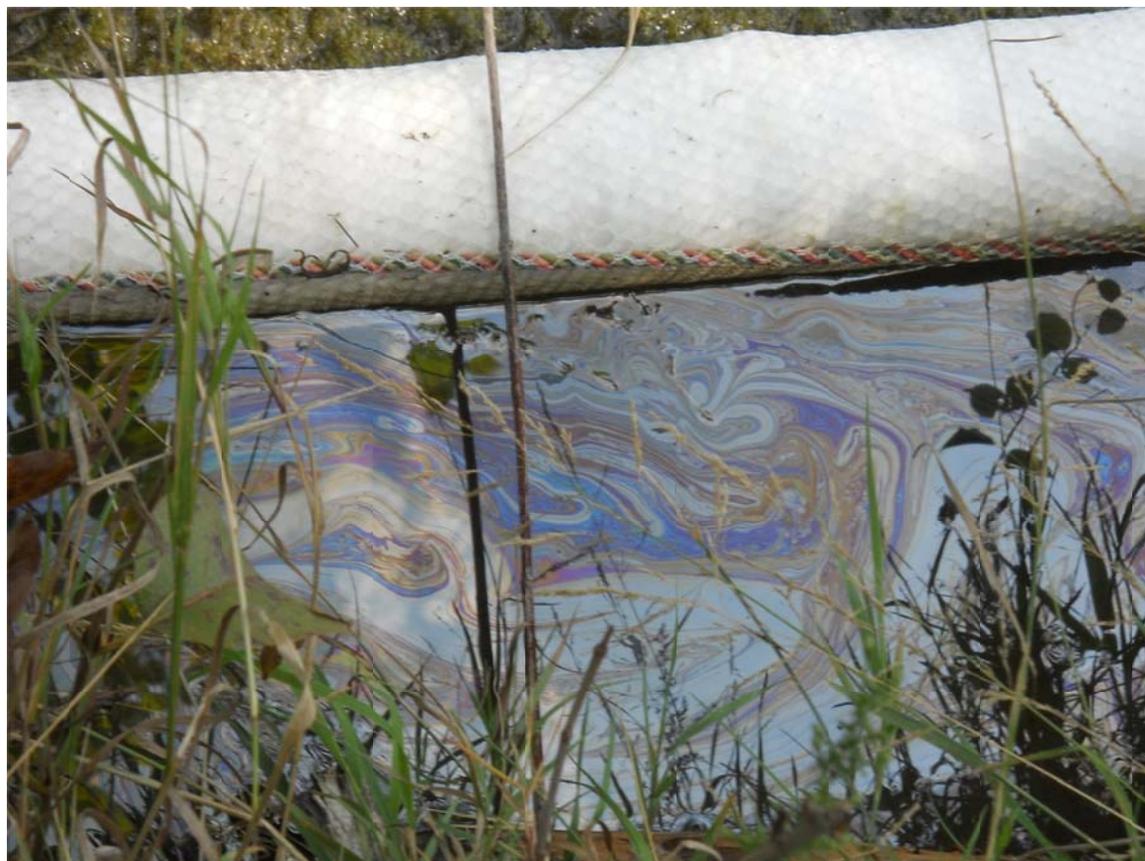
48. MP10.75 rainbow sheen observed within the boom.
