# Situation Photo Log

Monday, August 27, 2012

Kalamazoo River / Enbridge Spill

Prepared by:  
Larry Rader  
START-USEPA  
Situation Unit Leader

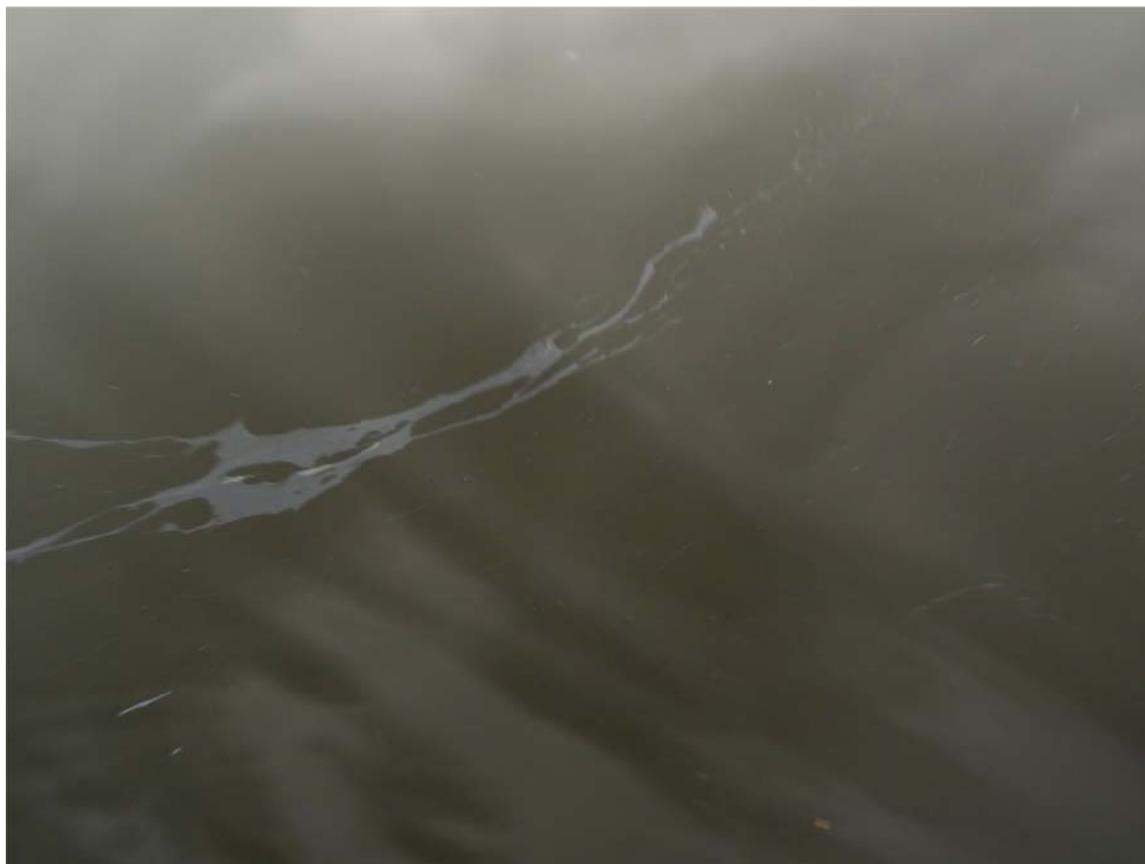
1. Sheen observed along LDB across from C0.4 boat launch.

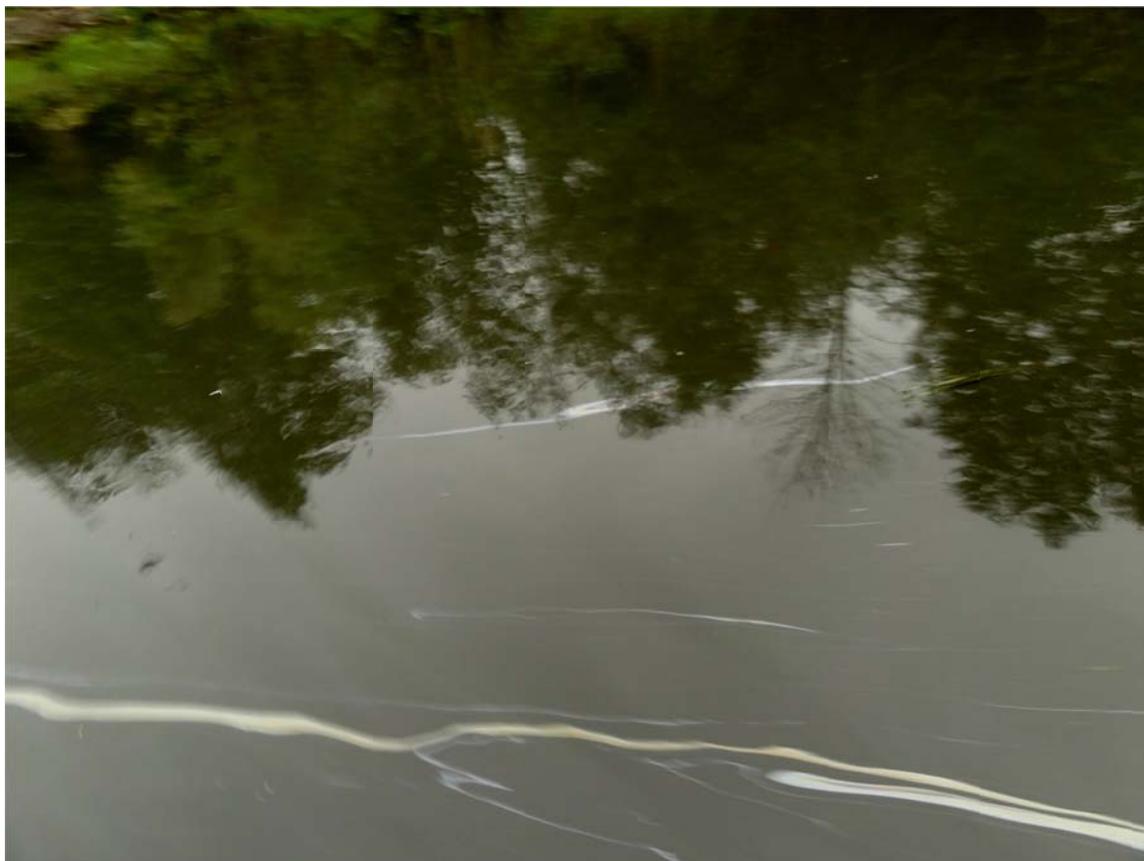
2. Sheen and tar globules observed near MP 5.5 LDB.

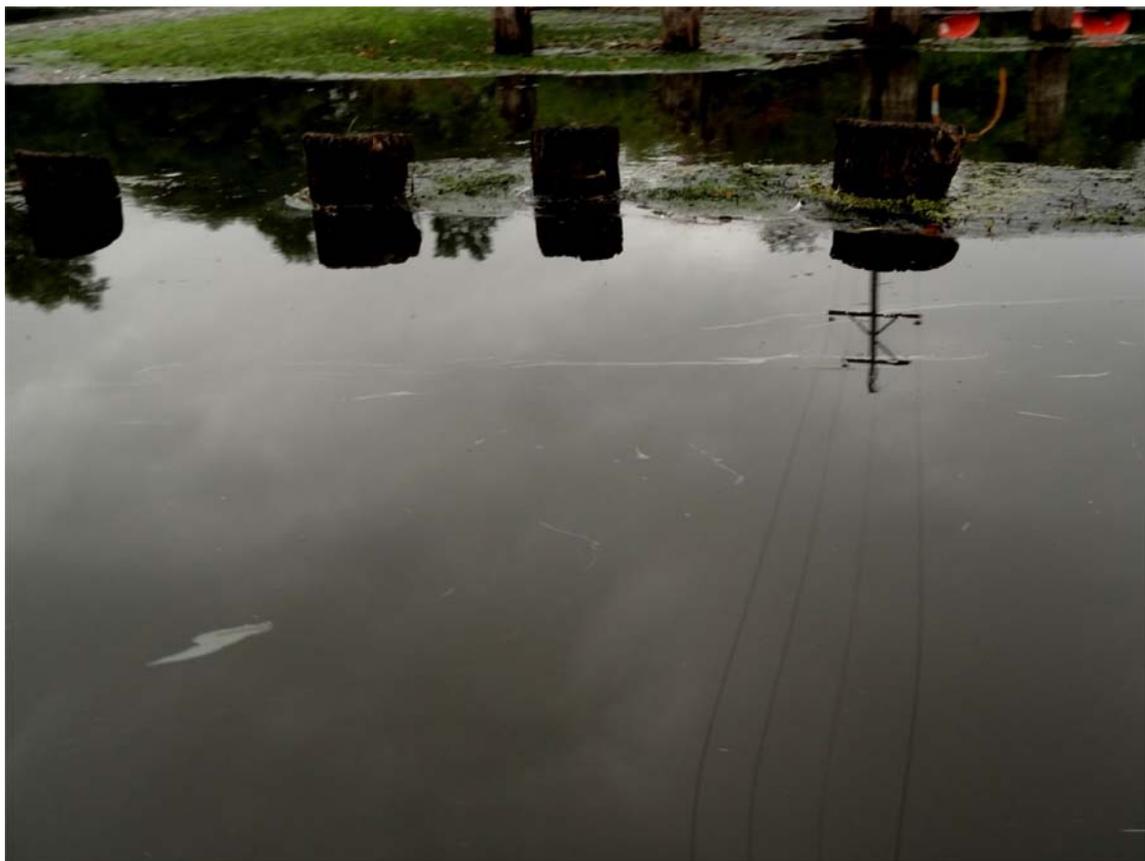
3. Sheen and tar globules observed at the trestle above Ceresco Dam.

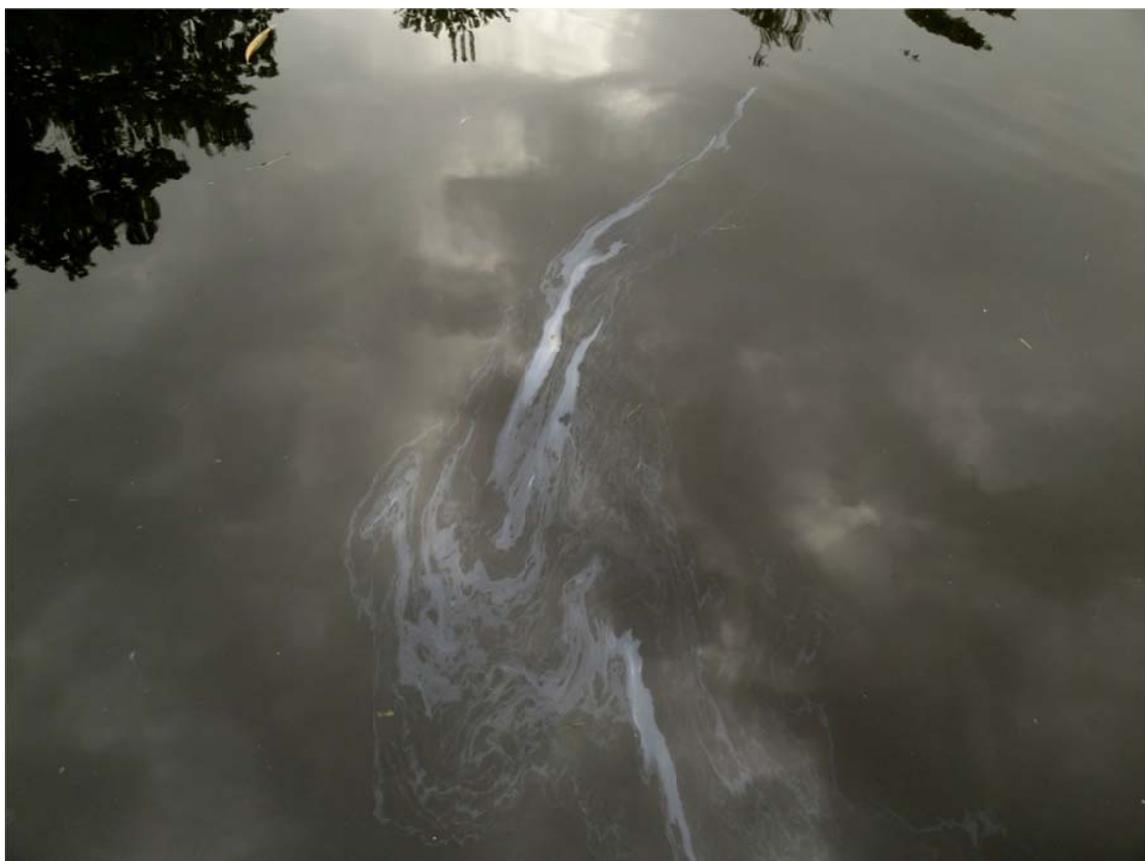
4. MP5.75, sheen and tar globules observed just downstream from trestle.

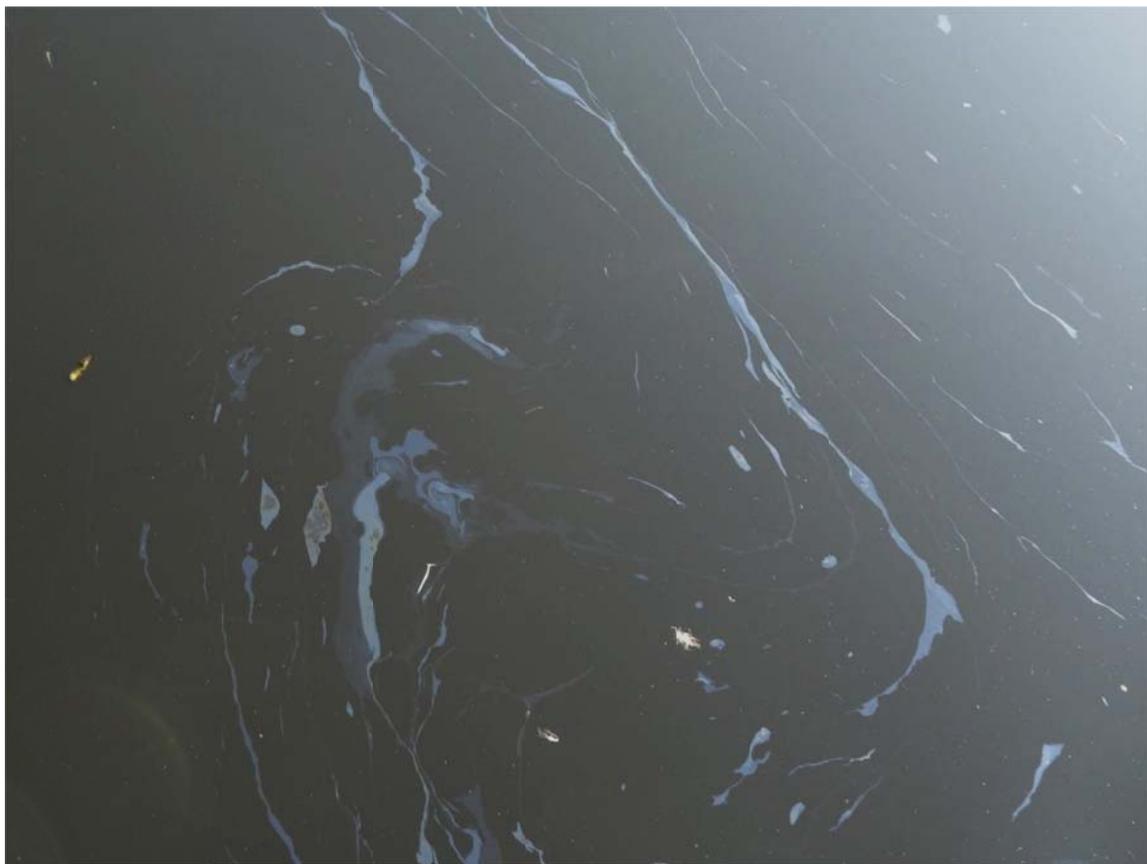
5. MP5.75 LDB, sheen and tar globs observed.

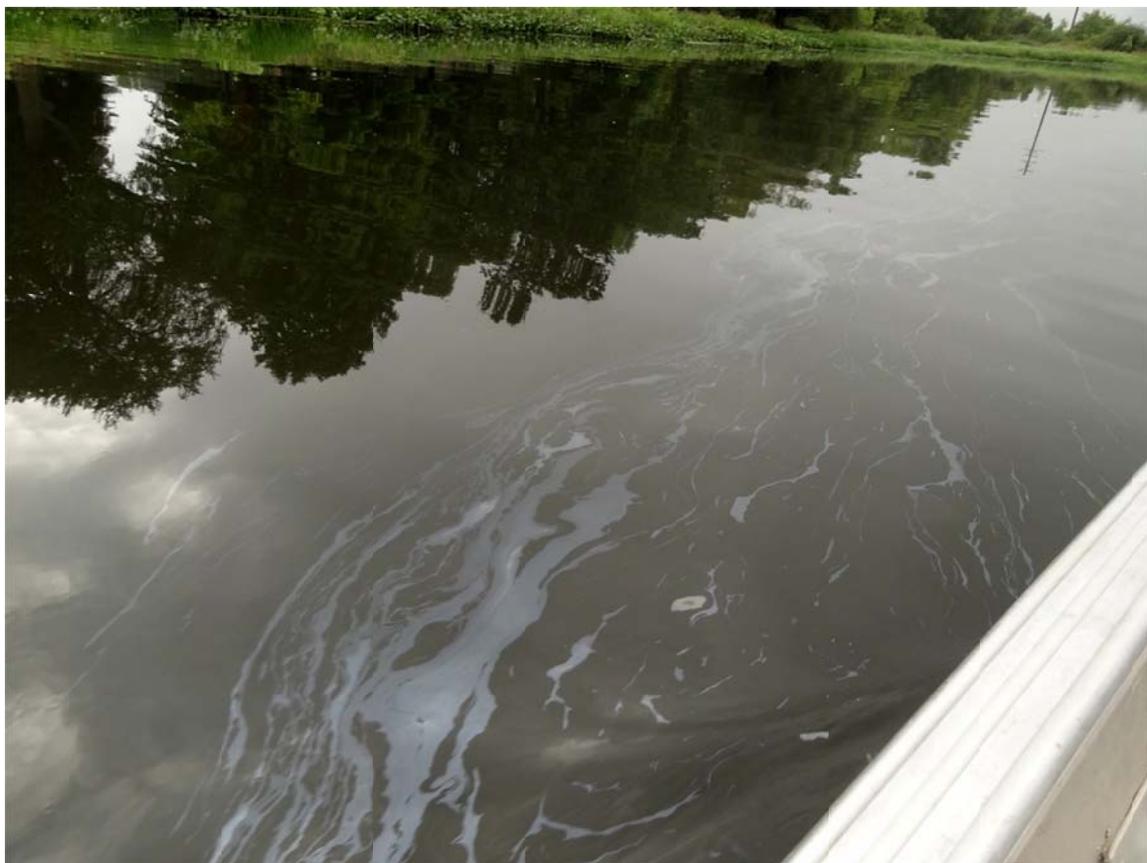
6. MP5.75, tar globules and sheen observed in center of river channel.

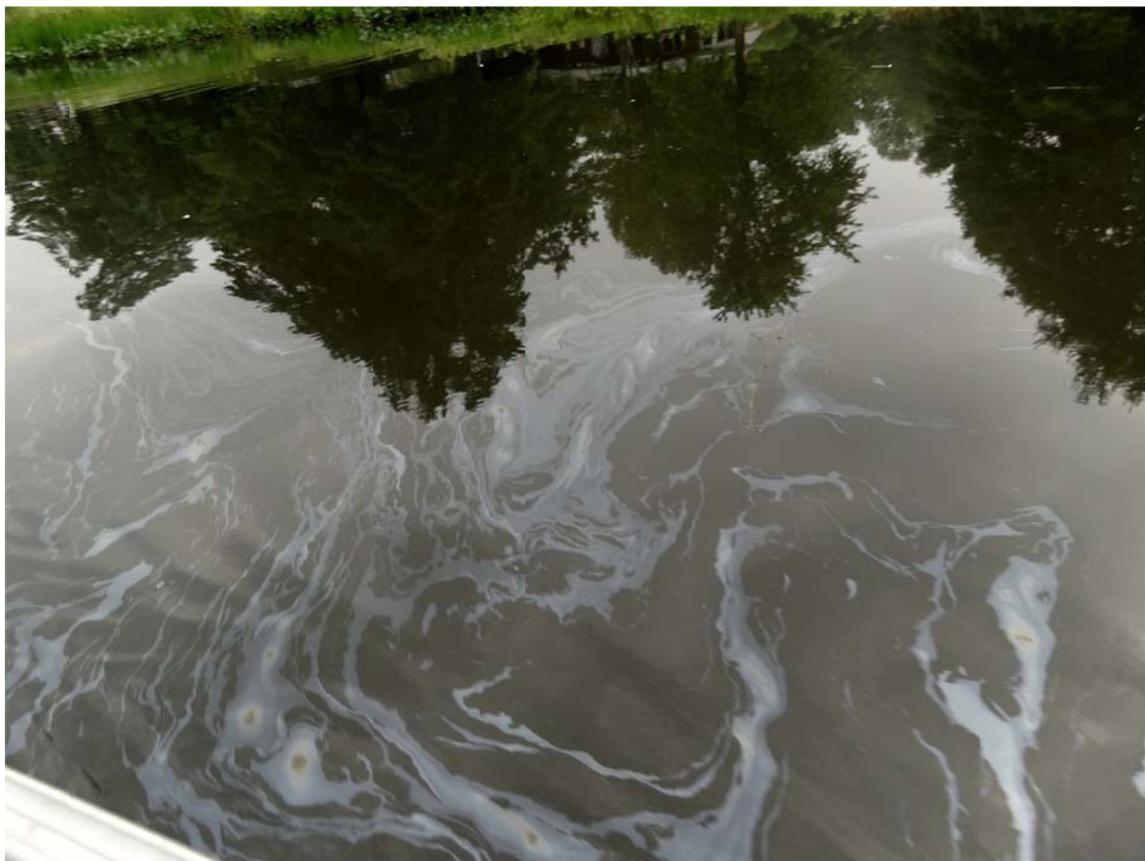
7. MP5.75 river channel, tar globs and silver sheen were observed.

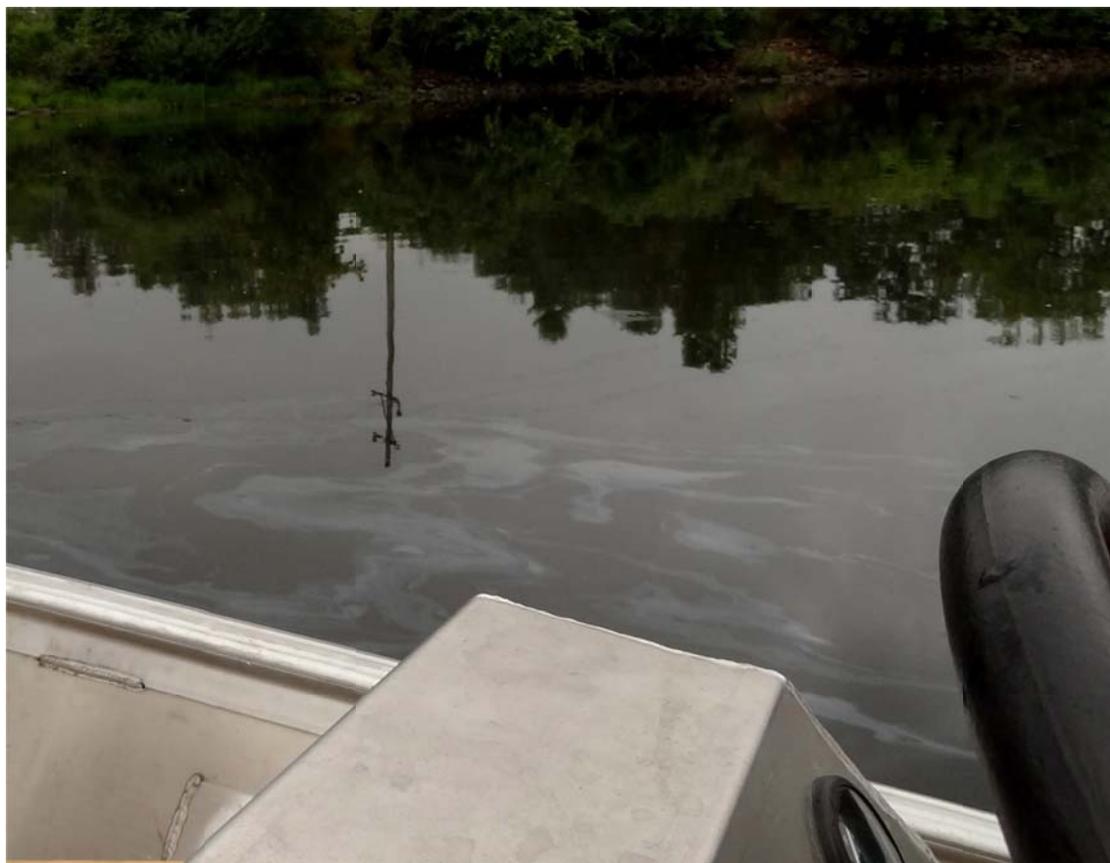
8. MP5.75 LDB, tar globs and silver sheen were observed.

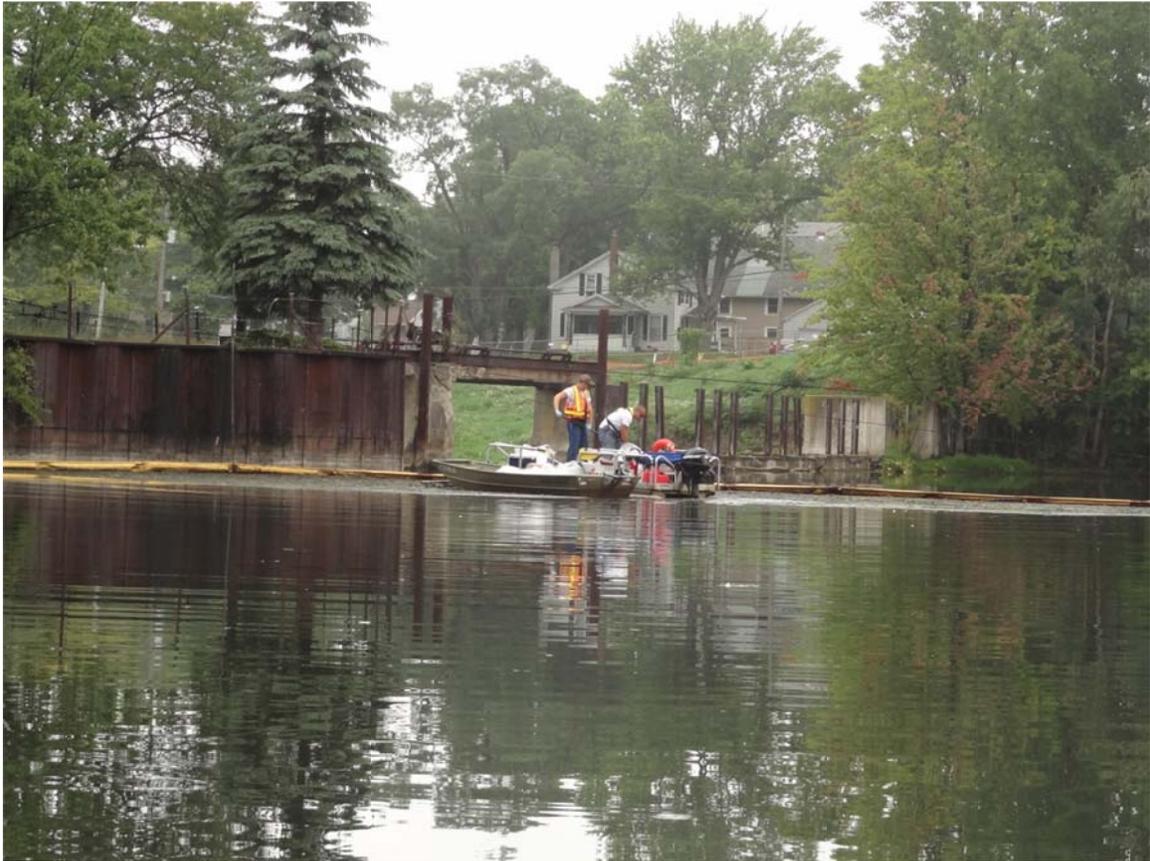
9. Crews removing debris from the control point at Ceresco Dam.

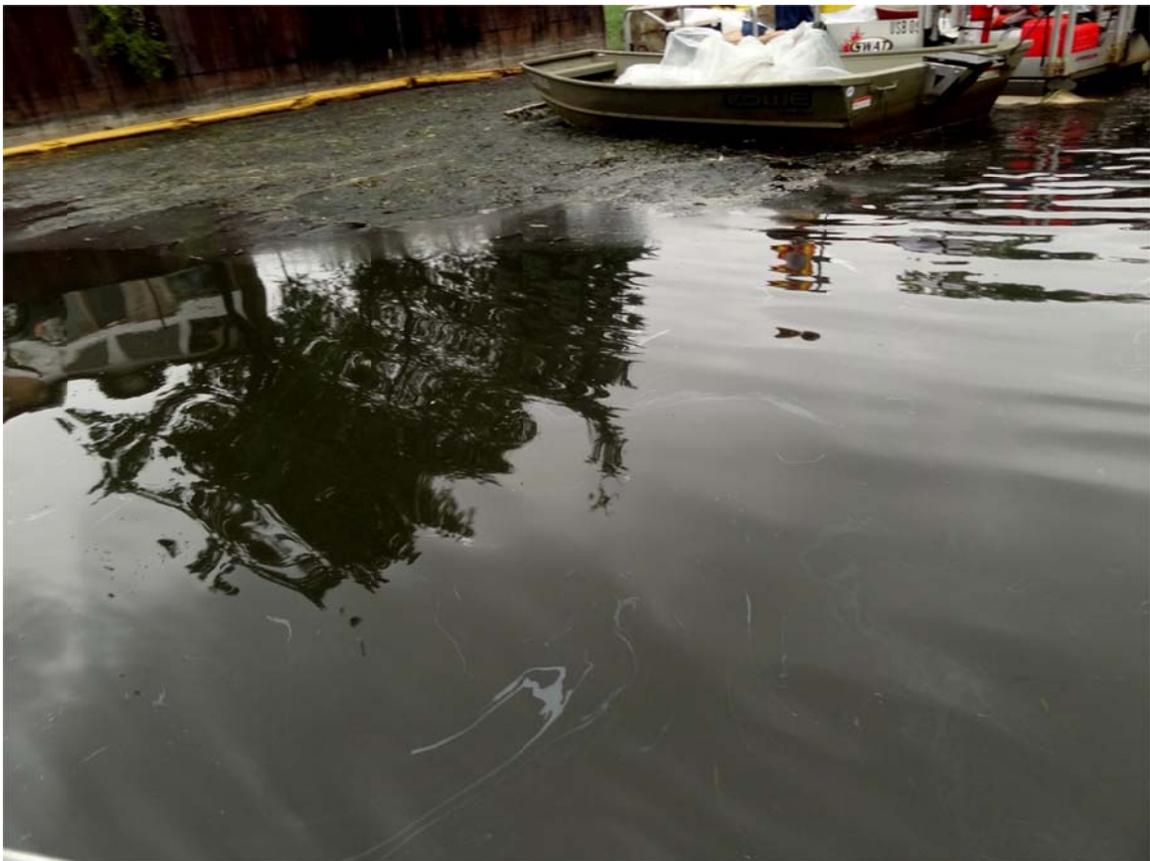
10. Sheen observed collecting along the control point boom at Ceresco Dam.

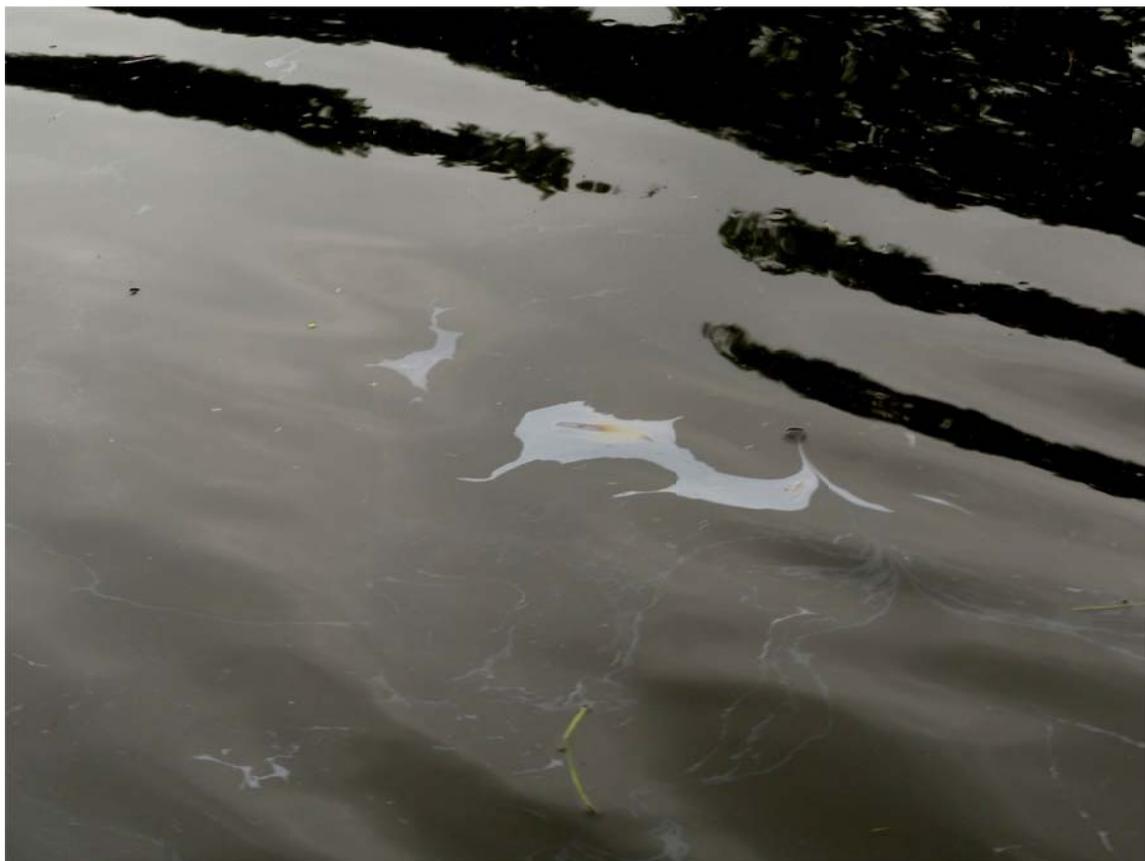
11. Sheen observed along the control point boom above Ceresco Dam.

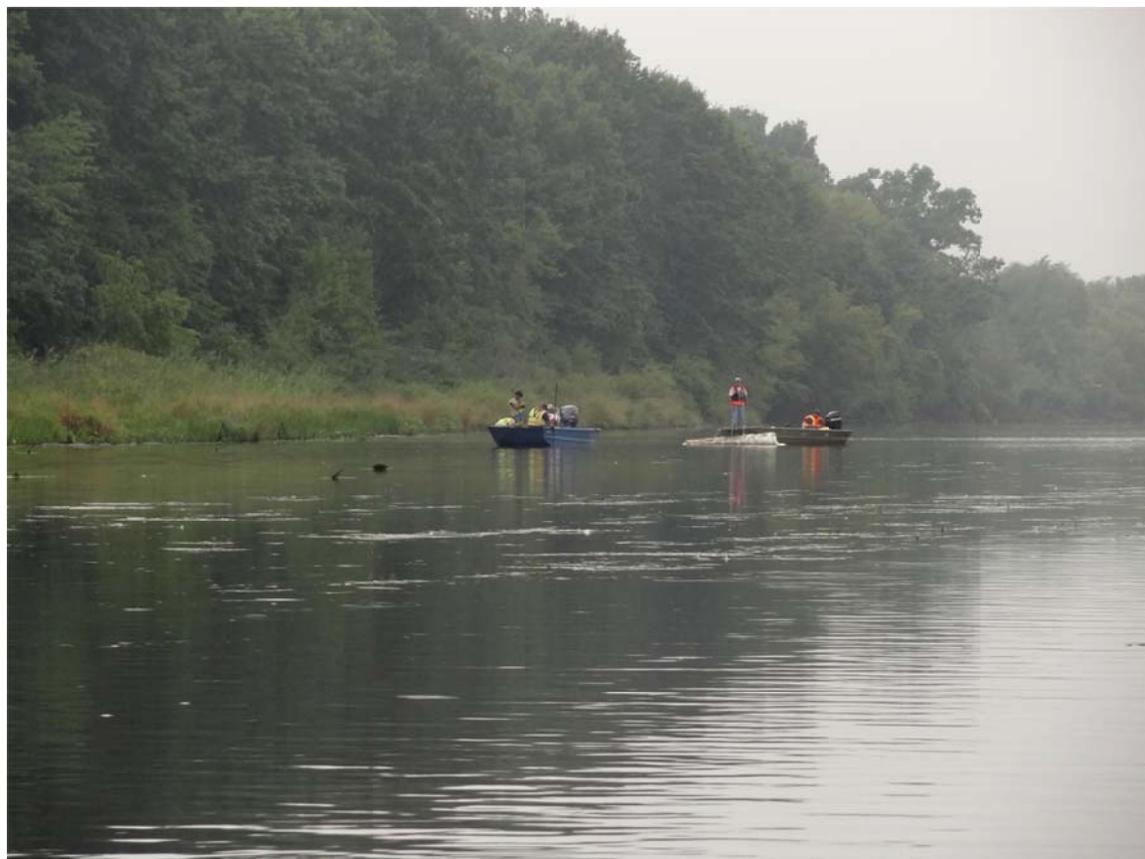
12. Poling crew observed along LDB across the river from C0.4 boat launch.

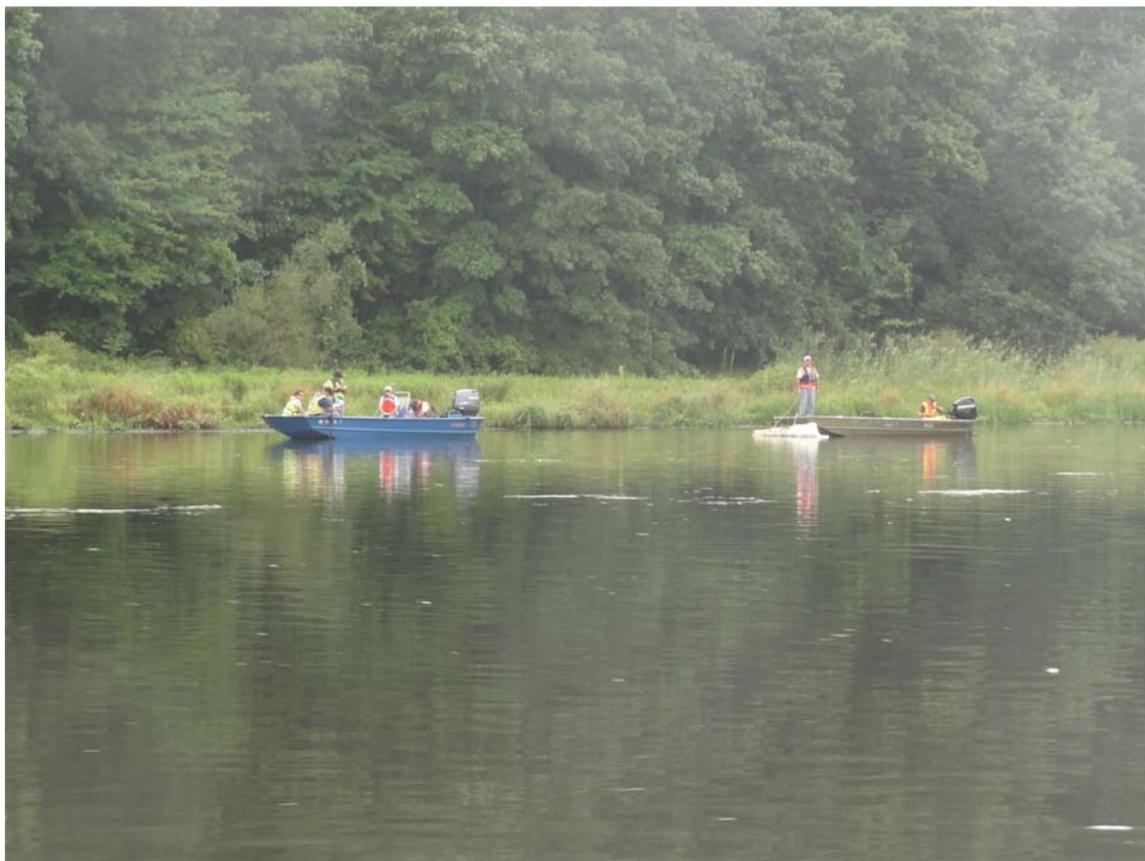
13. Poling crew observed along LDB across the river from C0.4 boat launch.

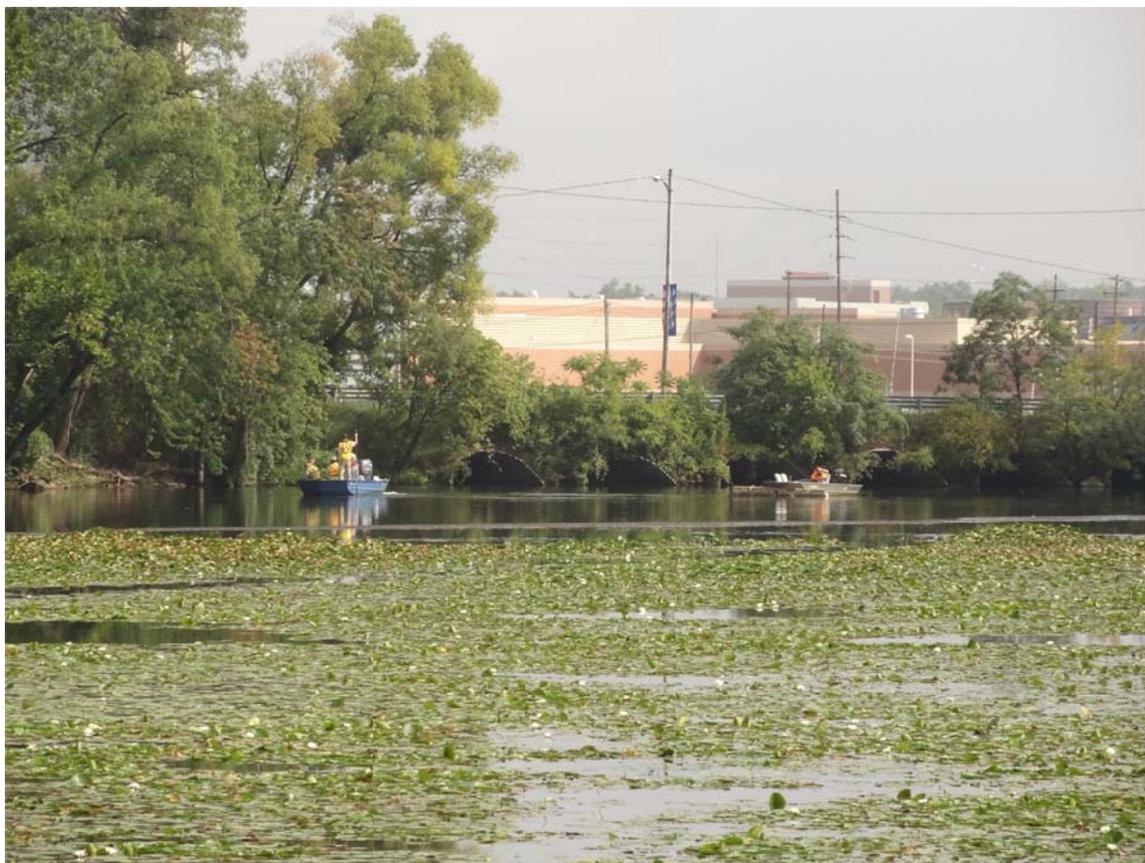
14. Poling crew observed at the Mill Pond culverts at MP15.75.

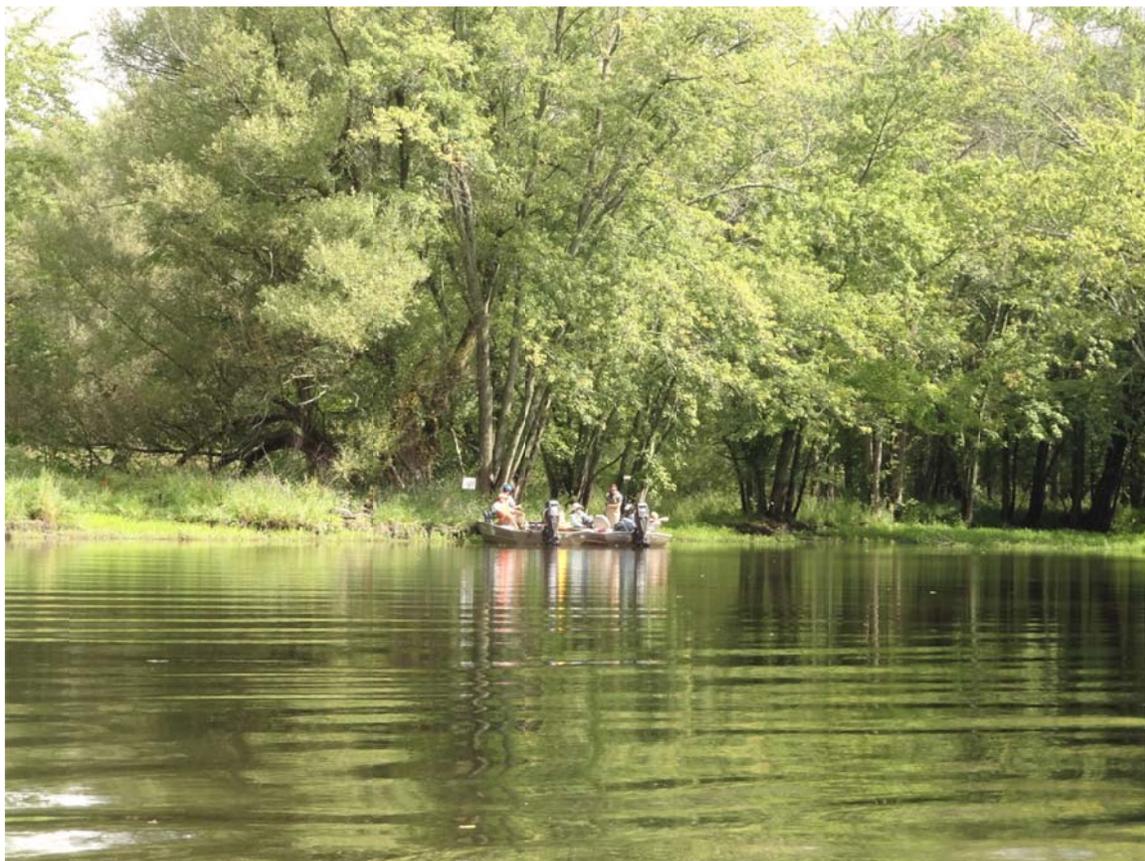
15. Poling crew observed near MP33.0 RDB.

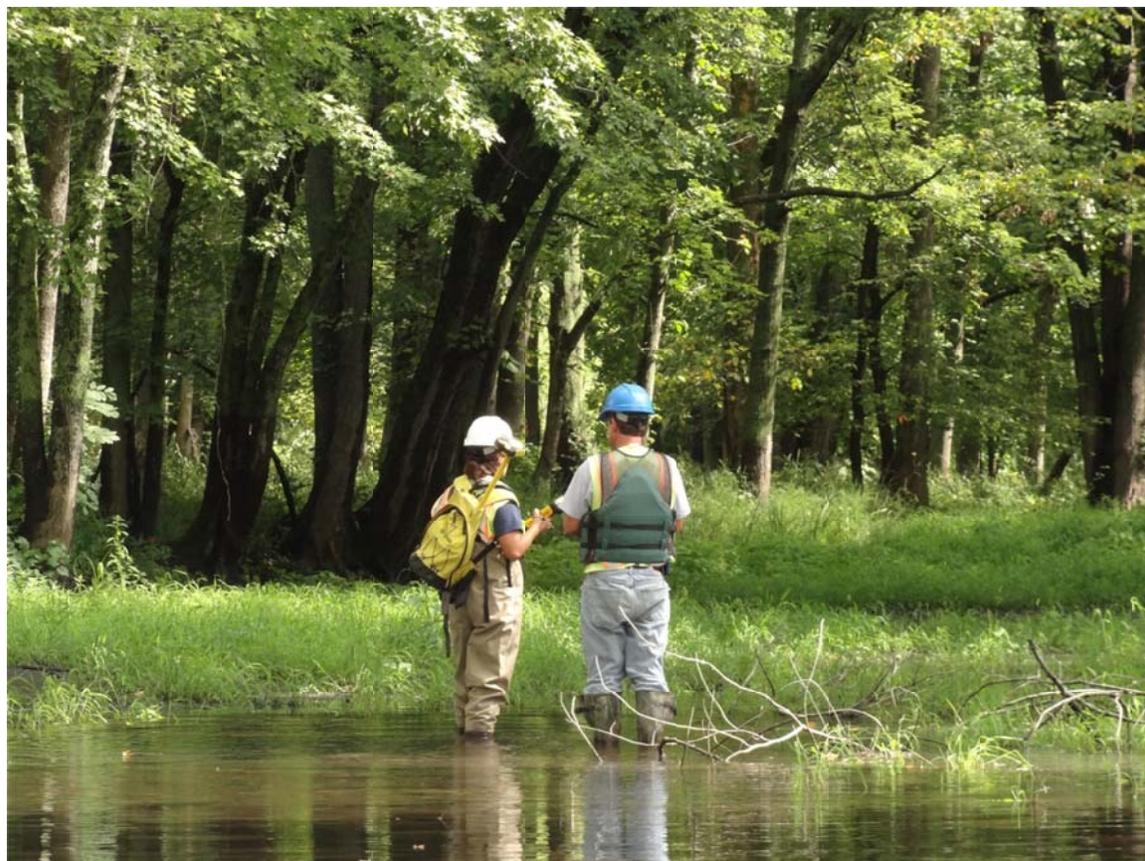
16. MP33.0 RDB, poling crew working along shoreline.

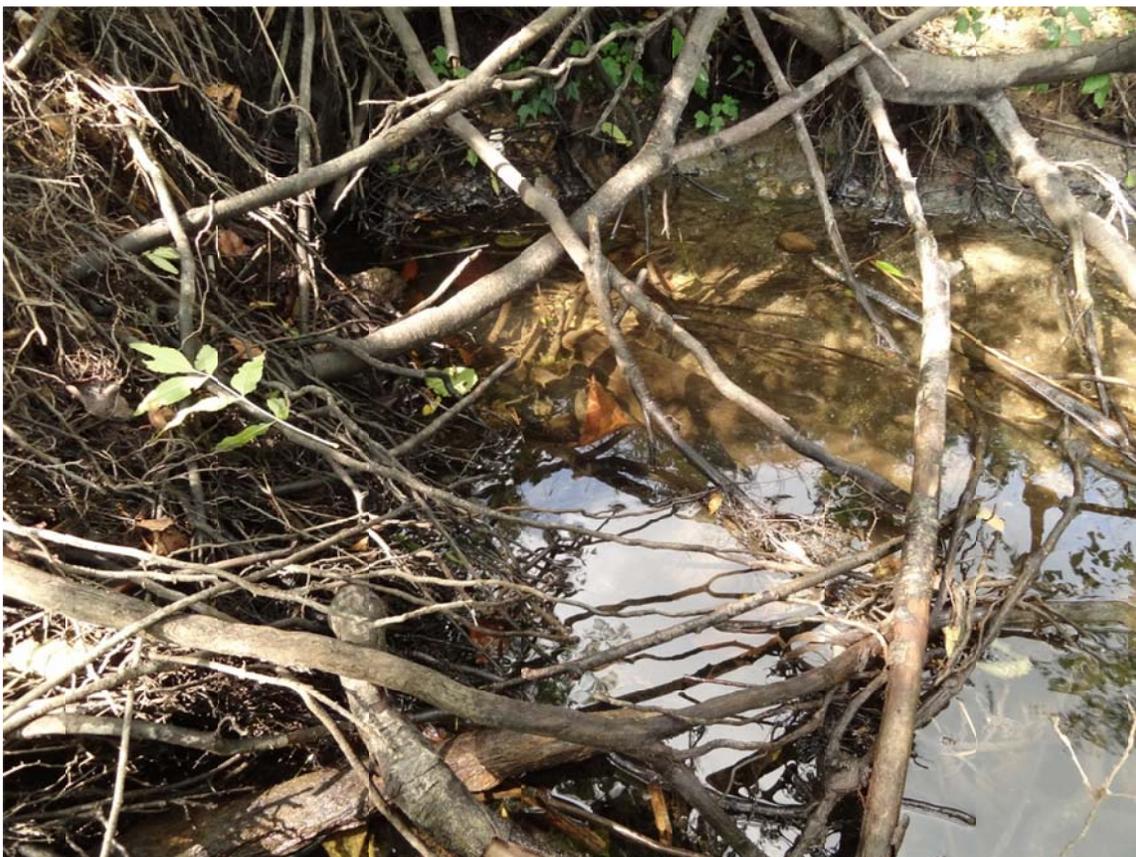
17. MP33.1 RDB, sheen and strong petroleum odor observed. Operations conducted a sheen test at this location later in the day.

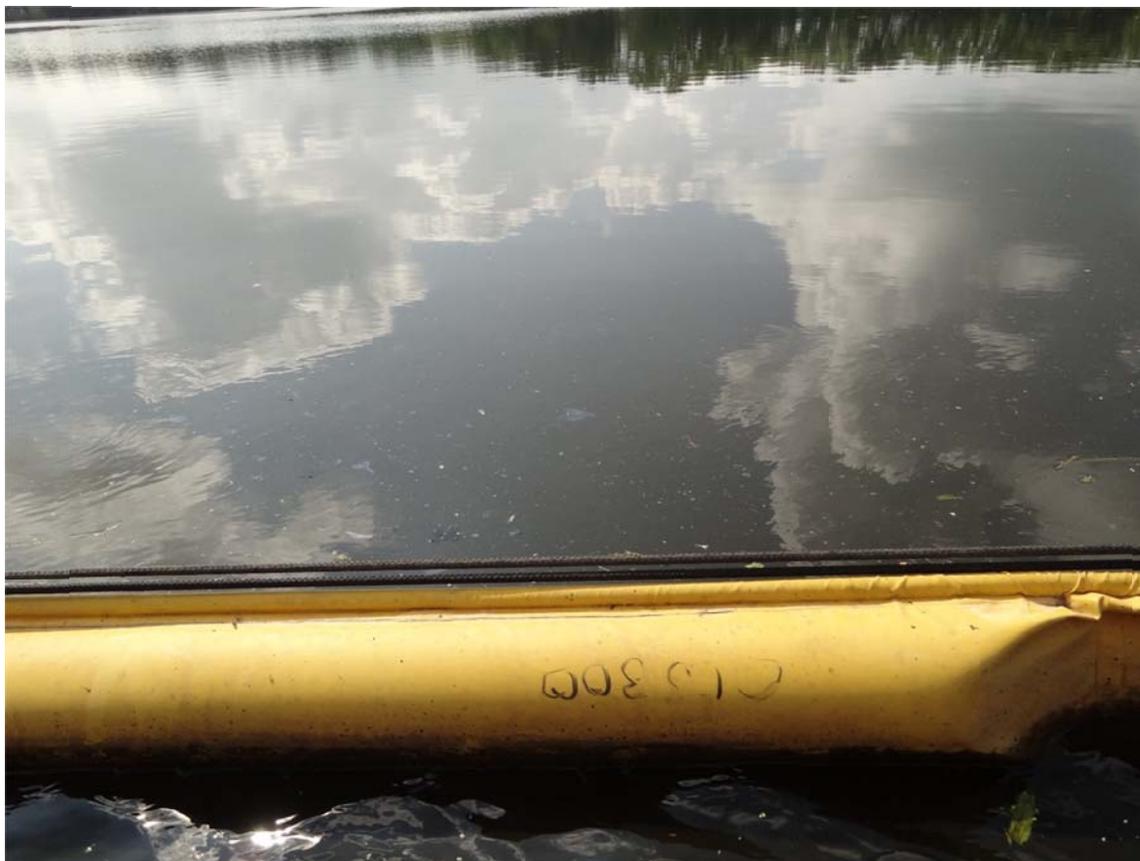
18. Morrow Lake Delta south cove boom, sheen and debris observed behind containment boom.

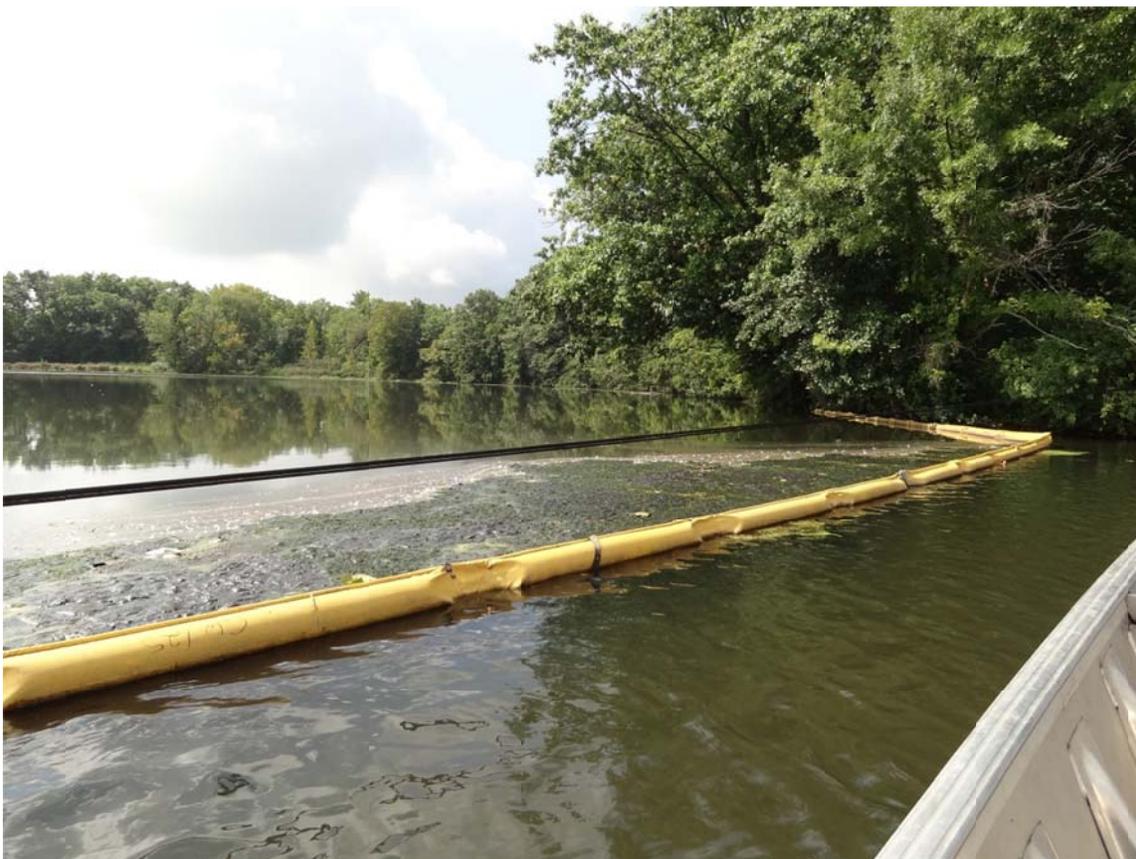
19. Debris observed behind containment boom in Morrow Lake Delta south cove.

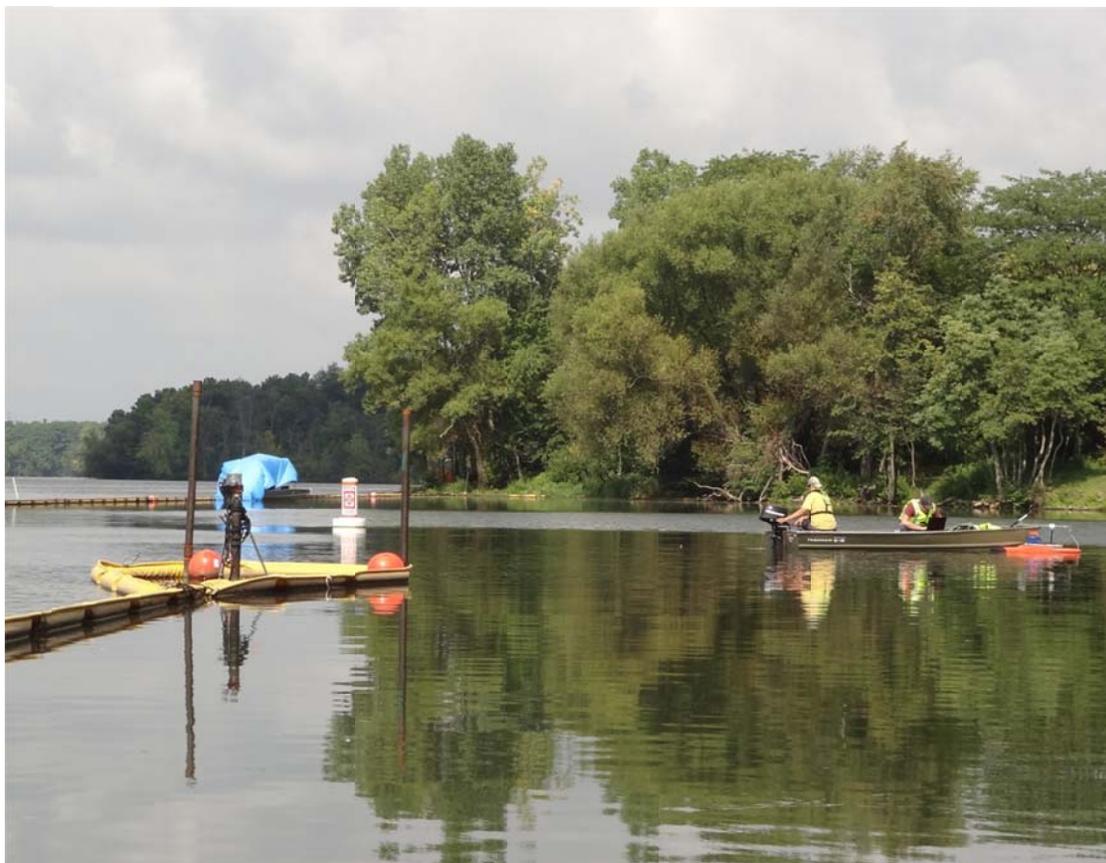
20. USGS Crew conducting river velocity study near E4.0 control point.

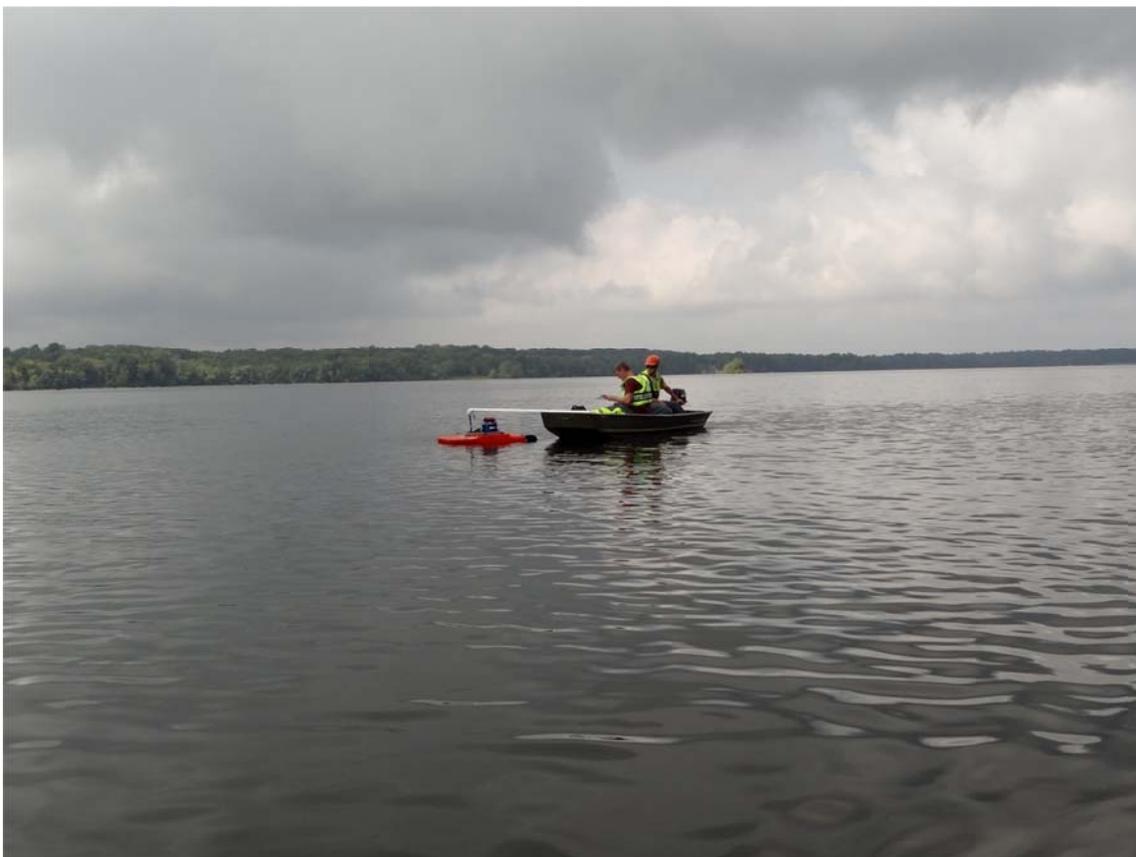
21. USGS velocity survey crew operating just downstream from E4.0 control point.

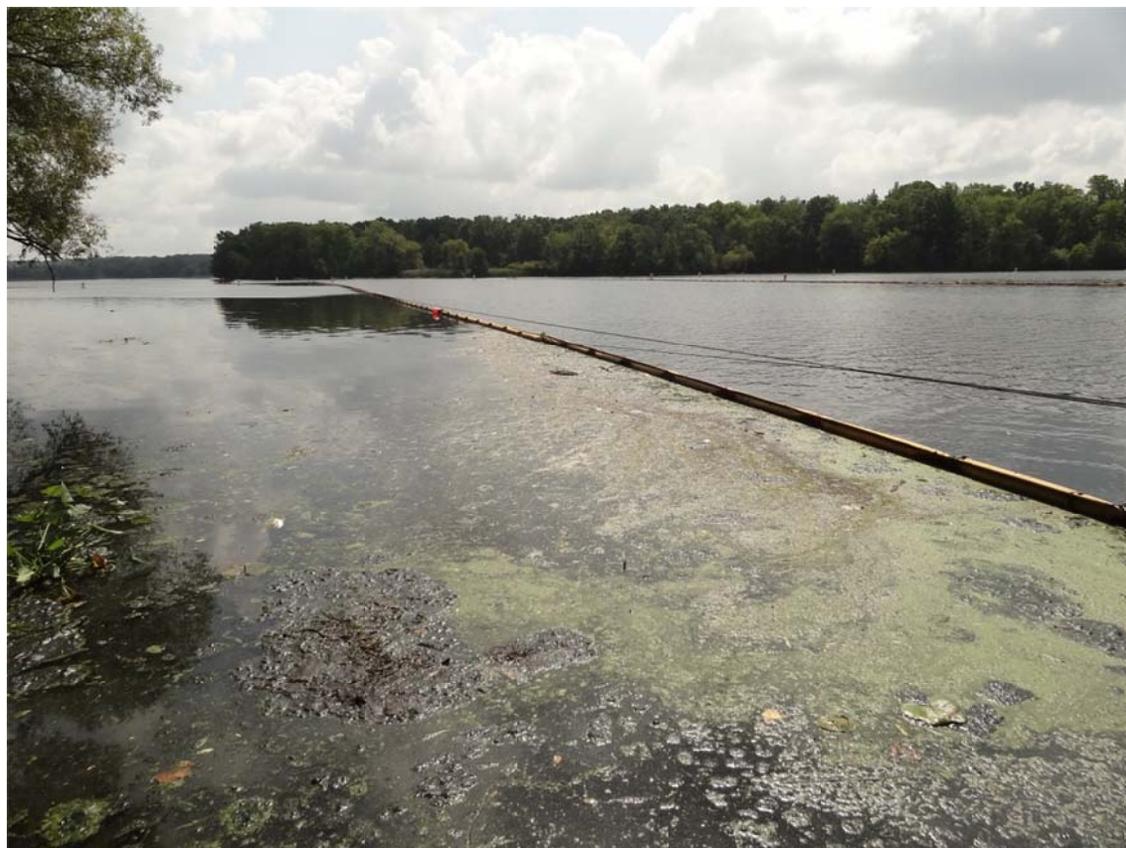
22. E4.0 control point, observed sheen and debris within containment.
