Situation Photo Log

Tuesday, August 28, 2012

Kalamazoo River / Enbridge Spill

Prepared by:
Larry Rader
START-USEPA
Situation Unit Leader

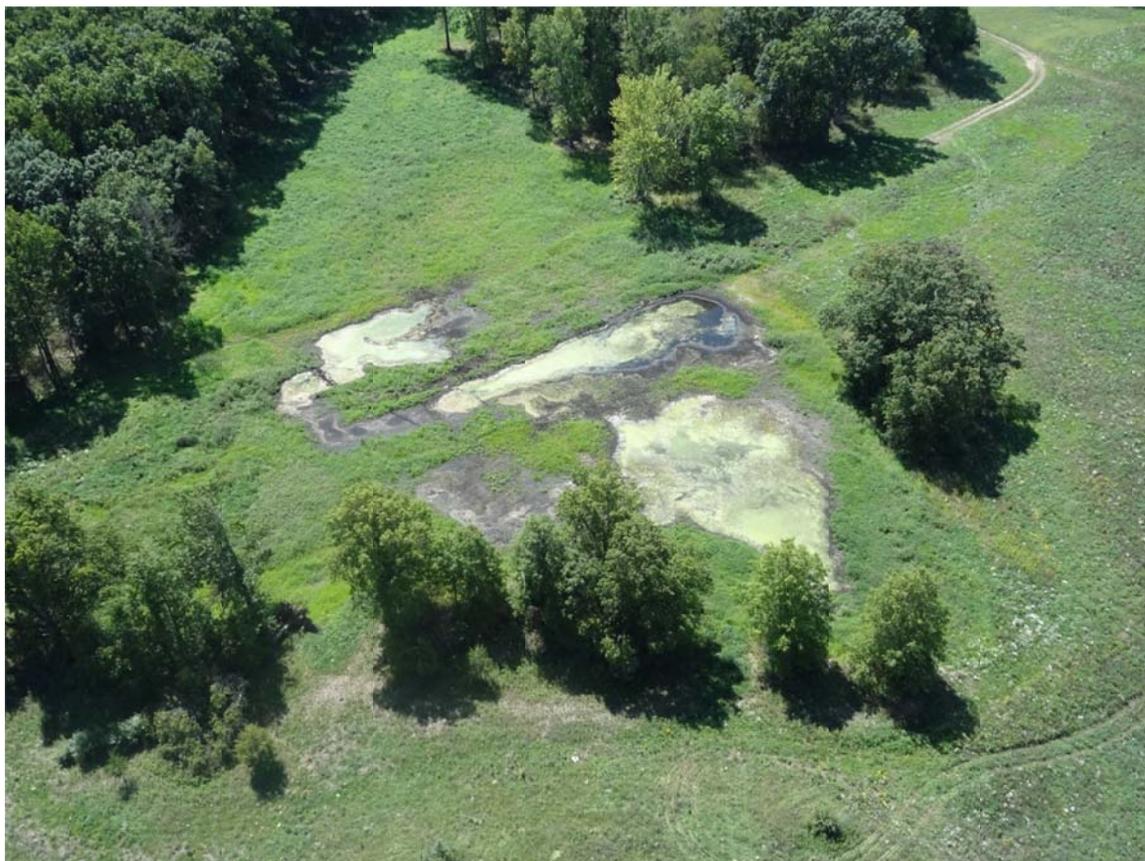
1. Source Area, no sheen observed.

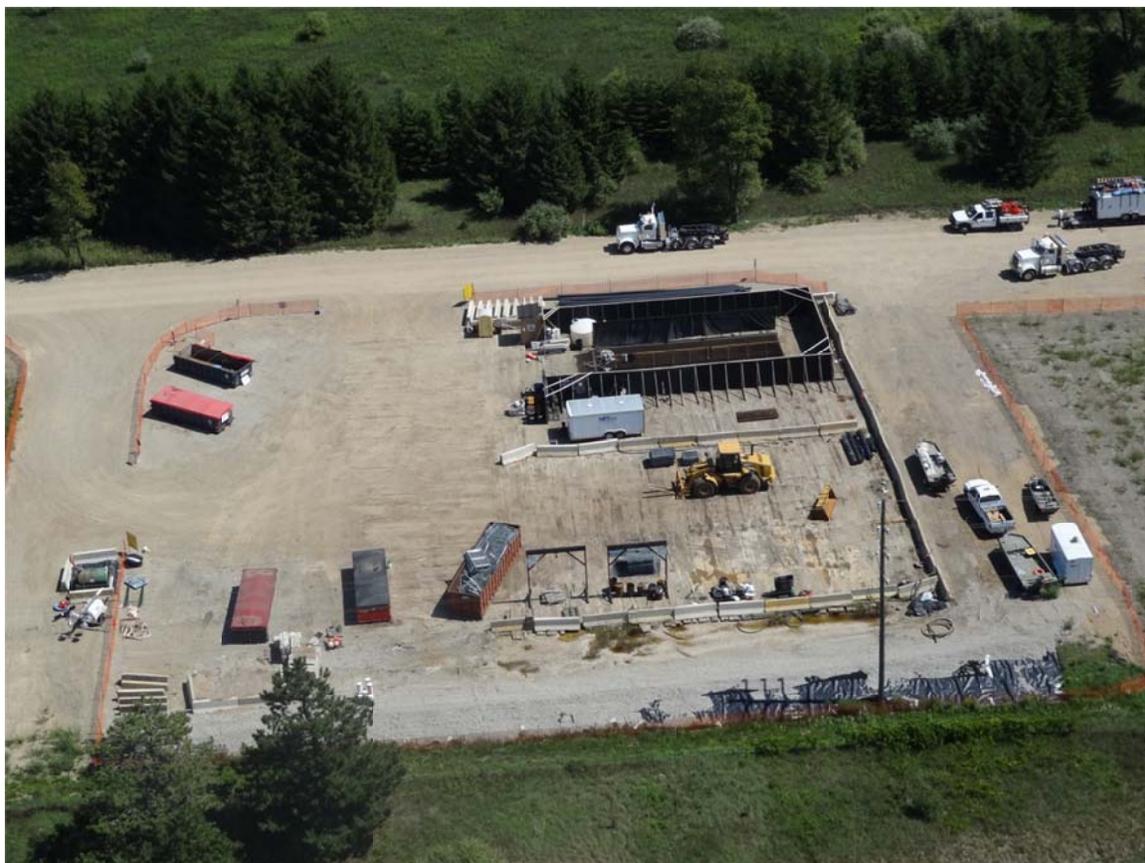
2. Frac Tank City decontamination pad, containment boom staged in decon pad.

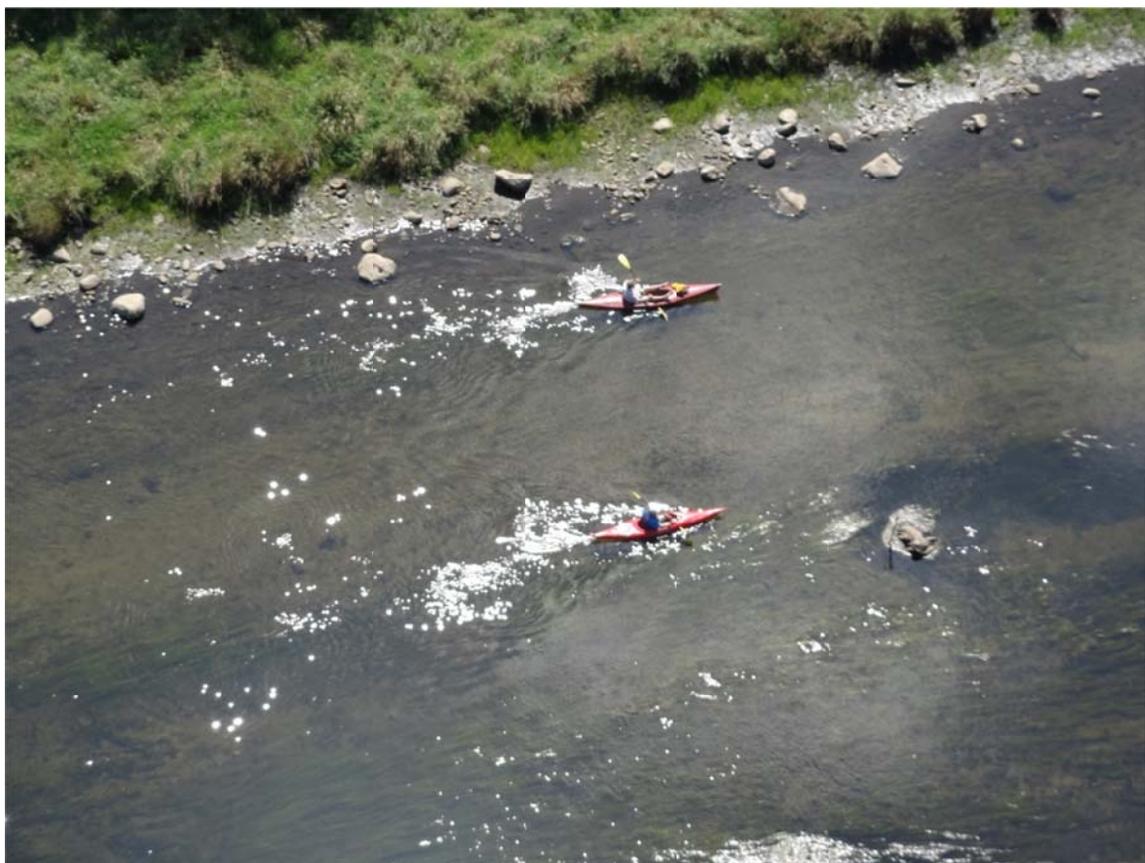
3. Kayakers observed just downstream from Island A.

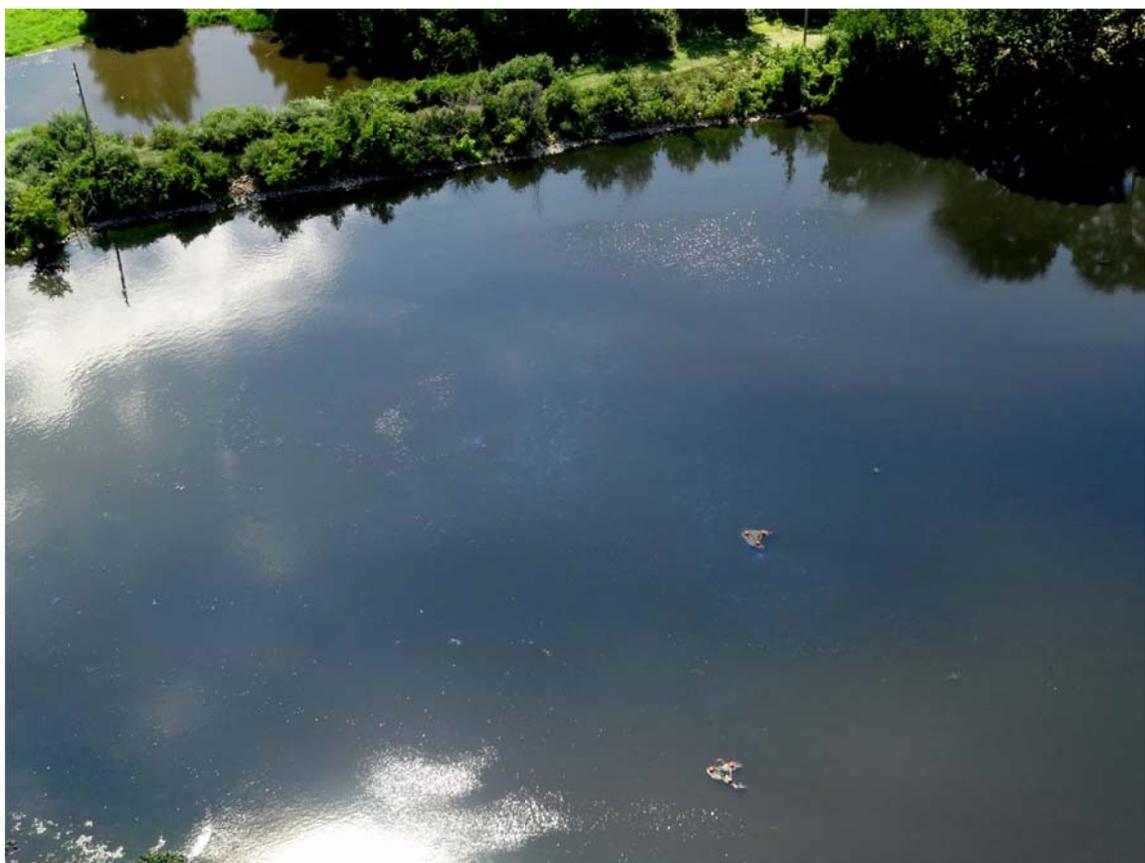
4. MP5.75 LDB, sheen observed downstream from treble.

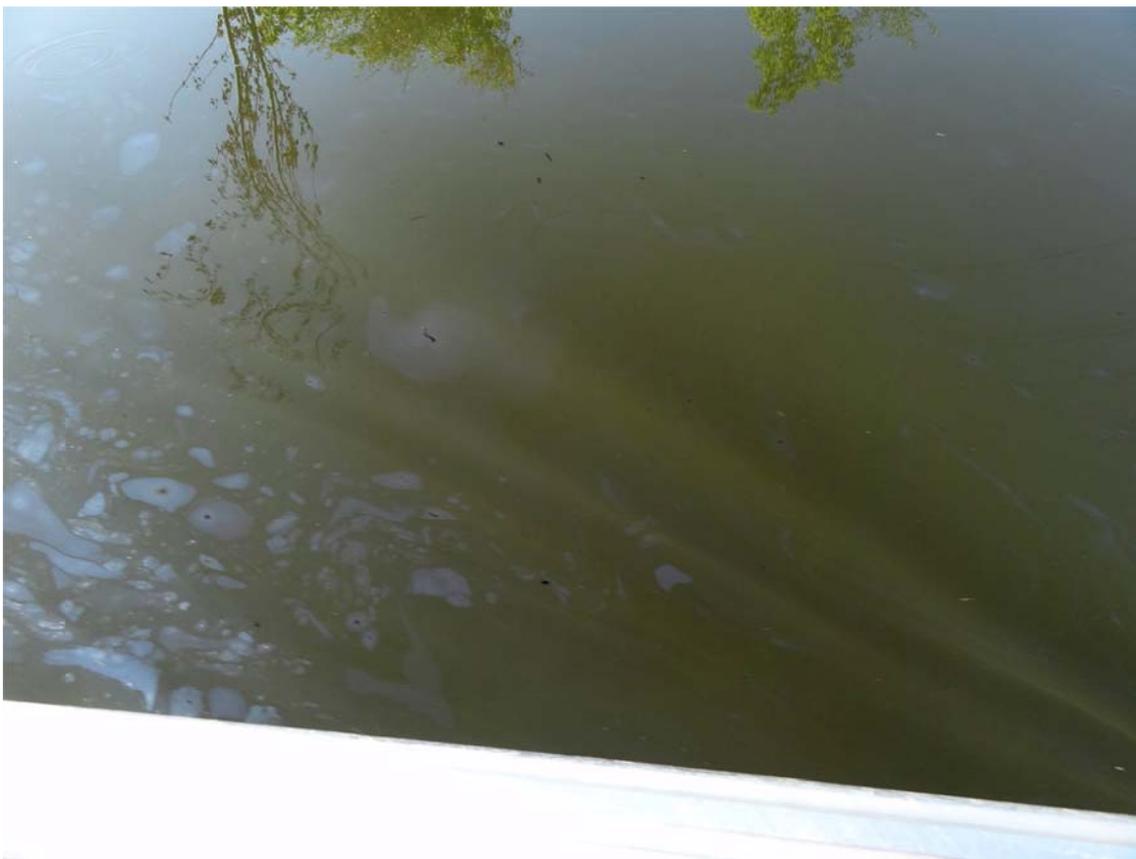
5. MP5.75, LDB sheen and tar globs observed downstream from trestle.

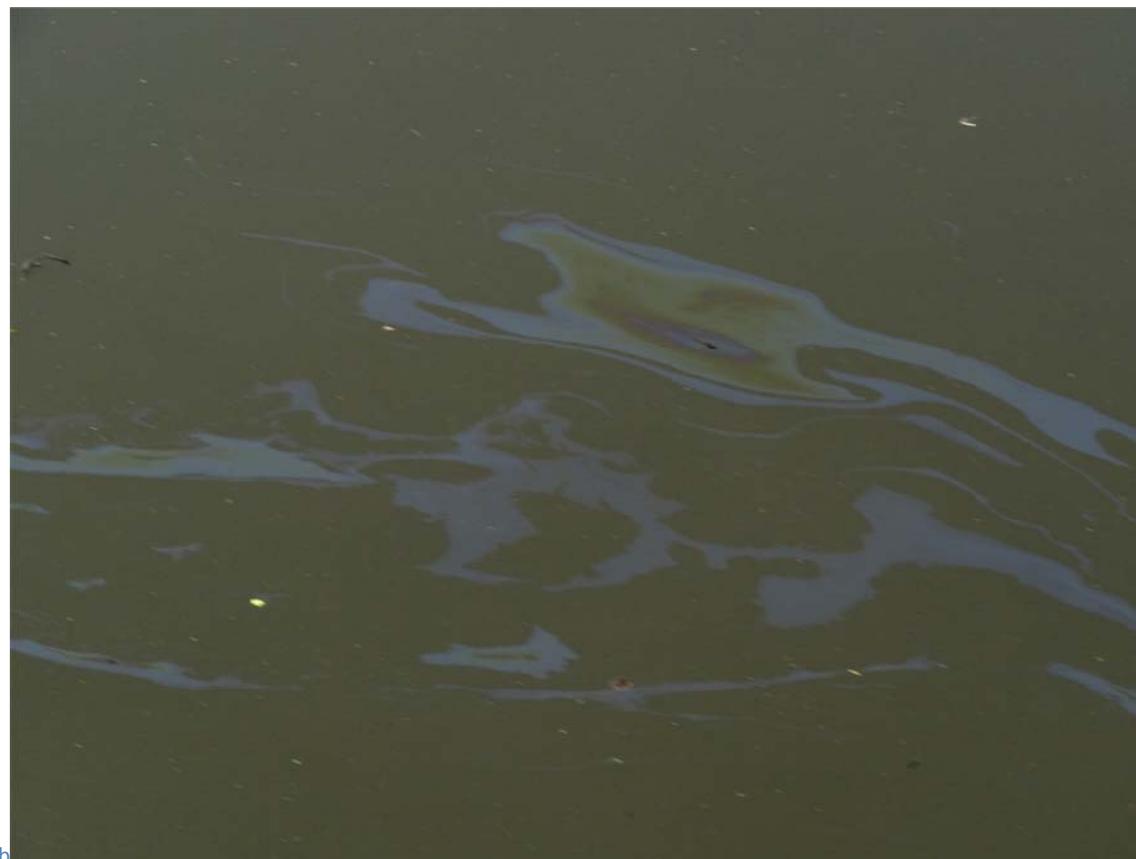
6. MP5.8, rainbow sheen and tar globs observed along Ceresco Dam containment boom.

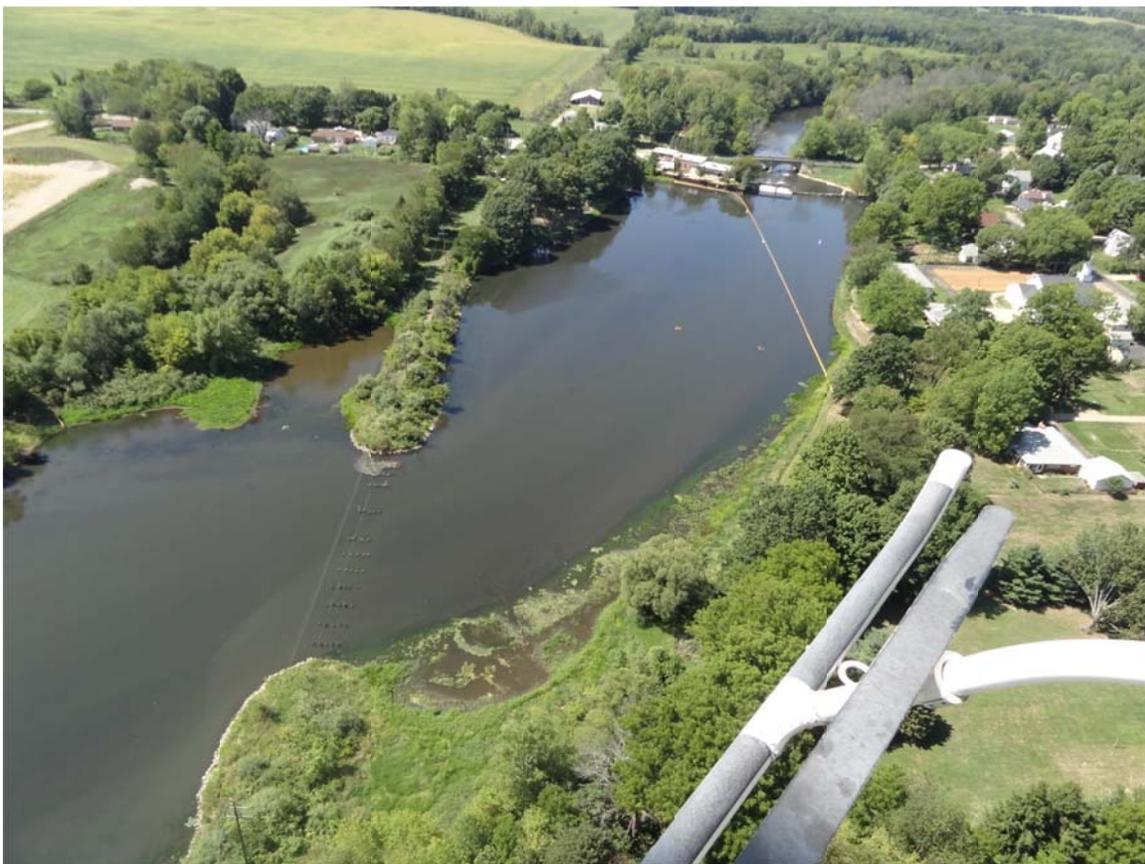
7. Overview of Ceresco Dam, looking west.

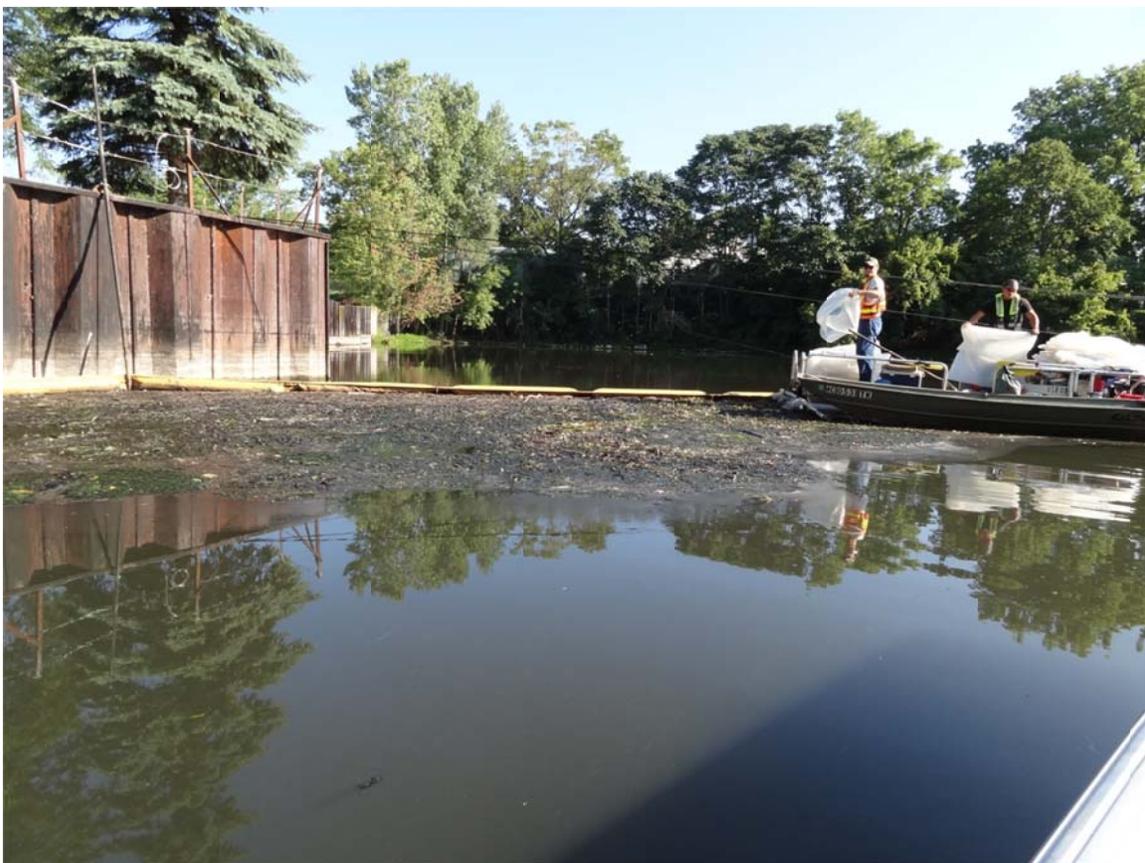
8. Ceresco Dam, observed crew removing debris from the control point.

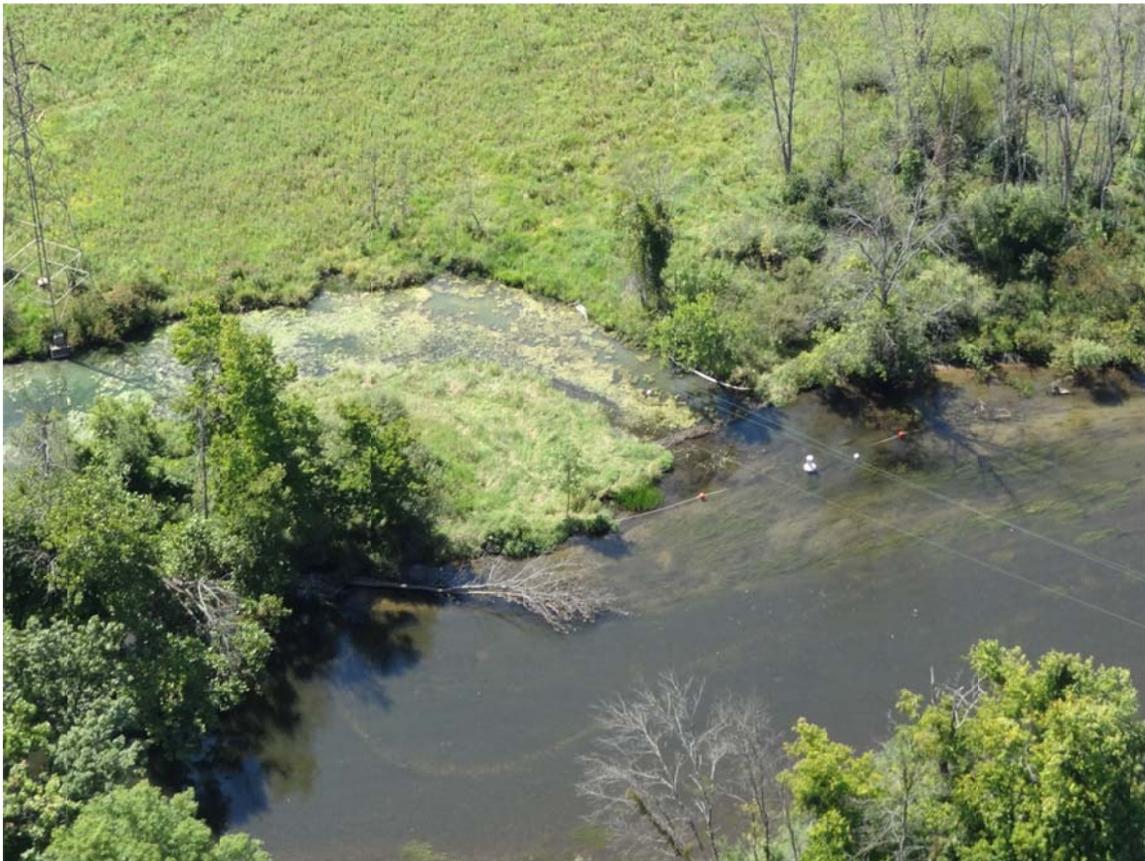
9. MP10.75 no sheen observed.

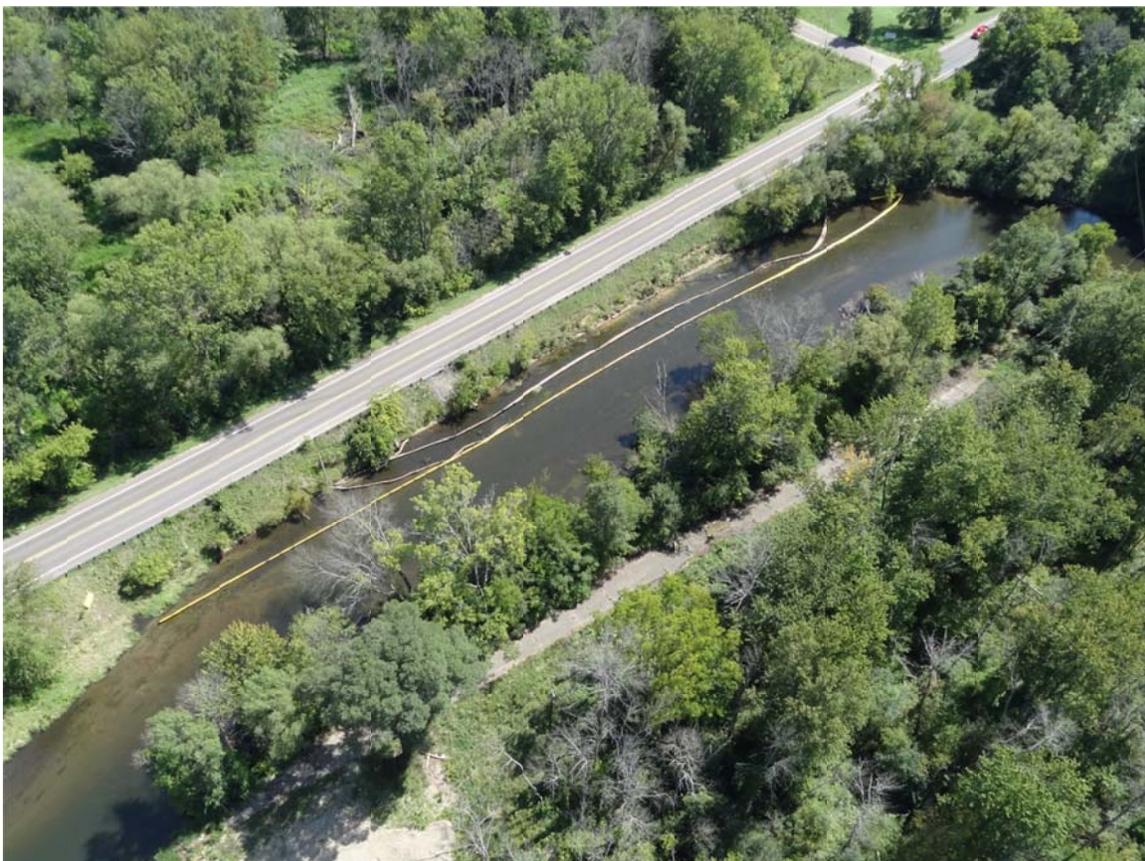
10. Containment boom and sediment curtain installed along west side of Raymond Road for planned shoreline restoration work.

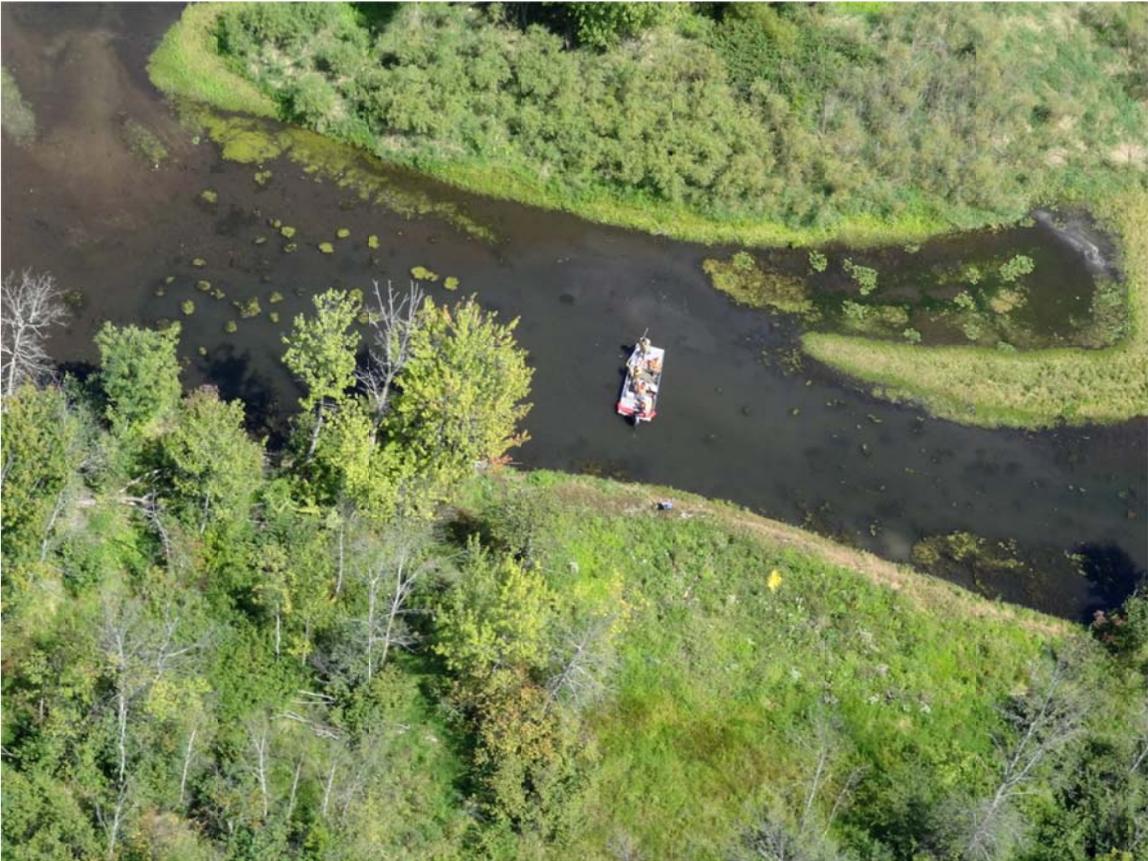
11. MP15.0 LDB, observed poling crew operating in south end of Mill Ponds.

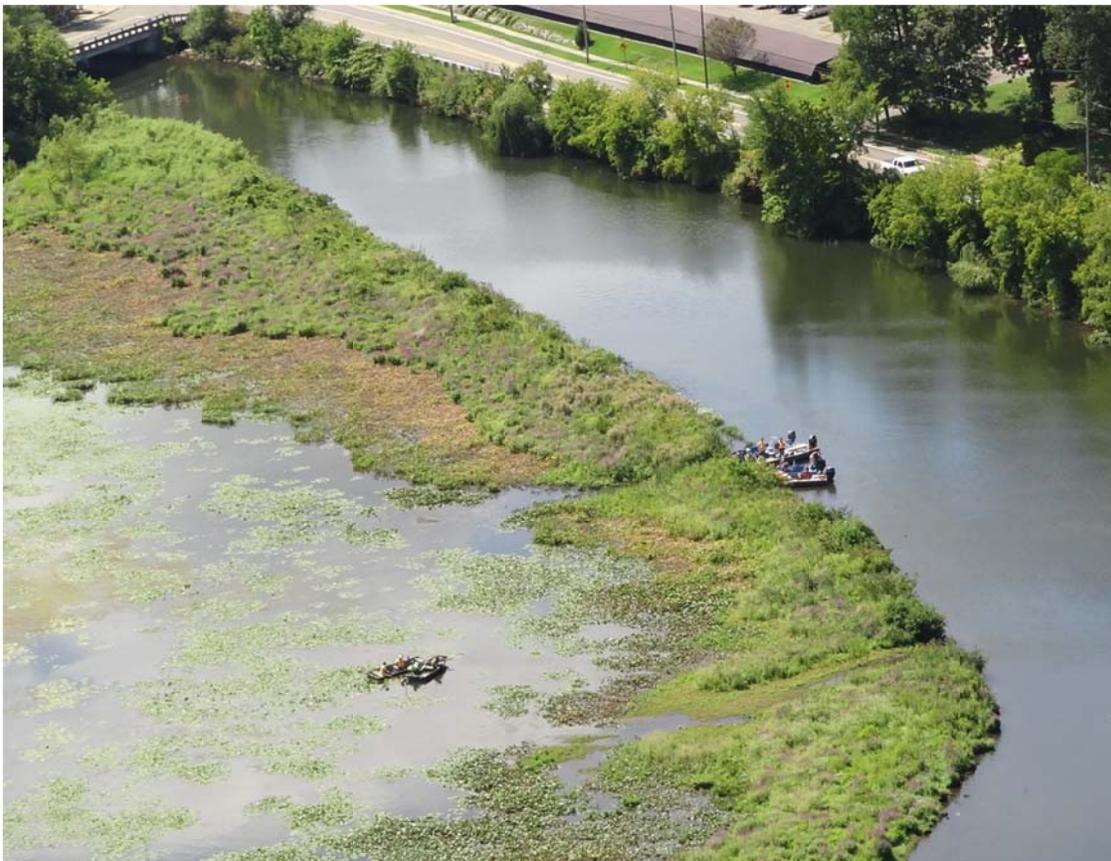
12. MP15.75 north Mill Pond, poling crew and support boats observed.

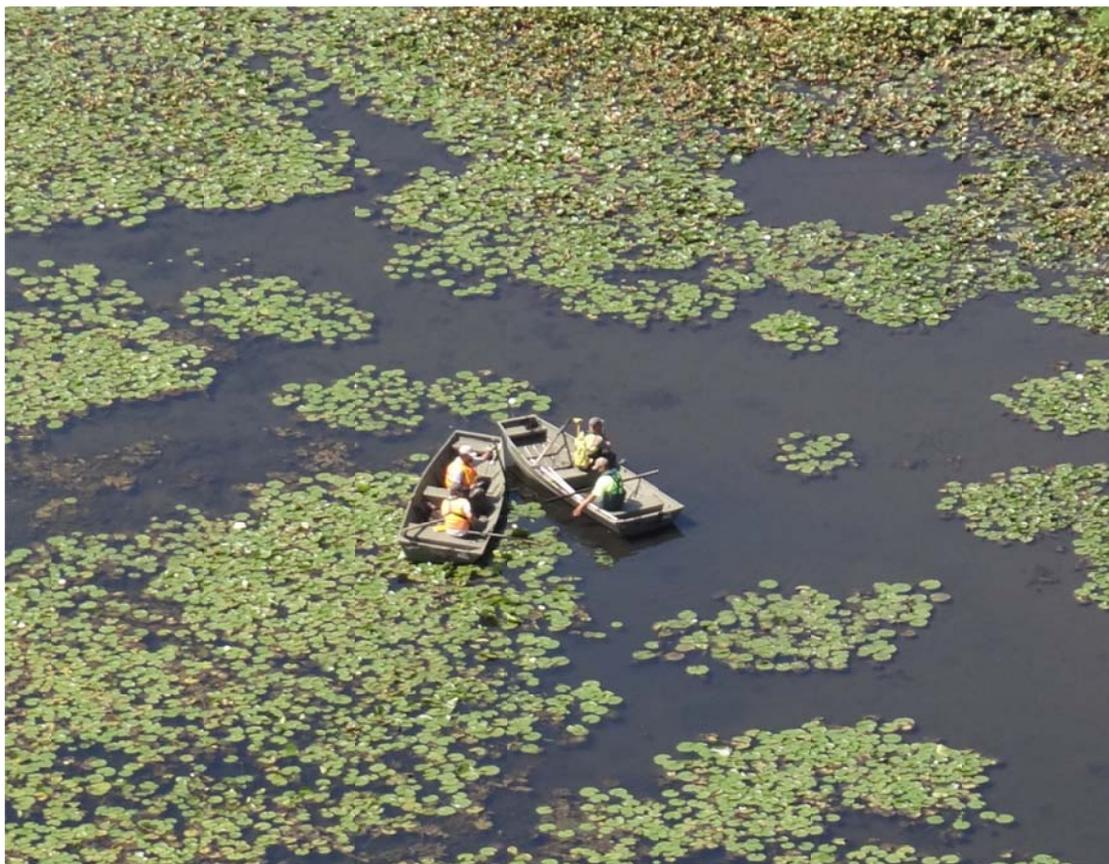
13. Poling crew operating from row boats in north Mill Pond.

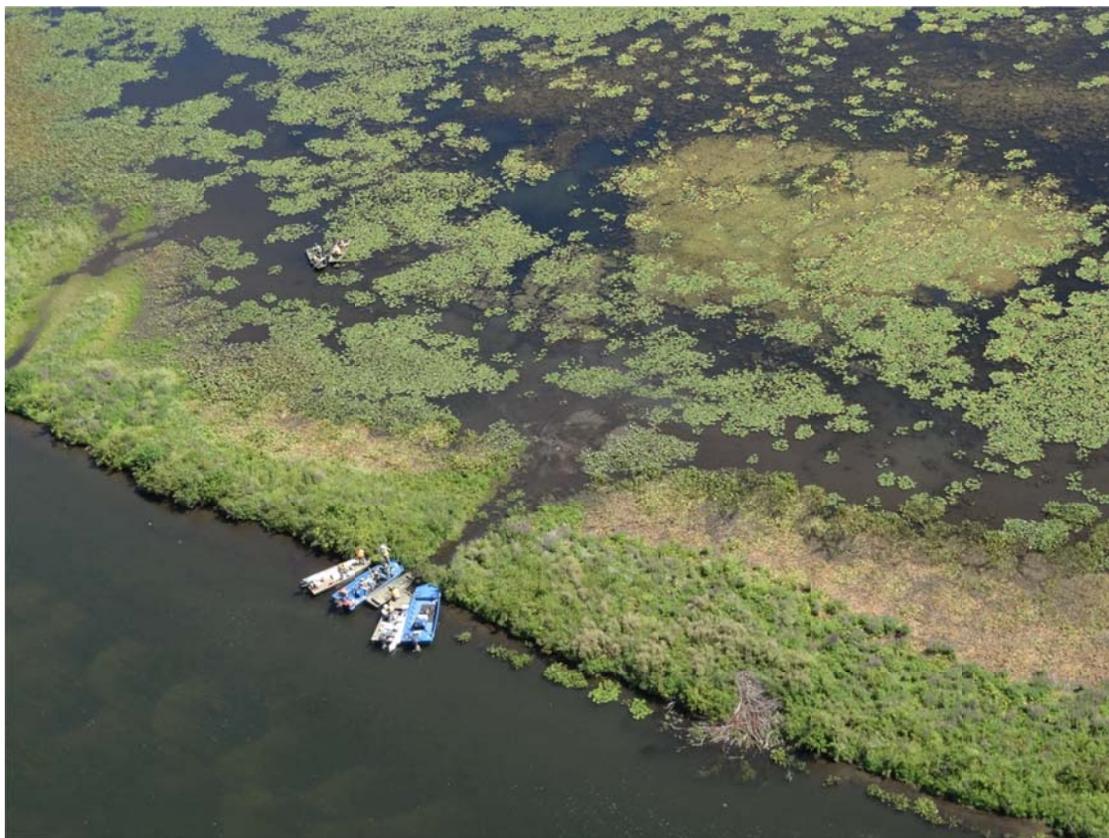
14. Support boats and row boat poling crew in north Mill Pond.

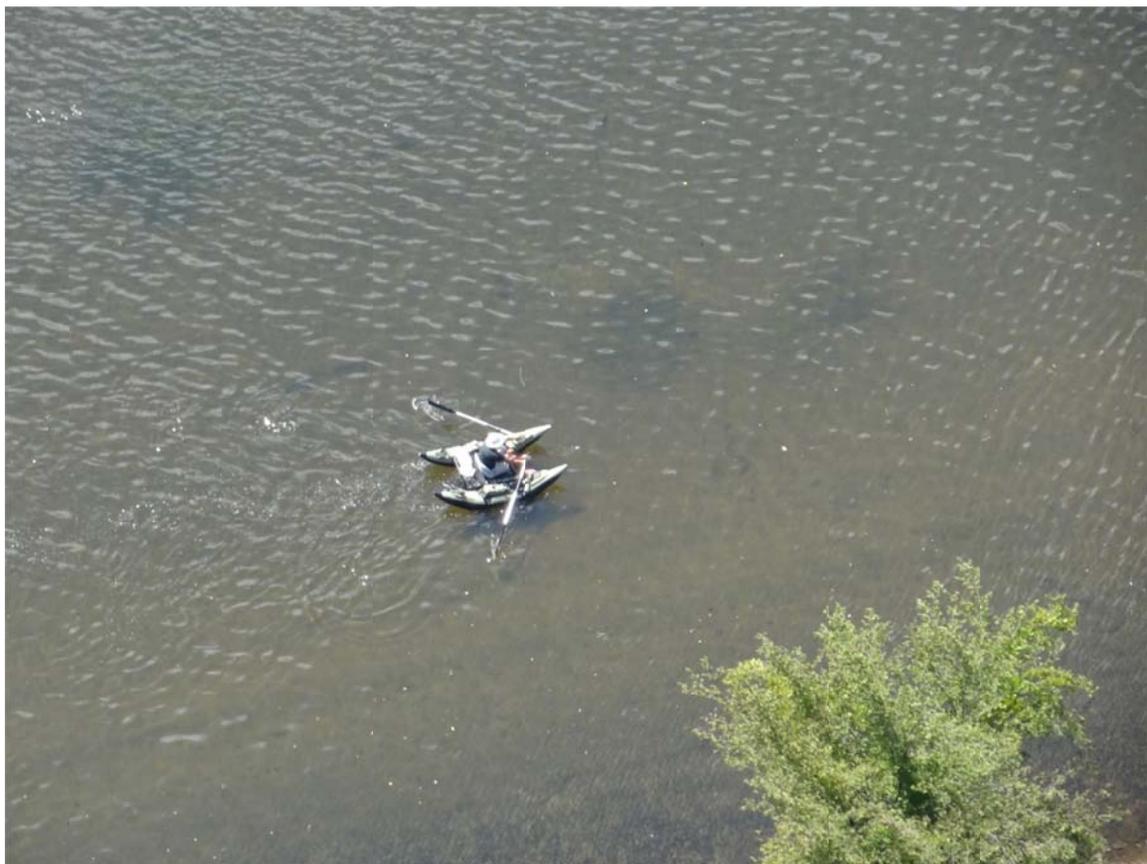
15. Kayaker observed near MP 19.0 in Battle Creek.

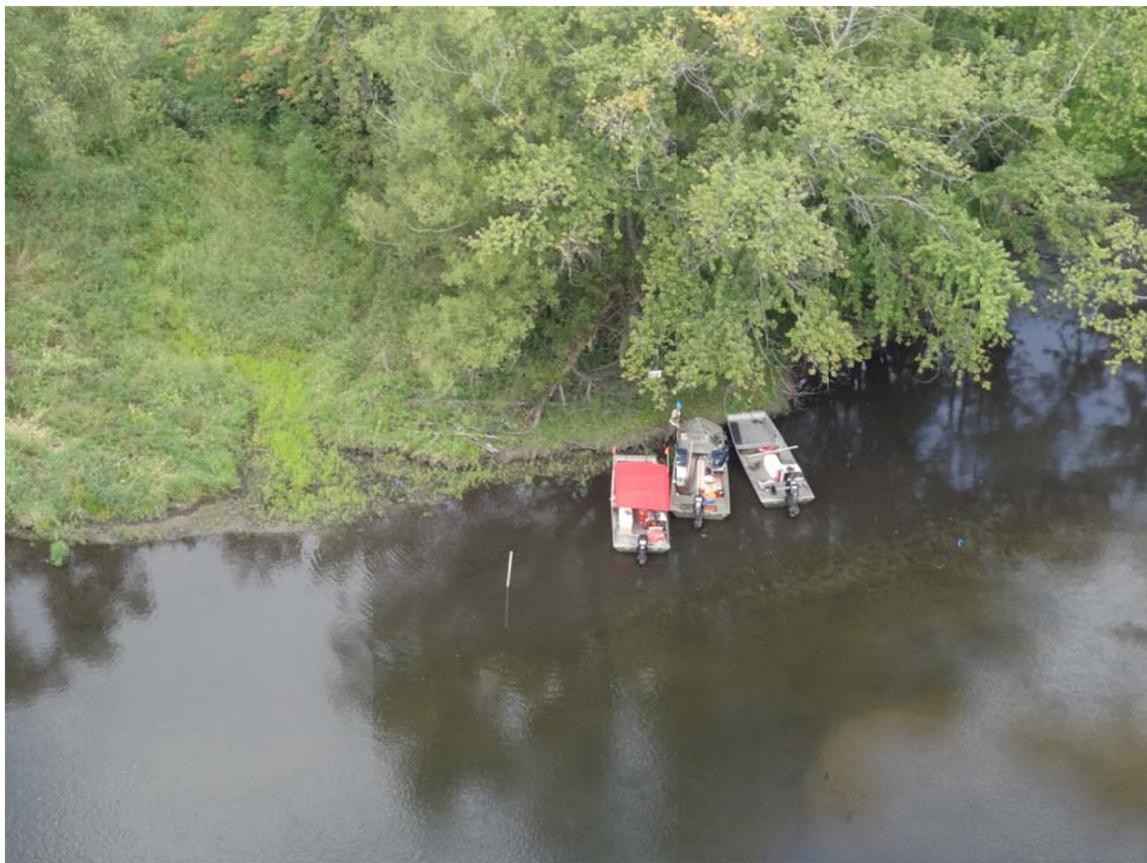
16. MP33.0 A, observed sediment trap survey crew.

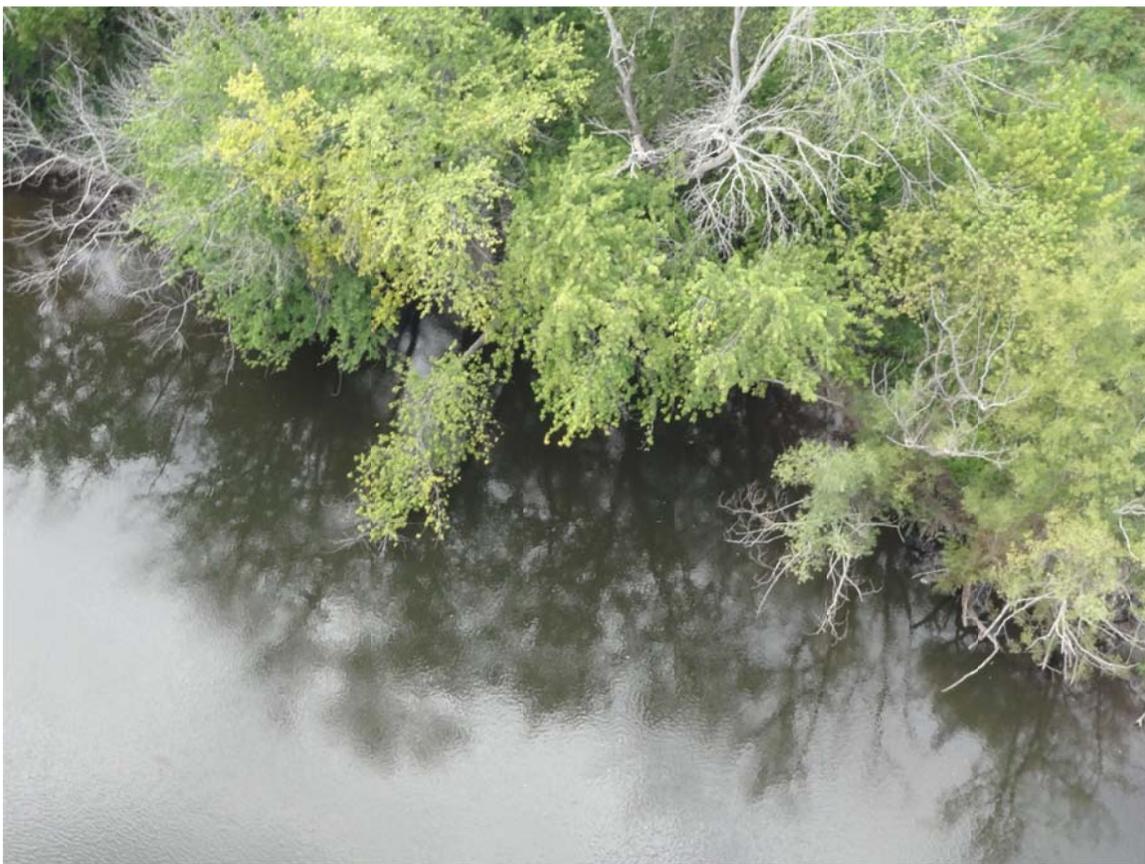
17. MP33.1 LDB, no sheen was observed from the air at this location.

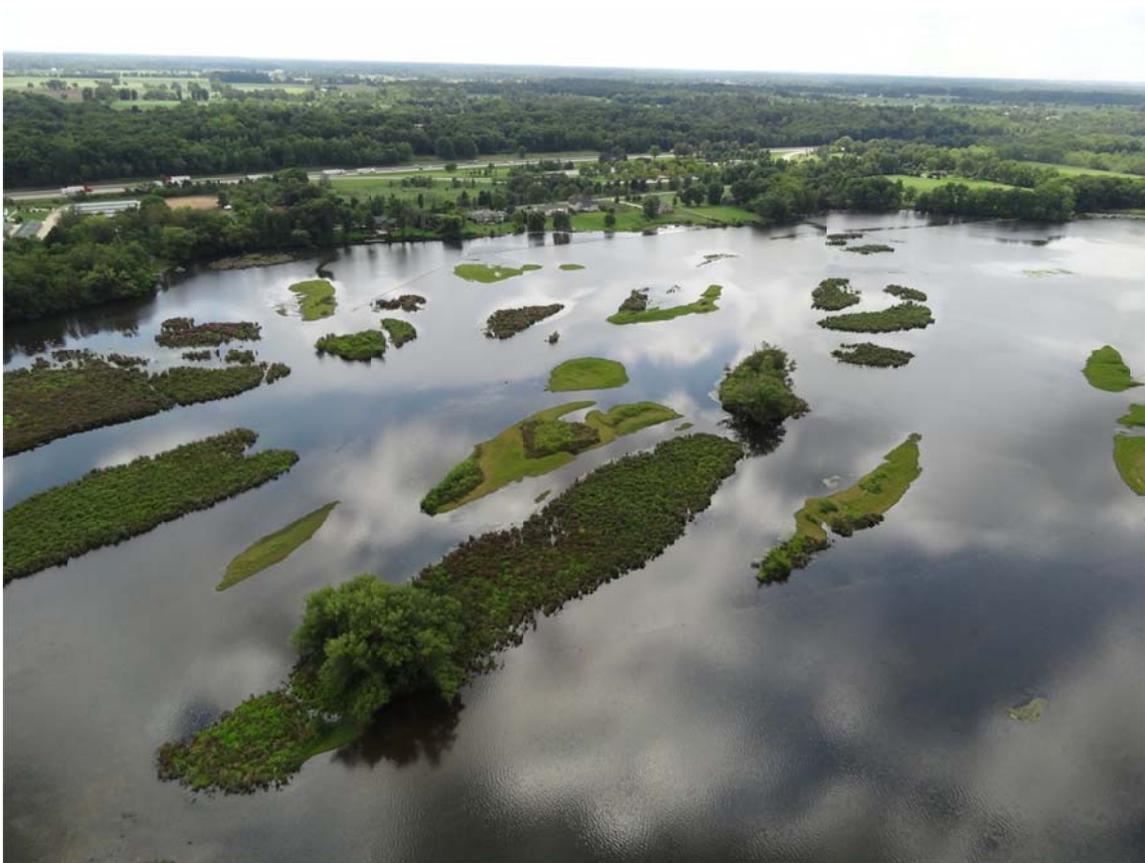
18. Morrow Lake Delta, no sheen observed.

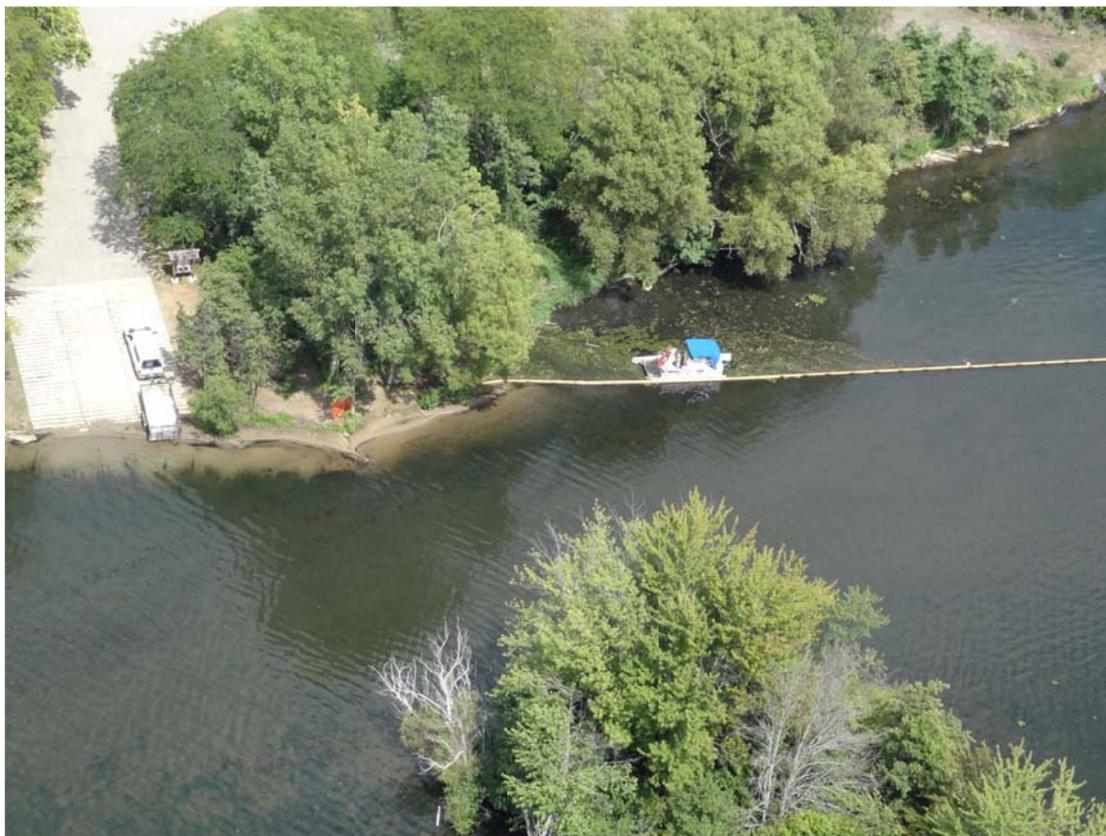
19. Morrow Lake Delta, observed a crew removing debris from E4.0 boom.

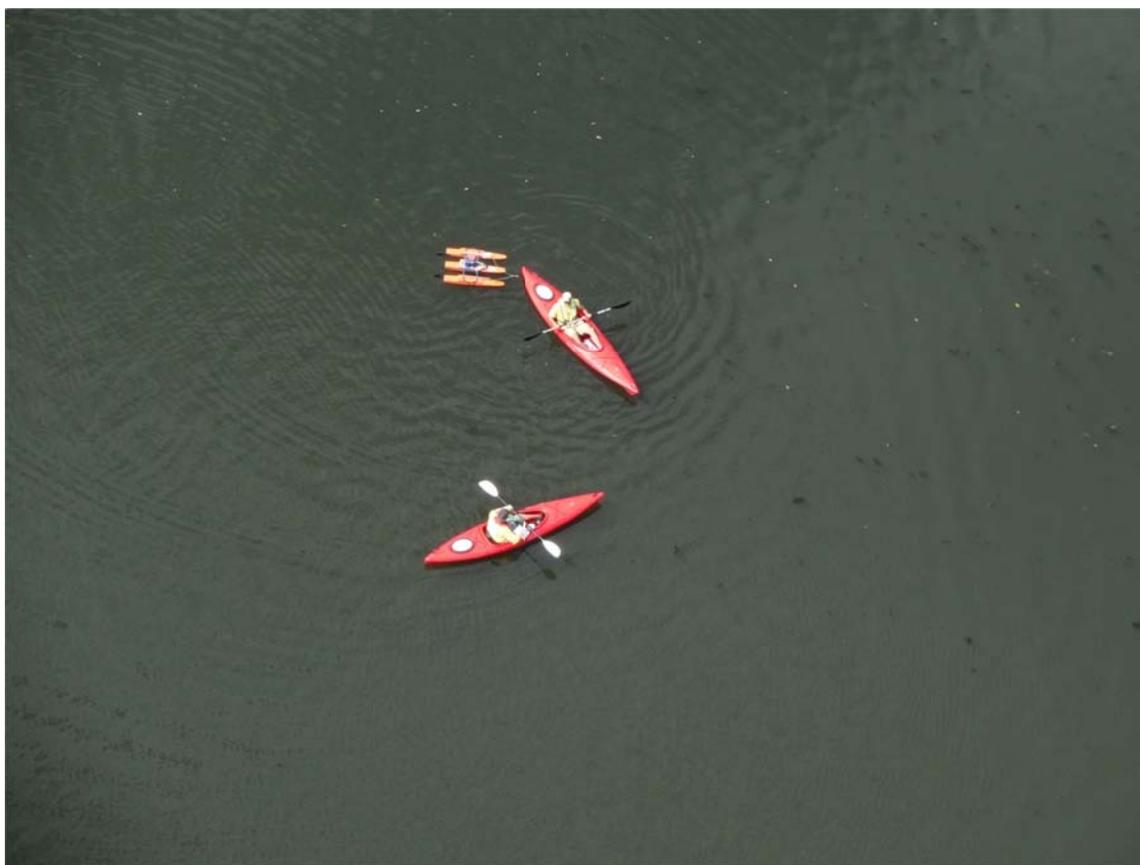
20. USGS crews continued water velocity survey work near Control Point E4.0 in Morrow Lake Delta.

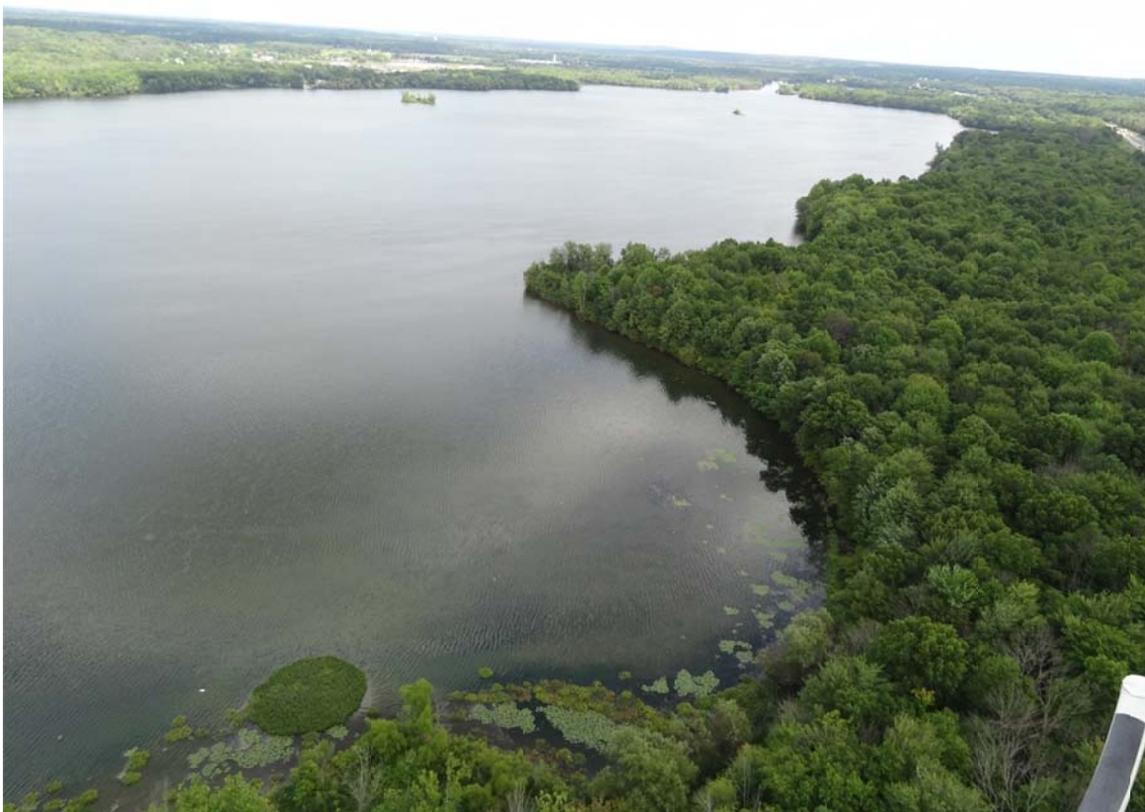
21. Overview of Morrow Lake, looking east from west end of lake.

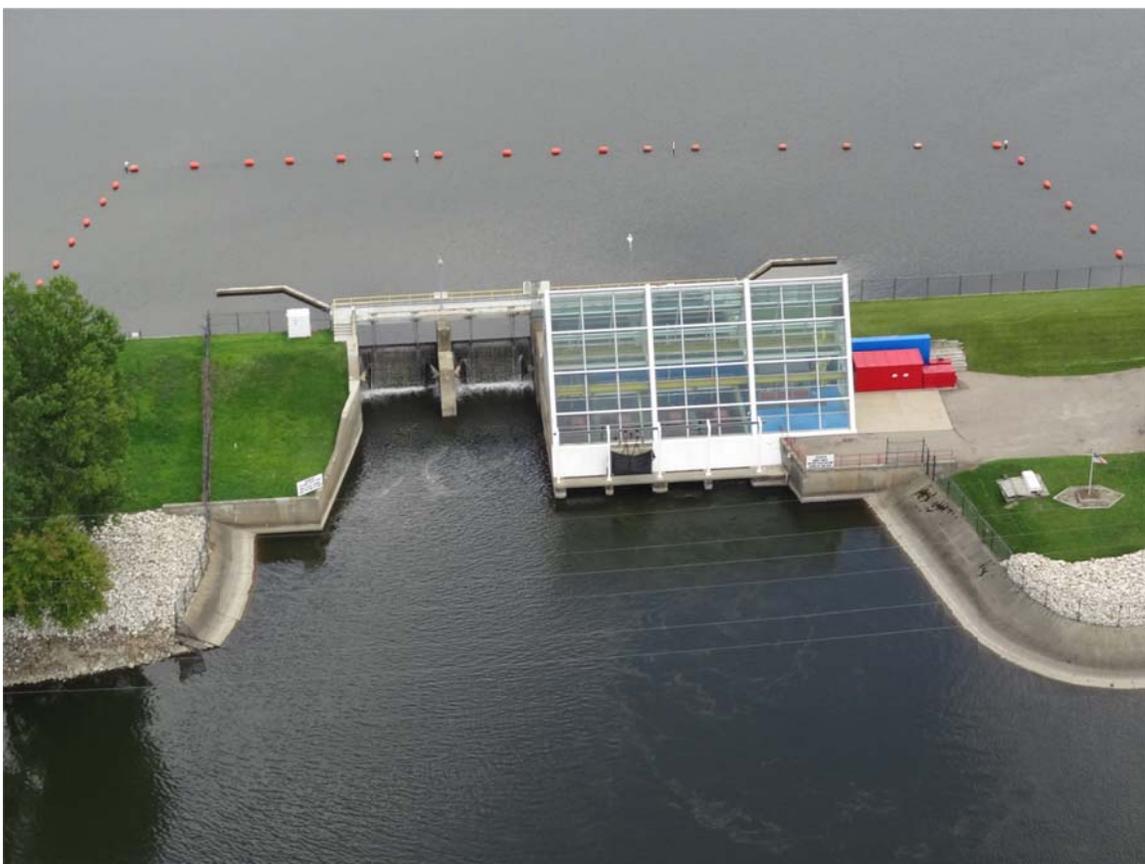
22. Close up of Morrow Lake Dam. Low flow observed over spillway of dam.
