# Situation Photo Log

Thursday, August 30, 2012

Kalamazoo River / Enbridge Spill

Prepared by:  
Larry Rader  
START-USEPA  
Situation Unit Leader

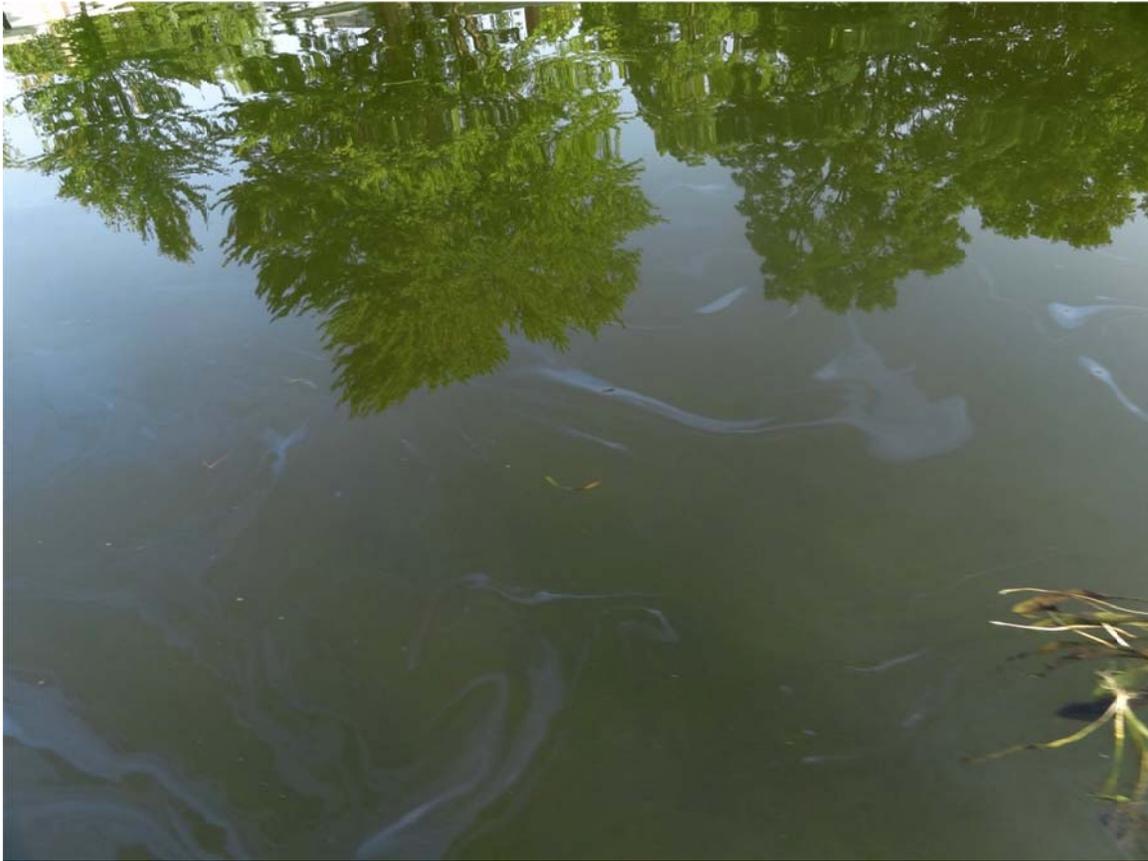
1. Sheen and tar globules observed at the trestle above Ceresco Dam.

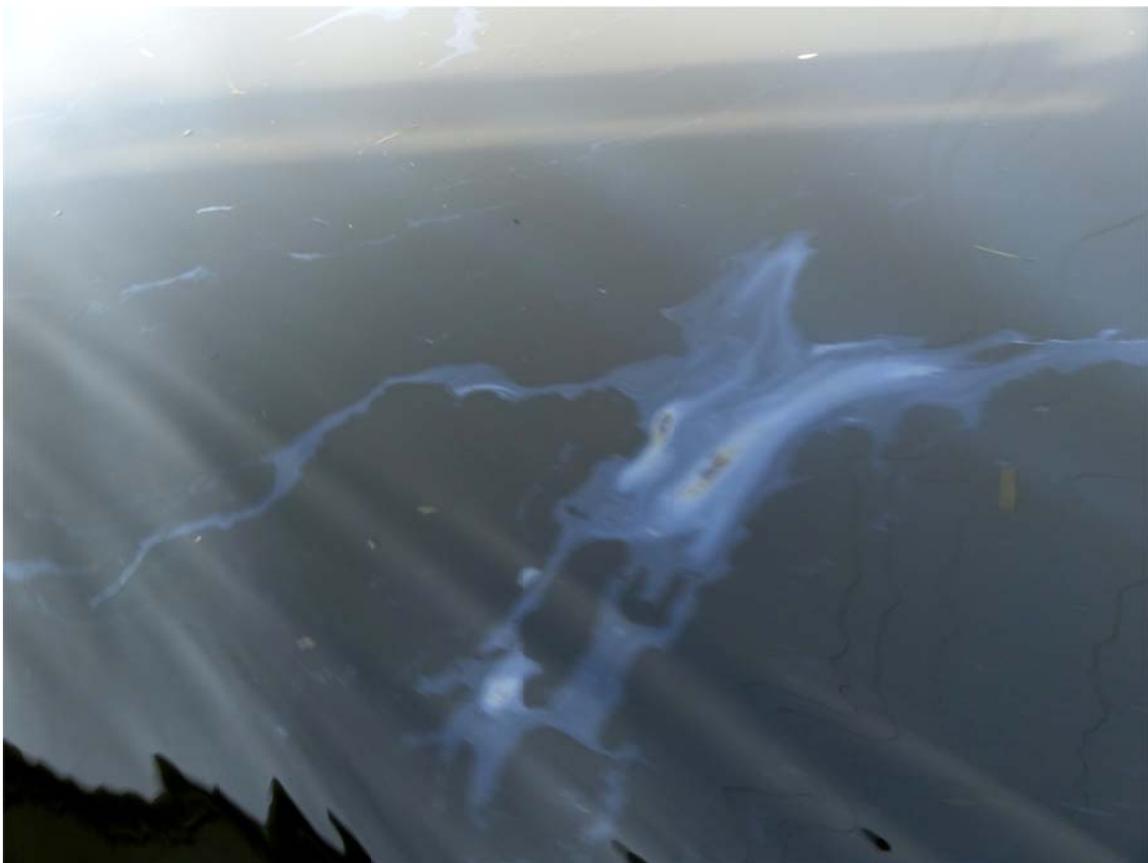
2. Sheen and tar globules observed within containment at Ceresco Dam.

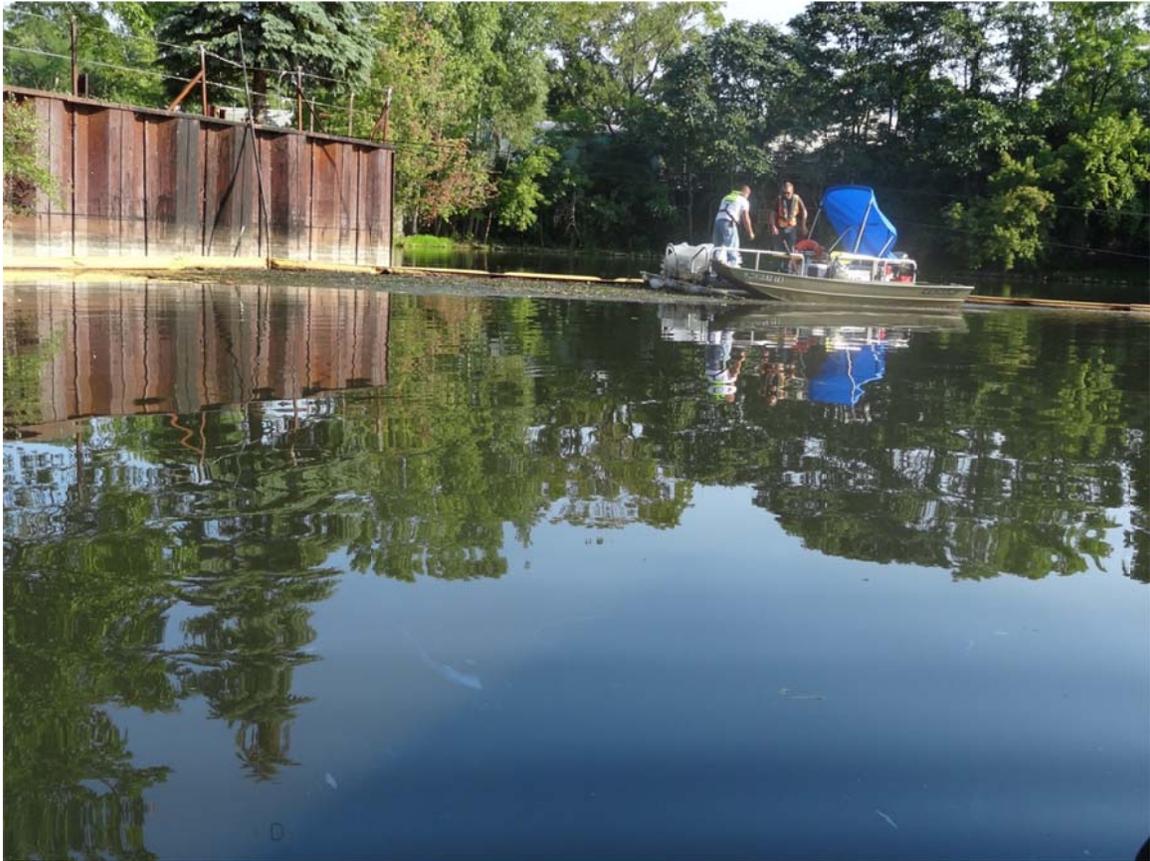
3. Crews removing debris from the control point at Ceresco Dam.

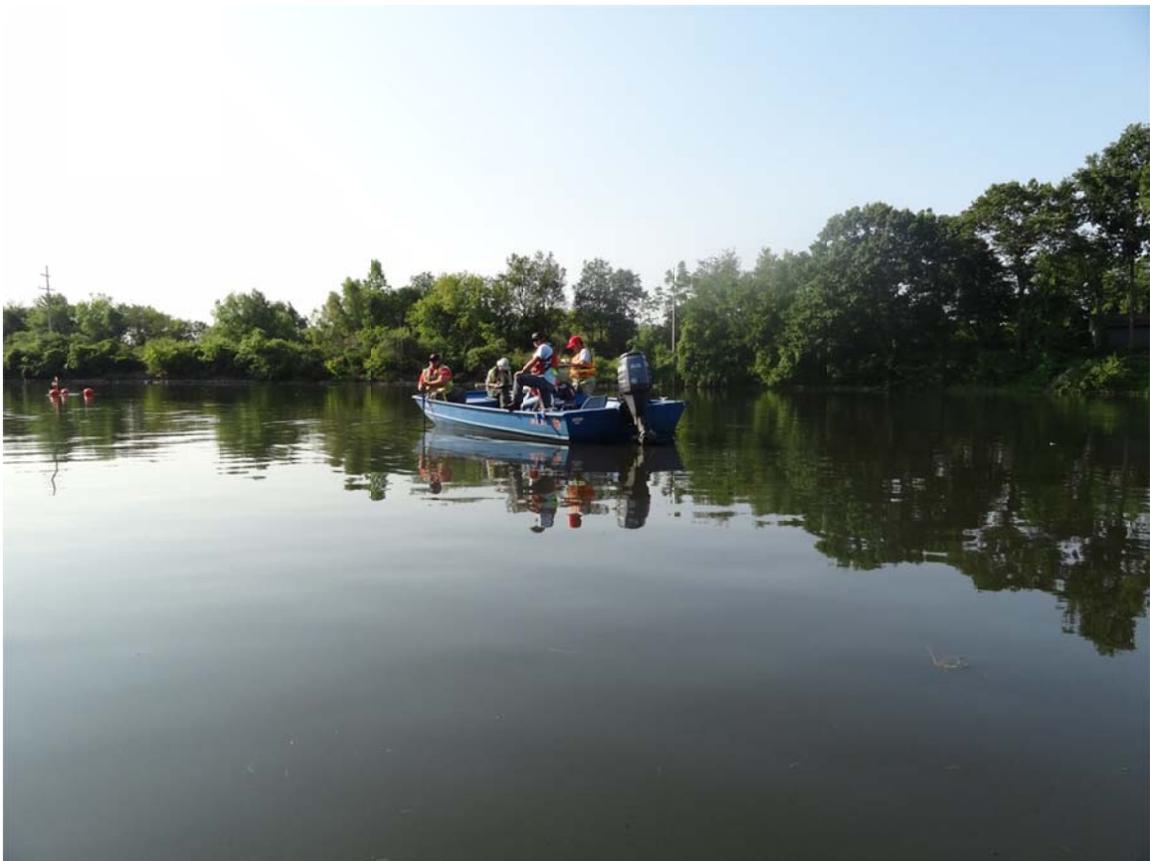
4. Sediment trap survey crew observed above Ceresco Dam.

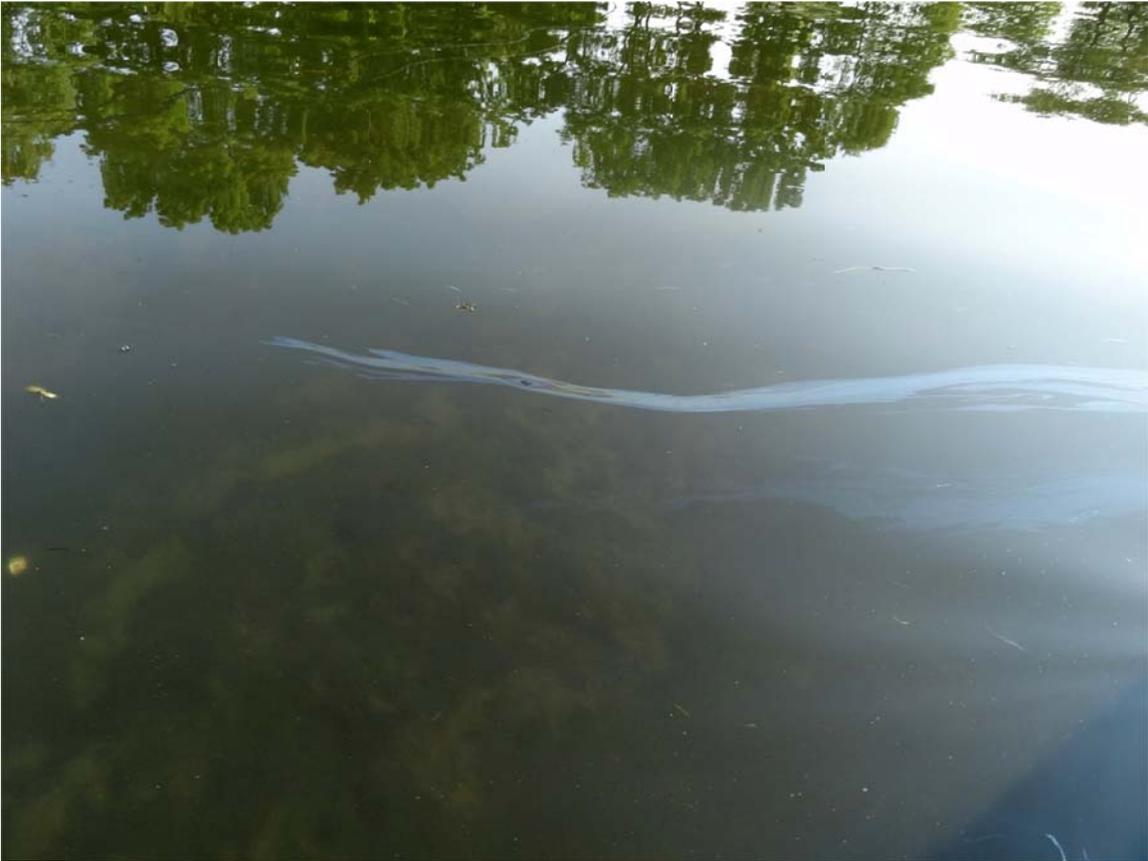
5. Sheen and tar globules observed in vicinity of sediment trap survey crew.

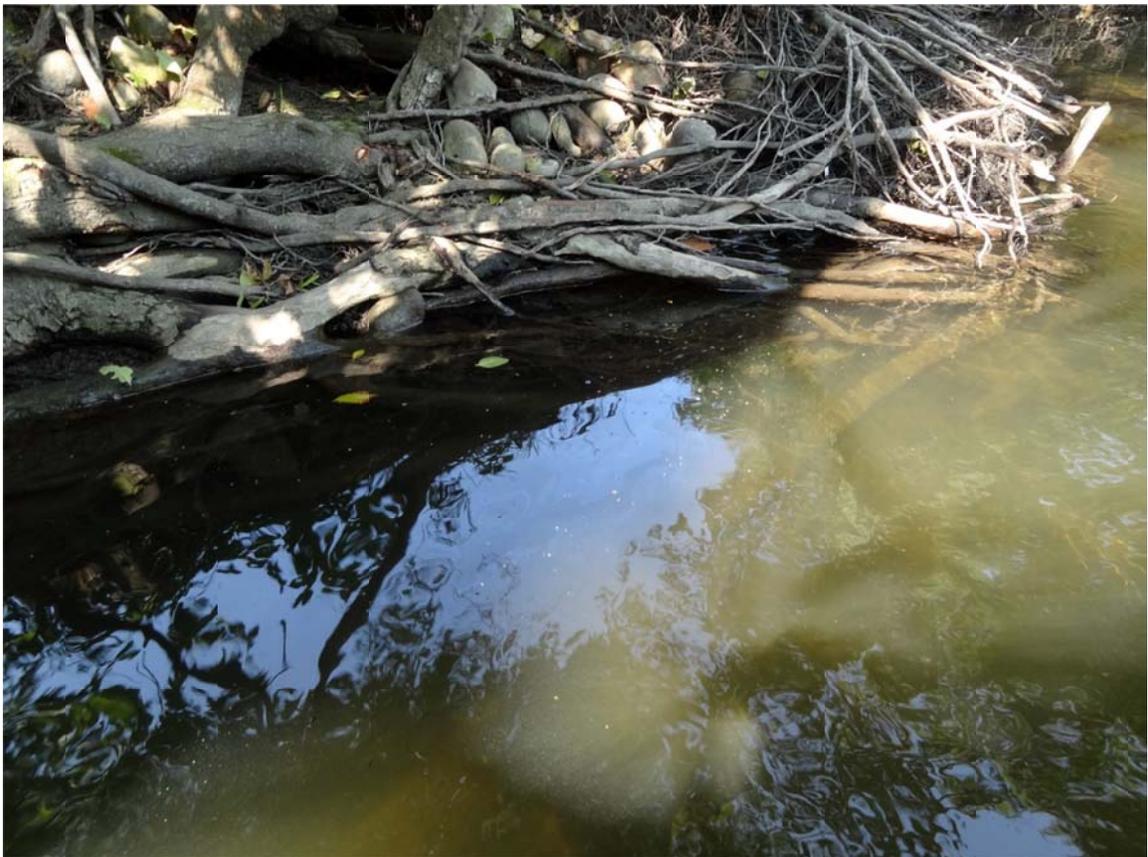
6. MP33.1 RDB, sheen and petroleum odor observed.

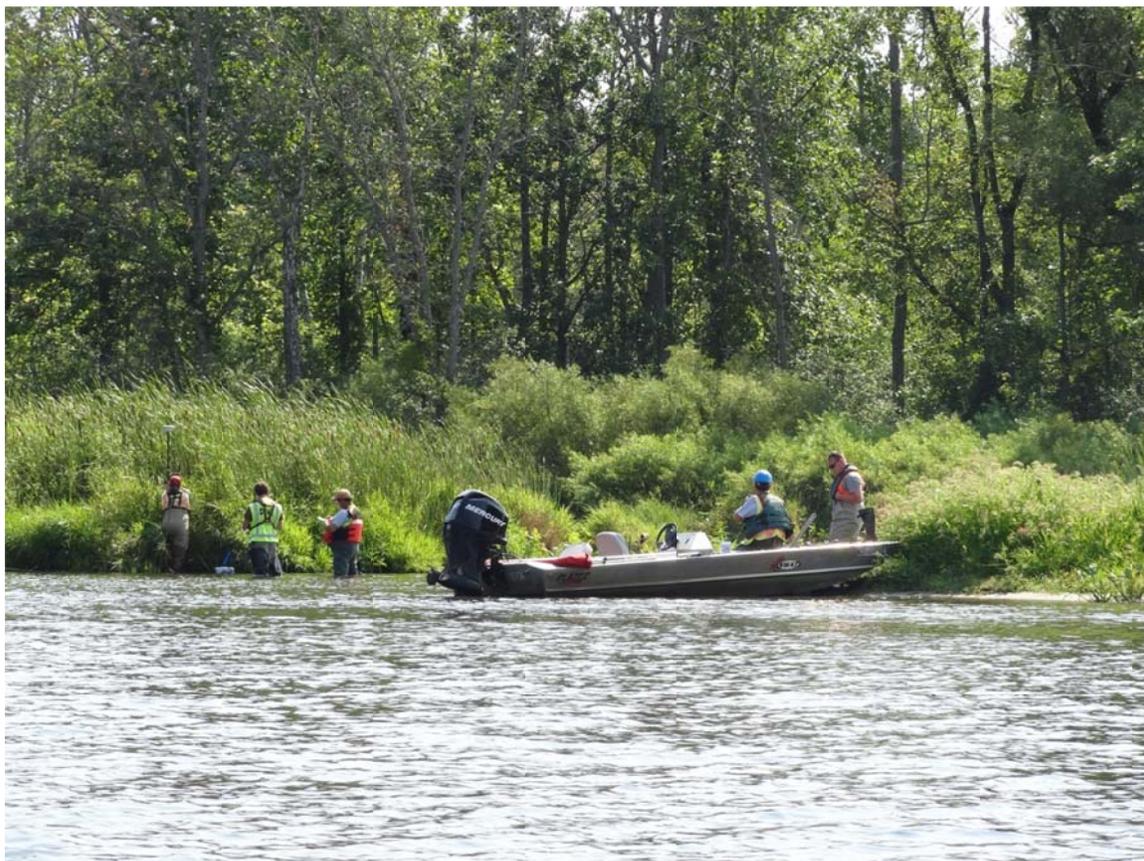
7. Sediment trap survey crew observed in Morrow Lake Delta.

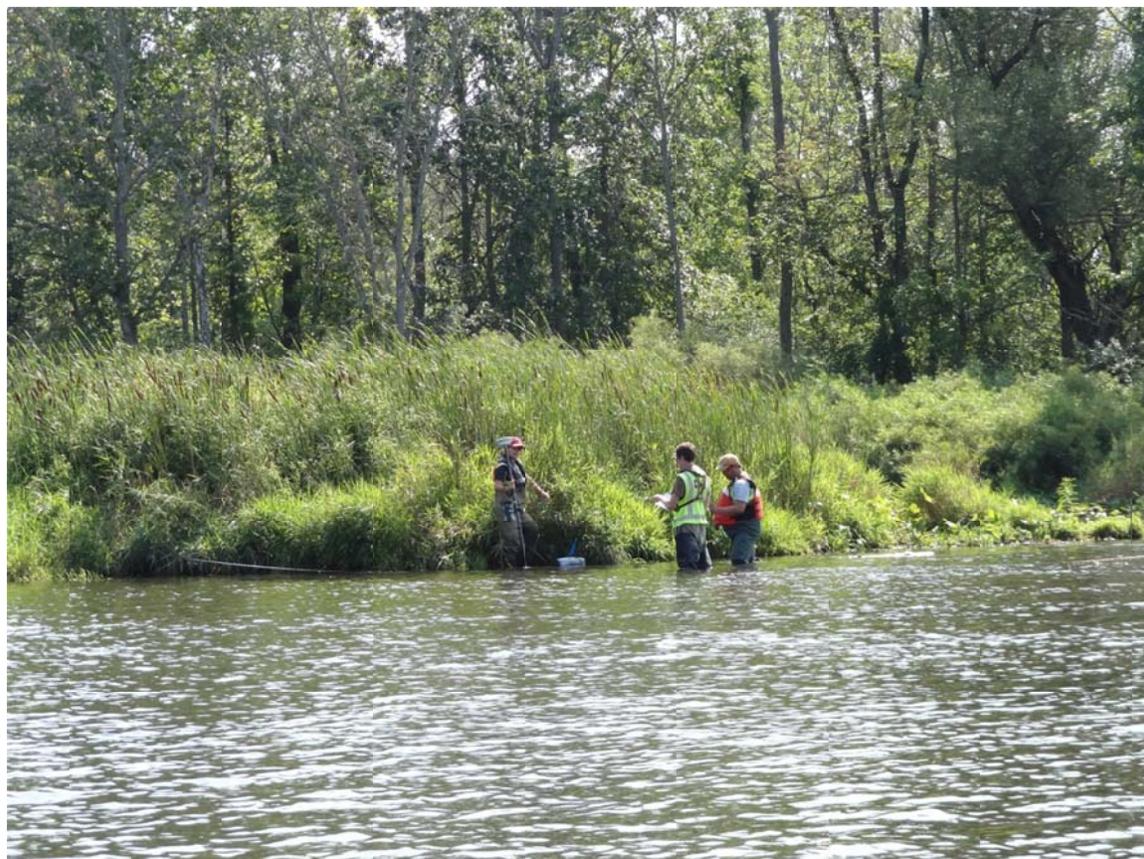
8. Sediment trap survey crew observed in Morrow Lake Delta.

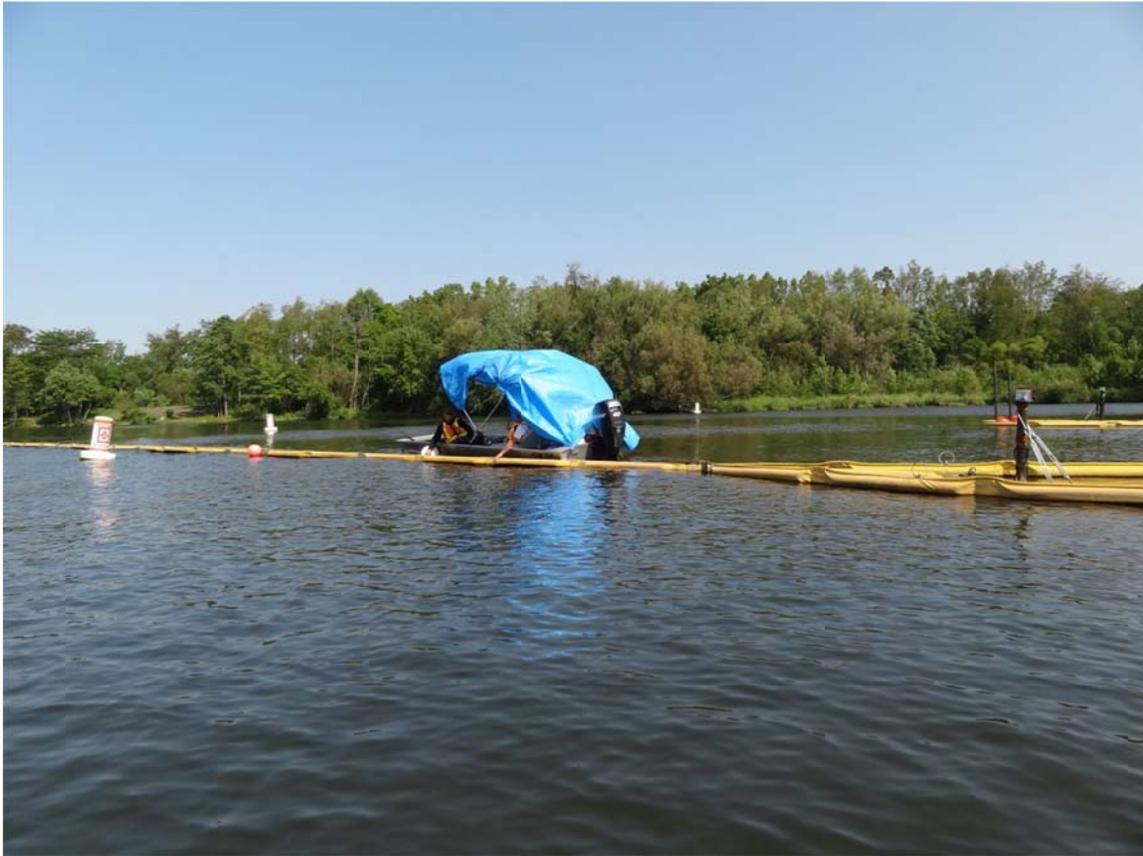
9. Crews inspecting boom and sediment curtain in Morrow Lake Delta.

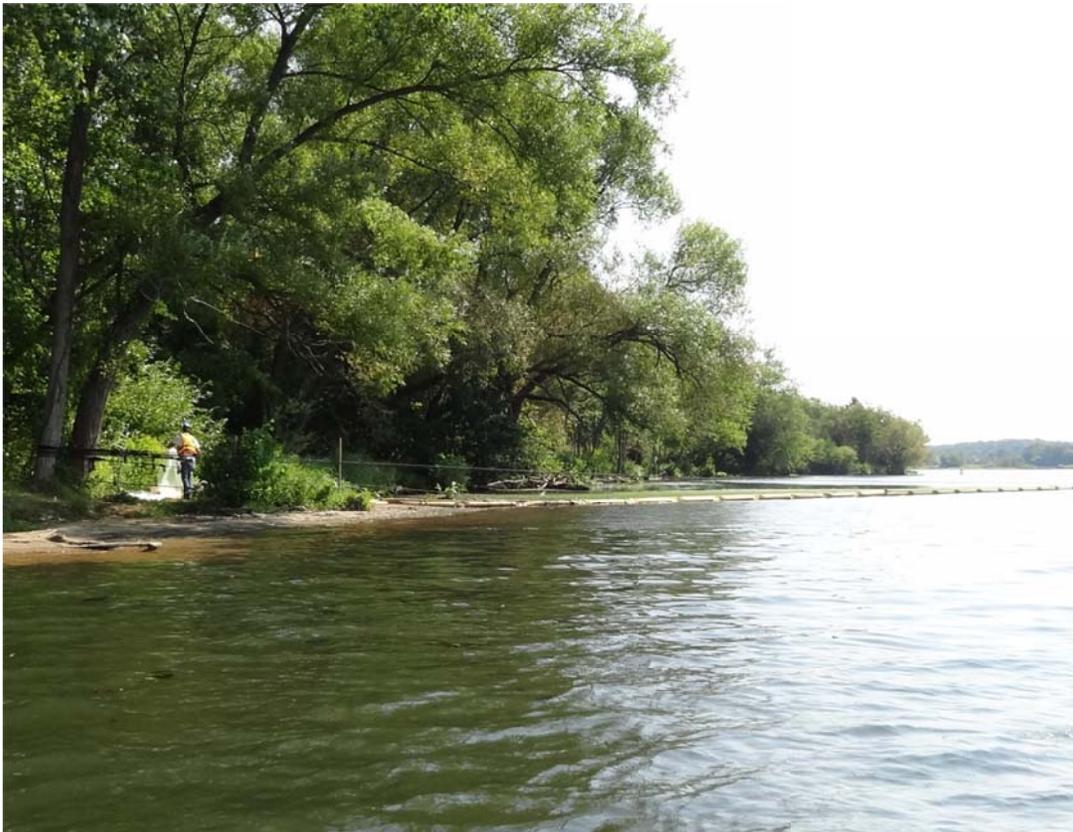
10. Crews removing vegetation and debris from E4.0 control point.

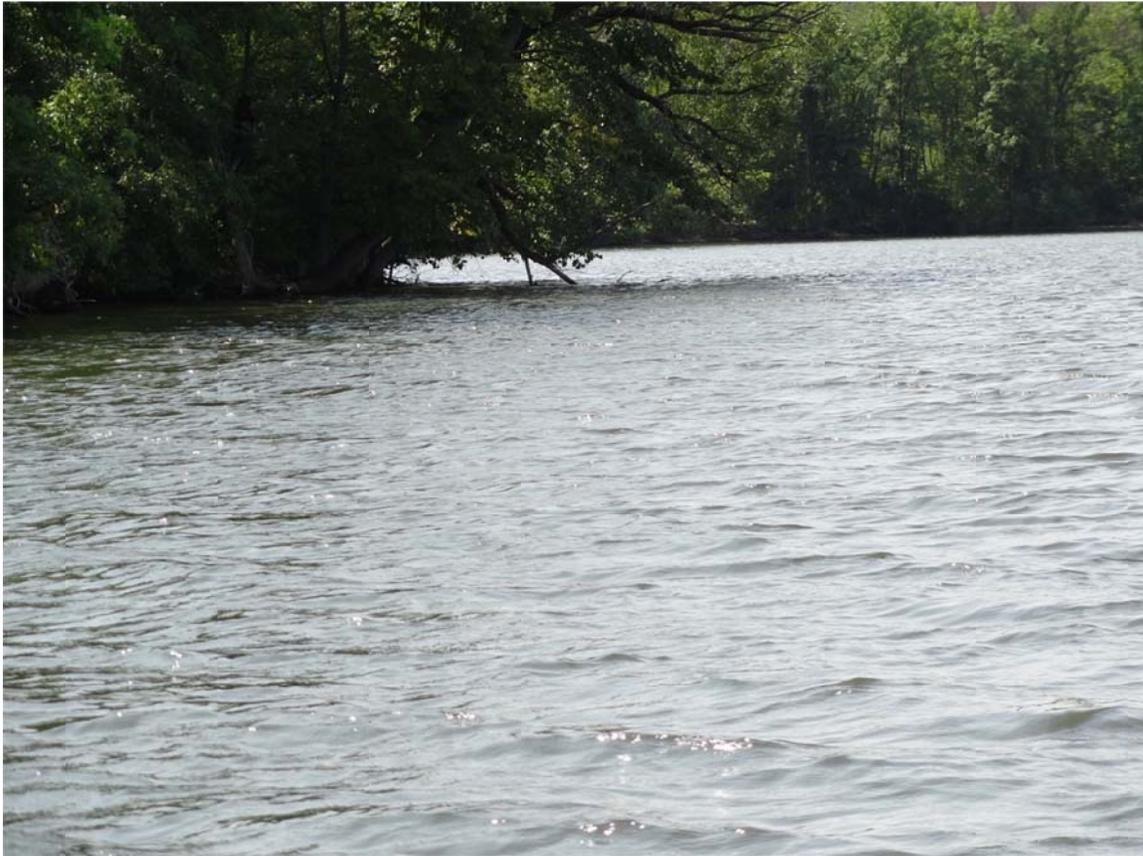
11. South cove of Morrow Lake. No sheen observed.

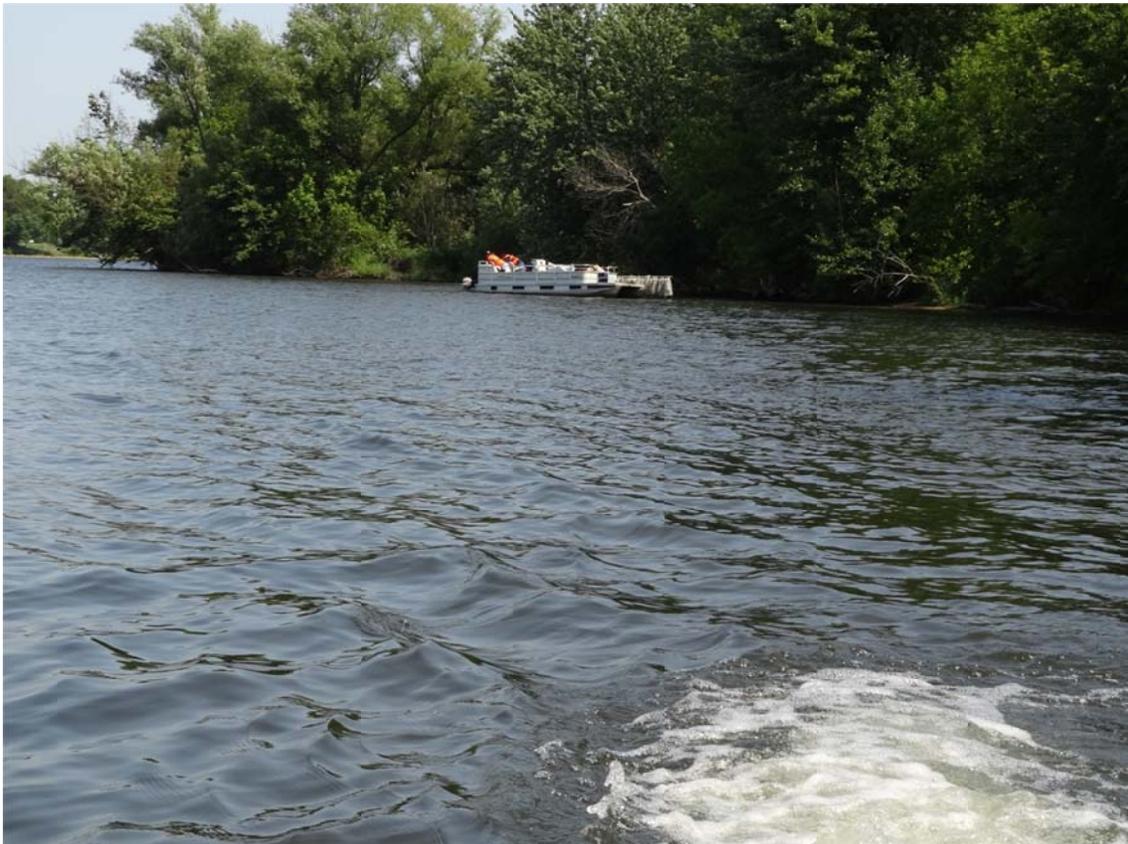
12. Sheen sweeper boat in southern cove of Morrow Lake.
