Situation Photo Log

Thursday, August 31, 2012

Kalamazoo River / Enbridge Spill

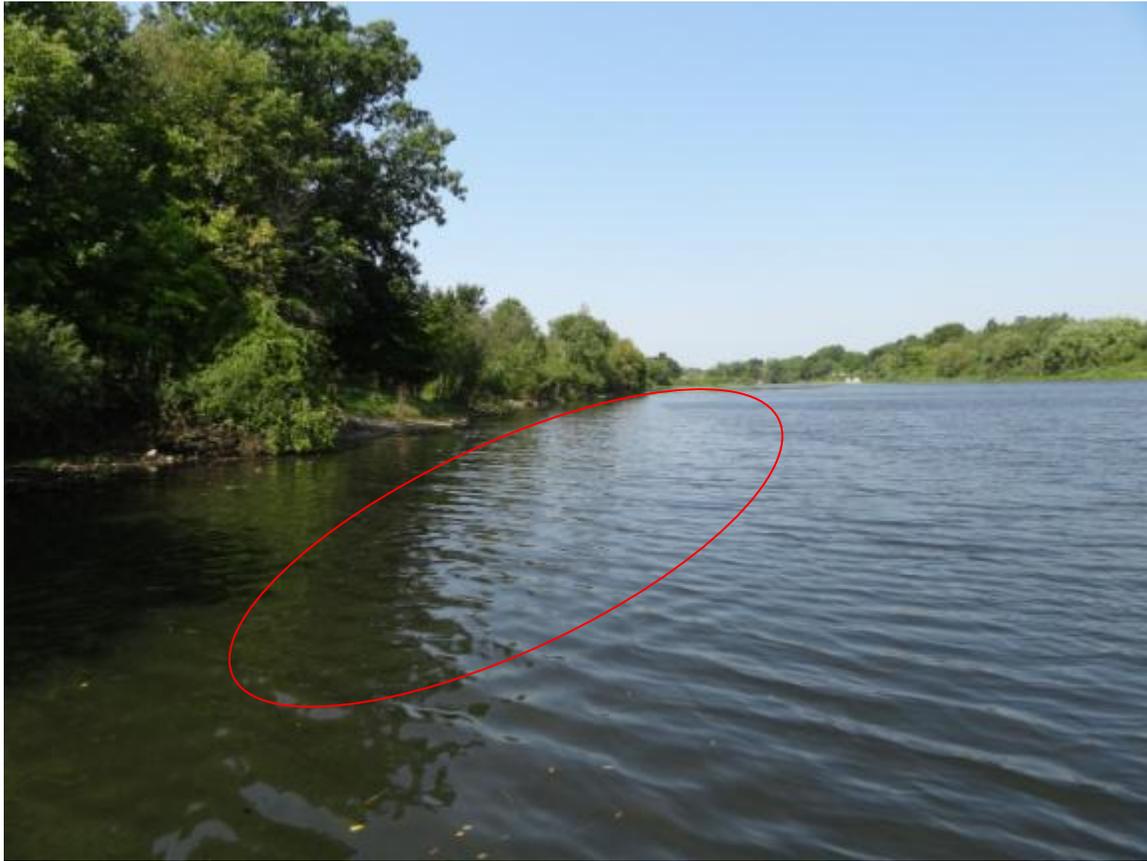
1. MP 5.30 to MP 5.63, area where sheen was observed.

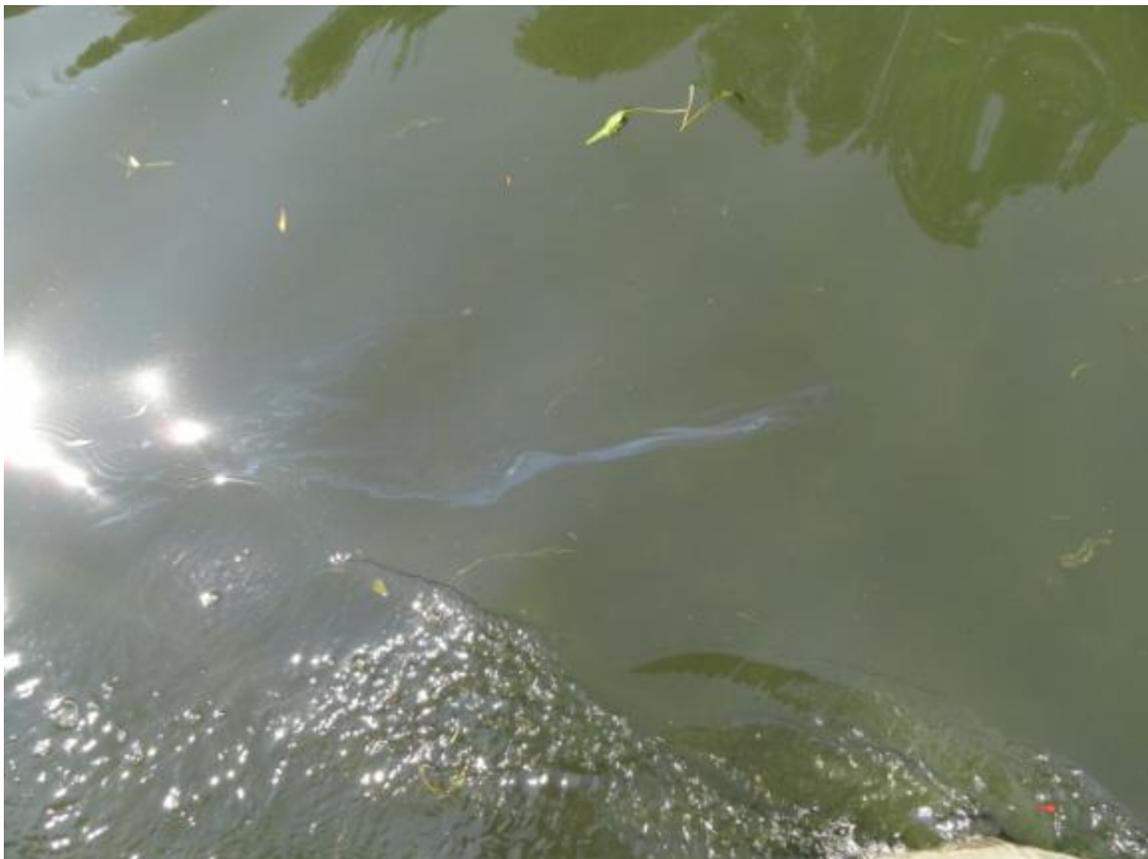
2. MP 5.35, Sheen and tar globules observed.

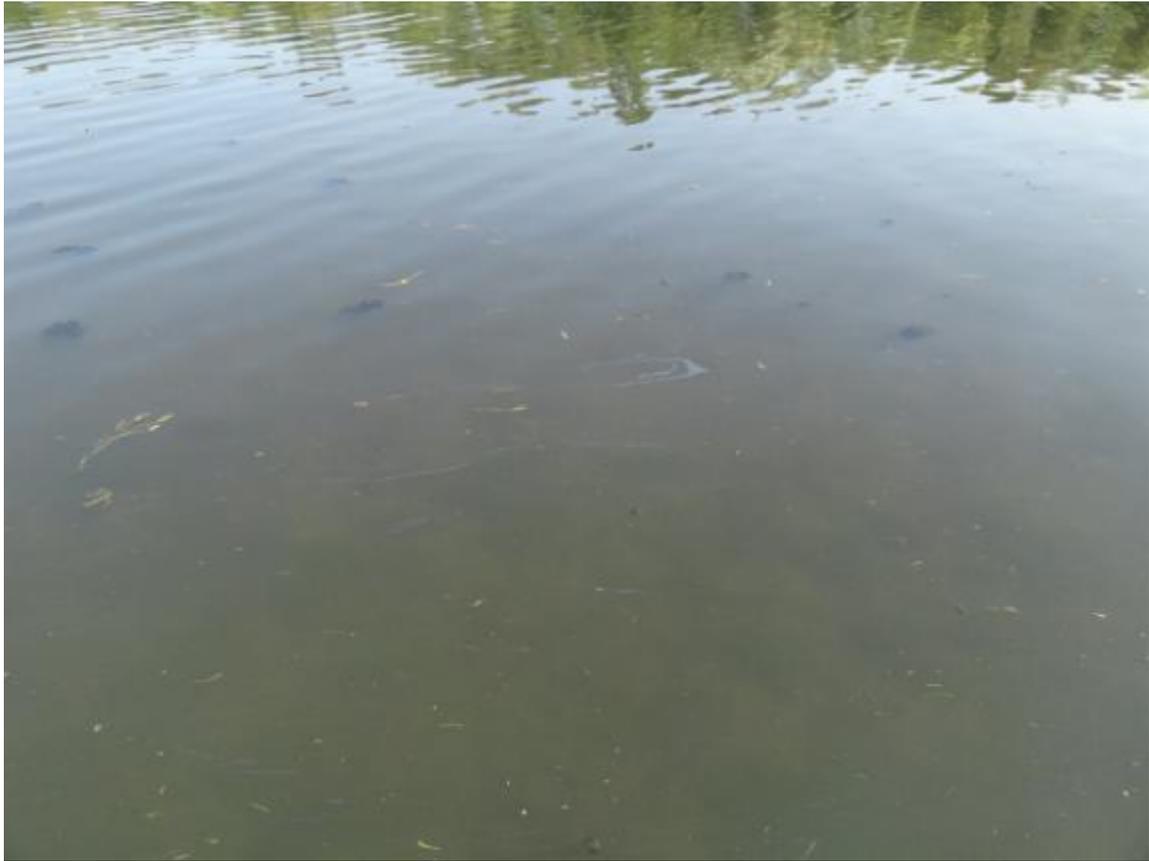
3. MP 5.50, sheen and tar globules observed in channel.

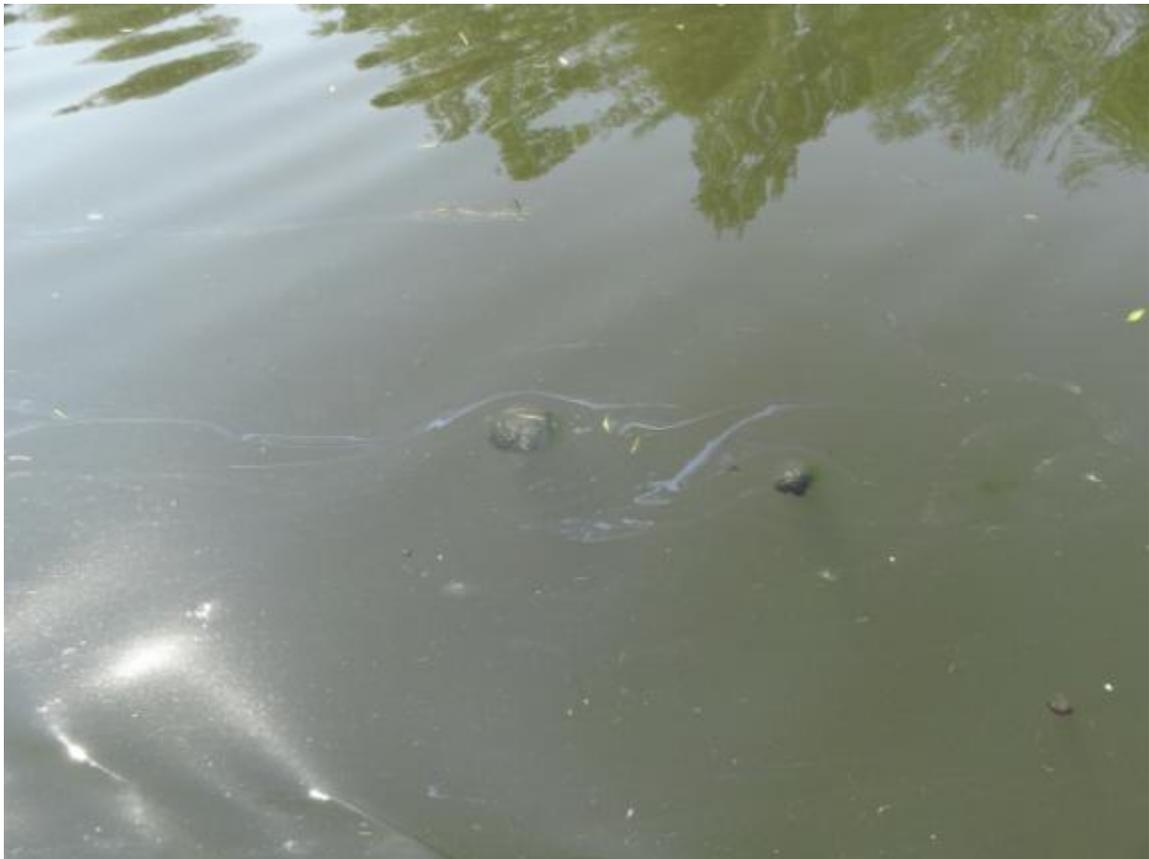
4. MP 5.50, sheen and tar globules observed in channel.

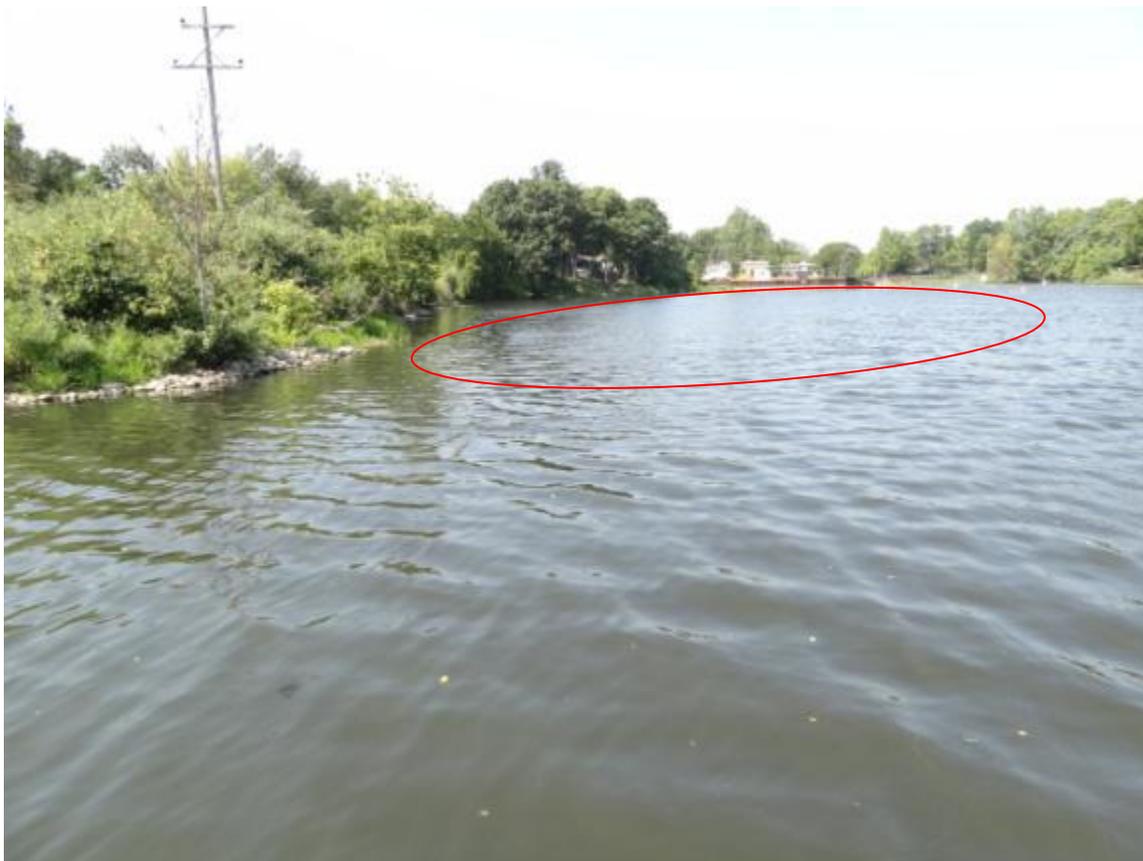
5. Ceresco Dam Impoundment, area where sheen and tar globules were observed.

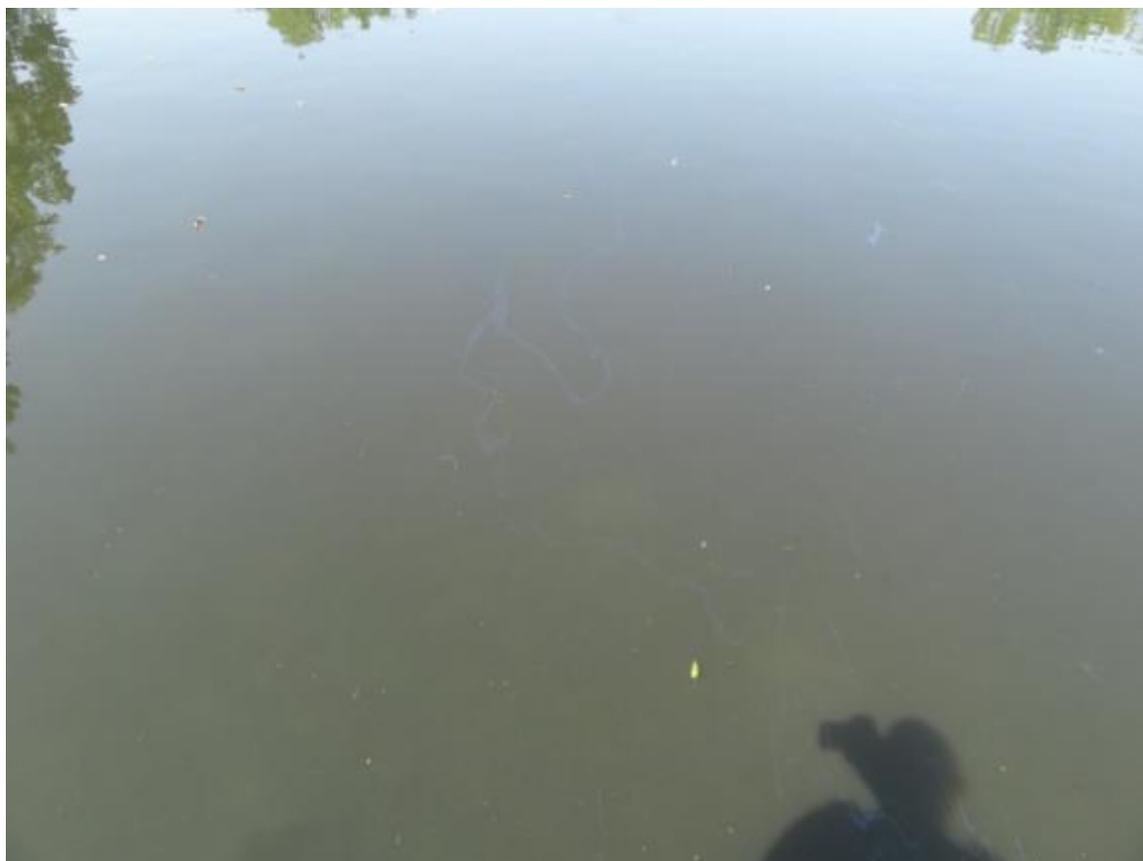
6. Ceresco Dam Impoundment, sheen and tar globules observed within containment.

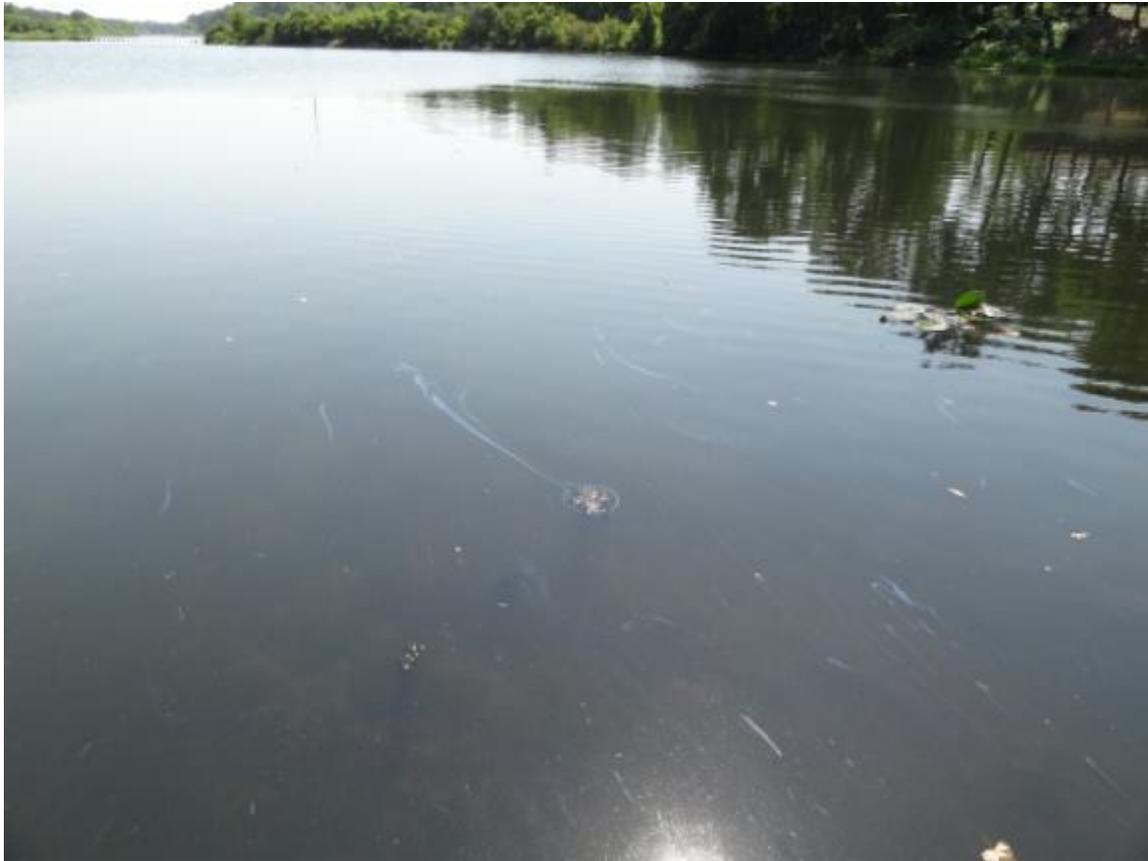
7. Ceresco Dam Impoundment, sheen and tar globules observed within containment.

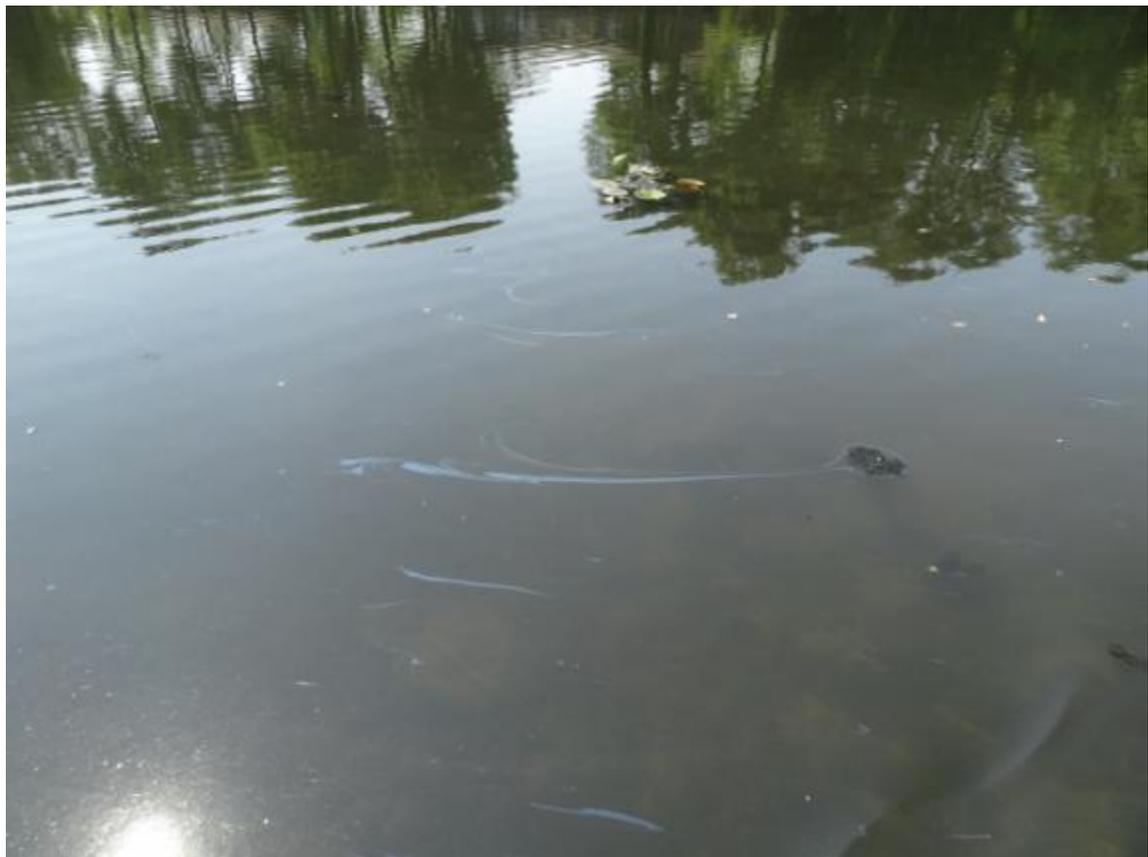
8. Ceresco Dam Impoundment, sheen and tar globules observed.

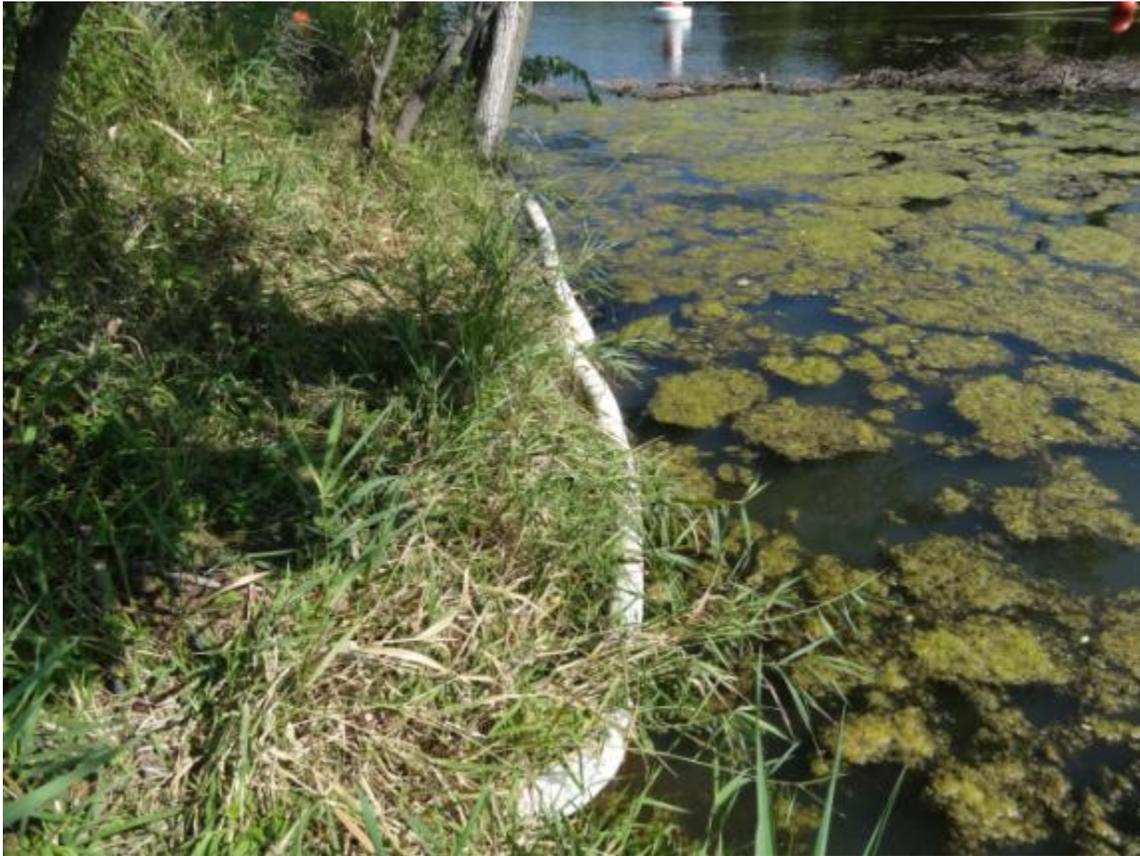
9. MP 10.75 LDB, absorbant boom remains in place around undercut bank.

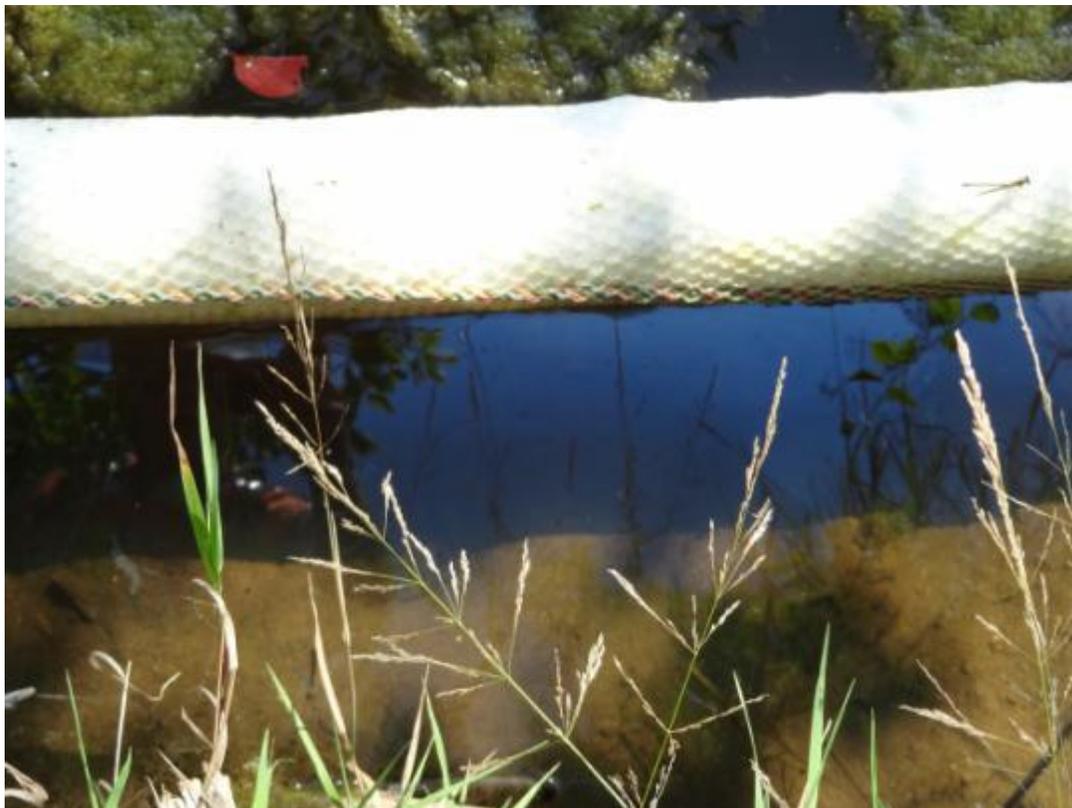
10. MP 10.75 LDB, silver sheen observed within containment.

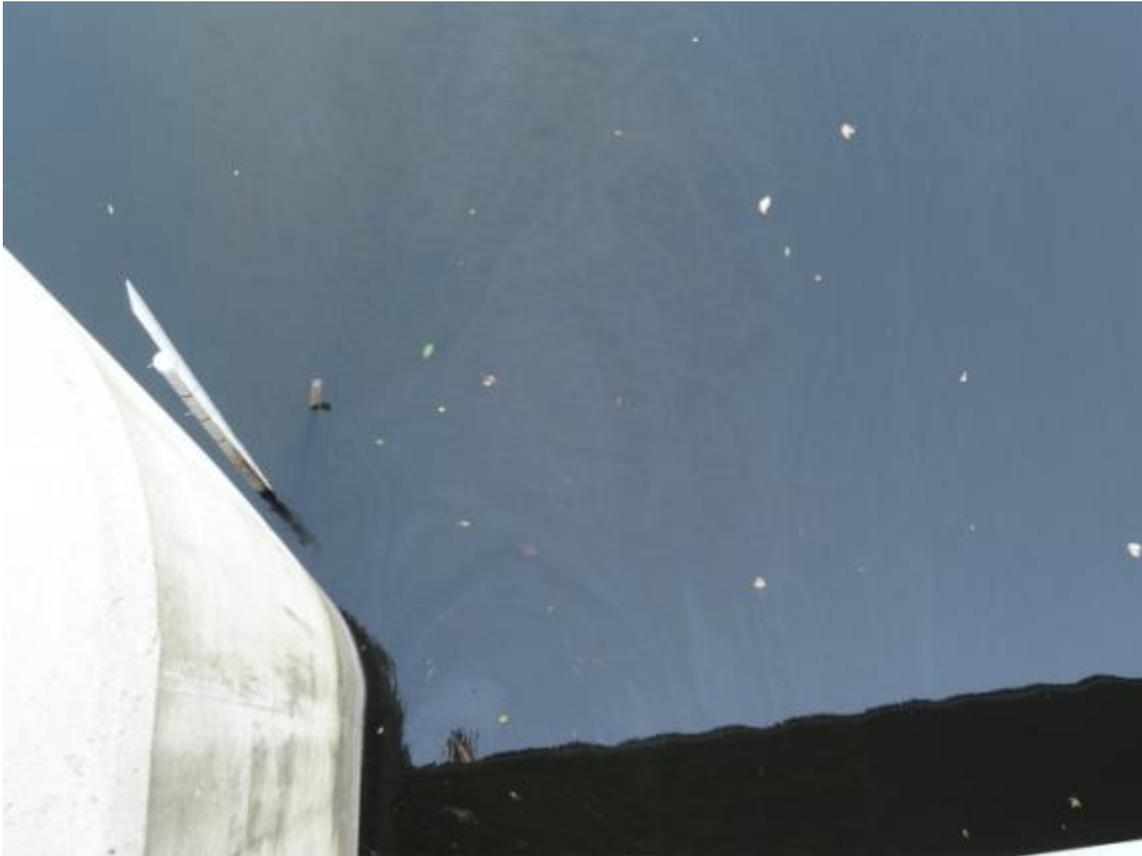
11. MP 21.5, sheen observed from Custer Road Bridge.

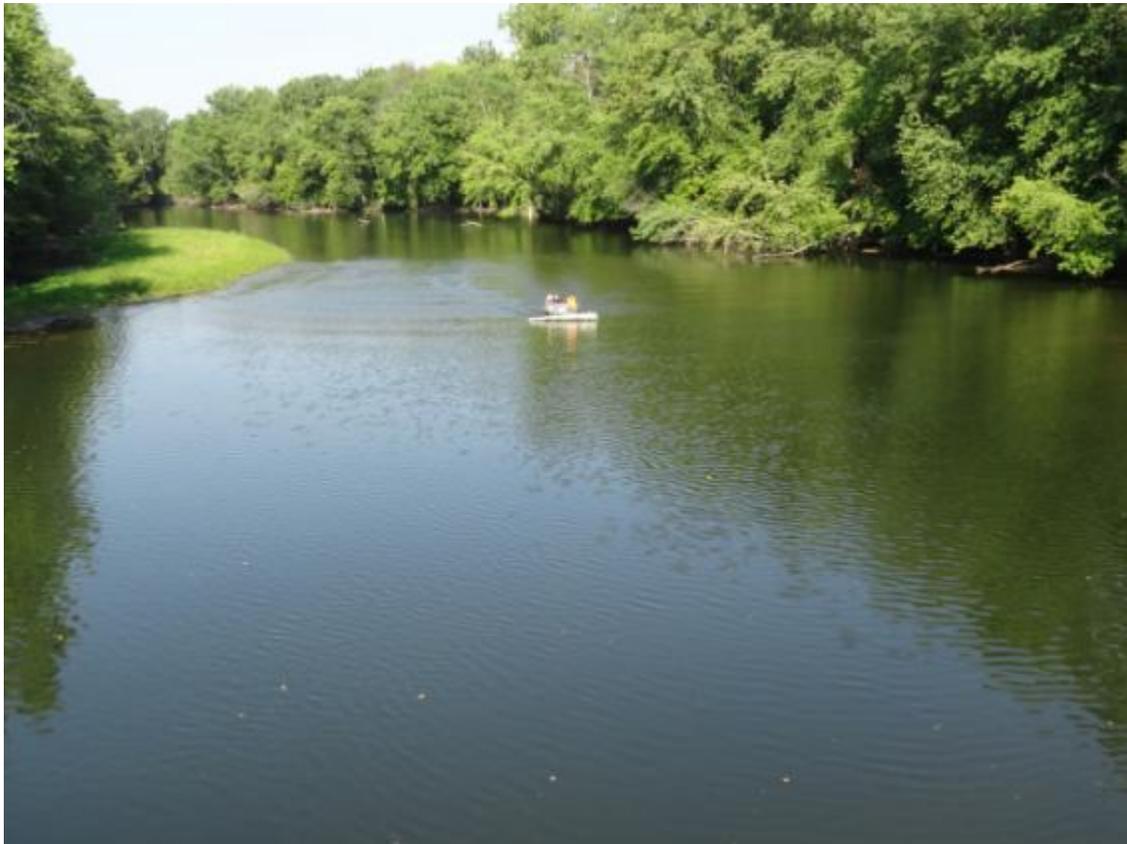
12. MP 21.5, sheen sweeper boat operating in area.

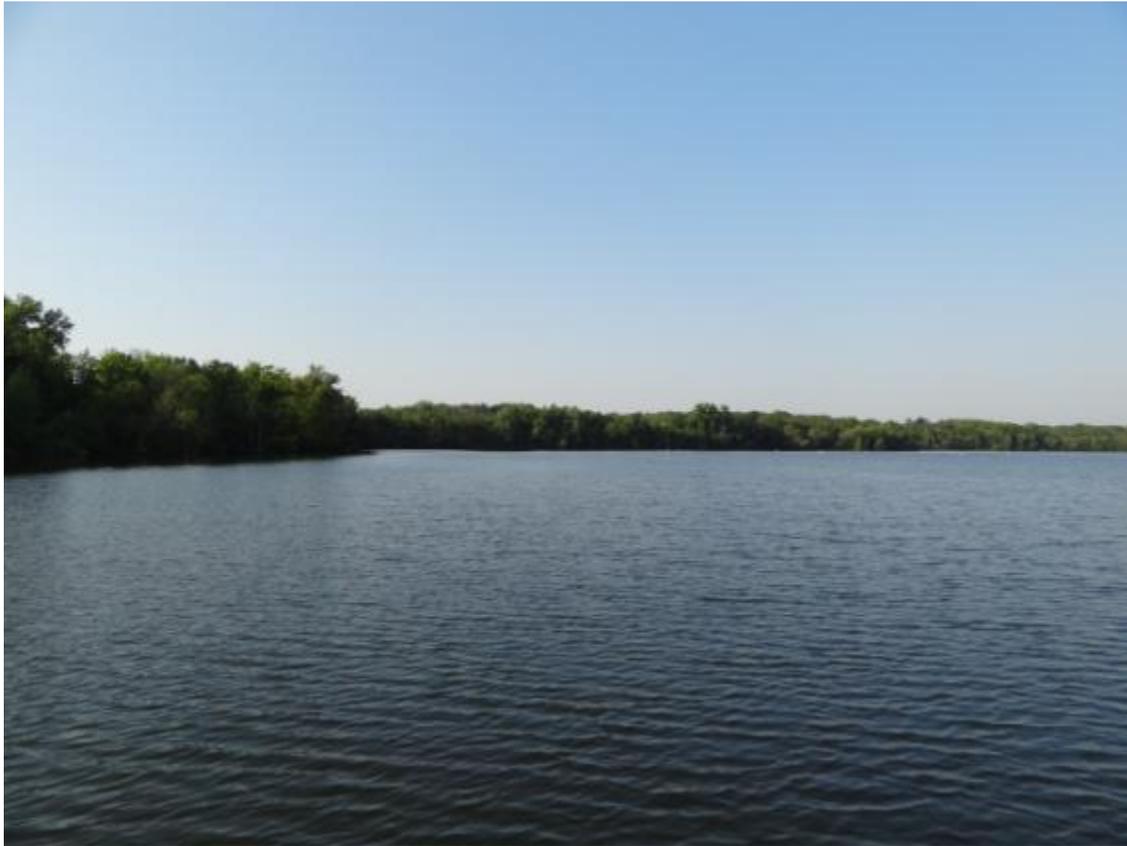
13. Morrow Lake South Cove, no sheen observed.

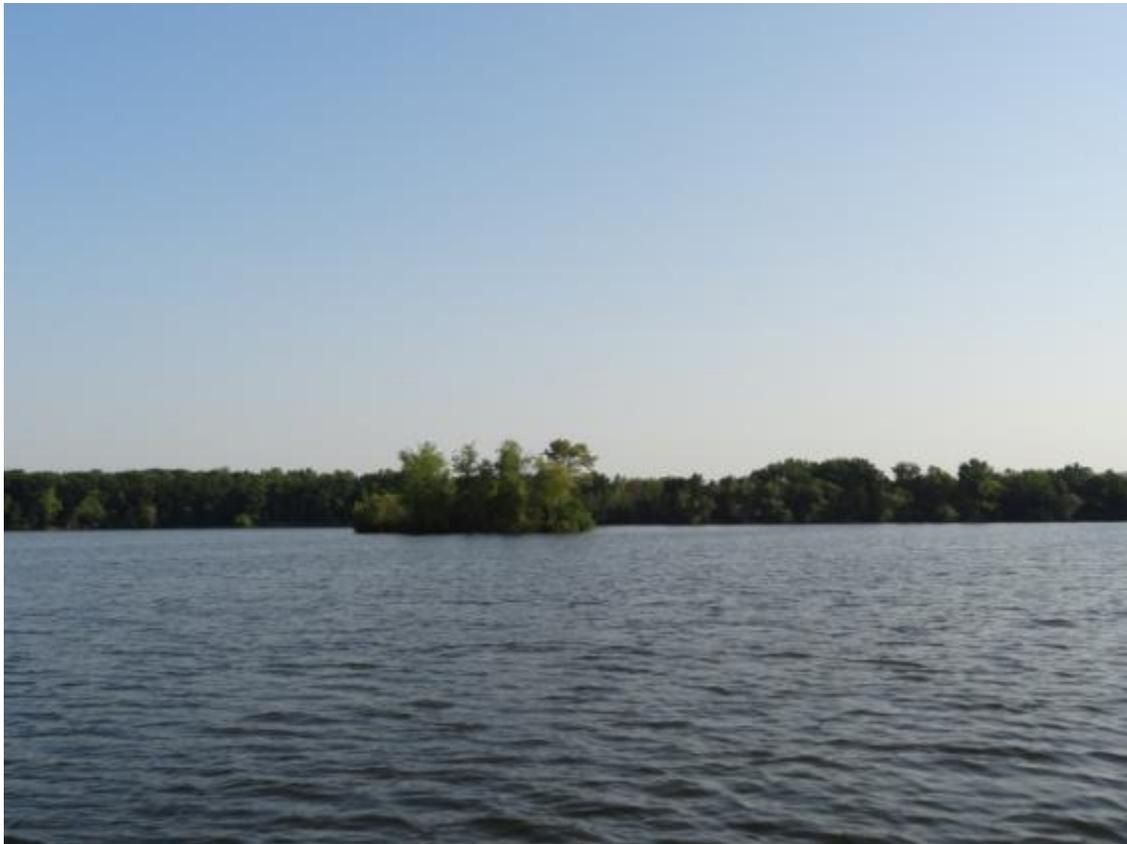
14. Rowe Island, no sheen observed.

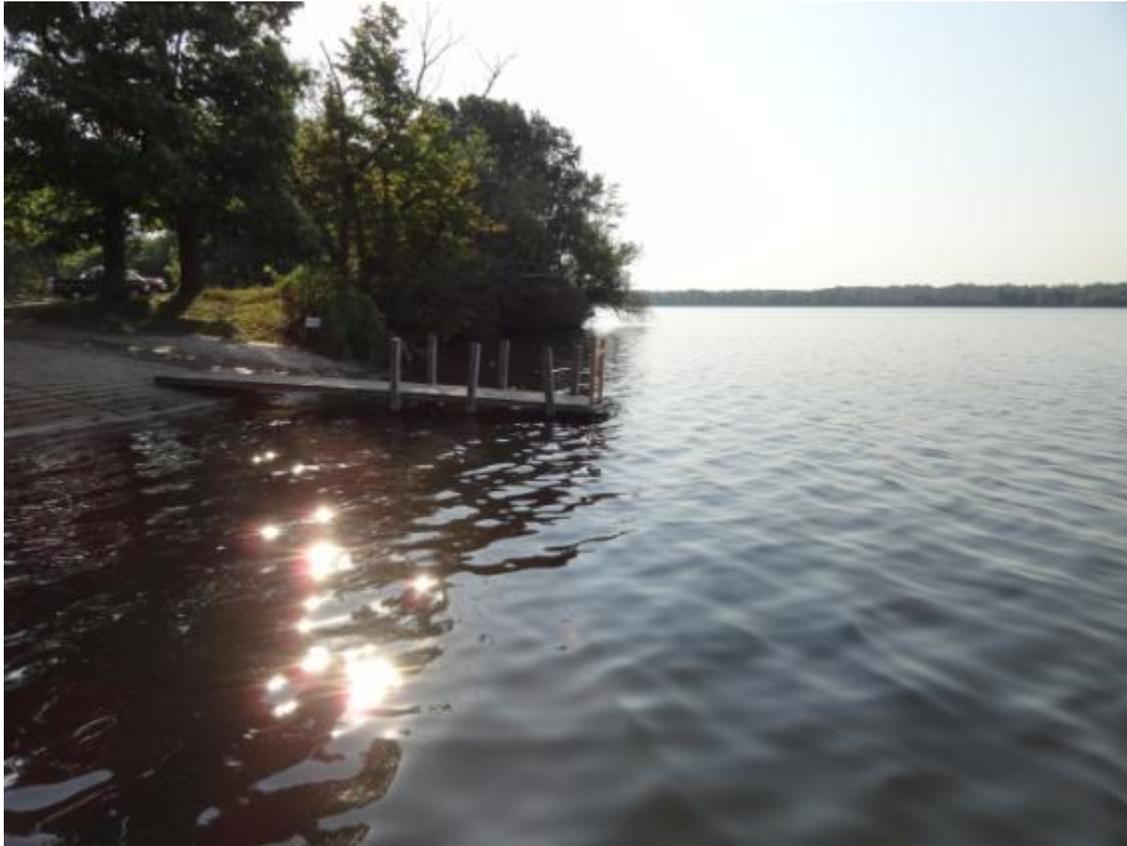
15. Morrow Lake, sheen observed around E 4.5 Boat Launch.

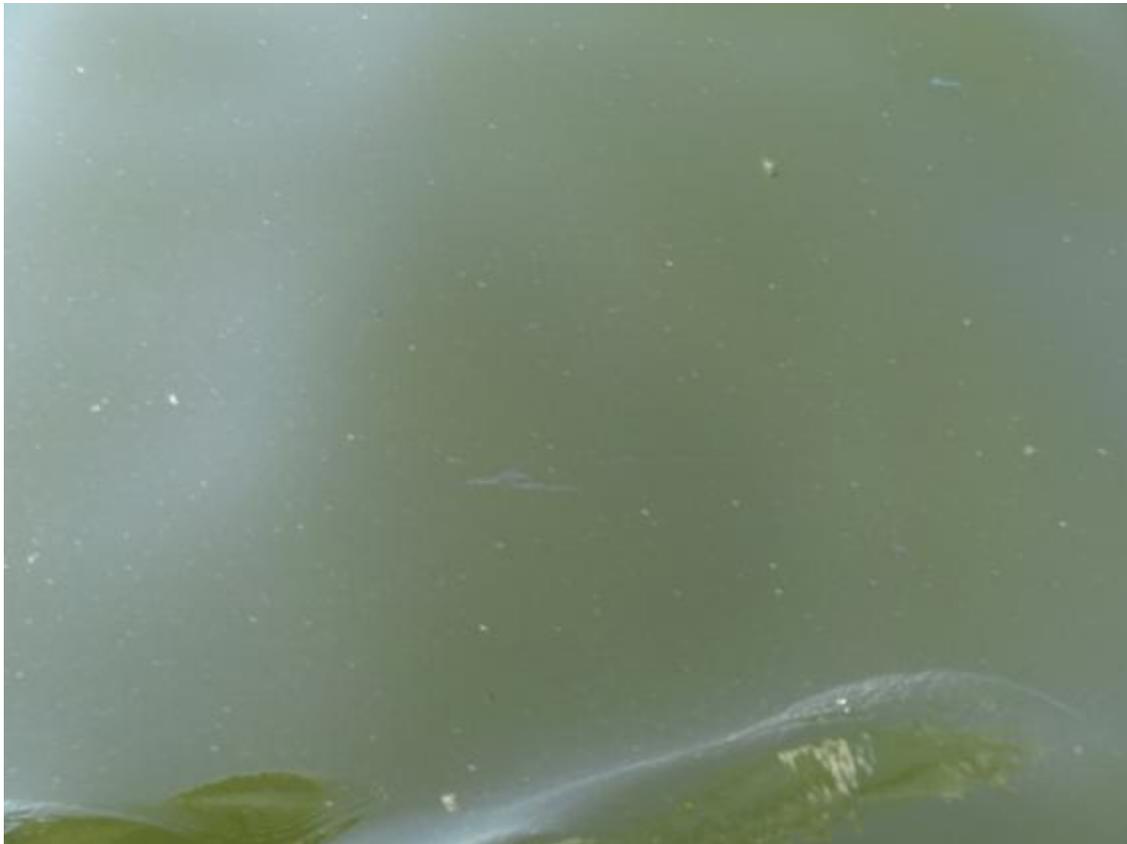
16. Morrow Lake, sheen observed around E 4.5 Boat Launch.

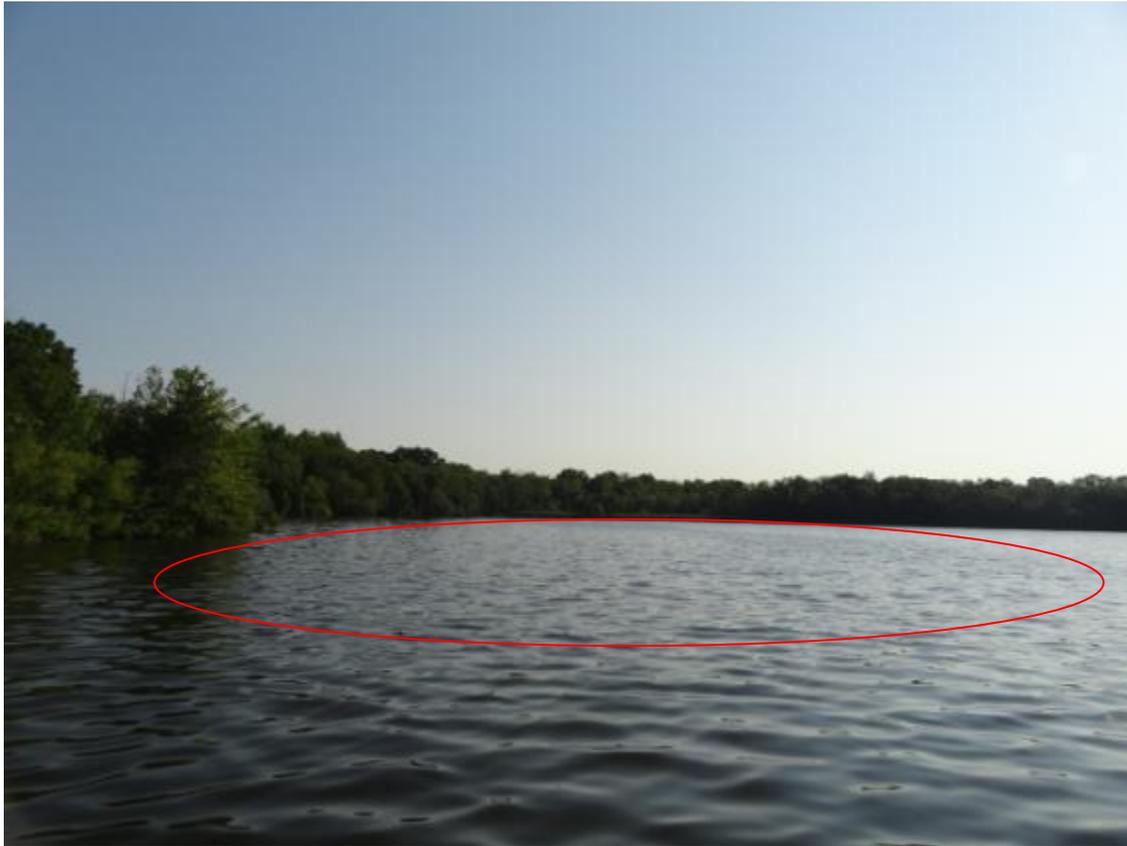
17. Morrow Lake North Cove, area where sheen was observed.

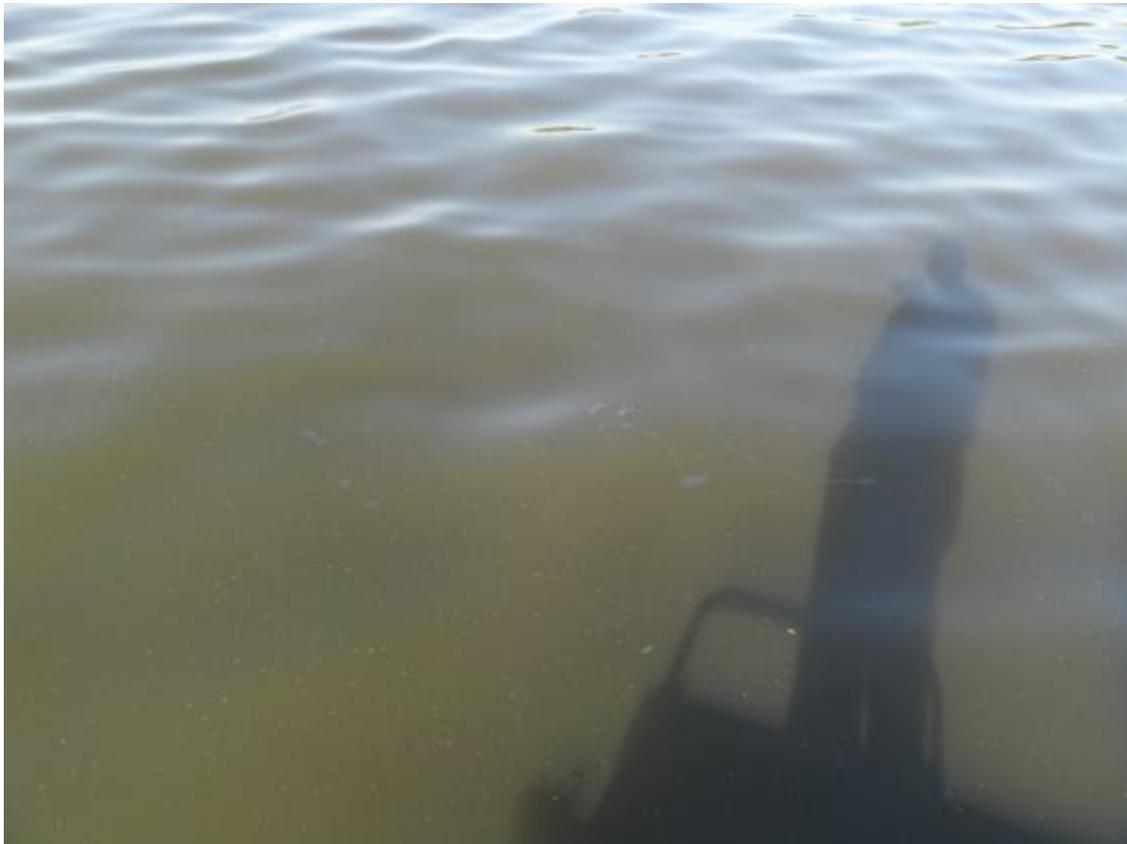
18. Morrow Lake North Cove, sheen observed.

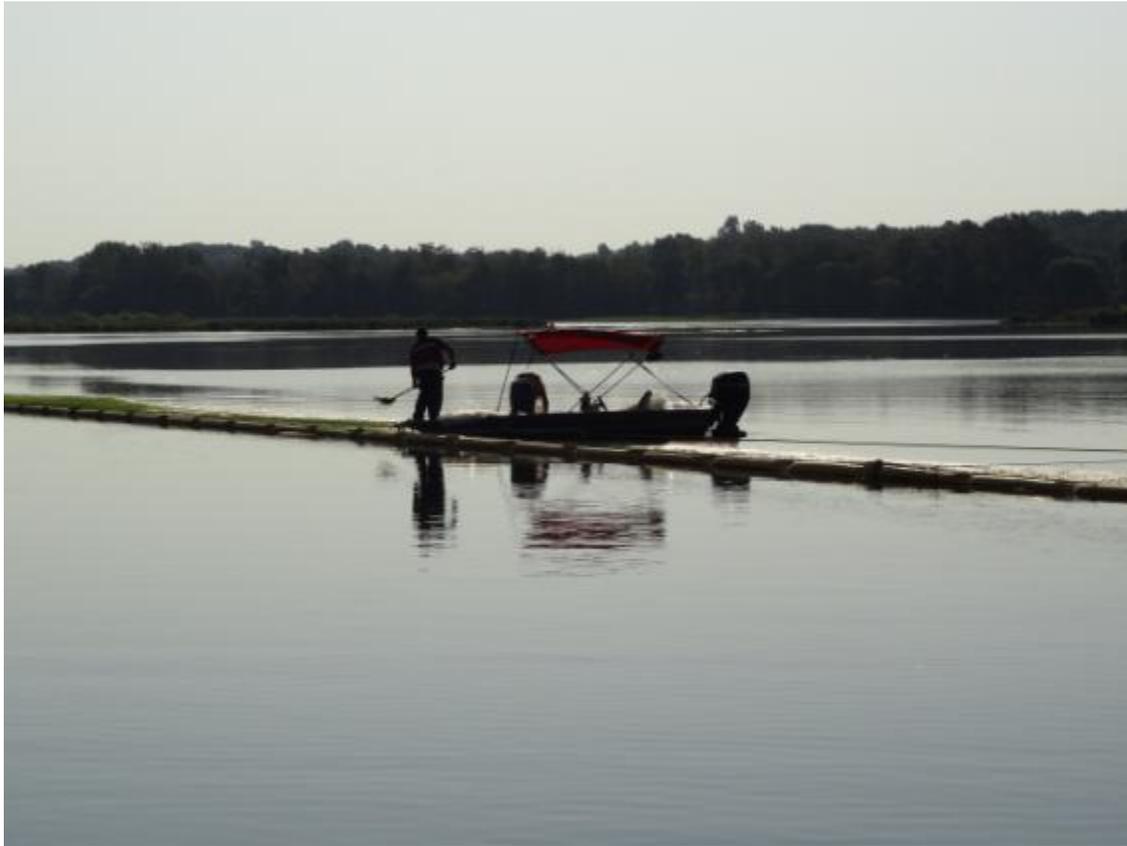
19. Morrow Lake Delta, crew observed clearing vegetative debris from Boom C.
