Situation Photo Log

Tuesday, September 04, 2012

Kalamazoo River / Enbridge Spill

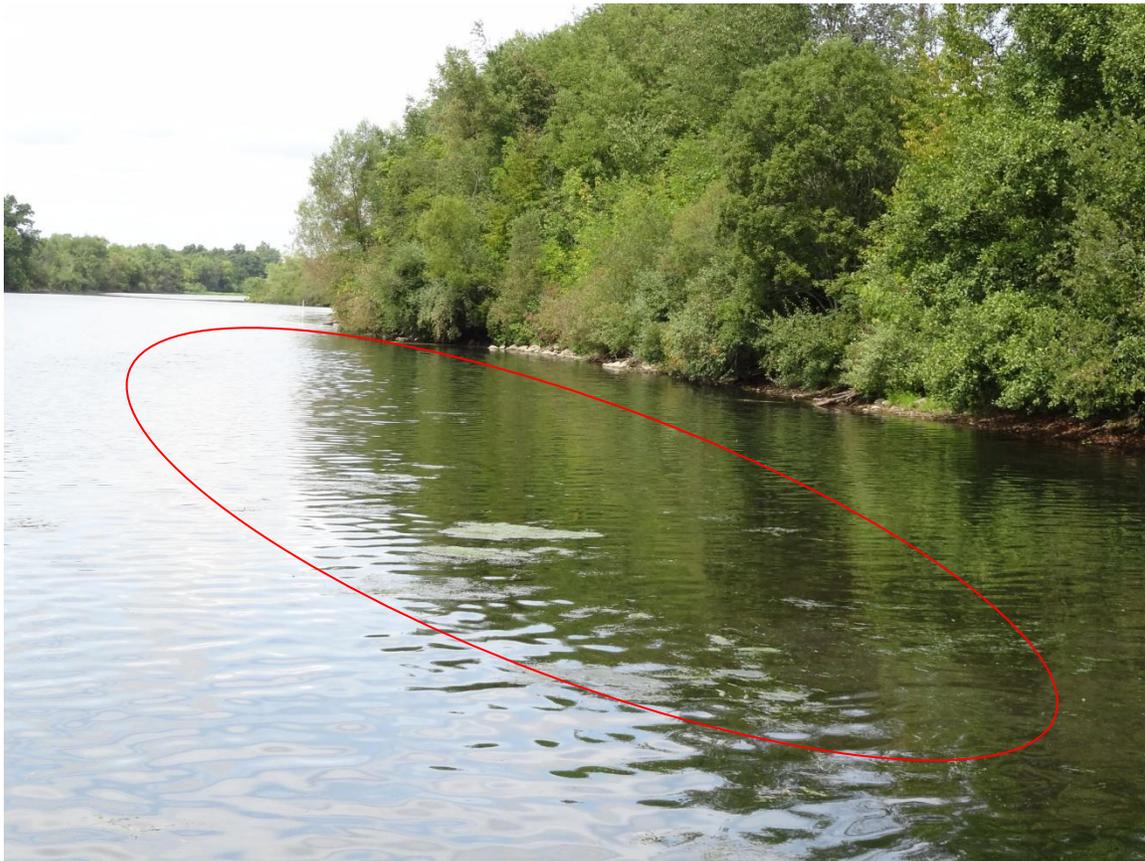
1. MP 5.0 to MP 5.15 RDB, sheen observed upstream of C 0.4 Boat Launch.

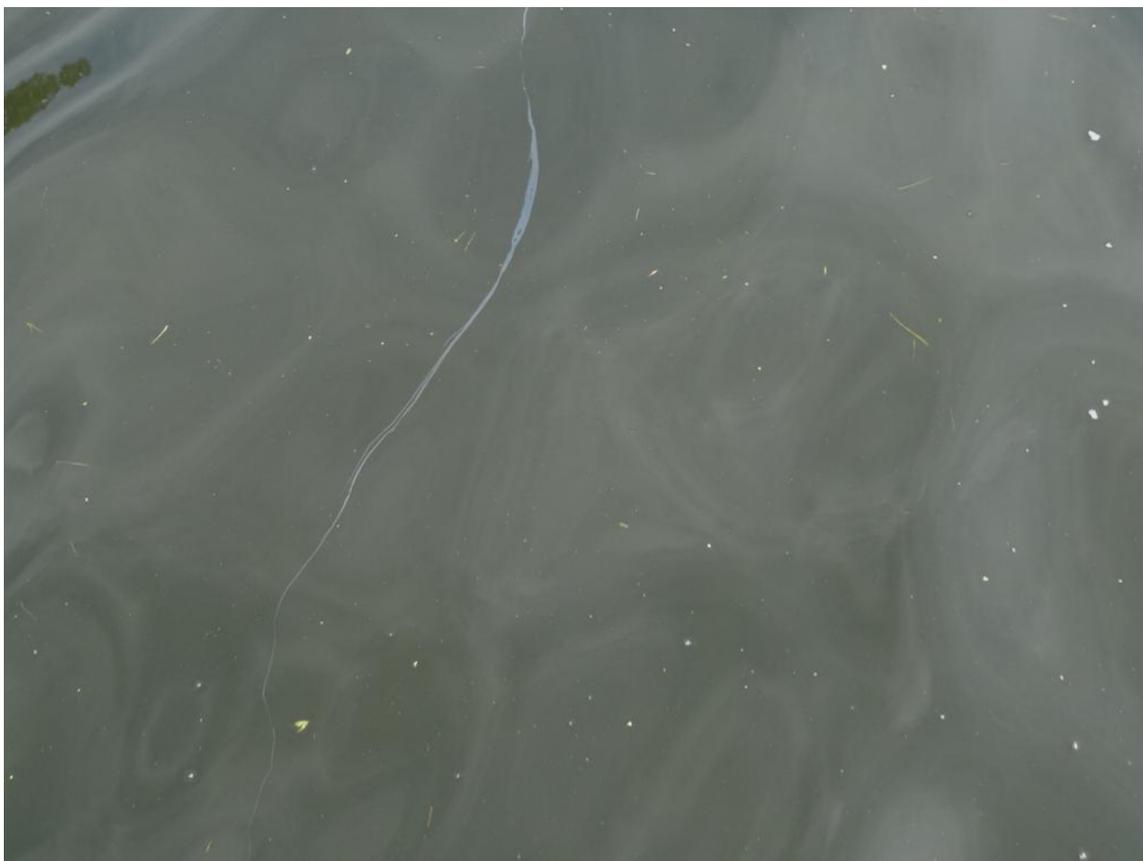
2. MP 5.0 RDB, sheen observed upstream of C 0.4 Boat Launch.

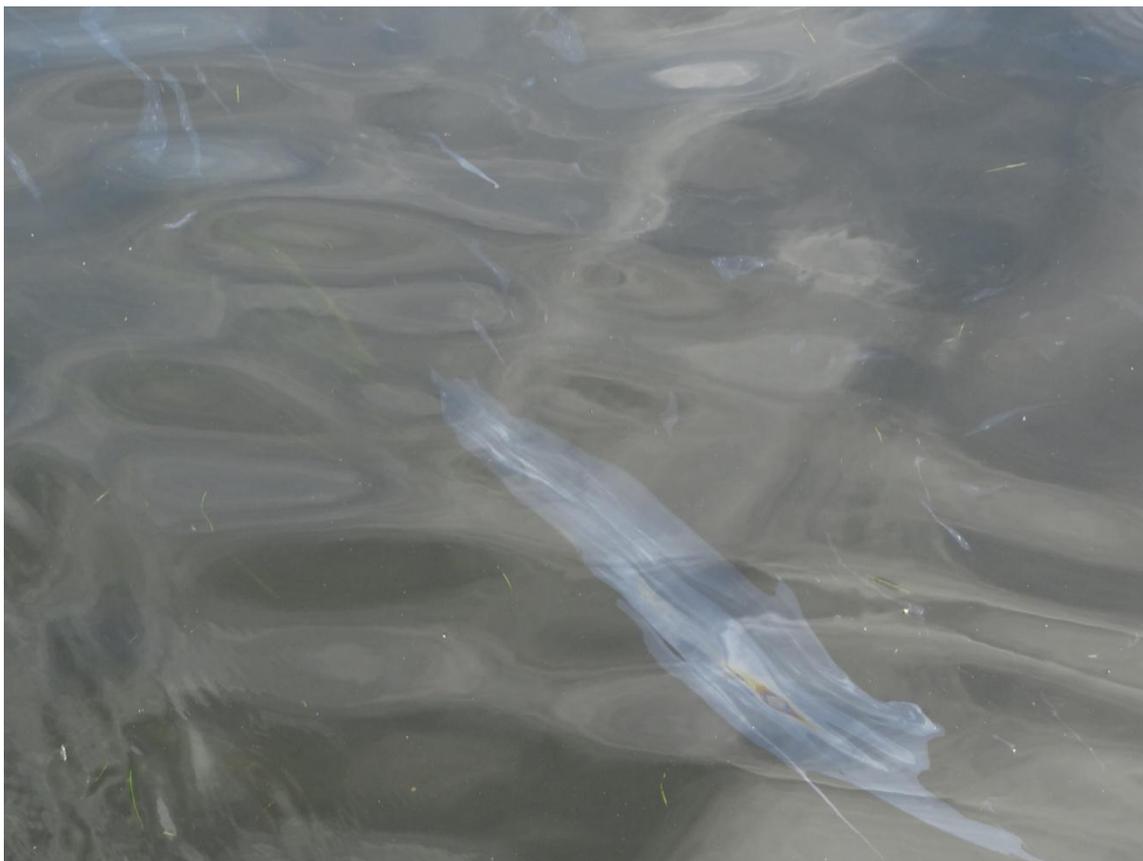
3. MP 5.15 RDB, sheen and tar globules observed near C 0.4 Boat Launch.

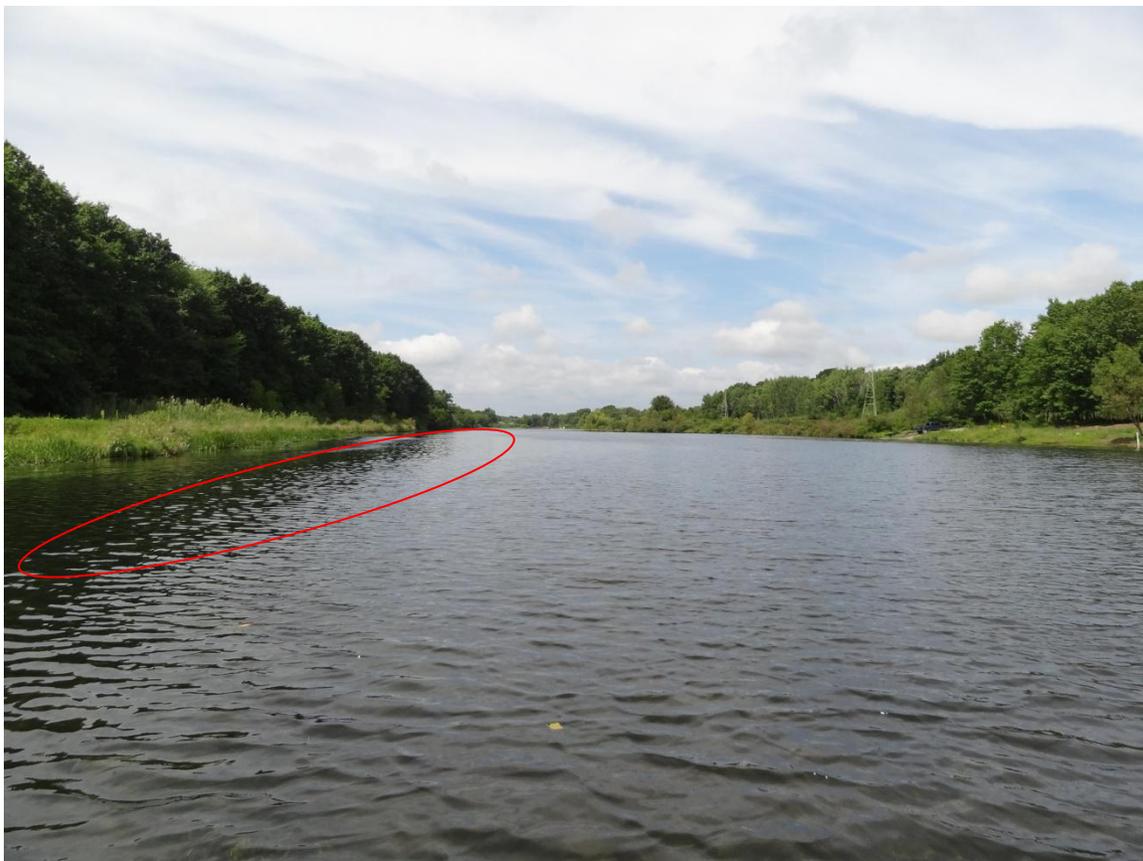
4. MP 5.10 to MP 5.63 LDB, sheen and tar globules observed.

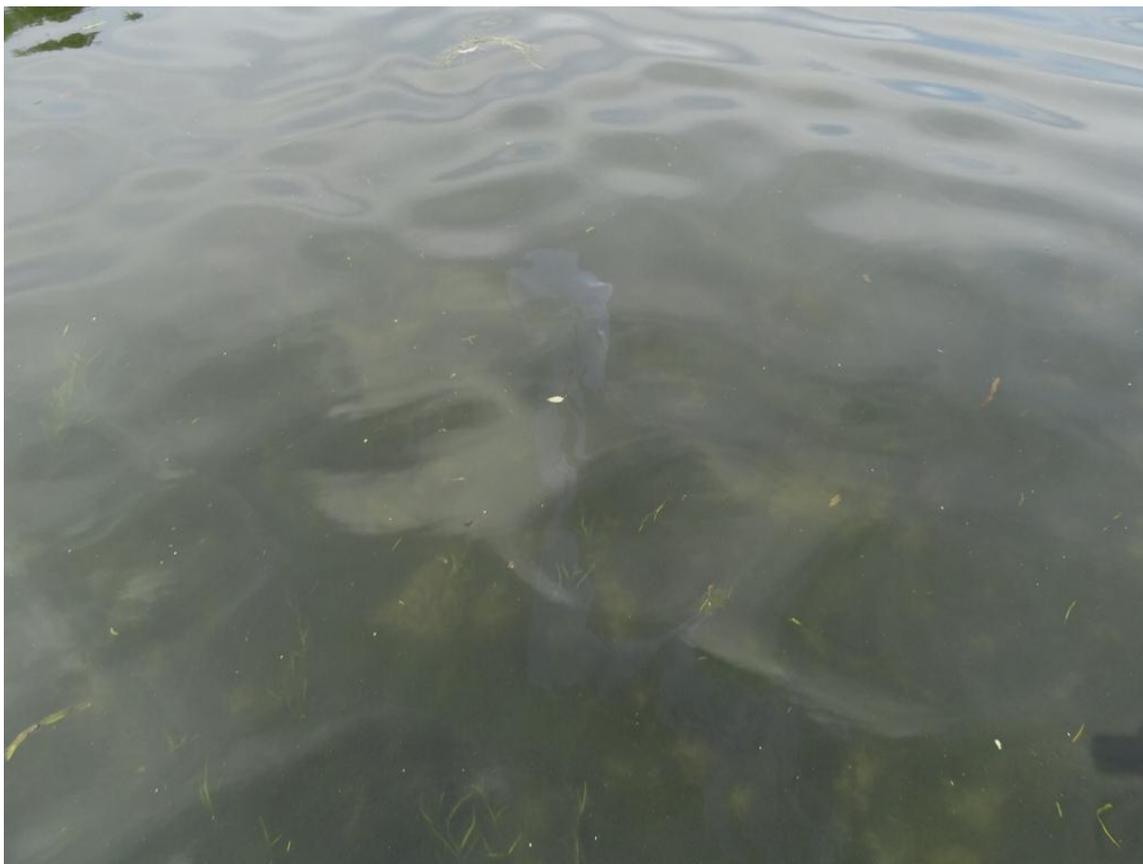
5. MP 5.25 LDB, sheen and tar globules observed.

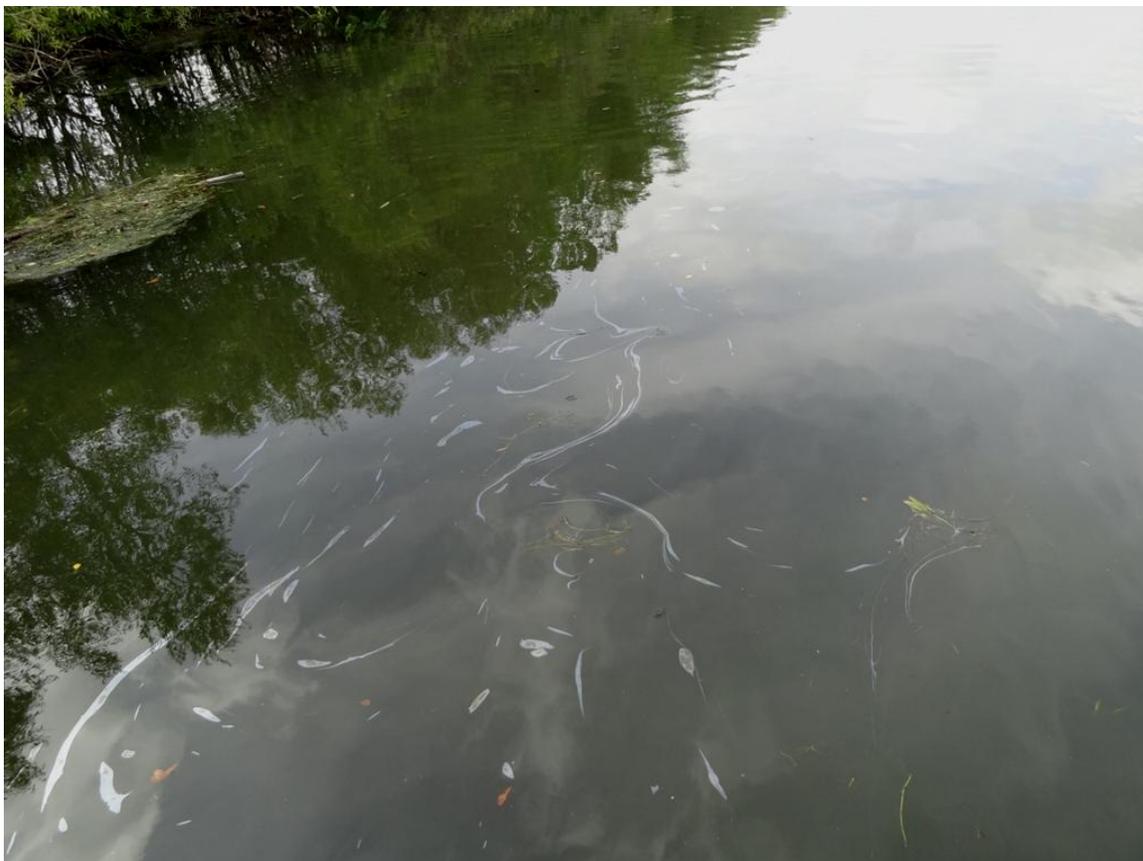
6. MP 5.50 LDB, sheen and tar globules observed.

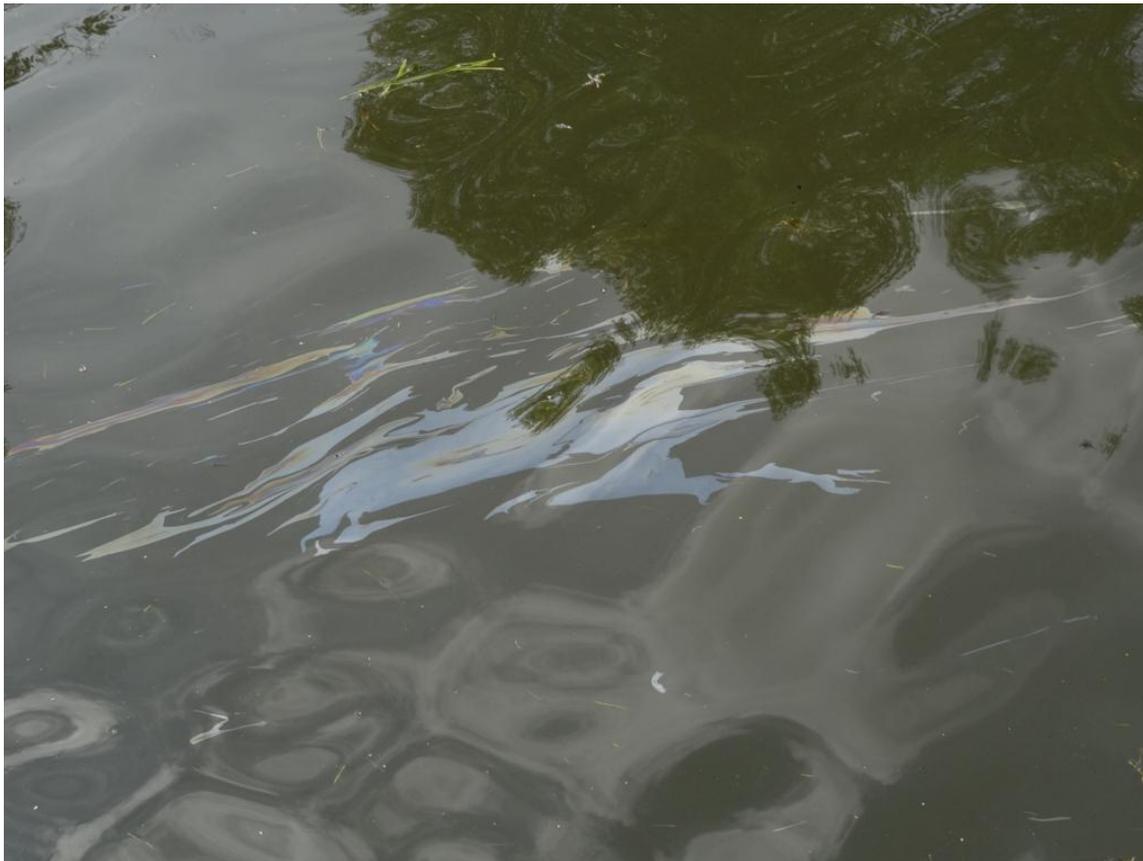
7. MP 5.50 LDB, sheen and tar globules observed.

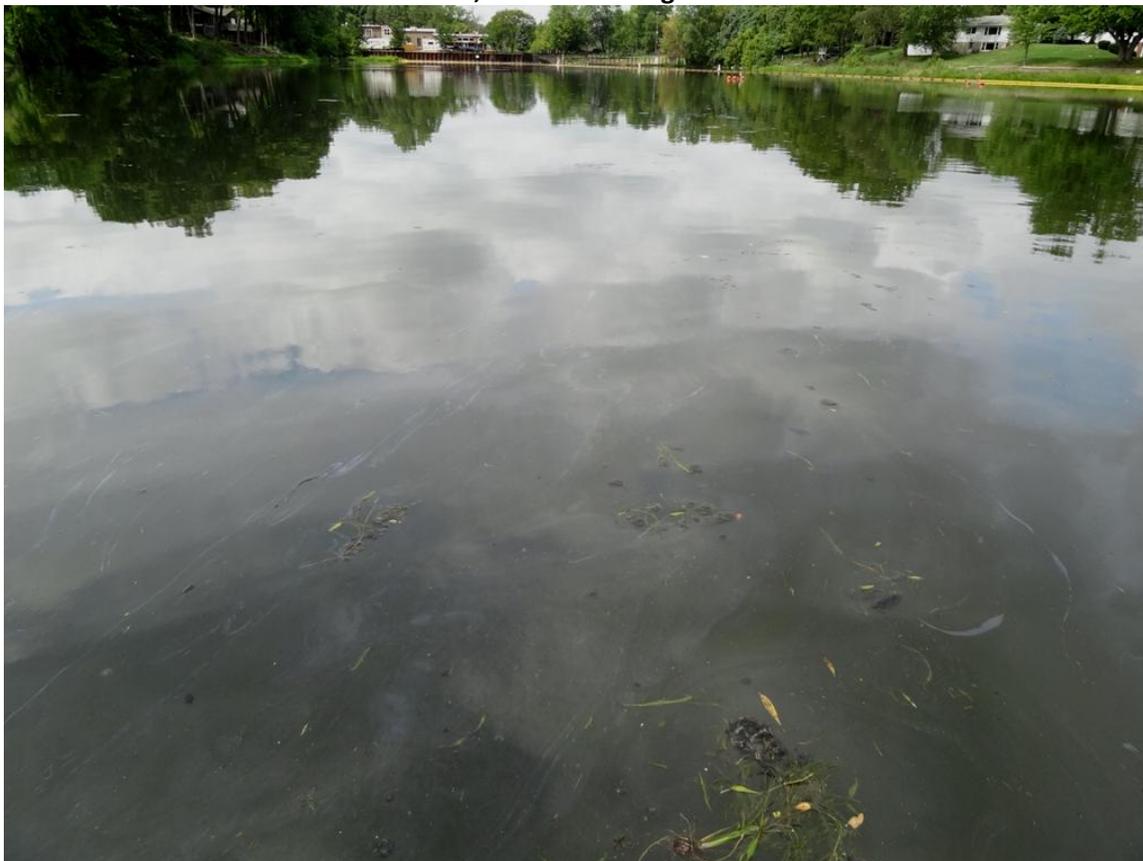
8. MP 5.63 LDB, sheen and tar globules observed downstream of the trestle.

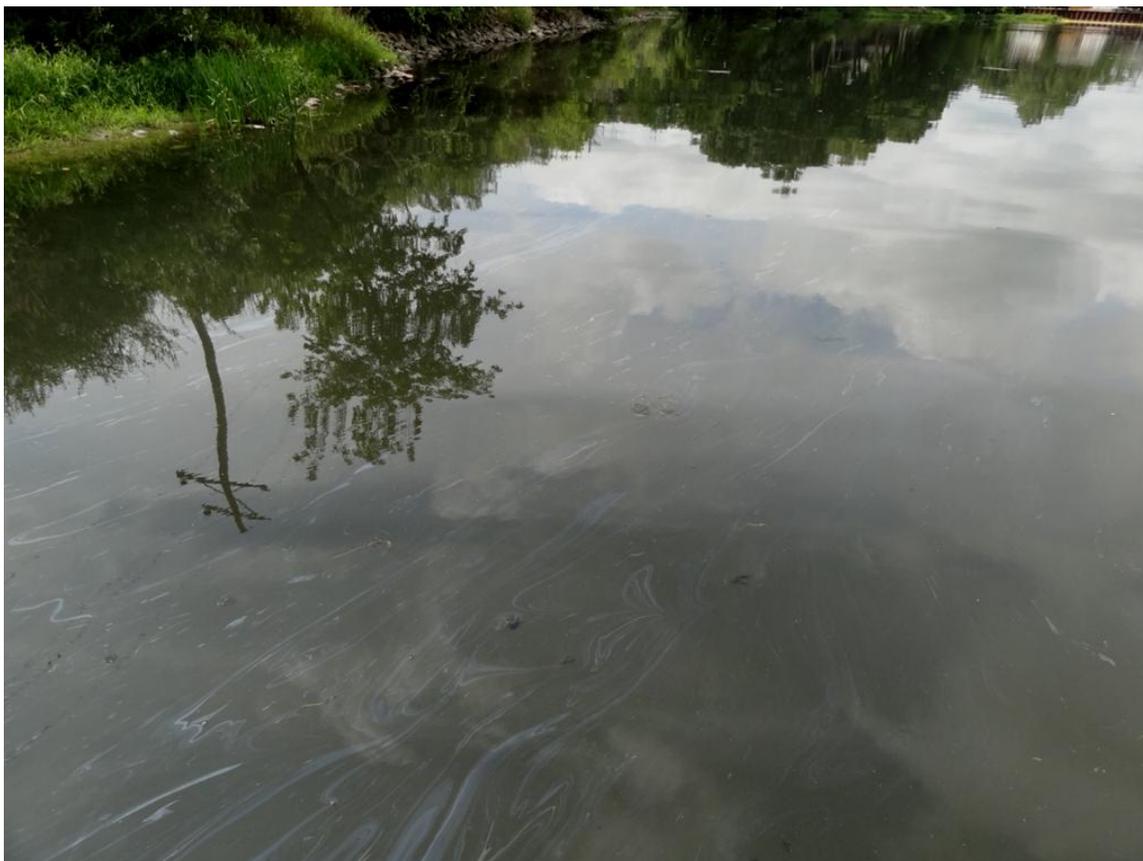
9. MP 5.63 LDB, sheen and tar globules observed downstream of the trestle.

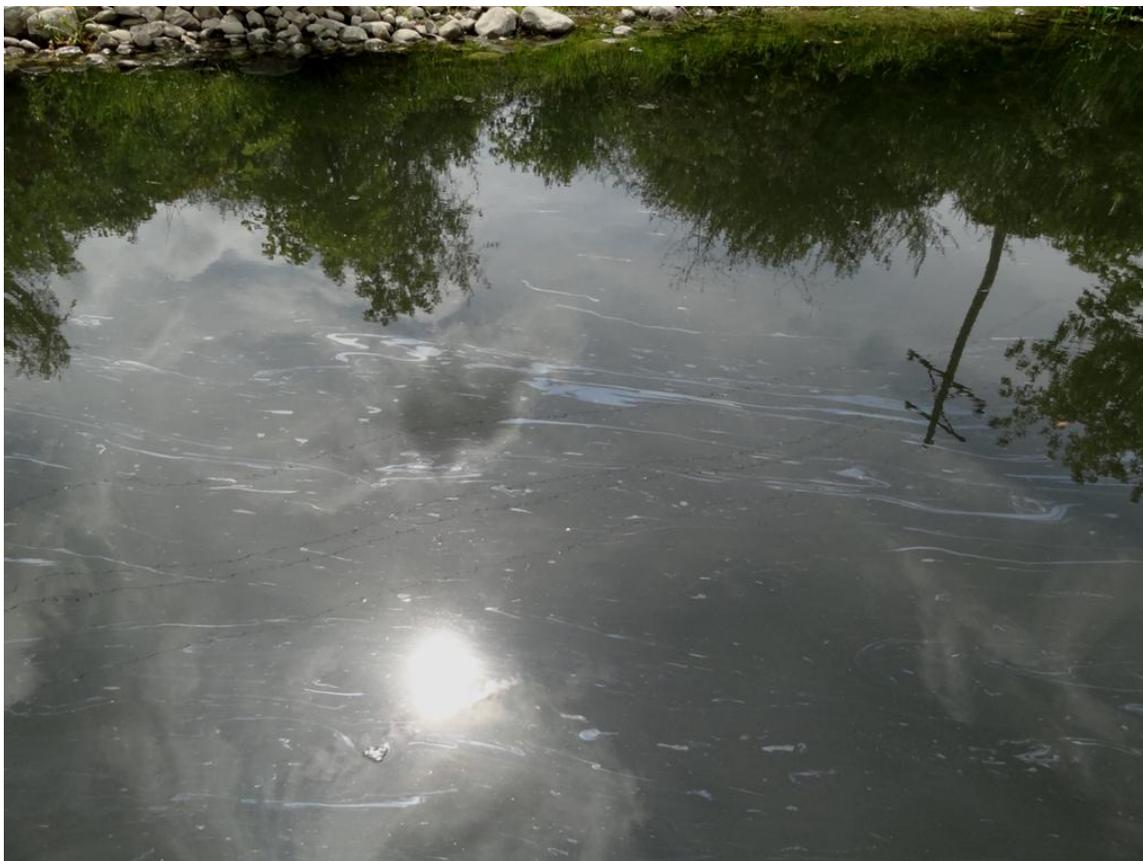
10. MP 5.63 LDB, sheen and tar globules observed downstream of the trestle.

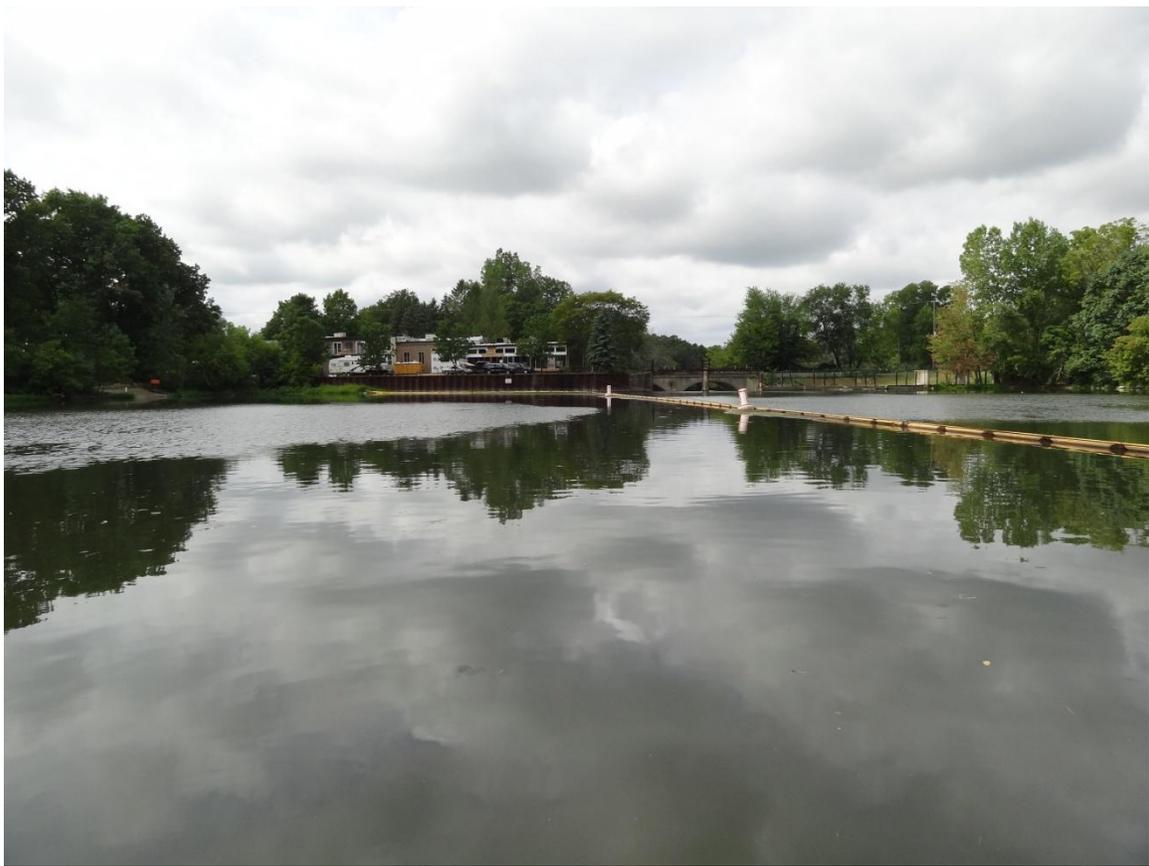
11. Ceresco Control Point, sheen and vegetative debris observed within containment.

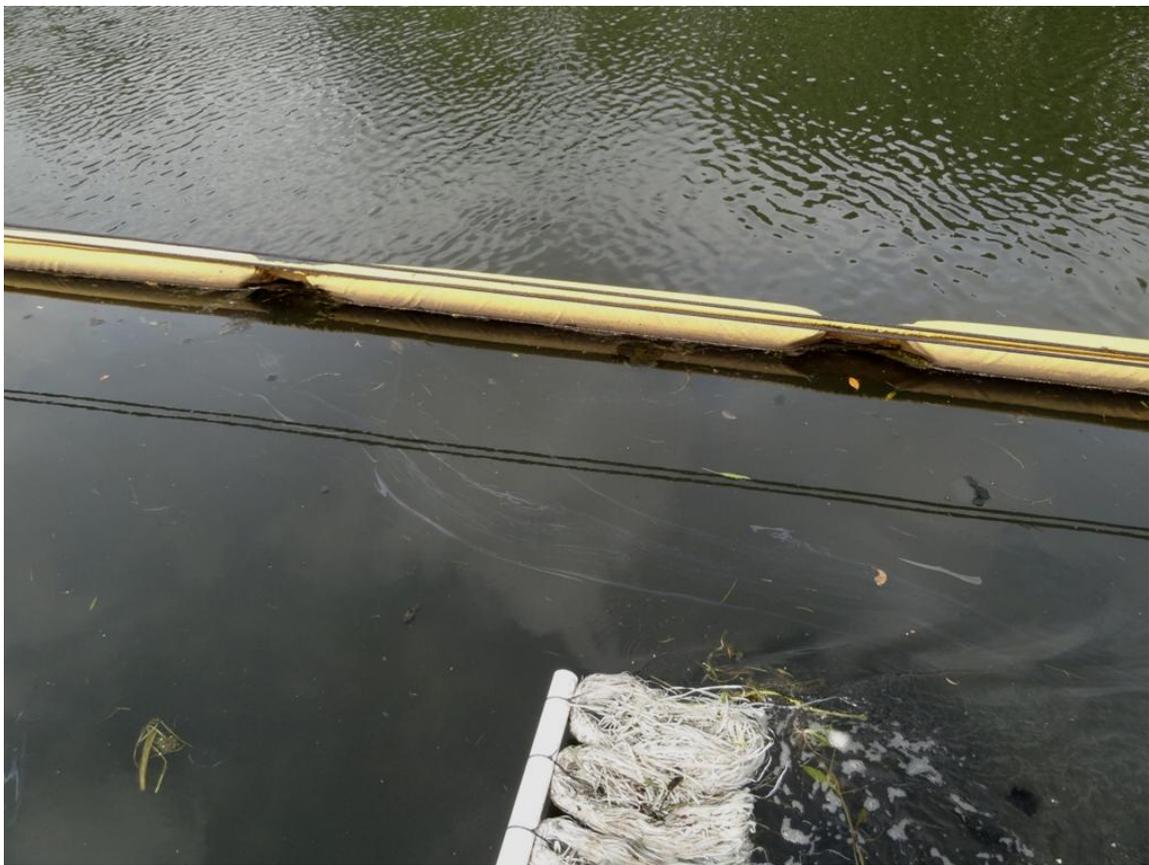
12. Ceresco Control Point, sheen observed at control point.

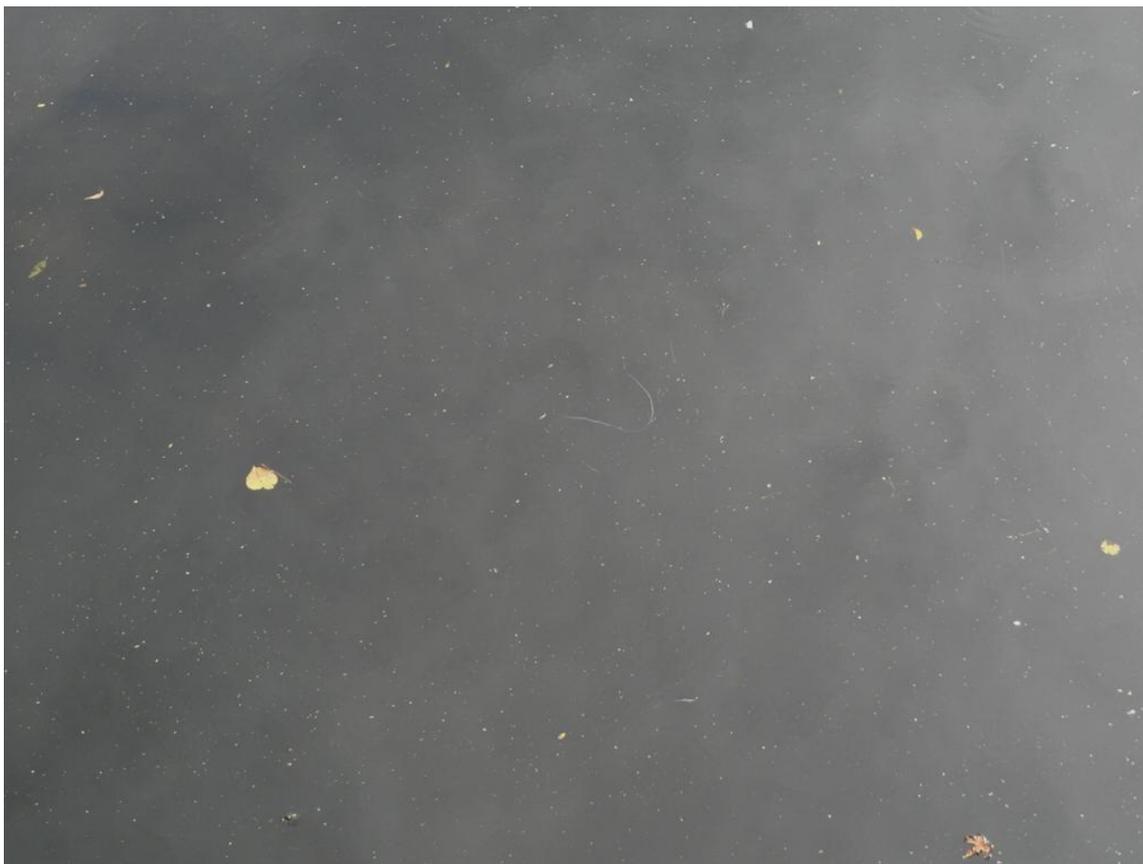
13. MP 21.50 RDB, few streamers of sheen observed from Custer Bridge. No response was required.

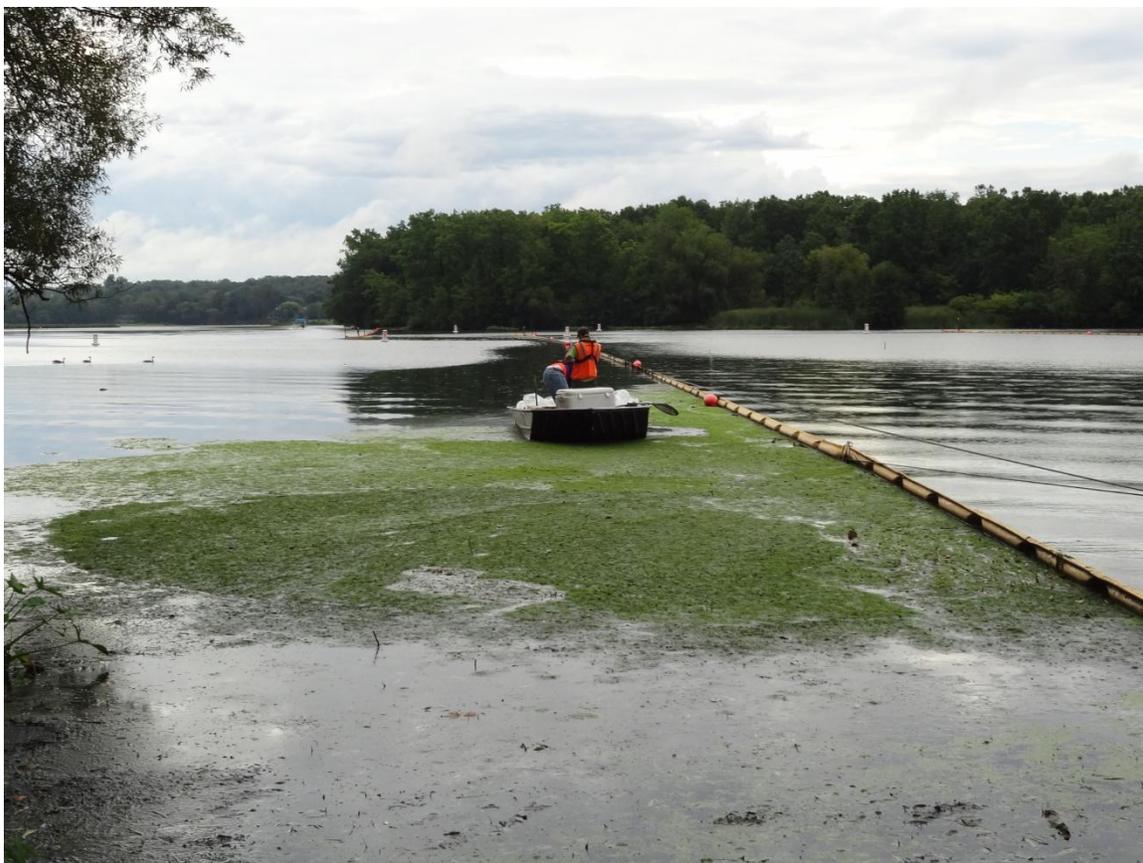
14. Morrow Lake Delta, crews observed removing vegetative debris from control point.

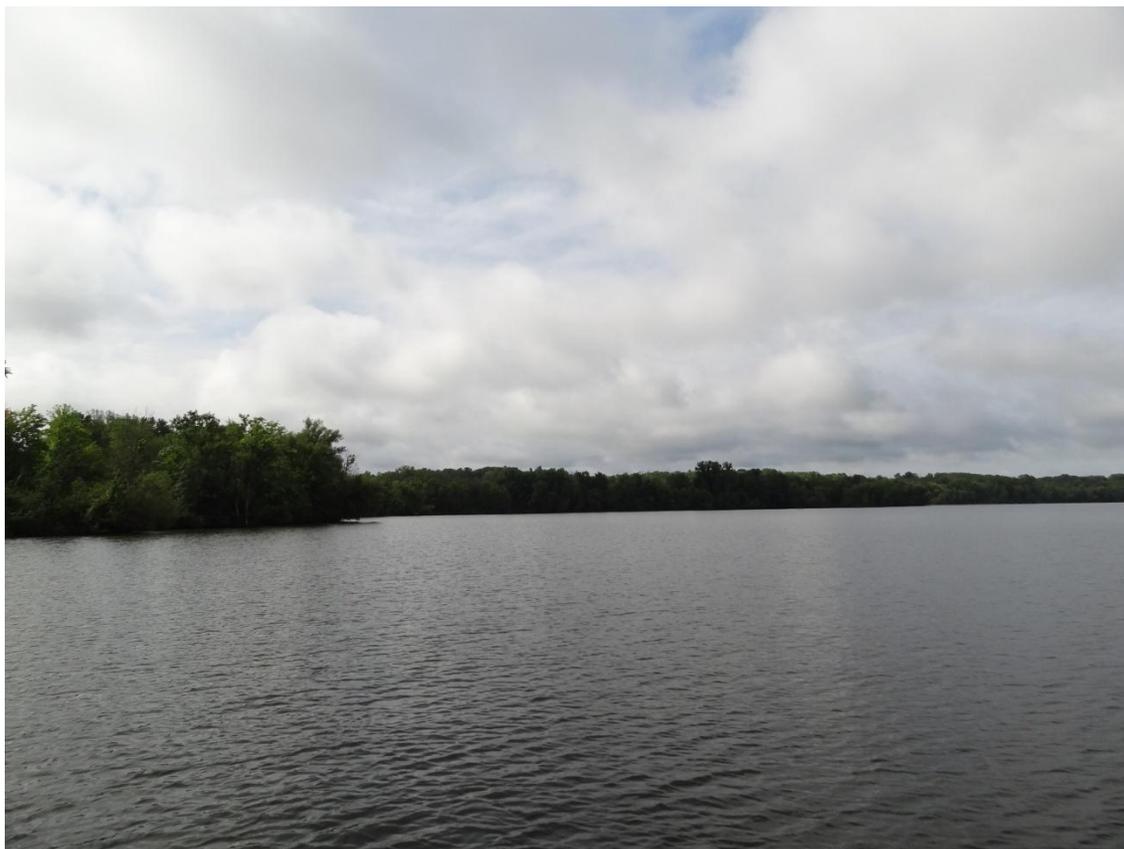
15. Morrow Lake South Cove, no sheen observed.

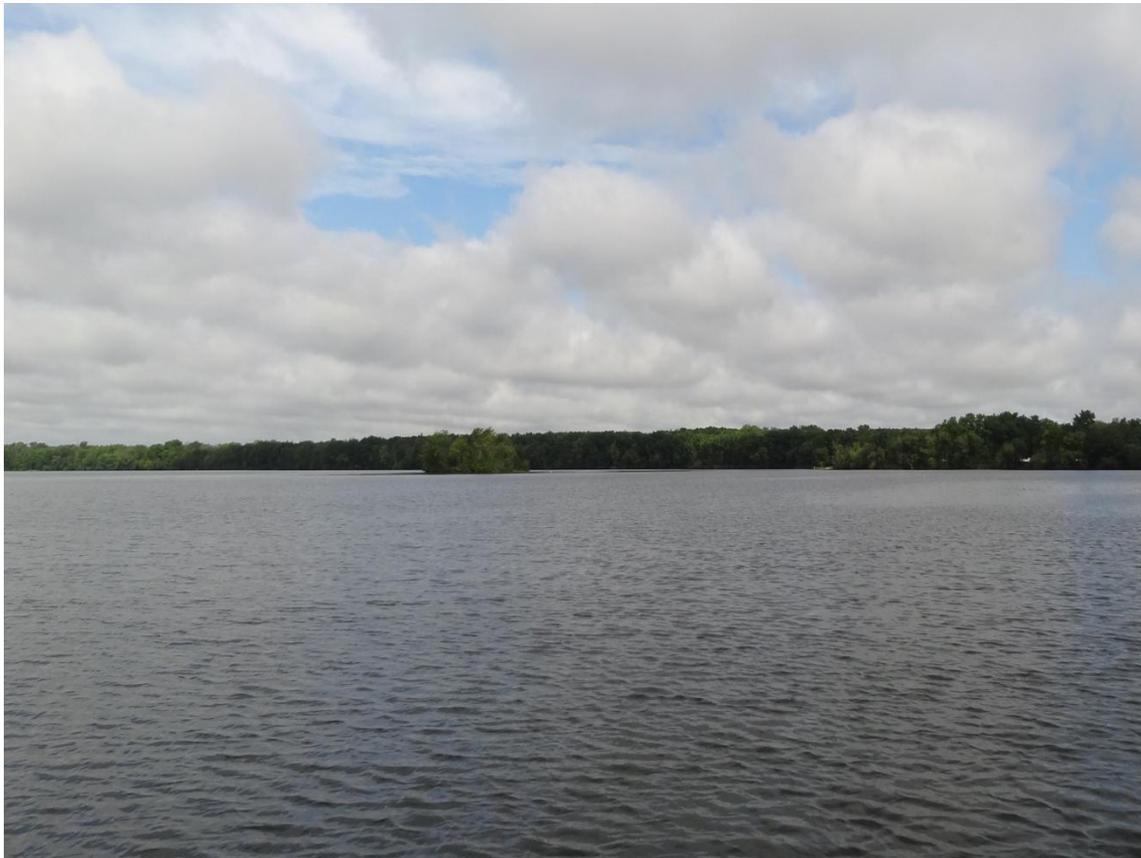
16. Morrow Lake Rowe Island, no sheen observed.

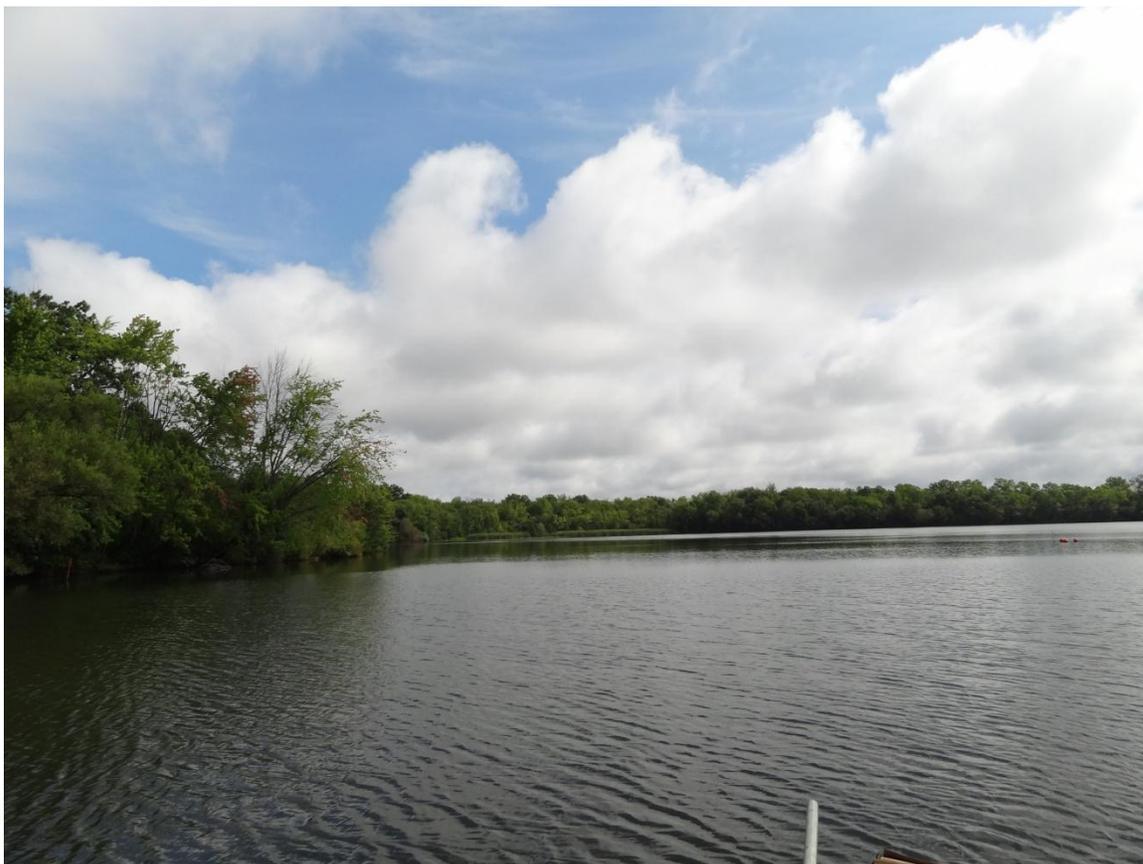
17. Morrow Lake North Cove, few random areas of sheen observed. No response was required.

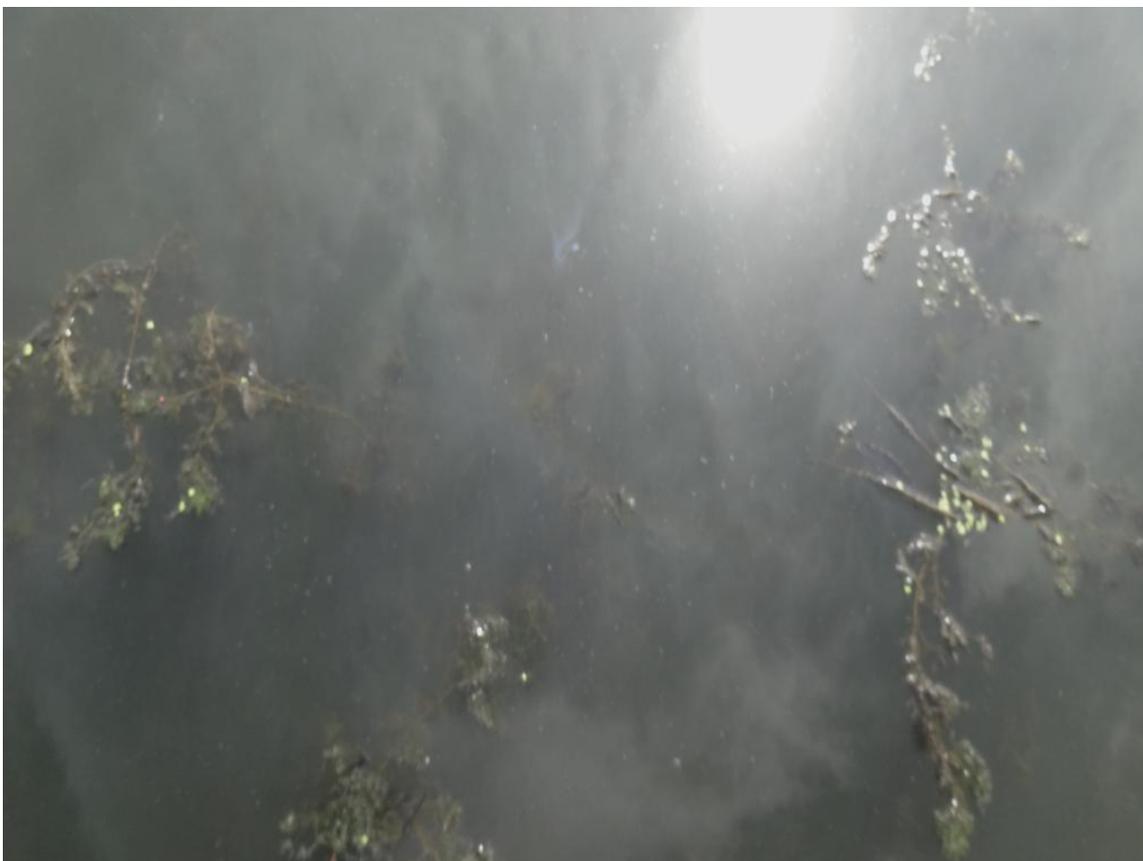
18. Morrow Lake North Cove, random sheen observed.
