# Situation Photo Log

Wednesday, September 5, 2012

Kalamazoo River / Enbridge Spill

Prepared by:  
Larry Rader  
START-USEPA  
Situation Unit Leader

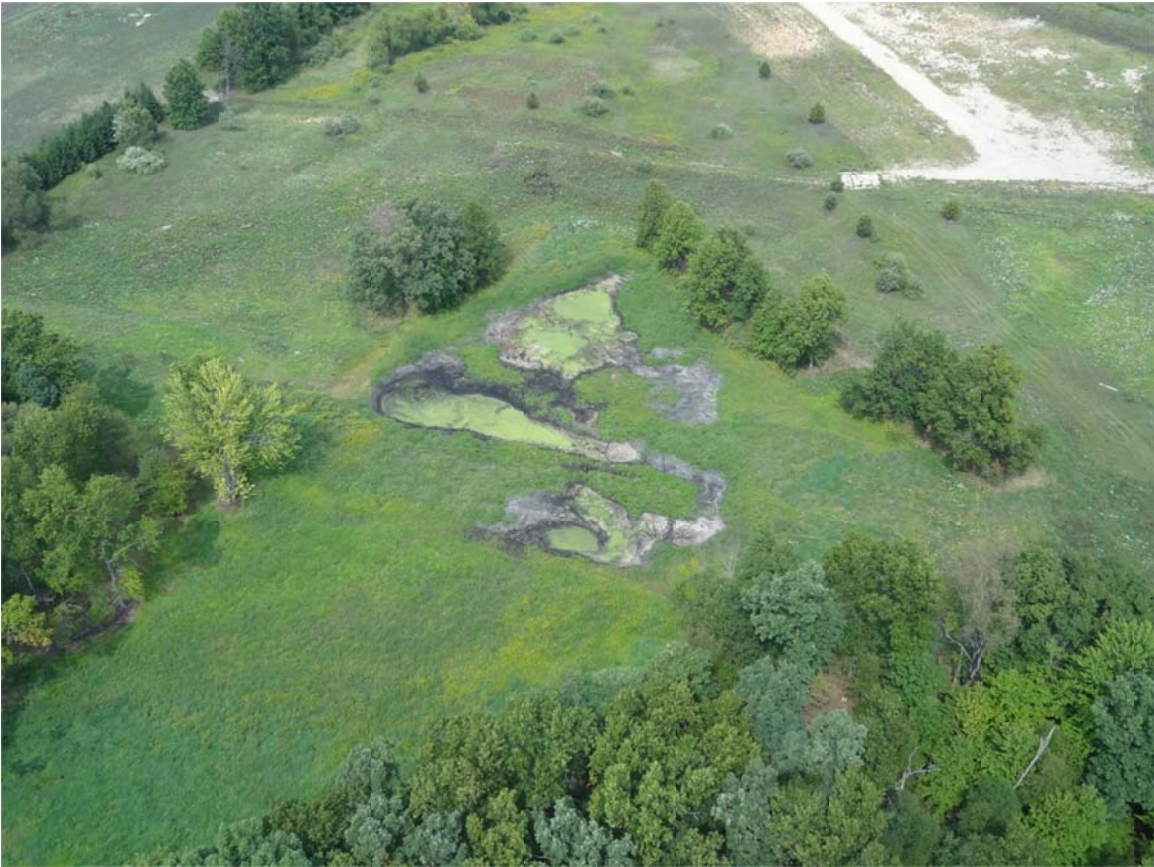
1. Source Area, no sheen observed.

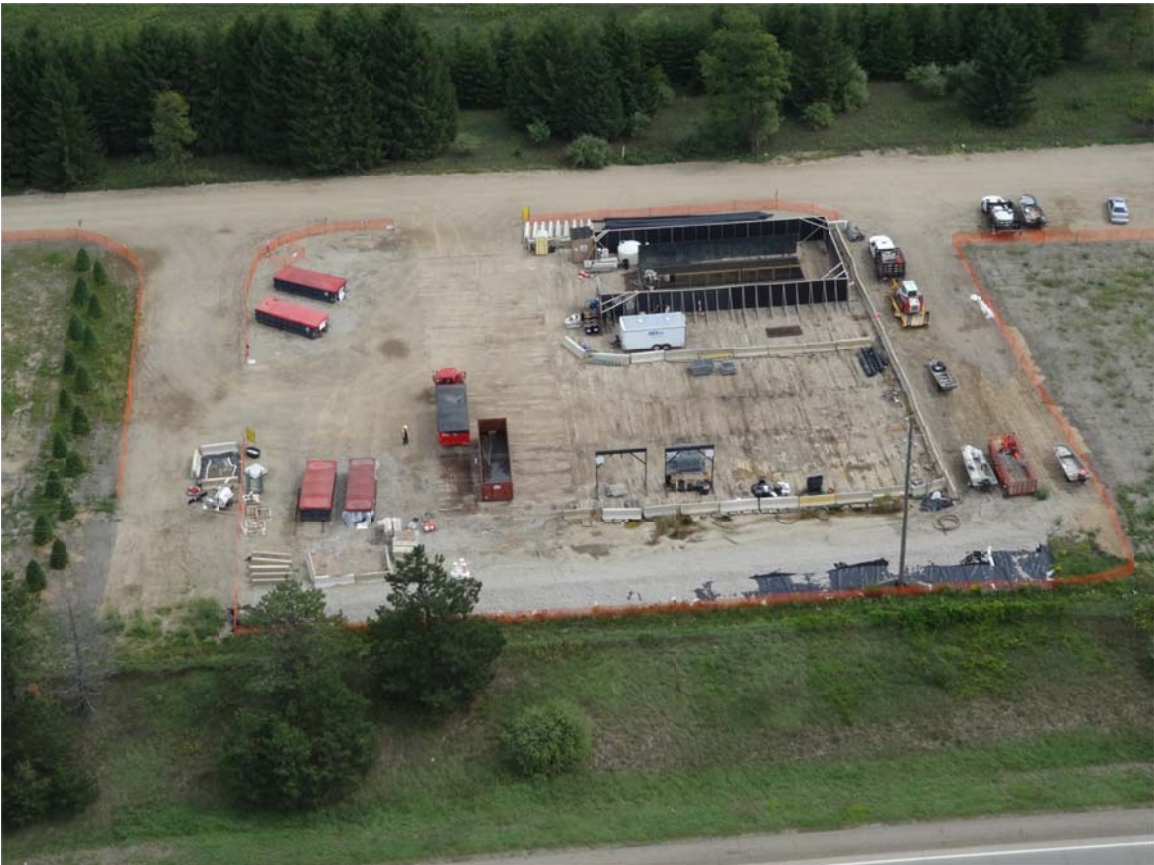
2. Frac Tank City decontamination pad, containment boom staged in decon pad.

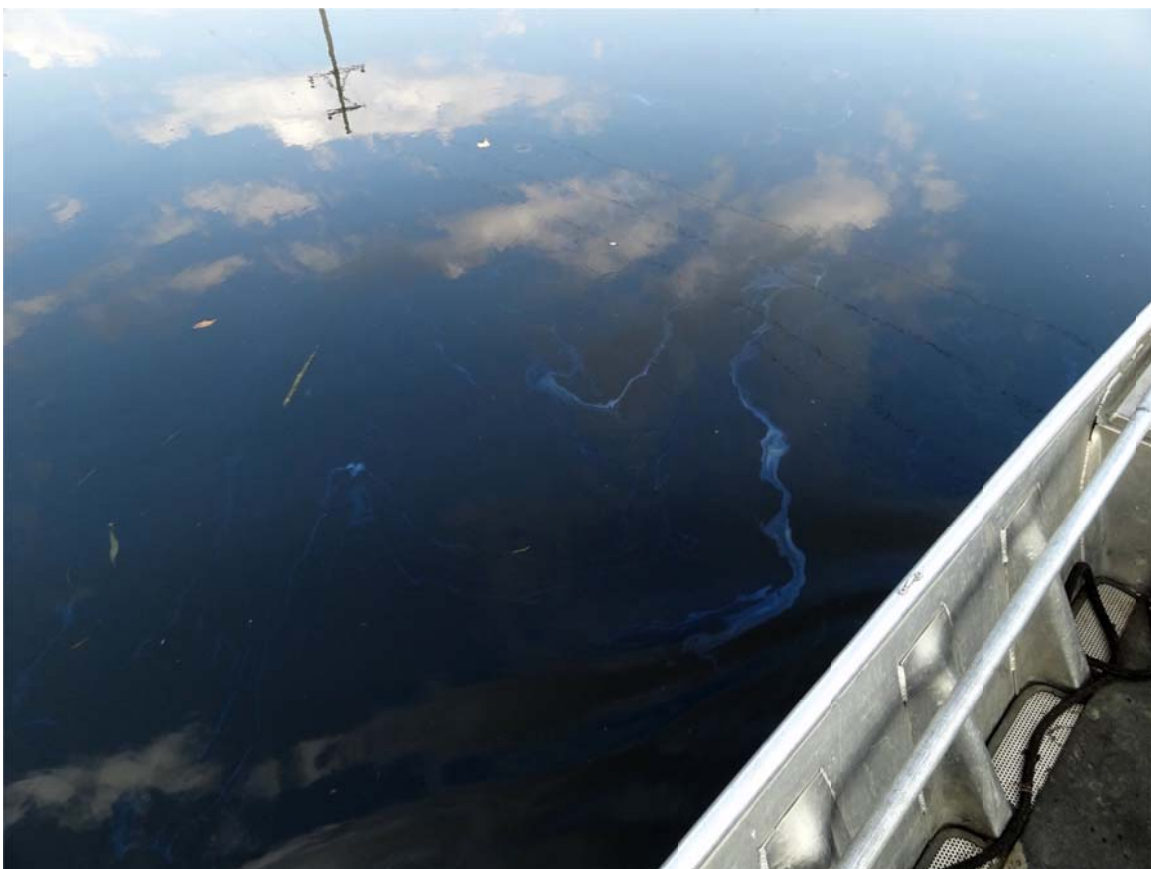
3. Sheen and tar globules observed near MP 5.5 LDB above Ceresco Dam.

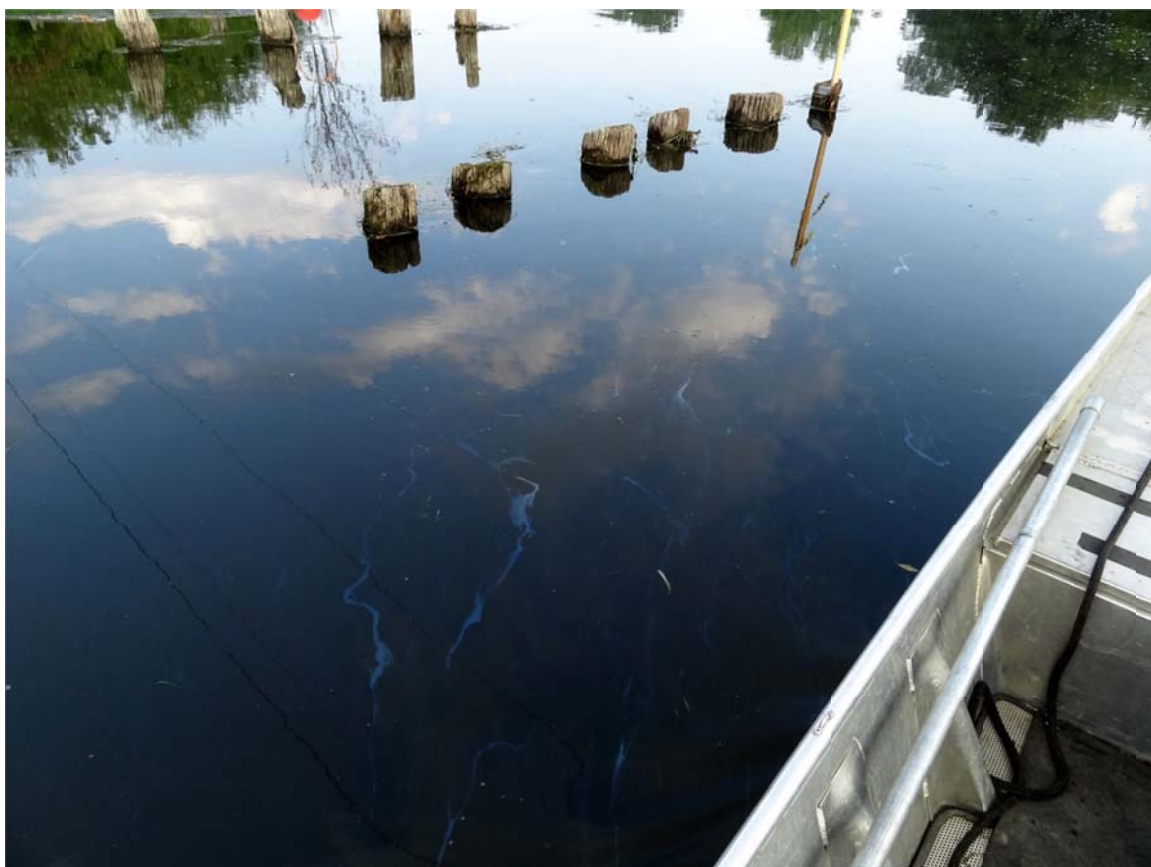
4. Sheen and tar globules observed at trestle above Ceresco Dam.

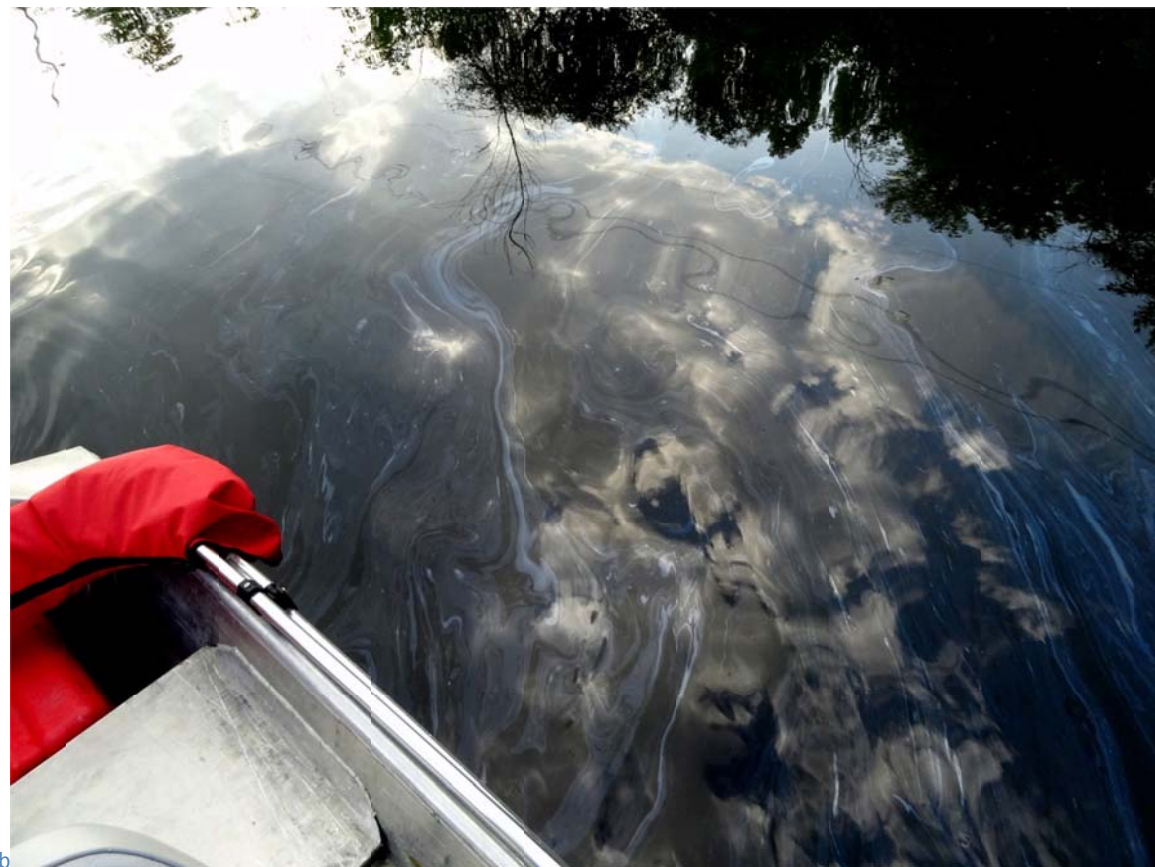
5. MP 5.75 river channel, rainbow sheen and tar globs observed downstream from trestle above Ceresco Dam.

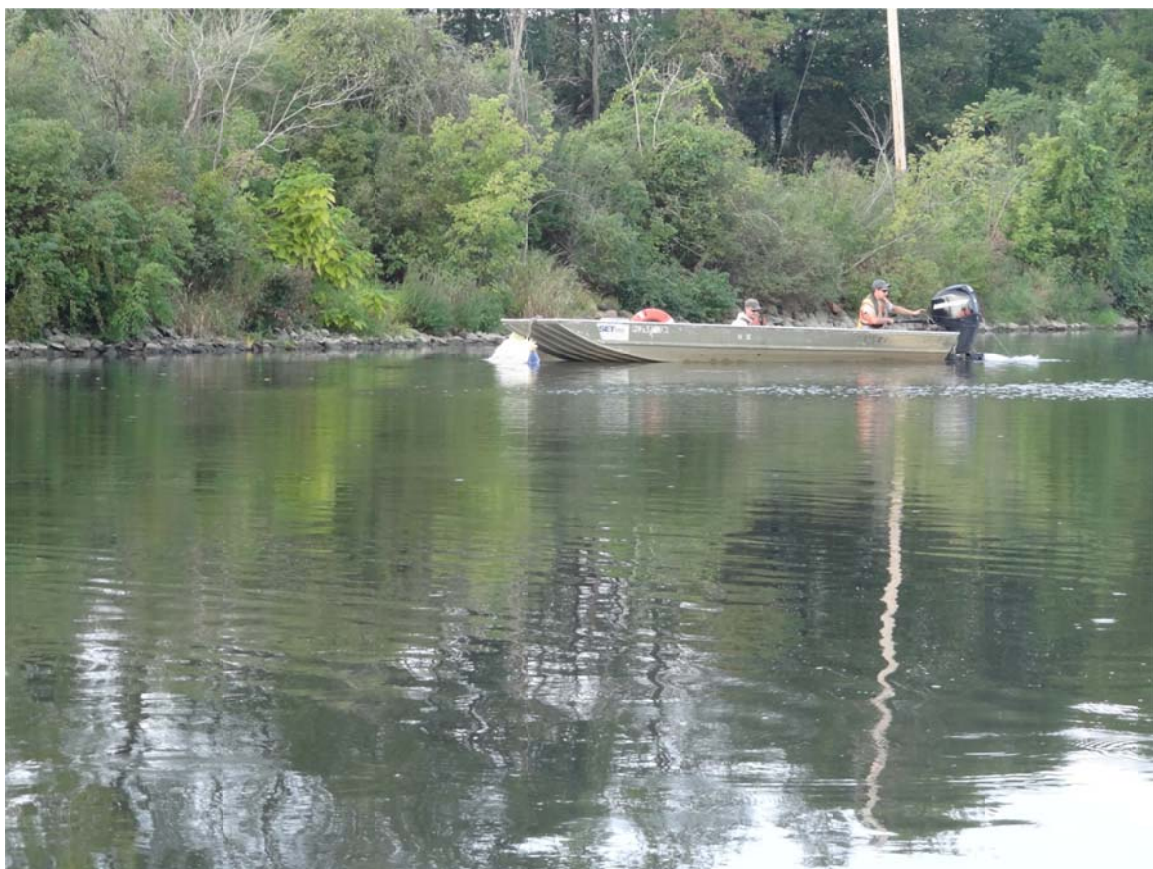
6. Sheen sweeper boat operating at MP 5.75 LDB above Ceresco Dam.

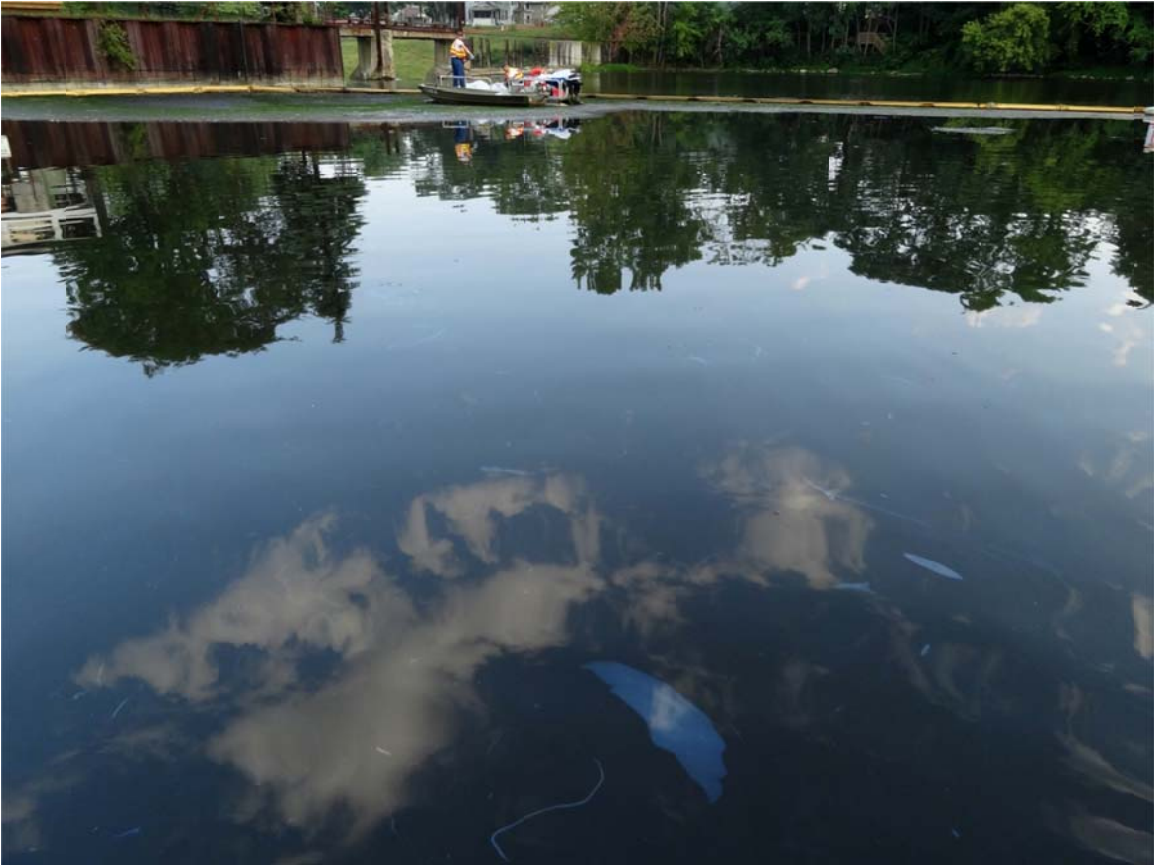
7. Ceresco Dam, observed sheen and crew removing debris from the control point.

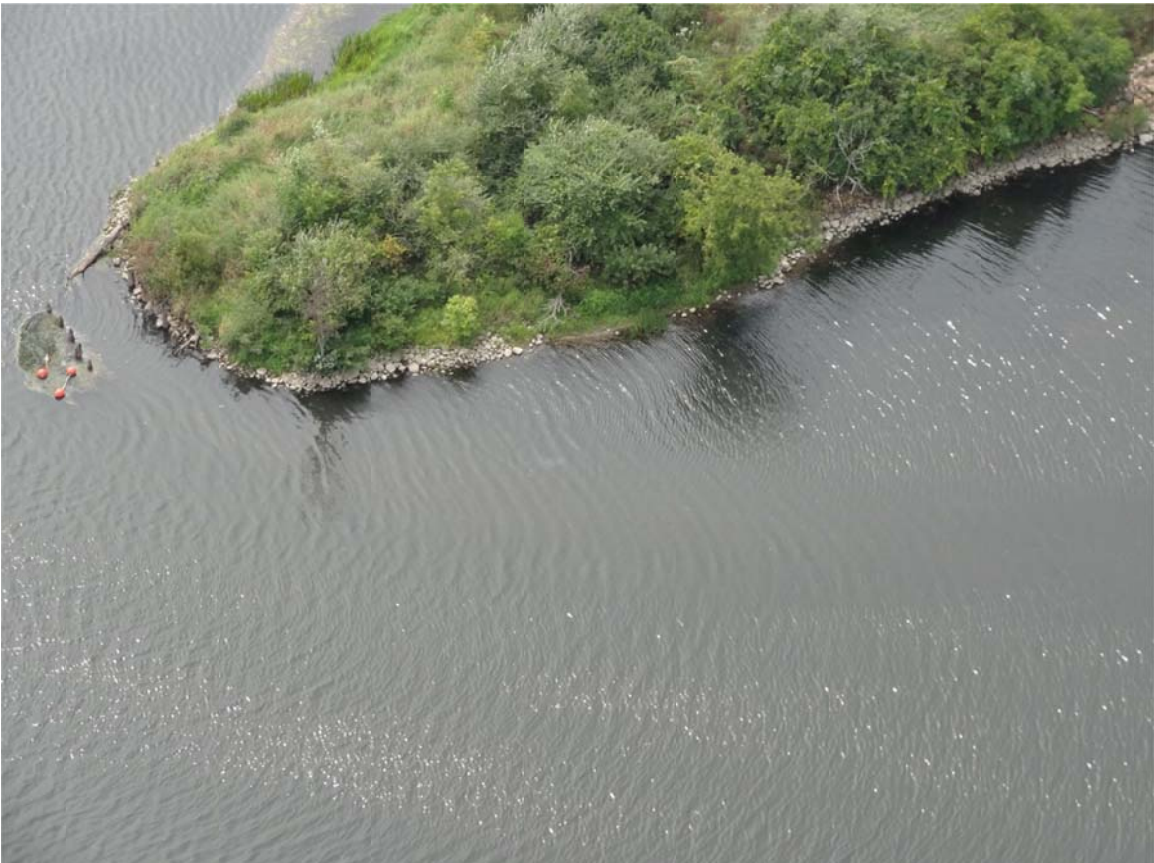
8. MP 5.75 LDB, sheen observed downstream from peninsula.

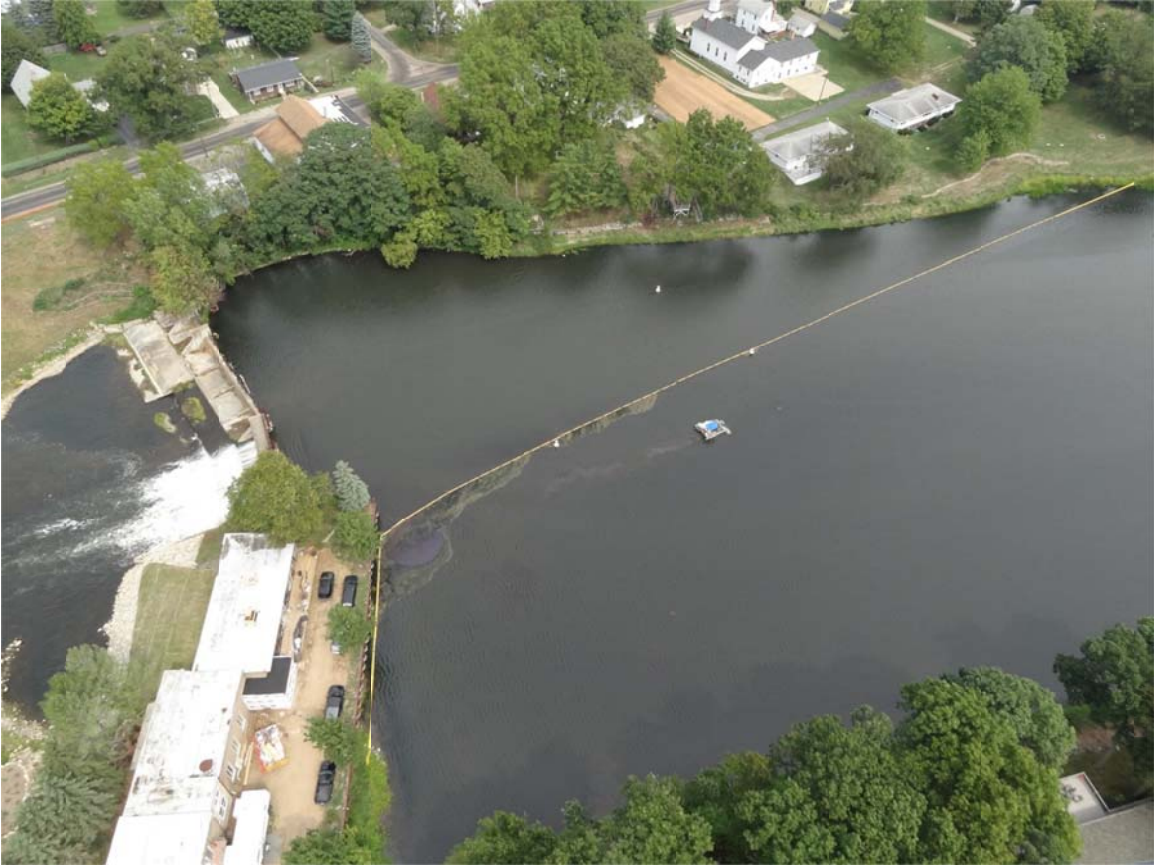
9. Ceresco Dam, observed sheen sweeper observed collecting sheen within containment.

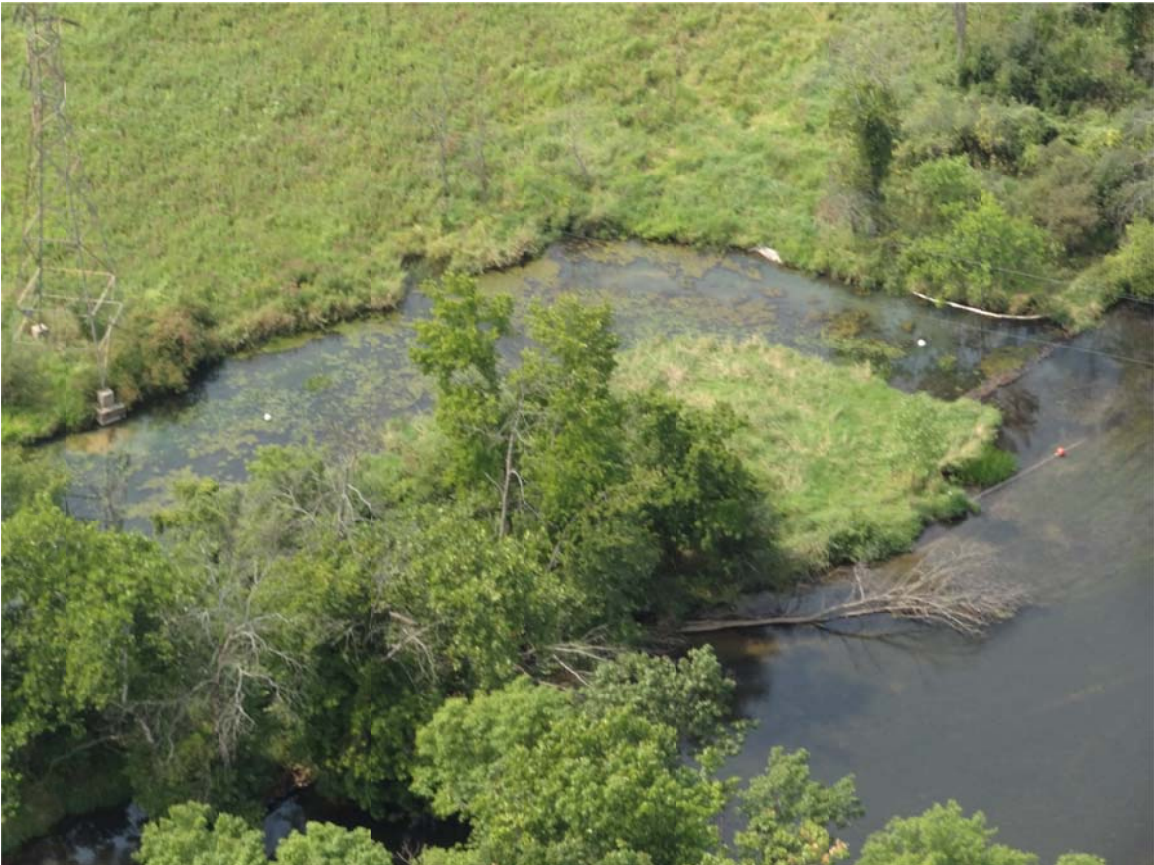
10. MP10.75 no sheen observed.

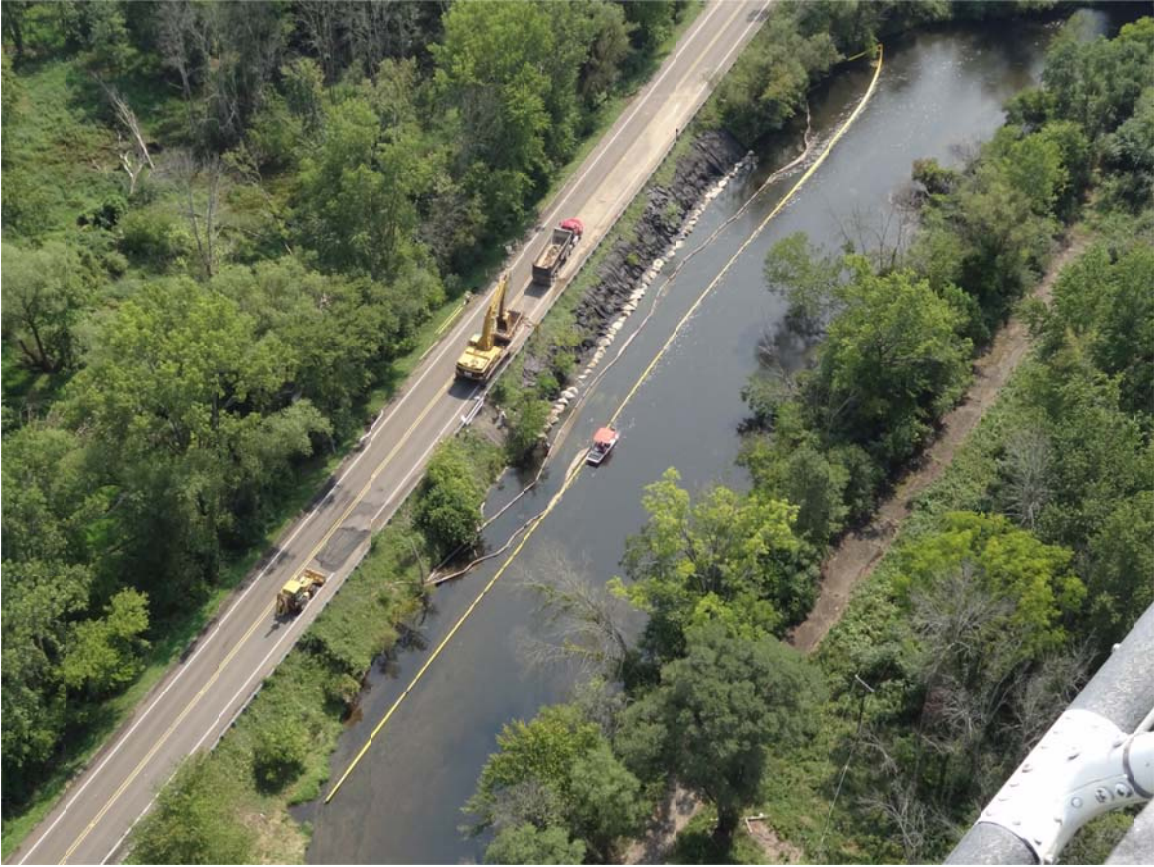
**11. Shoreline restoration work observed along west side of Raymond Road.**

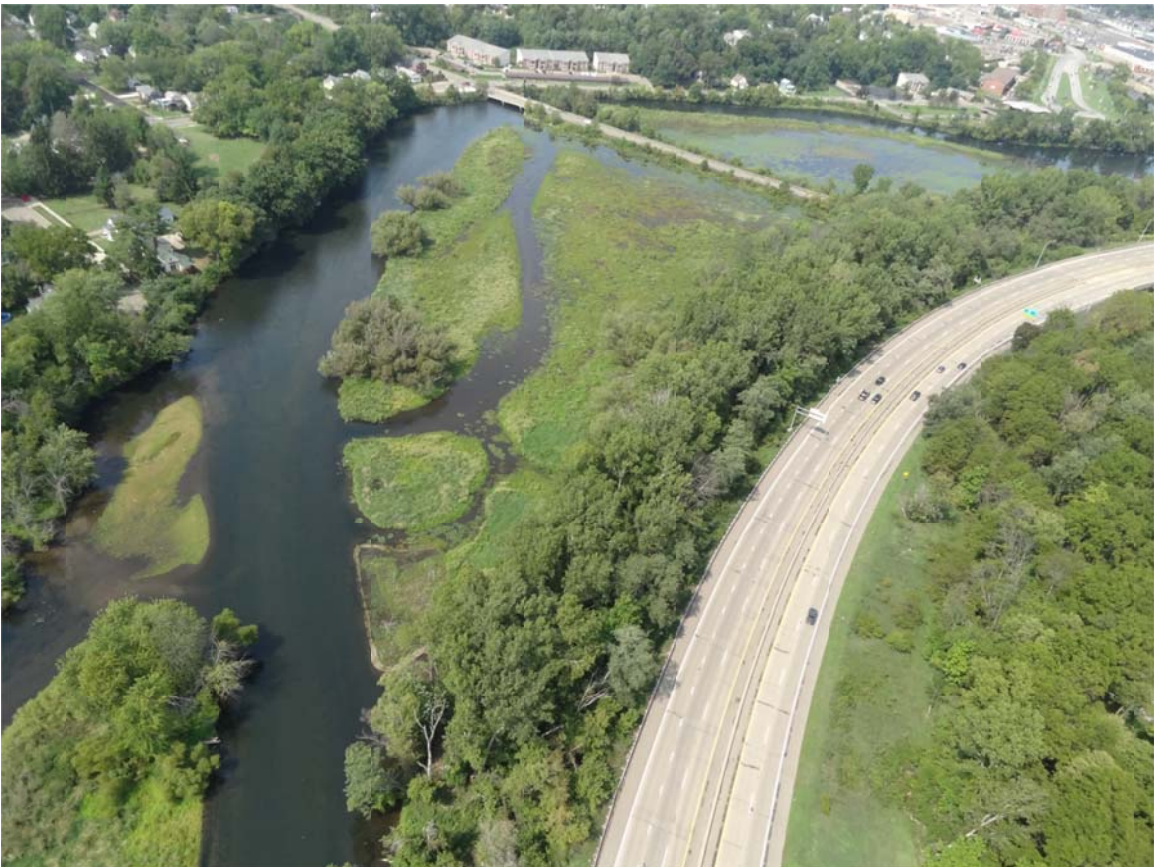
**12. South Mill Pond, no sheen observed.**

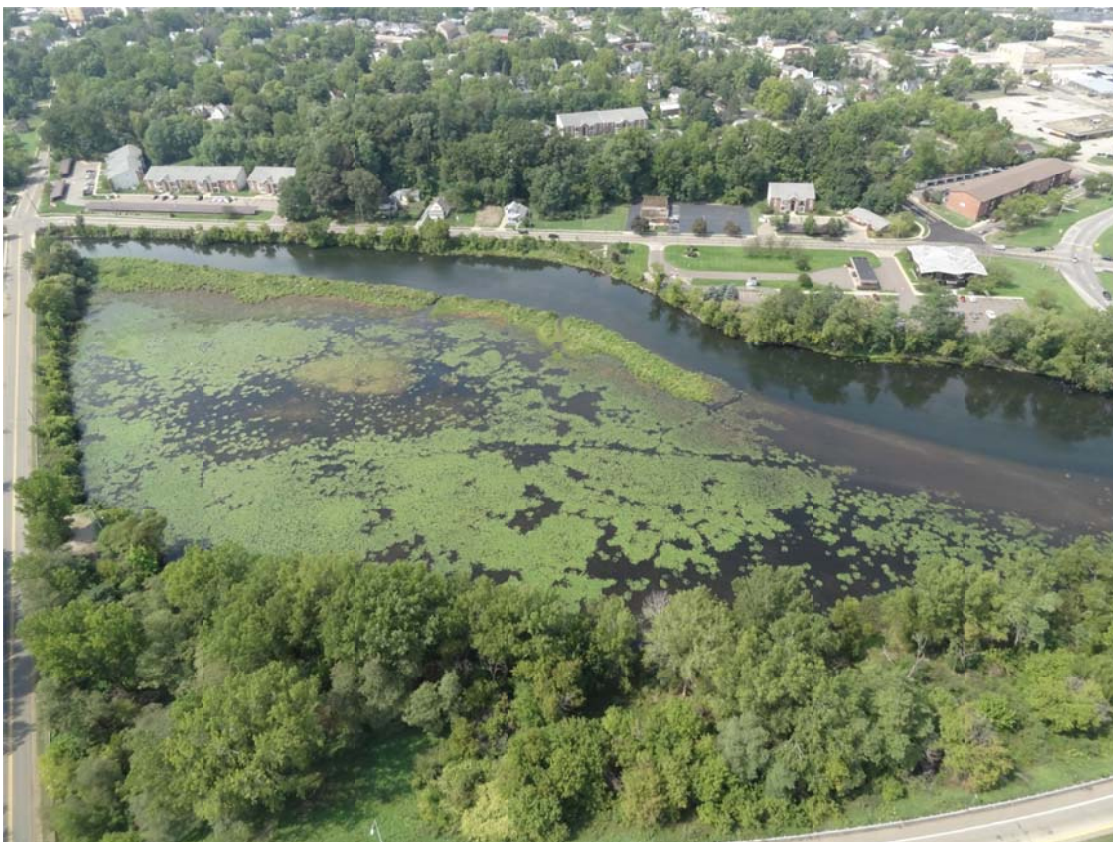
13. MP15.75 north Mill Pond, no sheen observed.

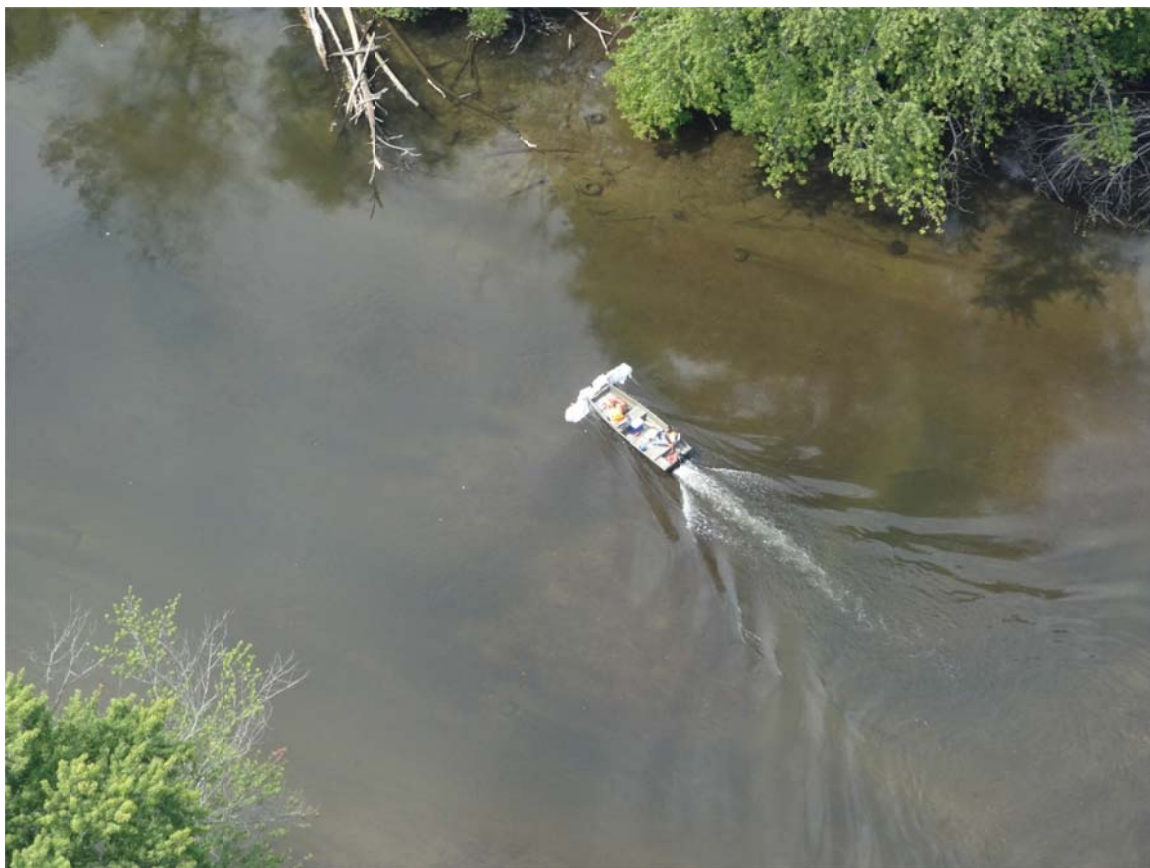
14. Observed sweeper boat heading upstream at MP 22.0.

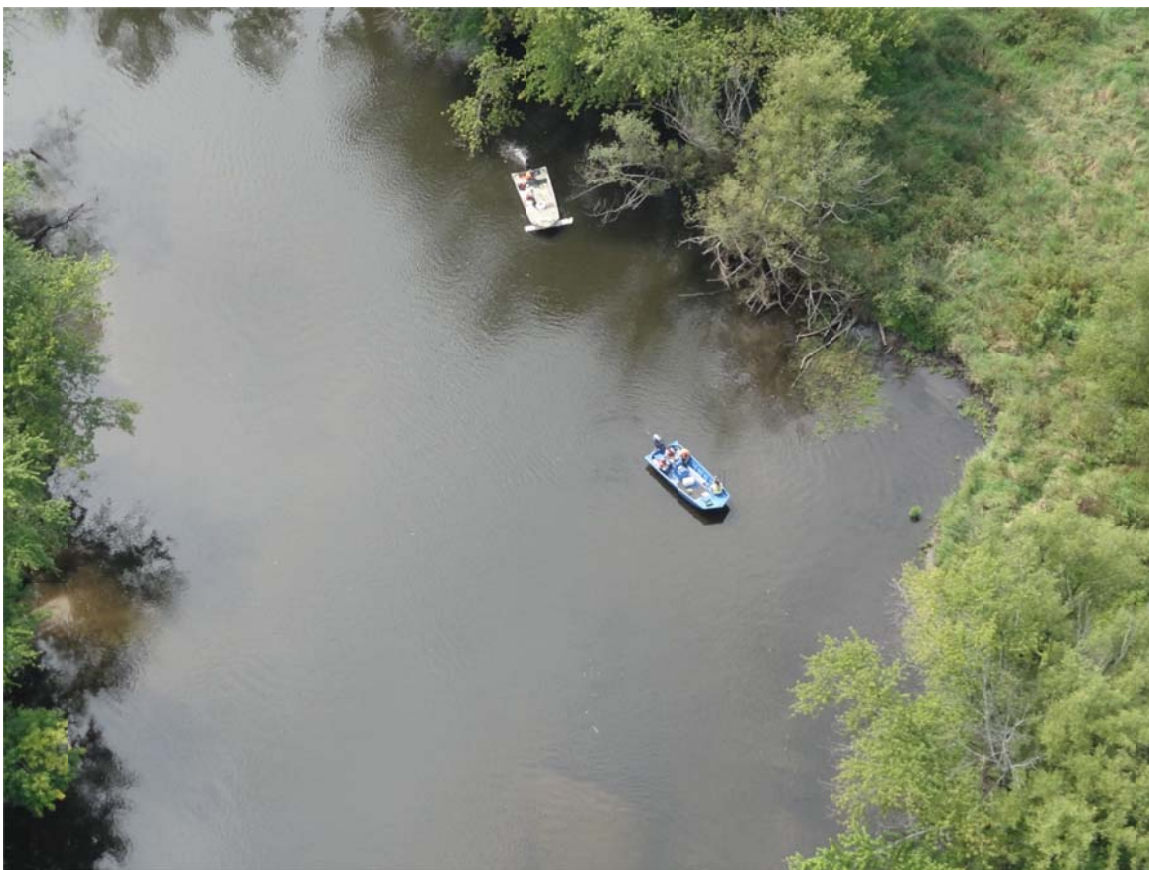
15. MP33.0 A, observed sediment trap survey crew and sweeper boat.

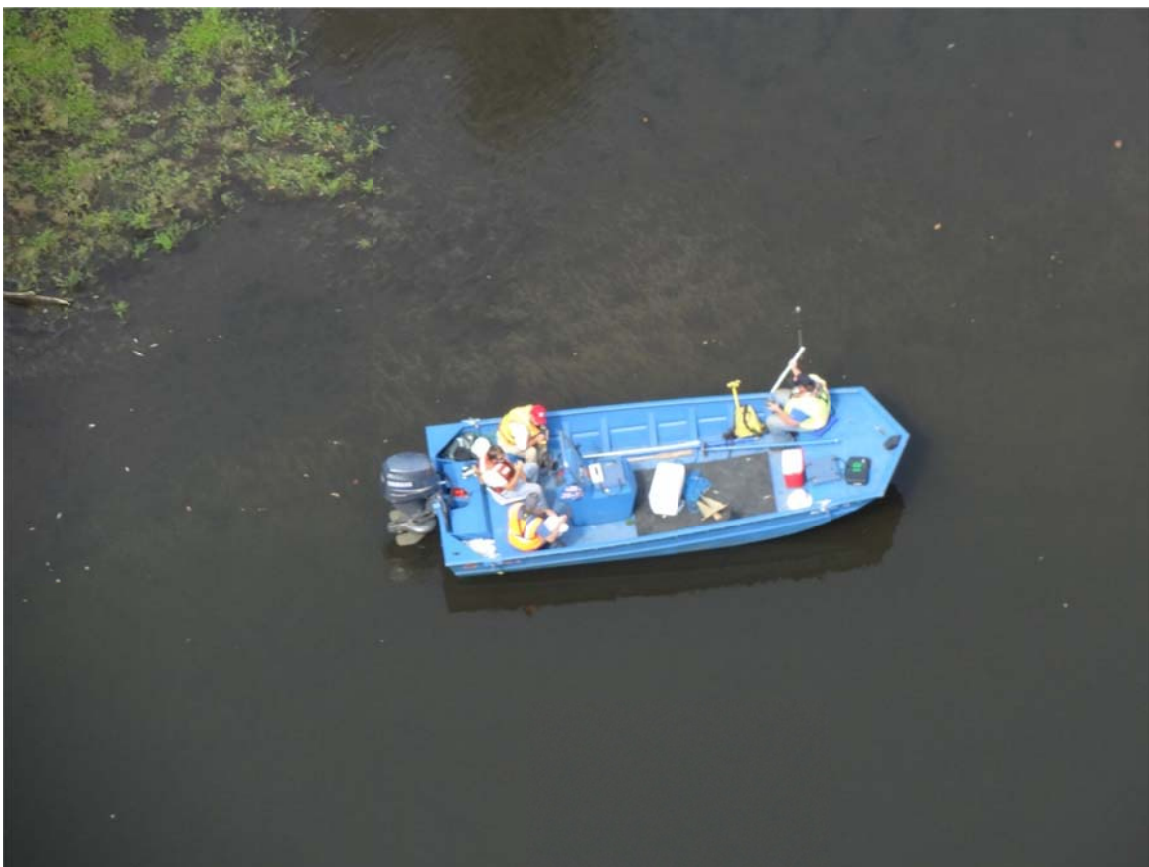
16. Sediment trap poling crew observed at MP 33.0 A.

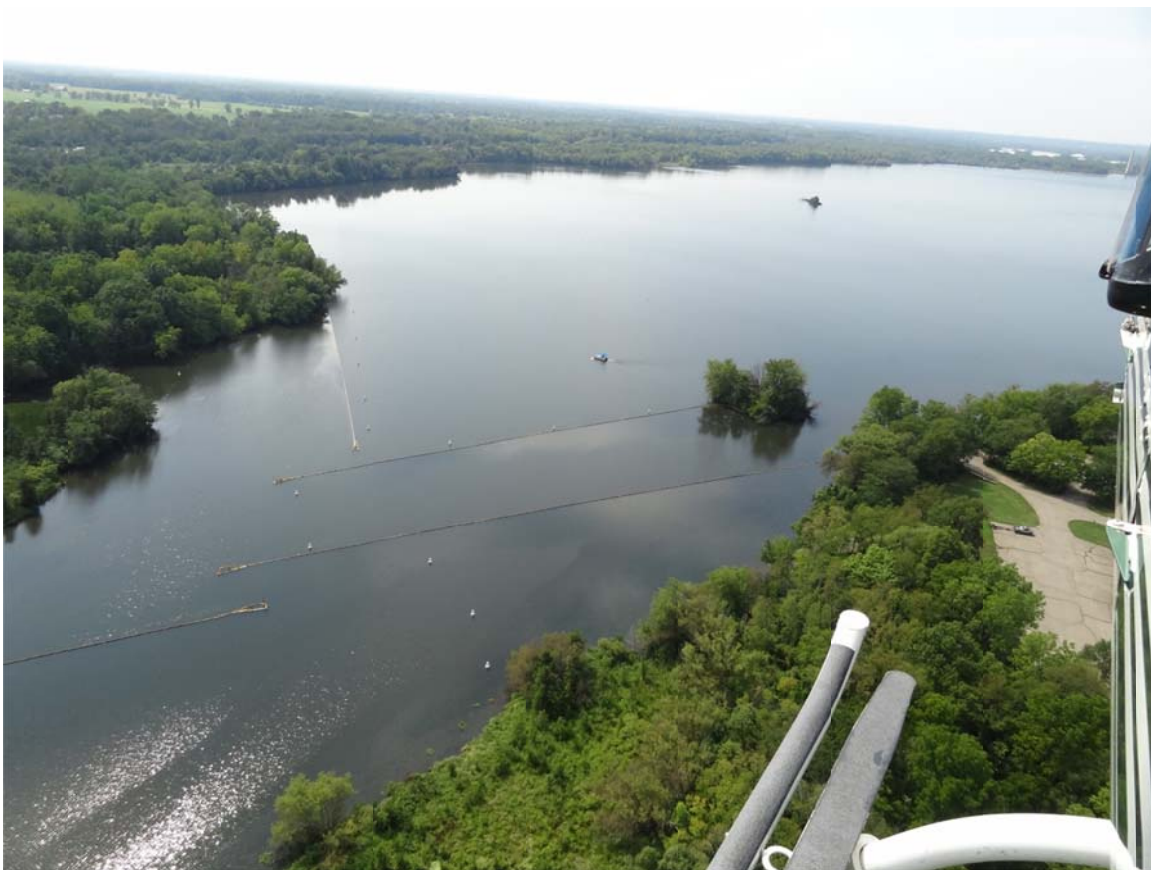
17. E 4.0 containment structure, some sheen and debris observed within containment.

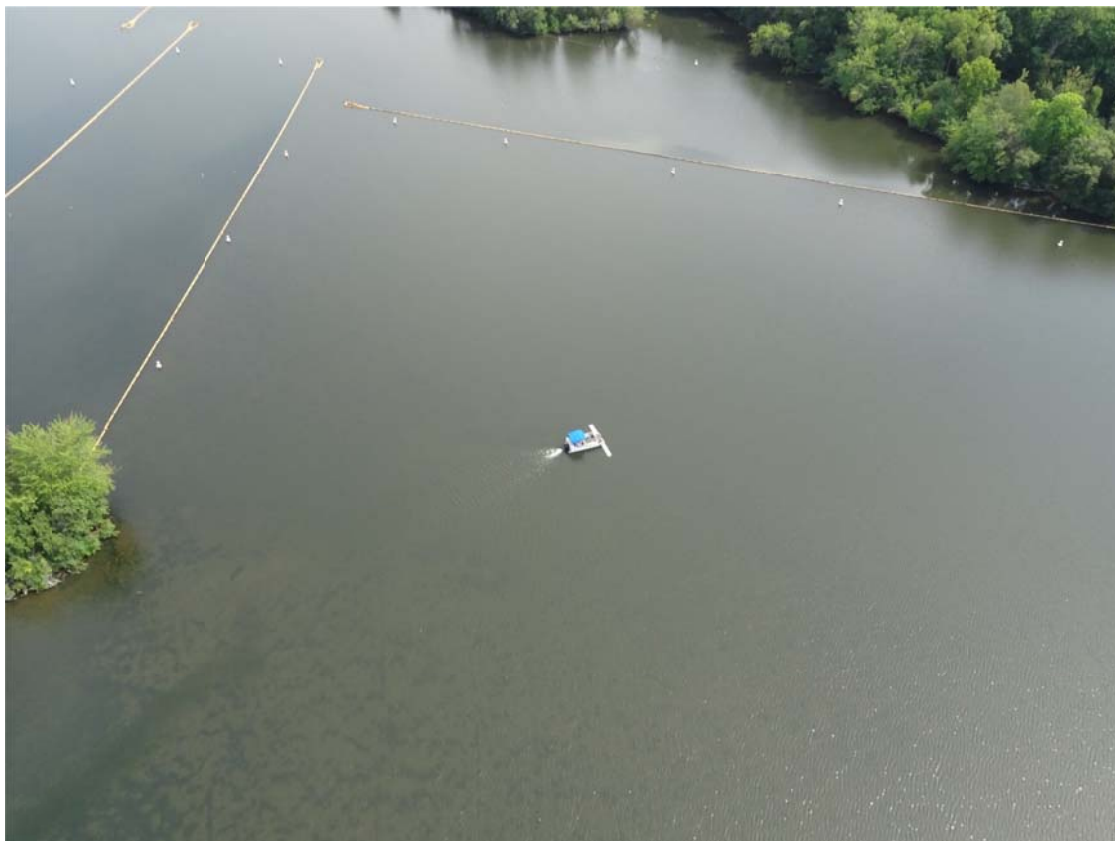
18. Sheen sweeper pontoon heading to south cove of Morrow Lake.

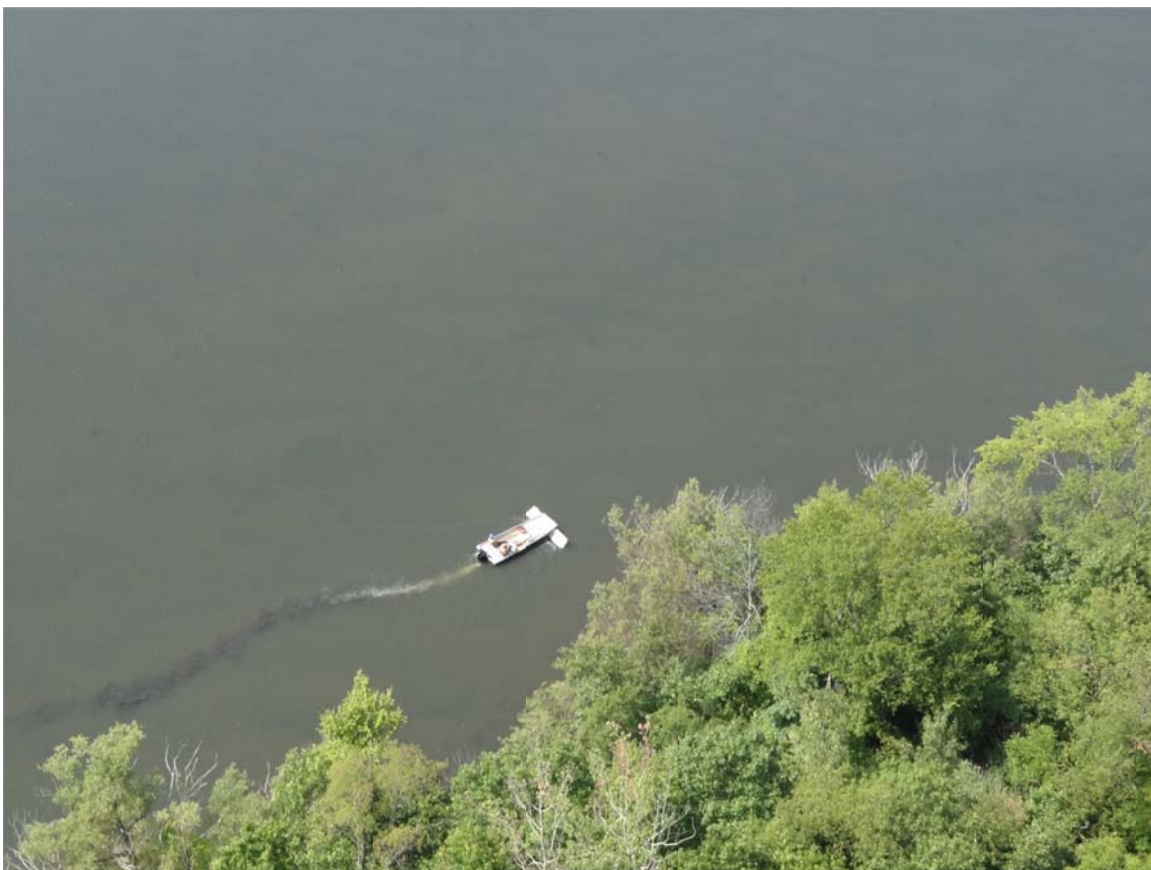
19. Sweeper boat operating in north cove on Morrow Lake.

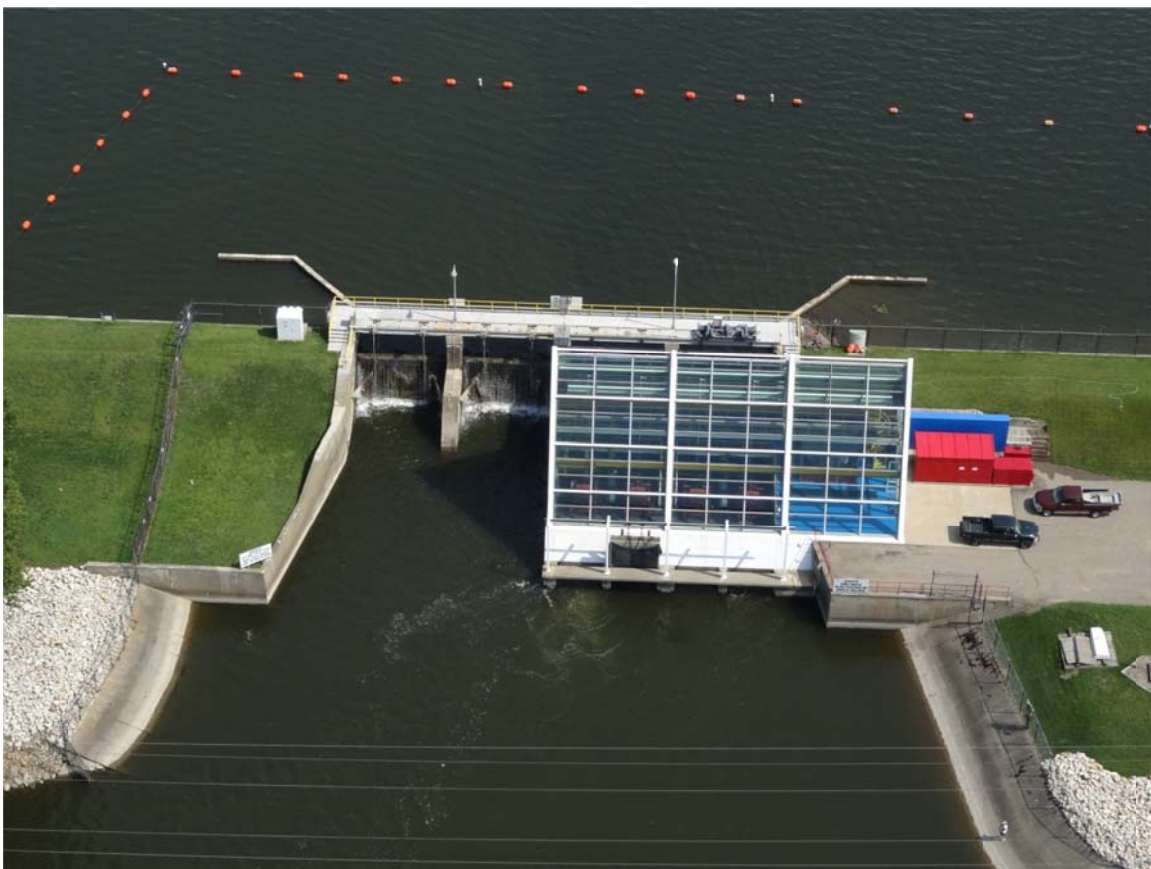
20. Close up of Morrow Lake Dam.
