# Situation Photo Log

Thursday, September 6, 2012

Kalamazoo River / Enbridge Spill

Prepared by:  
Larry Rader  
START-USEPA  
Situation Unit Leader

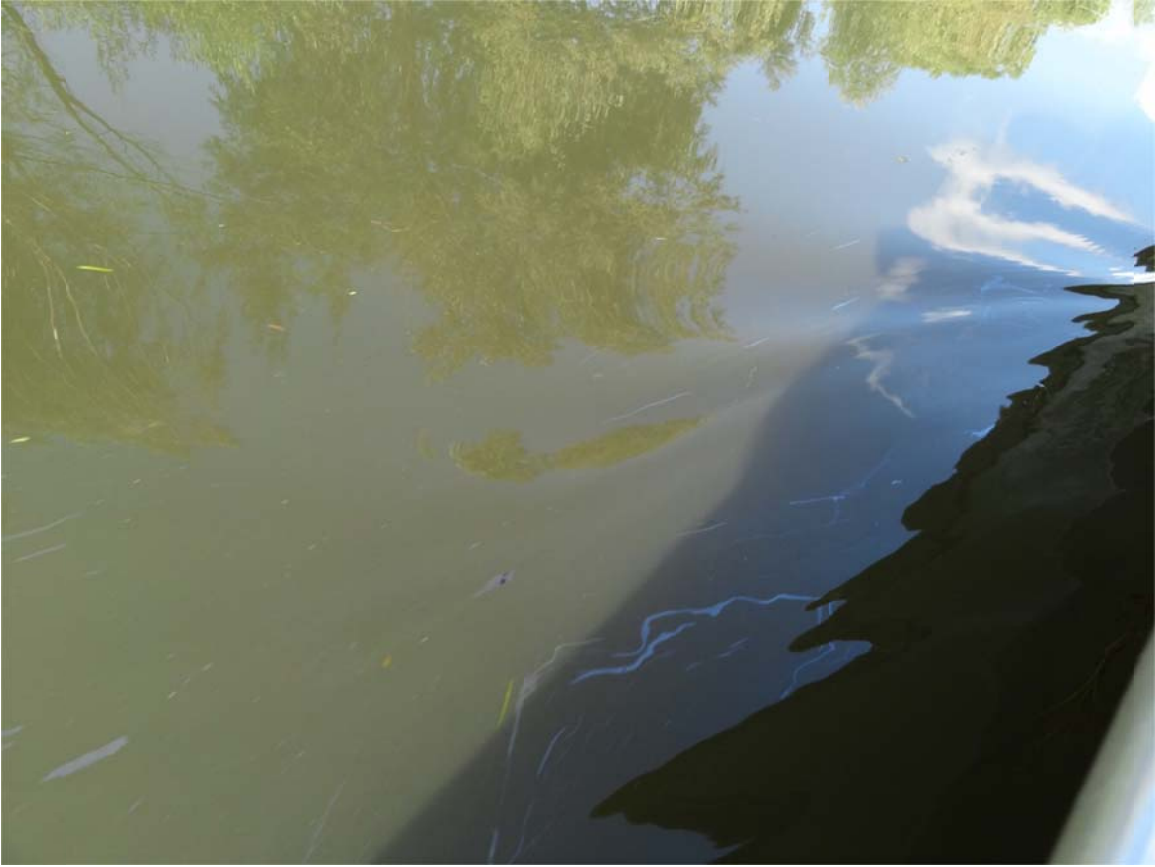
1. Tar globules and sheen observed near MP 5.25 LDB above Ceresco Dam.

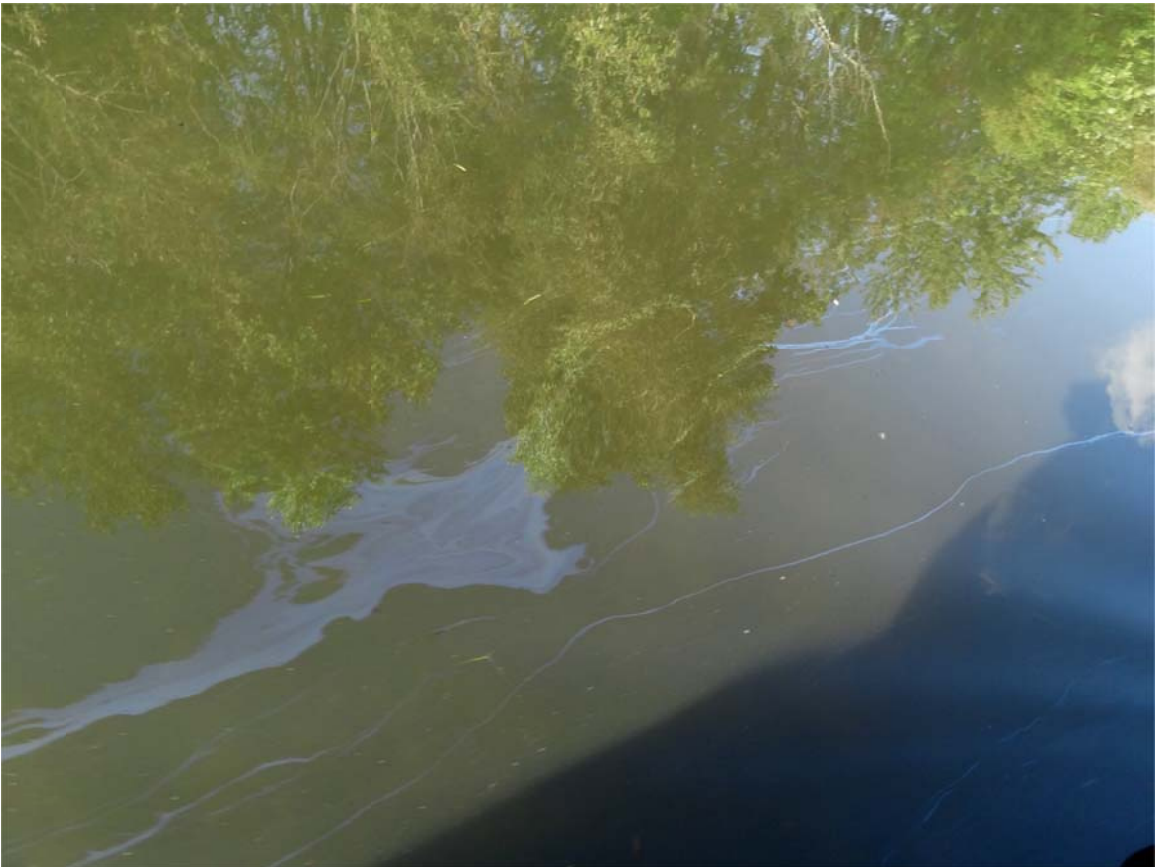
2. Sheen and tar globules observed near MP 5.5 LDB above Ceresco Dam.

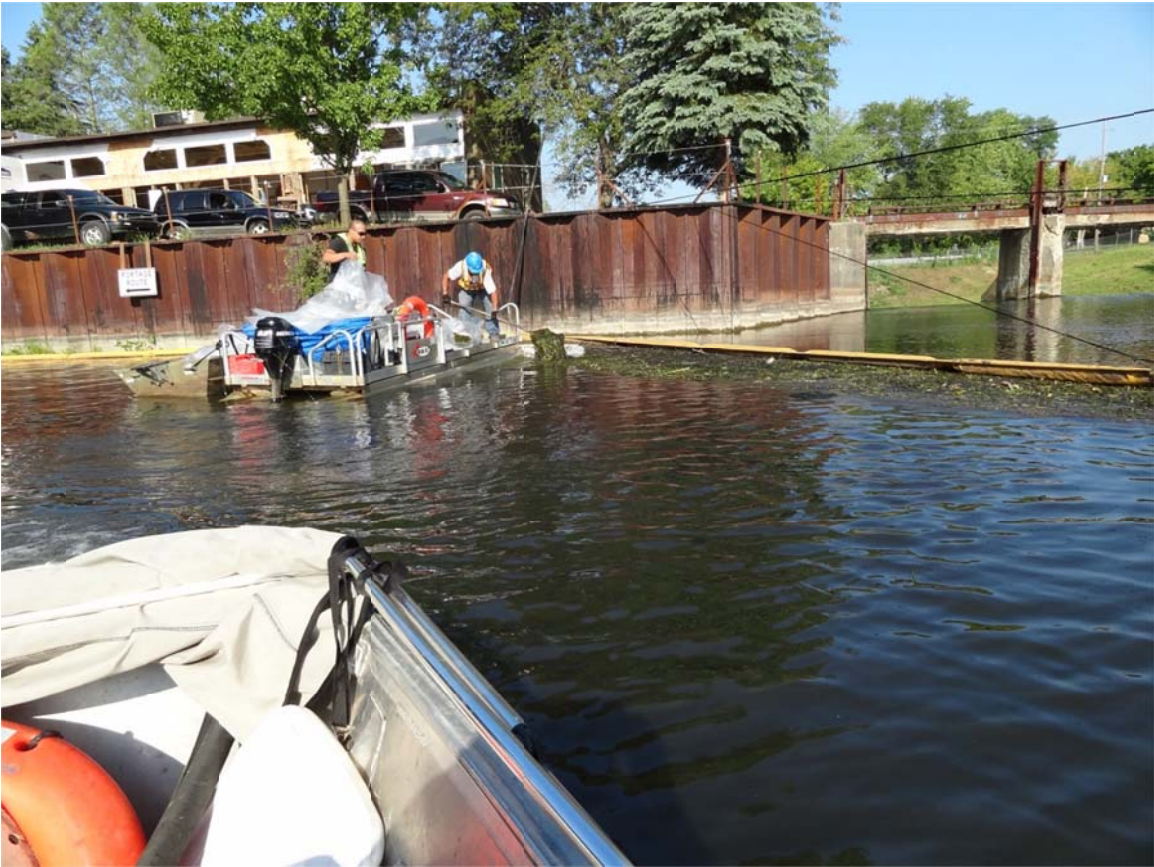
3. Vegetation removal from containment point above Ceresco Dam.

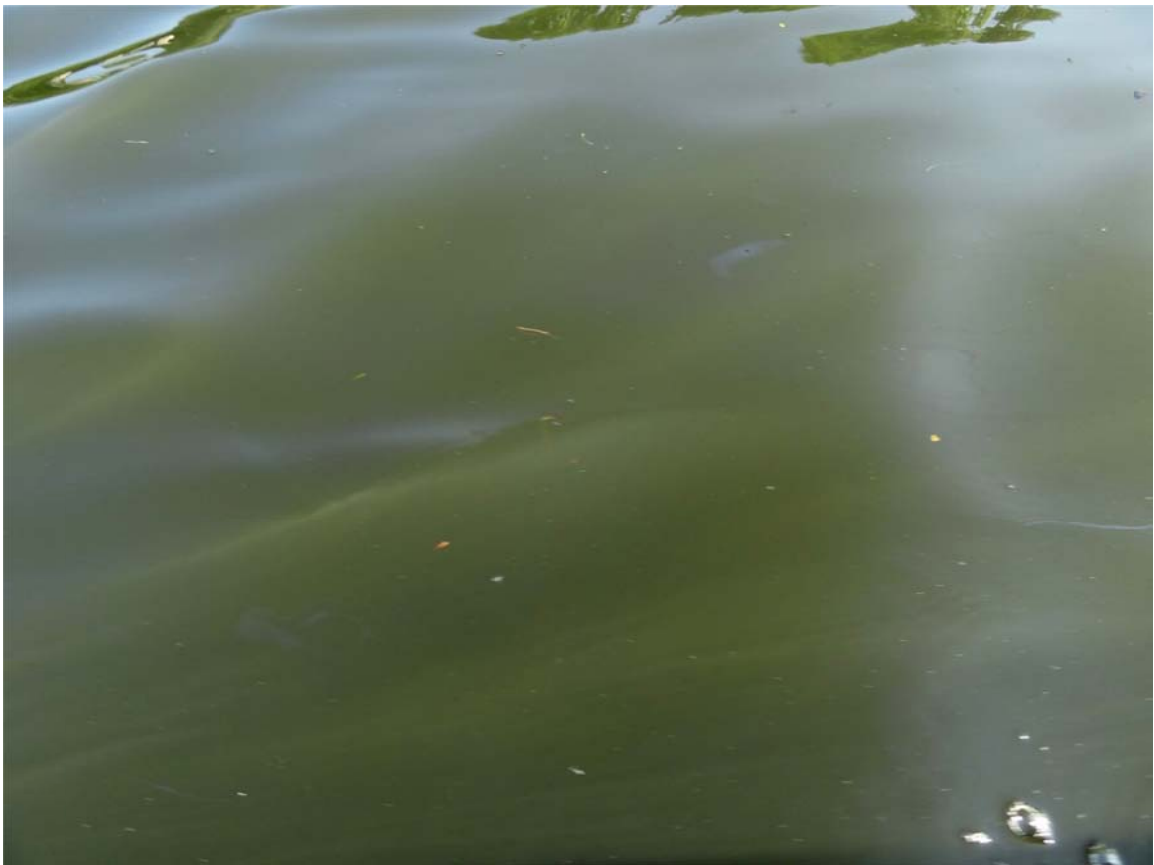
4. Sheen and tar globules observed along containment boom above Ceresco Dam.

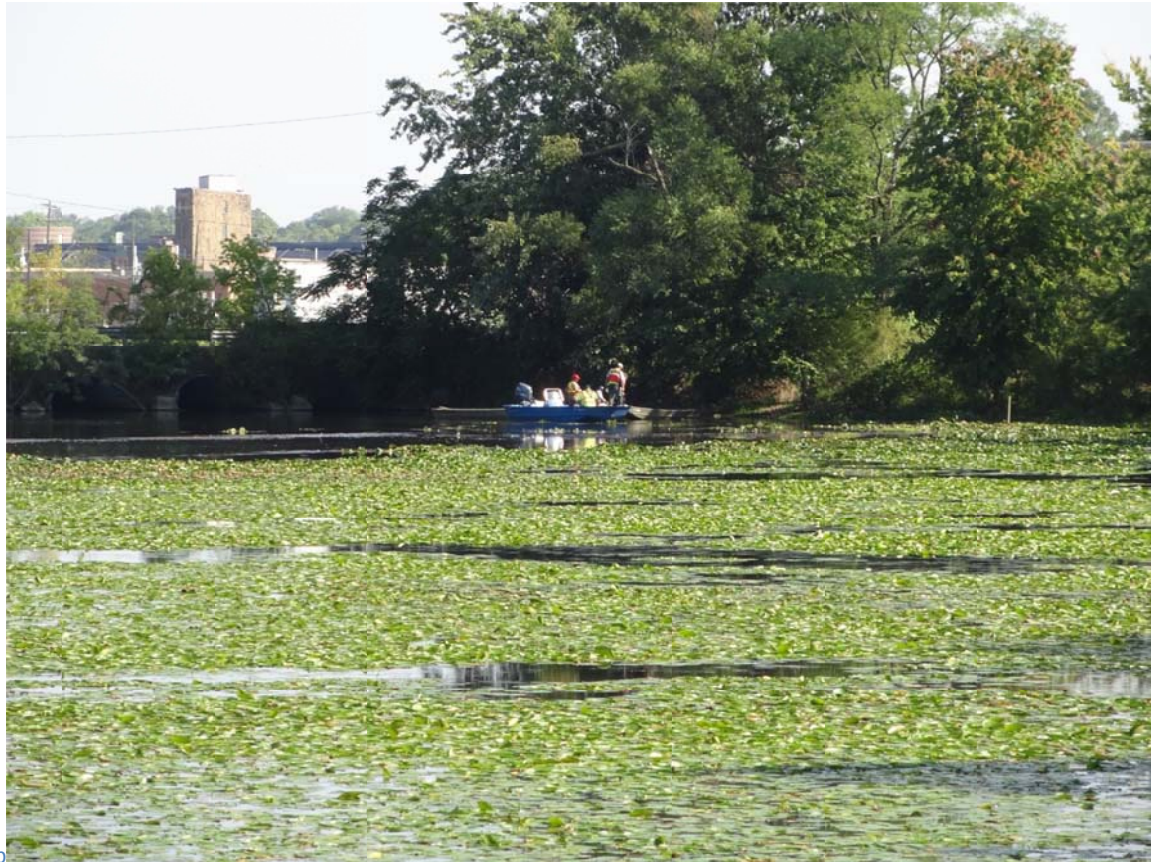
5. Poling crews conducting step-out surveys at north end of Mill Pond.

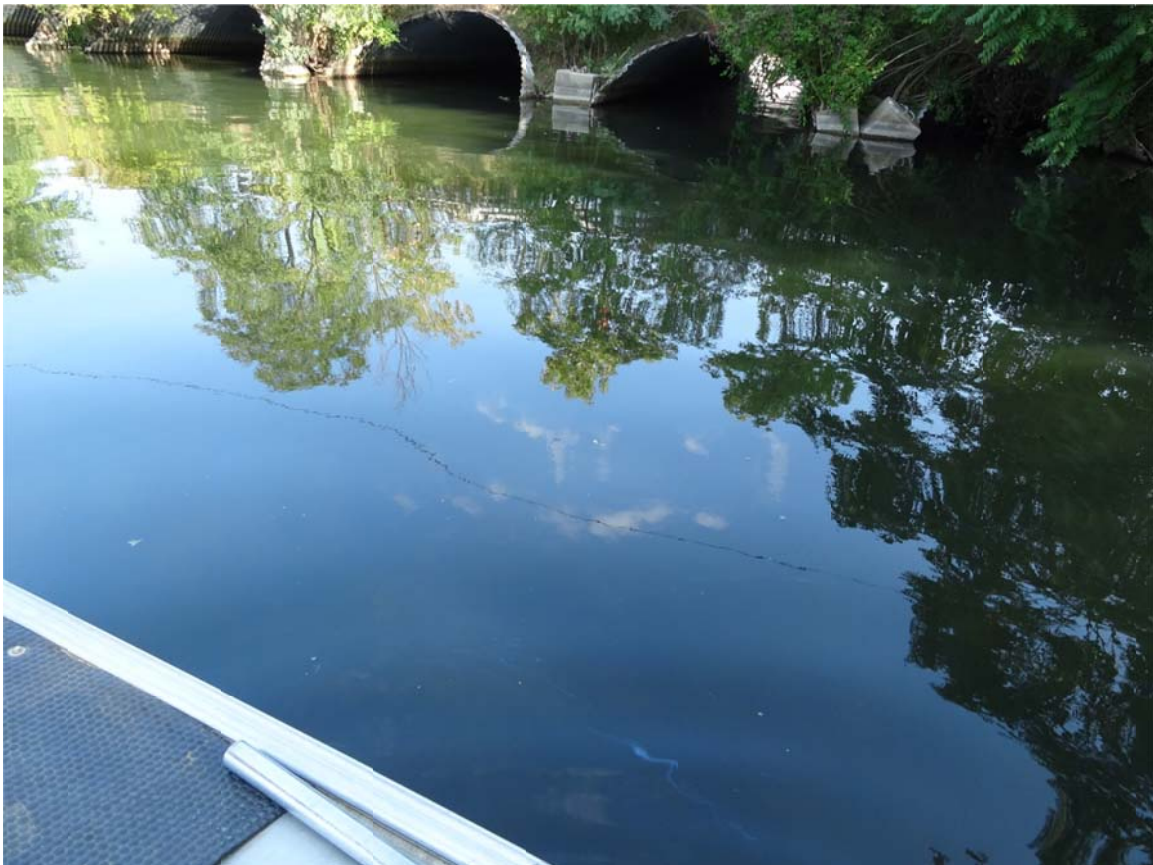
6. Sheen observed in north end of Mill Ponds near MP 15.75, following work of poling crews.

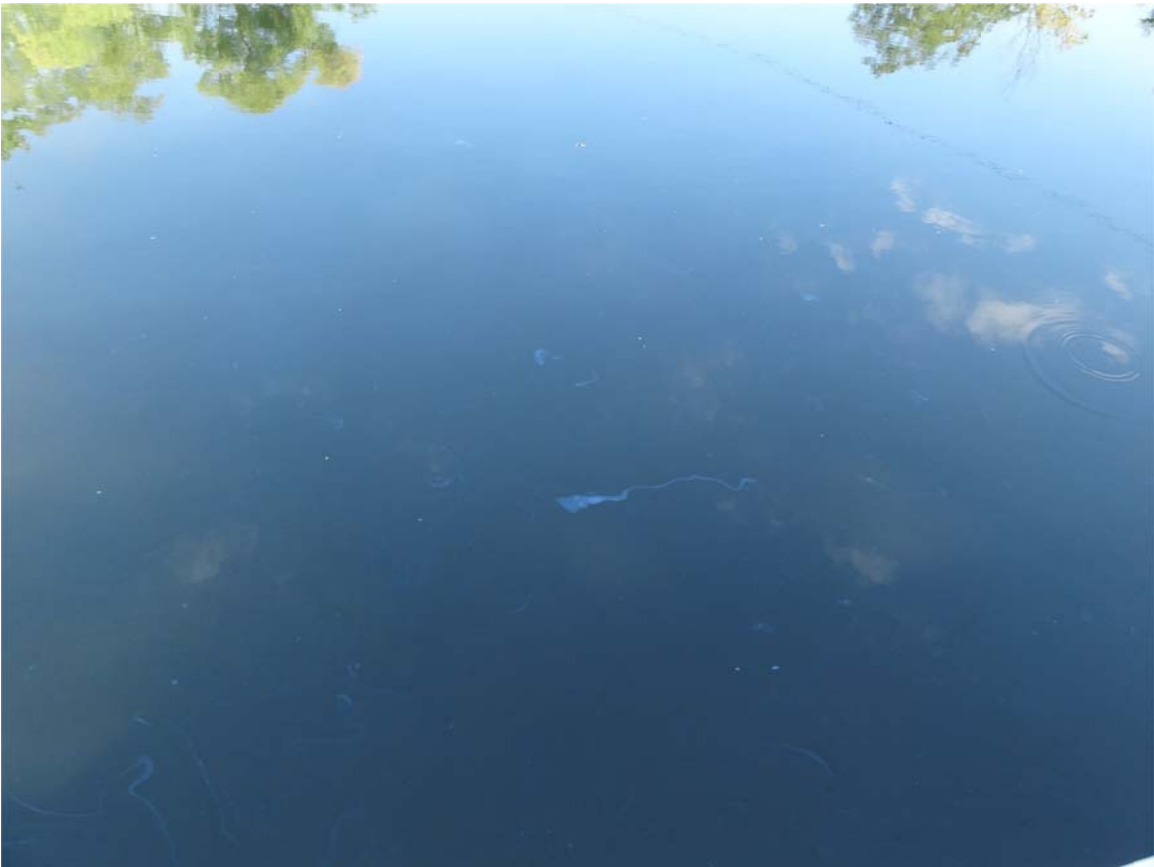
7. Sheen observed in north end of Mill Ponds near MP 15.75, following work of poling crews.

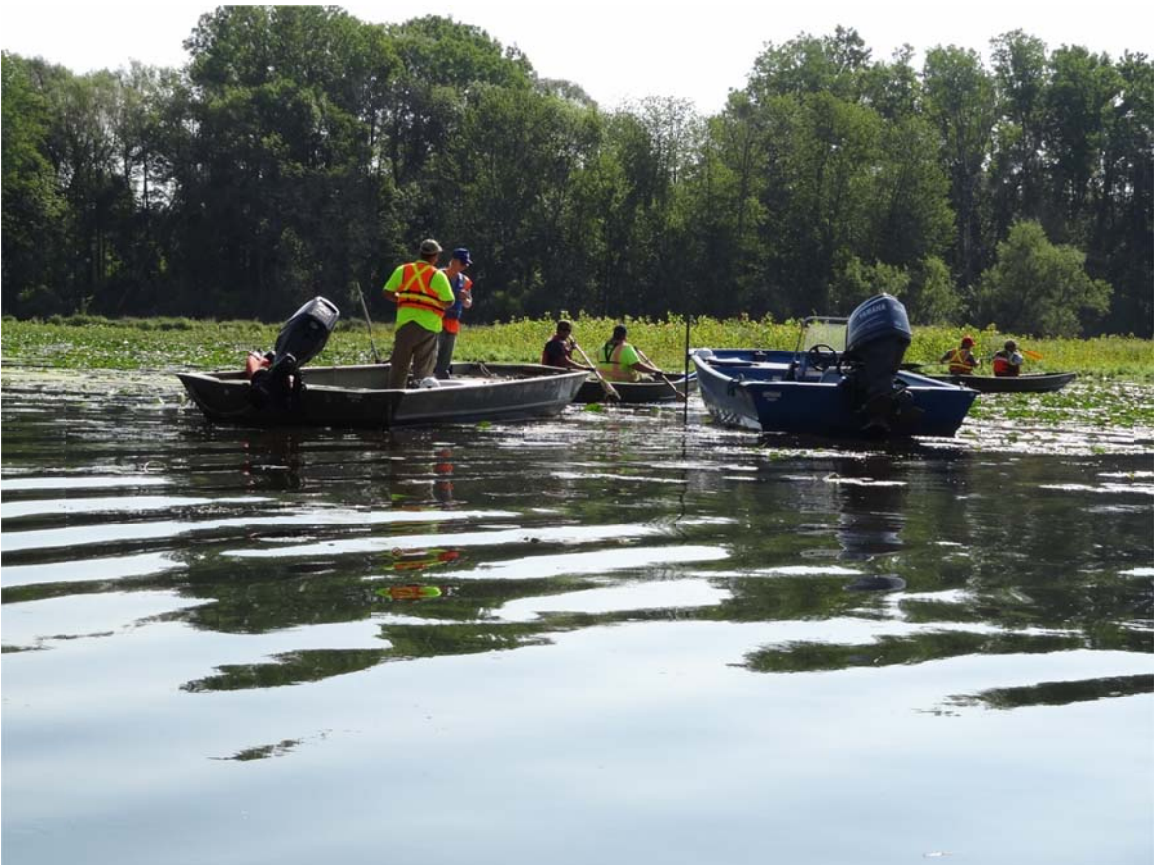
8. Mill Pond poling crew mobilizing to MP 15.5 at north end of south Mill Pond.

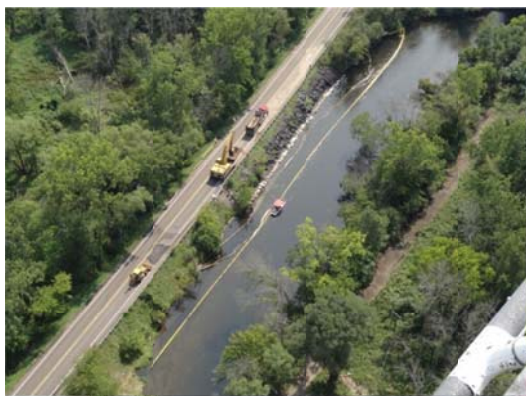
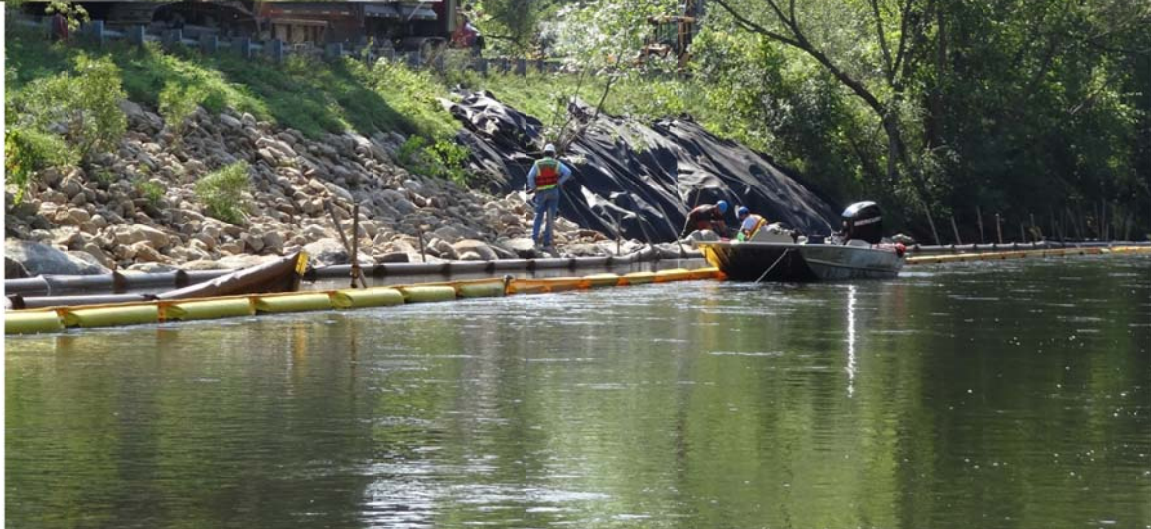
9. Shoreline restoration work observed along LDB at Raymond Road (aerial photo taken yesterday 9-5-2012).

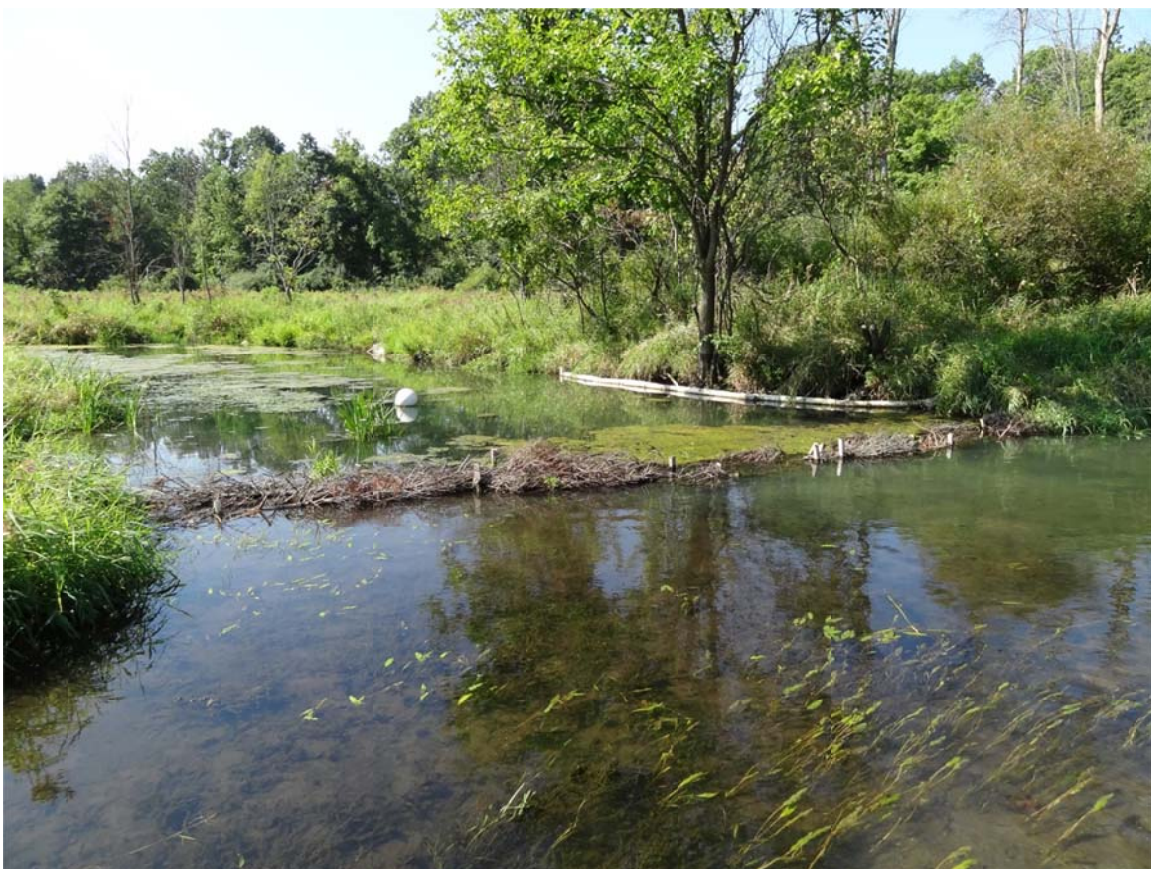
10. MP10.75, no sheen observed.

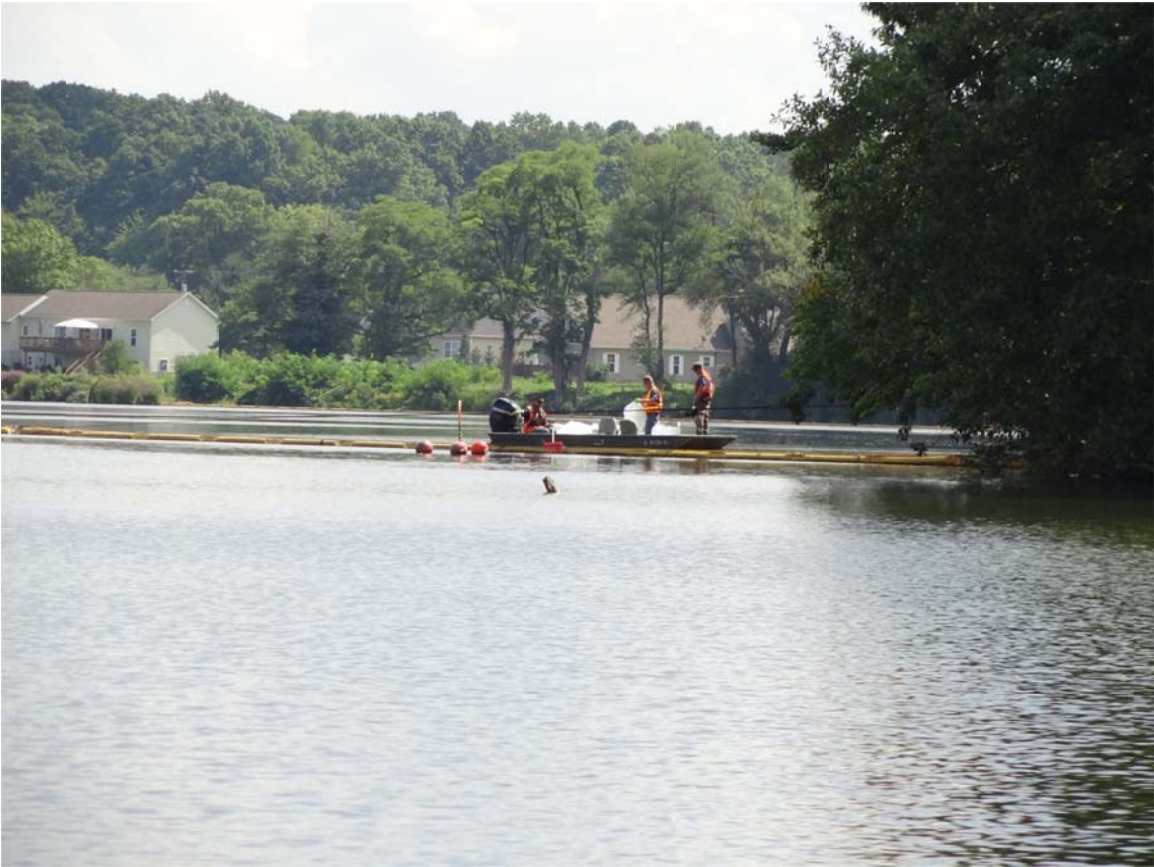
**11. Crews observed removing debris from containment configuration C in southwest portion of Morrow Lake Delta.**

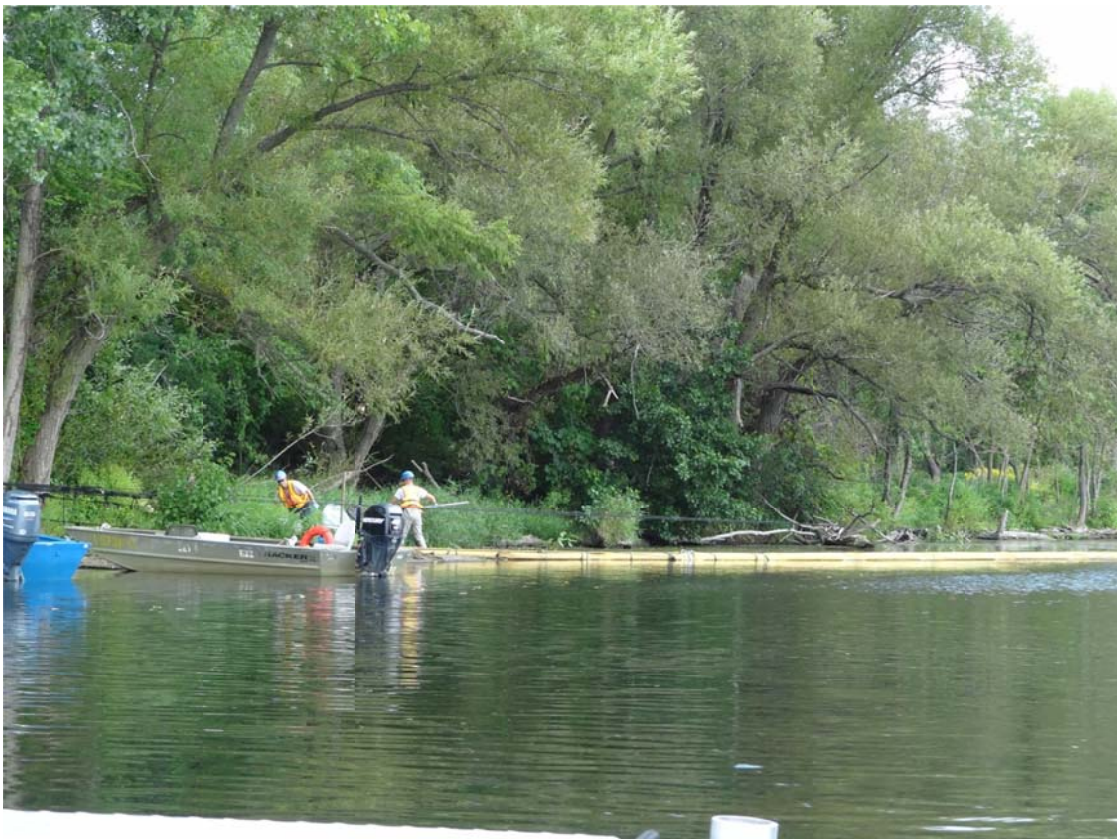
**12. Crews removing debris from E4.0 containment point.**

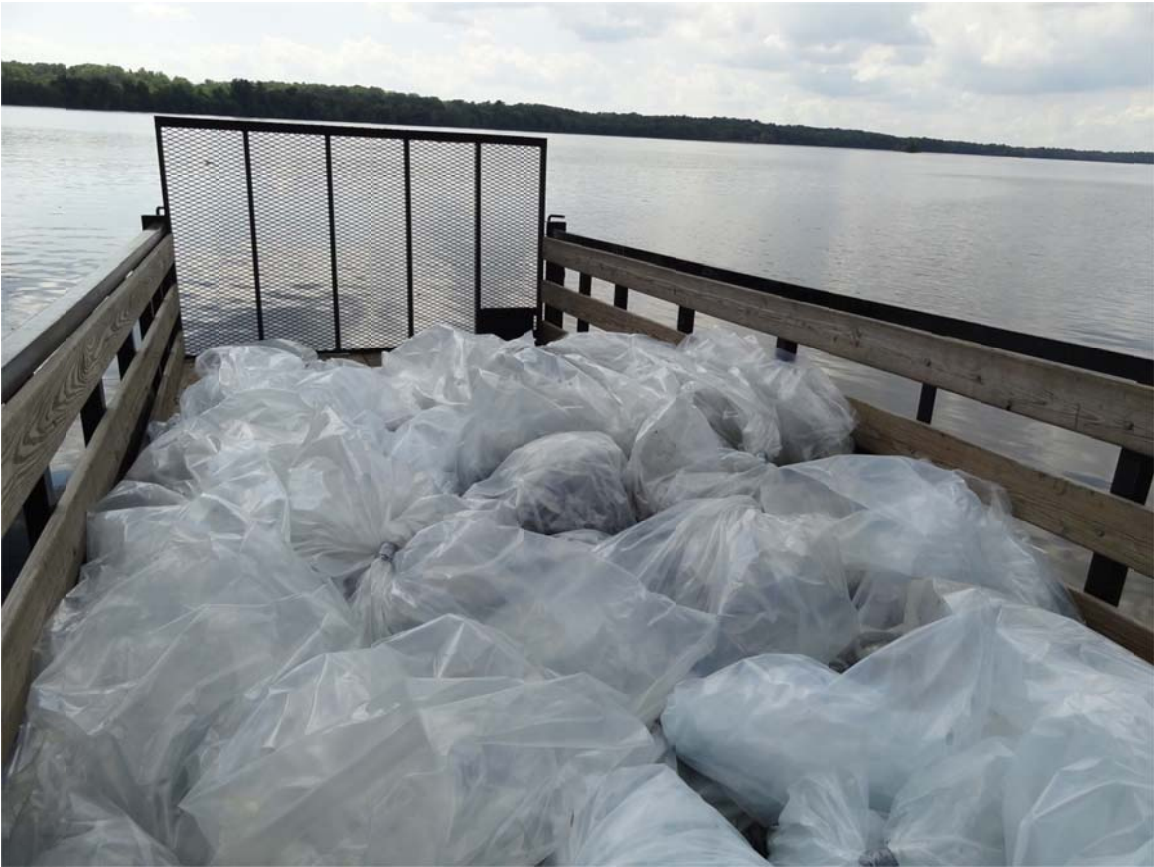
**13. Observed bags of vegetation removed from E 4.0 staged for transport at E 4.0 boat launch.**

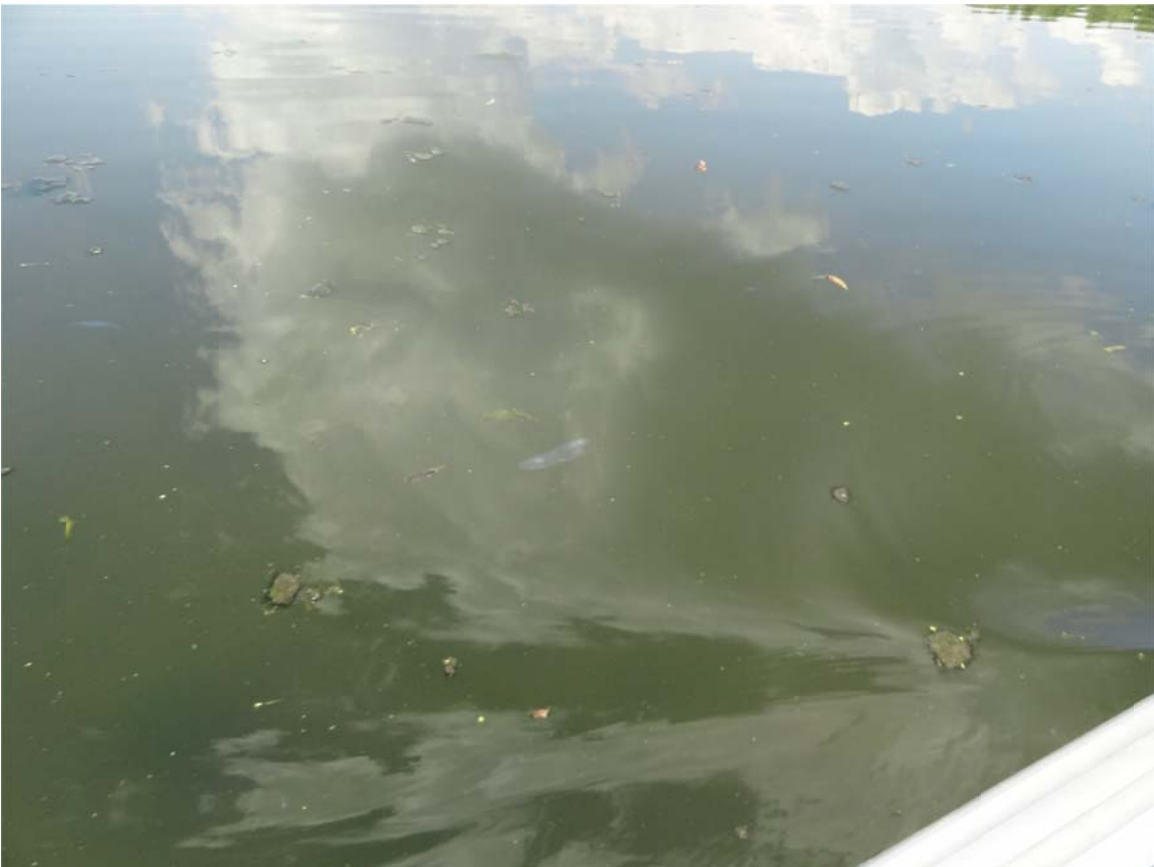
**14. Tar globules and sheen observed in north cove of Morrow Lake. Sheen sweeper boat was en route.**

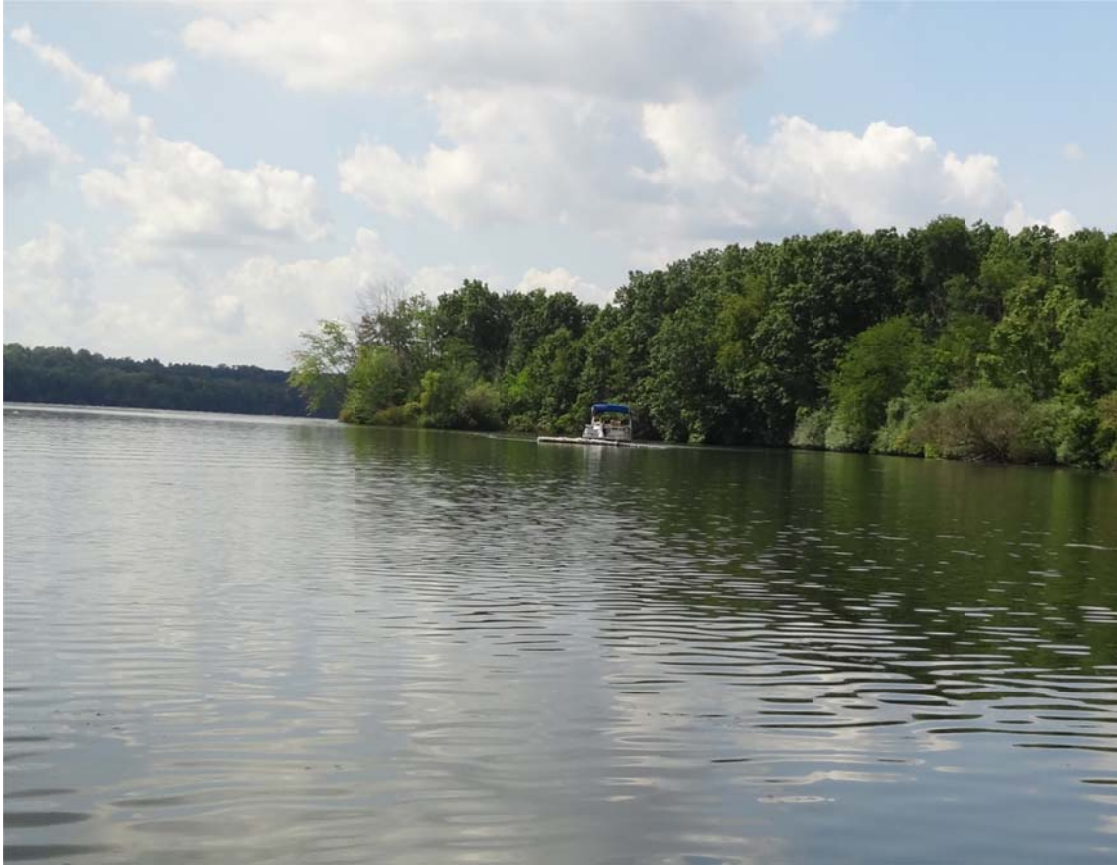
**15. Sheen sweeper pontoon boat en route to north cove of Morrow Lake.**

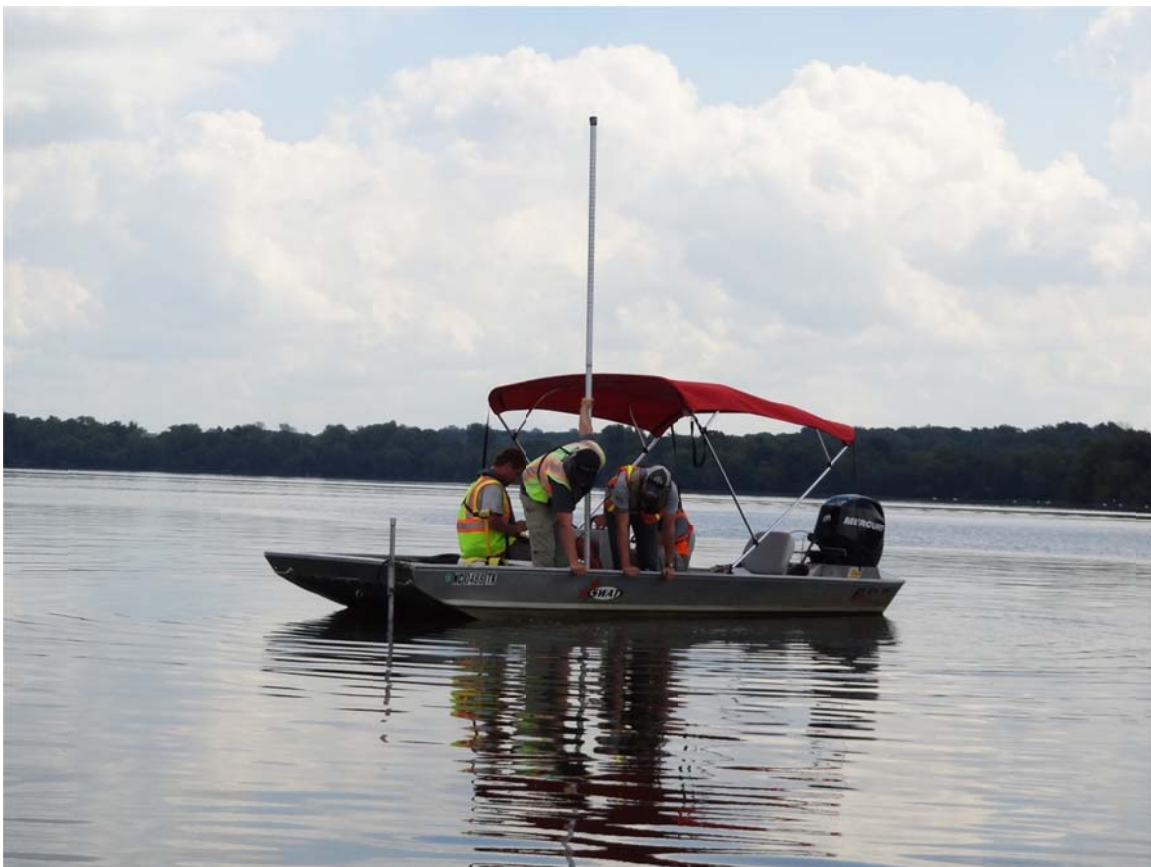
**16. Morrow Lake monitoring crew conducting poling operations in southwestern corner of Morrow Lake.**
