Situation Photo Log

Saturday, September 8, 2012

Kalamazoo River / Enbridge Spill

Prepared by:
Larry Rader
START-USEPA
Situation Unit Leader

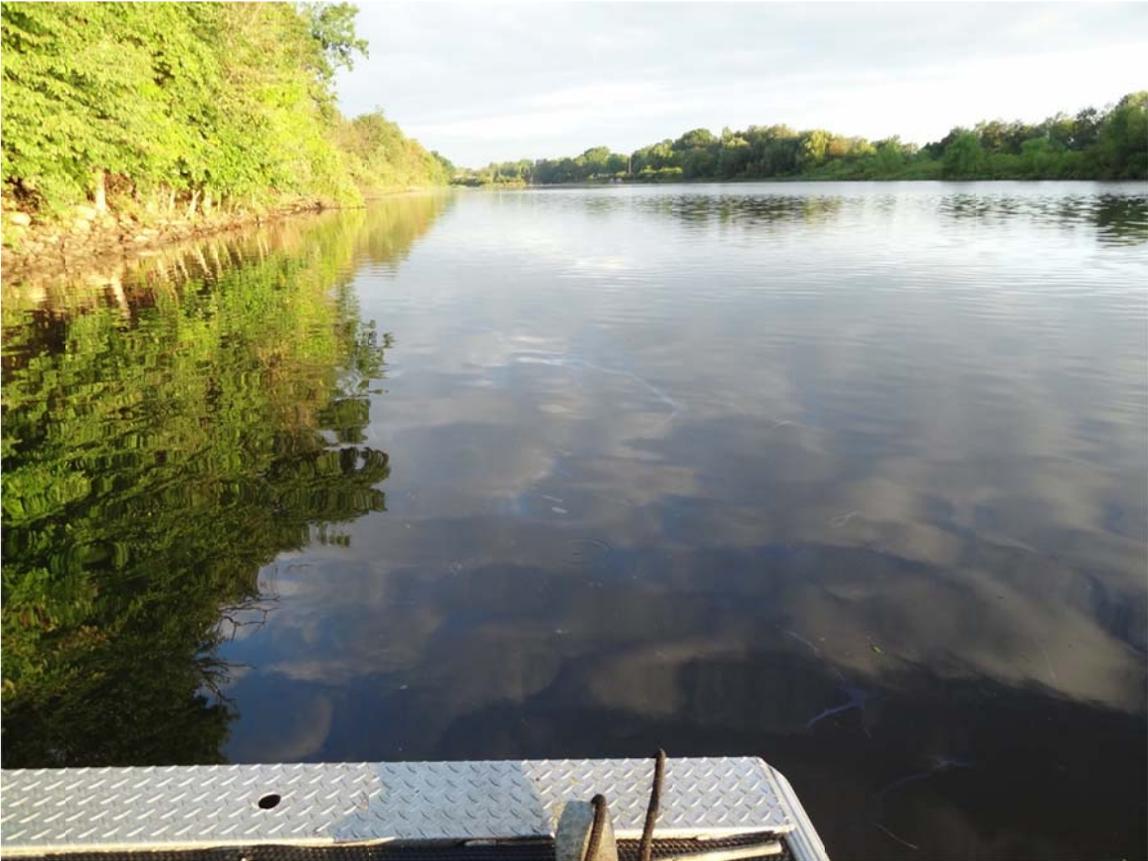
1. Sheen and tar globules observed near MP 5.25 LDB.

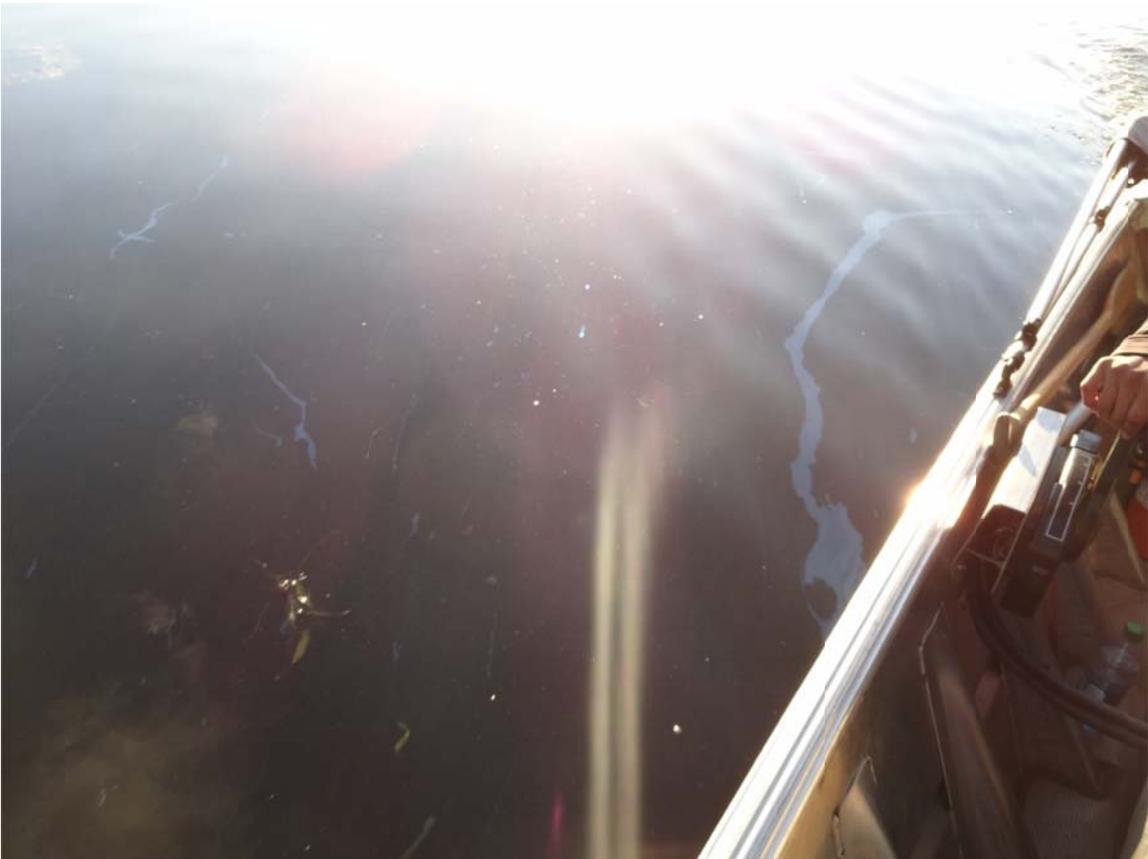
2. Sheen and tar globules observed near MP 5.7 LDB above Ceresco Dam.

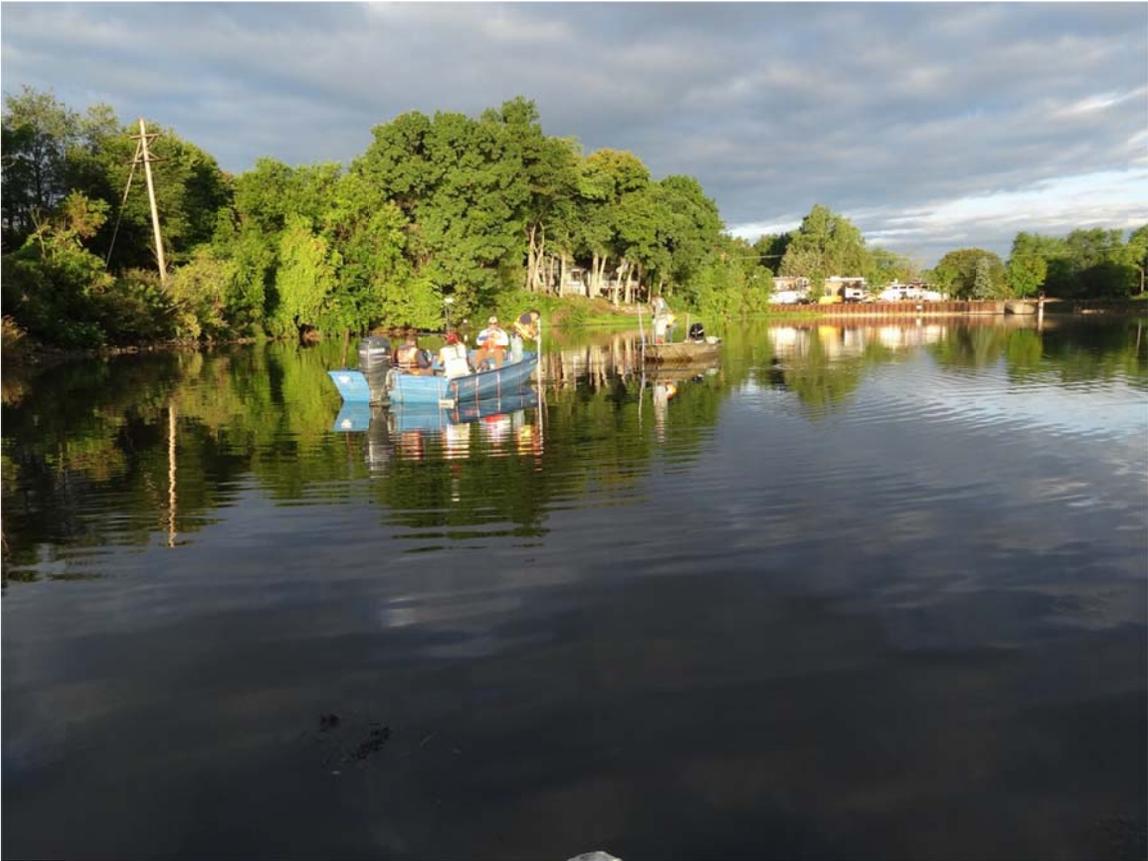
3. Bathymetry survey crew operating above Ceresco Dam.

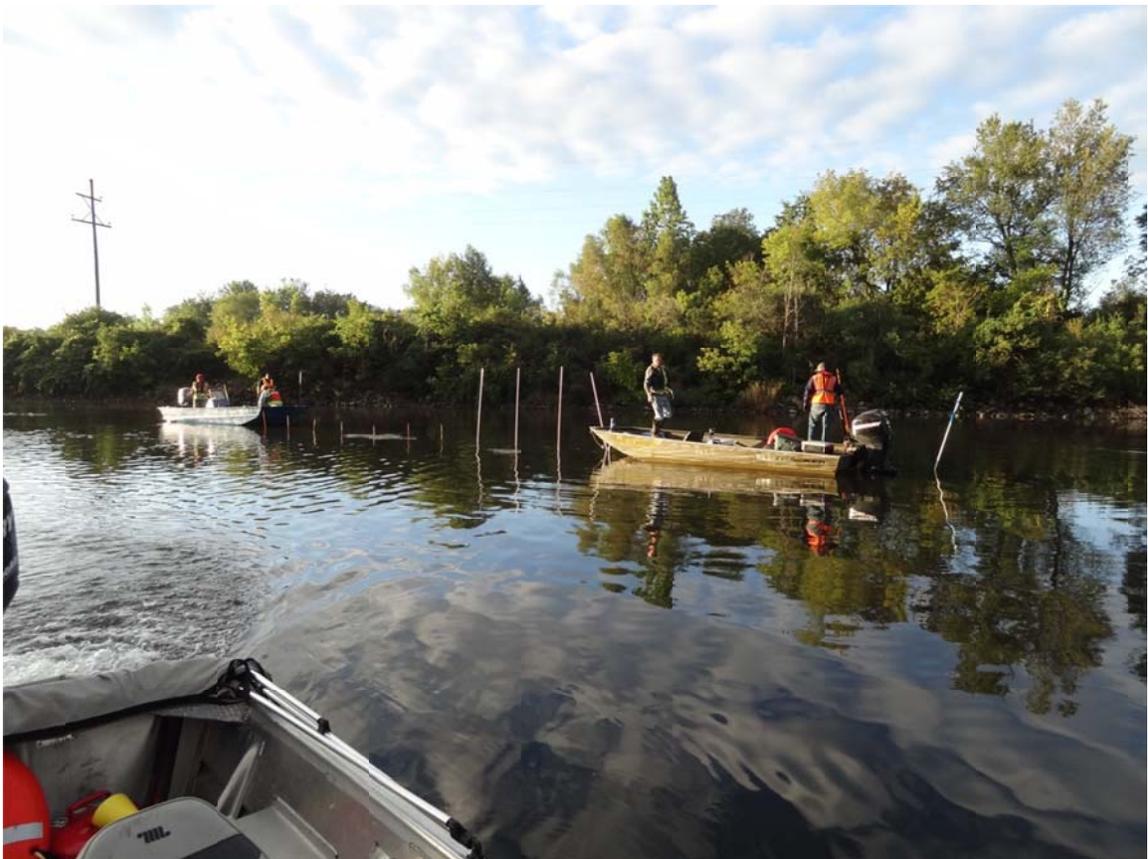
4. Bathymetry crew installing stakes above Ceresco Dam.

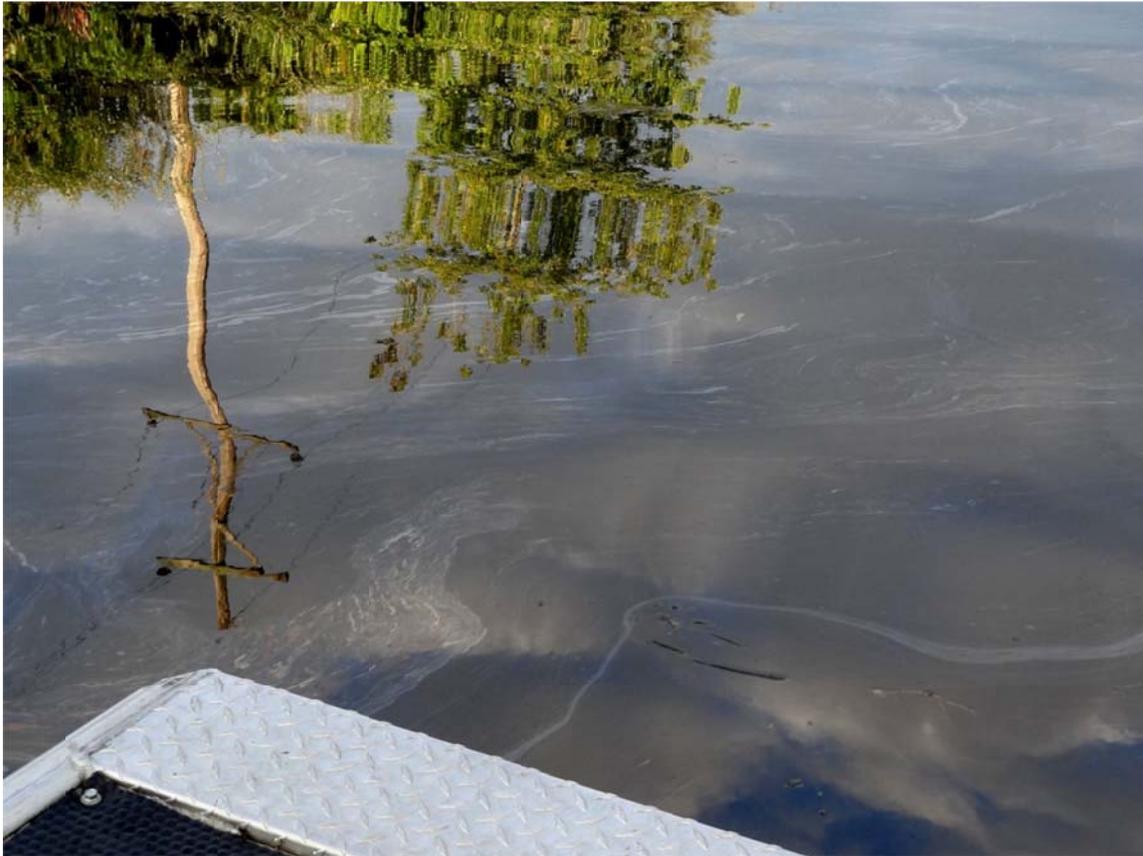
5. Sheen and tar globules observed at trestle along LDB above Ceresco Dam.

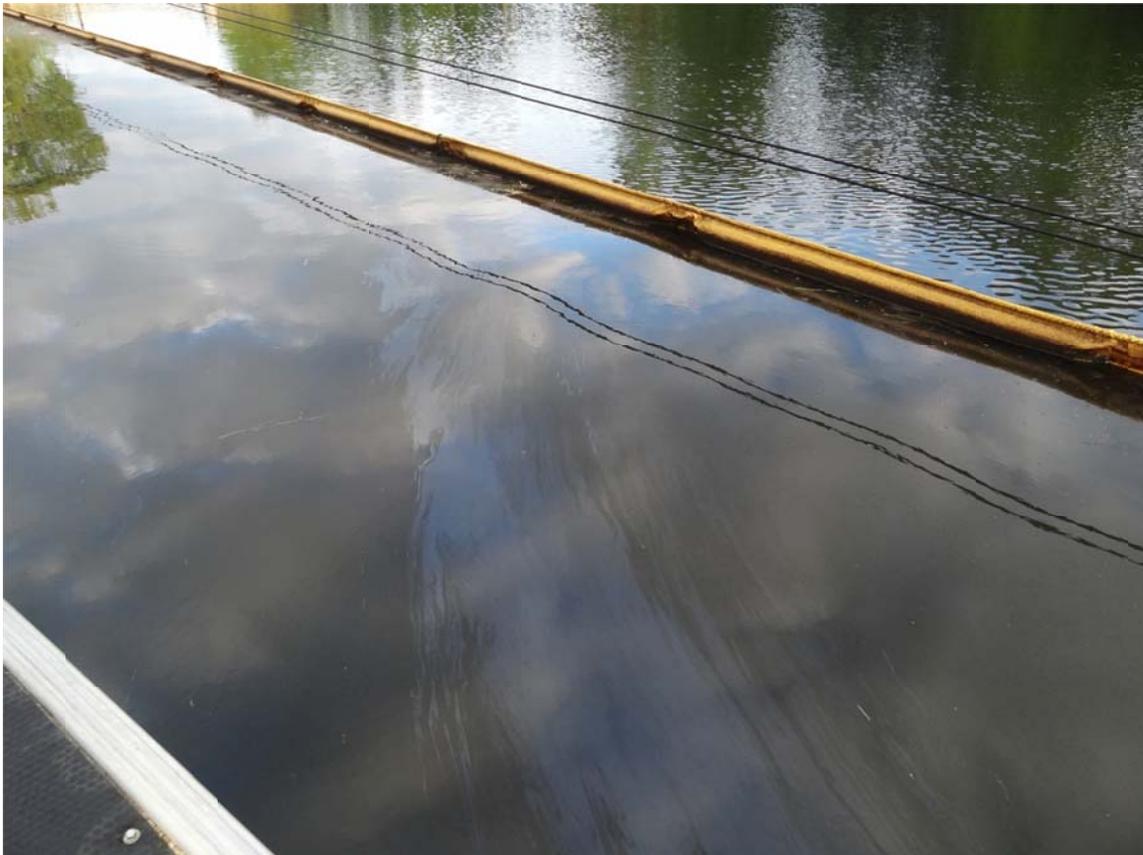
6. Sheen and tar globules observed along containment boom above Ceresco Dam.

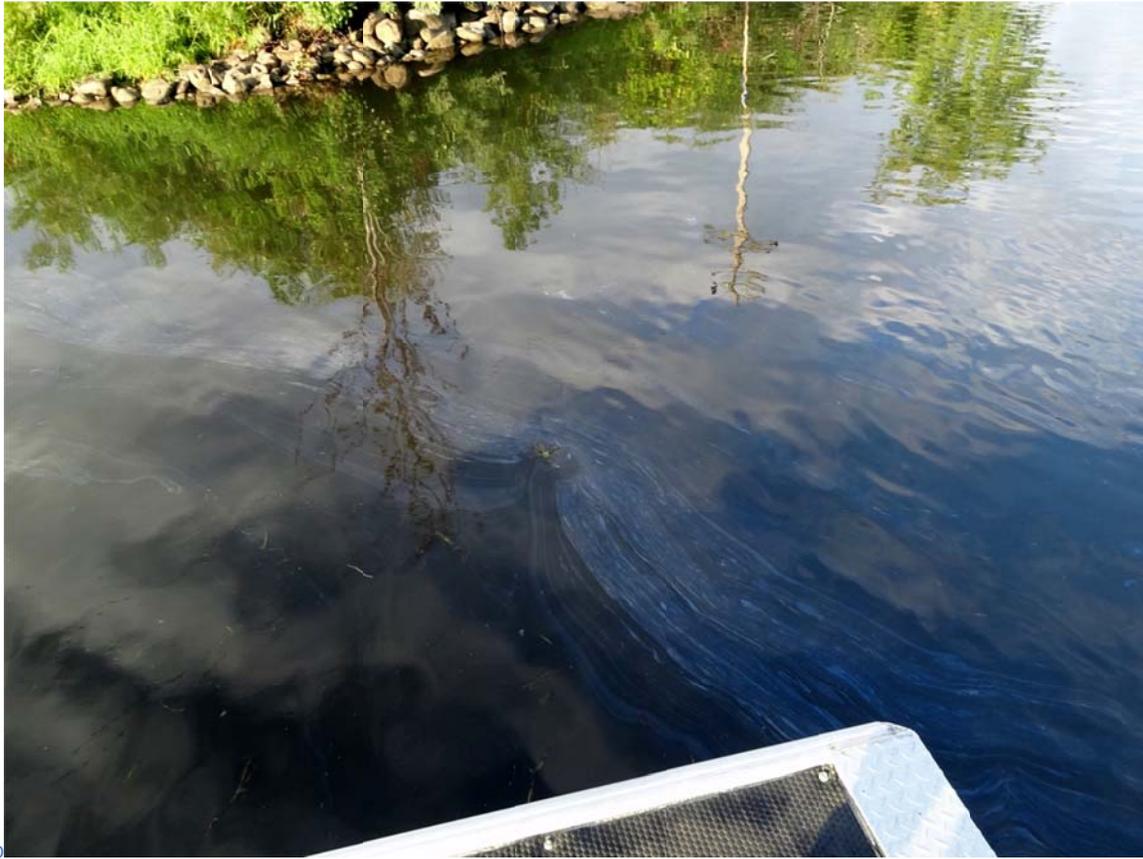
7. Sheen observed at trestle above Ceresco Dam.

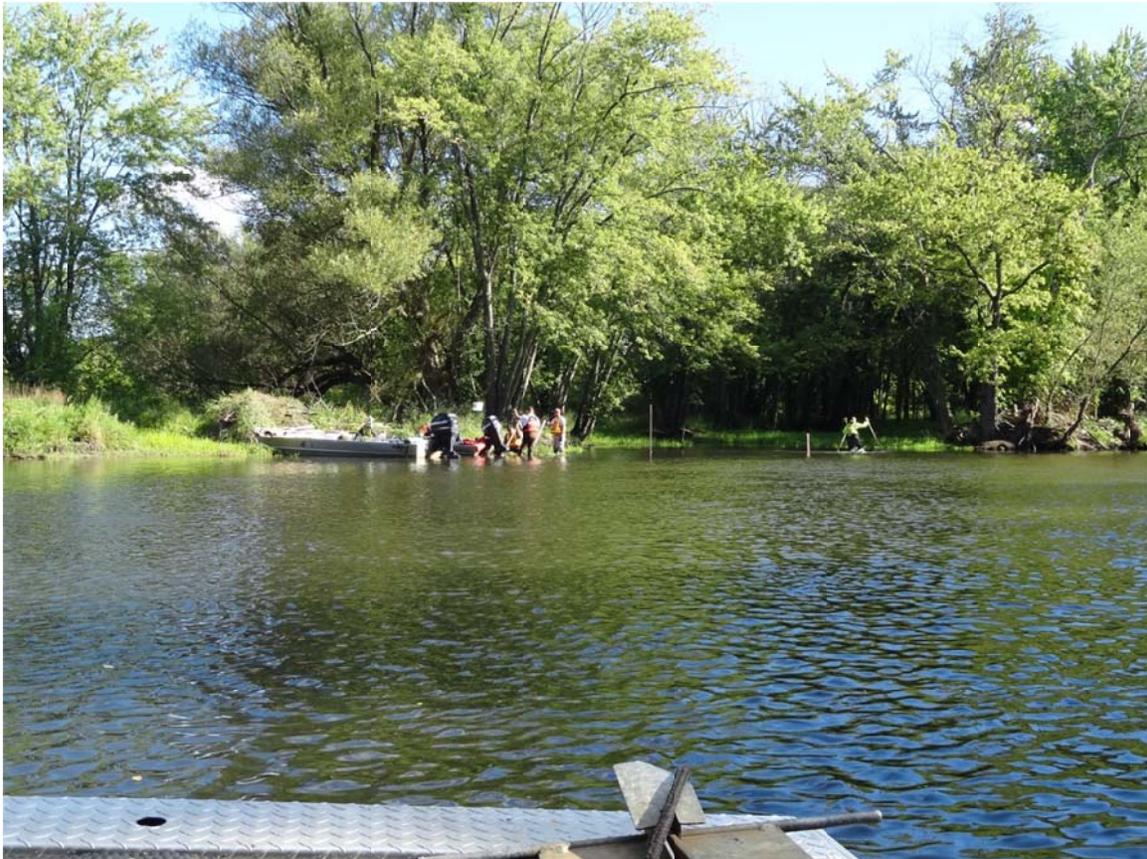
8. Crews installing sediment trap at MP 33.0 RDB.

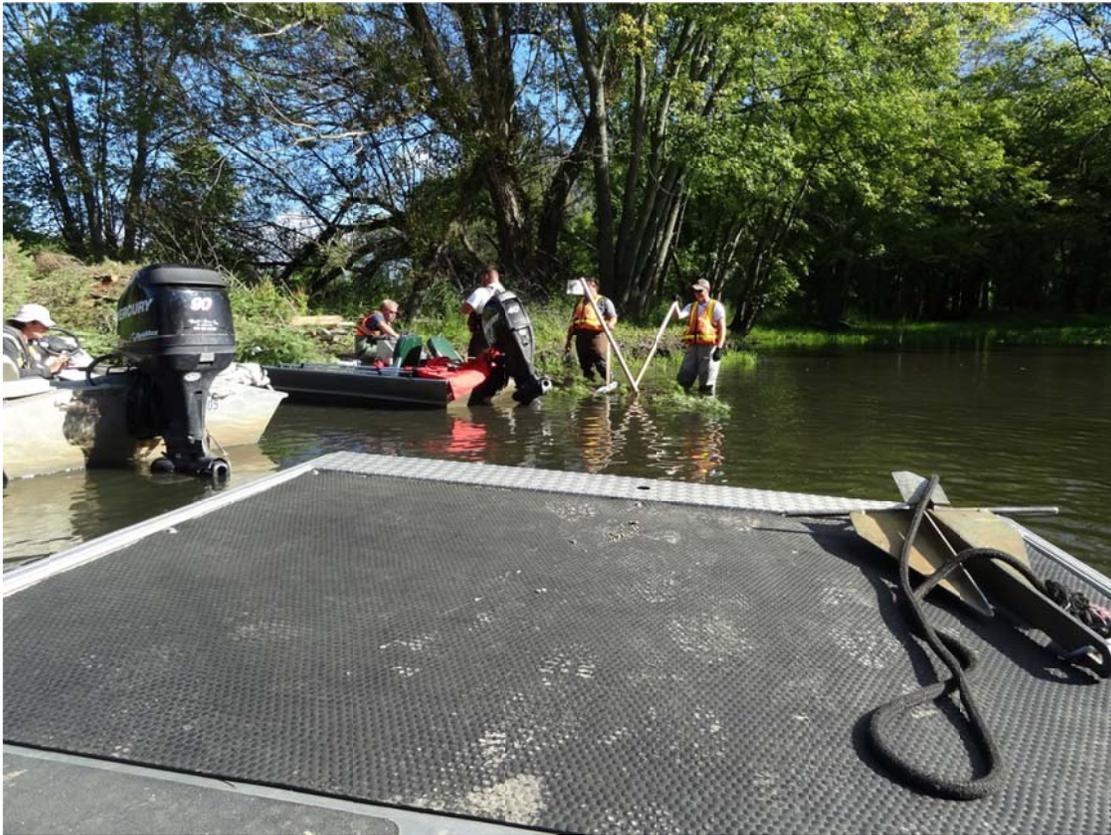
9. Sediment trap crew installing trees in sediment trap at MP 33.0A.

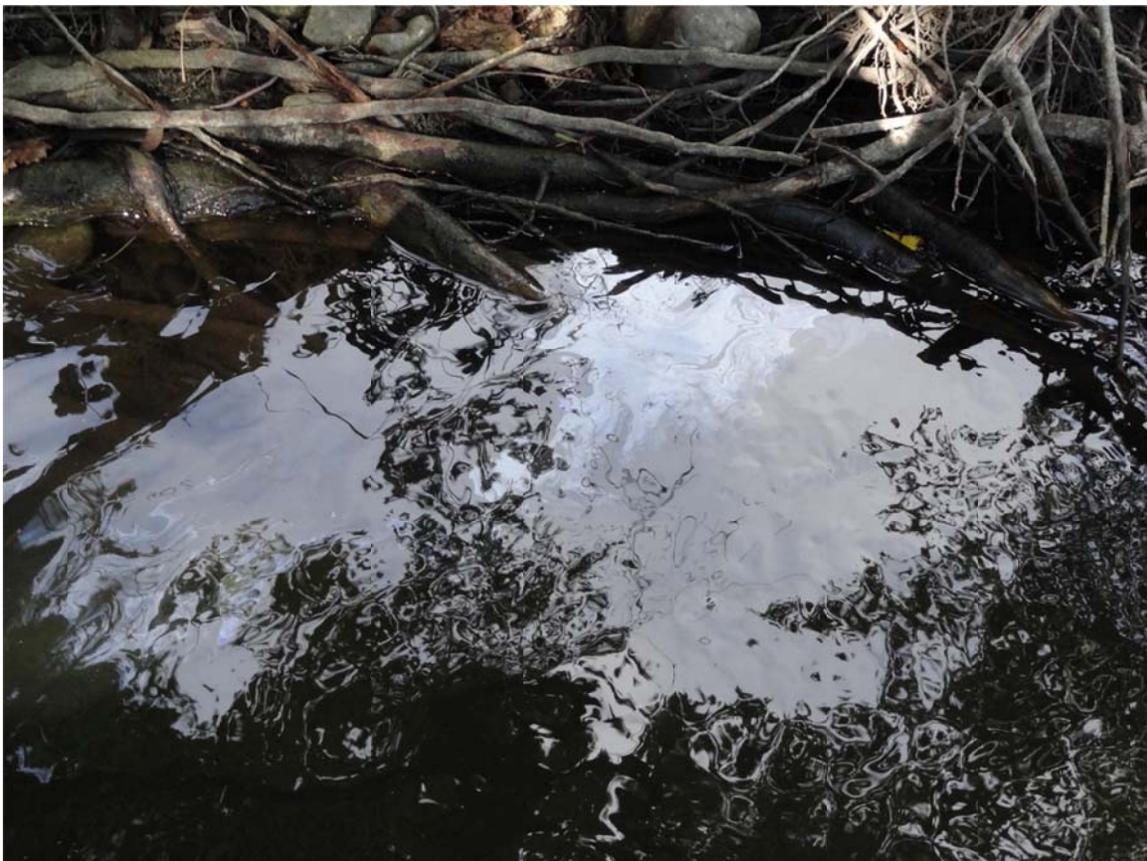
10. Sheen and petroleum odor observed at MP 33.1 RDB.

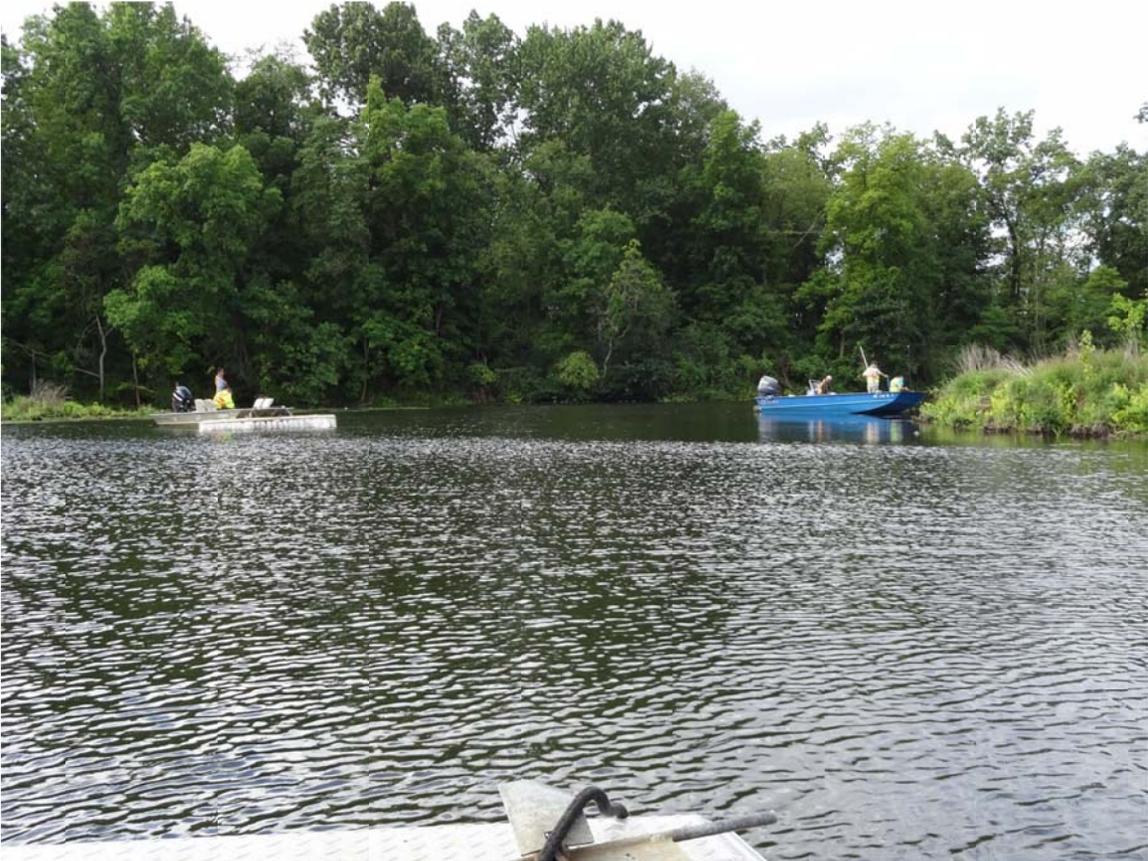
11. Morrow Lake Delta monitoring crew operating in Delta A.

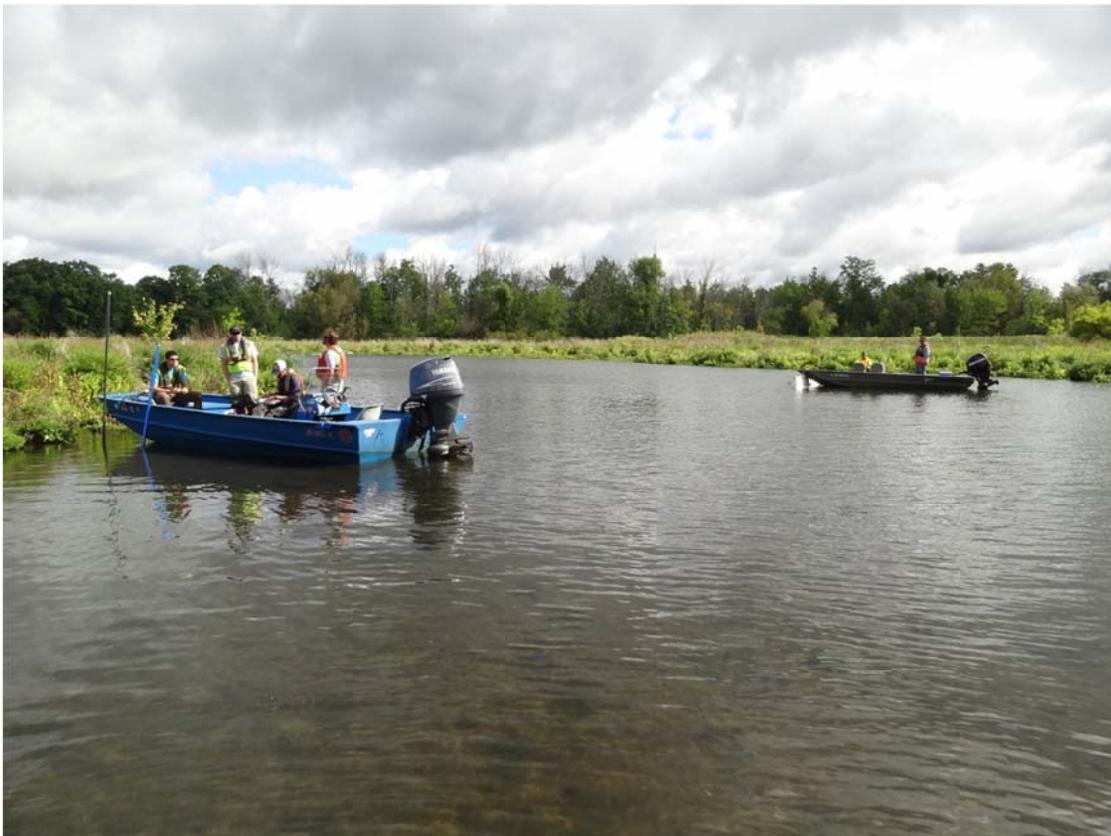
12. Morrow Lake monitoring crew operating in Morrow Lake Delta.

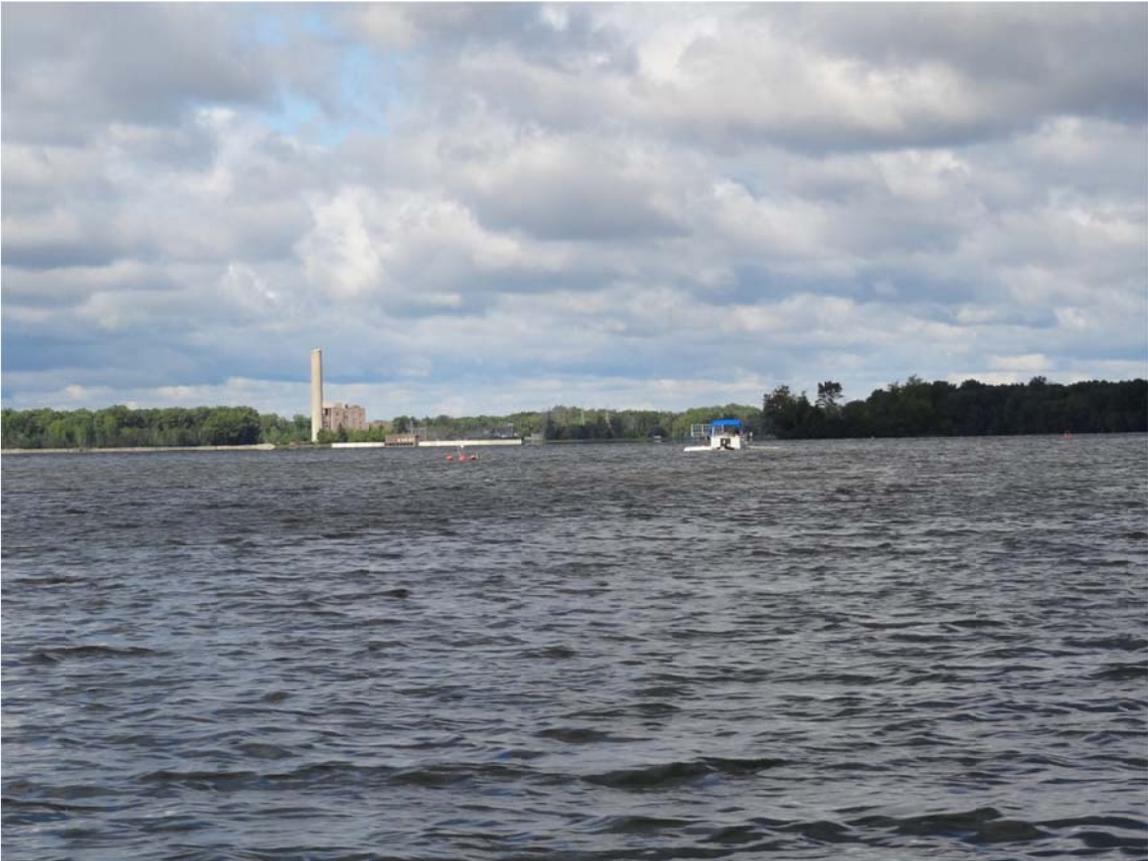
13. Sheen sweeper pontoon operating in central channel in Morrow Lake.

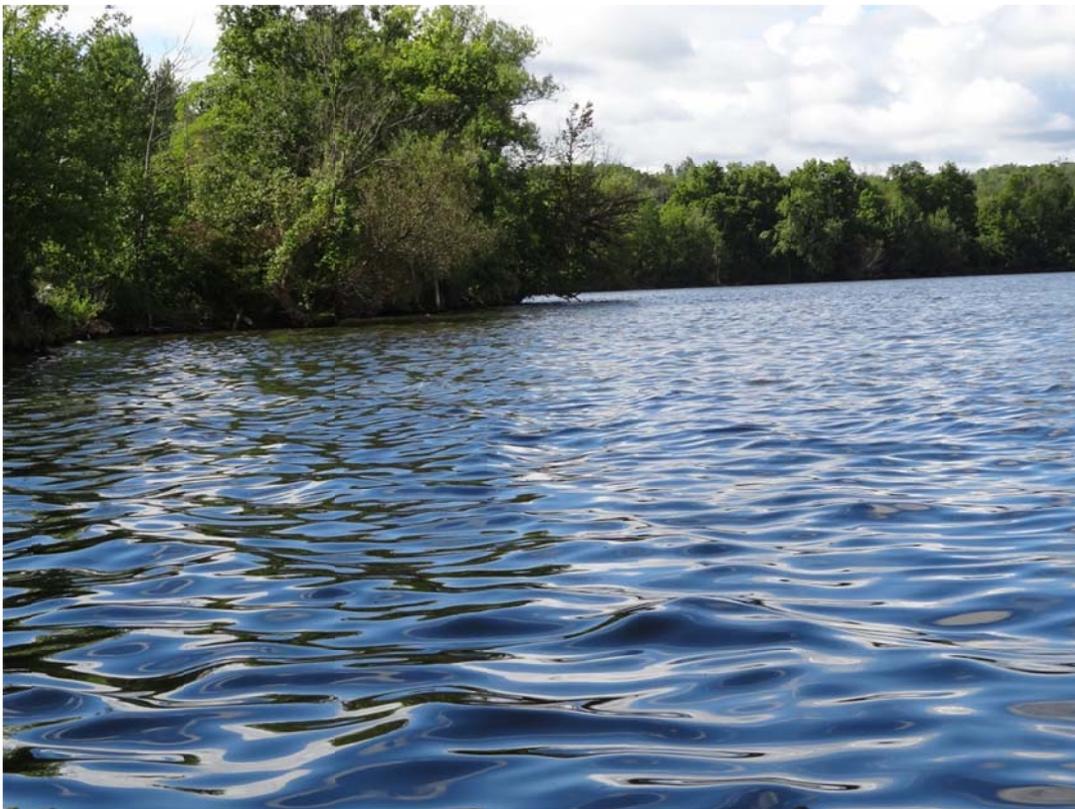
14. South cove of Morrow Lake, no sheen observed.

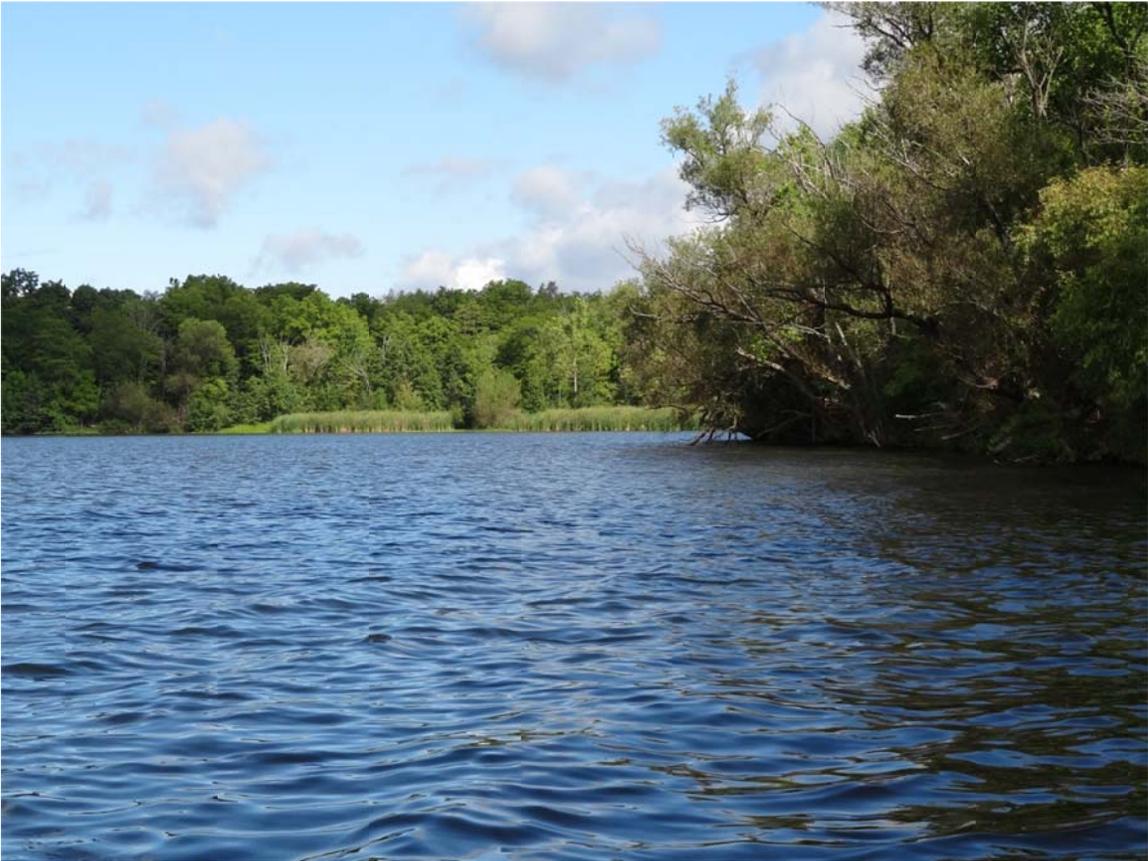
15. Northern cove of Morrow Lake. No sheen observed.

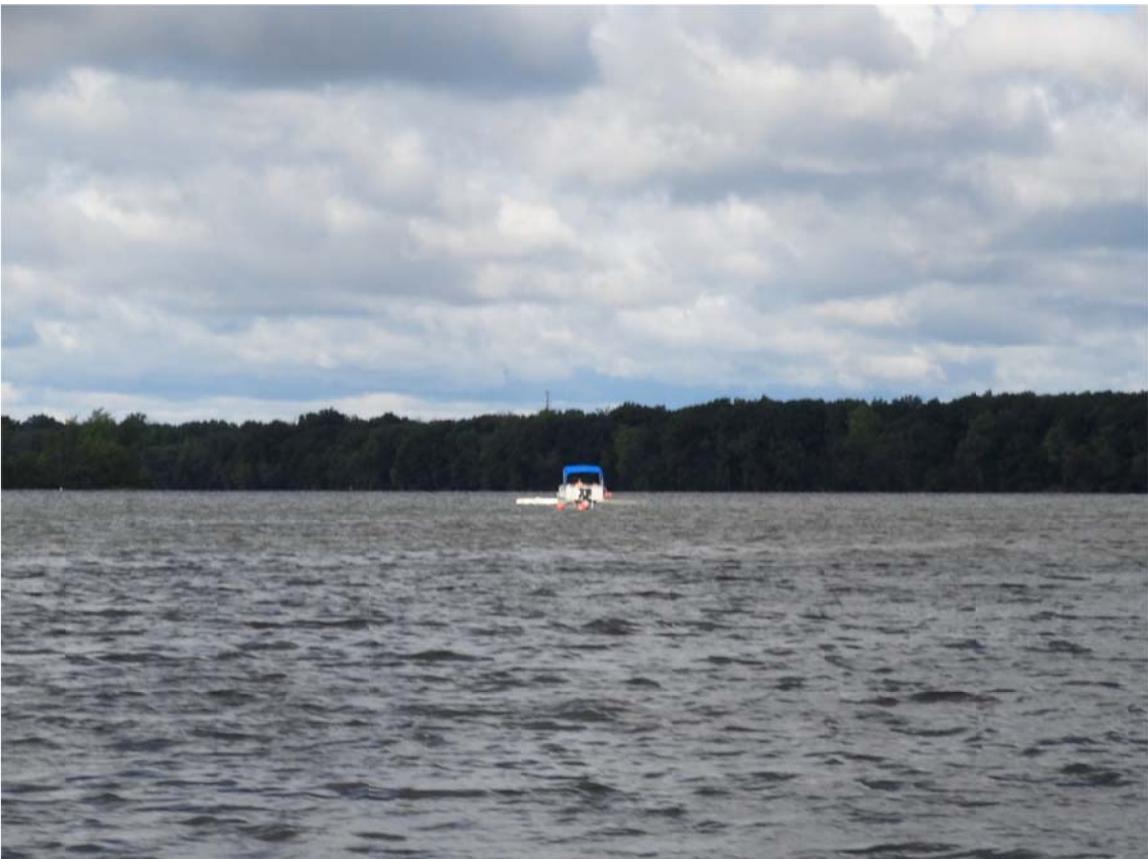
16. Sheen sweeper boat in central portion of Morrow Lake.
