# Situation Photo Log

Monday, September 10, 2012

Kalamazoo River / Enbridge Spill

Prepared by:  
Matthew Haak  
START-USEPA  
Situation Unit Leader

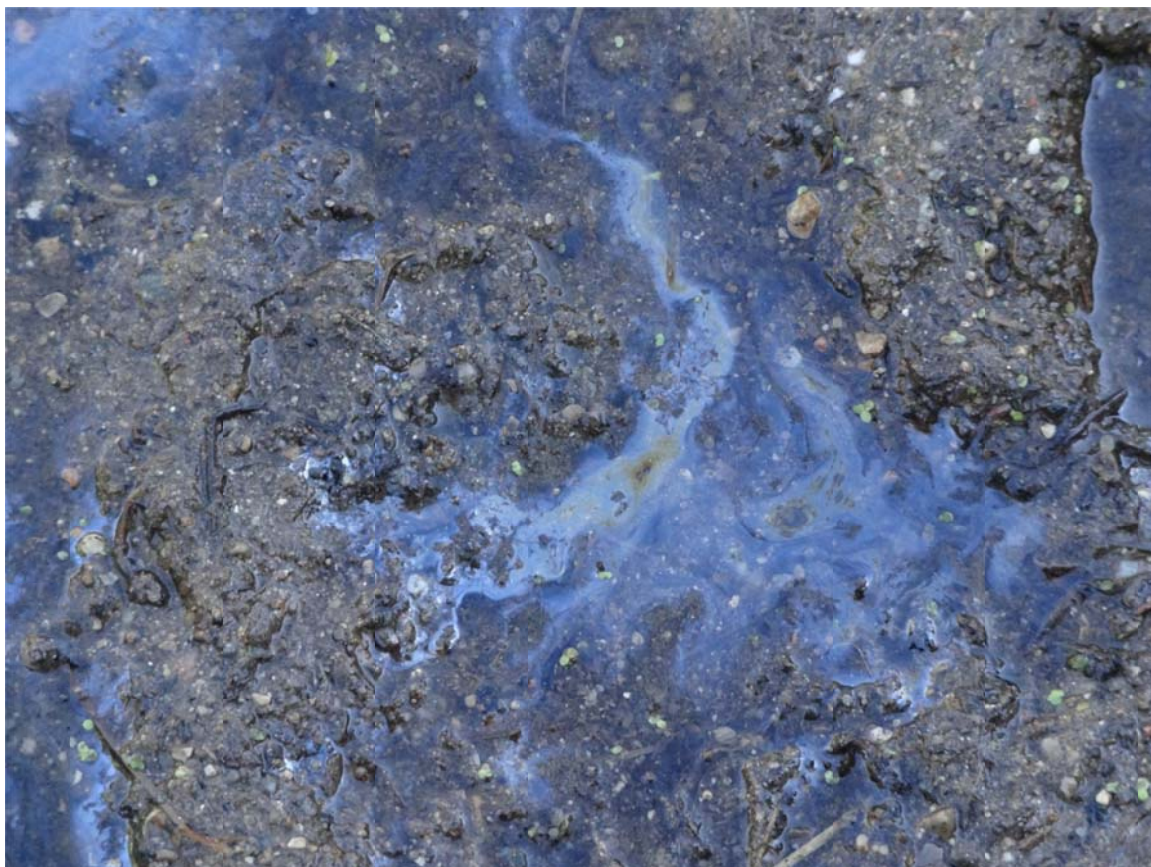
1. Sheen and tar globules observed at the downstream Ceresco portage.

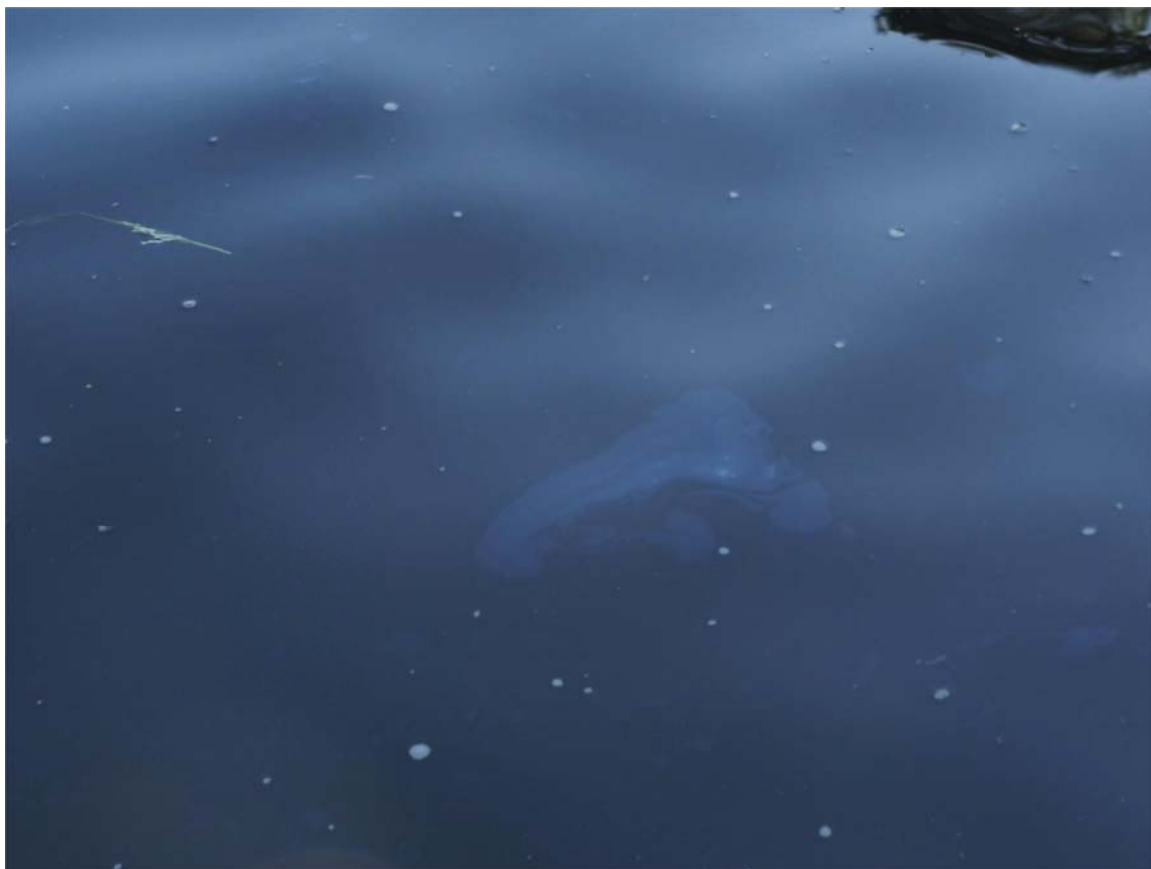
2. Sheen and tar globules observed at the downstream Ceresco portage.

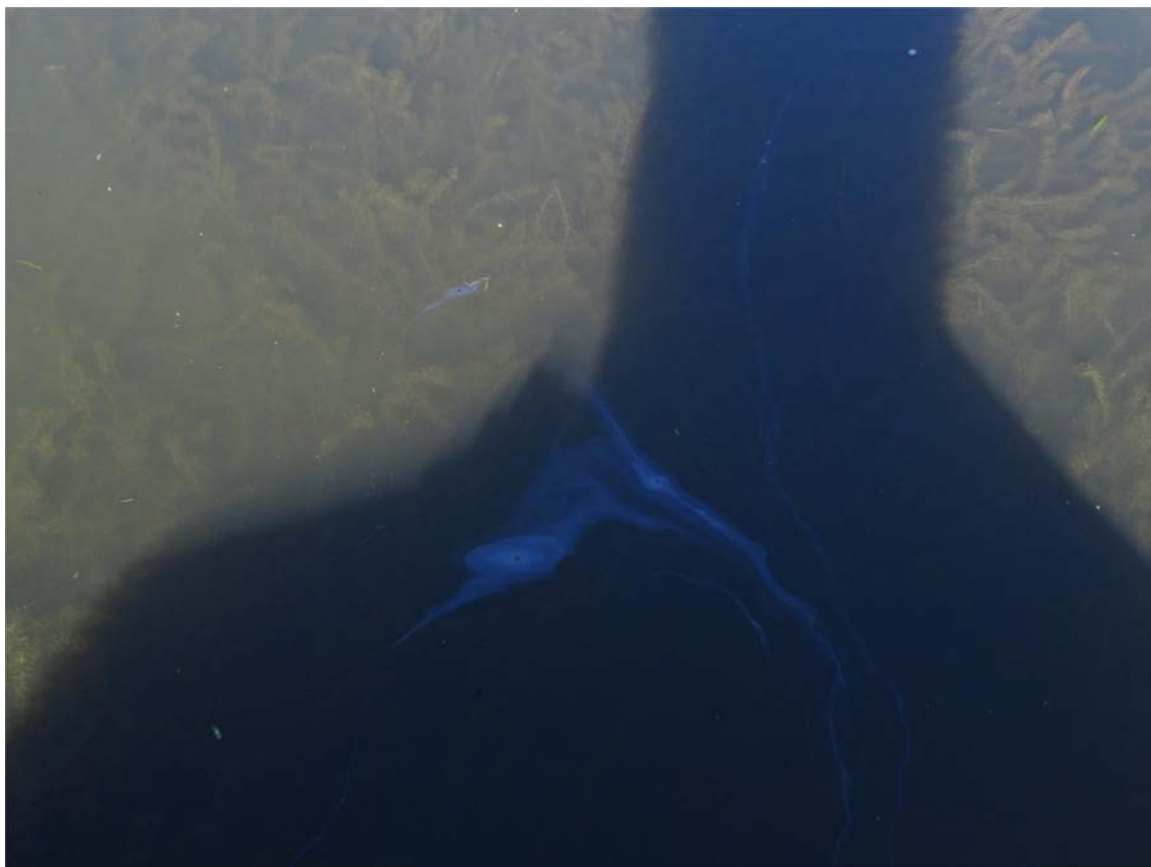
3. MP5.63 LDB above the rail road trestles.

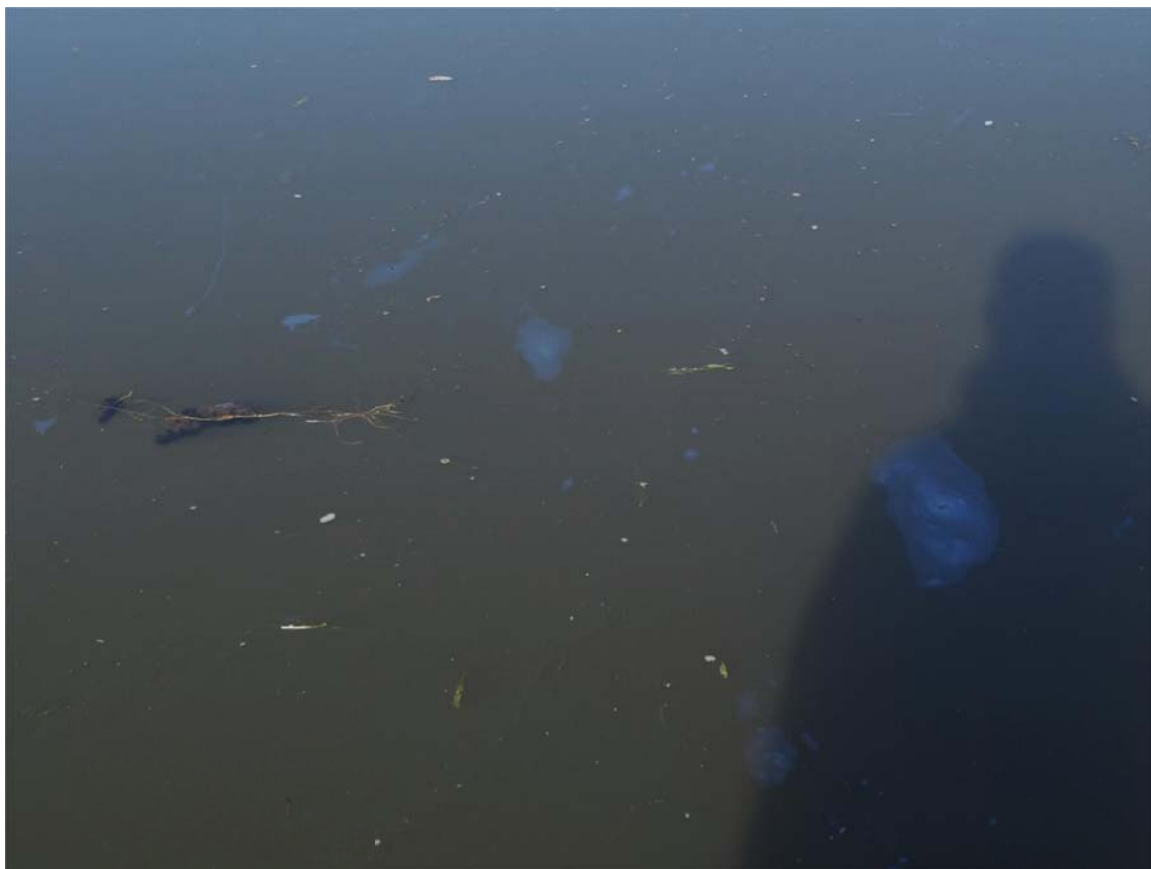
4. MP5.63 LDB below the rail road trestles.

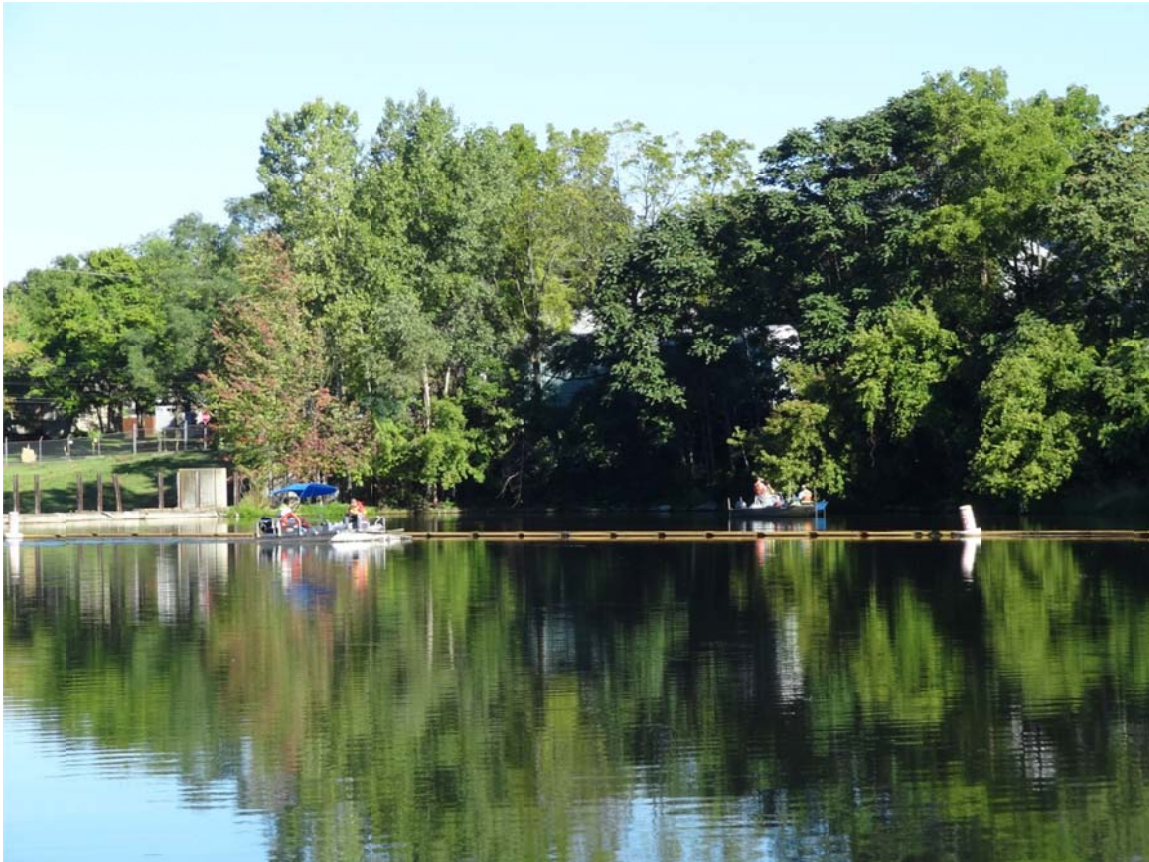
5. Observed the sheen sweep boat operating along the Ceresco Dam boom.

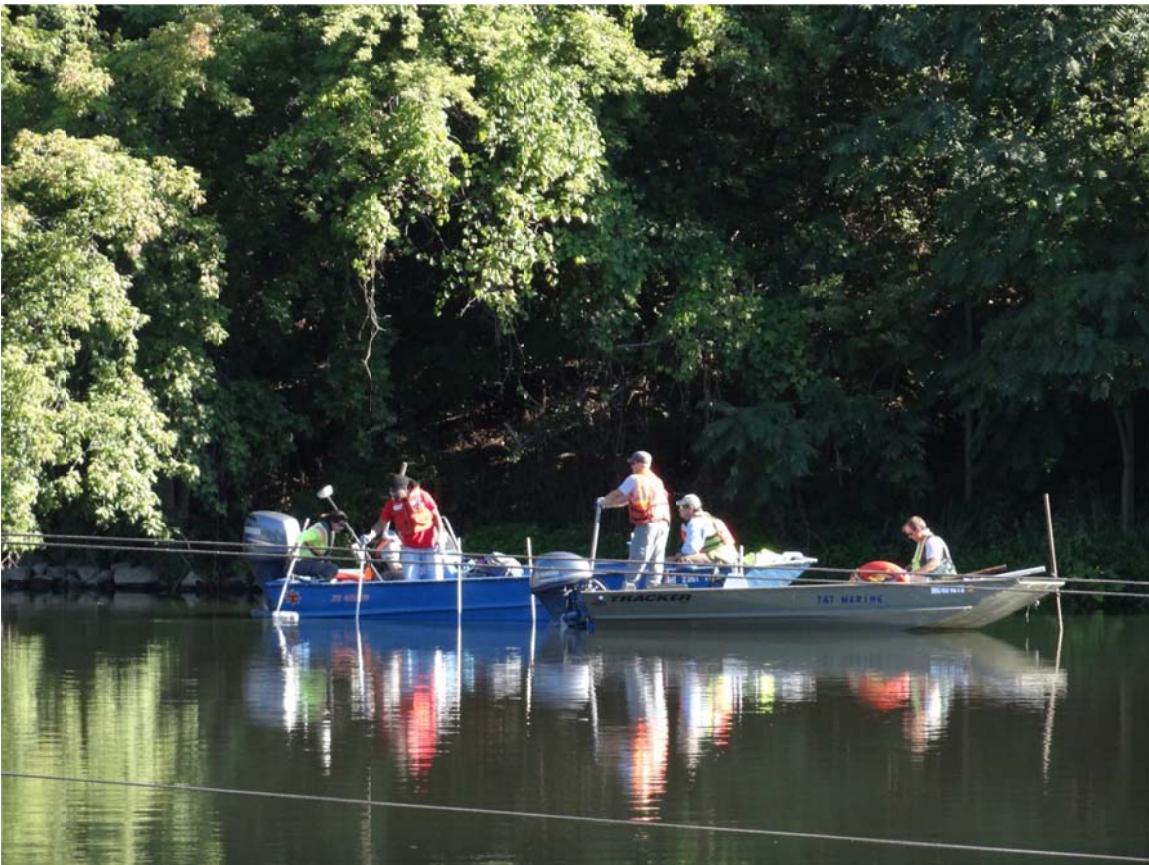
6. Ceresco bathymetry team observed operating.

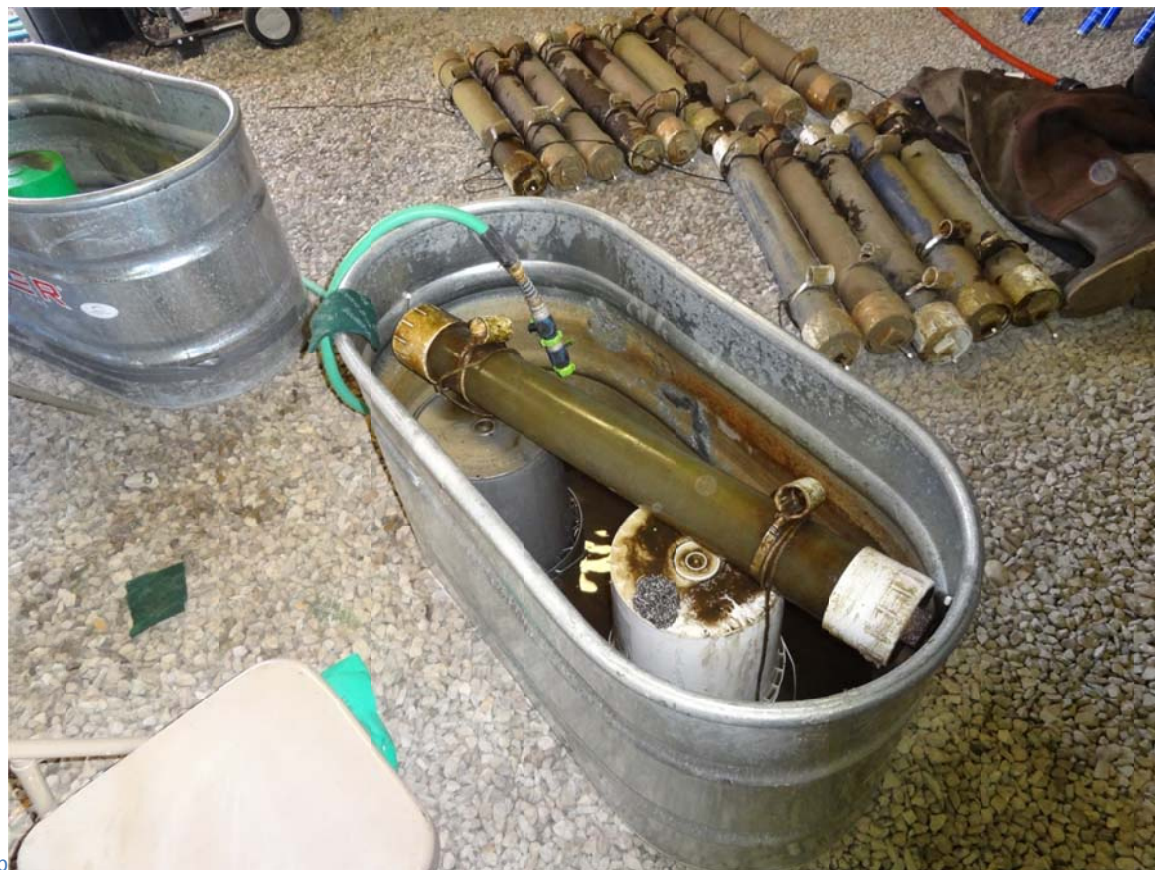
7. Walling Tube sampling observed within the barn at the C3.2 boat launch.

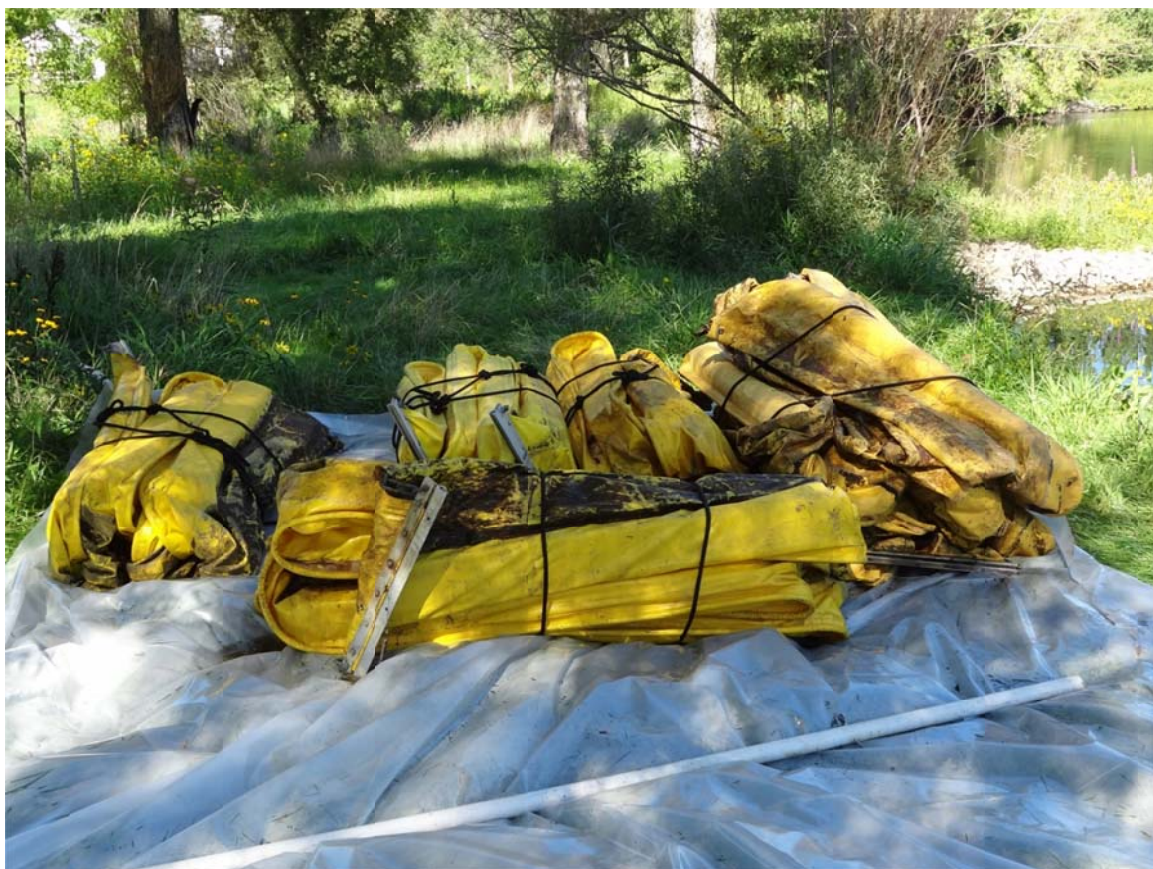
8. C3.2 boat launch observed the boom utilized at Raymond Road being demobilized and staged.

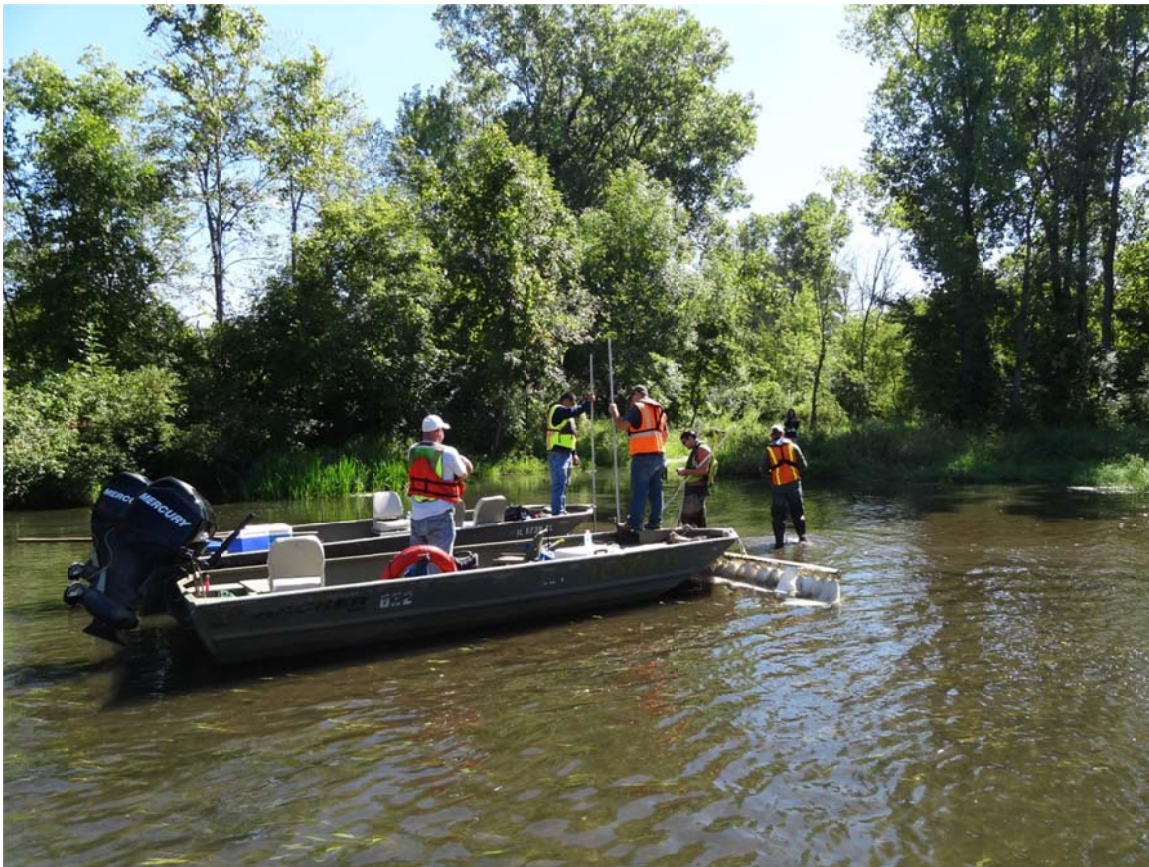
9. MP10.5 RDB observed a poling team.

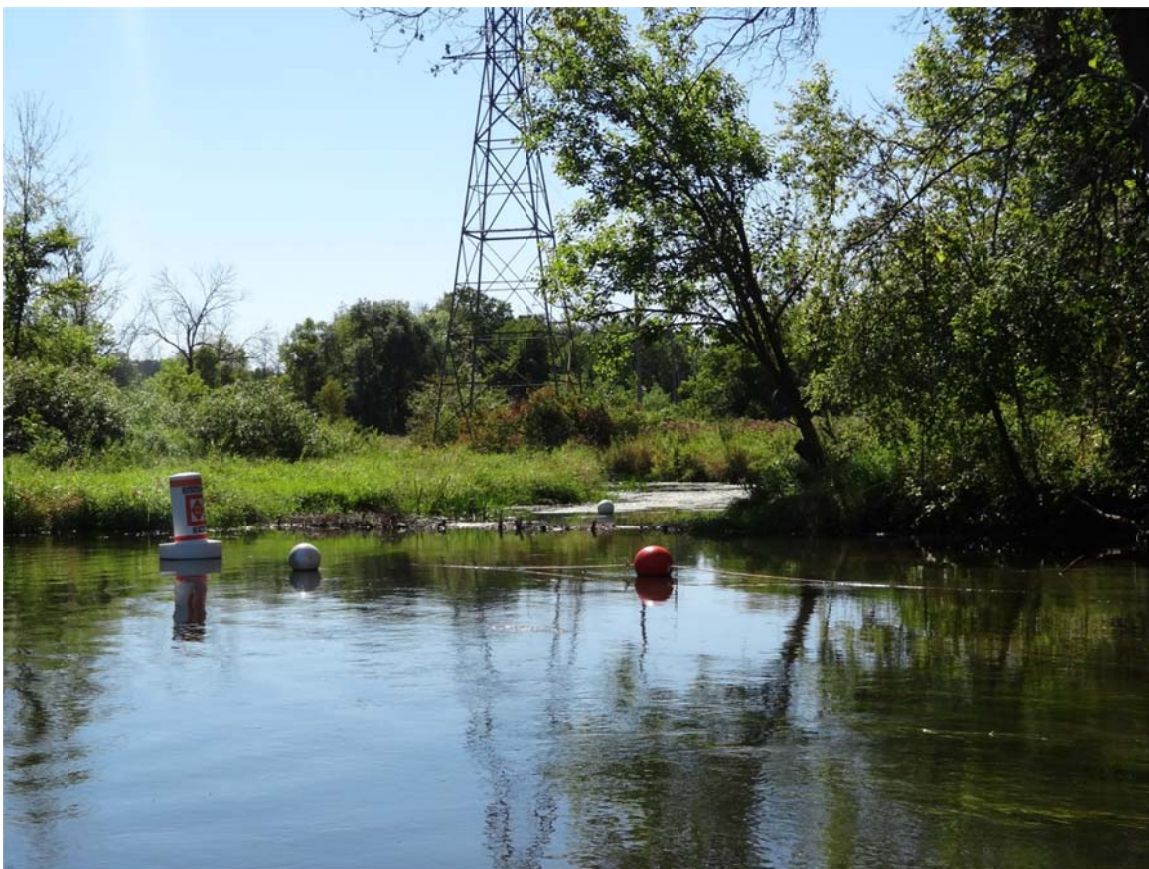
10. MP10.75 sediment trap no sheen observed.

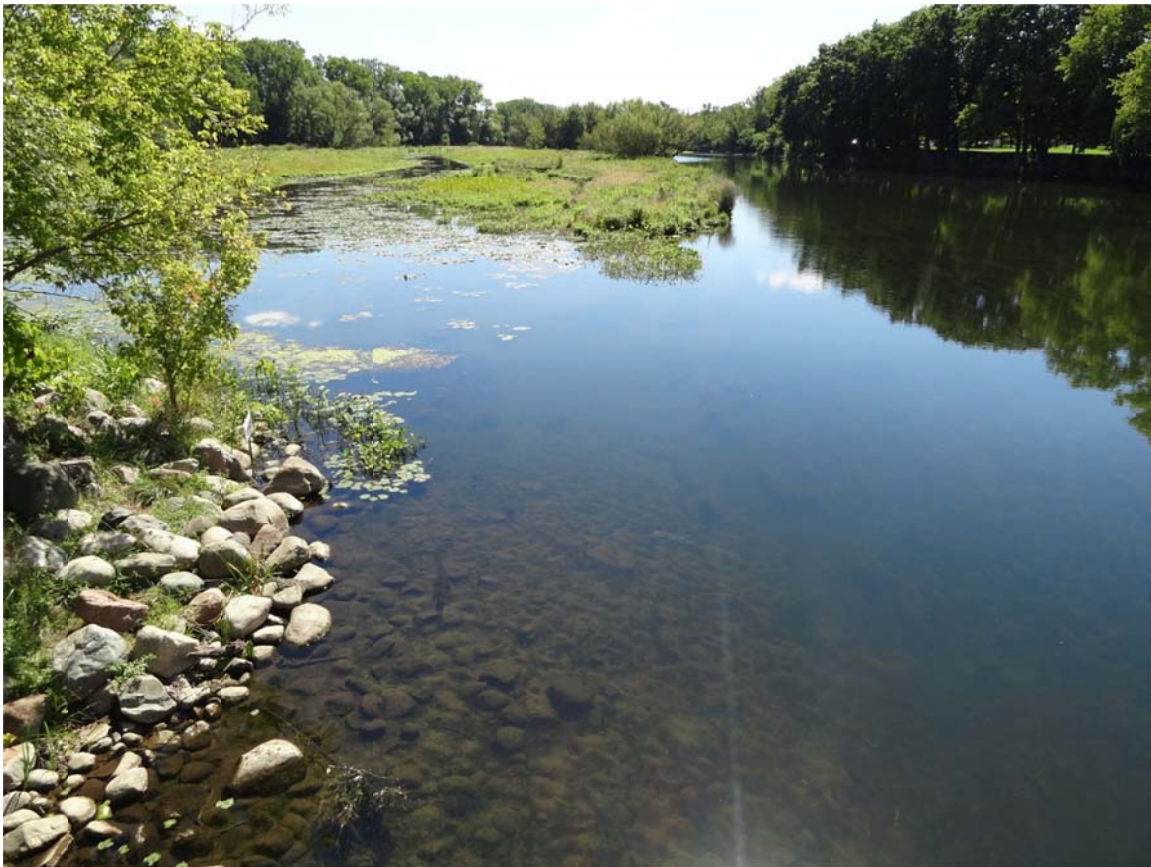
11. MP15.5 South Mill Pond no sheen observed.

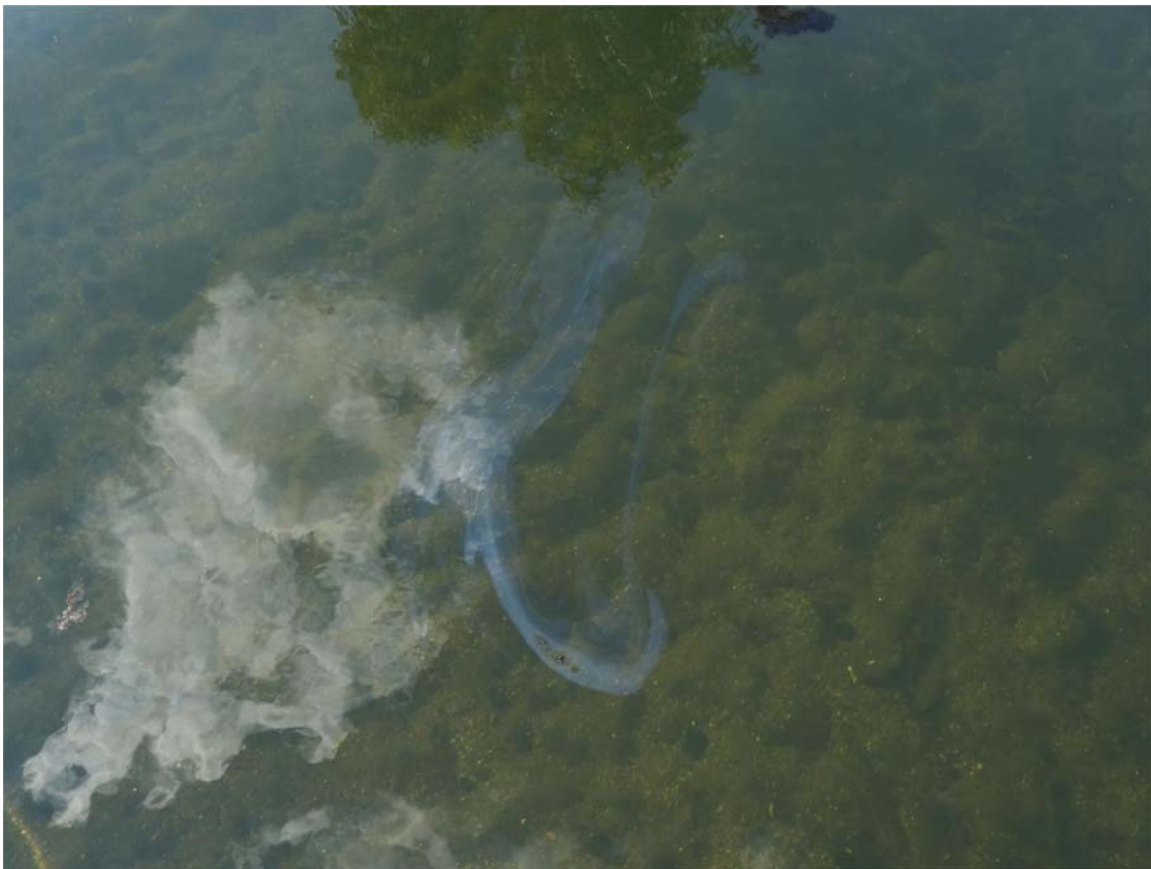
12. MP15.65 LDB tar glob and sheen observed.

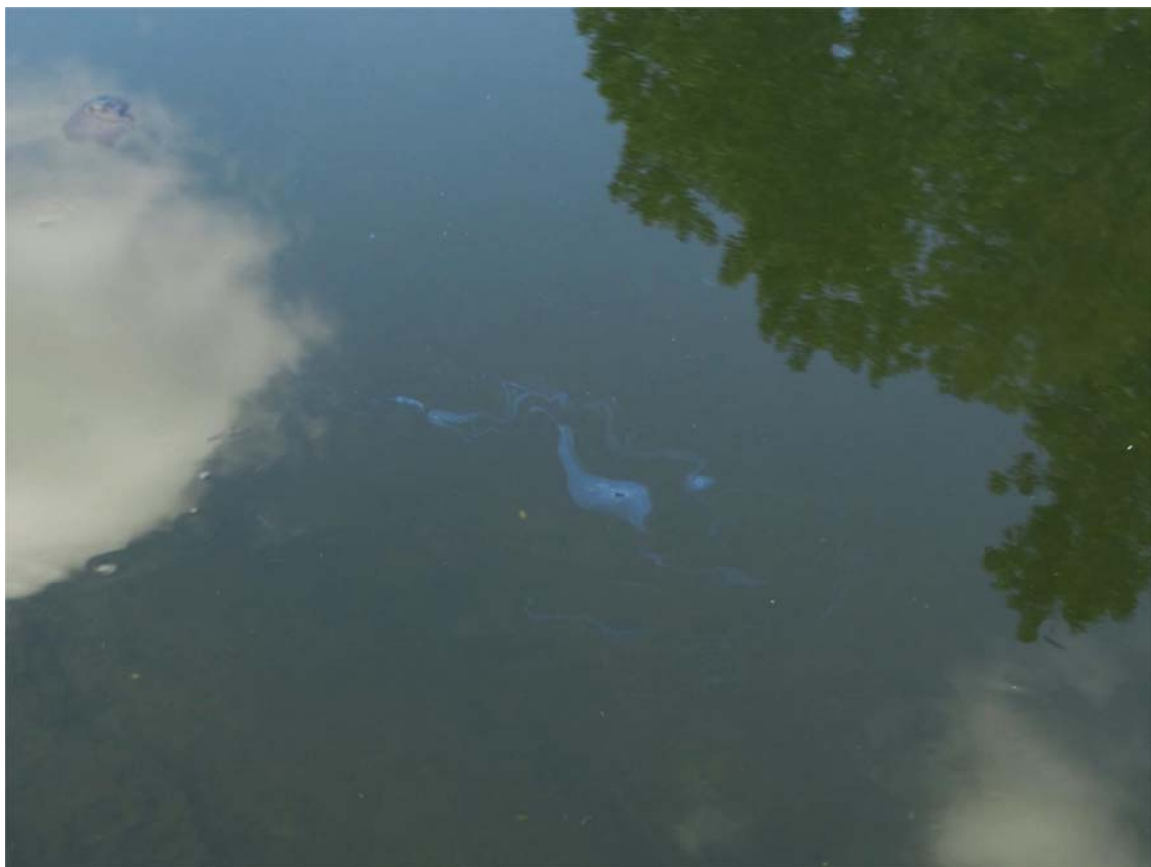
13. MP15.25 LDB sheen observed.

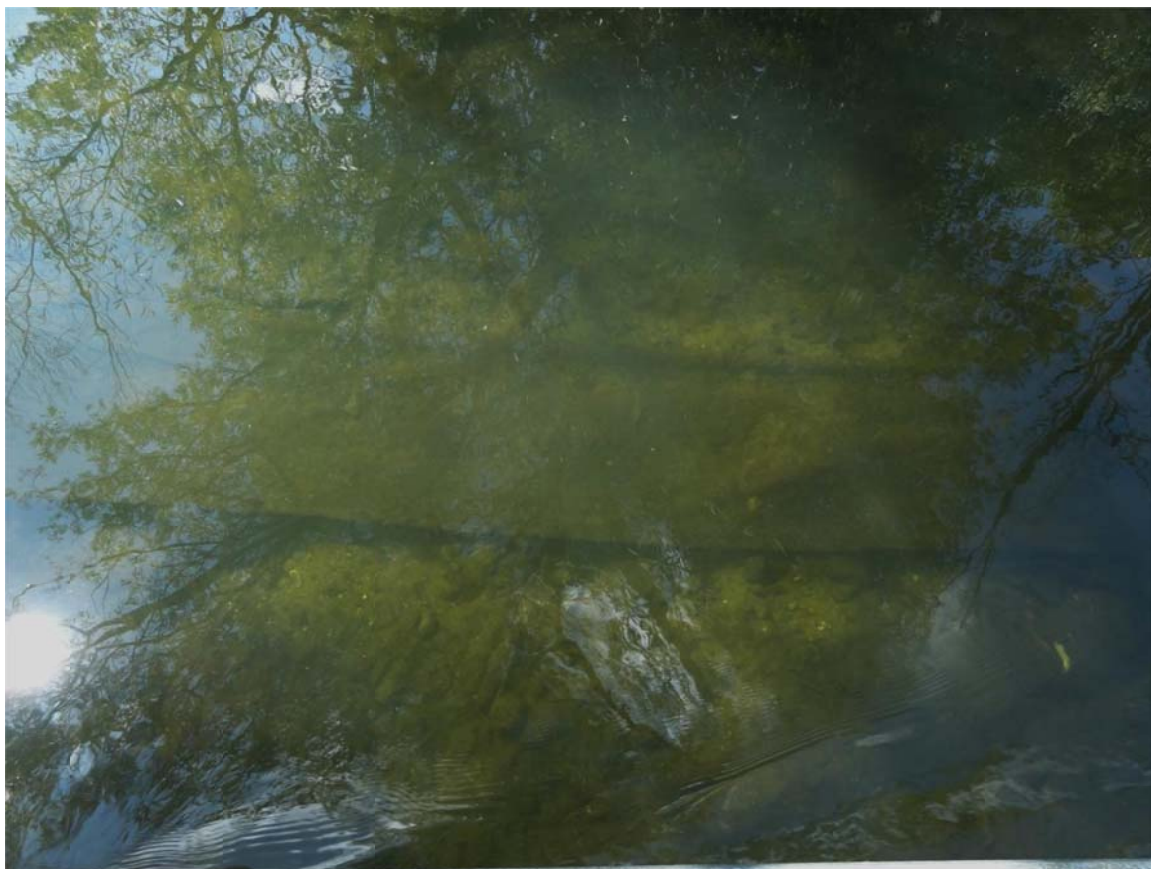
14. MP14.70 LDB sediment curtain observed, SWAT was notified.

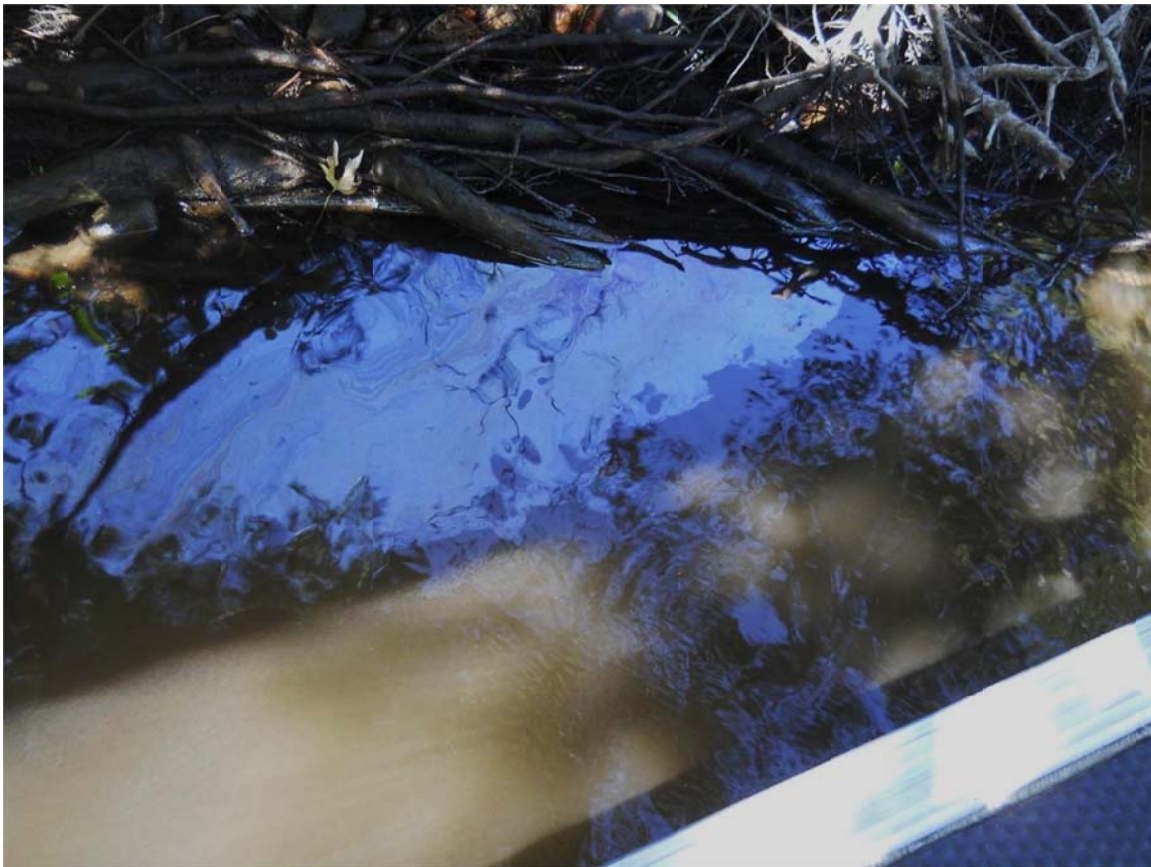
15. MP33.1 RDB observed rainbow sheen flowing out of the roots.

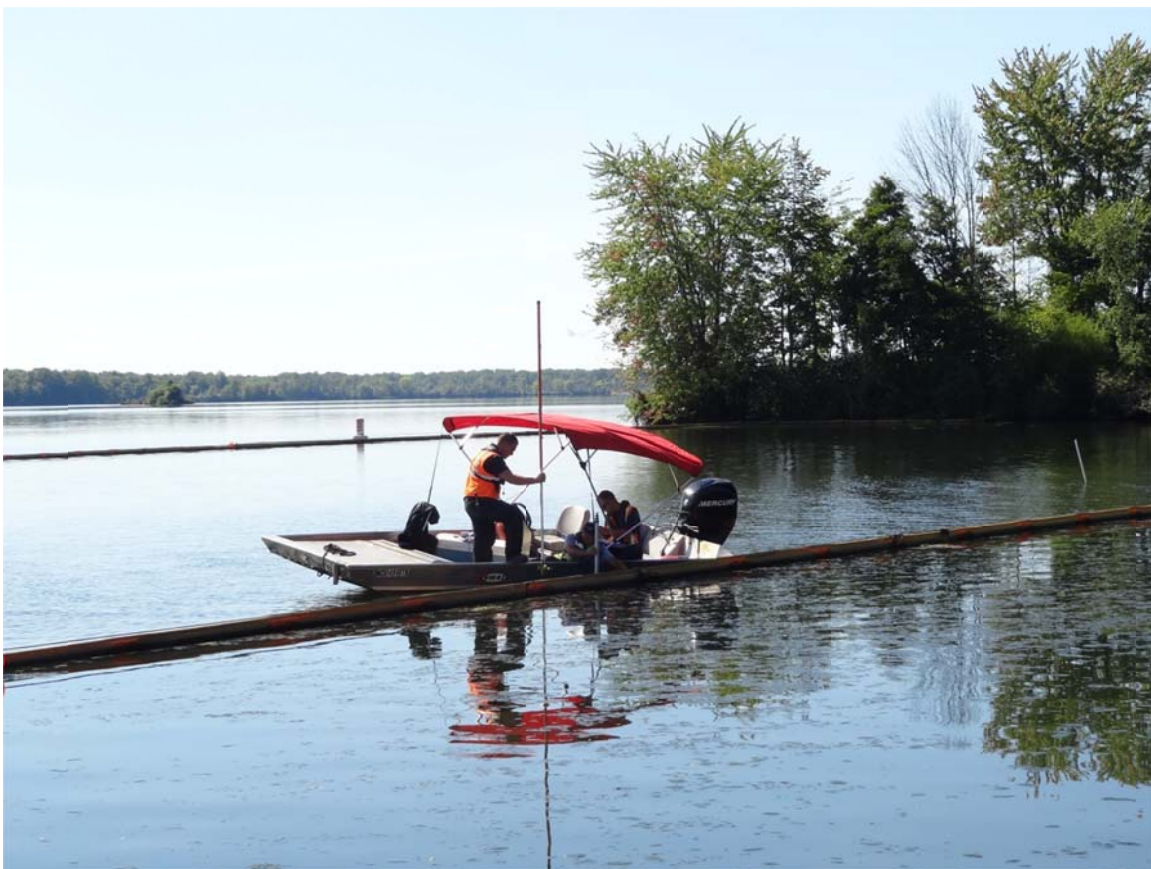
16. Observed a crew performing curtain inspections along Boom E of the Morrow Lake Delta.

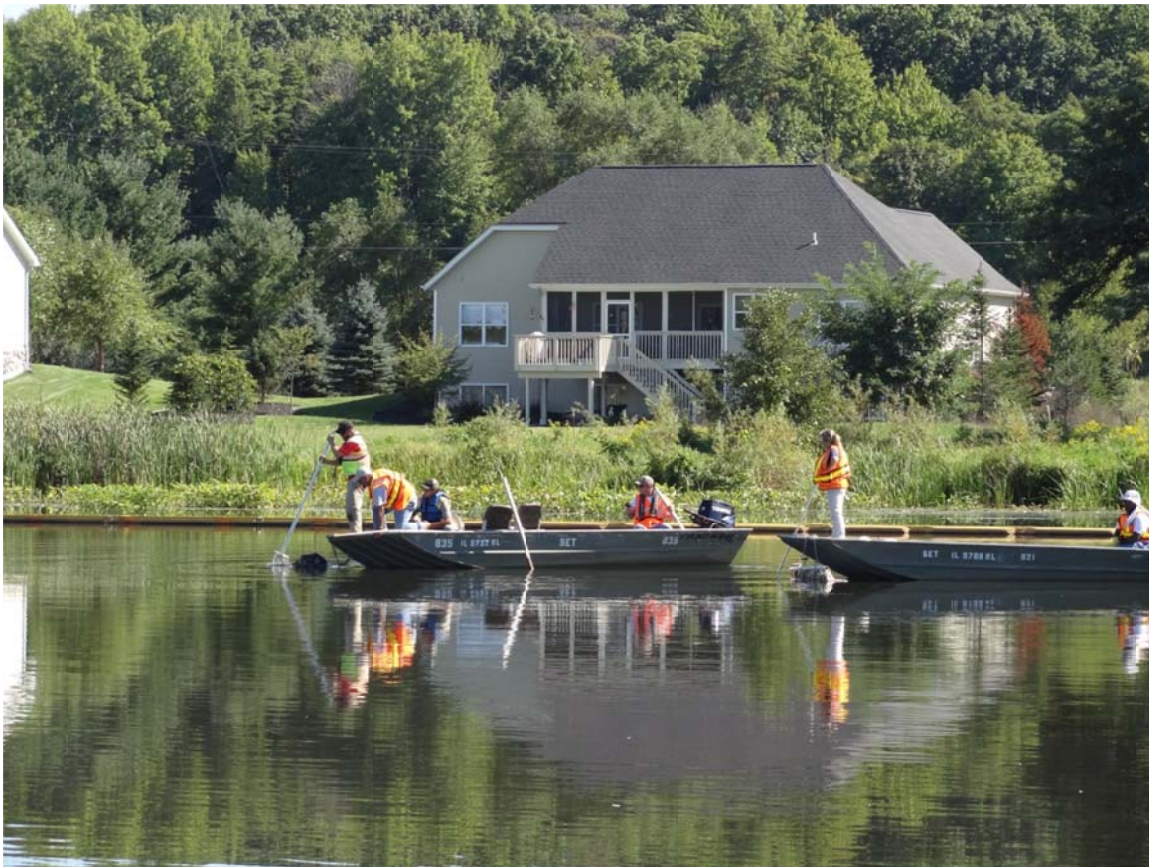
17. Morrow Lake Delta observed one of two poling teams.

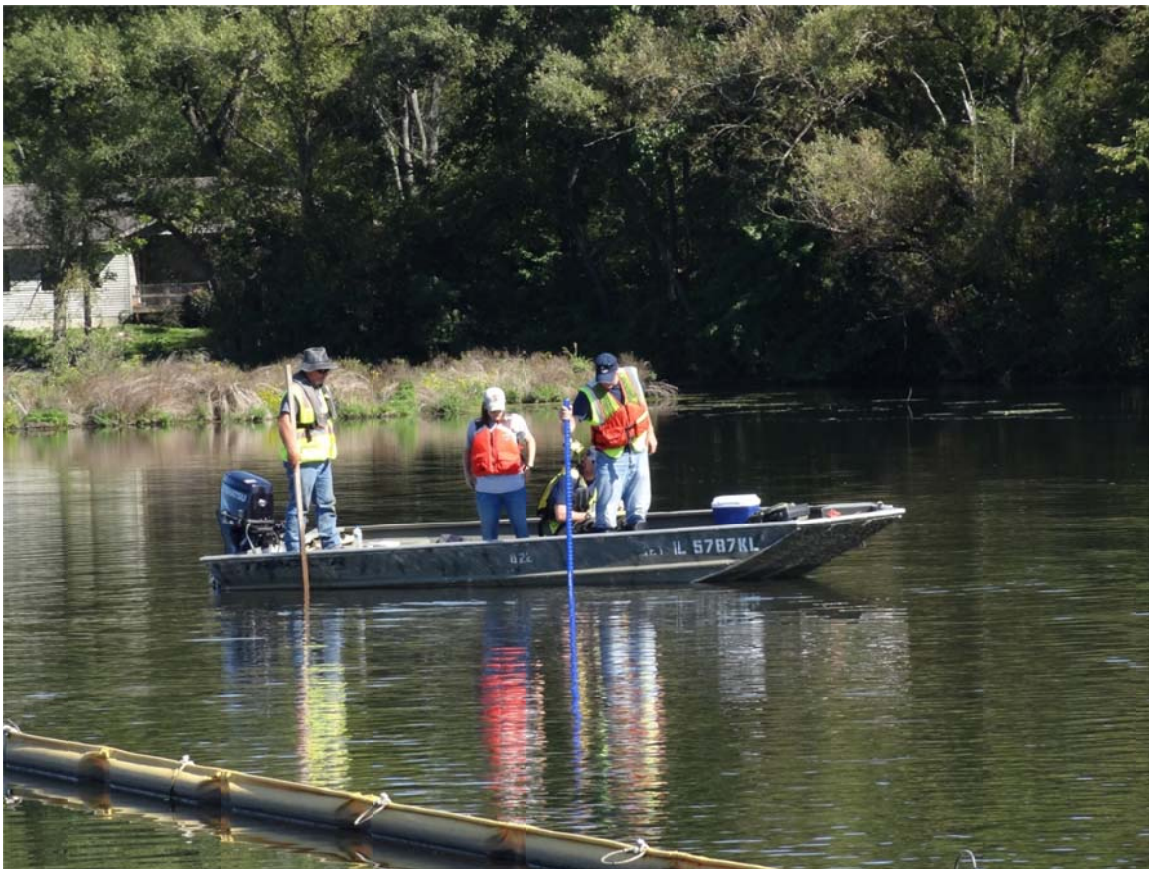
18. Morrow Lake Delta observed second of two poling teams.

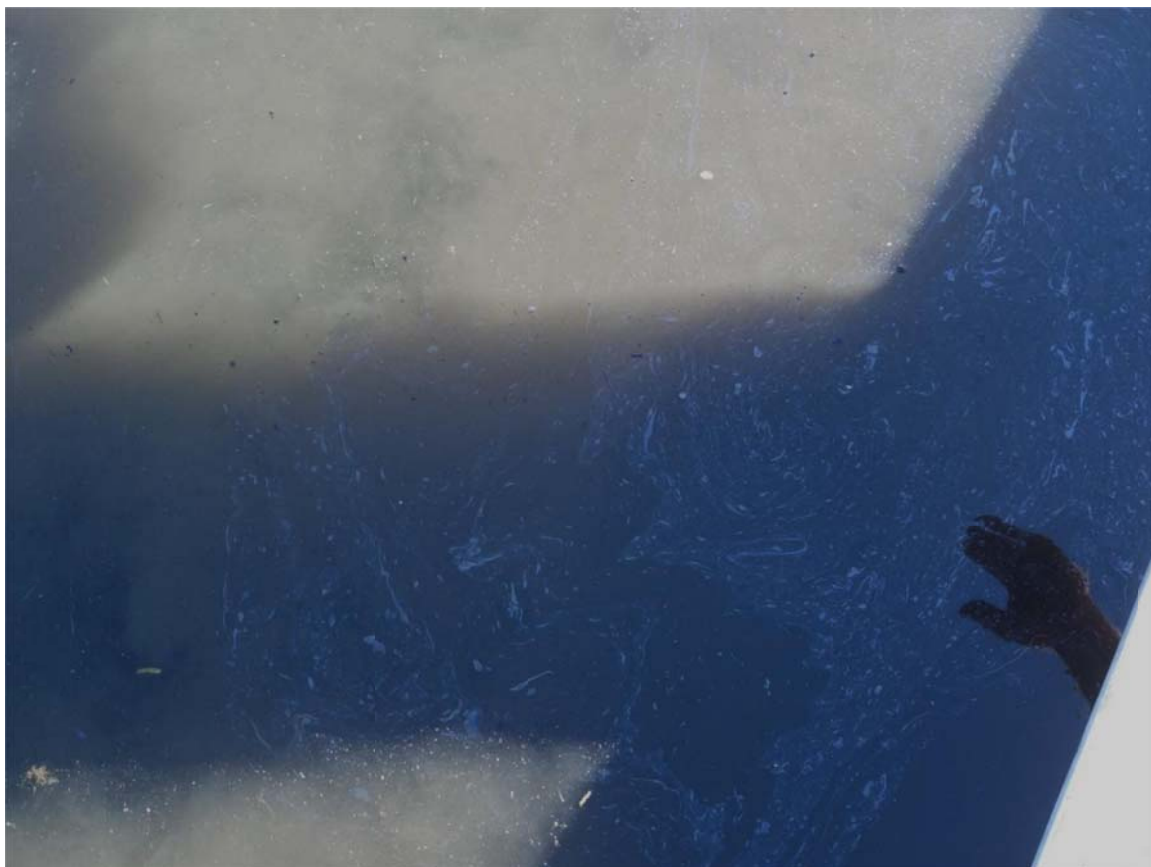
19. Morrow Lake Delta sheen near Boom A sheen generated by the boat.

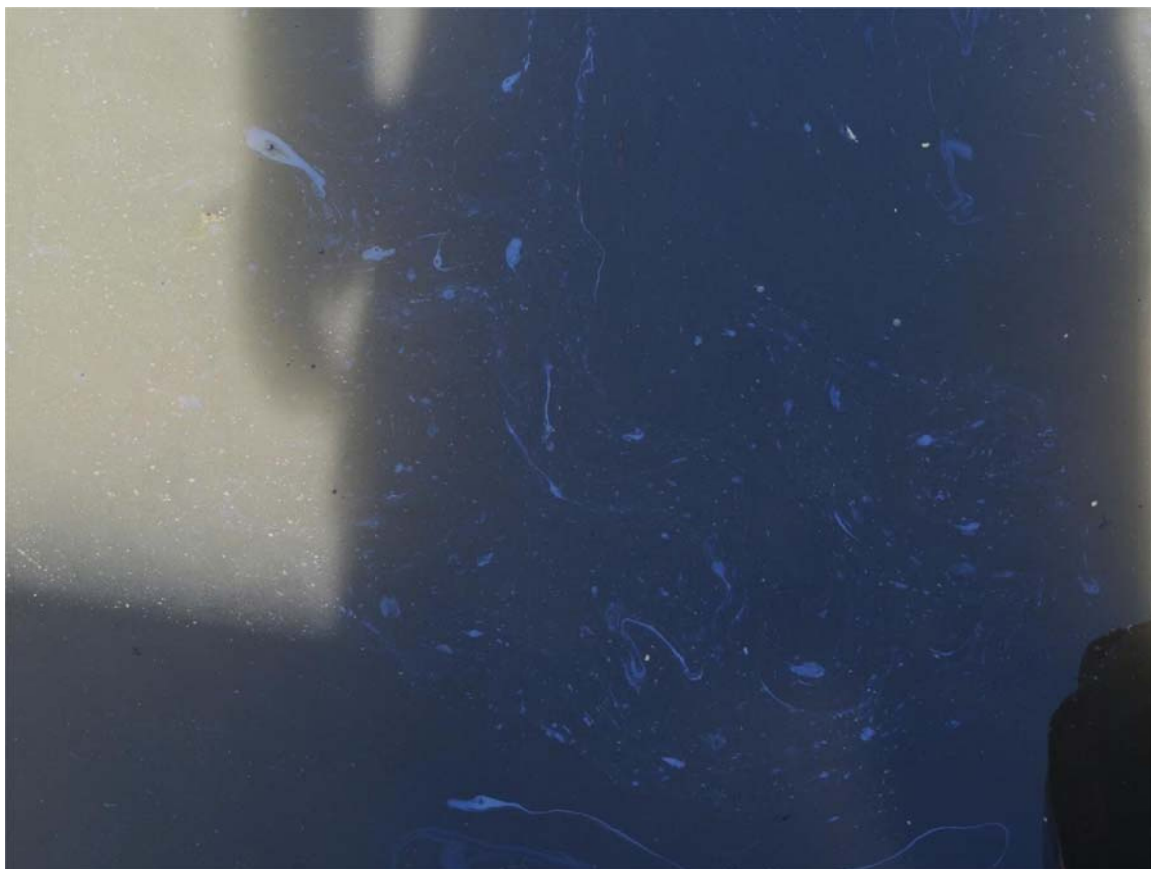
20. Morrow Lake Delta sheen near Boom A sheen generated by the boat.

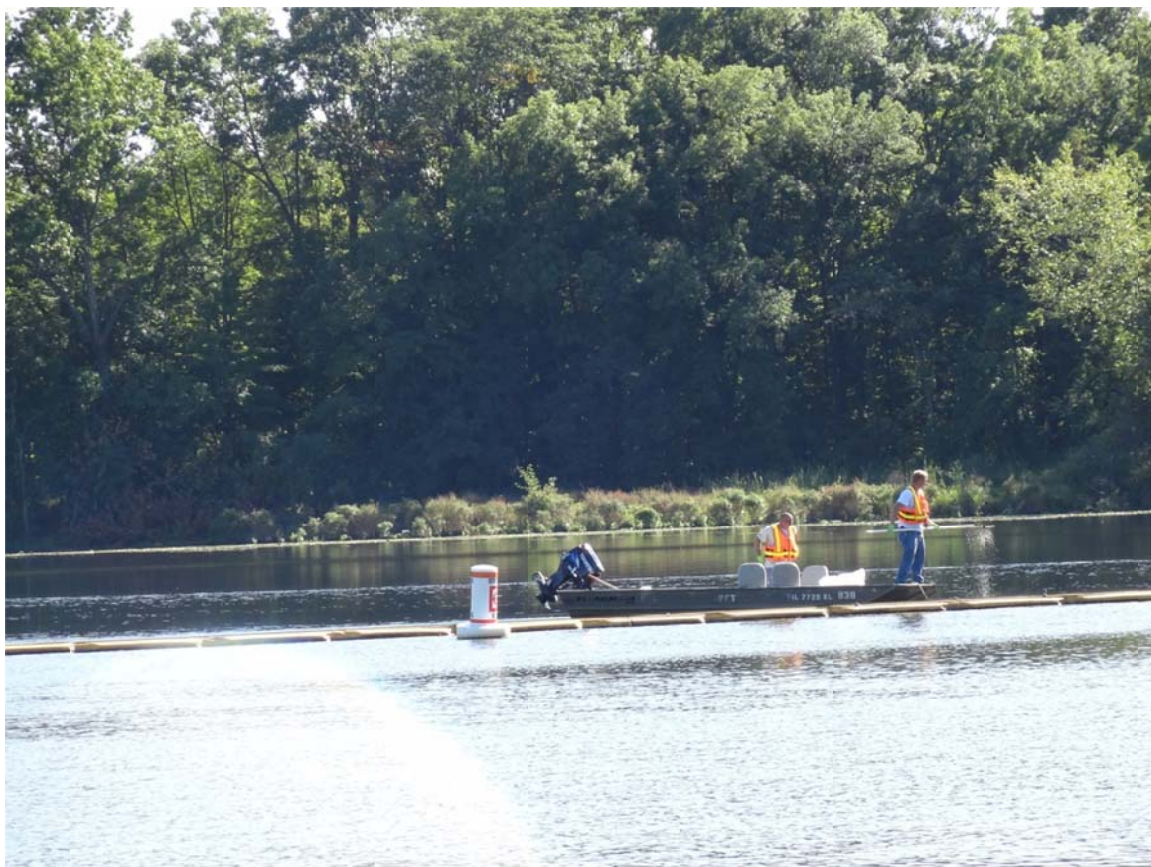
21. Morrow Lake Delta observed a crew removing debris from Boom C.

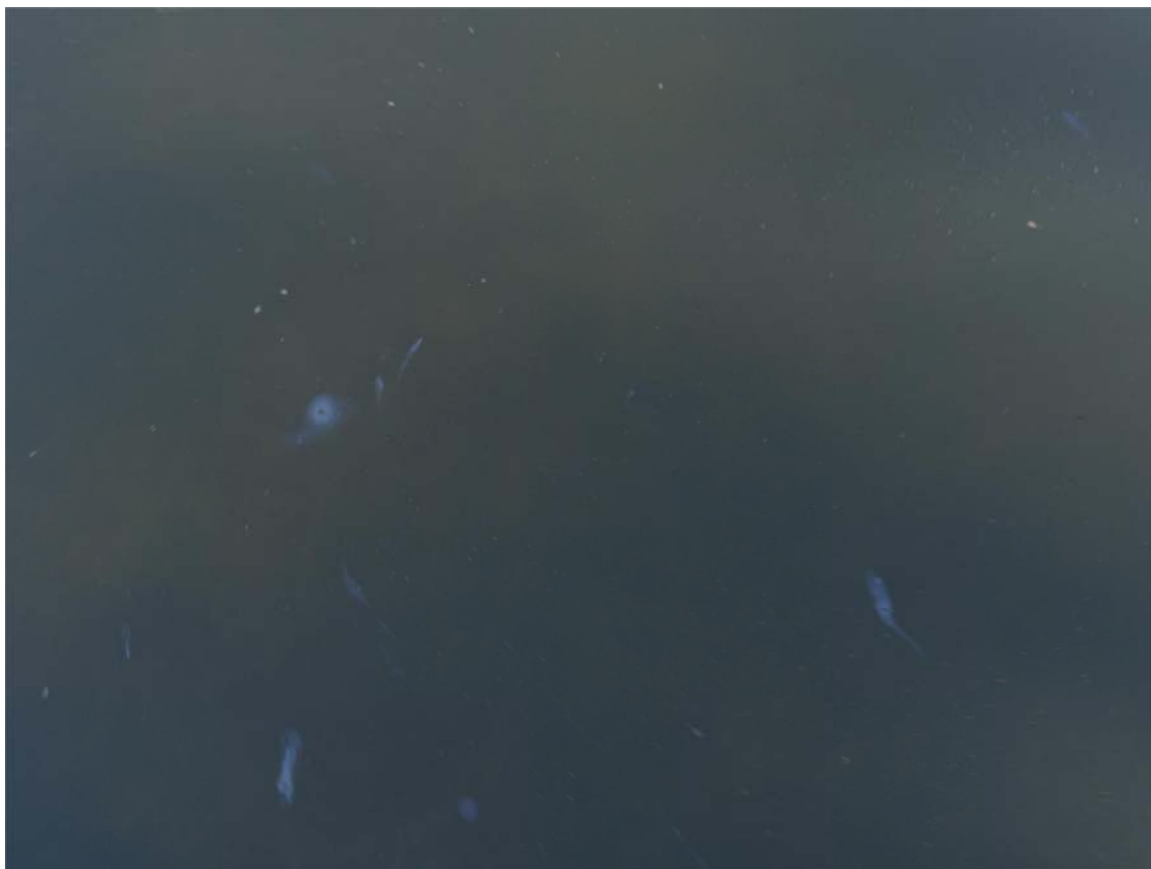
22. Morrow Lake southern cover observed sheen and tar globs.

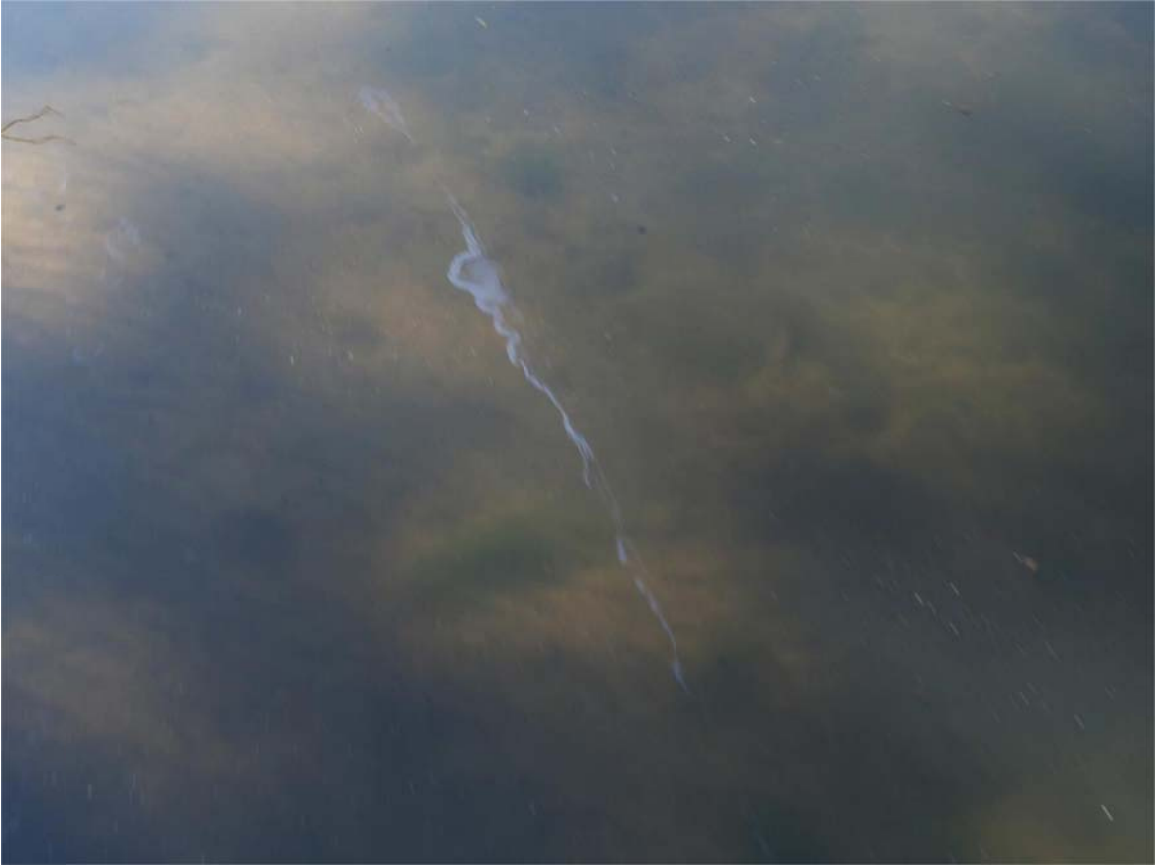
23. Morrow Lake southern cover observed 4' ribbon of sheen.
