# Situation Photo Log

Monday, September 10, 2012

Kalamazoo River / Enbridge Spill

Prepared by:  
Matthew Haak  
START-USEPA  
Situation Unit Leader

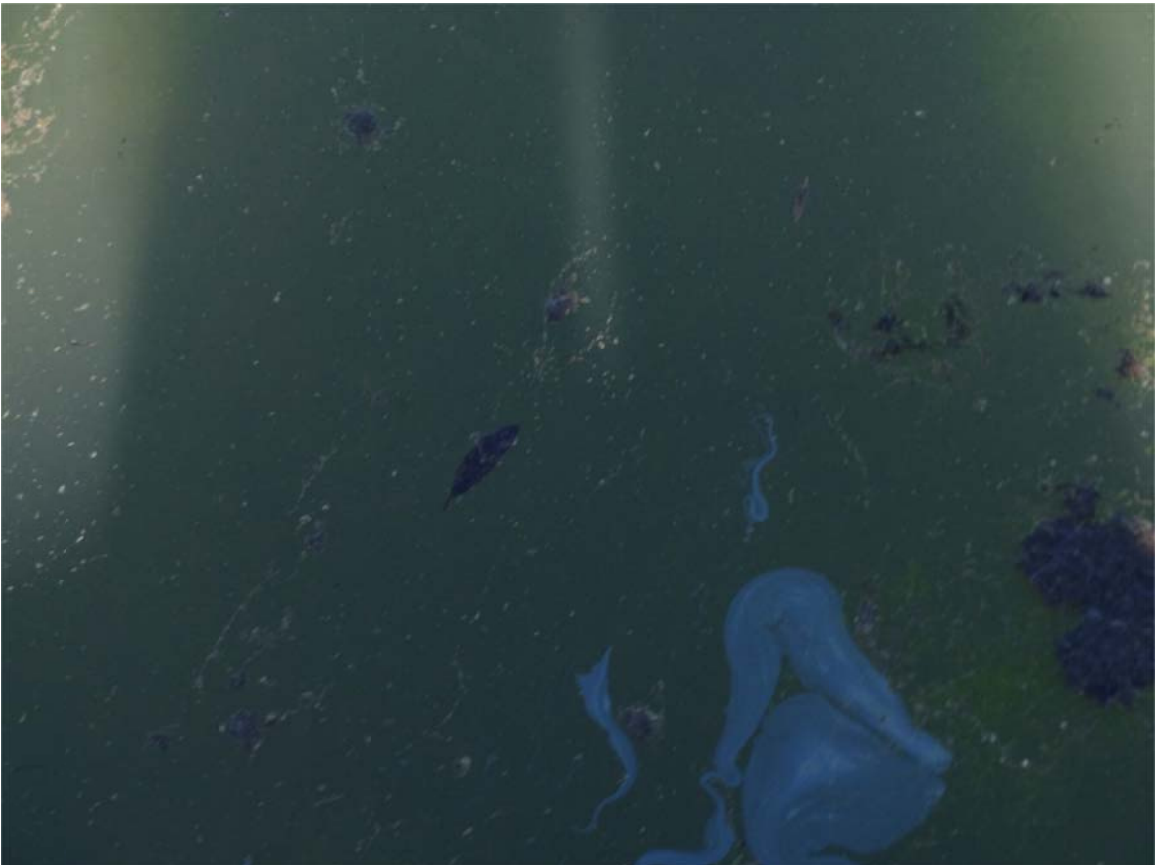
24. Morrow Lake north cove sheen observed.
