# Situation Photo Log

Tuesday, September 11, 2012

Kalamazoo River / Enbridge Spill

Prepared by:  
Matthew Haak  
START-USEPA  
Situation Unit Leader

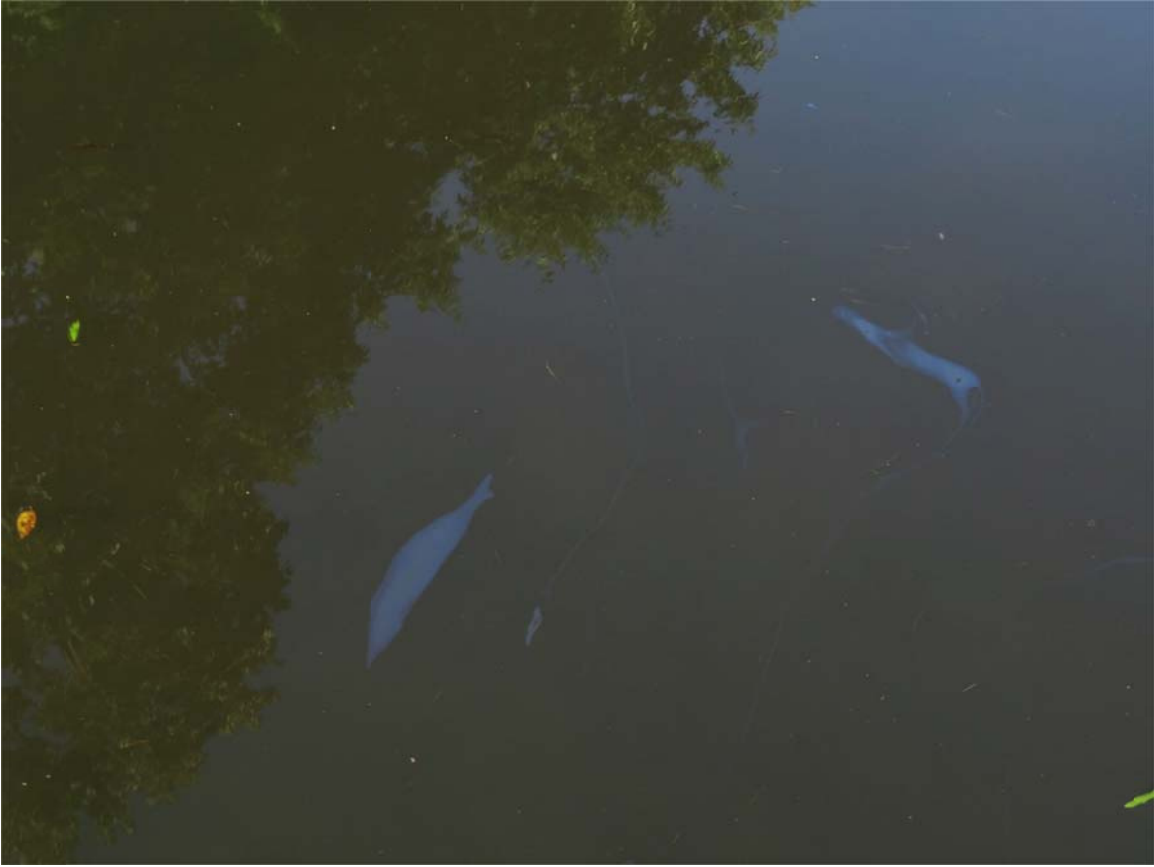
1. Sheen and tar globules observed at MP5.0 LDB.

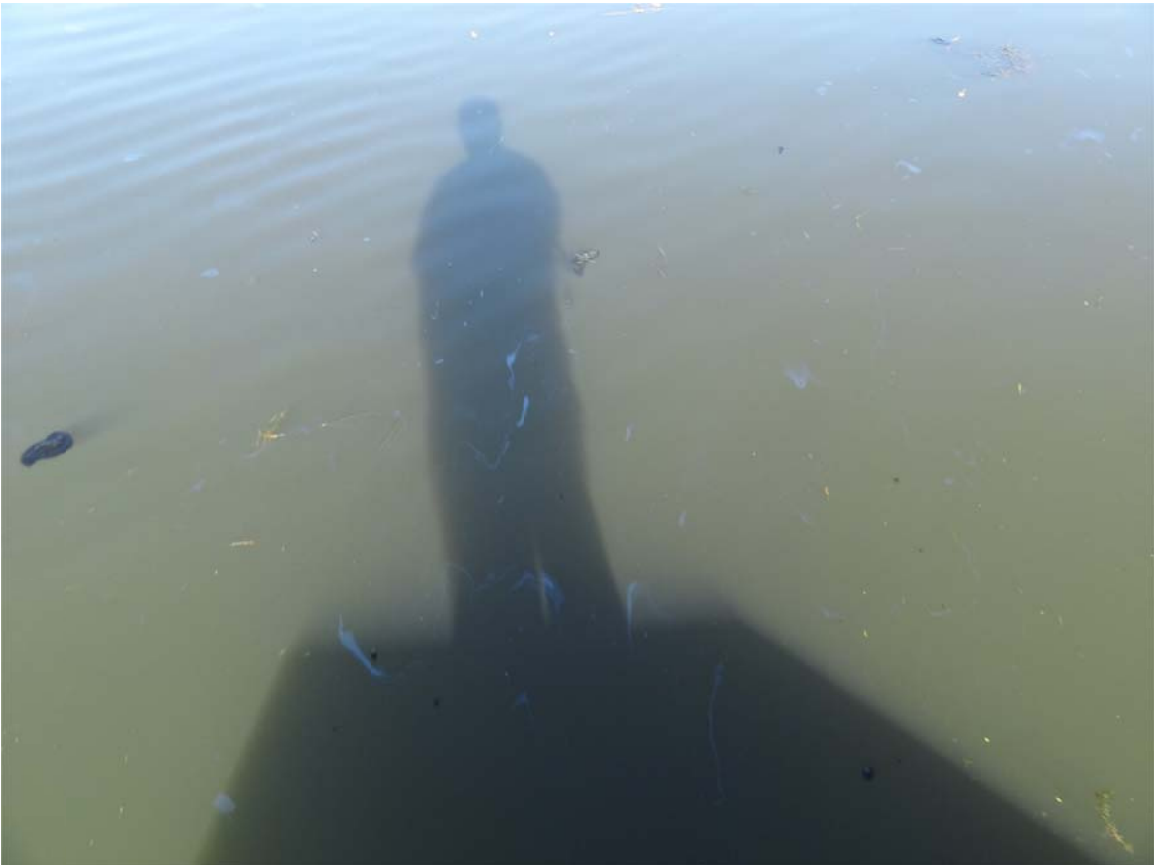
2. MP5.63 RDB below the railroad trestles sheen observed.

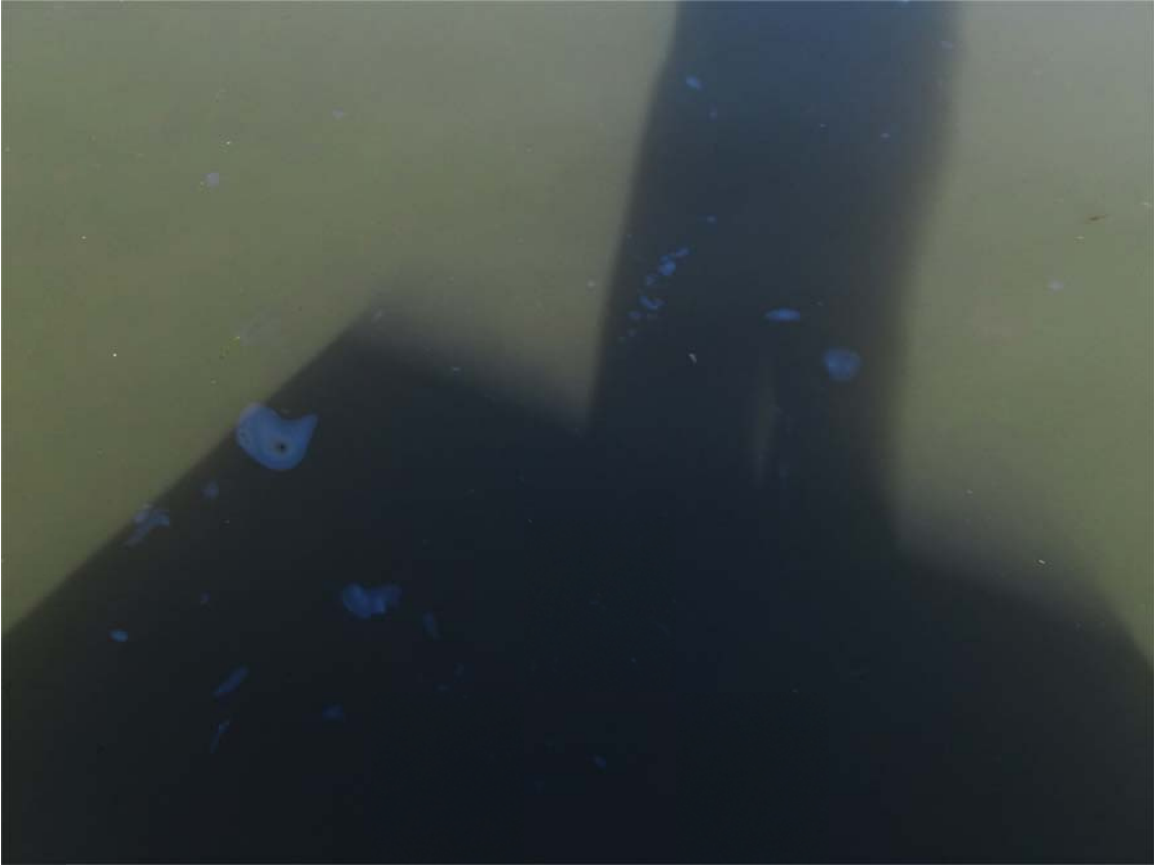
3. MP5.63 RDB below the railroad trestles sheen observed.

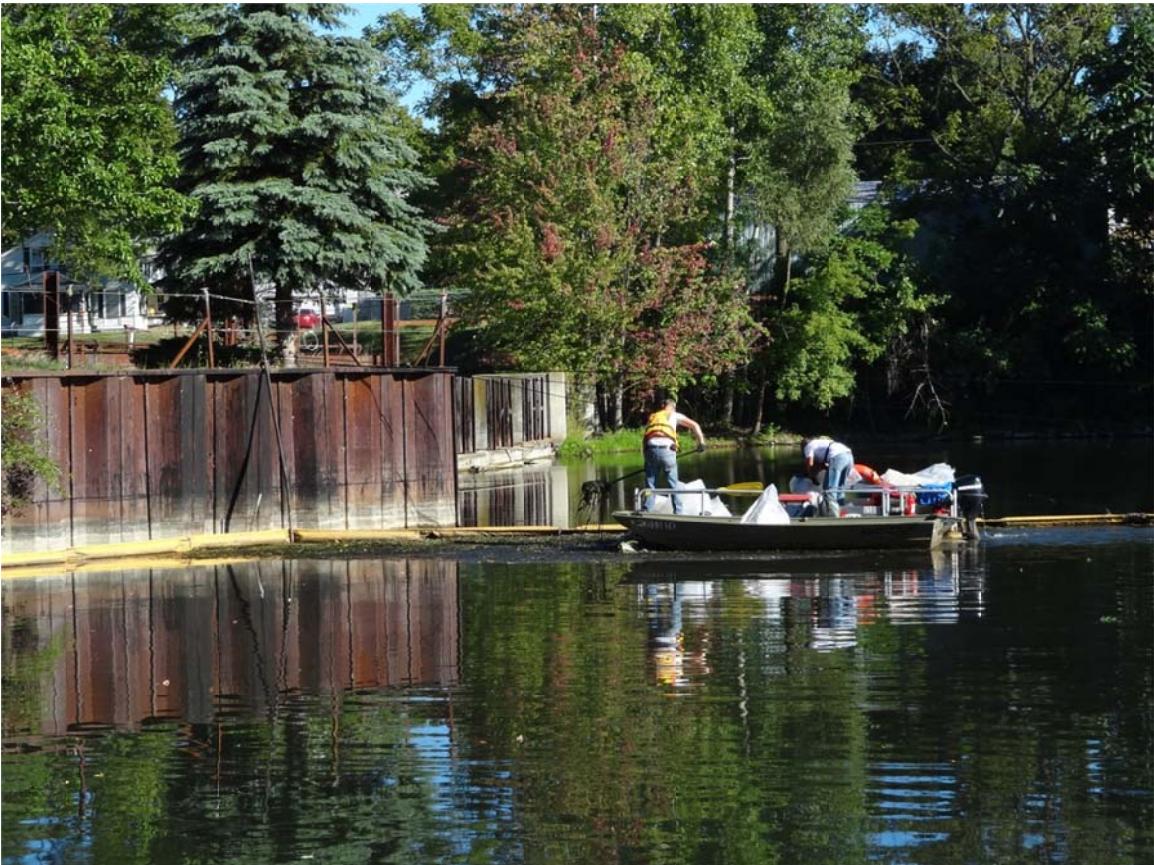
4. Ceresco Dam observed crew removing debris from boom.

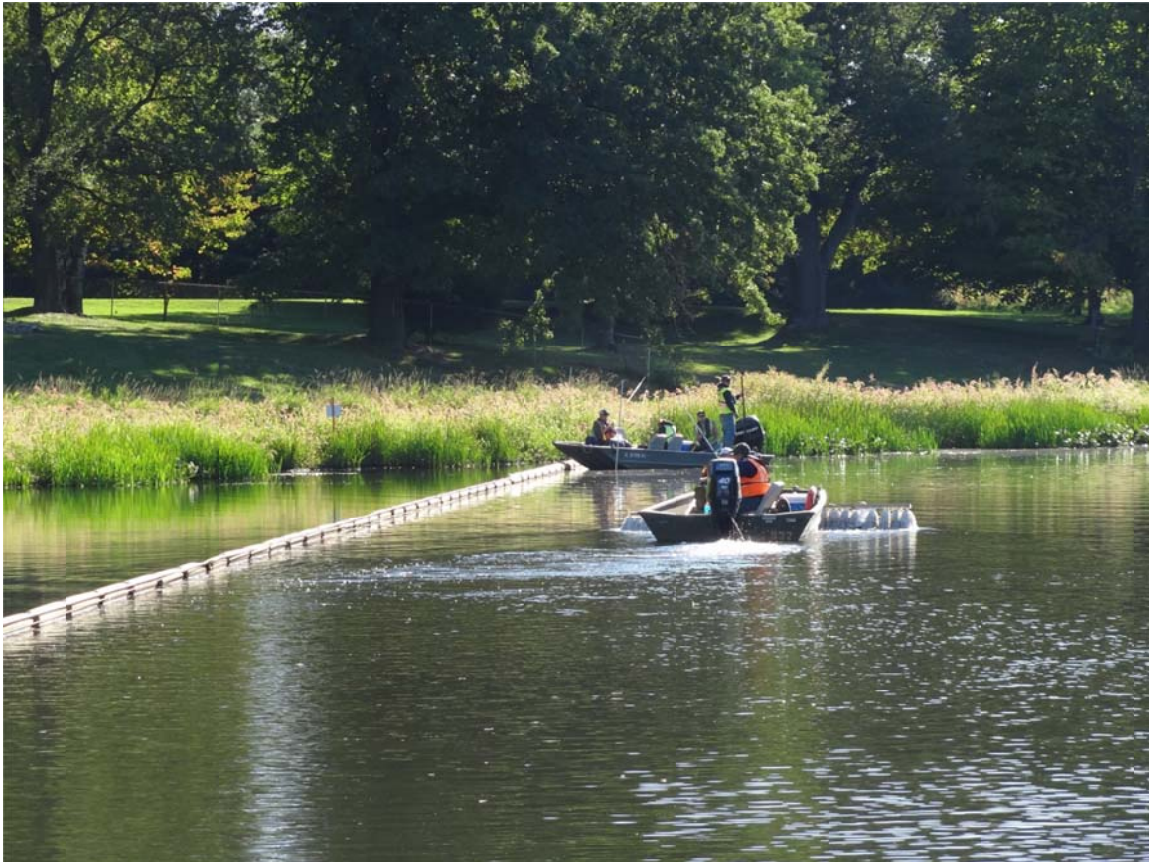
5. Poling crew observed above Ceresco Dam.

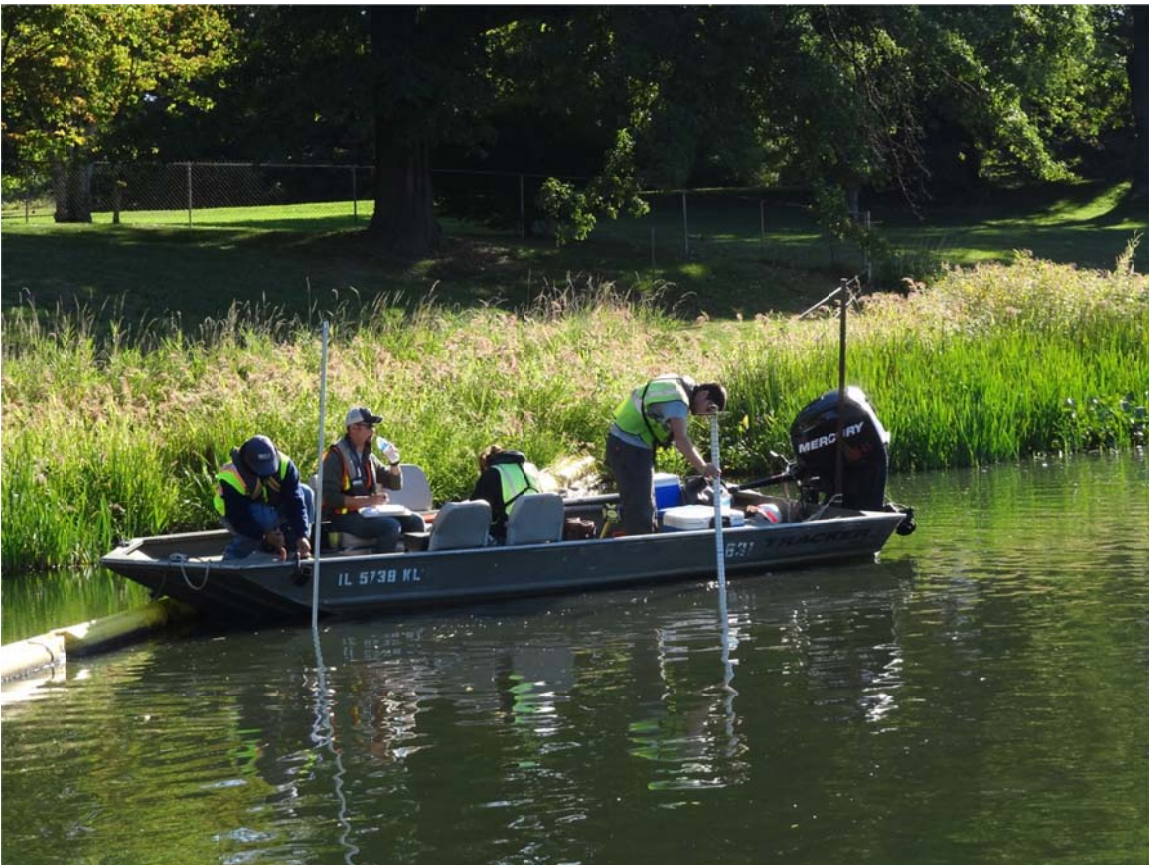
6. Poling crew observed above Ceresco Dam.

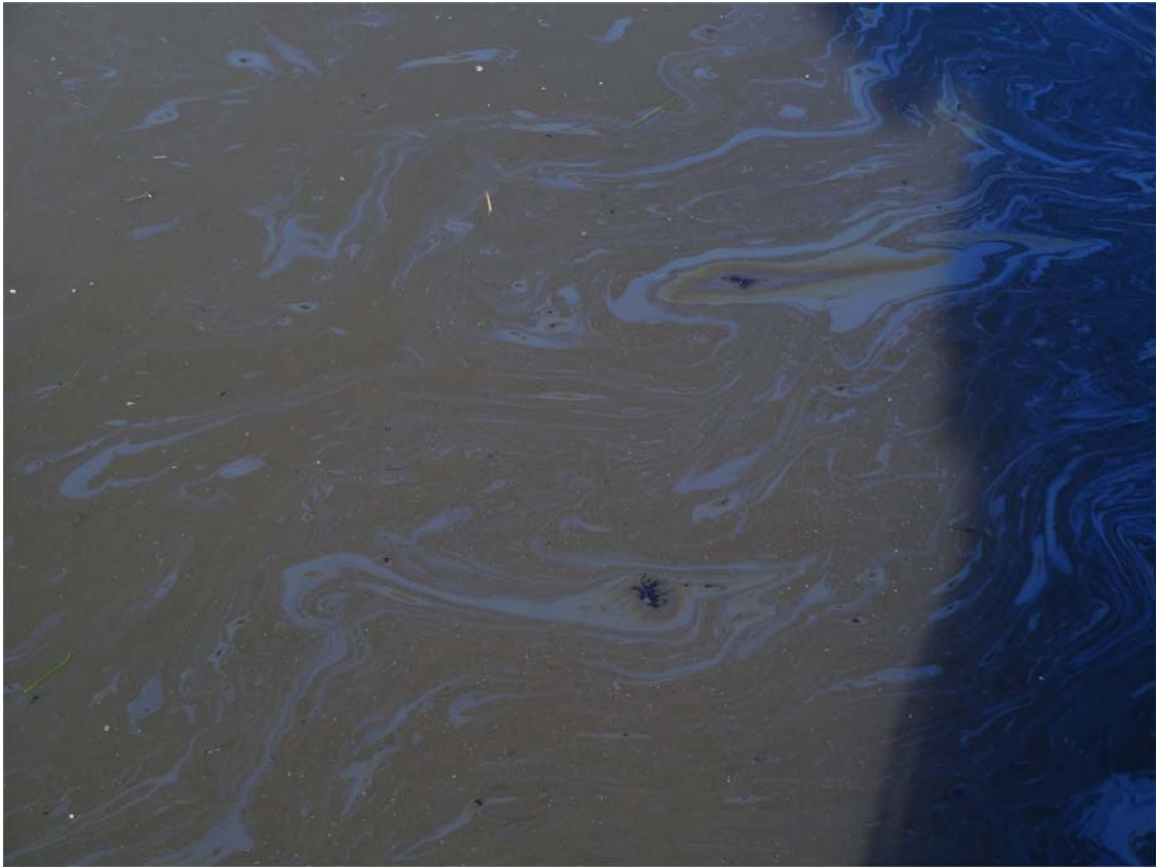
7. Sheen and tar globs observed down from the bathymetry team above Ceresco Dam.

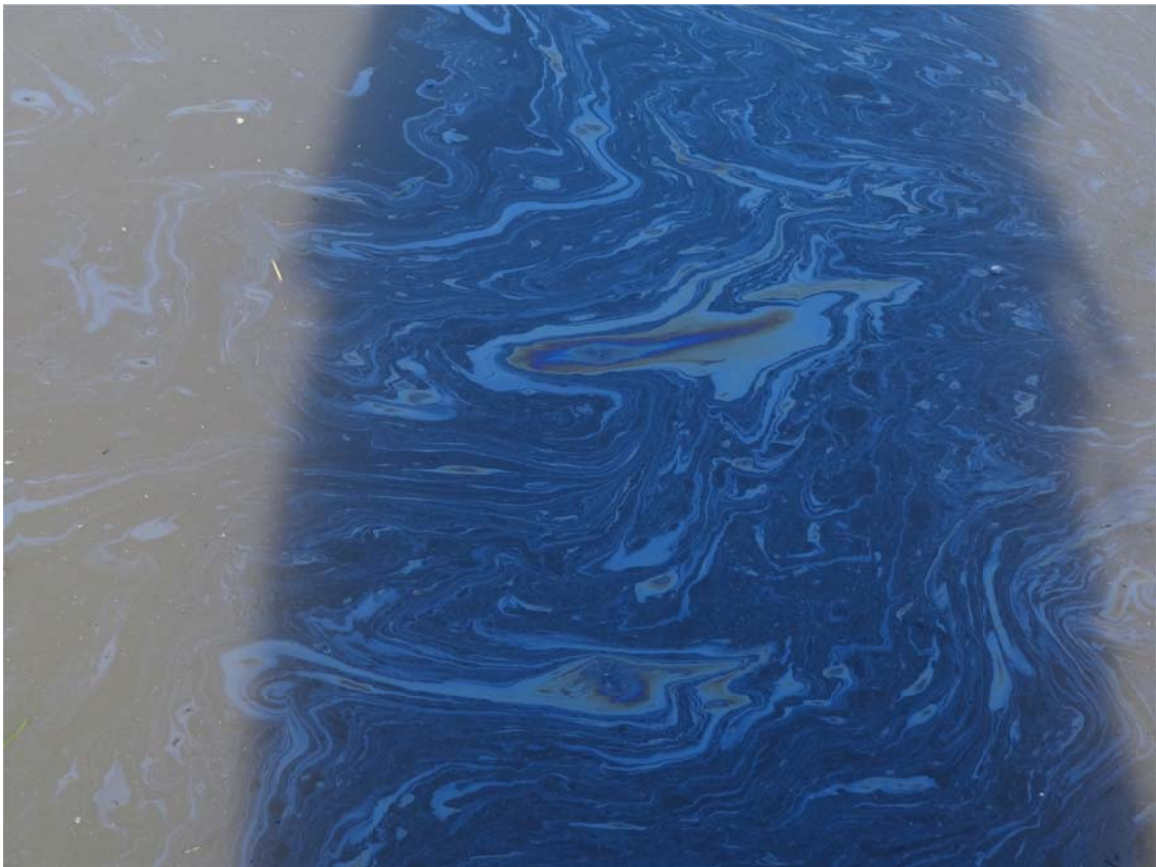
8. Sheen and tar globs observed down from the bathymetry team above Ceresco Dam.

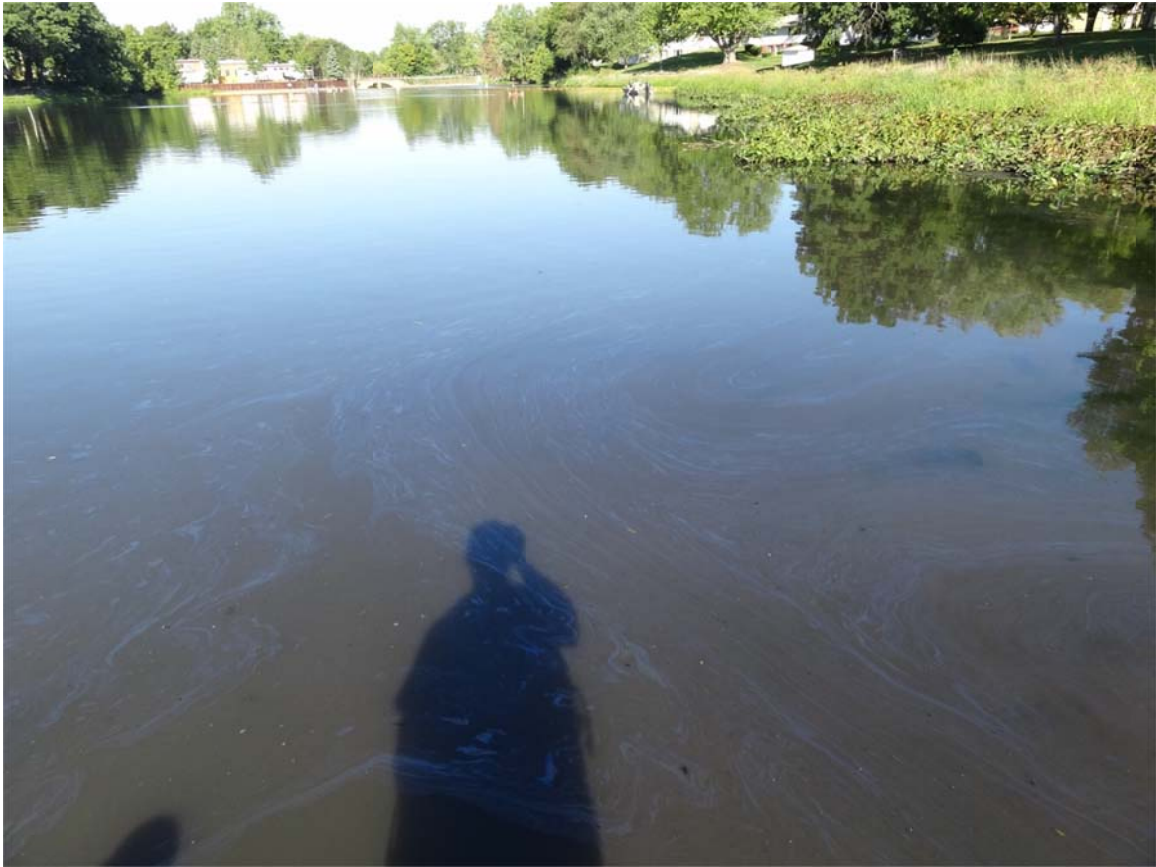
9. Sheen and tar globs observed down from the bathymetry team above Ceresco Dam.

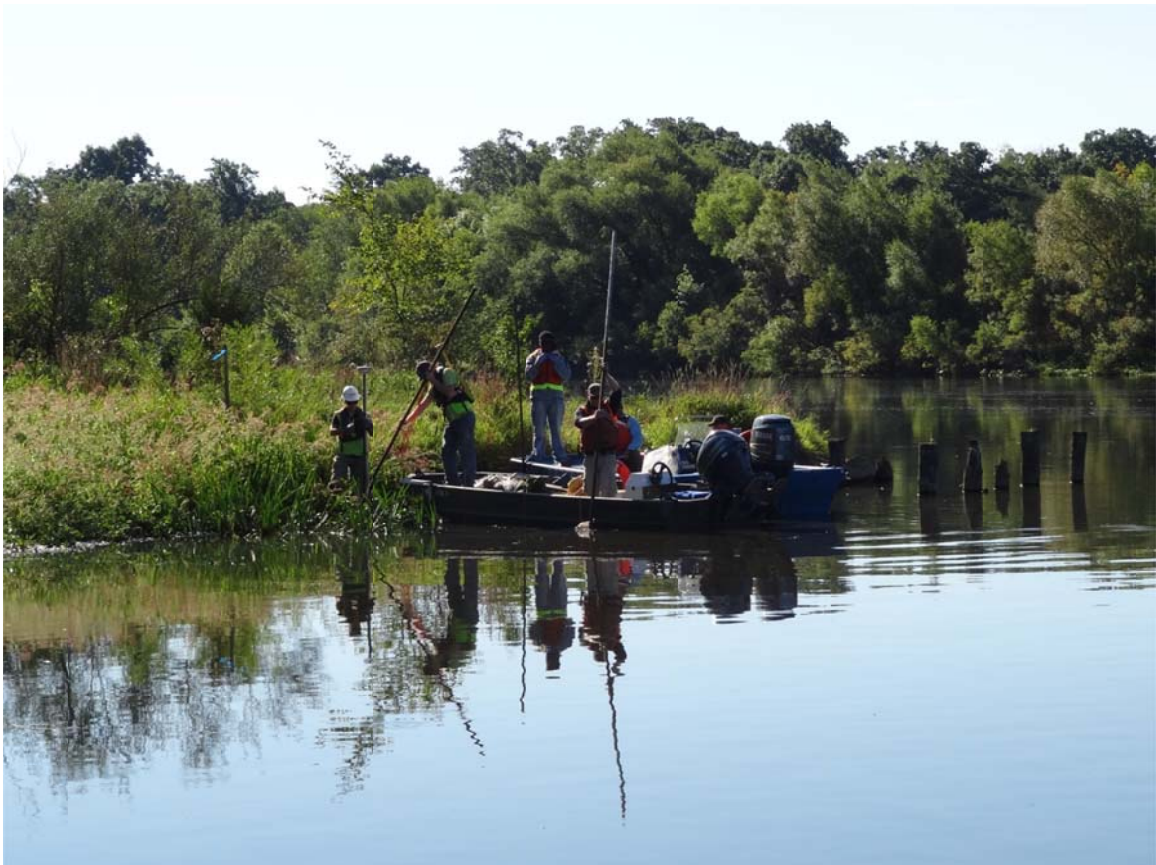
10. Bathymetry team observed above Ceresco Dam.

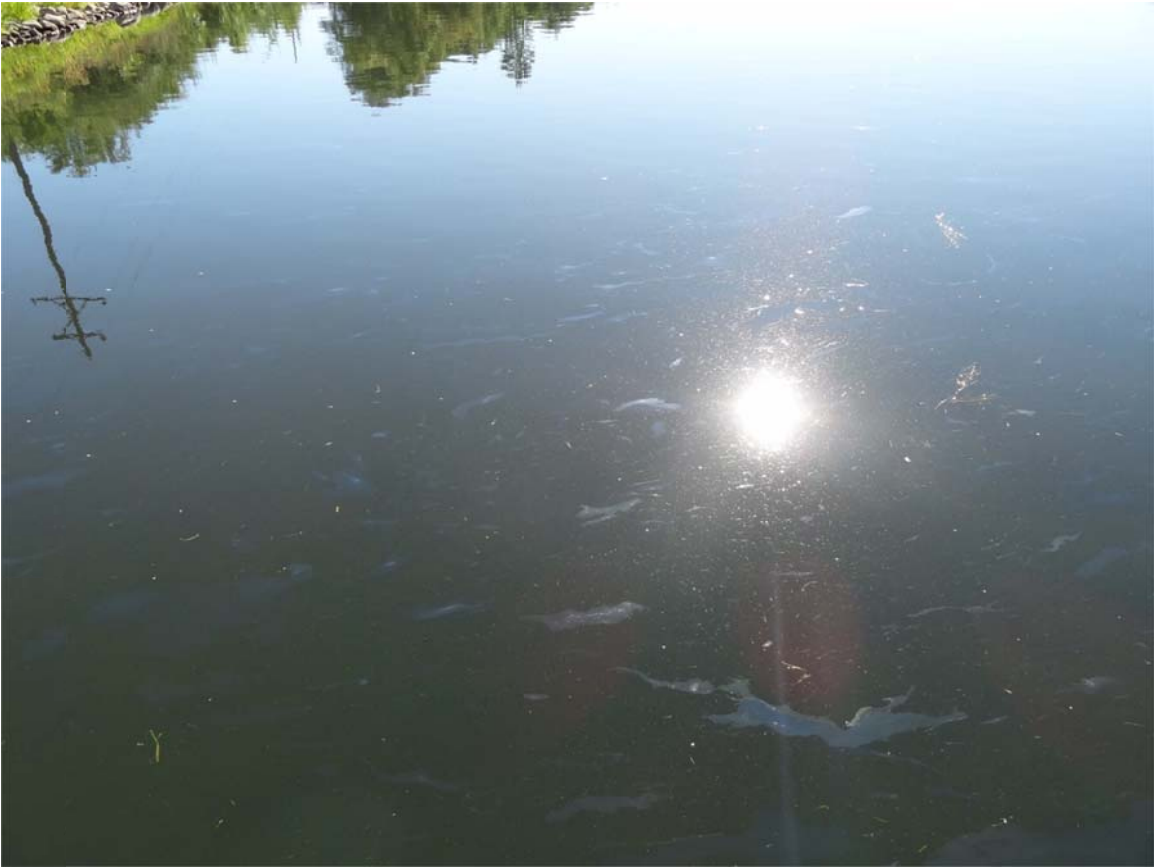
11. MP5.55 RDB sheen observed.

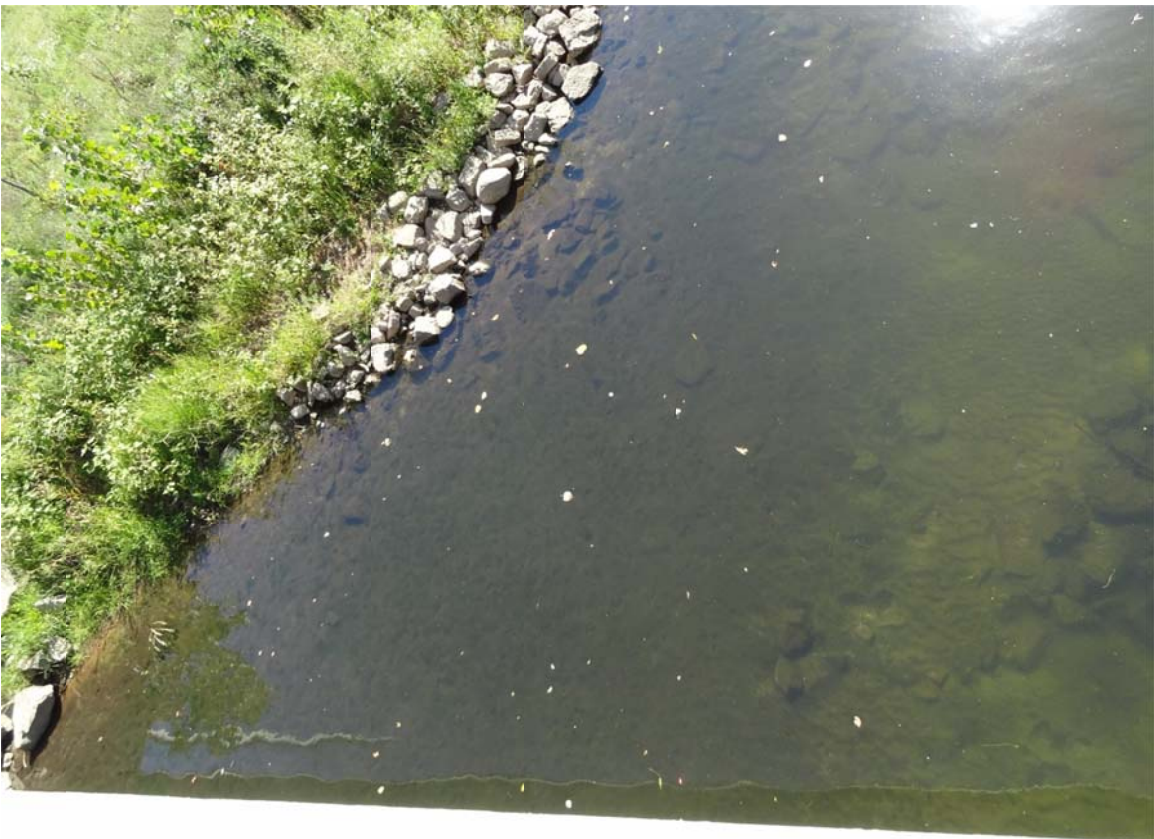
12. MP21.5 Custer Bridge no sheen observed.

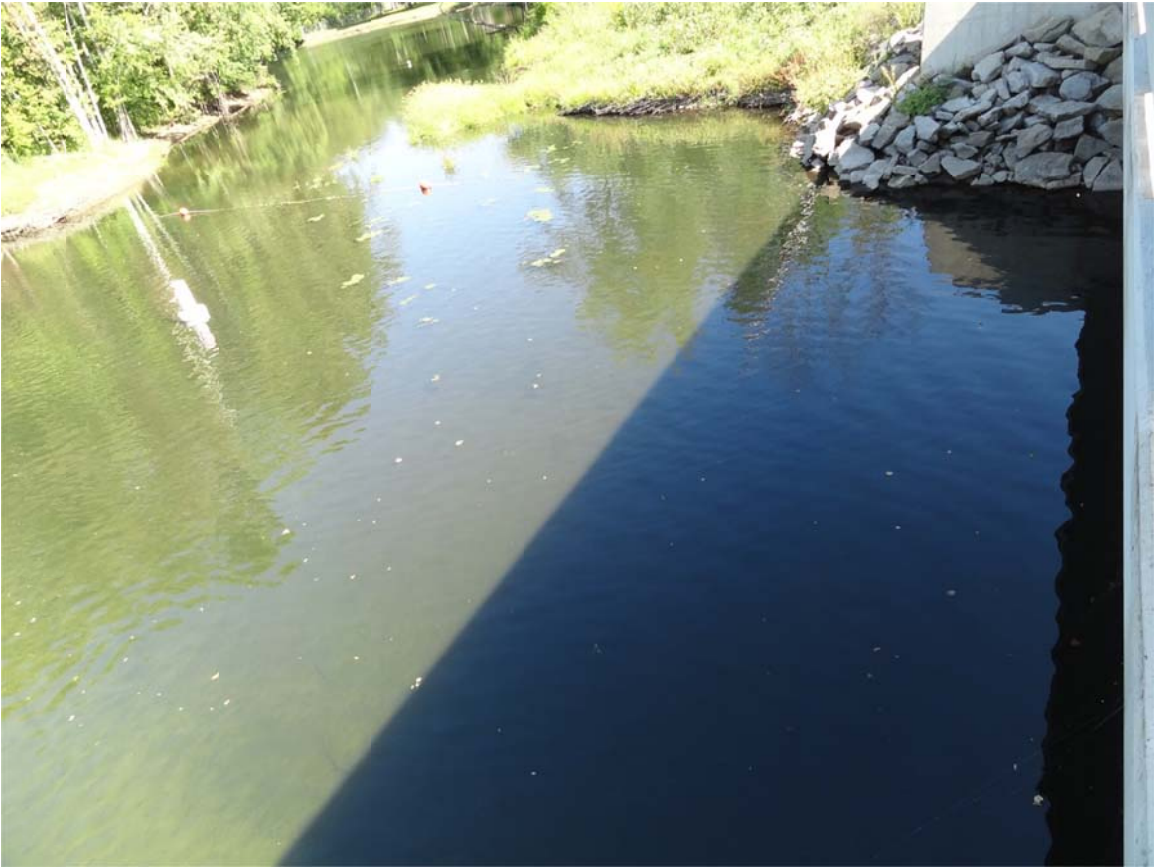
13. MP21.5 Custer Bridge no sheen observed.

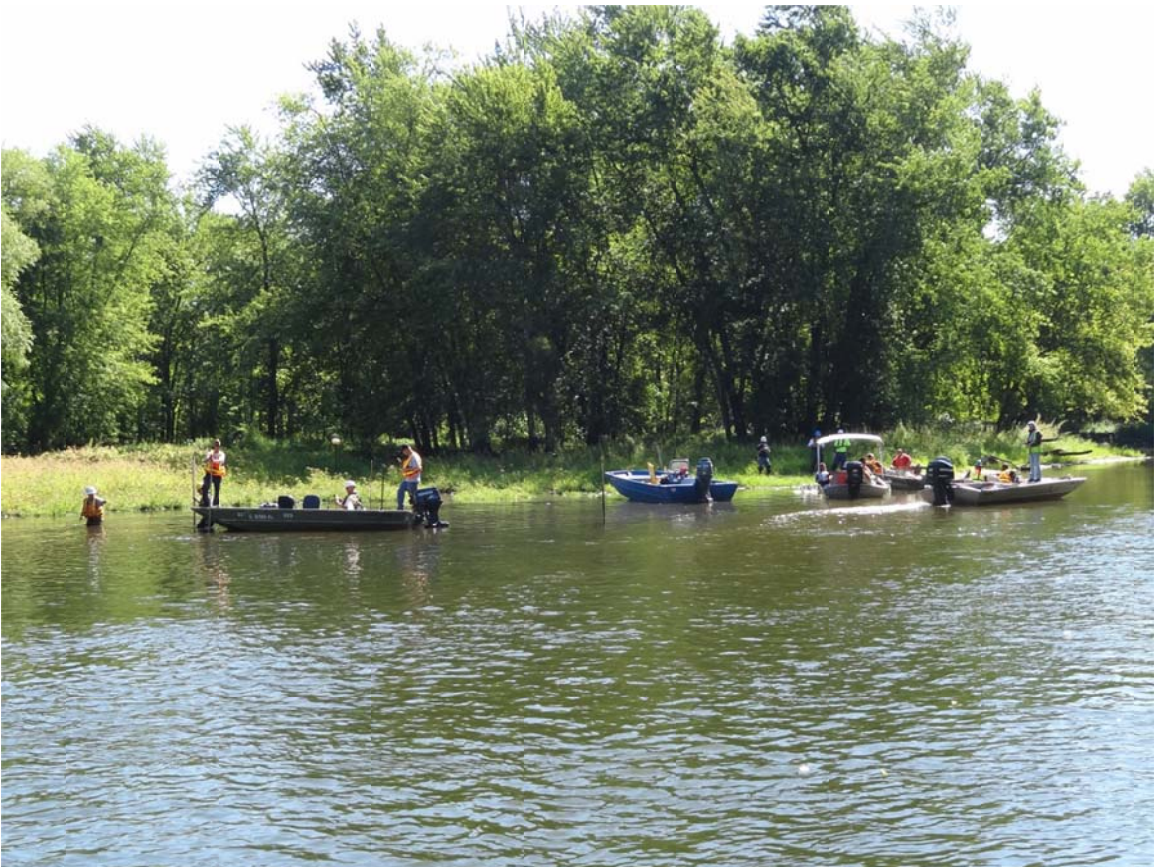
14. MP26.0 RDB observed crews working on the installation of the sediment trap.

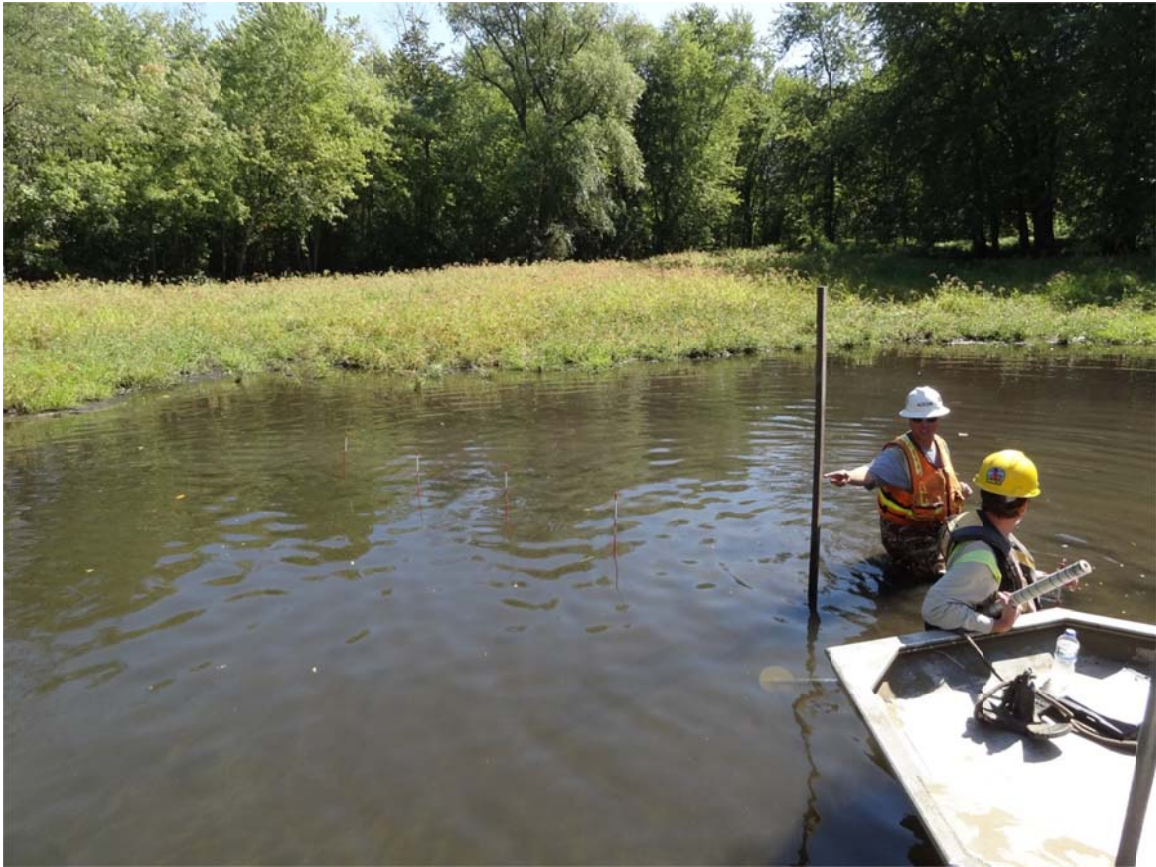
**15. MP26.0 RDB observed crews working on the installation of the sediment trap.**

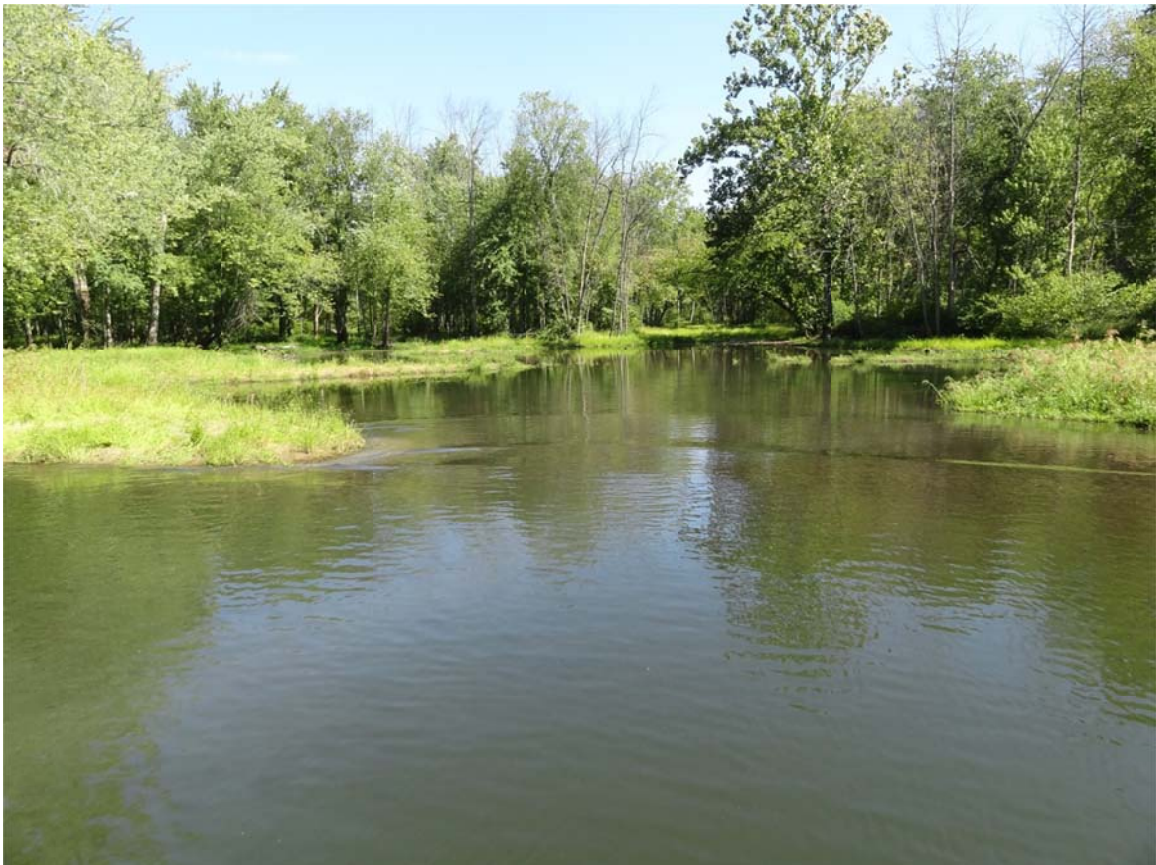
**16. MP30.8 observed sheen when the boat reversed out of the area.**

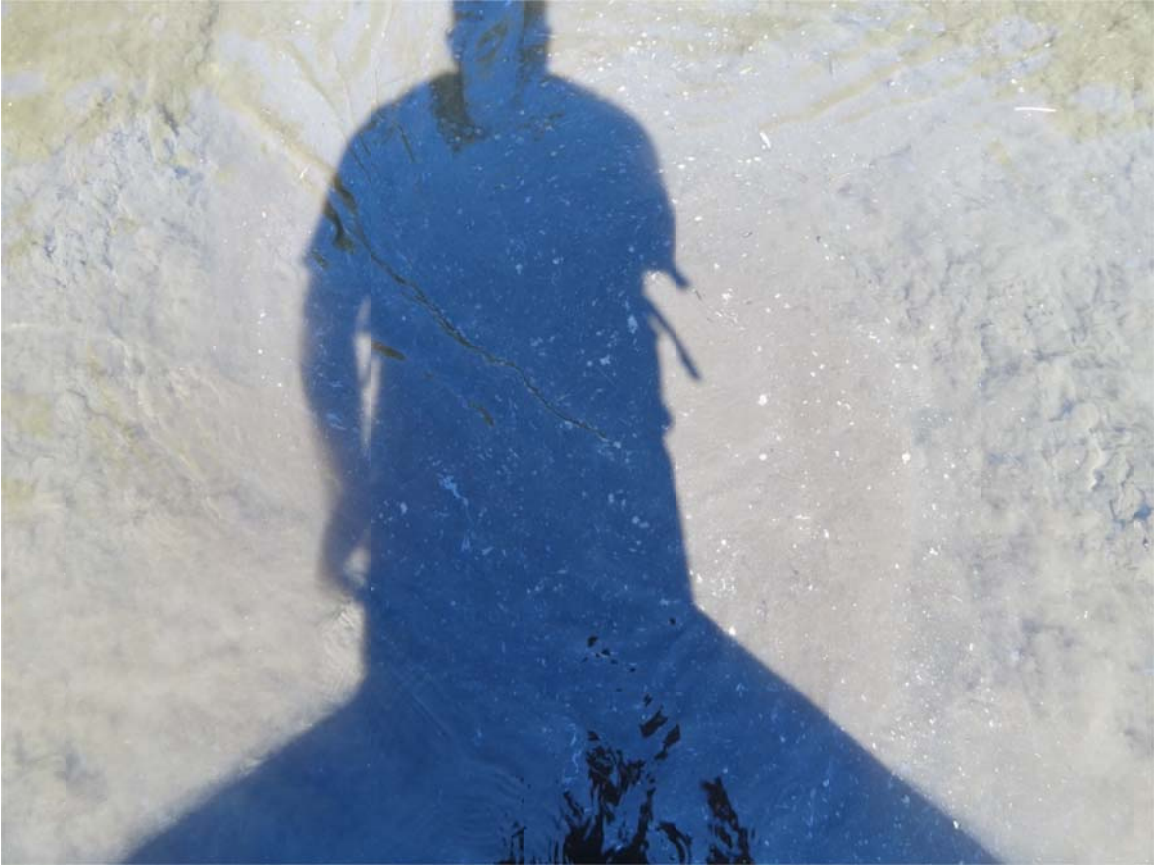
17. MP30.8 observed sheen when the boat reversed out of the area.

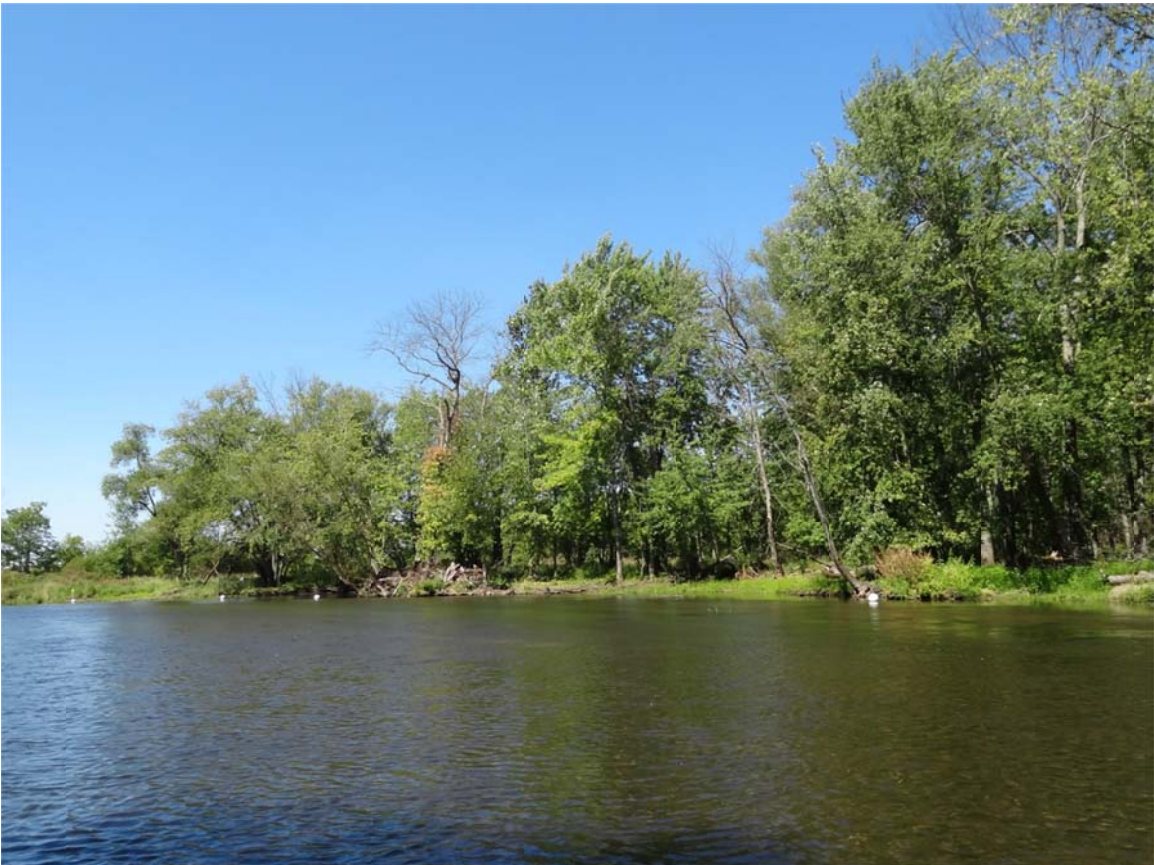
18. MP33.0A sediment trap observed installed.

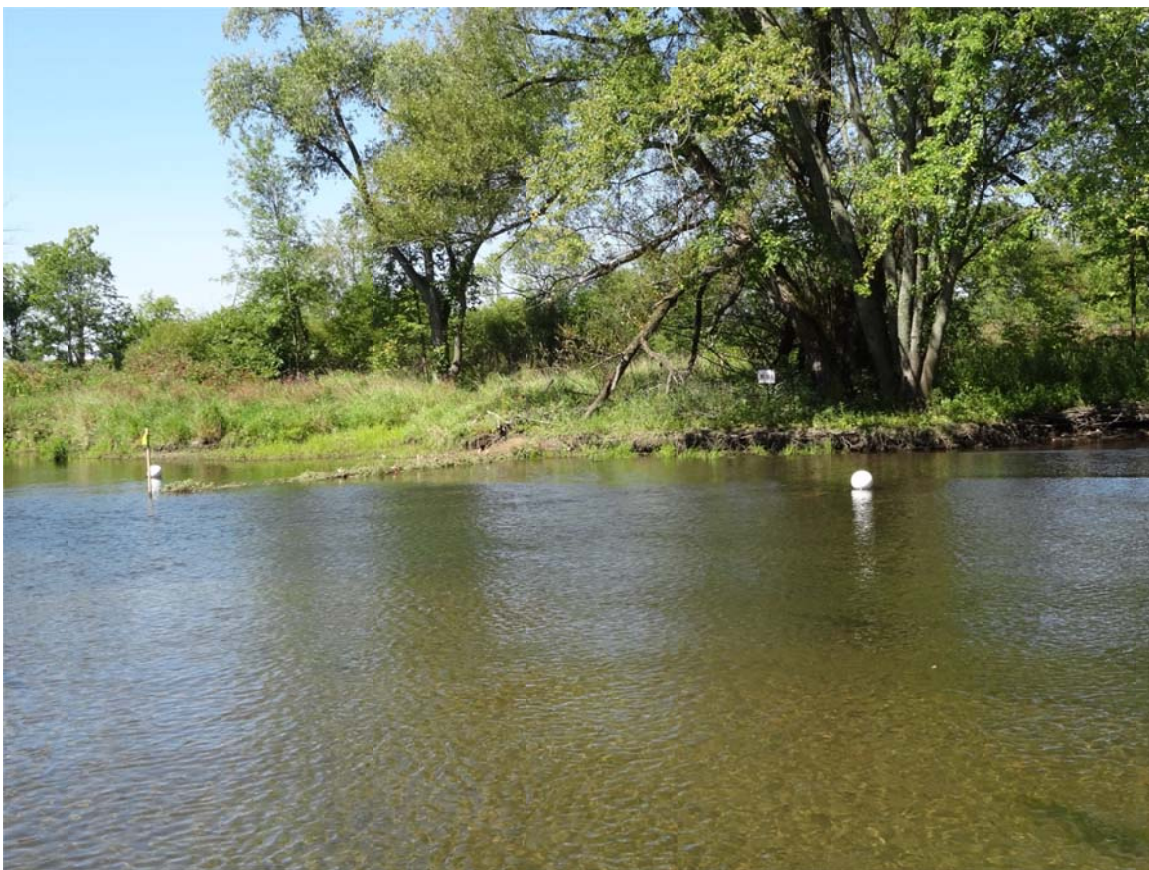
19. MP33.0A sediment trap observed installed.

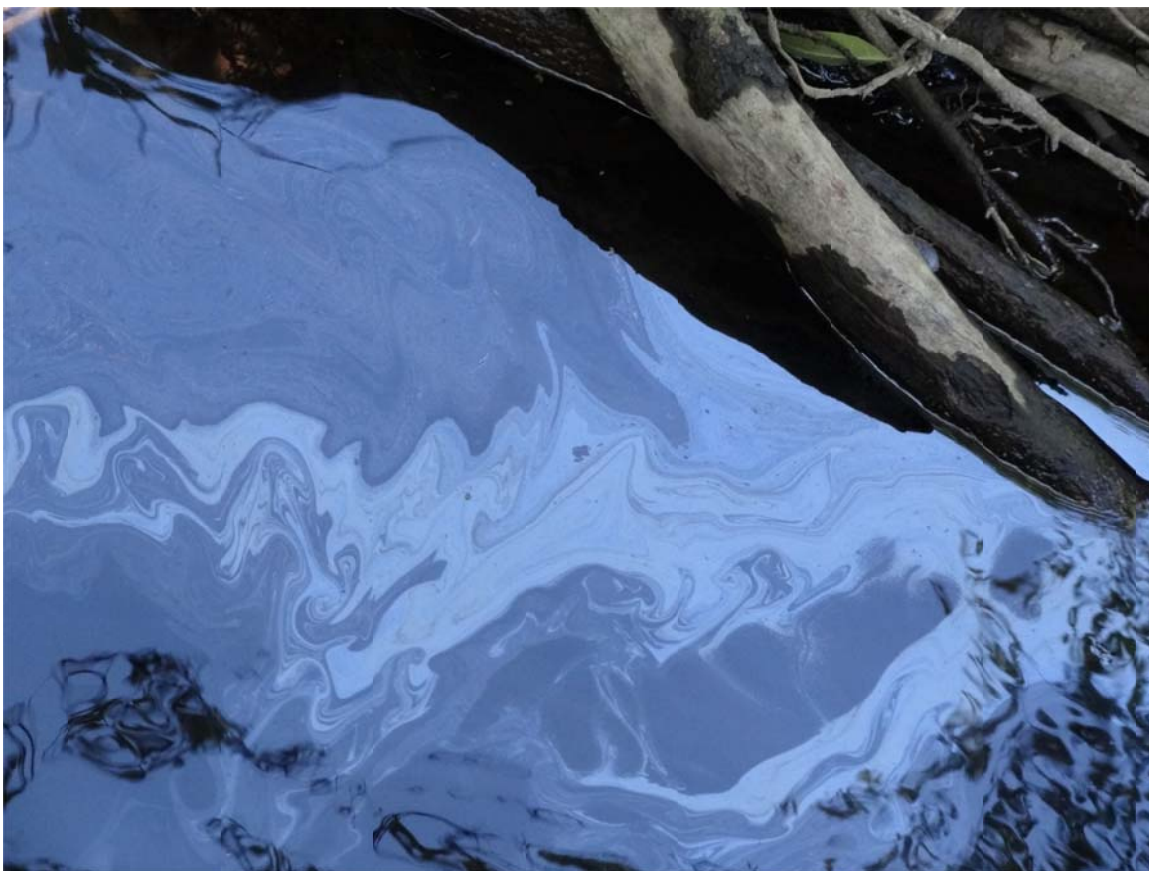
20. MP33.1 RDB site continues to sheen with a strong petroleum odor.

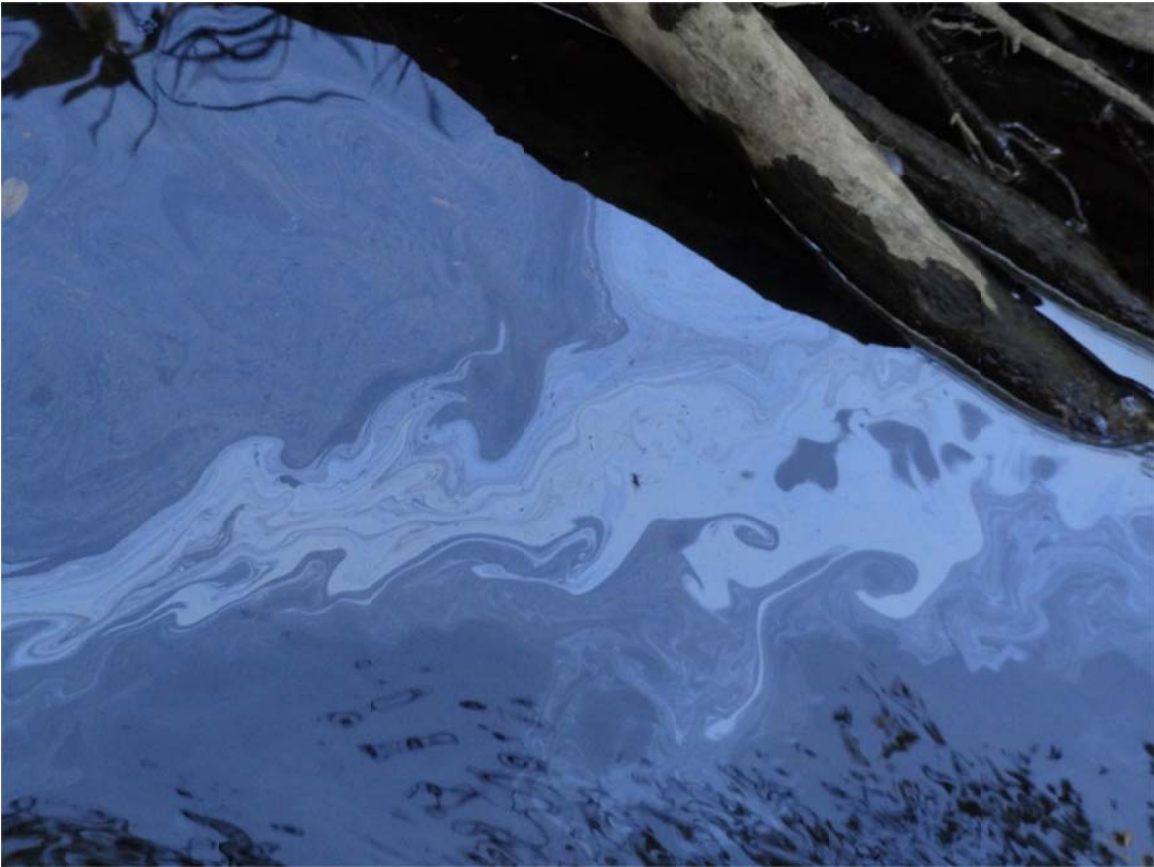
21. MP33.1 RDB site continues to sheen with tar glob observed in sheen.

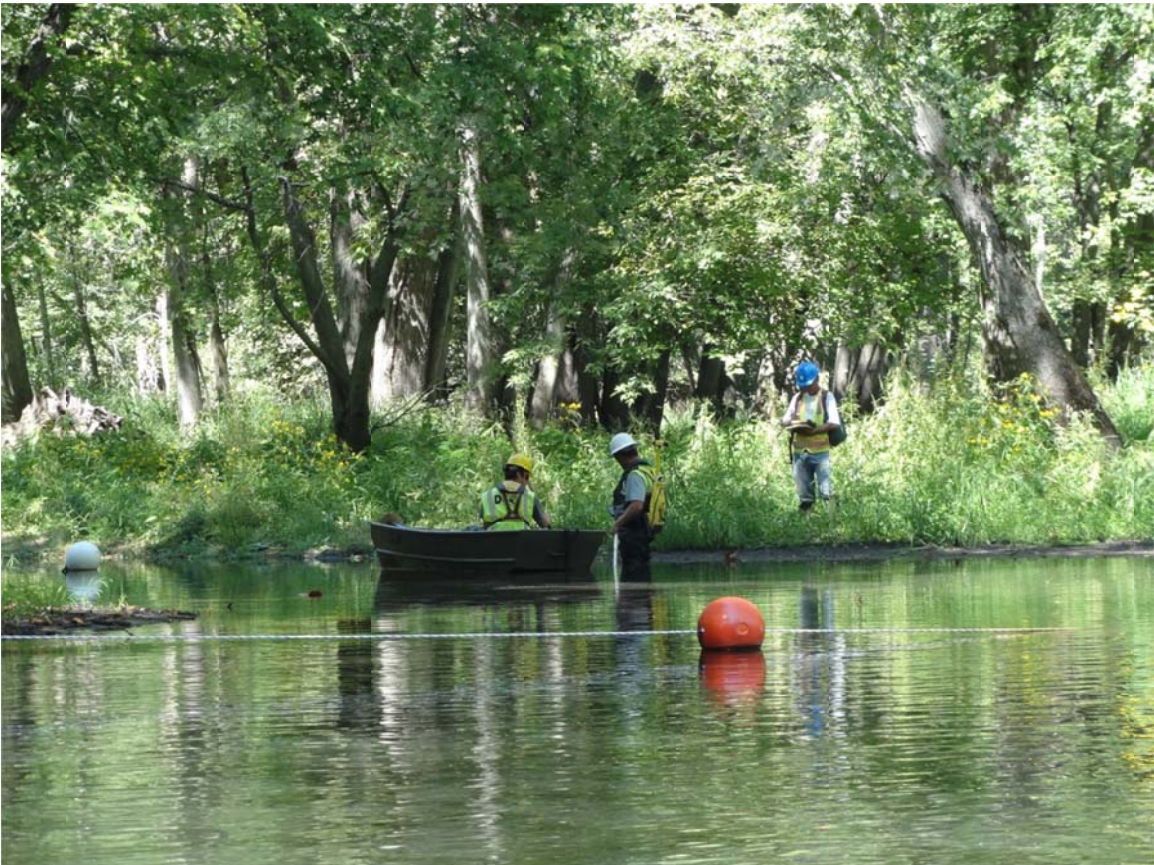
22. MP28.25 observed a crew monitoring the sediment trap location.

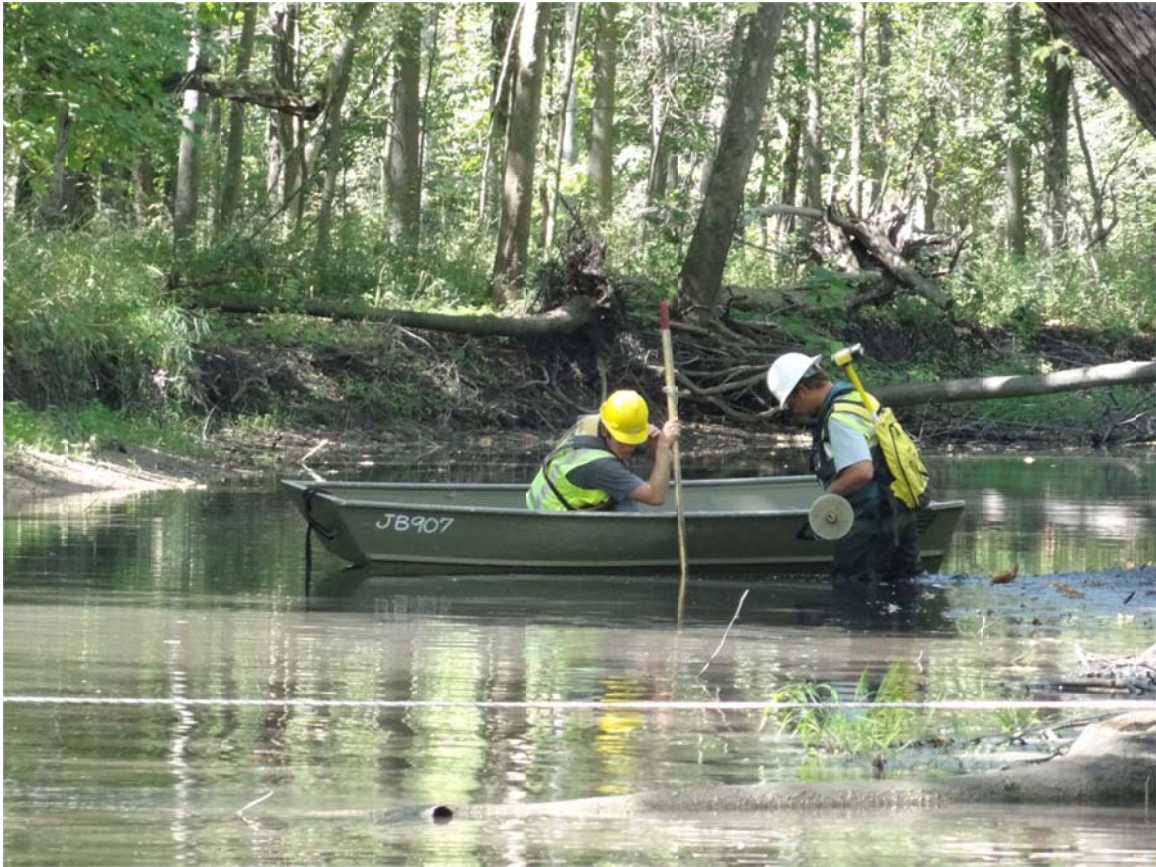
23. MP28.25 observed a crew monitoring the sediment trap location.
