# Situation Photo Log

Tuesday, September 11, 2012

Kalamazoo River / Enbridge Spill

Prepared by:  
Matthew Haak  
START-USEPA  
Situation Unit Leader

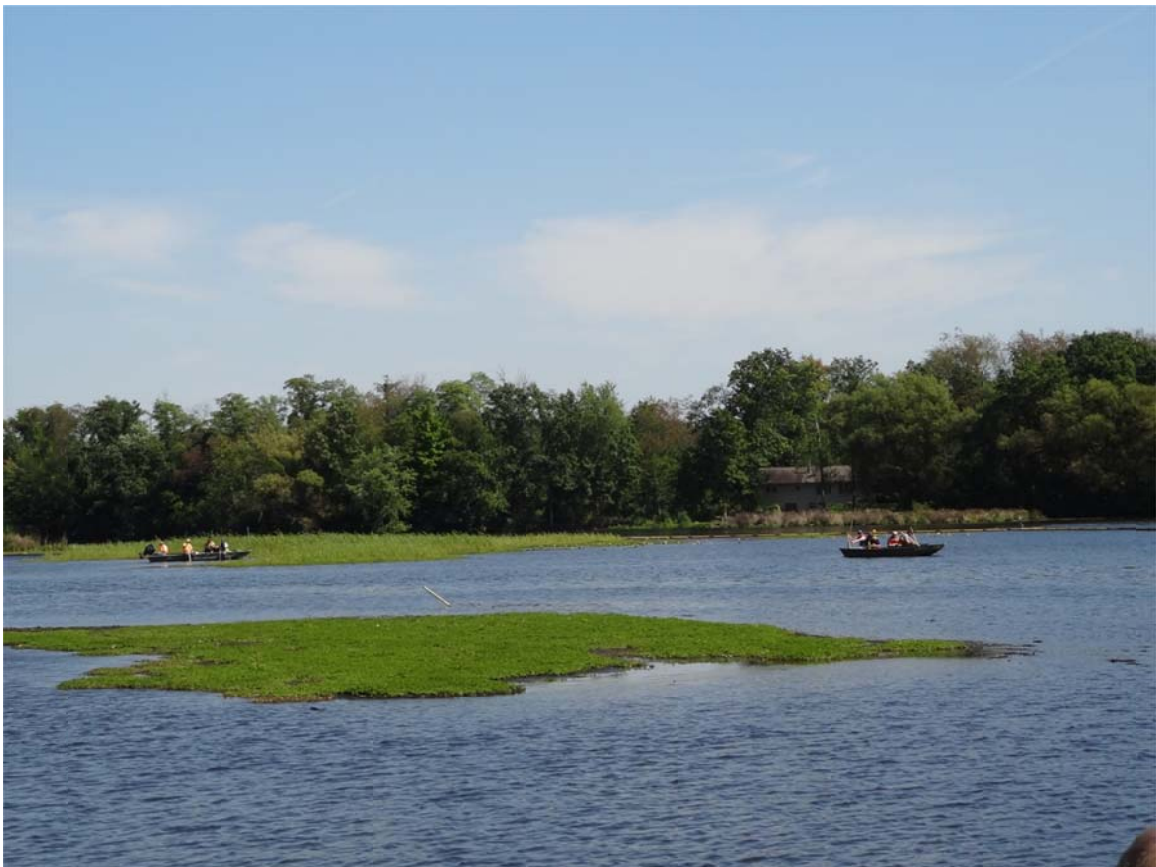
24. Morrow Lake Delta observed a poling crew operating.

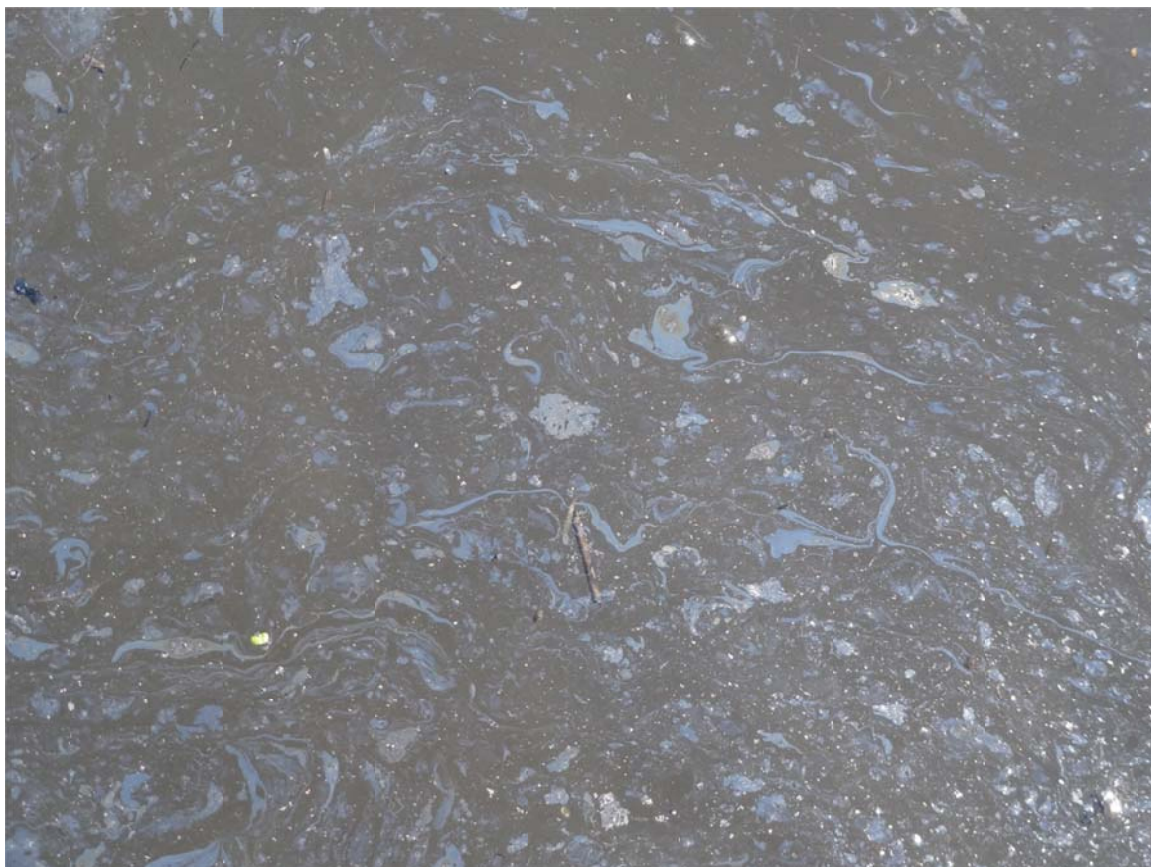
**25. Morrow Lake Delta A sheen and tar globs observed when the boat reversed out of the area.**

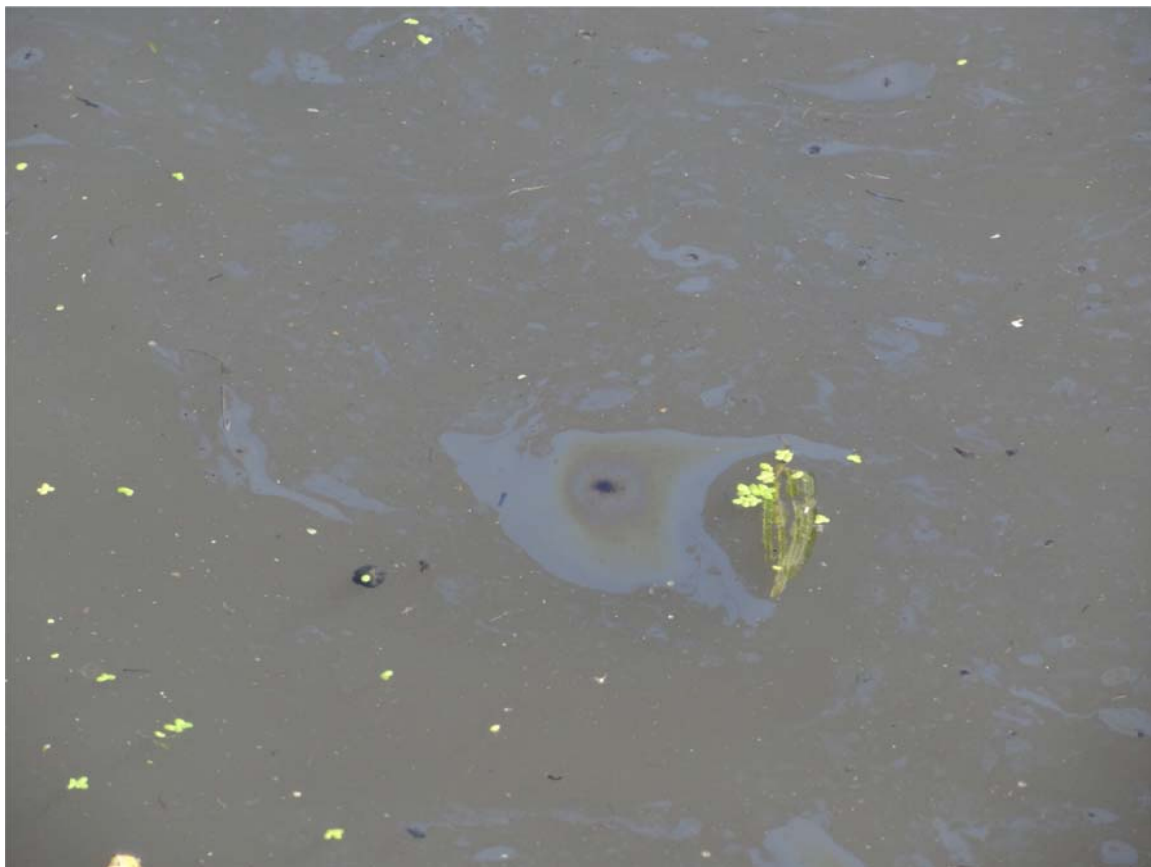
**26. Morrow Lake Delta A sheen and tar globs observed when the boat reversed out of the area.**
