Situation Photo Log

Wednesday, September 12, 2012

Kalamazoo River / Enbridge Spill

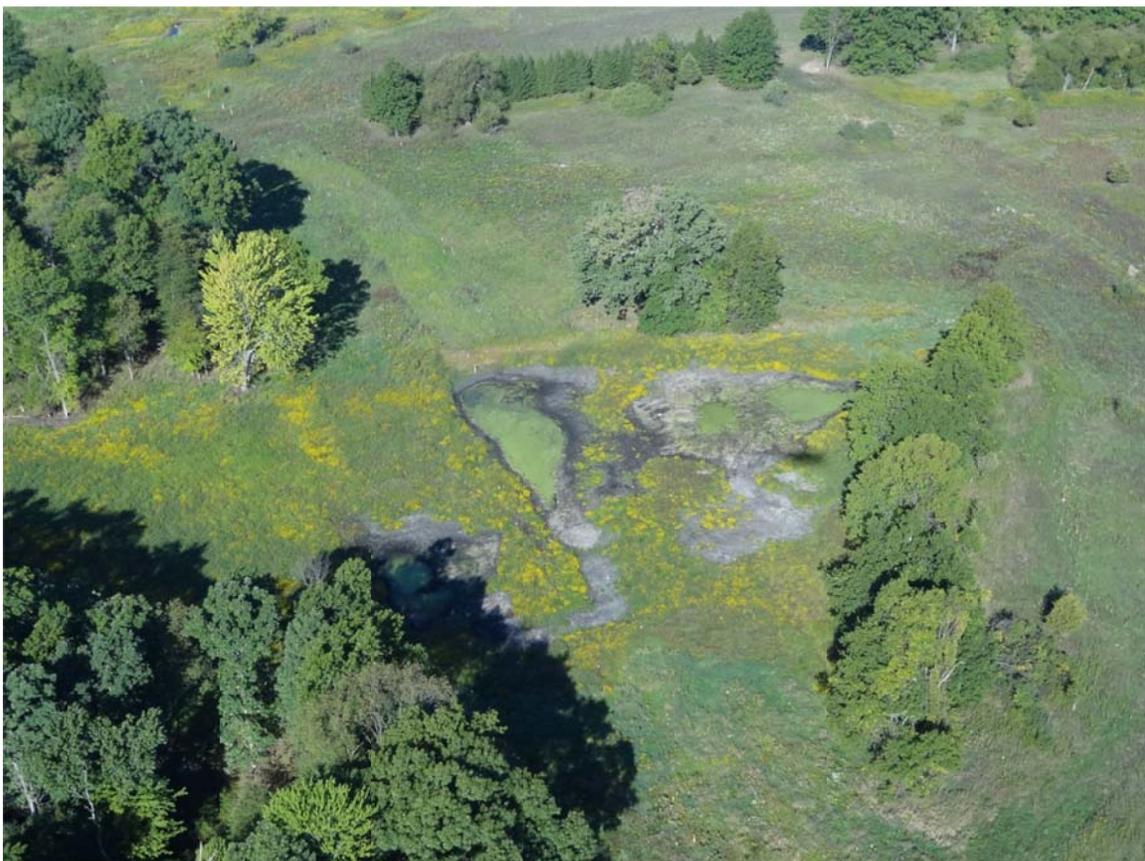
1. Source Area, no sheen observed.

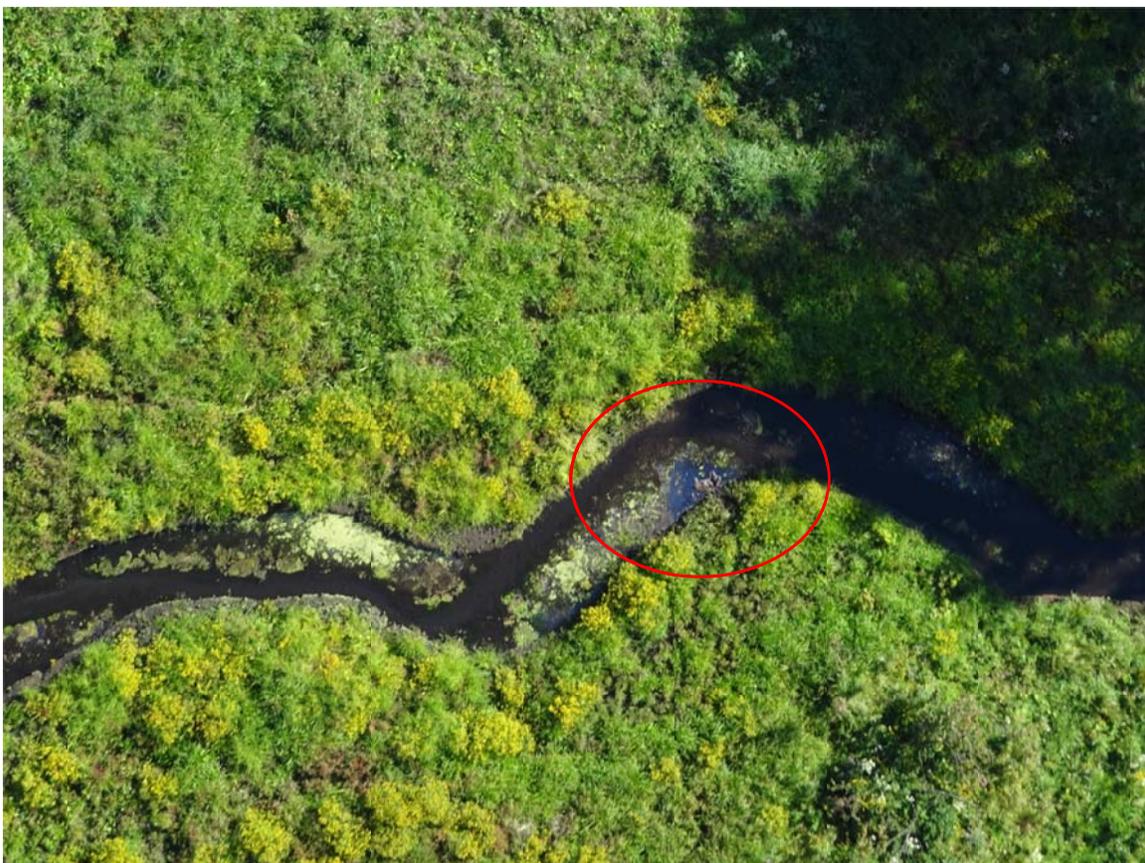
2. Talmadge Creek MP0.0 sheen observed.

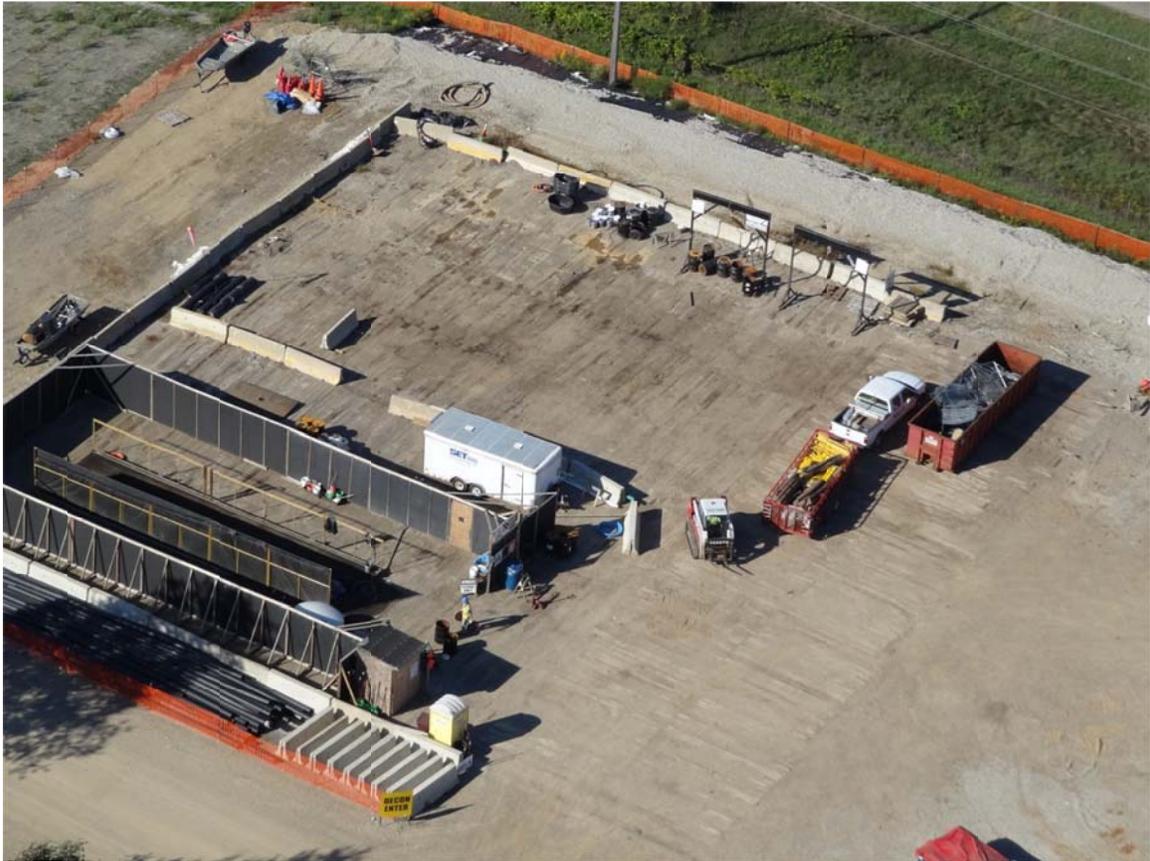
3. Frac-Tank City observed boom arriving at the decontamination pad.

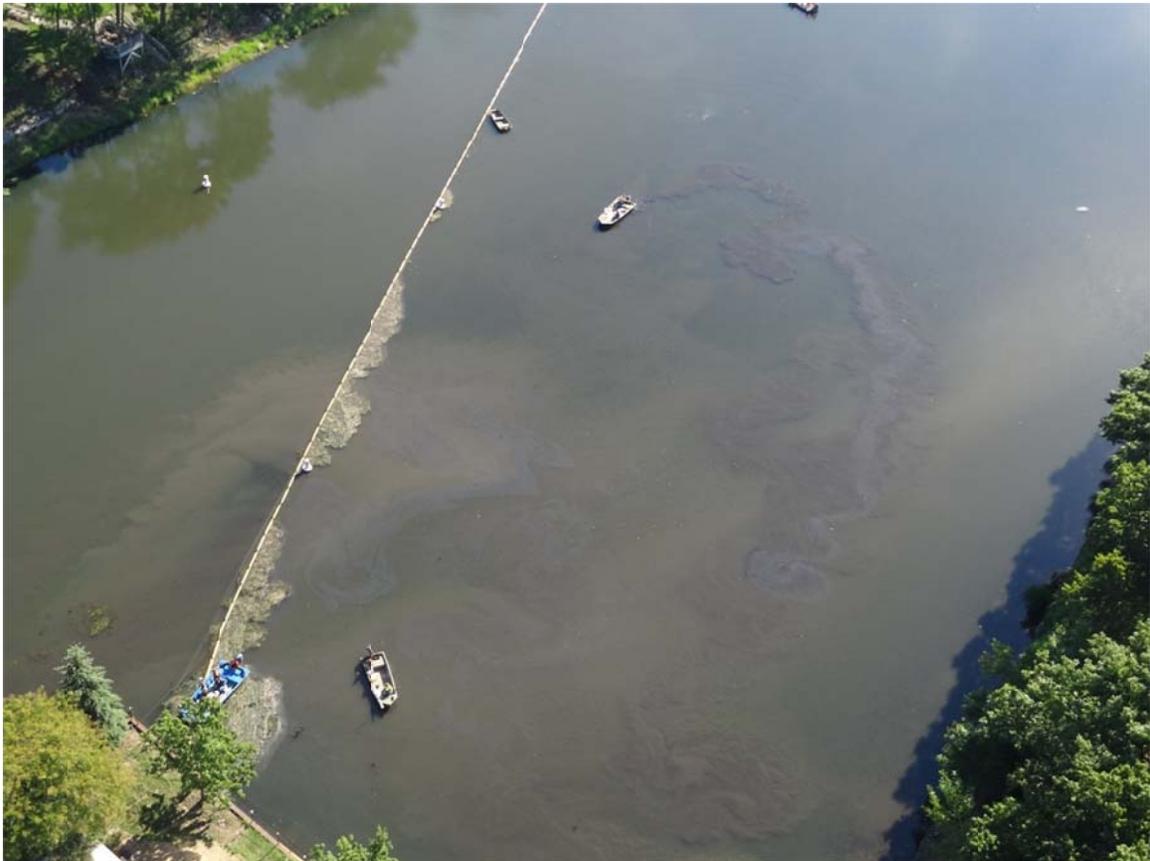
4. Ceresco Dam observed boat operations generating sheen.

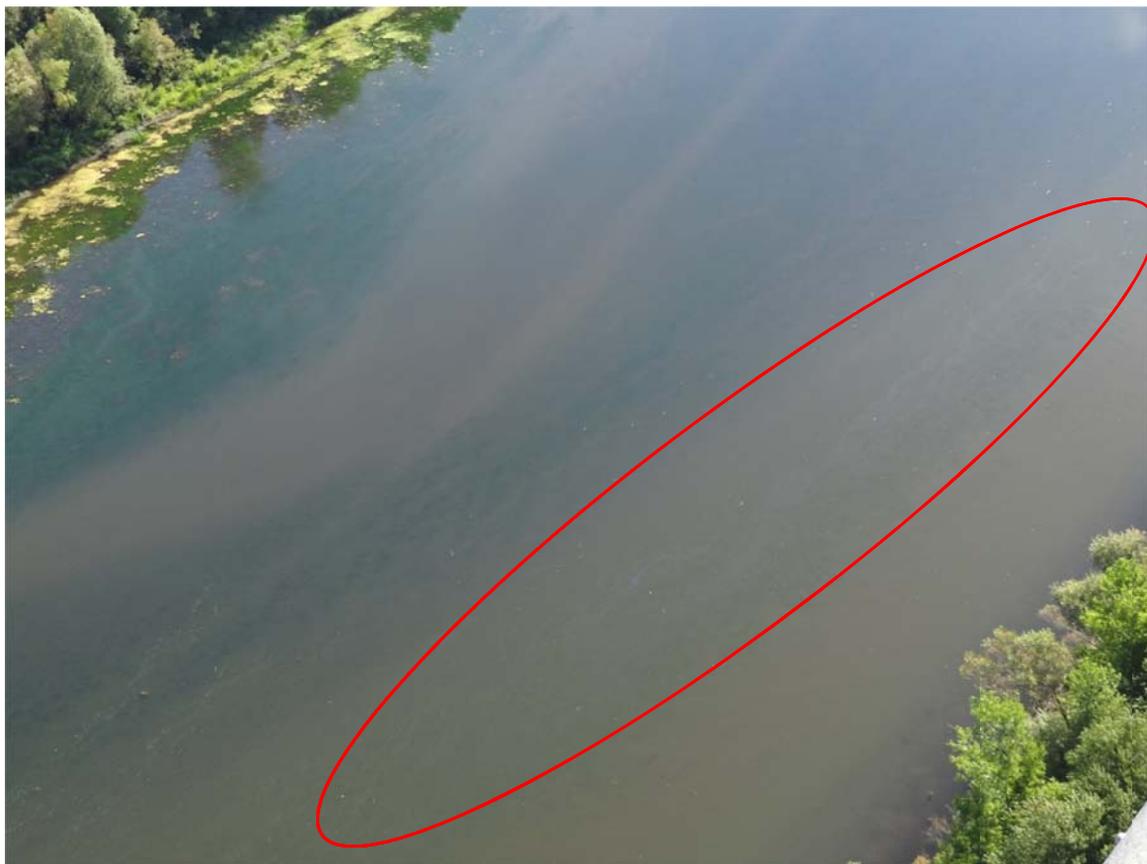
5. MP4.5 LDB observed sheen.

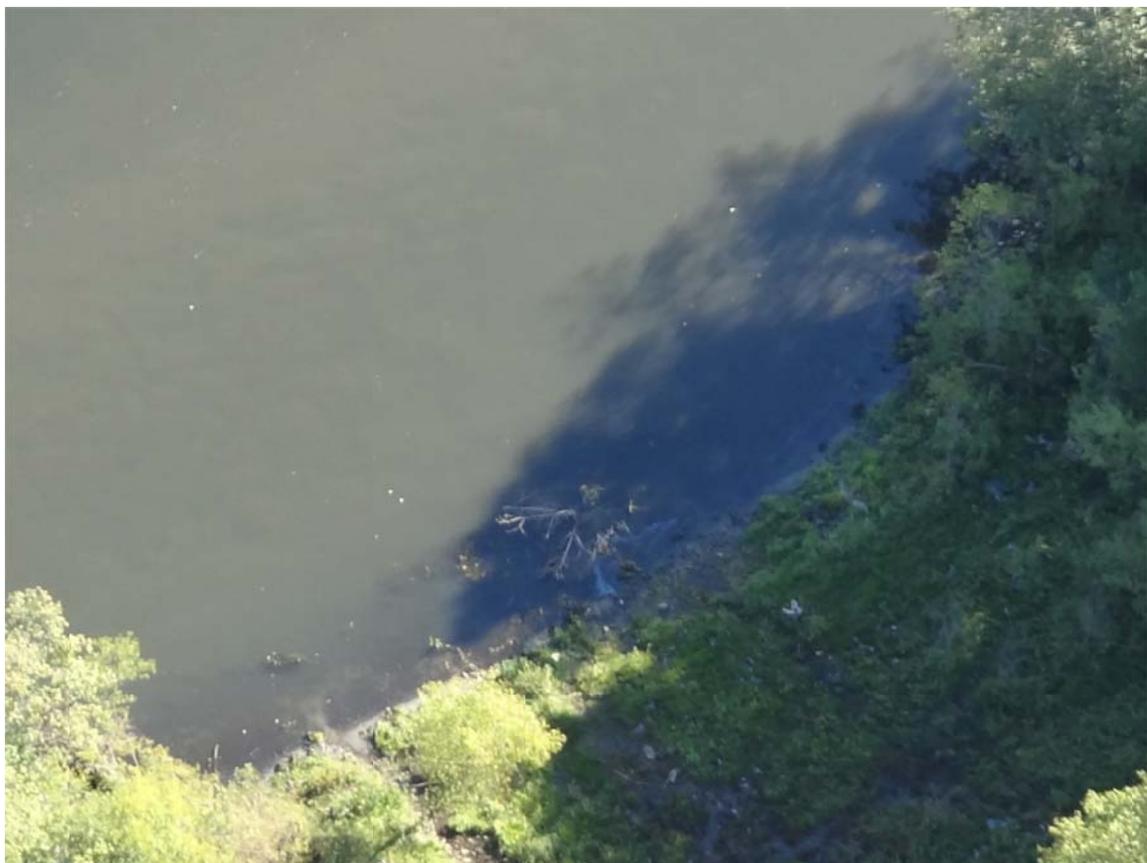
6. MP5.3 LDB observed sheen just down from the former C0.5 boat launch.

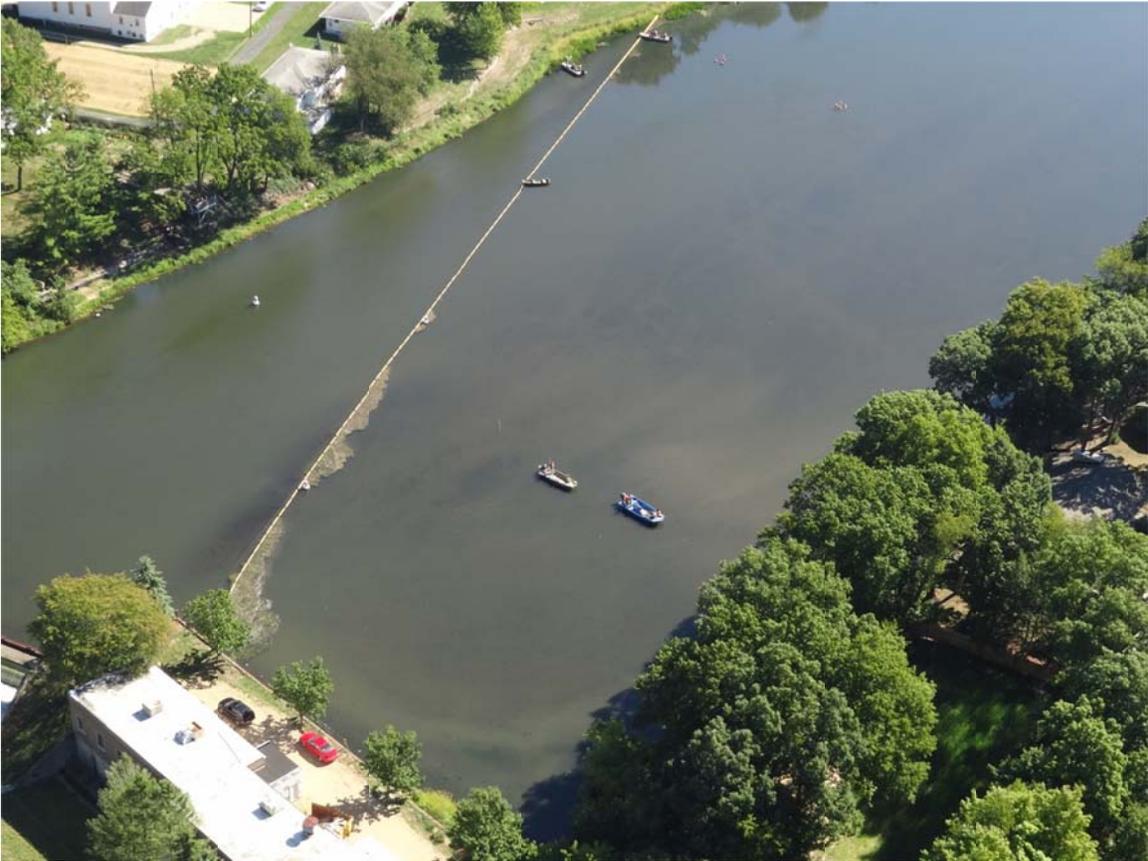
7. Ceresco Dam observed bathymetry crews operating.

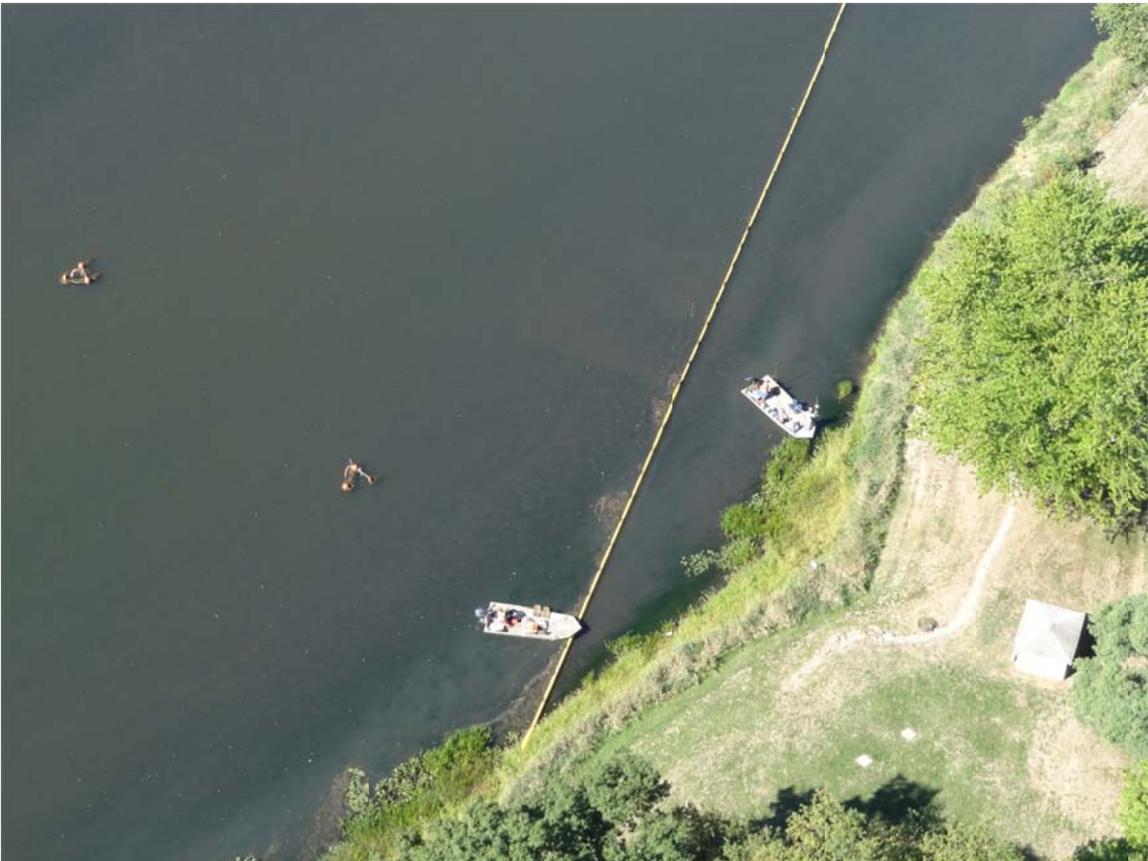
8. Ceresco Dam observed bathymetry crews operating.

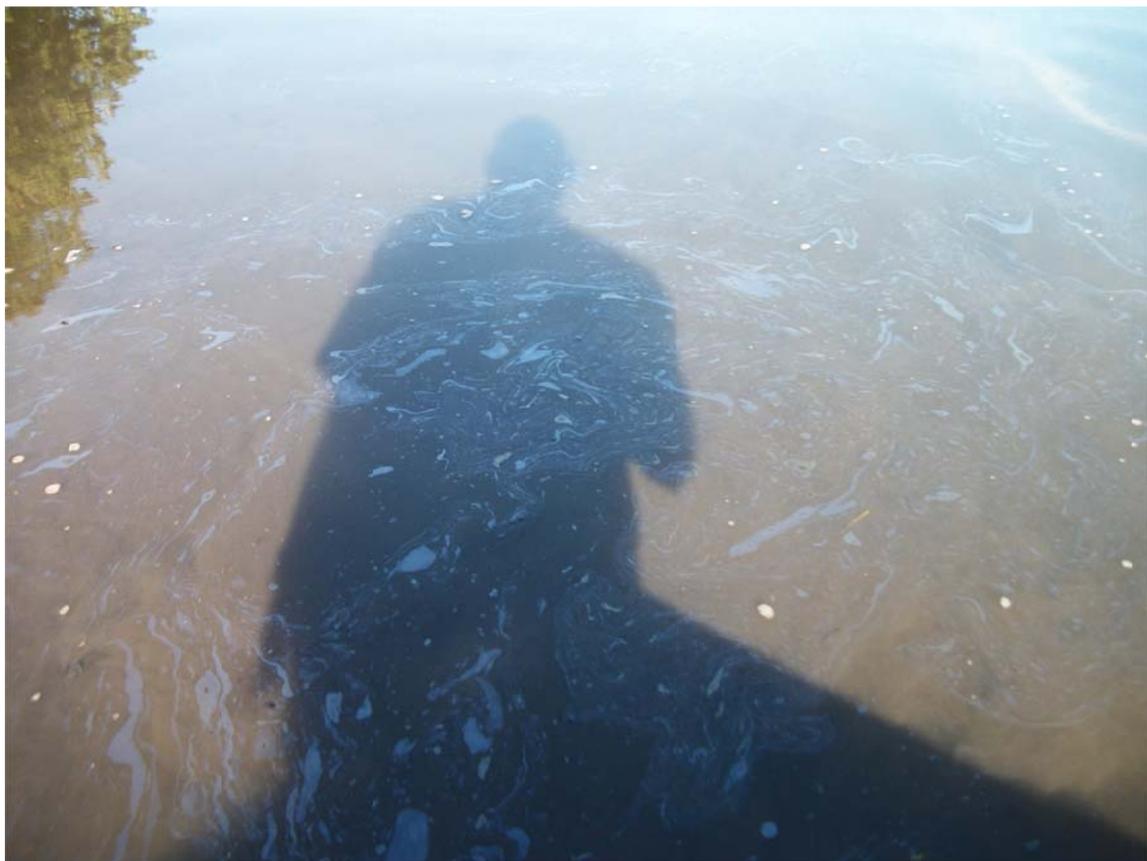
9. Ceresco Dam sheen observed.

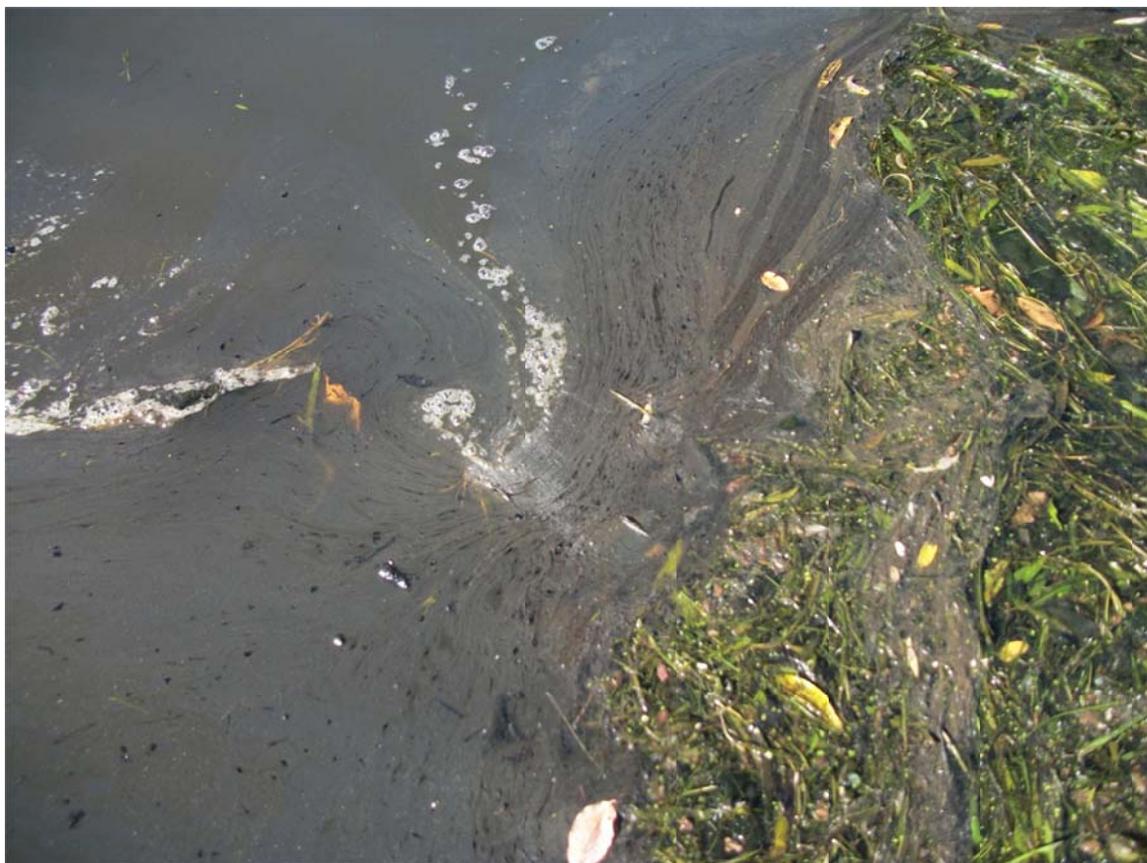
10. Ceresco Dam observed product collecting in the vegetation along the control point boom.

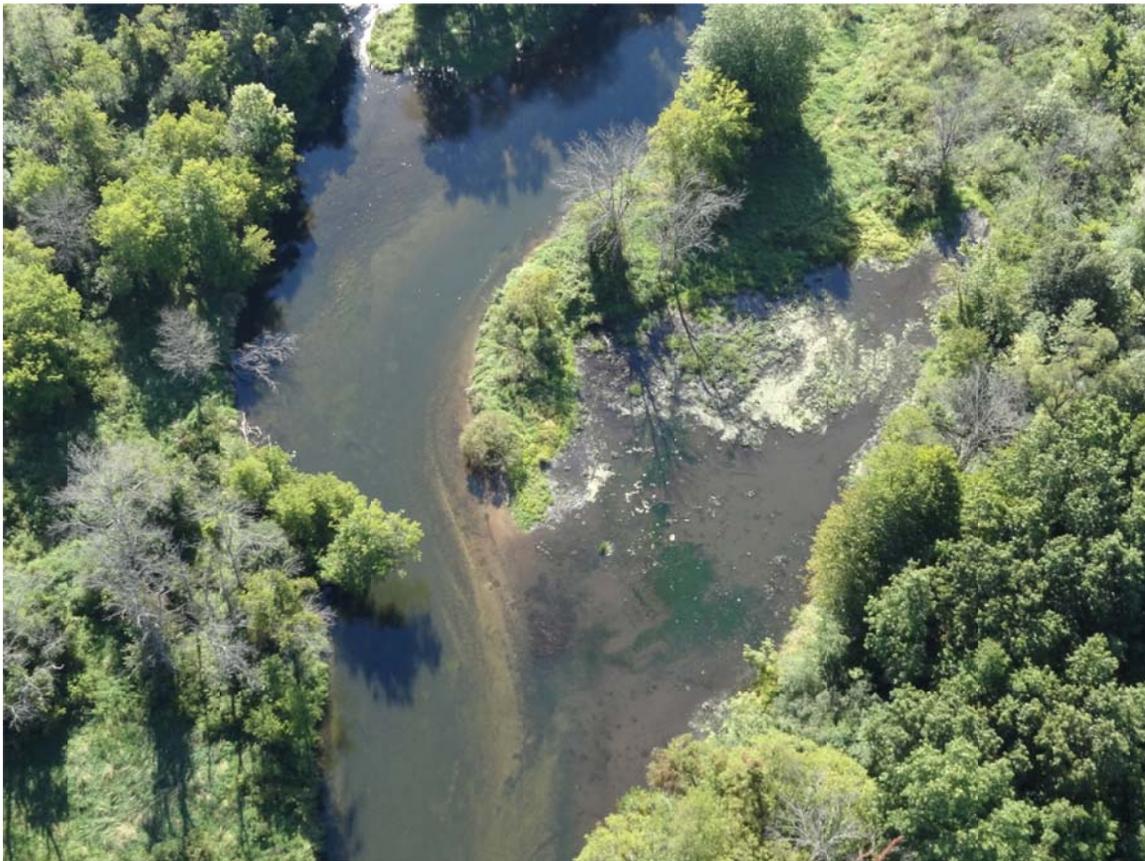
11. MP10.4 & MP10.5 proposed sediment trap locations.

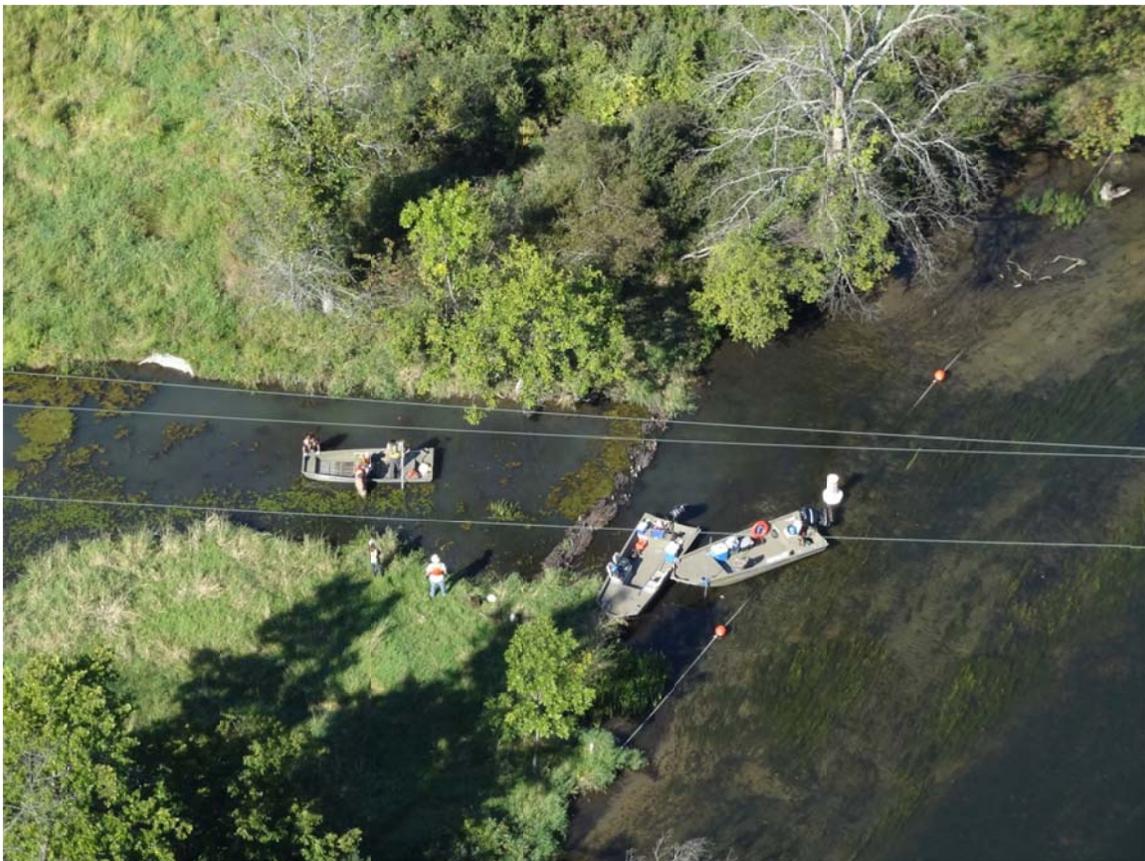
12. MP10.75 observed crews performing sediment trap monitoring.

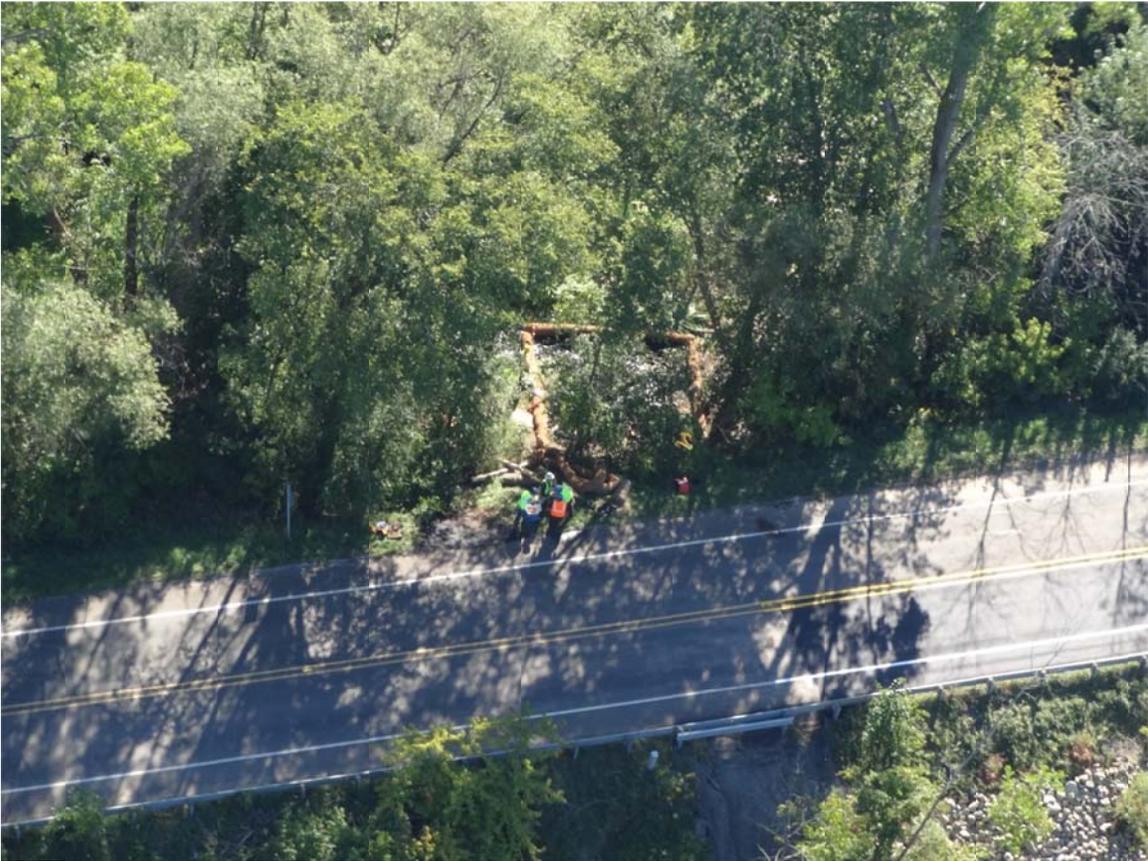
13. MP12.25 off Raymond Rd., observed crew installing core log sediment trap structures.

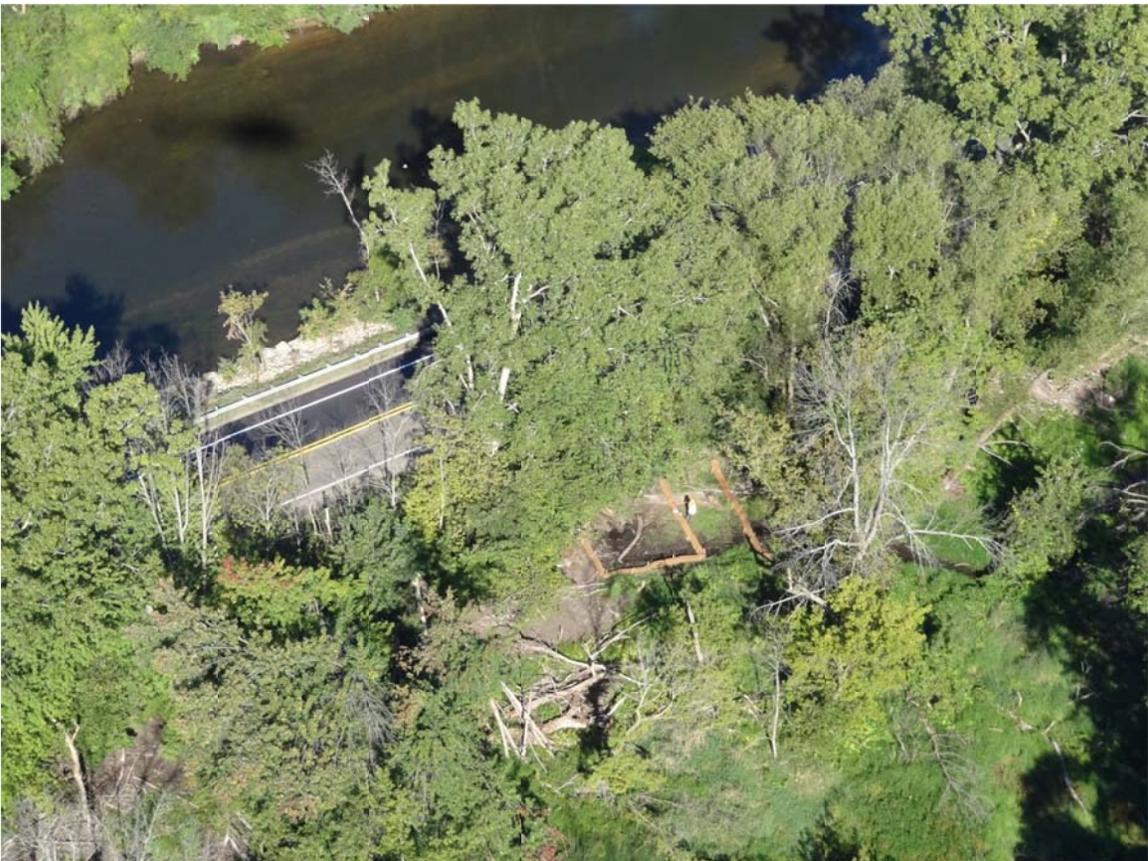
14. MP12.25 off Raymond Rd., observed crew installing core log sediment trap structures.

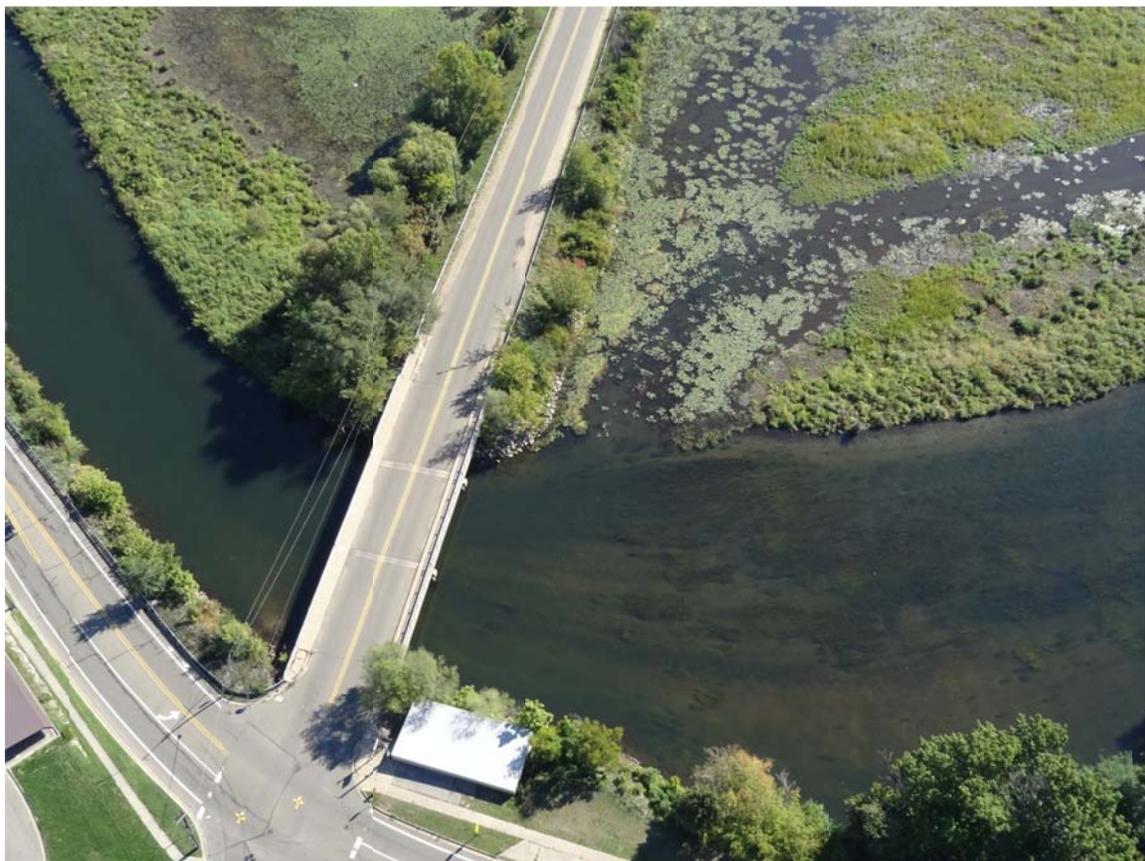
15. MP15.5 South Mill Pond no sheen observed.

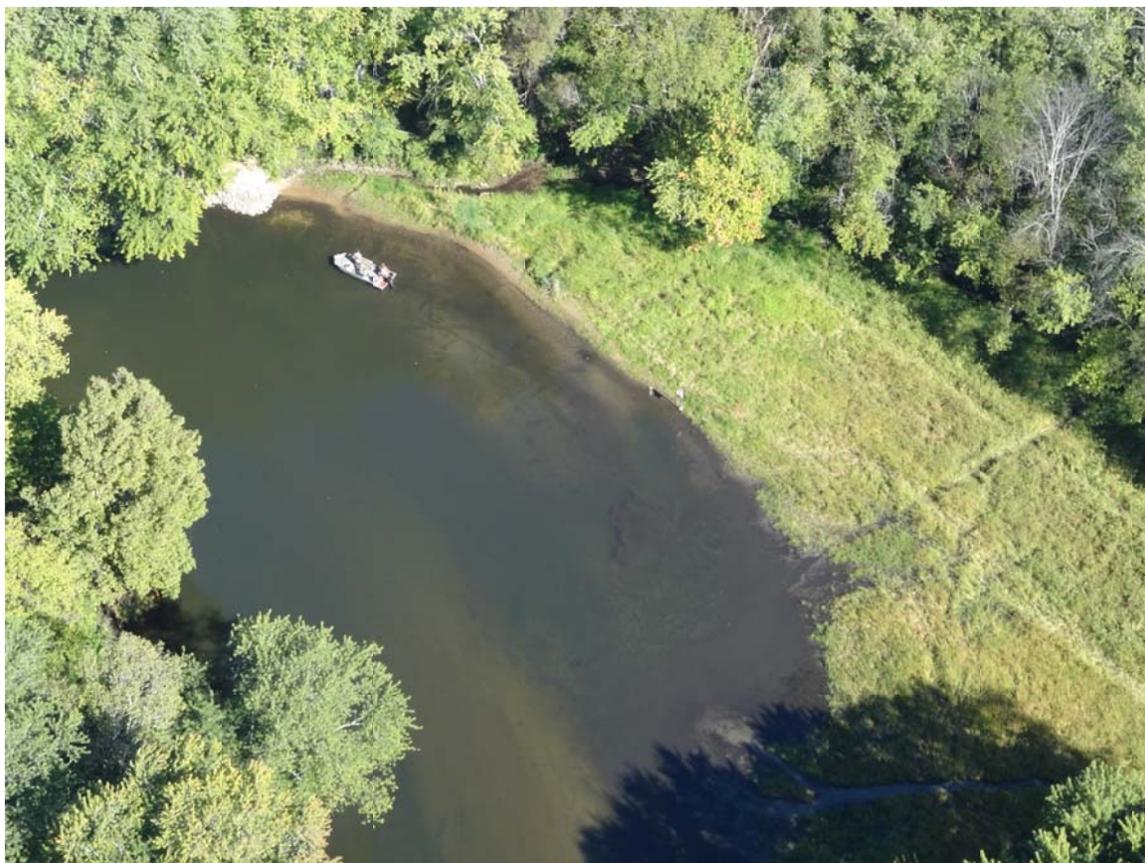
16. MP26.0 RDB sediment trap location observed a crew operating.

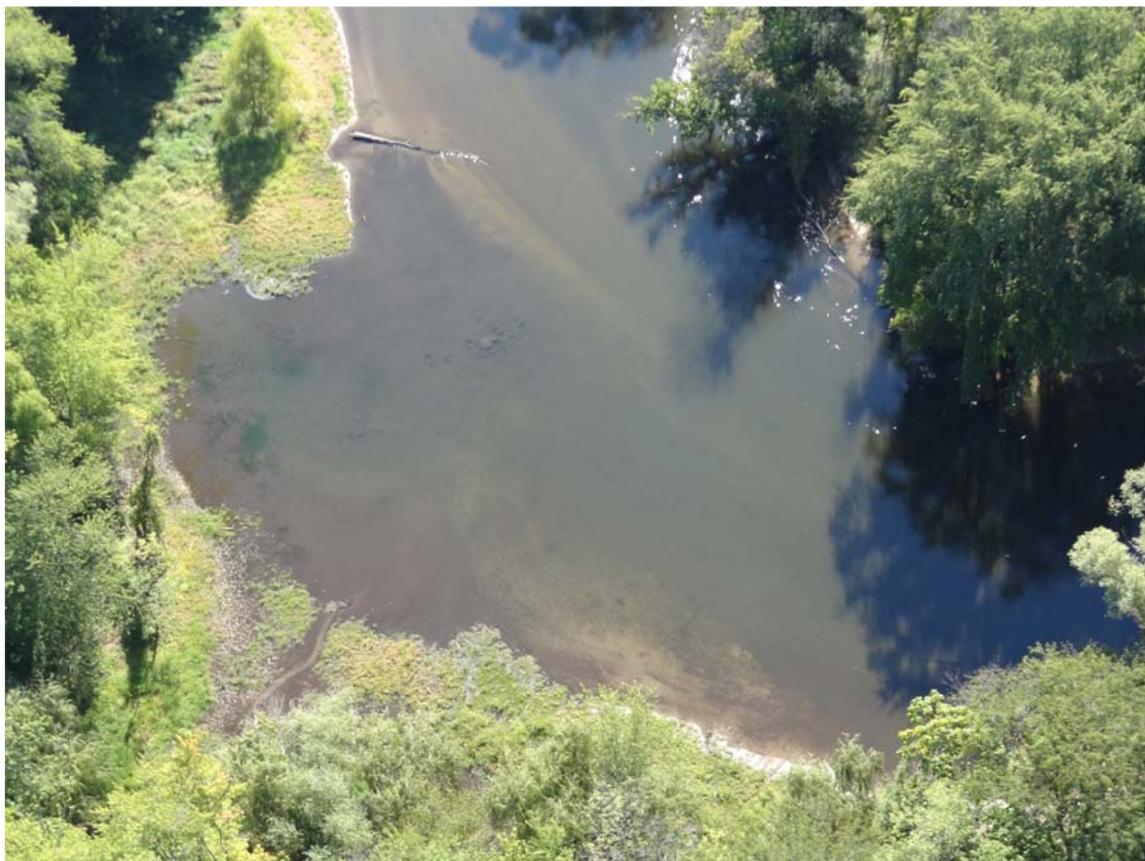
17. MP26.25 RDB no sheen observed.

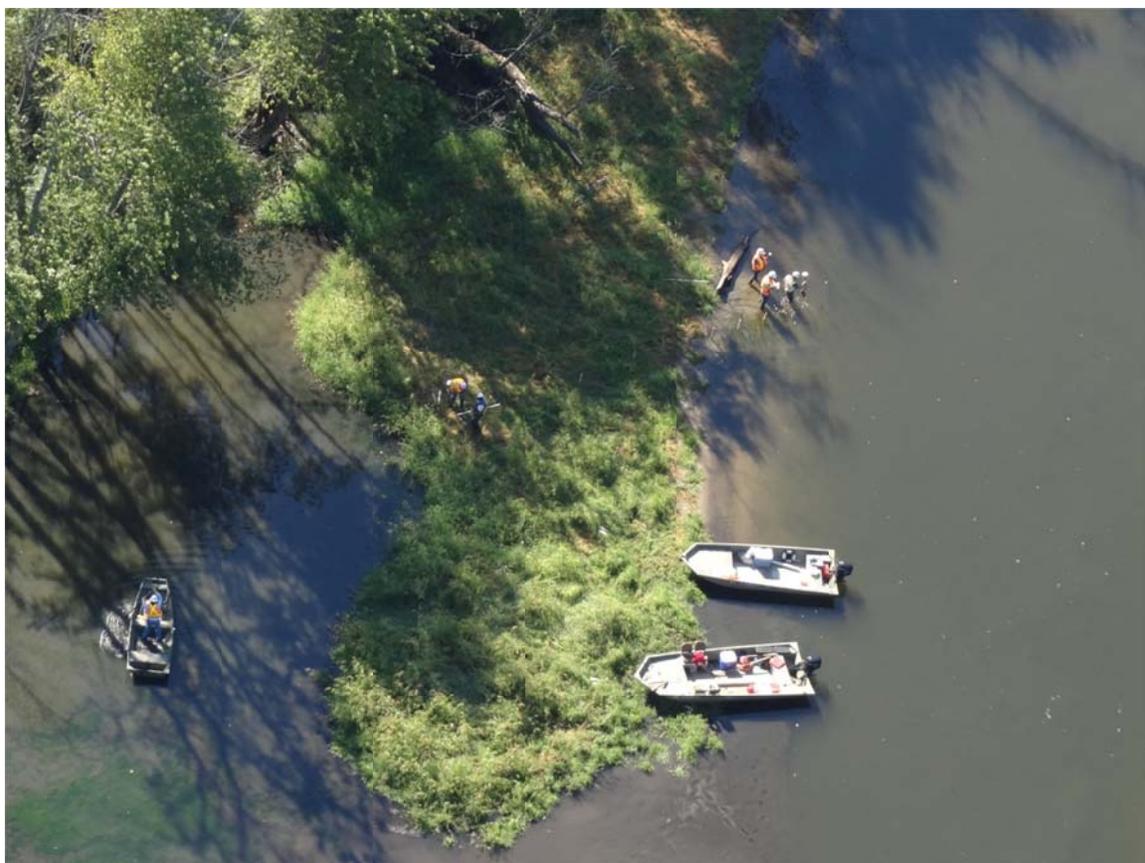
18. MP30.1, observed sediment trap survey crew.

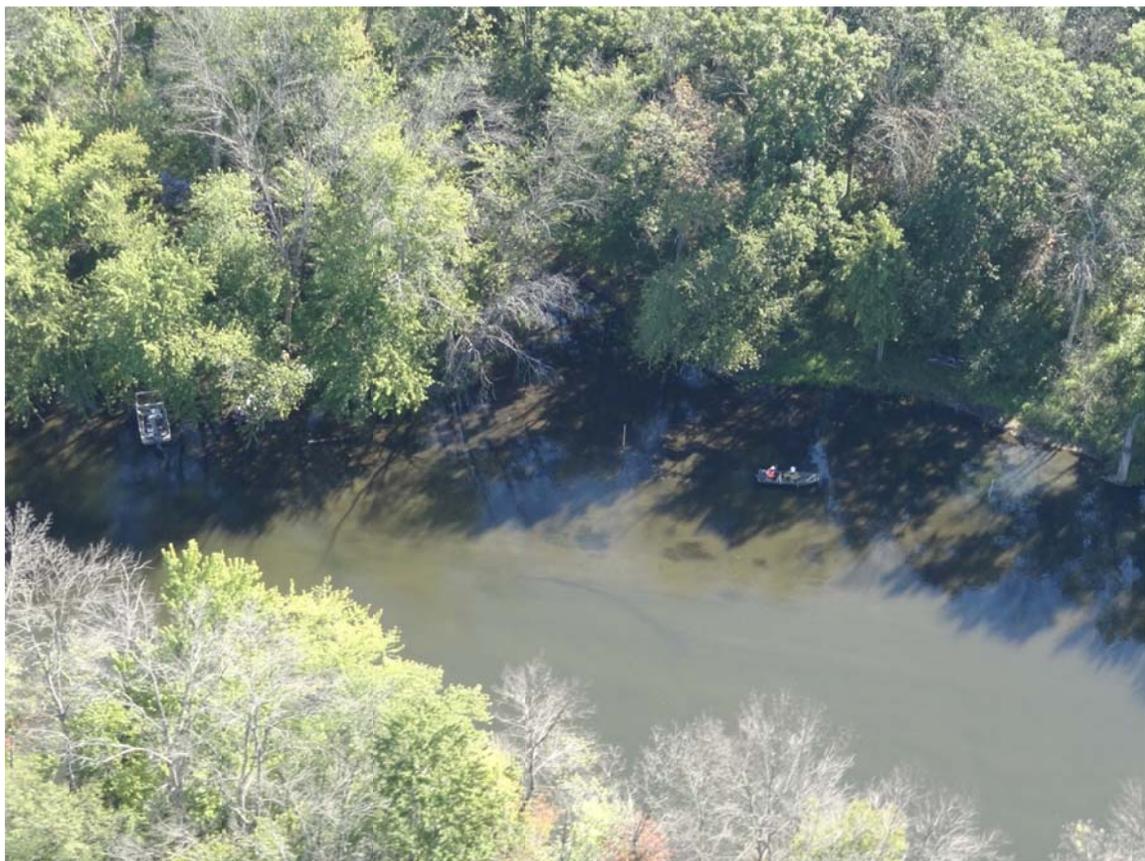
19. MP33.0B, observed sediment trap survey crew.

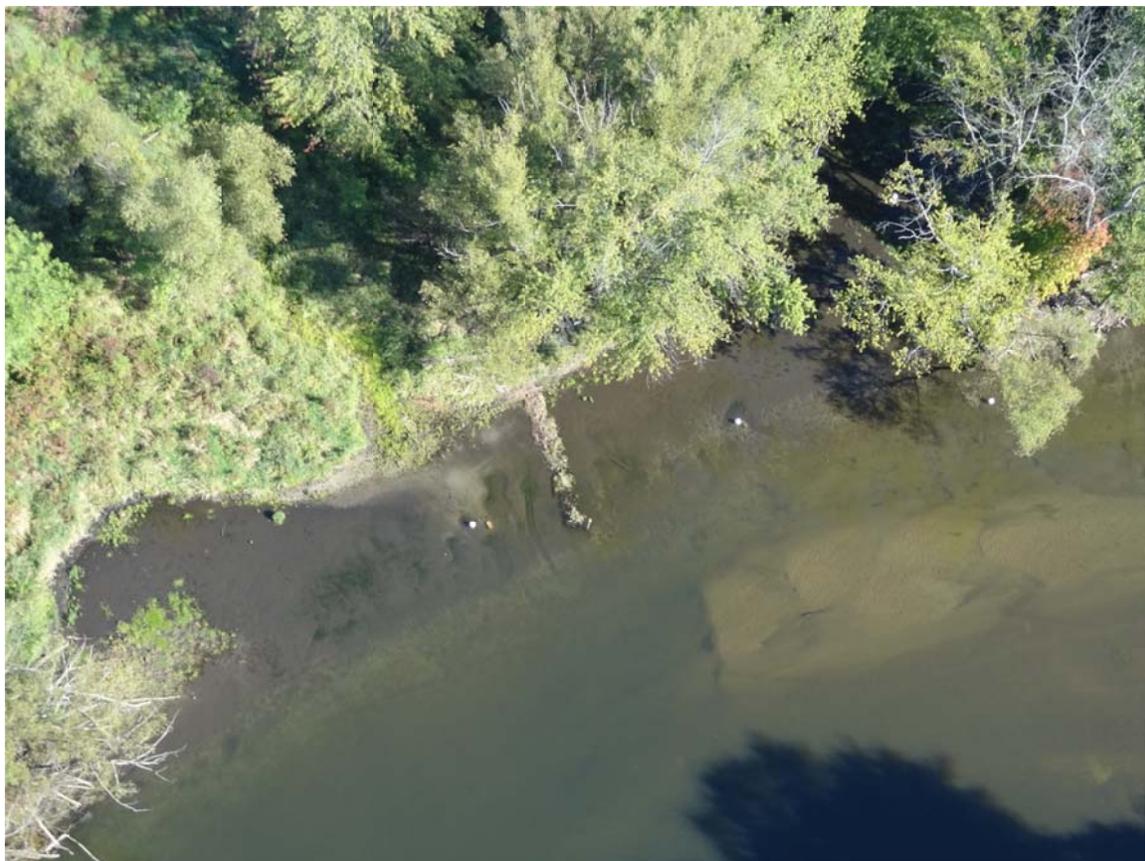
20. MP330.A observed the sediment trap installed.

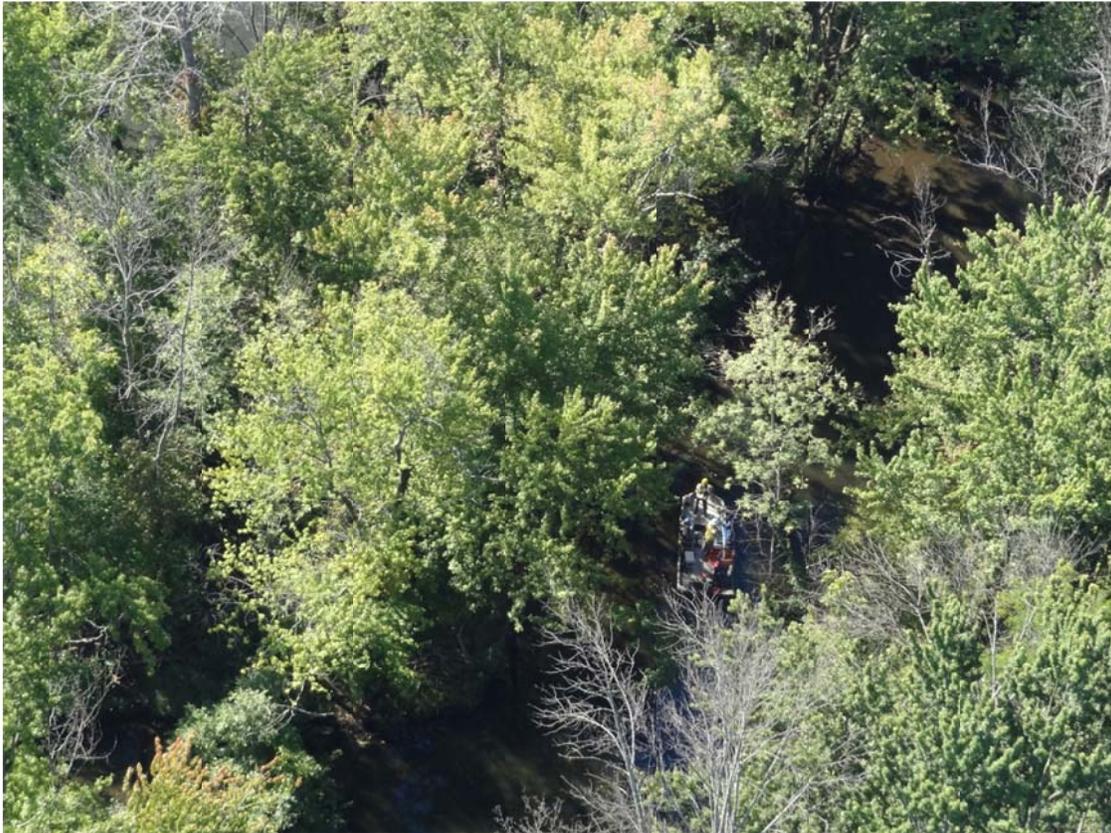
21. MP36.10 observed a crew performing sediment trap monitoring.

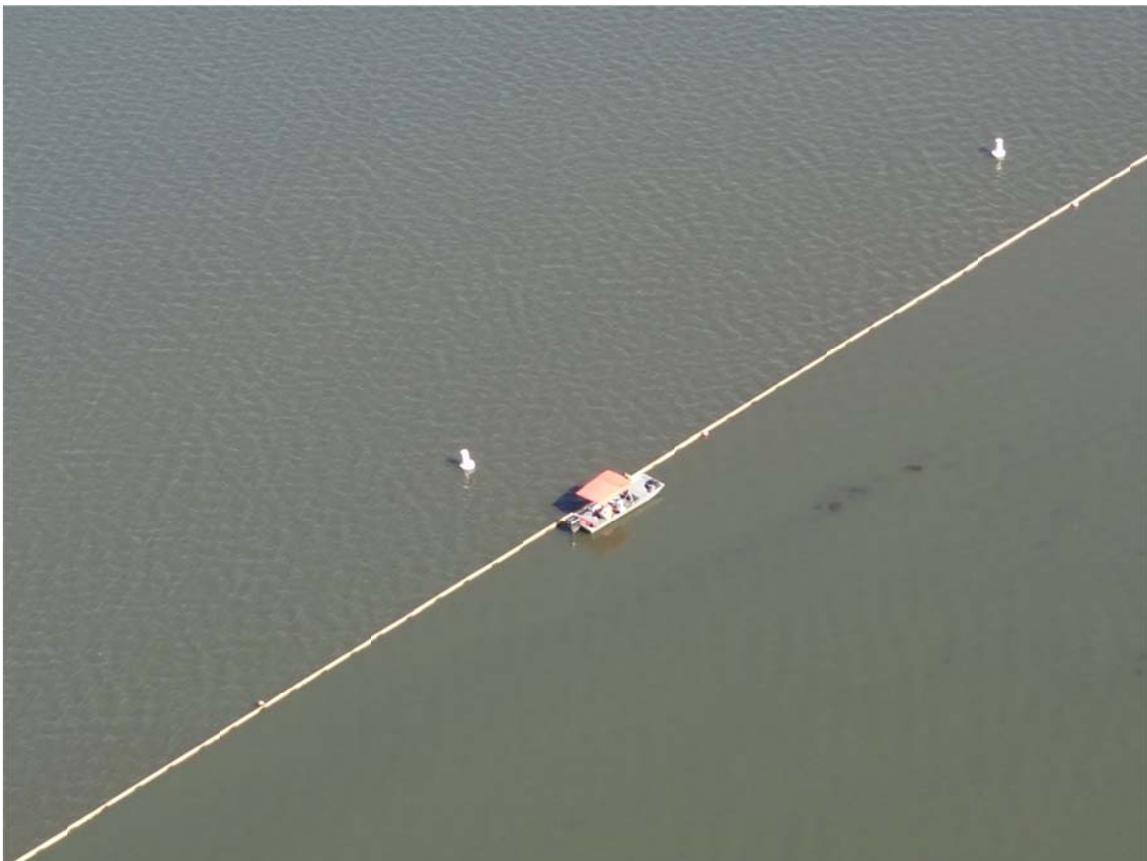
22. Morrow Lake Delta observed a crew performing boom and curtain inspections.

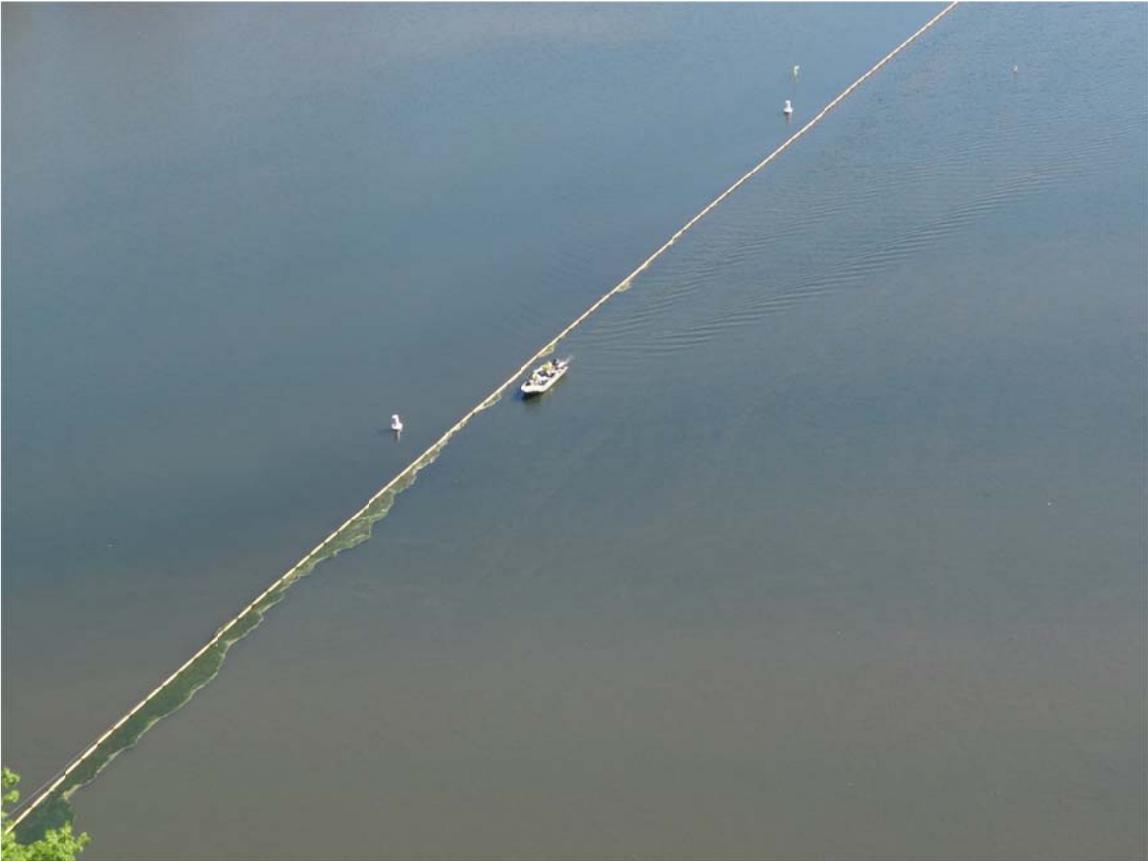
23. Morrow Lake Delta observed a crew performing boom maintenance.
