Situation Photo Log

Wednesday, September 12, 2012

Kalamazoo River / Enbridge Spill

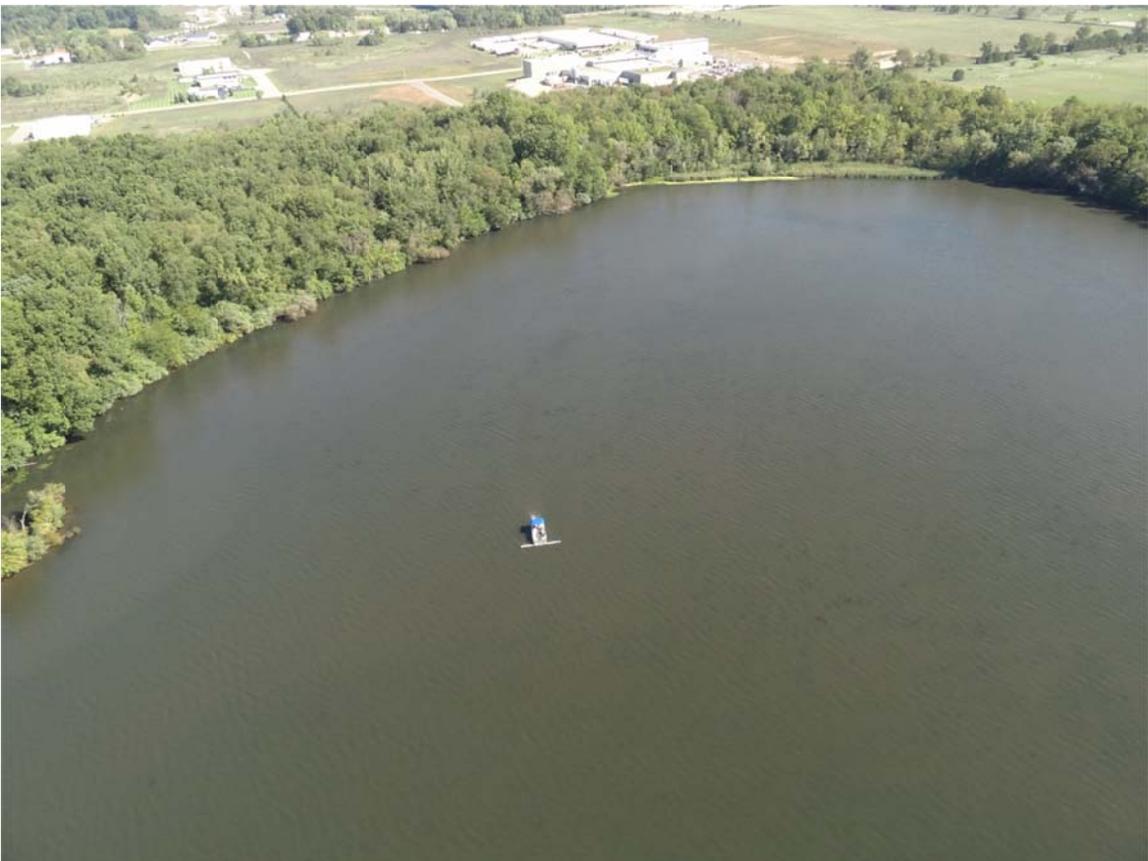
24. Morrow Lake north cove observed the sweep boat operating.
