Situation Photo Log

Friday, September 14, 2012

Kalamazoo River / Enbridge Spill

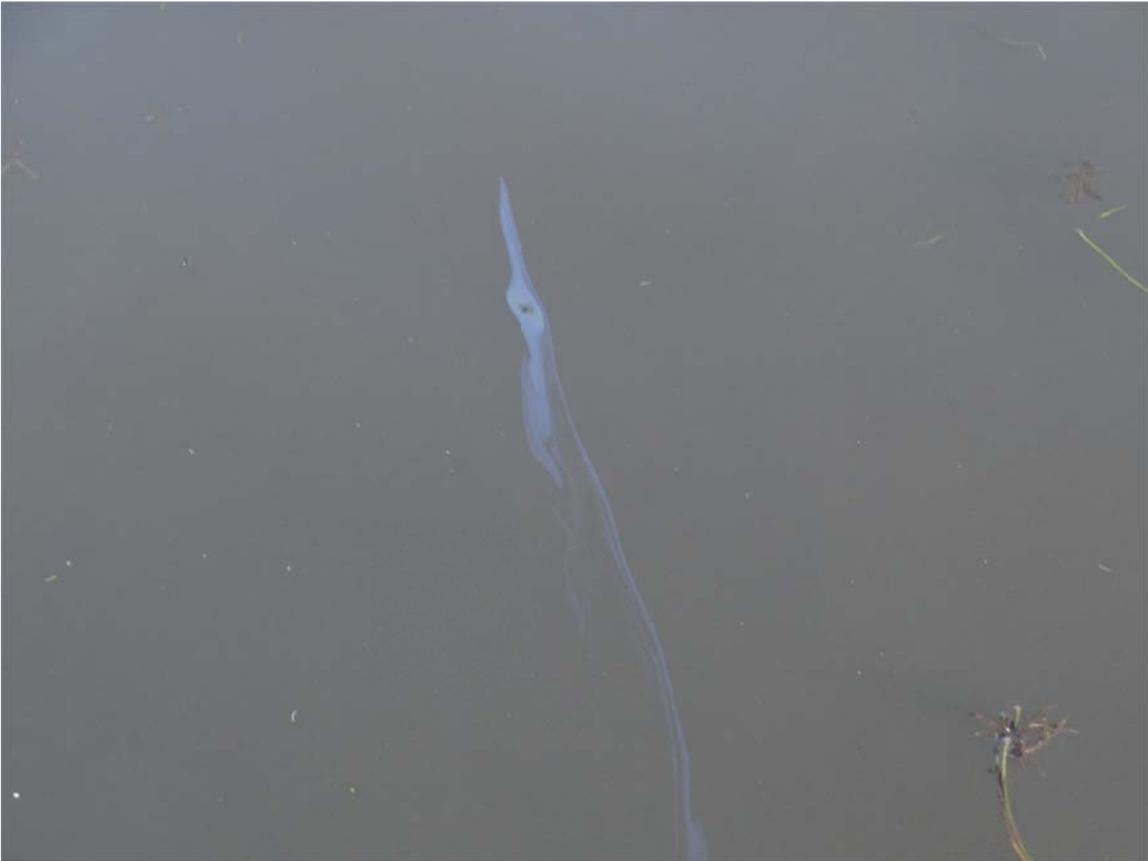
1. Sheen and tar globules observed at MP5.15 LDB.

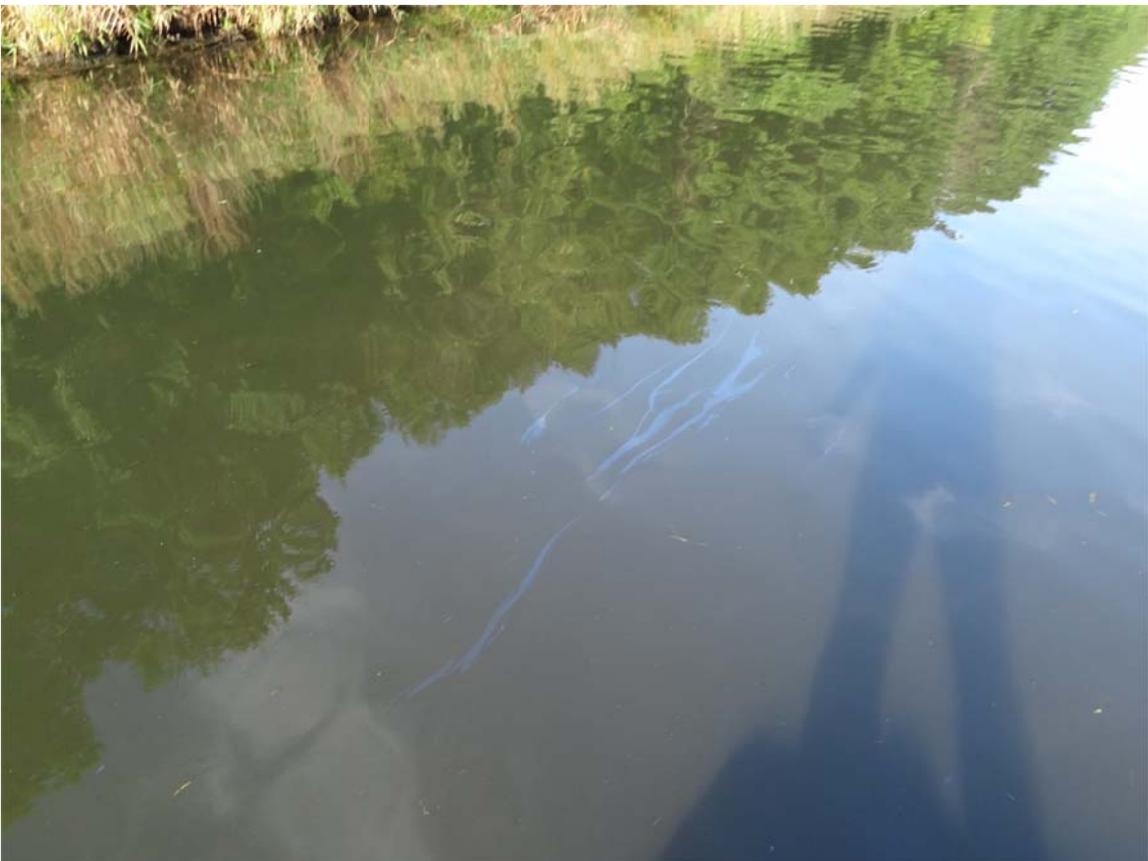
2. Sheen and tar globules observed at MP5.20 LDB.

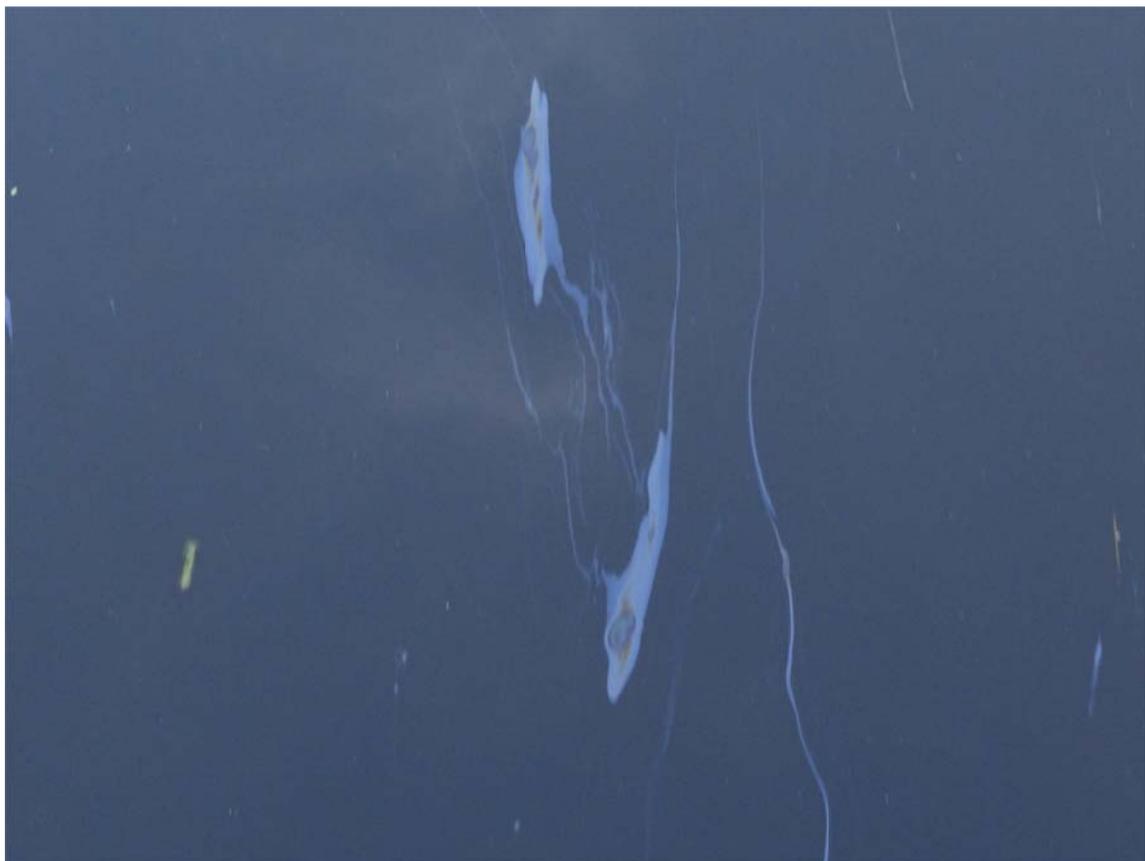
3. Sheen and tar globules observed at MP5.25 LDB.

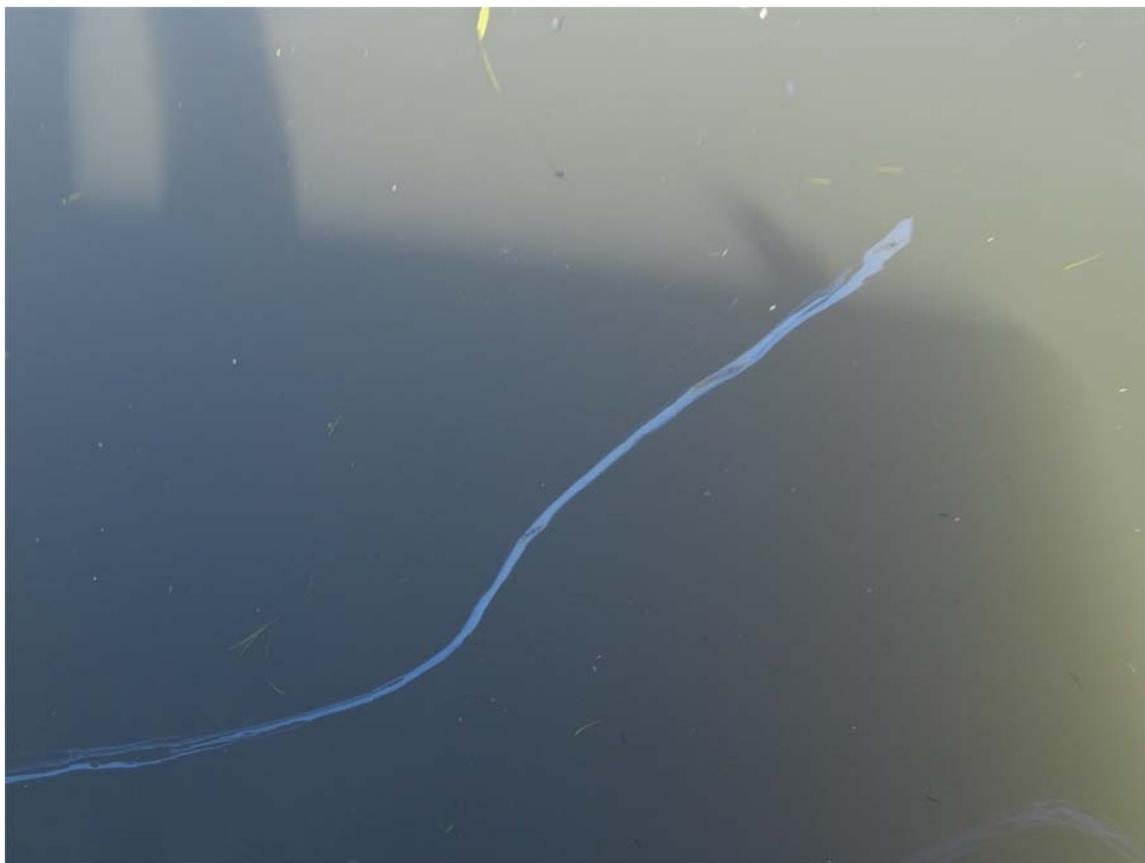
4. MP5.5 LDB sheen and tar globs observed.

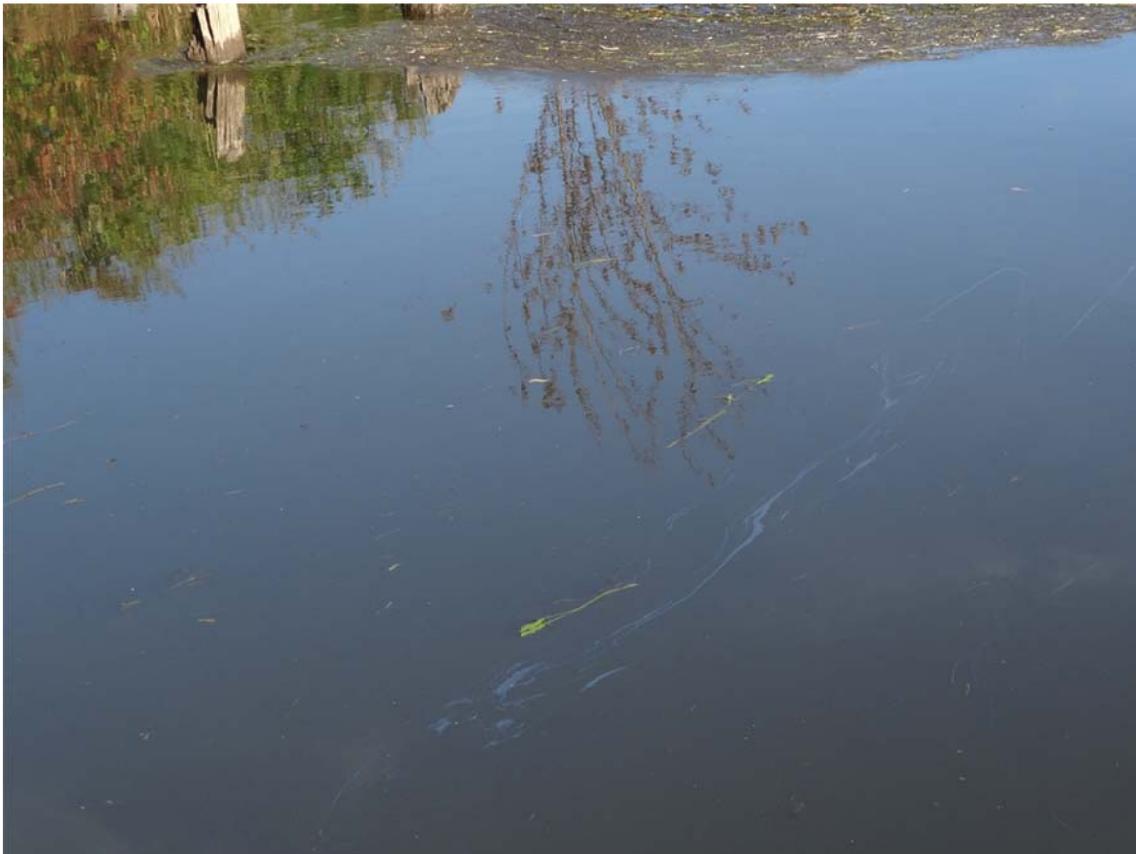
5. MP5.63 LDB at the railroad trestles sheen observed.

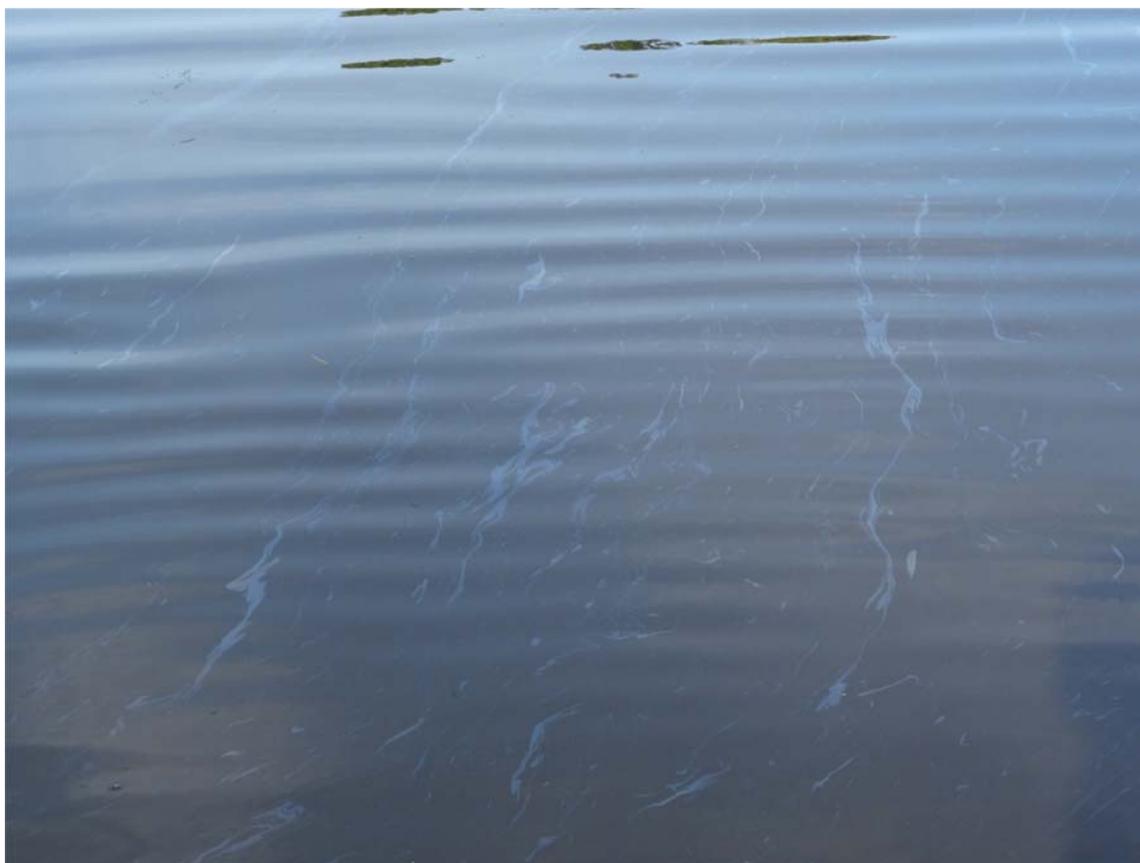
6. MP5.63 LDB below the railroad trestles sheen and tar globs observed.

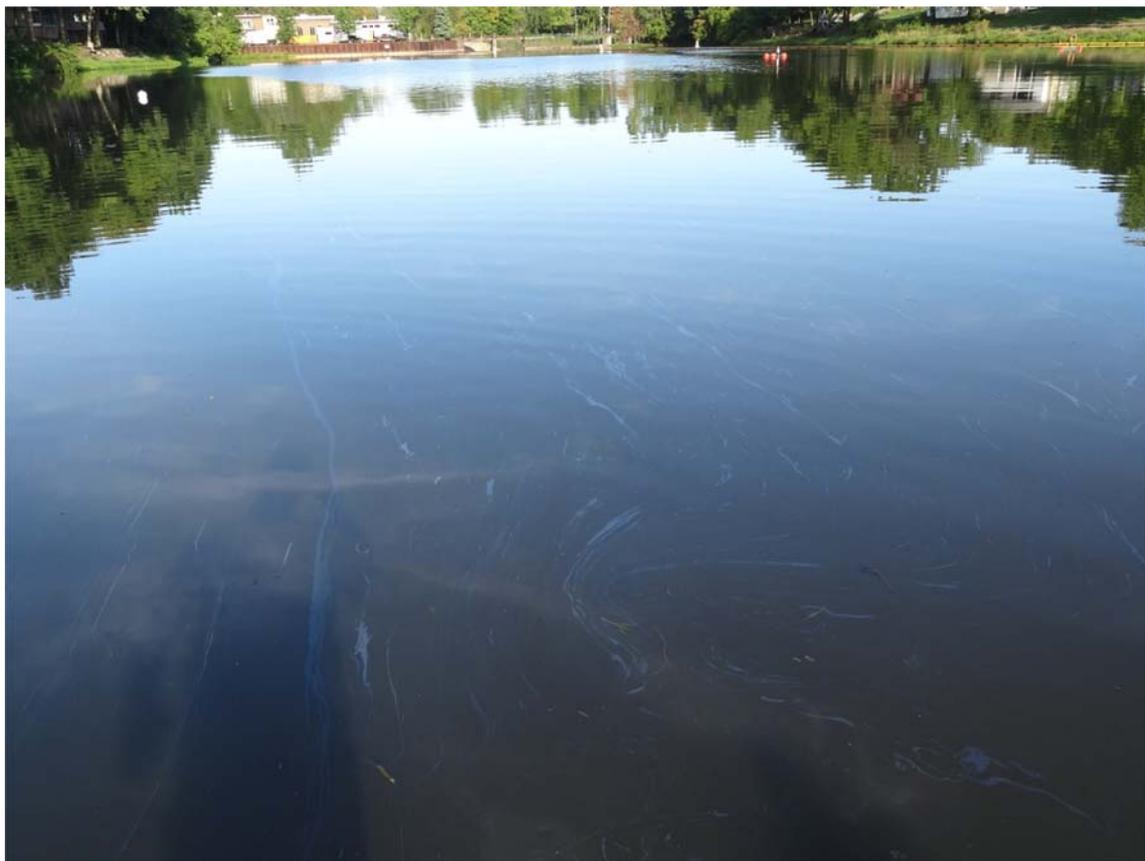
7. MP5.63 LDB below the railroad trestles sheen and tar globs observed.

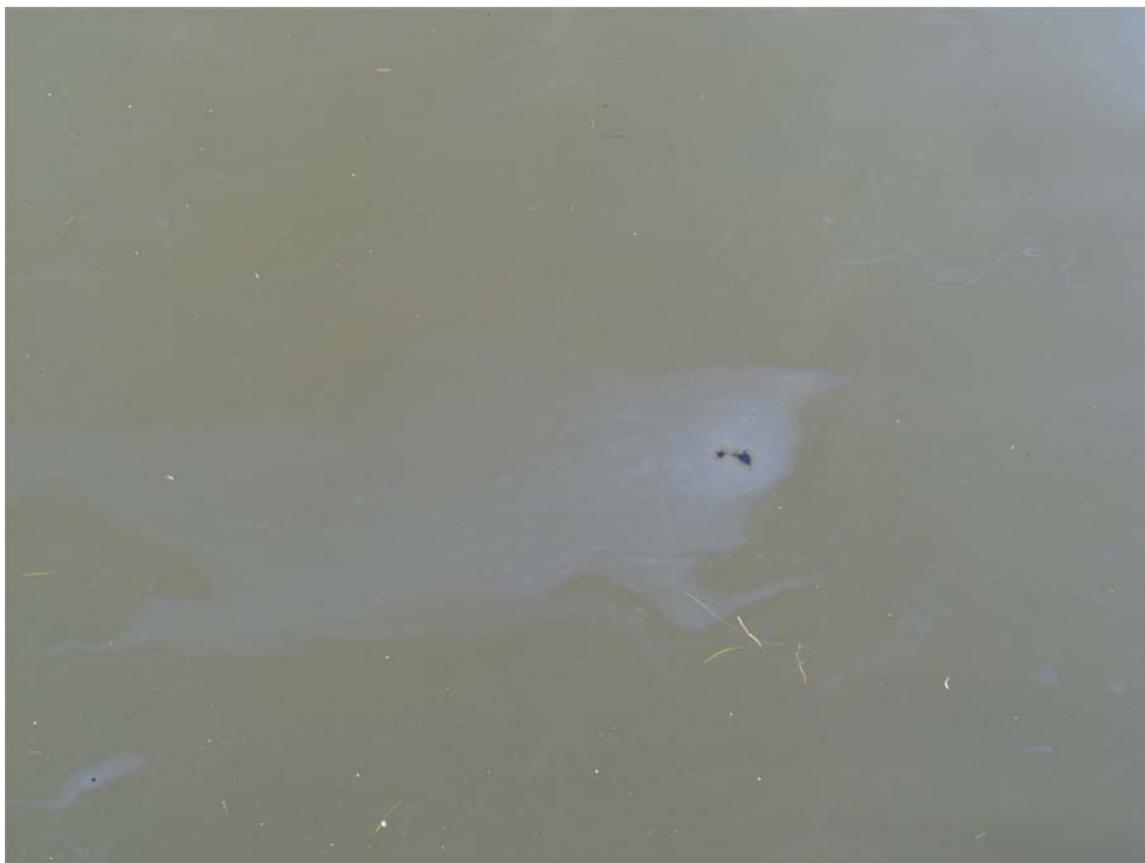
8. MP5.63 LDB below the railroad trestles sheen and tar globs observed.

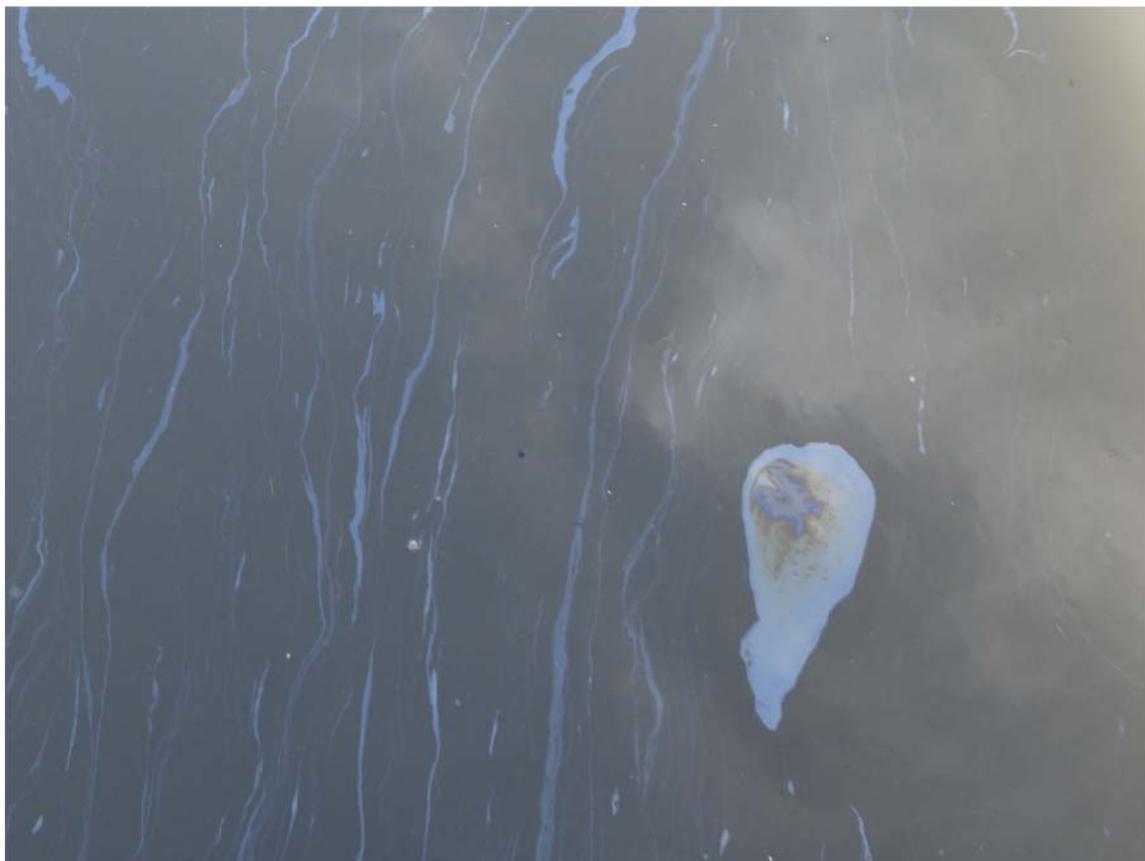
9. MP5.63 LDB below the railroad trestles sheen and tar globs observed.

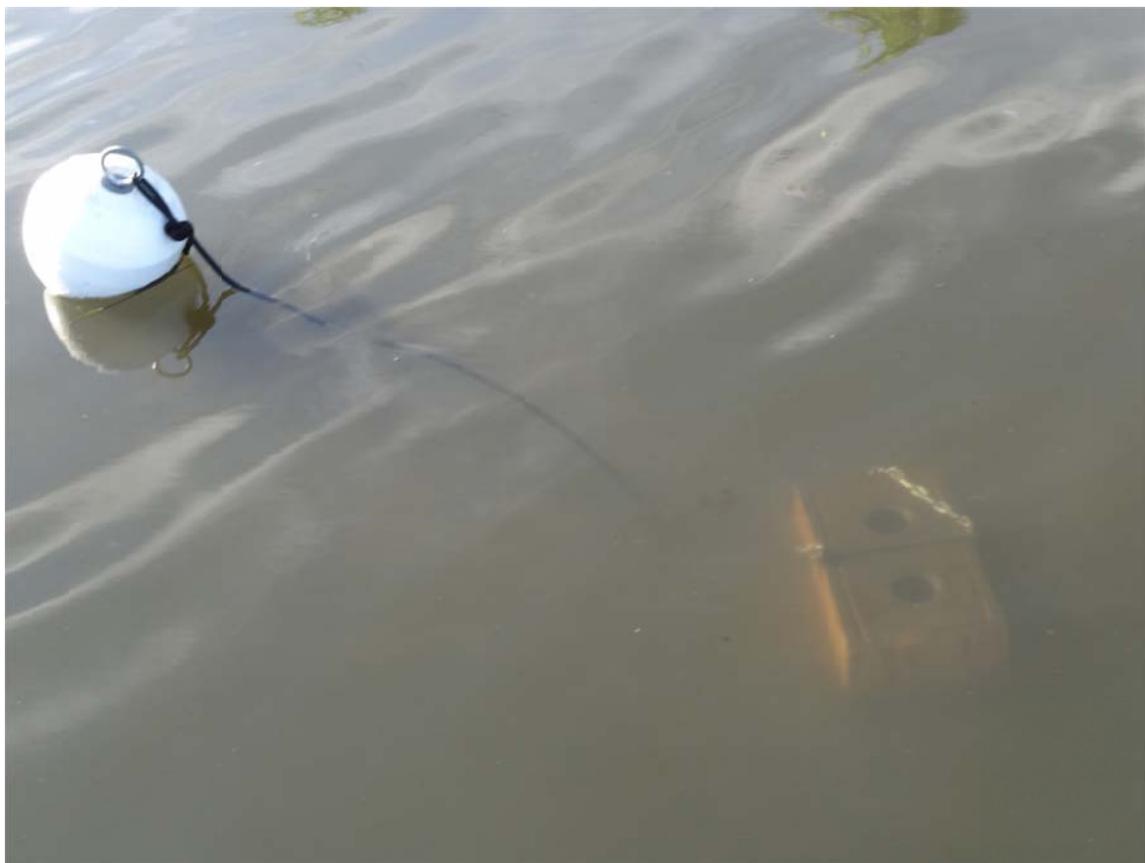
10. CSD observed above Ceresco Dam.

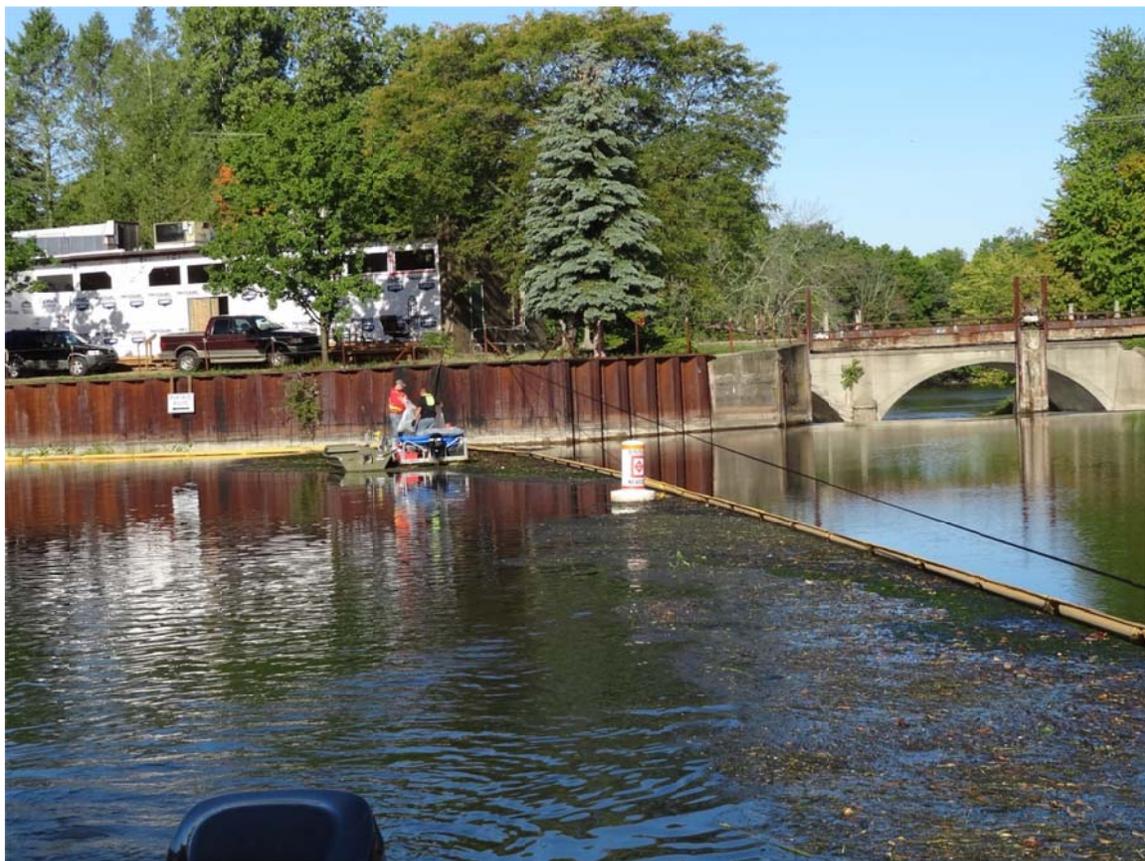
11. Ceresco Dam observed a crew performing boom maintenance.

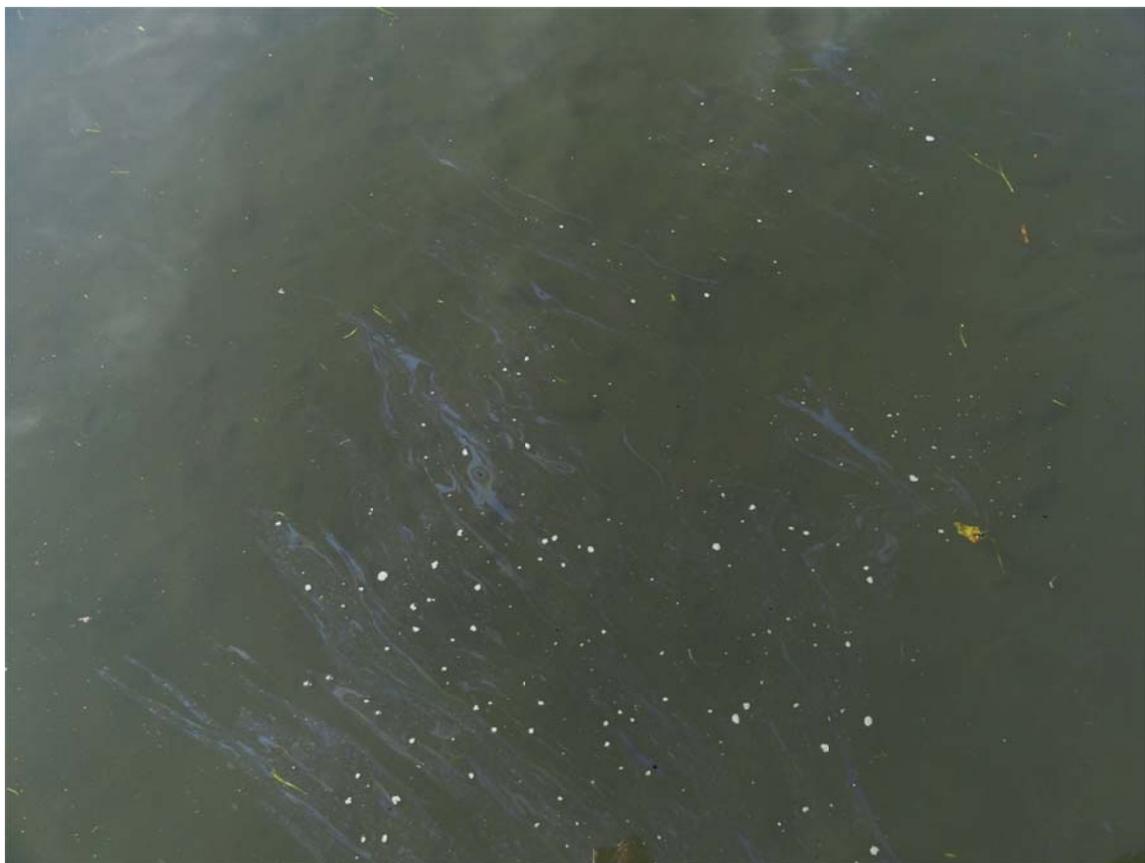
12. Observed sheen and tar globs observed collecting along the Ceresco Dam control point boom.

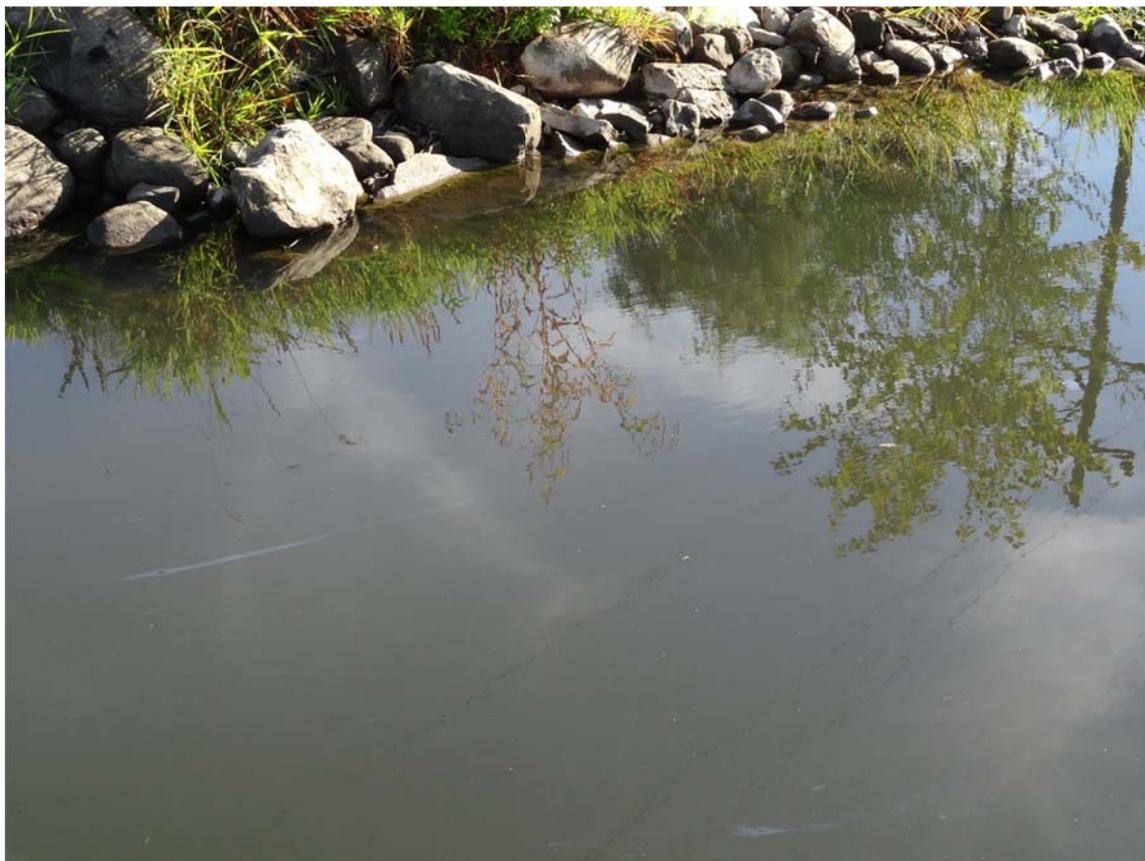
13. MP5.55 RDB sheen and tar globs observed.

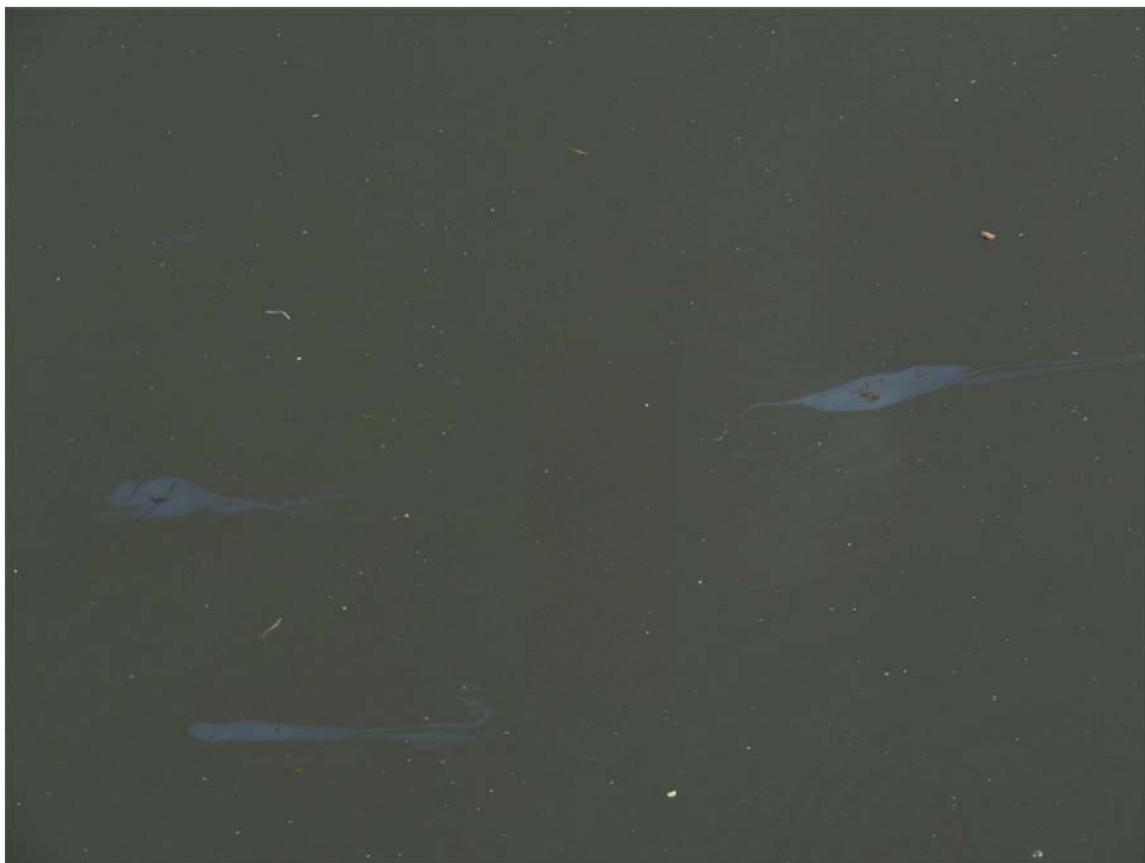
14. MP5.55 RDB sheen and tar globs observed.

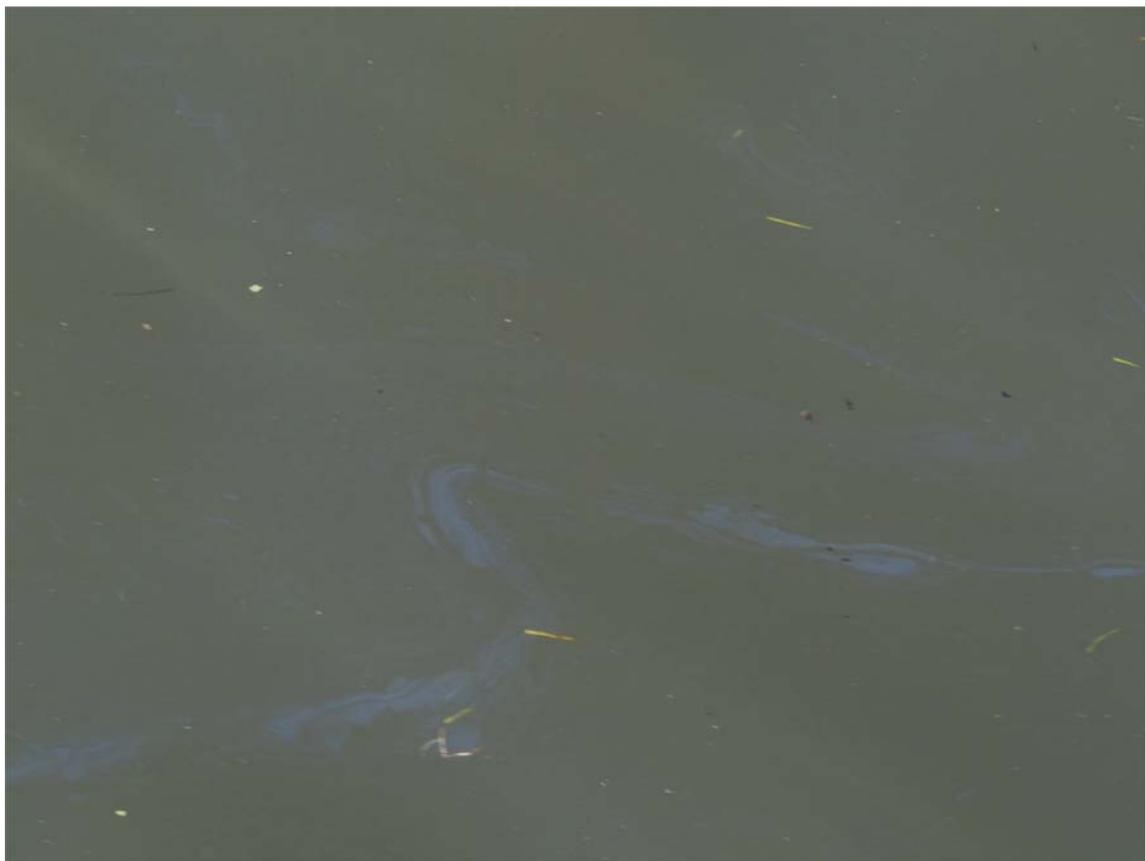
15. MP5.0 – MP5.15 RDB sheen and tar globs observed.

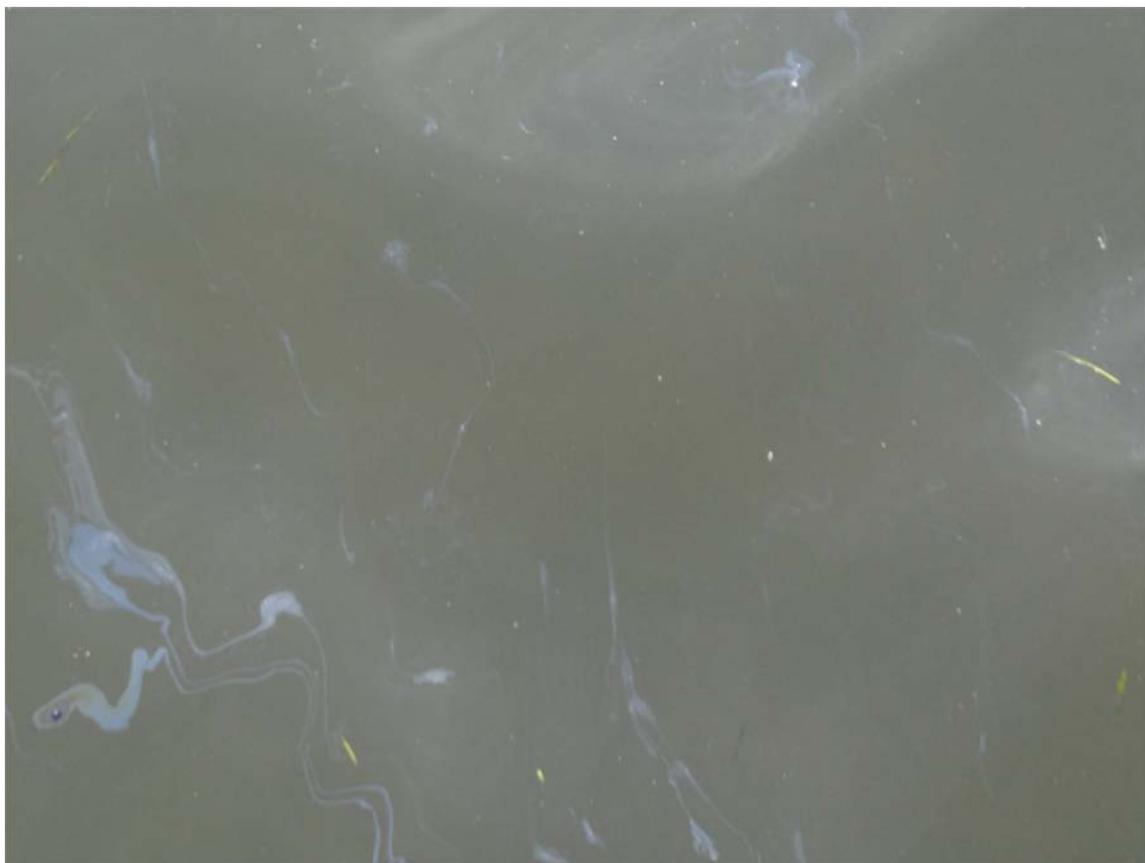
16. MP5.0 – MP5.15 RDB sheen and tar globs observed.

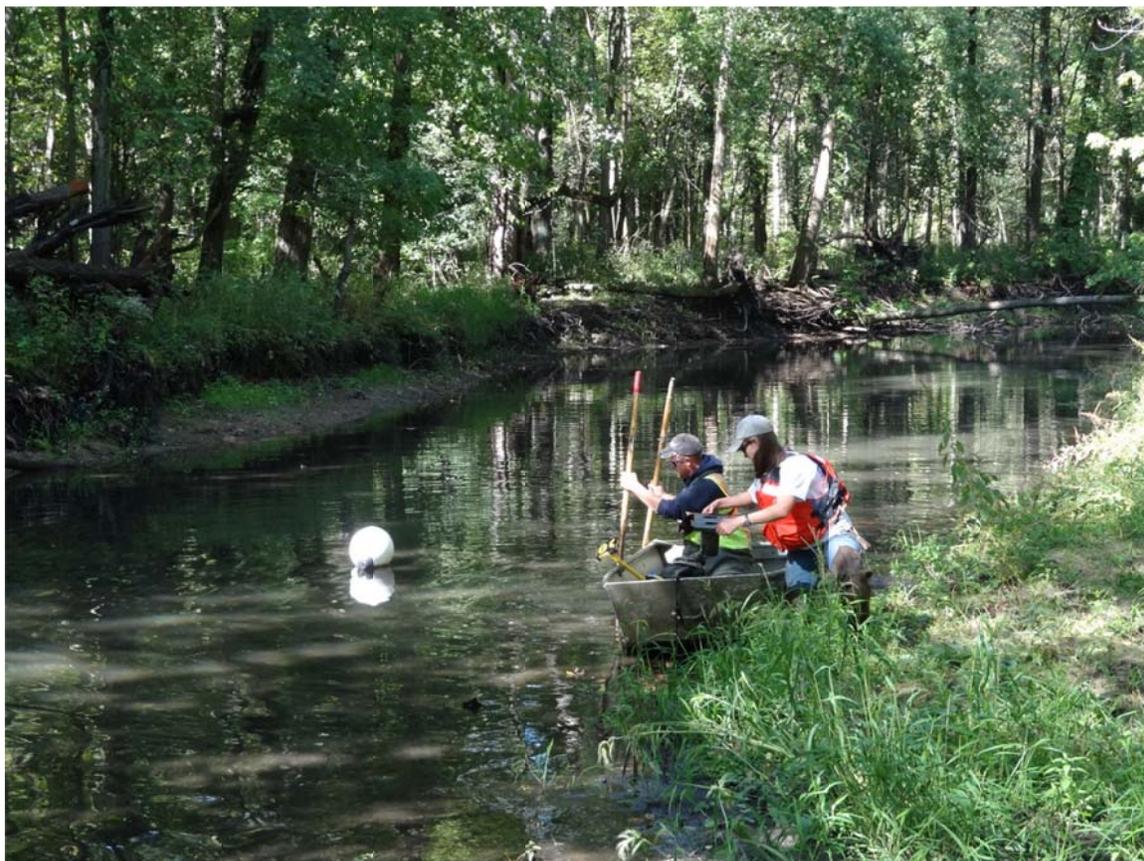
17. MP28.25 Oxbow observed a crew reinstalling the CSD.

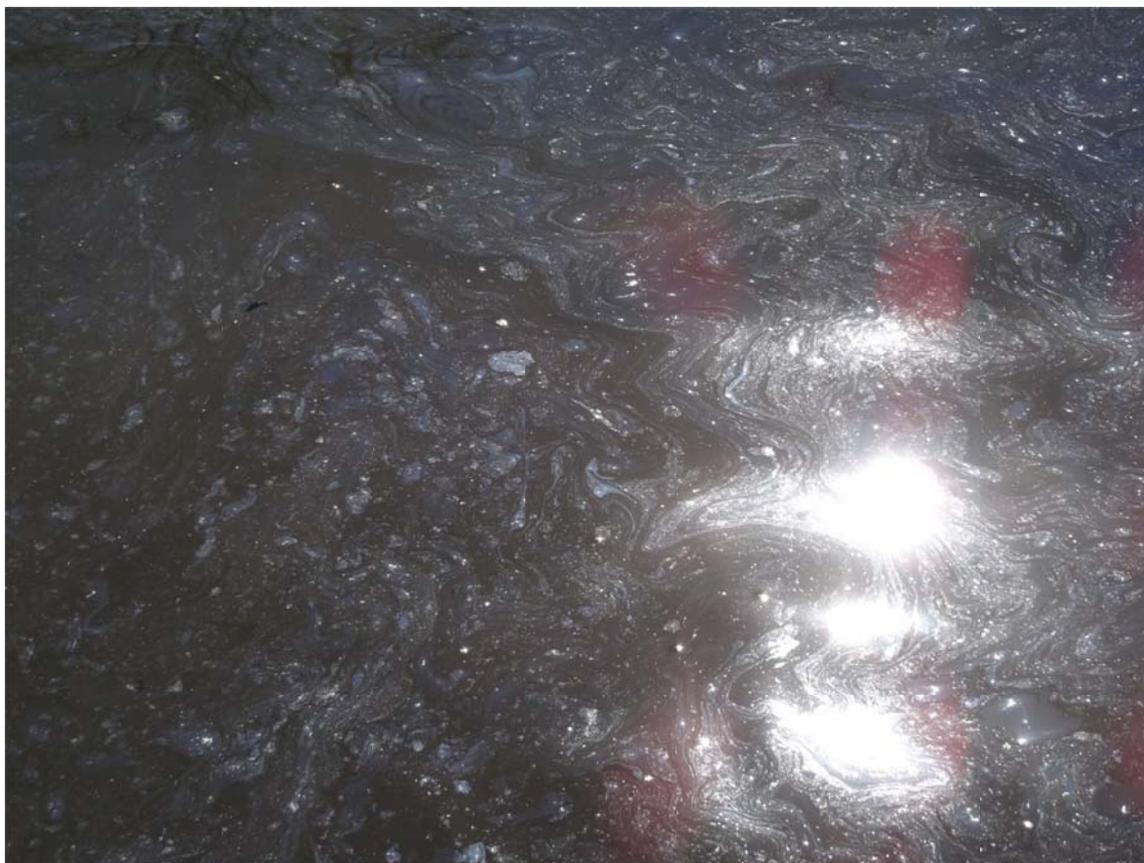
18. MP28.25 RDB sheen observed around the boat. The sediment was agitated when docking to observe the work.

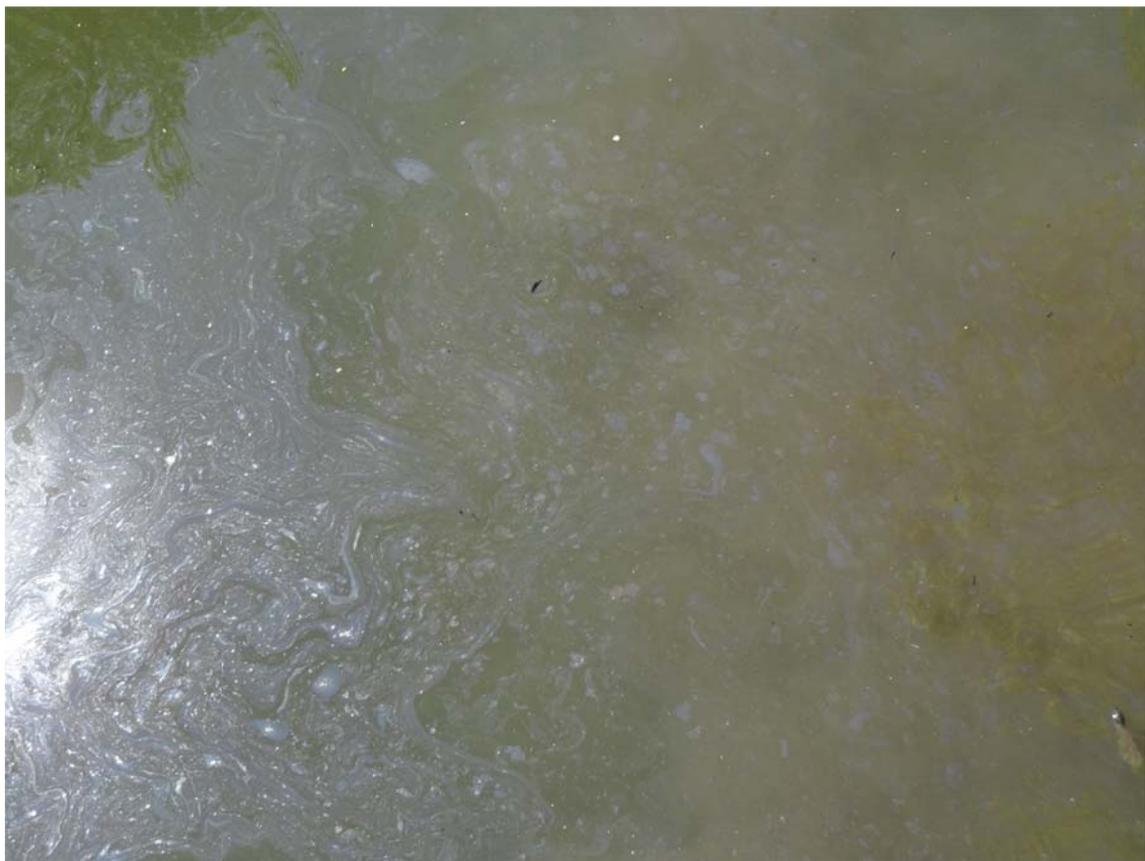
19. MP28.25 RDB sheen observed around the boat. The sediment was agitated when docking to observe the work.

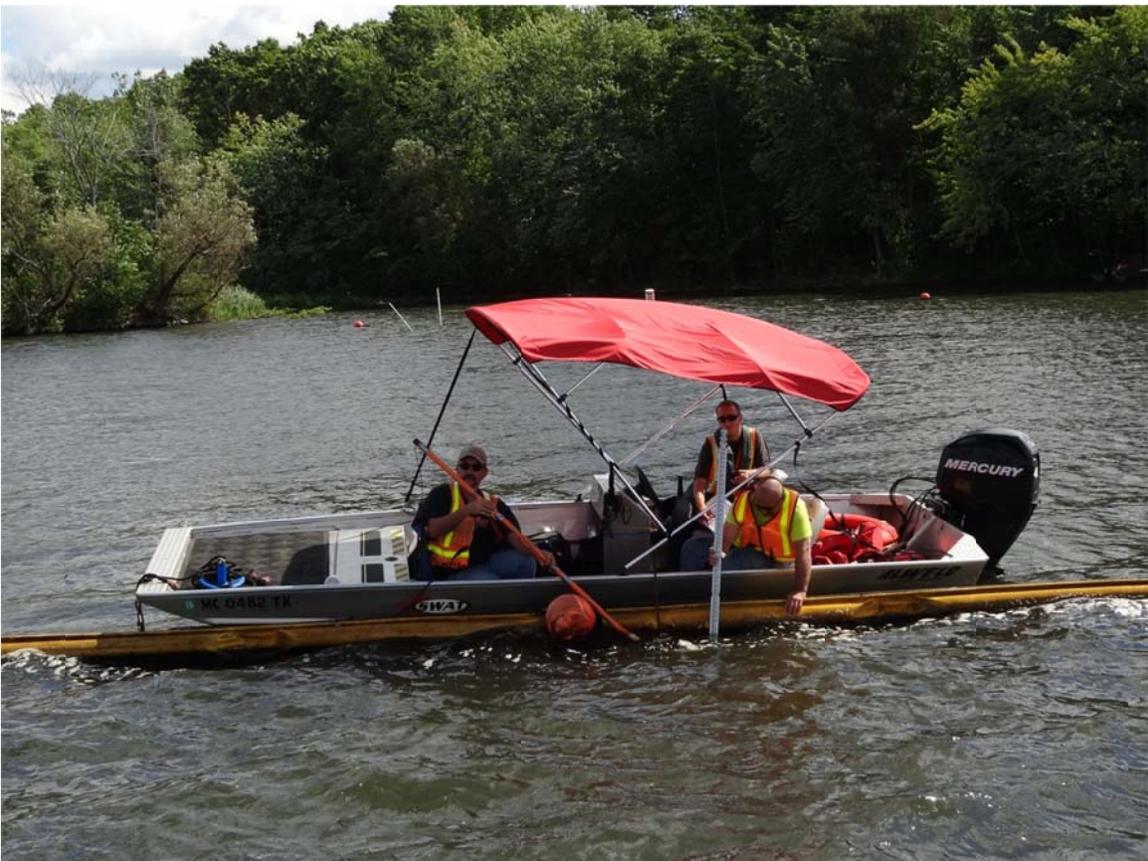
28. Morrow Lake Delta Boom F observed a crew performing boom and curtain inspection.
