# Situation Photo Log

Monday, September 17, 2012

Kalamazoo River / Enbridge Spill

Prepared by:  
Matthew Haak  
START-USEPA  
Situation Unit Leader

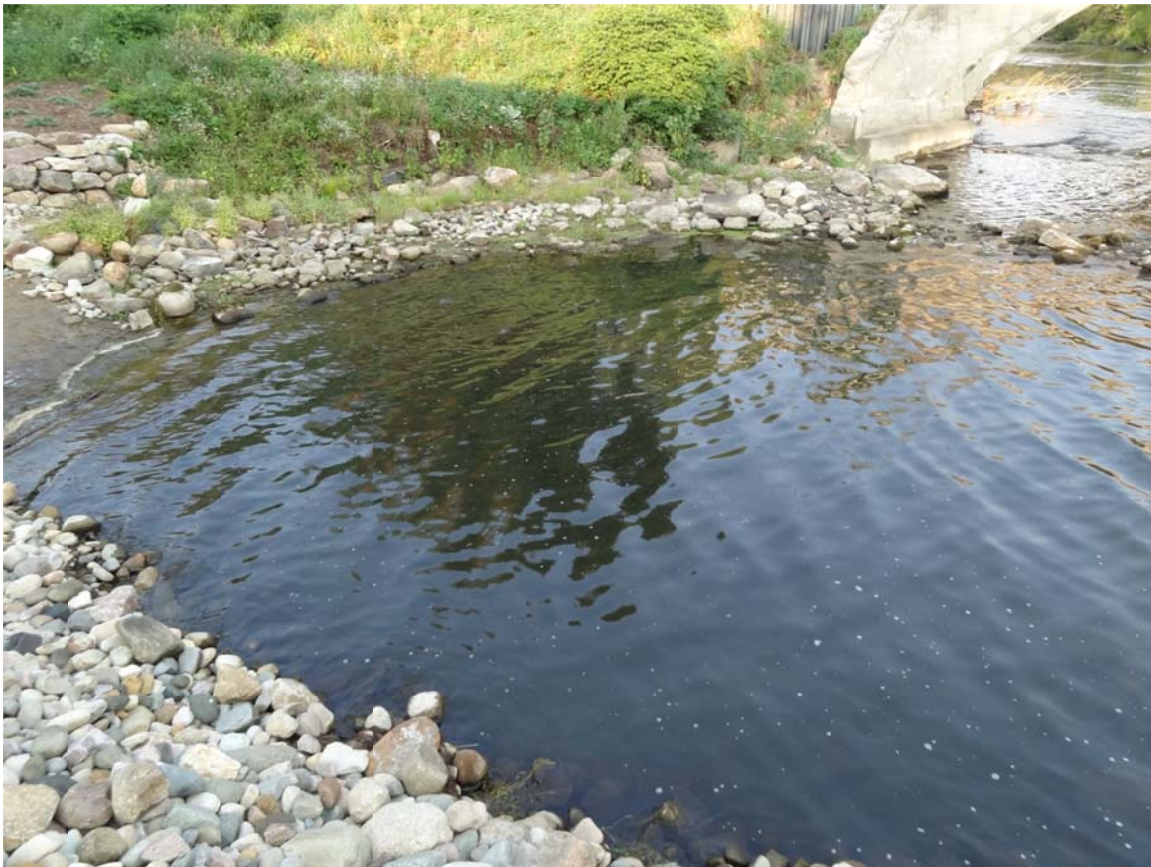
1. Portage below Ceresco Dam sheen was observed.

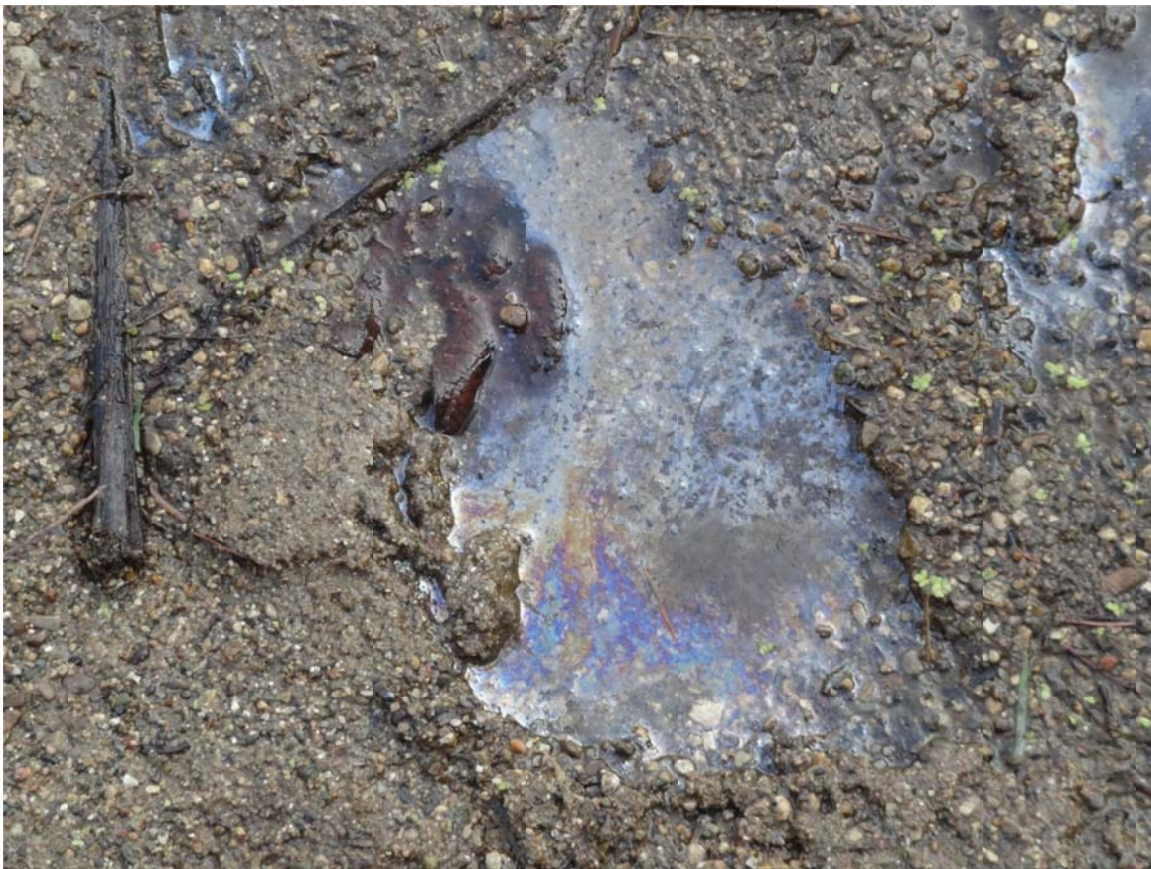
2. Portage below Ceresco Dam sheen was observed.

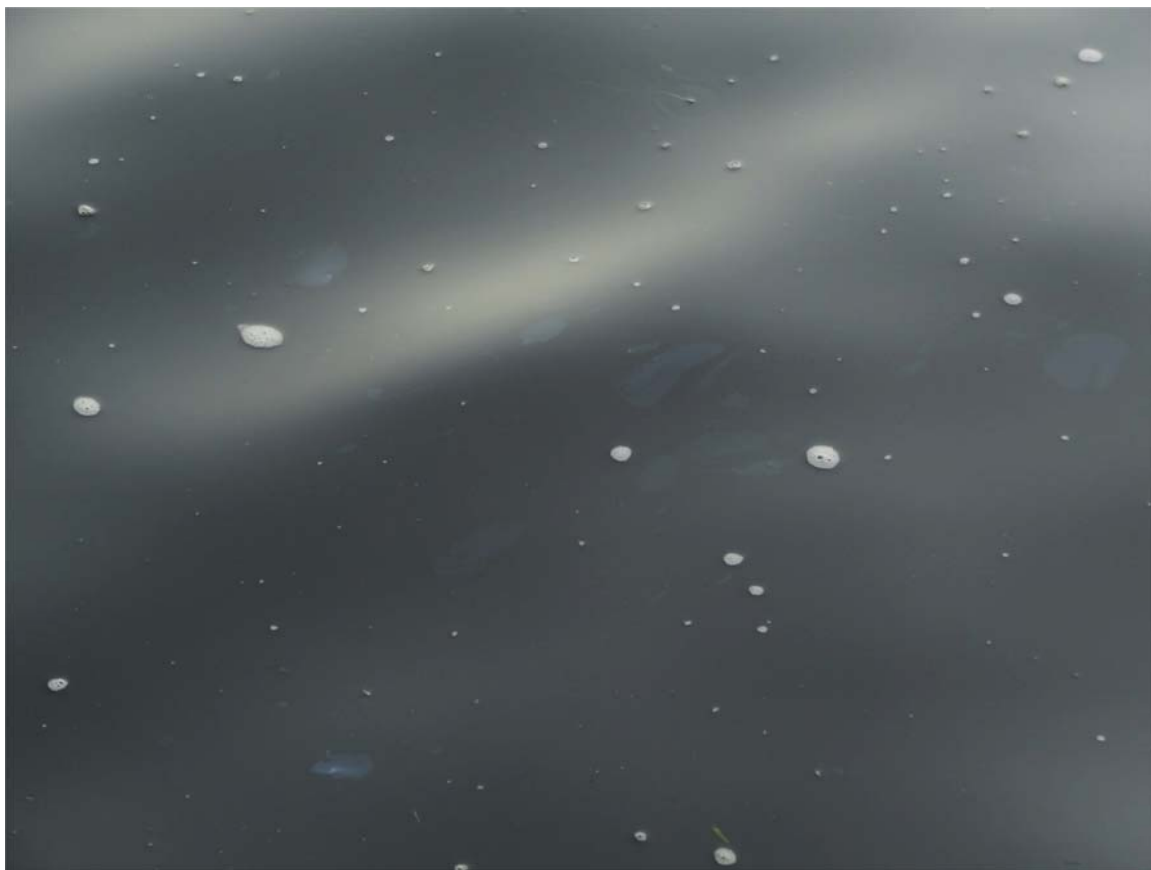
3. Portage below Ceresco Dam sheen was observed.

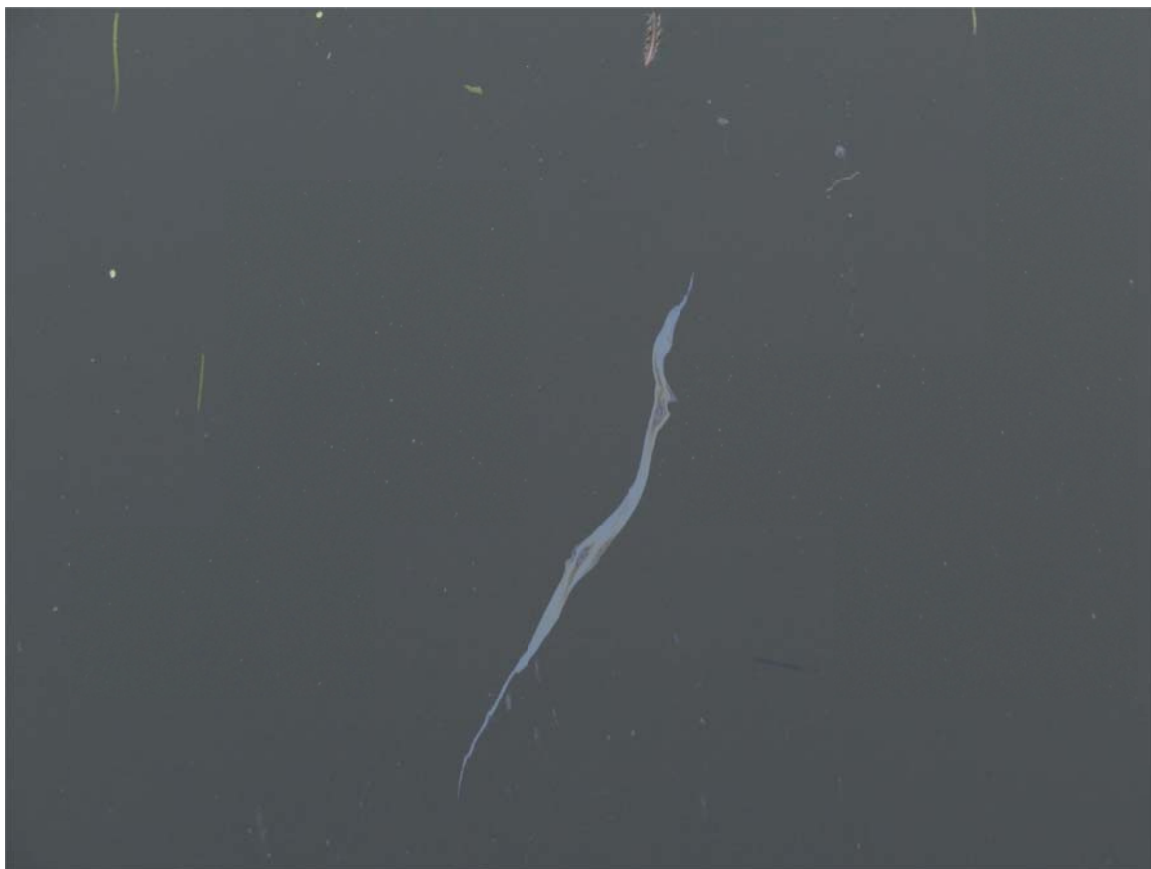
4. MP5.25 LDB sheen observed. Ribbons of sheen and tar globs were observed between MP5.15 – MP5.63 LDB.

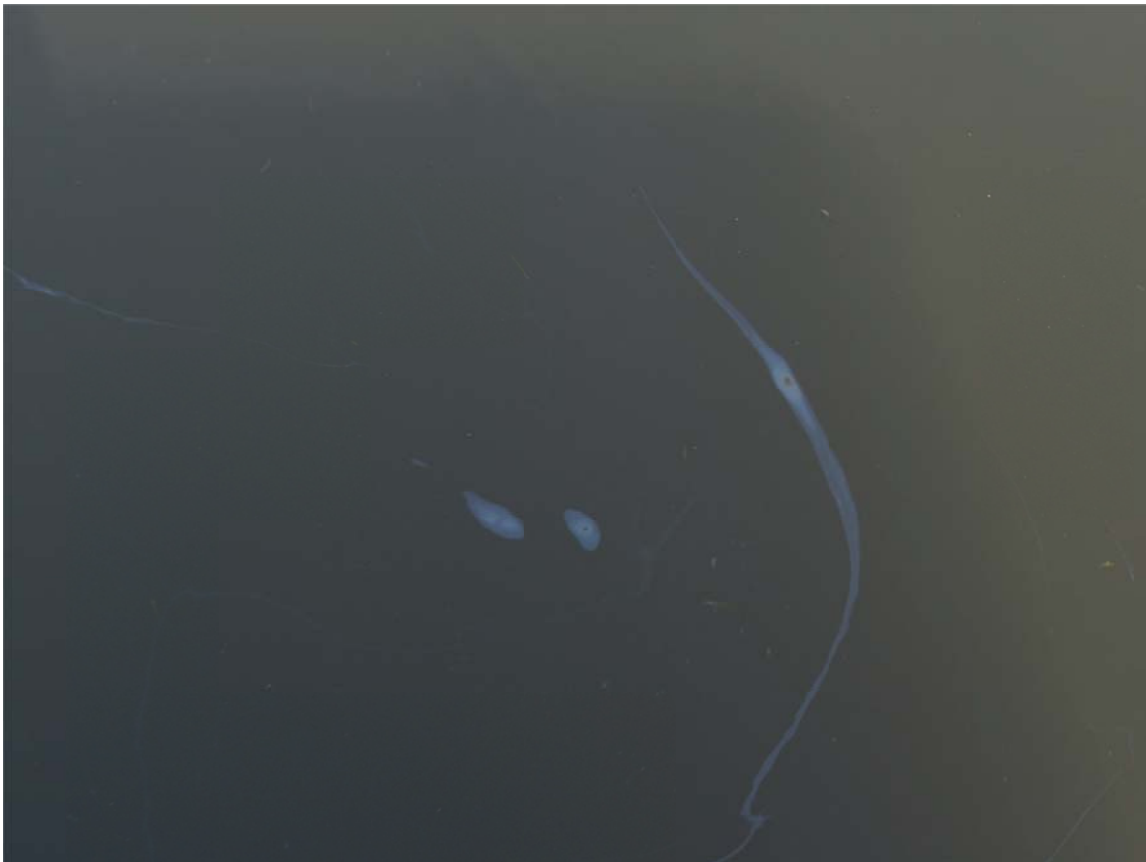
5. MP5.35 LDB sheen observed. Ribbons of sheen and tar globs were observed between MP5.15 – MP5.63 LDB.

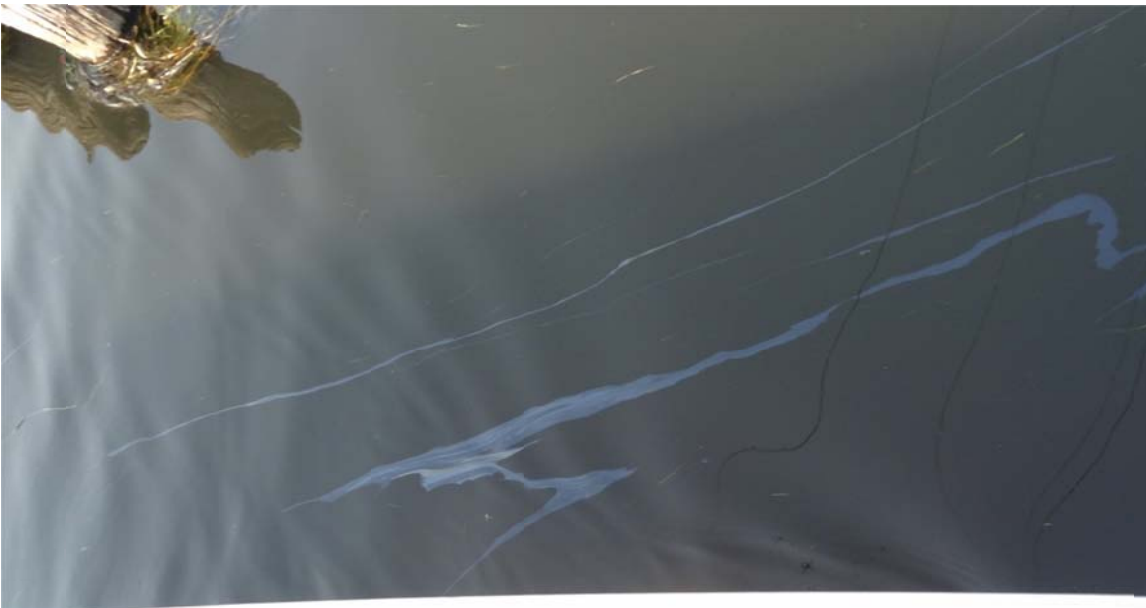
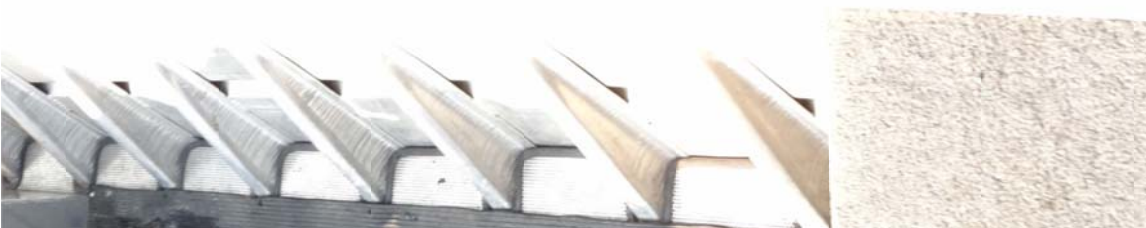
6. MP5.63LDB sheen observed. Ribbons of sheen and tar globs were observed between MP5.15 – MP5.63 LDB.

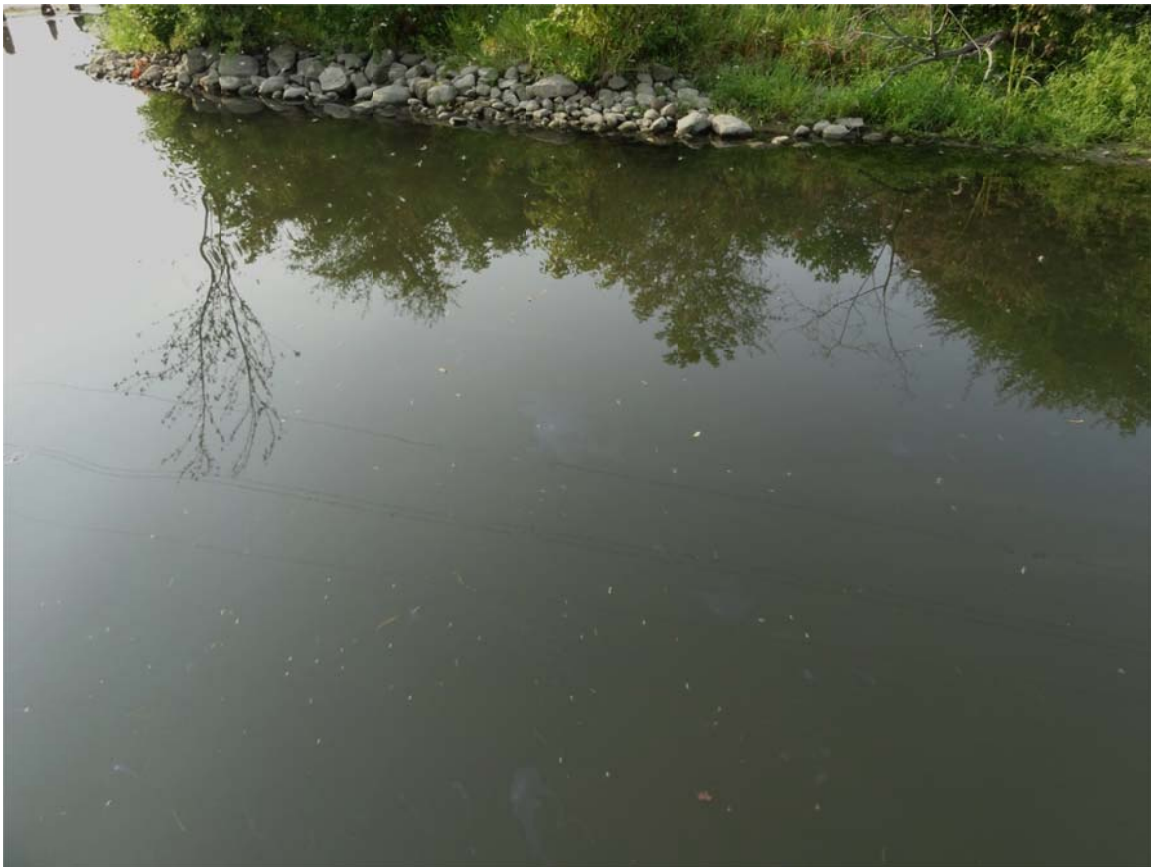
7. MP5.63 LDB sheen observed. Ribbons of sheen and tar globs were observed between MP5.15 – MP5.63 LDB.

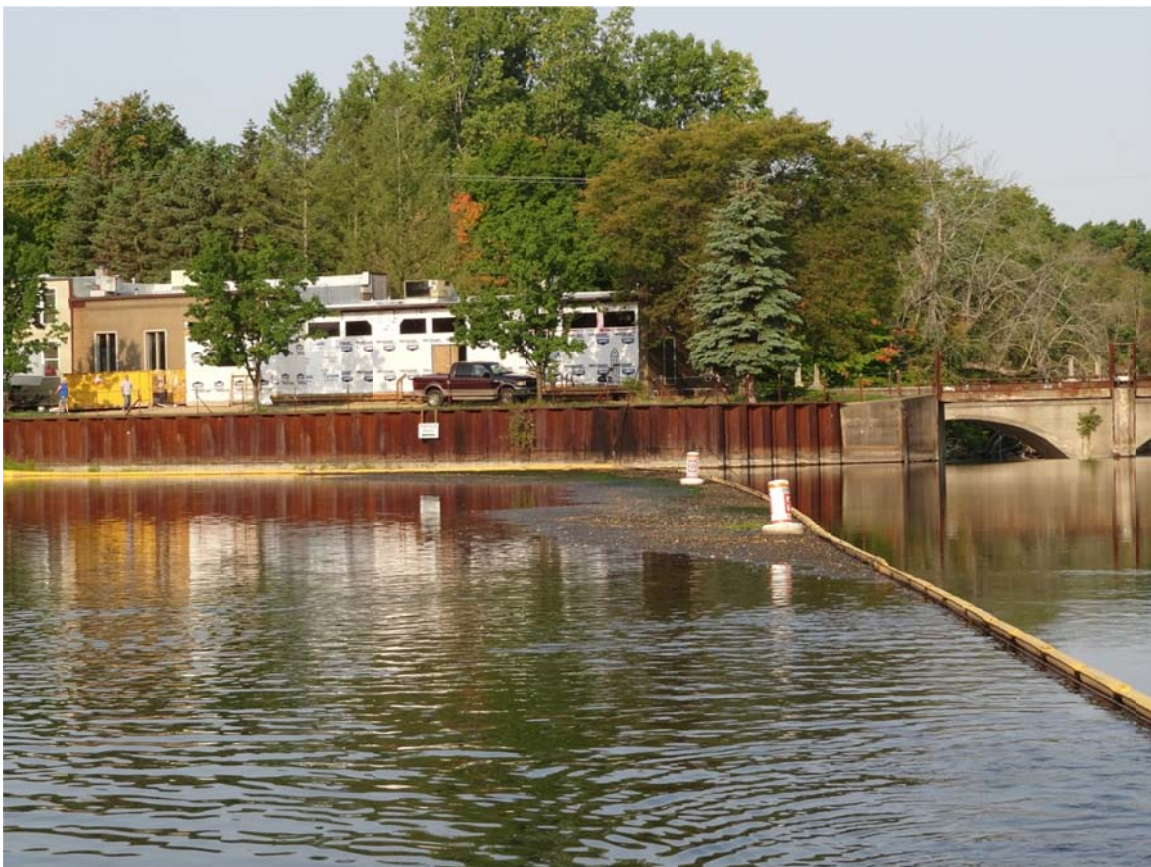
8. Observed debris collecting along control point boom at Ceresco Dam.

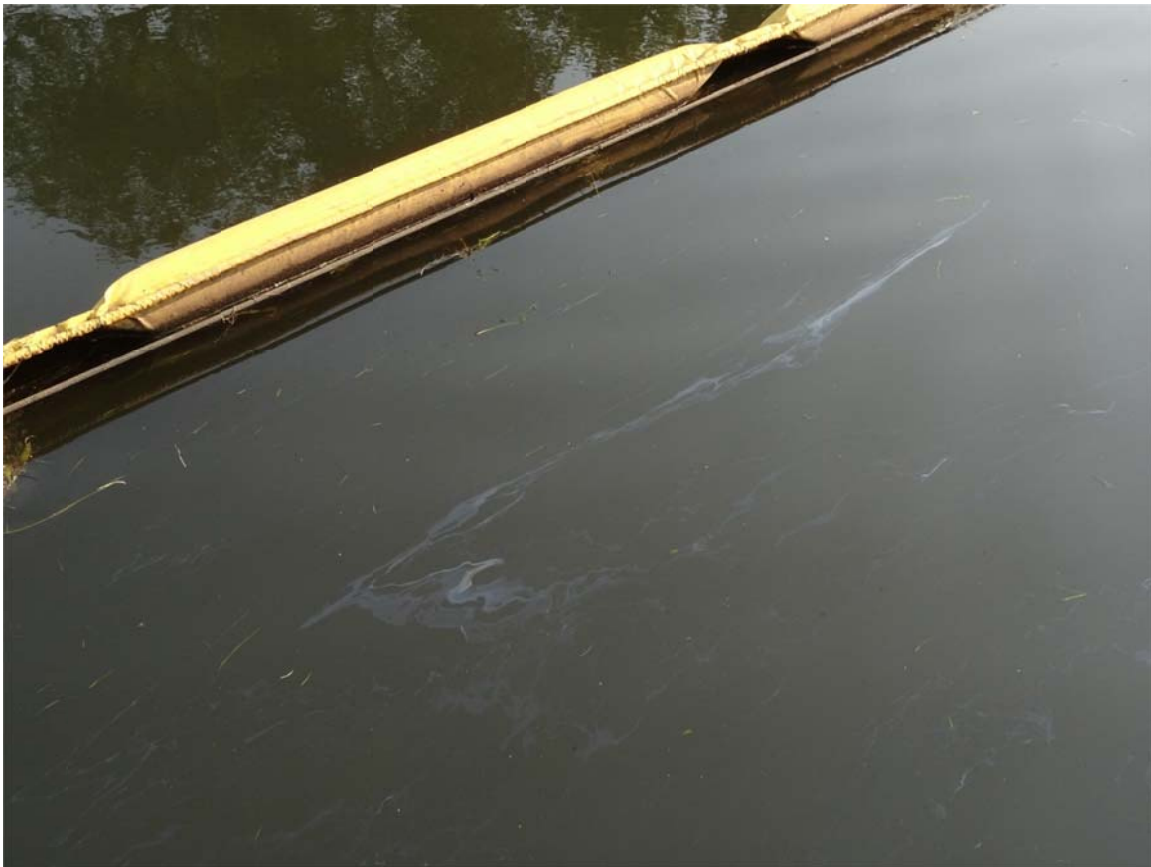
9. Sheen and tar globs observed collecting along the Ceresco Dam control point boom.

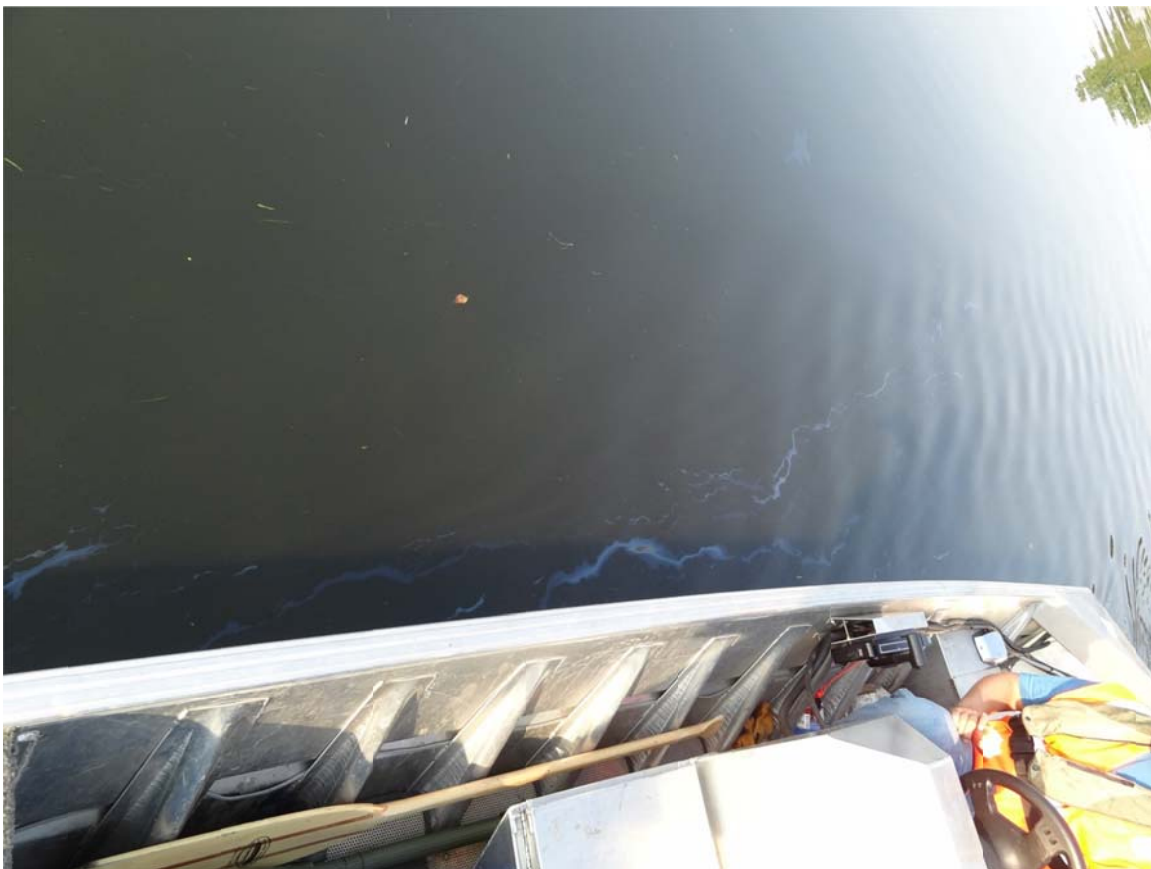
10. MP5.75 RDB sheen and tar globs observed.

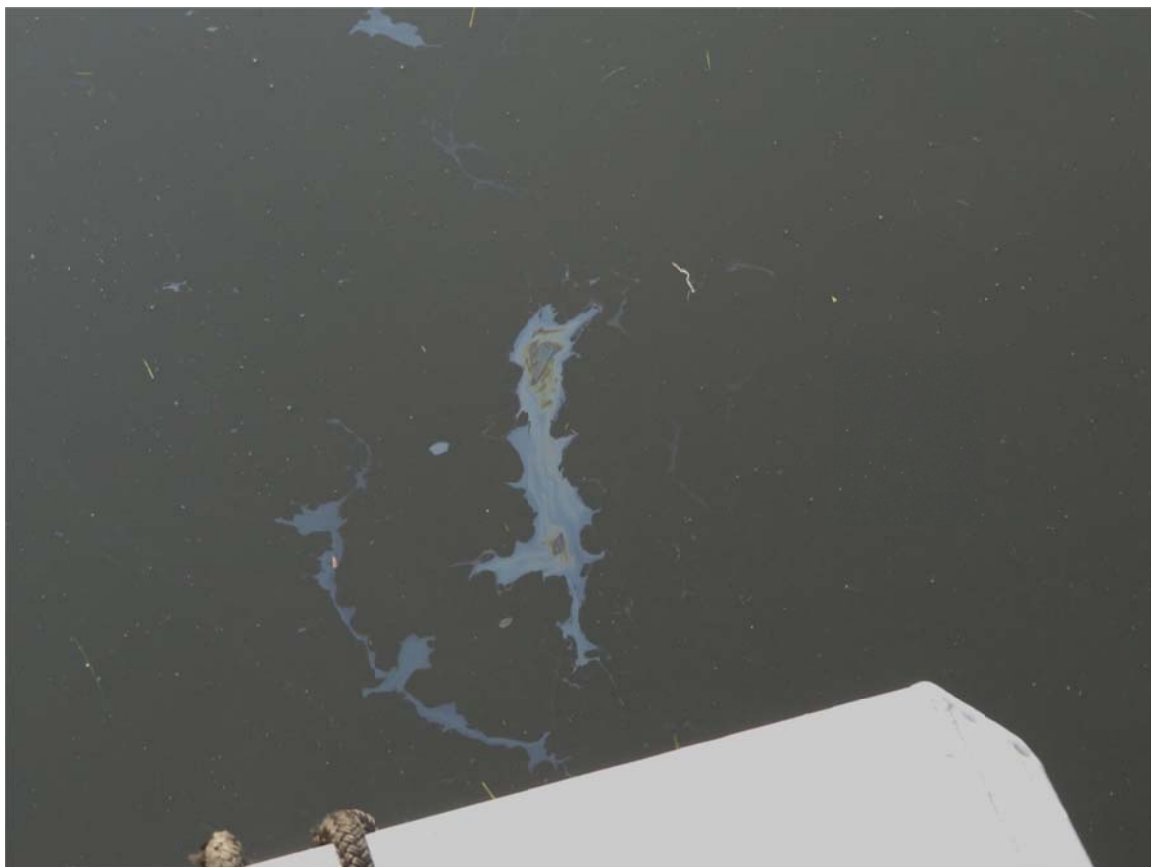
11. MP5.75 RDB sheen and tar globs observed.

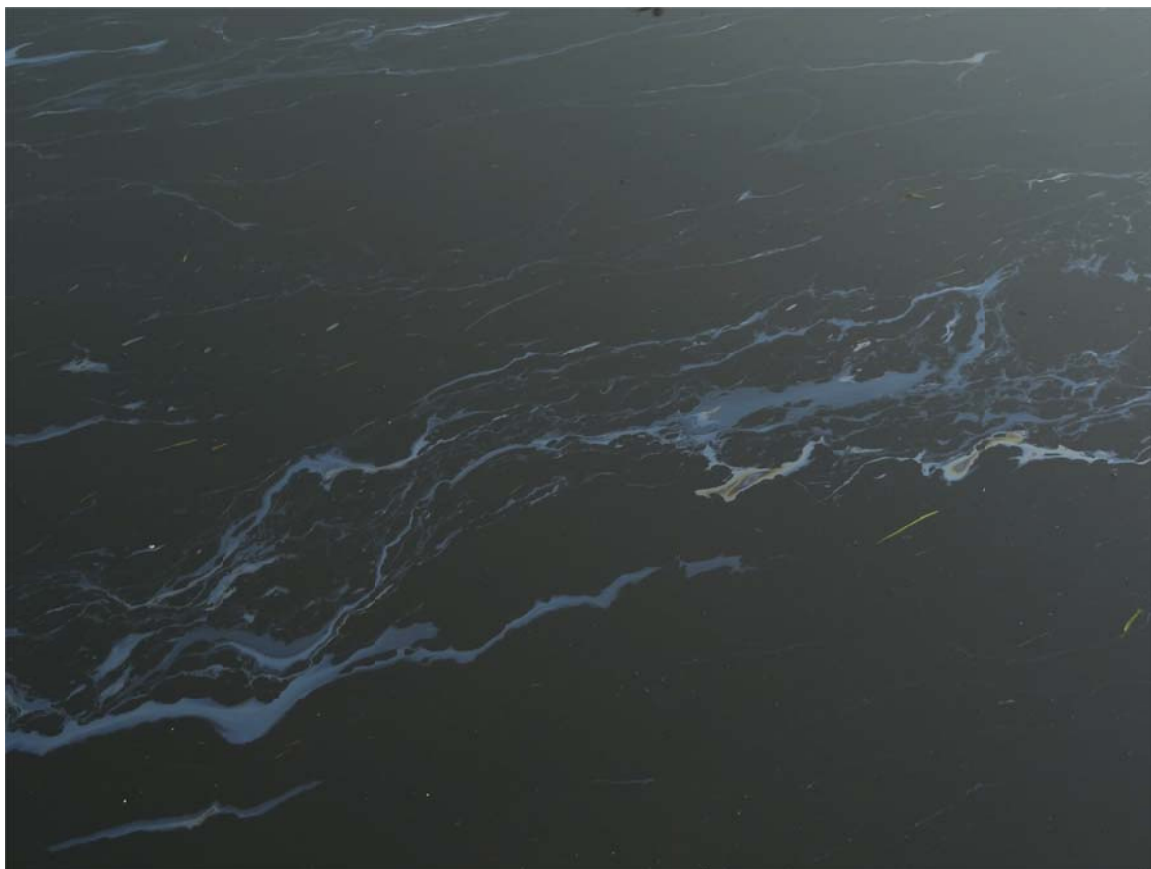
12. MP5.70 RDB sheen and tar globs observed.

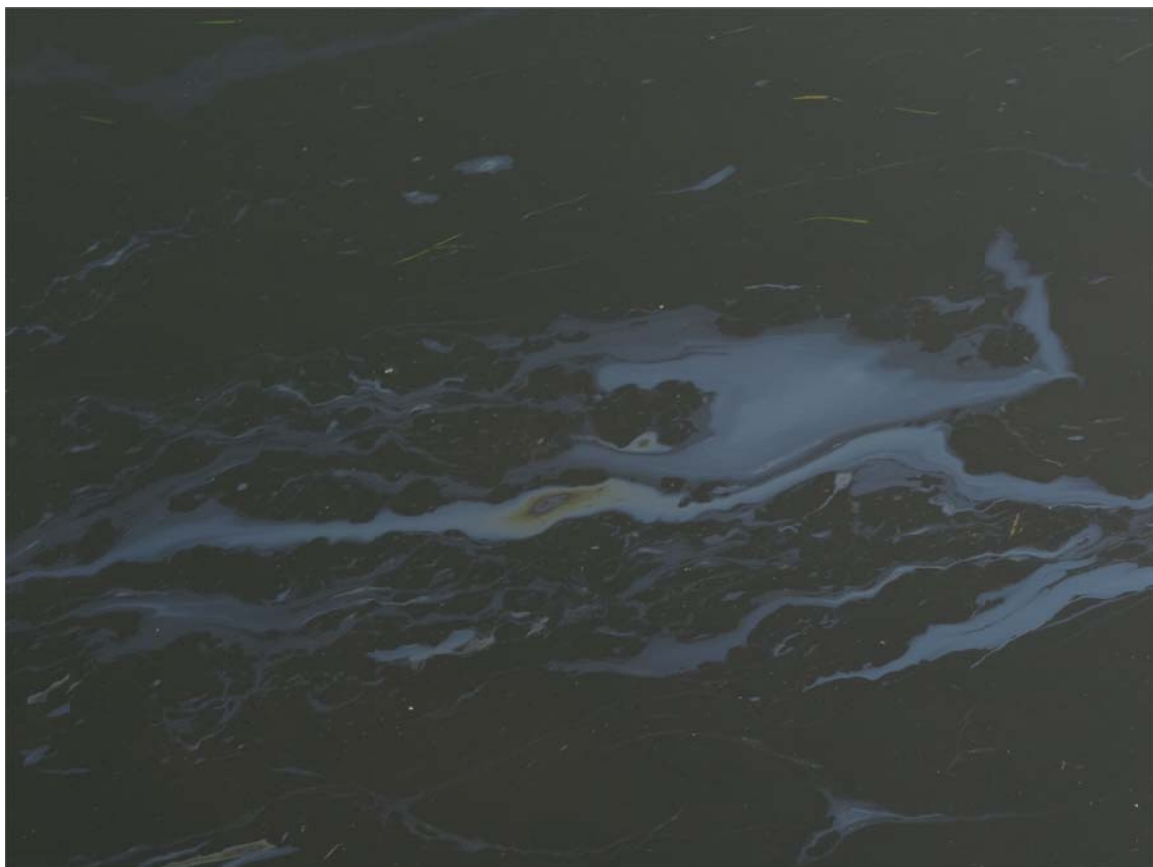
13. MP5.63 RDB sheen and tar globs observed.

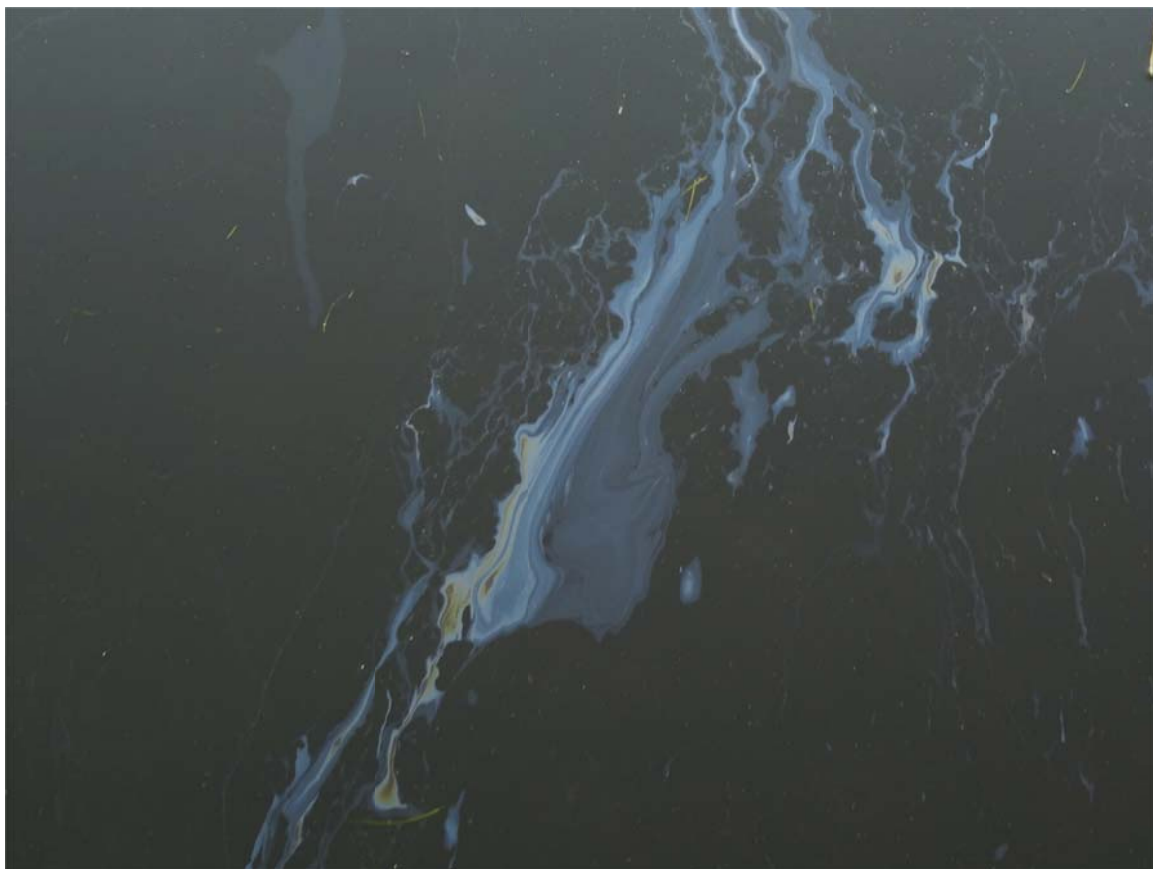
14. MP5.63 RDB sheen and tar globs observed.

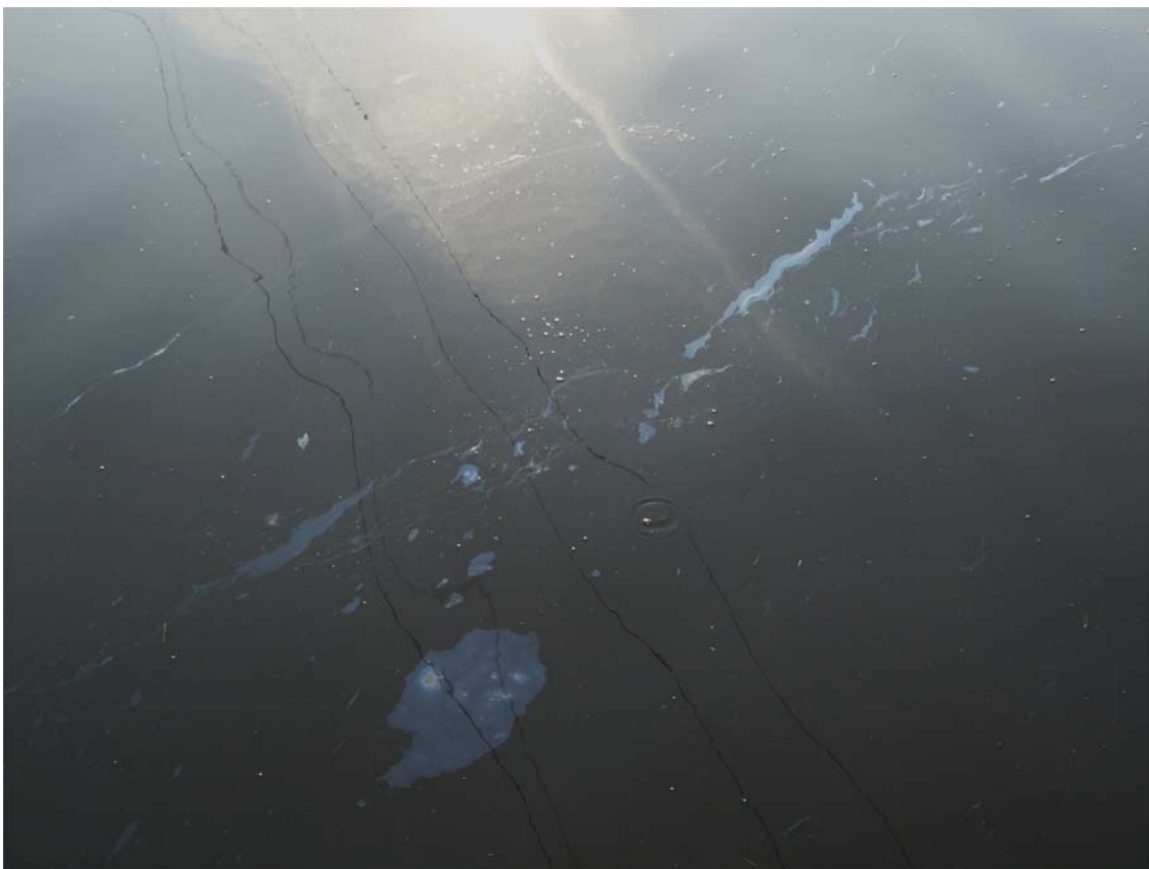
16. MP5.55 RDB observed sheen and tar globs flowing through the railroad trestles.

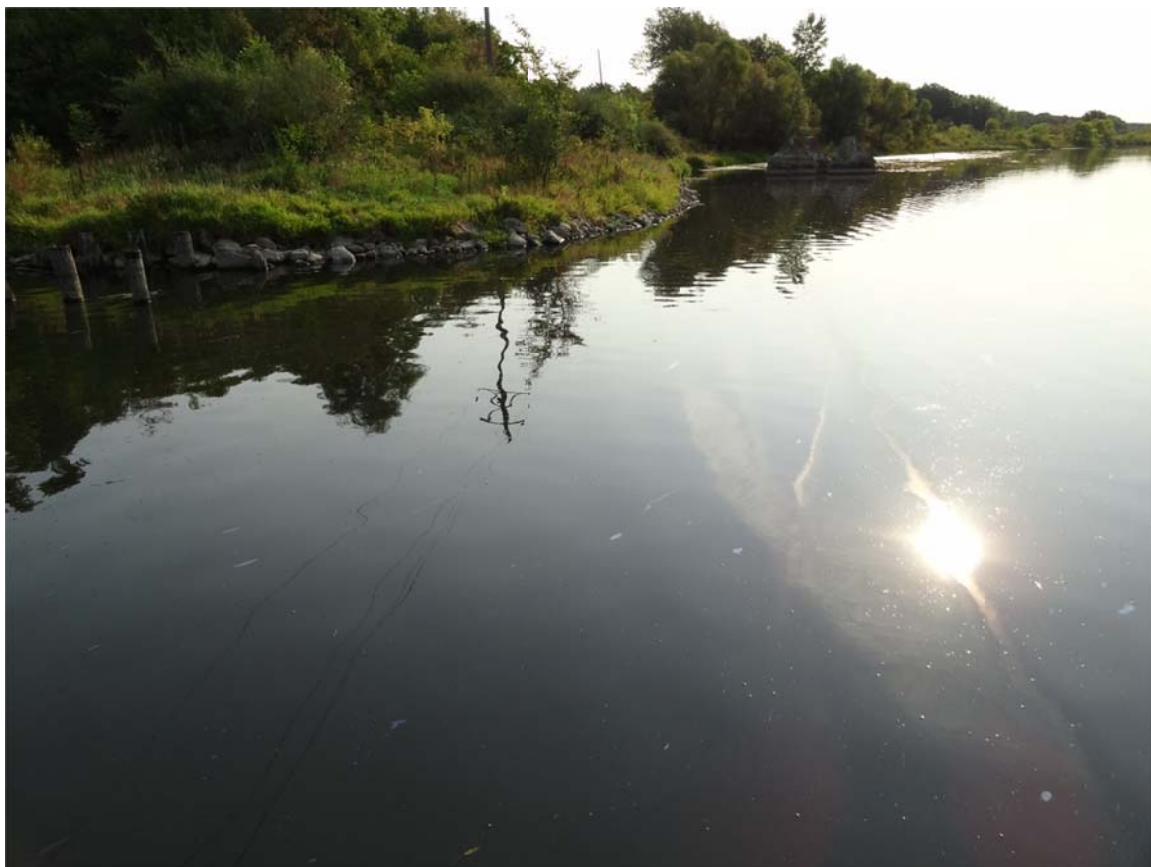
17. MP5.55 RDB observed sheen and tar globs.

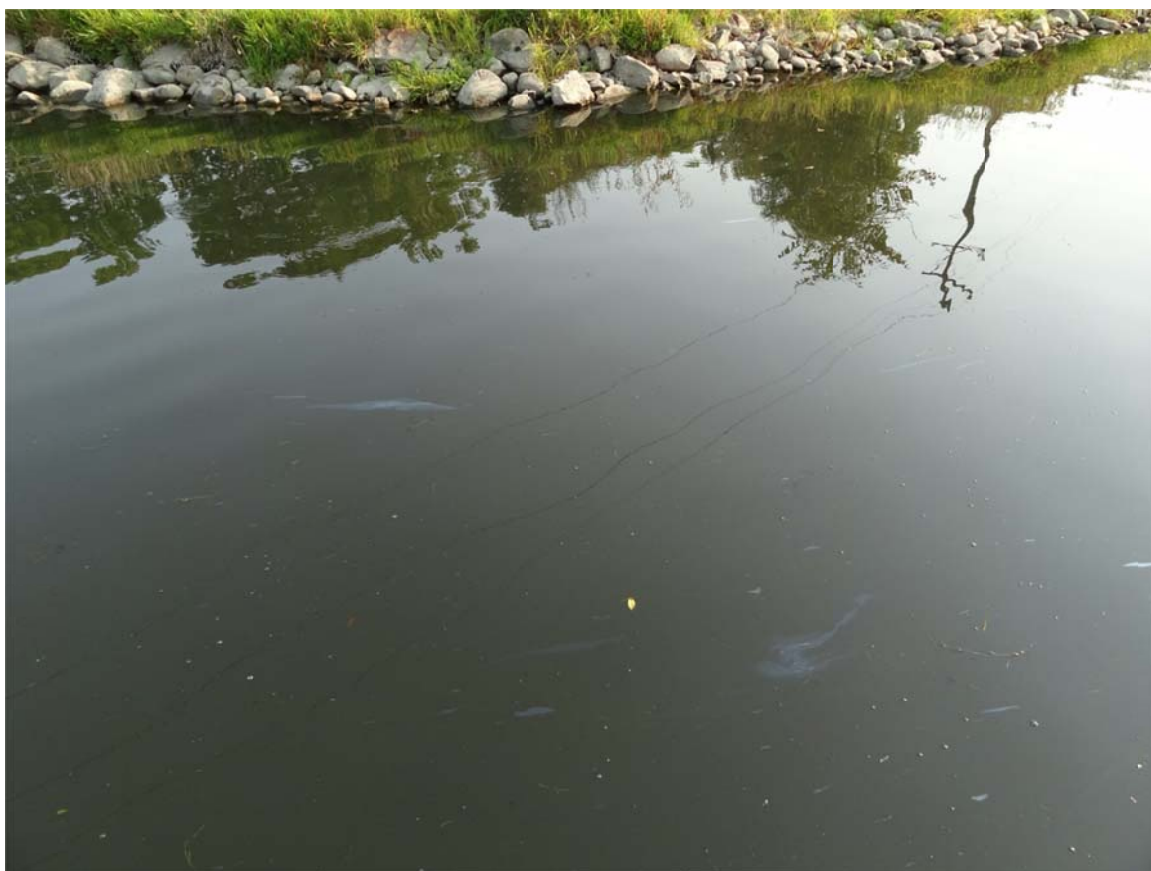
18. MP5.55 RDB observed sheen and tar globs.

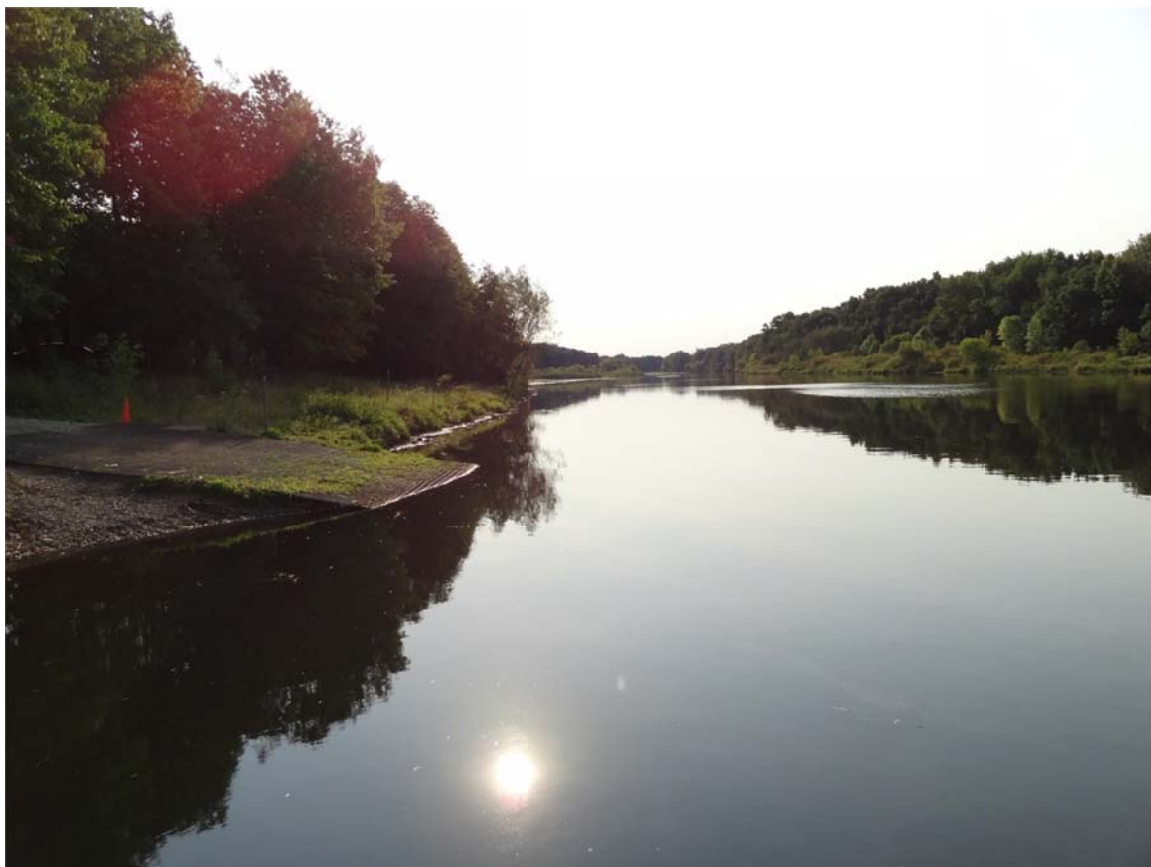
19. MP4.9-MP5.15 RDB area where sheen and tar globs were observed.

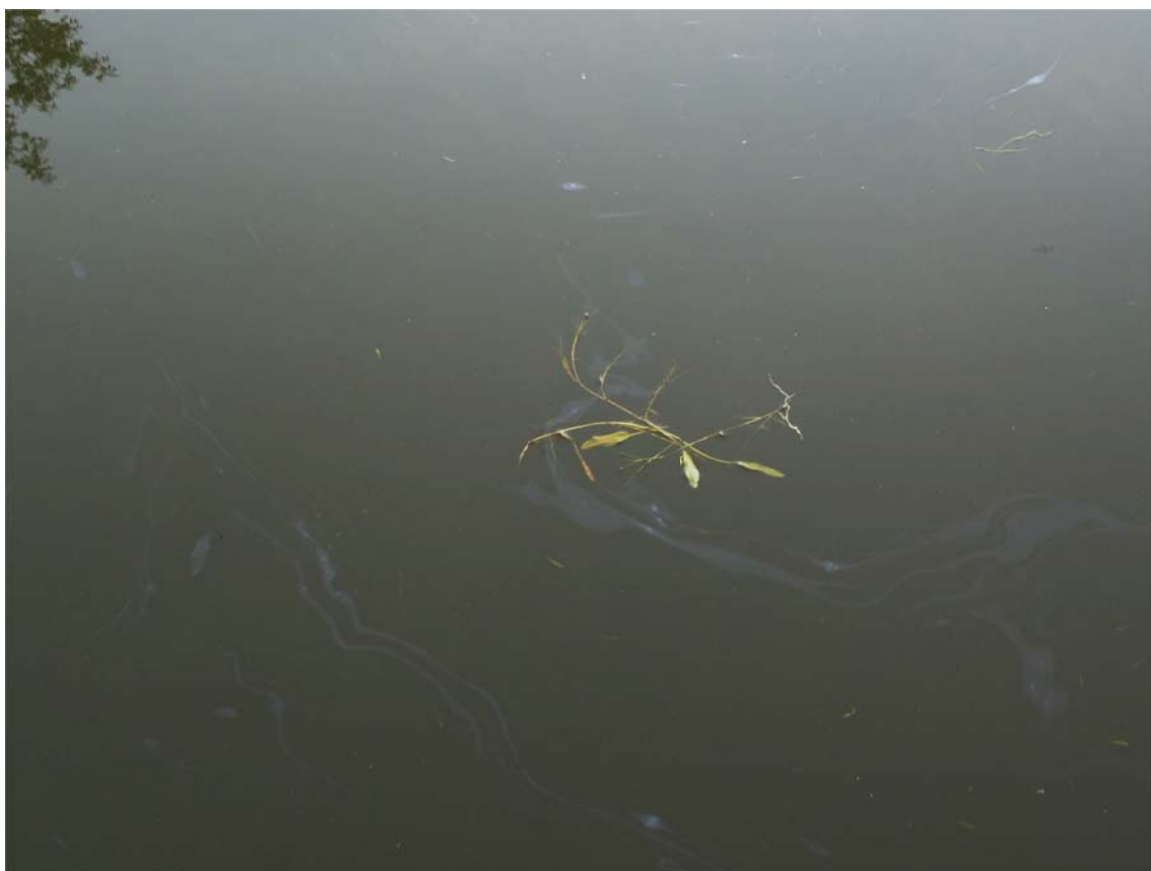
20. MP5.10 RDB sheen observed.

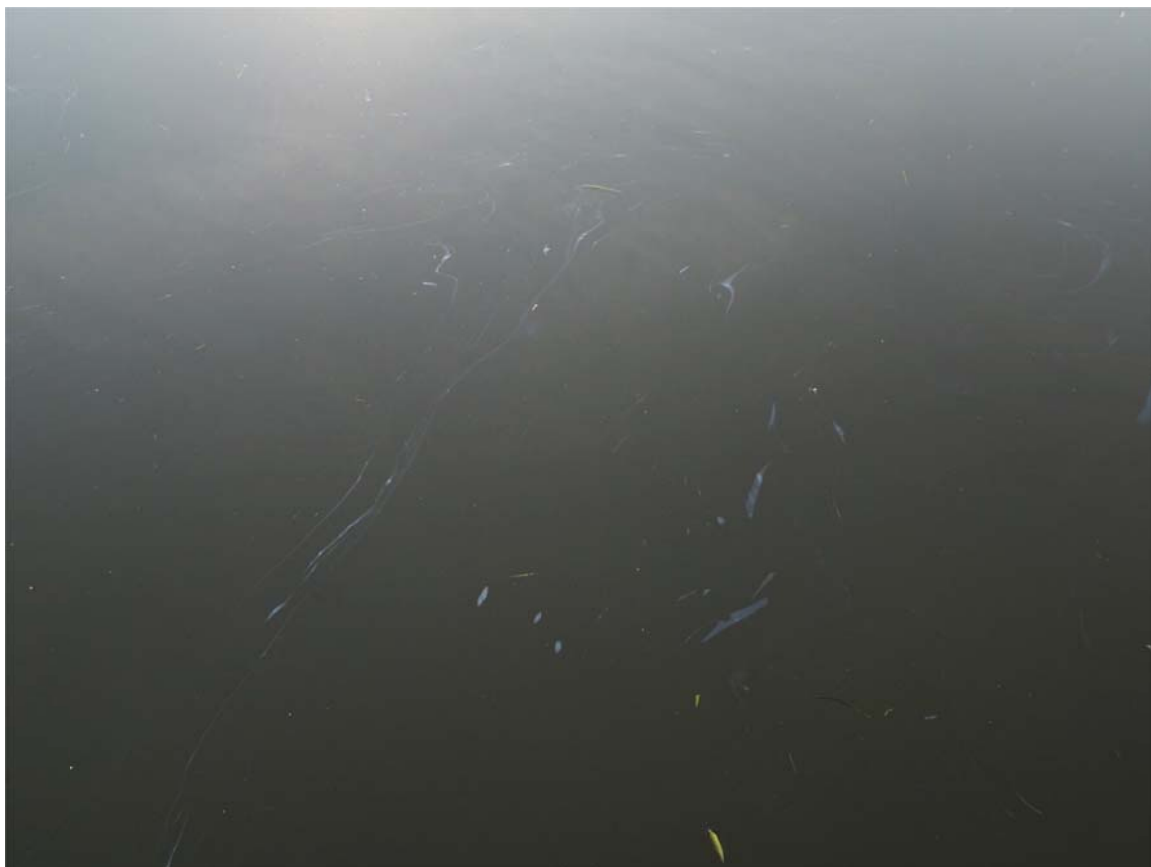
21. MP5.0 RDB observed sheen and tar globs.

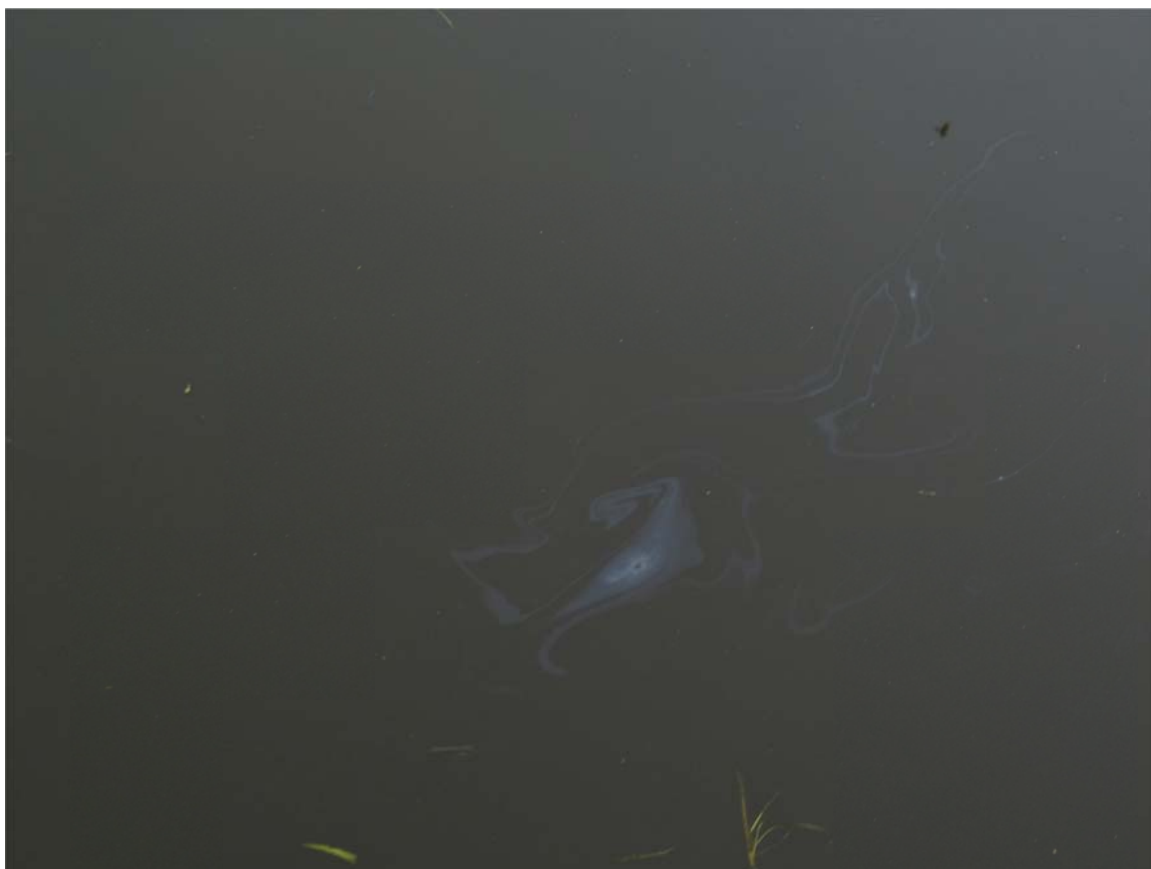
22. MP4.9 RDB observed sheen and tar globs.

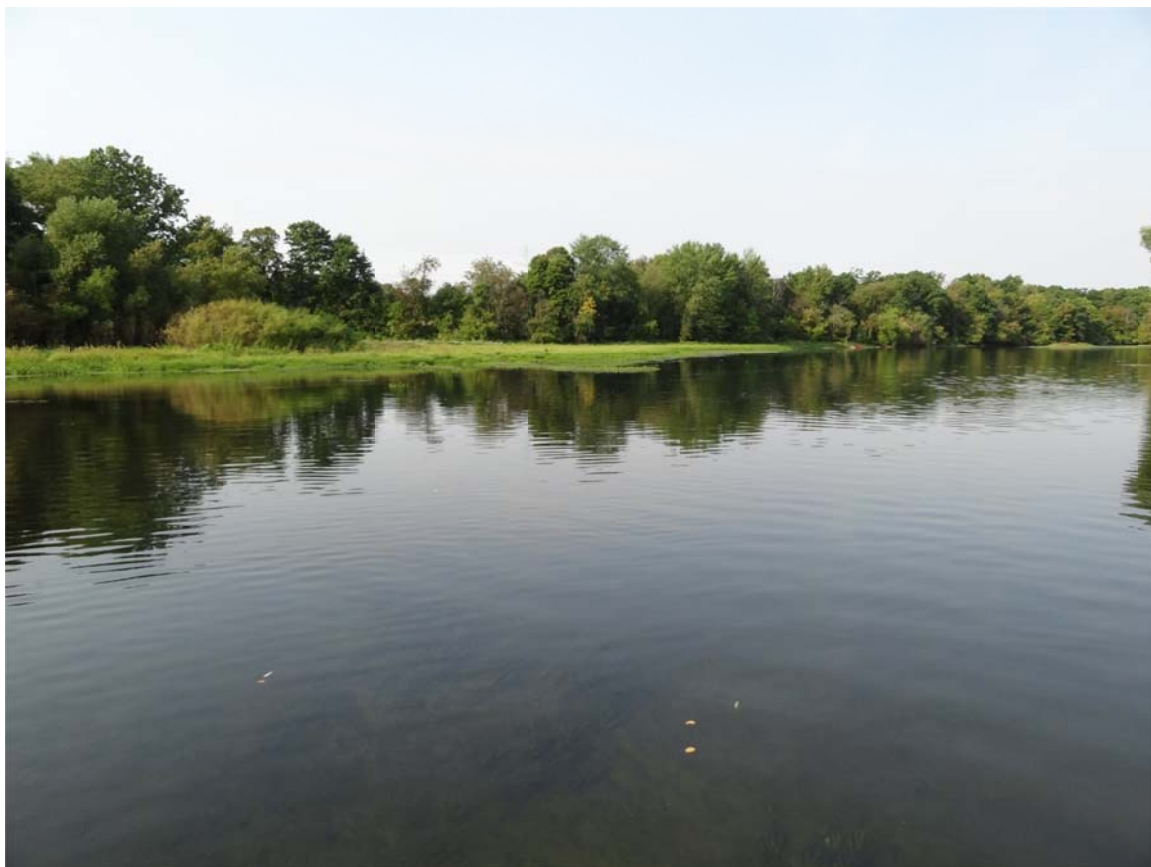
**23. MP4.5 LDB area where sheen was observed.**

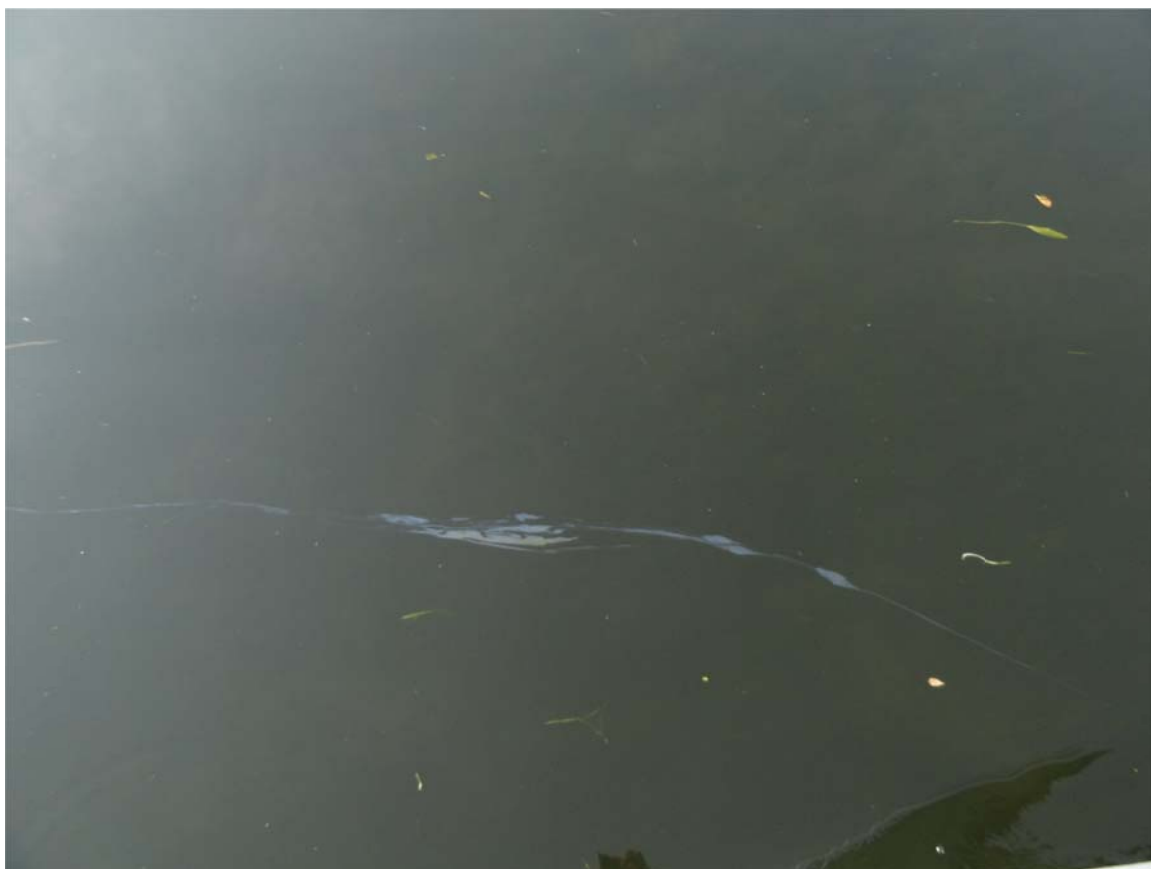
**24. MP4.5 LDB observed sheen and tar globs.**
