# Situation Photo Log

Monday, September 17, 2012

Kalamazoo River / Enbridge Spill

Prepared by:  
Matthew Haak  
START-USEPA  
Situation Unit Leader

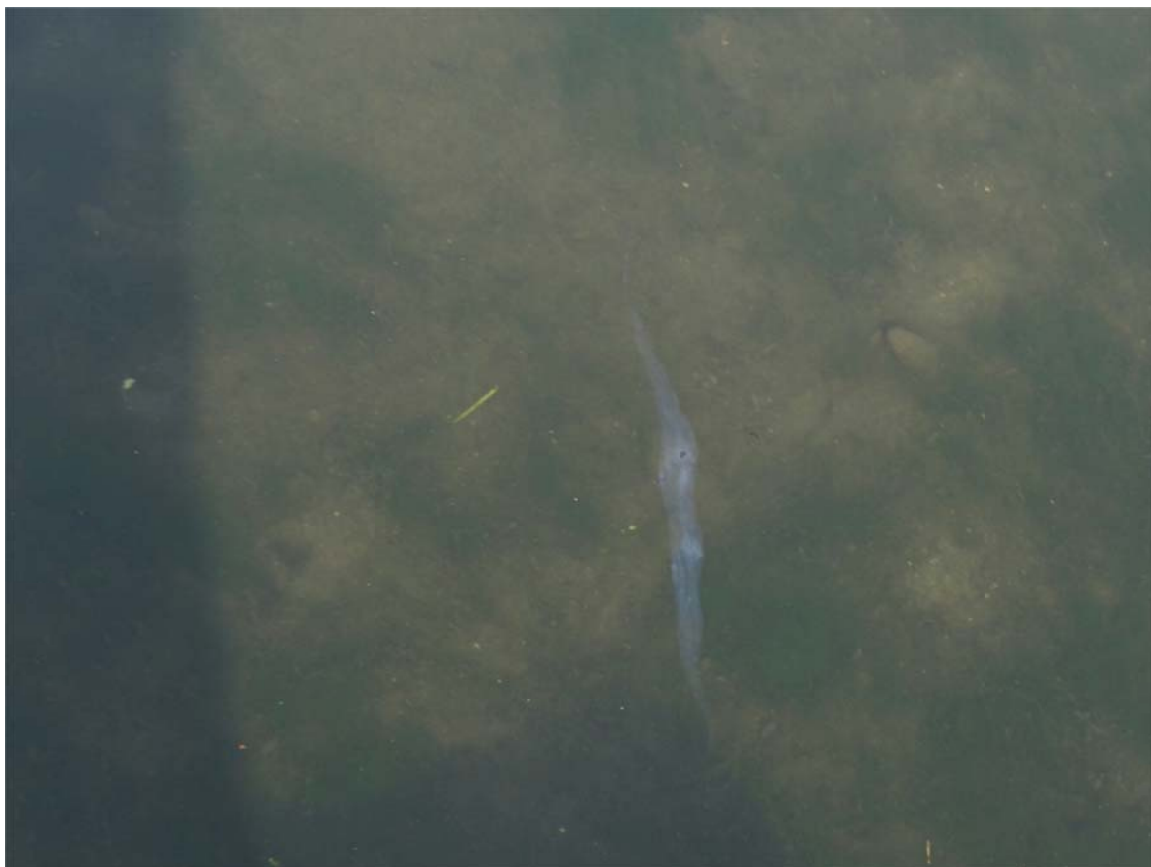
25. MP4.5 LDB observed sheen and tar globs.

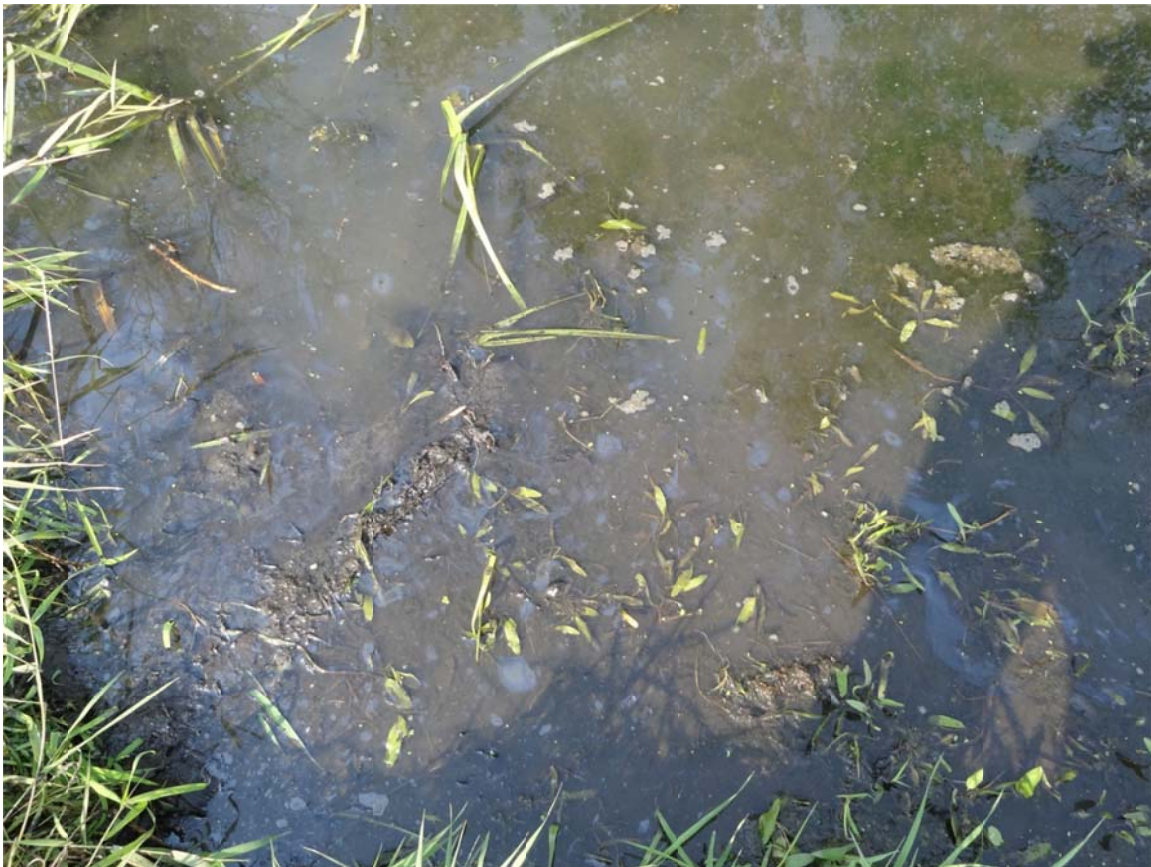
27. MP10.75 observed sheen and tar globs.

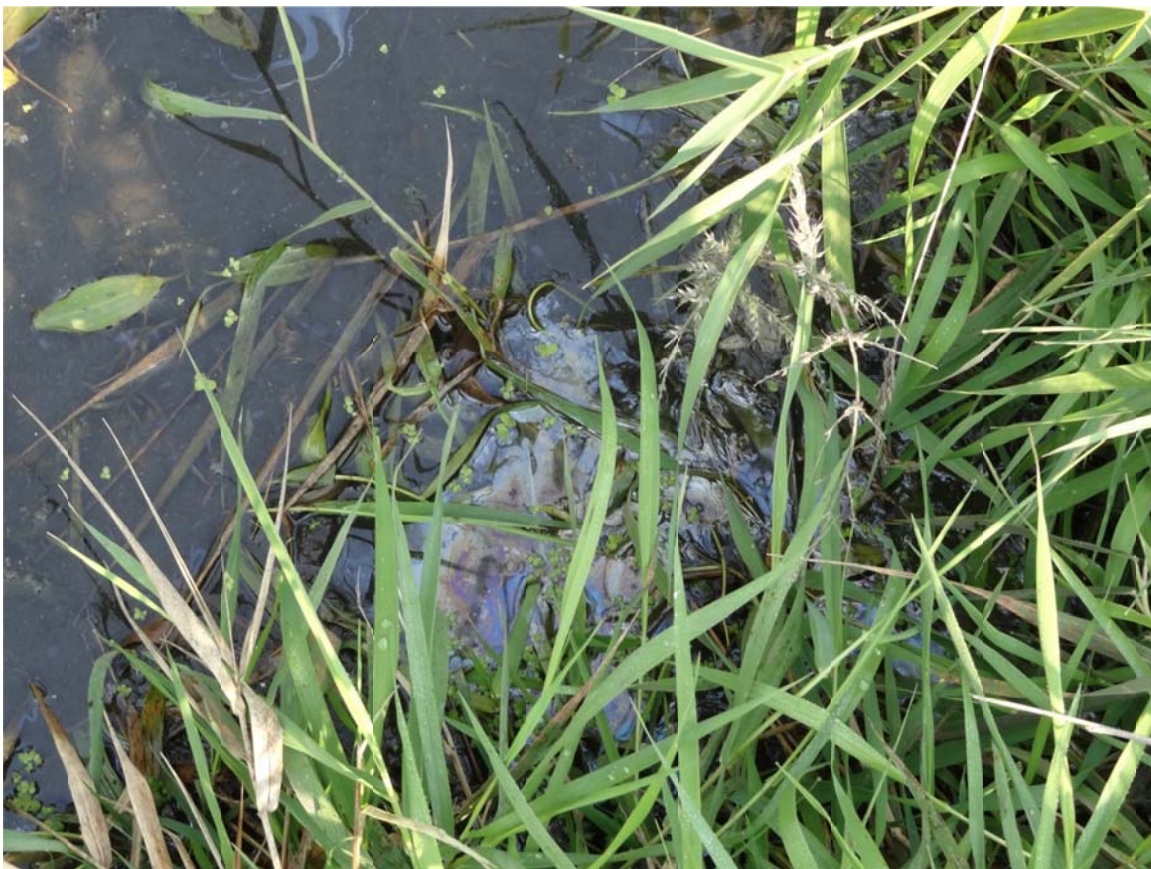
28. MP10.75 observed sheen and tar globs.

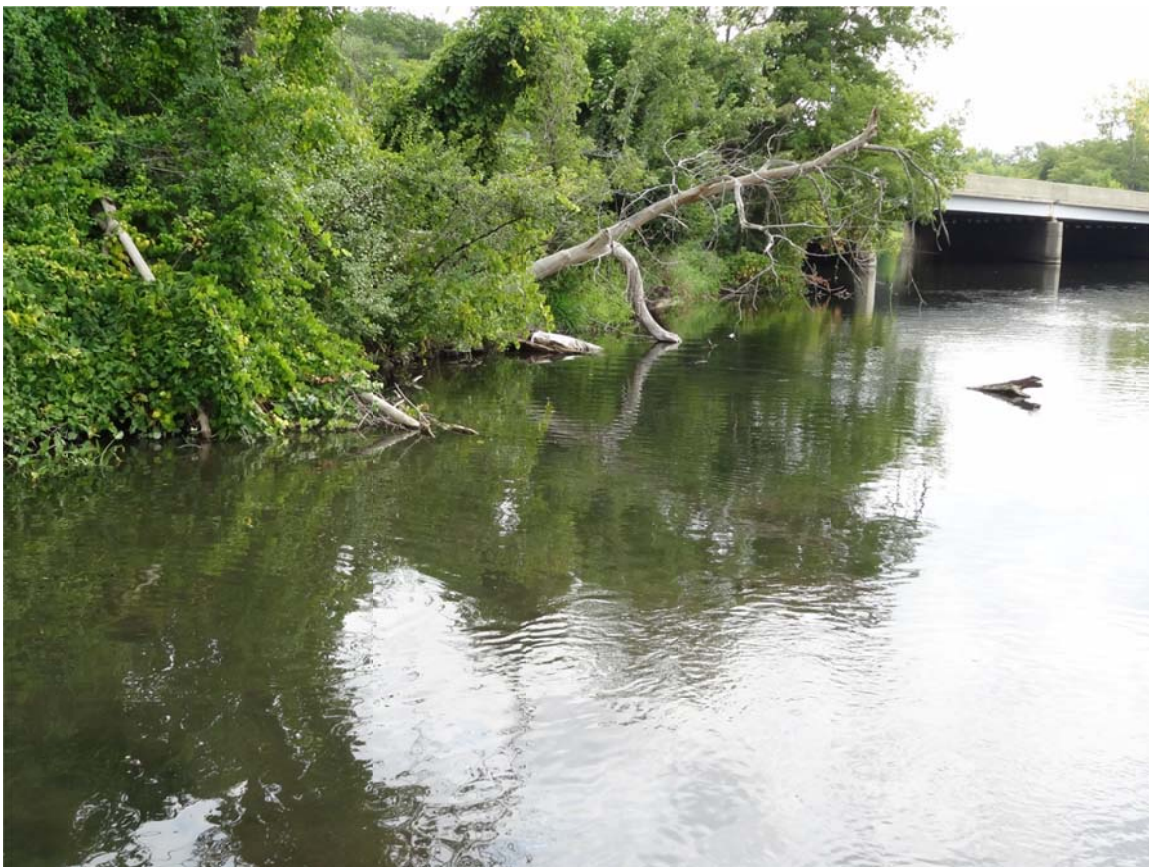
30. MP15.0 RDB area where the boat agitated the sediment, heavy sheen was observed.

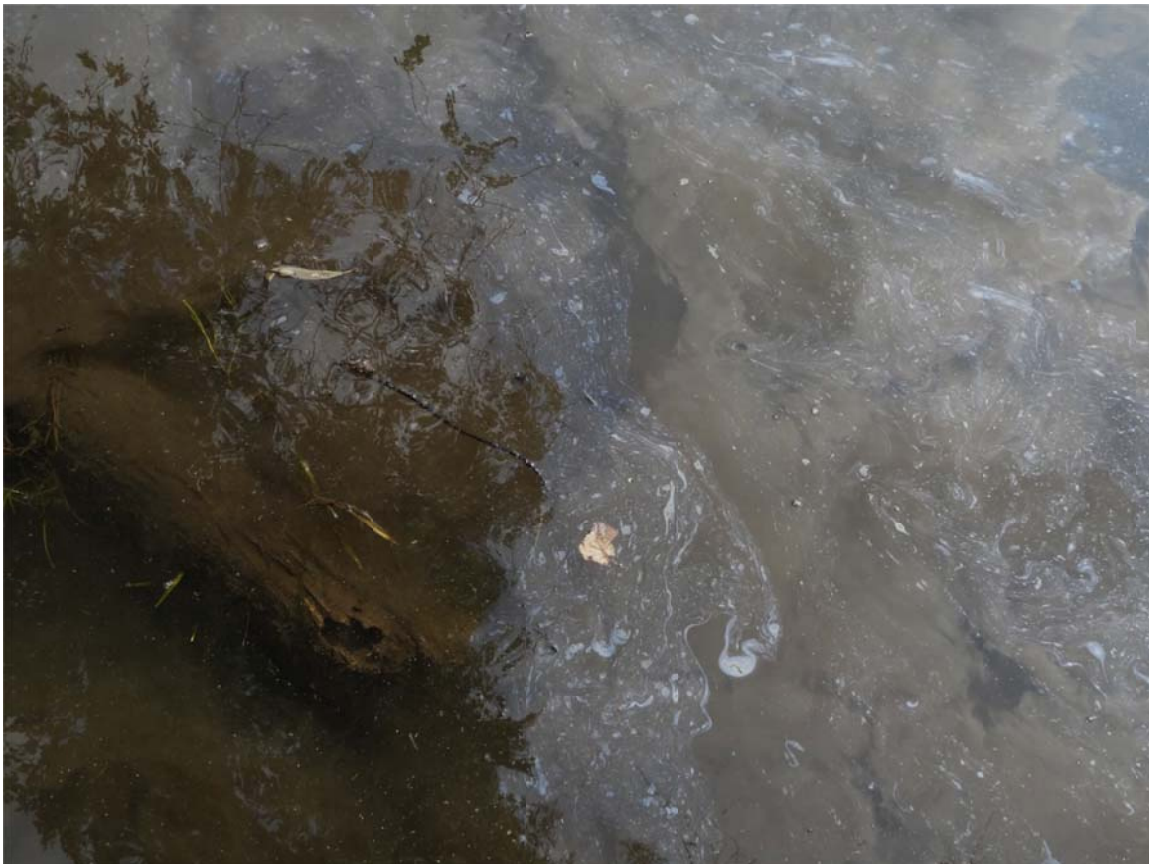
**31. MP15.0 RDB area where the boat agitated the sediment, heavy sheen was observed.**

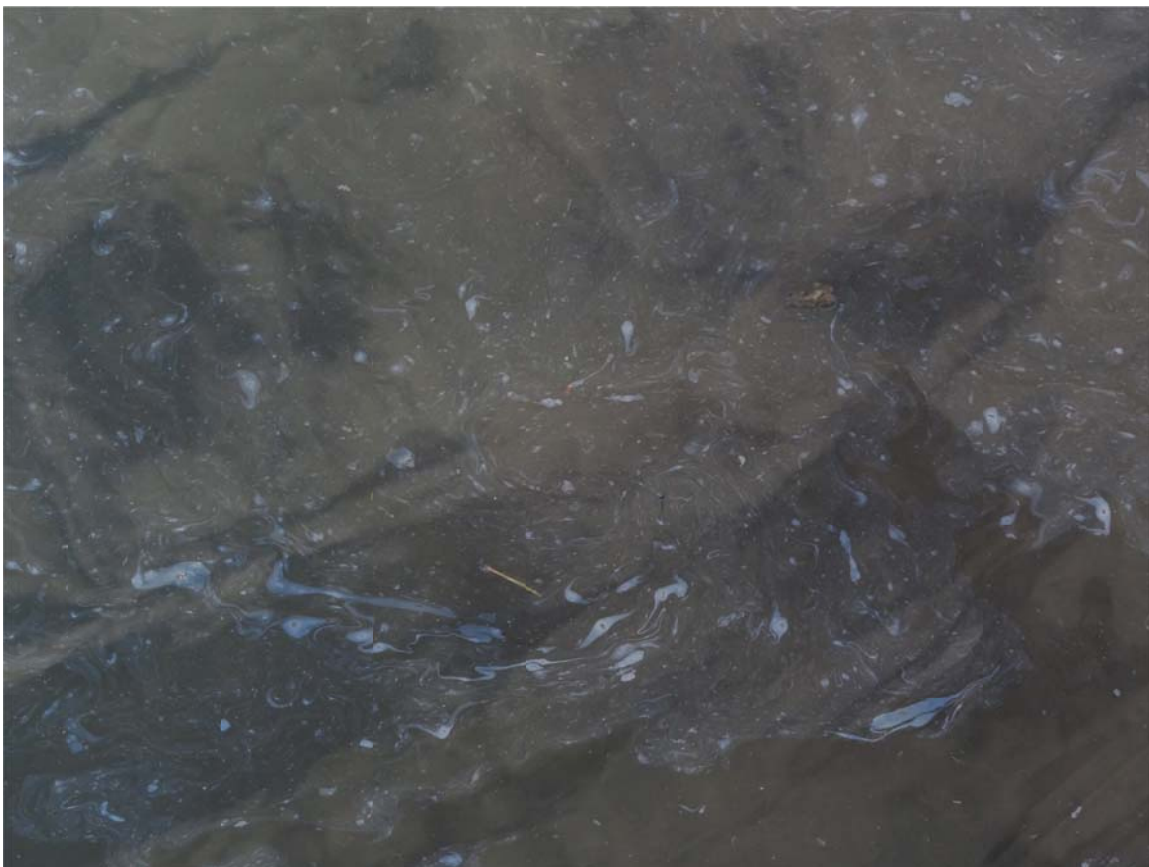
**32. MP15.0 RDB area where the boat agitated the sediment, heavy sheen was observed.**

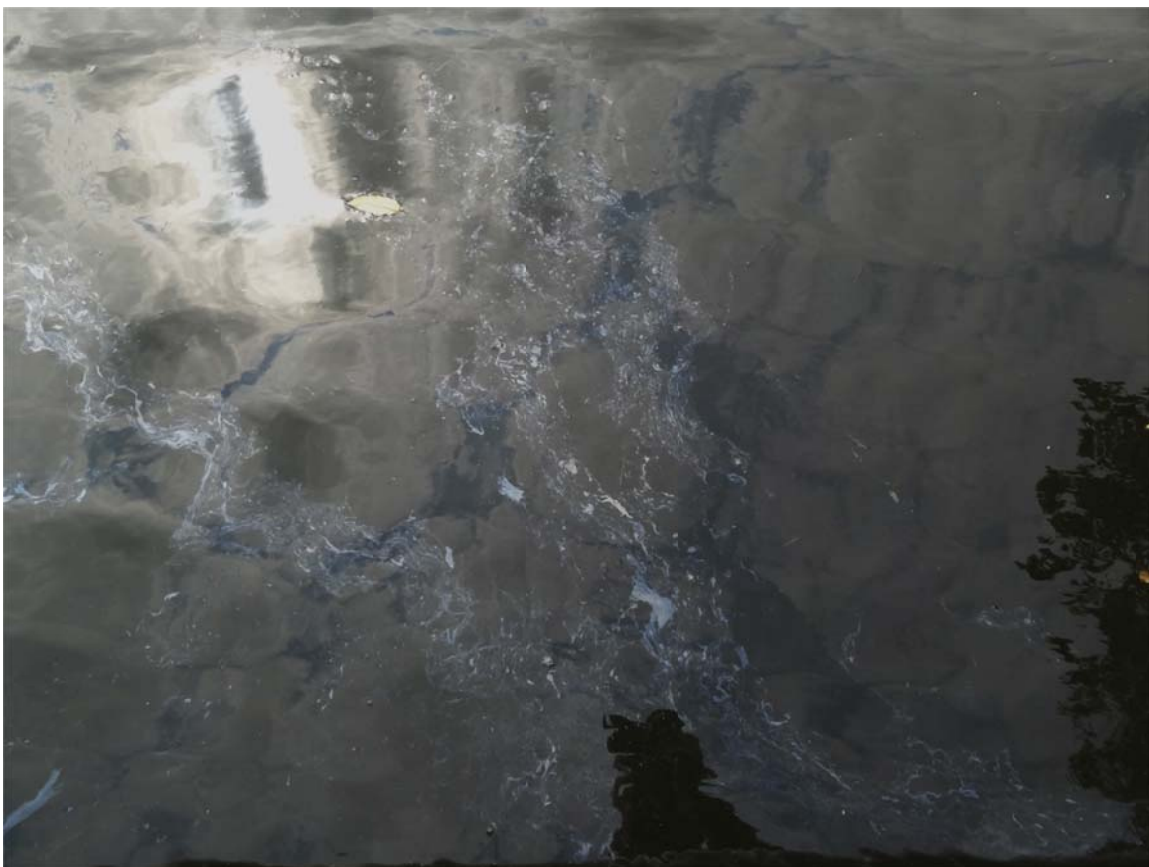
33. MP15.5LDB boat agitated the sediment heavy sheen was observed.

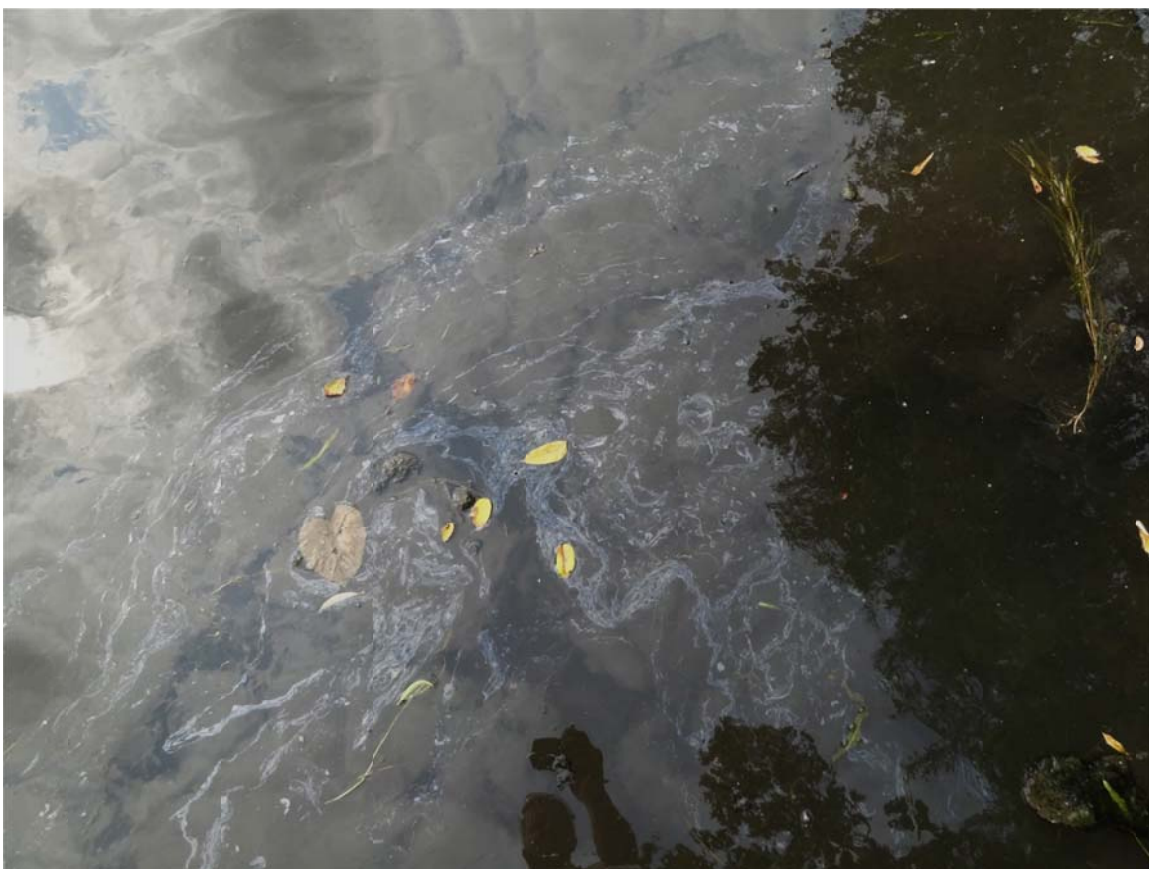
34. MP15.5LDB boat agitated the sediment heavy sheen was observed.

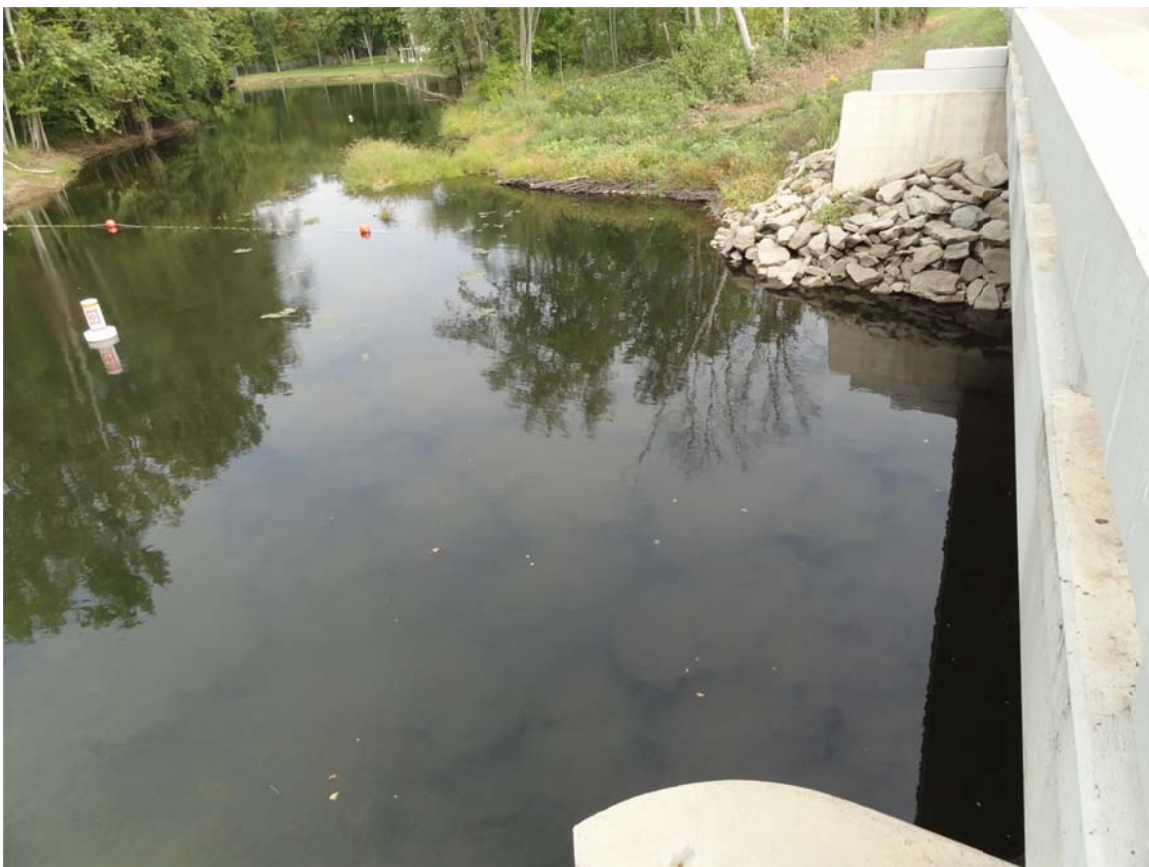
35. MP21.5 RDB Custer Drive Bridge sheen was observed.

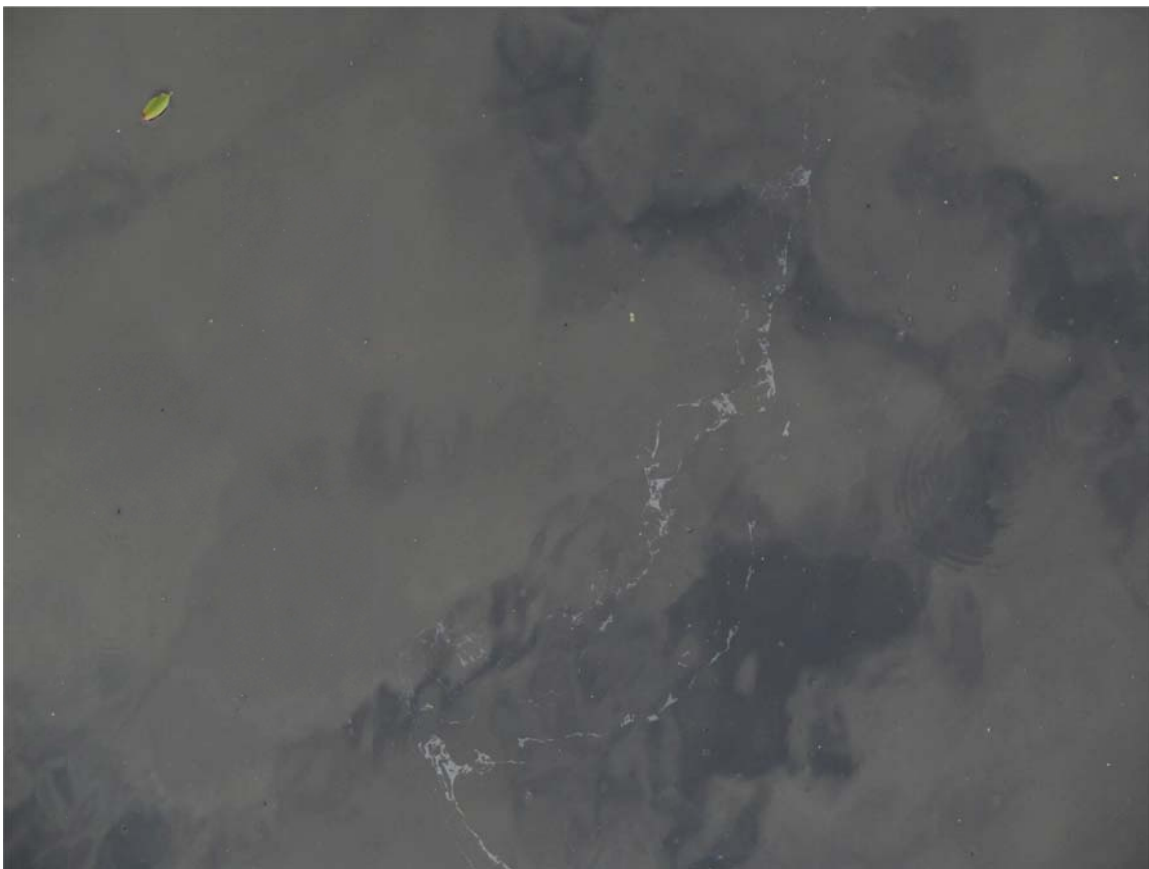
36. MP21.5 RDB Custer Drive Bridge sheen was observed.

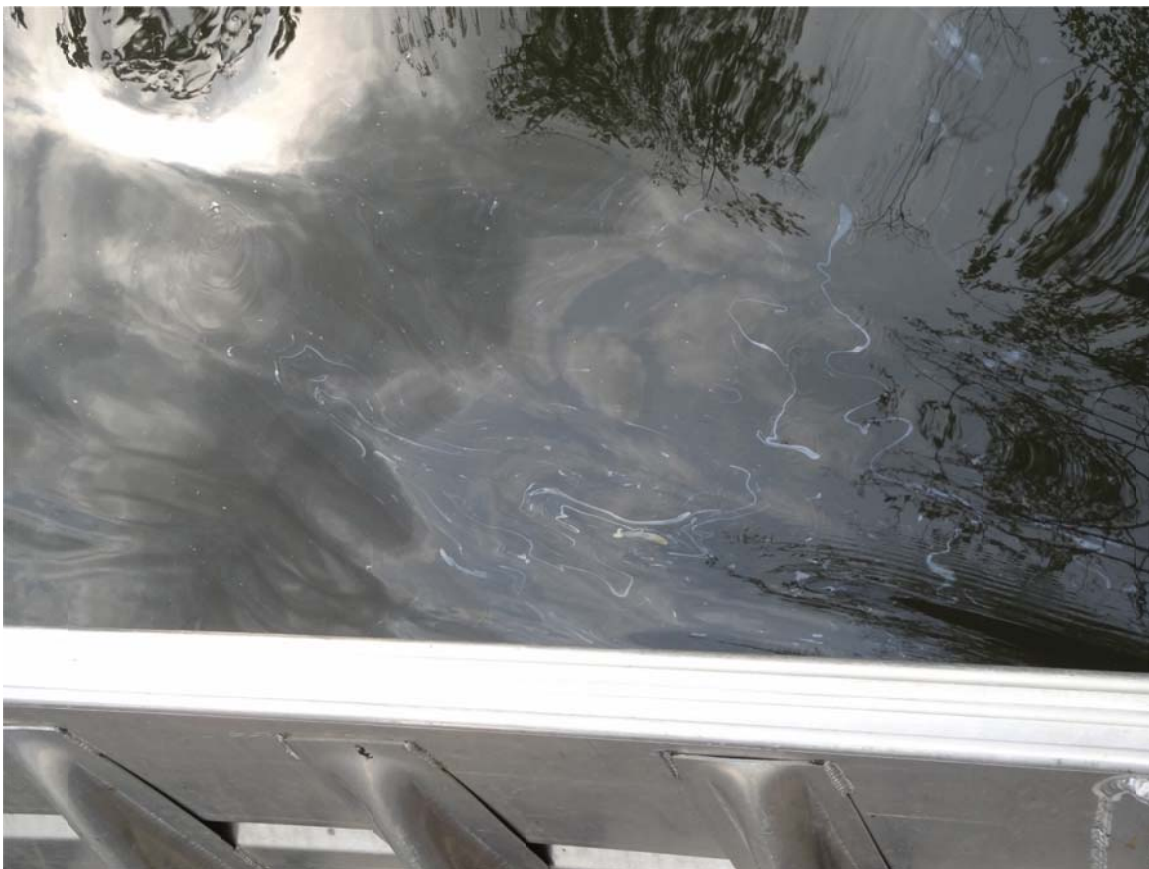
38. MP28.25 observed sheen and tar globs.

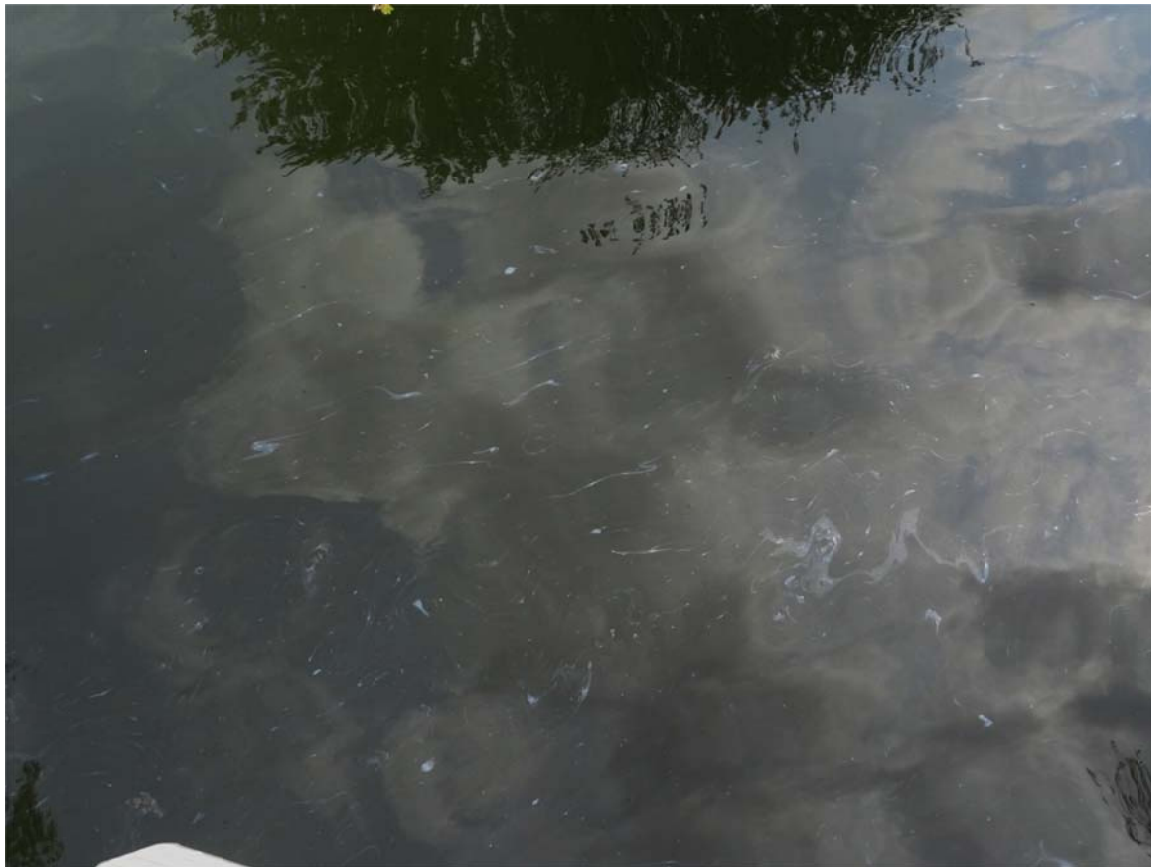
39. MP28.25 observed sheen and tar globs.

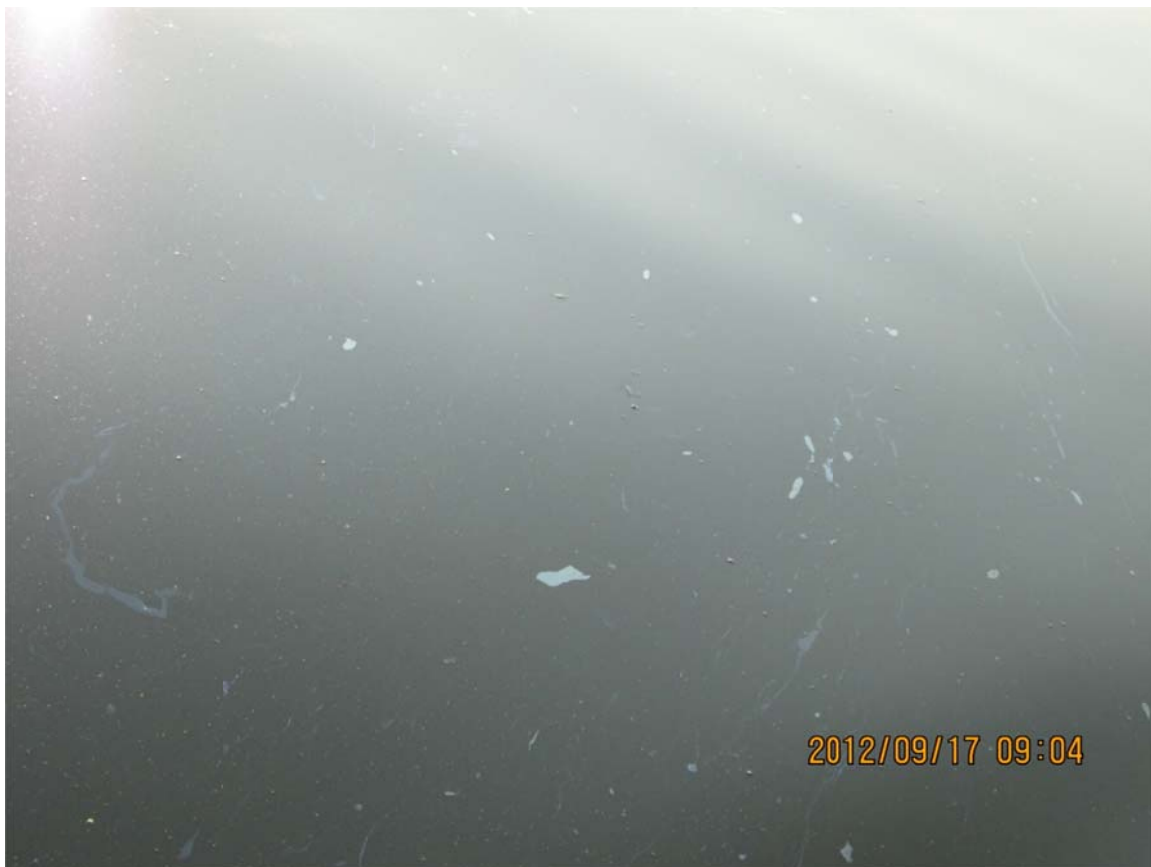
43. Morrow Lake west of Rowe Island sheen and tar globs observed.

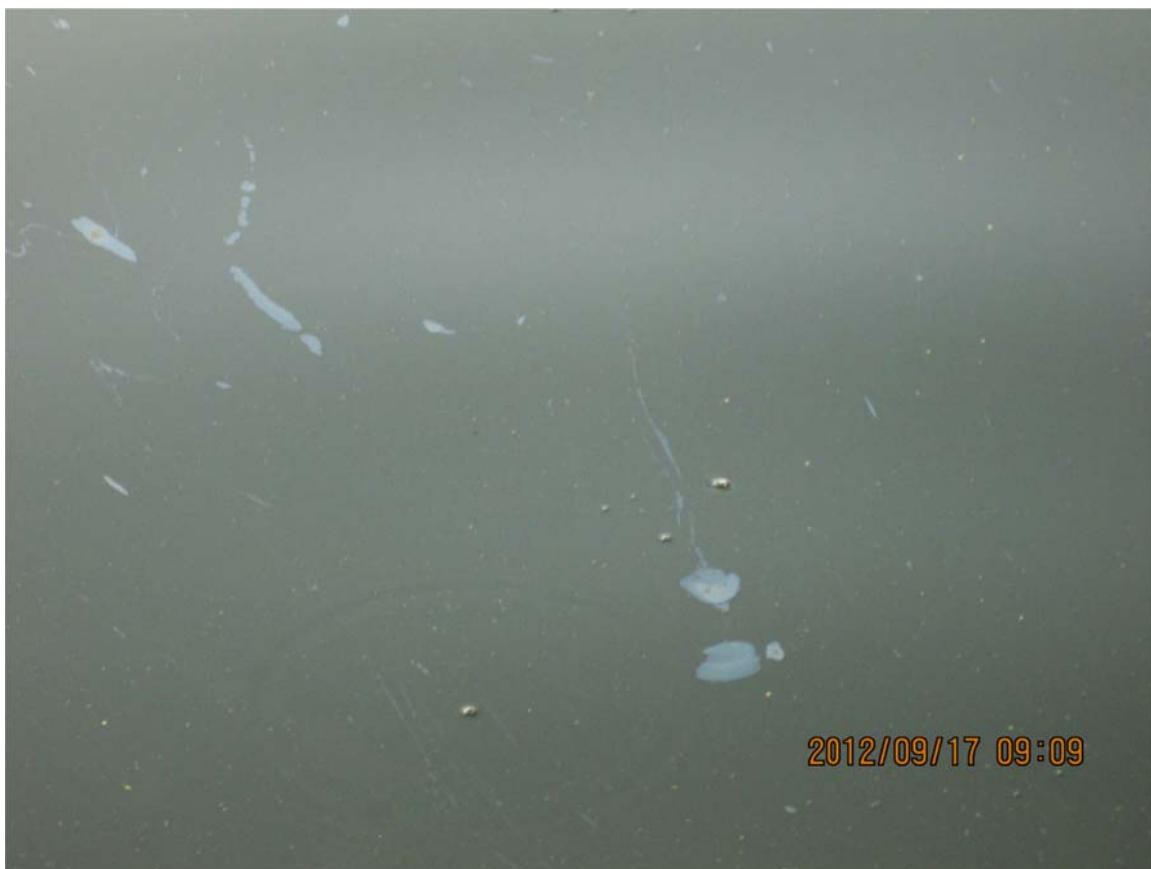
44. Morrow Lake between MP38.25 – MP38.5 north shore sheen and tar globs observed.

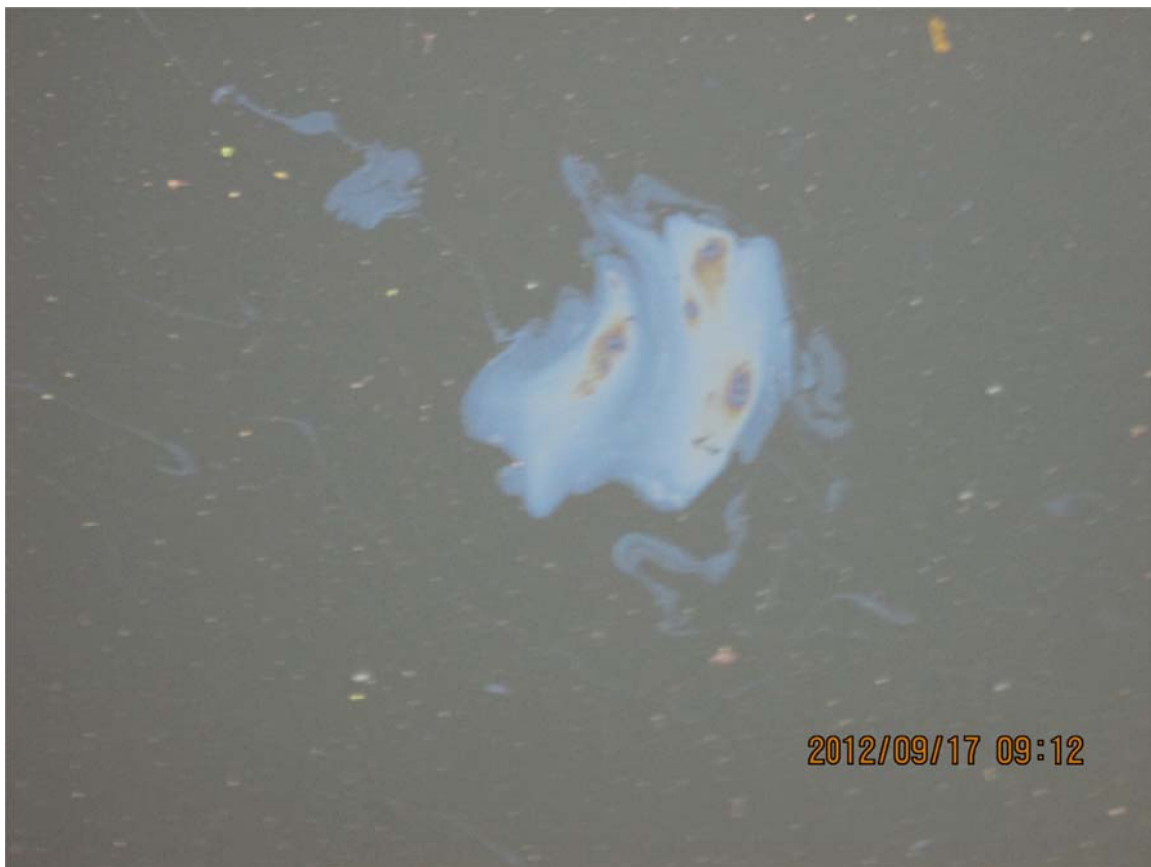
45. Morrow Lake between MP38.25 – MP38.5 north shore sheen and tar globs observed.

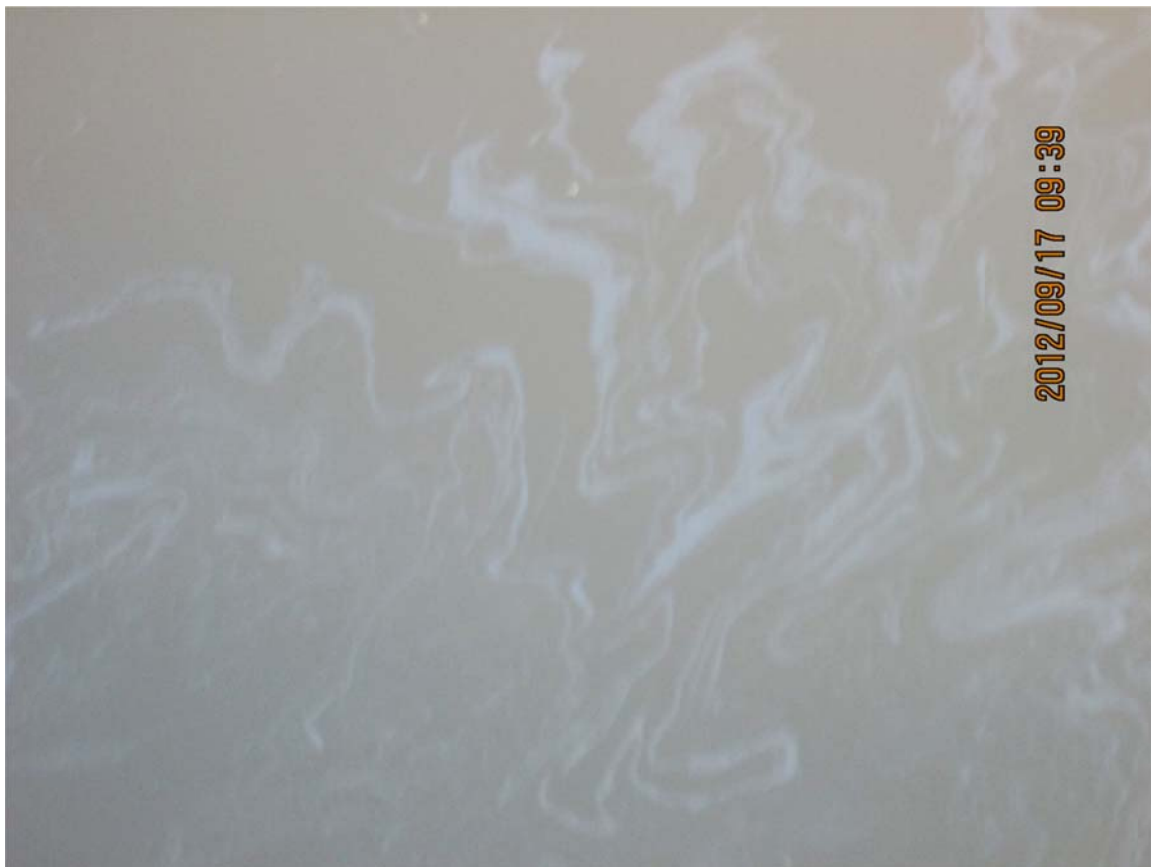
46. Morrow Lake southern cove sheen and tar globs observed.

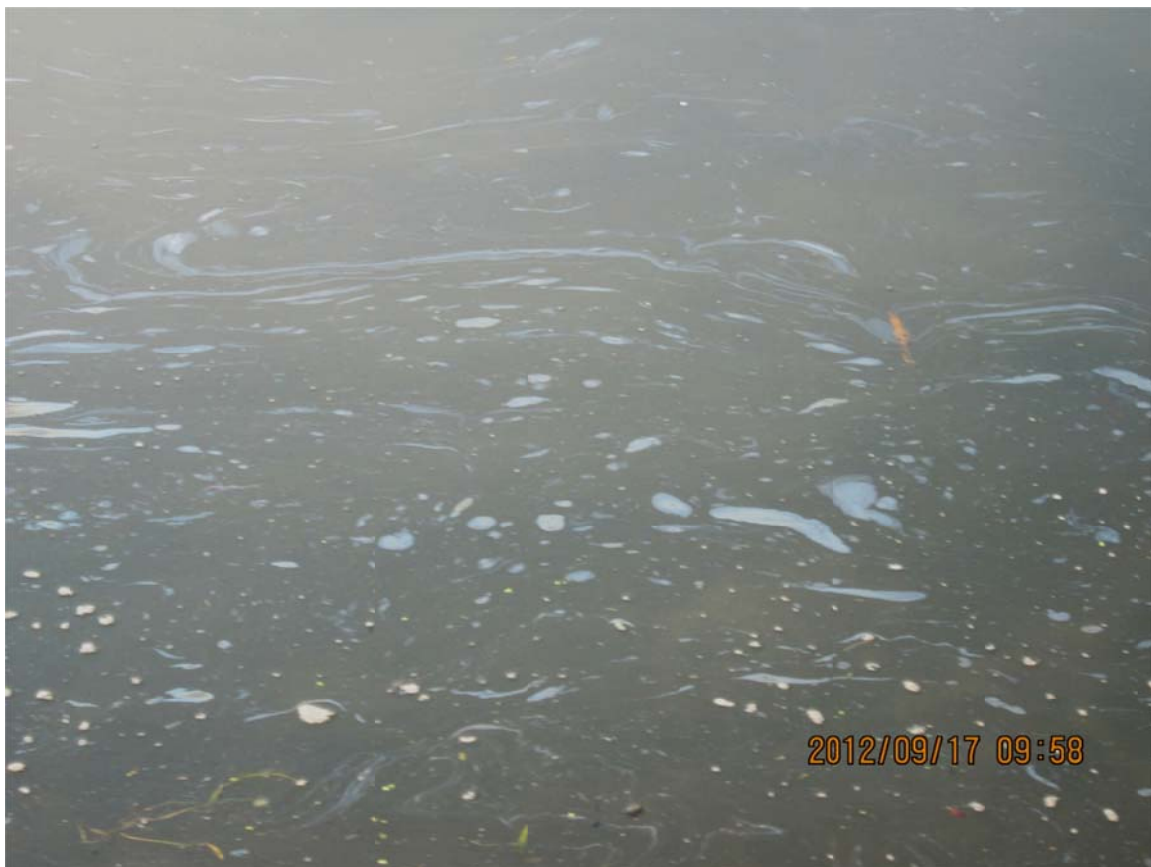
47. Morrow Lake Delta Boom C sheen and tar globs observed collecting along the boom.

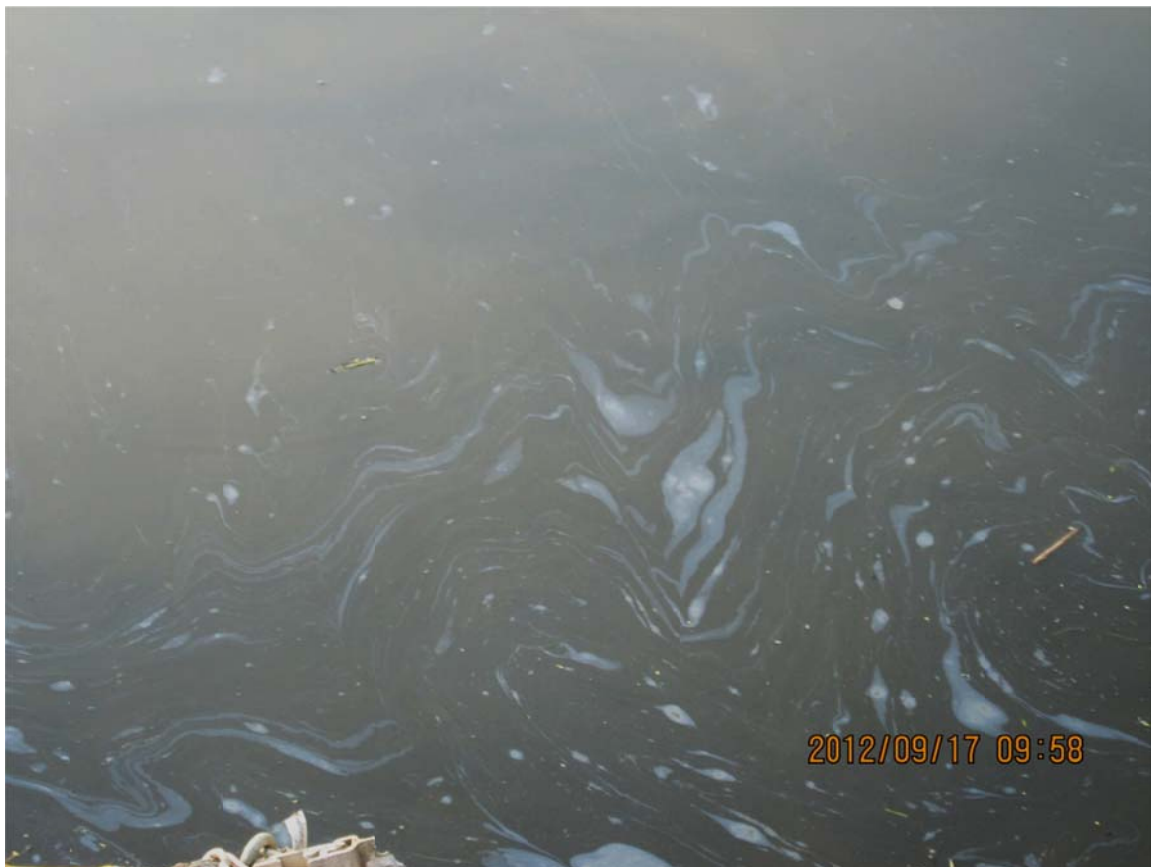
48. Morrow Lake Delta Boom C sheen and tar globs observed collecting along the boom.

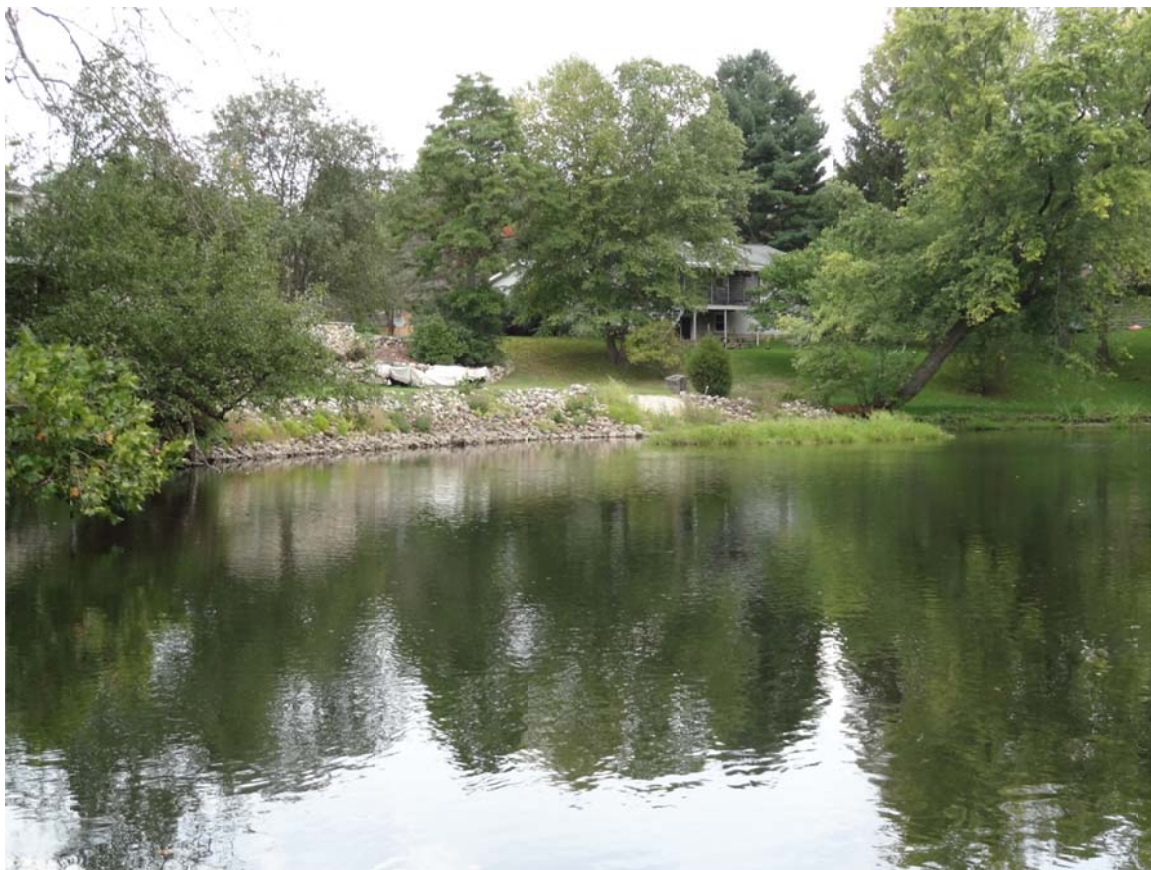
49. MP23.1 RDB sheen and tar globs observed.

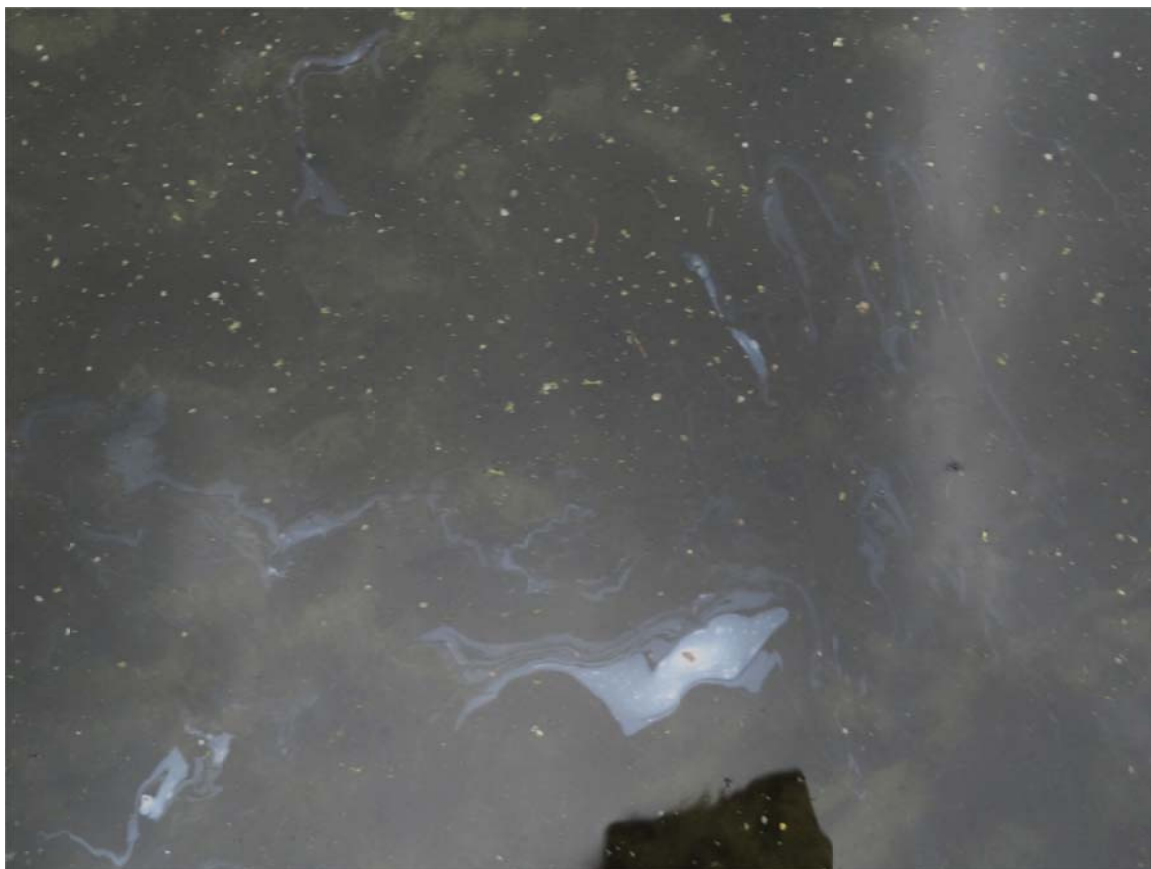
50. MP23.1 RDB sheen and tar globs observed.
