# Situation Photo Log

Tuesday, September 18, 2012

Kalamazoo River / Enbridge Spill

Prepared by:  
Matthew Haak  
START-USEPA  
Situation Unit Leader

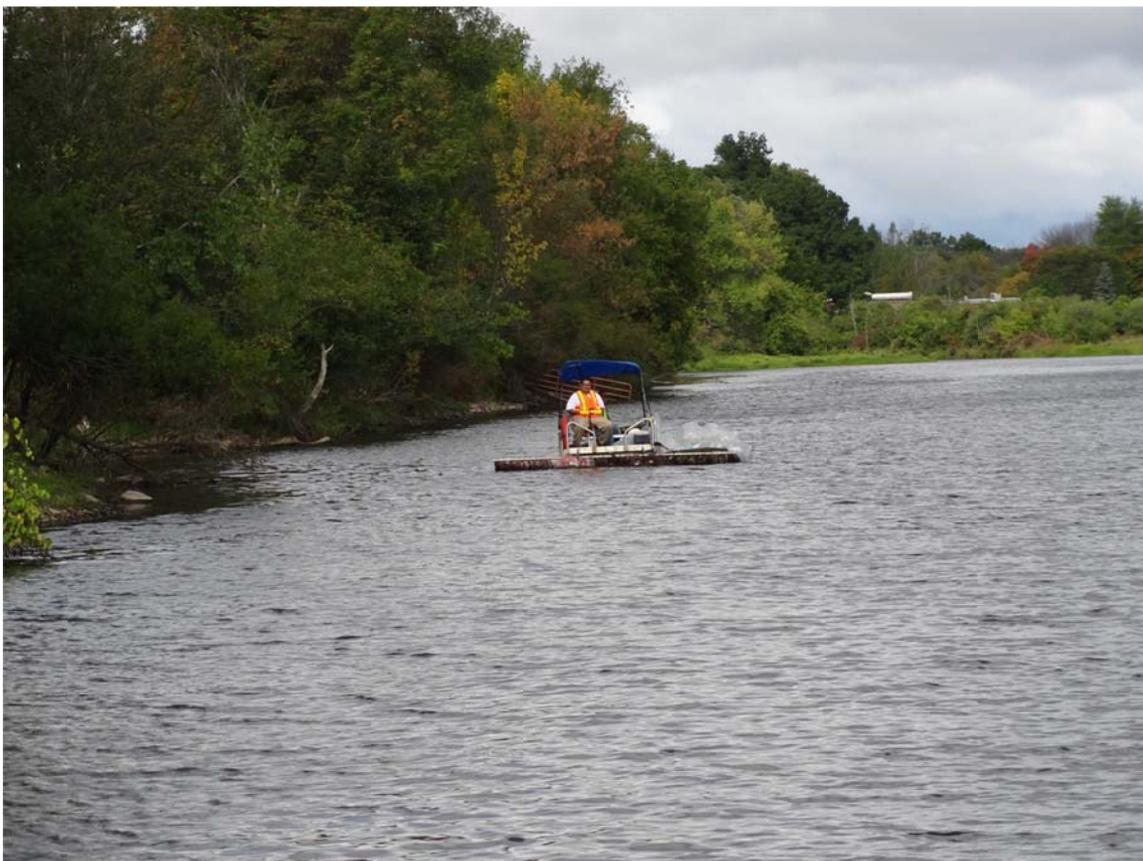
1. Observed the boom maintenance/sweep boat returning from the Ceresco Dam control point boom.

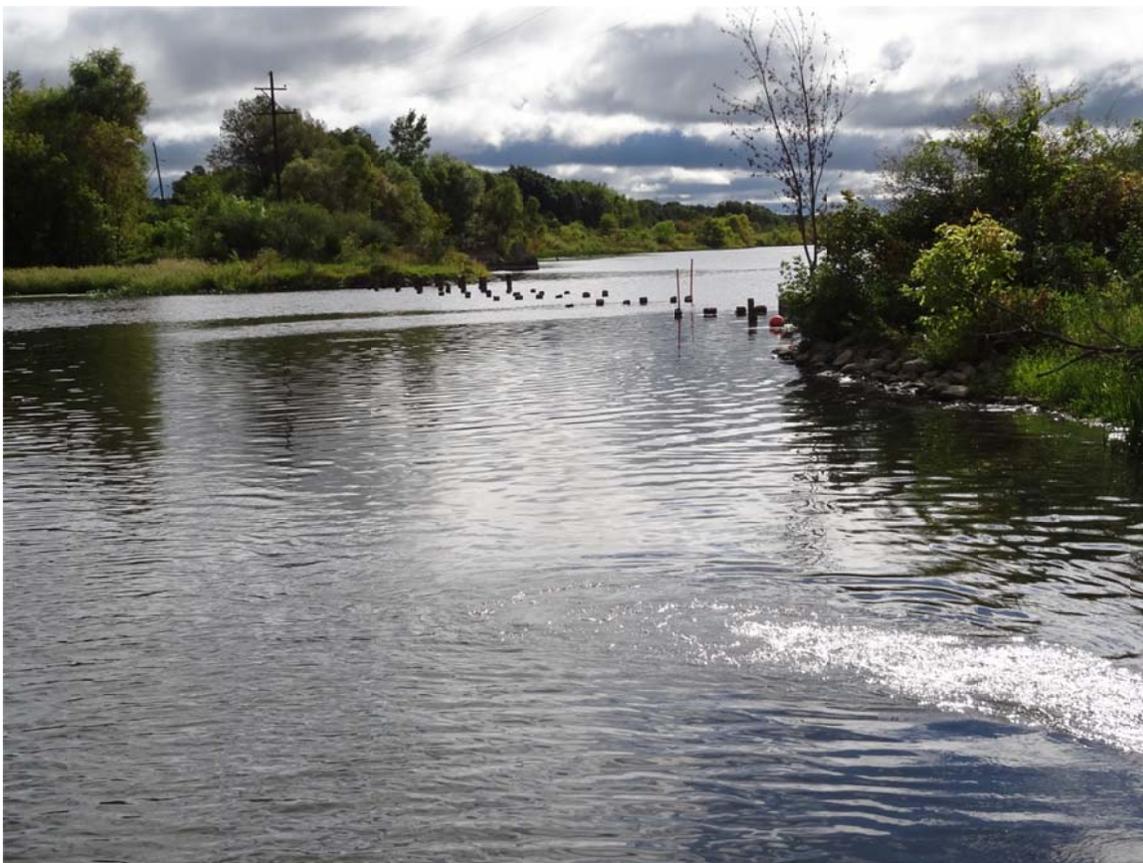
2. MP5.63 LDB area where sheen and tar globs were observed.

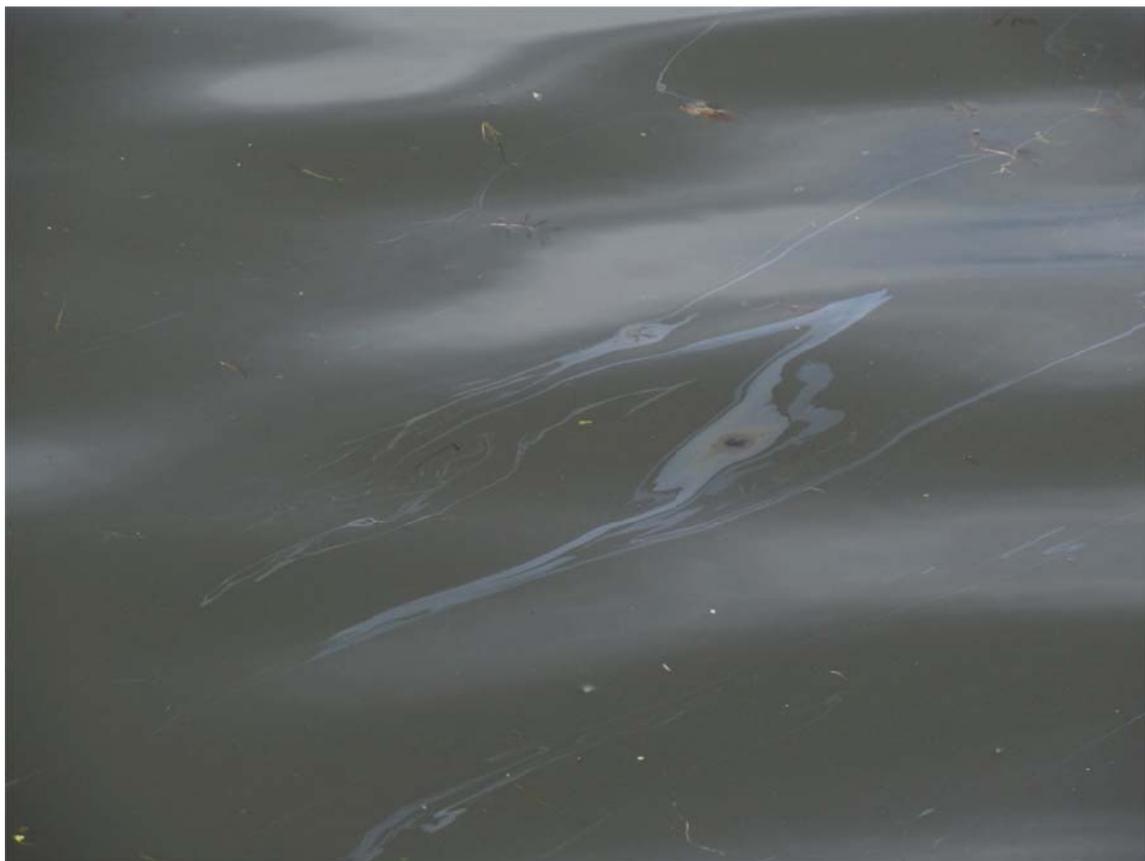
3. MP5.63 LDB observed sheen and tar globs.

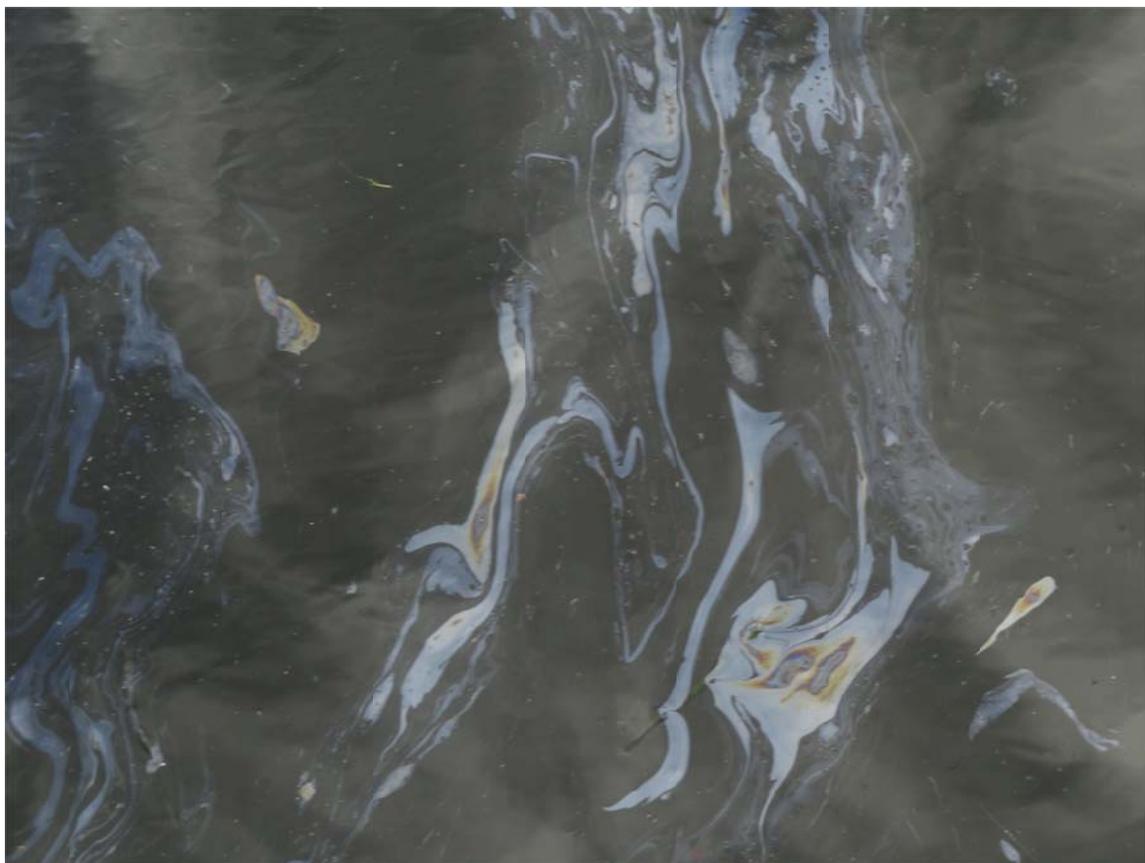
4. MP5.63 LDB observed sheen and tar globs.

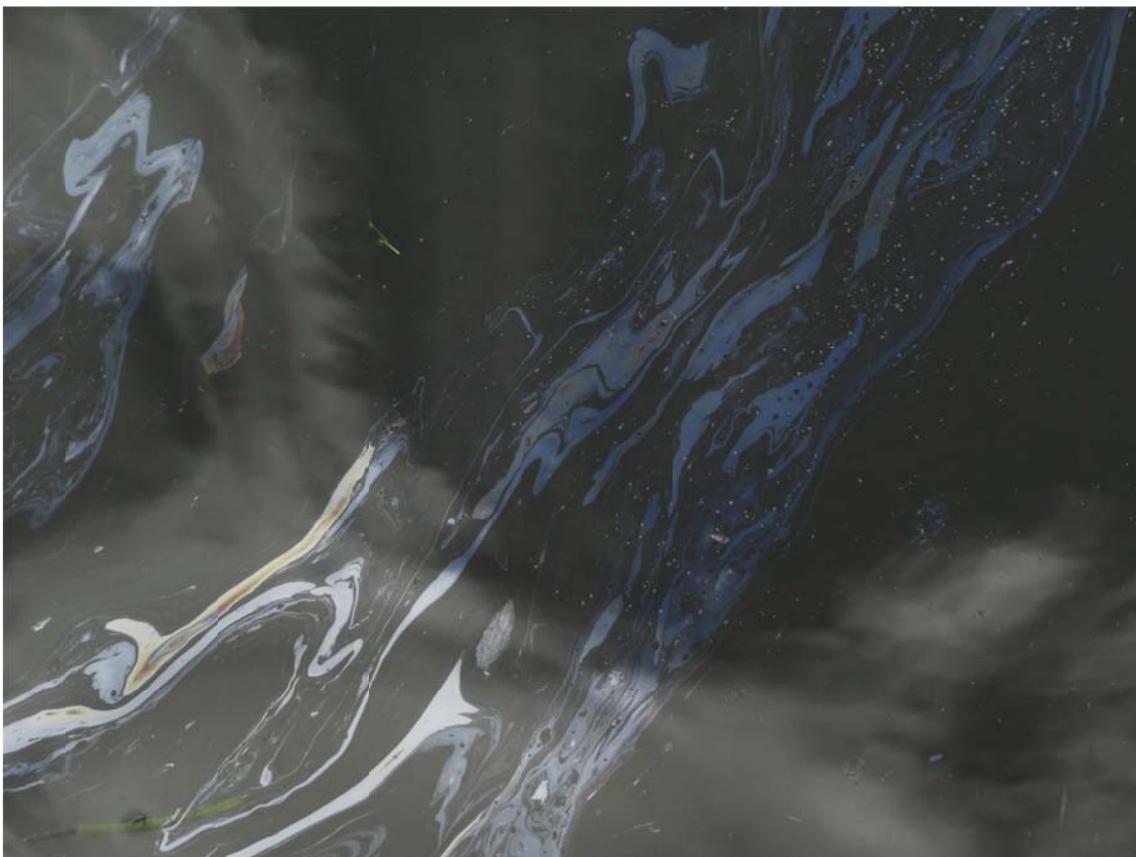
5. MP5.63 LDB observed sheen and tar globs.

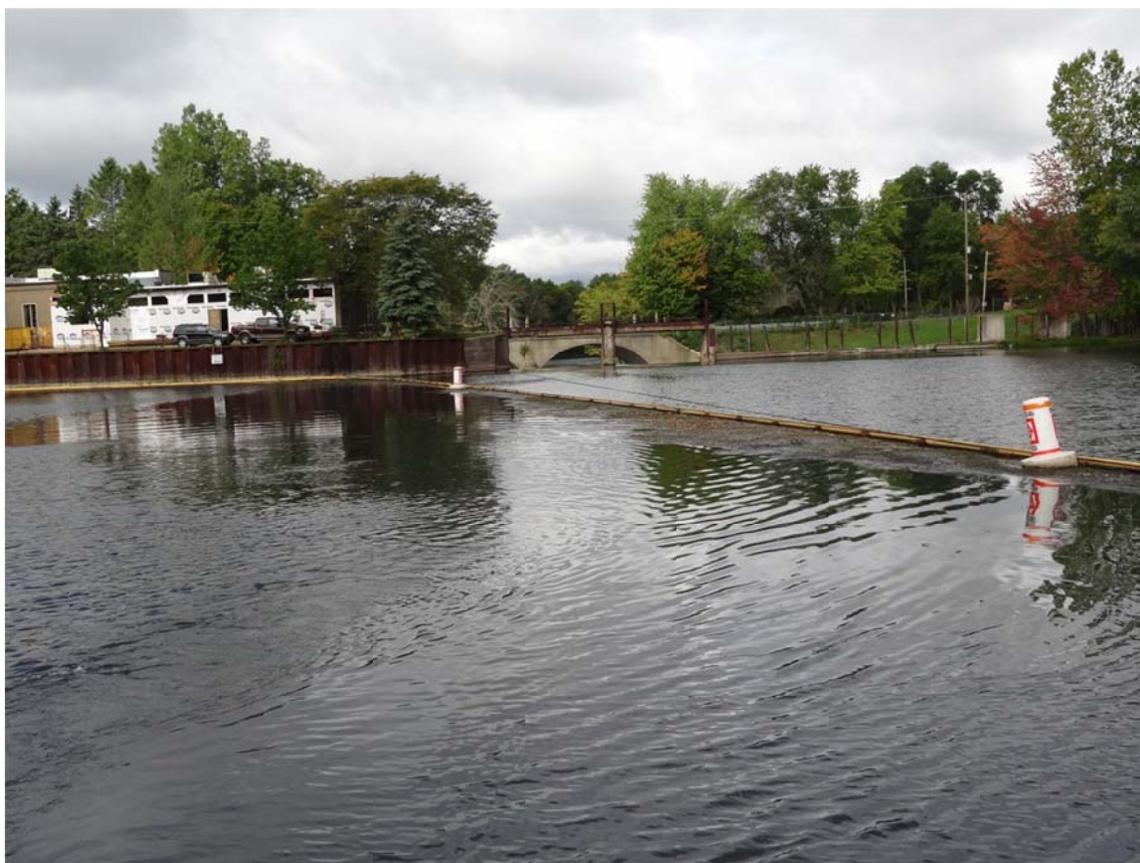
6. MP5.75 area where sheen and tar globs were observed. Sheen and tar globs appear to have been agitated by the sweep/maintenance boat.

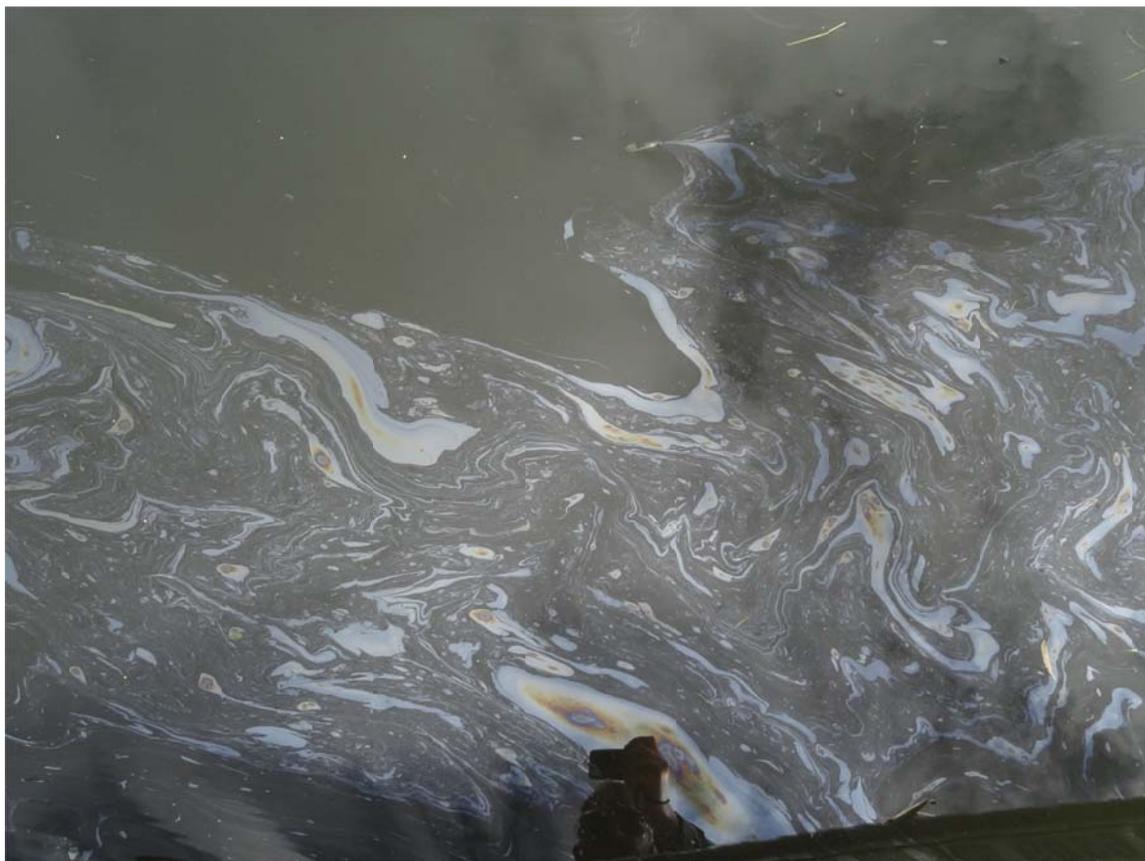
7. MP5.75 area where sheen and tar globs were observed. Sheen and tar globs appear to have been agitated by the sweep/maintenance boat.

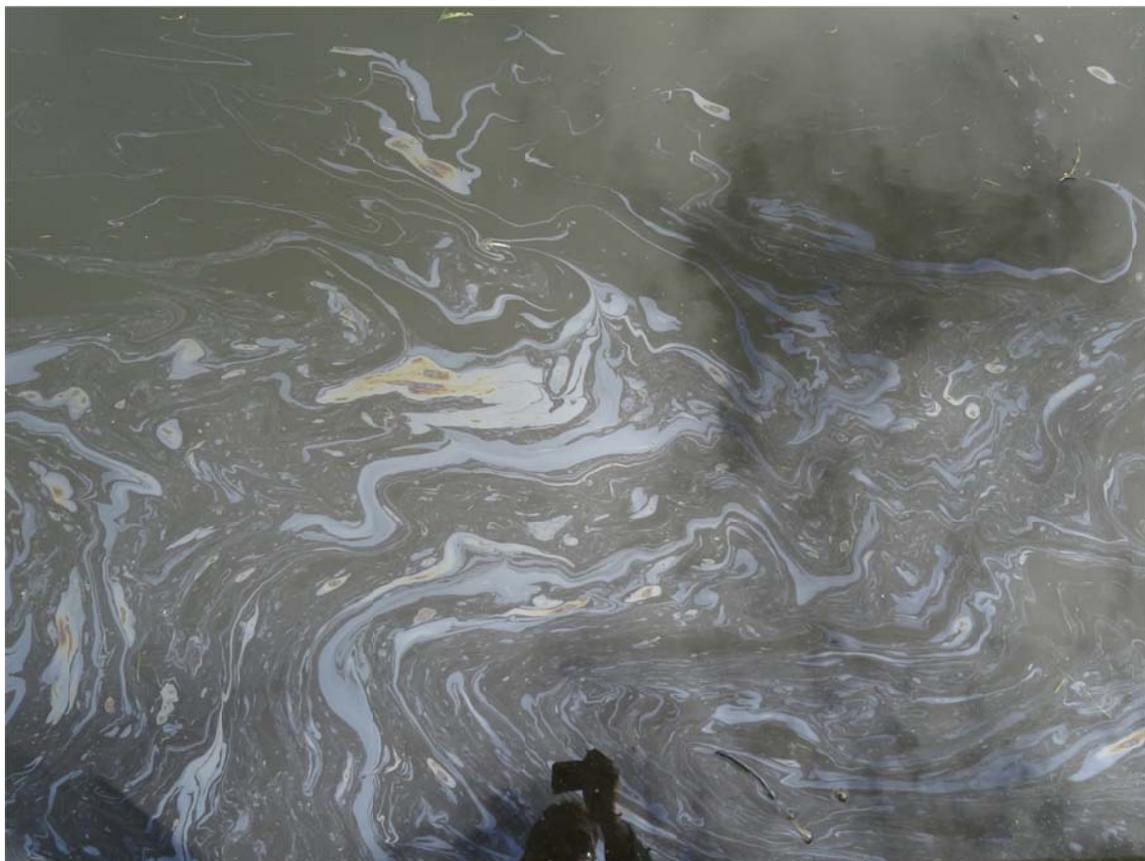
8. MP5.75 area where sheen and tar globs were observed. Sheen and tar globs appear to have been agitated by the sweep/maintenance boat.

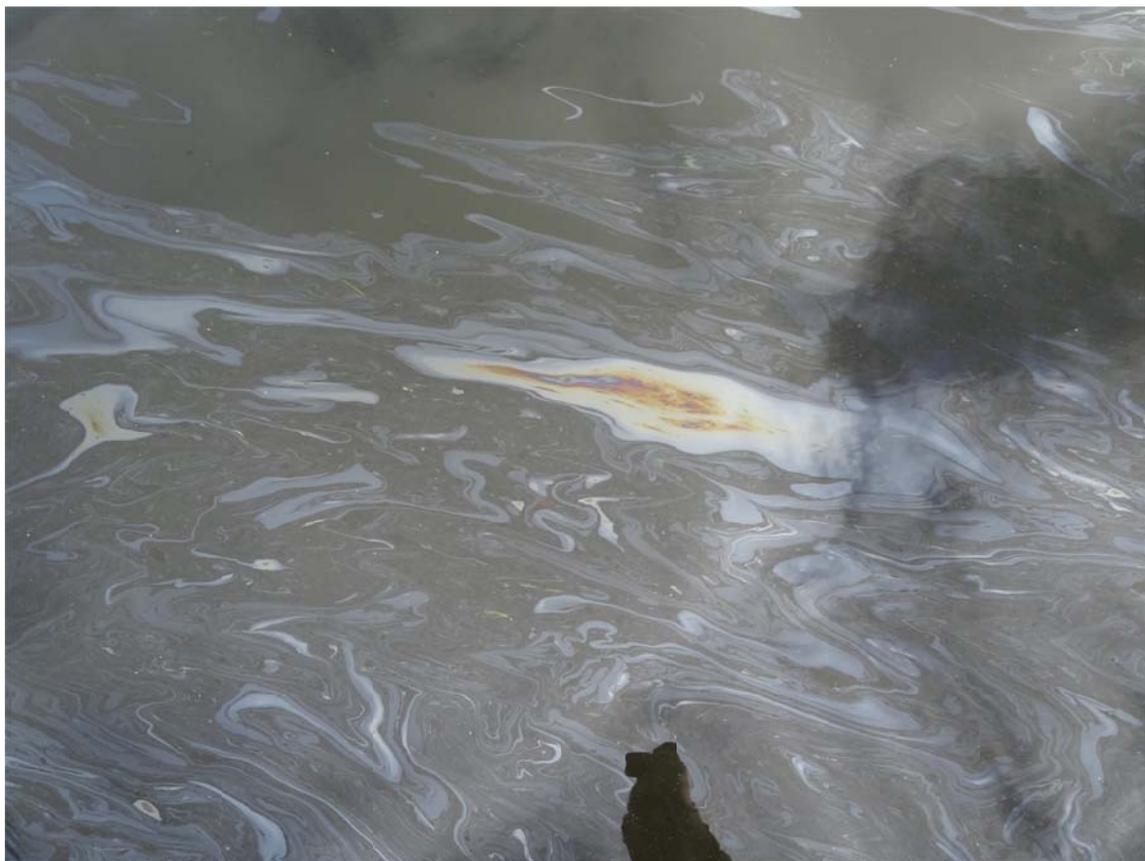
9. MP5.75 area where sheen and tar globs were observed. Sheen and tar globs appear to have been agitated by the sweep/maintenance boat.

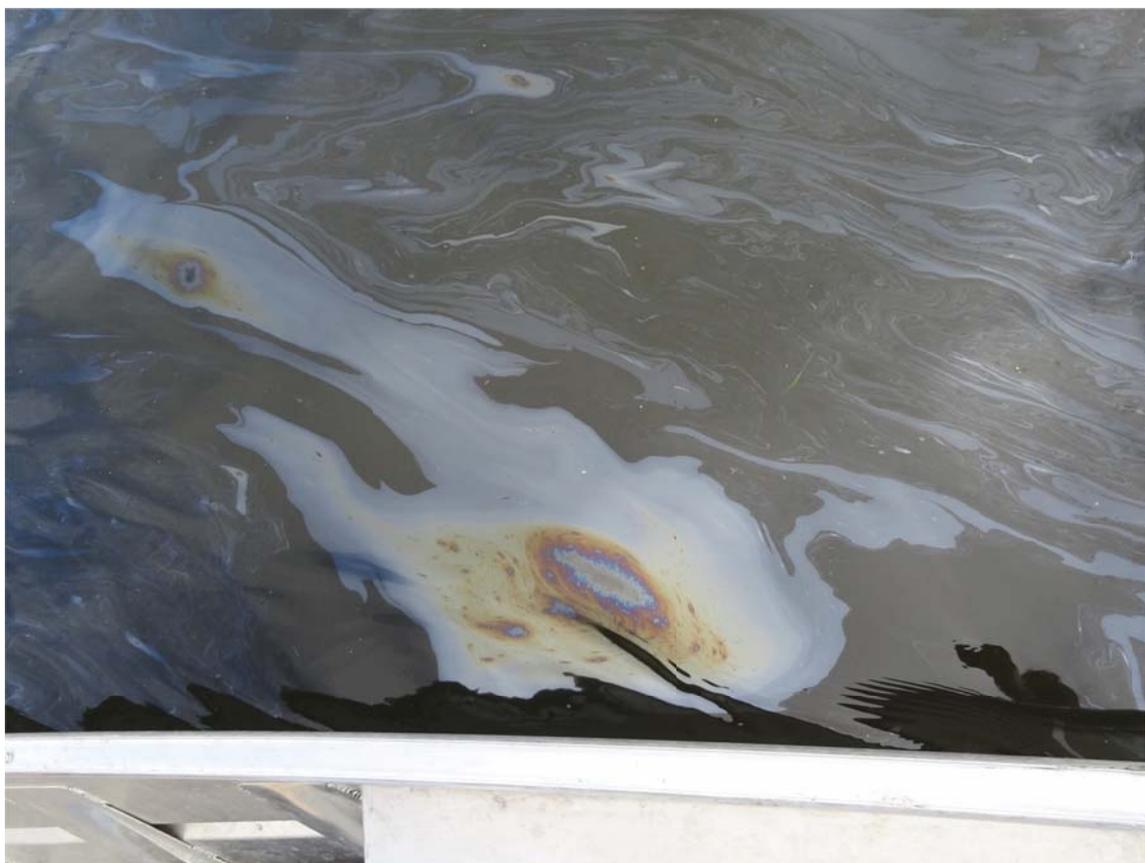
10. MP5.75 area where sheen and tar globs were observed. Sheen and tar globs appear to have been agitated by the sweep/maintenance boat.

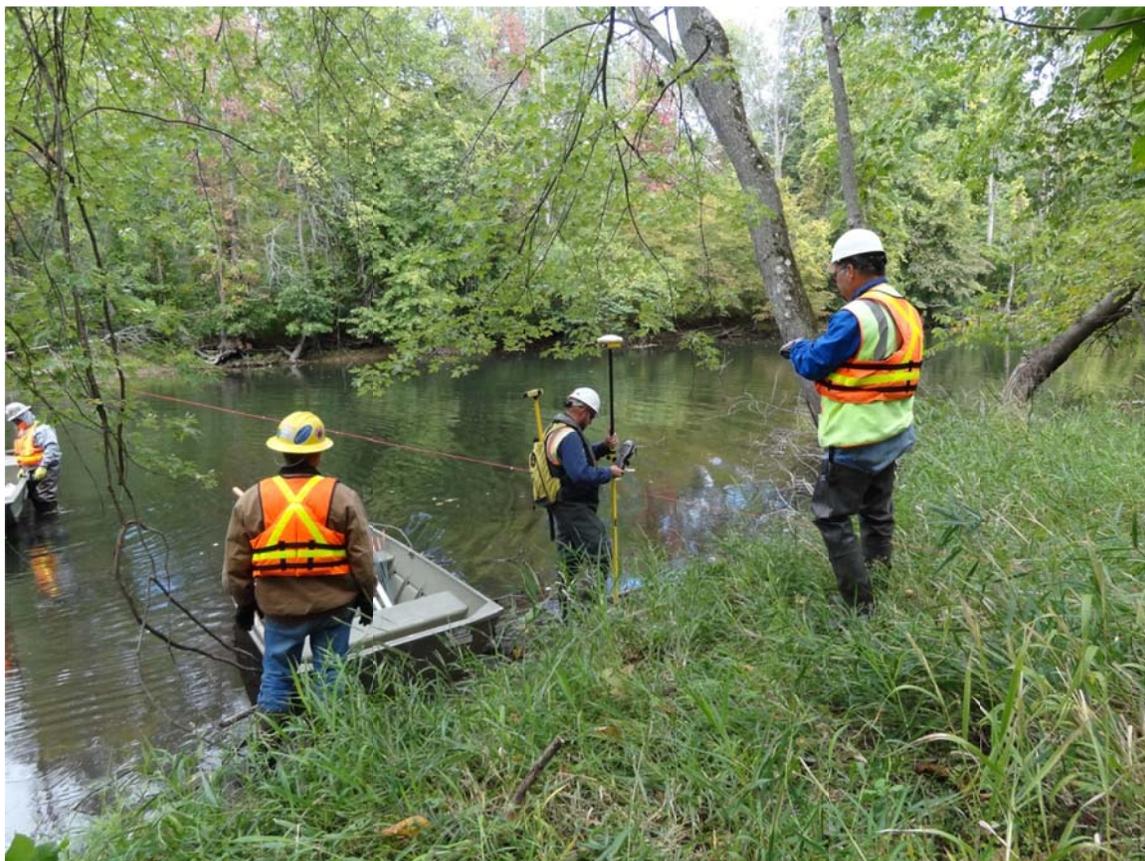
11. MP21.5 Sediment Trap Bathymetry survey crew observed.

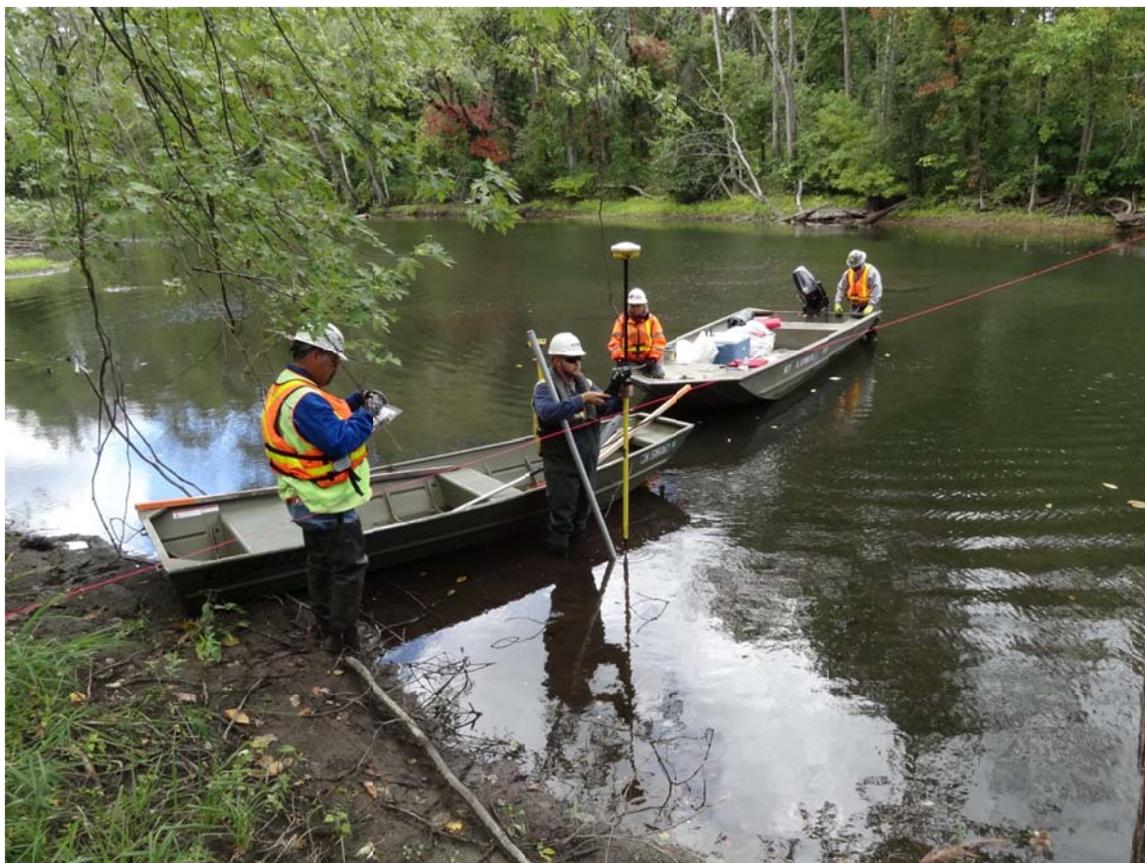
12. MP21.5 Sediment Trap Bathymetry survey crew observed.

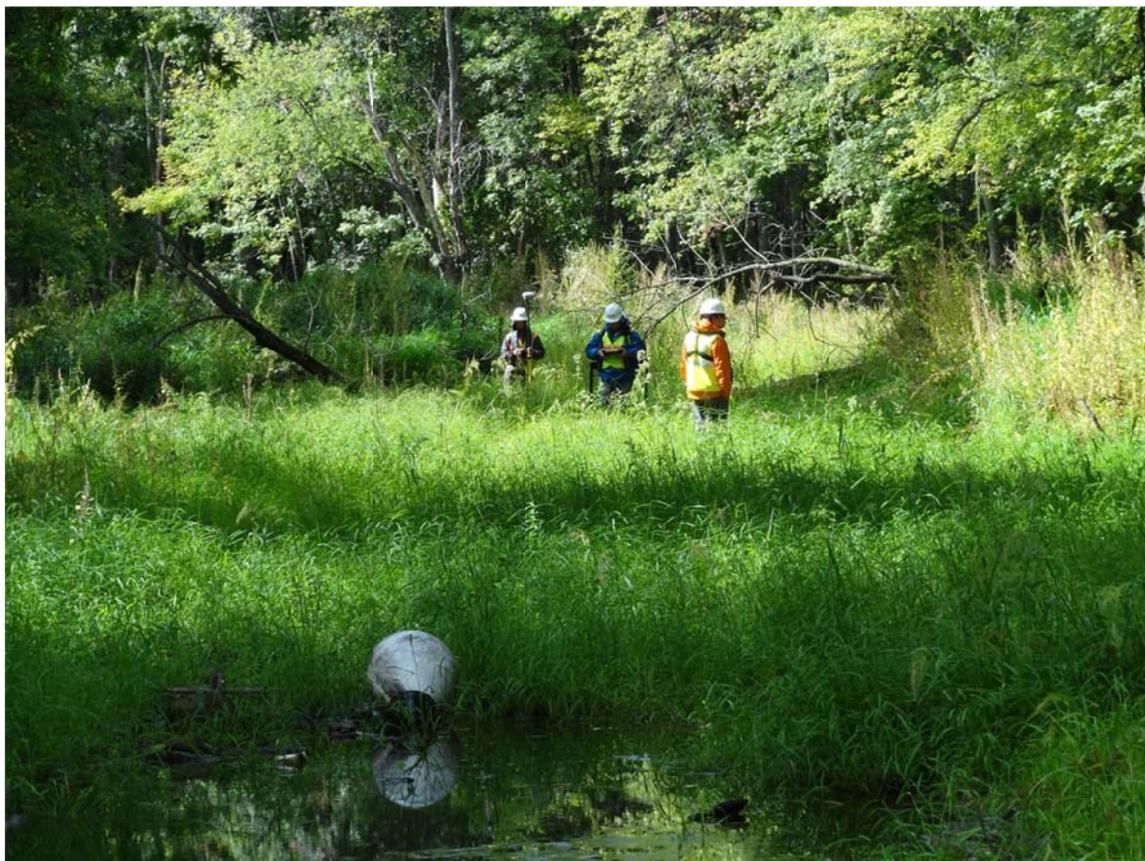
13. MP28.25 Sediment Trap Bathymetry survey crew observed.

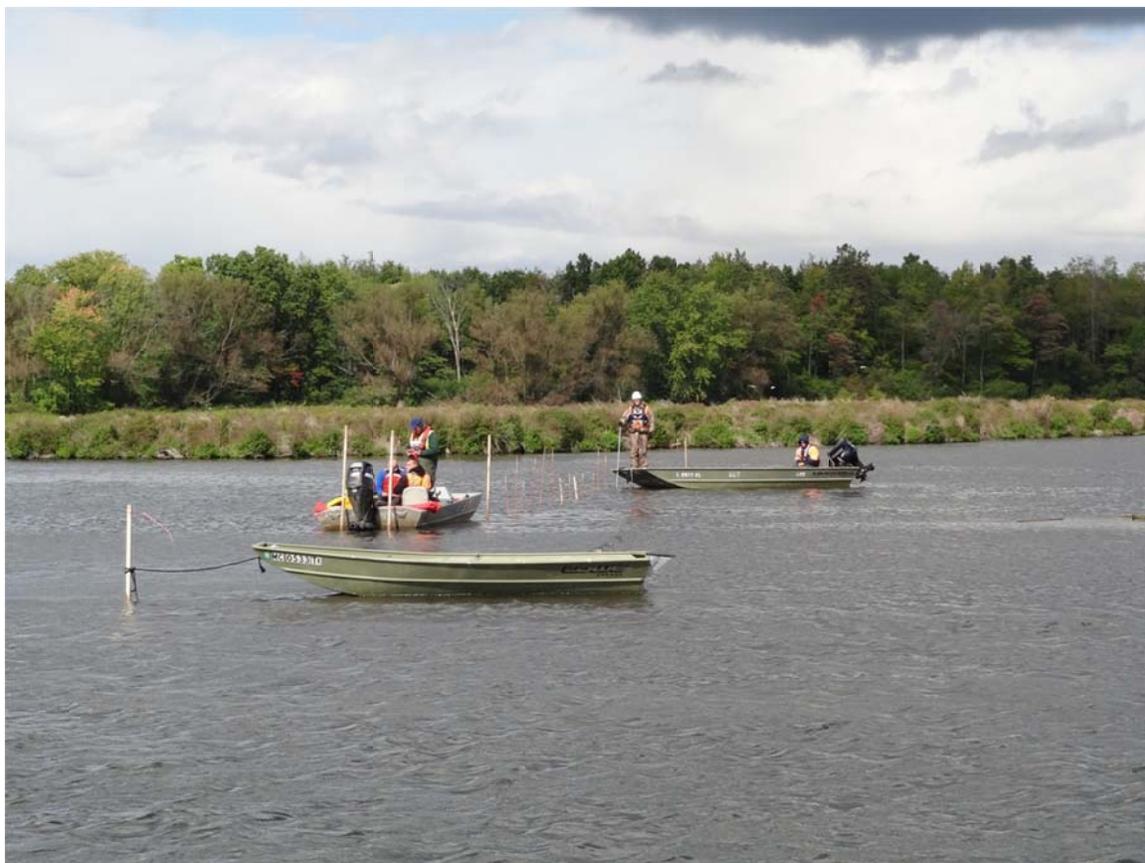
14. Morrow Lake Delta Bathymetry survey crew observed.

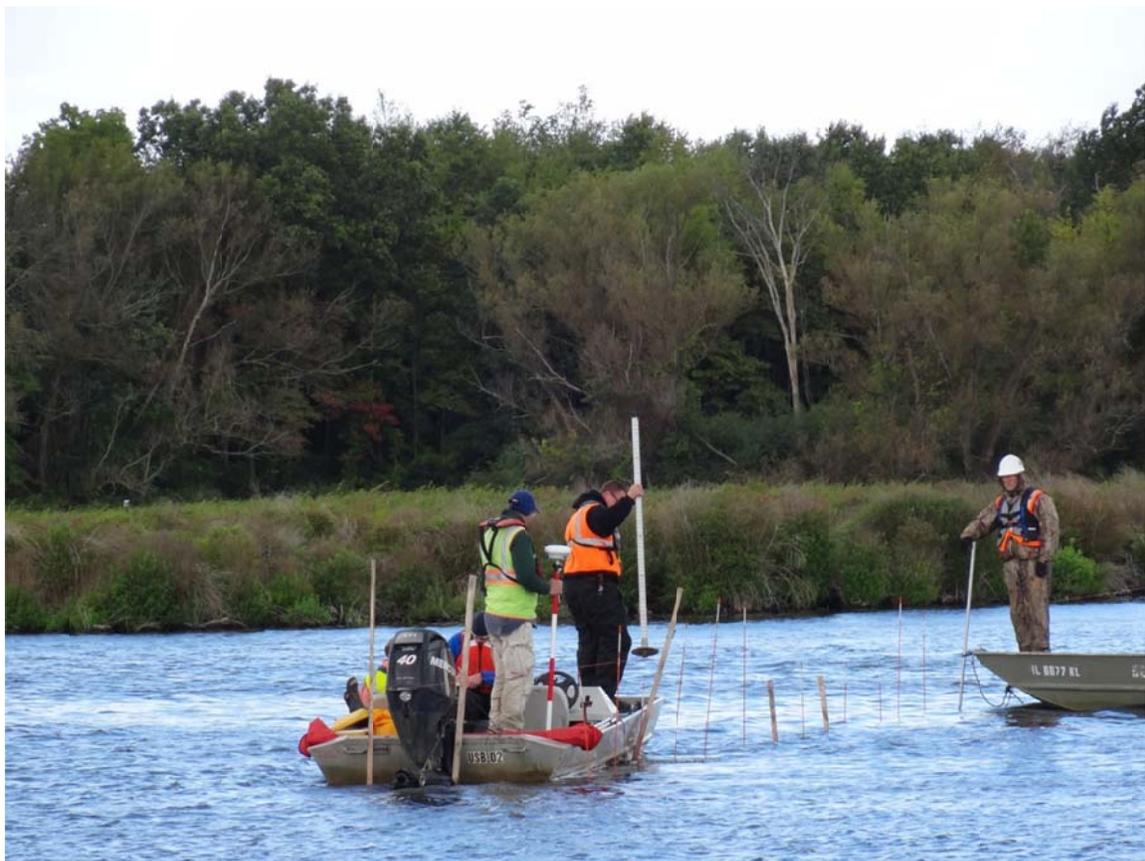
15. Morrow Lake Delta Bathymetry survey crew observed.

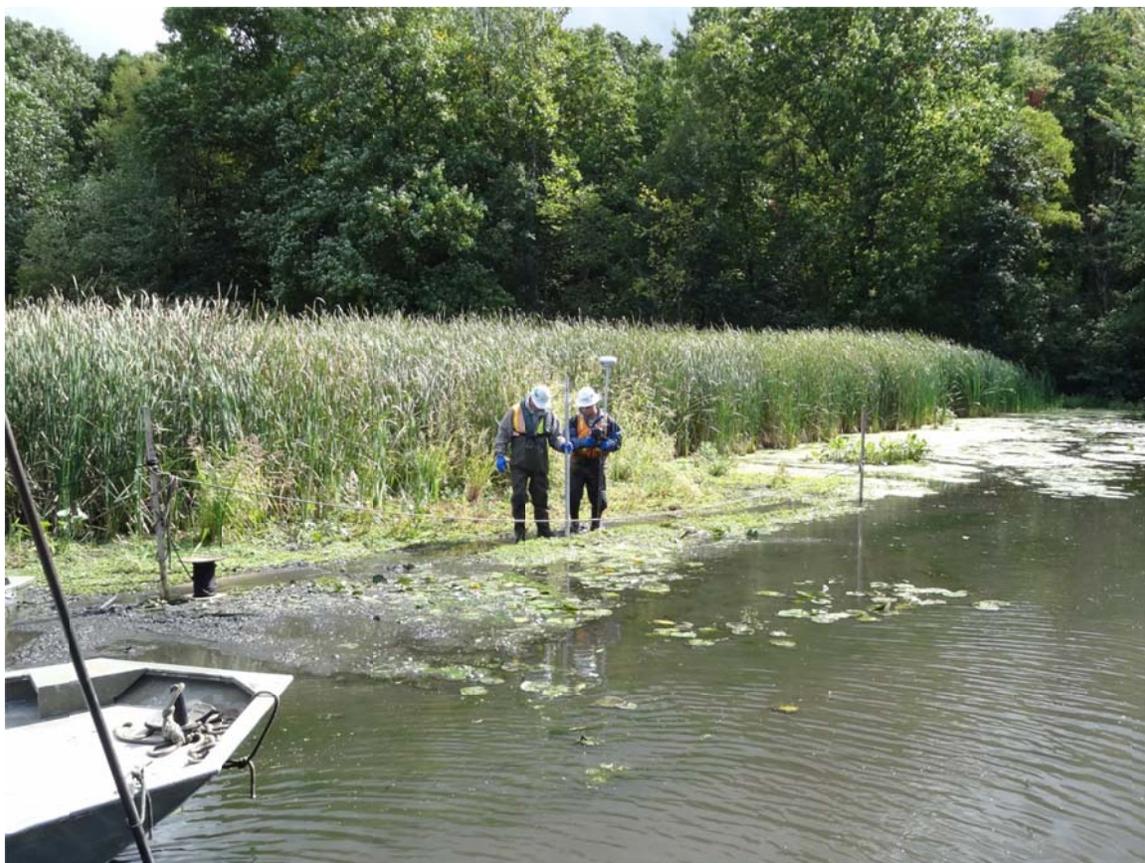
16. Morrow Lake Delta Bathymetry survey crew observed.

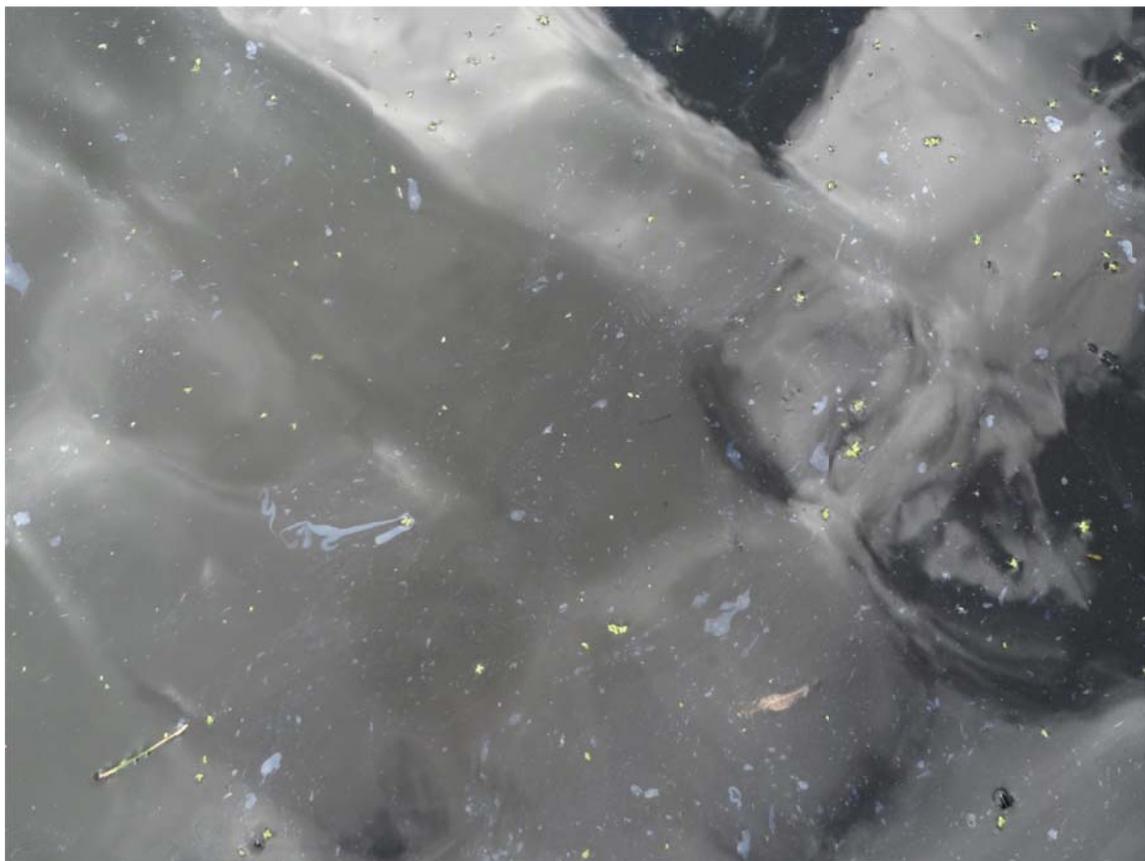
17. Morrow Lake Delta MP37.75 sheen observed around the Bathymetry survey crew boats.

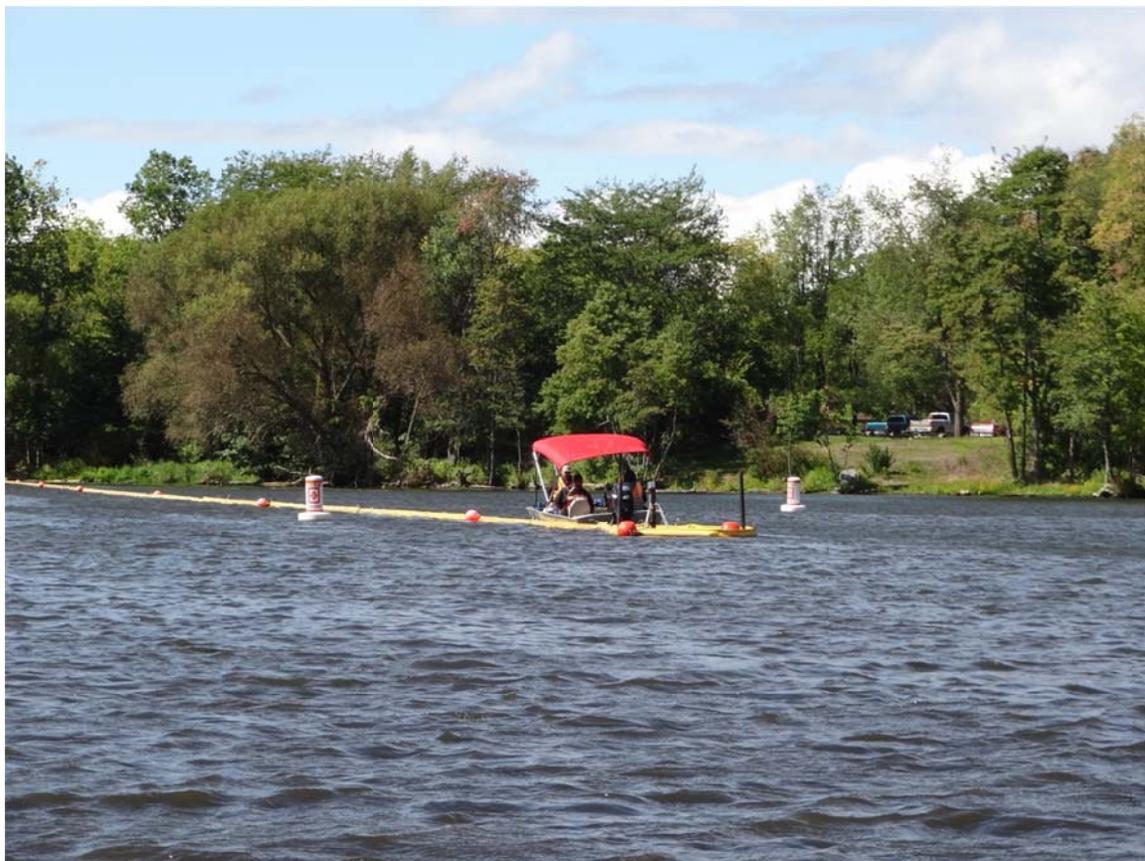
18. Morrow Lake Delta observed a crew performing boom/curtain camera inspections.

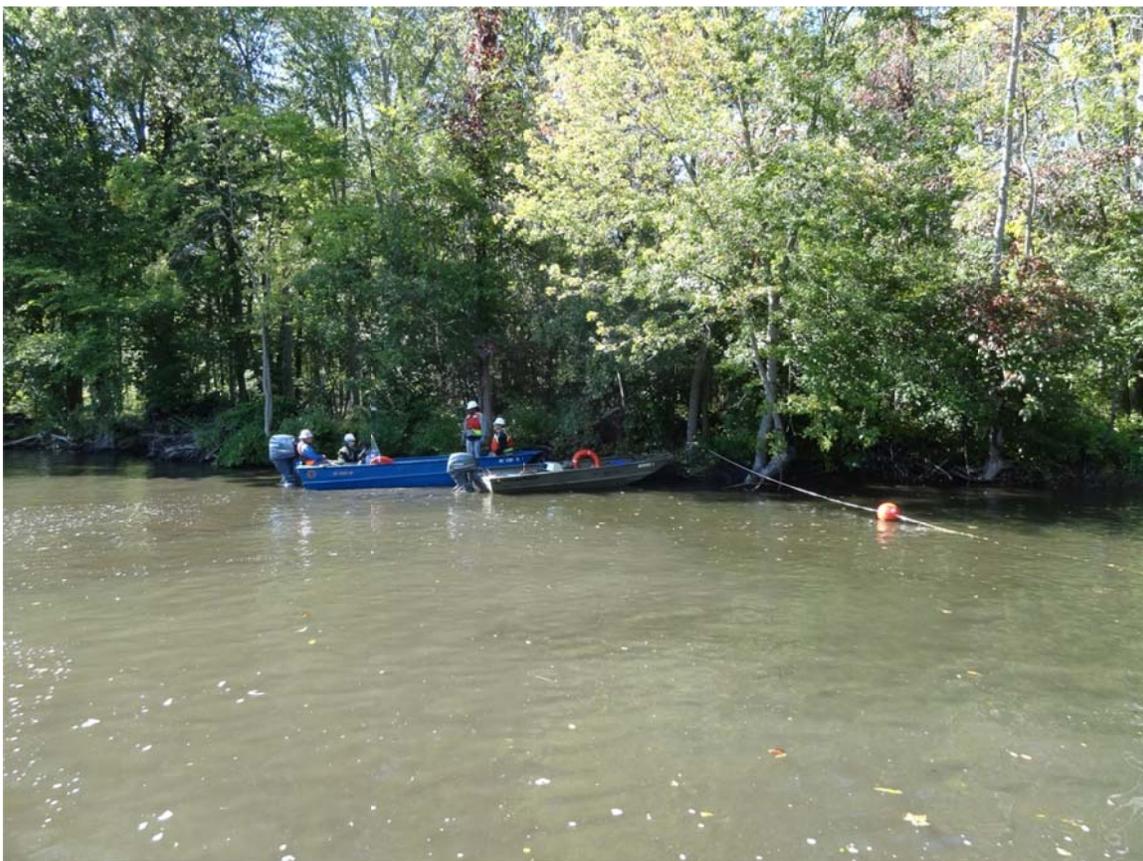
19. MP36.1 Sediment trap observed a crew performing Bathymetry survey.

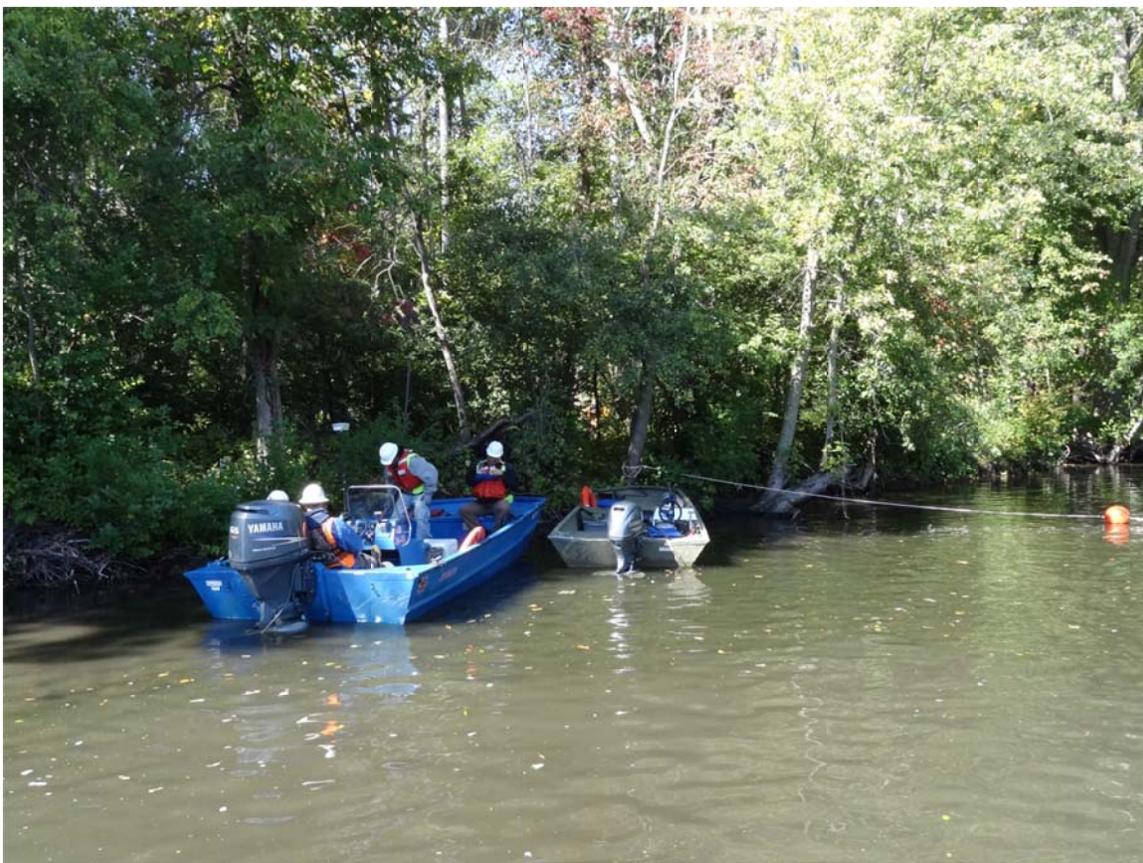
20. MP36.1 Sediment trap observed a crew performing Bathymetry survey.
