Situation Photo Log

Wednesday, September 19, 2012

Kalamazoo River / Enbridge Spill

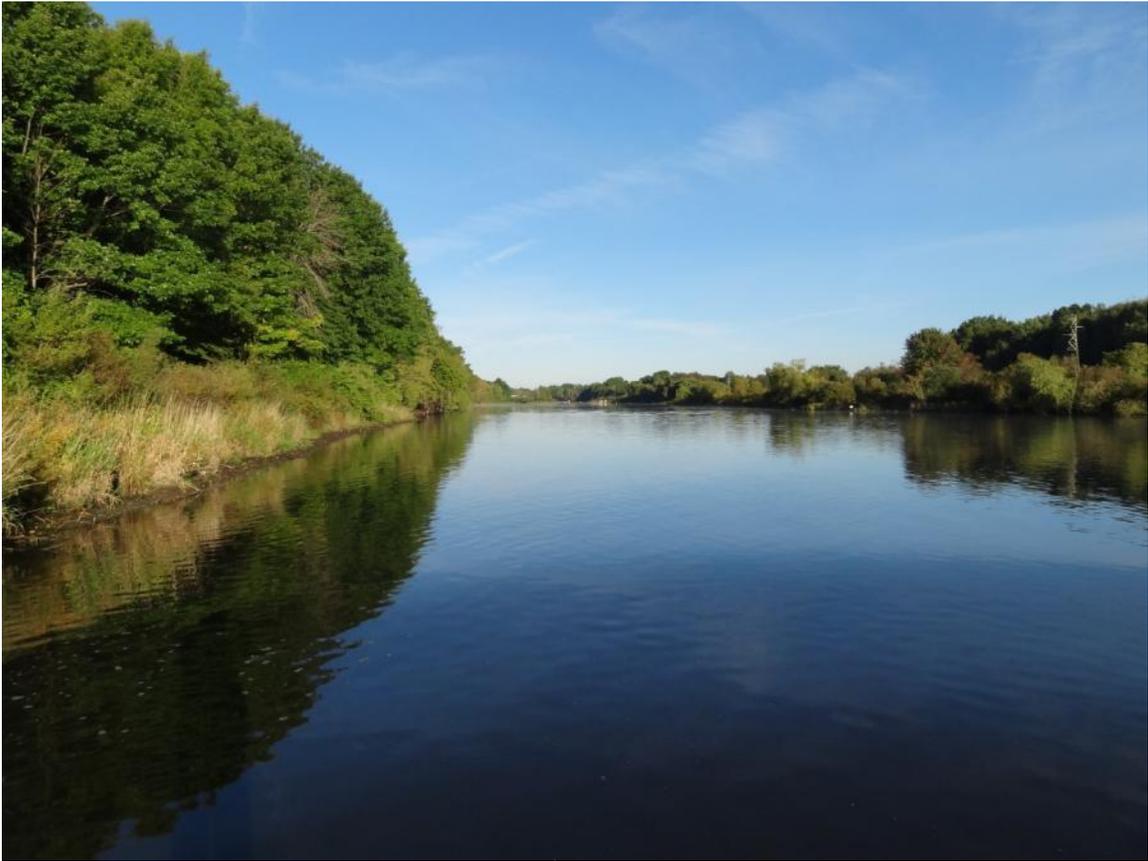
1. MP5.40 LDB area where sheen and tar globs were observed.

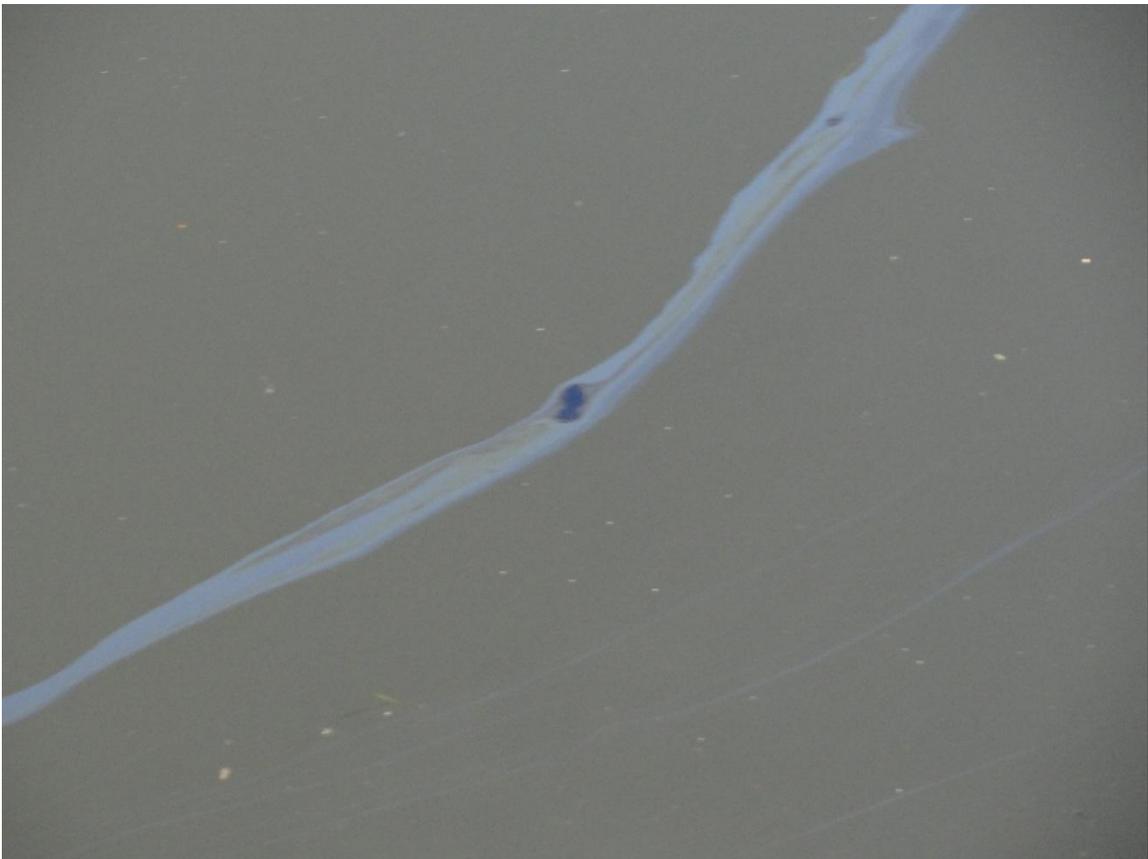
2. MP5.40 LDB observed sheen and tar globs

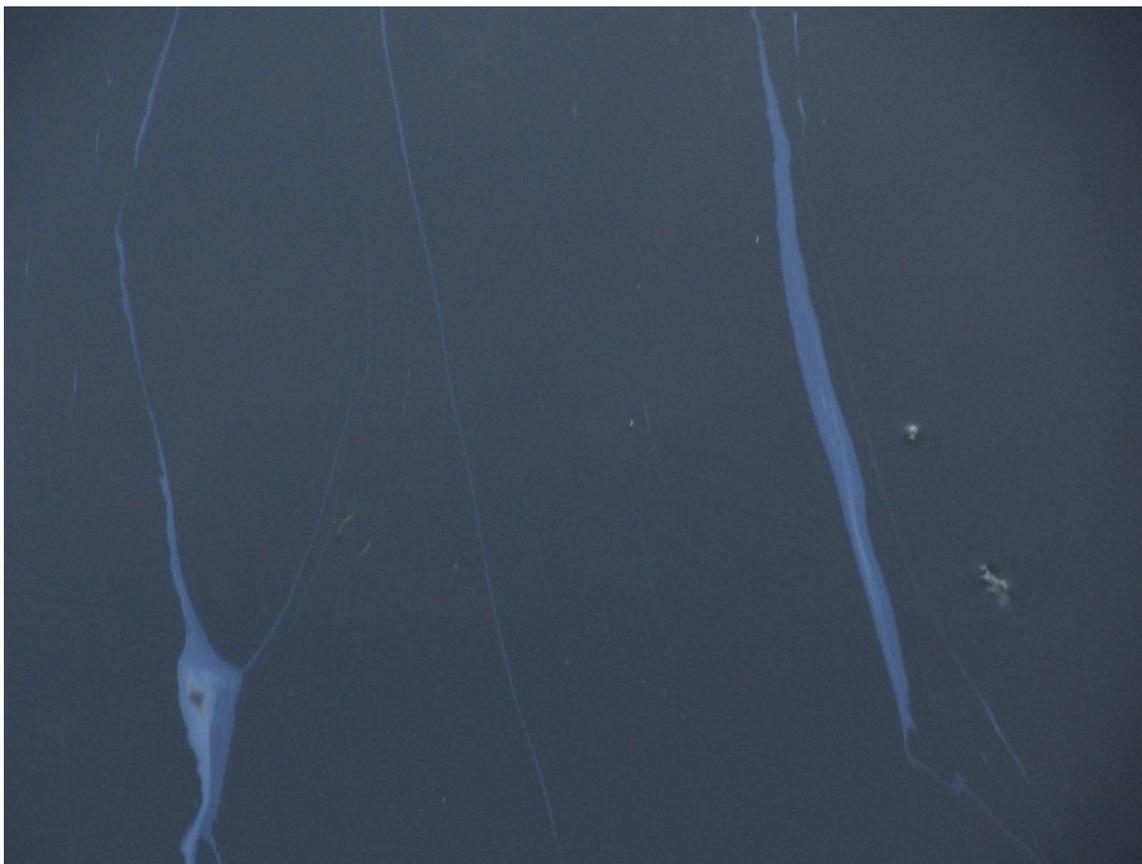
3. MP5.40 LDB observed sheen and tar globs.

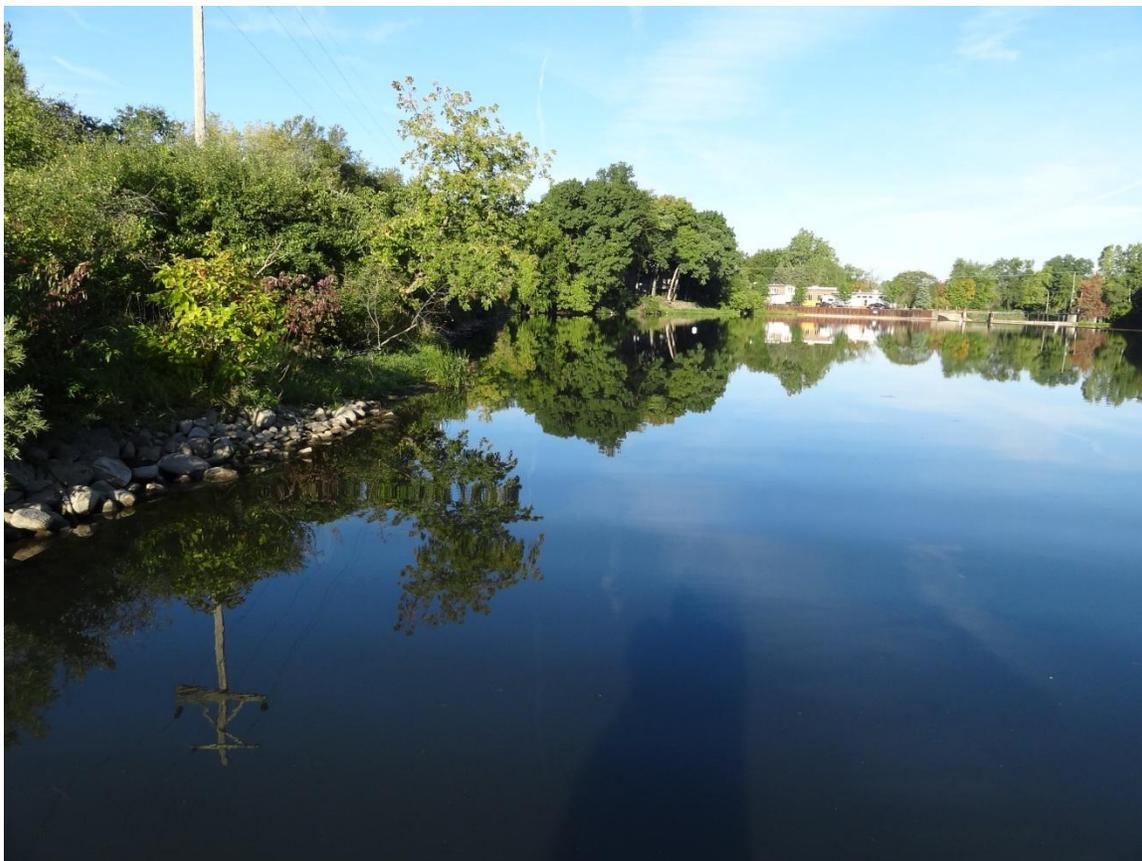
4. MP5.63 LDB area where sheen and tar globs were observed.

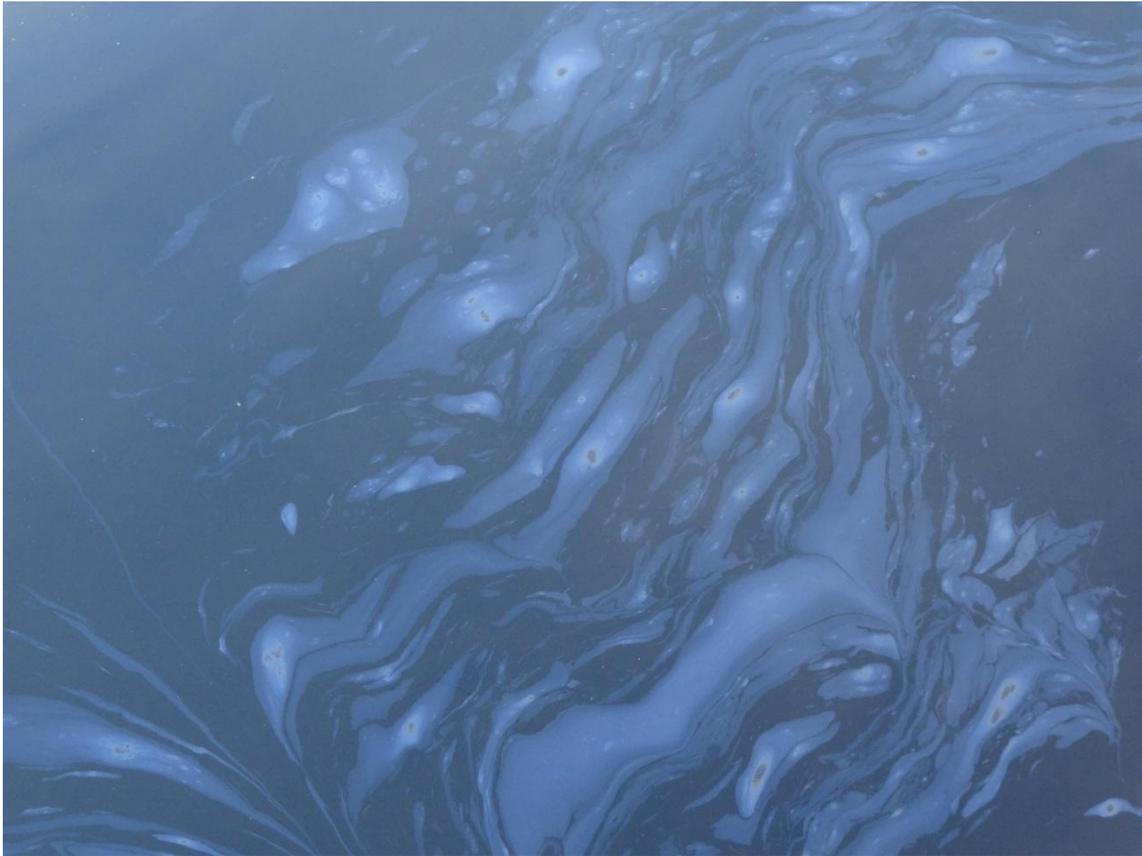
5. MP5.63 LDB observed sheen and tar globs.

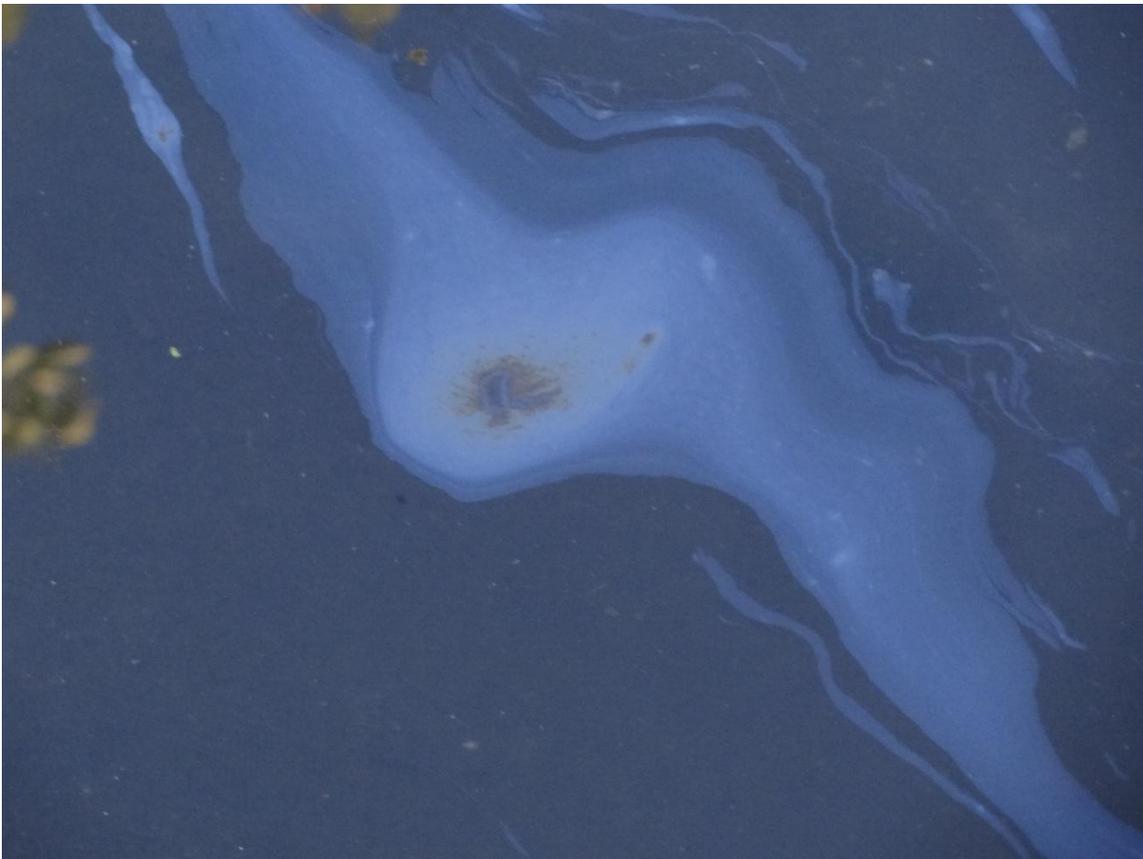
6. MP5.63 LDB observed sheen and tar globs.

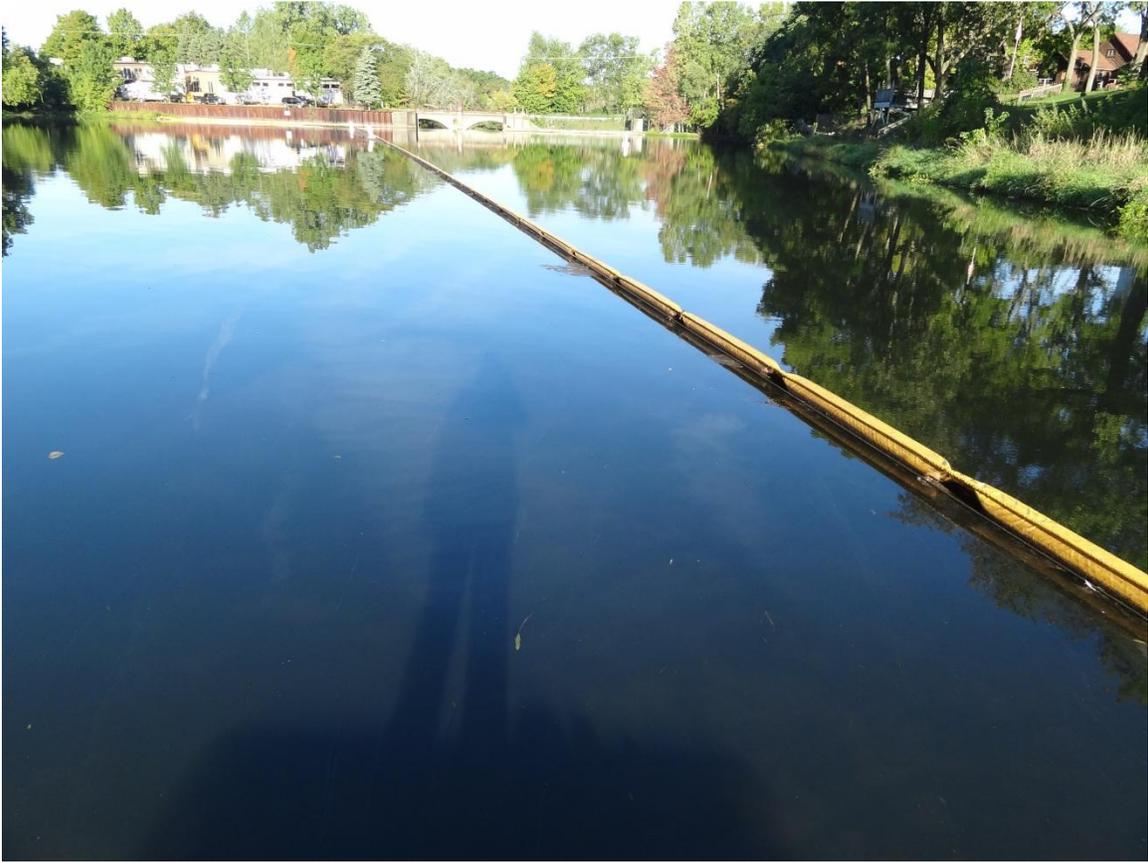
7. MP5.75 area where sheen and tar globs were observed.

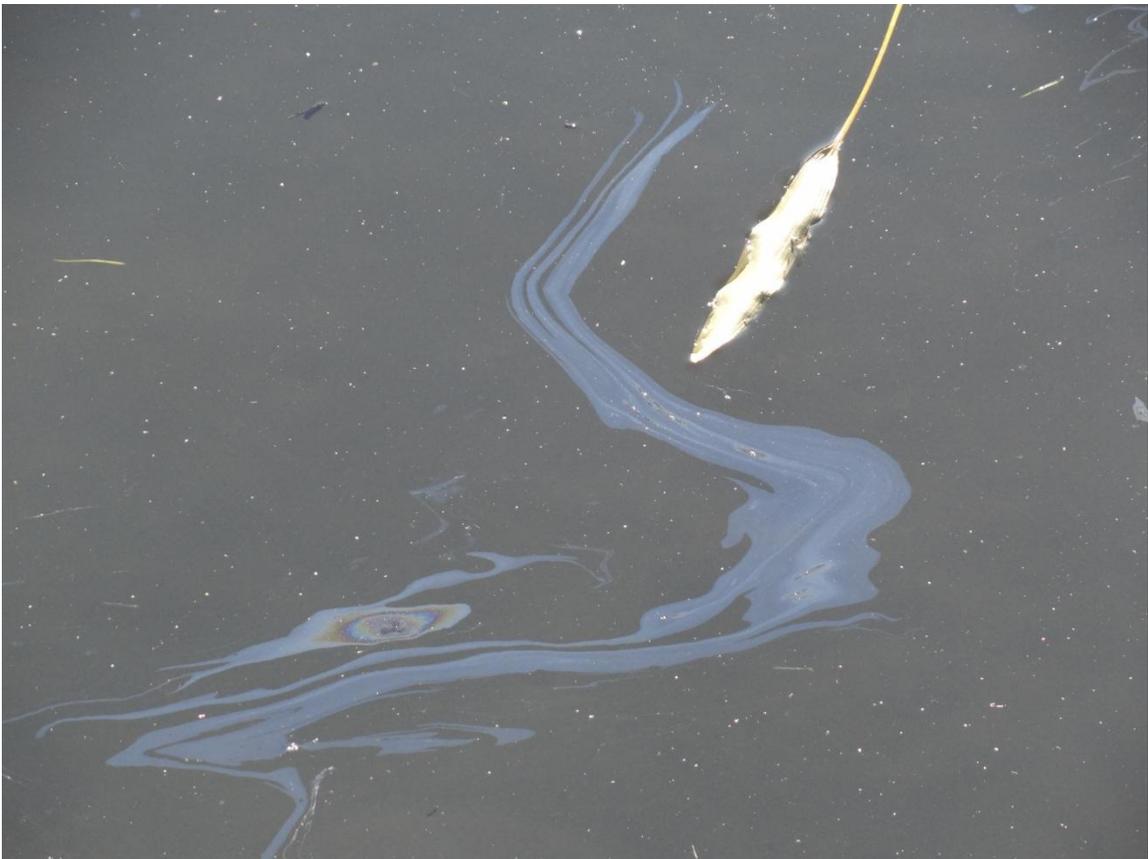
8. MP5.75 observed sheen and tar globs.

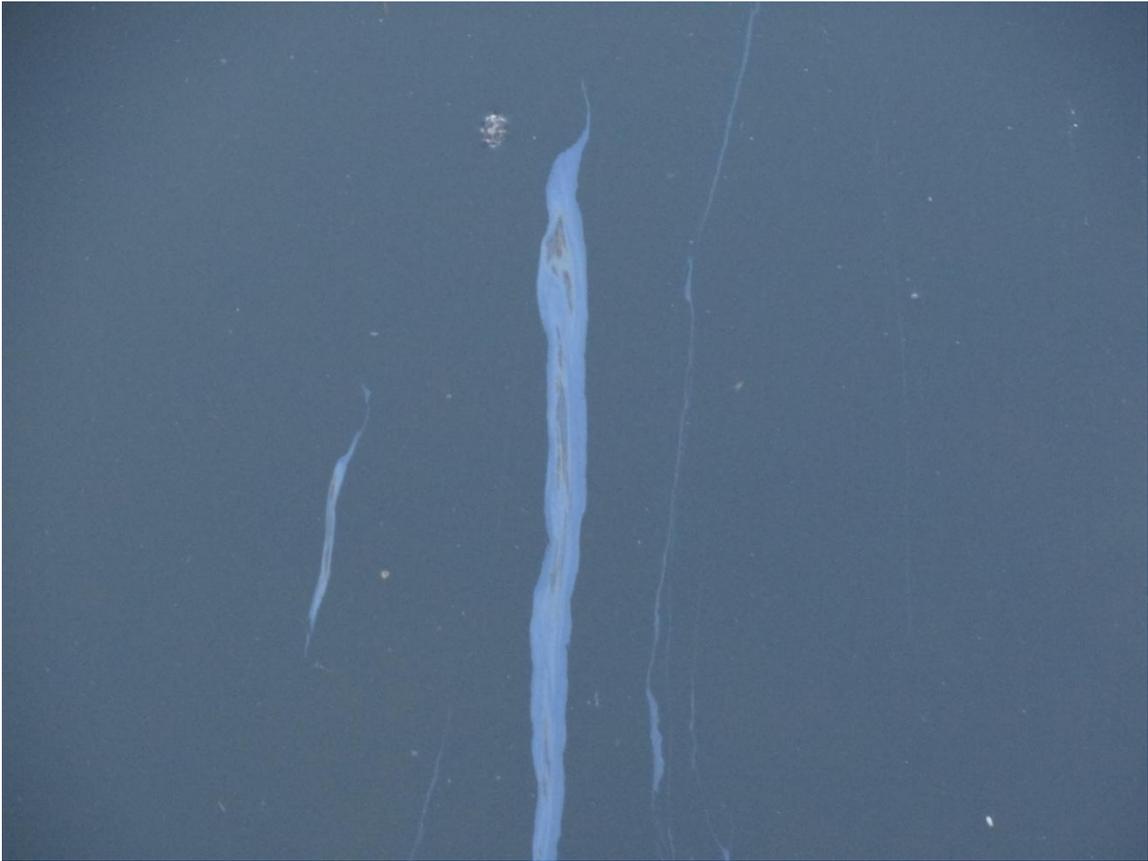
9. MP5.75 sheen and tar globs were observed.

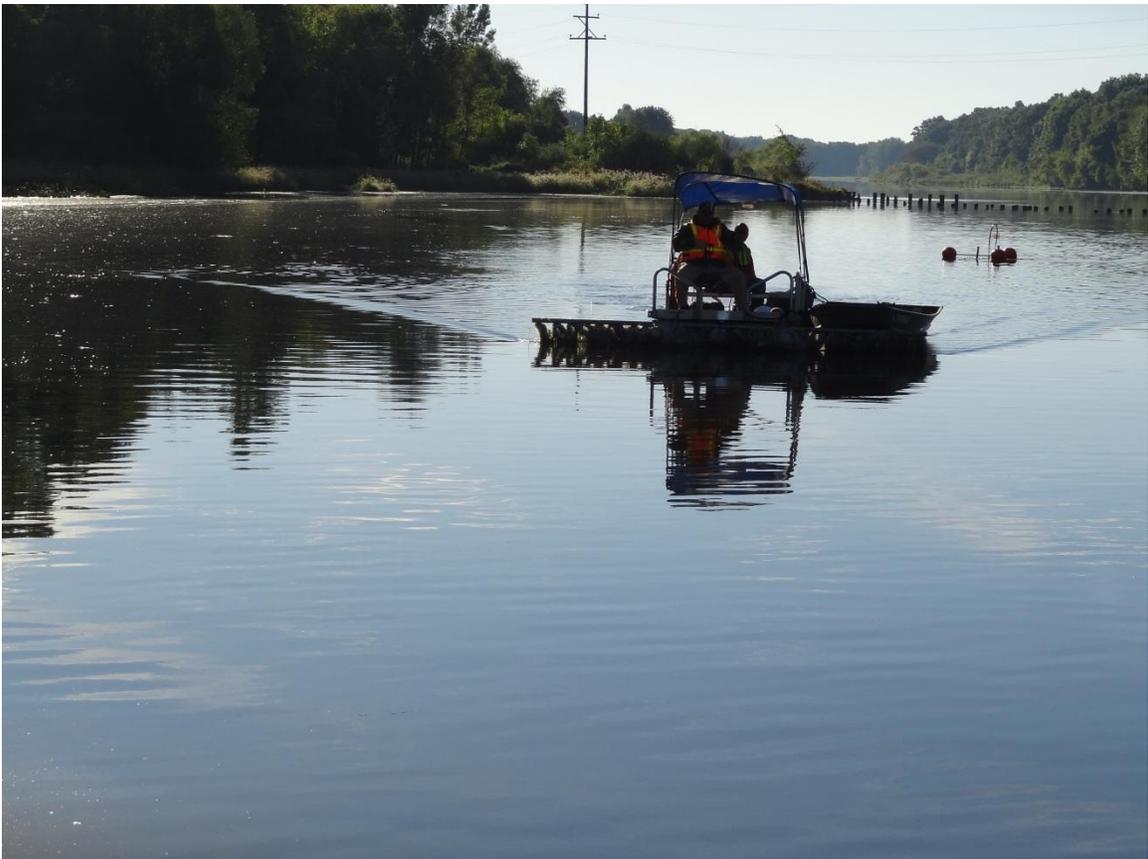
10. MP5.65 Observed the boom maintenance/sweep boat.

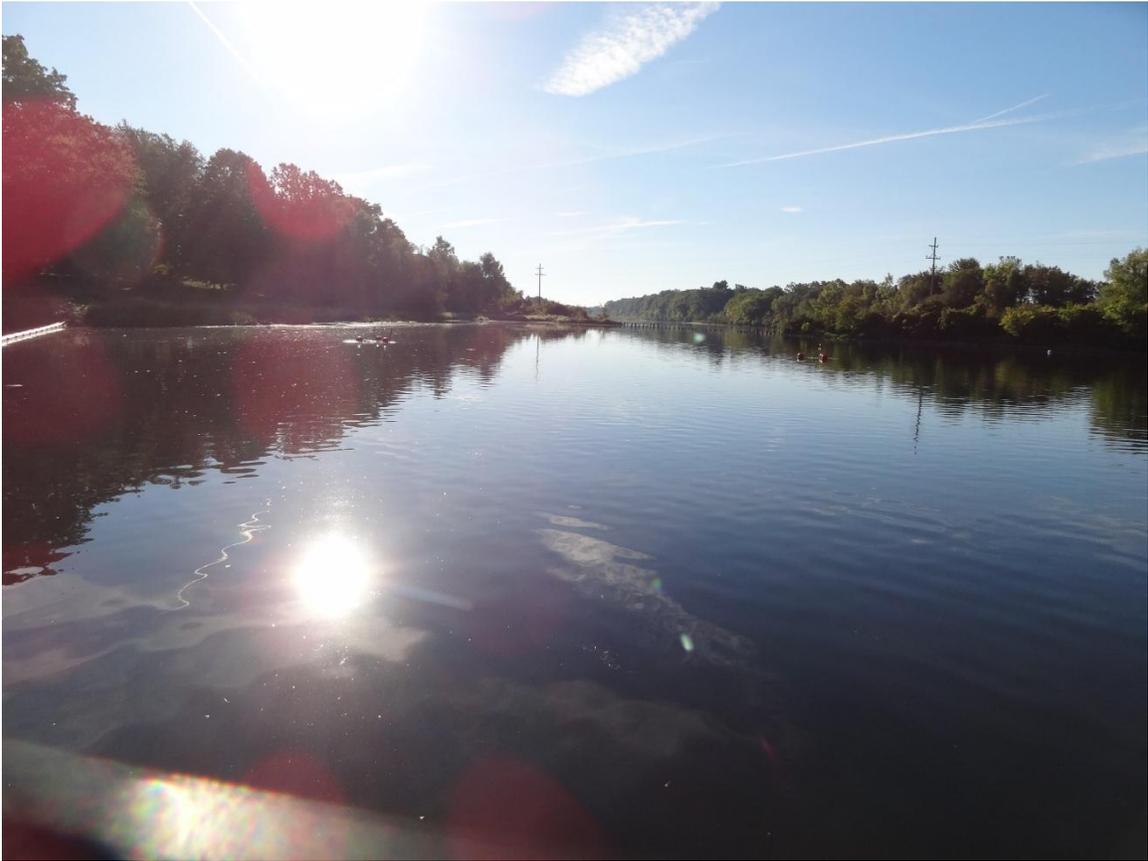
11. MP5.65 RDB area where sheen and tar globs were observed.

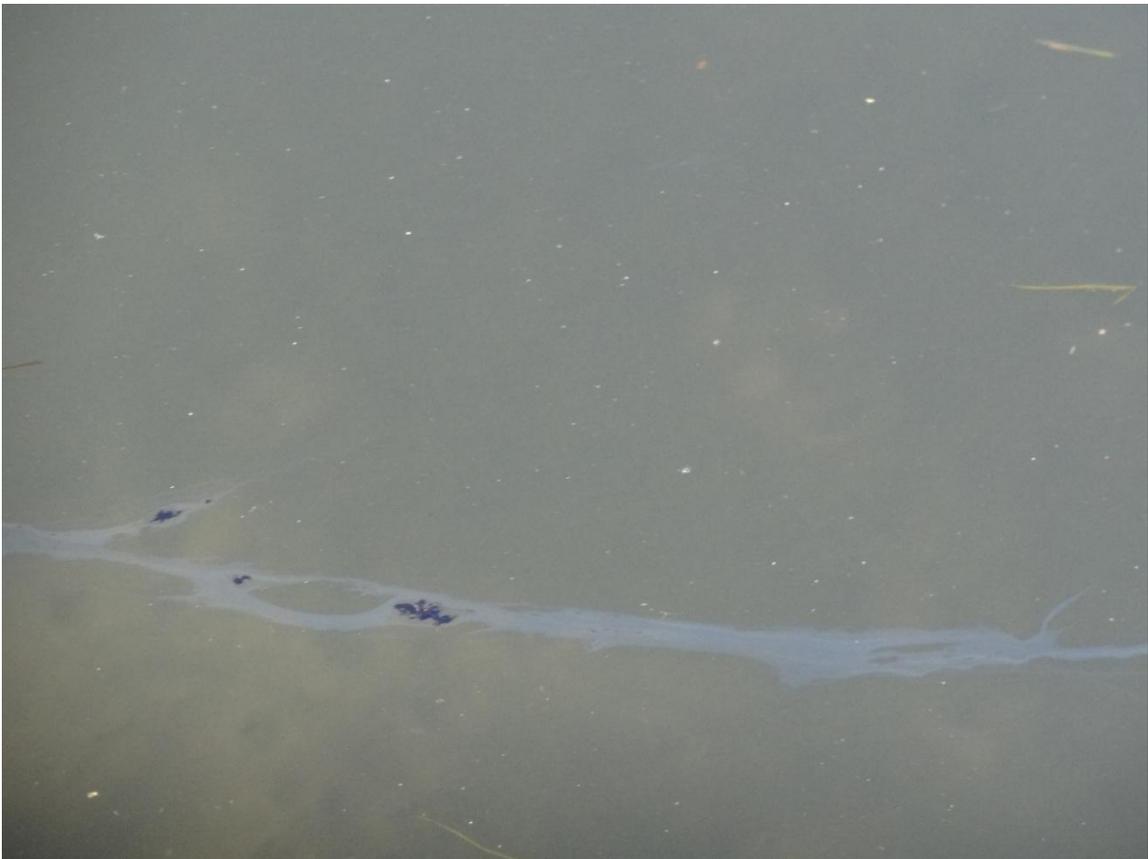
12. MP5.65 RDB observed sheen and tar globs.

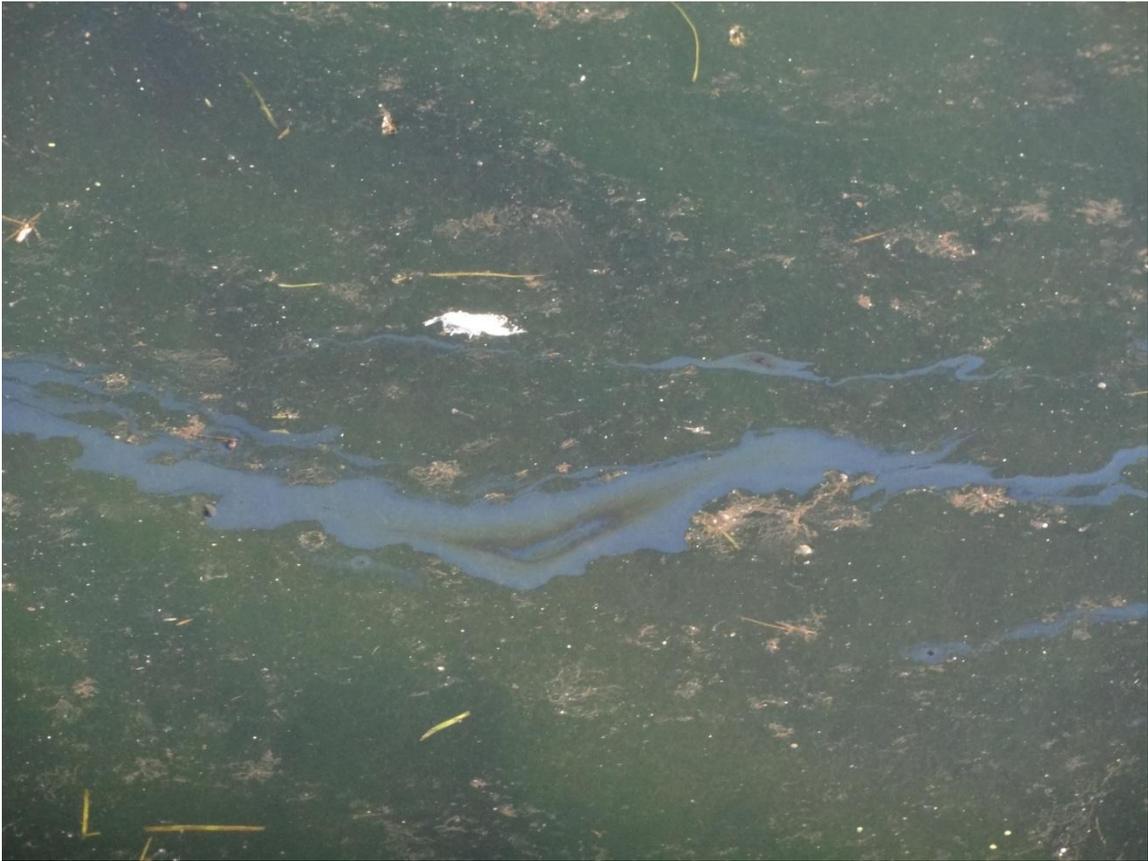
13. MP5.75 RDB observe sheen and tar globs.

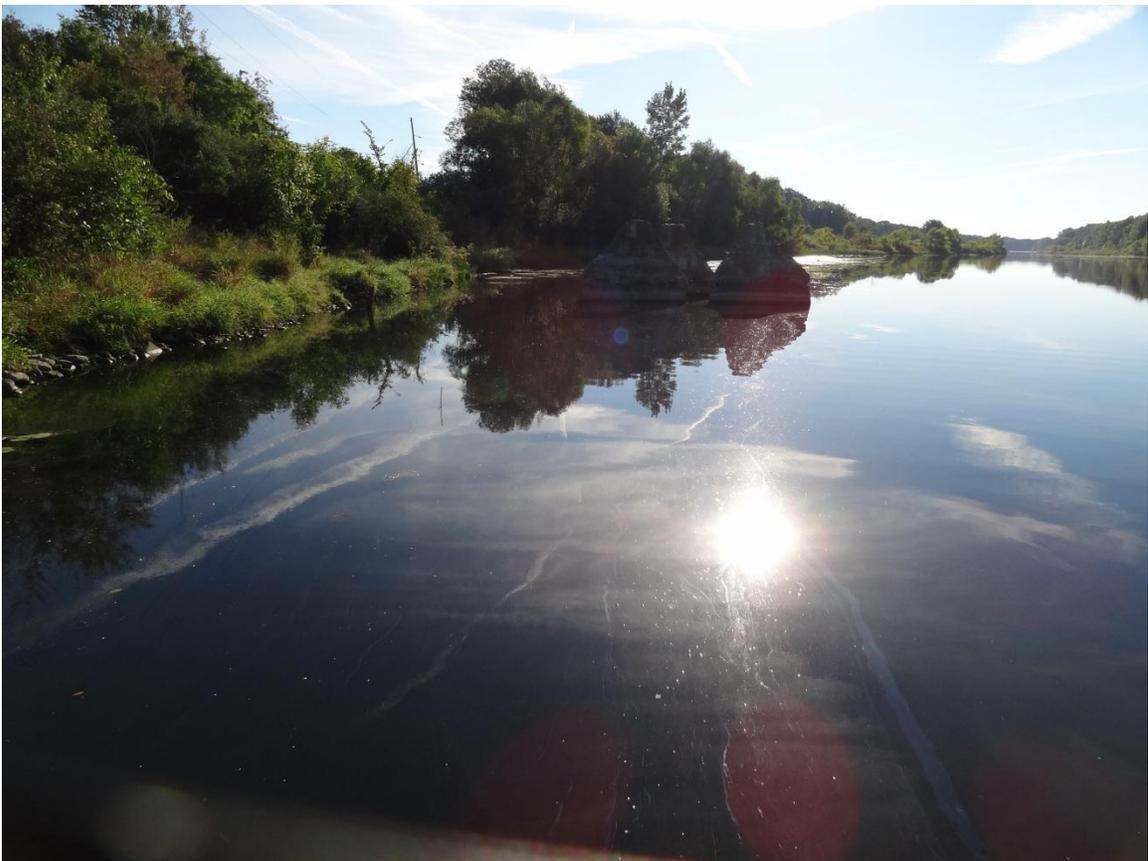
14. MP5.60 RDB area where sheen and tar globs were observed.

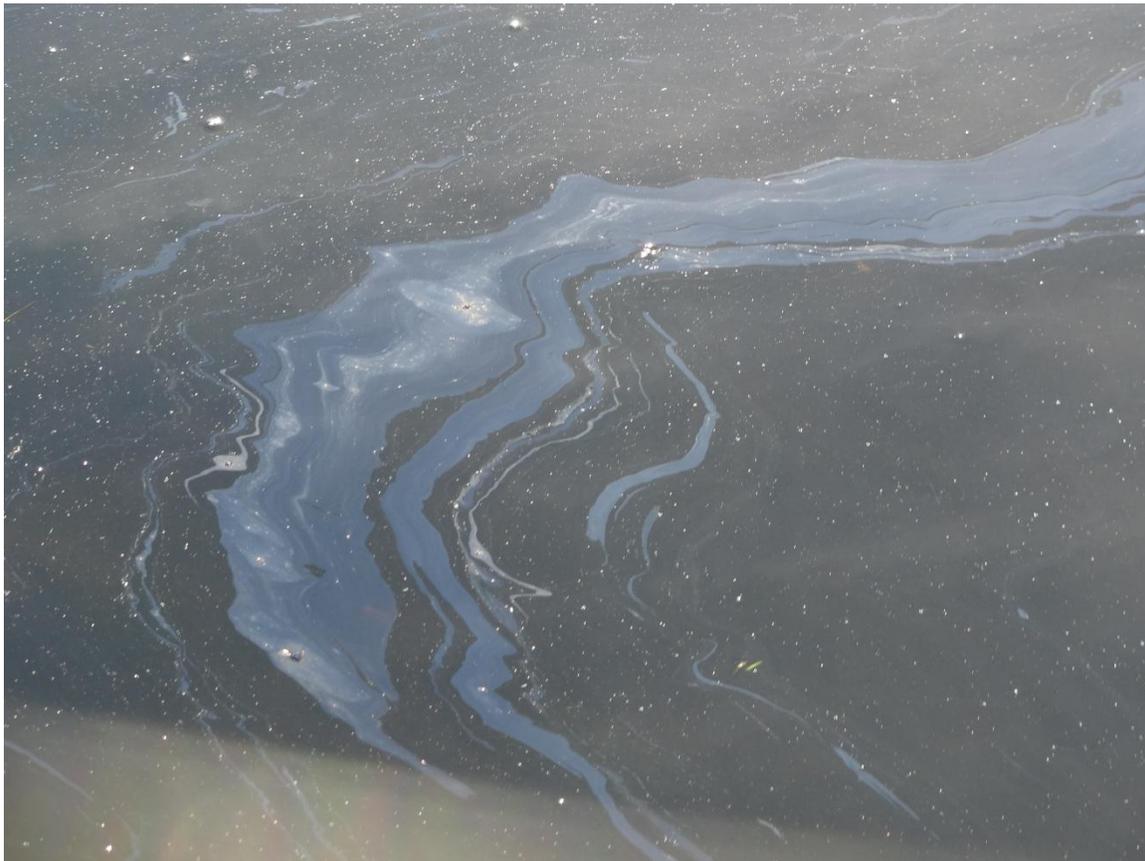
15. MP5.60 RDB sheen and tar globs observed.

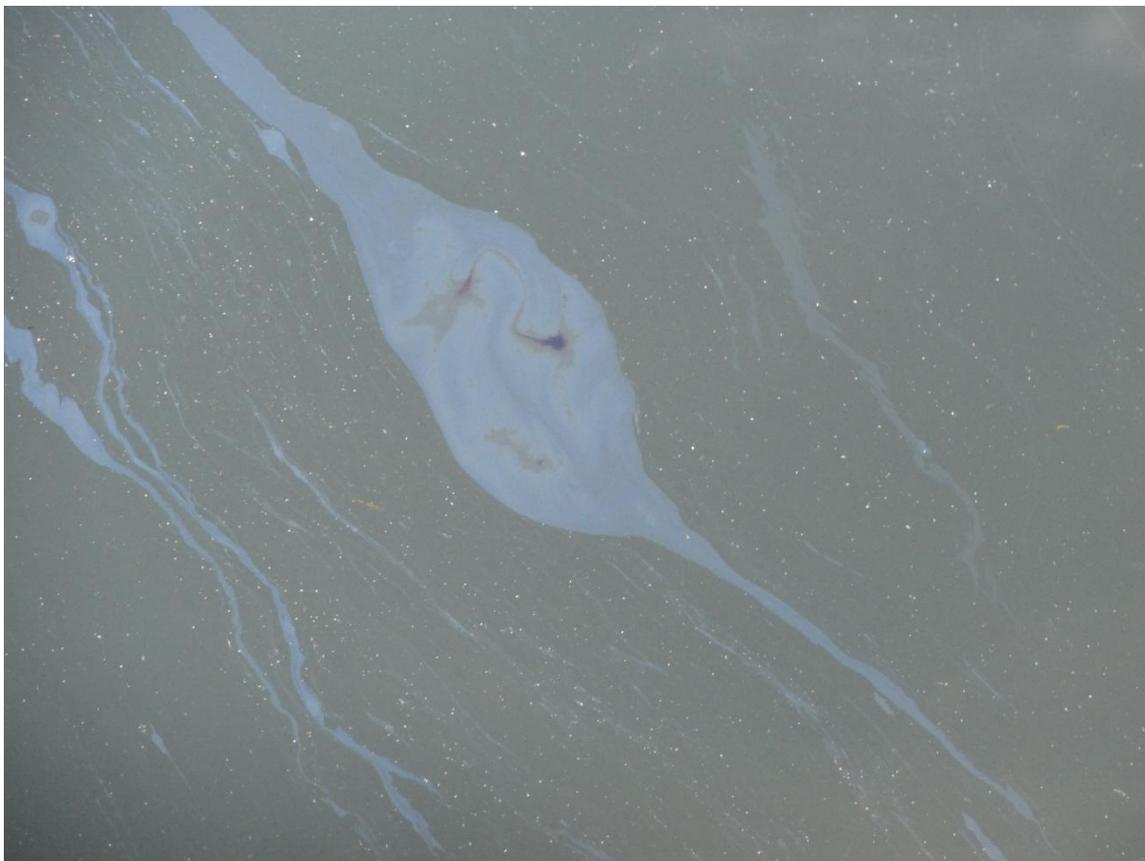
16. MP5.60 RDB sheen and tar globs observed.

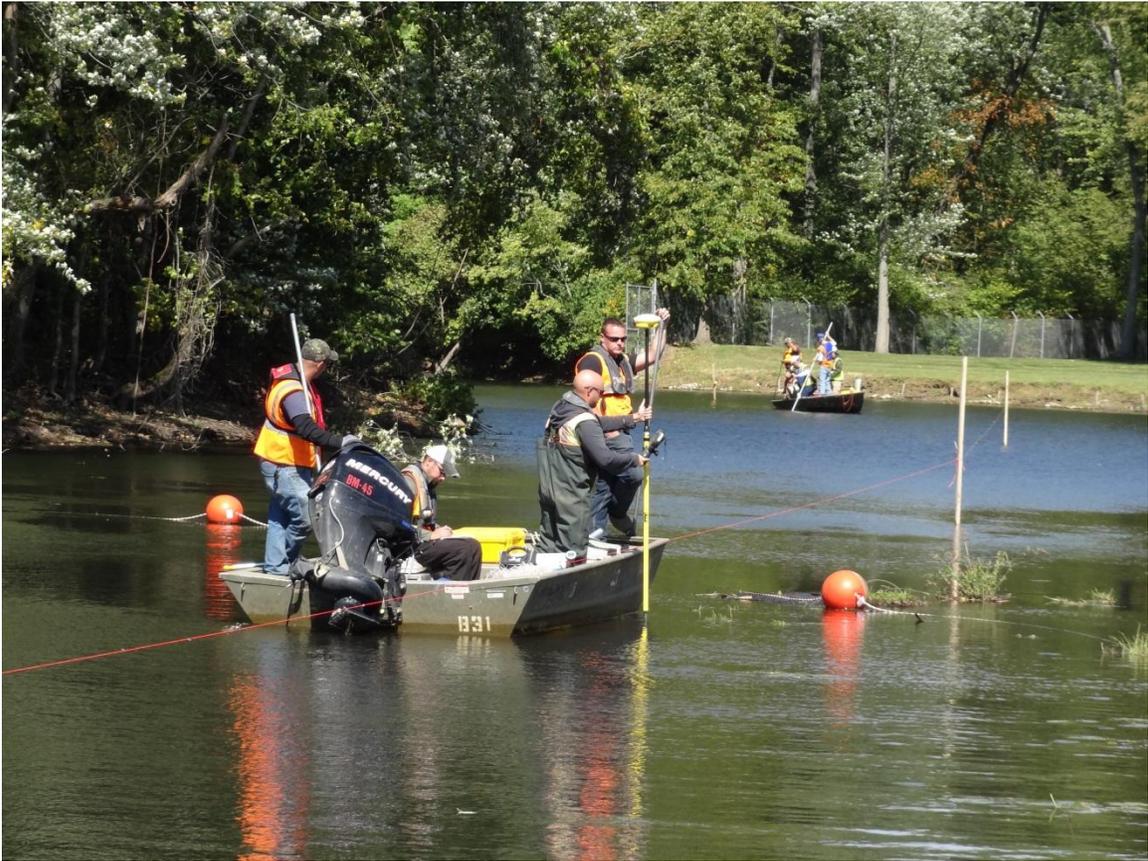
17. MP21.50 Sediment Trap Bathymetry survey crews observed.

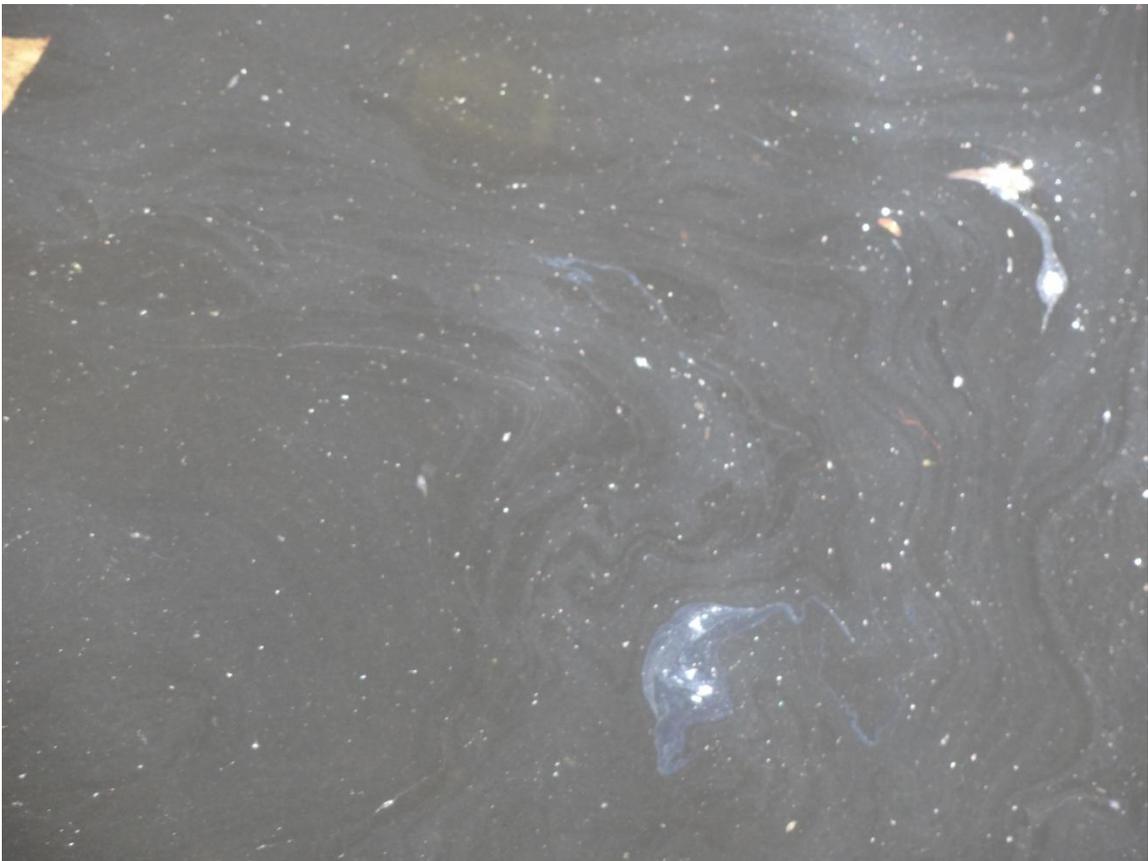
18. MP21.50 RDB sheen and tar globs observed upstream of Custer Road Bridge.

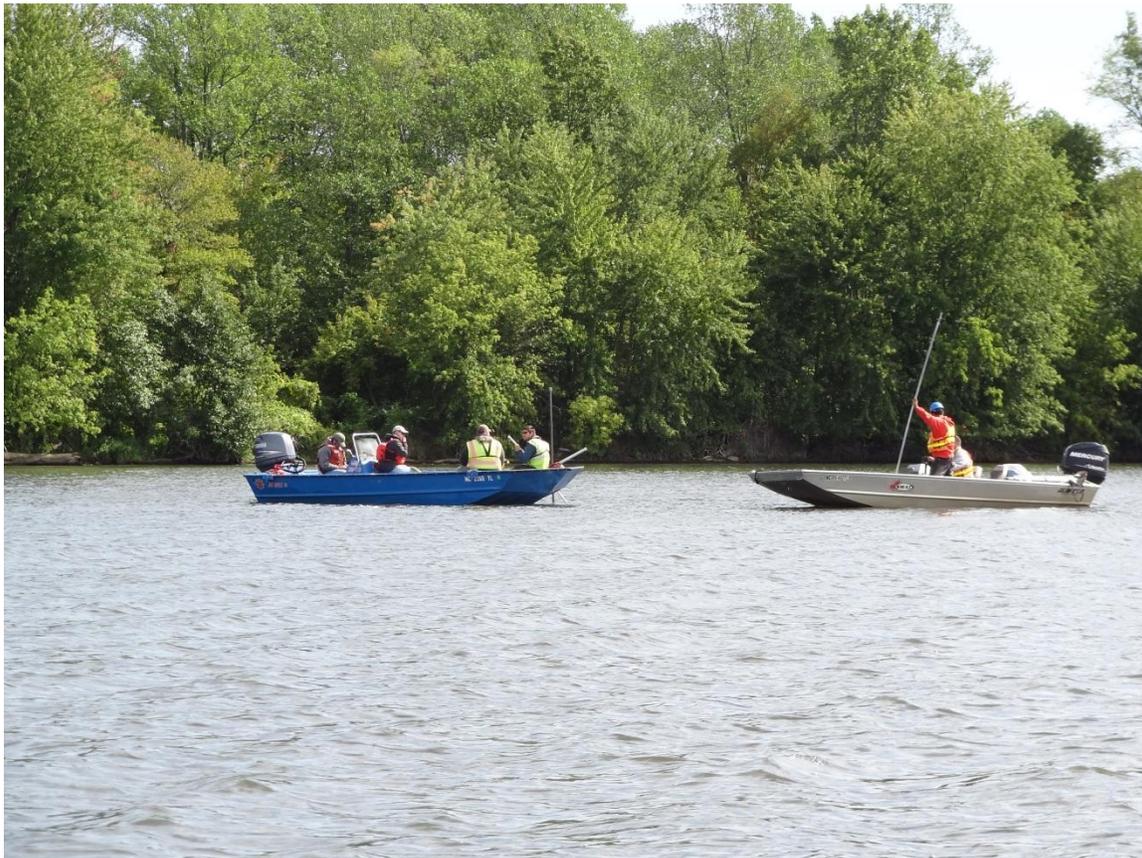
19. Morrow Lake South Cove poling crew observed.

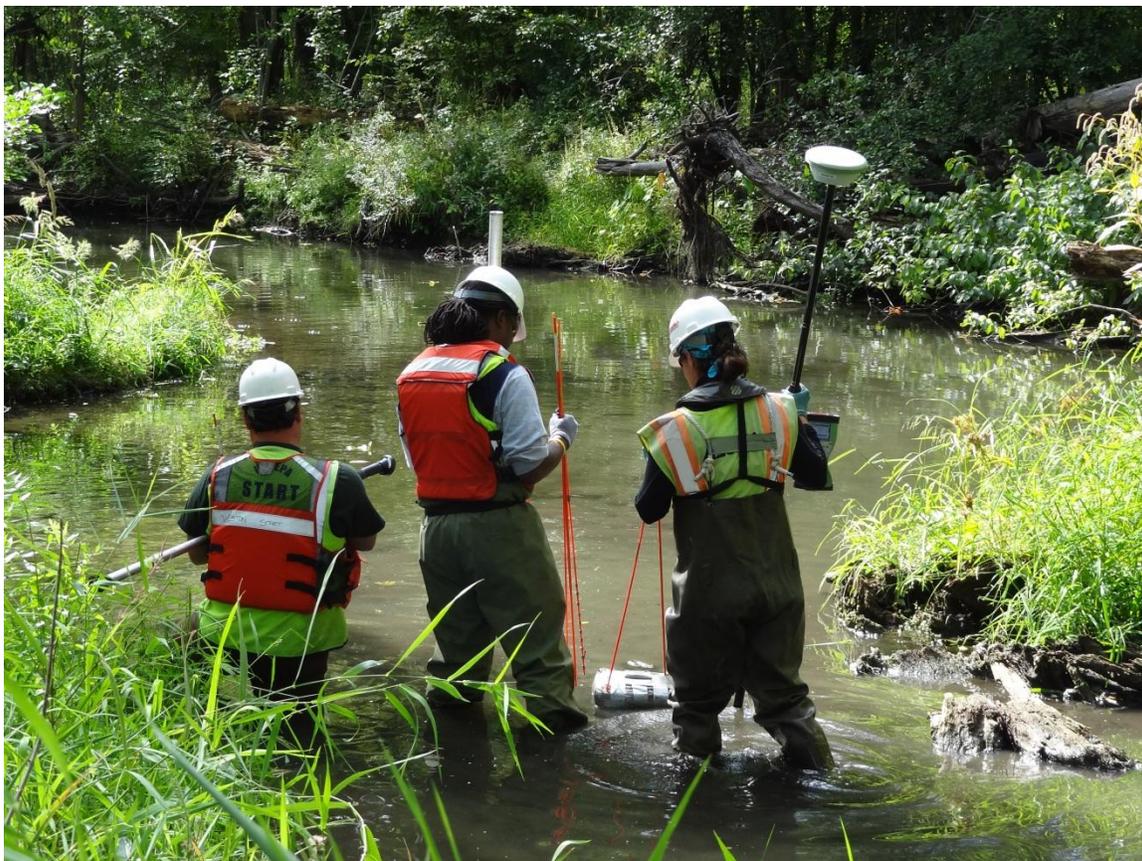
20. MP36.1 Sediment Trap Bathymetry survey crew observed.

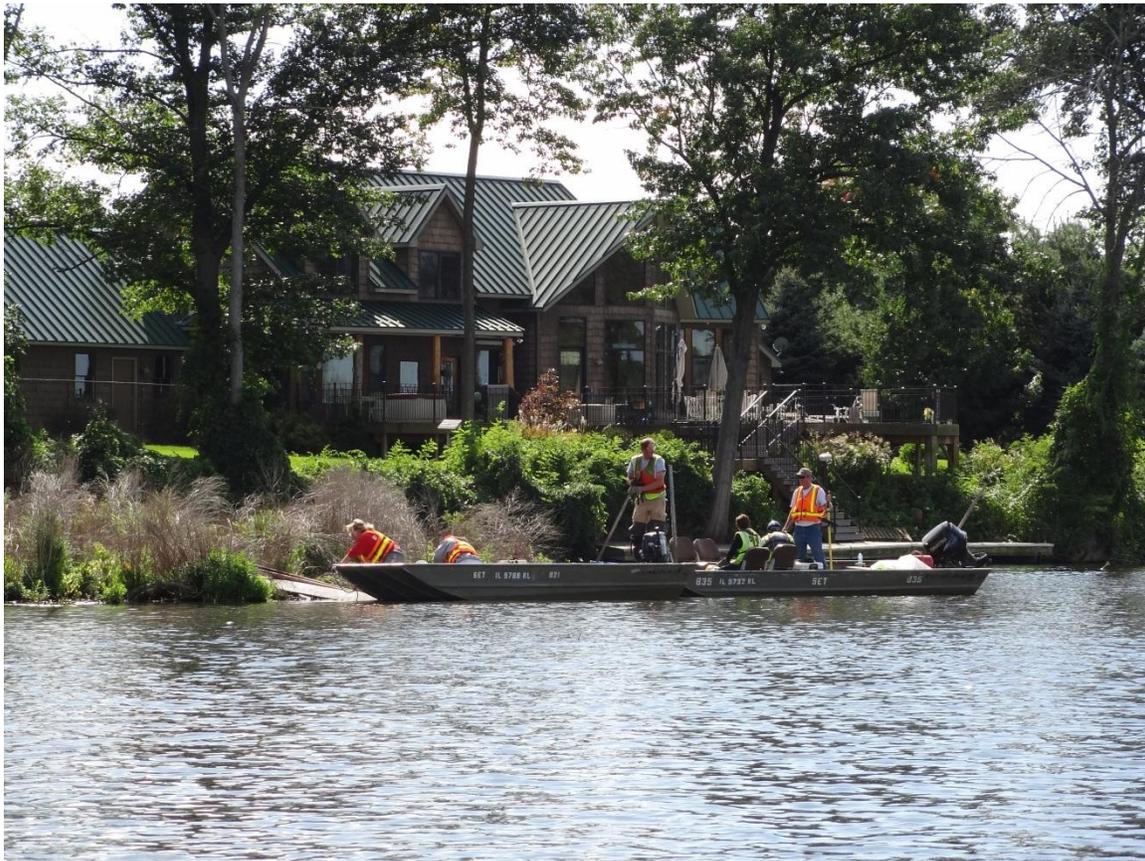
21. Morrow Lake Delta Bathymetry survey crew observed.

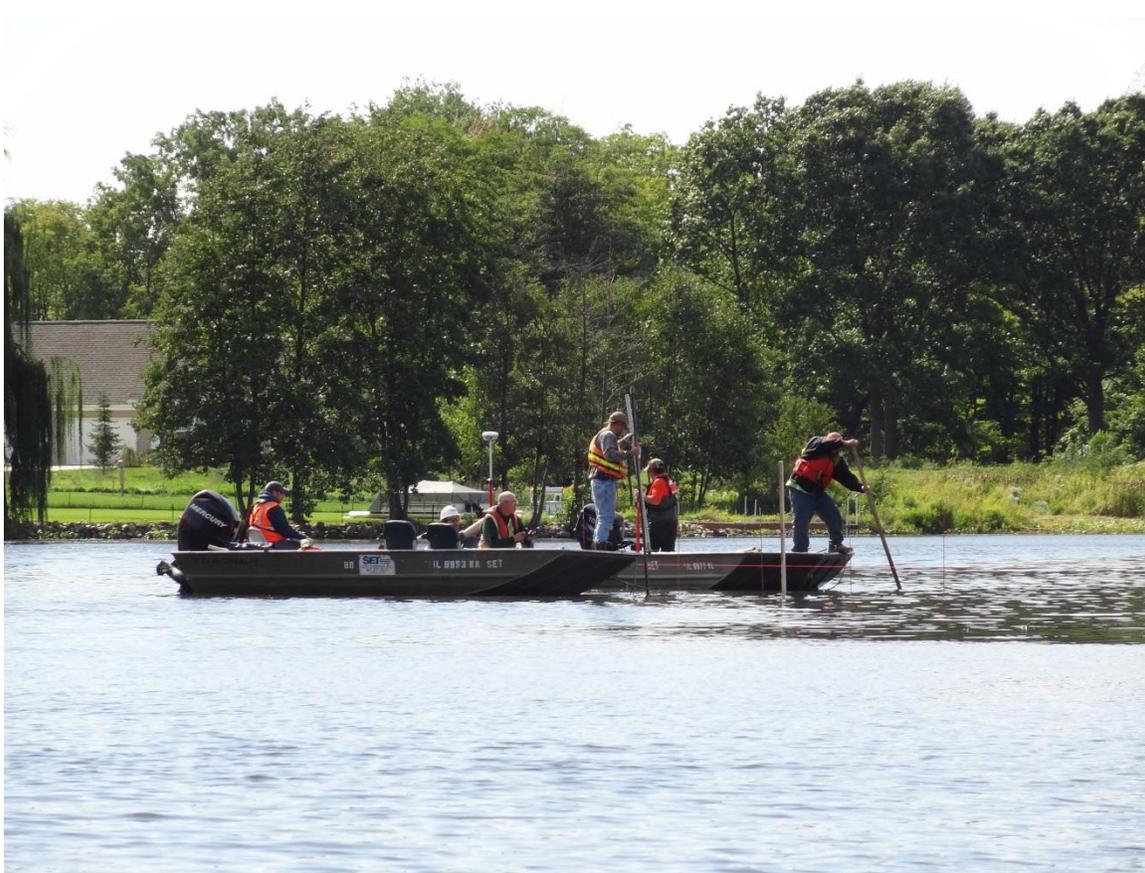
22. Morrow Lake Delta Bathymetry survey crew observed.

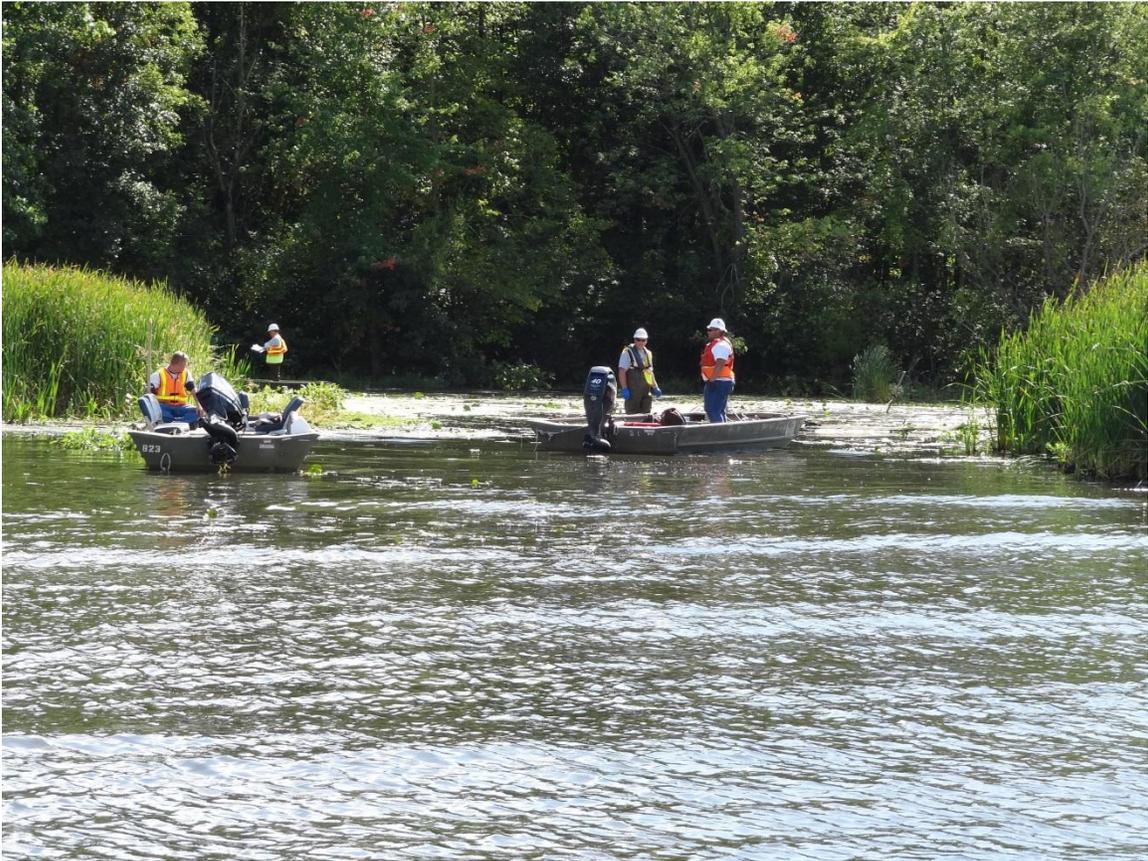
23. Morrow Lake MP37.75 Island Bathymetry survey crew observed.
