Situation Photo Log

Wednesday, September 19, 2012

Kalamazoo River / Enbridge Spill

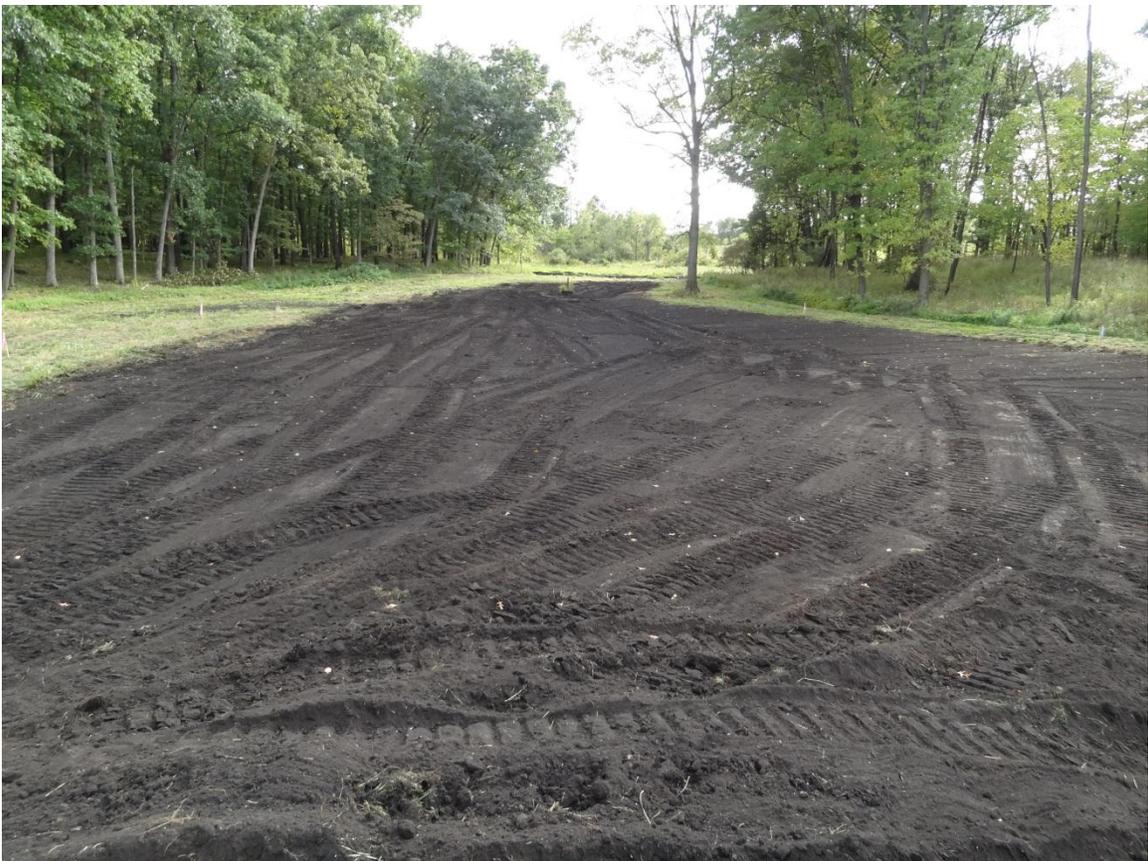
24. Swale area at Source.

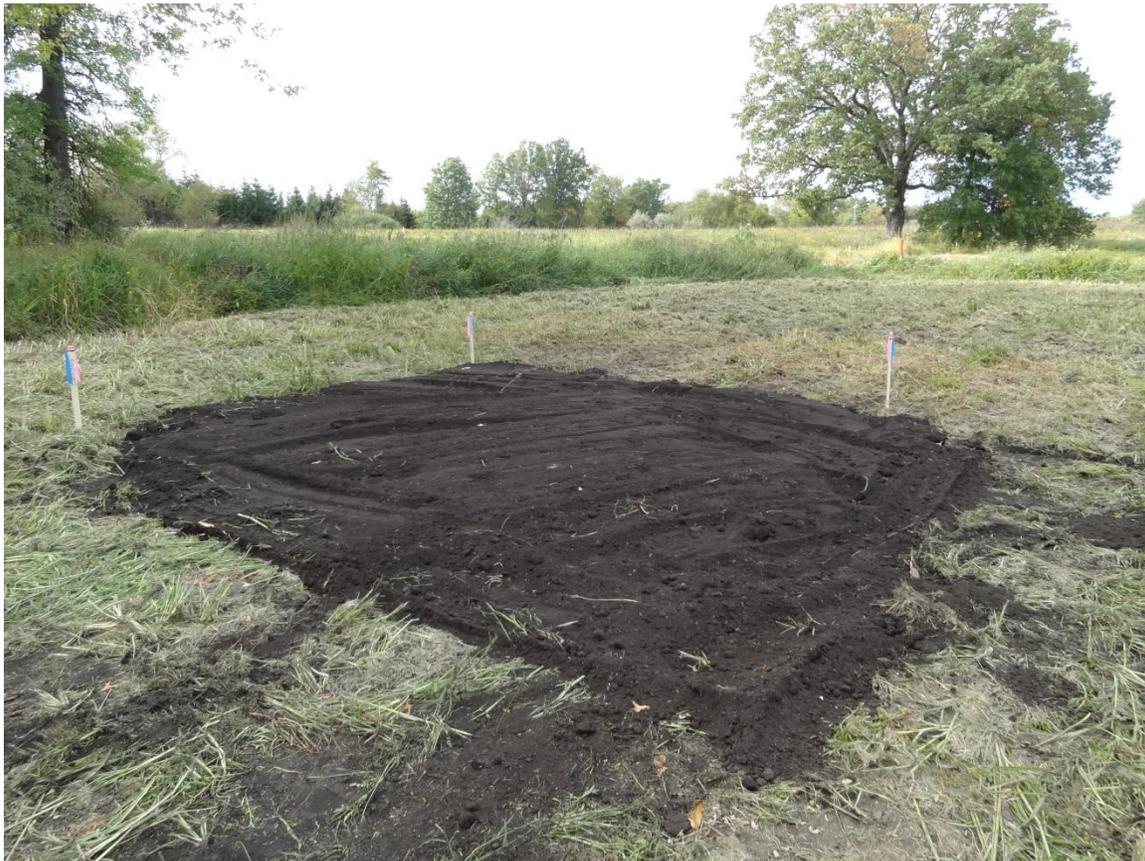
25. Excavated area in southwest corner at Source.

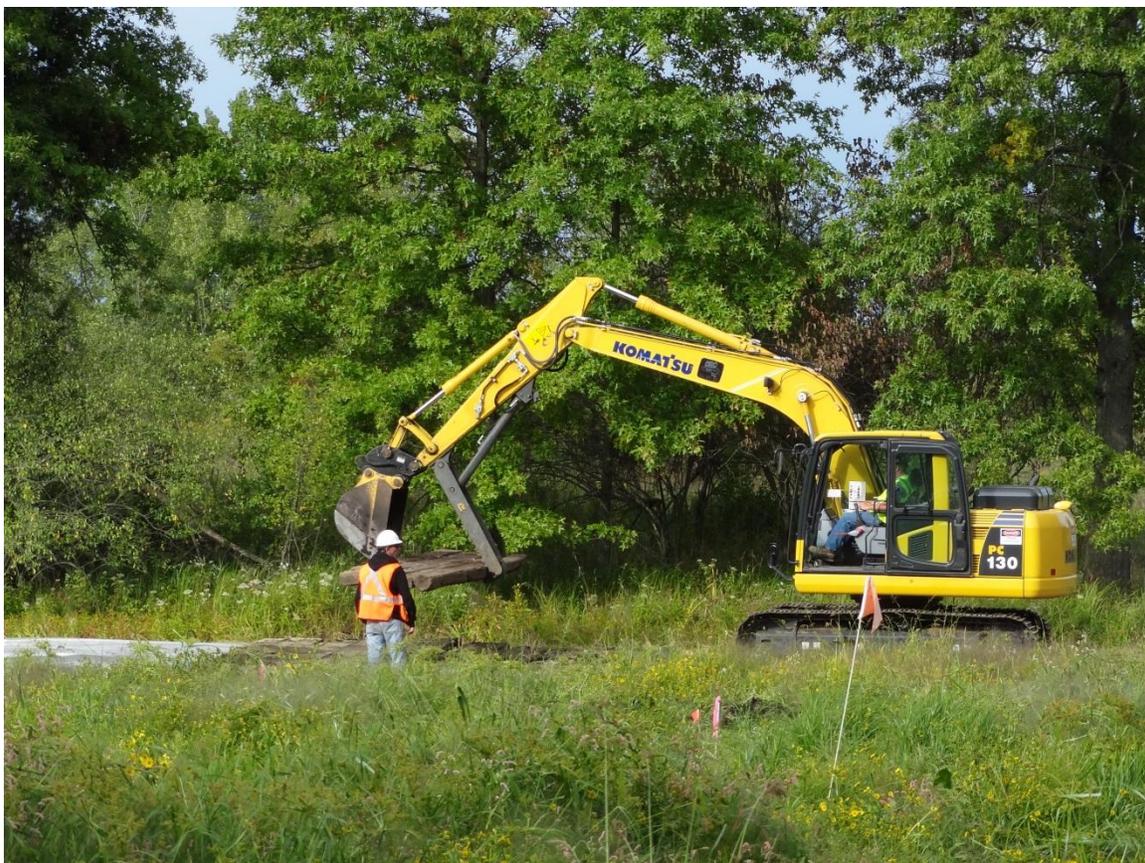
26. Placing of mats at Source for access to excavation locations.
