Situation Photo Log

Friday, September 21, 2012

Kalamazoo River / Enbridge Spill

Prepared by:
Matthew Haak
START-USEPA
Situation Unit Leader

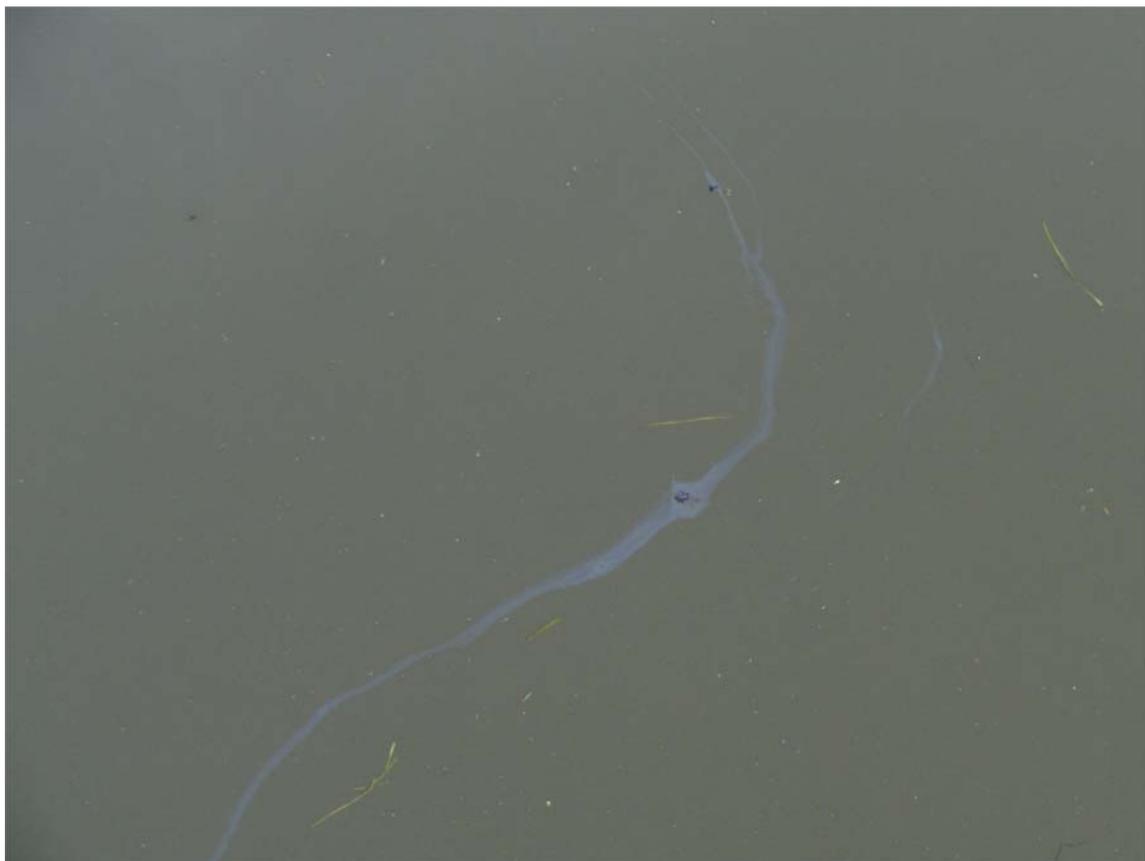
1. MP5.40 LDB sheen and tar globs were observed.

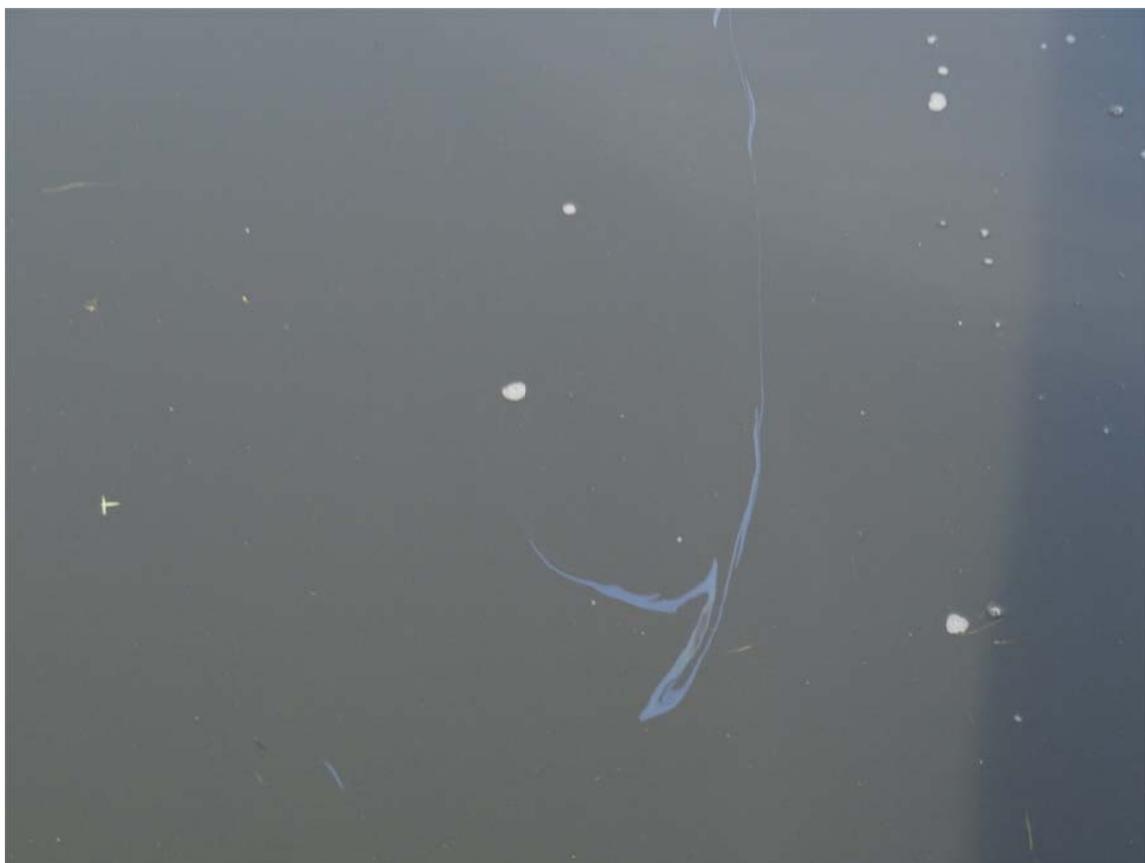
2. MP5.45 LDB observed sheen and tar globs.

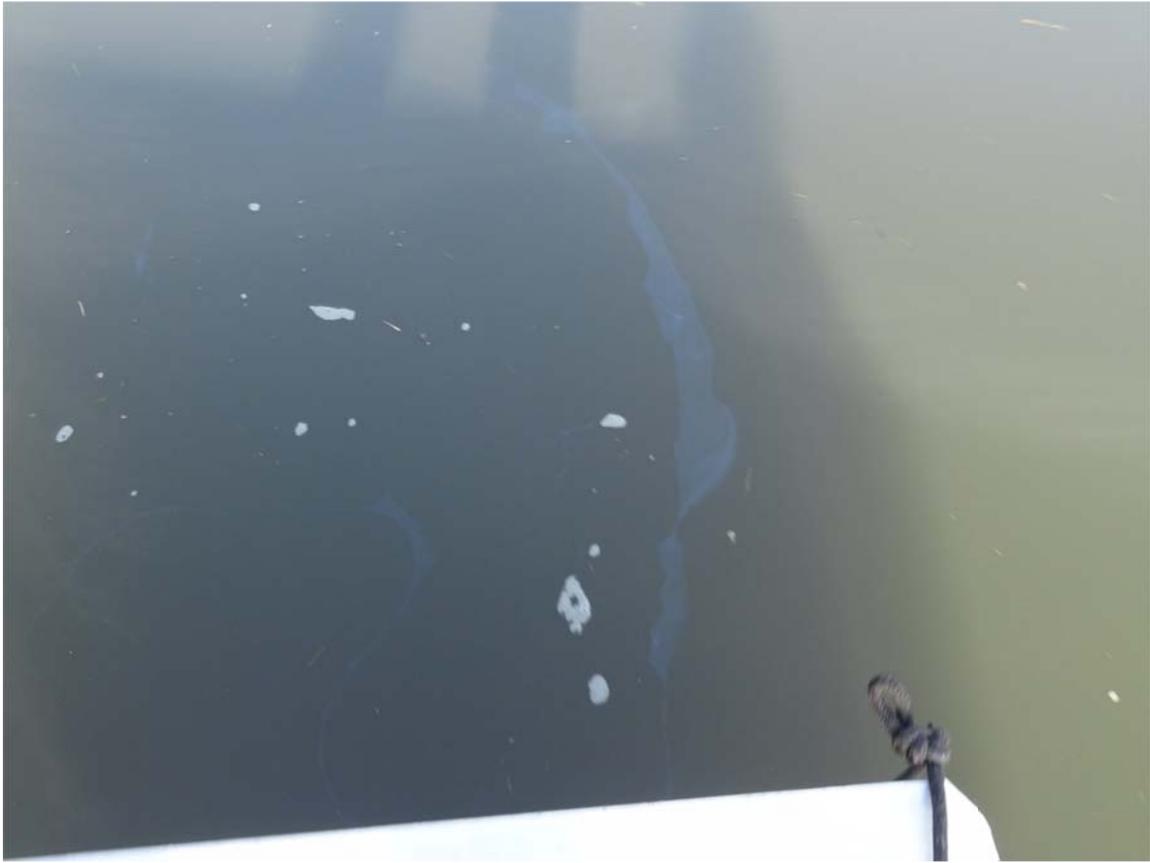
3. MP5.55 LDB observed sheen and tar globs.

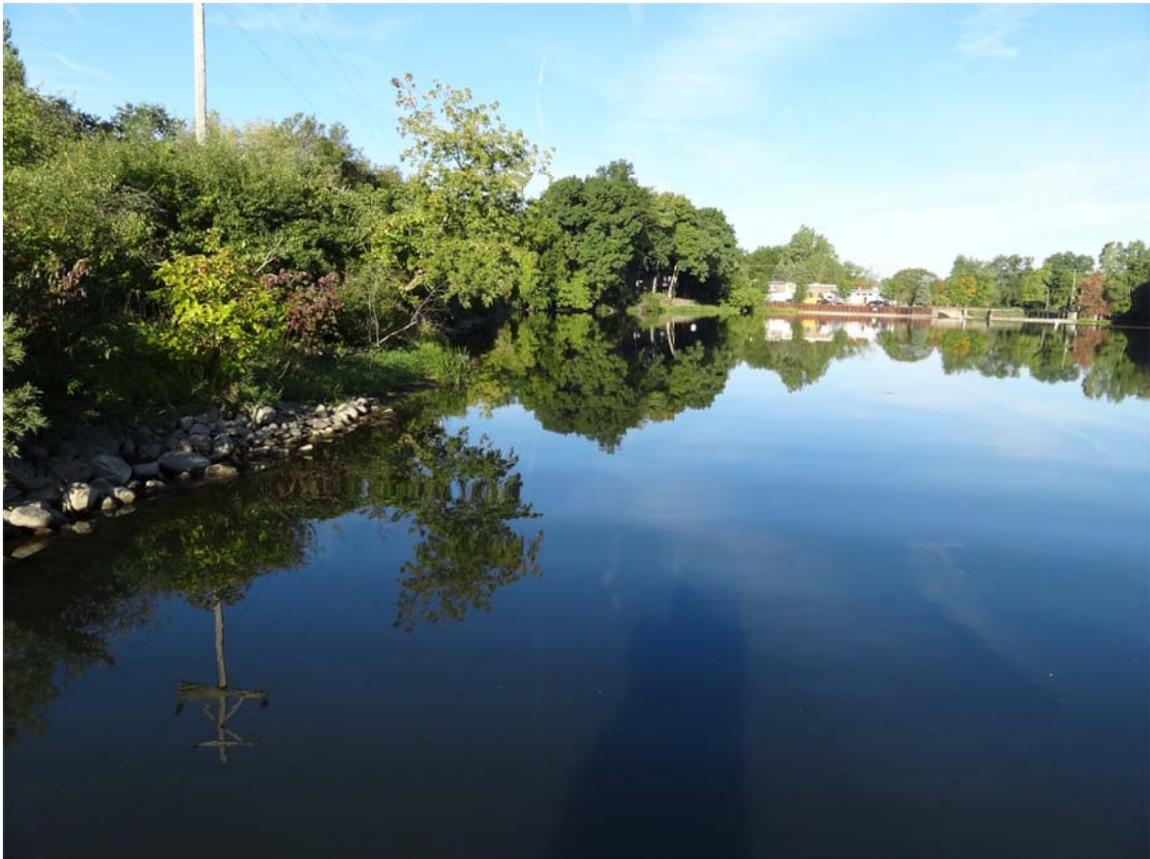
4. MP5.63 LDB area where sheen and tar globs were observed.

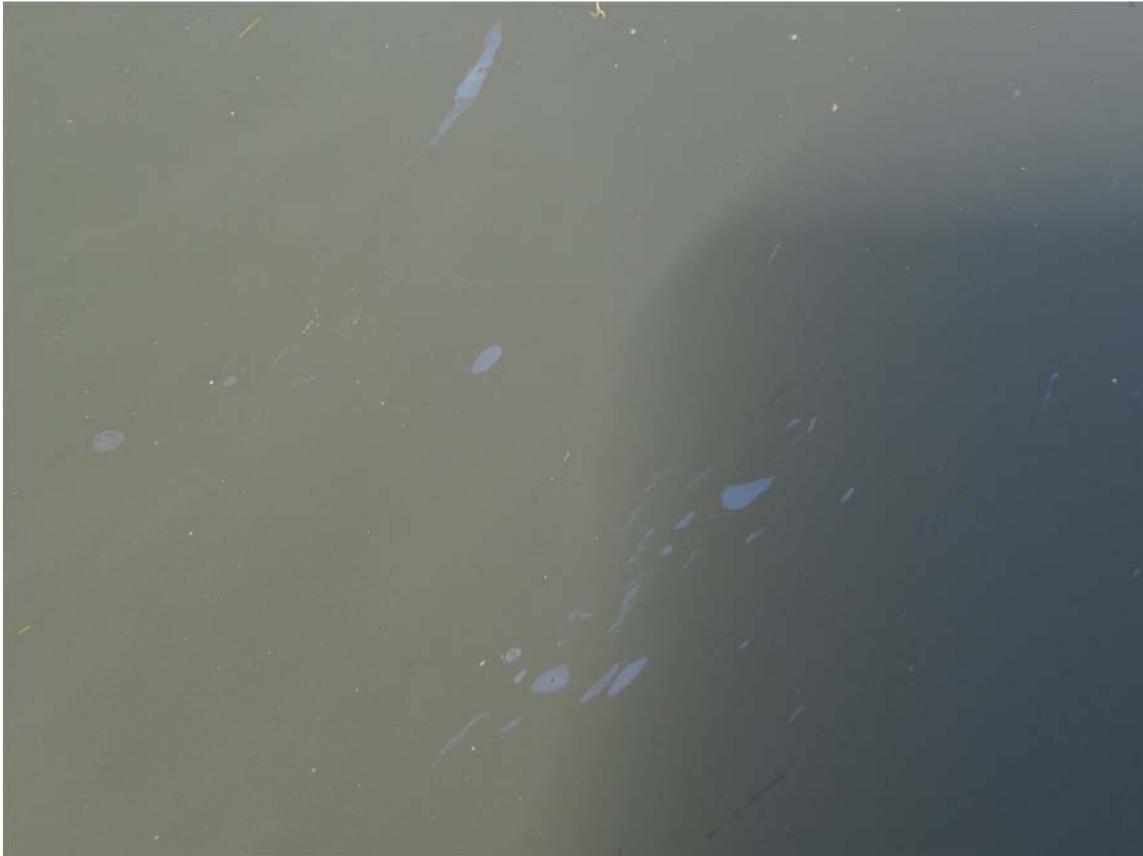
5. MP5.63 LDB observed sheen and tar globs.

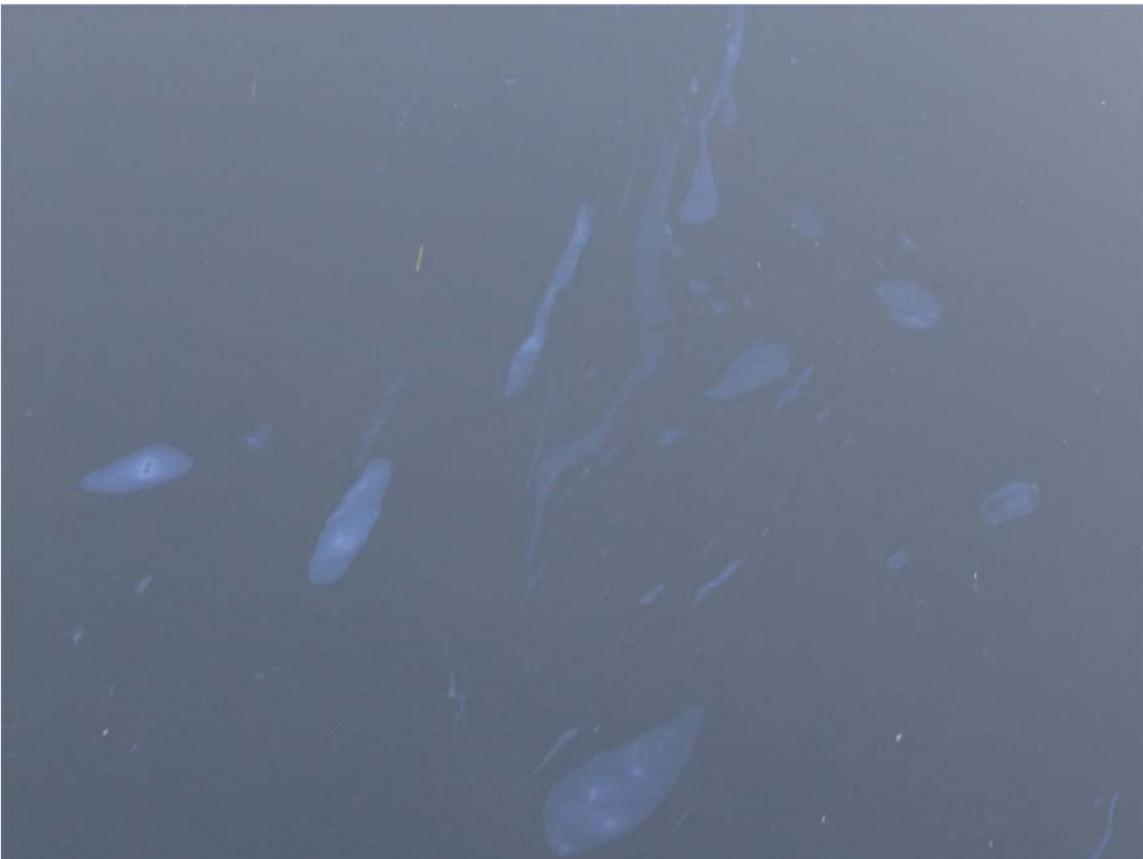
6. MP5.63 LDB observed sheen and tar globs.

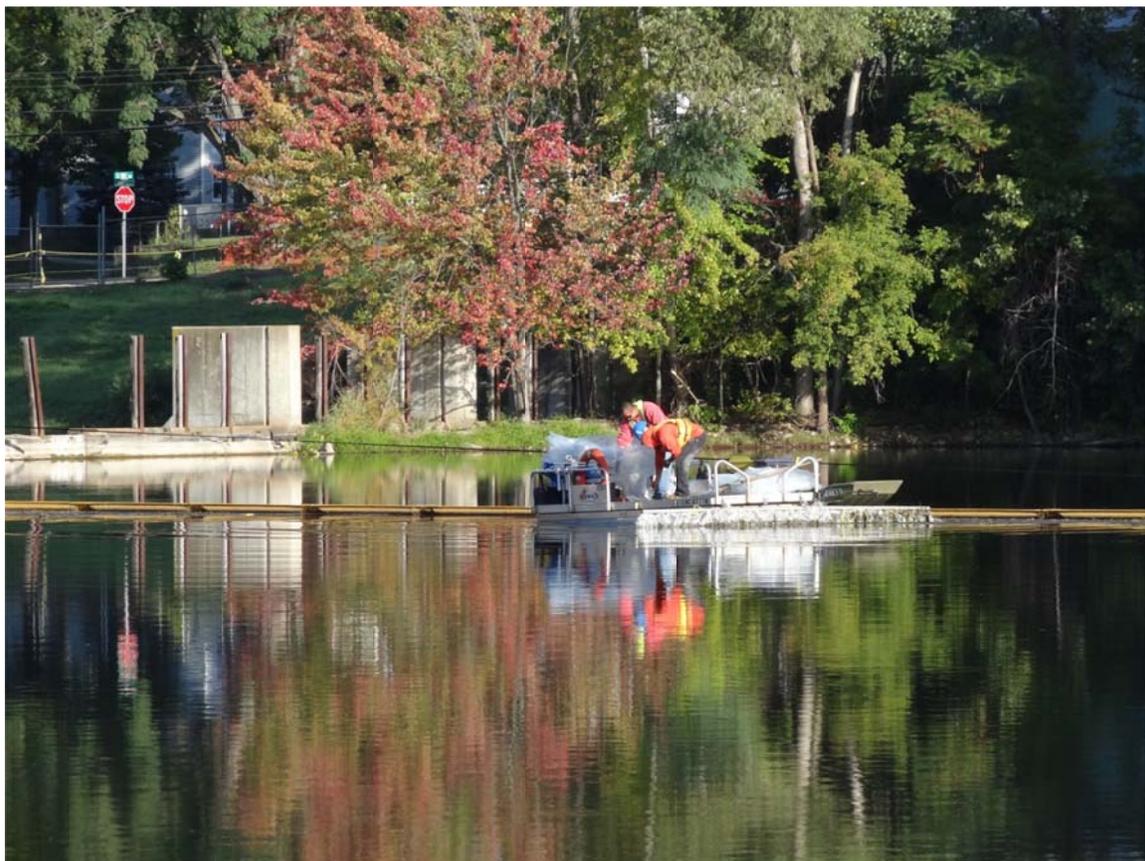
7. Ceresco Dam control point boom observed a crew performing debris removal.

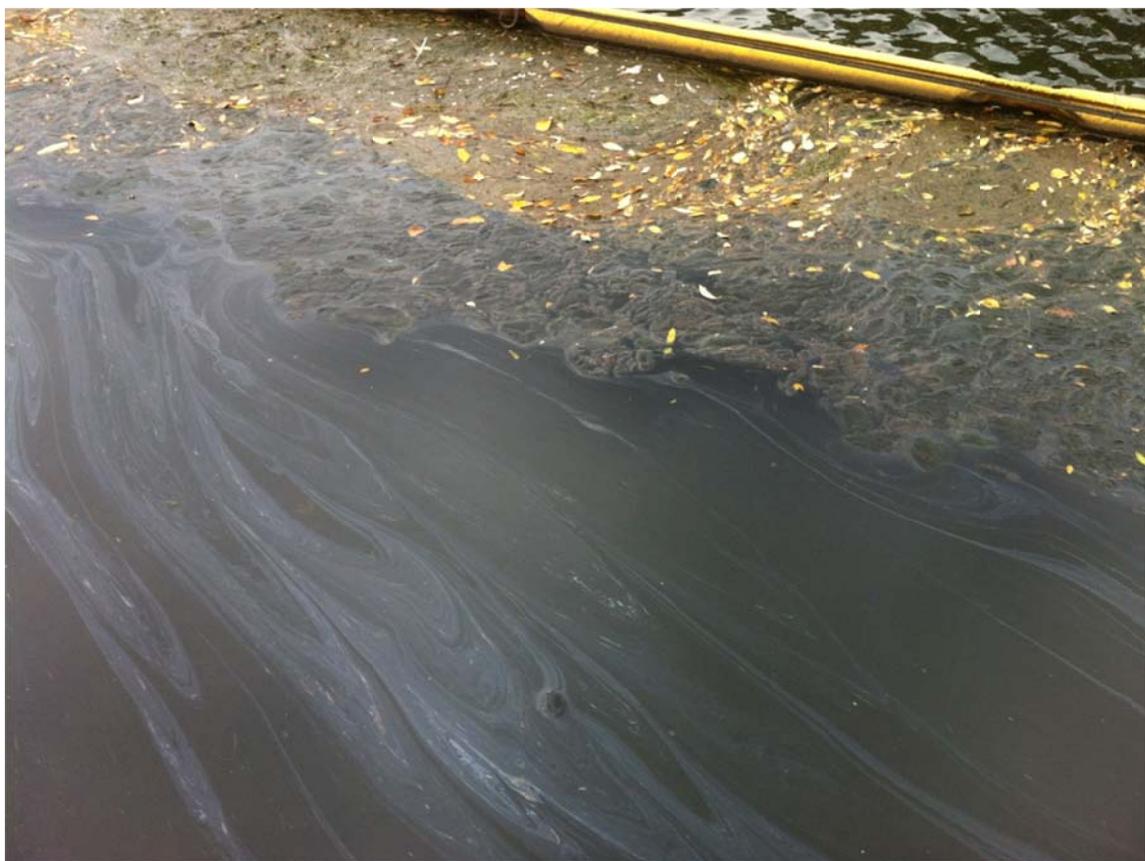
8. MP5.75 observed sheen and tar globs collecting along the control point boom.

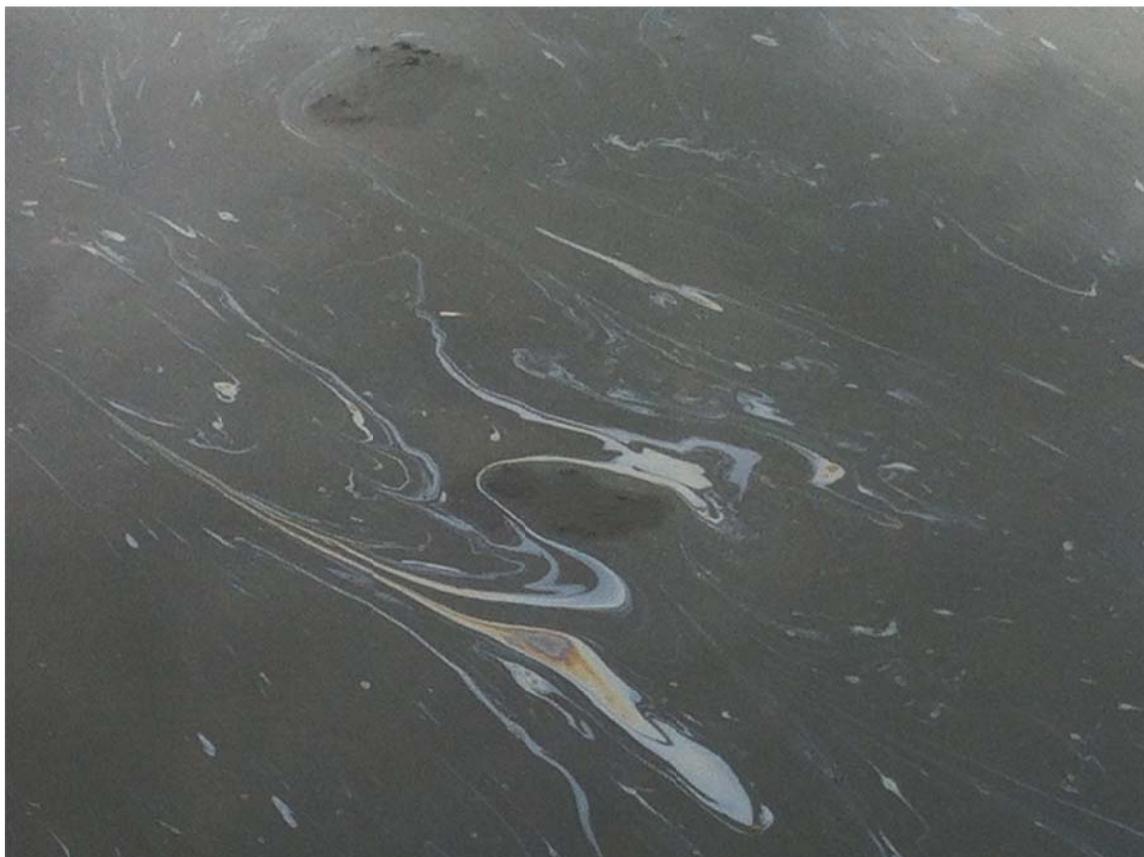
9. MP5.75 observed sheen and tar globs collecting along the control point boom.

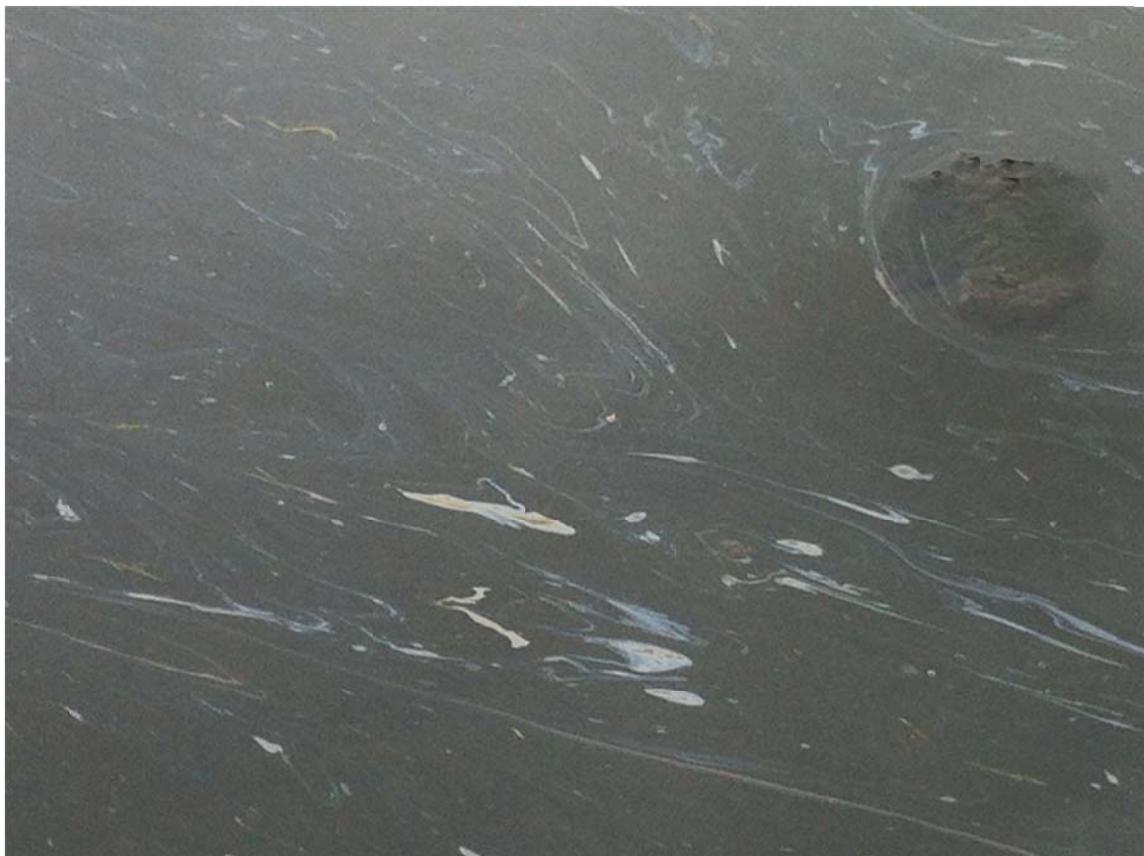
10. MP5.75 observed sheen and tar globs collecting along the control point boom.

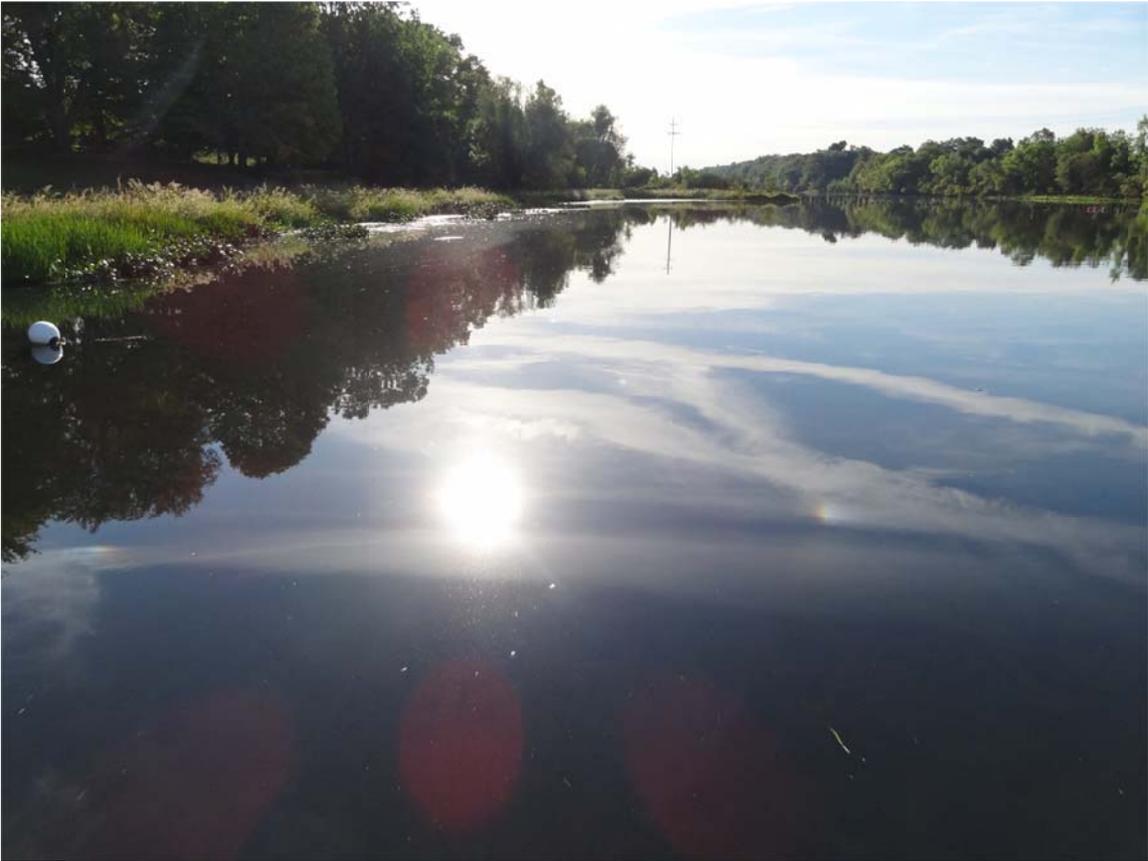
11. MP5.65 RDB area where sheen and tar globs were observed.

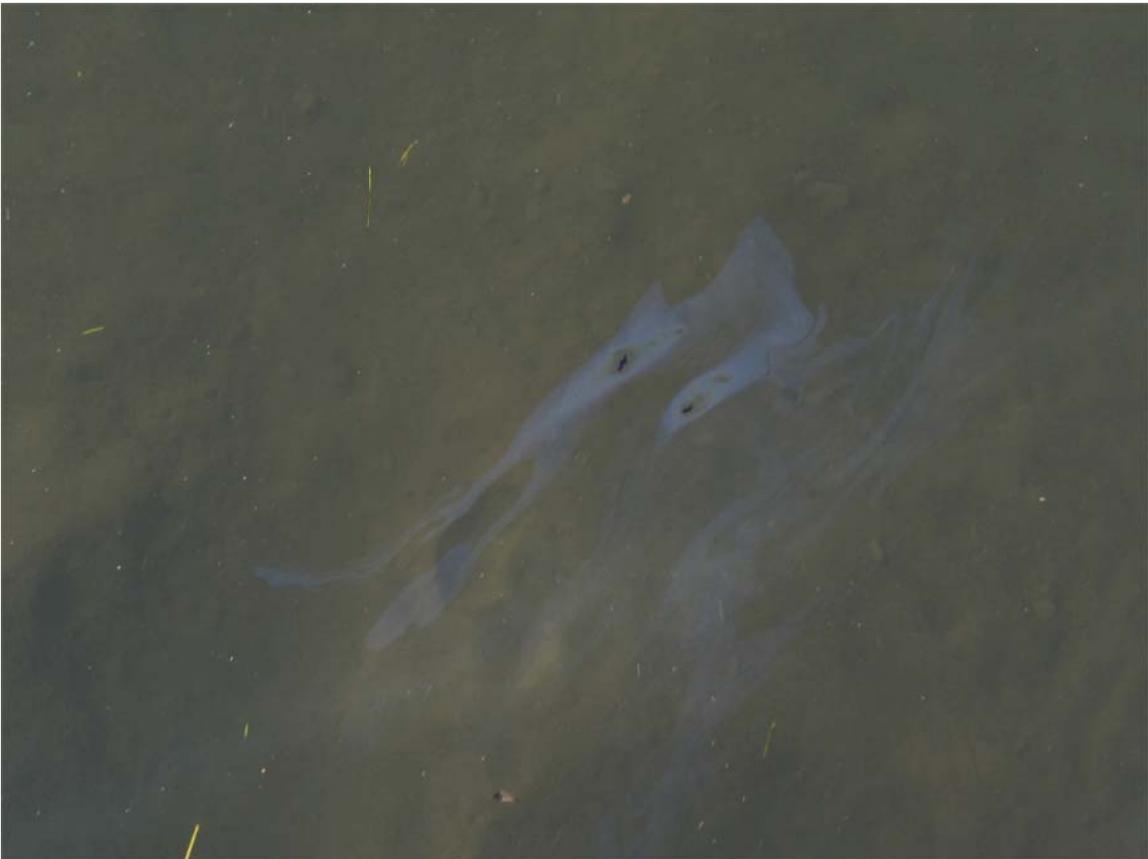
12. MP5.65 RDB observed sheen and tar globs.

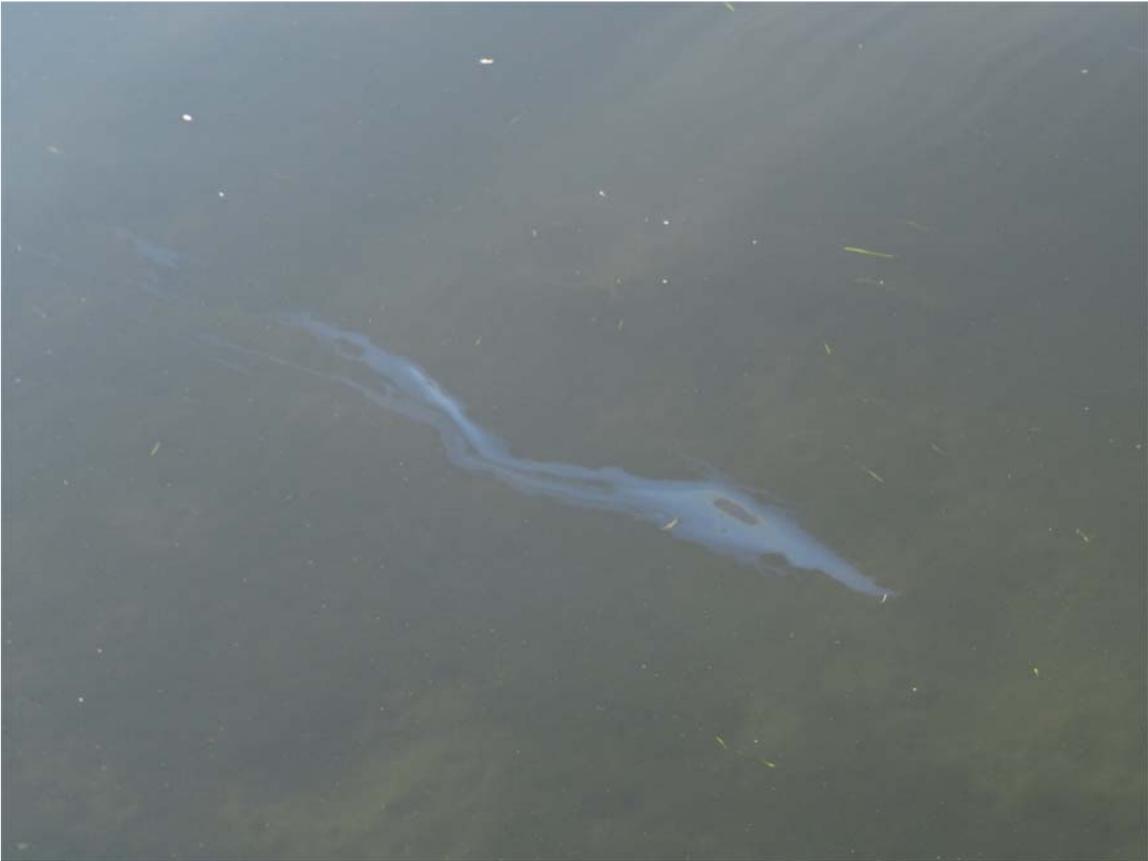
13. MP5.63 RDB observed sheen and tar globs.

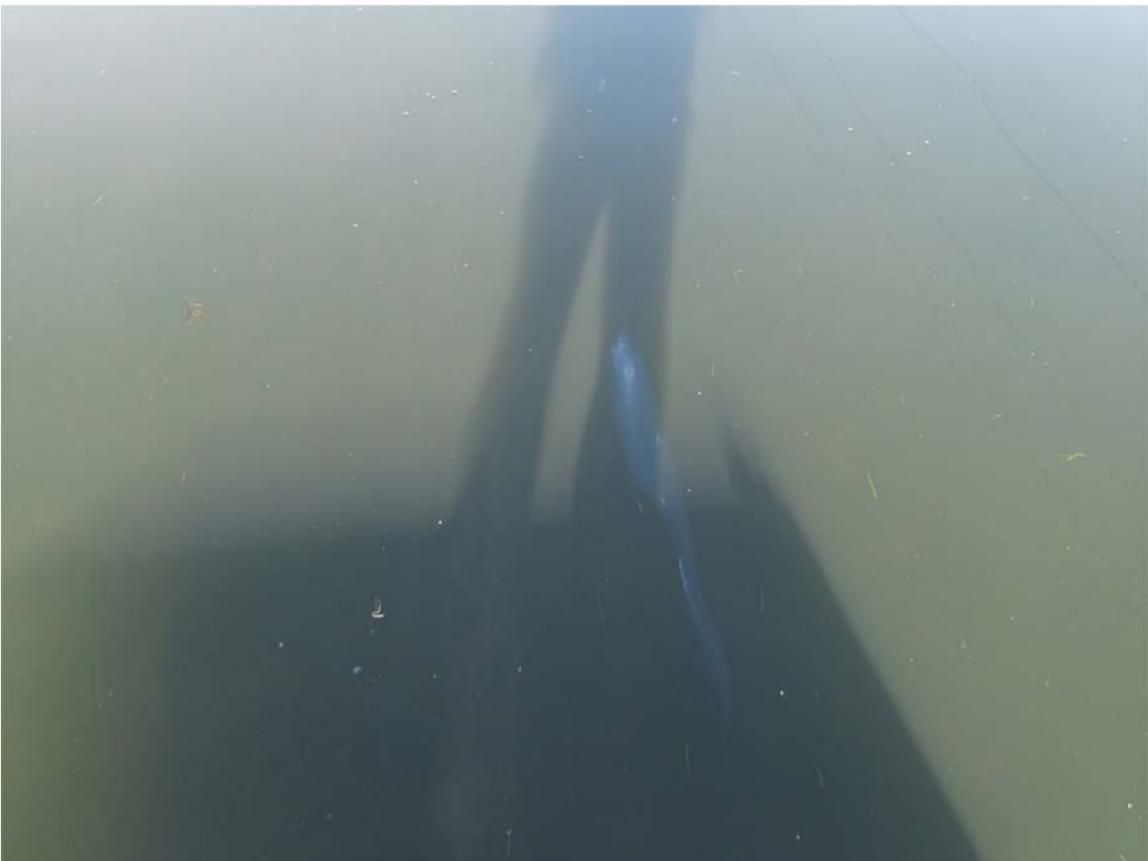
14. MP5.55 RDB sheen and tar globs were observed.

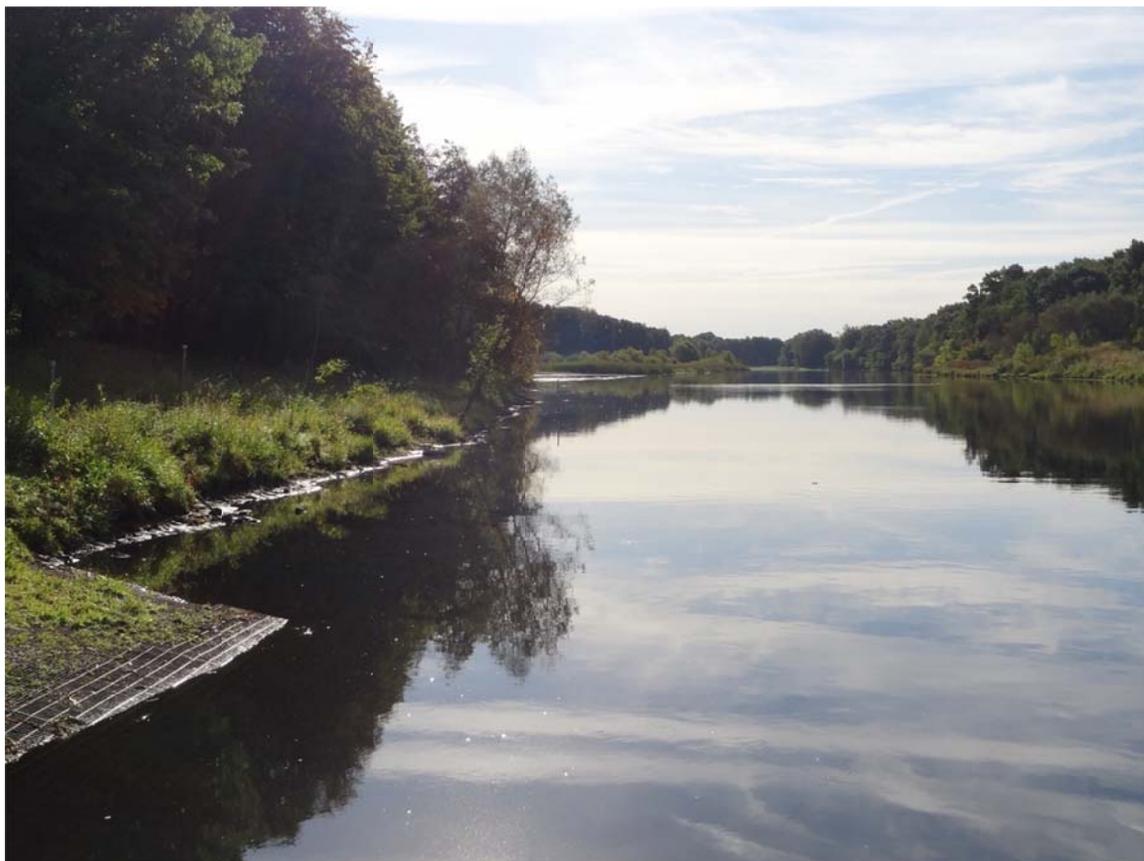
15. MP5.0 – C0.4 boat launch area where sheen was observed.

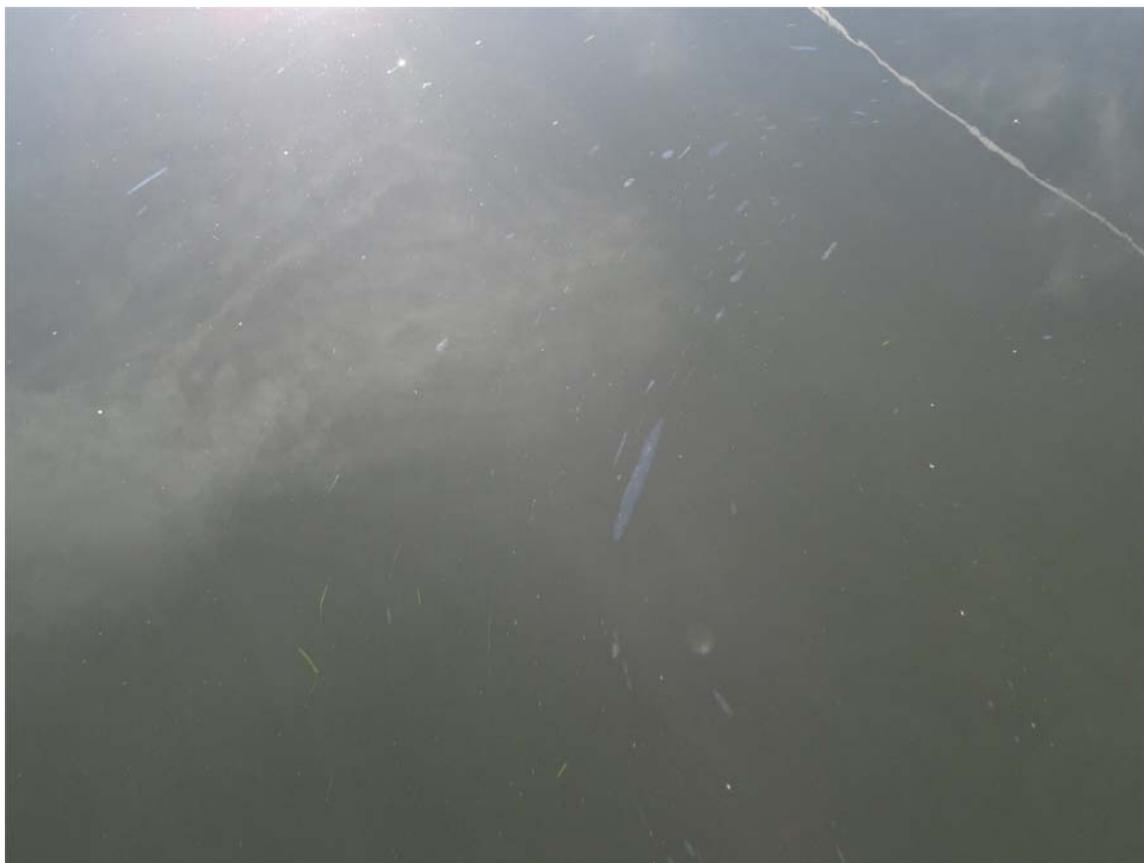
16. MP5.15 RDB sheen and tar globs observed.

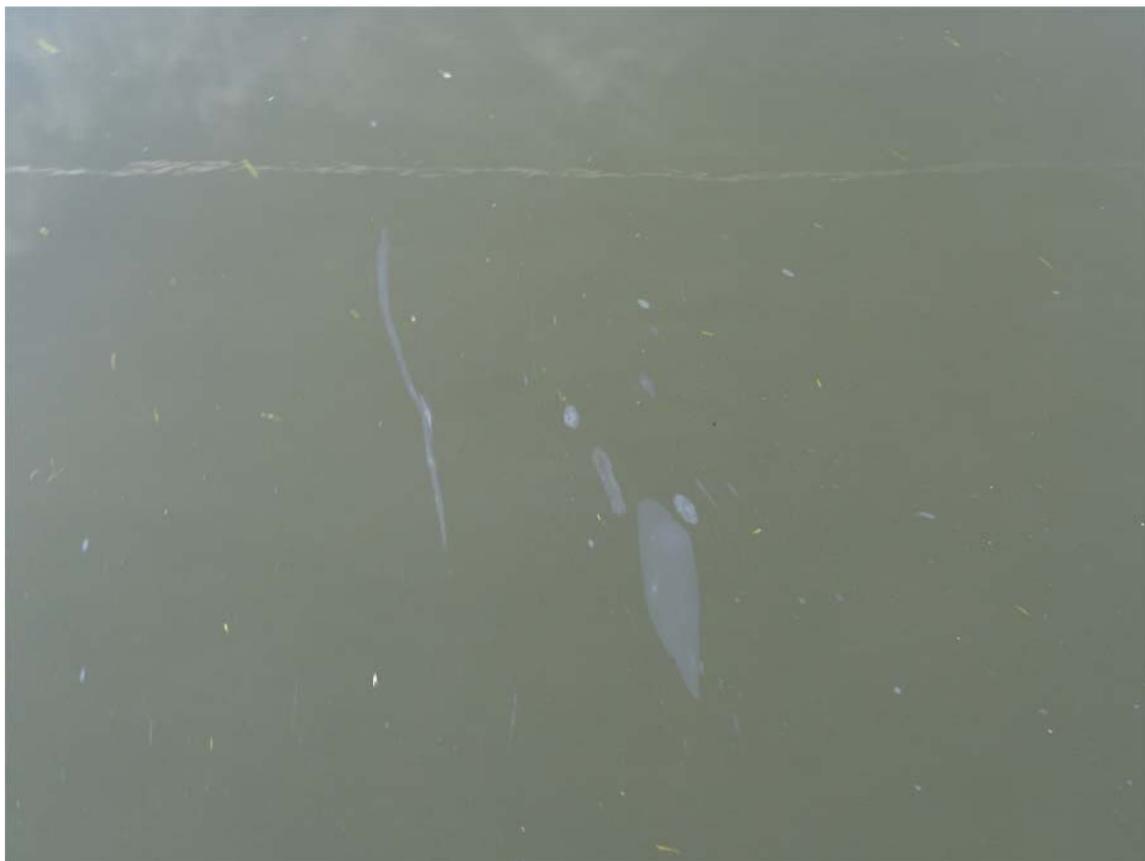
17. MP5.15 RDB sheen and tar globs observed.

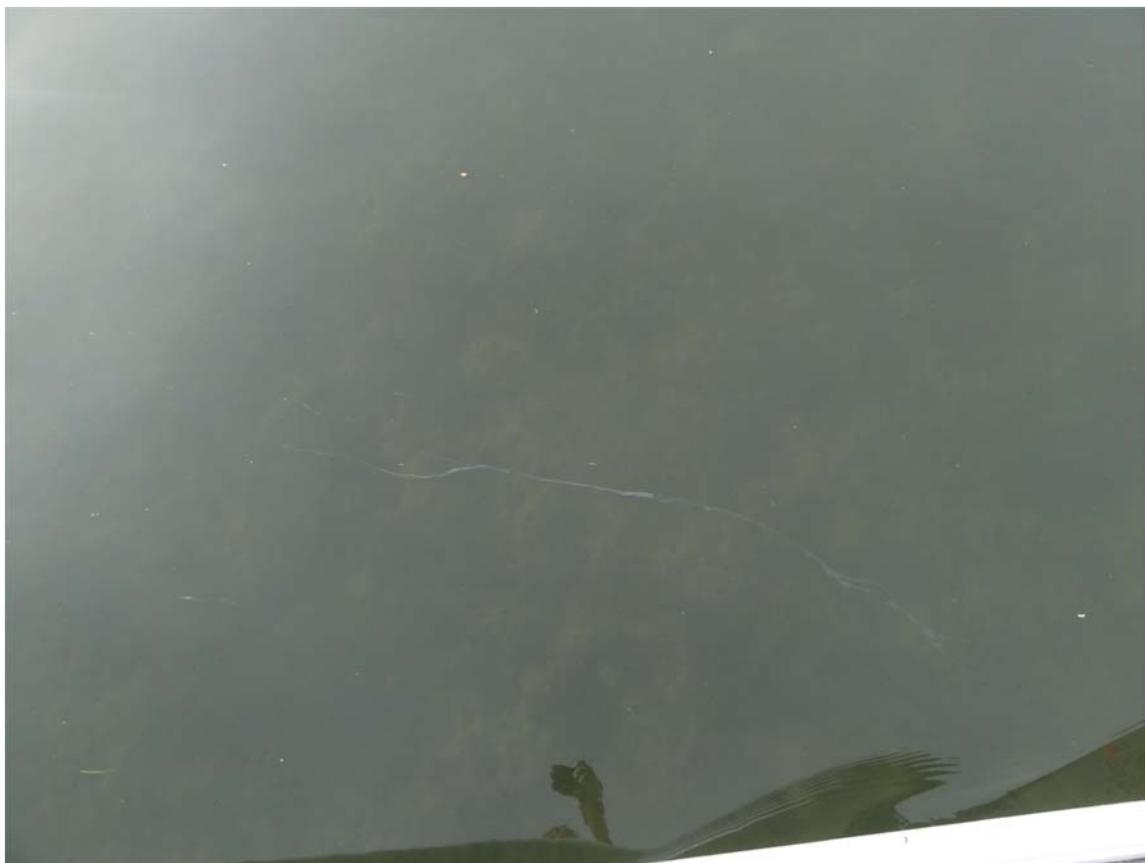
18. MP4.5 center channel observed ribbons of sheen.

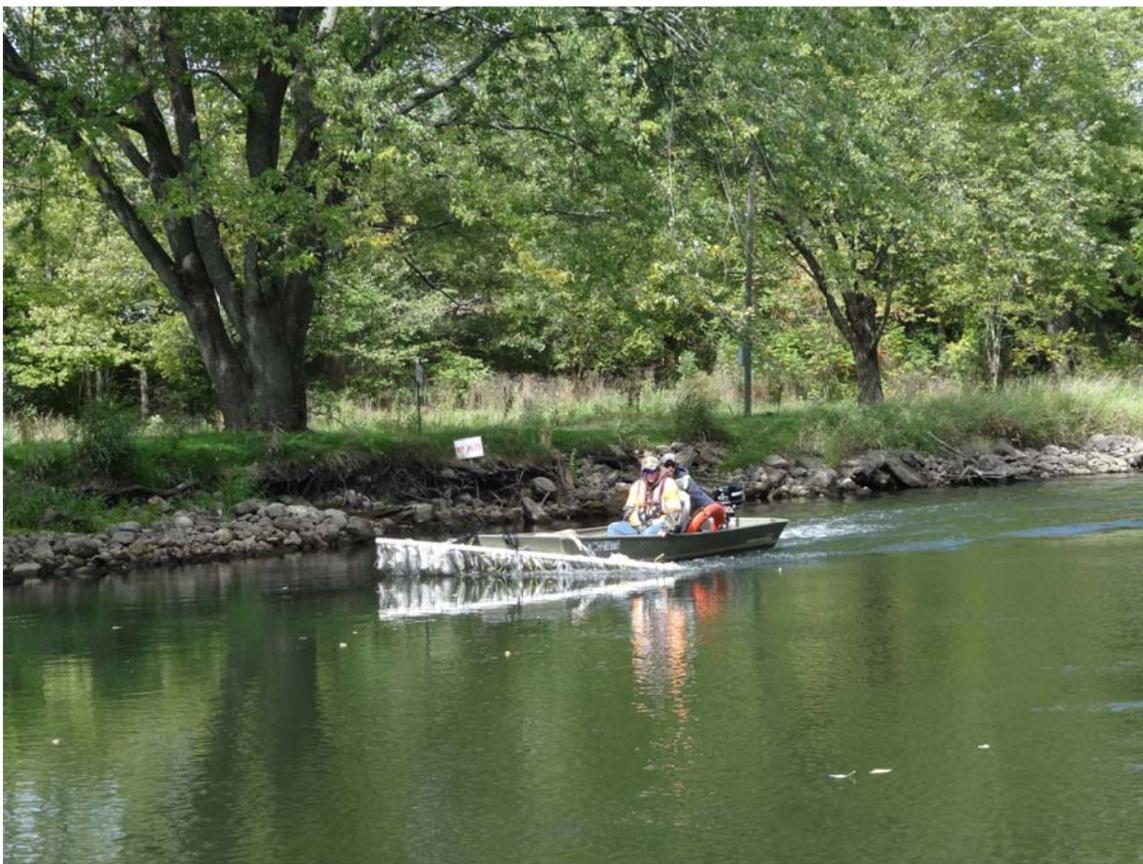
19. Observed the sweep boat operating between MP21.5 – 30.8.

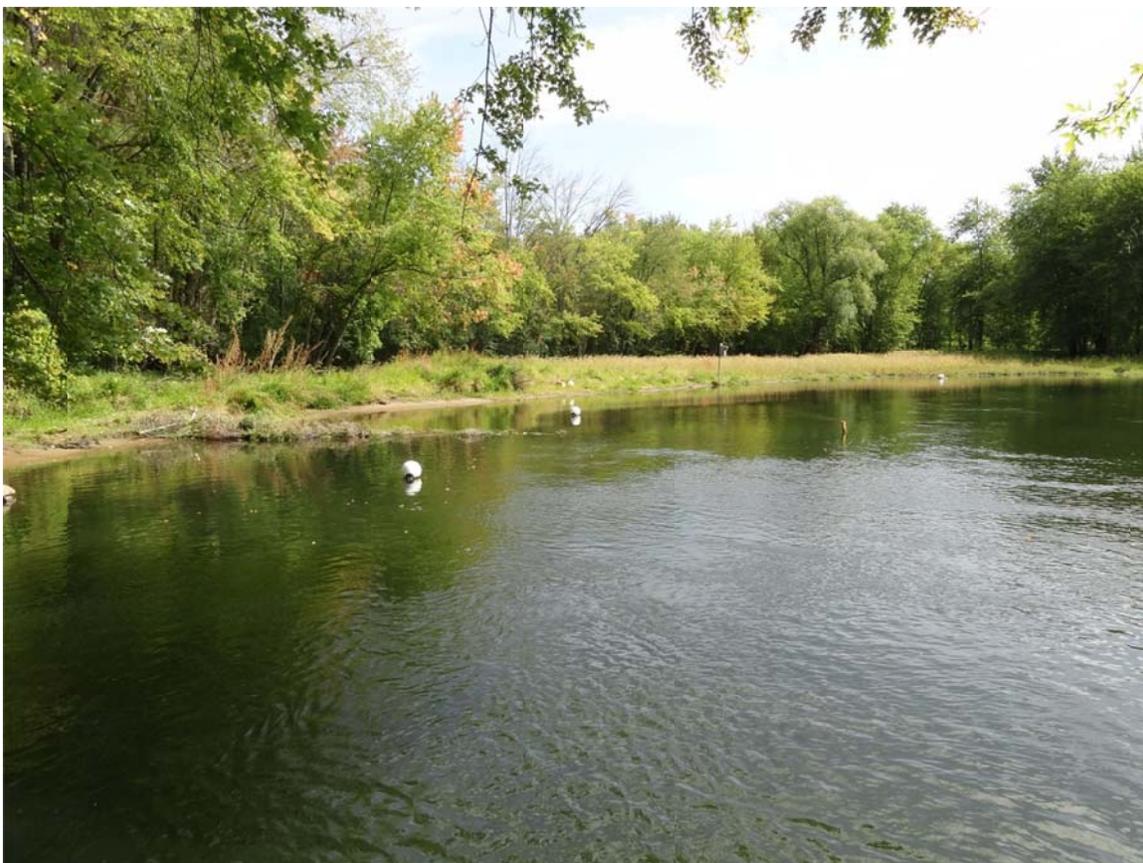
20. MP26.25 sediment trap, no sheen observed.

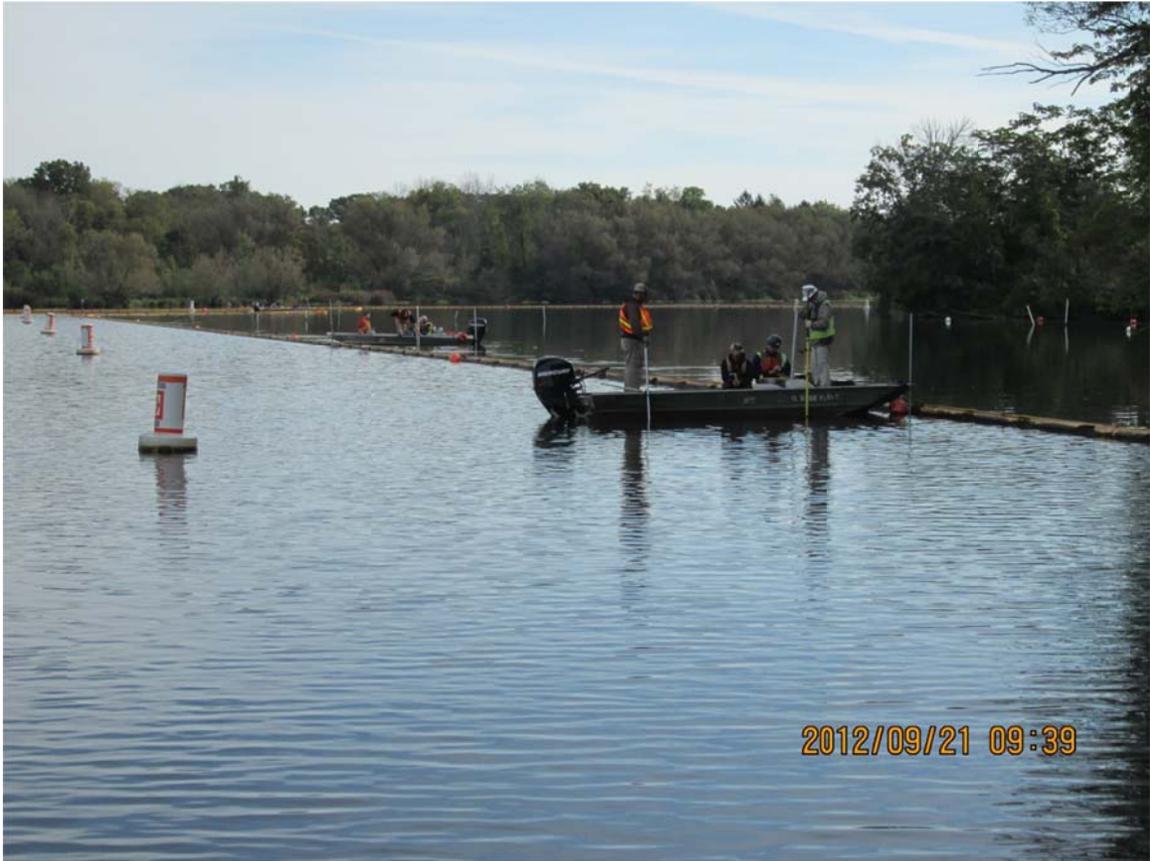
21. Morrow Lake Delta poling crew observed on Gate F.

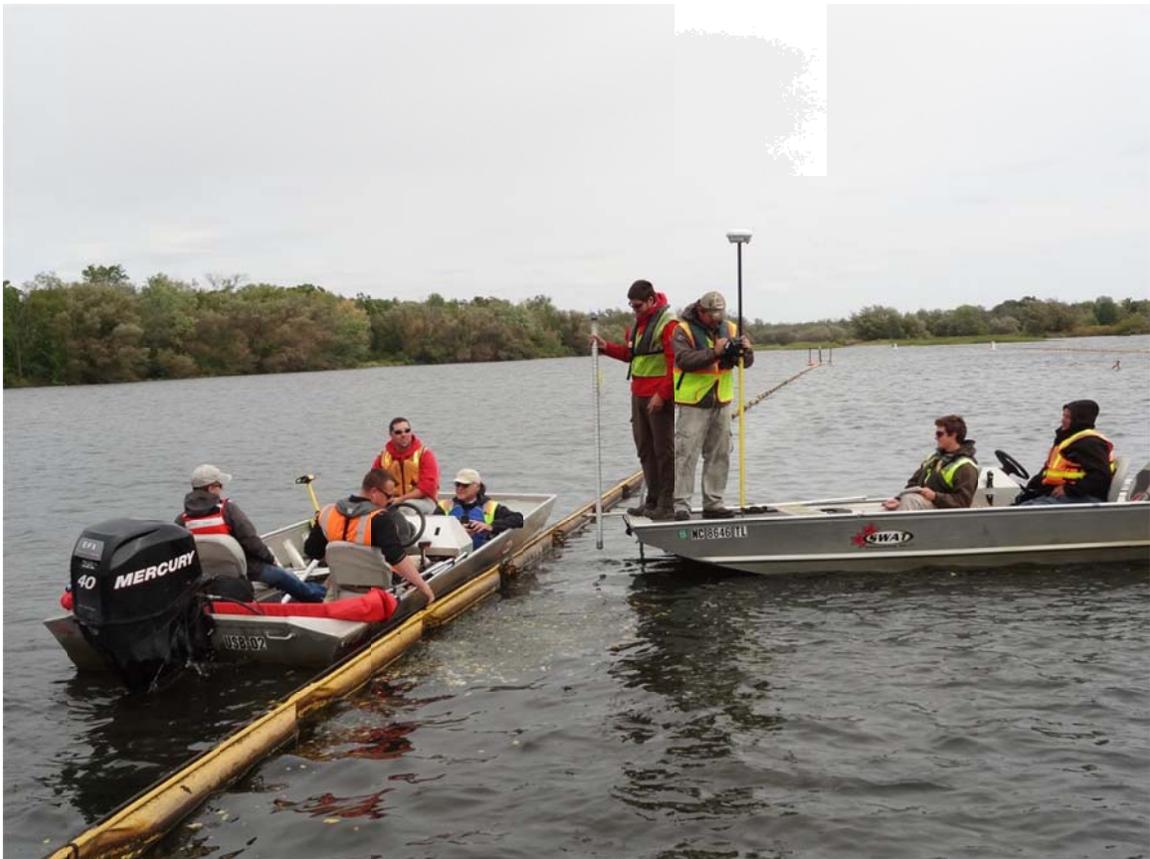
22. Morrow Lake Delta observed a poling crew operating along Gate C.

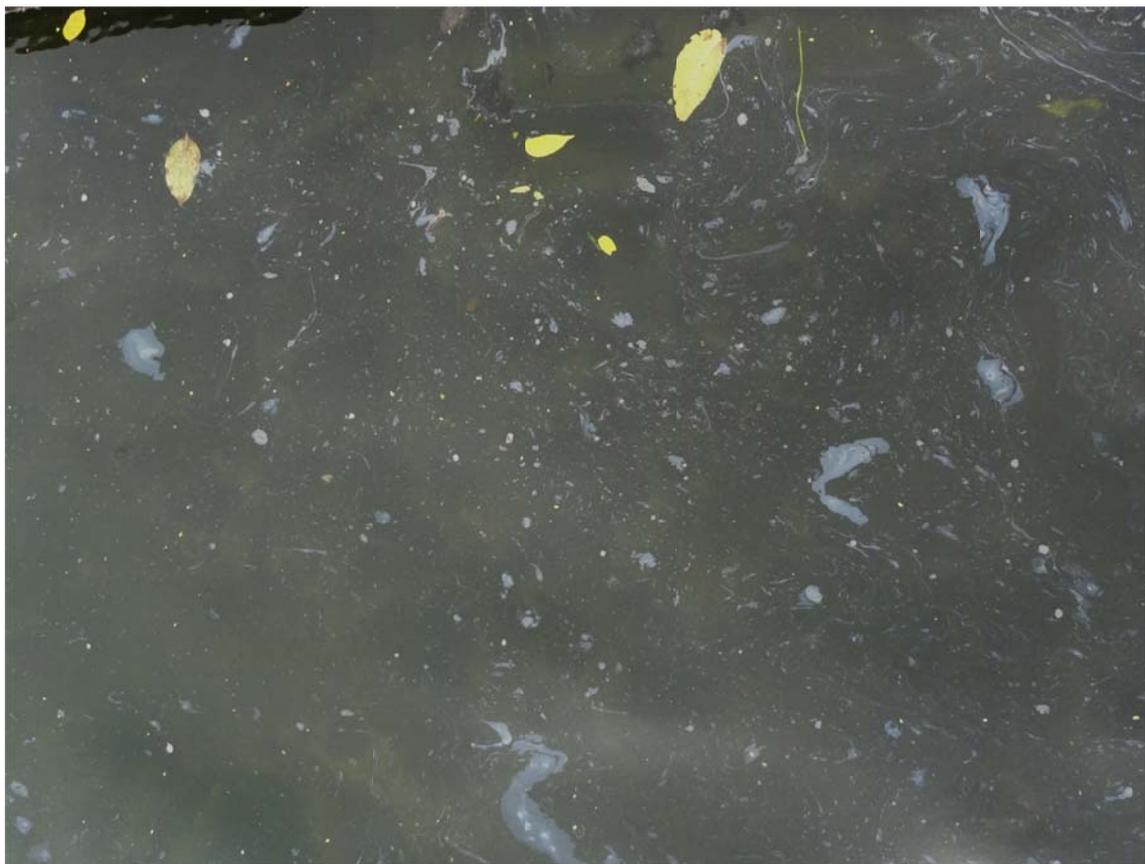
23. Morrow Lake Delta sheen observed collecting along Gate C.
